SUMMARY OF REVEGETATION WORK ON DREDGED MATERIAL SITES
IN THE ST. PAUL DISTRICT, CORPS OF ENGINEERS

Robert Anfang, St. Paul District, Corps of Engineers

Gary Wege, St. Paul Field Office, U.S. Fish and Wildlife Service

May 1989

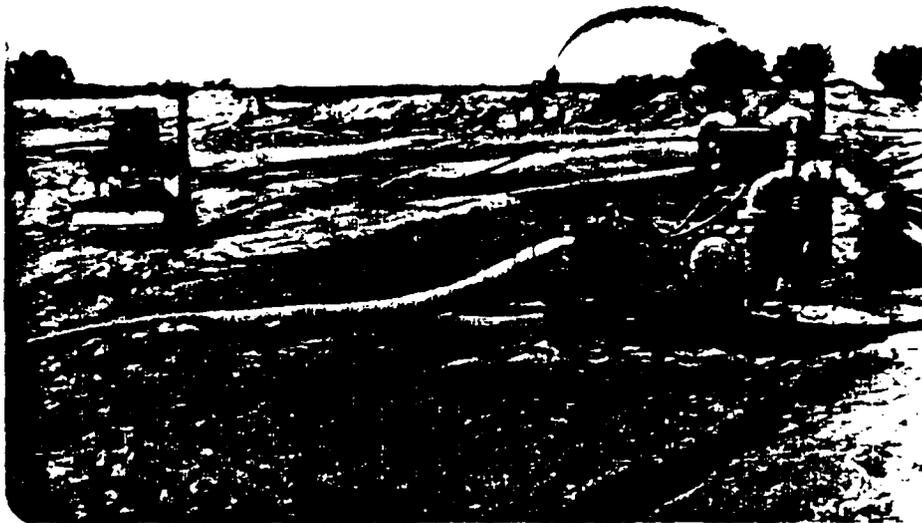
Chopper pump with sprinkler in background.

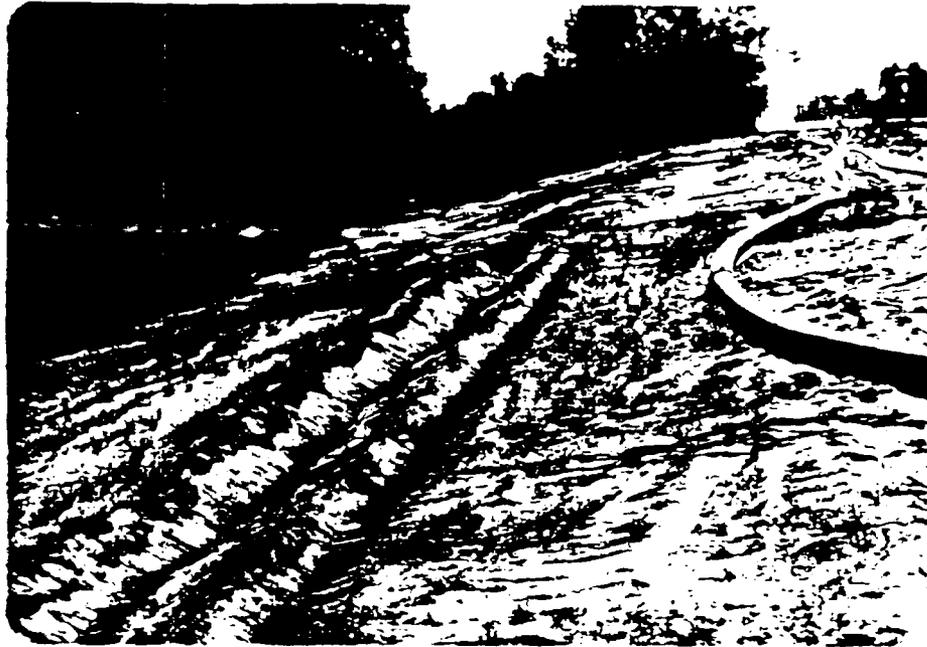
Side slope with and without furoughs created by bulldozer blade.

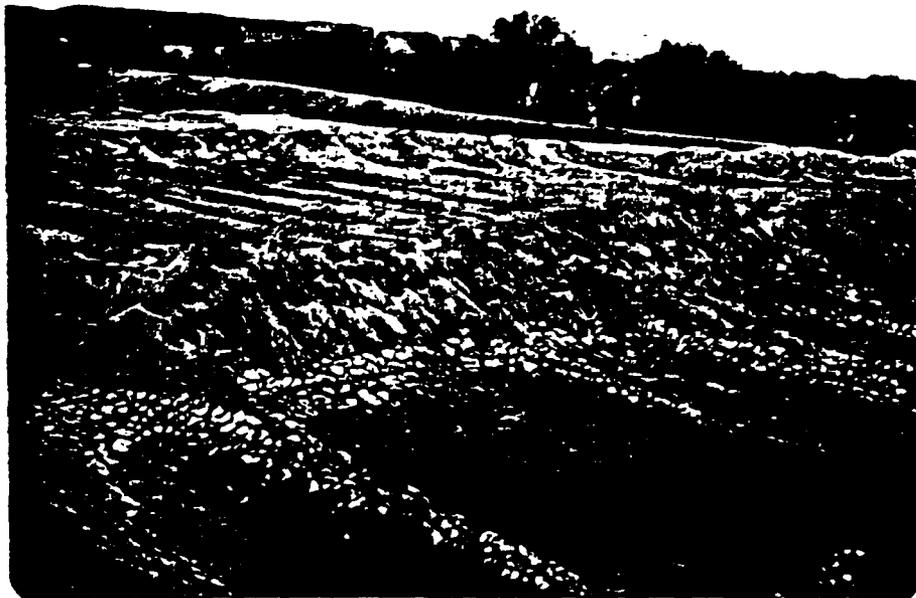
Partially dried organic sediment behind low-head berms.

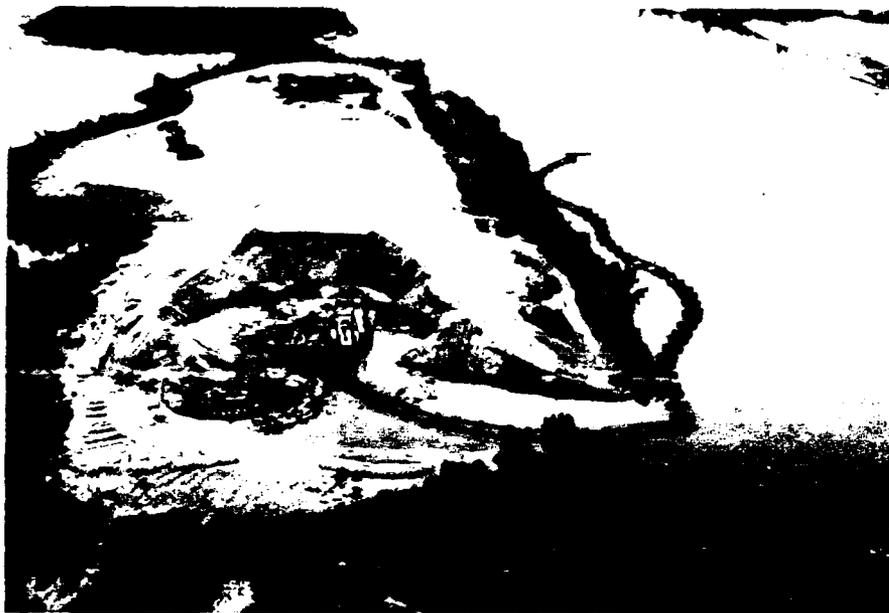
Figure 1. Removing material from Lost Island in 1986 to create islands in Weaver Bottoms. Seeded area on right side slope of island.

During 1986, dredged material was placed in the confined disposal area

at Lost Island, and some of the seeded area was affected by construction equipment. In these areas, the seeded species were destroyed and the successional process was set back to year 1. Winged pigweed and clammyweed were the only species found on these disturbed sites.

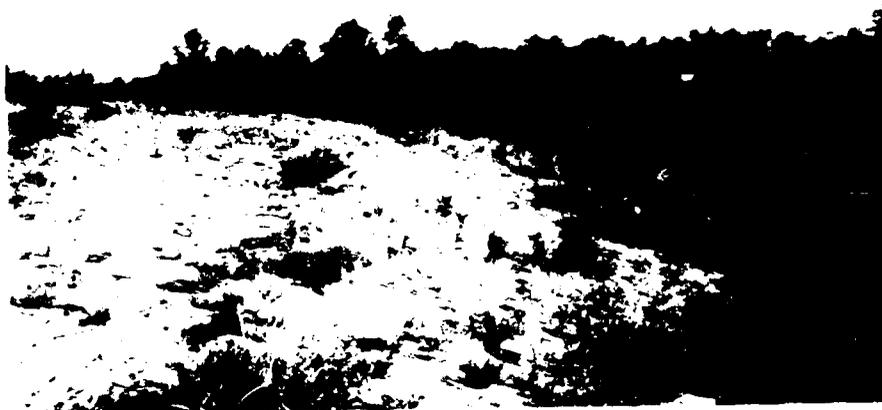
Figure 2. Lost Island control area in 1948. Short grasses and weedy species predominate.

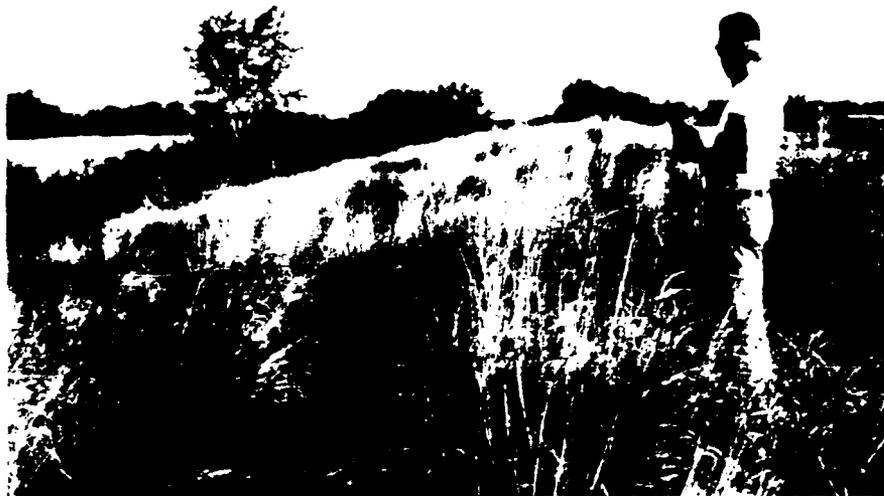
Figure 5. Crosby Island seed area in August 1986. The island is covered with beachgrass and the seeded area is on the left side of the island.

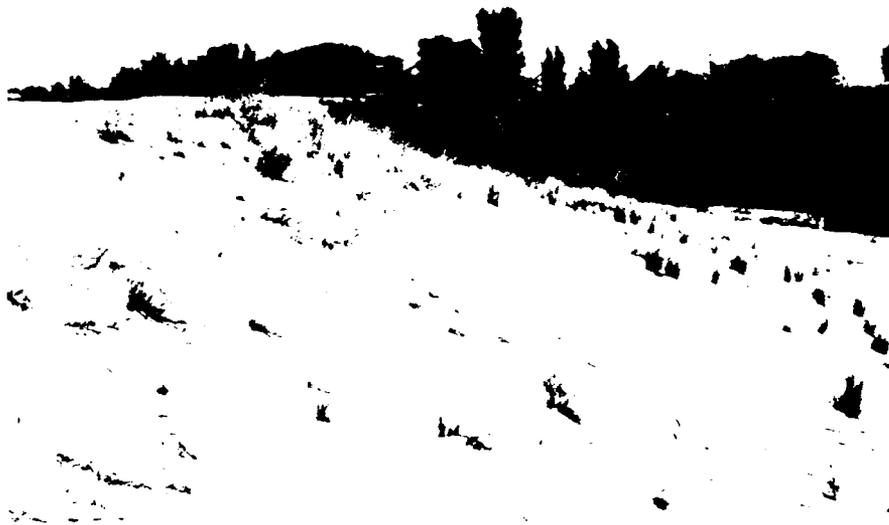
Figure 8. In August of 1995 Canada wild rye was growing on the silted area at Crosby Island.

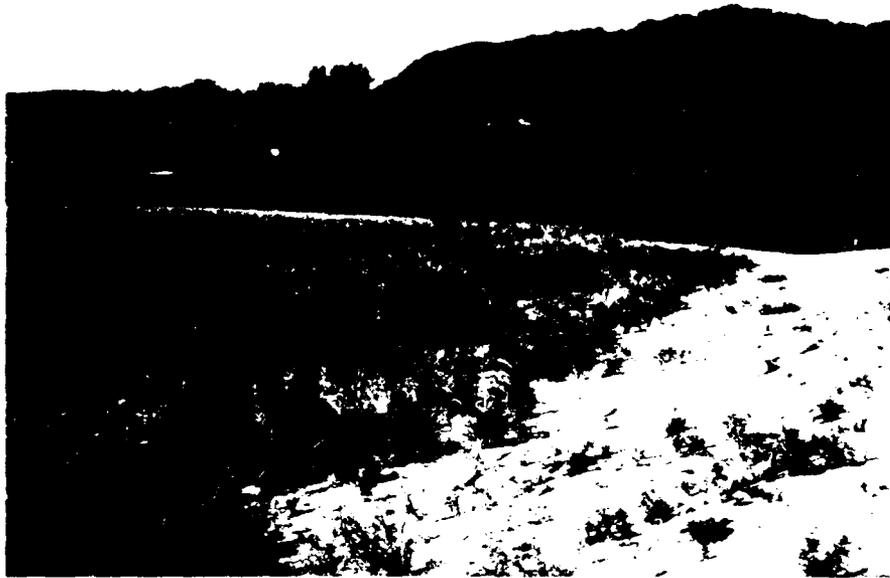
Figure 9. Beachgrass plantings at Crosby Island in August of 1947. A portion of area burned in lower left corner recovered the next year.

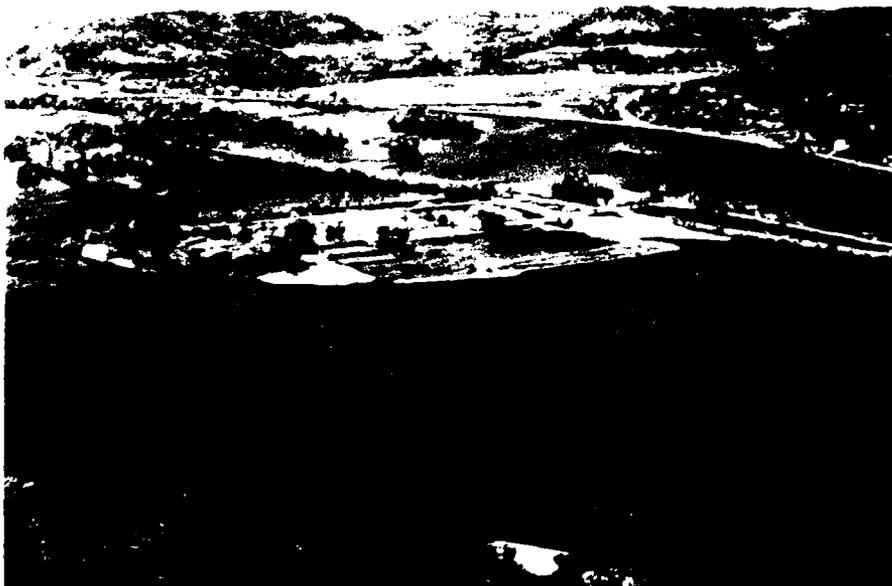
Figure 12. Beneficial use of dredged material at the Alma Marina in 1986.

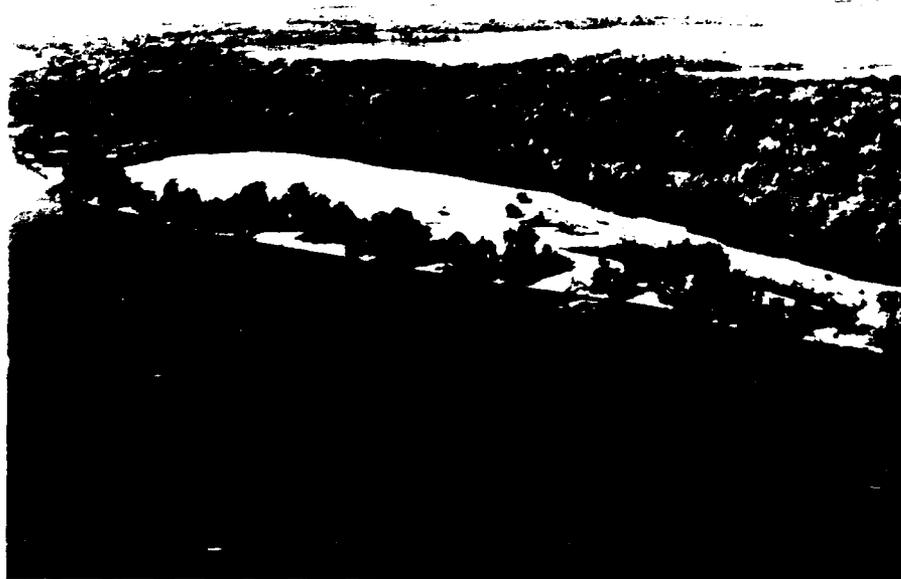
Figure 14. Aerial view of Teepeeota Point in 1986. Fine material was dredged from the open water area in back of the island.

From 8 August to 13 September 1984, fine material was dredged from a backwater area near the island using a Mud Cat and pumped onto the site through an 8-inch pipe. The first method of placement involved cutting holes in the pipe to allow the fine material to escape, but this caused erosion of the side slopes of the disposal site. The next method involved excavating pits and pumping the fine material into them but they soon overflowed and also eroded. The final method used an irrigation sprayer which was dead-headed to a bulldozer and automatically retrieved from up to 600 feet away using a winch. This procedure allowed the fine material to dry slightly and the water to soak away or run off between applications of the fine material. This method appeared to be working and capable of applying an adequate amount of fine material. However, the contract was beginning to expire and it was not possible to apply more than about 1/4 inch of fine material over the area. Overflow from the dredge was pumped into the bottom of the disposal site where it accumulated to a thickness of at least 6 inches. No vegetation seeding was conducted at Teepeeota Point.

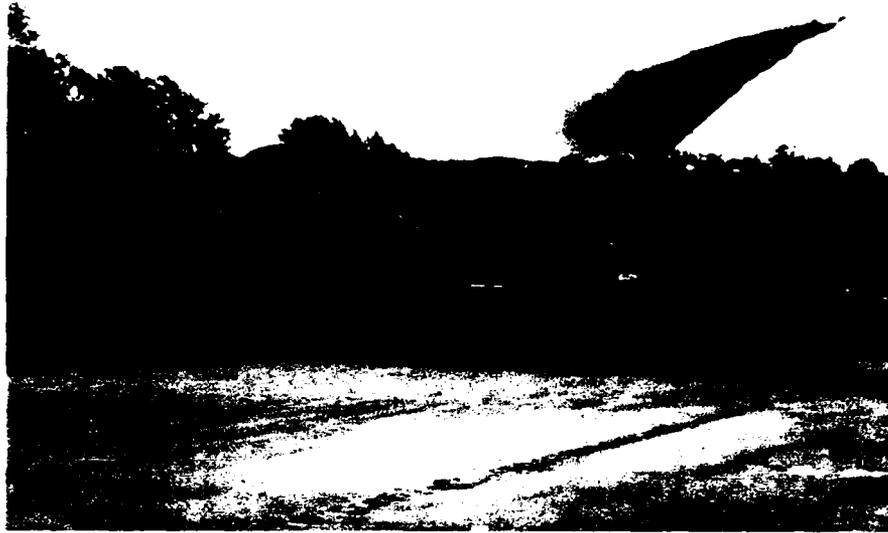
Figure 15. Using an irrigation sprayer to place fine material on Teepeeota Point in August of 1984.

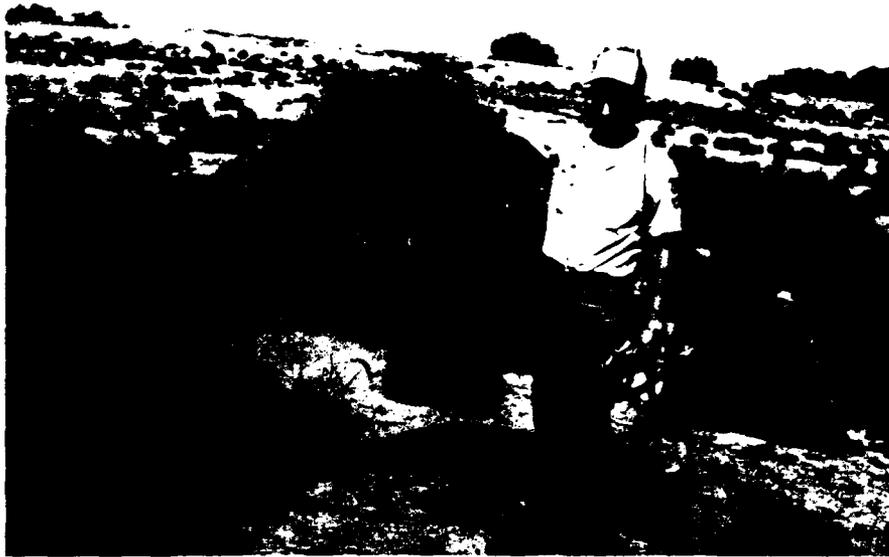
Figure 17. Winged pigweed in the bottom of the disposal area at Teepeeota Point area attained large size.

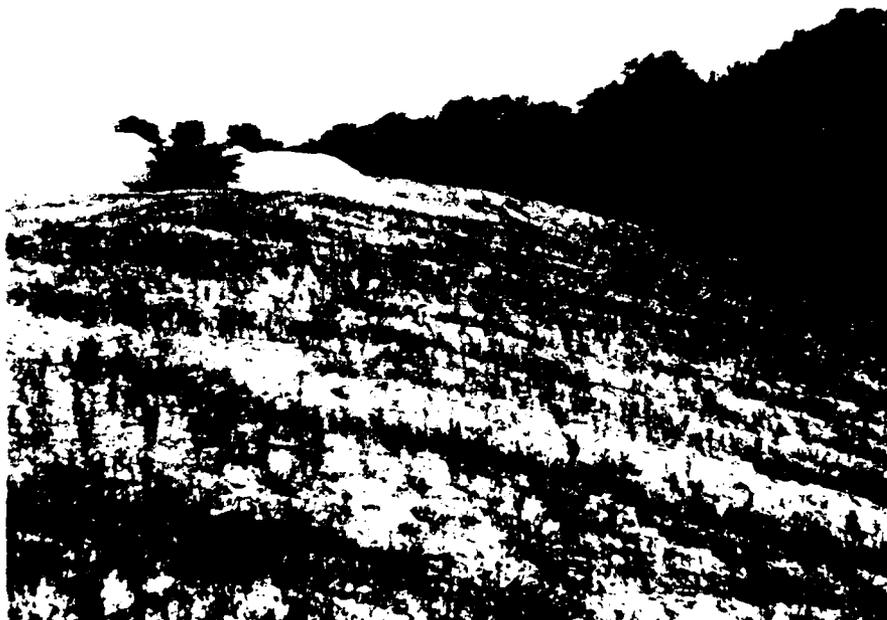
Figure 18. The sprayed area at Teepeeota Point had a cover of 13 percent in August of 1988.

<u>Area</u>	<u>Aug. 1985</u>	<u>Aug. 1986</u>	<u>Aug. 1987</u>	<u>Aug. 1988</u>
Fine Sediment	20.5	19.6	16.5	13.6
Control	3.5	7.5	9.6	0.4

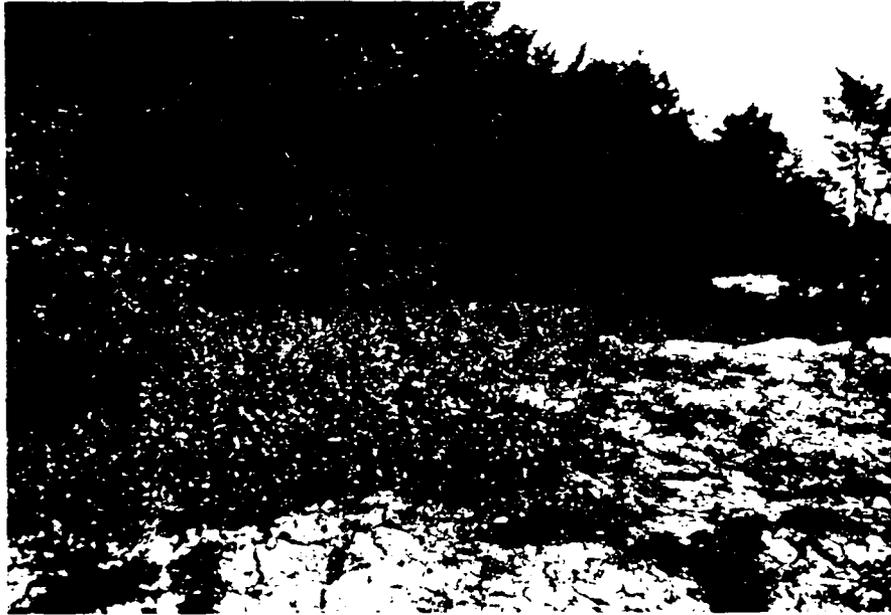
Figure 19. Island 58 in August of 1985 soon after spreading the material. Cottonwood sprouts were just starting to appear.

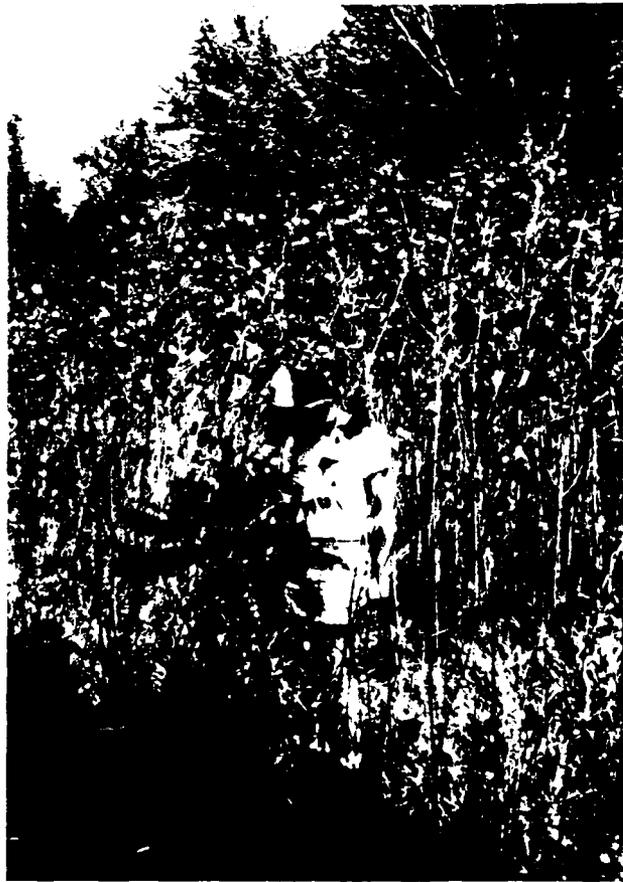
Figure 20. In 1988 the cottonwood at island 58 was over 10 feet tall. Grass species are not common.

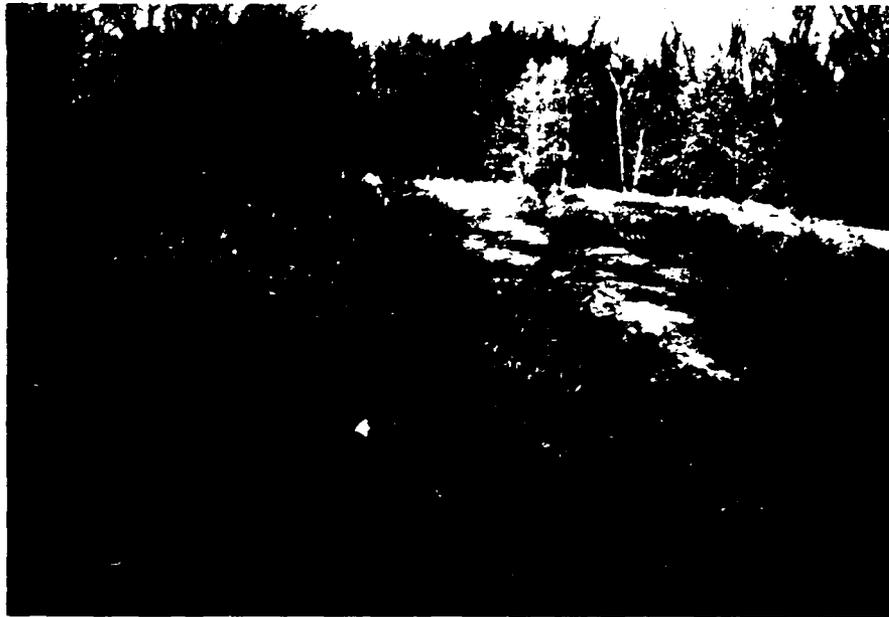
Figure 21. Fine material at Jackson Island was mostly vegetated by weeds and grasses in 1984.

In late May 1984, fine sediment from the auxiliary lock at Lock and Dam No. 9 was placed on a 1-acre site on Jackson Island at river mile 644.5. The sediment contained a high amount of clay and dried to produce a very hard and cracked surface. The area was seeded with the following mixture, but it could not be incorporated into the soil. A bulldozer ran over the area after seeding. Corps and Service employees were used to conduct the seeding operation, which cost approximately \$200 for the seed.

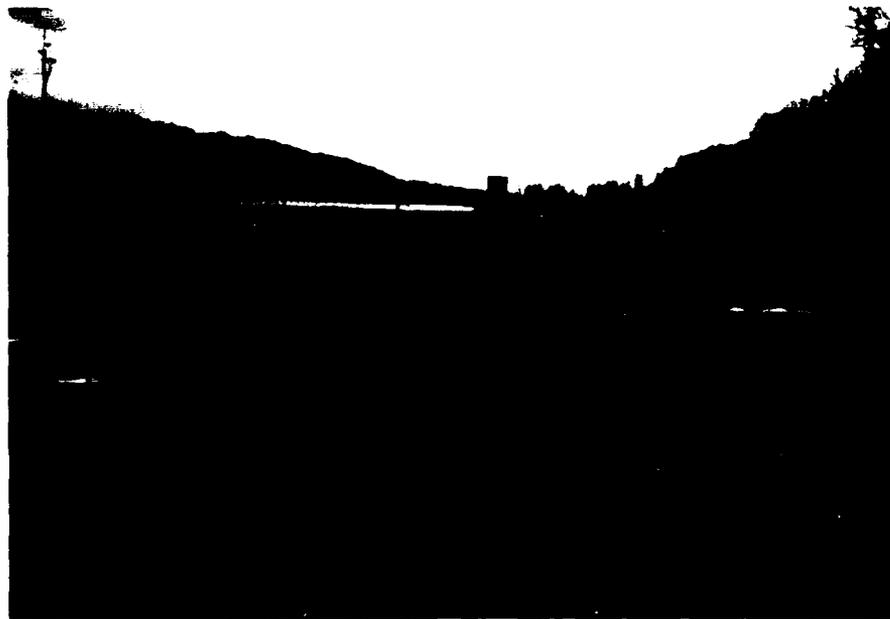
Figure 24. Minneapolis Park Beaches about 1 month after seeding. Heavy use has prevented good establishment.

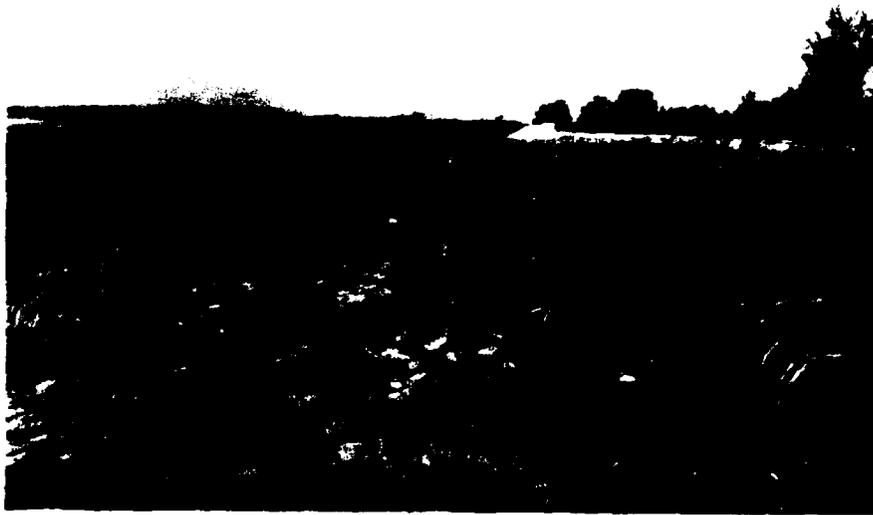
Figure 26. MN 10 in August of 1988. Winged pigweed predominates the control area.

Species found on MN 10 are shown below.

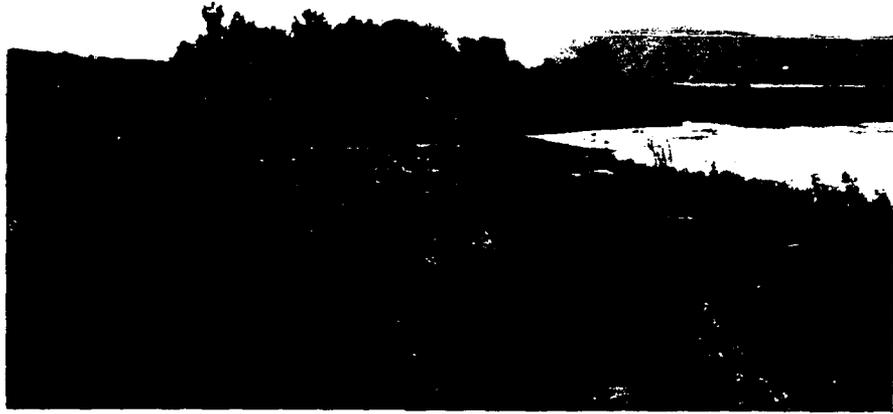
Figure 27. Switchgrass was drill seeded on MN 11 in 1991.

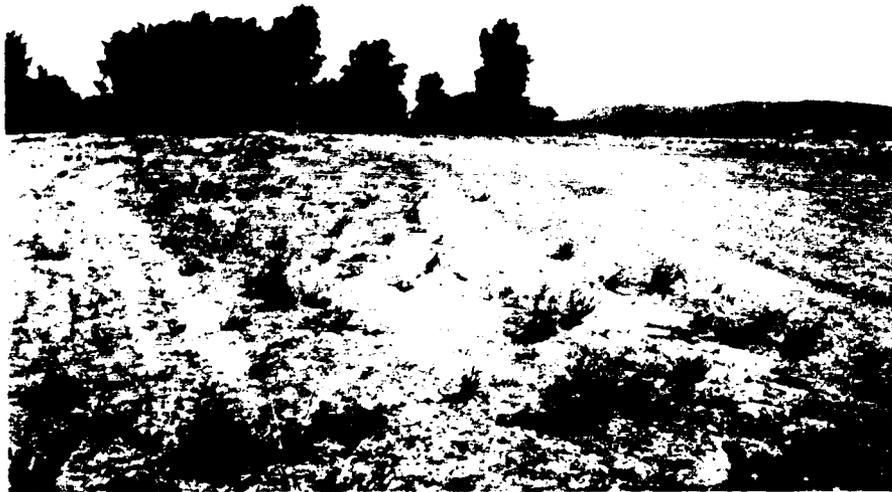
Figure 28. Fine material was not placed on MN 12. Sand dropseed was drill seeded in 1988.

Closure MN 12 was seeded with sand dropseed. Sand dropseed was growing on the site but this could also be natural regrowth. Some winged pigweed was also present. Most of the beachgrass sprigs were brown and do not appear to be very vigorous, but they could come back next year from the roots as was the case at Crosby Island. The beachgrass should have been planted in middle to late May, but this was not possible due to contracting problems. The drought of 1988 could also be the cause of some of the poor condition.

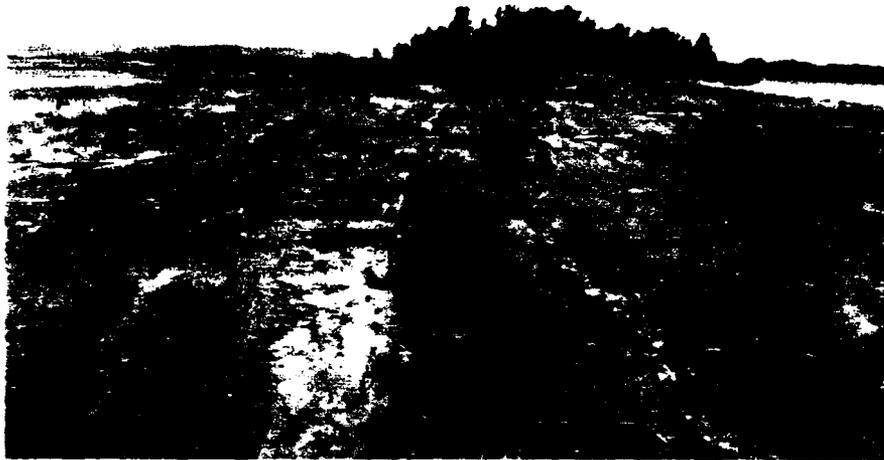
Figure 29. Fine material was placed on MN 13 and drill seeded in 1988.

The wet zone of closure MN 13 was planted with rice cutgrass sprigs. The sprigs are only about 3 inches tall when planted and could not be found during the 1988 sampling. There is some naturally occurring rice cutgrass in the area. Many of the grasses were too immature to identify. Some of the species present in 1988 included:

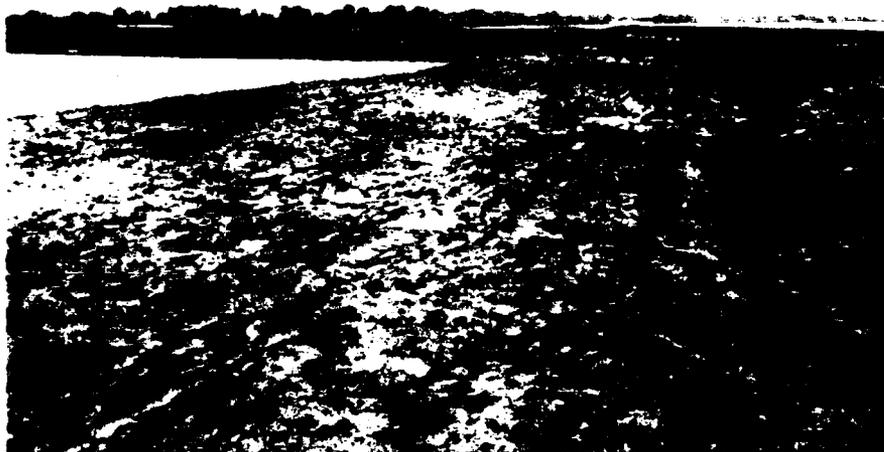
Figure 30. Fine material was spread on Mallard Island in July of 1988. The island was not seeded and is used as a control site.

Both Swan and Mallard Islands had about 6 inches of fine material placed on top of the sand. The fine sediment was incorporated with the sand using a disk or bulldozer. Due to the thickness of the fine material the disk did not mix the fine material with the sand to a great degree and resulted in a silt/clay surface soil (Swan Island). Using a bulldozer with the blade slightly tilted and making several passes over the surface resulted in better incorporation and a coarser soil texture, which may result in better soil aeration and growing conditions (Mallard Island and the side channel closures). Mallard Island was used as a control and did not receive any further treatment. The incorporation of fine material on Mallard Island was completed in July 1988. Swan Island was drill seeded with the following species, and the side slopes were mulched with 1 ton/acre of hay and anchored using a disk.
