Enhanced Preliminary Assessment Report:

Rural Ridge Army Housing Units Rural Ridge, Pennsylvania

October 1989

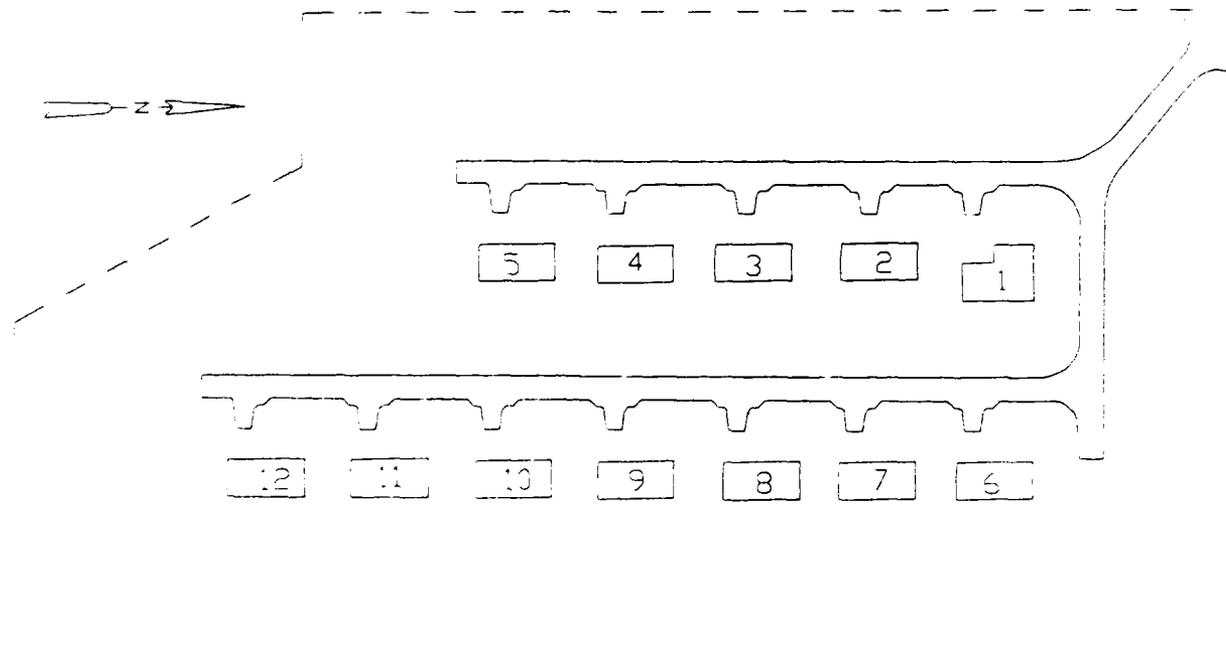
FIGURE 3 Site Plan Map of Rural Ridge Army Housing Units

Figure 3 presents the site plan of the housing property.

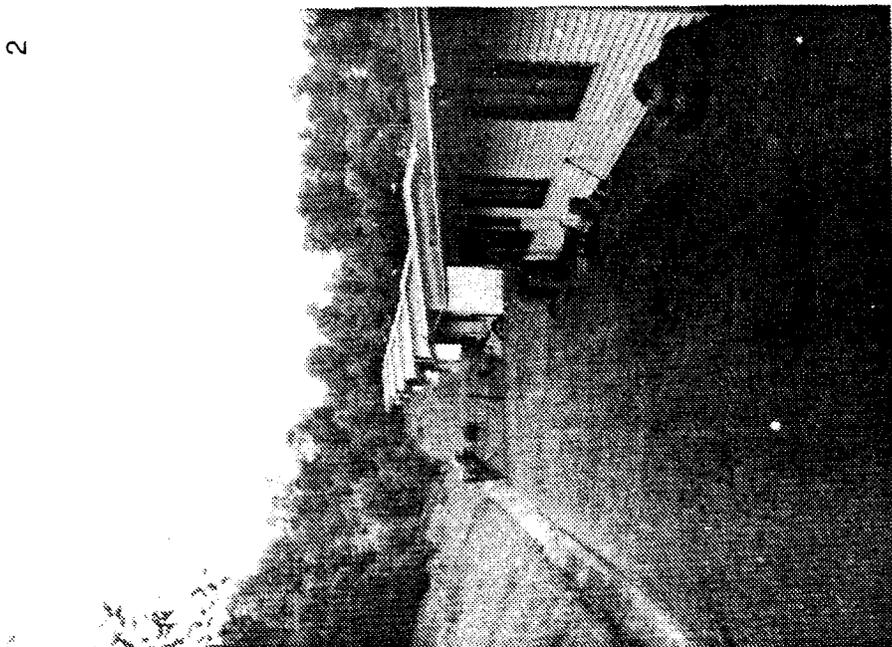
2

1. A row of houses on upper level of housing area at Rural Ridge; a similar row is located at a lower level.
2. A view from the backside of the upper-level row of houses; an open storm drain (seen as a clear gully) runs from the bottom left towards the center of this view.
3. Play area for children, across the street from the houses.
4. A church yard and cemetery at the north end of the housing area; another church yard at the south end is not shown.
5. An electrical transformer mounted at the top of a utility pole; area's transformers are the property of the U.S. Government.
