The Effect of Phosphate Coatings on Fatigue Crack Initiation in Quenched and Tempered Low Alloy Steel

R.A. Farrara* and J.C. Ritter

MRL Technical Report
MRL-TR-90-14

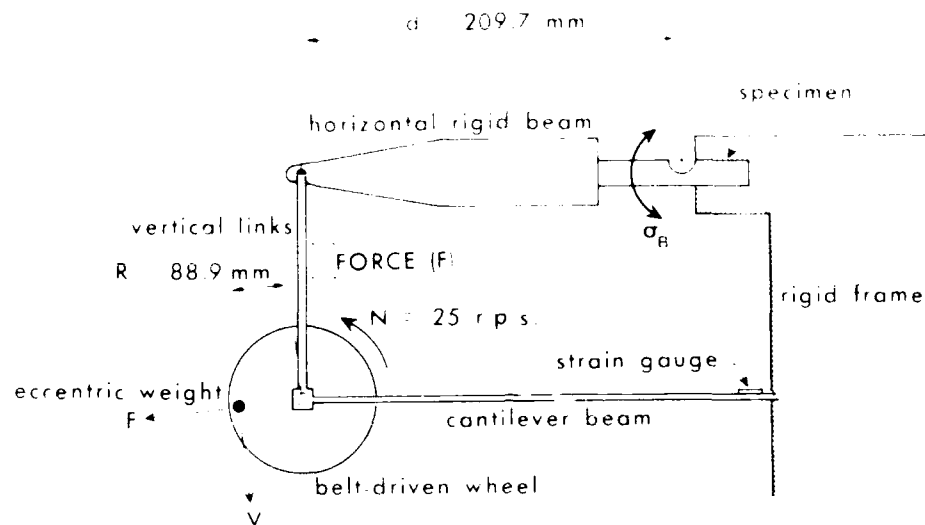
Figure 2: Schematic Diagram of Testing Machine.

The specimens were subjected to constant amplitude fatigue testing, using completely reversed ($R = -1$) bending moments at 25 Hz in a cantilever fatigue machine designed by the National Physical Laboratory in Teddington, England. The bending moment is determined by the amount of eccentrically located mass attached to a wheel that is belt driven by a synchronous motor rotating at 25 Hz (1500 rpm). Sinusoidal motion of the wheel is transmitted to the free end of the cantilevered specimen through vertical links attached to the spindle and a horizontal arm that contains one end of the specimen. The other end of the specimen is clamped rigidly. A schematic diagram of this specimen loading arrangement is shown in Figure 2 and the equations for calculating the bending stress are given in Appendix 1.

The machine is instrumented with strain gauges (full bridge configuration) attached to two of the cantilever bars [2]. The strain gauge bridge is energized by a regulated 6 V DC power supply, and the sinusoidal movement of the cantilever bars creates an AC voltage output that is amplified (gain of 100) and displayed on a millivoltmeter calibrated in RMS voltage levels. The peak voltage signal is monitored continuously and is used as a trigger to shut down the machine when the output peak reaches a pre-set level, usually set at 50 mV above the value displayed for an uncracked specimen. This shut-down device provides a simple and moderately reproducible control of final crack depth, usually of the order of 0.1-0.2 mm crack growth. Thus the criterion for failure requires that, after a crack is initiated, crack growth occurs rapidly so that the total number of cycles to failure is approximately the same as the number of cycles to initiate the crack.

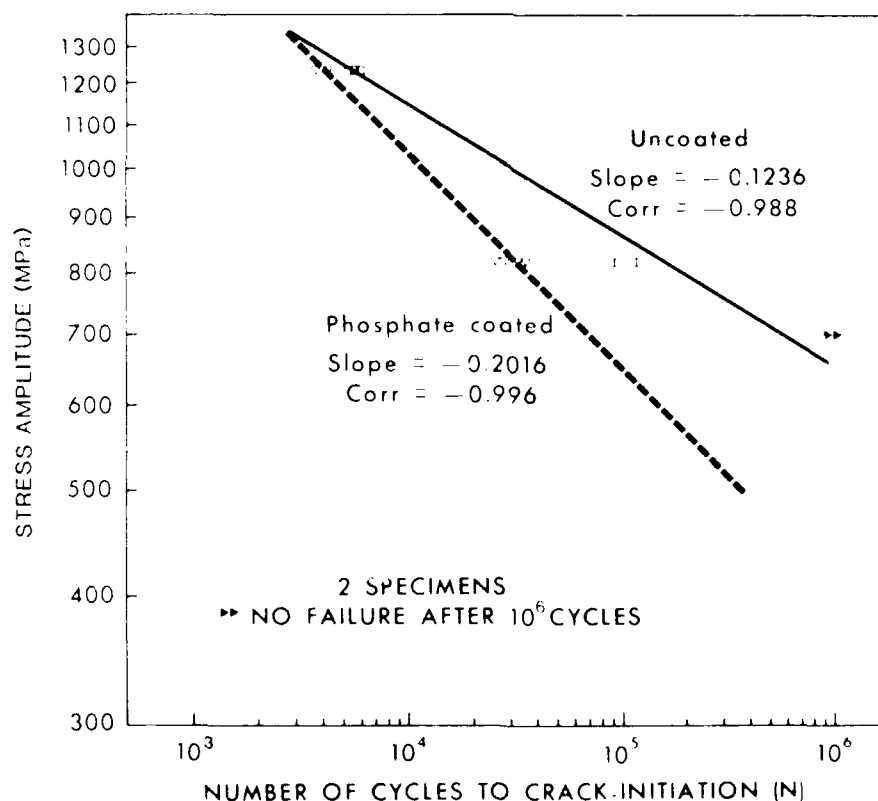
Figure 3: Fatigue Test Results - Phosphate Coated v Uncoated. Open square symbols refer to uncoated test specimens, open triangles refer to phosphate coated. $R = -1$ in all tests.

The data are plotted in Figure 3 as the \log_{10} of applied tensile stress (σ_p) versus $\log_{10}N$. Best fit straight lines, using a least square method through the data points, provide the following linear equations:

At values of stress above the cross-over point of the curves in Figure 3 (1360 MPa and 2745 cycles) the phosphate coatings have no effect on fatigue life. However, this level of stress is considerably above the yield strength of the steel and significant plastic straining of the surface region would be expected during cyclic loading.

The increasing effect of the phosphating as the cyclic stress is reduced provides an insight into the basic cause of the deleterious effect on crack initiation. Figure 3 shows that small changes in the stress level result in large changes in fatigue life if the stress level is low, i.e. near the endurance limit, but small changes in stress result in small changes in life if the stress level is high, i.e. significantly above the endurance limit. A similar case is available in the literature, on notch effects [3], where comparison of the fatigue lives for notched and unnotched specimens of mild steel reveals a similarly large difference in life for the two specimens at a low nominal stress level, diminishing to a negligible difference in life at very high stress level (approaching UTS). This was attributed to the effective notch factor being close to the elastic stress concentration factor at low stress (and long cyclic life). As the nominal stress increased, the effective notch factor shifted closer to unity, reaching unity at the UTS when the life was one quarter cycle. That is, the notched fatigue strength approached the unnotched.

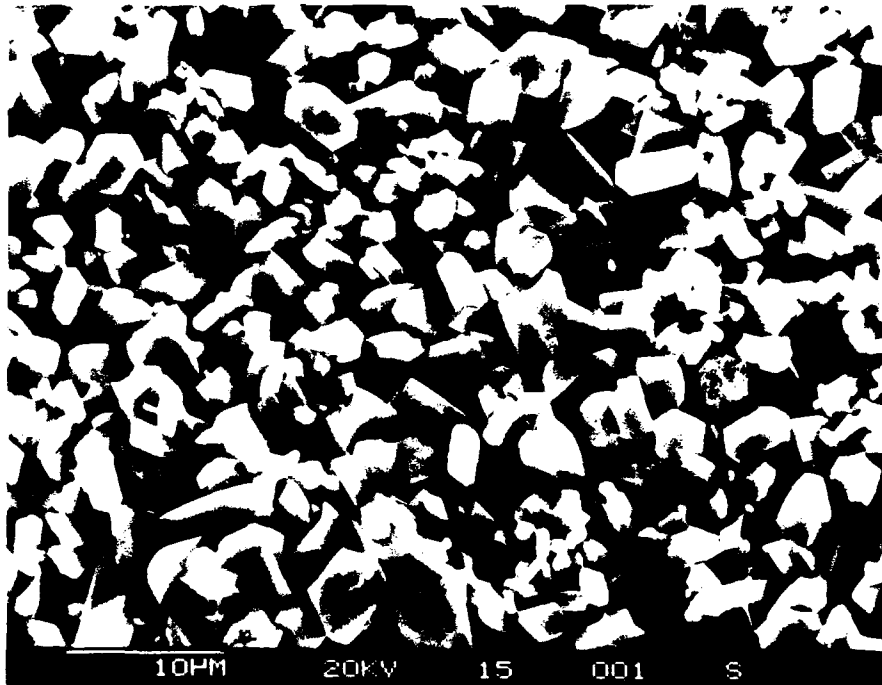
A. Detail of coating morphology. SEM X2000

Figure 5A shows the blocky crystalline morphology of the manganese phosphate coating, while Figure 5B shows fatigue crack initiation below this coating. Figure 6A shows the stripped surface, while Figure 6B gives a metallographic section revealing deep pits and crevices compared with the as-reamed surface (Fig. 4A). Figure 7A shows the distinctive platelet morphology of the zinc phosphate coating, while Figure 7B shows fatigue crack initiation. Figure 8A shows the stripped surface, and Figure 8B is a metallographic section showing surface pitting not so severe as beneath the manganese phosphate, and only partially obscuring the machining grooves.

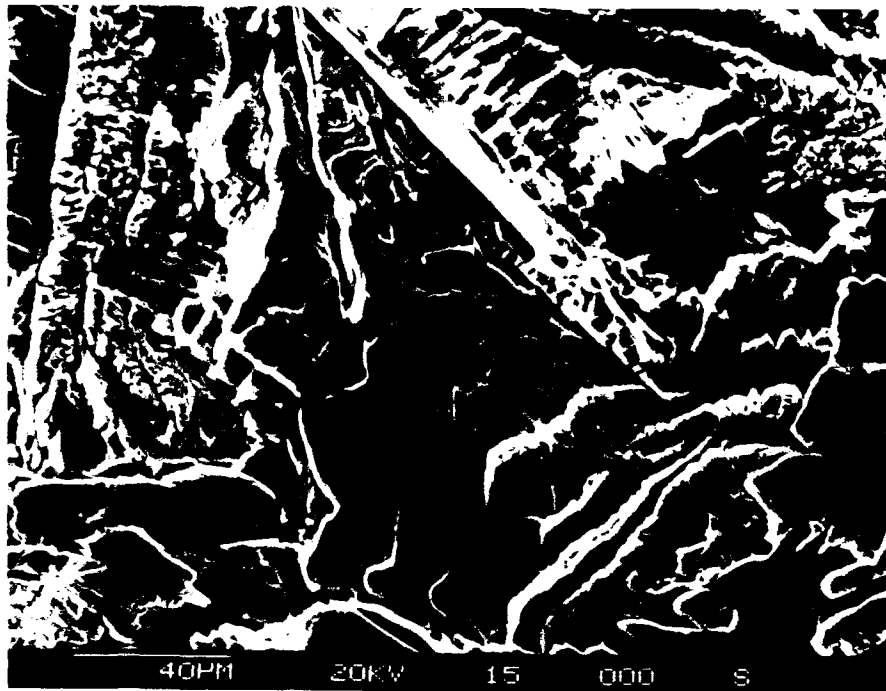
A. Detail of coating morphology. SEM X500
