13. Abstract (Maximum 200 words). Copper and nickel seawater piping systems were severely pitted after exposure to marine and estuarine waters. Surfaces were uniformly covered with thick deposits, ranging in color from blue-green to reddish-brown to black. Pits developed under surface deposits containing 10^6 - 10^5 cm^{-2} sulfate-reducing bacteria in association with other bacteria. Pits were irregular in shape, lacking a consistent morphology. The observed corrosion was attributed to the presence and activities of microorganisms that resulted in differential aeration cells, large cathode:anode surface ratios, concentration of chlorides, development of acidity within pits, and reactions of the base metals with microbologically produced sulfides. Chlorine and sulfur reacted selectively with iron and nickel in the alloys, leaving copper-rich spongy pit interiors.

Microbiologically Influenced Corrosion in Copper and Nickel Seawater Piping Systems

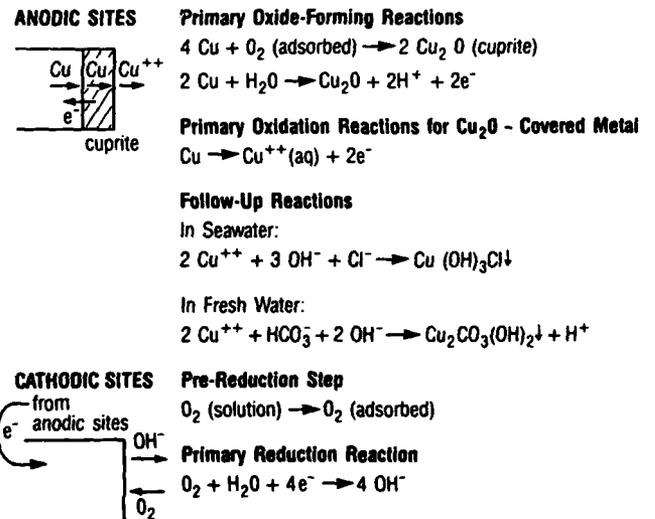
Figure 1. Typical cathodic and anodic reactions on copper alloys in oxygenated seawater and fresh water.

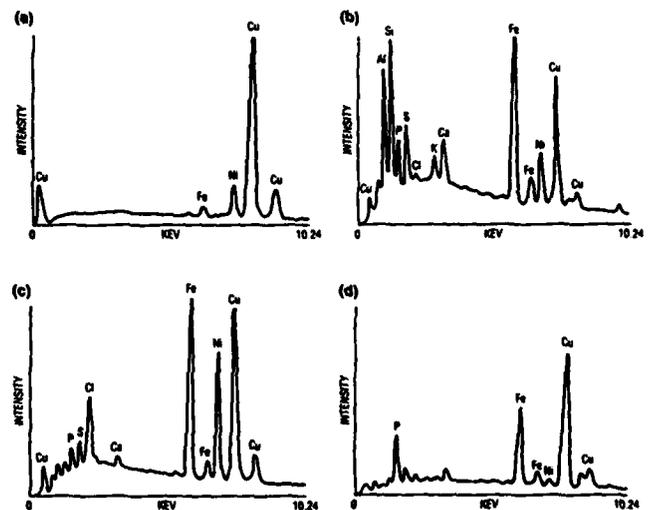
Figure 4. (a) EDAX spectrum of clean copper alloy before exposure (b) EDAX spectrum of pitted region of copper alloy, showing accumulation of aluminum, silicon, phosphorus, sulfur, calcium and elevated amounts of iron and nickel. (c) EDAX spectrum of pitted region of copper alloy, showing the accumulation of chlorine and elevated amounts of iron and nickel. (d) EDAX spectrum of spongy material beneath bacteria, showing an accumulation of phosphorus, an enrichment of iron and a depletion of nickel in the base of the pit.

EDAX spectra for the pitted copper alloy indicate that nickel had been selectively removed from the alloy in the presence of sulfate-reducing bacteria. Verink and Pourbaix (1971) and Efirid (1970) reported denickelification of Cu/Ni alloys associated with occluded cells in salt solutions where lowering of the pH had taken place. A detailed discussion of the mechanisms for selective attack and dealloying has been addressed by Shreir (1977b).

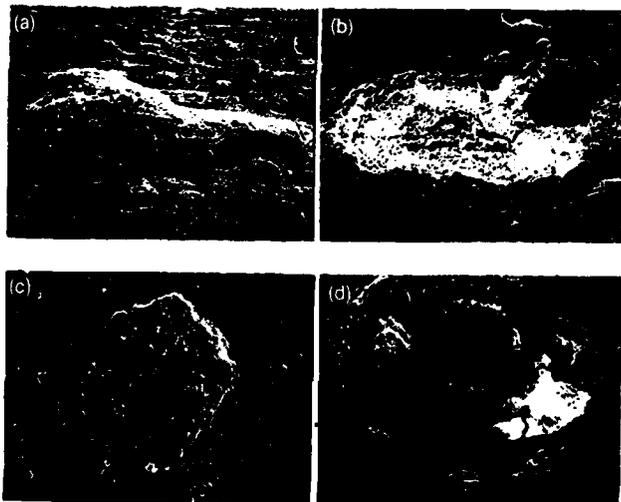
Figure 6. (a) and (c) Blisters on the surface of nickel tube. (b) and (d) Pits in nickel tube.

The microbiologically influenced corrosion of nickel reported in this paper was characterized by the formation of blisters and pits containing sulfate-reducing bacteria. Differential aeration cells appear to have been formed, with low oxygen concentration immediately underneath the deposits. This created an environment for the growth and activities of sulfate-reducing bacteria. The surface area under the deposit became anodic and corroded while the electrons that were generated reacted at the cathodic region of high oxygen concentration. Chlorine and sulfur accumulated within the region of the pit and reacted with the iron and nickel in the alloy. Nickel had been selectively removed from the alloy, leaving a spongy copper-rich material in the base of the pit.

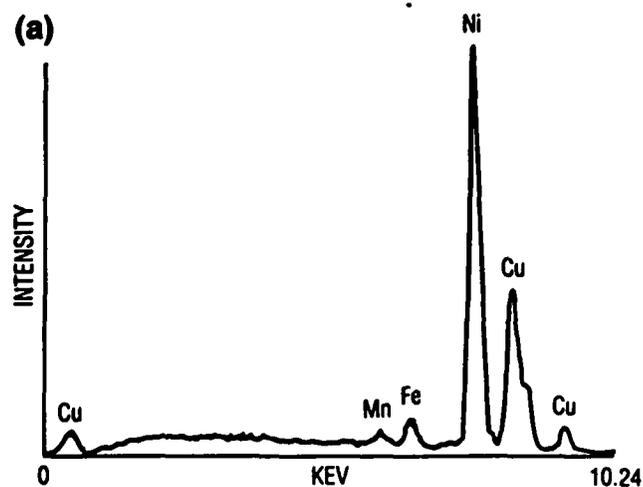
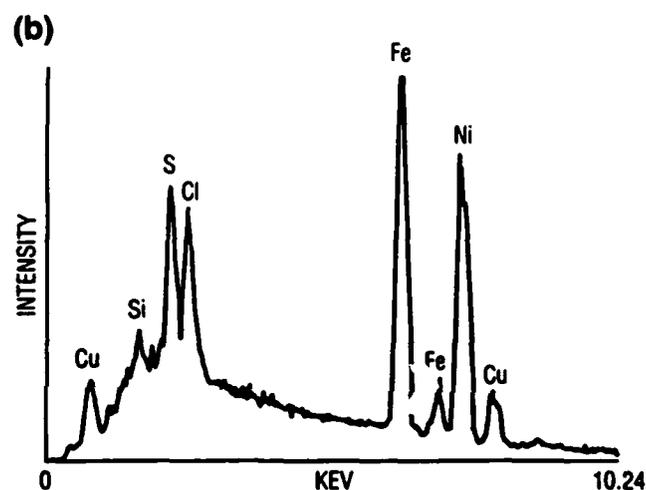
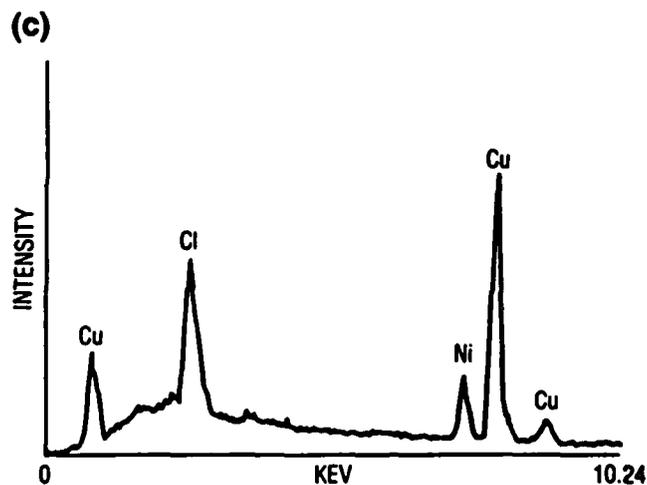
Figure 7. (a) EDAX spectrum of unexposed nickel alloy. (b) EDAX spectrum of nickel alloy after exposure to estuarine water for six months showing accumulations of silicon, sulfur, and chlorine with elevated concentrations of iron and nickel. (c) EDAX spectrum of the residual metal in the base of the pit showing nickel depletion and copper enrichment.

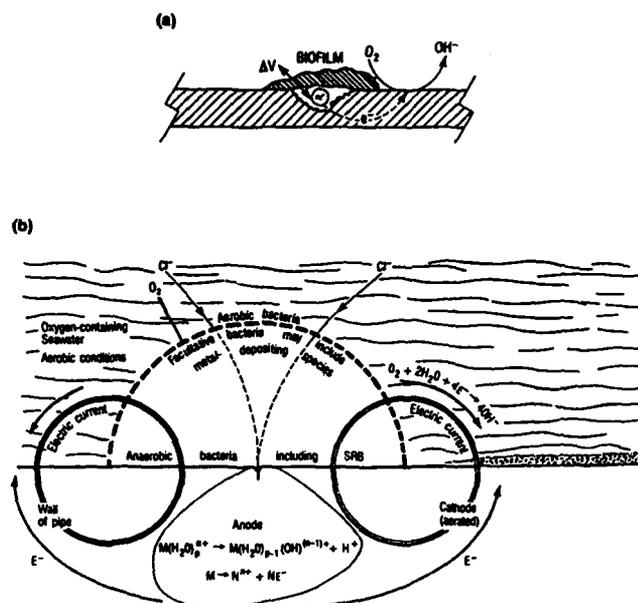
Pitting in predominantly copper alloys has been attributed to under-deposit attack (Figure 8a). Under-deposit corrosion is extremely important for these alloys because it initiates a series of events that are individually or collectively extremely corrosive (Shreir, 1977). Dead barnacles, dirt, debris or microbiological colonies accumulating on the surface result in the formation of differential aeration cells (Figure 8b). In an oxygenated environment, such as unpolluted natural seawater, the area immediately under the deposit becomes deprived of oxygen. That area becomes a relatively small anode compared to the large surrounding oxygenated cathode. Cathodic reduction of oxygen may result in an increase in pH of the solution in the vicinity of the metal. At the anodic site the metal will form metal cations. If the metal hydroxide is the thermodynamically stable phase in the solution, the metal ions will be hydrolyzed by water with the formation of H^+ ions. If the cathodic and anodic sites are separated from one another, the pH at the anode will decrease and that at the cathode will increase. Cl^- from the electrolyte will migrate to the anode to neutralize any buildup of charge (Hoar, 1947). The low solubility of copper chlorides and hydroxychlorides maintains

Figure 8. (a) Differential aeration cell formed by microbial colonies. (b) Detailed reactions resulting from the formation of a differential aeration cell.

Schumacher (1979) reported that predominantly nickel alloys were susceptible to under-deposit corrosion and oxygen concentration cells (Figure 8 a,b). Gouda et al. (1990) demonstrated pitting of nickel/copper tubes

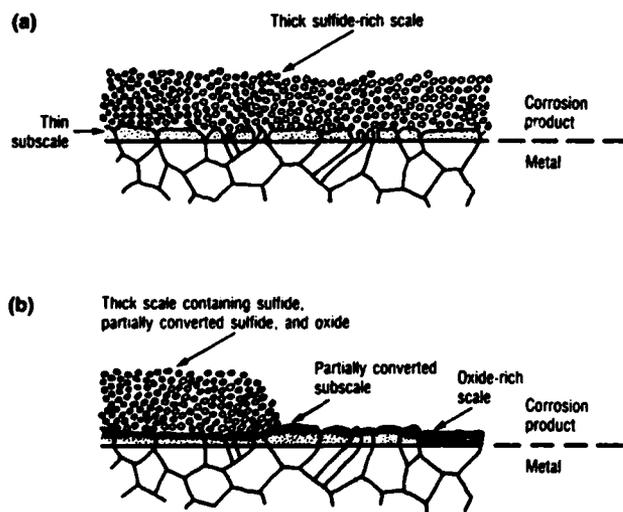
Figure 9. (a) Schematic of thick sulfide-rich scale forming on copper alloy (Taken from Syrett, 1980 with permission). (b) Schematic showing disruption of sulfide-rich film on copper alloy by the introduction of aerated seawater (Taken from Syrett, 1980 with permission).

ions. For these reasons turbulence-induced corrosion and sulfide attack of copper alloys cannot be decoupled easily. In the presence of oxygen, the possible corrosion reactions in a copper sulfide system are extremely complex because of the large number of stable copper sulfides (Ribbe, 1976), their differing electrical conductivities, and catalytic effects. Transformations between sulfides, or of sulfides to oxides, result in changes in volume that weaken the attachment scale and oxide subscale leading to spalling. Bared areas re-passivate, thus forming cuprous oxide (Figure 9b).
