USAFSAM-TR-90-24

**TESTING AND EVALUATION OF THE MEDICAL  
TECHNOLOGY PRODUCTS MODEL 1001a  
INFUSION PUMP**

December 1990

Final Report for Period November 1988 - April 1990

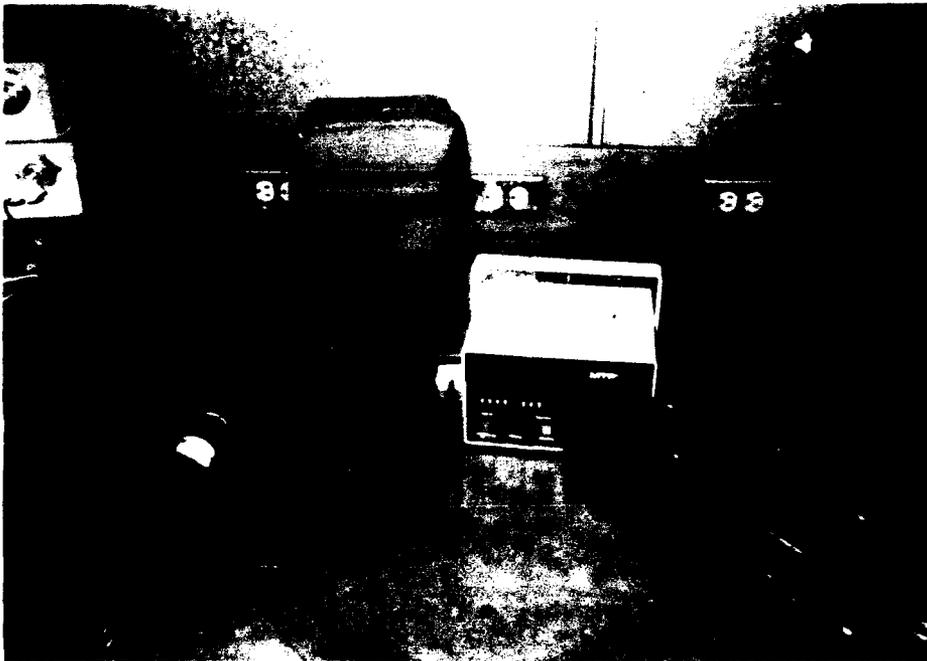
Figure 1. The MTP Model 1001a Infusion Pump.

The United States Air Force Military Airlift Command (MAC) directs and controls aeromedical evacuation missions for the USAF and most of the Department of Defense (DOD). There is often a critical need to monitor and control the rate of infusion of intravenous fluids being administered to patients. The aeromedical evacuation system, whose command and control is received from the 375th Military Airlift Wing (MAW) at Scott AFB IL, has primarily used the IMED Volumetric Infusion Pump, Model 928 for the past several years. At present, the Model 928 is no longer being manufactured. The MTP Model 1001a Infusion Pump, manufactured by Medical Technology Product Inc of Huntington NY, is the selected replacement (Fig. 1).

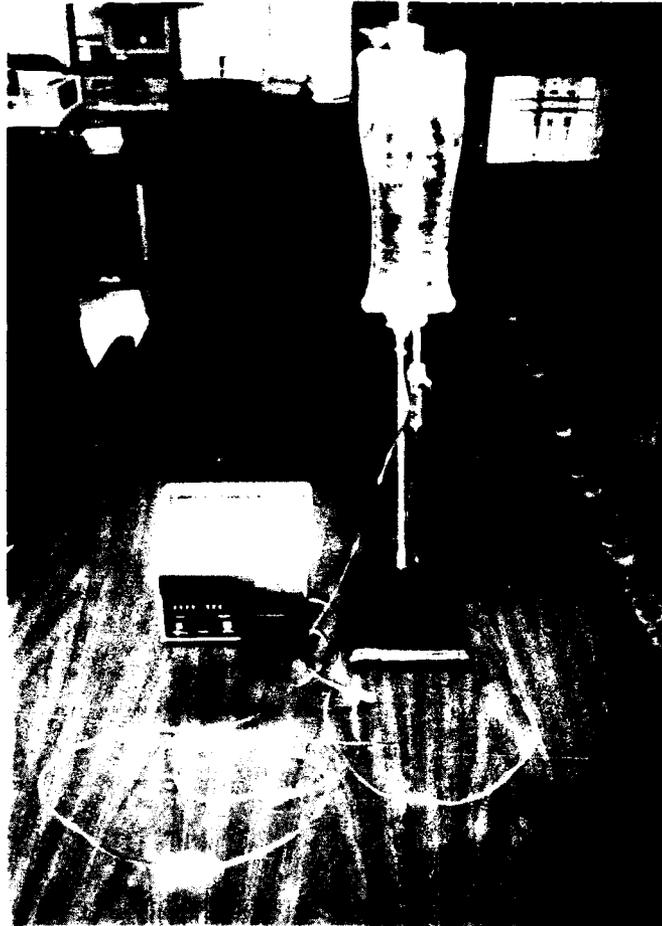
**Figure 2. Basic test setup.**

3. Test Setup: The basic test setup included an MTP IV set attached to an IV solution bag, installed and threaded through the MTP pump head assembly, with the patient end connected to an IV extension set (Fig. 2). The patient end of the extension set was looped and spiked into the same IV solution bag through the injection port. These components formed a continuous loop pathway for the IV solution to travel when the MTP was in operation. Specifically, the following components were used to assemble the basic test setup (Some tests required modified versions of the basic test setup. Those versions will be described in the appropriate sections.):

- a. Travenol Intravenous Solution, 0.9% Sodium Chloride, 1,000 ml.
- b. Medical Technology Products Inc Universal IV Standard Pump Set, Model 1200.
- c. Pharmaseal K52 Novex 3-Way Stopcock, With Extension Tube.

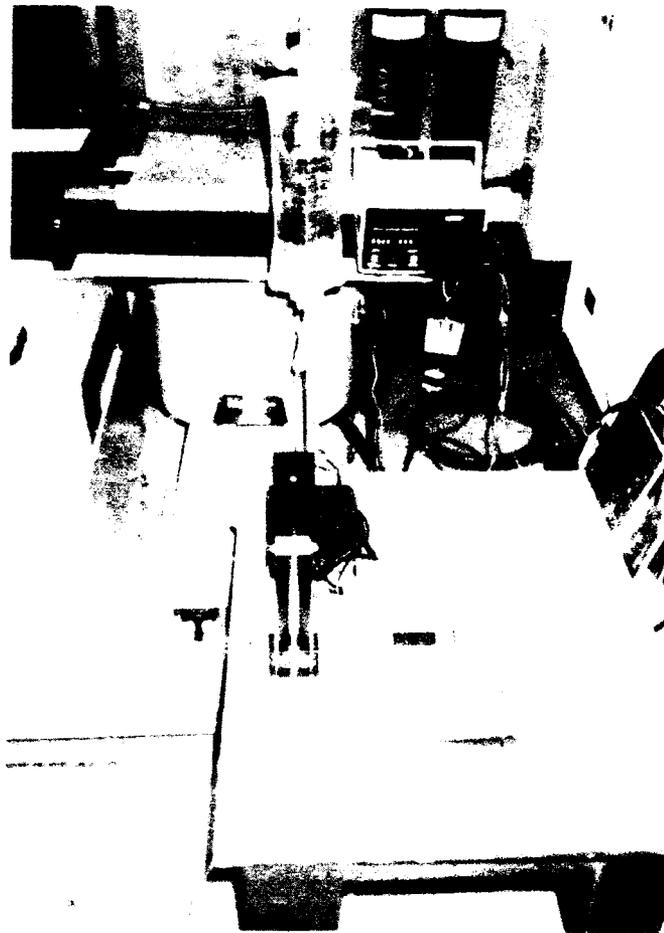
Figure 4. Vibration test setup.

4. Test Procedures: The console and table were operated by technicians from TSNB, who programmed the control console for five 15-min cycles, totaling 75 min, on each axis for the sinusoidal testing; and 30 min on each axis for the random testing. During the tests the unit was closely observed, and infusion rate checks were conducted every 15 min. All functions and alarms normally evaluated as part of the performance check were evaluated at least once.

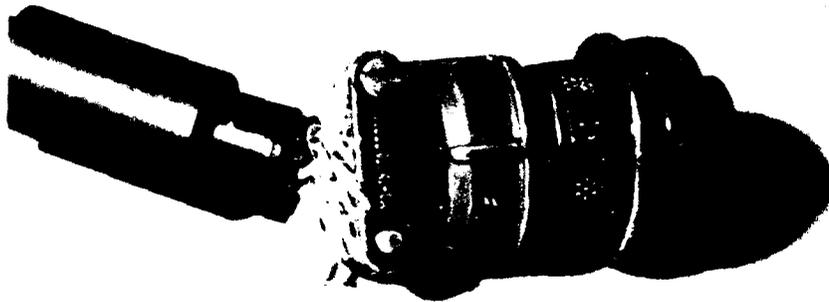
**Figure 7. Power cable assembly following initial vibration.**

a. During the first series of vibration tests, the Y-axis, sinusoidal and random, were completed without any problem. However, during X-axis random testing, the MTP's LED display failed. Investigation revealed the bracket that secures the battery assembly broke in 2 places, allowing the battery assembly to bounce around inside the MTP. The battery was destroyed. Another problem was the power cable wires had been pulled loose from the screw connections at the back of the MTP. See Figs. 5, 6, and 7. As a result of these problems, the MTP was returned to the manufacturer for repairs.

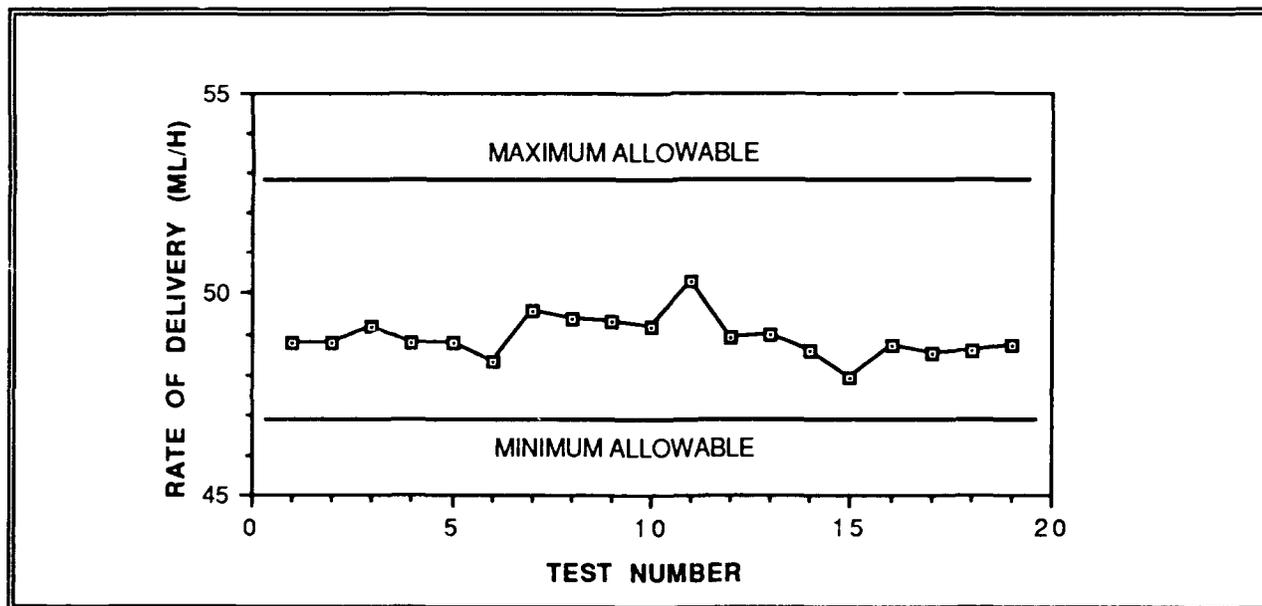
Figure 8. MTP Delivery Set at 50 ml/h During Vibration Testing

(1) Infusion Rate: The MTP infused extremely accurately on all 3 vibration axes, when set at 50 and 150 ml/h (Figs. 8 and 9). When set at 499 ml/h, however, the unit delivered at excessively high rates about half the time. This rate was first noticed while vibrating on the Z-axis (Fig. 10). Shortly after starting on the X-axis, with the same results, the volumetric chamber was changed to the larger size, Model 404-35A. For the rest of the X axis and all the Y-axis, the MTP's infusion rate was extremely accurate (Fig. 11).

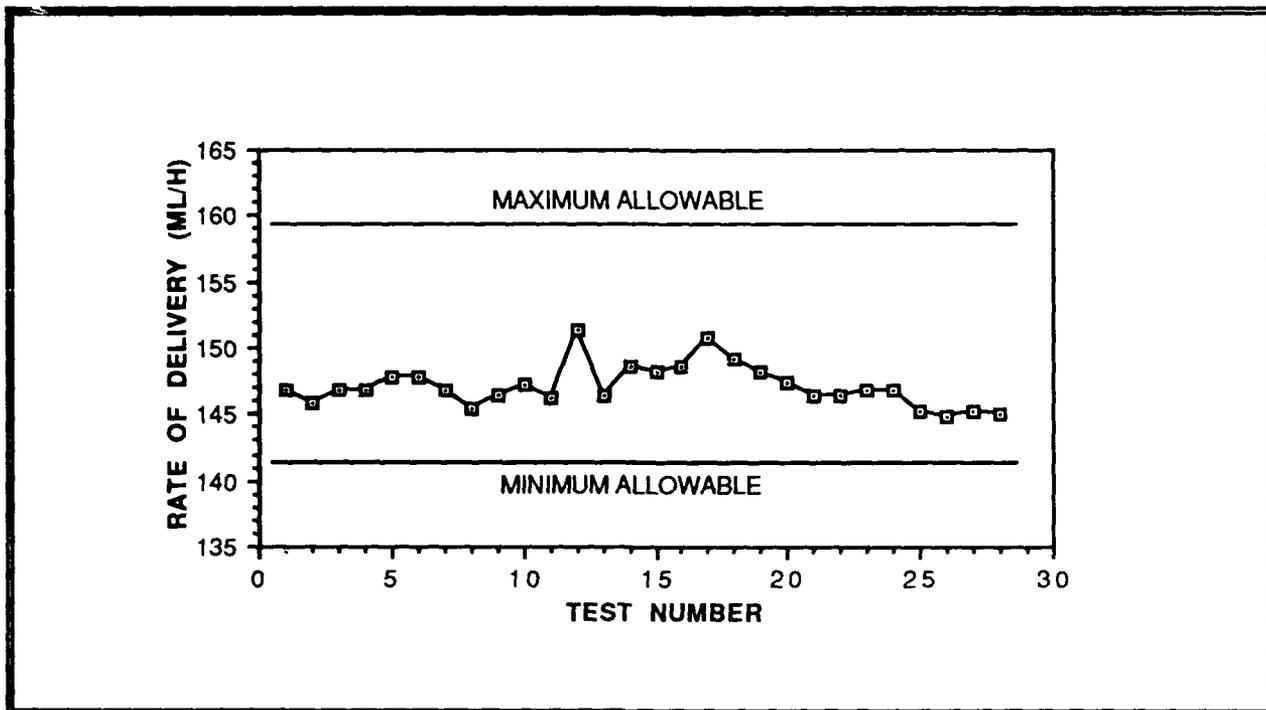
Figure 9. MTP Delivery Set at 150 ml/h During Vibration Testing

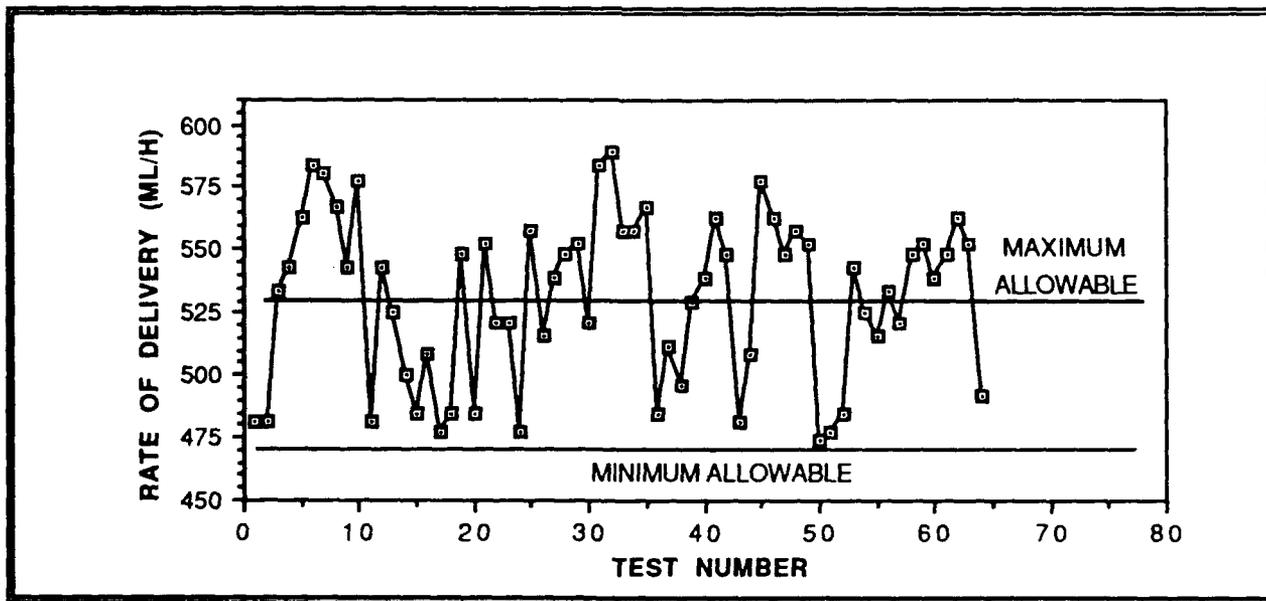
Figure 10. MTP Delivery Set at 499 ml/h During "Z" Axis.

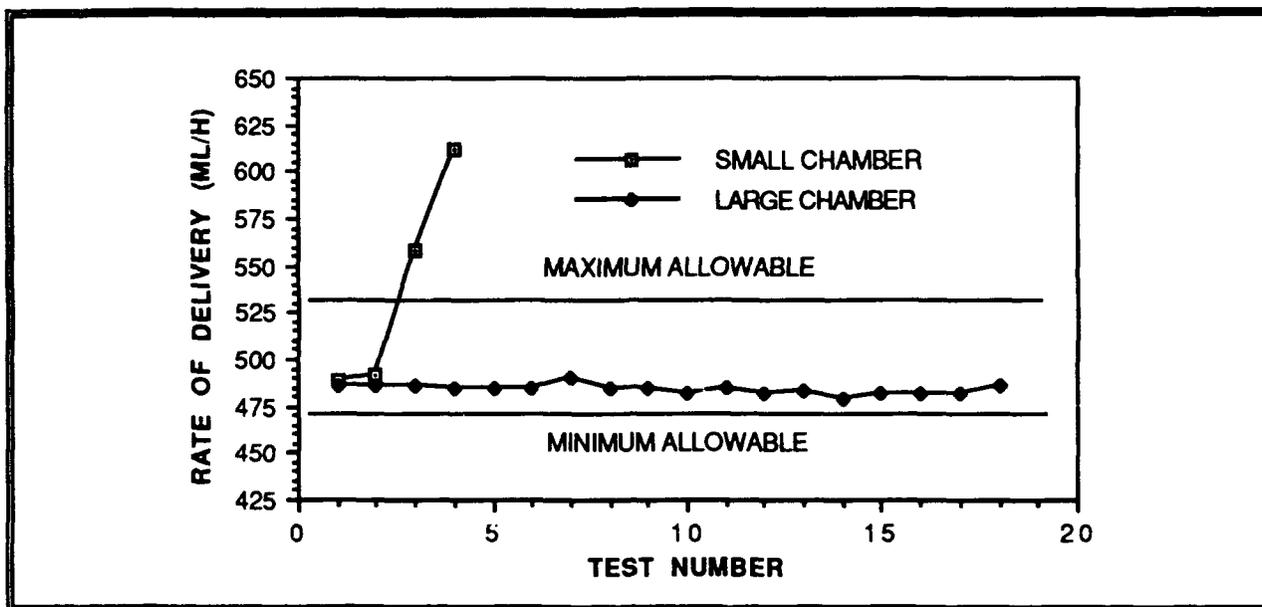
Figure 11. MTP Delivery Set at 499 ml/h During "X" & "Y" Axes.

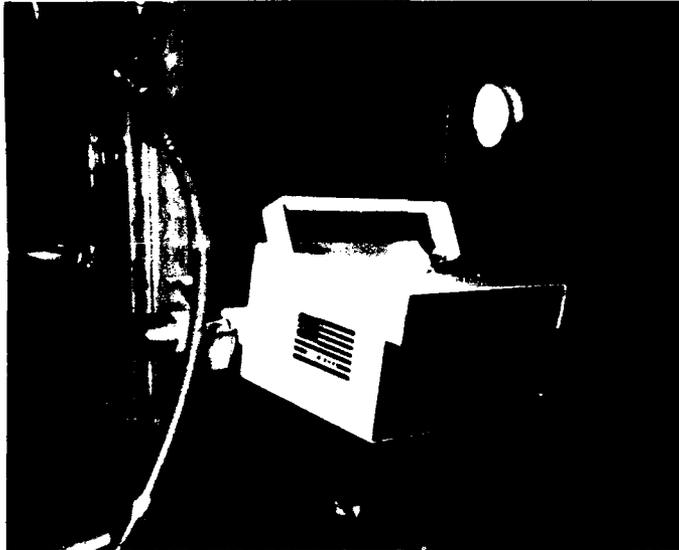
Figure 13. Mounting on the C-141 aircraft using the Aeromedical Equipment Securing Pole.

(c) On the C-9, C-130, and C-141 aircraft, it is recommended that the Aeromedical Equipment Securing Pole, which tightly clamps into a cantilever arm or litter bracket, be used for securing the 1001A. A prototype was provided for 375 AAW/SGNL in December 1989. When used on the C-9, a separate cantilever arm should be used for the unit placed in close proximity to the patient litter.

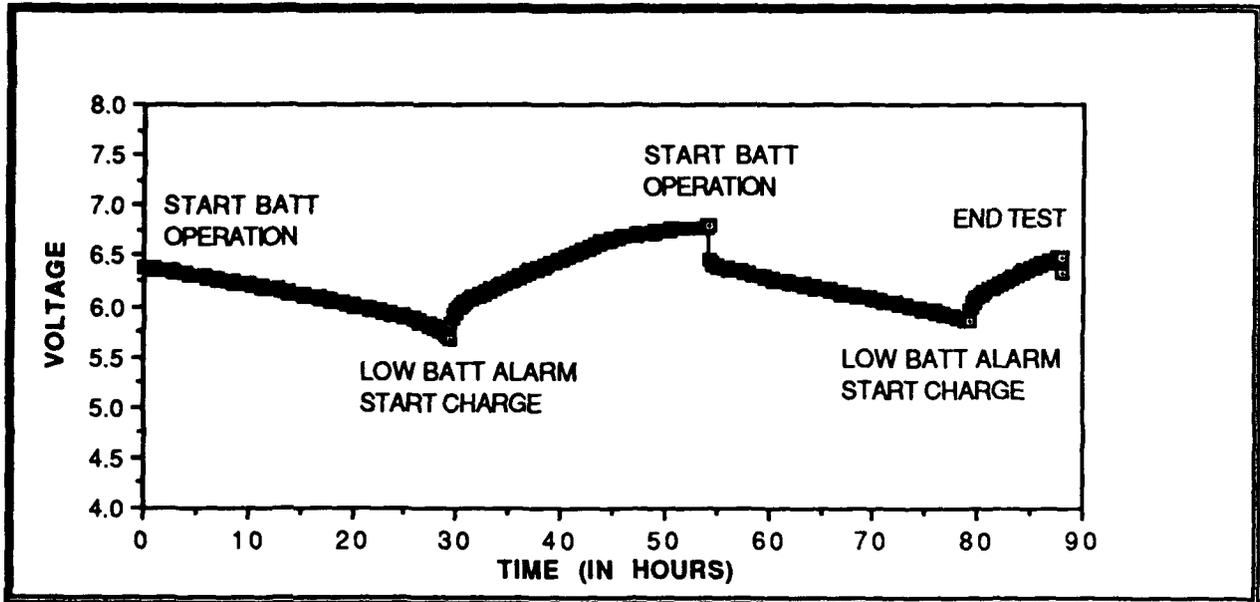
Figure 14. Voltage during battery operation and charging on 110 VAC.

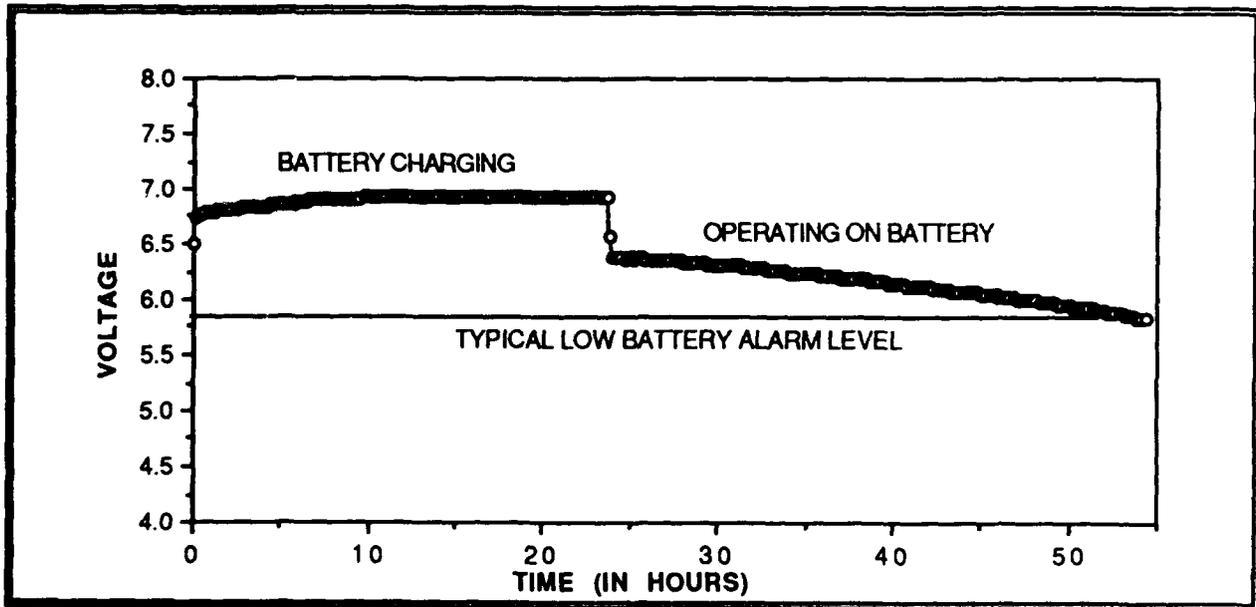
Figure 15. Voltage during battery operation and charging on 110 VAC, post rapid decompression testing.

window. Then, the chamber was depressurized to an equivalent of 40,000 ft, over a period of 60 s. The unit was observed. The chamber was pressurized to ground level. The MTP was removed. The MTP battery voltage was recorded and the flow check was performed. The unit was placed in the chamber, and the process was repeated twice, with the rapid decompressions occurring over intervals of 7 and 1 s.

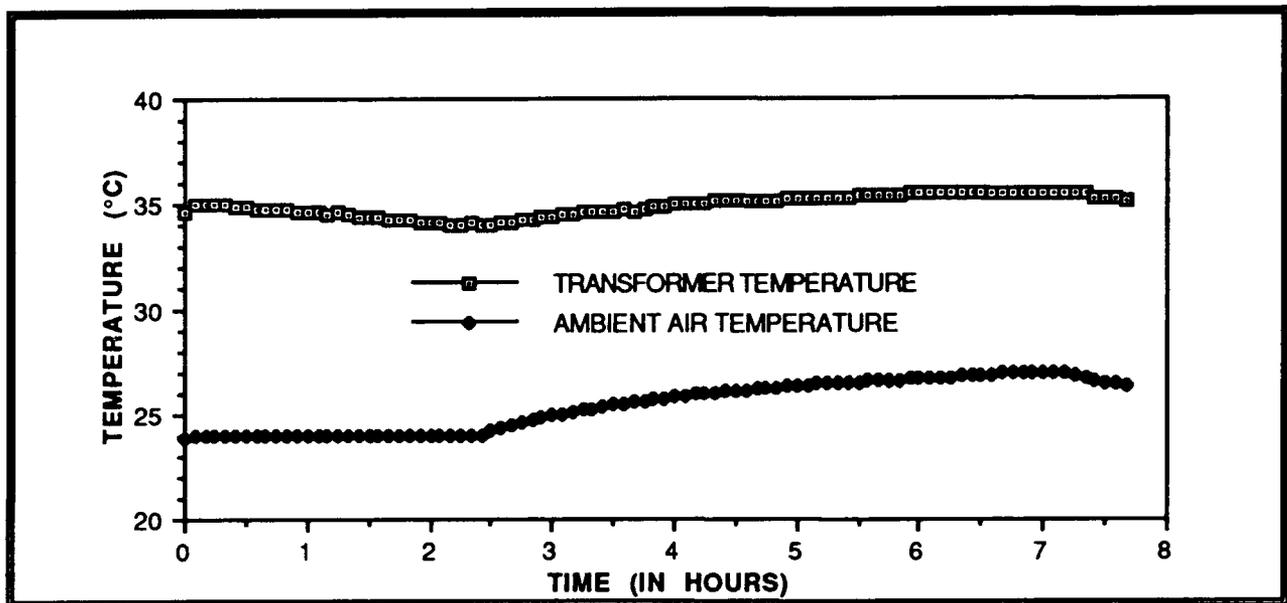
Figure 16. Temperature of transformer/charger during 400 Hz operation.

. During 8 h of operation on 400 Hz, there was no significant increase in transformer temperature, as shown in Figure 16.
