USACERL Technical Report M-91/18
July 1991

Guide for Visual Inspection of Structural Concrete Building Components

by
Douglas E. Ellsworth
Keith Ginnado

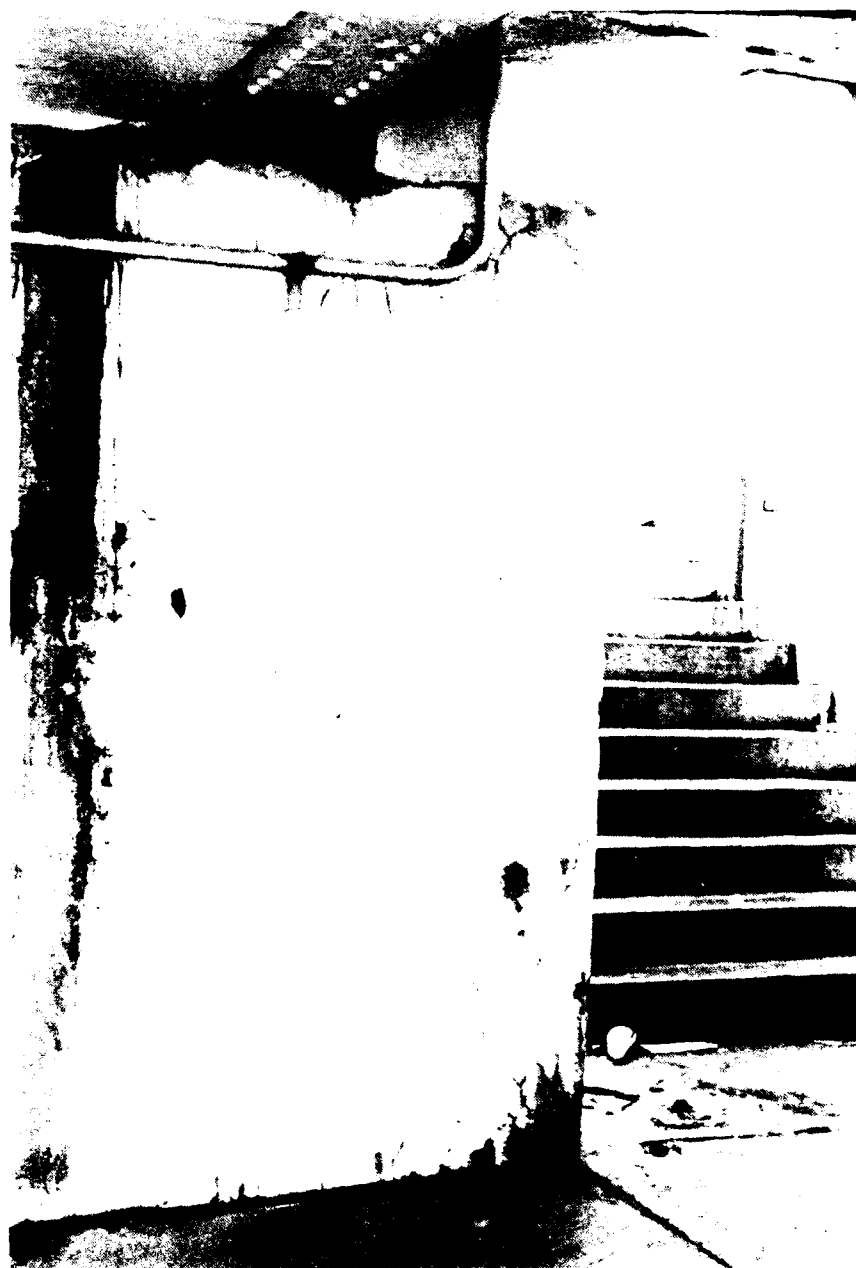
Figure 3. Random pattern cracking of a wall.

Map cracking, sometimes known as pattern cracking, is characterized by fine openings on the surface of the concrete. Map cracks generally result from a decrease in the volume of the material near the surface or an increase in subsurface material volume. Map cracking is structurally significant if the pattern follows the pattern of the underlying reinforcing steel or demonstrates separation of the concrete materials (Figure 3).

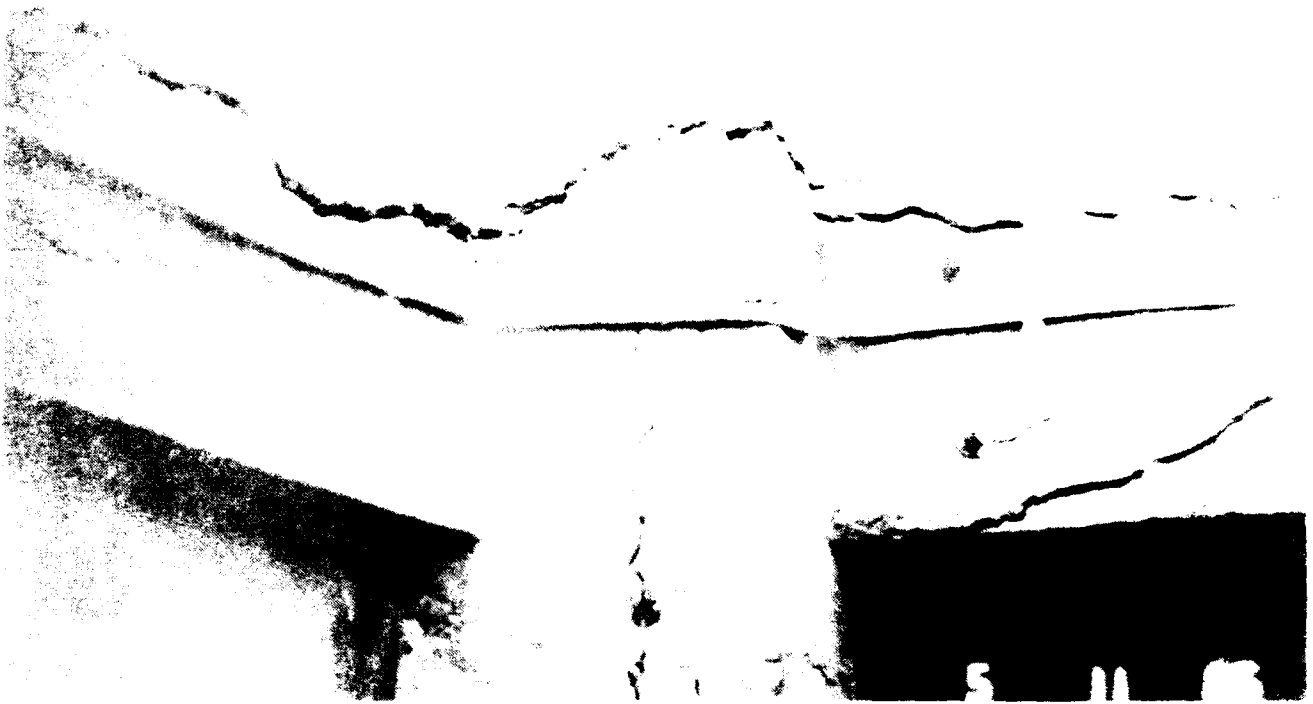
Figure 5. Single, continuous cracking in beams due to corrosion of reinforcement.

Single, continuous cracks with a definite direction and magnitude can indicate a structural deficiency. Cracks of this type are usually longitudinal, transverse, diagonal (Figure 4), vertical, or spiraling and will often continue to grow in depth and length (Figure 5) if the structural deficiency is not identified and corrected.

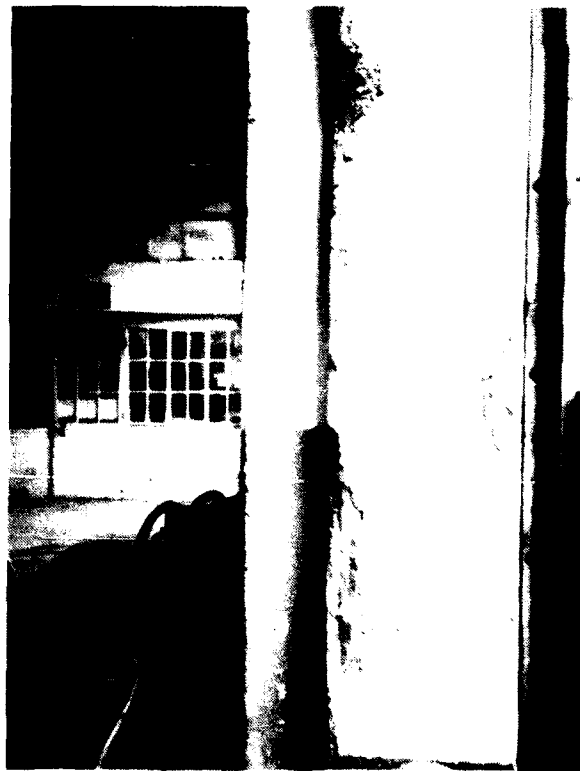
Figure 7. Abrasion/impact damage to a concrete column.

equipment crossing areas not designed for abrasive conditions. Impact damage from collision with a concrete member can result in severe material loss (Figure 7).

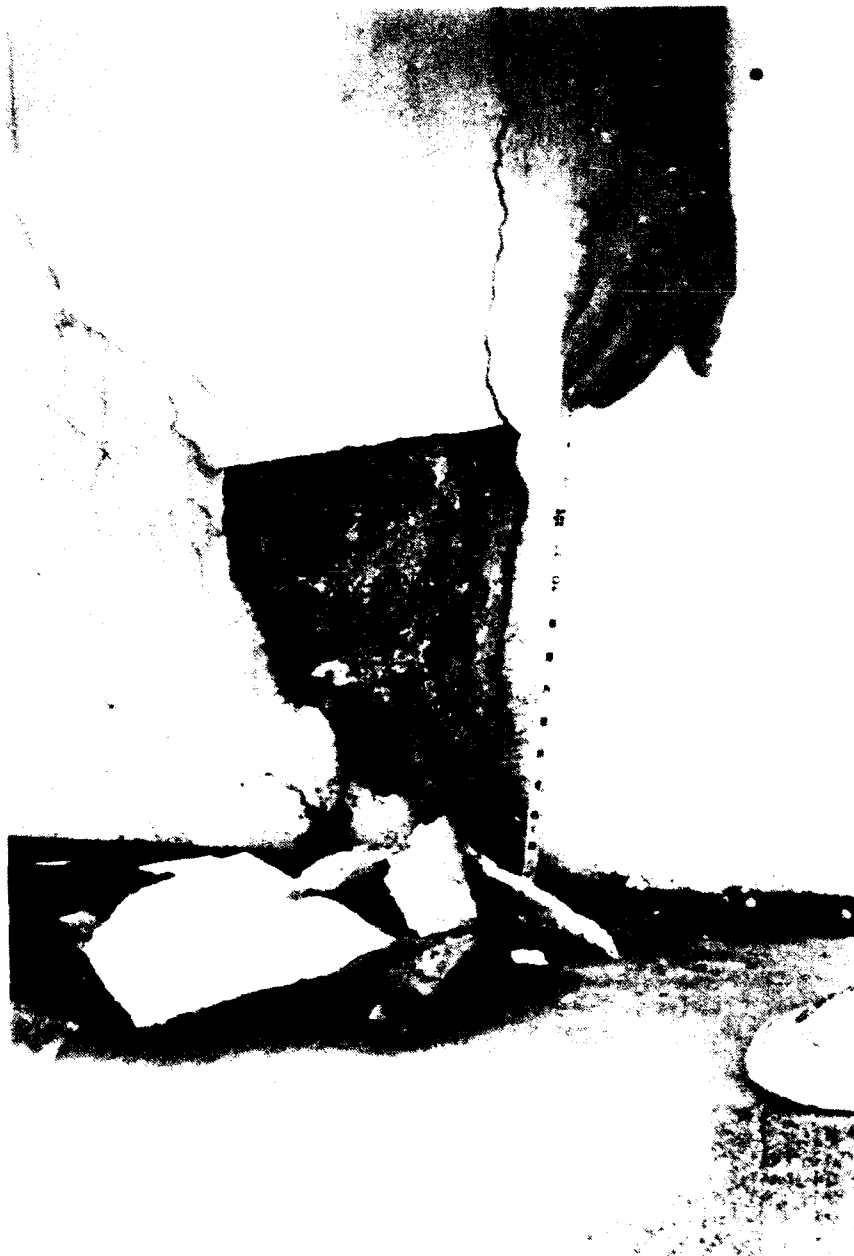
Figure 13. Flaking of a concrete wall.

Flaking is the delamination of the surface concrete from the subsurface mass. It occurs because of improper construction practices or freezing and thawing of permeable concrete (Figure 13). High water content of the concrete mix can cause a concentration of fine aggregates and water at the surface. If finishing techniques are carried out while excess bleed water is still on the surface, delamination of the surface layer can later occur.

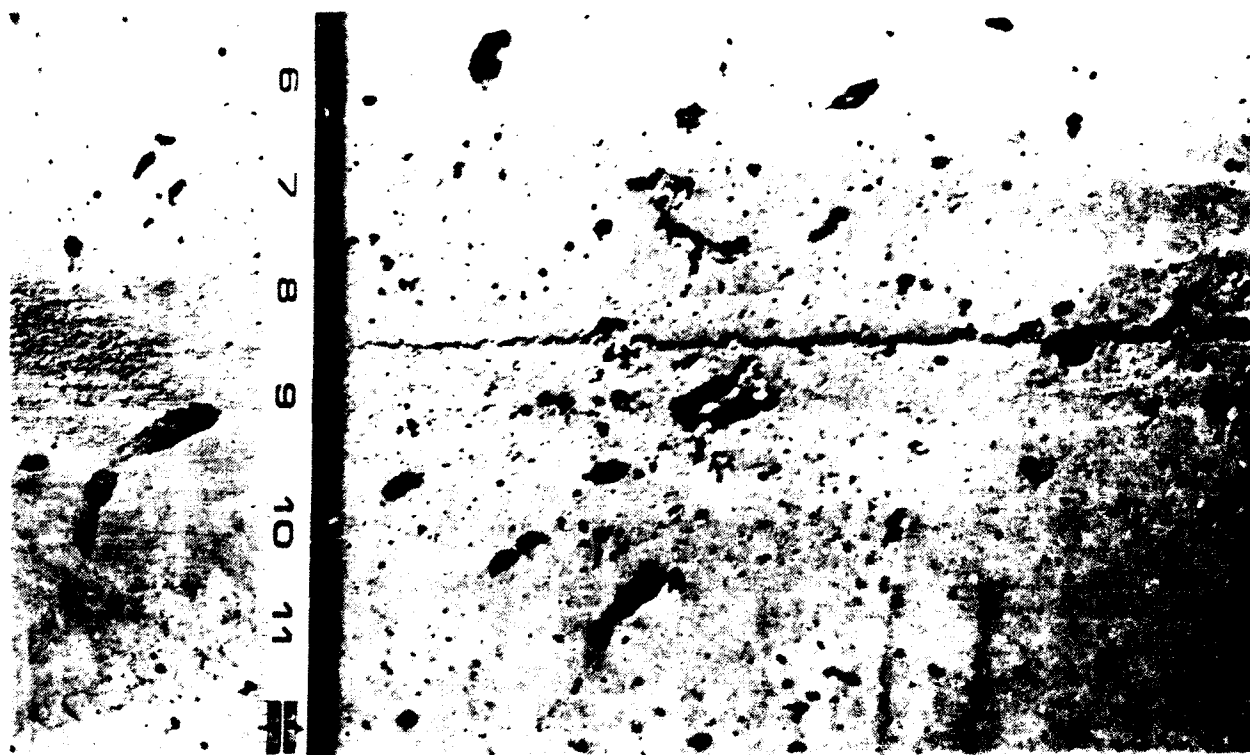
Figure 15. Major honeycombing of a wall.

Honeycombing is usually found in vertical rather than in horizontal surfaces and can occasionally extend completely through, resulting in a structurally unsound member (Figures 14 and 15). Honeycombing is caused by bleed water carrying fine aggregates to the surface, creating voids in the concrete mass. Bleed water will carry fine aggregates to the surface if the formwork is removed prematurely or if the concrete has an excessive water content. The surface can be rough with cavities up to several inches deep.

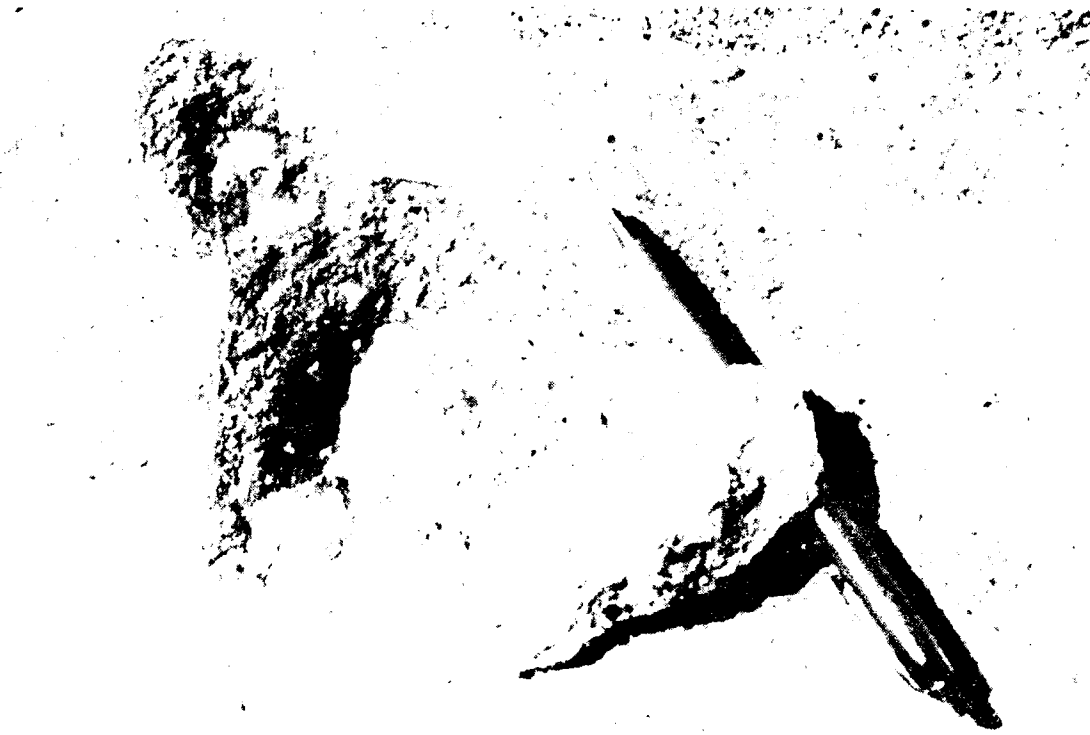
Figure 16. Popout.

Inadequate provision for structural movement can cause popouts (Figures 16 and 17). Restraining movement creates internal stresses that can result in conical depressions in the surface as the concrete relieves these stresses. Internal stresses caused by corrosion of reinforcement, cement-aggregate reactions, or internal ice crystal formations (from freezing water trapped within the concrete mass) can cause popouts. The shallow conical depressions in the surface of the concrete are classified by diameter: small is 0.4 in. (10 mm), medium is 0.4 to 2.0 in. (10 to 50 mm), and large is greater than 2 in. (50 mm).

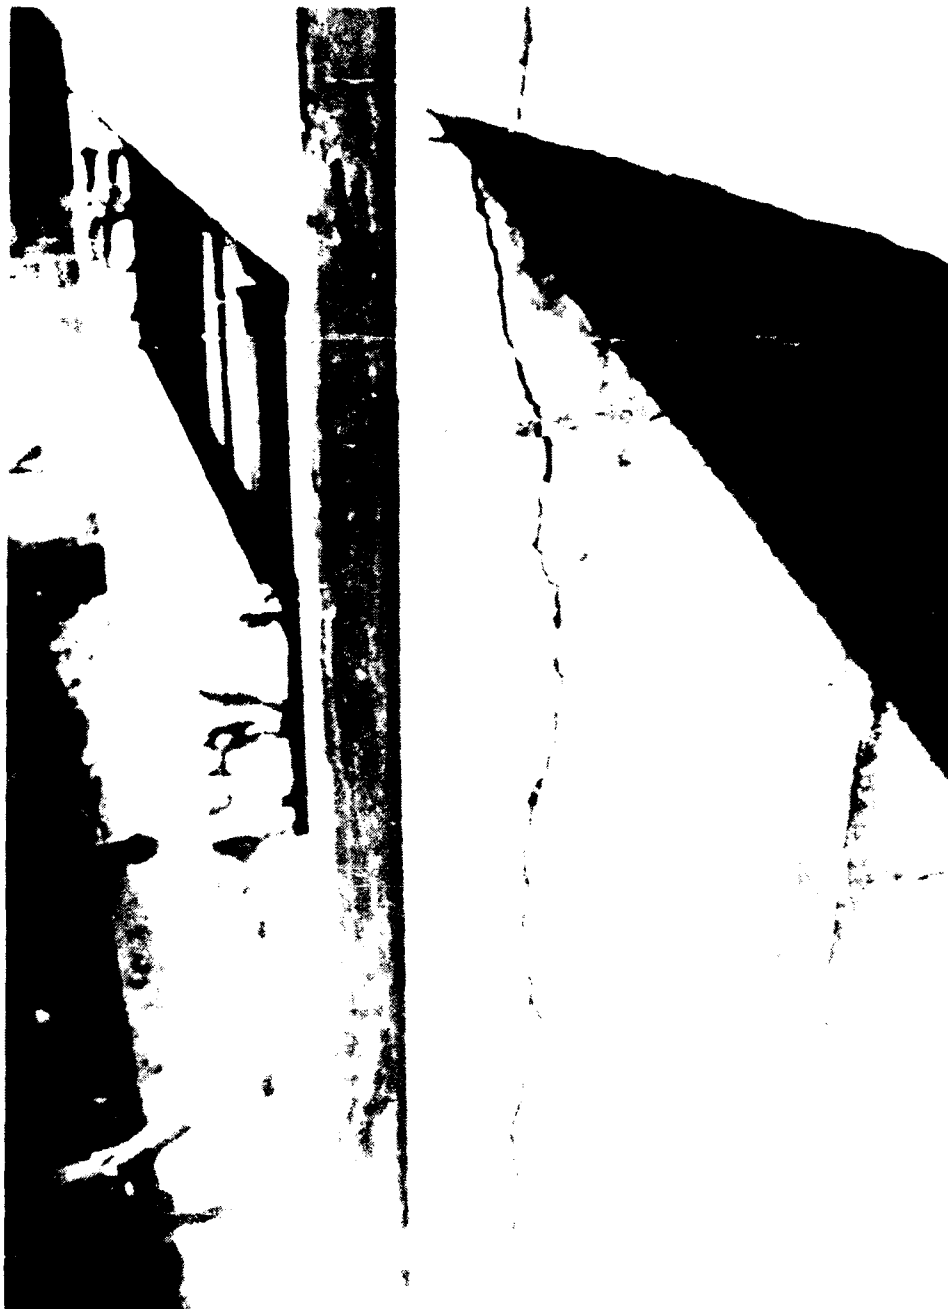
Figure 19. Vertical crack in a column.

Corrosion of reinforcement in concrete can cause major cracking in concrete members (Figure 19). Rusting steel expands, causing cracks in the restraining concrete mass. When corrosion worsens, the concrete bond to the steel is lost. Tensile forces acting on such a deteriorated member can cause collapse (Figure 20).

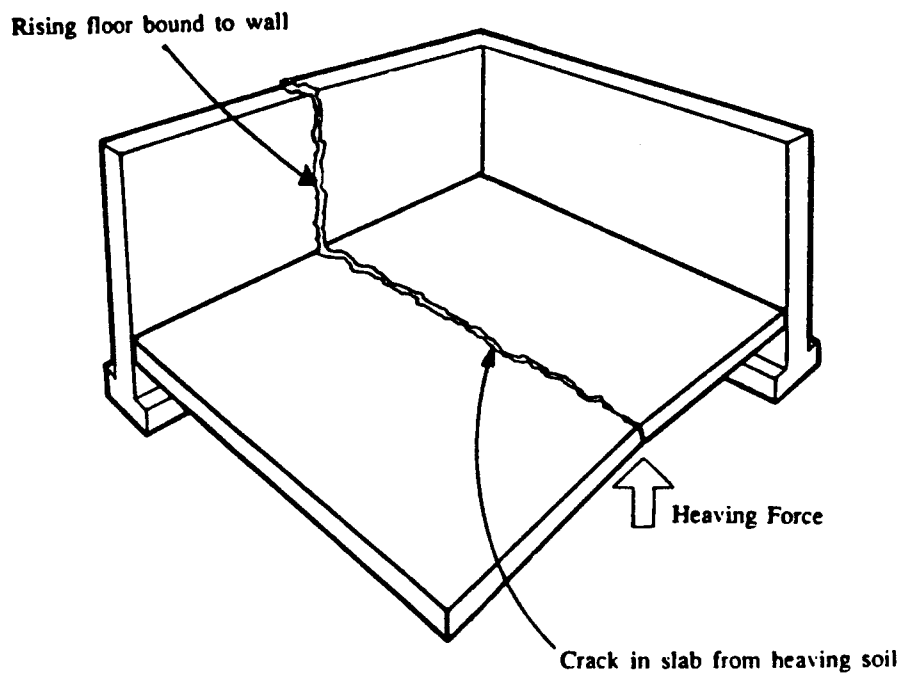
Figure 33. Heaving soil under a floor slab causing cracks in concrete wall and slab.

Heaving soil makes a basement floor convex and causes cracks parallel to the edges of the foundation wall (Figure 31). If a floor is free of the wall but not free of a column, a concentric crack will form around the column (Figure 32). If a floor on a heaving soil is bound to a wall at one point, the upward thrust causes the wall to crack at that point (Figure 33). If a wall is settling, cracks occur at each end of the portion that is moving downward (Figure 34). Differential settlement occurs when the magnitudes of the loads on two intersecting walls are considerably different (Figure 35). Lateral movement of a foundation wall caused by soil pressure results in diagonal cracks at each end and vertical cracks in the center area (Figure 36). A single vertical crack denotes upward movement of a foundation. However, if the crack is very narrow, it could be drying, shrinkage, or thermal crack (Figure 37).

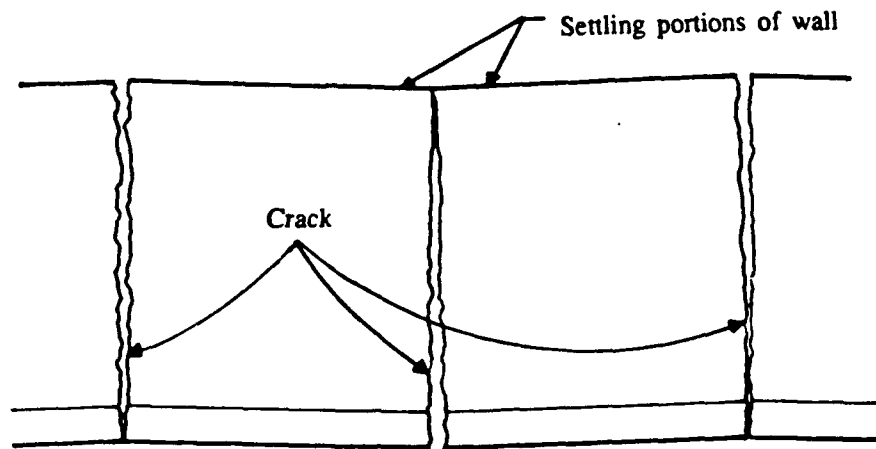
Figure 34. Foundation wall settlement.

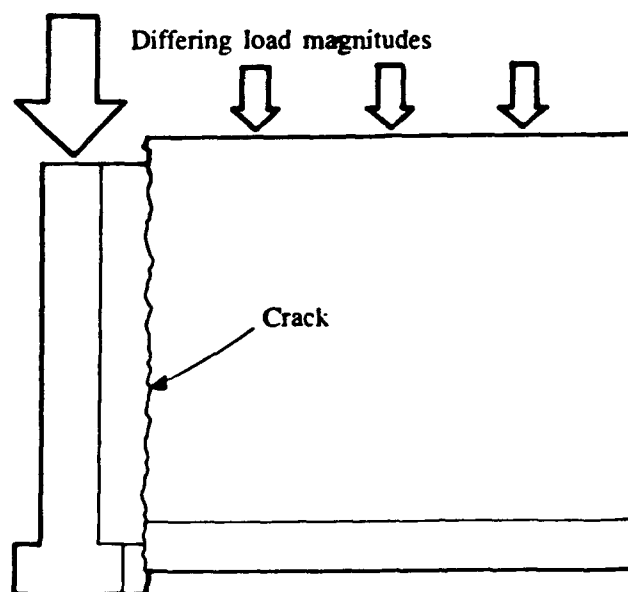
Figure 35. Differential settlement in a foundation wall.

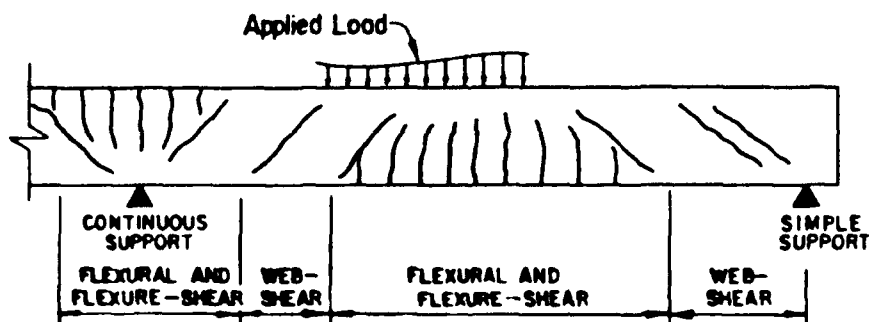
Figure 38. Types of cracking in concrete beams and girders.

Beams and girders transfer the load, through bending and sheer, to the column and thus to the ground. A 1 1/2-in. (3.8 cm) concrete cover over this reinforcement should be maintained to prevent corrosion of the steel by the environment. Figure 38 shows types of cracking in concrete beams and girders.

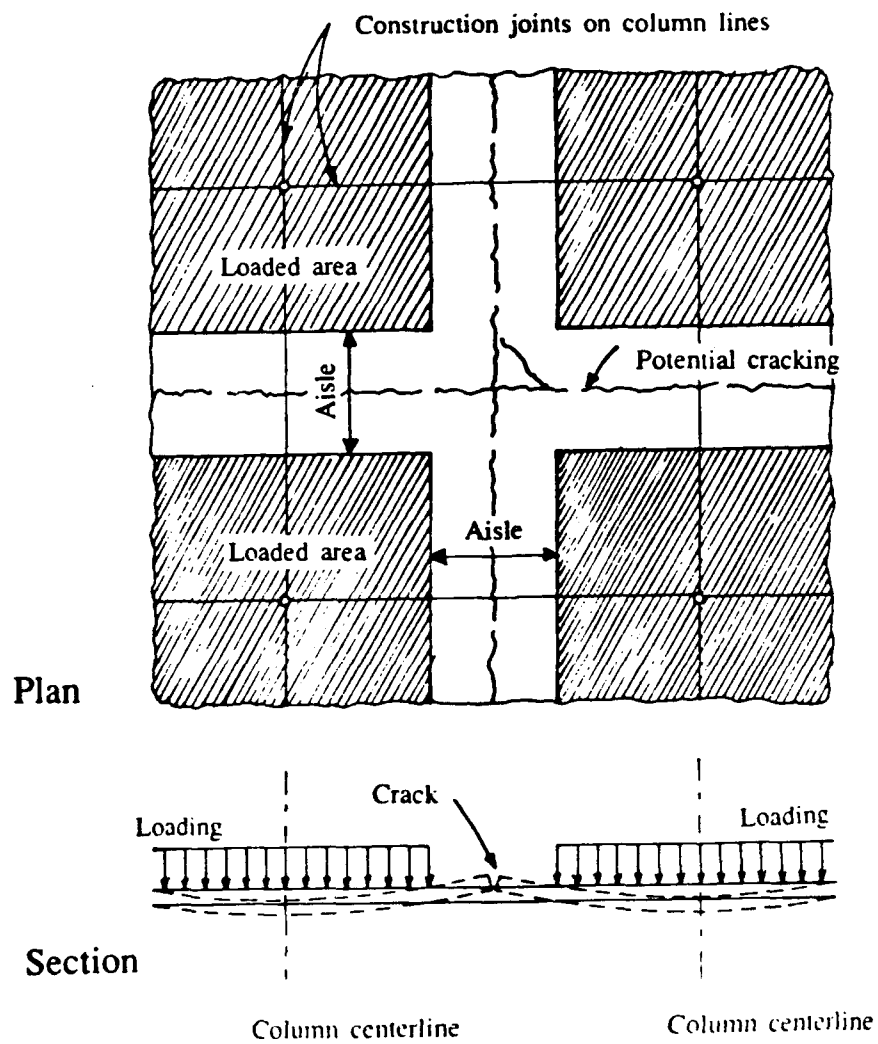
Figure 41. Cracking of a concrete slab.
