Drop Test - - Cessna Golden Eagle 421B

May 1992
DOT/FAA/CT-TN91/32

14. Sponsoring Agency Code ACD-210	
15. Supplementary Notes					
16. Abstract This report presents the results of two airplane vertical impact tests conducted at the Federal Aviation Administration (FAA) Technical Center, Atlantic City International Airport, New Jersey. These tests entailed dropping a low wing, twin engine Cessna 421B aircraft from a vertical height of 11.2 feet, resulting in an impact velocity of approximately 26.0 feet per second (ft/s). In both tests the aircraft was configured to simulate actual in-flight conditions including seats, occupants, and fuel. The structural response of the airframe, seats, and simulated occupants (anthropomorphic dummies) were measured throughout the tests, and the results are presented in this report. The data collected in these tests and future tests of other commuter type aircraft will provide the basis for improved seat standards for commuter airplanes. These tests describe the impact response characteristics of commuter category airplane airframes, floor structures, seats, seat attachments and occupant restraint systems.

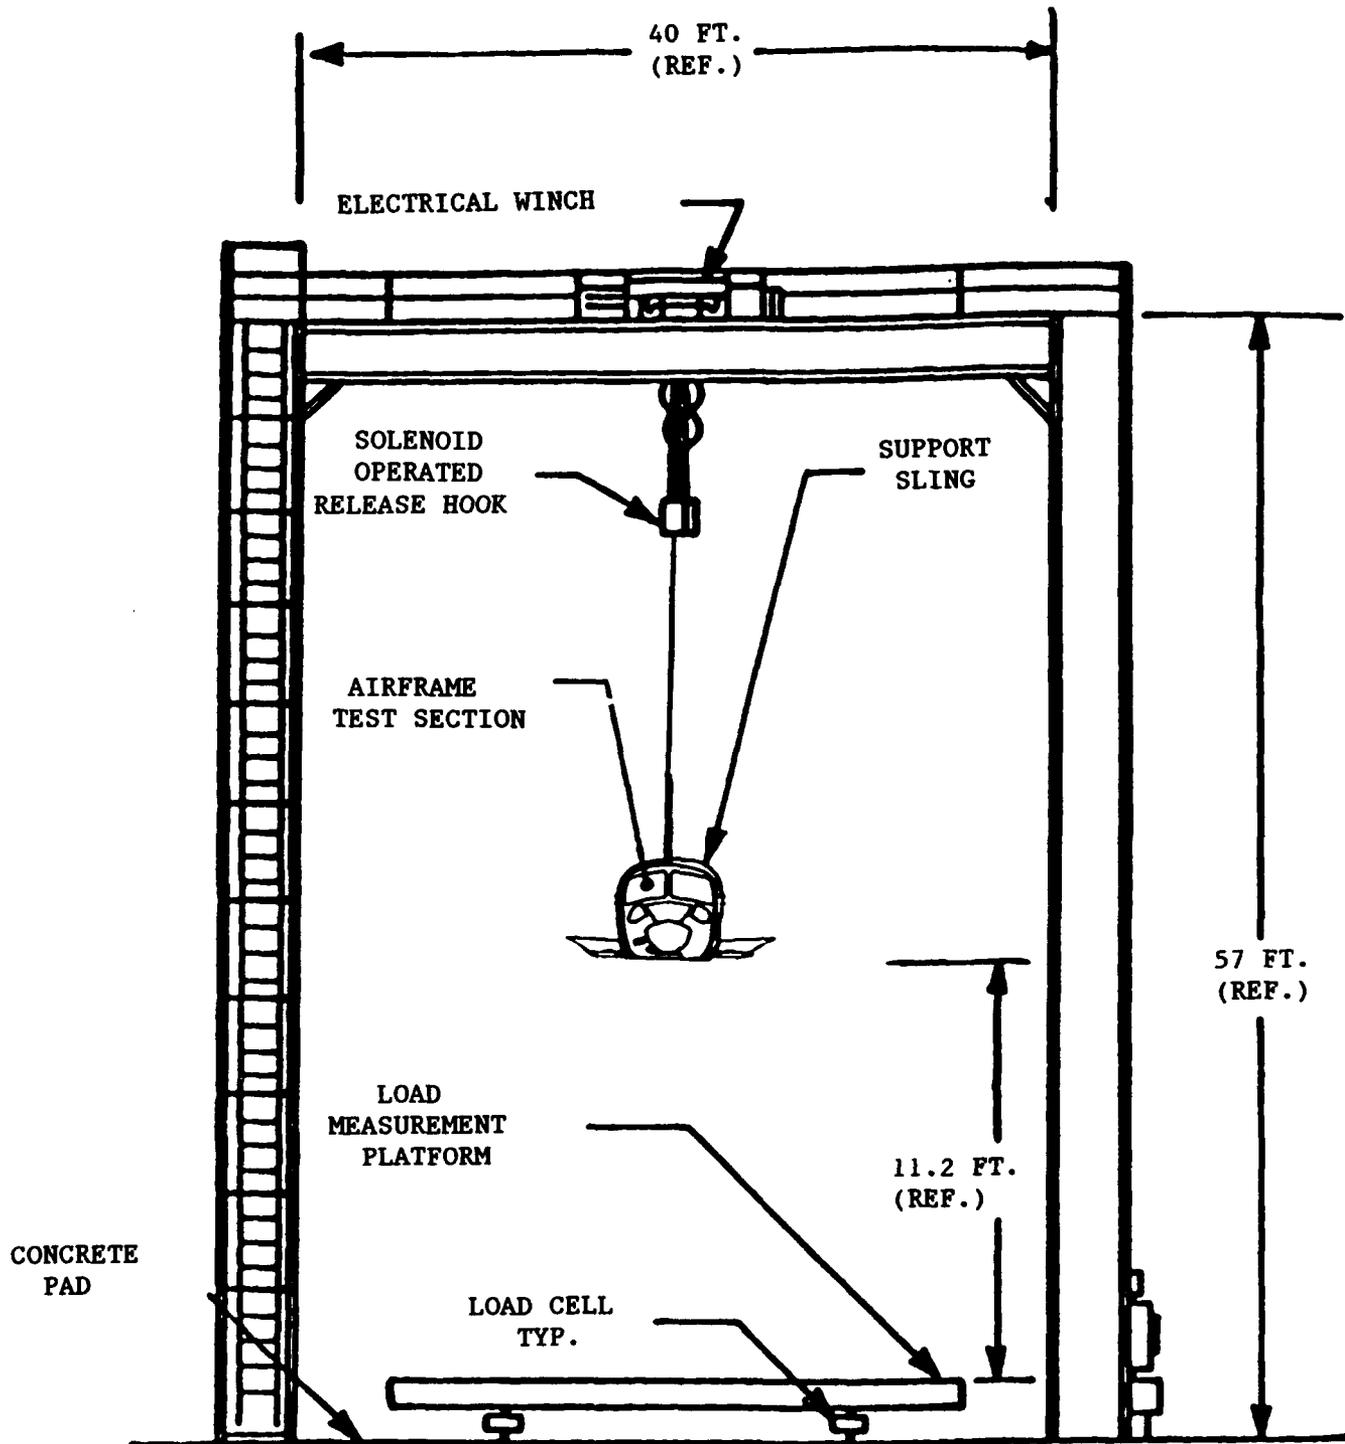
FIGURE 1. DROP TEST FACILITY

The Technical Center drop test facility, figure 1, is comprised of two 50-foot vertical steel towers connected by an elevated platform. A fixed mounted electric power winch on the platform is controlled from the base of one of the tower legs. The tower and lifting capacity of the winch is rated at 25,000 pounds. Attached to the winch is a reeved hoisting cable which is used to raise the test article. A sheave block assembly hanging from the free end of the reeved cable is, in turn, engaged to a solenoid operated release hook. The release hook is connected to the airframe by a cable/turnbuckle sling assembly. Located directly below the winch cable assembly and between the tower legs is a 15- by 36-foot wooden load-measurement platform which rests upon I-beams and 12 interconnected 50,000-pound load cells. At impact, the output of each load cell signal is summed through a sum/amplifier system arrangement.

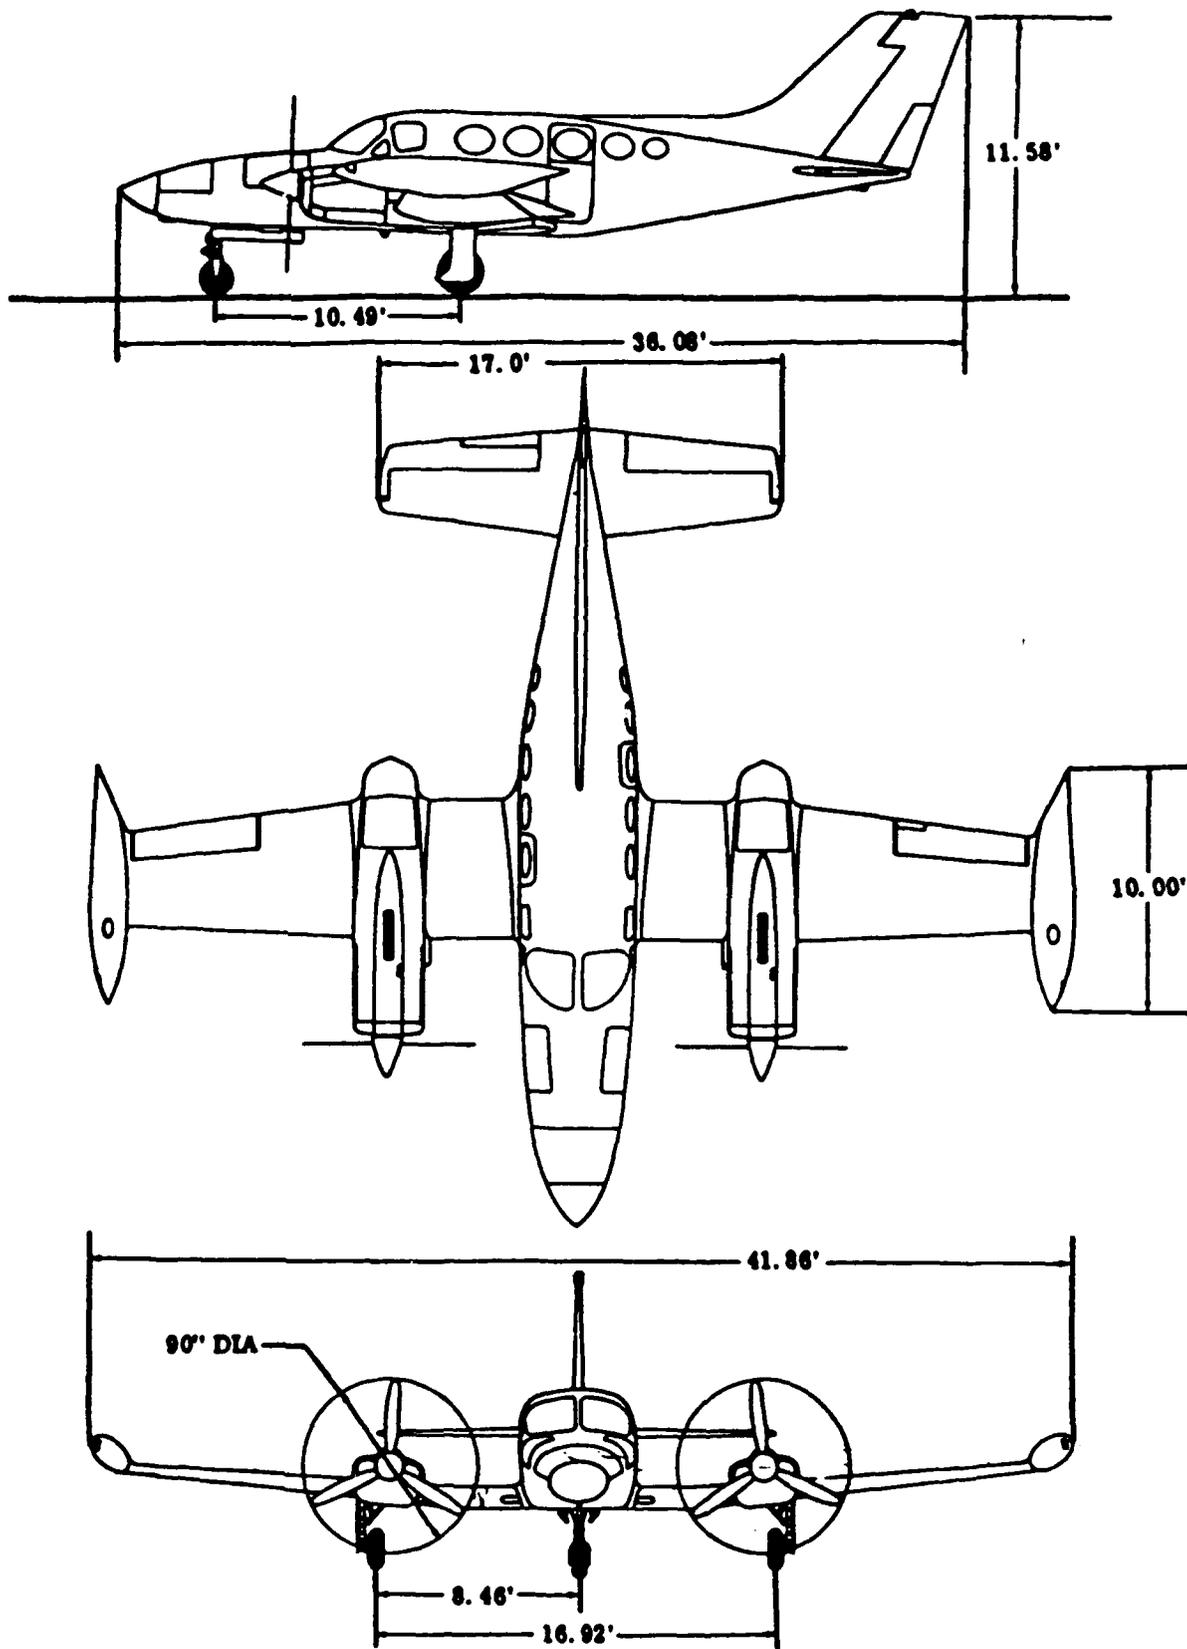
FIGURE 2. CESSNA 421B

The specifications of the Cessna Model 421B (figure 2) are as follows:

<u>MANUFACTURER TYPE CERTIFICATE</u>		<u>TEST CONFIGURATION</u>
Wing span	41.9 ft	26.5 ft
Length overall	36.0 ft	36.0 ft
Height overall	11.5 ft	5.0 ft
Wing area	215 ft	N/A
Maximum takeoff weight	7450 lbs	N/A
Weight empty	5000 lbs	N/A
Max. landing weight	7200 lbs	5200/7200 lbs
Engine weight	500 lbs each	N/A
Center of gravity at fuselage station 152.6 to 157.8 inches		156.52 inches

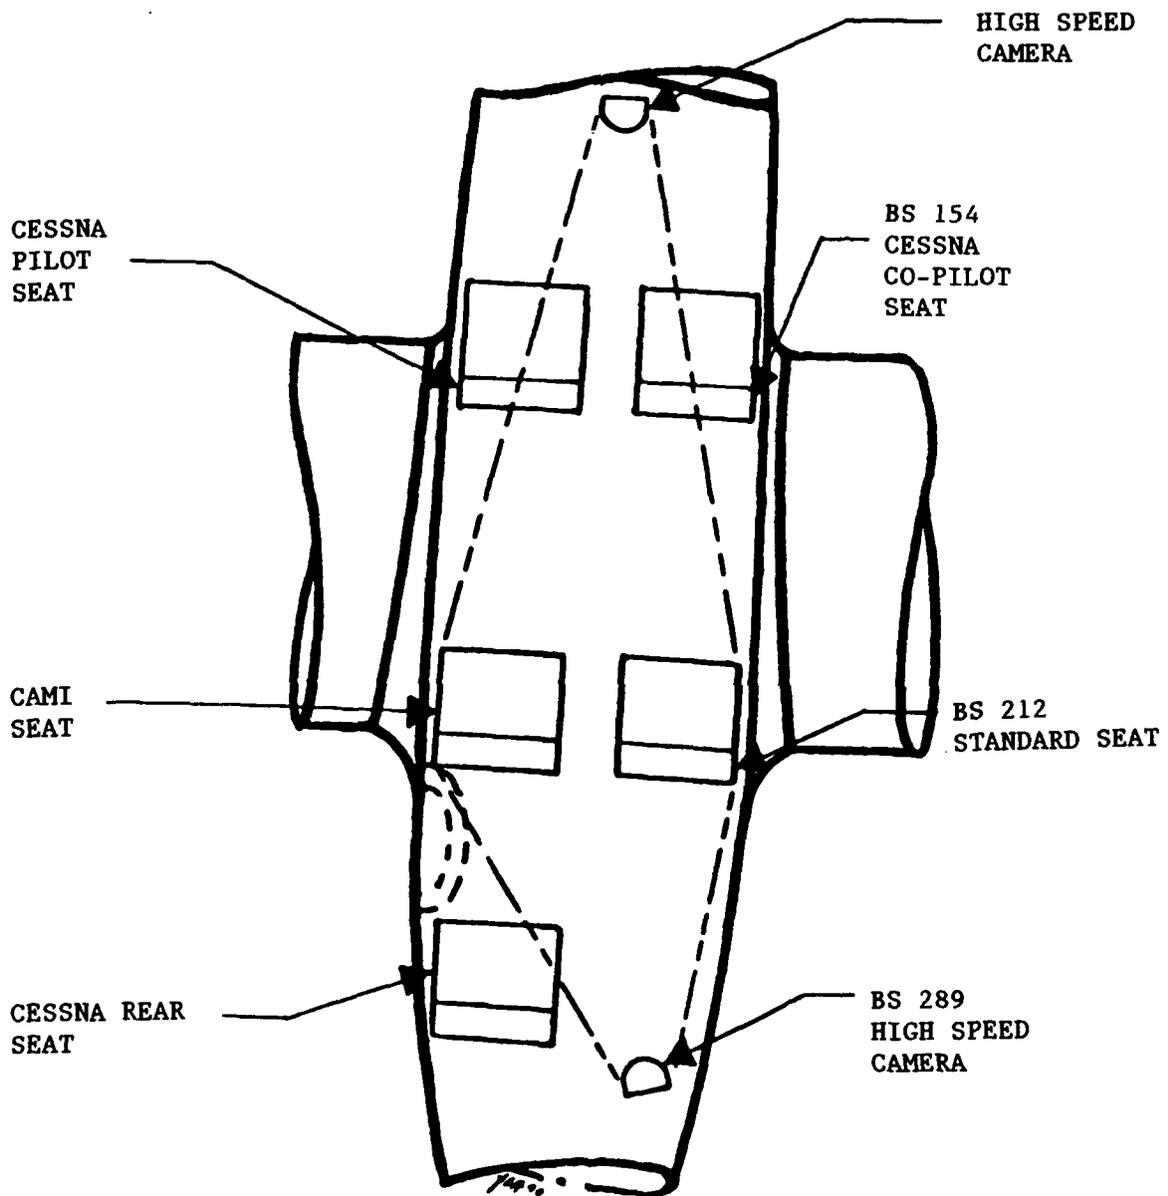
FIGURE 3. AIRCRAFT INTERIOR LAYOUT

The interior airplane cabin was configured to replicate a five-seat occupancy (figure 3) as follows:

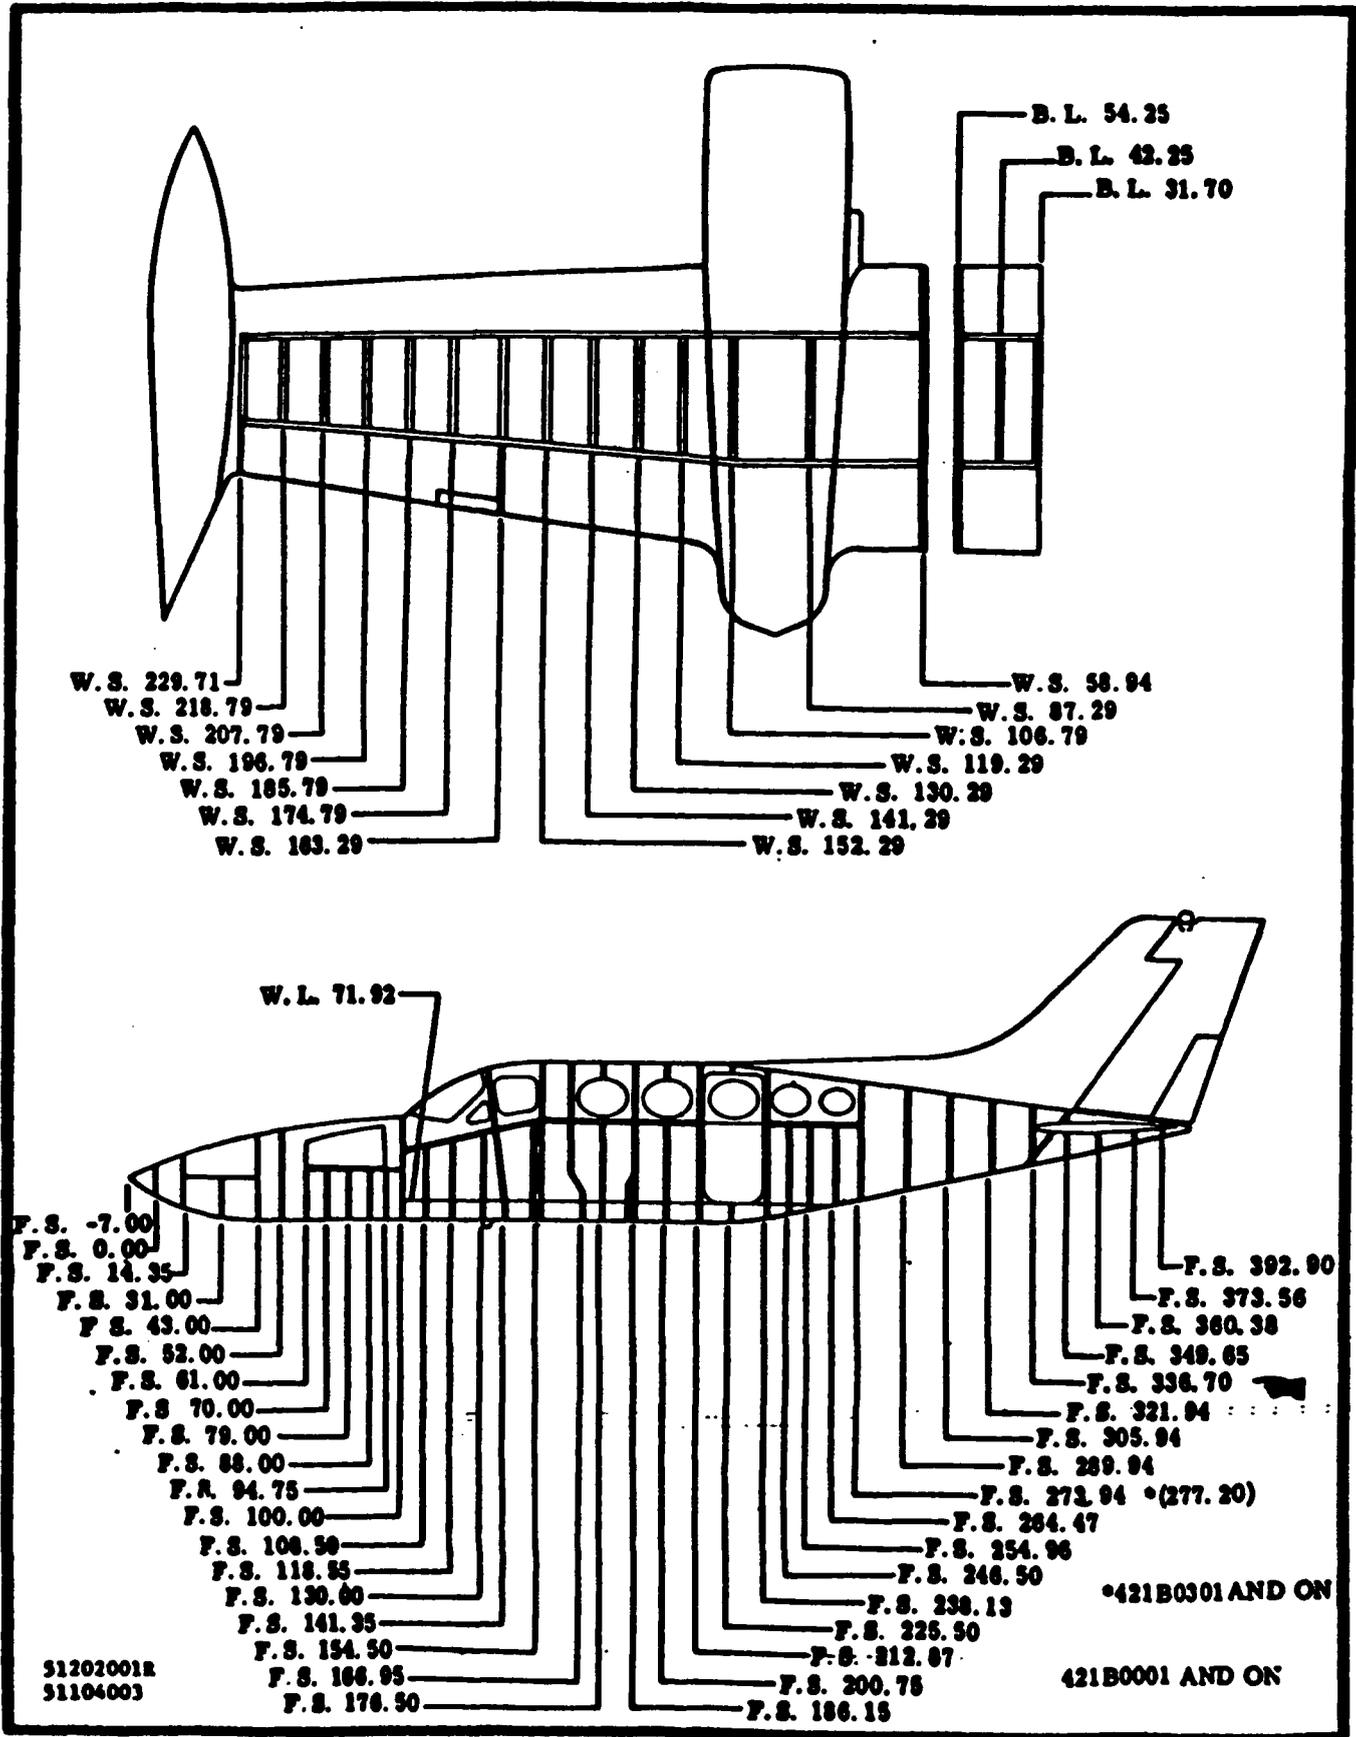
FIGURE 4. FUSELAGE STATION CONFIGURATION

Figure 4 illustrates the fuselage station configuration of the test aircraft.

Table 2 gives a summary of the number, location (figure 4), and types of sensors used for this test.

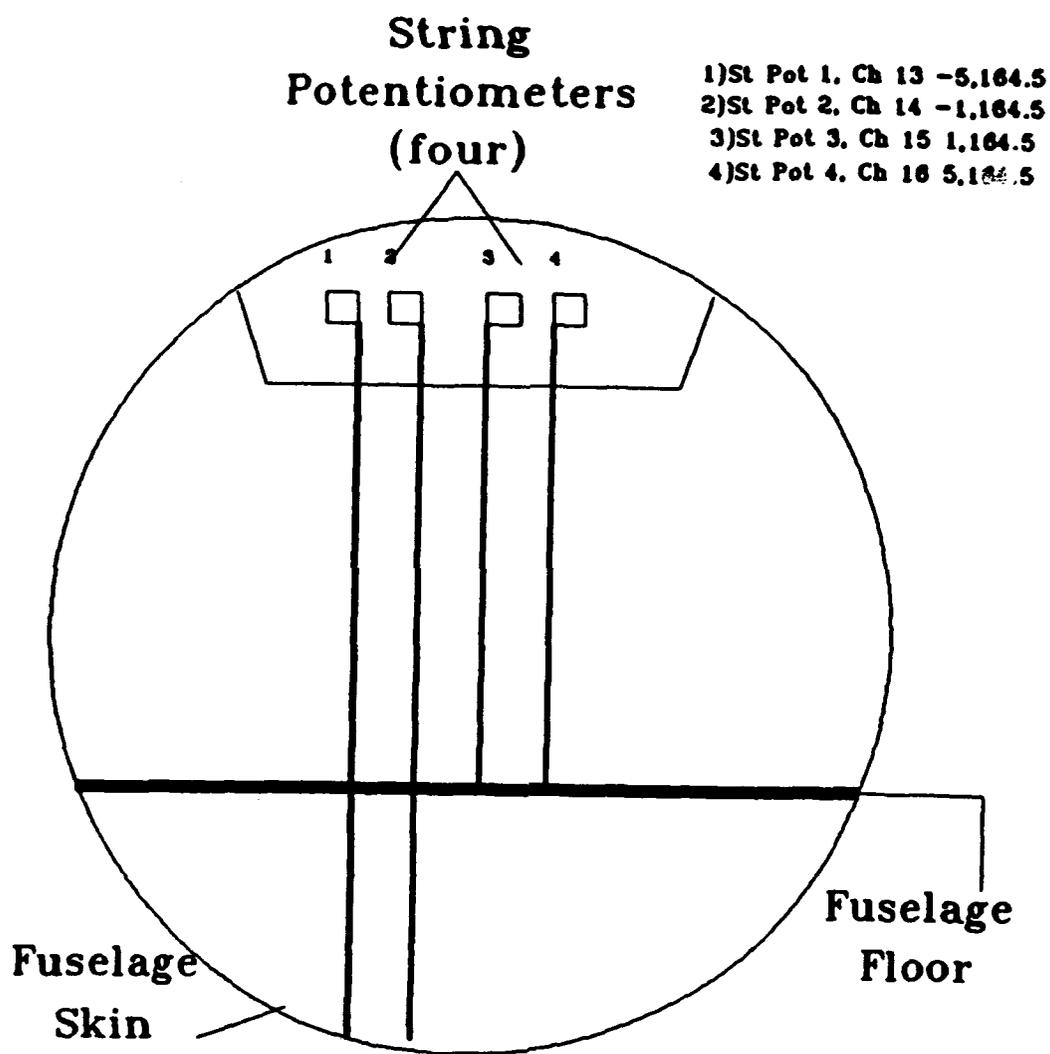
FIGURE 5. POSITIONING OF POTENTIOMETERS

Four string potentiometers were located at FS 164.5. Two of them were located behind the pilot and copilot seats and attached from the fuselage to the floor panels. The other two were also located behind the pilot and copilot seats and attached from the fuselage to the airframe skin (figure 5). These string potentiometers measured any deflection between the upper end of the bulkhead and floor. Two additional string potentiometers were mounted on the CAMI seat in order to measure its seat pan deflection (figure 6).

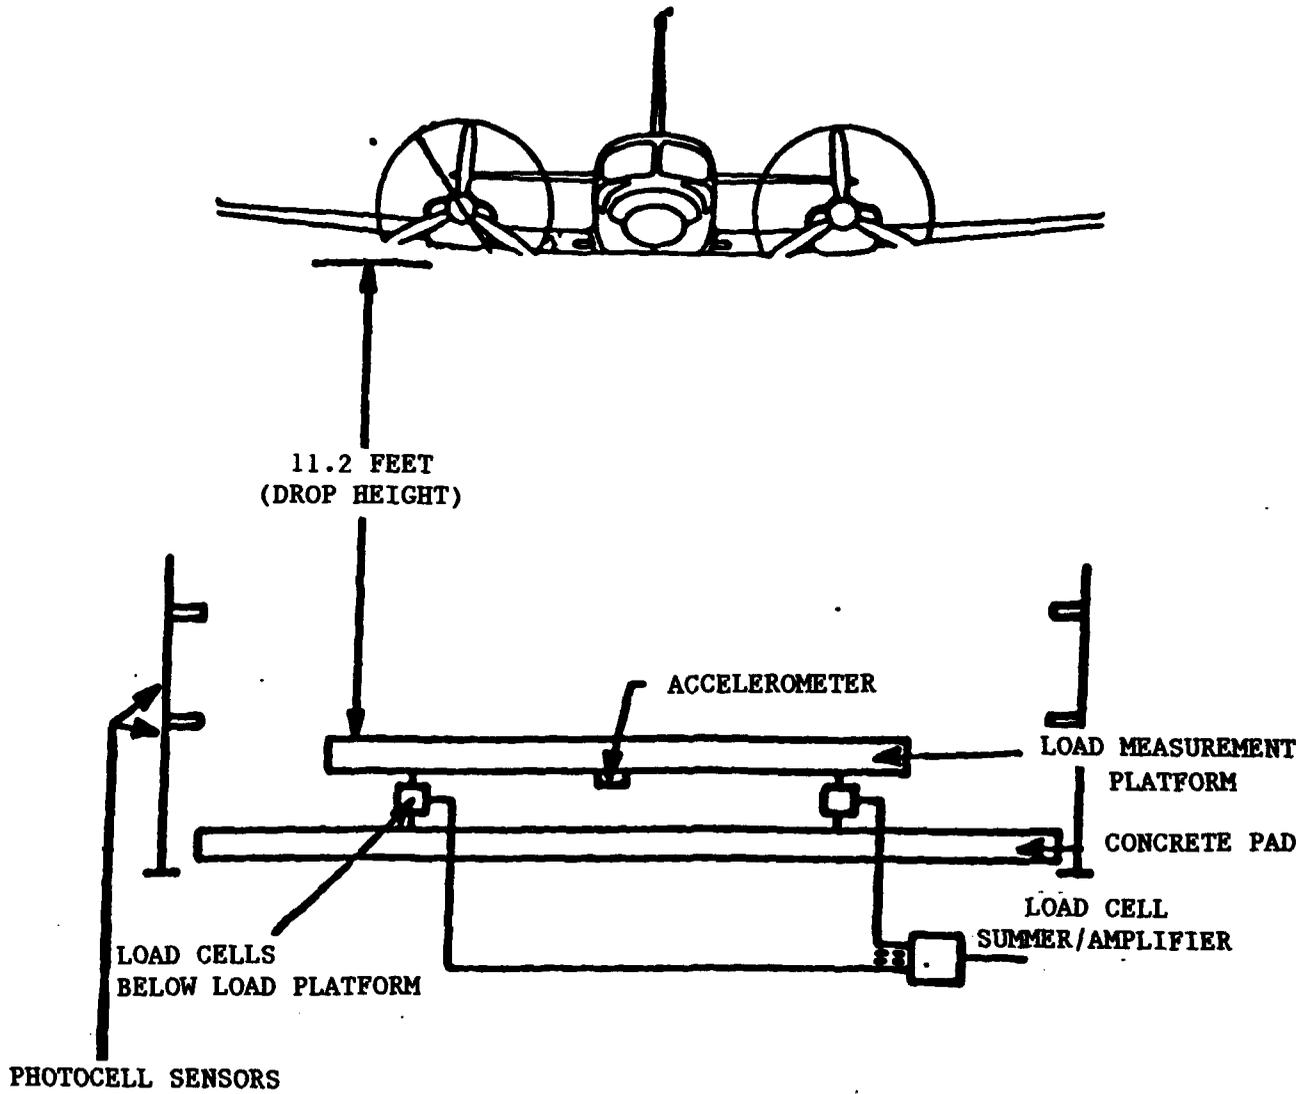
FIGURE 7. TEST ARRANGEMENT

The wooden impact platform was supported by 12 load cells. Three groups of 4 load cells were connected to three electrical summing boxes. The output of the summing boxes were fed to a summing/amplifier to record the total forces on the platform. A vertical accelerometer was also placed under the platform (figure 7).

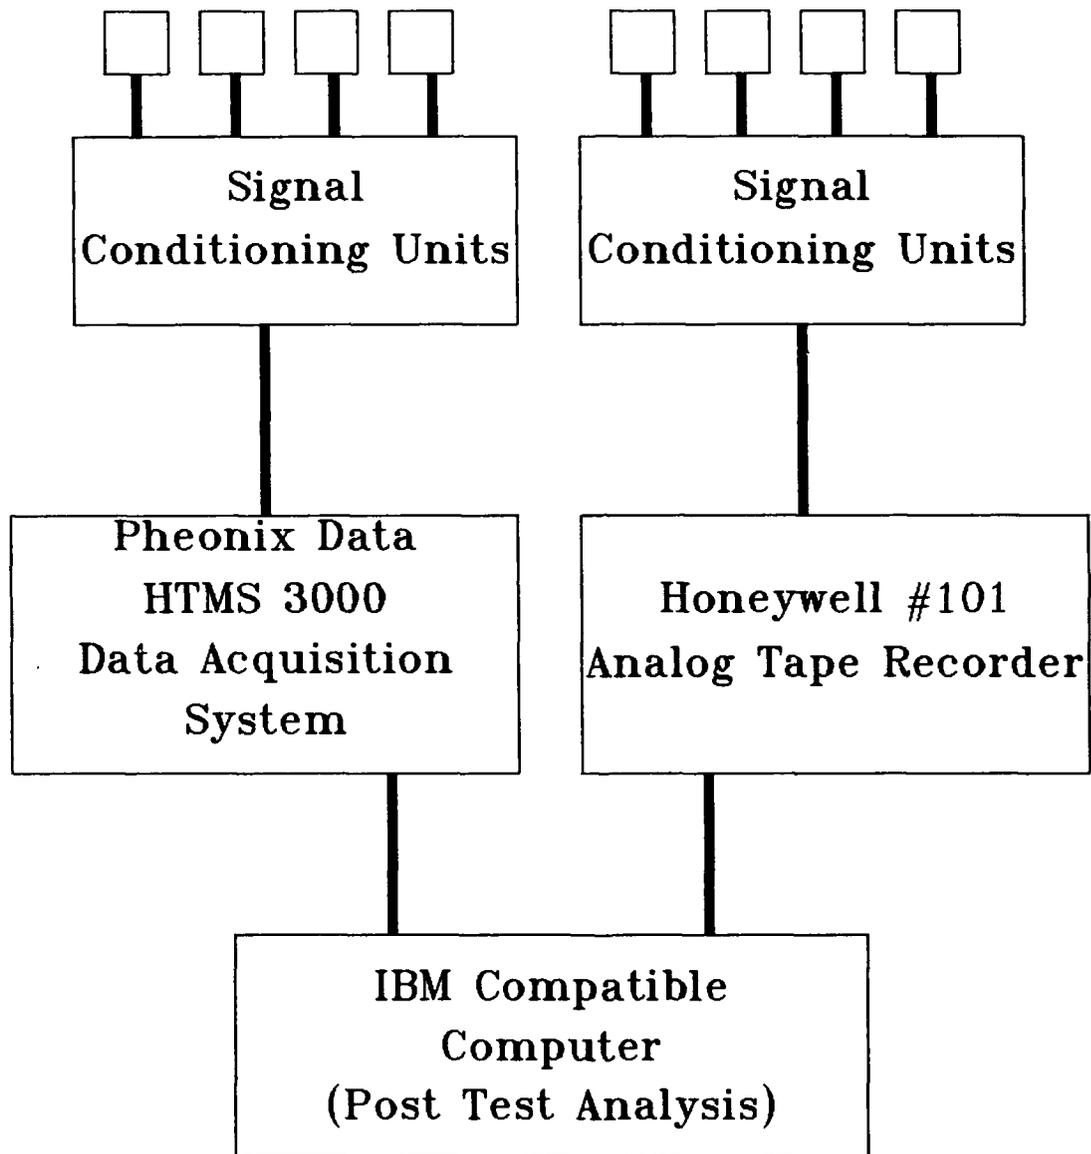
FIGURE 8. INSTRUMENTATION SCHEMATIC

A functional diagram of the data collection instrumentation system is shown in figure 8. Each sensor was initially checked and calibrated with a dedicated signal conditioner. The raw data were then filtered at 1000 cycles per second (Hz), and digitalized, and then sampled at approximately 5,000 samples per second. The data were stored on a Phoenix Data HTMS-3000 Data Acquisition System for a permanent record and for subsequent data reduction. An IBM compatible computer was used for post-test analysis and generation of graphs.
