Technical Report GL-93-6
May 1993

**US Army Corps
of Engineers**
Waterways Experiment
Station

Geogrid Reinforced Base Courses for Flexible Pavements for Light Aircraft: Test Section Construction, Behavior Under Traffic, Laboratory Tests, and Design Criteria

by *Steve L. Webster*
Geotechnical Laboratory

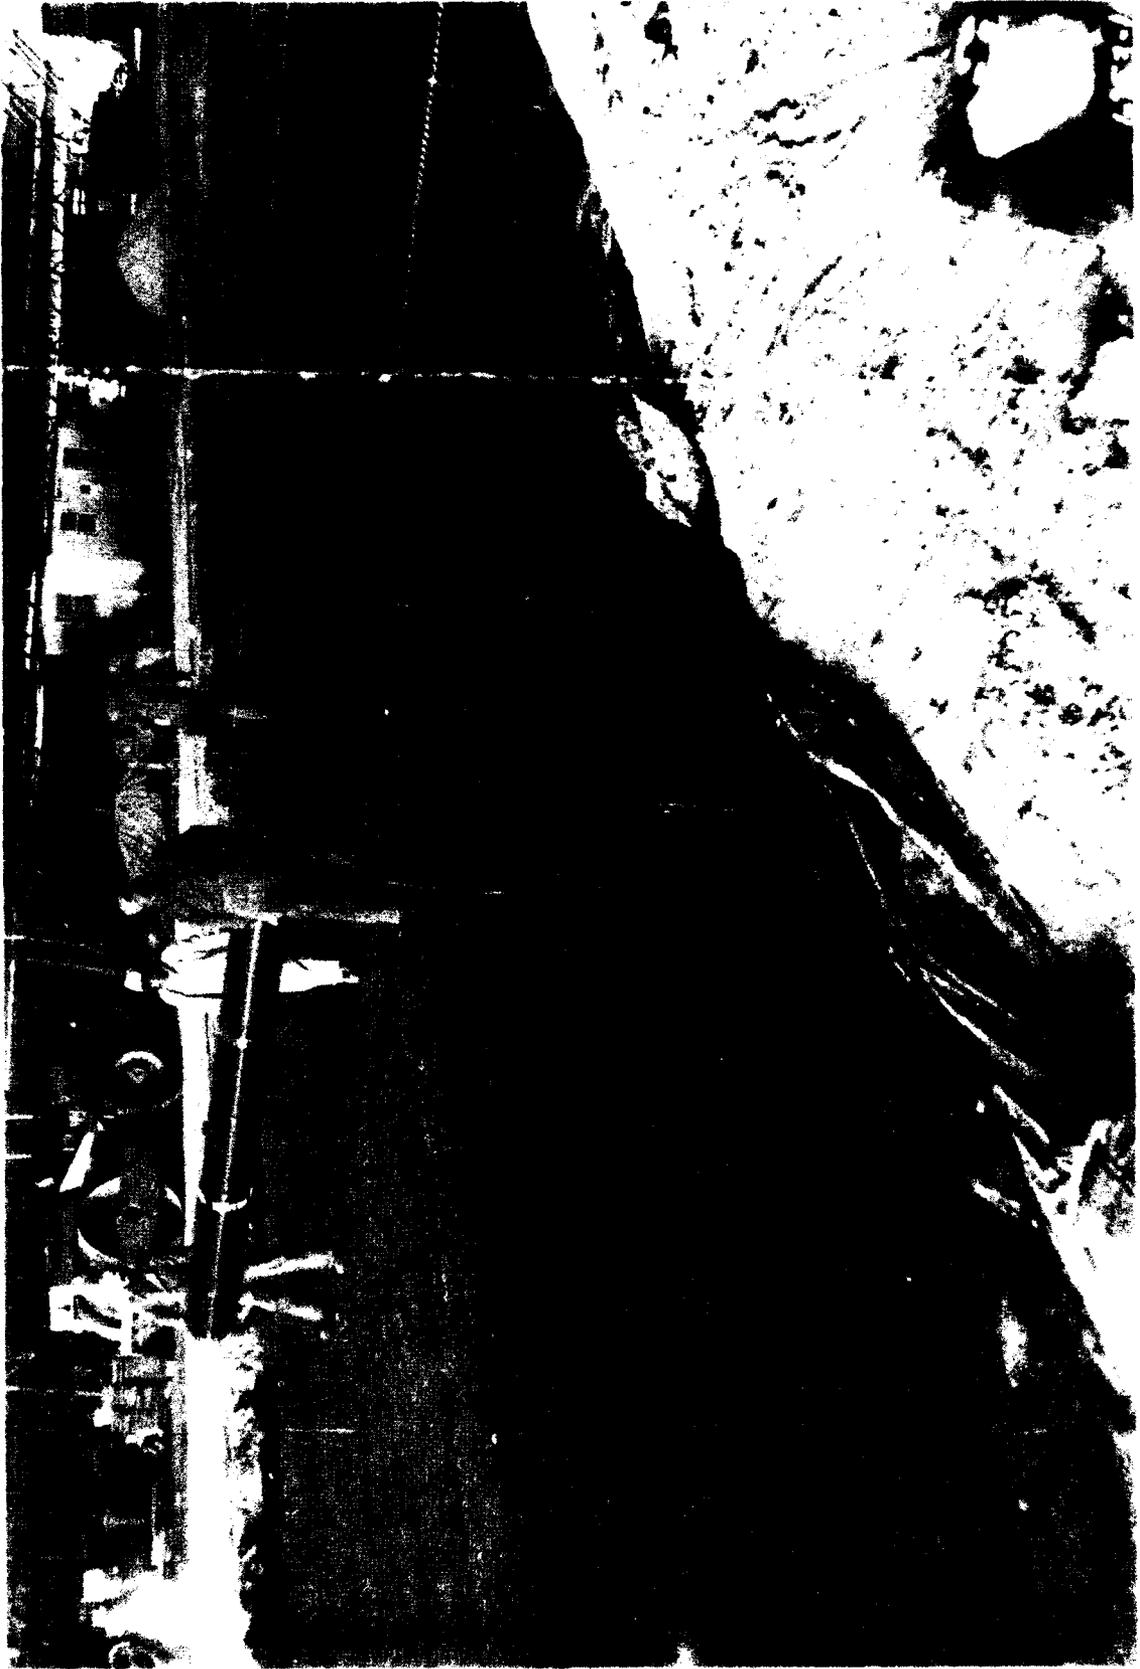
Figure 1b. Geogrid installed on the subgrade

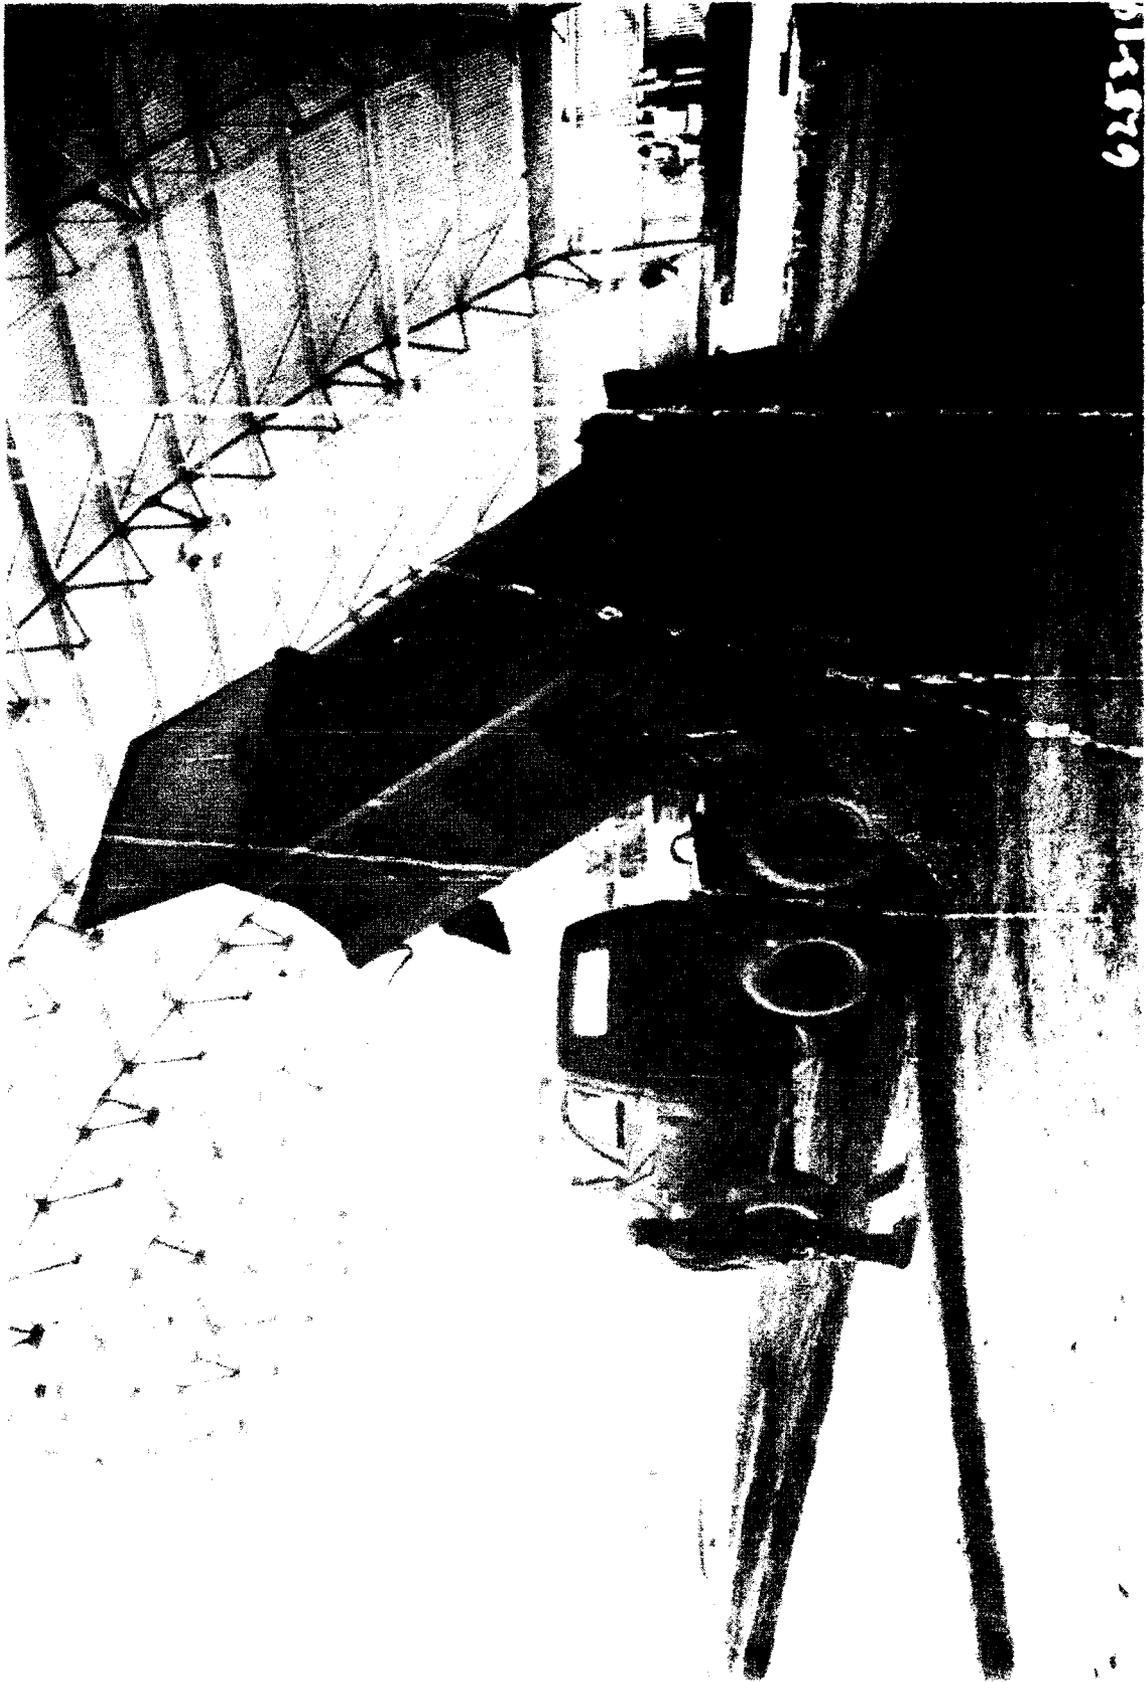
Figure 16. Installing crushed limestone base course

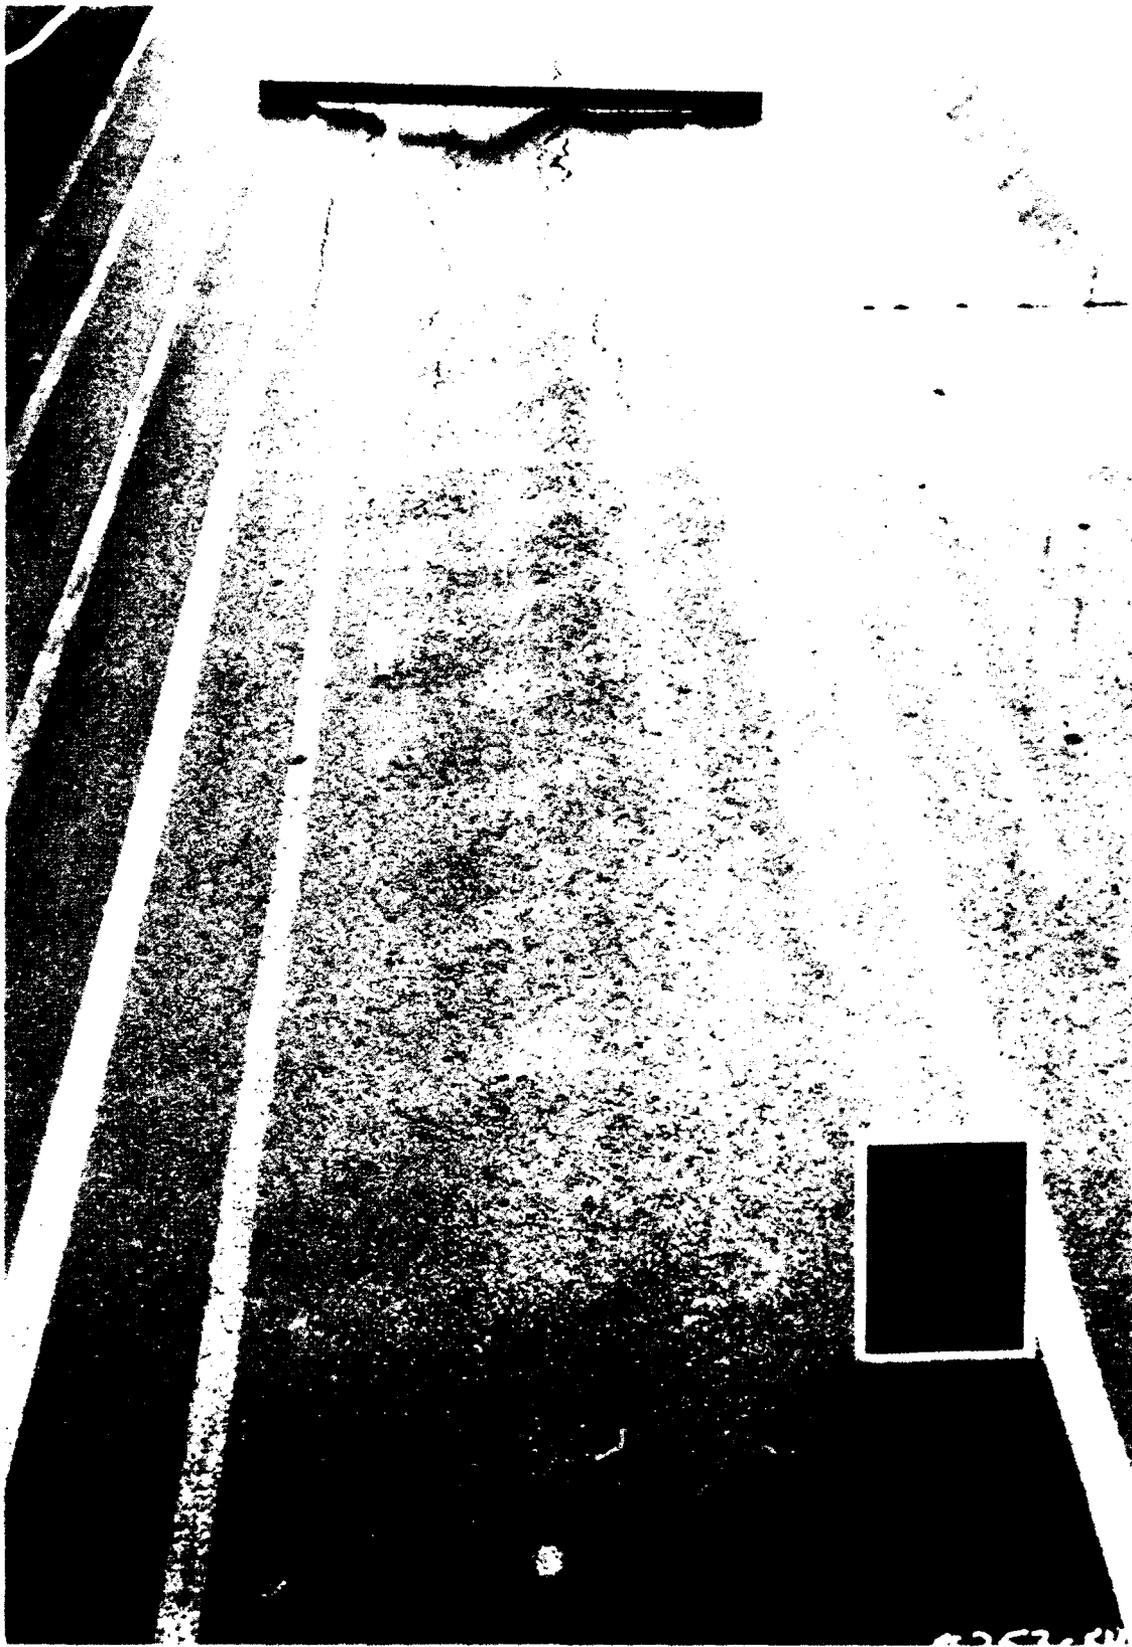
Figure 49. Lane 1, Item 3 (6-in. base, reinforced) and Item 4 (6-in. base, control) after 2016 passes of traffic

a. Lane 1. Test items 1 and 2 showed no visible damage and had less than 1 in. of rutting at the conclusion of traffic tests. Figure 49 shows items 3 (6-in. base, SS-2) and 4 (6-in. base, control) after 2016 passes of traffic. The traffic lane is outlined by the two wide painted lines in the photo. The perpendicular line across the traffic lane marks the change from item 3 (bottom of photo) and item 4 (top of photo). Item 3 had an average rut depth of 0.5 in. while item 4 averaged just over 3 in. The longitudinal cracks and severe rutting in item 4 virtually stopped at the line separating the two items. Figure 50 (looking in opposite direction from figure 49) shows the rutting in item 4 and a portion of the AC surface removed. Two clay subgrade ridges were visible just beneath the AC layer (dark areas at C/L and 8-in. left of C/L on the pin board). Aggregate skid marks were visible on the surface of what was left of the base layer. The skid marks indicated that the base material had moved laterally toward the outside edges of the traffic lane. Figure 51 shows the trench after the remaining base material was removed. The two subgrade ridges can be seen protruding up to the bottom of the AC surfacing. The base thickness was approximately 7.5 in. thick just outside the right side (East) lane line. Figure 36 shows the cross-section elevations for the trench (East is on the left side of figure 36). The mode of failure was lateral movement of the base material originating at the base/subgrade interface. The geogrid reinforcement prevented this from occurring in item 3. Figure 52 shows the trench after some of the subgrade material was removed. The vertical face on the side of the trench shows the material layer interfaces at this failure location.

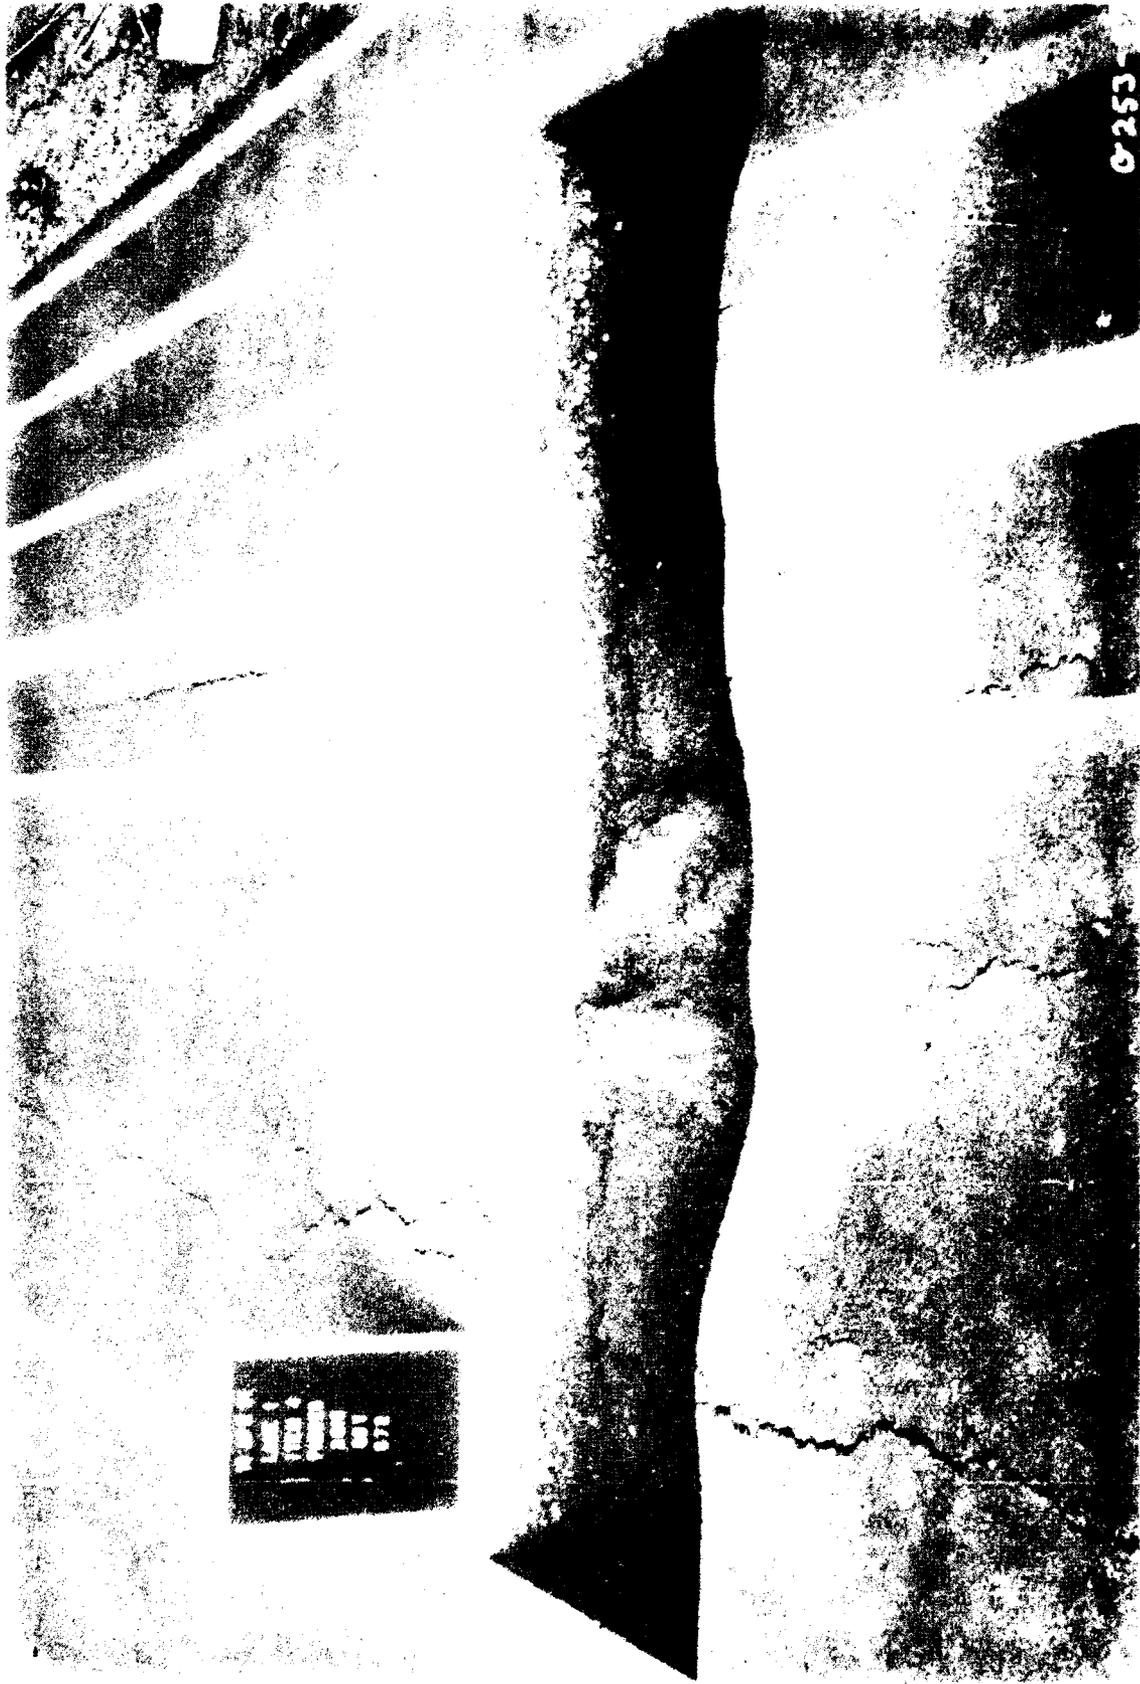
Figure 1. Fracture in base of top of base material removed.

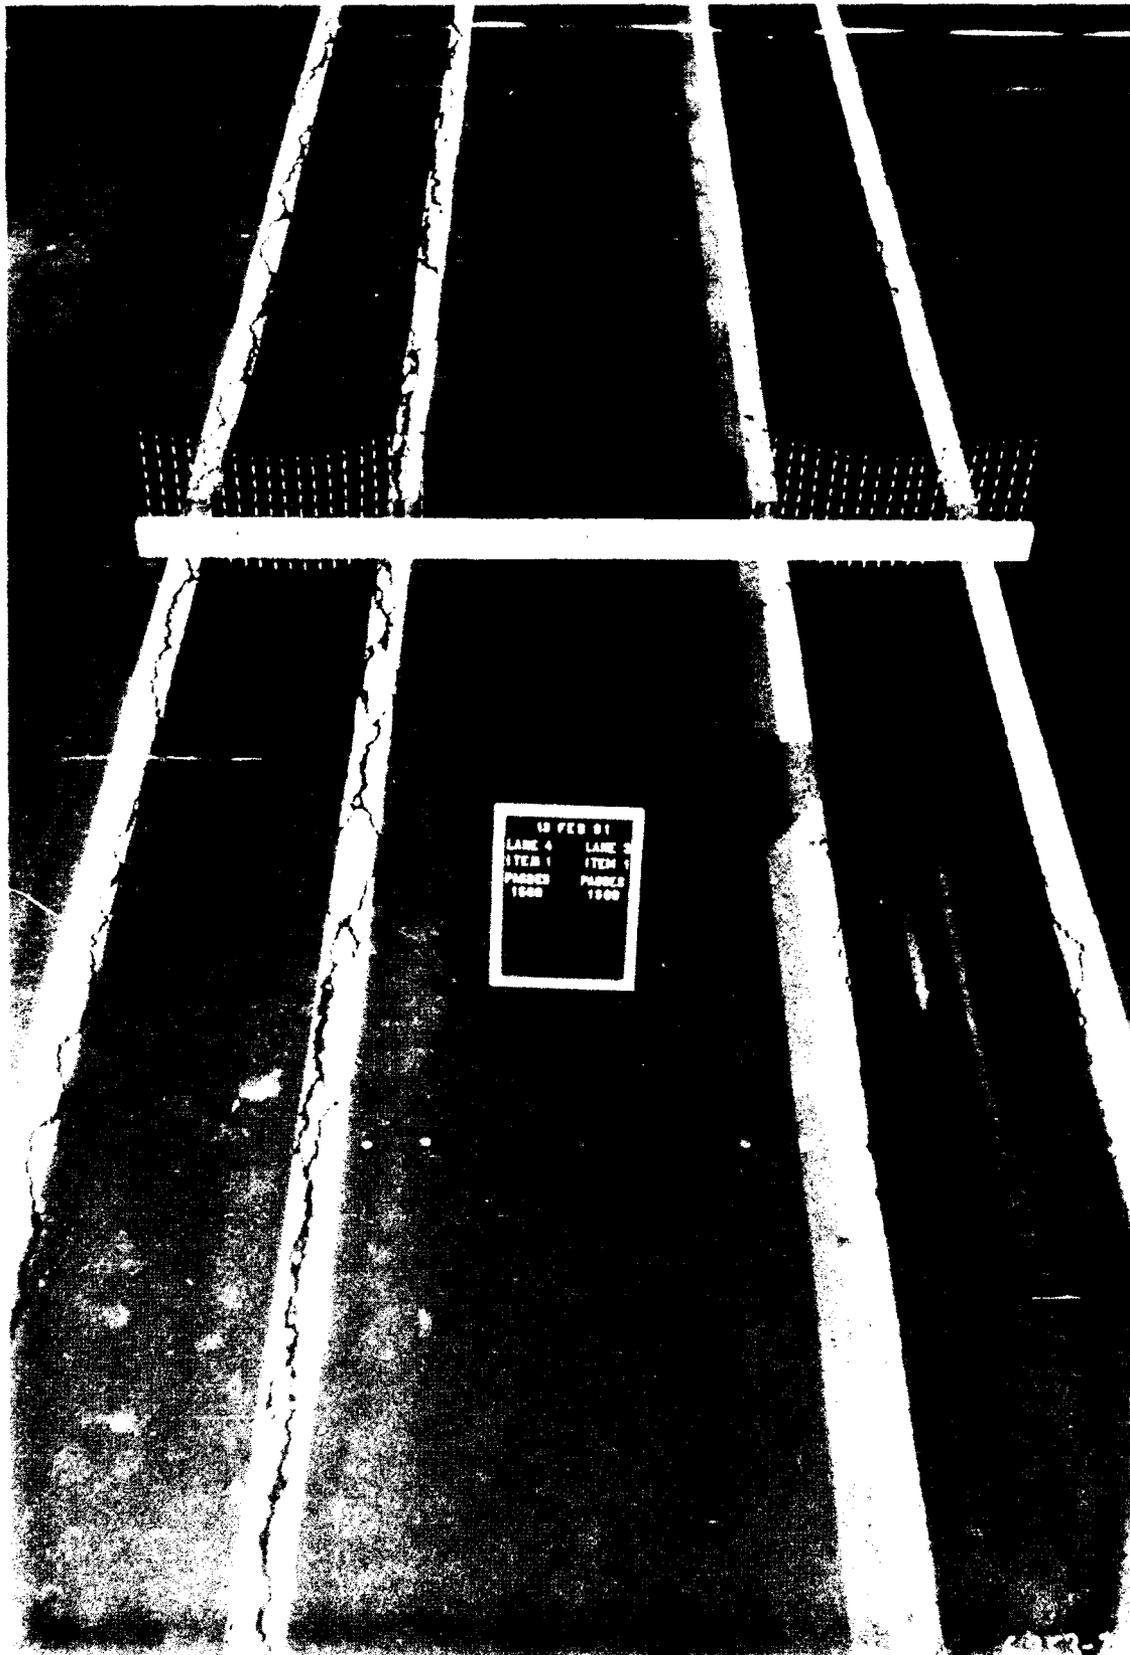
Figure 53. L111 (Geogrid 2) on left and L111 (CR 702) on right after 1000 passes

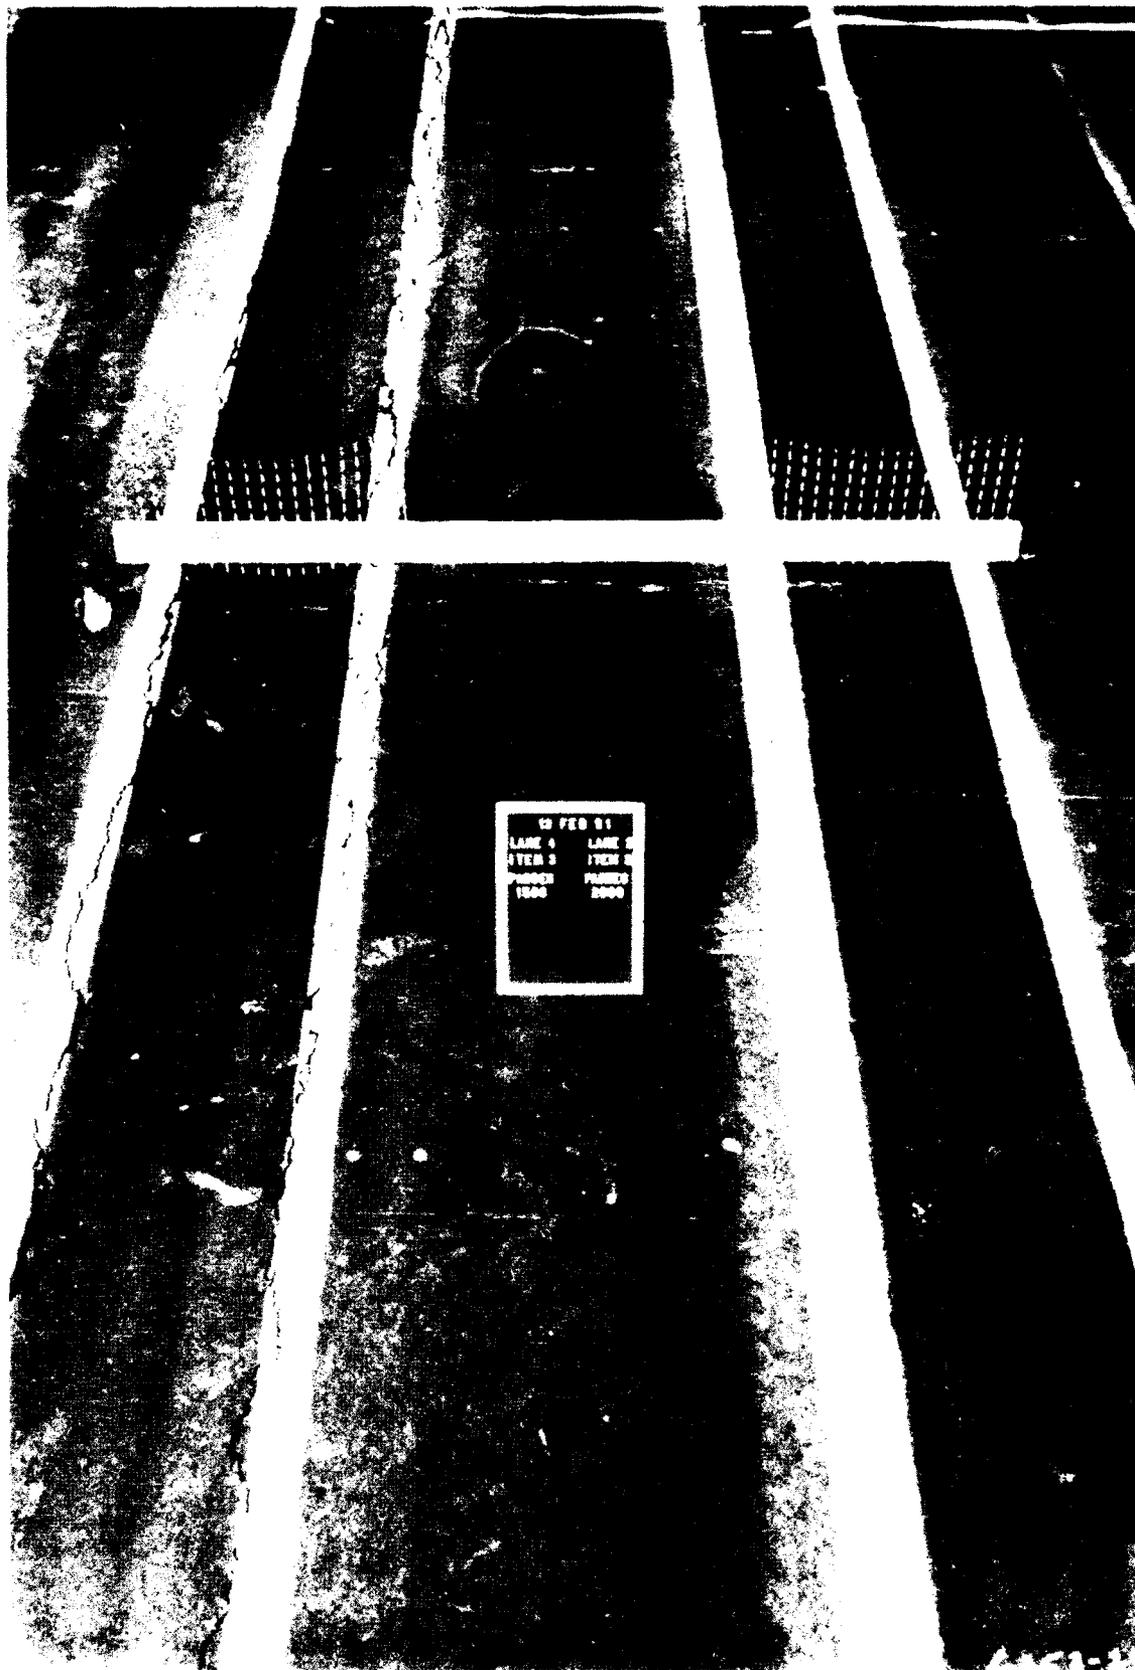
Figure 55. L413 (Fortrac 35/20-20) on left after 1500 passes and L313 (SS-2) on right after 2000 passes

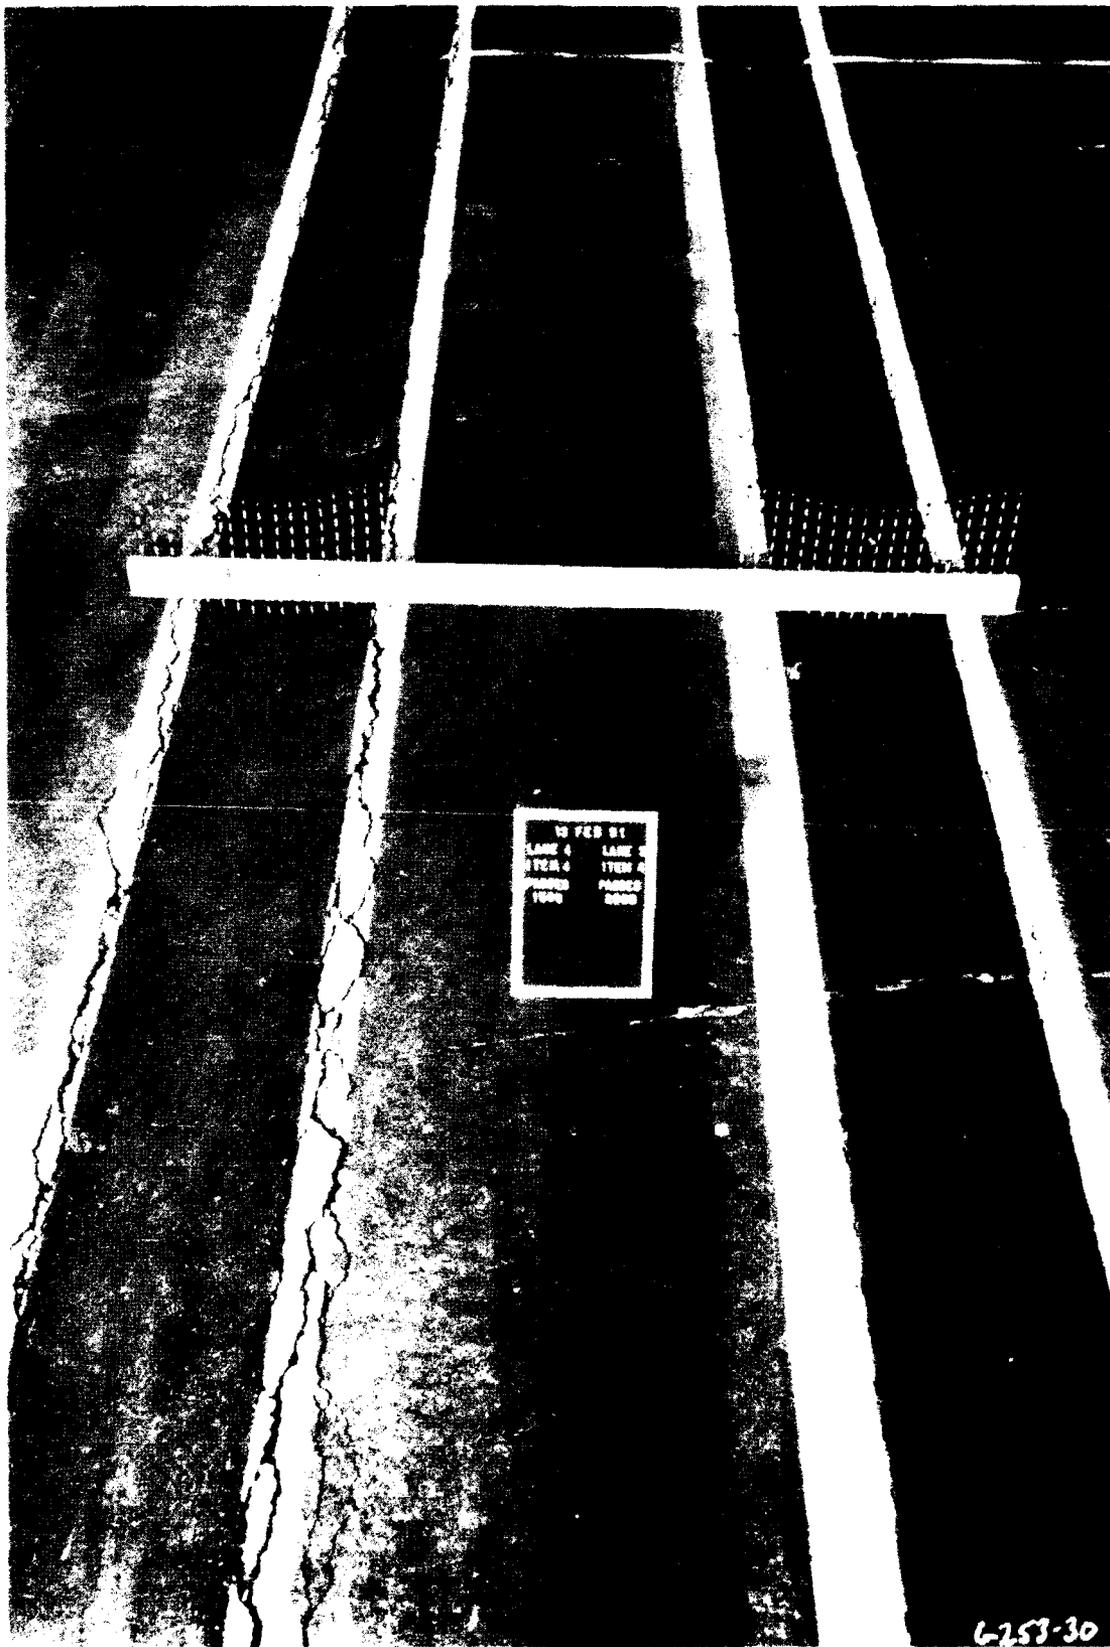
Figure 56. L4I4 (control) on left after 1500 passes
and L3I4 (SS-1) on right after 2000 passes
