AERONAUTICAL RESEARCH LABORATORY

Technical Report 34

AN ASSESSMENT OF COMSCAN,
A COMPTON BACKSCATTER IMAGING CAMERA, FOR THE ONE-SIDED
NON-DESTRUCTIVE INSPECTION OF AEROSPACE COMPONENTS

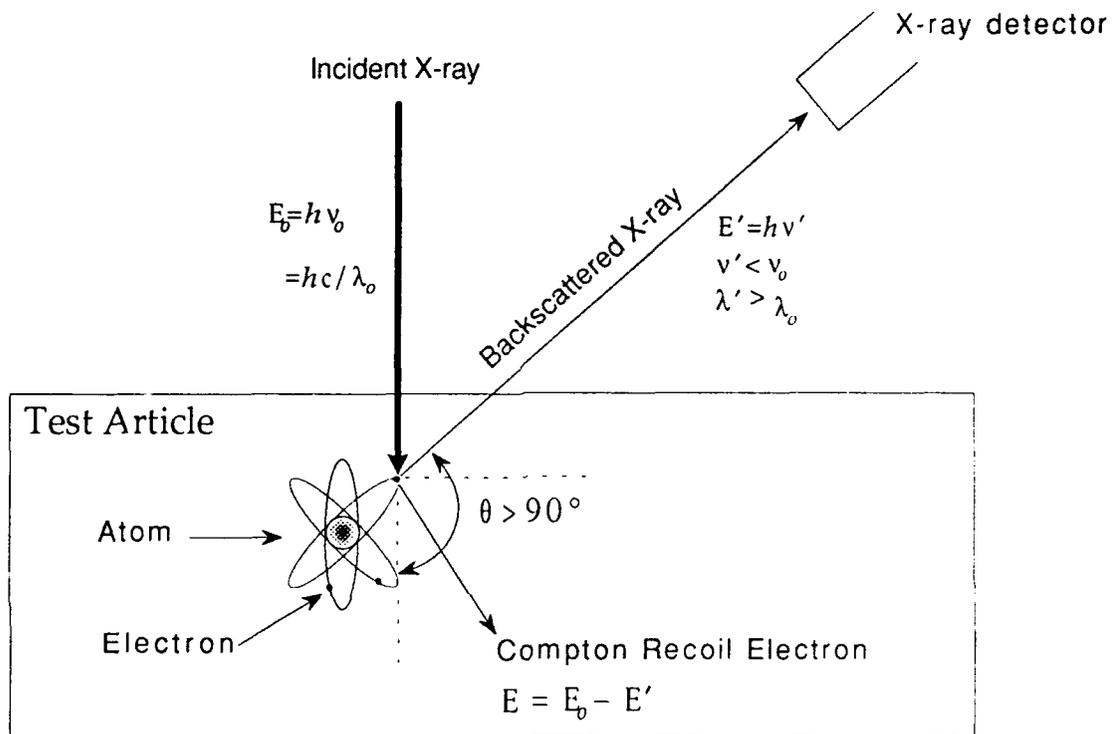
Figure 1. The Compton backscatter process. An X-ray photon of energy, E_0 , scatters from an atomic electron with reduced energy, E' .

The basis of Compton scatter imaging is the detection of X-rays scattered by electrons in the target specimen (Figure 1). For materials with an atomic number up to about thirteen (Aluminium) and for X-rays in the energy range from about 80 keV to 500 keV the dominant interaction process is Compton scattering.

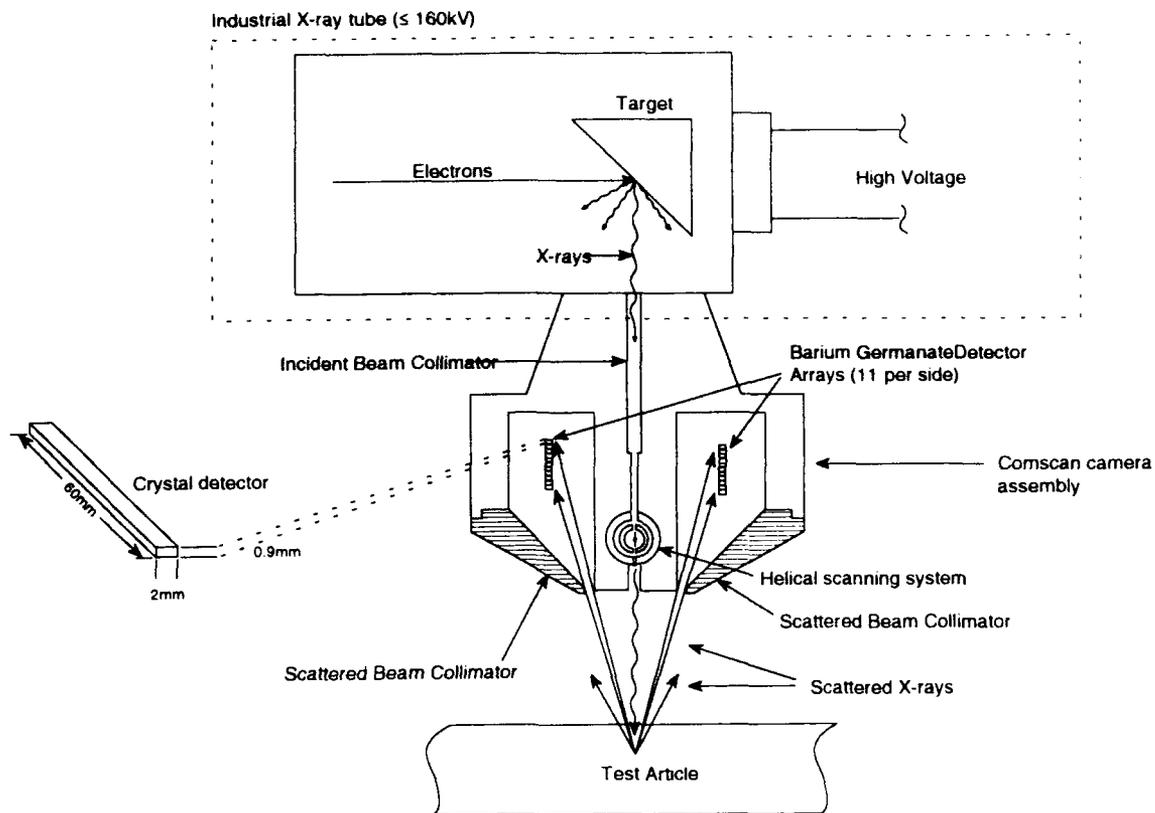
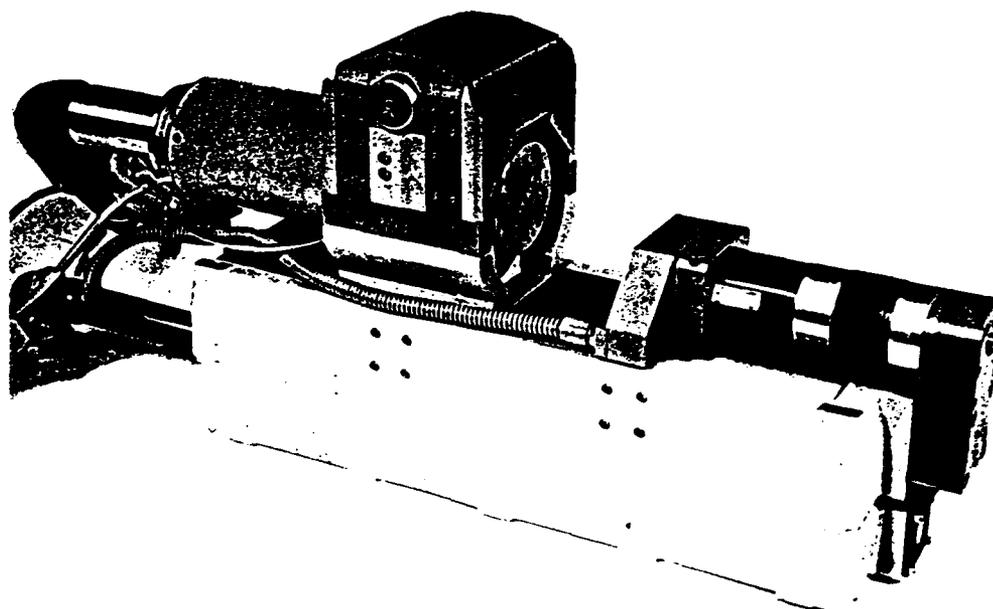
Figure 2. X-ray Source and Detector Geometry

A schematic of the COMSCAN system developed by Philips is shown in Figure 2. X-rays are produced by a conventional industrial X-ray tube operating at up to 160 kV and 18.75 mA (3kW total power). Line scanning and collimation of the X-rays into a pencil beam are achieved simultaneously with a novel rotating collimator system. The crossover region of helically cut slits (diamond shaped) on concentric drums generates a 'hole' or exit slit which passes, unattenuated, a portion of the fan beam produced by the X-ray tube. As the drums are rotated by a small motor the result is a flying X-ray spot (pencil beam) of dimensions about 0.5 mm*0.5 mm at the exit surface of the collimator. The complete raster pattern is generated with the aid of a motor which drives the entire camera assembly, consisting of the X-ray tube and detectors, forward at the end of each line until the required area has been scanned. The entire camera assembly consisting of the X-ray source, detectors, scanning motors and associated electronics is integrated into a single portable unit.

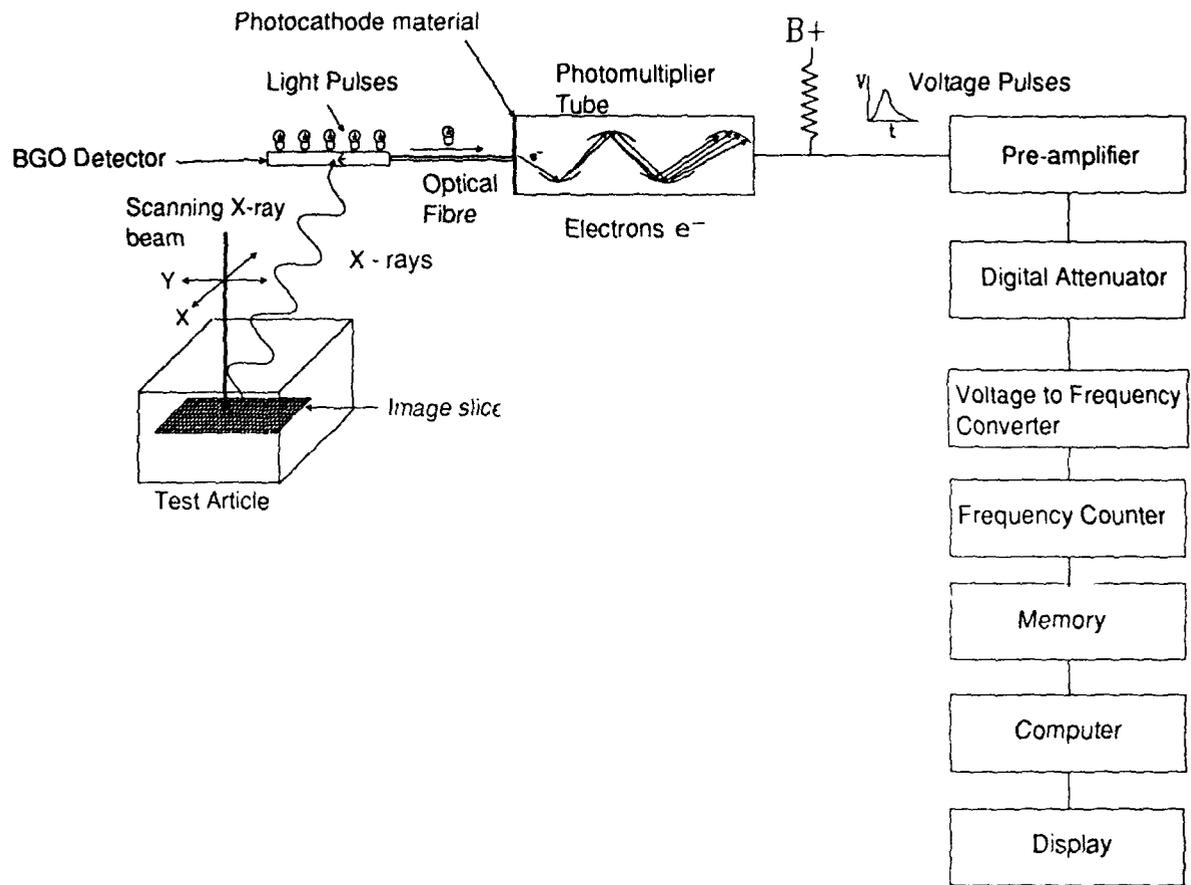
Figure 3. Basic components of the Comscan System.

The data are acquired by the process illustrated in Figure 3. Two independent sets of Bismuth Germanate ($\text{Bi}_4\text{Ge}_3\text{O}_{12}$) scintillation detectors intercept the backscattered X-rays through two fixed slit collimators placed symmetrically with respect to the exit slit.

There are two banks of 11 detectors each on opposite sides of the exit slit, each detector measuring approximately $0.9 \text{ mm} \times 2 \text{ mm} \times 60 \text{ mm}$. Each detector acquires data, in the form of scattered X-ray photons, from a different depth within the specimen resulting in 22 image slices with one pass. Odd and even image slices are recorded by alternate detectors which lie on opposite sides of the exit slit.

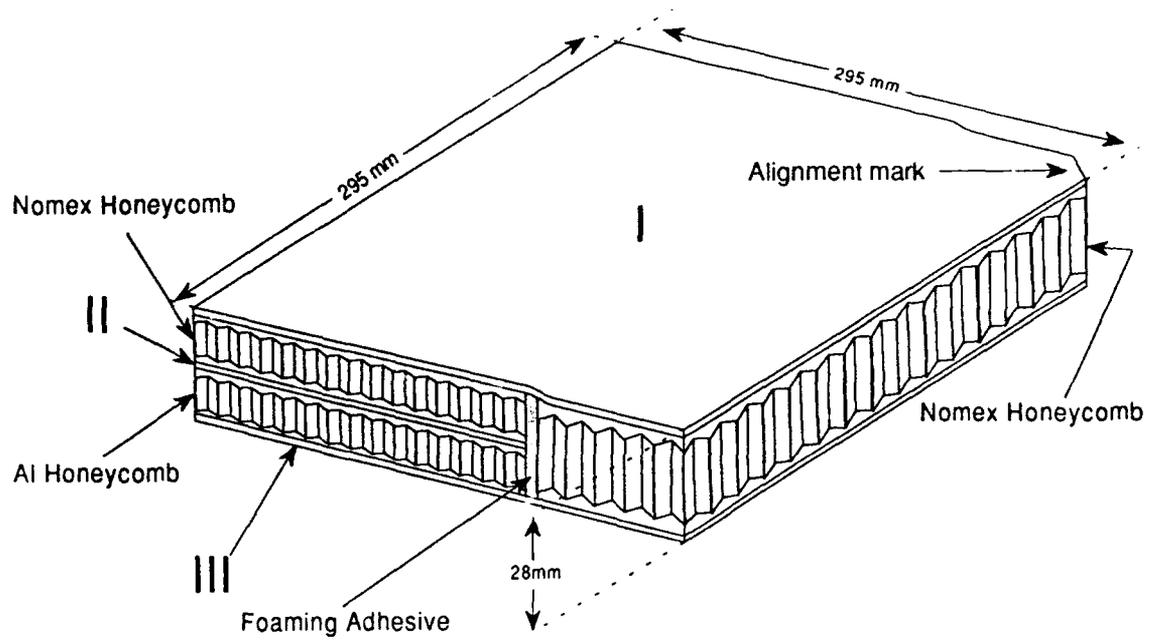
Figure 6. Specimen P1.

Two honeycomb composite specimens were manufactured at ARL for this work. Only the more complex of the two, designated P1, was scanned. This panel is shown in Figure 6. It is a square panel of side length 295 mm notched at one corner for easy identification of orientation. The carbon fibre sheets are each 10 plies thick (total thickness approximately 1 mm) the layup sequence being +45°, -45°, 0°, 90°, 0°, 0°, 90°, 0°, -45°, +45°. A septum divides the panel internally, one part consisting of a 1" core of nomex honeycomb and the other a dual core of 1/2" aluminium honeycomb and 1/2" nomex honeycomb placed back to back and separated by another carbon fibre sheet identical in layup to the face sheets. The surface directly above the join of the different sections is stepped owing to a slight thickness mismatch and the join line has been filled with a foaming adhesive.

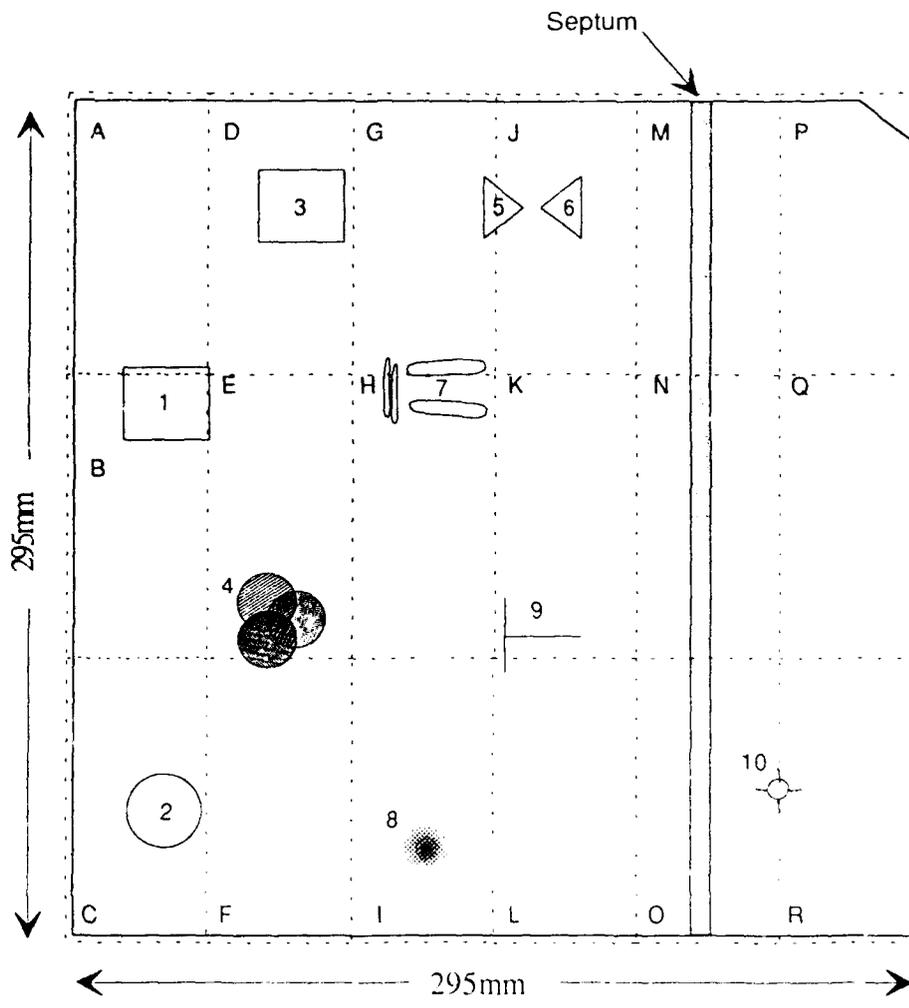
Figure 7. Plan view of specimen P1 showing implanted defects/features in the upper (I) and middle (II) composite skins. The dashed lines denote boundaries of individual scan areas and numbers are used to specify individual features.

Artificial defects were placed in all three skins and between the skins and honeycomb core. Figures 7 and 8 show the position and type of each defect and Table 2 gives a brief description of each. The results are described below.

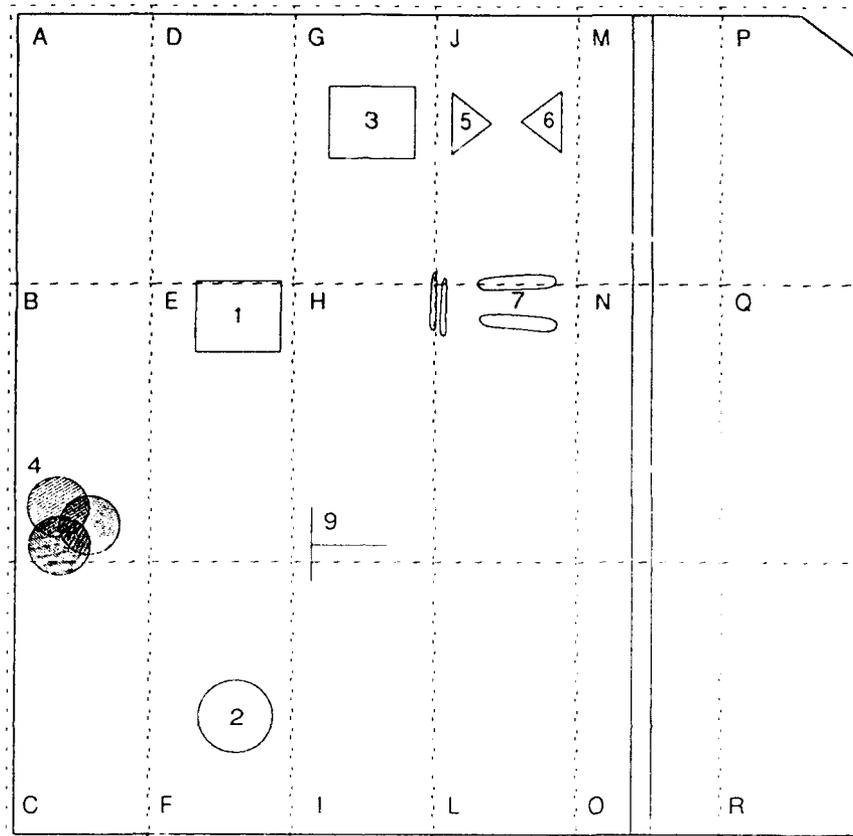
Figure 8. Plan view of specimen P1 showing implanted defects/features and their position in the lower (III) composite skin.

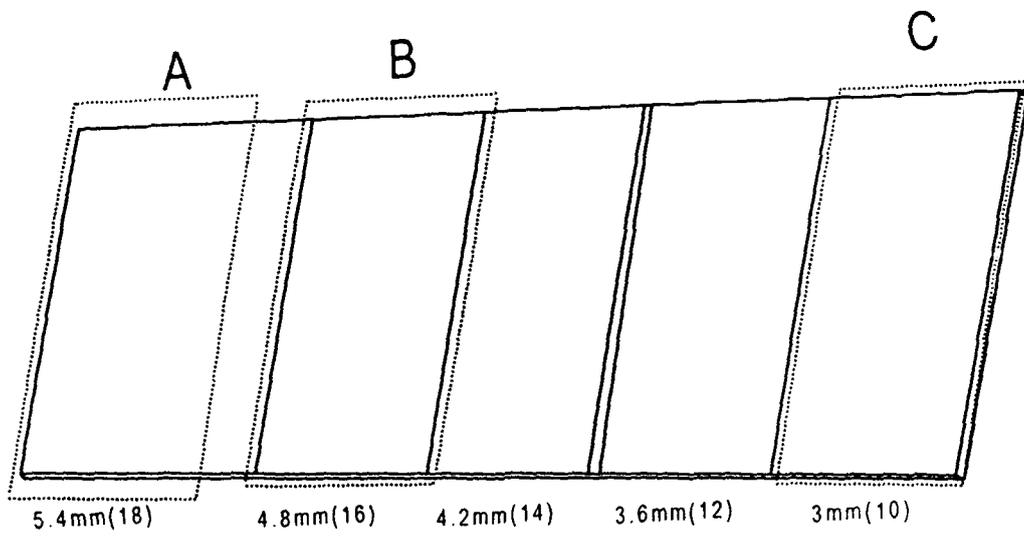
Figure 9. Step wedge specimen P2. Dotted areas refer to sections which were scanned (refer to text) and the numbers in parentheses refer to the part thickness in plies.

Panel P2 (Figure 9) is a carbon fibre composite step wedge specimen made up of woven fibre plies. The panel itself was believed to have been manufactured as a standard for ultrasonic inspection and although defects were known to exist in the panel the type of defect was unspecified. A transmission X-ray, Figure 10 (a), of the part shows a series of irregular dark patches and these are also visible as lighter areas in the COMSCAN images (Figure 22). The defects, as seen by COMSCAN, appear to be at or very close to the surface of the part. An ultrasonic C-scan over the same area is shown in Figure 10 (b), however, shows a variety of overlapping defects, probably Teflon inserts, of which the most evident is at a depth no closer than the middle of the panel.

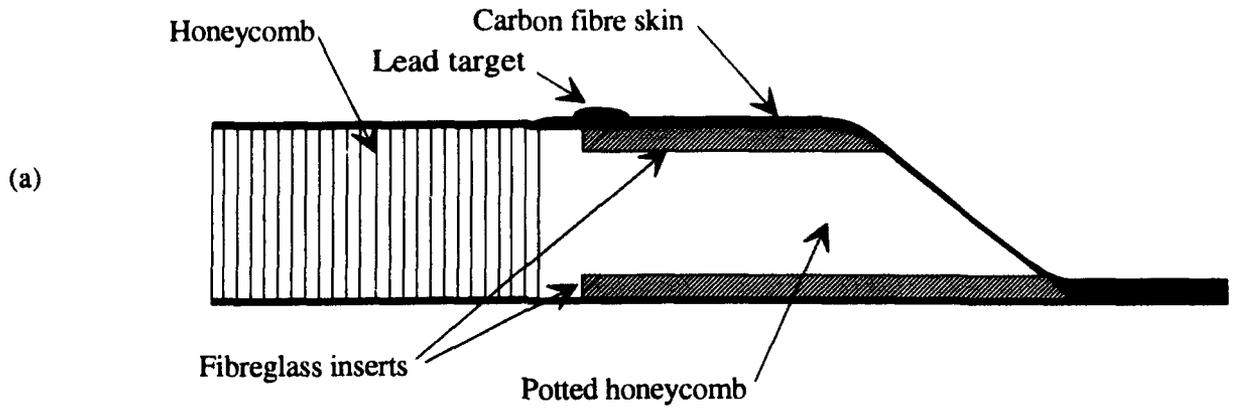
Figure 23. (a) Cross-sectional view of specimen P3.

(b) Image obtained by COMSCAN

Slice 3 Depth~3mm. The bright lower half of the image is from the fibreglass insert which is surrounded by the potted honeycomb (grey). Dark spots within the grey area indicate porosity which was later confirmed by visual inspection of a cross-section of the part. At the left edge is a circular lead target used in an earlier radiographic inspection.
