EVALUATION OF CRACK ARREST FRACTURE
TOUGHNESS OF PARENT PLATE, WELD METAL
AND HEAT AFFECTED ZONE OF BIS 812 EMA SHIP
PLATE STEEL

MRL-TR-93-9

MATERIALS RESEARCH LABORATORY

MRL Technical Report
MRL-TR-93-9

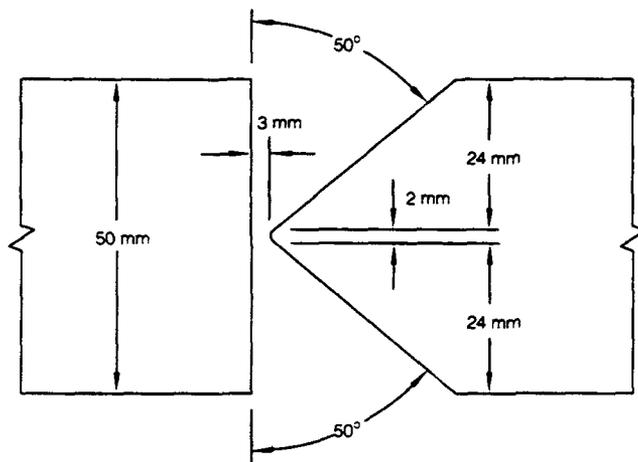
Welding of BIS 812 EMA steel was performed using multipass weld runs on a K-type weld preparation profile as shown in Figure 2. The material was supplied in the welded condition by the Australian Submarine Corporation (ASC). The welding procedure employed [4] by ASC was manual metal arc welding (MMAW) for the initial root pass and submerged arc welding (SAW) for subsequent fill and cap passes. Figure 3 shows the weld sequence and total number of passes. Two welded coupons were supplied and each was subjected to ultrasonic, x-ray and magnetic particle non destructive test procedures to ensure minimum defect levels.

Figure 2: K-type weld preparation.

The weld preparation selected for determining arrest toughness of the weld metal and HAZ is the K-prep. as shown in Figure 2. The K-prep. weld is not used in the fabrication of submarine hull segments but has been used in this work to allow the notch tip of the specimen to be positioned in the weld metal or HAZ and encourage crack propagation entirely within that microstructure as illustrated in Figure 5. For weld metal specimens, the notch is positioned in the centre of the weld and for HAZ specimens, 1 to 2 millimetres from the fusion boundary.

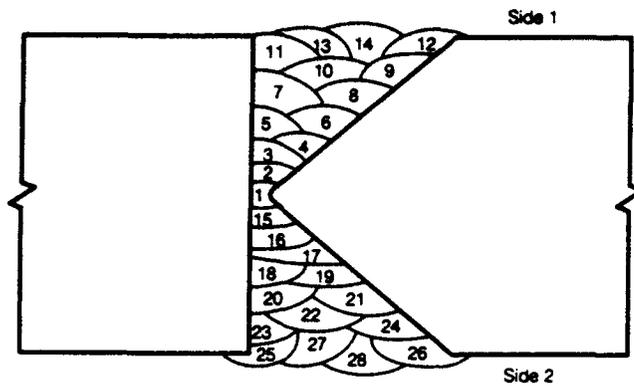
Figure 3: Weld sequence and number of passes [4] for BIS 812 EMA K-preparation weld.

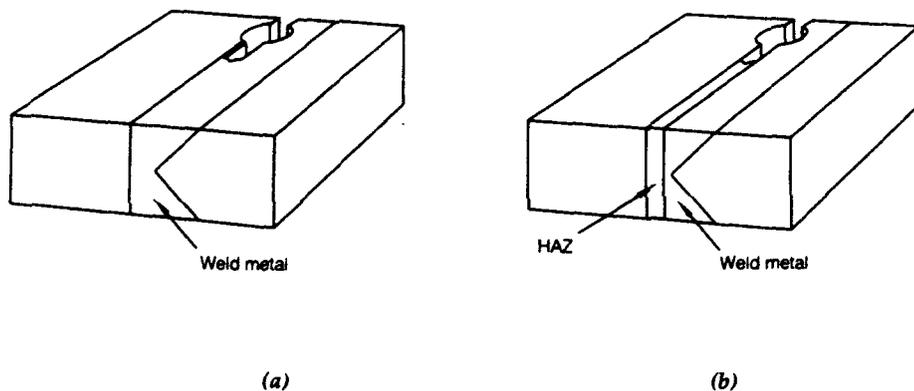
Figure 5: Positioning of K_{Ia} specimen notch with respect to (a) weld metal and (b) heat affected zone.

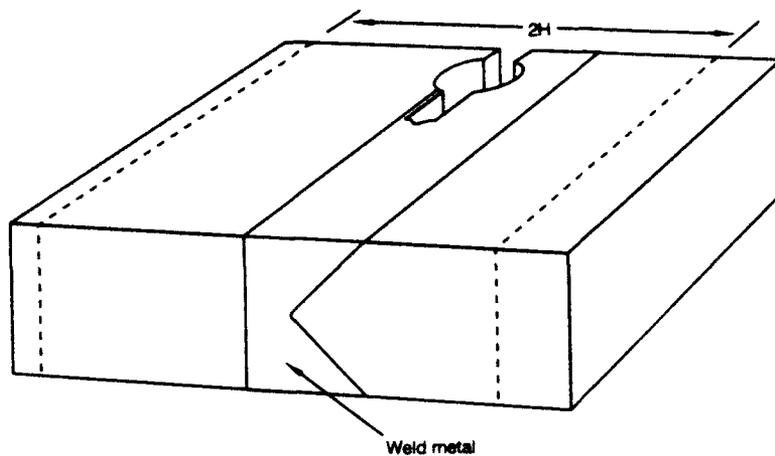
Figure 6 illustrates how the weld metal and HAZ regions are located for positioning of the crack starter notch. The specimen is machined to size except for the 2H dimension which is deliberately kept oversized. The end faces of the specimen are etched to show the weld profile, allowing the weld metal and HAZ to be identified. Once these regions have been identified the notch can be positioned and the 2H dimension reduced to that of the ASTM specification for assessment of crack arrest fracture toughness [5].

Figure 6: Oversize K_{Ia} specimen showing finished specimen size indicated by dashed lines.

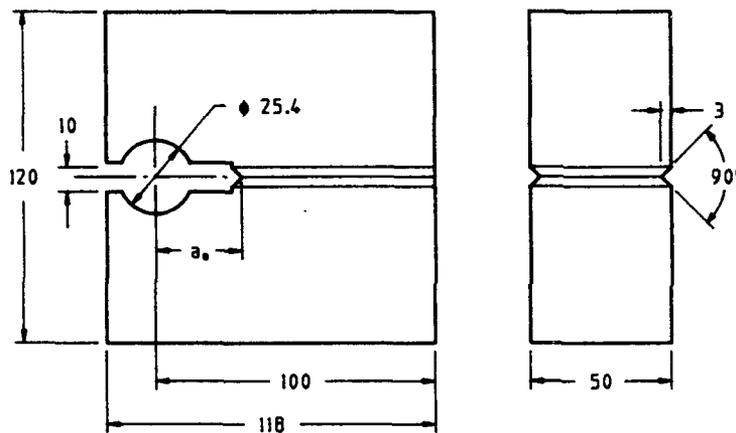
The specimen used for determining crack arrest fracture toughness, shown in Figure 7, differed slightly from the recommended test specimen configuration in ASTM E1221 [5]. The W/B (specimen width to thickness) ratio recommended by ASTM E1221 was decreased from 4 to 2 and the face groove depth was reduced from $B_n/B = 0.75$ (B = specimen thickness and B_n = nett thickness of the specimen at the face grooves) to (i) $B_n/B = 0.88$ and (ii) $B_n/B = 1.0$. A reduction in the W/B ratio allowed specimens of full plate thickness to be used without increasing the other specimen dimensions which may have required load levels greater than the test machine capacity, while earlier work [3] showed face grooves of the recommended depth of $B_n/B = 0.75$ caused a number of specimens to fracture into two. A reduction in face groove depth has been shown [6] to produce a reduction in blunt notch initiation toughness, K_{Ic} , which lowers the level of stored elastic strain energy prior to fracture. This reduction in strain energy reduces the total energy available for crack propagation, increasing the probability of cracks arresting within the specimen. Changing face groove depth also alters the propagating crack velocity which may affect the crack arrest fracture toughness.

Figure 7: K_{1a} specimen dimensions (showing 3 mm deep face grooves per side).
