# Fracture Analysis of an All-Ceramic Bearing System

Jeffrey J. Swab and Mary P. Sweeney

ARL-TR-512

September 1994

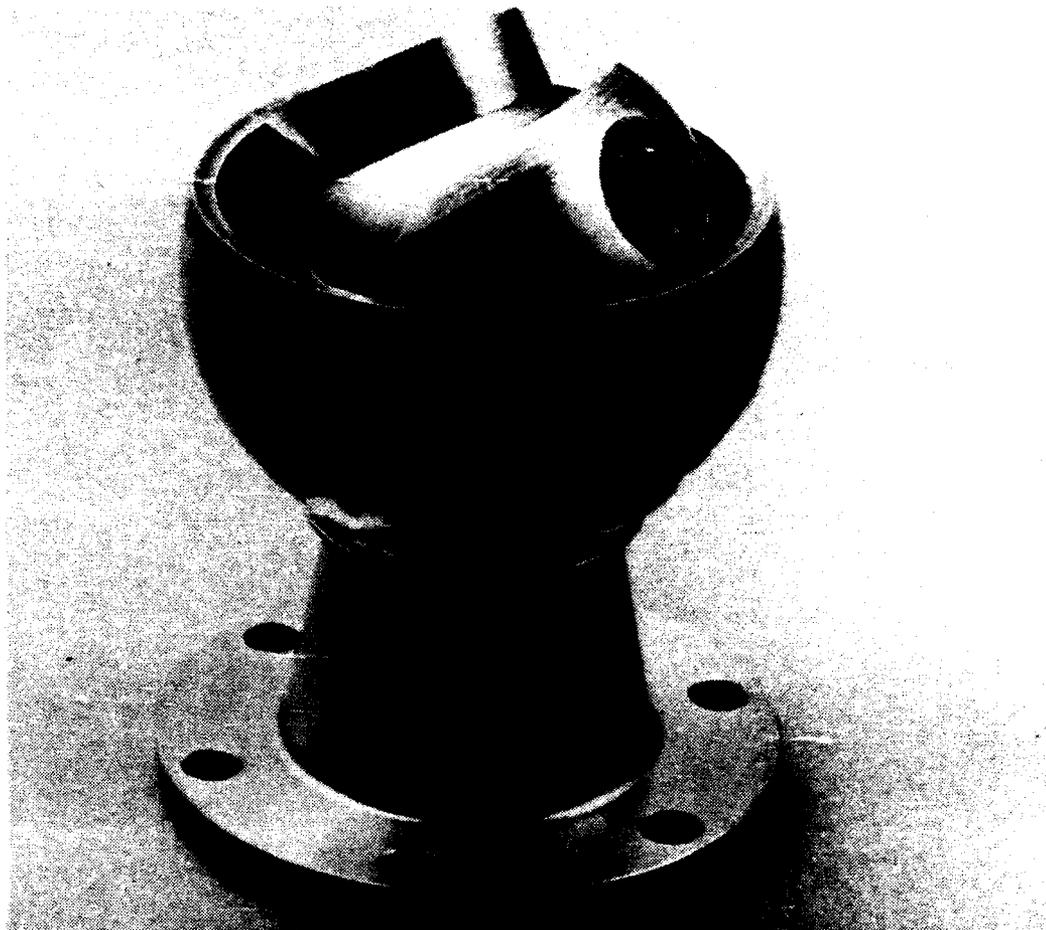
Figure 3. Gimbal assembly containing all-ceramic gimbal and spin bearings.

The IR seeker GOA, without the mirror magnet and optics, is shown in Figure 3. This assembly consists of two types of ceramic bearings: one duplex spin bearing, with each raceway containing six balls, Figure 4, and four gimbal bearings, each containing six balls, Figure 5. Ball spacing in the spin bearing is maintained by a lubricant-impregnated polyimide retainer. The gimbal bearing balls are caged in a beryllium-copper retainer and a hydrocarbon lubricant is injected. Both bearing lubricant systems were the same as used in the steel bearing systems.

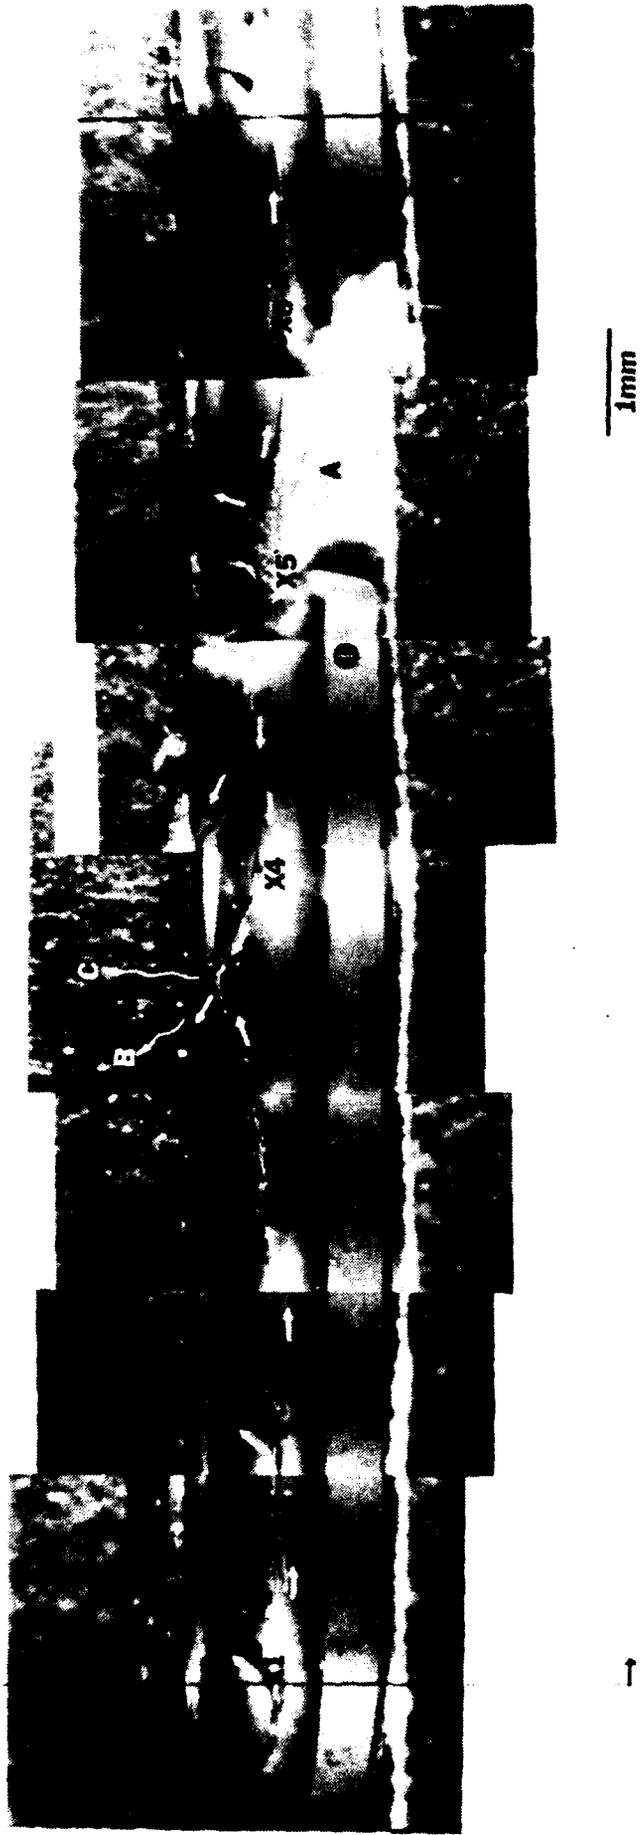
Figure 6. Montage of the reconstructed End #1 inner race. A is a possible area of fracture initiation. B and C are crack termination points. B is were the crack which propagated to the left of area A terminated and C is were the crack which propagated to the right of area A terminated. X indicates the approximate location of each ball. Arrows indicate the direction of crack propagation.

The reconstruction of End #1 showed that there were two macrocracks which combined to traverse the entire circumference of the raceway. It appears that both macrocracks initiated in the area labeled A with one macrocrack propagating to the left and the other to the right. This is confirmed by inspecting the entire crack propagation pattern and noting the intersection of the cracks at point C. One macrocrack propagated a short distance to the left of area A and was the first to terminate, at the top of the race, (point B). The second macrocrack propagated to the right of area A and traversed the remaining circumference of the raceway and terminated at point C when it encountered the free surface created by the first macrocrack.

Six areas of damage can also be seen in Figure 6. These damage areas coincide with the approximate location of the six balls (marked by the X's in the figure). The amount of damage in these areas appears to diminish as the macrocrack proceeds away from the initiation site.

of each reconstructed inner race. The race in Figure 6 is labeled as End #1. This is the forward race in the seeker, see Figure 2. The other race, Figure 7, is labeled as End #2.

Three parts, labeled 1, 2 and 3 in Figure 6, of the End #1 inner race were examined. Figures 8 and 9 show the fracture surface of part 1. Both photographs reveal the presence of a series of machining related microcracks which are approximately 25-30  $\mu\text{m}$  deep and connected to the raceway surface. An examination of this fracture surface at an angle, Figure 10, demonstrates that these microcracks have linked together in a step-wise fashion. Characterization of the fracture origin is as follows: Machining Damage, located at the surface with a depth of 25-30  $\mu\text{m}$ , (MS<sup>s</sup>, surface, 25-30  $\mu\text{m}$  deep).

The growth of microcracks can also account for the variations in the amount of damage at each ball location. First the stress at each ball location may be different, probably less than the stress in area A, which will affect how many and to what extent microcracks will grow. The interaction between the micro- and macrocracks will also influence the amount of damage. As the macrocrack propagates it will encounter the microcracks beneath and around each ball. The energy supplied by the macrocrack will cause many microcracks to grow simultaneously. Thus

the piece missing at each ball location (X1, X2, X5 and X6) is probably not a single piece but rather many pieces that were created due to this interaction. Each interaction will reduce the energy of the macrocrack resulting in less damage at the next ball location. This explains why the damage at X3 and X4 is significantly less than at the other ball locations.

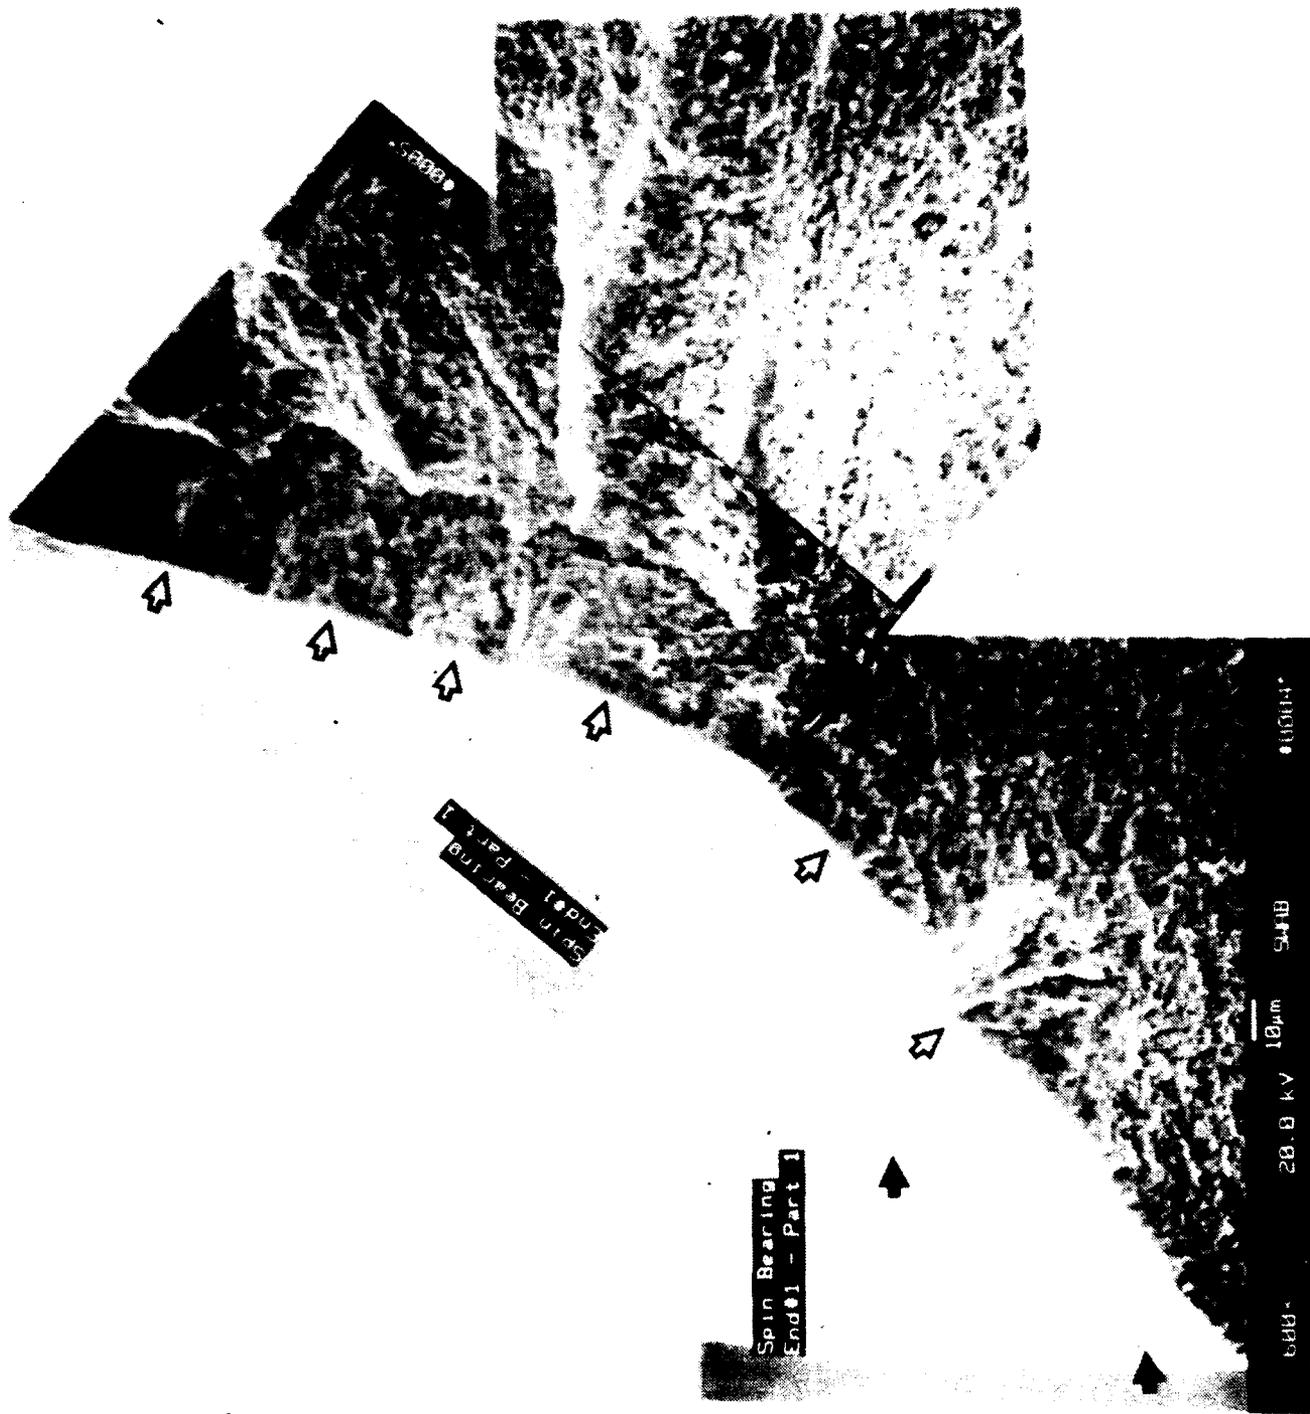
Figure 9. High magnification montage of the fracture surface of part 1 from End #1. Open arrows indicate the surface connected microcracks, (MSS, surface, 25-30  $\mu\text{m}$  deep). Solid arrows point out some of the machining striations in the raceway.

The first fractographic indication that the microcracks in this system were related to machining was the appearance (uniform shape and size) of the series of subsurface microcracks in Figure 9. Similar machining induced cracks have been shown to limit the strength of silicon nitride<sup>18</sup> and other ceramic materials.<sup>19</sup> Second was the step-wise propagation of the crack (see Figure 10) in part 1. Mecholsky et. al.<sup>16</sup> showed that grinding introduces two types of microcracks: one which is parallel to the grinding direction and one which is perpendicular to the grinding direction. The parallel microcracks are typically more severe. The grinding direction of the raceways is along the radial axis. Based on the stress state discussed previously the axial tensile stresses appear to be sufficient to grow the parallel (more severe) microcracks while the radial tensile stresses grow the perpendicular microcracks. These growing microcracks then link together, with the parallel microcracks becoming the steps and the perpendicular microcracks the risers, resulting in the step-wise propagation of the crack.

4) What can be done to reduce or eliminate these microcracks? - The most obvious answer is to use an alternate machining process that does not introduce microcracks in to the ceramic. Unfortunately at present, there are no alternatives to diamond grinding of silicon nitride. However, the following recommendations to adjust the machining procedure may be sufficient for this ceramic bearing application.

- 1) Develop a machining procedure specifically for the raceways.
- 2) Reduce the material removal rate during coarse grinding.
- 3) Eliminate grinding with coarse grit wheels.
