Technical Report SL-94-18  
September 1994

## Effects of Shear Reinforcement on the Large-Deflection Behavior of Reinforced Concrete Slabs

by Stanley C. Woodson

U.S. Army Corps of Engineers  
Waterways Experiment Station  
3909 Halls Ferry Road  
Vicksburg, MS 39180-6199

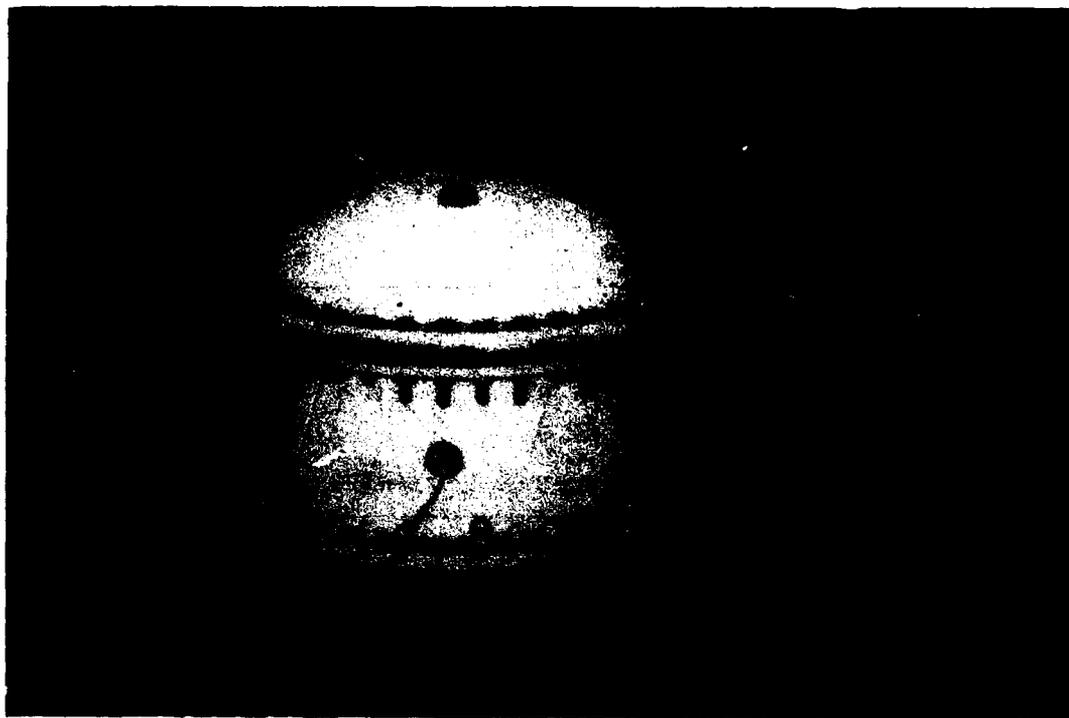
Figure 4.38. Four-Foot-Diameter Blast Load Generator

Sixteen one-way reinforced concrete slabs were statically (slowly) loaded with water pressure in the 4-foot-diameter blast load generator located at the U.S. Army Engineer Waterways Experiment Station (WES). The design, construction, and loading of the specimens are described herein. The responses of the slabs to the uniform loading and the effects of the reinforcement details on the responses are evaluated.
