FATIGUE BEHAVIOR OF A CROSS-PLY  
METAL MATRIX COMPOSITE AT ELEVATED  
TEMPERATURE UNDER STRAIN CONTROLLED  
MODE

THESIS

Leon B. Dennis, Captain, USAF

AFIT/GAE/ENY/94D-7

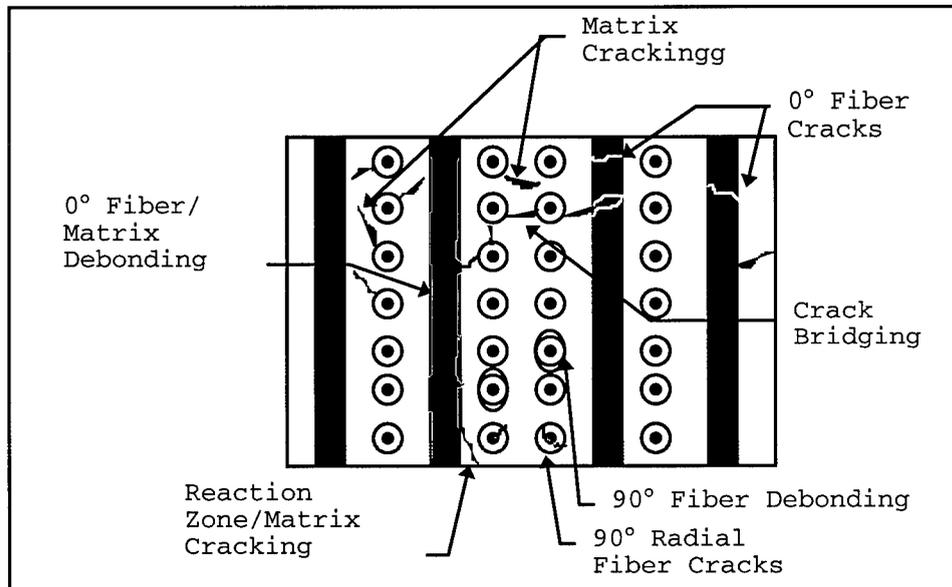
Figure 2.1: Typical MMC Crack Growth

MMC damage due to fatigue is complex as compared to most monolithic metals, which usually has a critical crack propagate along a single path. Experimental techniques are established for measuring both the crack length and predicting the crack growth rate [2]. This information allows a fatigue life to be predicted for the monolithic metal. Since in composites many cracks may develop simultaneously in the matrix, fibers, and/or the fiber-matrix interfaces, fatigue life prediction may be much more complex. Depending on the loading level, the cracks may develop and propagate primarily in the fibers, matrix, or both[10]. Figure 2.1 illustrates these typical type of crack locations. Because many simultaneous cracks may exist and/or be growing at a given time, specimen failure may not be caused by a single crack, but by the coalescence of the many cracks. Thus, the single crack growth criteria used for monolithic materials is not enough.

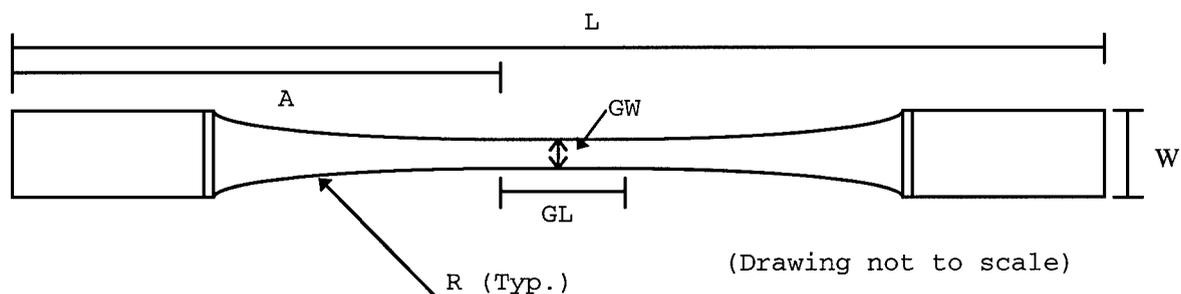
$L = 13.65$ cm	$A = 6.83$ cm
$GL = 1.905$ cm	$R = 34.8$ cm
$W = 1.270$ cm	$GW = 0.51$ cm

Figure 3.1: Dogbone Specimen Geometry

The design of the dogbone specimen involved tradeoffs between obtaining a maximum width reduction in the gage length versus a maximum radius of curvature at the specimen shoulder. Dogbone specimens frequently fail at the specimen shoulder because of localized stress concentrations caused by the high shear stress near the end of the transition in the shoulder region [3]. This requires a large shoulder radius to minimize the stresses and chances for failure. However the larger radius increases the specimen length, increasing the compression buckling problem. Figure 3.1 presents the resulting specimen design. The design was the result of tradeoffs among the shoulder radius, gauge length minimal area, and buckling considerations.

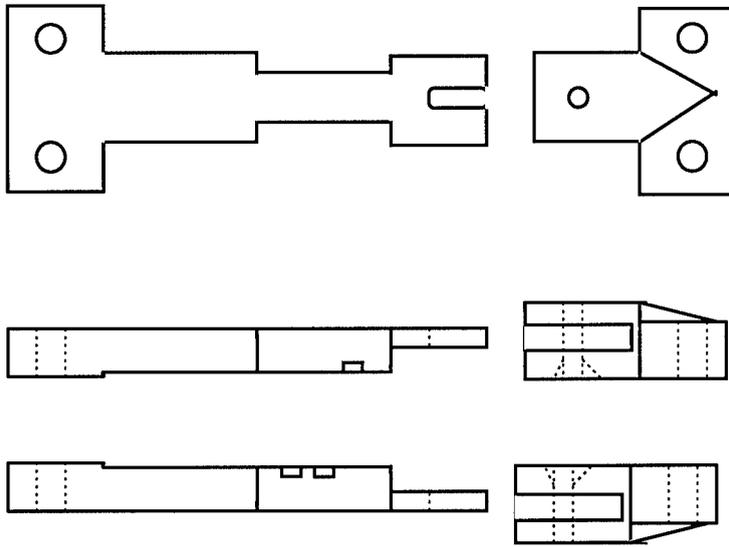
Figure 3.2: Buckling Guide Geometry

A slight modification of the guide (Modified AFIT Buckling Guide) was incorporated to strengthen the bending resistance to withstand the higher strain loadings of this study. An outside of the fork slider surface was added (See Fig 3.2). This addition served to strengthen the guide and prevent out of plane bending at the higher loads.

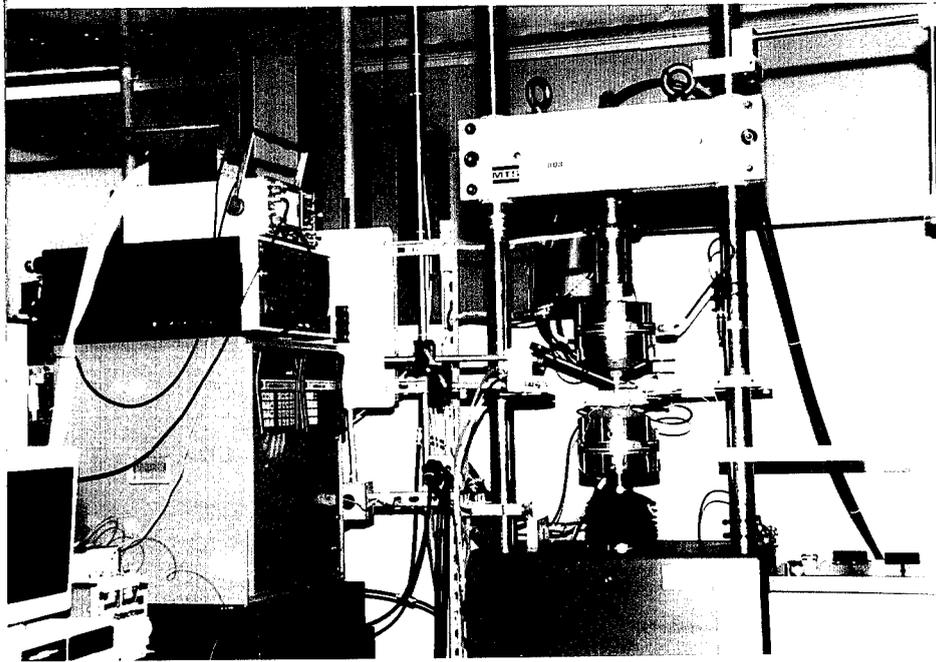
Figure 3.3: Fatigue Testing Apparatus

Figures 3.3 and 3.4 illustrate the testing setup. The mechanical loading was accomplished on a 22 Kip servo-hydraulic motor test frame (MTS model 823) with water cooled hydraulic grips. A ceramic rod, air cooled, 12.7 mm (0.5 inch) gauge length extensometer (MTS model 632.50004) measured the displacement within the gauge length.

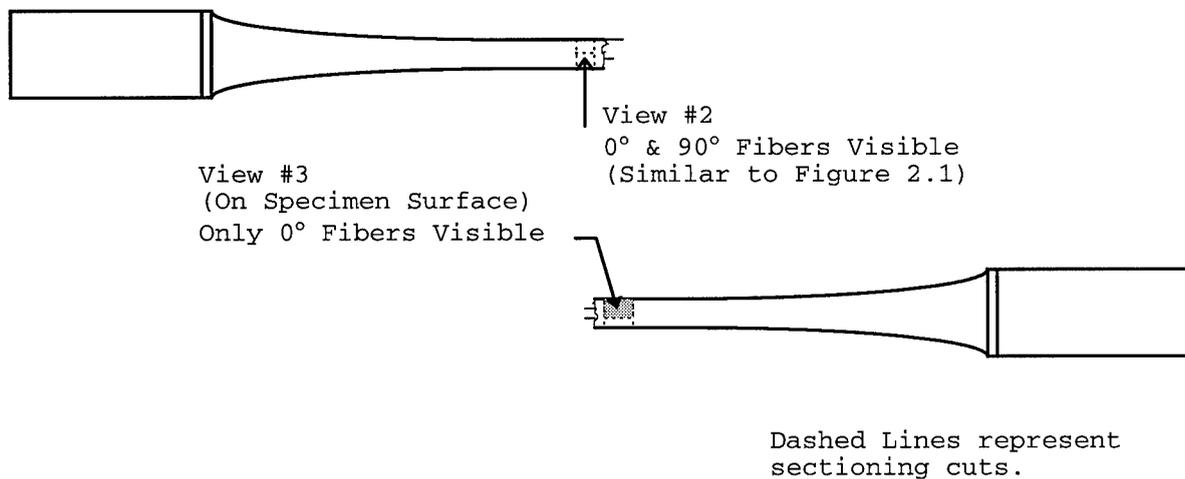
Figure 3.5: Typical Failed Specimen Sectioning

One of the failed specimen halves of each test was heat treated prior to sectioning. This heat treatment allowed the alpha phase of the matrix to precipitate, especially along slip bands. The alpha phase is reported to allow easier observation of slip bands. The heat treatment included wrapping the specimens in Tantalum Foil and placing the specimens in an inert atmosphere at  $427^\circ\text{C}$  for 24 hours. The heat treated specimens were sectioned as described above.

As described in Chapter III, Figure 3.5 illustrated the two views typical of the micrography of the sectioned samples. As shown, one view is an edge view, looking from inside to outside (view #2), while the other typical view (view #3) shows a layer of the longitudinal fibers obtained by removing the material covering the fibers. View #2

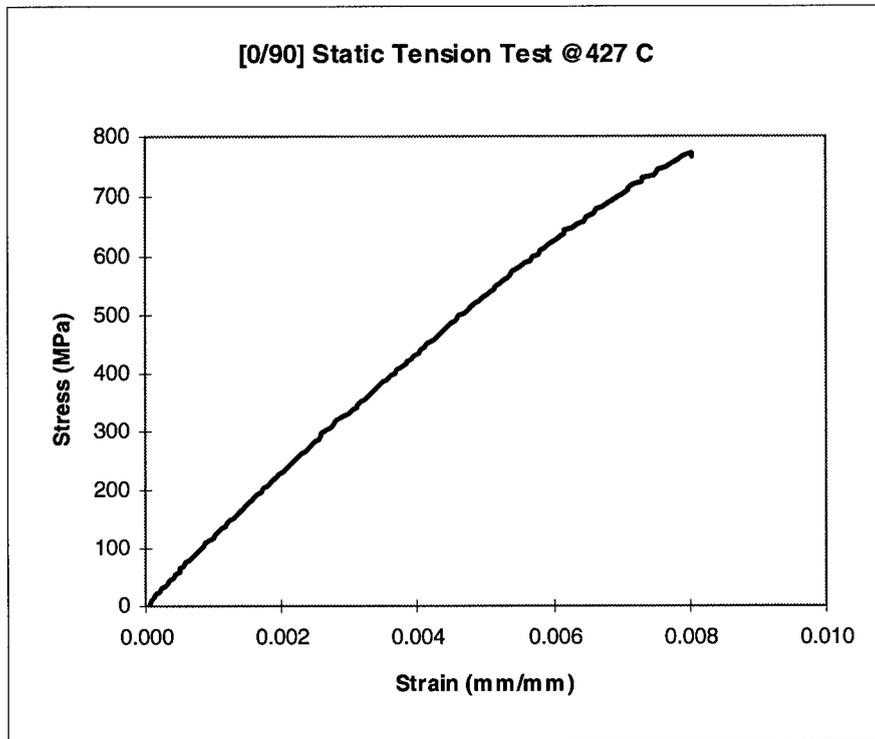
Figure 4.1 shows the monotonic tension stress-strain response of the  $[0/90]_{2s}$  composite when tested under strain controlled mode, at a strain rate of 0.2%/sec. This test was performed at 427° C up to tensile failure, providing the maximum strain limit of the material. The curve shows the three stage stress strain response characteristic of crossply laminates. In the first stage, the linear-elastic response region extends to the first knee at approximately 0.06% strain (80 MPa). Boyum [3] reported a knee at the same load level and temperature. This stage is characteristic of undamaged material (no cracks or debonds). At the 0.06% knee, 90° fiber debonding initiates[23].

Figure 4.1: Monotonic Tension Test (0.2%/sec Strain Rate)

This debonding decreases the stiffness of the material, illustrated by slight decrease in slope of the stress-strain response, from 126.4 GPa to 103.5 GPa. After the debonding, the response is fairly linear until 0.55% strain, where a slight nonlinear response initiates. At this point, Sanders[23] reported that, for unidirectional Ti-15-3 composite, plastic deformation of the matrix initiates. This suggests matrix plasticity initiates at this strain.

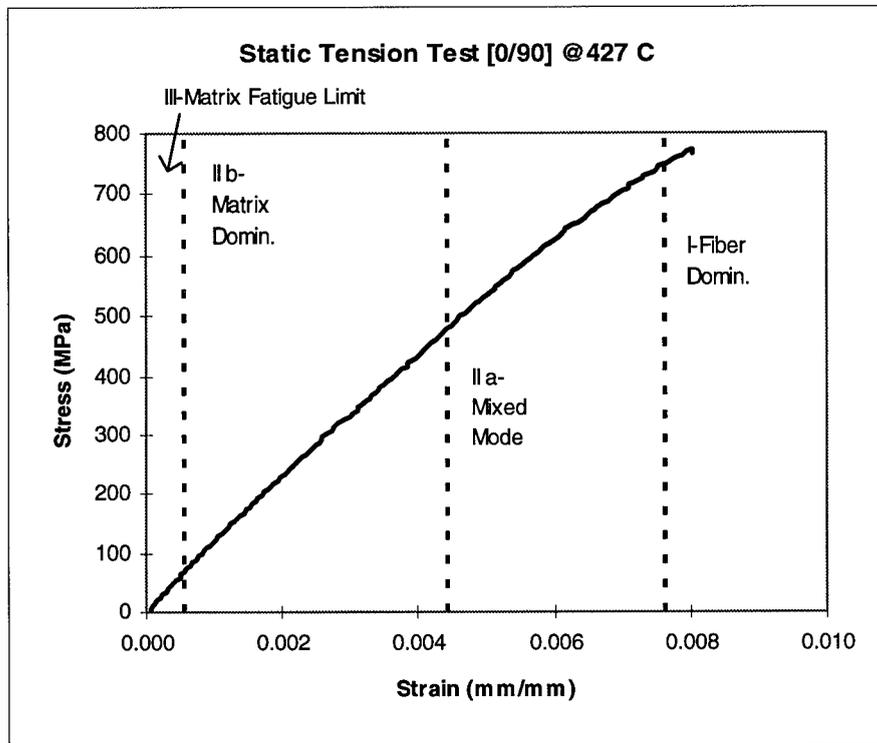
Figure 4.2: Monotonic Stress-Strain Curve/Fatigue Failure Mode Region Overlay

<u>Max <math>\epsilon</math> (%)</u>	<u>Failure Mode</u>	<u>Region of Fatigue Curve</u>
$\epsilon < 0.45$	Matrix Failure	IIb
$0.75 > \epsilon > 0.45$	Mixed Fiber and Matrix Failure	IIa
$\epsilon > 0.75$	Fiber Fracture	I

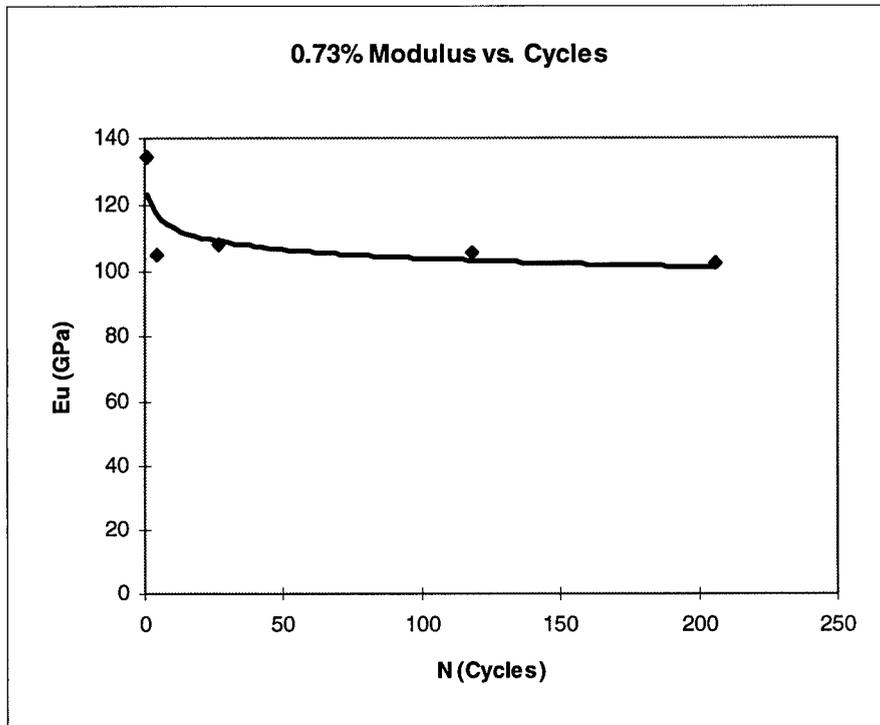
Figure 4.3 illustrates the variations in the unloading modulus, or stiffness response over the fatigue life of the specimen tested at a maximum strain level of 0.73%. The unloading modulus was found to be the most consistent modulus measurement for this work. The unloading modulus is the modulus measured from the portion of the stress-strain

Figure 4.3: Modulus History, 0.73% Test

response that starts at the maximum load and ends at zero load. An initial drop in stiffness can be observed after the first cycle due to debonding of fiber matrix interfaces in the 90° plies. The modulus then remained relatively constant over the entire fatigue life. This is one of the characteristics of fiber dominated failure. As will be discussed further in the fractography section, the evidence indicated that the failure was rapid and thus was fiber dominated. Figure 4.4 illustrates maximum and minimum stress response over the fatigue life of the same specimen. The maximum and minimum stress remained relatively constant,

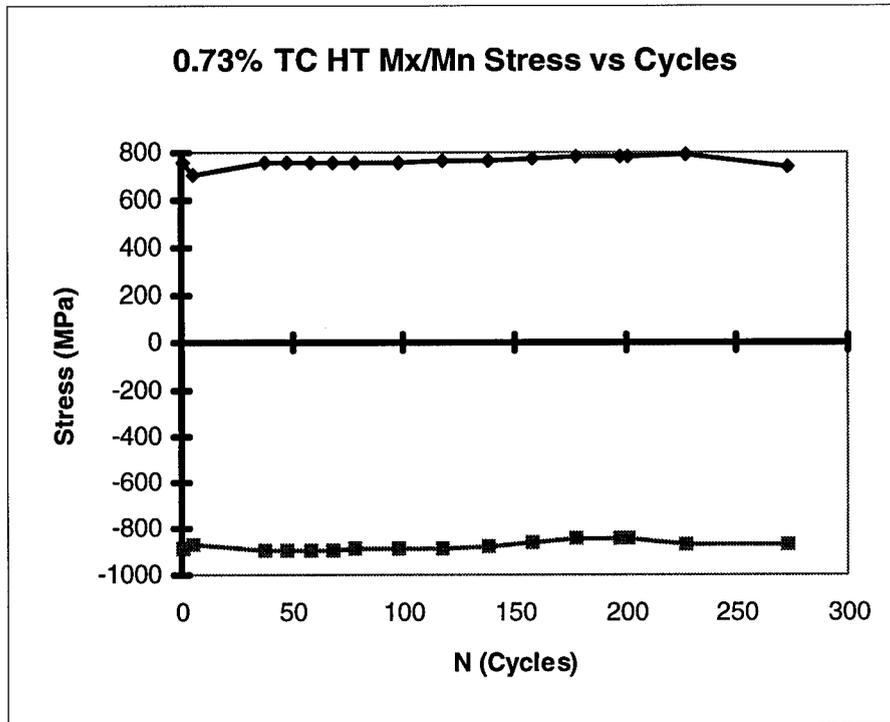
Figure 4.4: Maximum/Minimum Stress History, 0.73%.

following the same trend as the modulus response. It will be shown that the specimen micrograph showed a small amount of matrix cracking initiating from the 90° fiber interfacial region, thus supporting the mixed mode conclusion.

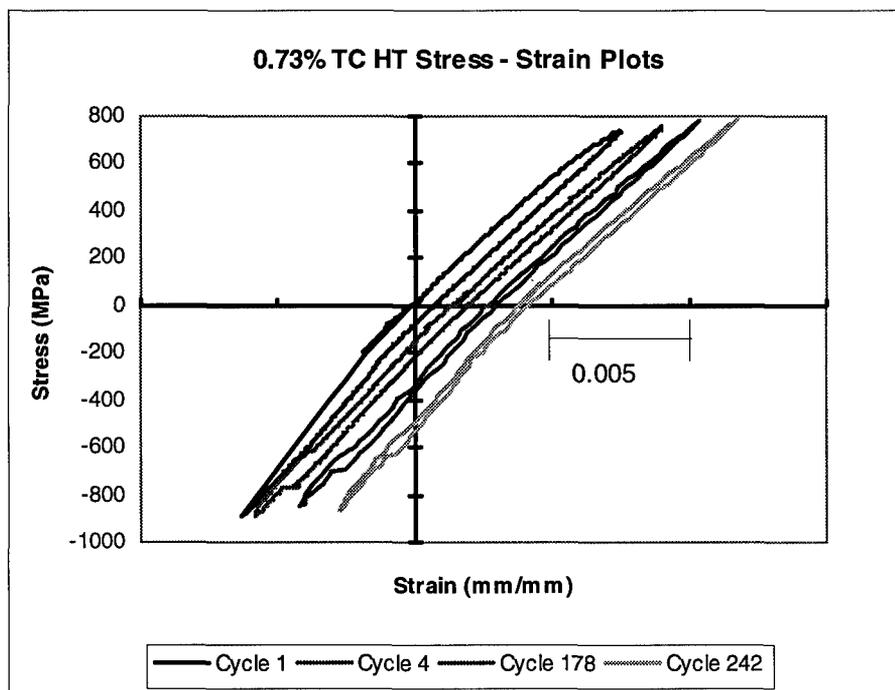
The cycle 178 (N=178) plot has the decrease in hysteresis discussed and the variation of compression and tension stiffnesses. The N=242 plot does not show much change from the N=178 plot, with little hysteresis and no noticeable change in stiffness.

Figure 4.5: Stress-Strain Plots, 0.73% (Offset)

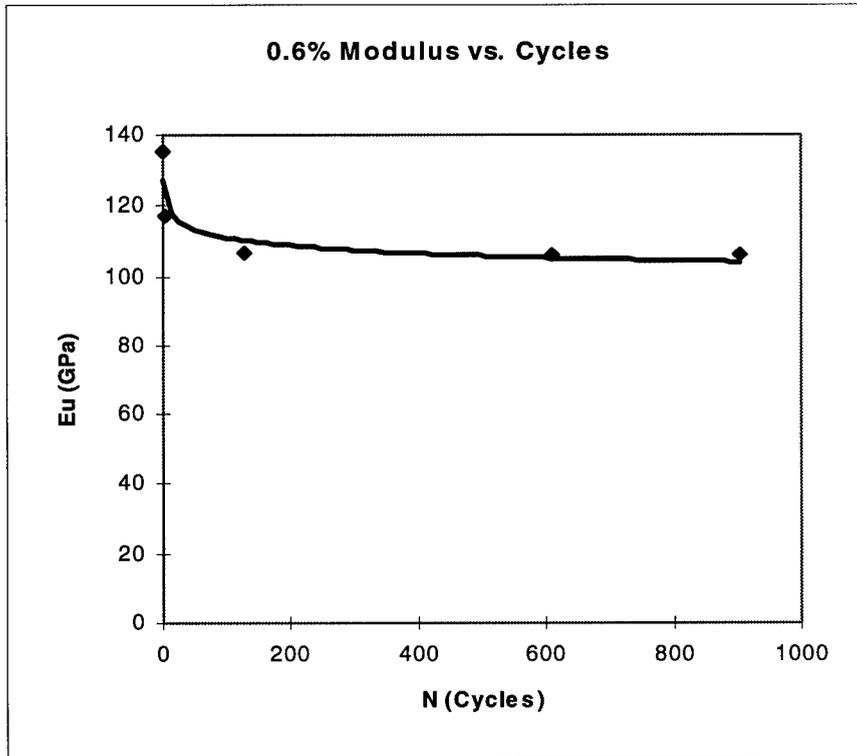
Figure 4.6: Modulus History, 0.6%

As mentioned earlier, the failure was evidently rapid near the end, not showing a large change of modulus nor stress near the end. This response also supports the deduction that although the failure was mixed mode, a larger share of the failure was fiber dominated.

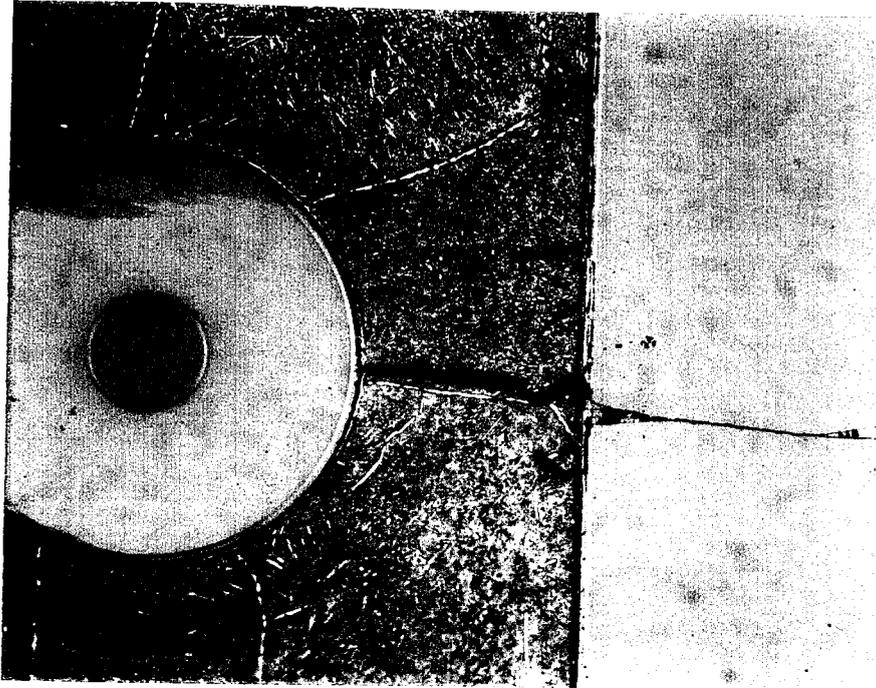
Figure 4.8: Fiber and Matrix Cracking, 0.6% (500X)

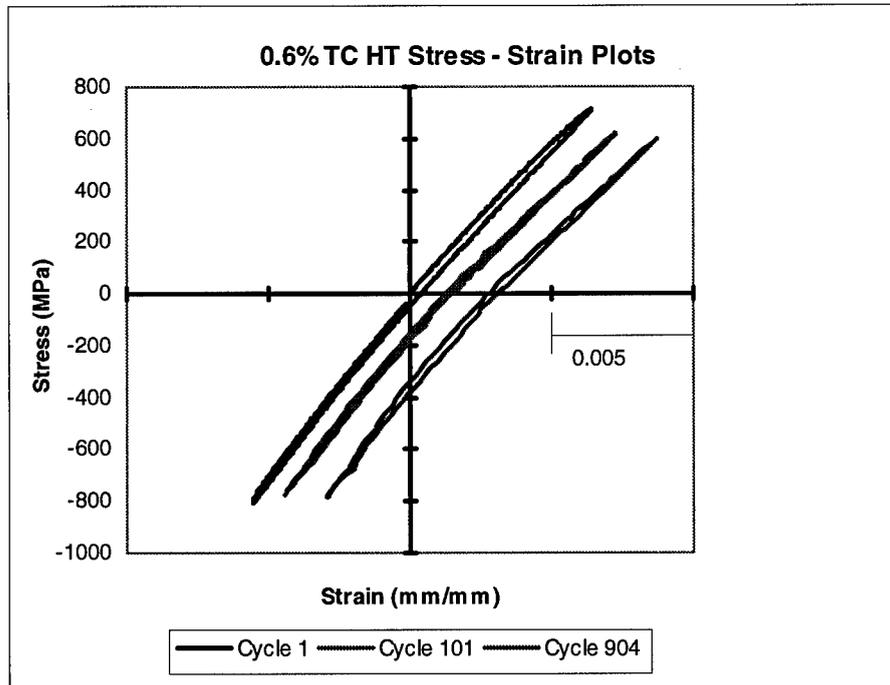
Also of note is the stiffening of the material in compression. This happened consistently for most of the experiments. One possible explanation is that cracks and debonds that formed compressed back together, effectively stiffening the material. The ratio of the compression

Figure 4.9: Stress-Strain Plots, 0.6% (Offset)

modulus to the unloading modulus at the fatigue half-life was approximately 1.22 for the tests, or a 22% stiffness increase in compression. For example, the 0.73% test  $E_c/E_u = 122.2/105.8 = 1.155$ , the 0.6% test  $E_c/E_u = 134.6/106.1 = 1.2686$ , and the 0.4% test  $E_c/E_u = 142.9/113.2 = 1.2624$ .

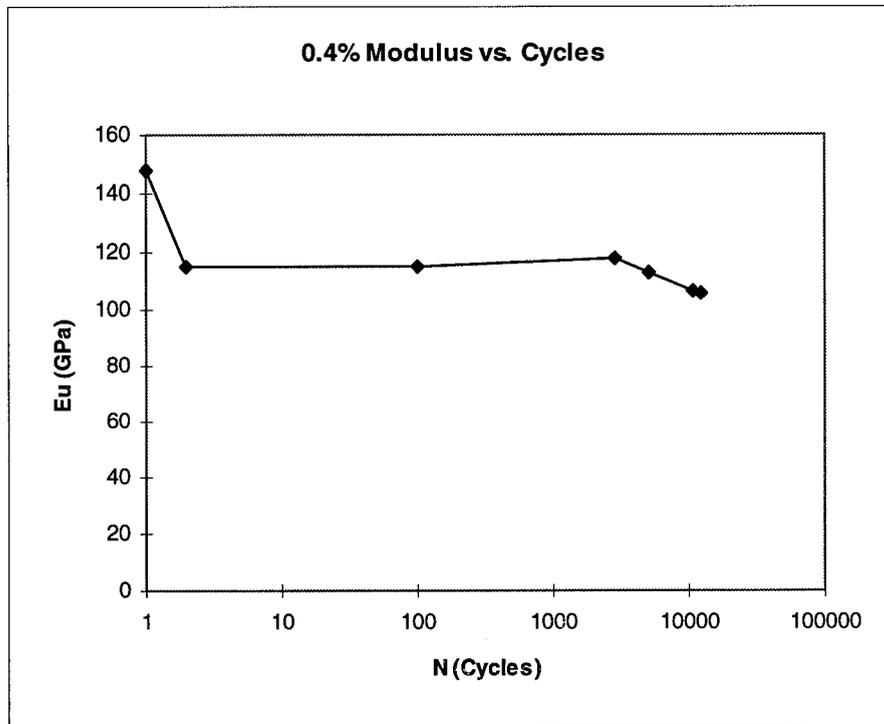
Figure 4.10: Modulus History, 0.4%

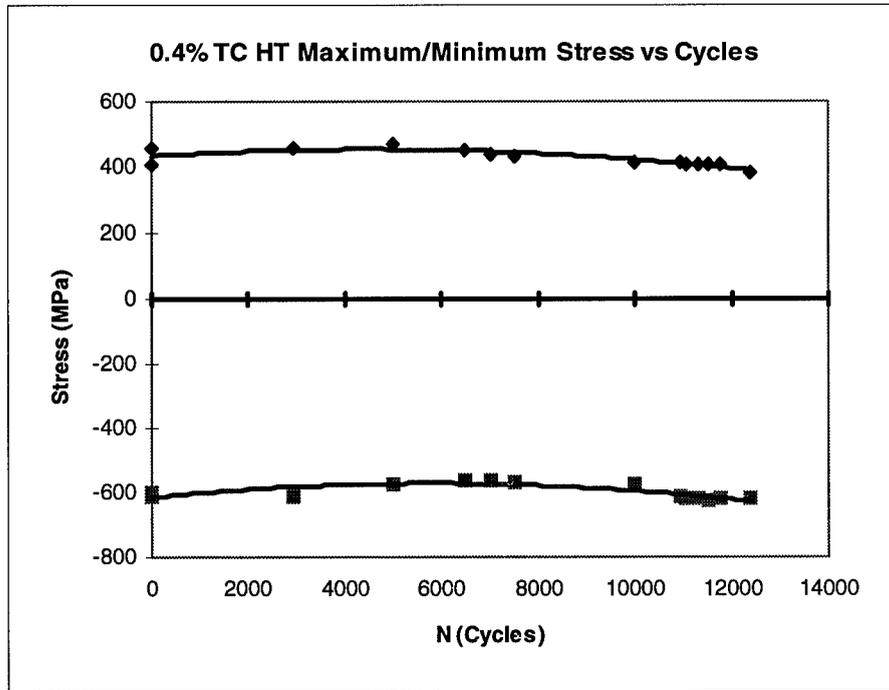
Figure 4.11 shows the typical histories of the maximum stress and minimum stress for the same test, with the dominant failure mode of matrix cracking. The maximum and

Figure 4.11: Maximum/Minimum Stress History, 0.4%

minimum stress history plots demonstrate an overall trend of decreasing maximum stress level over the latter half of the specimen life. This trend supports the theory that matrix cracking was the dominant mode of failure, since damage was slowly accumulating and thus the material deformed to a given strain with less stress at higher fatigue cycles.

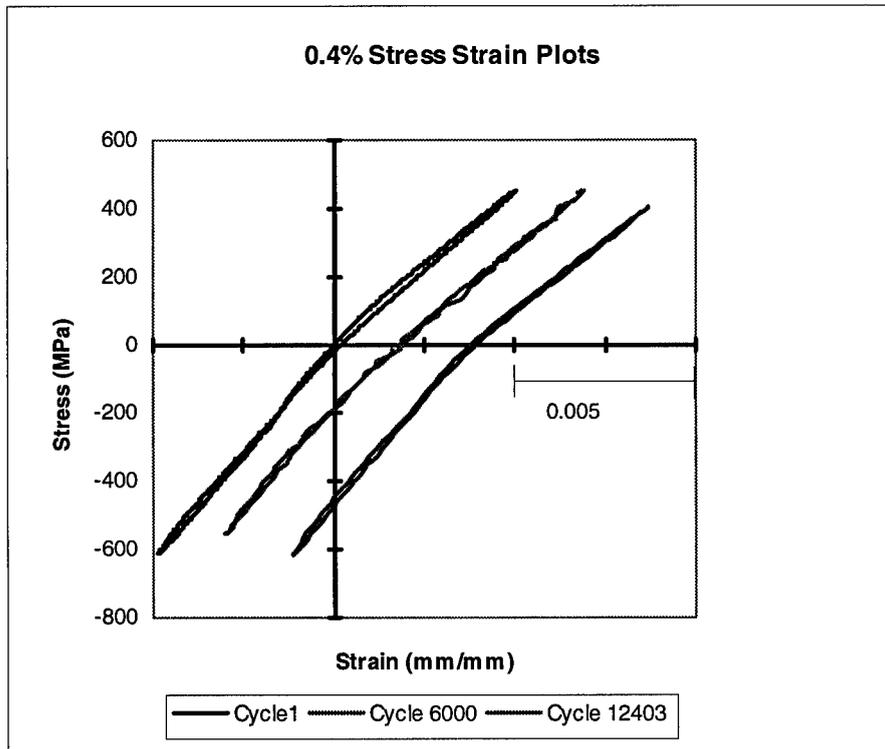
Figure 4.12 shows the typical stress-strain history for the same specimen. Similar to the prior discussions, the first, half-life, and near final cycles are presented. The stress-strain plots illustrate that the material degradation was present, but was not severe. This observation is consistent with that in the modulus response history.

Figure 4.12: Stress-Strain Plots, 0.4% (Offset)

Again, the first cycle had a larger hysteresis, as compared to the rest of the stress-strain responses, as expected. The modulus is indicated by the slope of the stress-strain plots. A stress-strain slope becoming more horizontal indicates a decreasing stiffness, or modulus. This decreasing slope verifies the decreasing modulus trend shown in the modulus history.

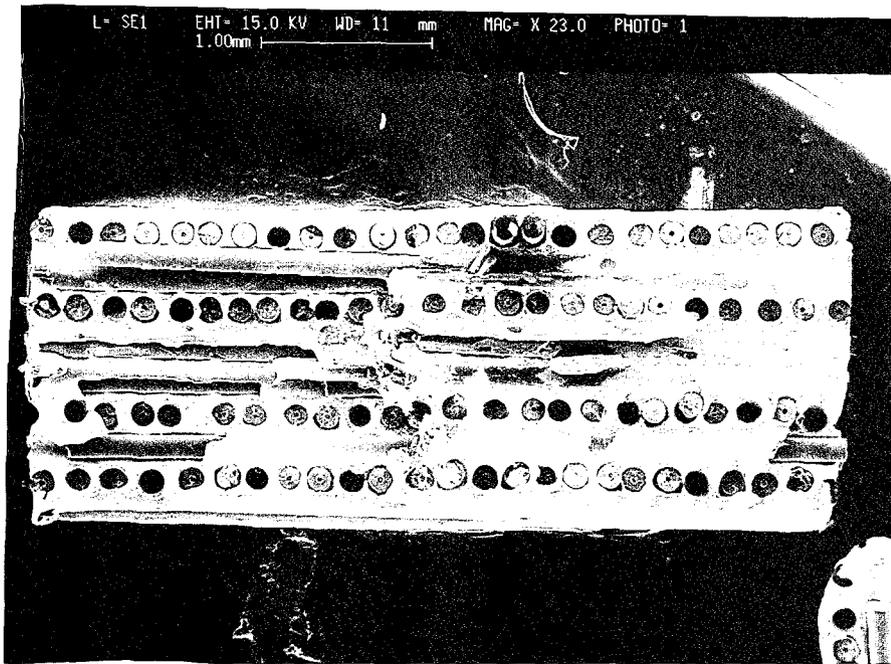
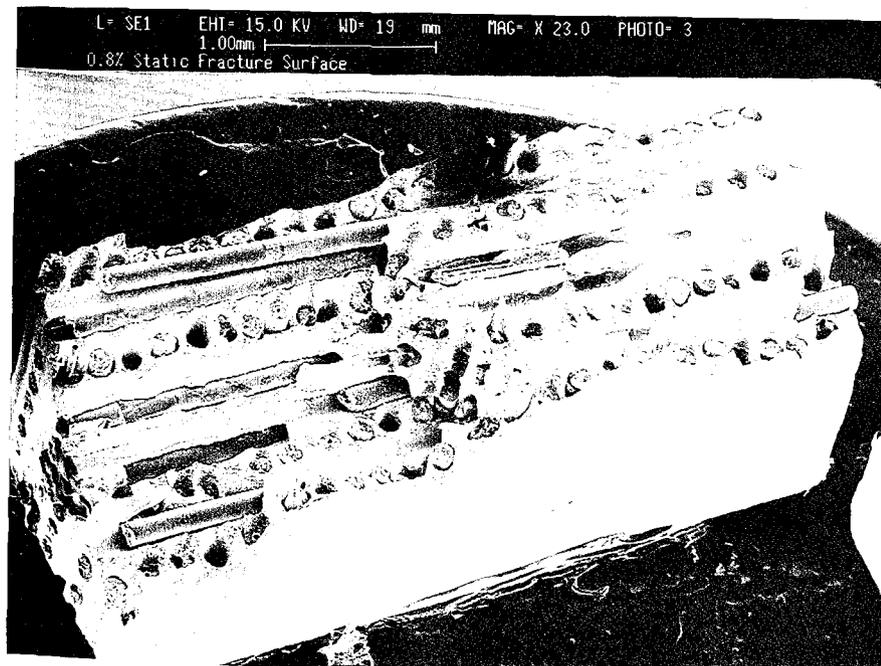
Figure 4.13: Fracture Surface, 0.8%

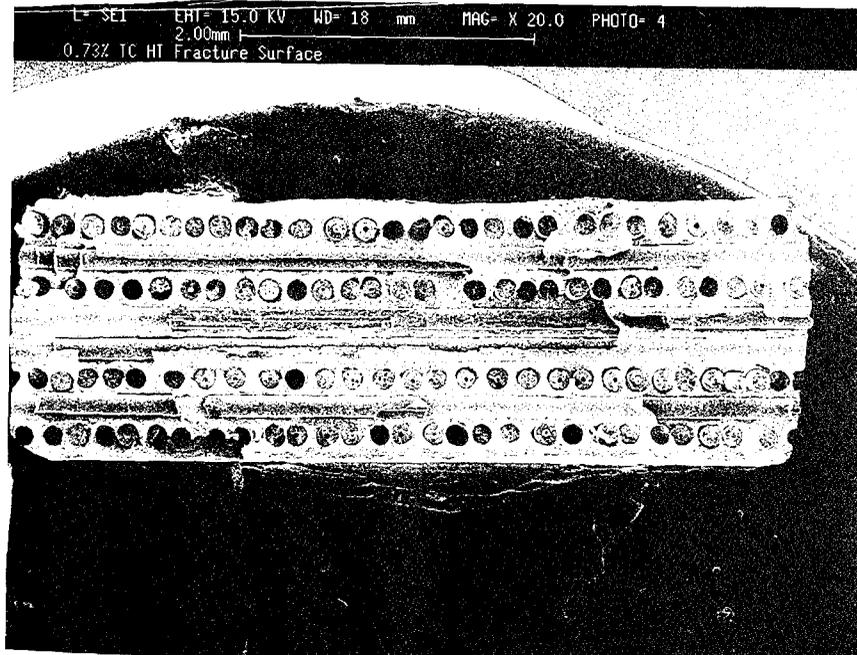
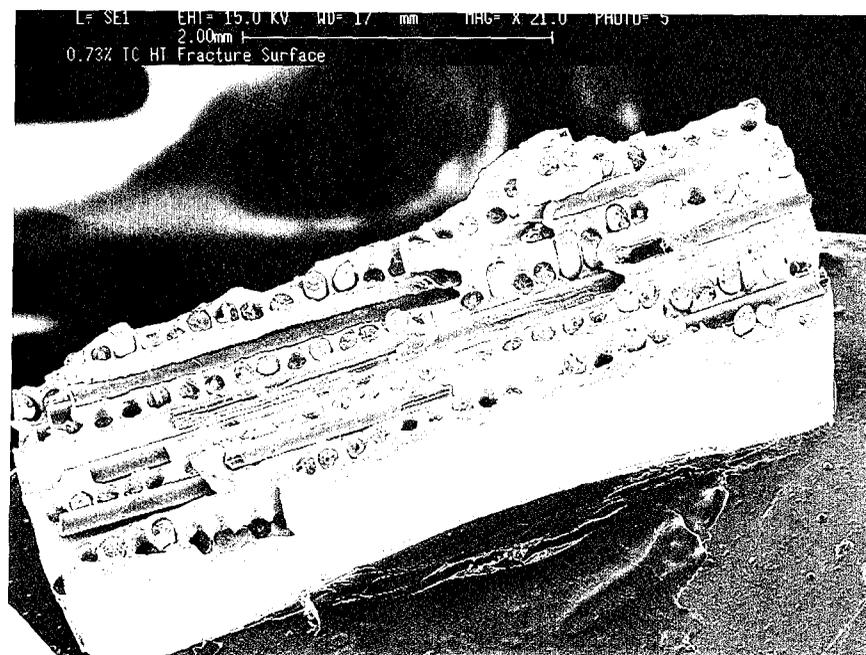
Figure 4.14: Fracture Surface, 0.73%

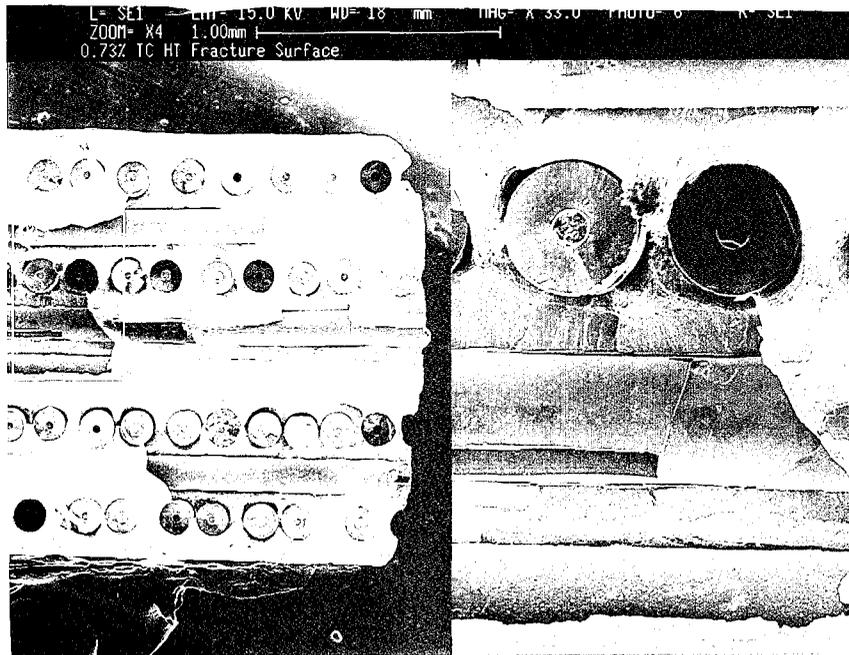
Figure 4.15: Fracture Surface Close-up, Mixed Mode (0.73%)

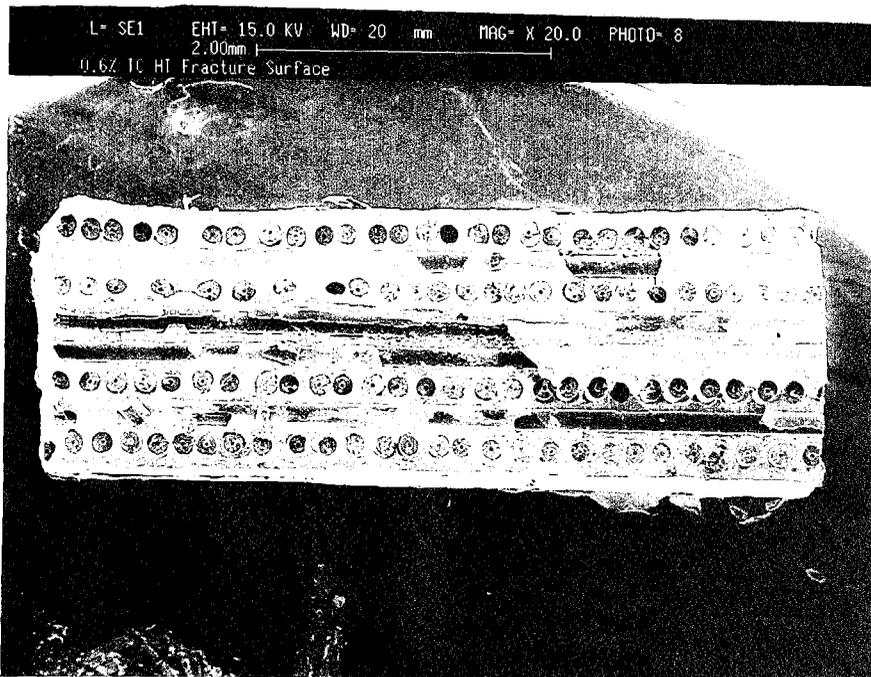
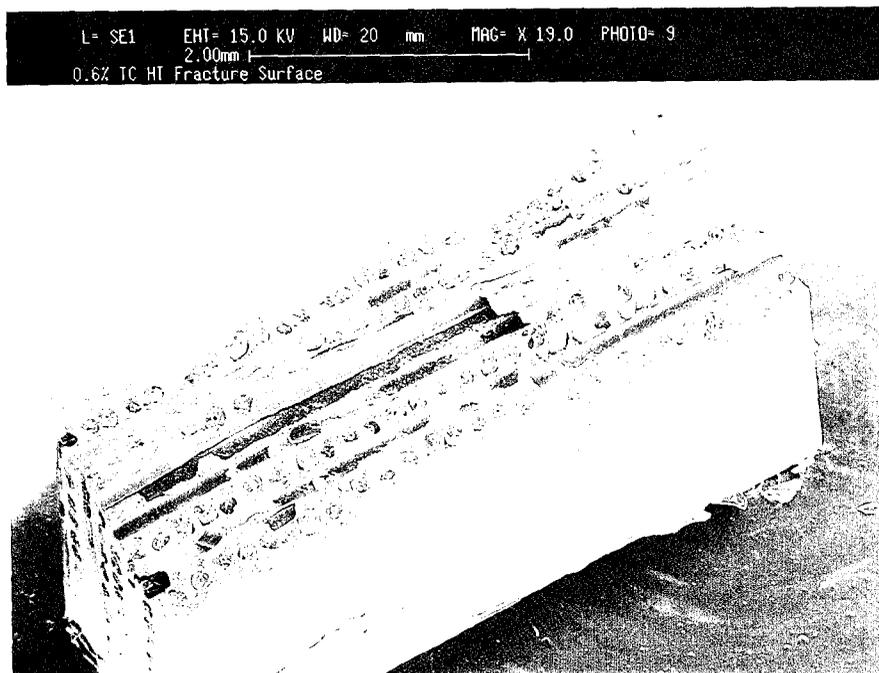
Figure 4.16: Fracture Surface, 0.6%

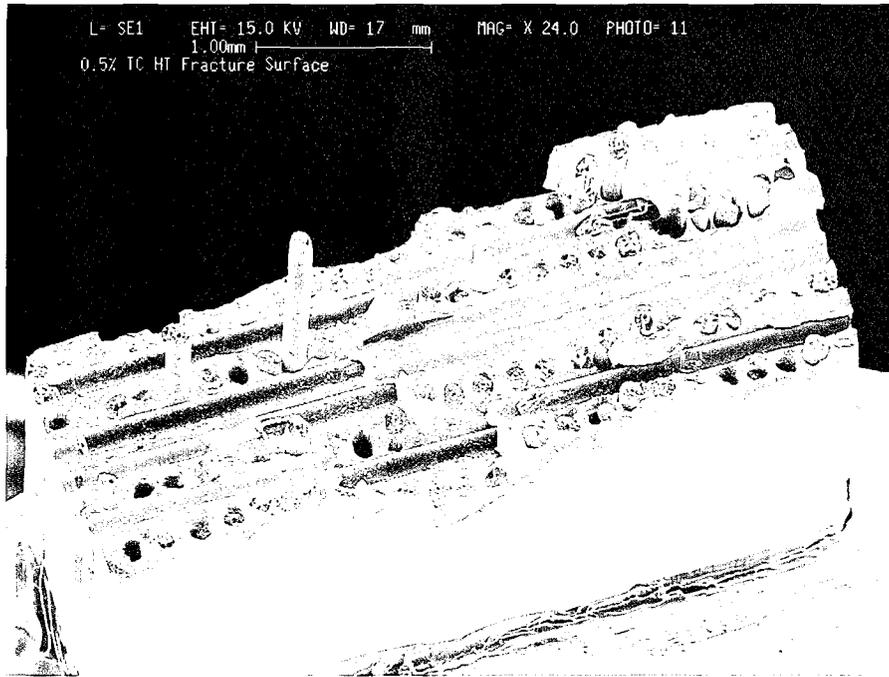
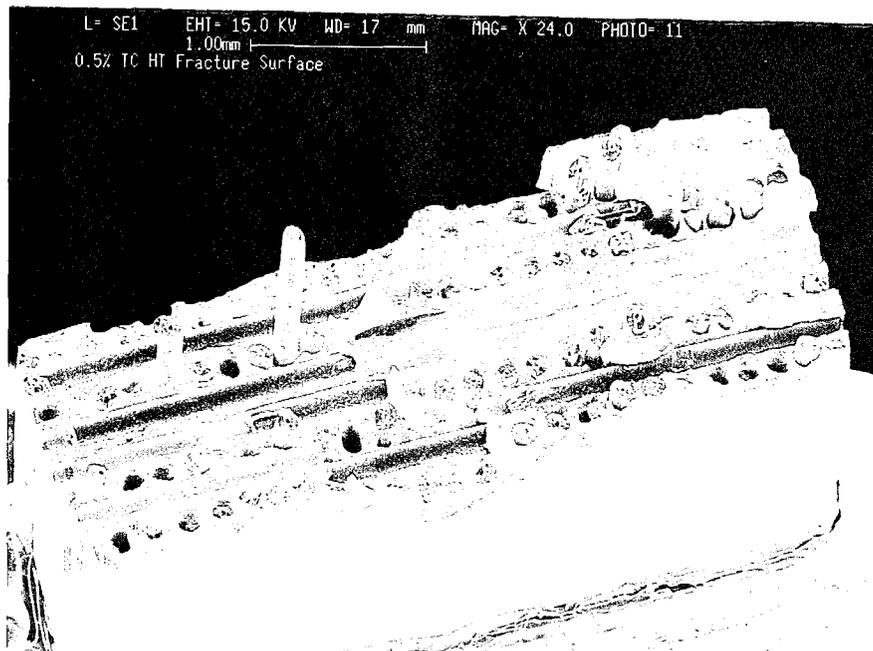
Figure 4.17: Fracture Surface, 0.5%

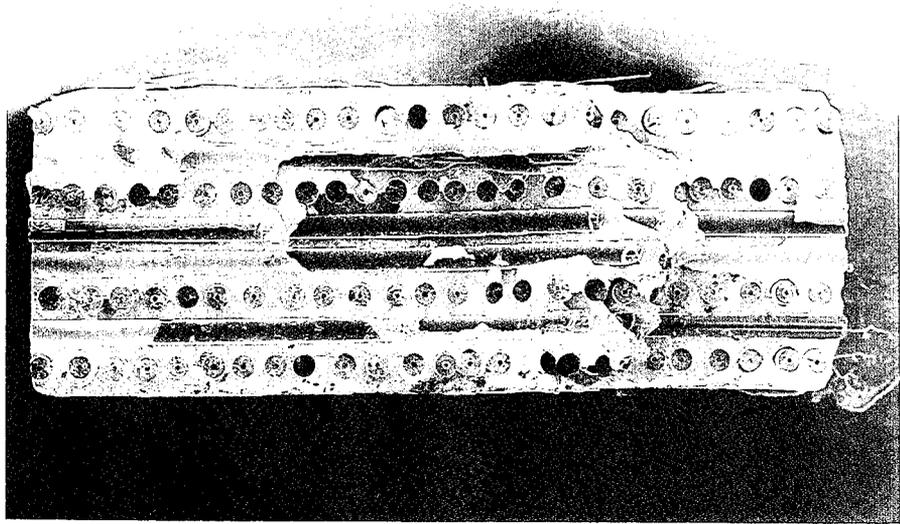
L= SE1 EHT= 15.0 KV WD= 17 mm MAG= X 22.0 PHOTO= 13  
1.00mm  
0.4% TC HT Fracture Surface

L= SE1 EHT= 15.0 KV WD= 18 mm MAG= X 20.0 PHOTO= 14  
2.00mm  
0.4% TC HT Fracture Surface

Figure 4.18: Fracture Surface, 0.4%

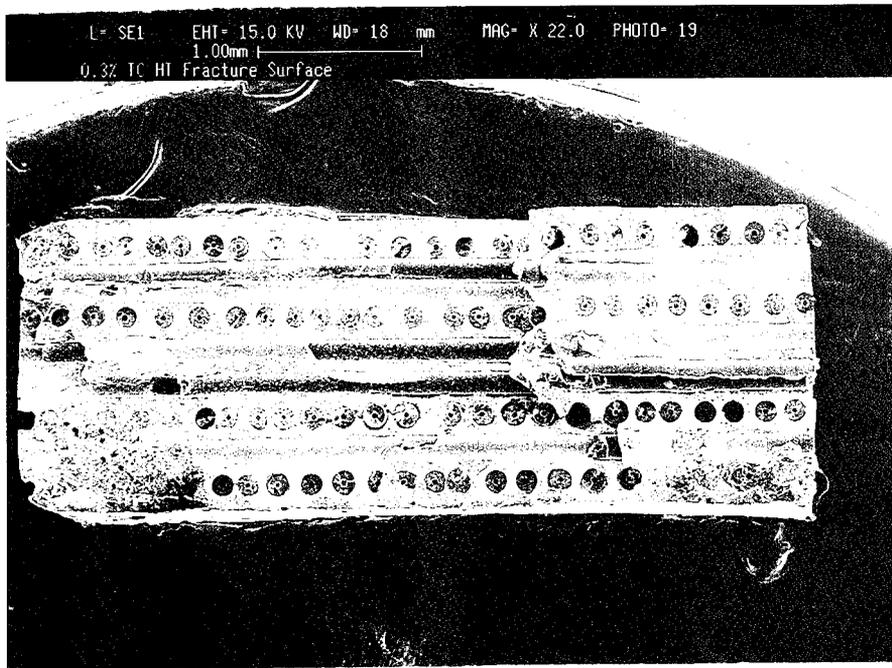
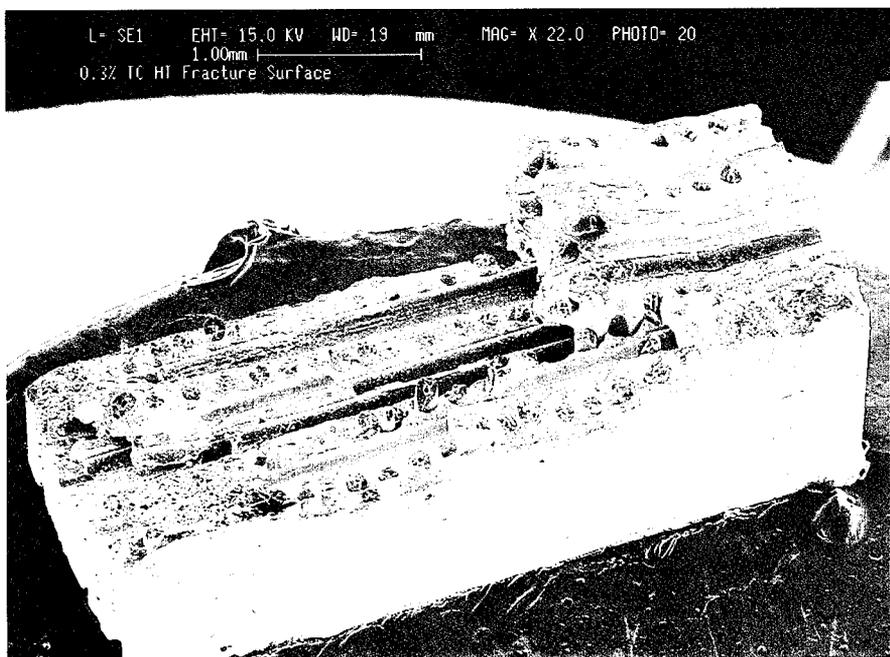
Figure 4.19: Fracture Surface, 0.3%

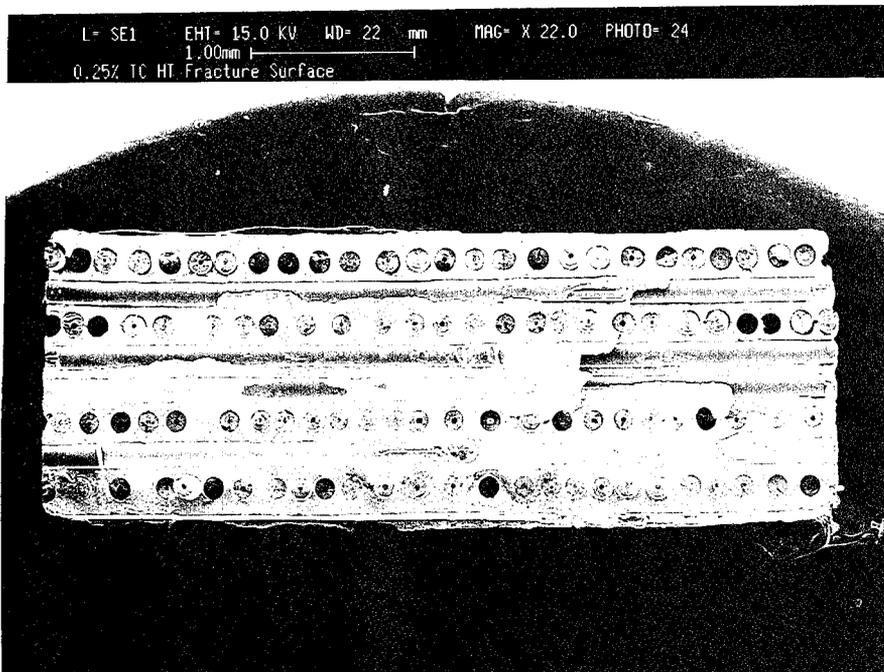
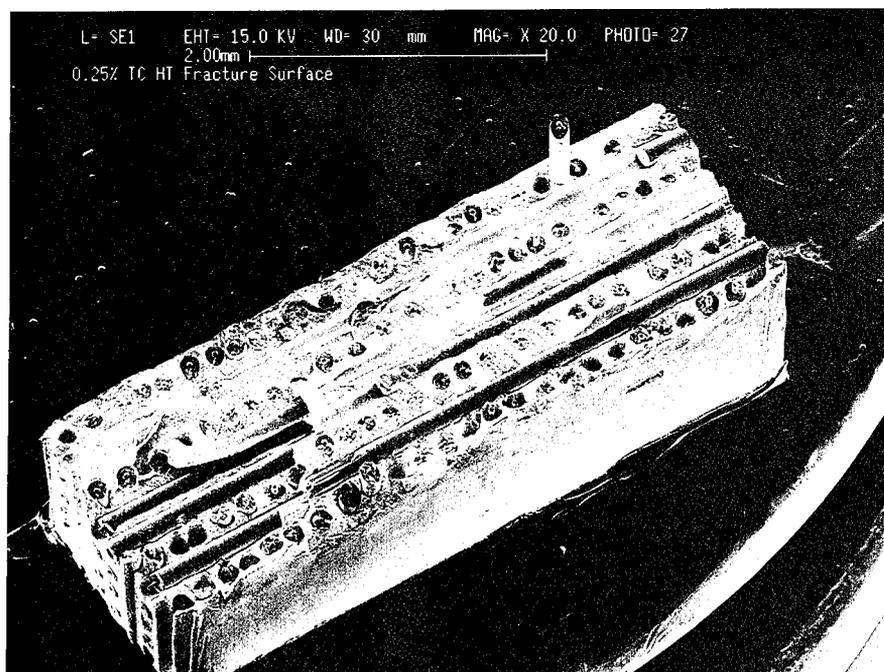
Figure 4.20: Fracture Surface, 0.25%

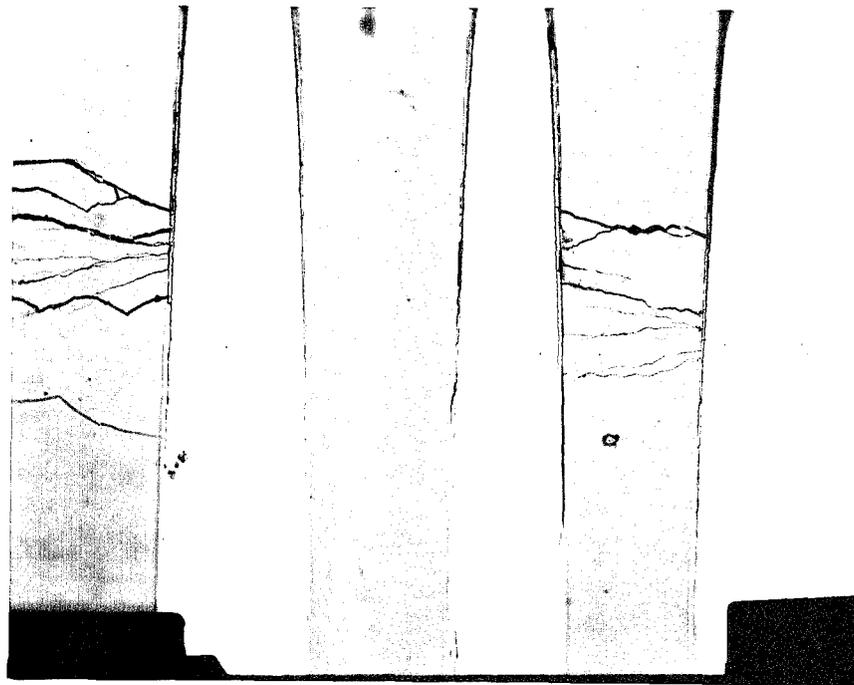
Figure 4.21: Longitudinal Fiber Cracks, 0.8% (200X)

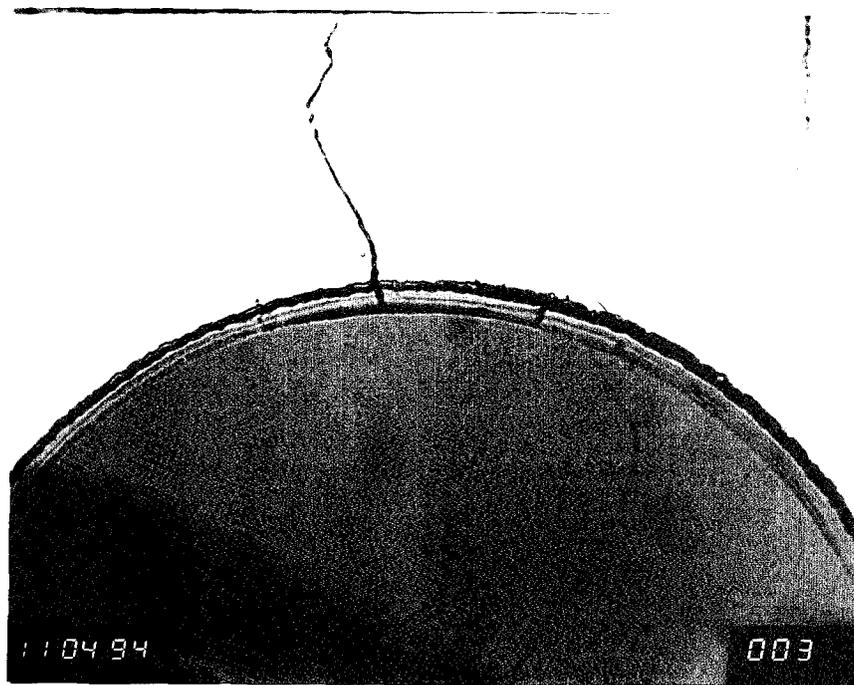
Figure 4.22: 90° Radial Crack, View #2, 0.73% (1000X)

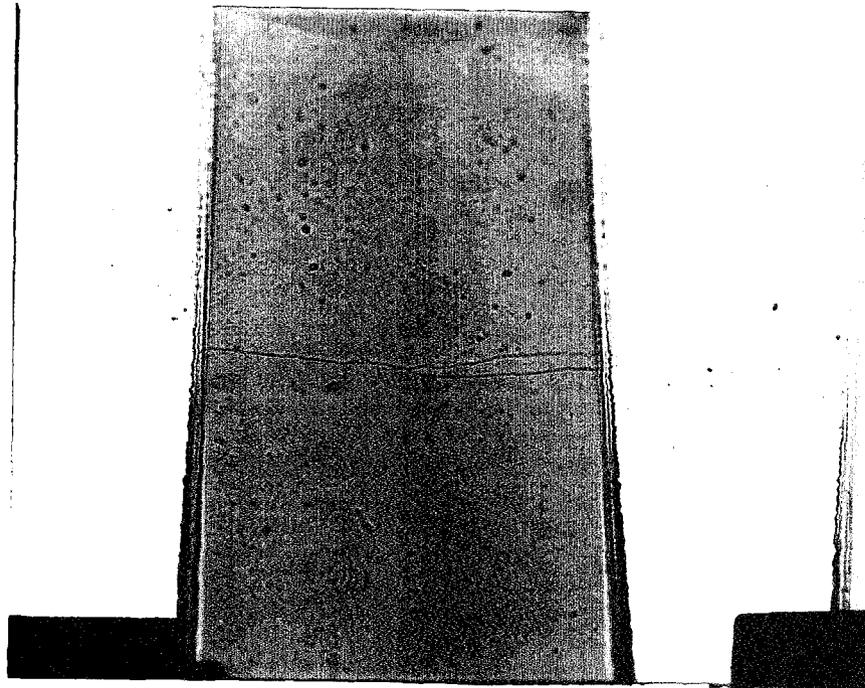
Figure 4.23:  $0^\circ$  Fibers, View #3, 0.73% (500X)

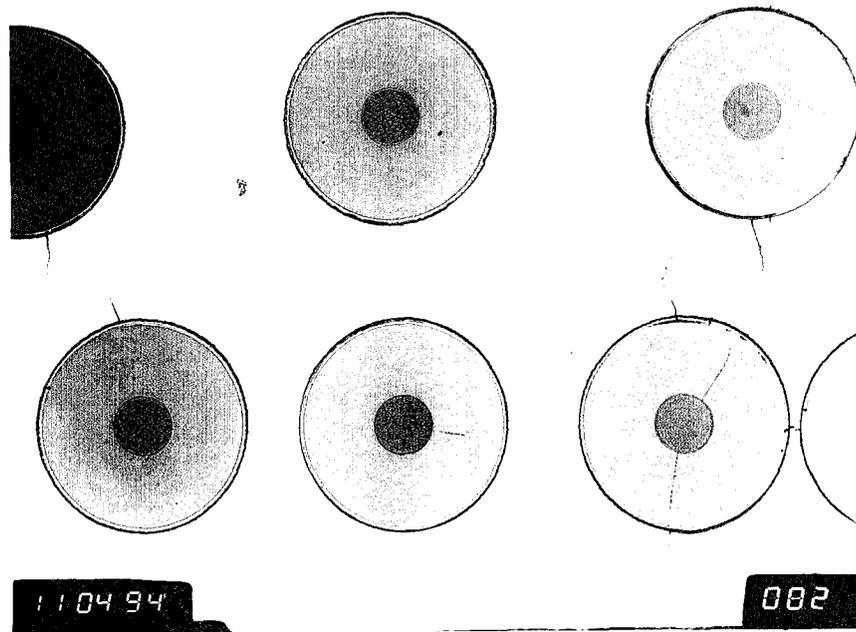
Figure 4.25: Fiber & Matrix Cracks, View #2, 0.6% (200X)

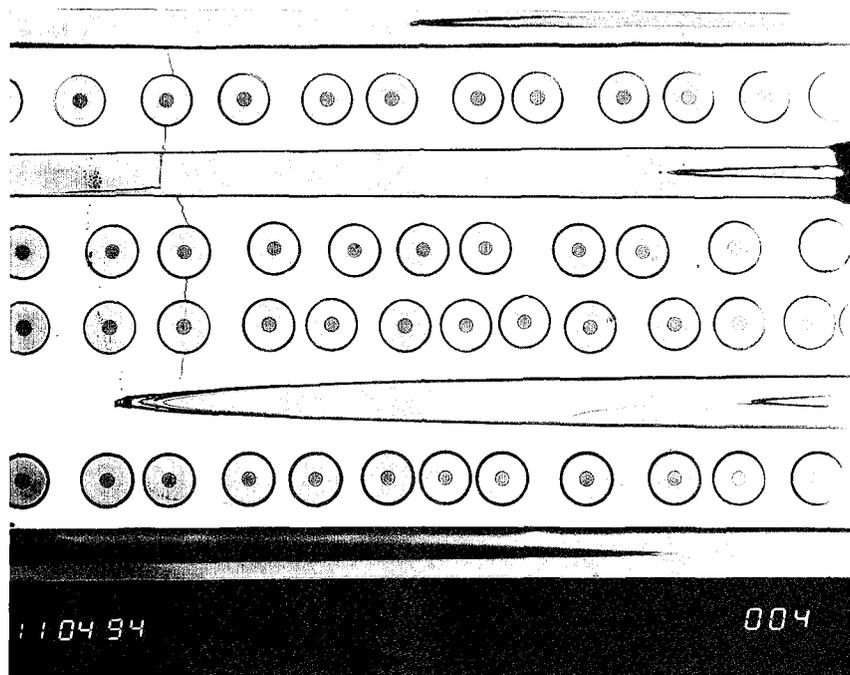
Figure 4.26: Matrix and Fiber Cracks, View #2, 0.6% (50X)
