FATIGUE BEHAVIOR OF A CROSS-PLY  
METAL MATRIX COMPOSITE AT ELEVATED  
TEMPERATURE UNDER STRAIN CONTROLLED  
MODE

THESIS

Leon B. Dennis, Captain, USAF

AFIT/GAE/ENY/94D-7

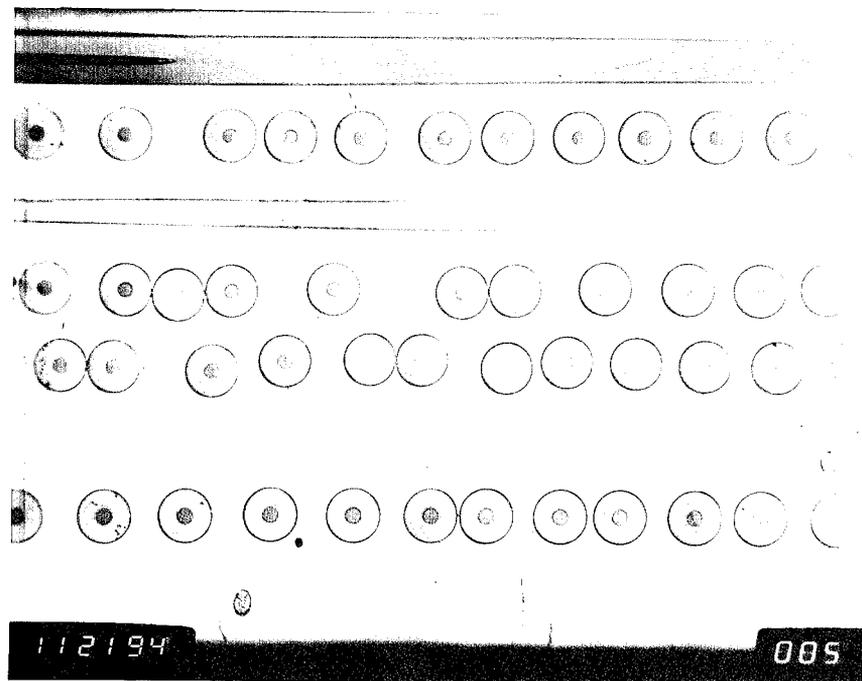
Figure 4.28: Numerous Cracks, View #2, 0.4% (50X)

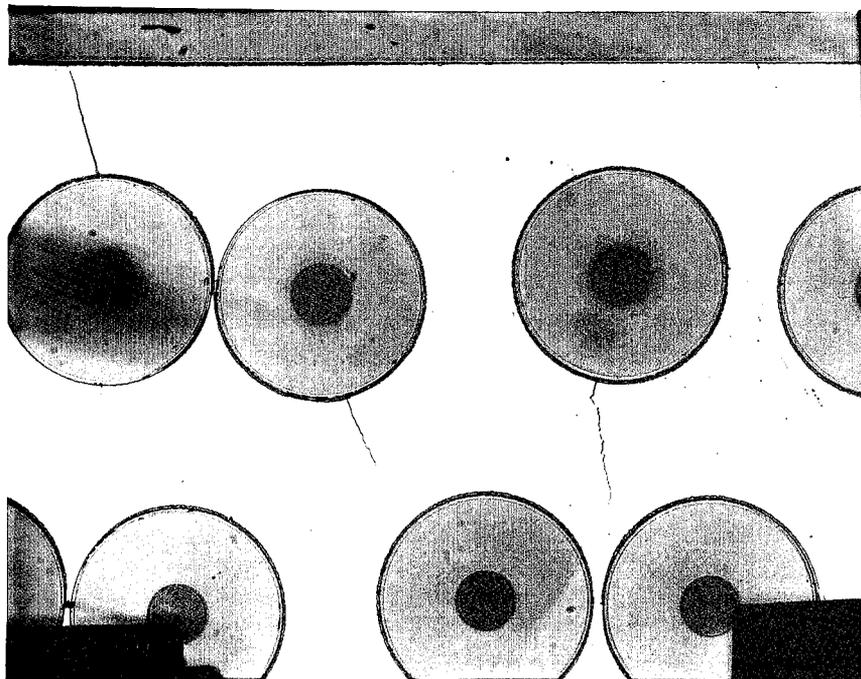
Figure 4.30: Matrix Cracks, View #2, 0.4%I (200X)

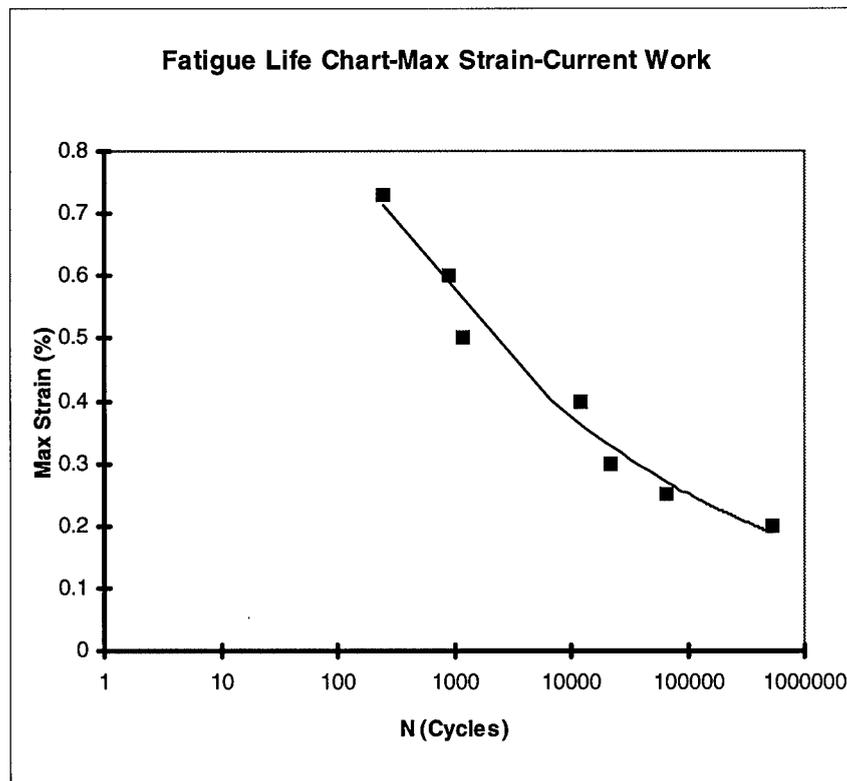
Figure 5.1: Fatigue Life Curve - Max Strain

Seven fully reversed fatigue tests were accomplished in this investigation. Figures 5.1 and 5.2 show the fatigue life based on a maximum strain and a maximum stress respectively. The maximum stress was measured near the mid-life of the specimen where a relatively steady response of stresses was observed. The abscissa is typical of fatigue plots, representing the number of fatigue cycles plotted on a logarithmic scale.

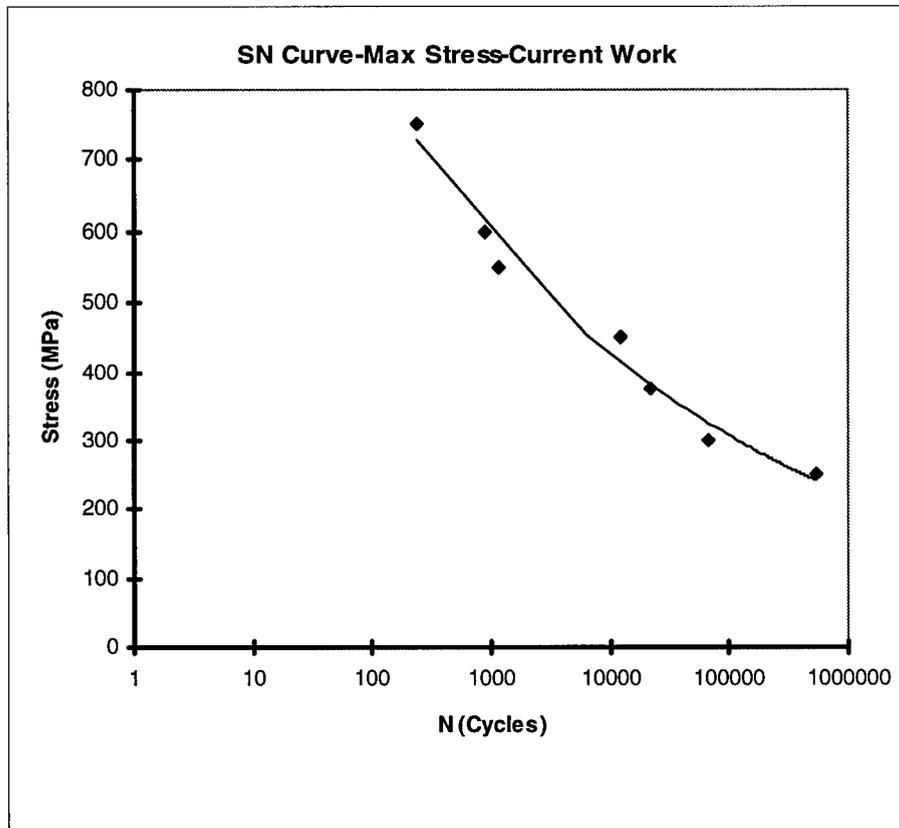
Figure 5.2: Fatigue Life Curve - Max Stress

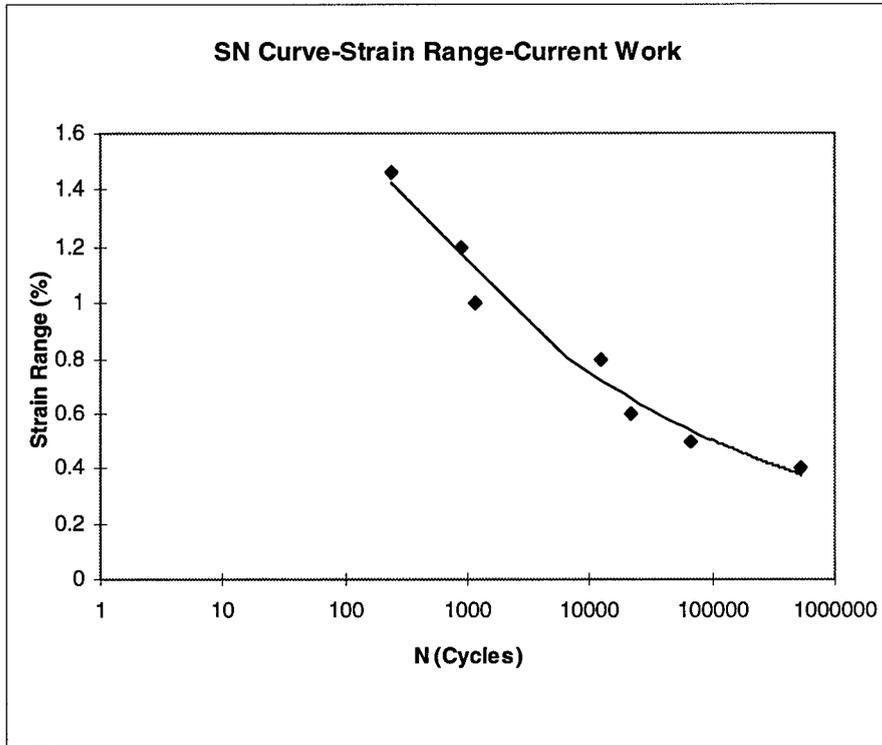
Figure 5.3: Fatigue Life Curve - Strain Range

Figures 5.3 and 5.4 present the fatigue life results in terms of different variables, strain range and steady state stress range, respectively. The plots are again somewhat typical of MMC's in their general trend. The data follows a relatively smooth decreasing trend with good correlation. Thus it appears that the fatigue data of the current work

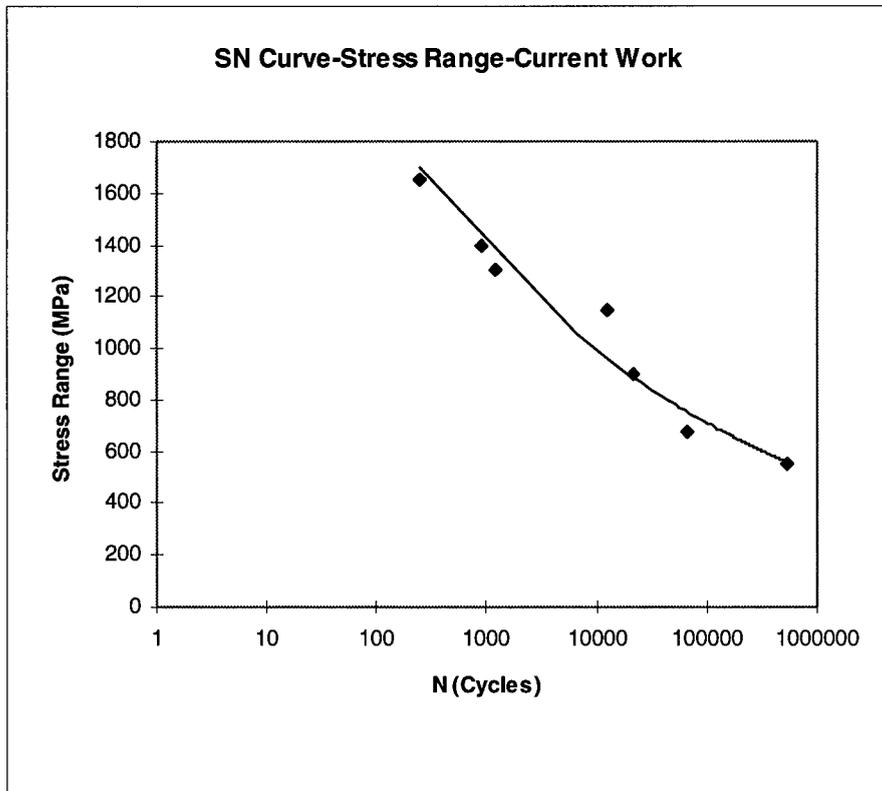
Figure 5.4: Fatigue Life Curve - Stress Range

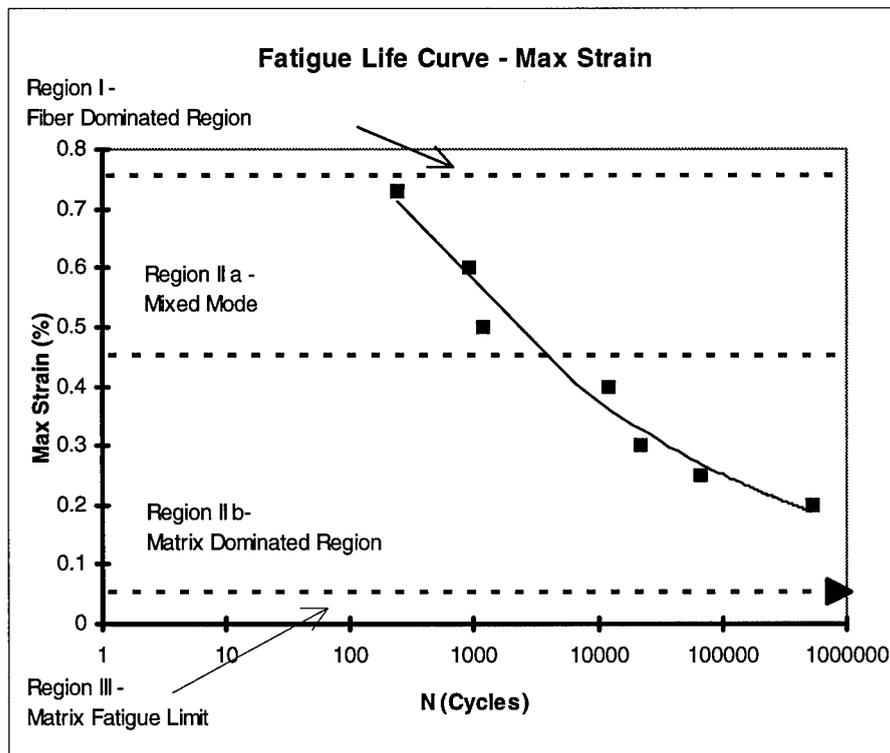
Figure 5.5: Partitioned Maximum Strain Fatigue Curve

dominant failure modes. The divisions were determined both by macroscopic response and by microscopic evidence. The previously stated criteria of dominant failure modes was applied. The Region III matrix fatigue limit was estimated because all current specimens failed. Sanders [23] estimated the maximum strain of Region III for the unidirectional 90° layup to be 0.05%. This appears to be a reasonable and conservative estimate because the crossply composite has the relatively stronger 0° layers present.

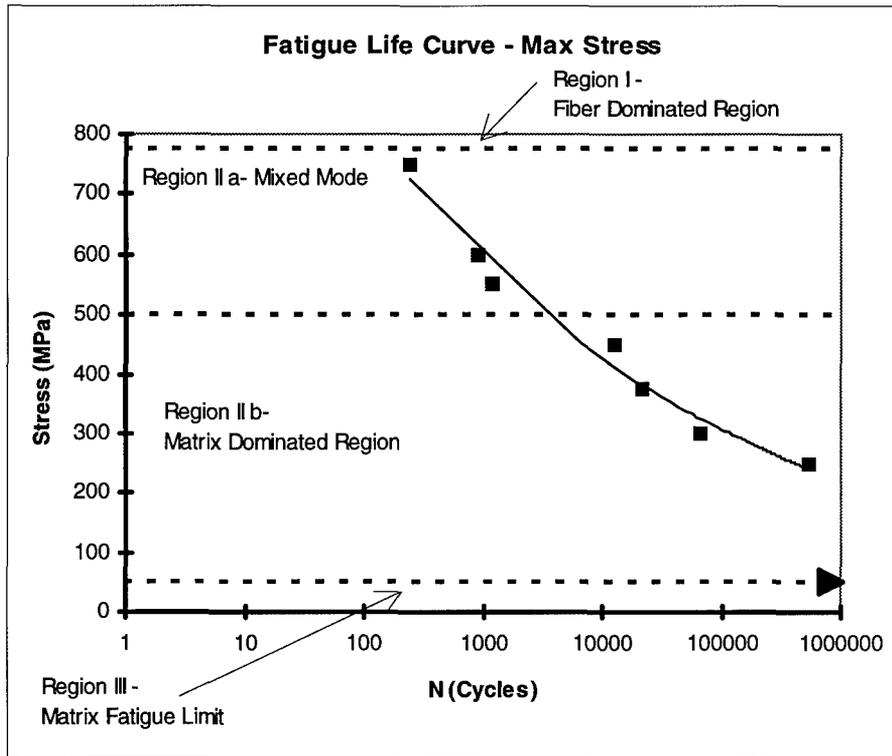
Figure 5.6: Partitioned Maximum Stress Fatigue Curve

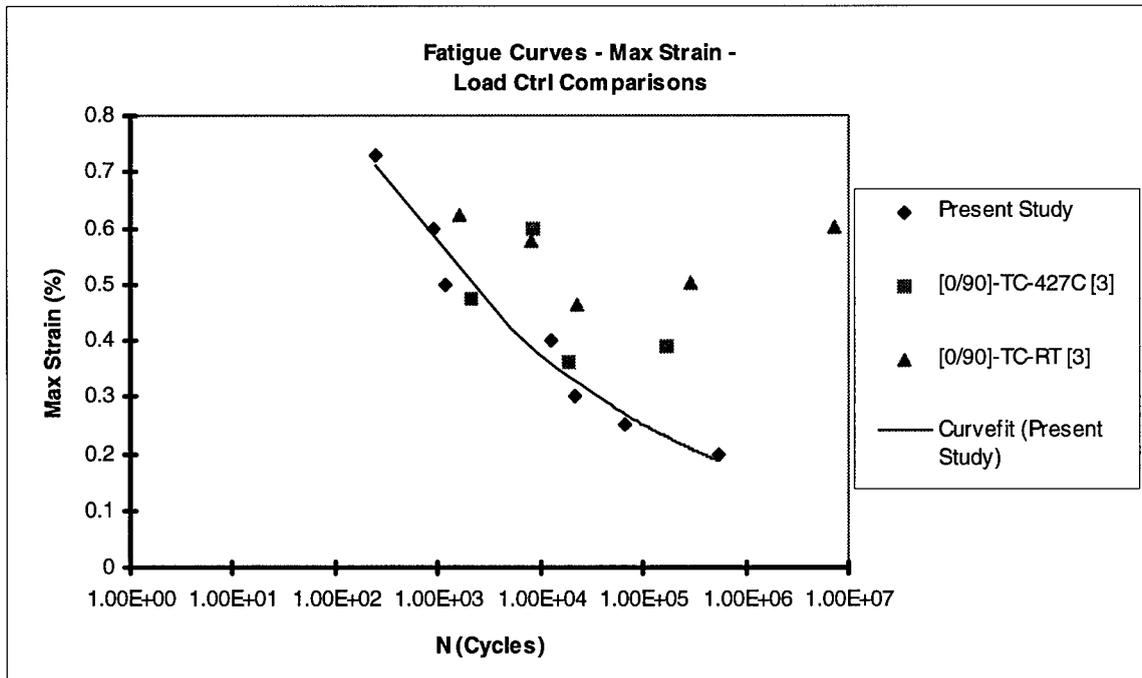
Figure 5.7: Maximum Strain Fatigue Curve - Strain Versus Load Control Comparison

Fig 5.7, but using the new basis. Again the current data has a well correlated trend. However the data that was scattered in the last comparison is now well correlated and follows the same general trend as the current test data. Therefore, the effective strain range basis method appears to be a good method for comparing fully reversed strain controlled results with fully reversed load controlled results, all other variables being constant.

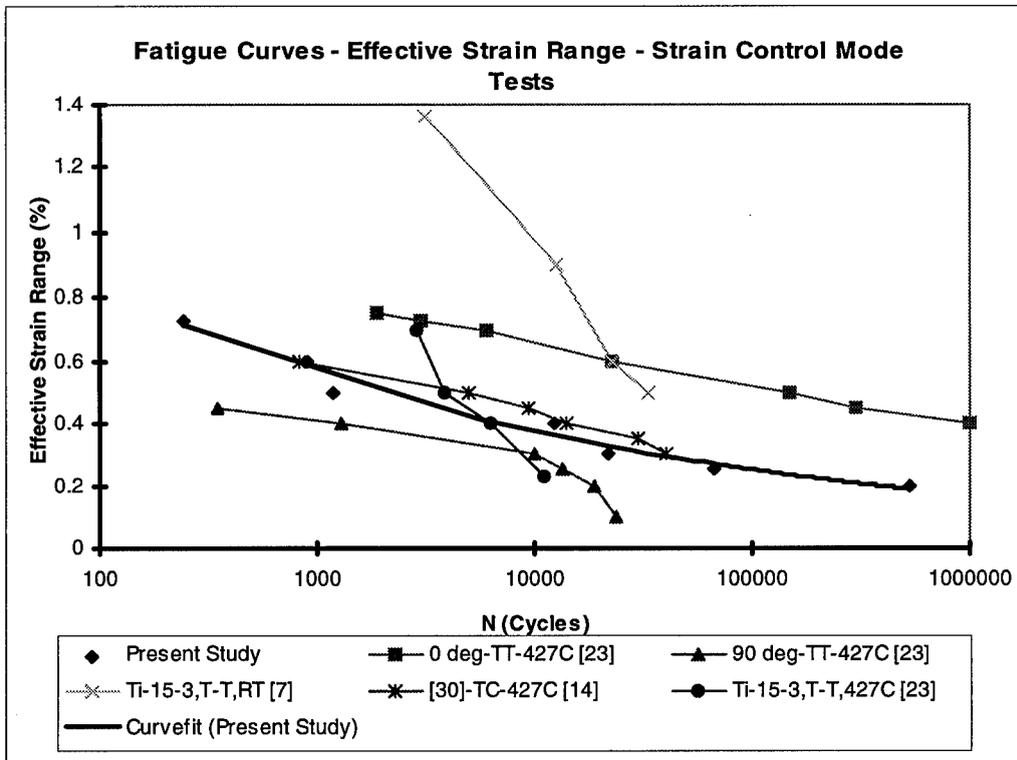
Figure 5.9: Effective Strain Range Fatigue Curve - Strain Control Comparison

Figure 5.10 presents the data of Figures 5.8 and 5.9 on the same plot in order to compare the two control modes. This allows all the data sets presented thus far to be observed on a single plot. An overall observation from Figure 5.10 is that both the matrix alloy and  $0^\circ$  specimens had longer fatigue lives than the cross ply composites. However, an exception was noted with the high temperature matrix alloy data. As discussed earlier, the trend fell with increasing fatigue. But of note is the fact that the failure criteria for the matrix was a 75% reduction in stress, as opposed to the typical failure definition of the specimen coming apart[23]. In another comparison, both the unidirectional  $90^\circ$  data and the high temperature matrix alloy data show a convergence for higher fatigue lives. This observation suggests that for lower loadings, the off-axis composite approaches the matrix alloy fatigue limit. Thus the presence of off-axis fibers for these cases impacts the higher loading fatigue lives more than lower loadings.

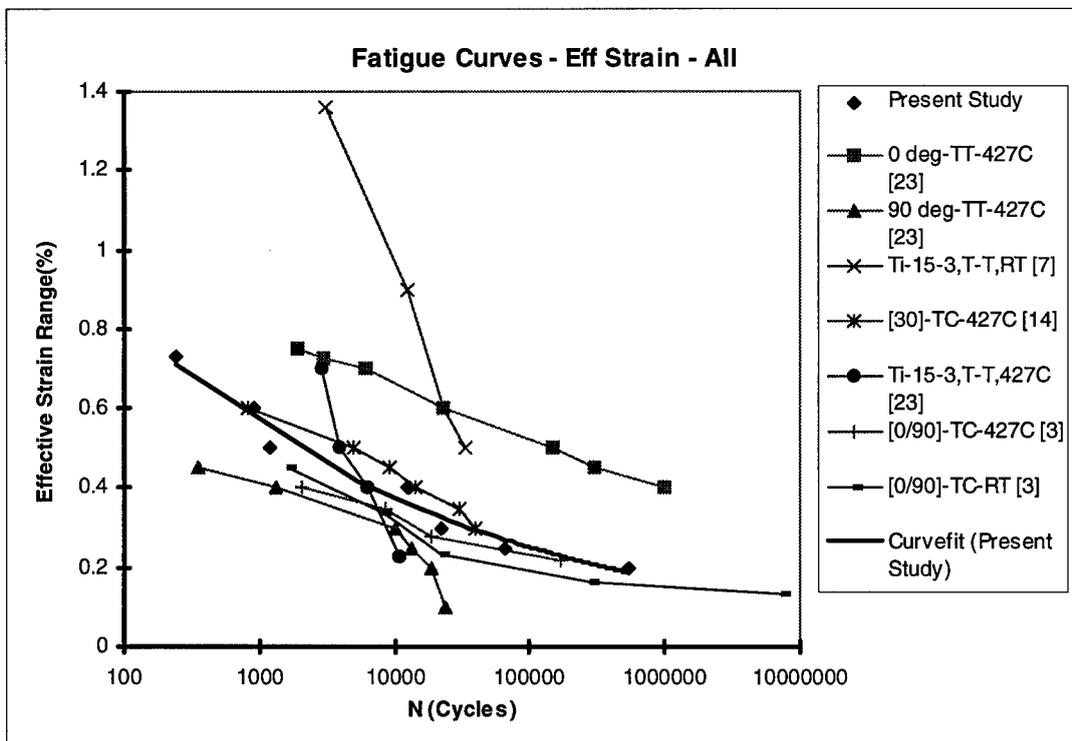
Figure 5.10: Effective Strain Range Fatigue Curve - Overall Comparison

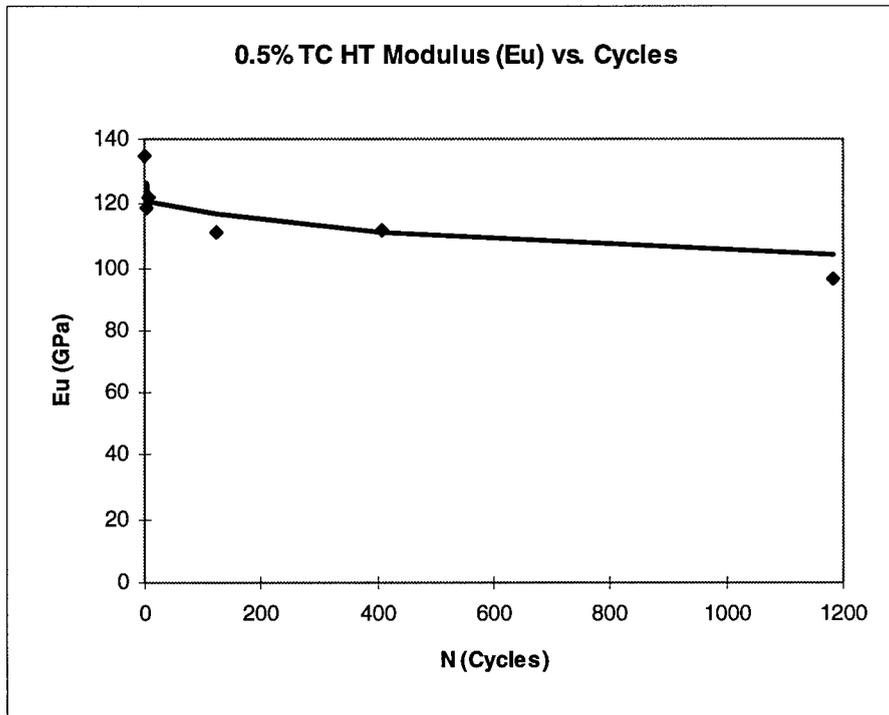
Figure A.1: Modulus History, 0.5% Test

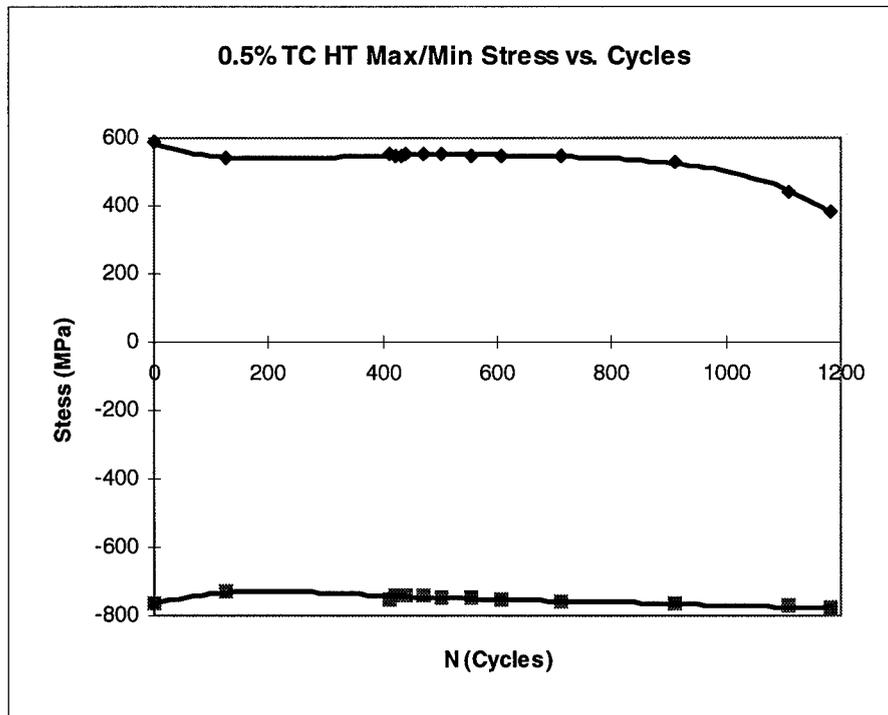
Figure A.2: Max/Min Stress History, 0.5%

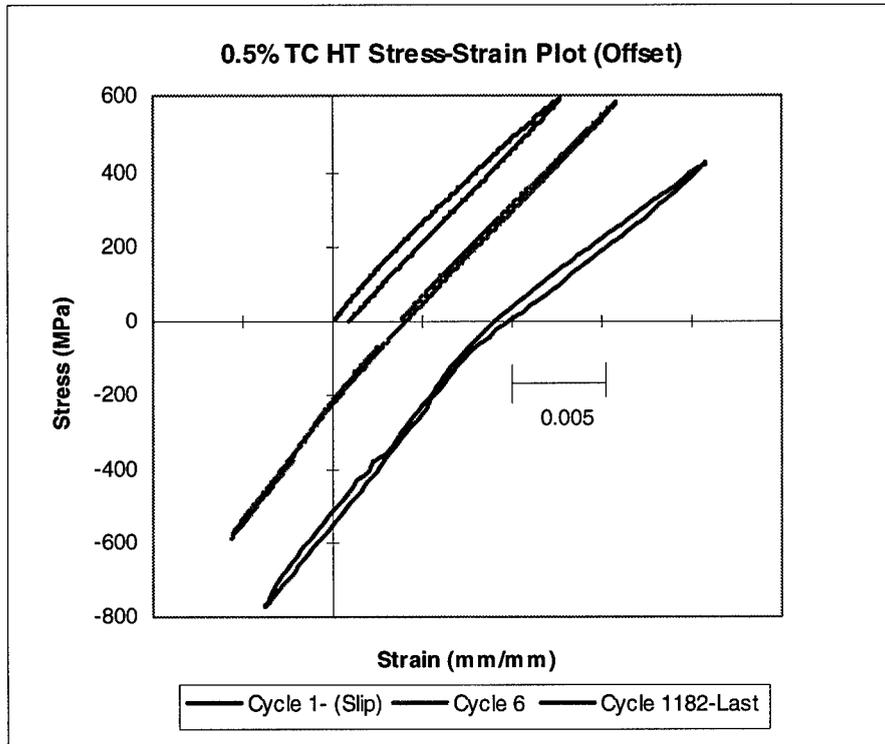
Figure A.3: Stress-Strain Plots, 0.5% (Offset)

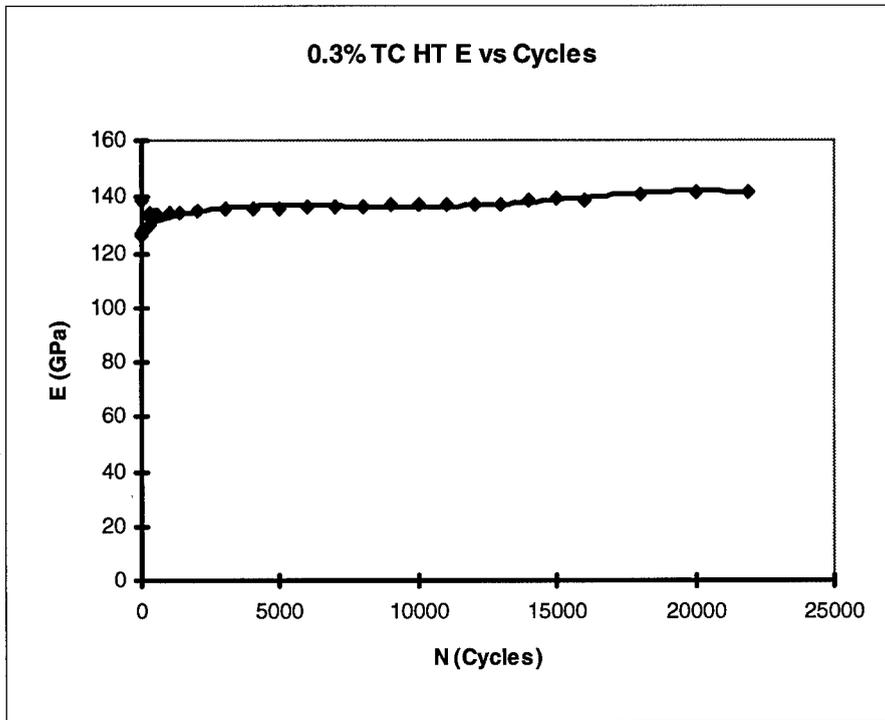
Figure A.4: Modulus History, 0.3% Test

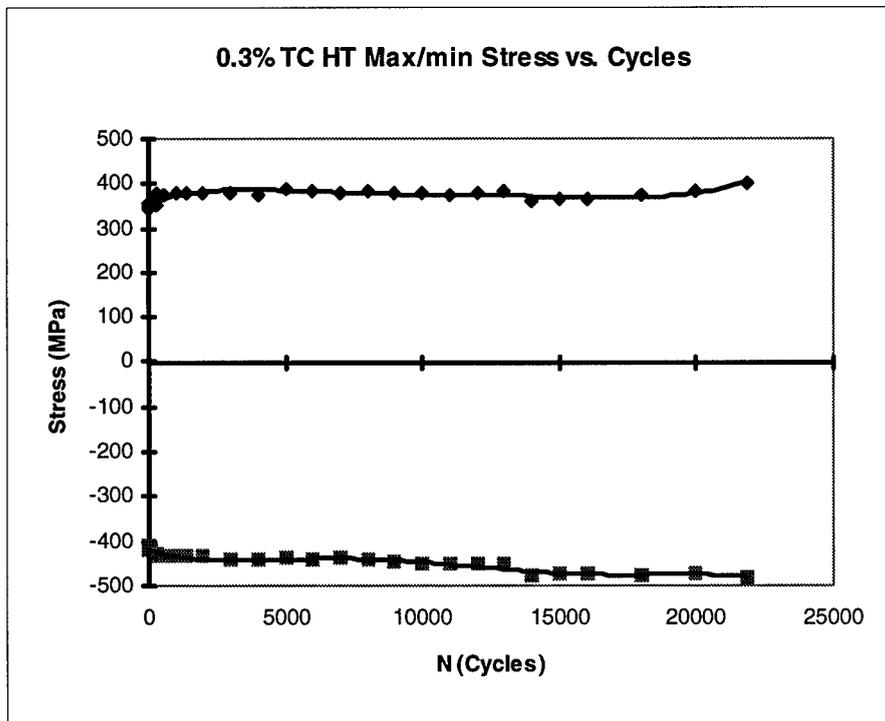
Figure A.5: Max/Min Stress History, 0.3%

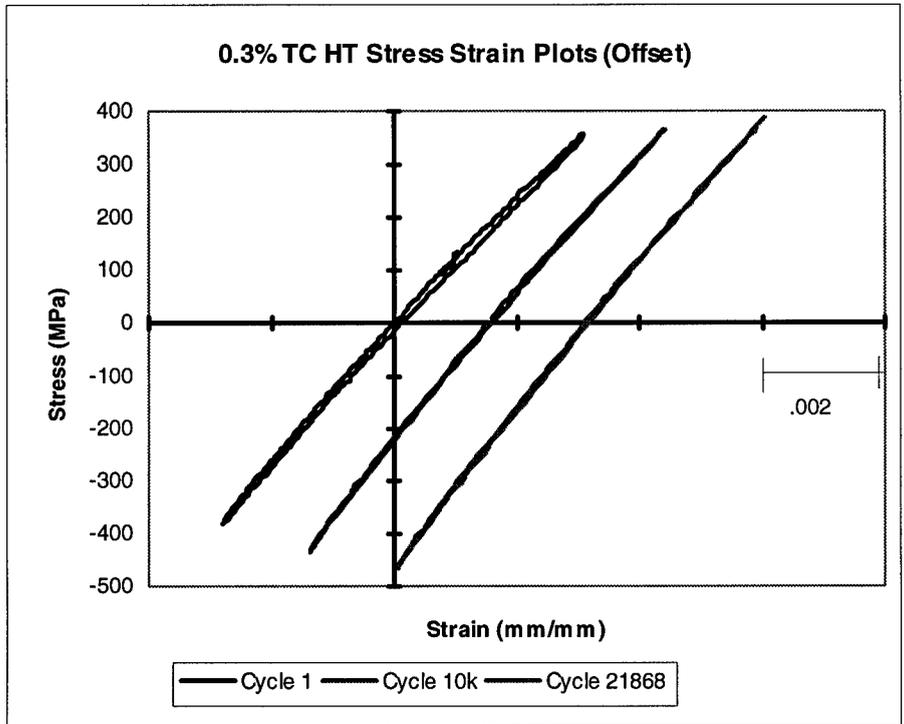
Figure A.6: Stress-Strain Plots, 0.3% (Offset)

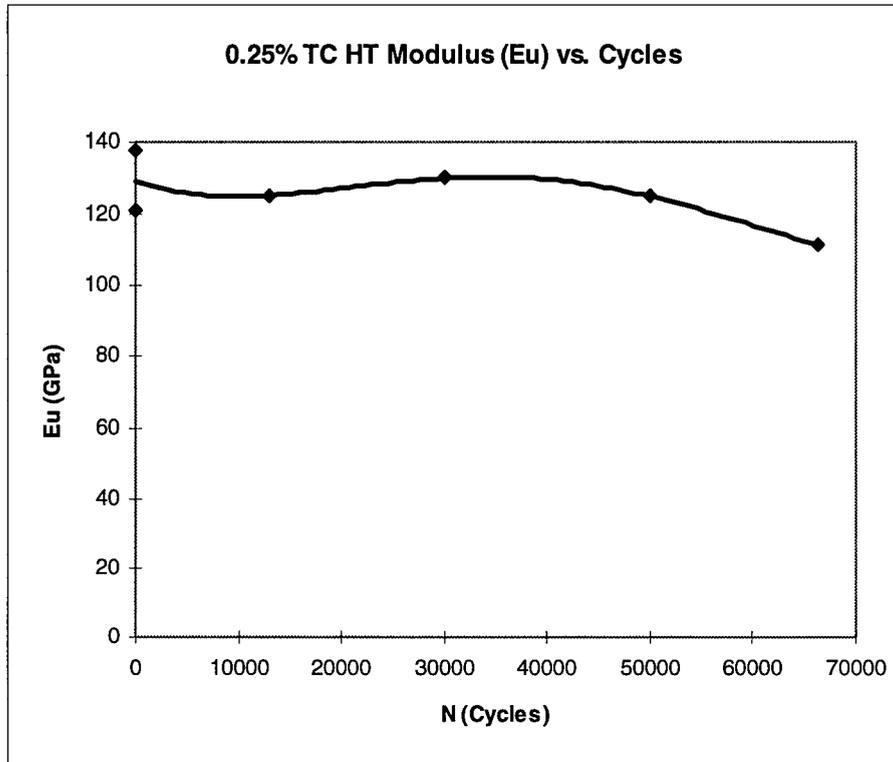
Figure A.7: Modulus History, 0.25% Test

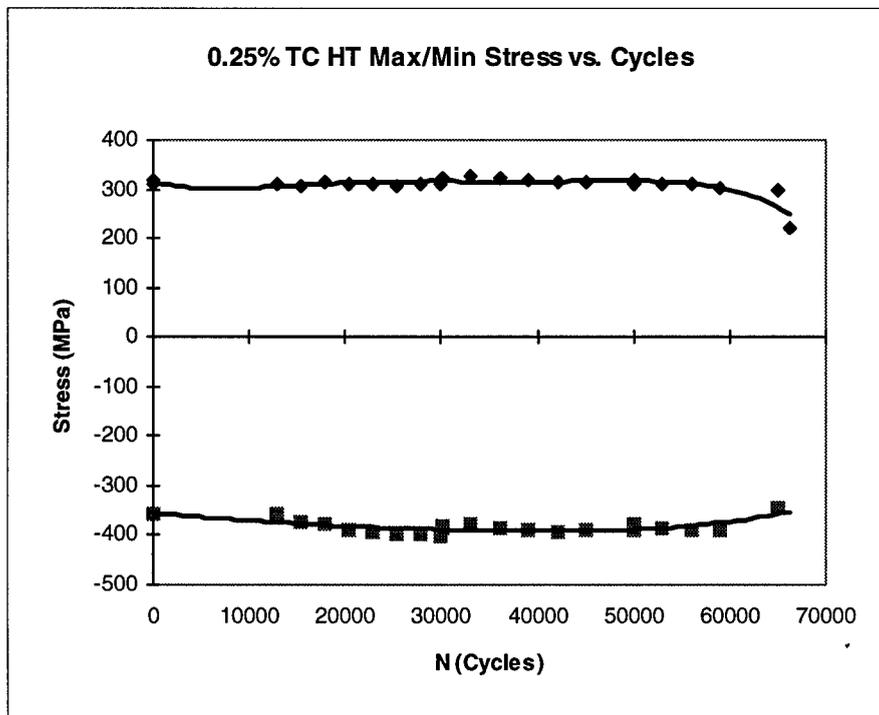
Figure A.8: Max/Min Stress History, 0.25%

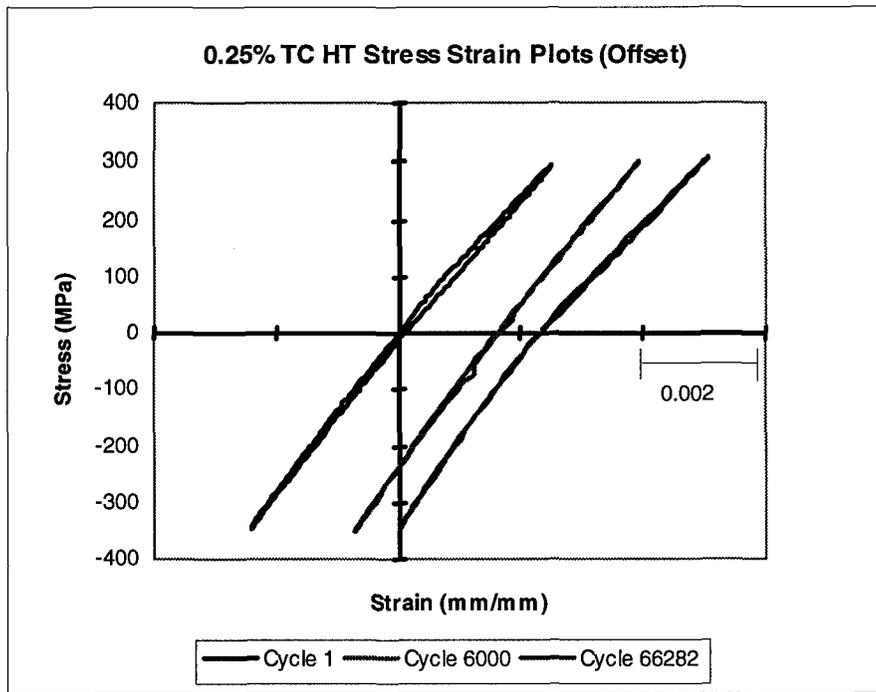
Figure A.9: Stress-Strain Plots, 0.25% (Offset)

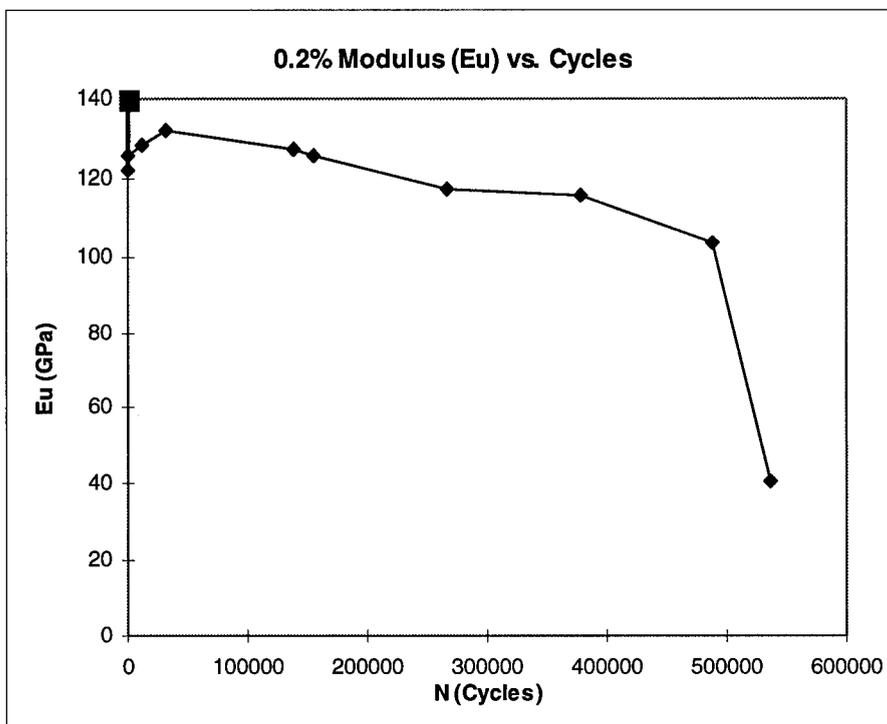
Figure A.10: Modulus History, 0.2% Test

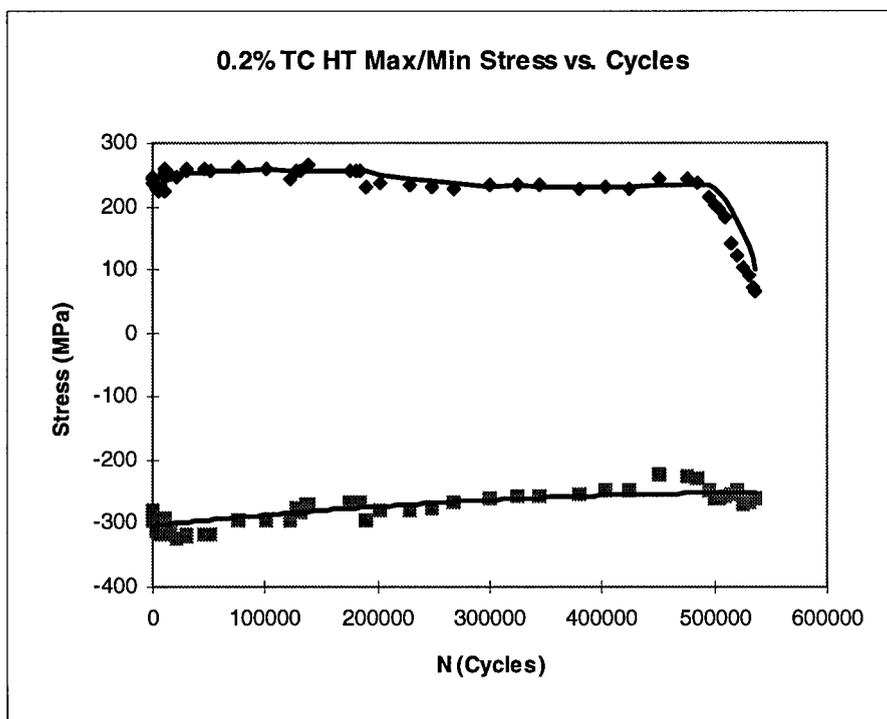
Figure A.11: Max/Min Stress History, 0.2%

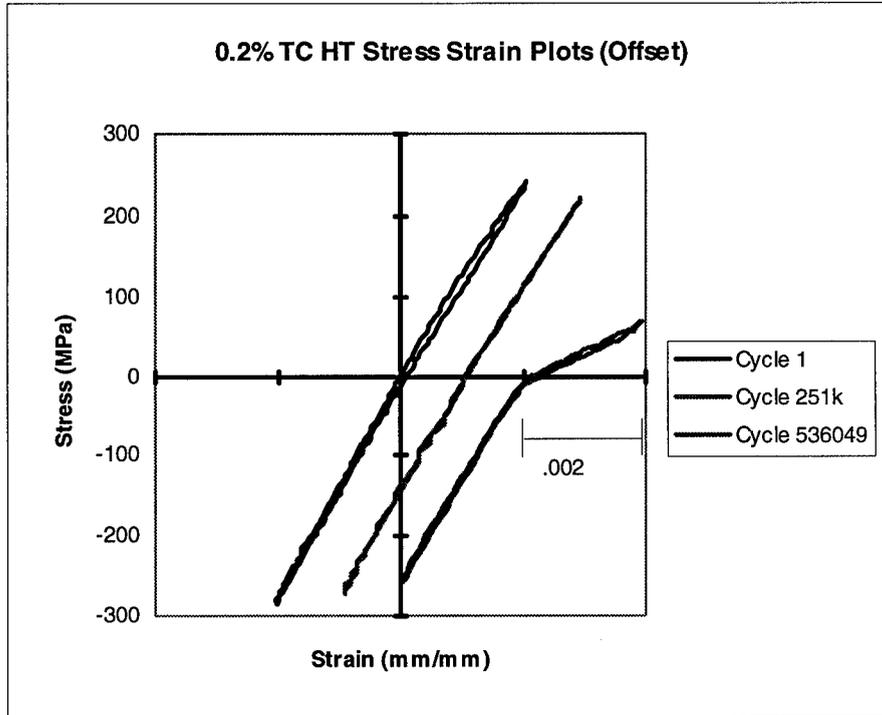
Figure A.12: Stress-Strain Plots, 0.2%(Offset)

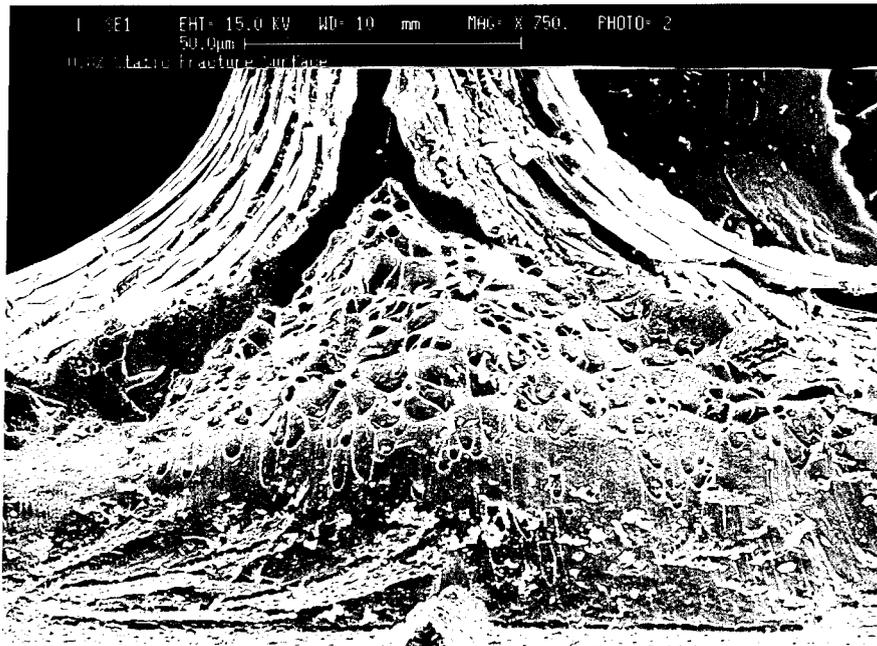
Figure B.1: Ductile Void Coalescence, 0.8% (Static)

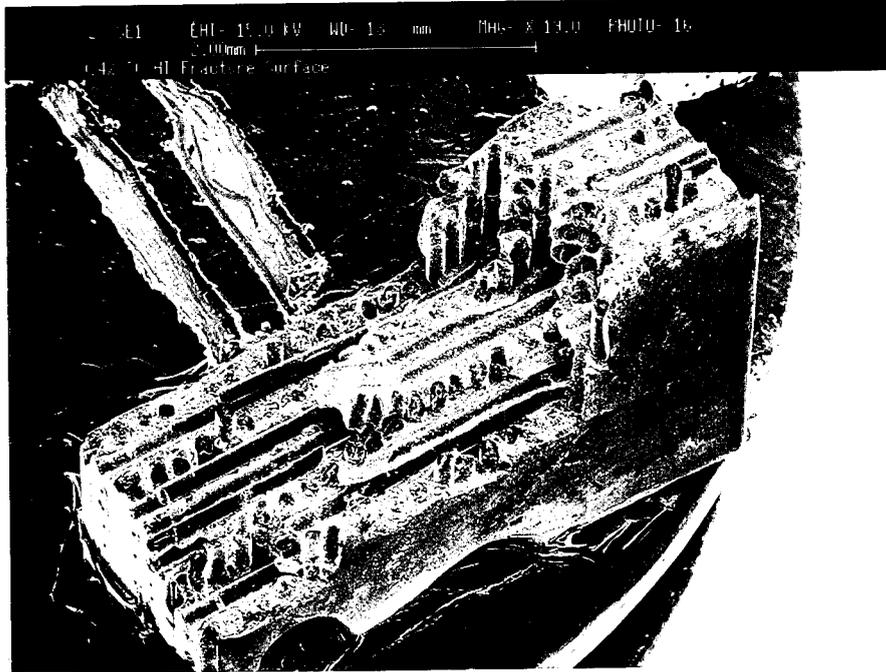
Figure B.3: Fracture Surface , 0.4%

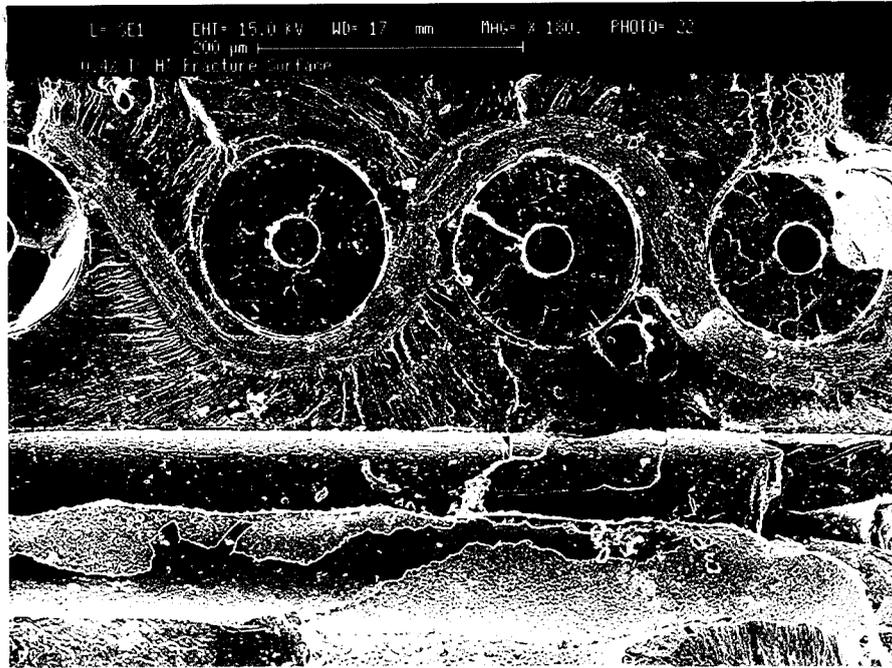
Figure B.4: Molyweave, Fracture Surface, 0.4%

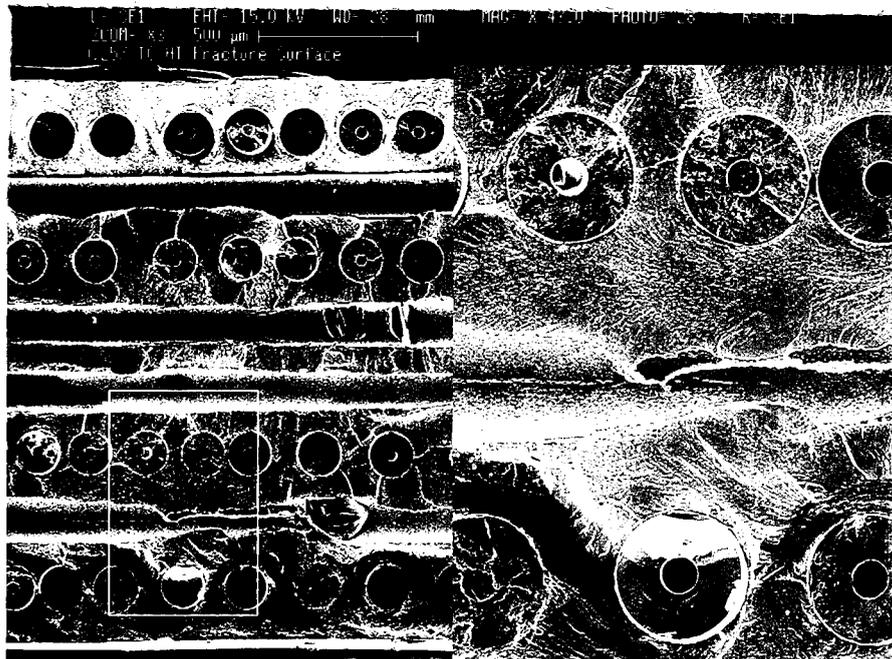
Figure B.5: Extensive Fatigue Striations, 0.25%

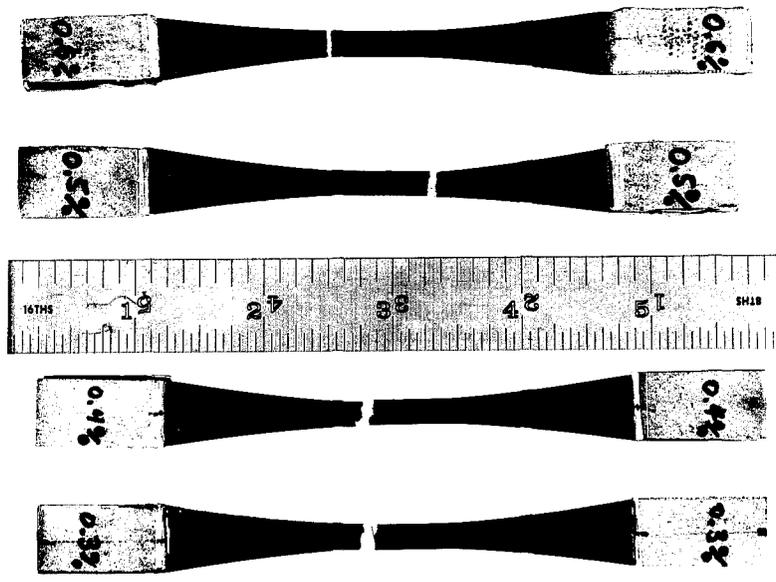
Figure B.6: Post-Fracture Specimen Comparison
