Technical Report REMR-CS-49
June 1995

Repair, Evaluation, Maintenance, and Rehabilitation Research Program

Applications of Precast Concrete in Repair and Replacement of Civil Works Structures

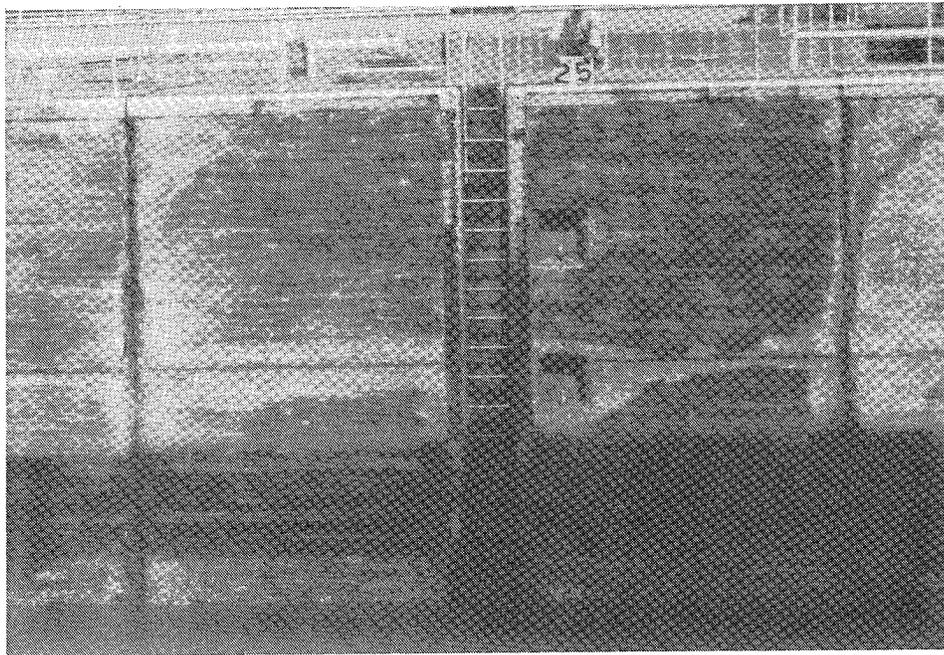
Figure 1. Typical condition of concrete prior to rehabilitation, Lock 22

The findings of the condition survey are summarized as follows: the lock was constructed before the common usage of intentionally air-entrained concrete; there were extensive areas of deteriorated concrete as a result of 50 plus years of cycles of freezing and thawing and impact and abrasion from barges and ice. In general, the deterioration extended about 10 ft down from the top of the lock wall and was approximately 6 in. deep in localized areas (Figure 1). The compressive strength of the underlying concrete averaged 6,180 psi, indicating its strength and quality were satisfactory. The recommended method of repair was to remove and replace the deteriorated concrete with air-entrained concrete.

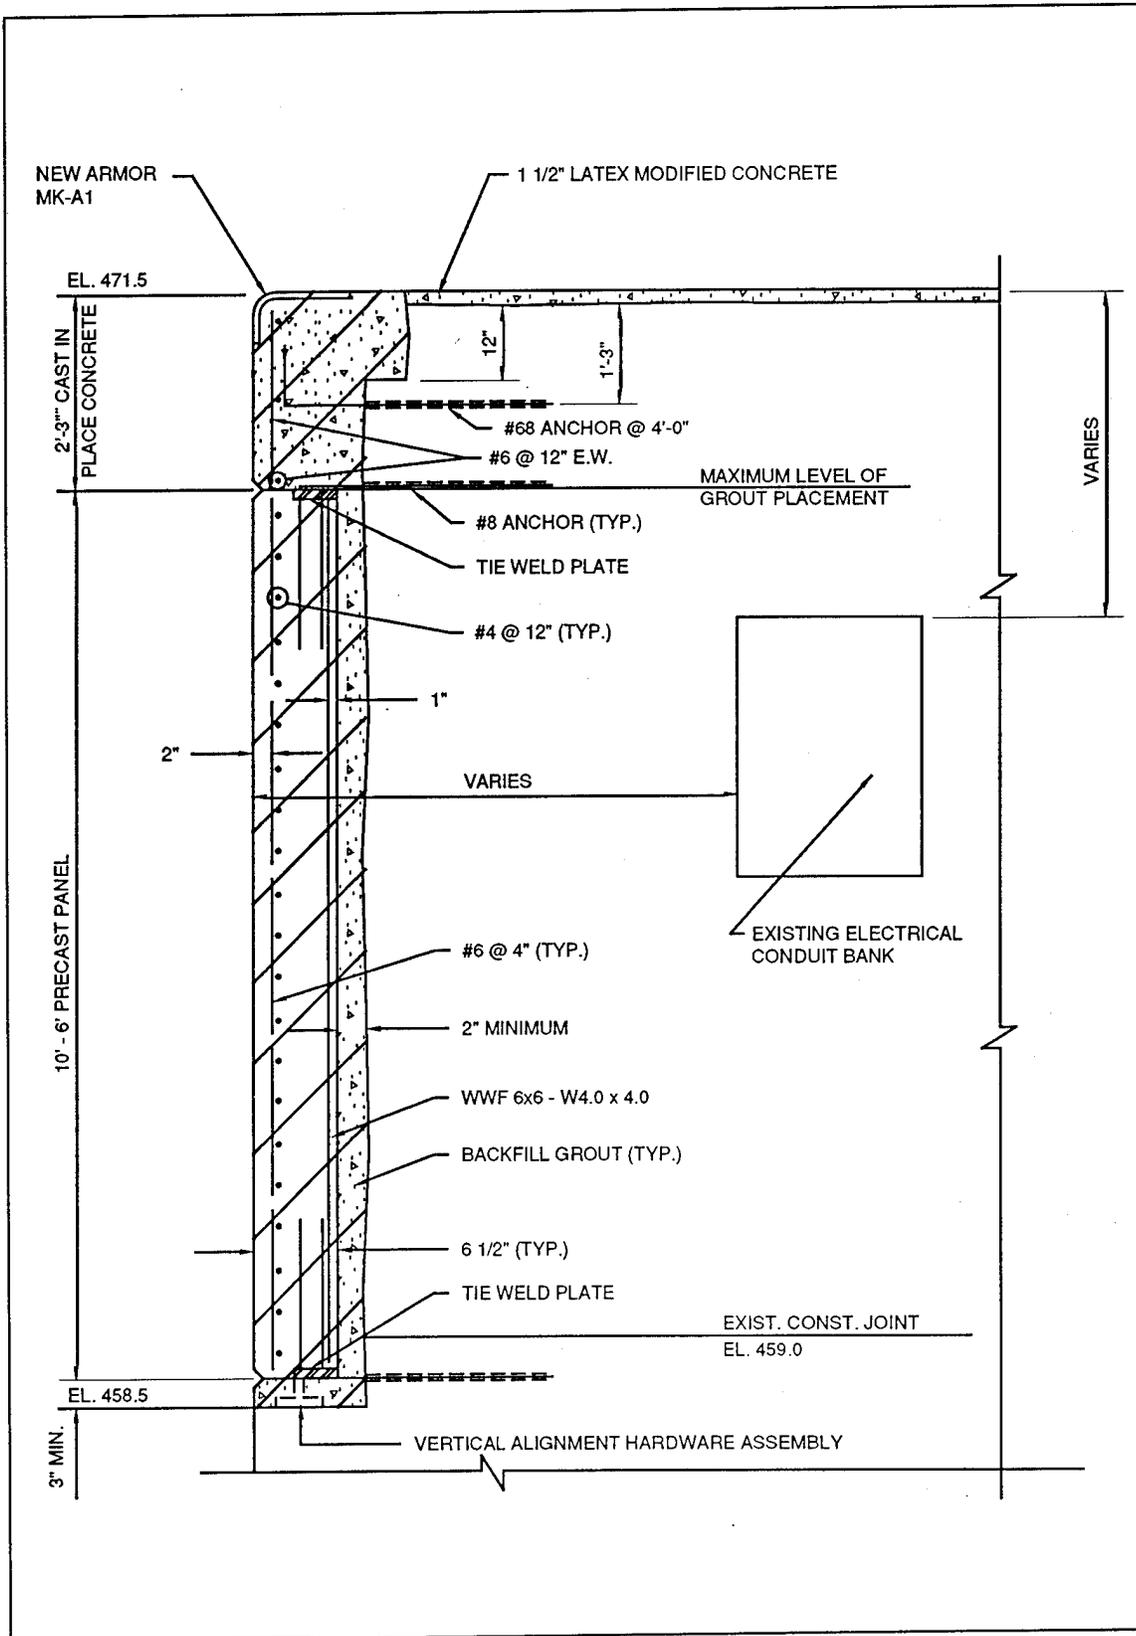
Figure 2. Typical lock wall repair section, Lock 22

The repairs extended 13 ft down from the top of the lock wall (Figure 2). The lower 10.5 ft of the lock wall was to be repaired with precast panels; the upper 2.5 ft, with cast-in-place concrete. The general construction procedure included removal of concrete, fabrication of panels, installation of anchors, setting and alignment of panels, and filling the void between the lock wall and the precast panel.

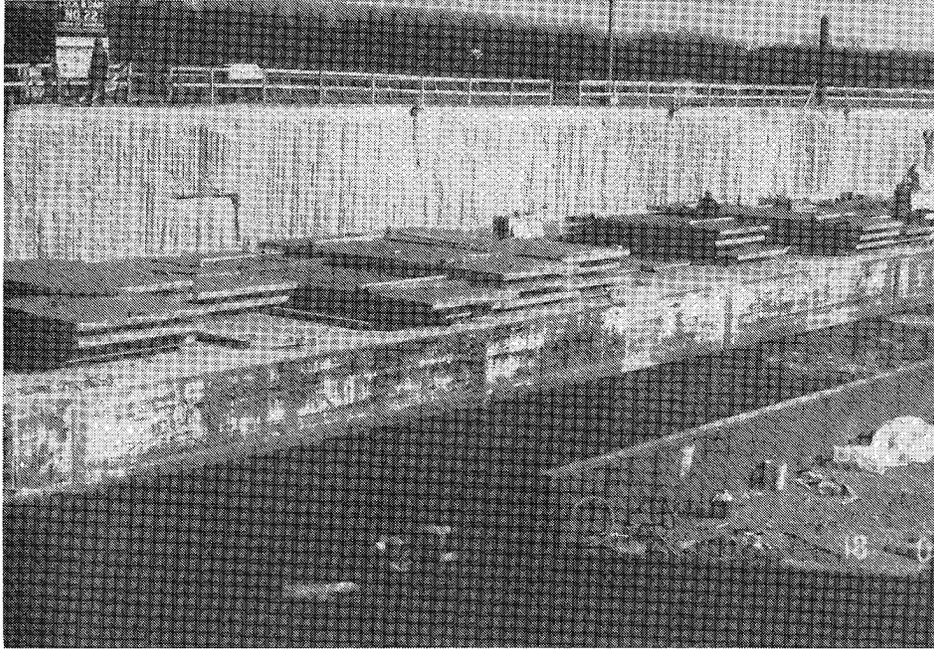
Figure 3. Condition of lock wall after removal of concrete. Precast panels on barges in lock chamber, Lock 22

Concrete removal began with an 8.5-in.-deep sawcut at the bottom of the repairs. Line drilling, which was accomplished prior to shutdown, and blasting techniques were used to remove from 8.5 to about 10.5 in. of concrete from the face of the lock walls. There were some areas of overbreak below the 8.5-in.-deep sawcut. Final cleanup was accomplished with hand-held chipping hammers, wet sandblasting, and a final wash with water (Figure 3).

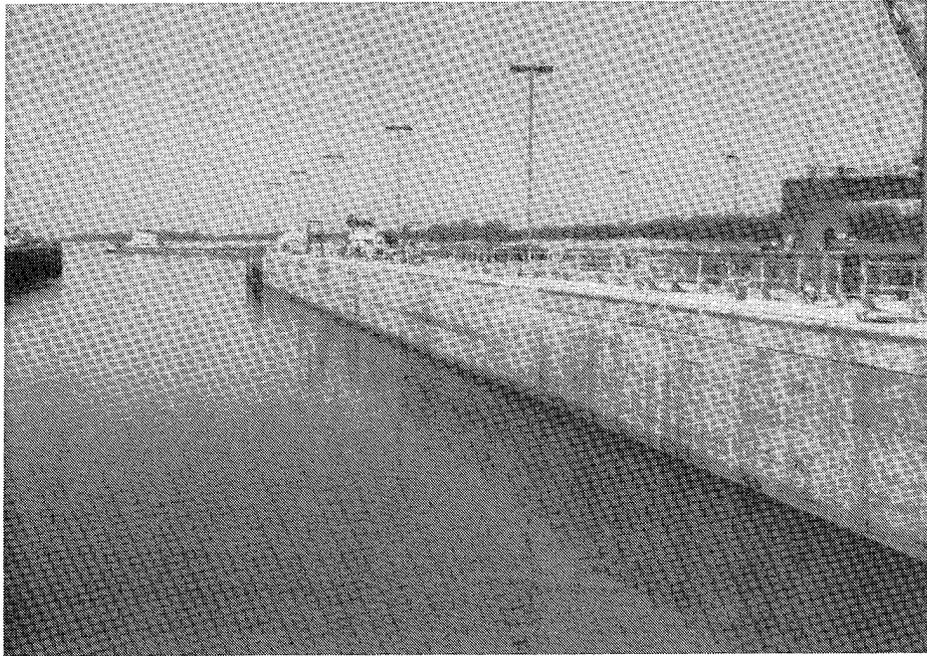
Figure 9. Completed lock wall rehabilitation, Lock 22

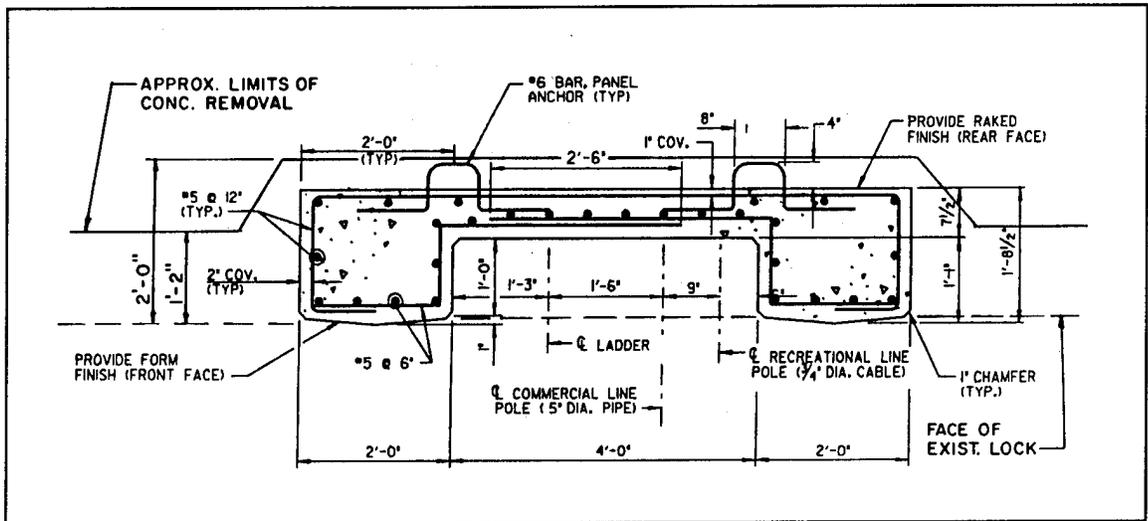
Figure 10. Typical ladder panel section, Troy Lock (from Miles 1993)

River wall panels were 5-1/2 in. thick with a typical length of 20 ft. Panels in the bottom row were 5 ft high for constructibility reasons in the tidal zone; those in the other two rows were 10 ft high. The panels were

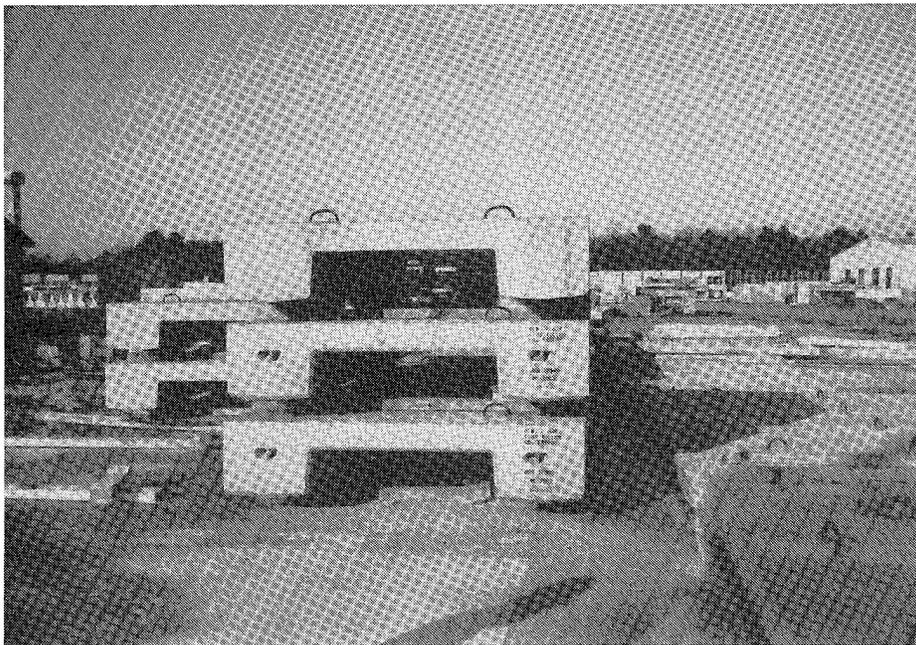
Figure 11. Panel storage in precast plant yard, Troy Lock (from Miles 1993)

Concrete was placed with a concrete bucket handled by a gantry crane and then consolidated with external form vibrators; additional internal vibration was used in the corners of the panels as necessary. The concrete was finished with a wood float and then raked to create a rough surface to improve bonding to the infill concrete. The panels were wet cured overnight in the molds; then they were removed from the molds, stacked, and covered with wet burlap, which was covered with polyethylene to prevent loss of moisture. The final curing required from 5 to 7 days until design strength had been reached, and then the panels were stored in the casting yard (Figure 11) until shipment to the lock.

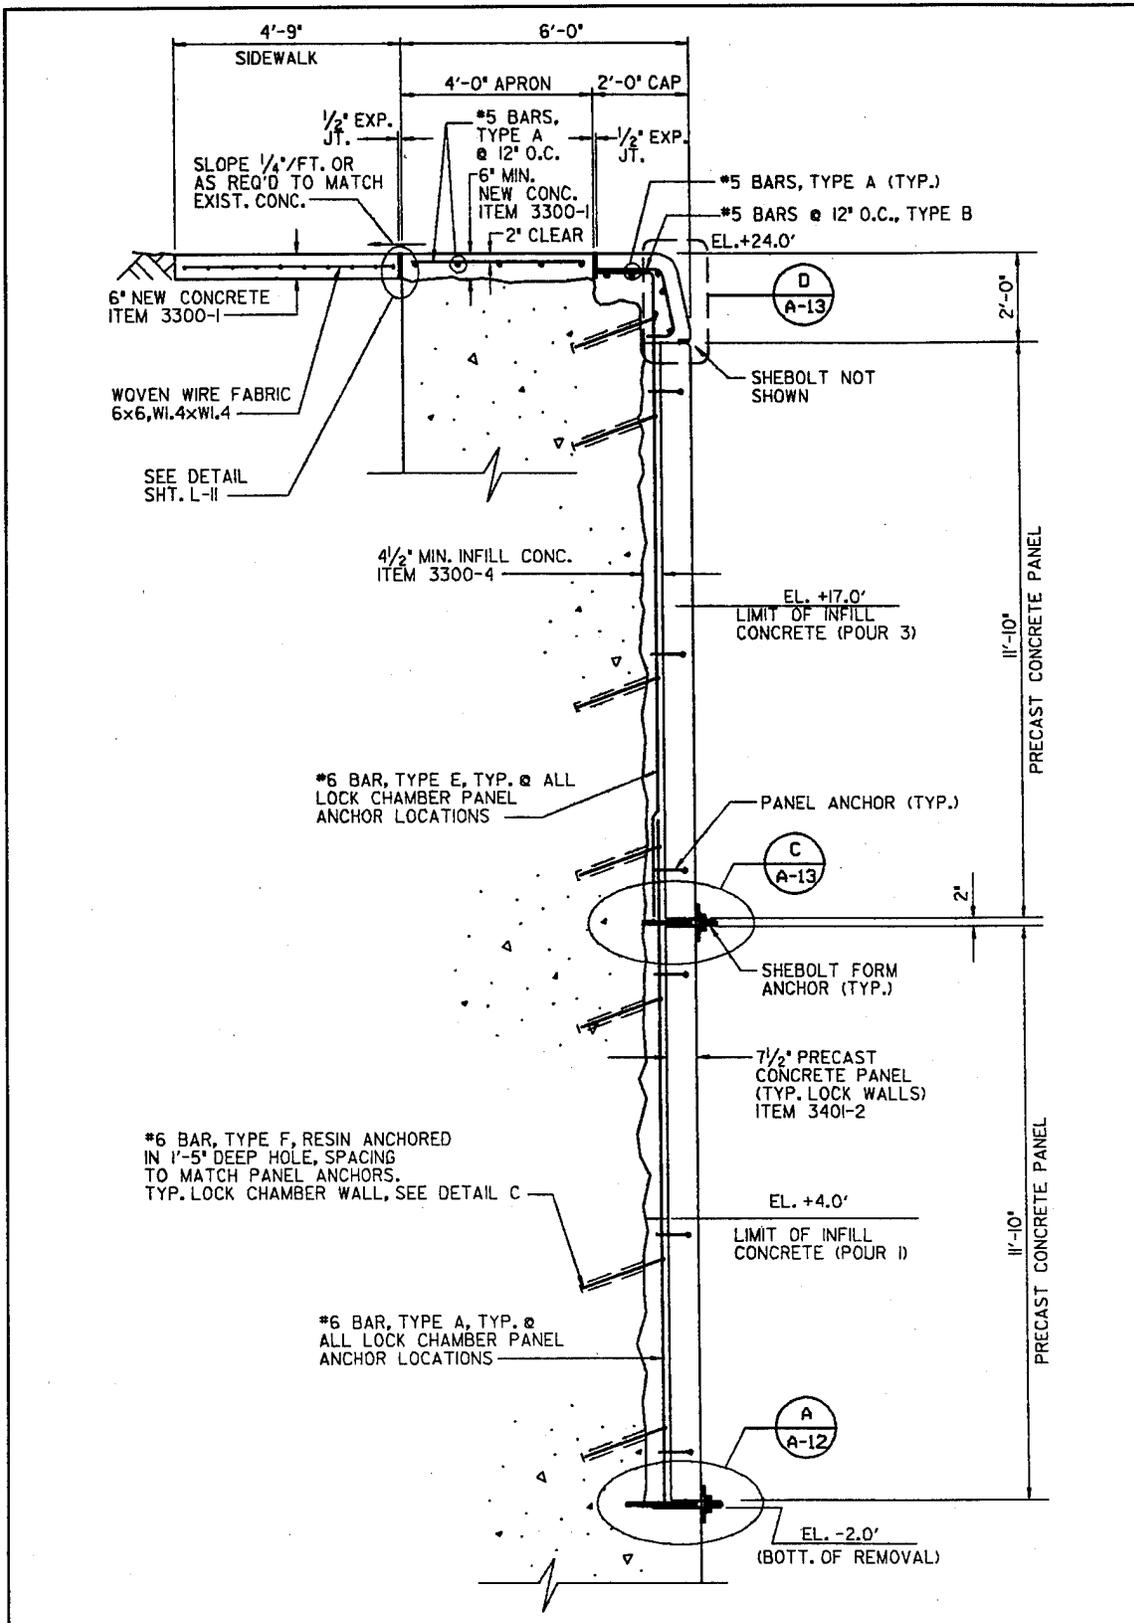
Figure 12. Typical land wall repair section, Troy Lock (from Miles 1993)

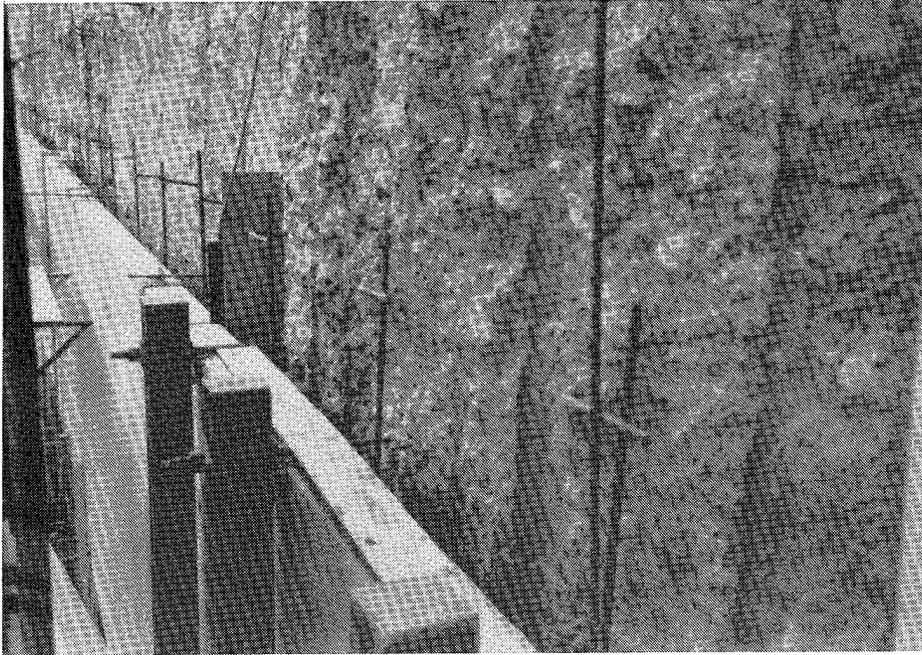
Figure 13. Top of precast panel prior to placing infill concrete, Troy Lock (from Miles 1993)

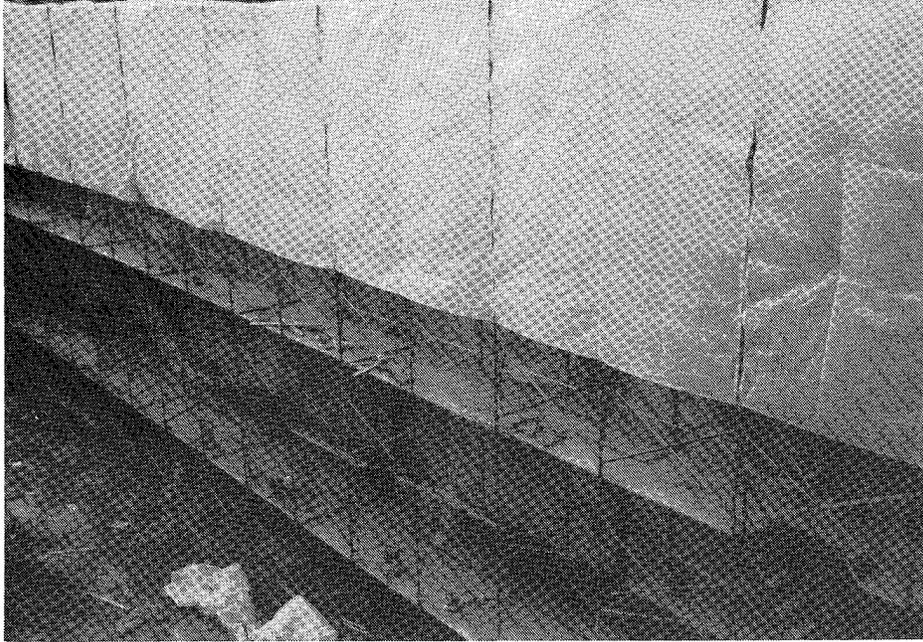
Figure 15. Heated enclosure for curing of infill concrete, Troy Lock (from Miles 1993)

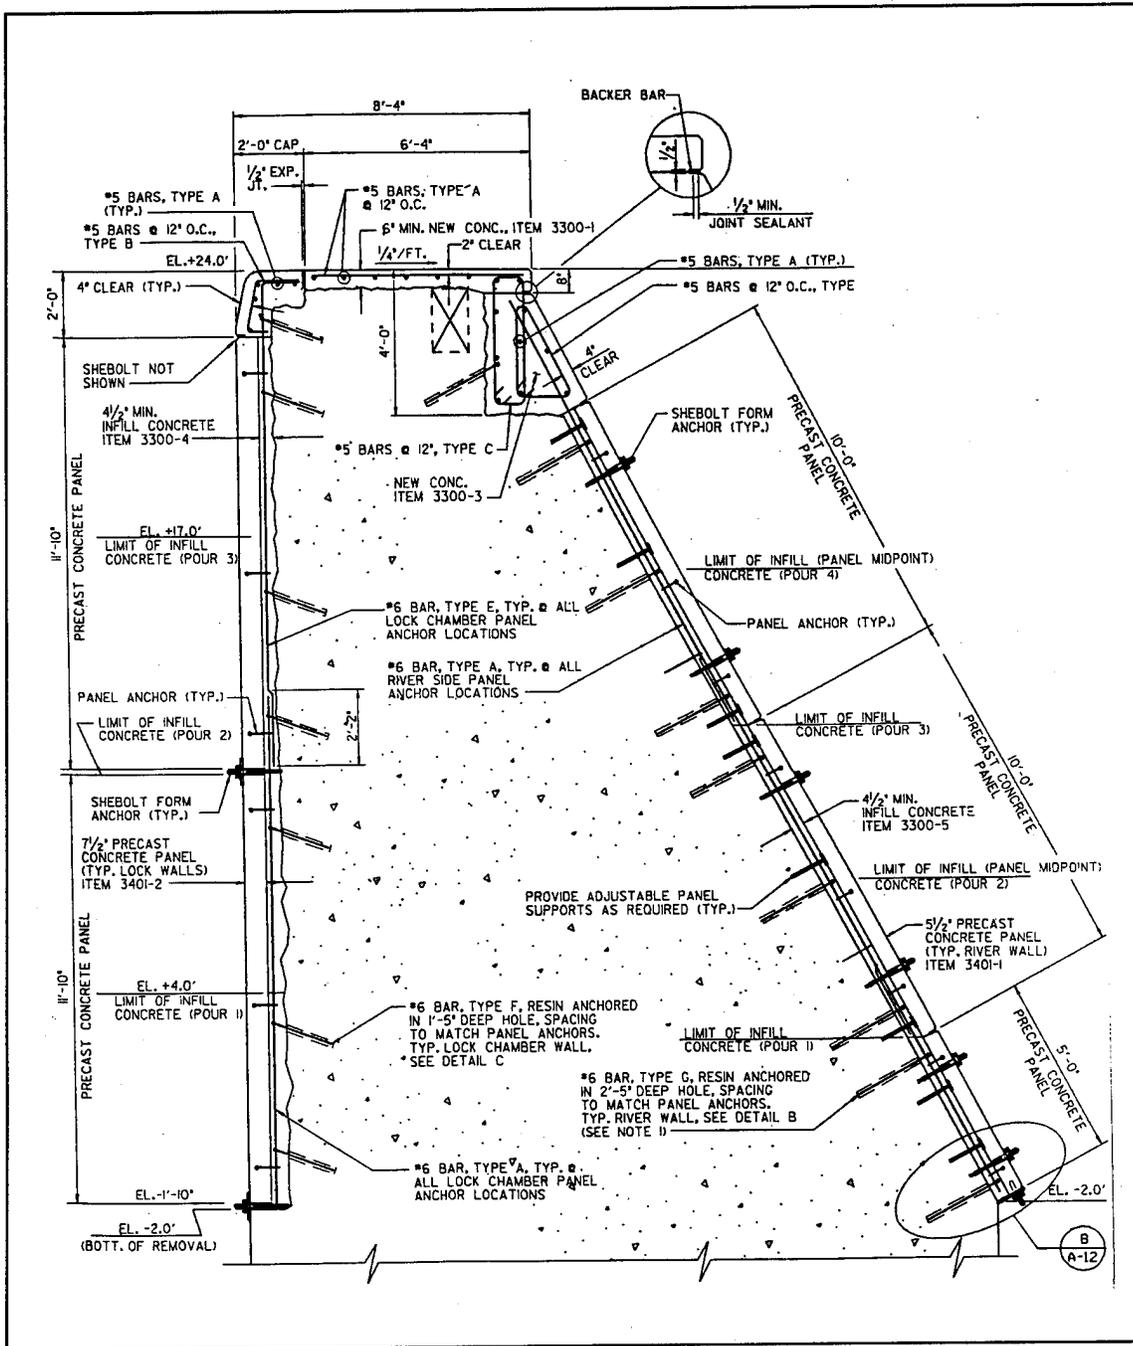
Figure 16. Typical river wall repair section, Troy Lock (from Miles 1993)

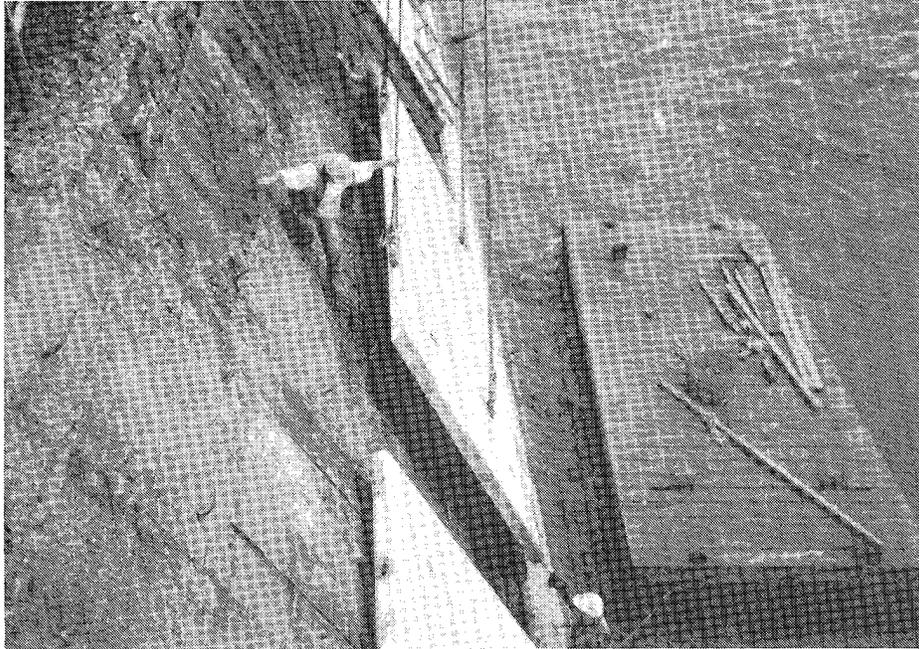
Figure 17. River wall panel installation, Troy Lock (from Miles 1993)

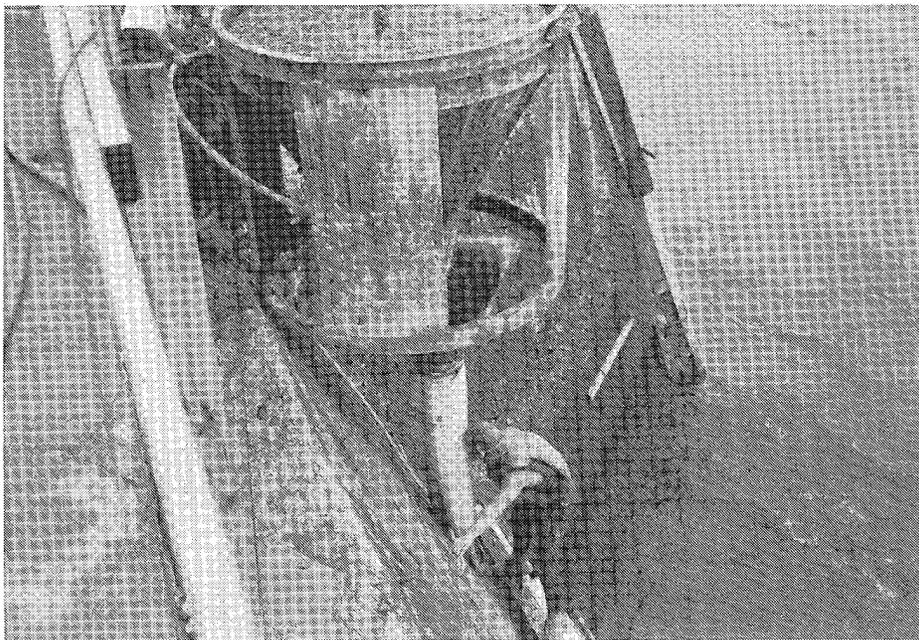
Figure 18. Infill concrete placement and consolidation on river wall, Troy Lock (from Miles 1993)

Except for the bottom row of panels, anchoring and infill concrete placement procedures (Figure 18) were similar to those previously described for the lock chamber. In this case, an antiwashout admixture allowed the infill concrete to be effectively placed underwater without a tremie seal having to be maintained. Curing consisted of keeping the top exposed surface of infill concrete wet for a minimum of 7 days. Heating was not required because ambient temperatures ranged from 50 to 80 deg F. After the infill concrete was properly cured, a polyurethane elastomeric joint sealant was added to the

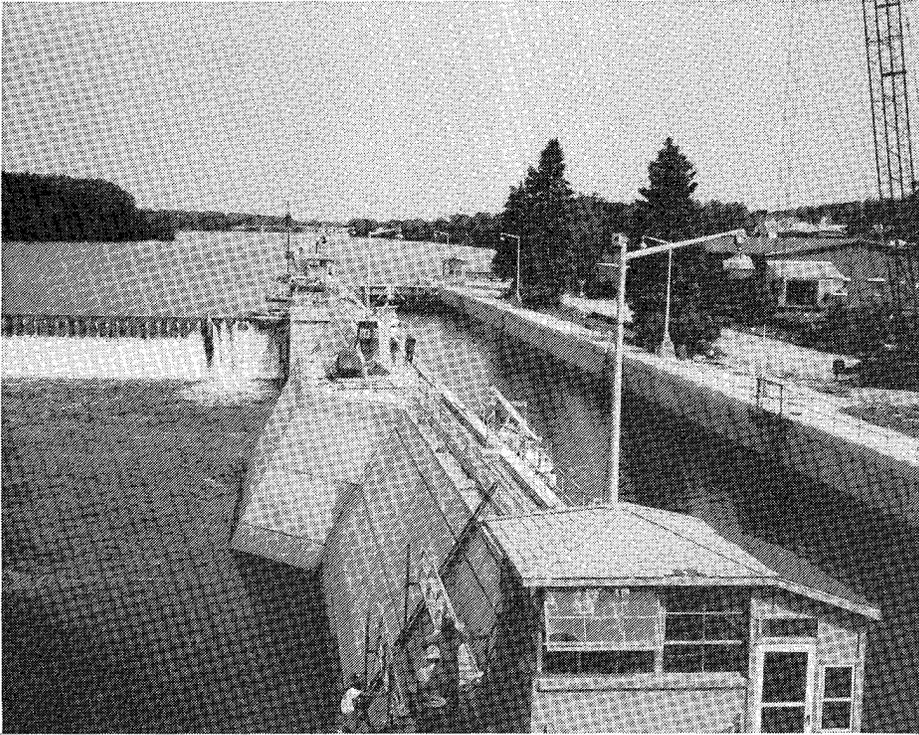
Figure 19. Precast concrete panel installation completed, Troy Lock (from Miles 1993)

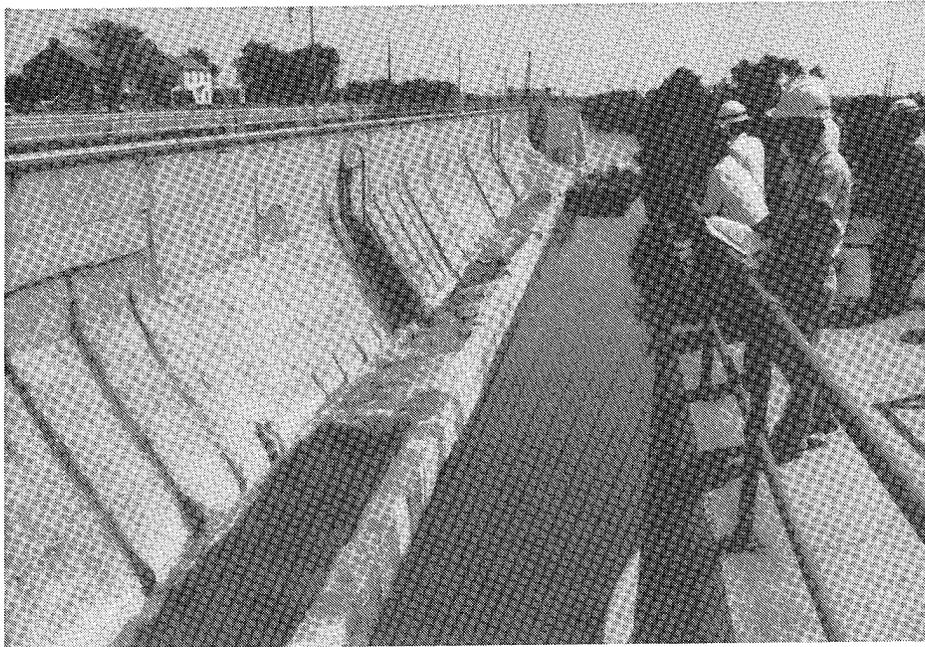
Figure 21. Condition of river wall prior to repair, Lockport Lock

WES performed a condition survey in 1978 (Stowe et al. 1980). A summary of the condition survey follows: freezing and thawing of non-air-entrained concrete was the major cause of damage; alkali-silica reaction was the minor cause. The average depth of damaged concrete was 0.2 and 1.3 ft in the lock chamber wall and just downstream of the lower gate bay, respectively. Severe damage existed at monolith joints, especially on the backside of the river wall (Figure 21). Beyond the damaged concrete zones, the concrete was sound (compressive strength 6,000 plus psi).

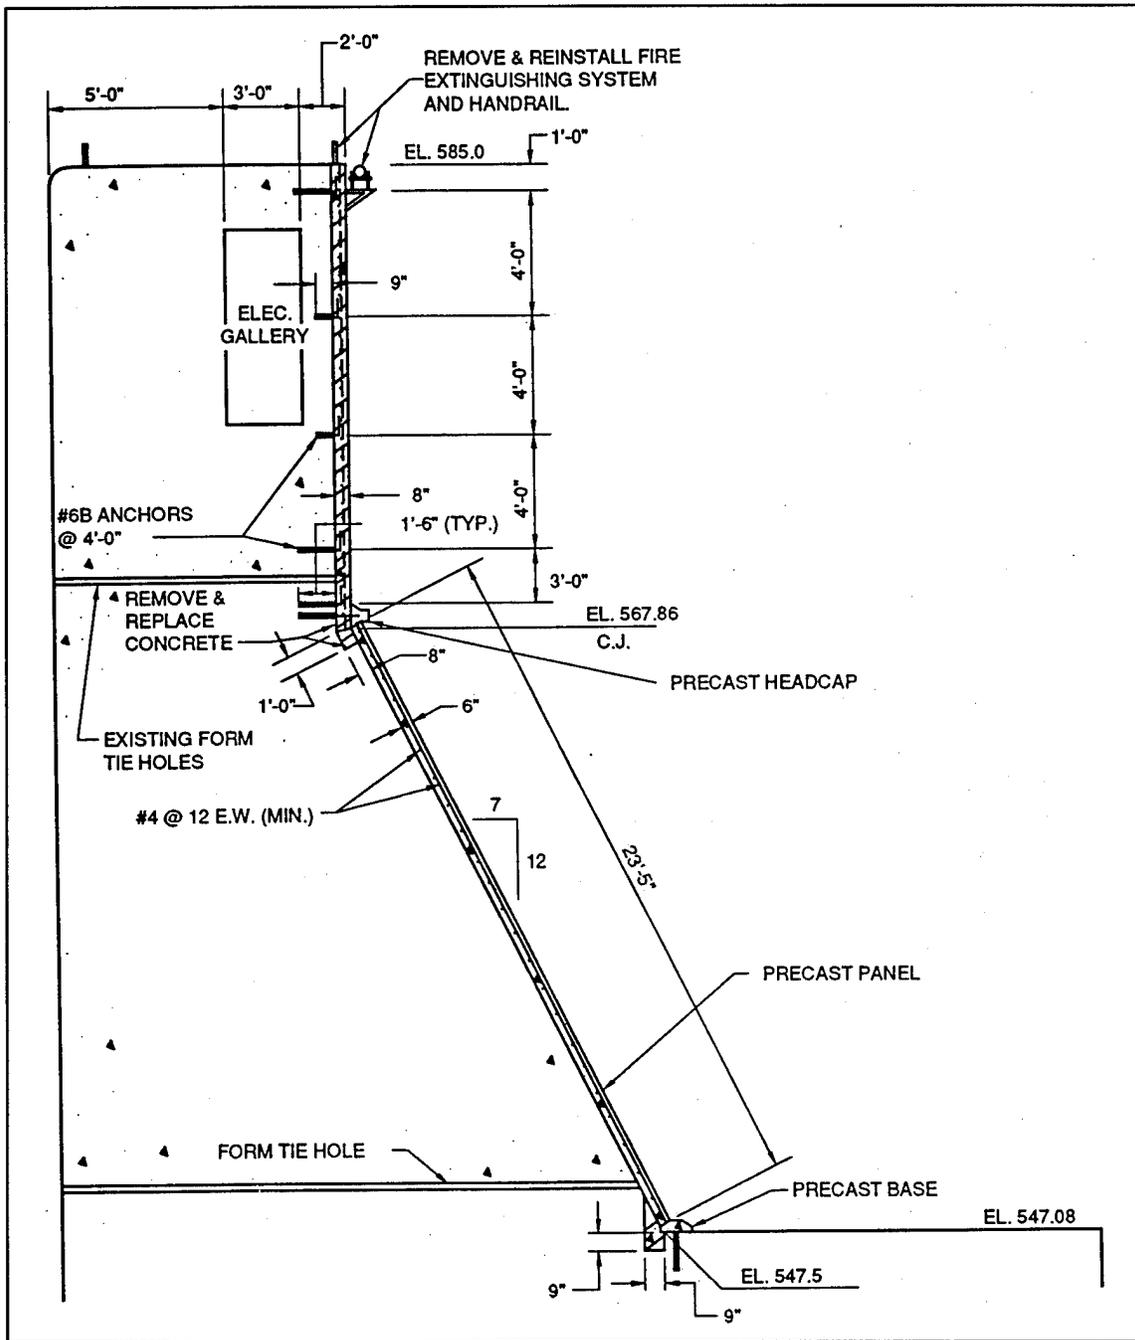
Figure 22. Typical river wall section, Lockport Lock

Major rehabilitation performed in 1984 during Stage I is documented by McDonald (1987b). Stage II rehabilitation consisted mostly of filling/emptying valves, constructing lower guide walls, sealing vertical monolith joints, and resurfacing the lower horizontal ledge of the river wall. Stage III rehabilitation included construction of bulkhead slots, installation of new, upper lift-gate machinery, and resurfacing of the riverside of the river wall. Conventional cast-in-place concrete and precast concrete panels were used to repair the riverside of the river wall (Figure 22).

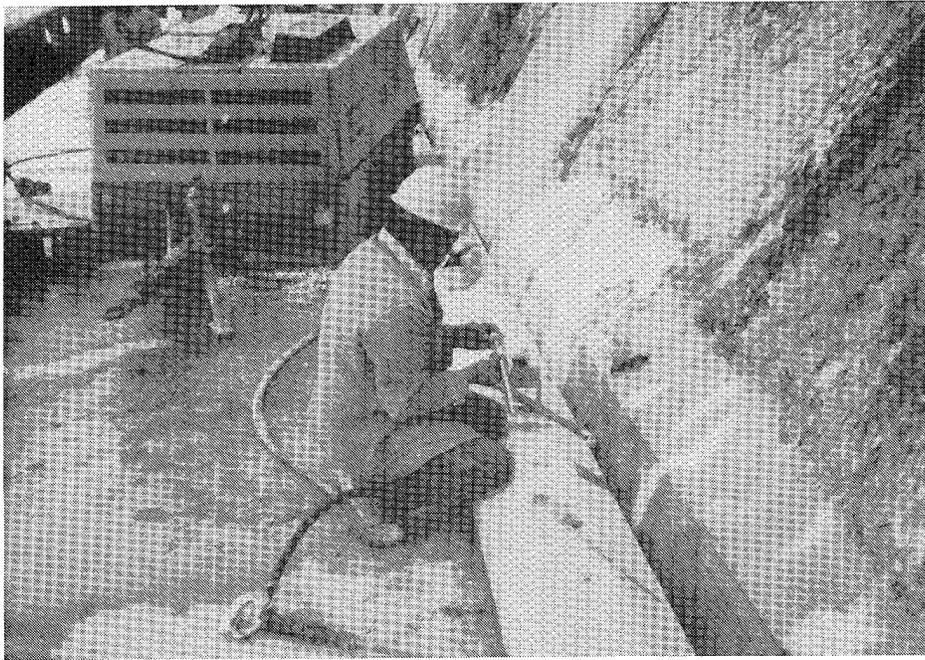
Figure 23. Precast base installation, Lockport Lock

loose concrete with a high-pressure water jet. Then the precast concrete base was installed. The reinforced concrete base was set along the horizontal surface at the base of the wall (Figure 23). The sections were 7.5 ft long by 7 in. high by 1.3 ft wide at the bottom. Two steel bearing plates were embedded in each section during precasting.

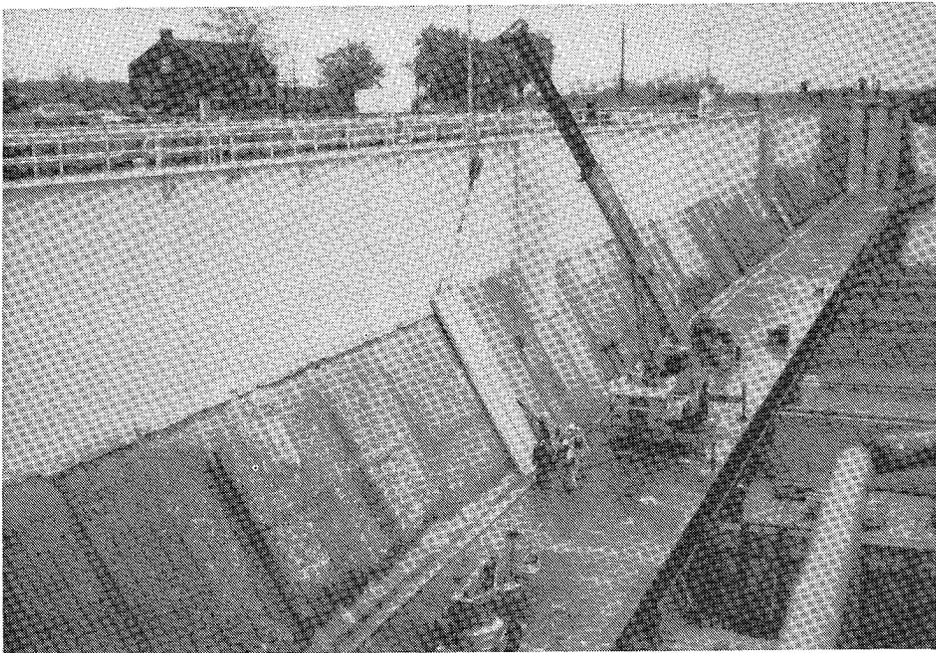
Figure 26. Completed river wall repair, Lockport Lock

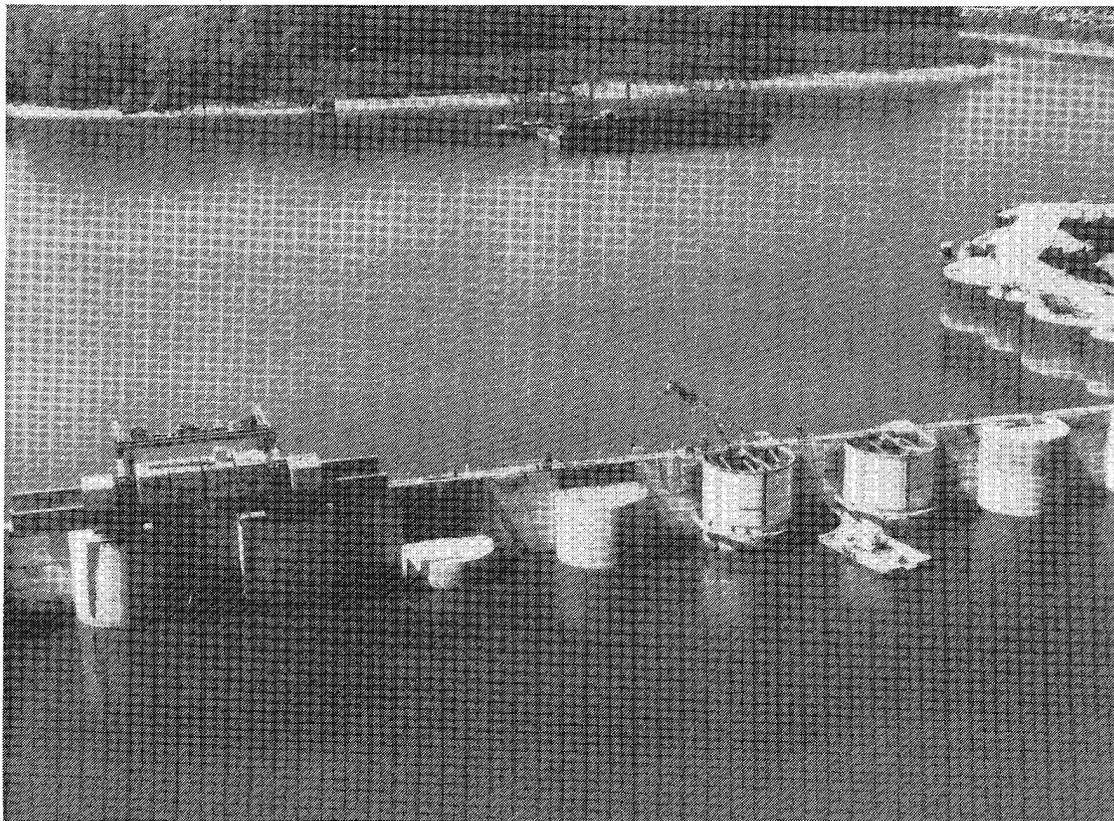
Figure 27. Precast concrete beams installed on downstream guidewall, Melvin Price Main Lock (from *Engineer Update* 1990)

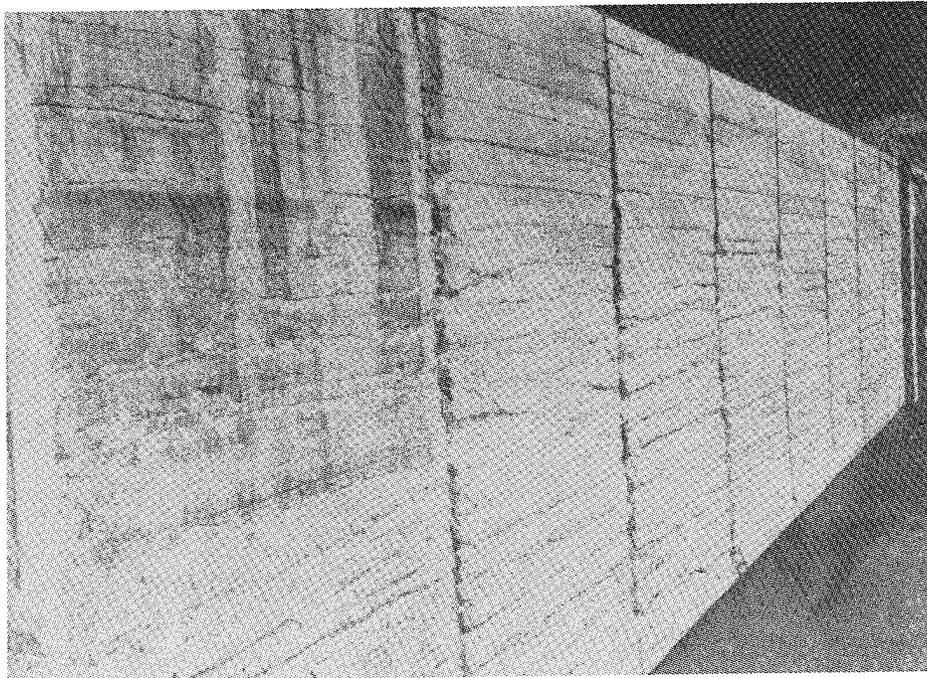
Figure 30. Upstream face of Barker Dam prior to rehabilitation (from Davis, Jansen, and Neelands 1948b)

The deteriorated concrete on the upstream face of the dam (Figure 30) was

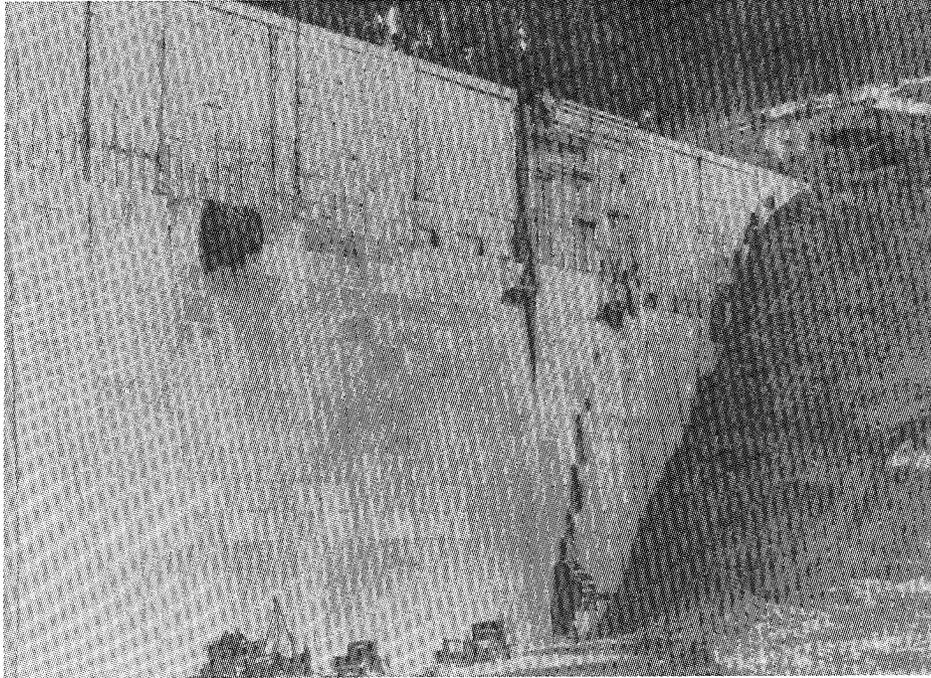
Figure 32. Portion of upstream face of Barker Dam with precast panels installed about three-fourths of its height (from Davis, Jansen, and Neelands 1948b)

A stepped footing of conventional concrete was constructed at the base of the dam. The precast panels and the preplaced aggregate rest on this footing. A flat-bed truck was used to transfer the panels from the storage yard to the damsite. They were lifted from the truck with a crawler-crane and lowered into position on the dam face for installation (Figure 32). Spacer shims

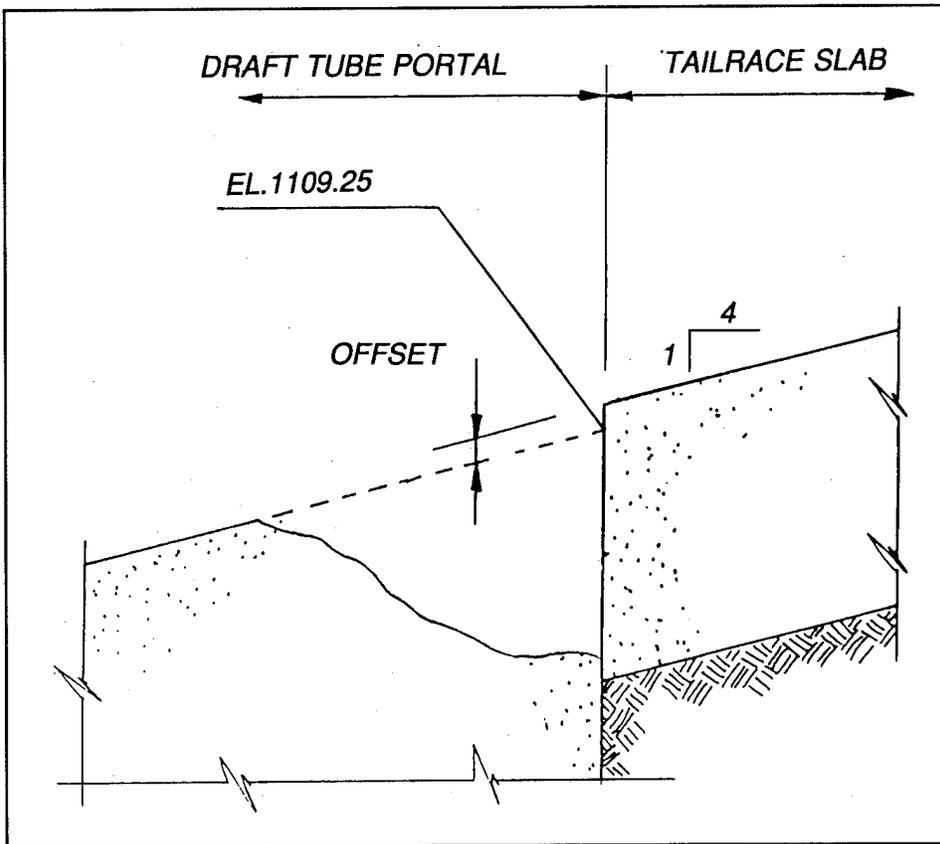
Figure 39. Spall at draft tube portal, Gavins Point Dam (from Harris, Palma, and Miller 1991)

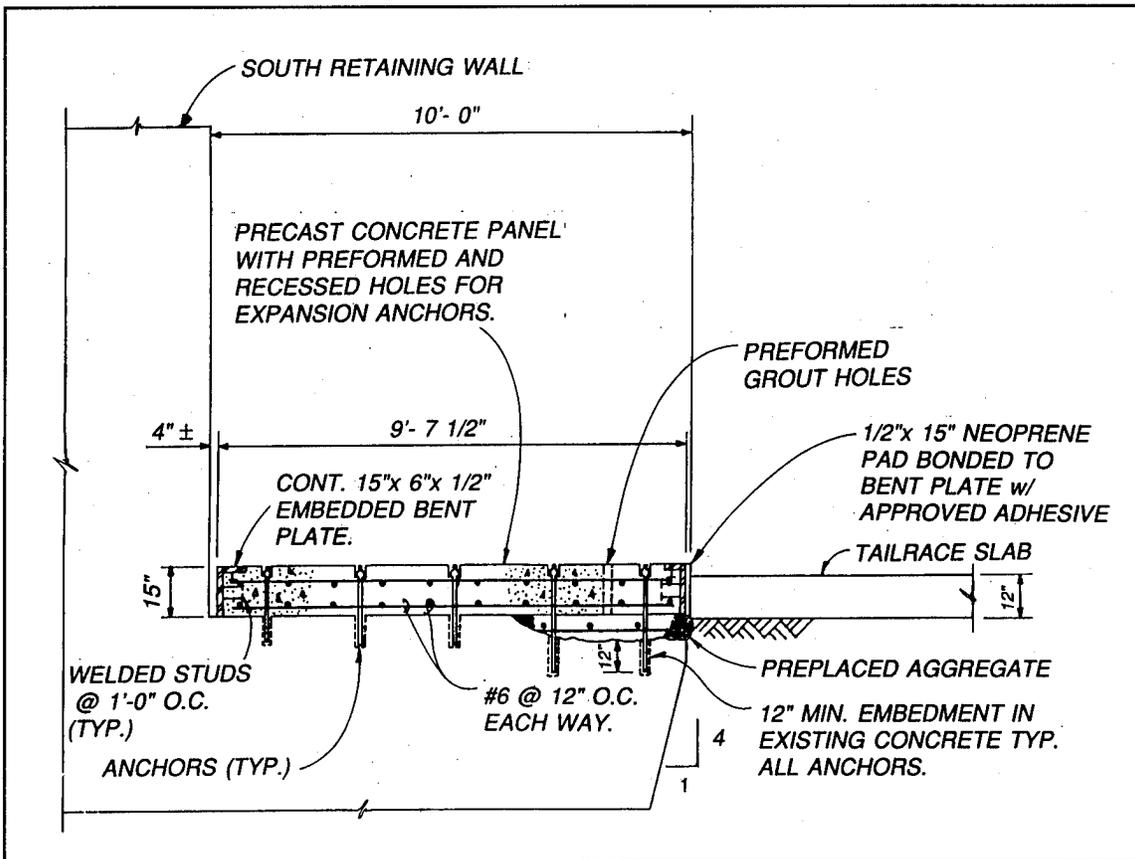
Figure 42. Spall repair at south retaining wall, Gavins Point Dam (from Harris, Palma, and Miller 1991)

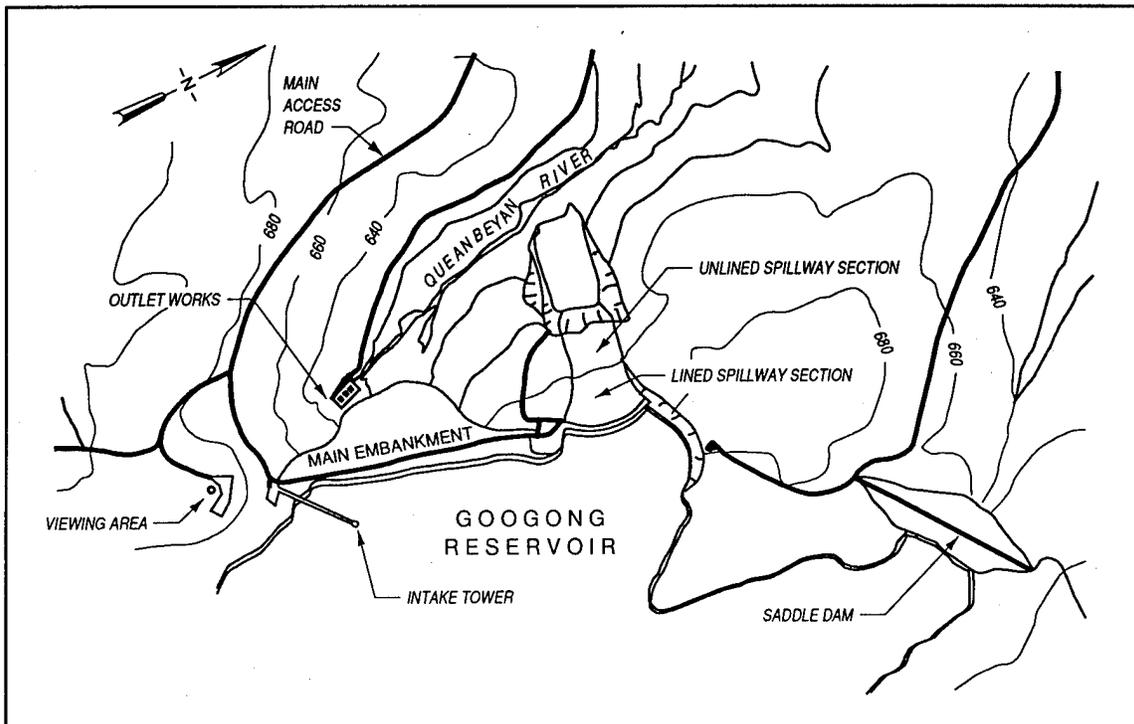
Figure 51. Layout of dam and appurtenant structures, Googong Dam (from ACT Electricity and Water 1991a)

A water intake tower with access bridge and water outlet facilities complete the structure (Figure 51).

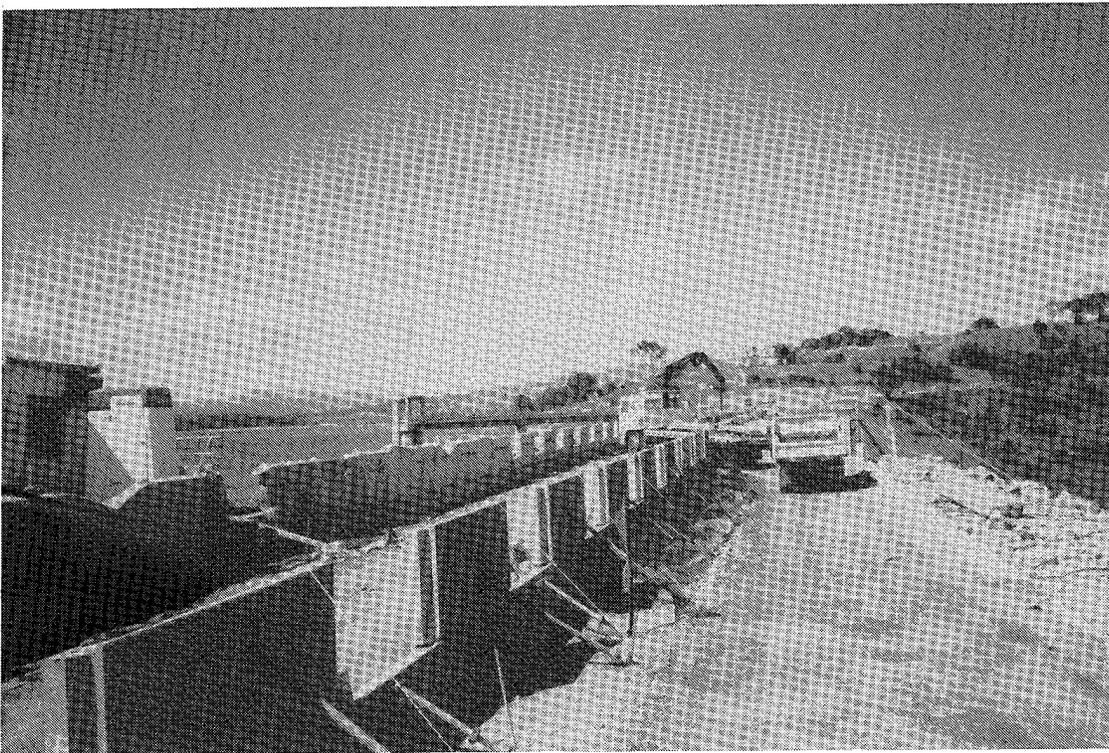
Figure 54. First tier of panels, Googong Dam

The first tier of panels had to be erected with an accurate degree of inward lean to compensate for the outward movement that would occur when the fill material was placed and compacted. To ensure the correct alignment, the panels were clamped together and propped from both sides (Figure 54). Subsequent tiers were supported on resin-bonded cork packing while the vertical joints were filled with closed-cell, expanded polyethylene foam strips. Higher tiers of panels were clamped together (Figure 55) and then pushed into alignment with timber wedges.
