Technical Report REMR-CS-49
June 1995

Repair, Evaluation, Maintenance, and Rehabilitation Research Program

Applications of Precast Concrete in Repair and Replacement of Civil Works Structures

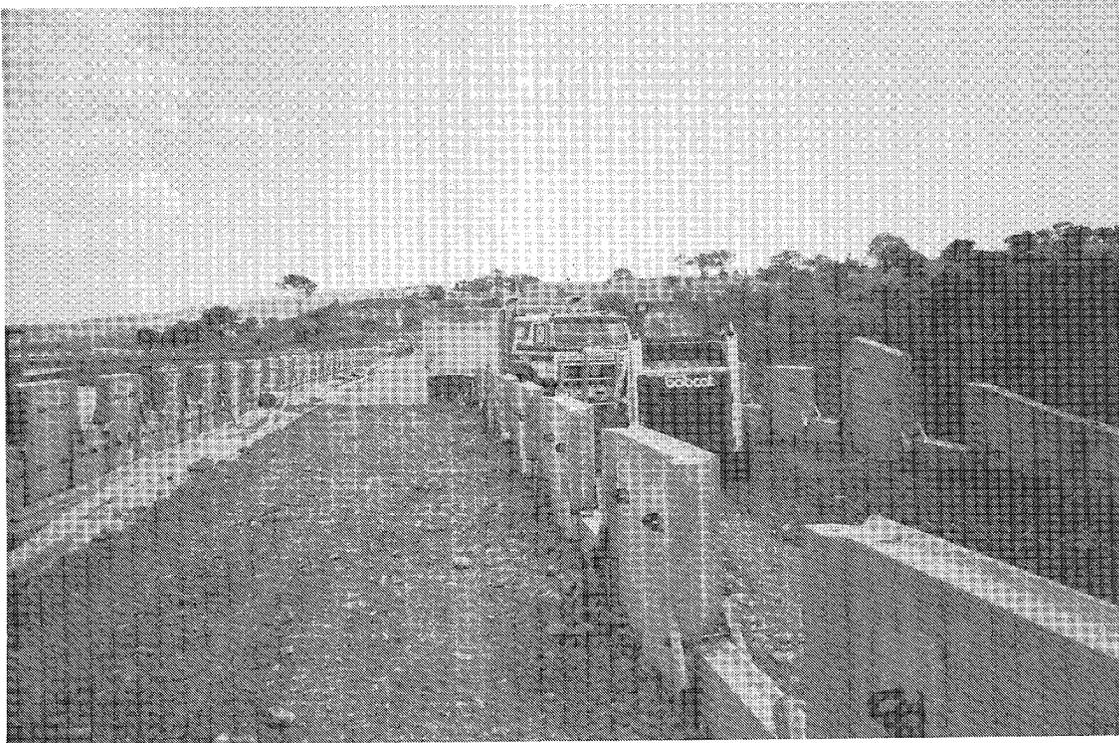
Figure 55. Precast panels clamped together during placement of granular fill, Googong Dam

The precast panels are held together with straps made of 10 polyester fiber bundles enclosed in a polyethylene sheath. Plastic was chosen over galvanized steel because the straps pass through a layer of clay fill placed against the upstream wall. The panels are held in place by friction that develops between the fill and the straps. Straps were spaced vertically at 31 in. As the fill material reached each strap layer, the straps were laid out from wall to wall

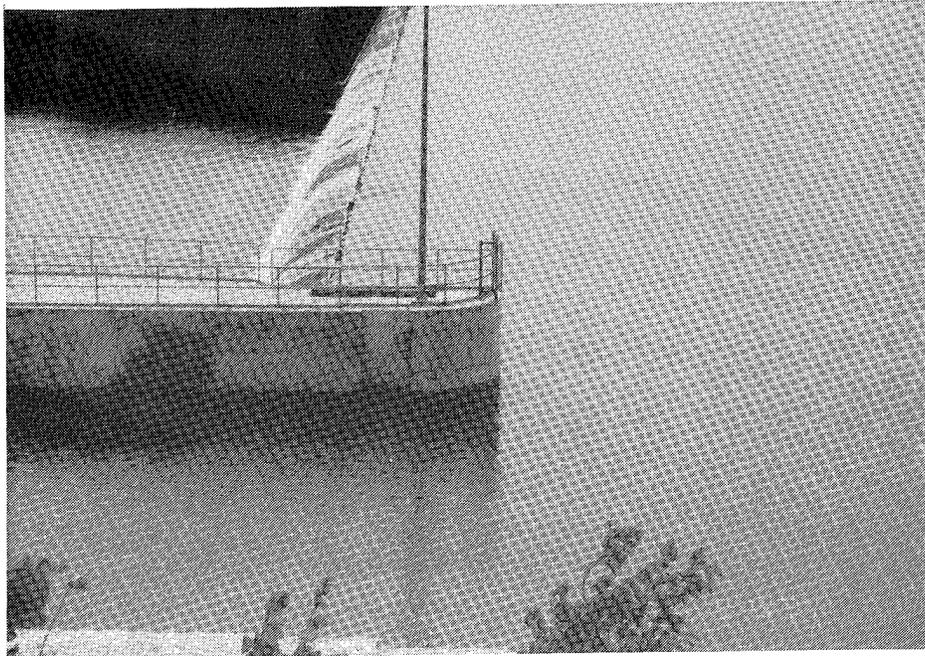
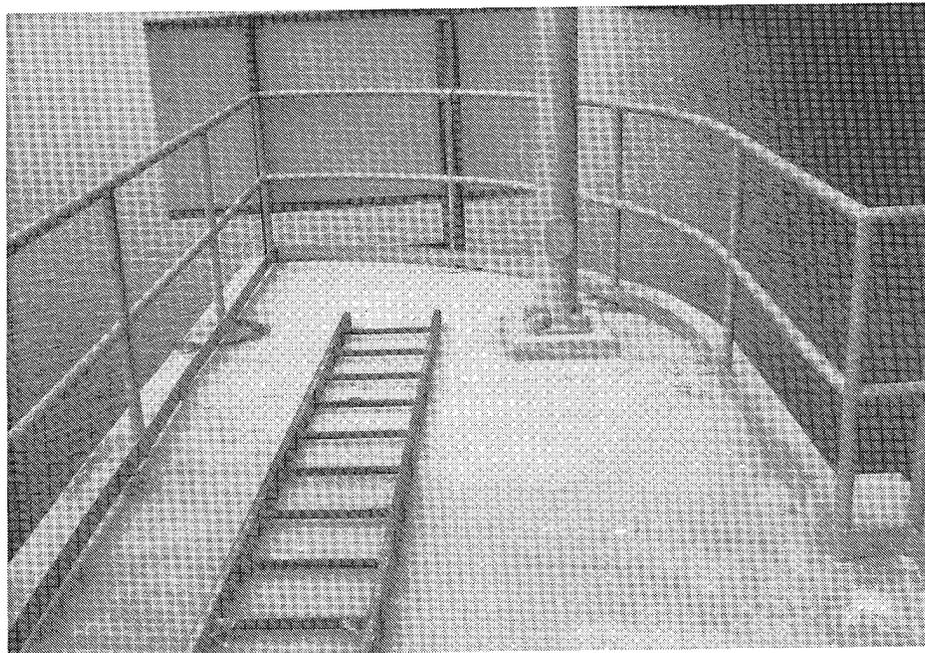
Figure 66. Completed pier nose section, Vischer Ferry Dam

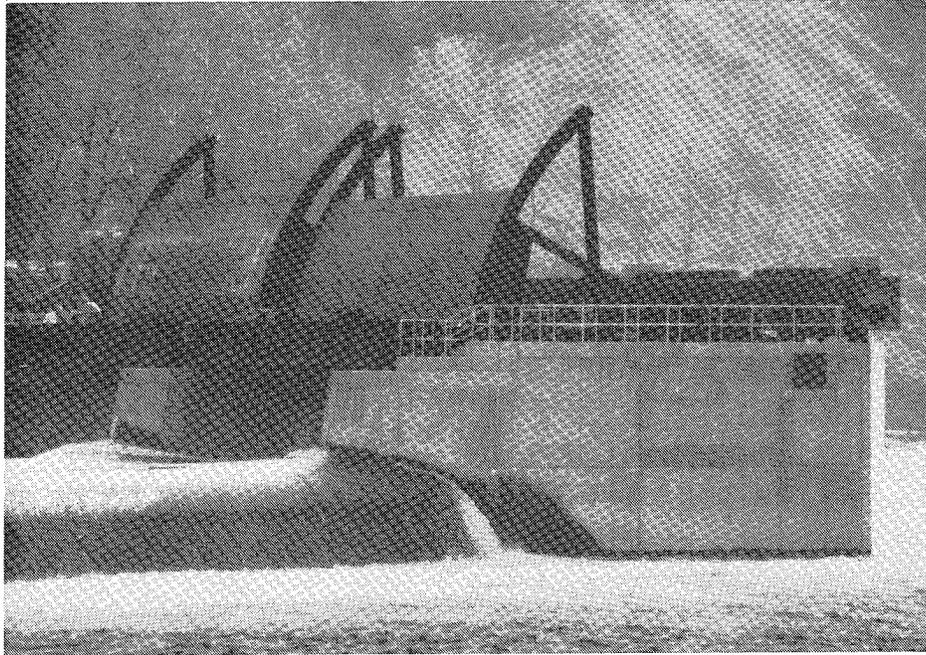
Figure 75. Completed gate piers with gates installed, C-1 Dam

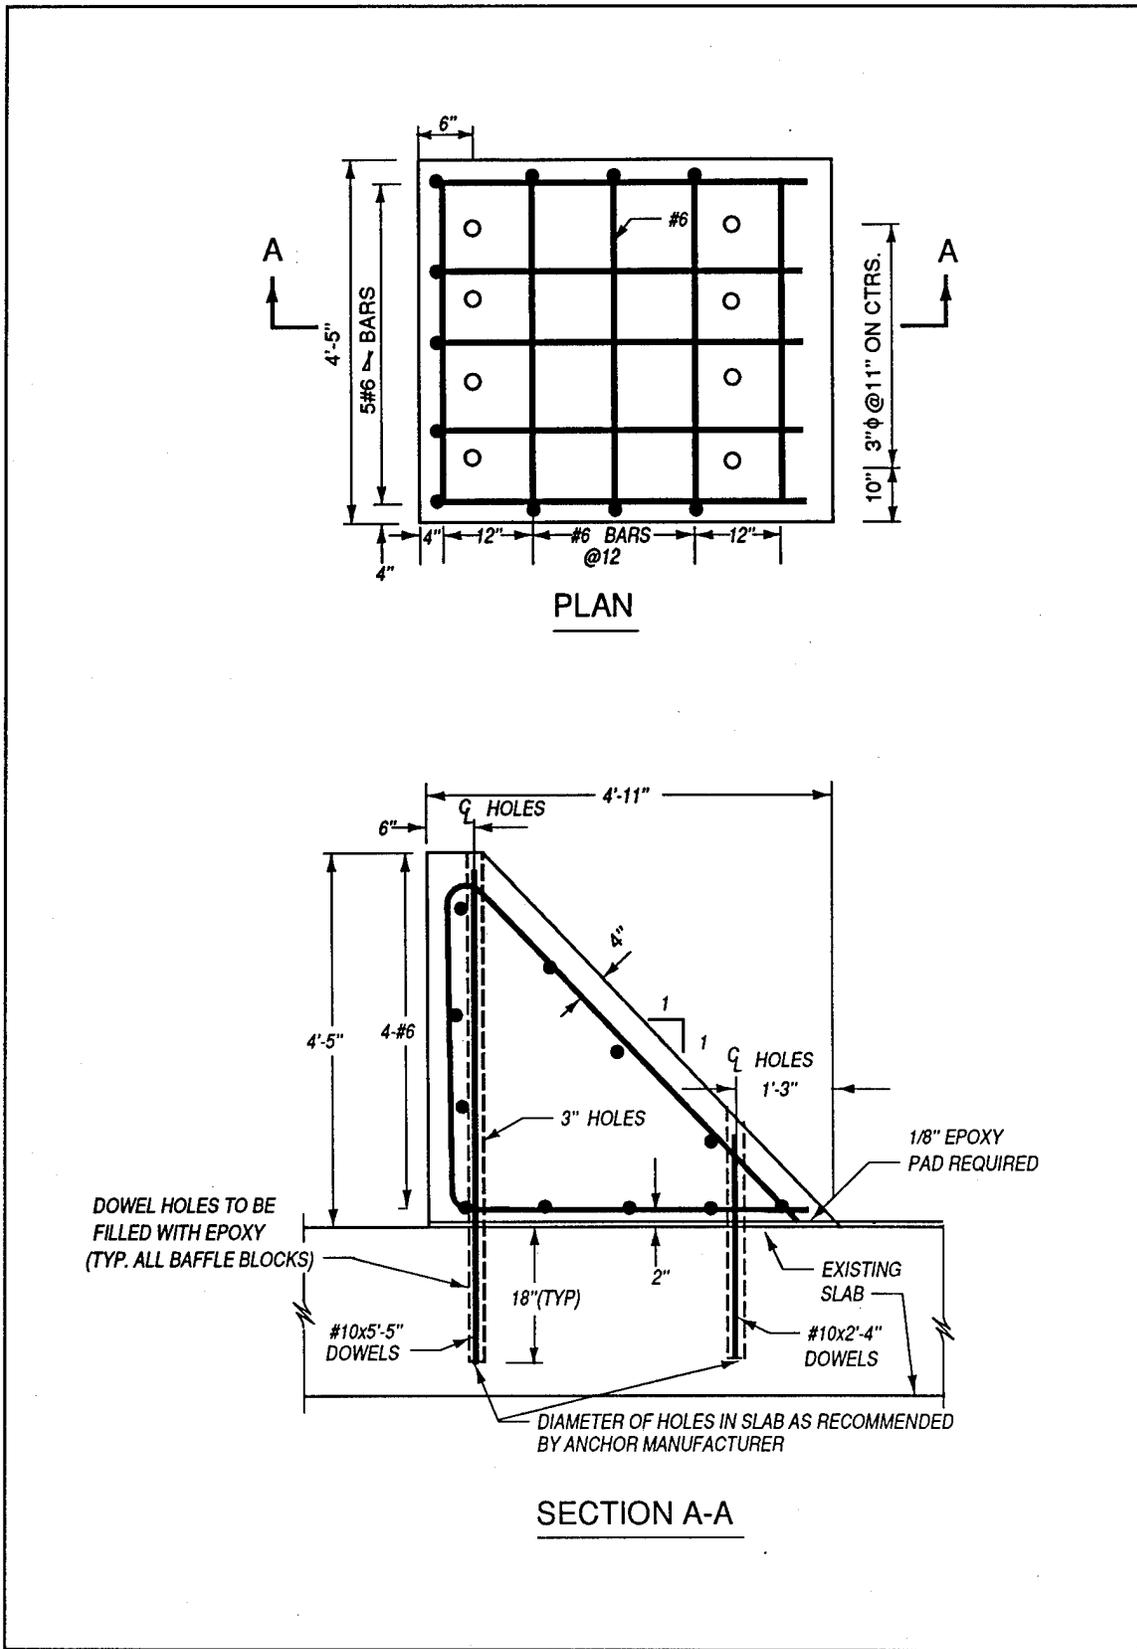
Figure 76. Design details for precast concrete baffle blocks, S-65 and S-65A structures, Central and South Florida Flood Control Project

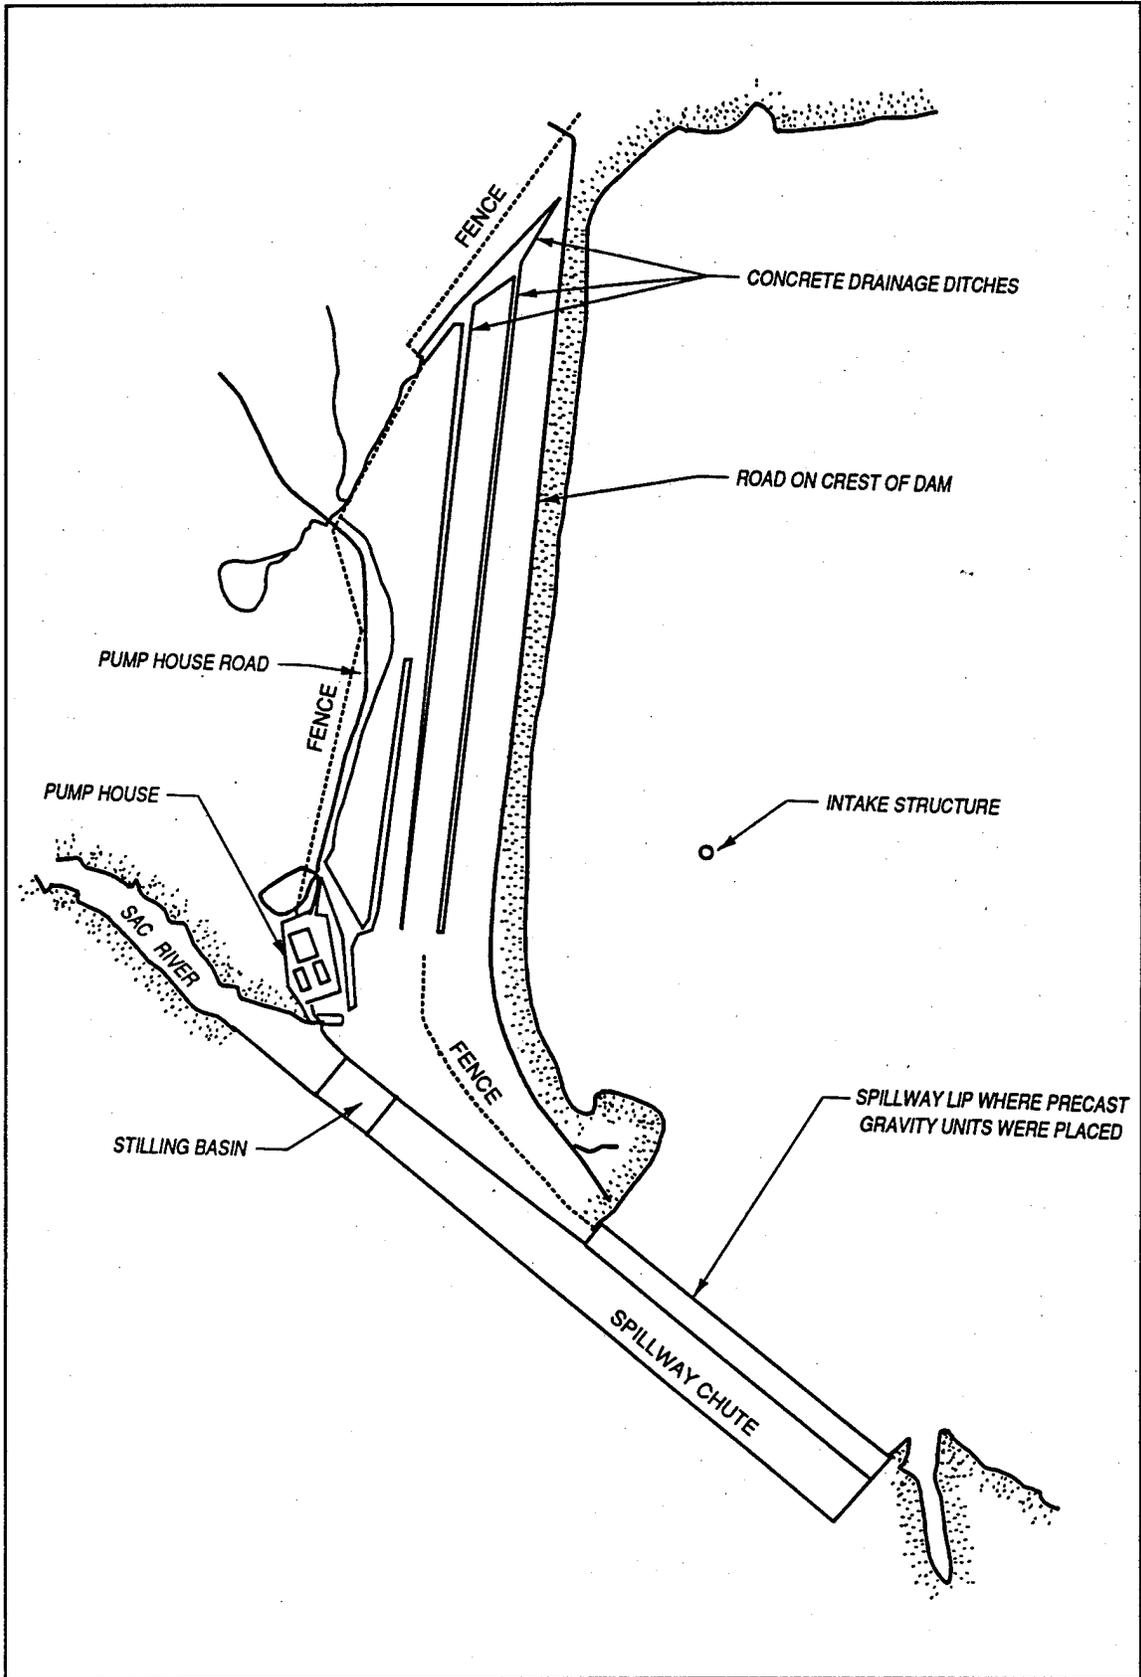
Figure 77. Layout of Fellows Lake and Dam (after Rogers and Ruggeri 1992)

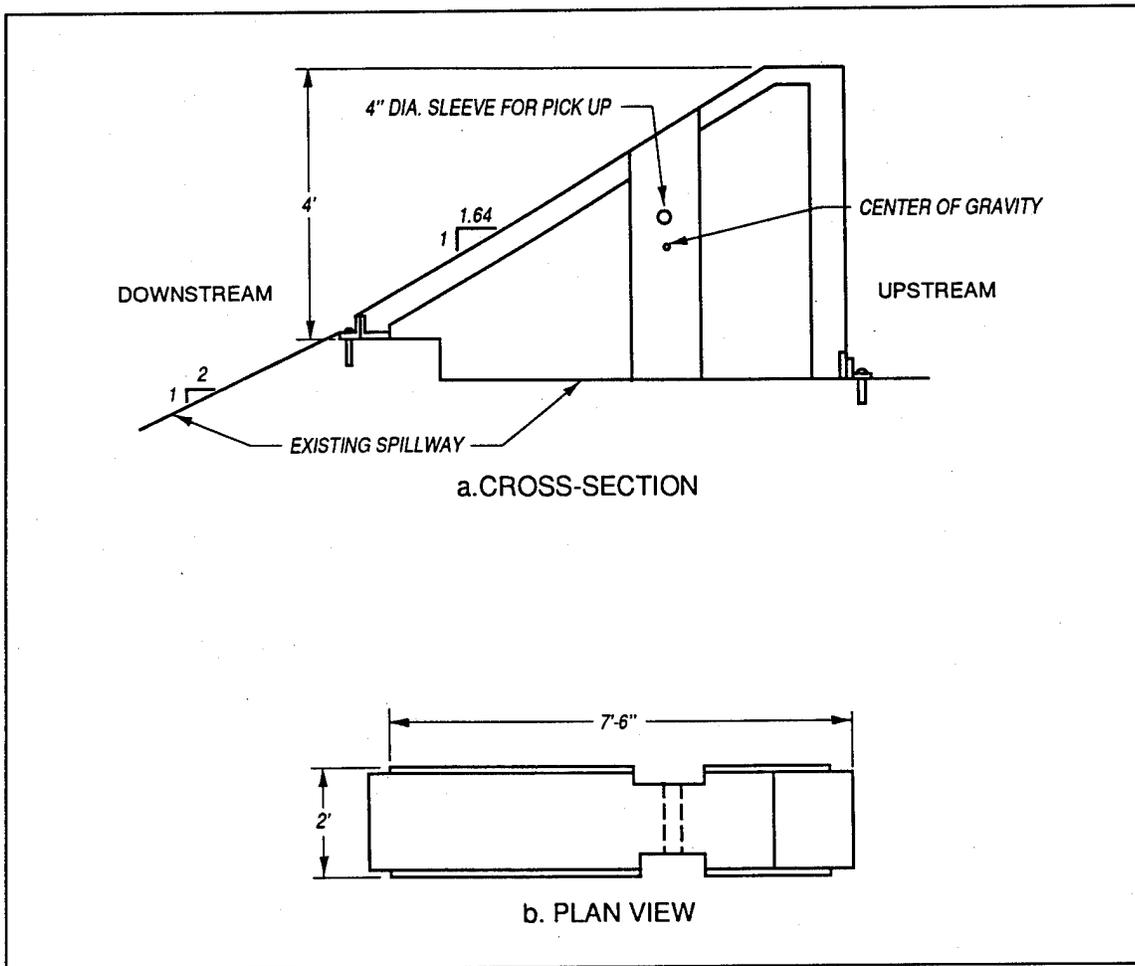
Figure 78. Precast concrete unit installed at Fellows Lake and Dam (after Rogers and Ruggeri 1992)

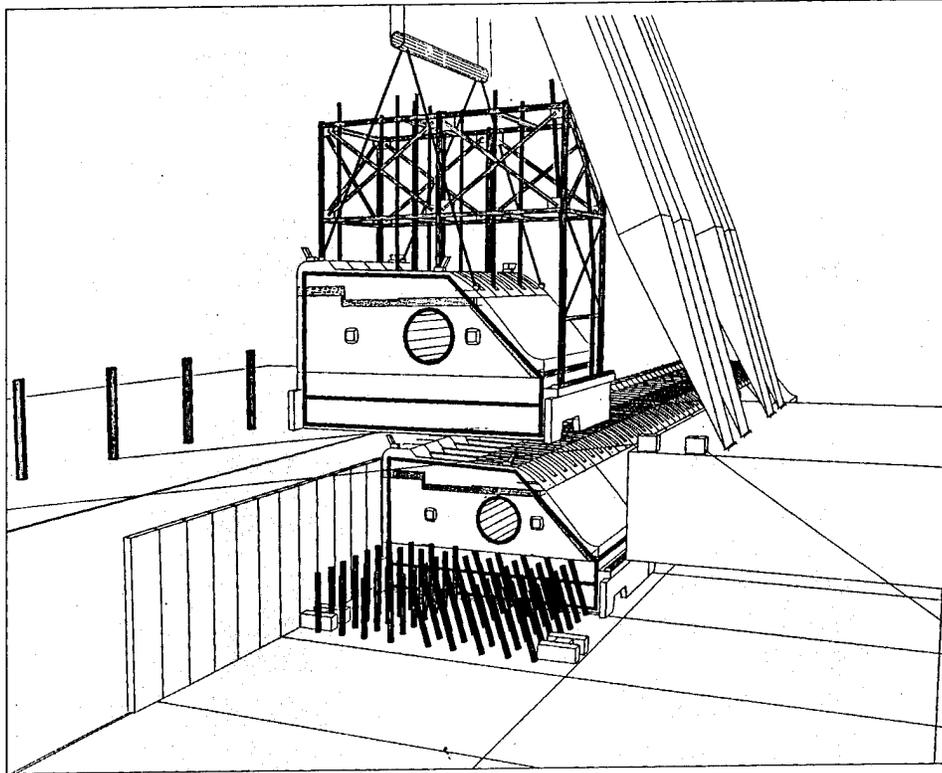
Figure 79. Concept for underwater installation of precast sill shells, Olmsted Dam (from Berner and Ghio 1994)

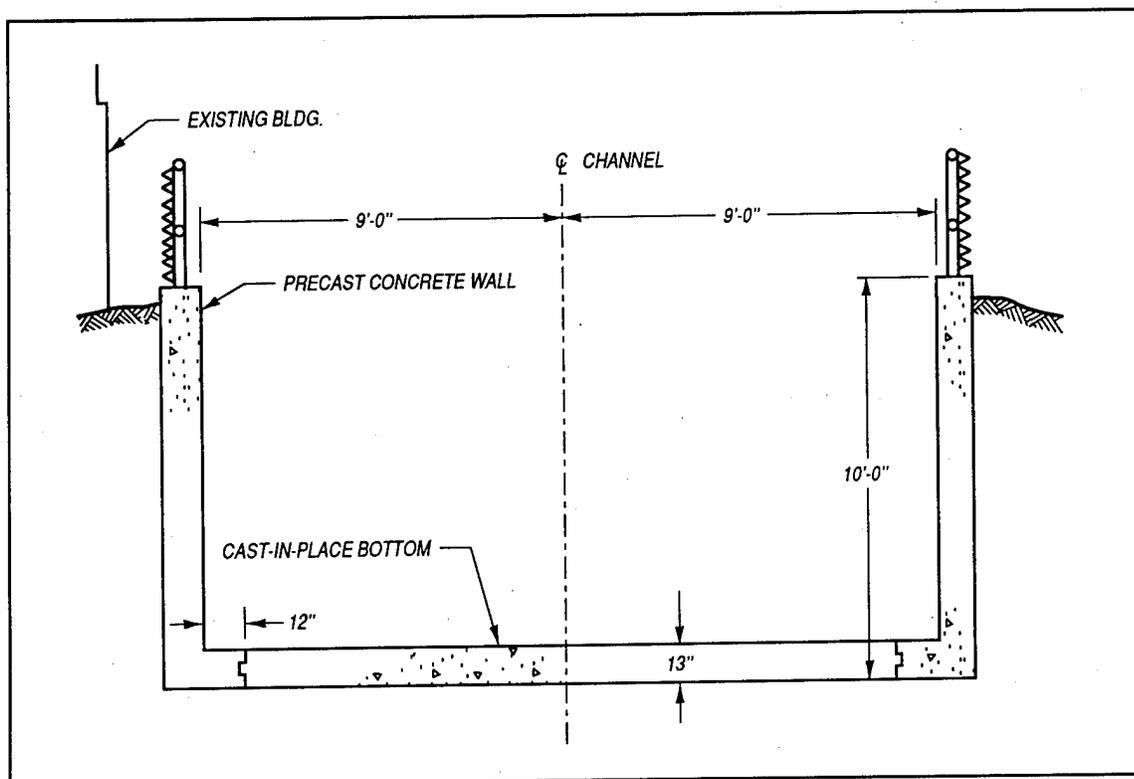
Figure 83. Typical channel repair section, Placer Creek (after Hacker 1986)

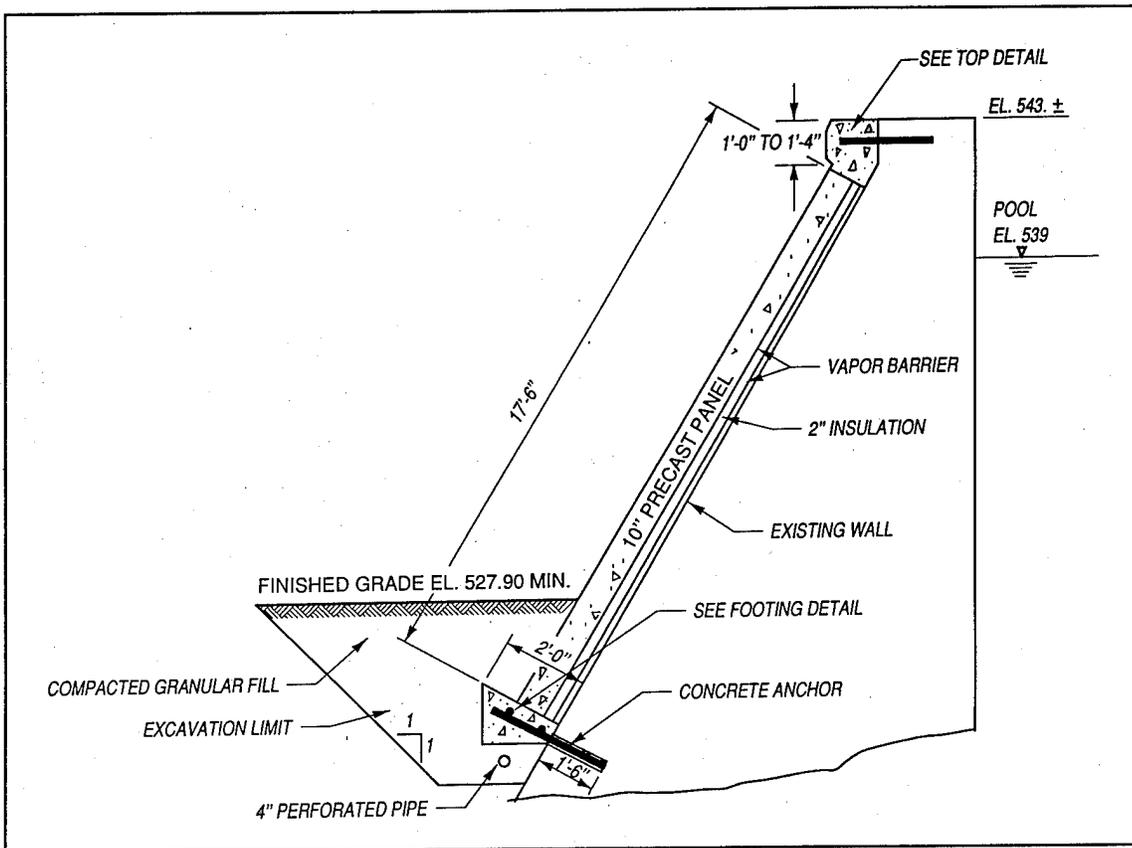
Figure 95. Typical repair section, Joliet Channel Wall

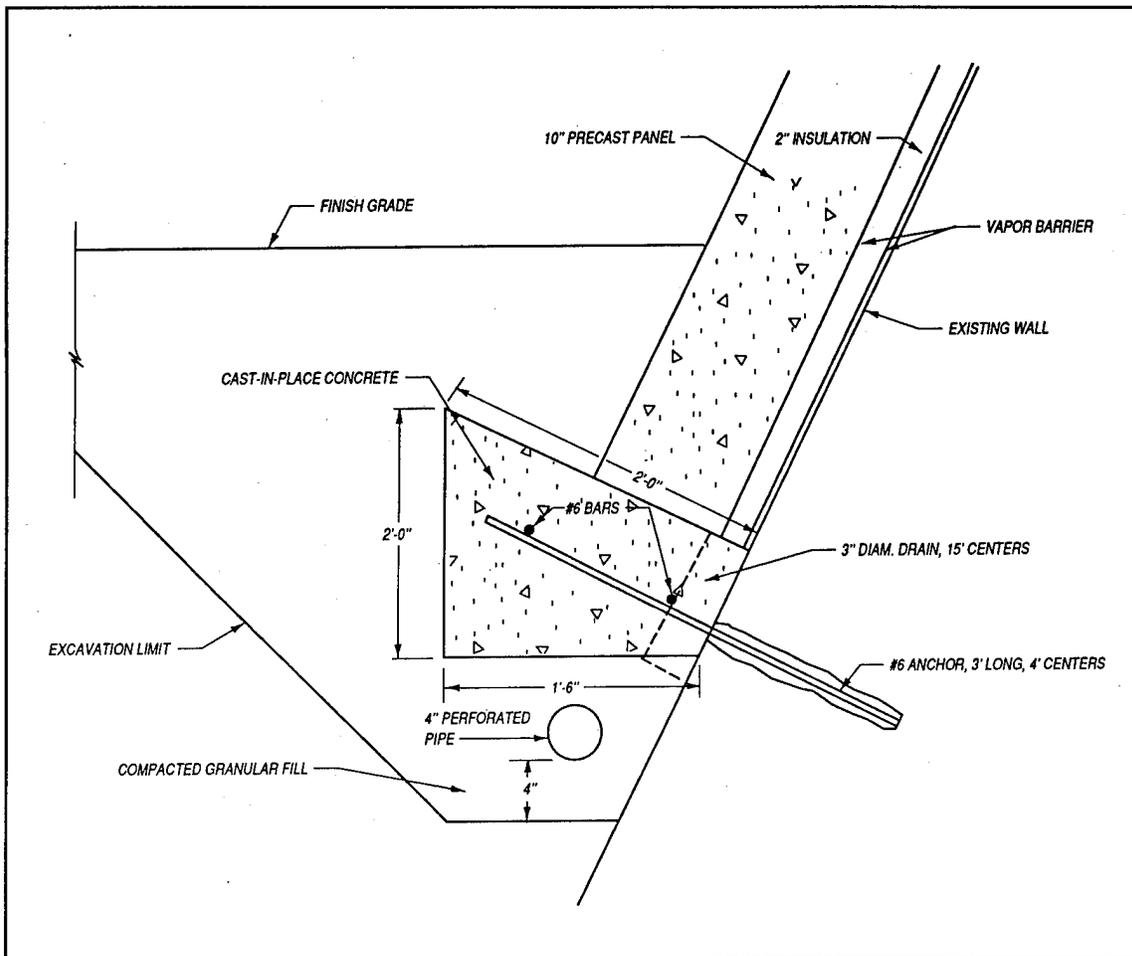
Figure 96. Footing detail, Joliet Channel Wall

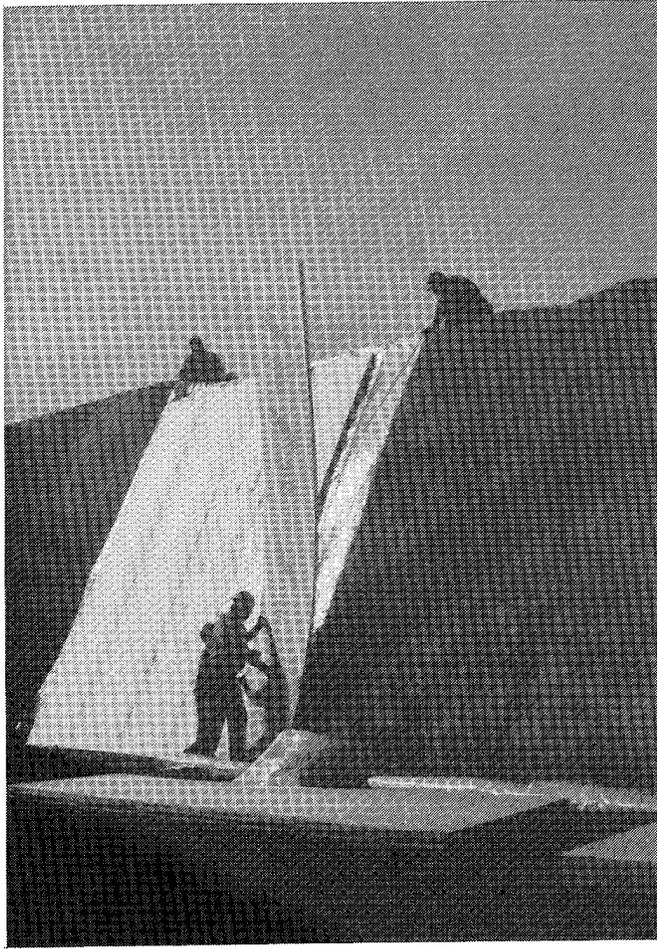
Figure 97. Placing insulation over first vapor barrier, Joliet Channel Wall

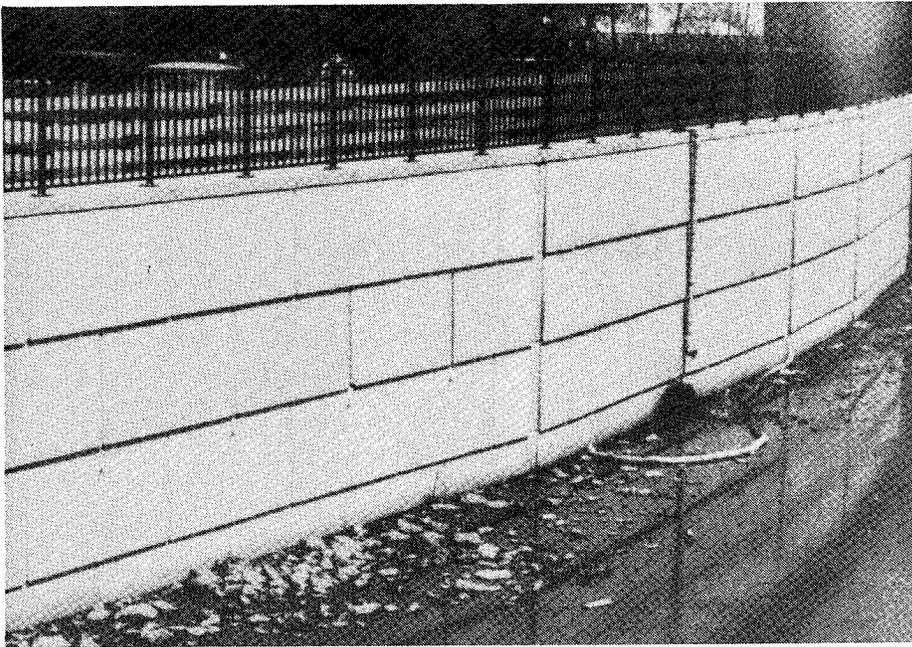
Figure 103. Completed project, West River Channel Wall

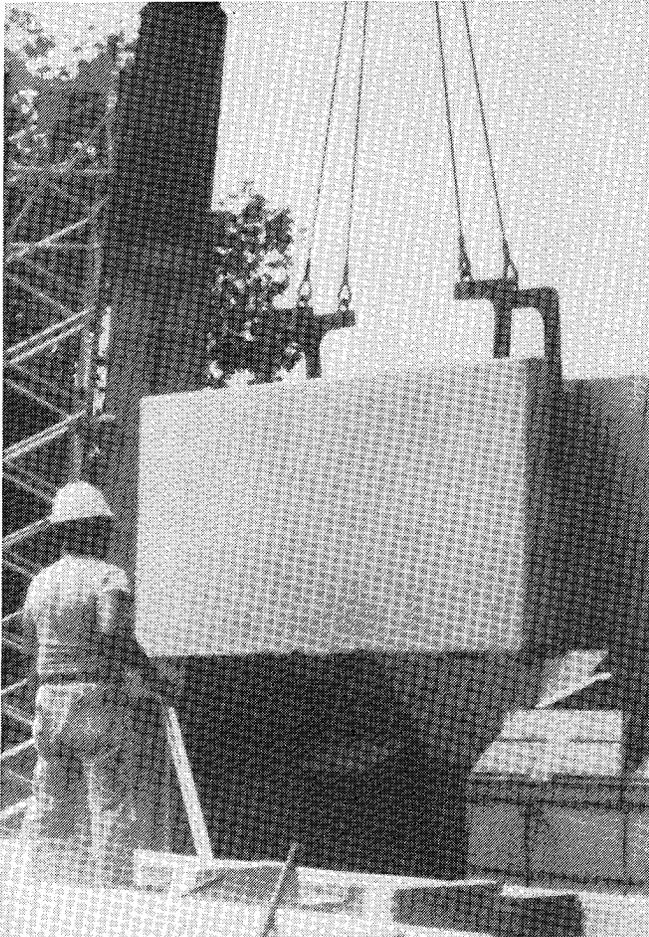
Figure 104. Typical Doublewal precast concrete modules

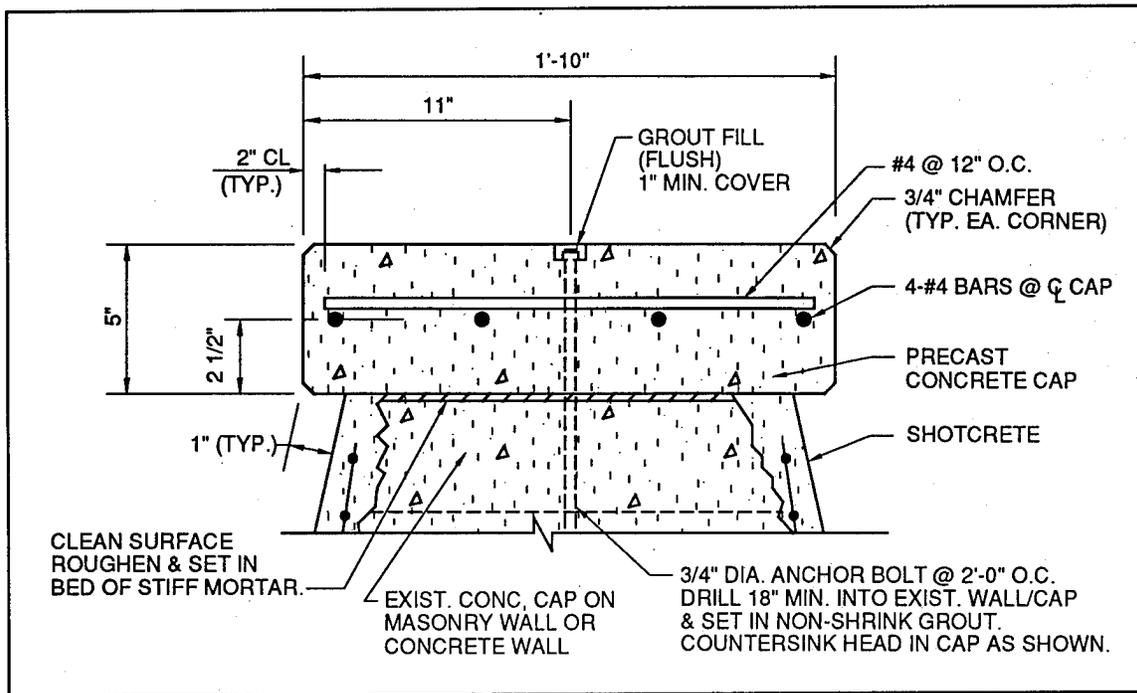
Figure 110. Precast cap detail, Hornell Floodwall

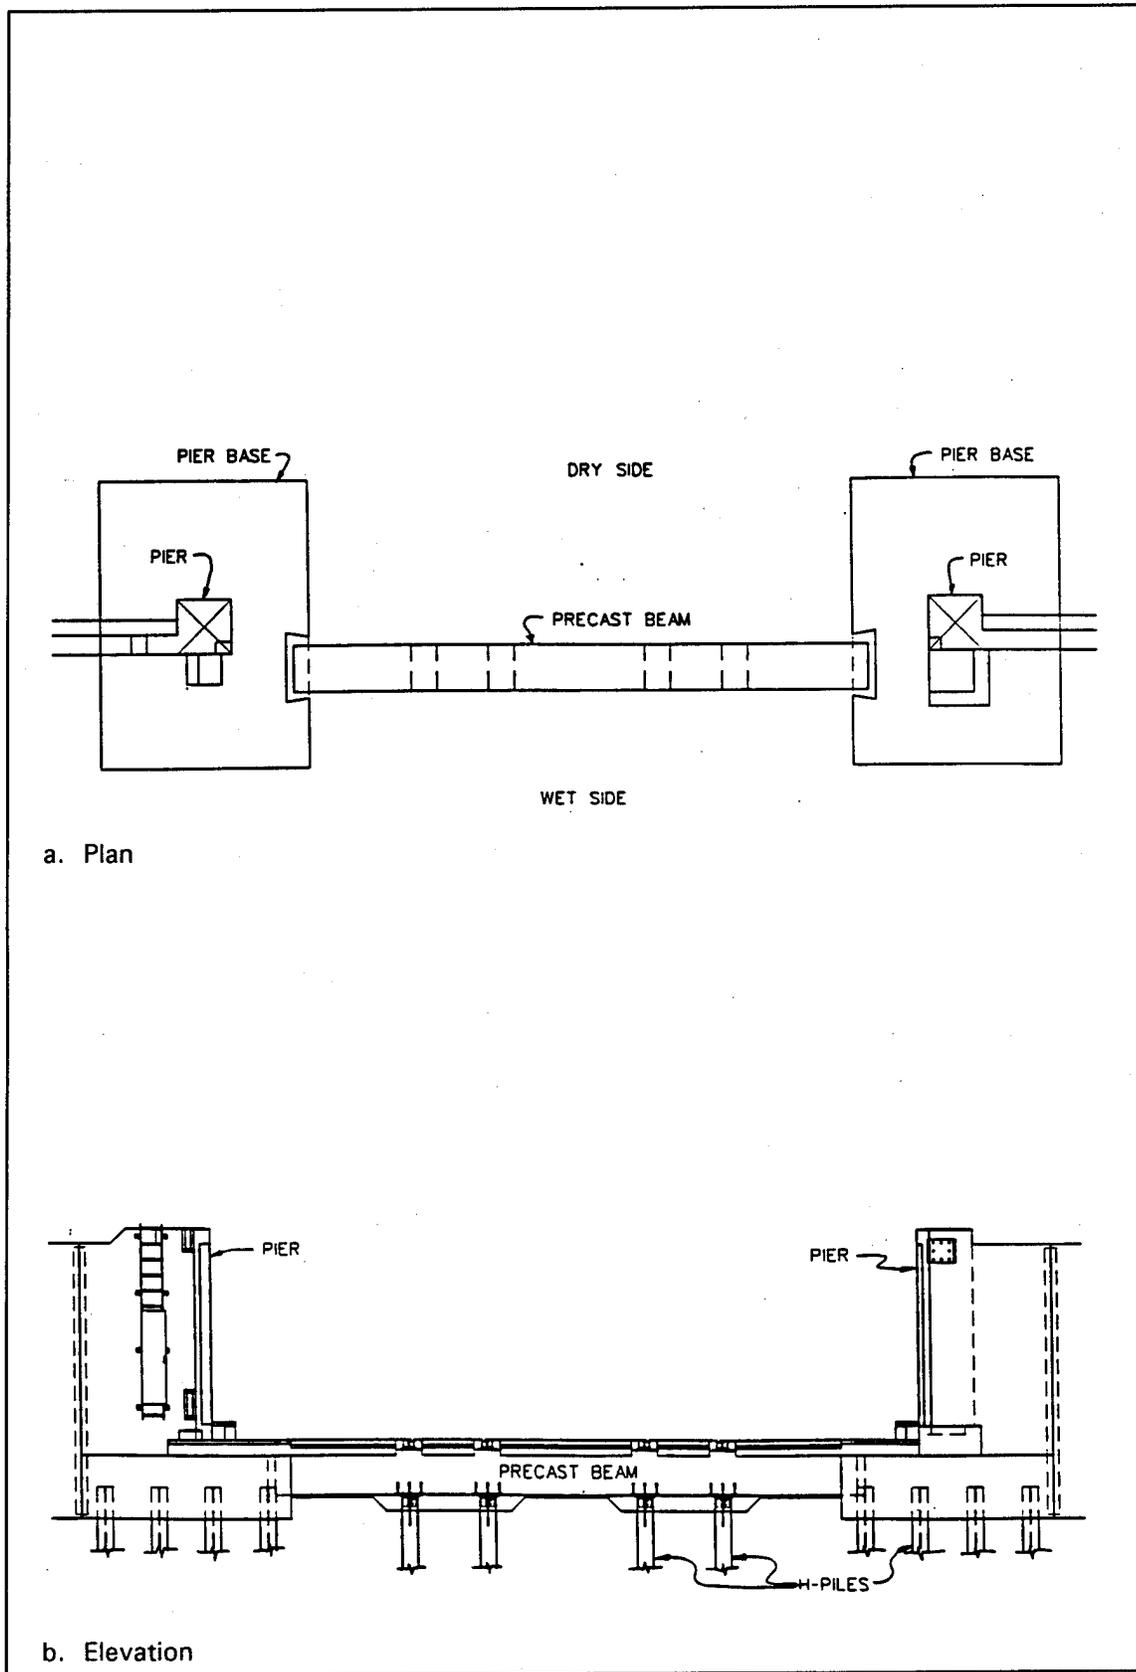
Figure 112. Closure structure, Pineville Levee and Floodwall (from Gunnels 1991)

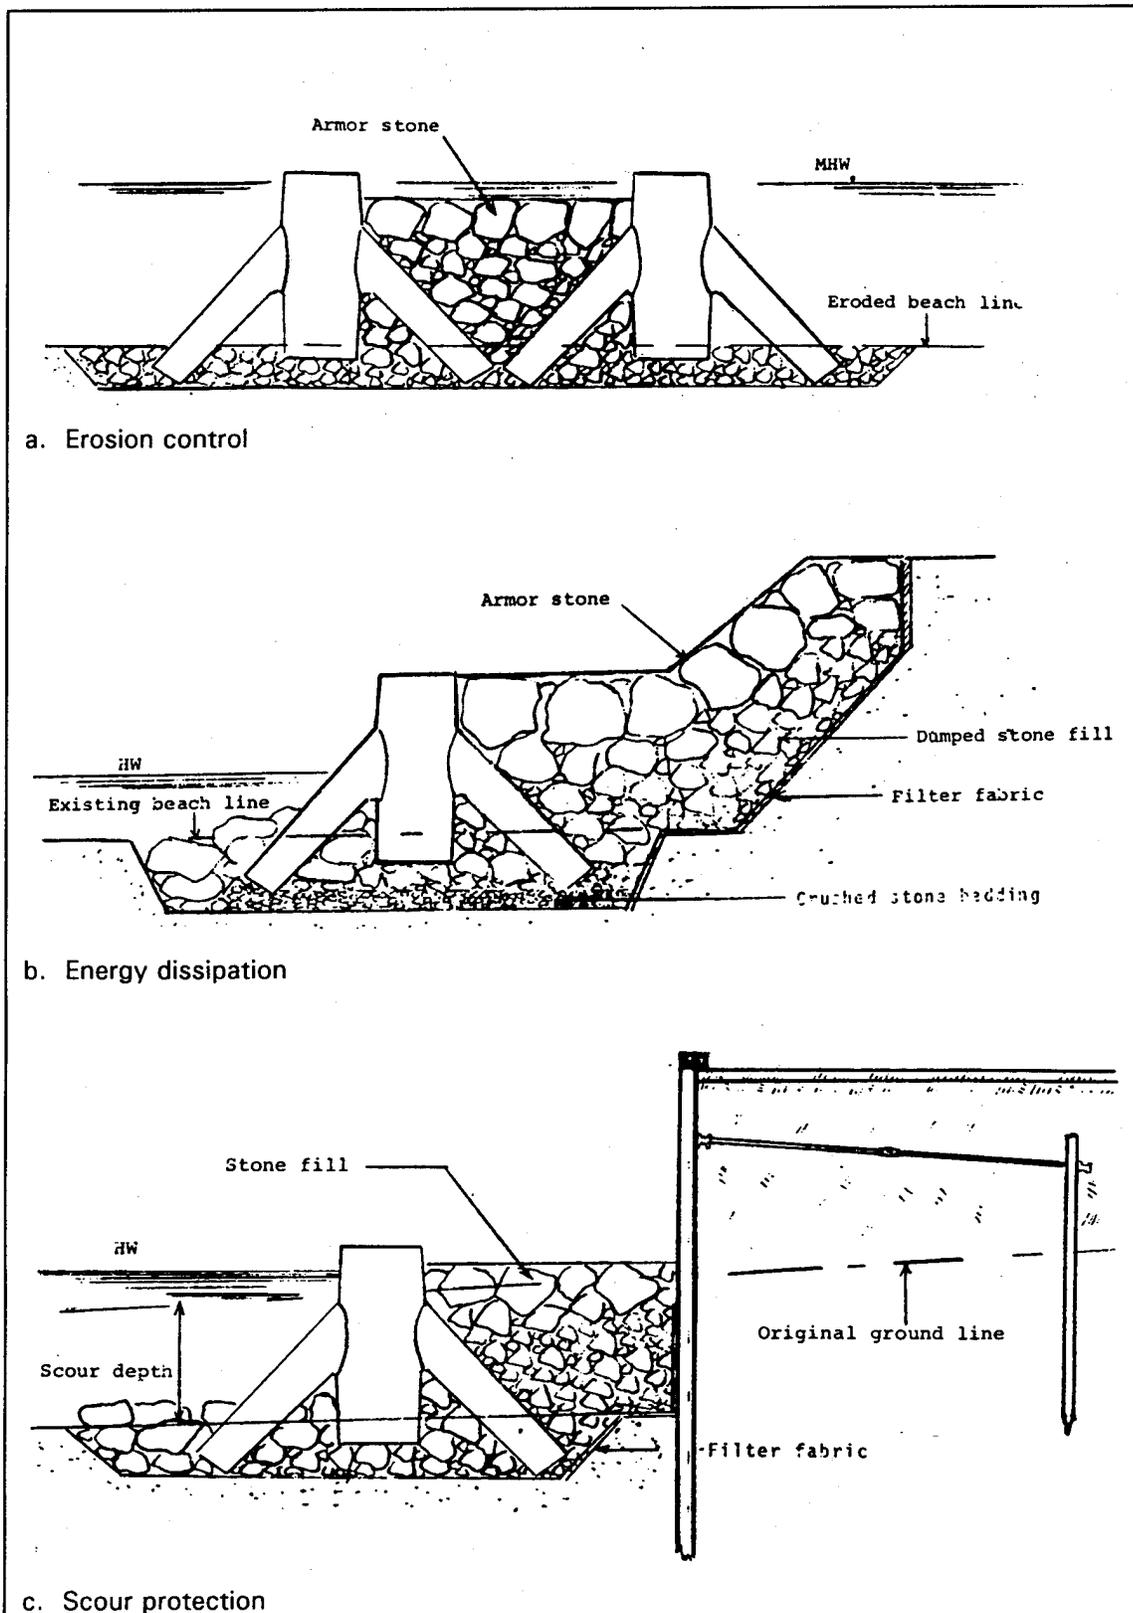
Figure 118. STA-POD armor system applications

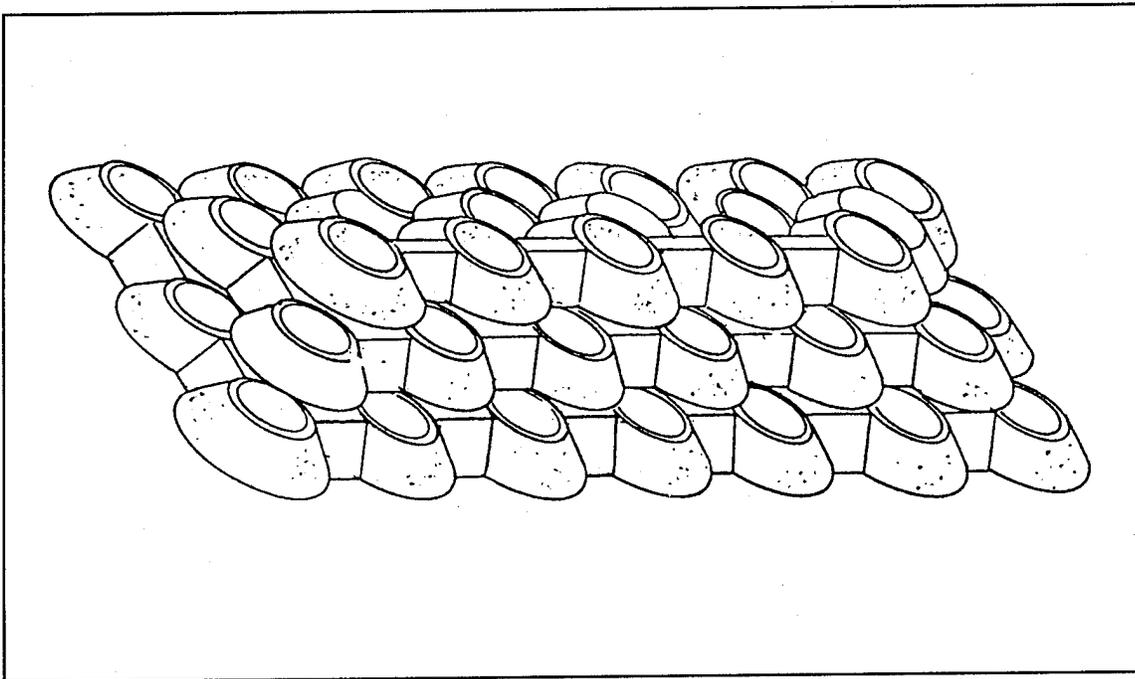
Figure 120. Beachcones arranged in triple pyramid (from Beachcones Research, Inc. 1992)

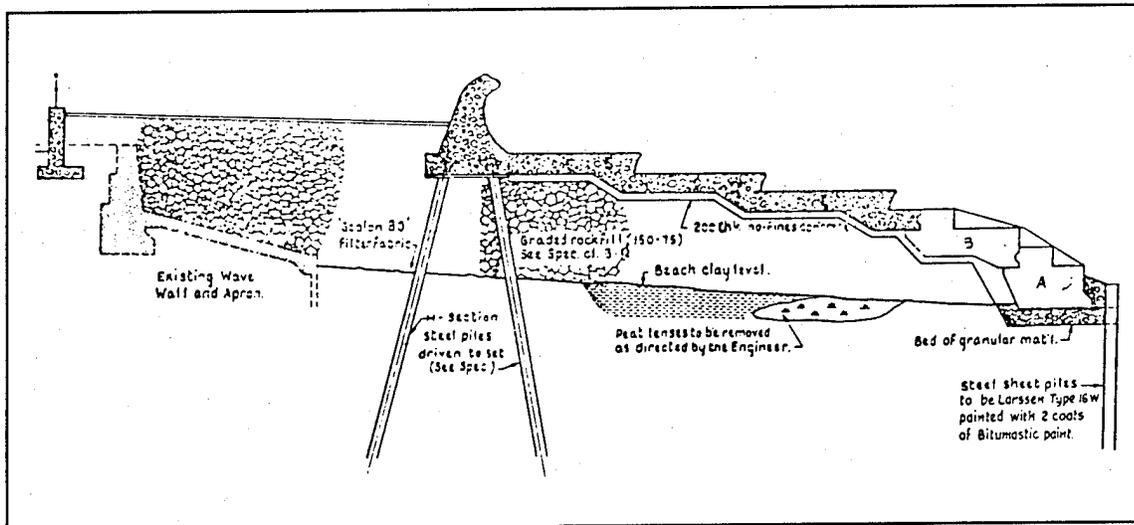
Figure 134. Cross section of sea-defense, coastal-protection structure at Newbiggin-by-the-Sea (from Barfoot 1988)

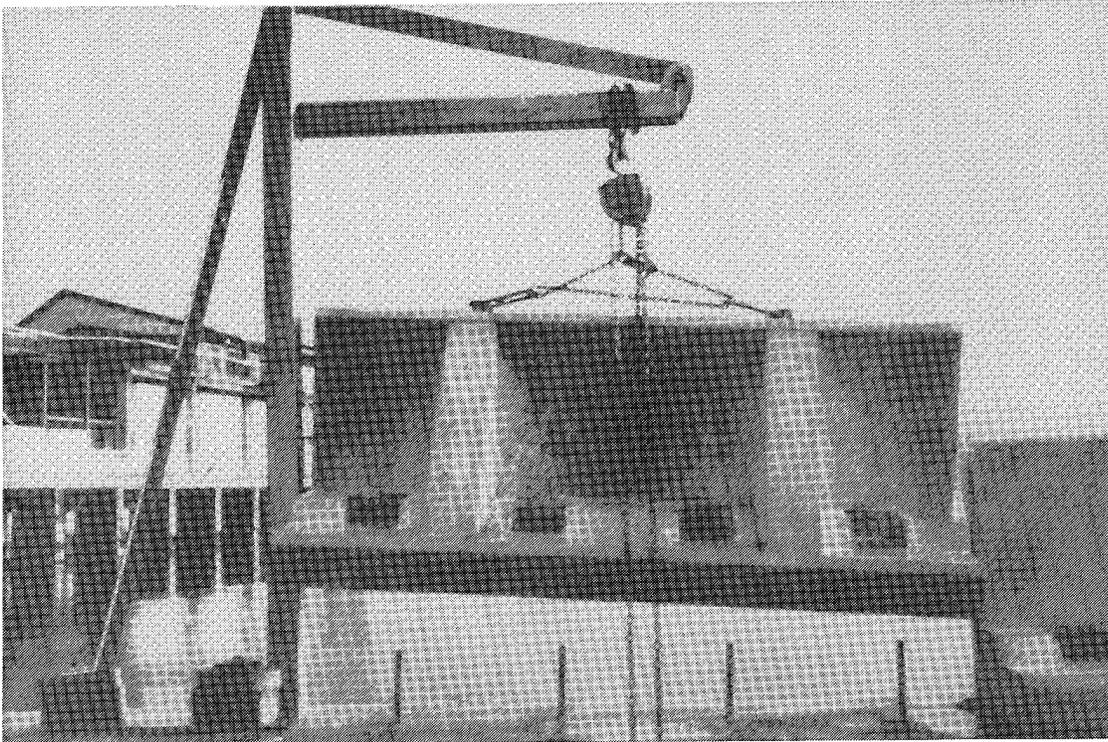
Figure 137. Precast wave deflector unit being placed by chain-block crane at Clyde Quay (from *New Zealand Concrete Construction* 1991)

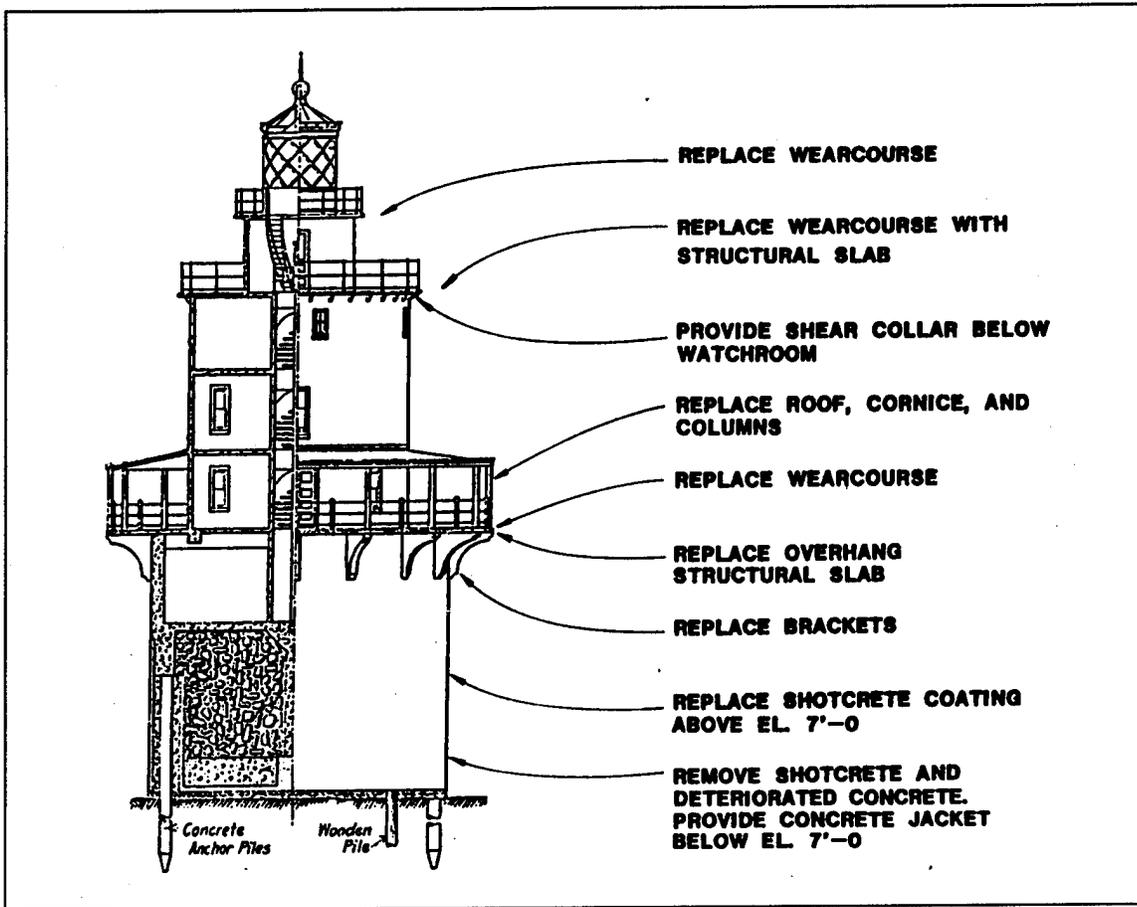
Figure 145. Brandywine Lighthouse repairs (from Paul 1987)

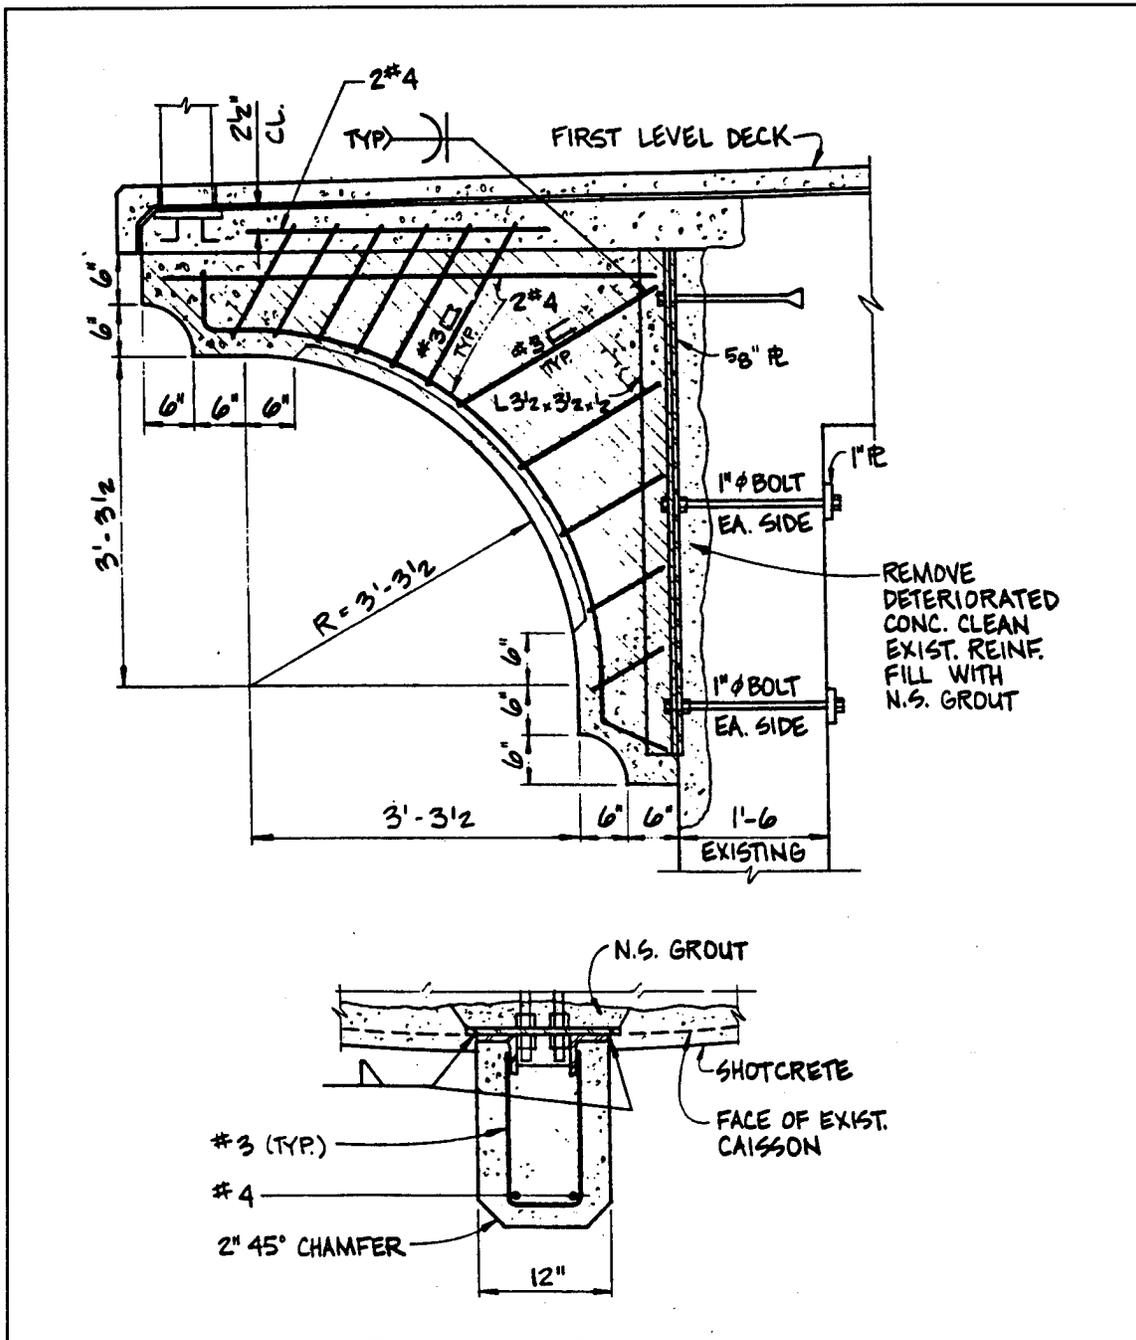
Figure 146. First-level precast concrete brackets, Brandywine Shoal Lighthouse (from Paul 1987)
