Technical Report REMR-CS-49
June 1995

Repair, Evaluation, Maintenance, and Rehabilitation Research Program

Applications of Precast Concrete in Repair and Replacement of Civil Works Structures

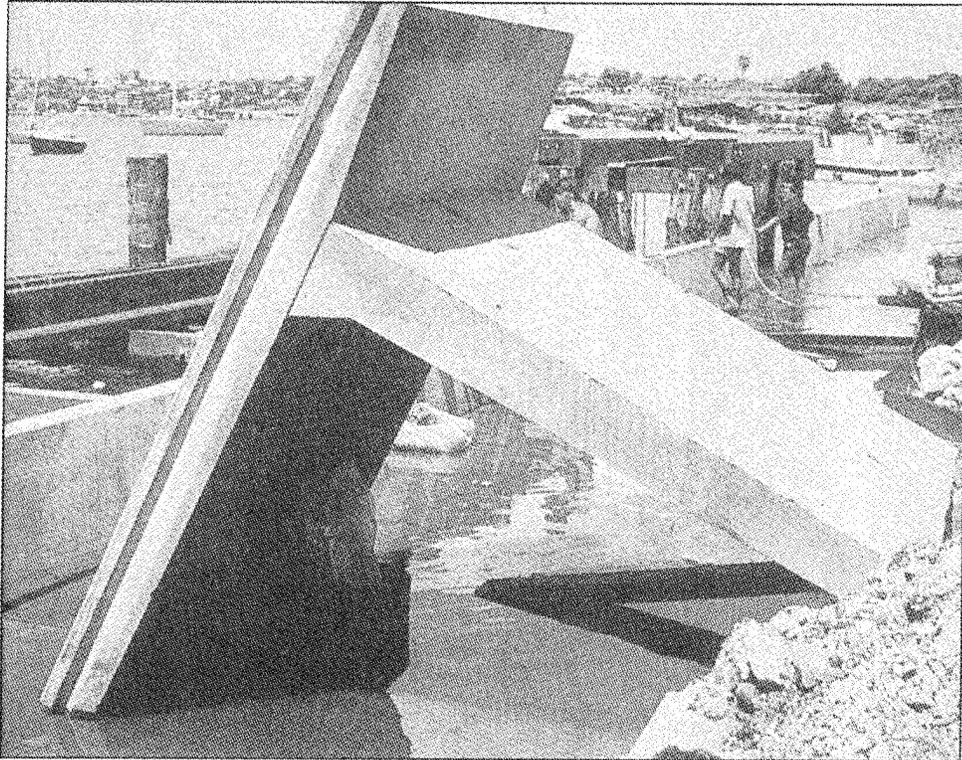
a. Precast concrete unit delivered adjacent to final placement position

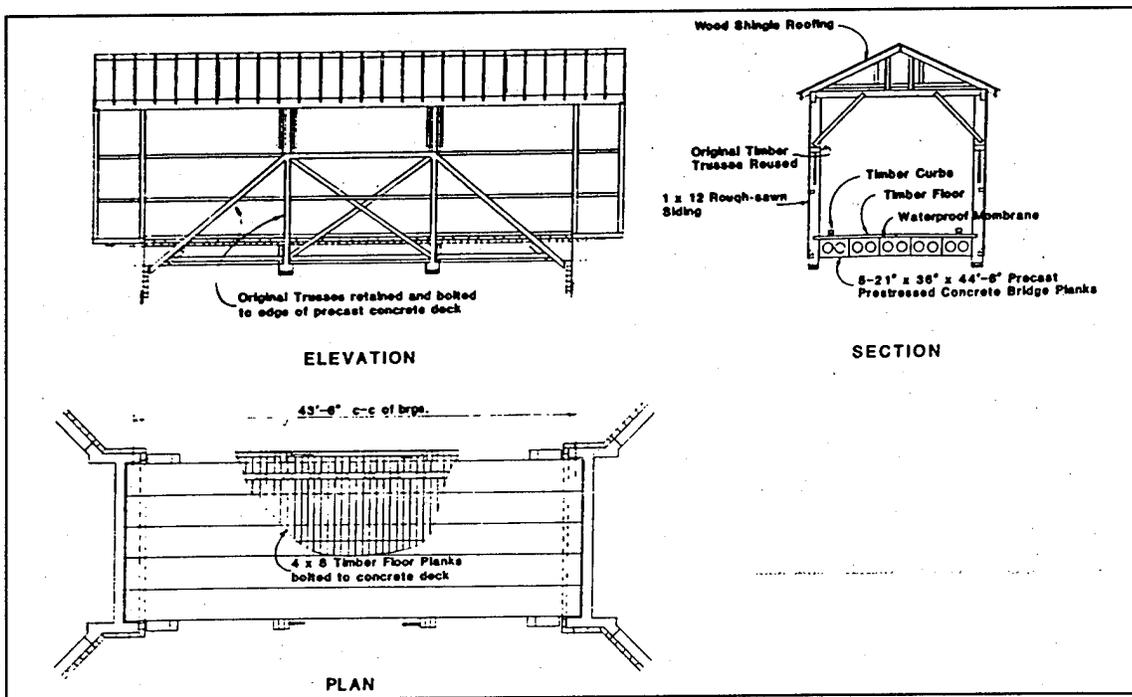
Figure 150. Restoration plans for Jediah Hill Covered Bridge (from PCI 1982)

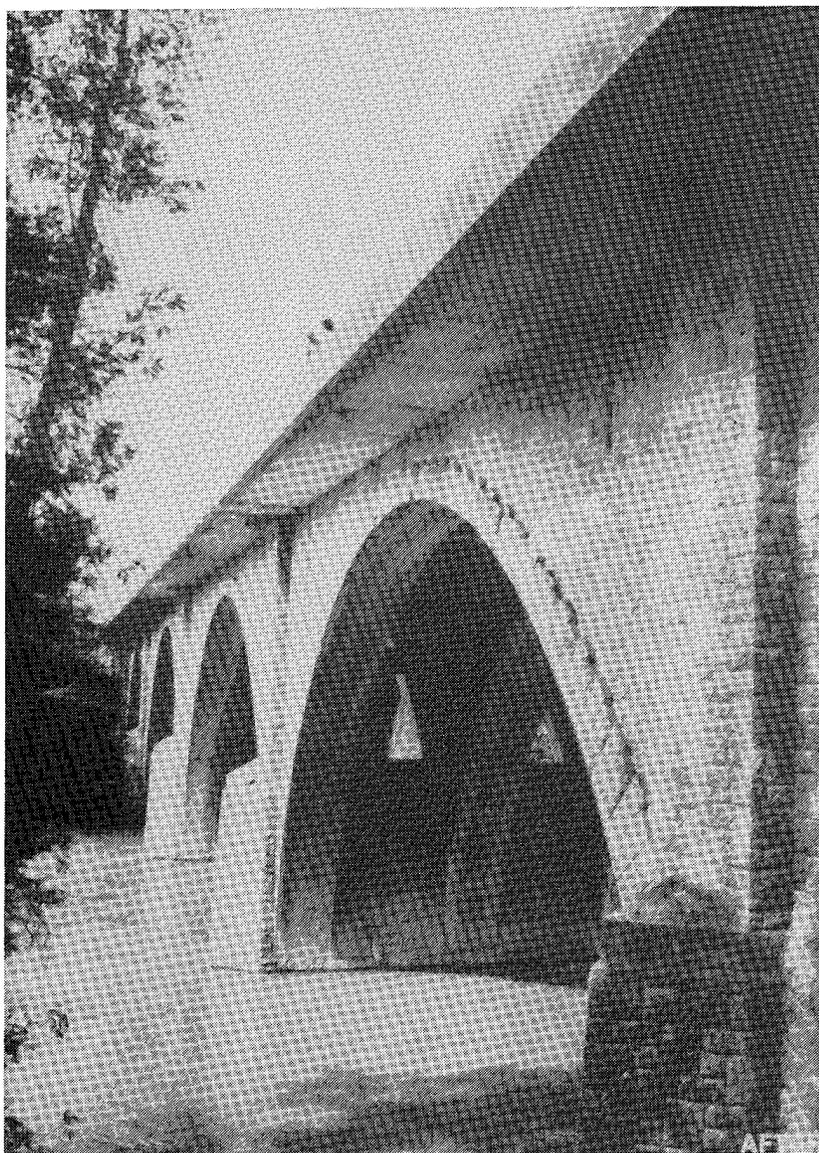
Figure 155. Dublin Scioto Bridge after rehabilitation (from PCI 1988)

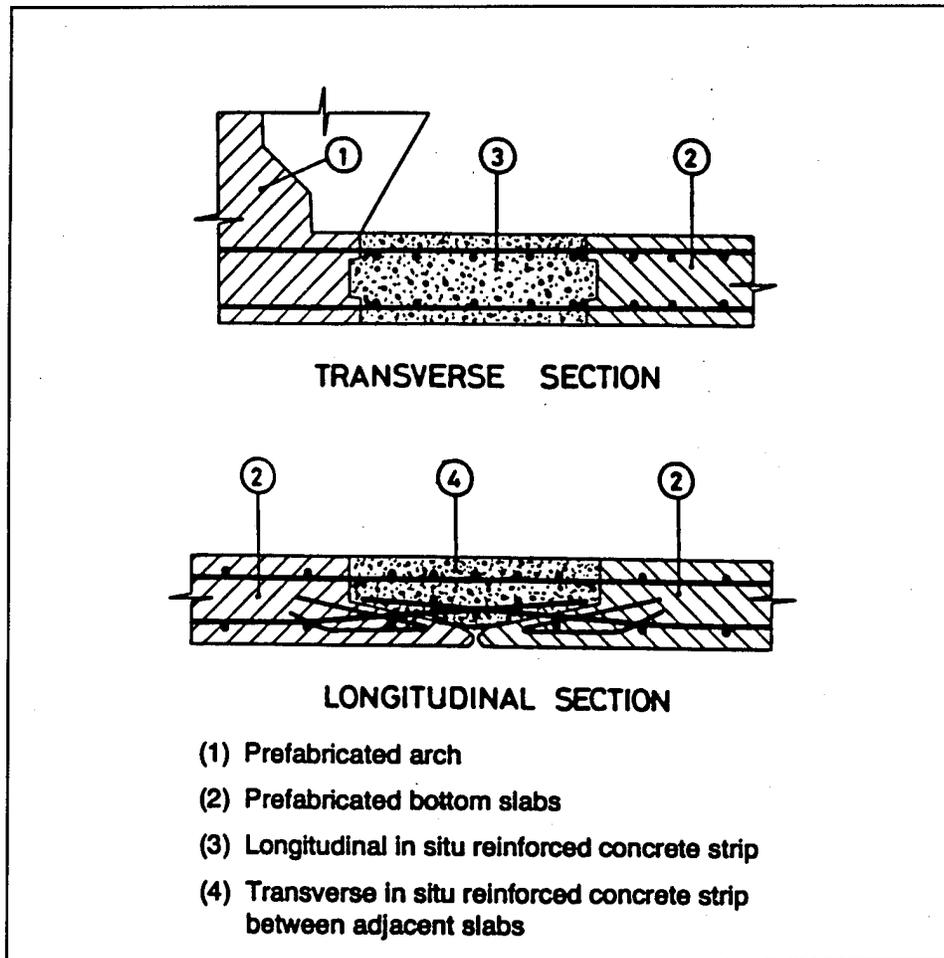
Figure 156. Details of transverse and longitudinal sections, Maria Christina Bridge (from Mainar and Arenas 1986)

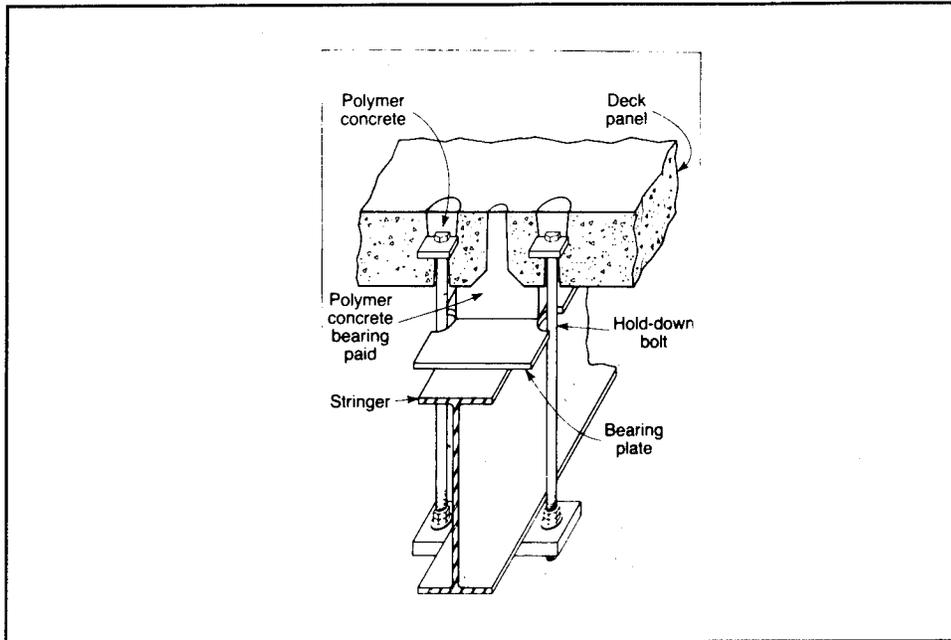
Figure 162. Bearing assembly, Woodrow Wilson Memorial Bridge (from ASCE 1984)

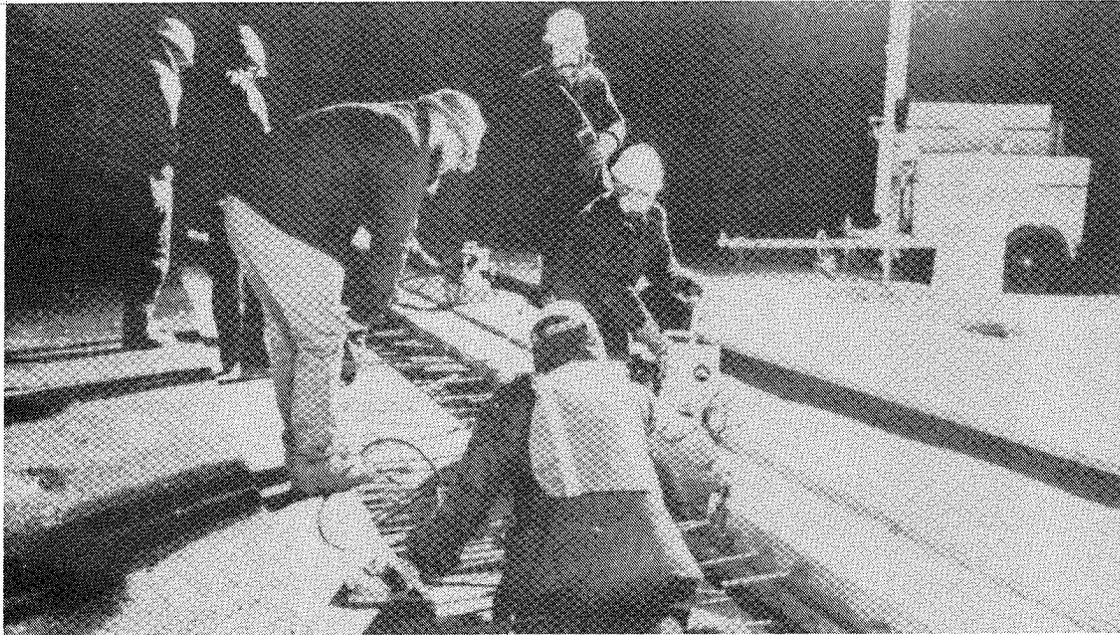
Figure 164. Space between anchor panels allows for posttensioning, Woodrow Wilson Memorial Bridge (from ASCE 1984)

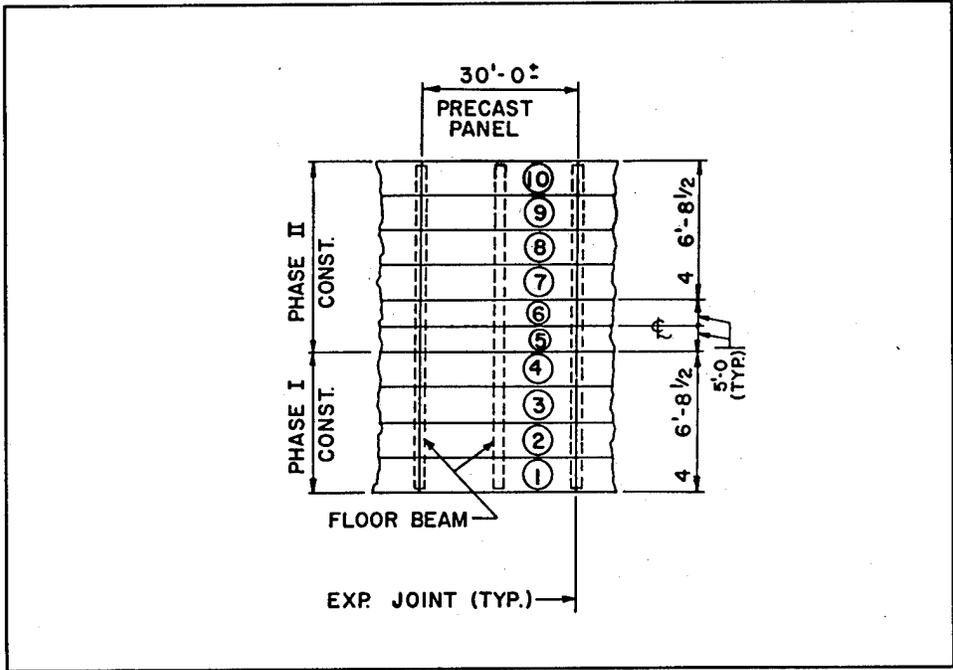
Figure 171. Layout of deck section with 10 precast slabs posttensioned transversely, Fremont Street Bridge (from Smyers 1984)

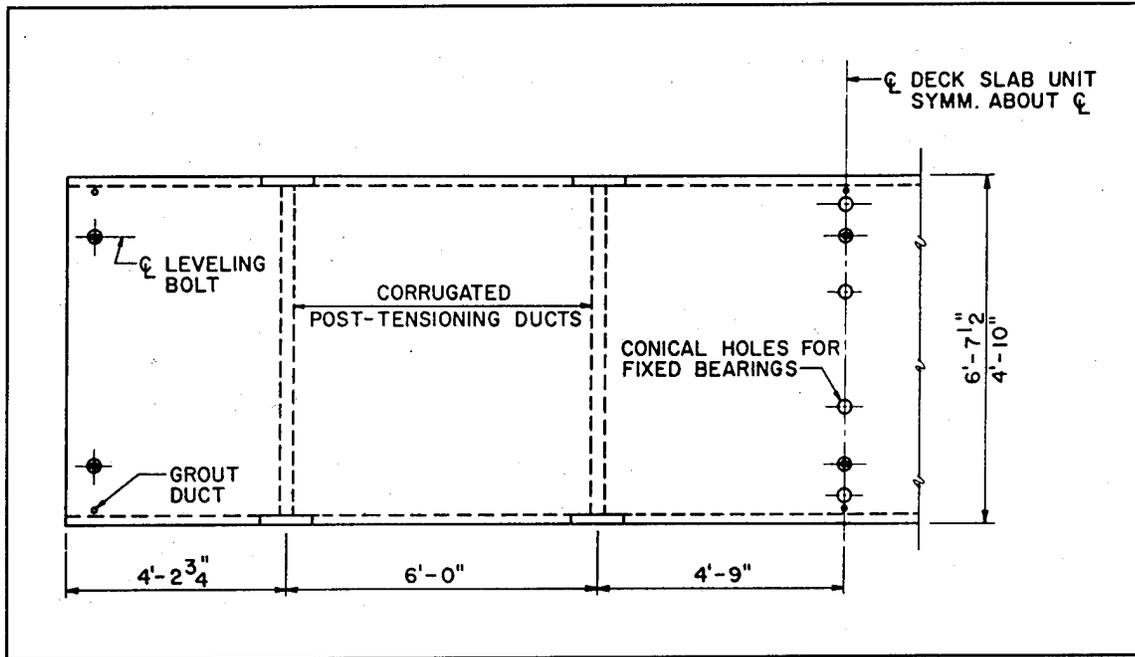
Figure 173. Sketch showing location of leveling bolts and posttensioning ducts, Fremont Street Bridge (from Smyers 1984)

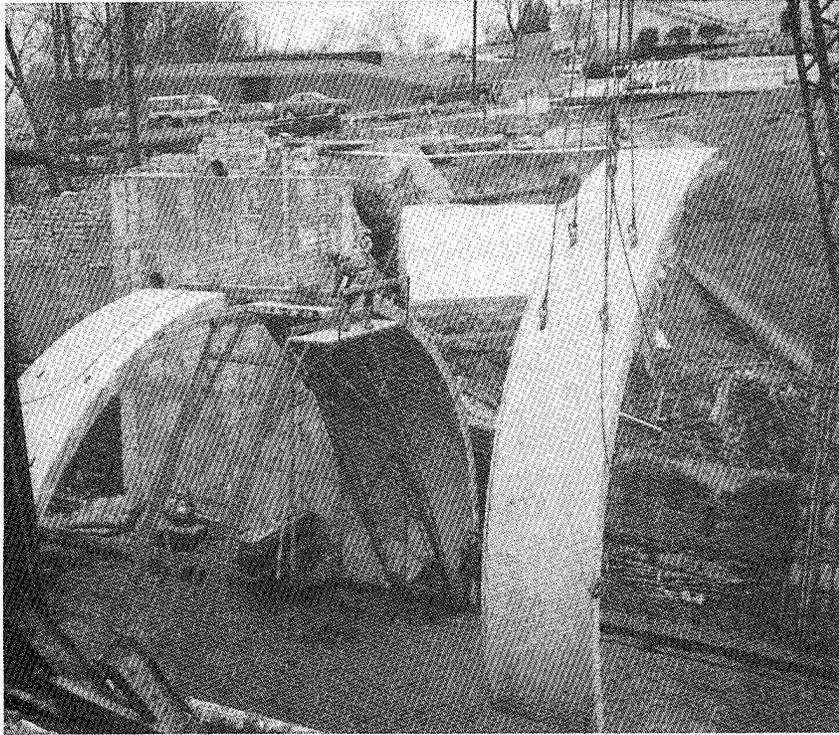
Figure 179. Precast arch sections being installed at Wears Creek (from Hurd 1990)

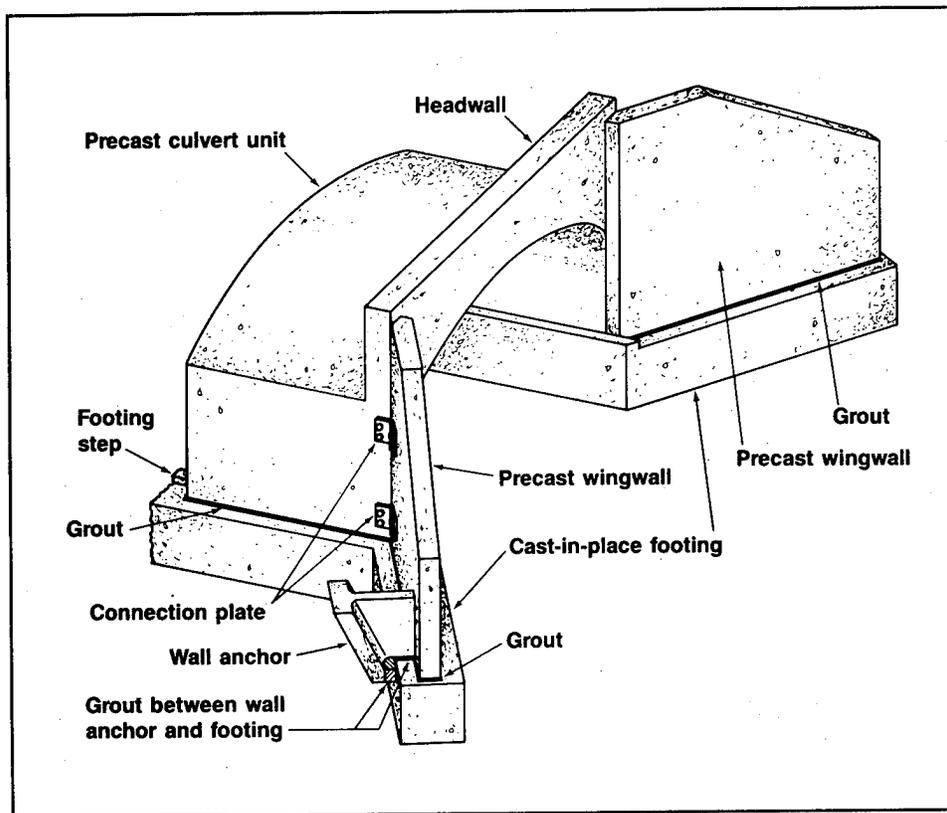
Figure 180. Plan of precast arch-box end section. Headwall is cast as part of the section; precast wingwall is attached during installation (from Hurd 1990)

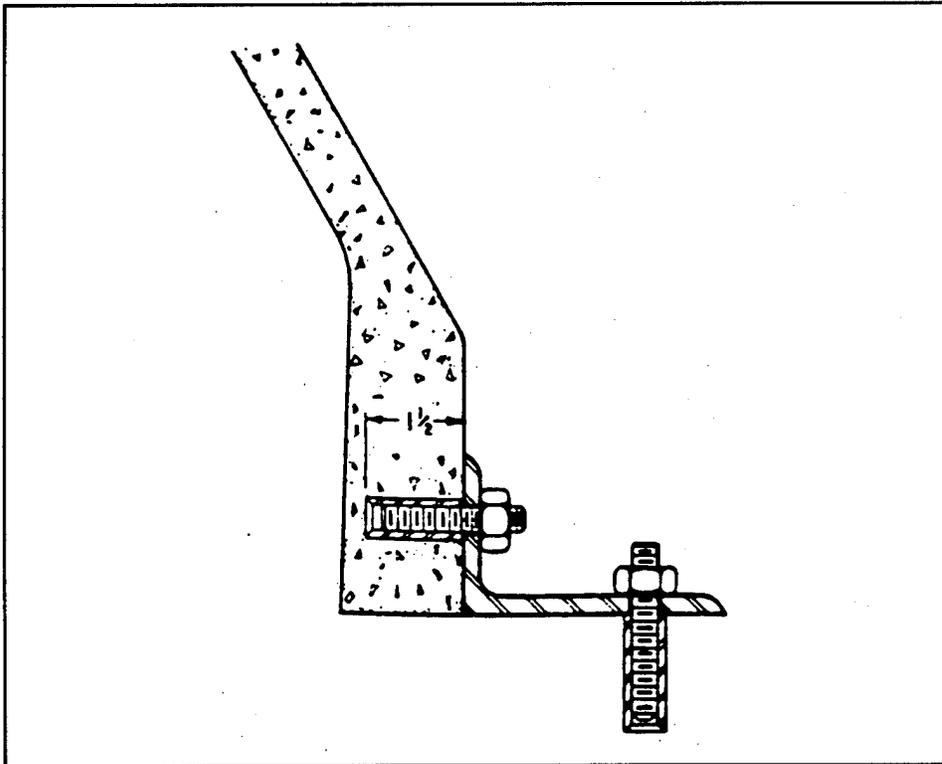
Figure 186. Cross section of anchoring system for precast concrete barrier shell on Pennsylvania Turnpike (from Barnaby and Dikeou 1984)

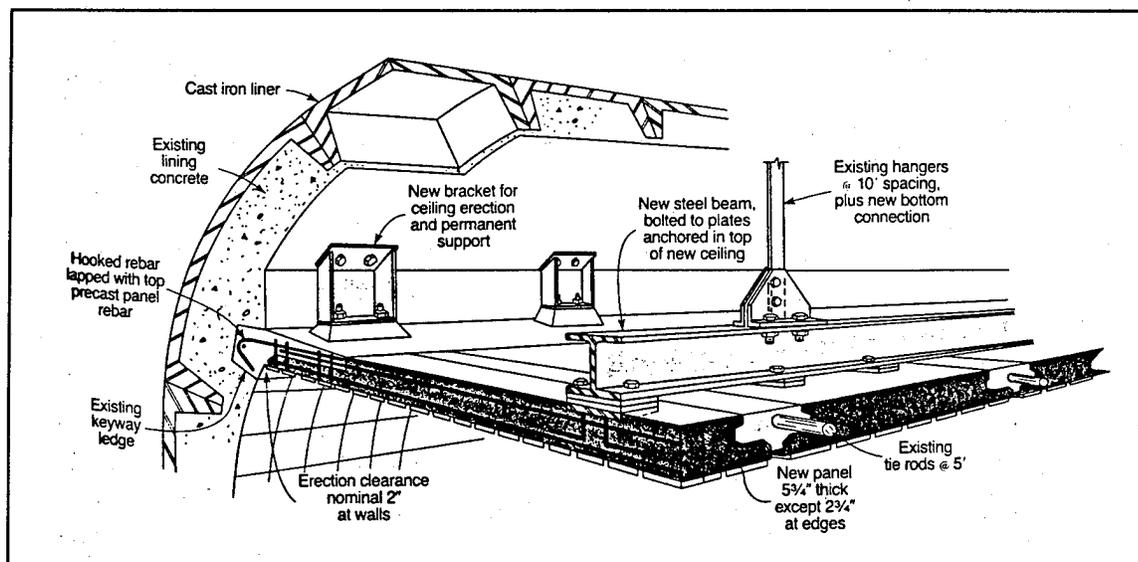
Figure 197. Ceiling replacement design for Holland Tunnel (from Monti and Eglot 1986)

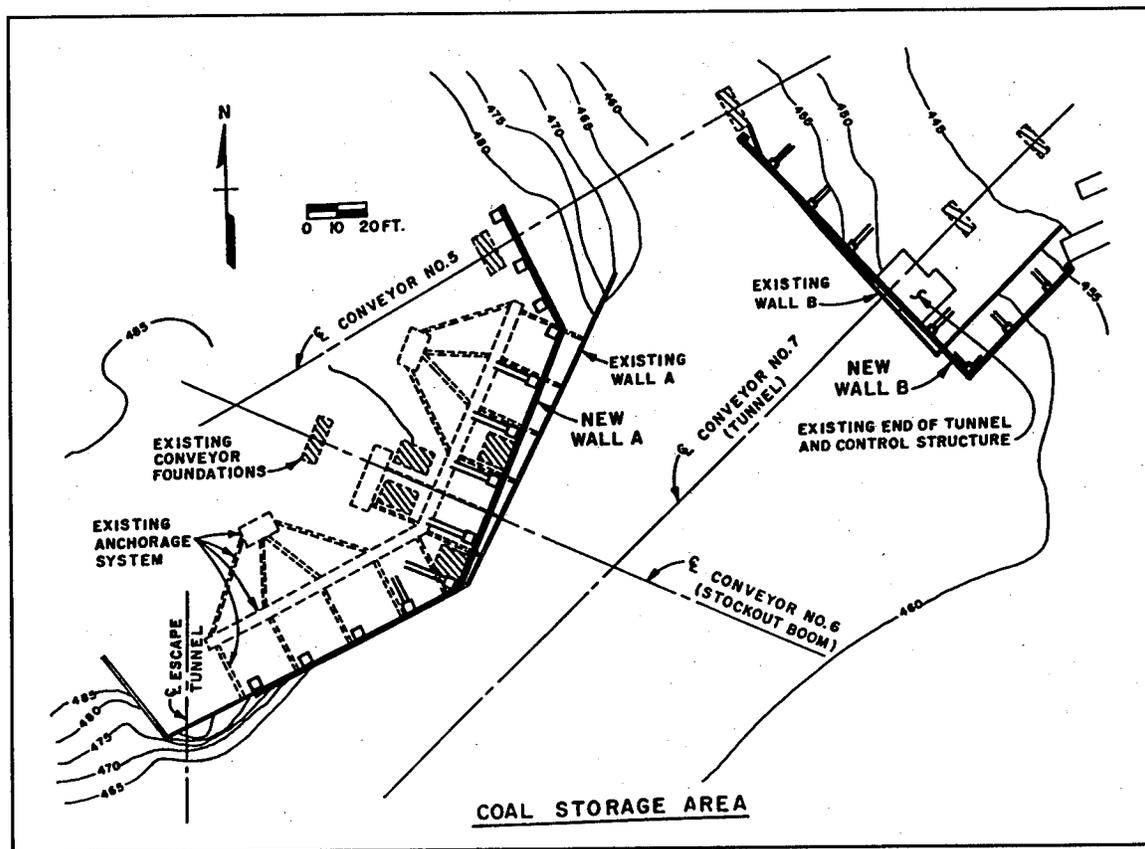
Figure 205. Diagram of Indiana Power & Light coal storage area (from PCI 1985)

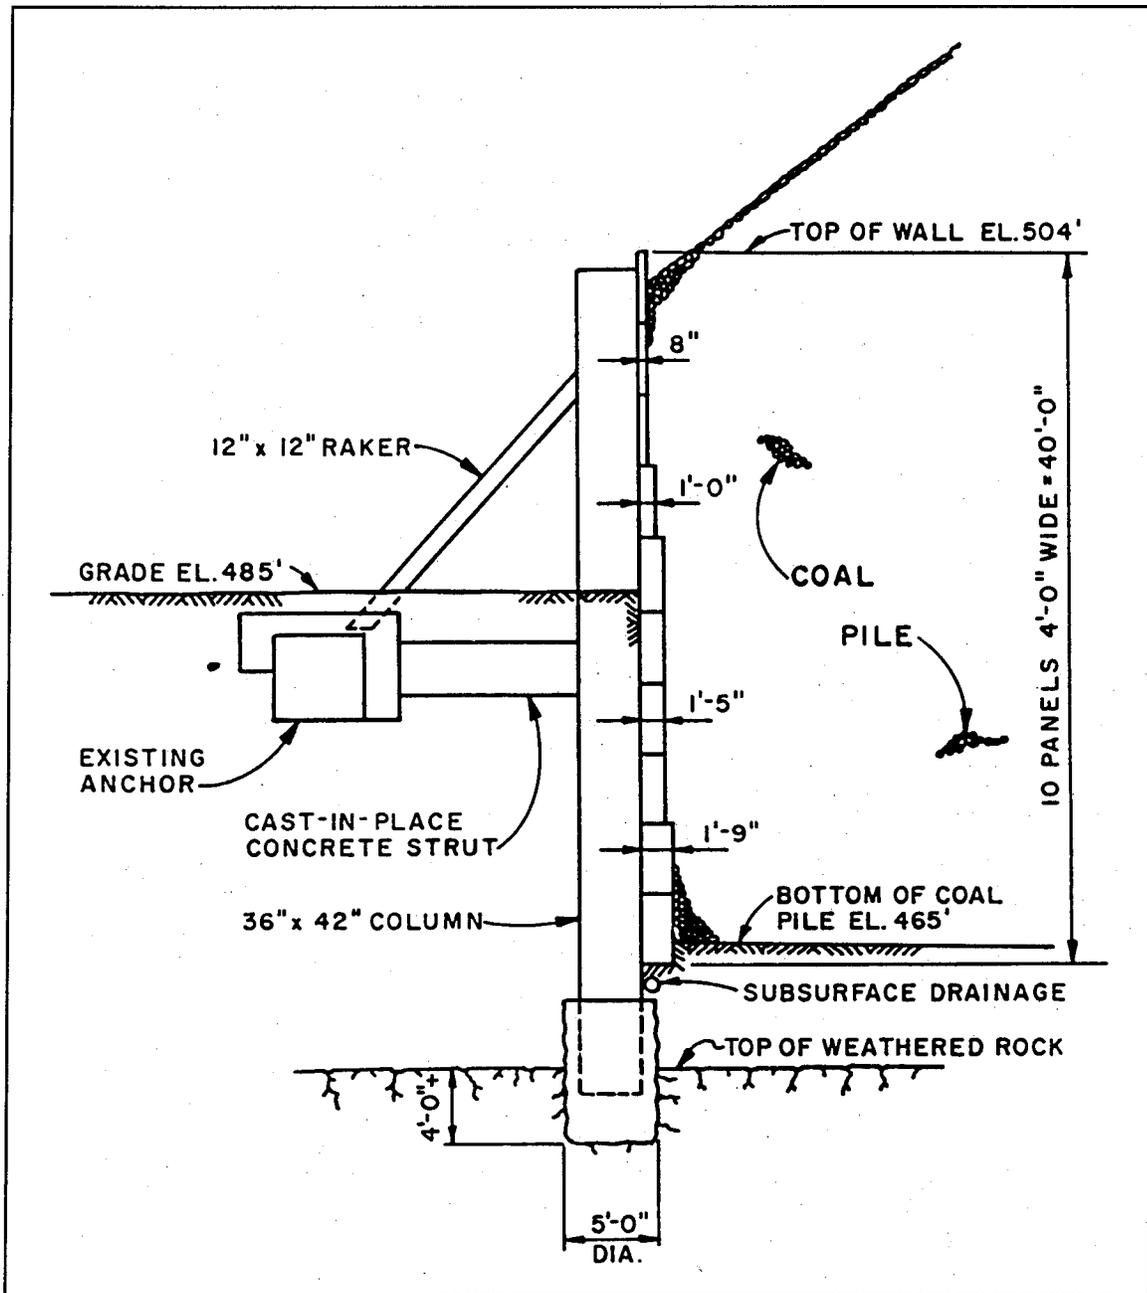
Figure 206. Typical precast panel section for Wall A at Indiana Power & Light coal storage facility (from PCI 1985)

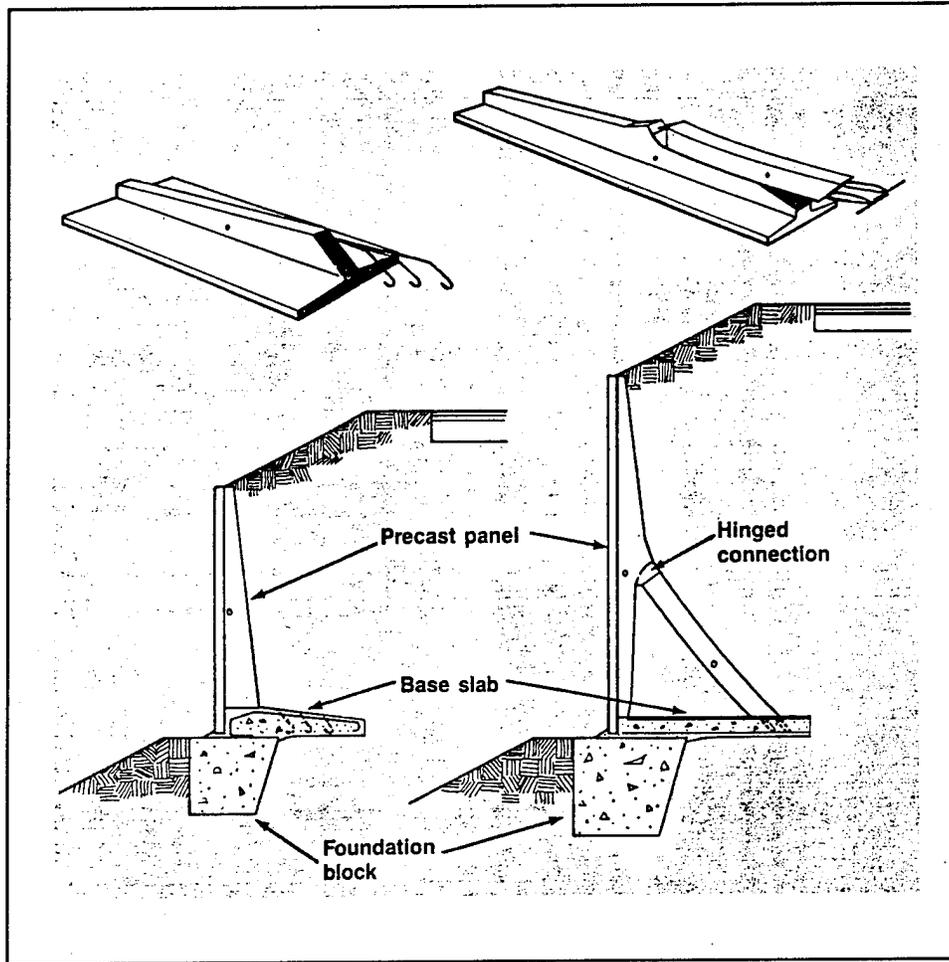
Figure 208. Design for retaining-wall system used for shopping mall in Massachusetts; this wall supports panels to 16 ft high (from Randall 1989)

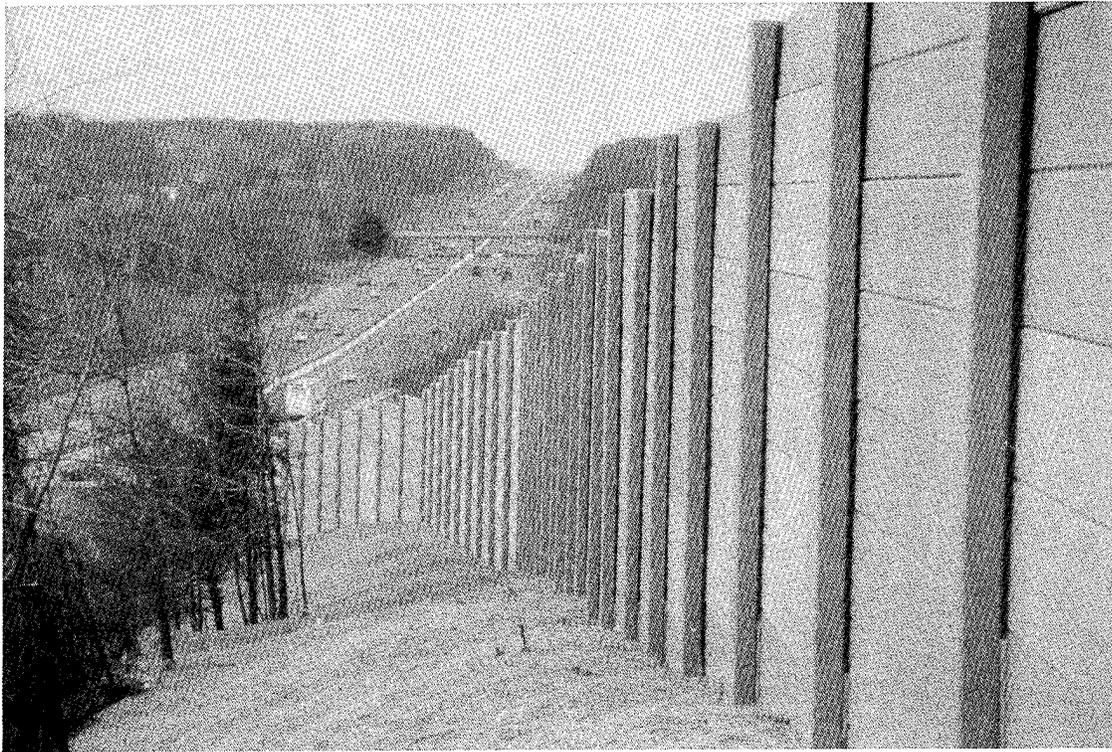
Figure 211. Section of precast concrete post and panel noise barrier wall installed along Interstate Route 80, New Jersey (from Guzaltan 1992)

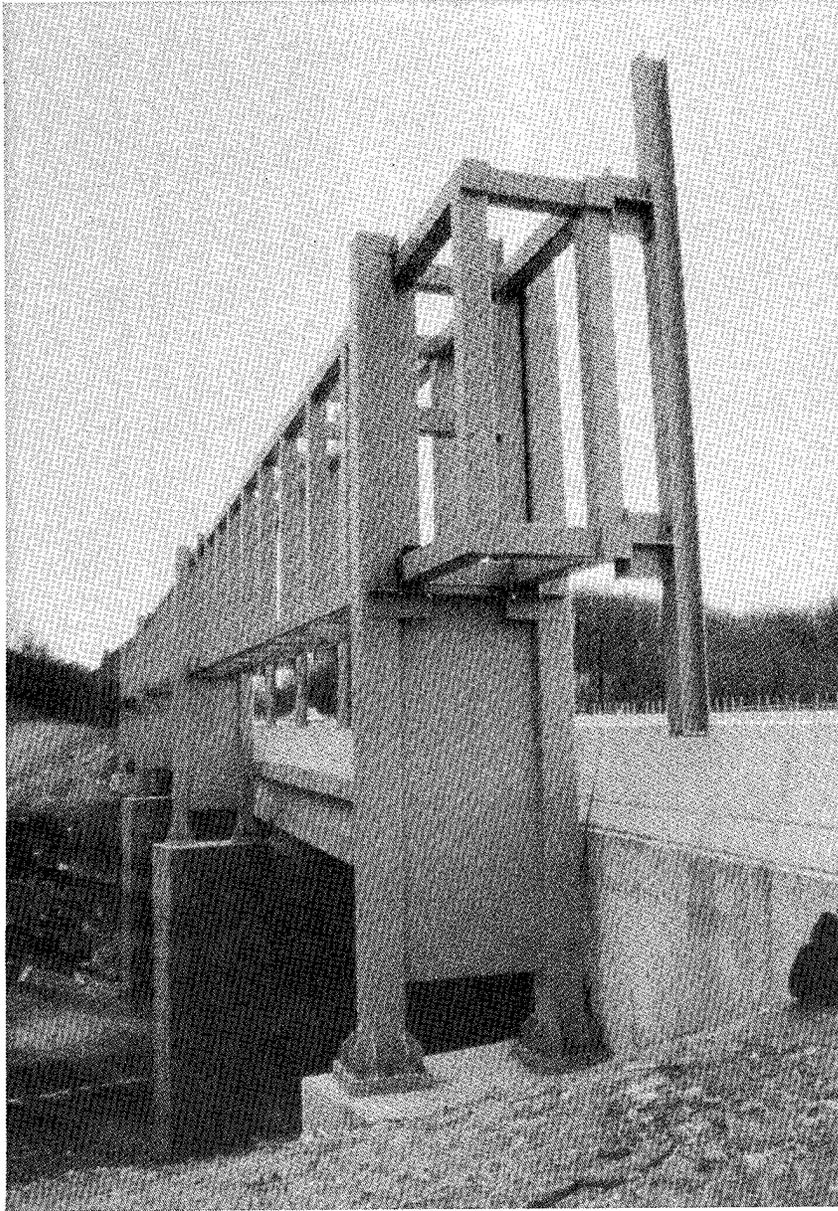
Figure 212. Concrete and steel structure used to support precast concrete panels along bridges on New Jersey Interstate Route 80 (from Guzaltan 1992)

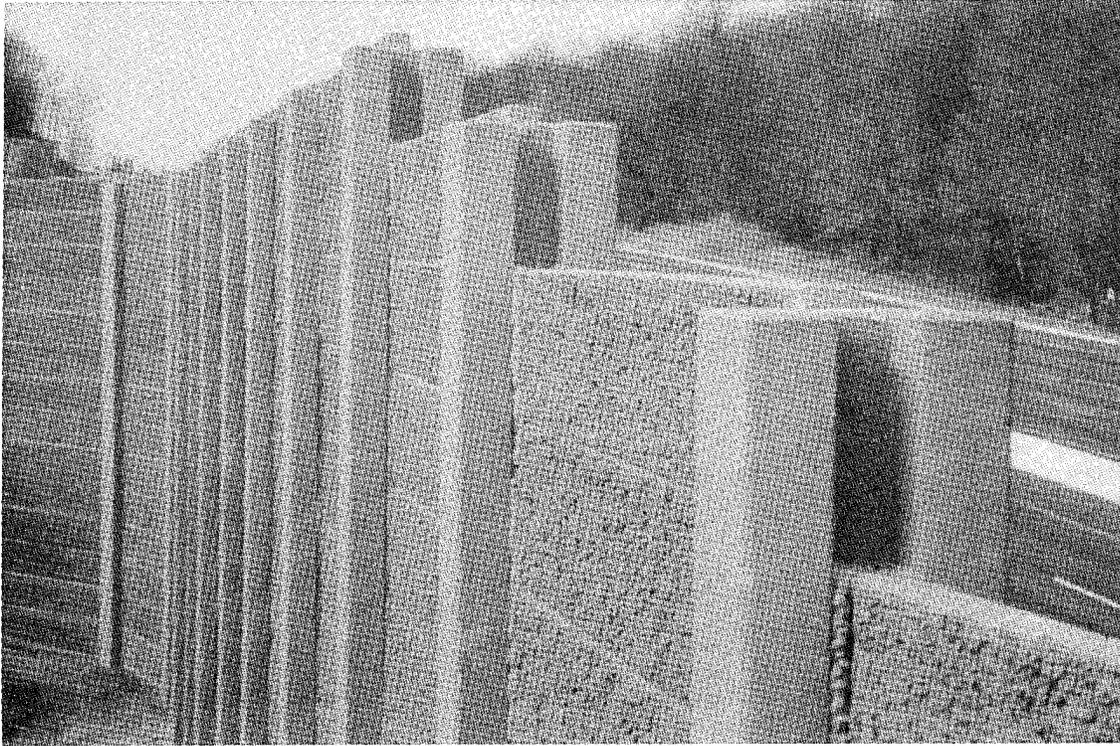
Figure 213. Precast I-shaped posts and panels used to form noise barrier wall along New Jersey Interstate Route 80 (from Guzaltan 1992)

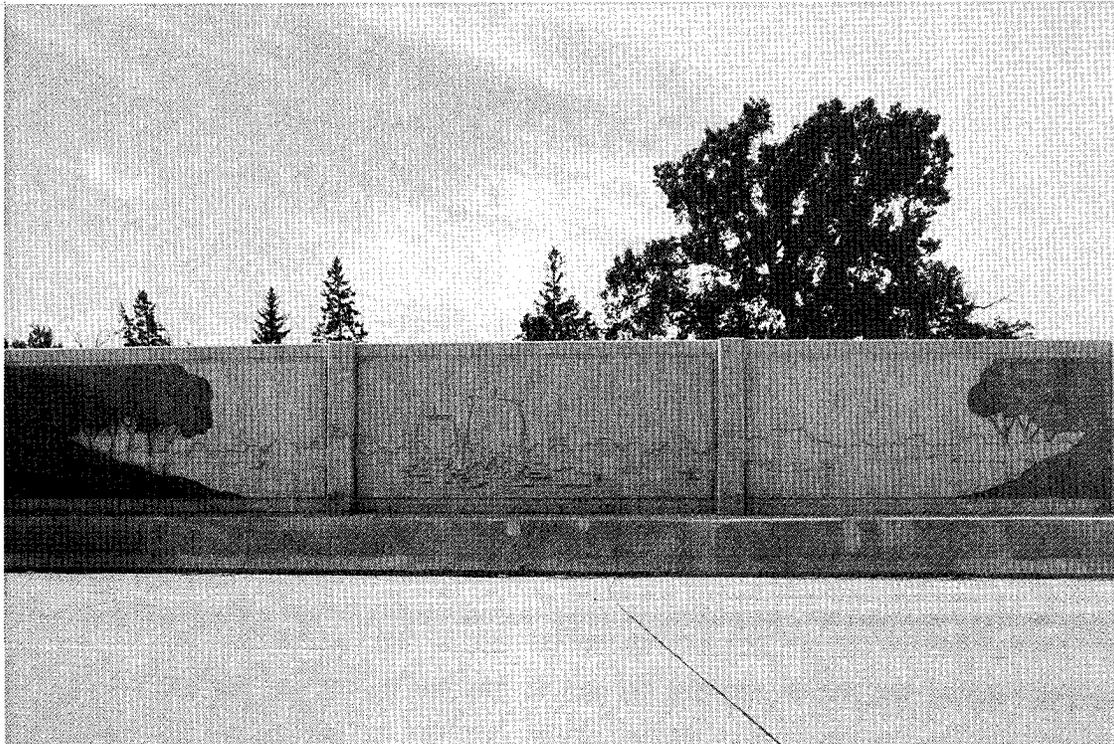
Figure 214. Precast concrete noise barrier with murals, Winnipeg, Canada (from Ulyatt and Winch 1992)

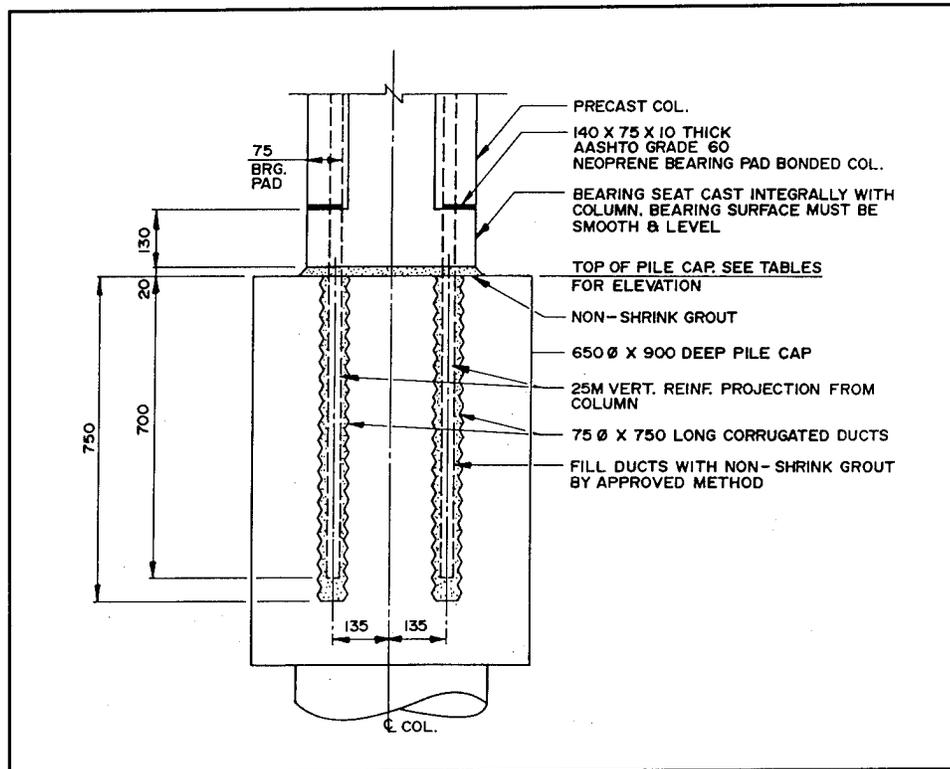
Figure 215. Drawing that shows how columns were anchored to pile caps, Winnipeg (from Ulyatt and Winch 1992)
