Analysis of Accidents  
Related to Scaffolding and Floor/Wall Openings

A thesis submitted in partial fulfillment  
of the requirements for the degree of

University of Washington

1995

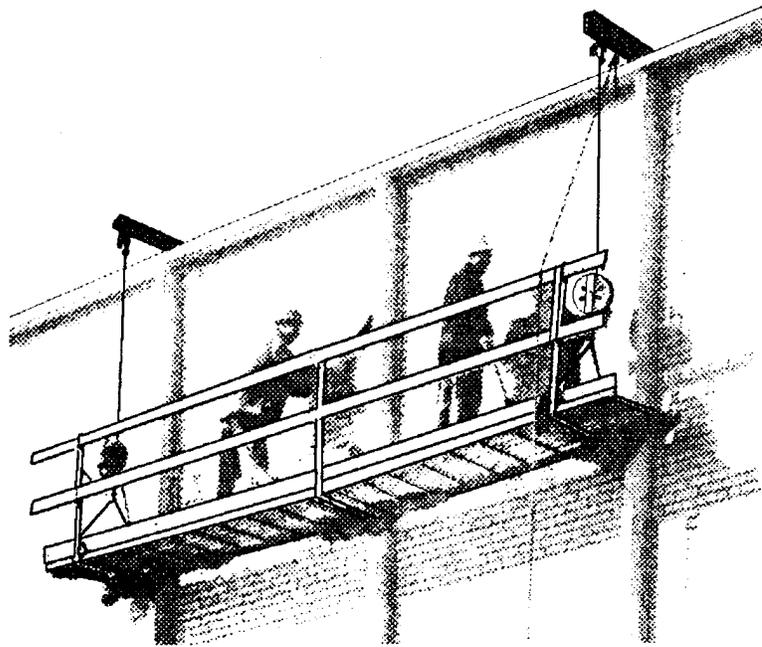
Figure 1: Two-Point Suspended Scaffold (29 CFR 1926.451(i))

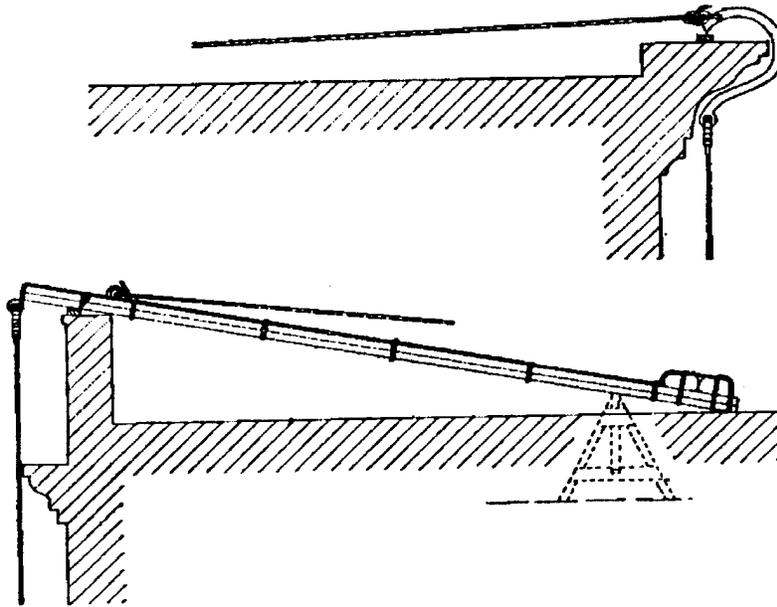
Figure 5: Two-Point or Single-Point Suspension Tie-Back Systems

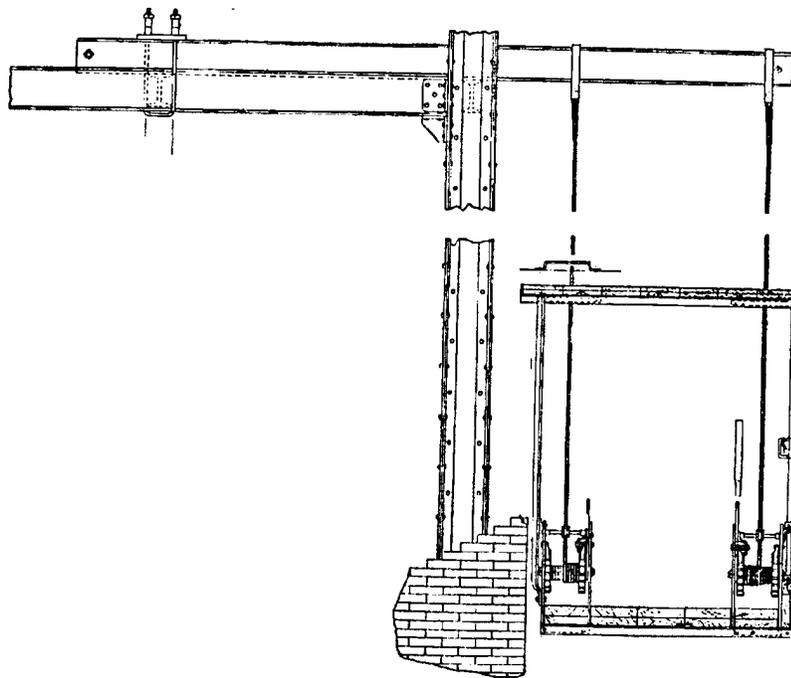
Figure 4: Mason's Multi-Point Suspension Scaffold Cross Section  
(29 CFR 1926.451(h))

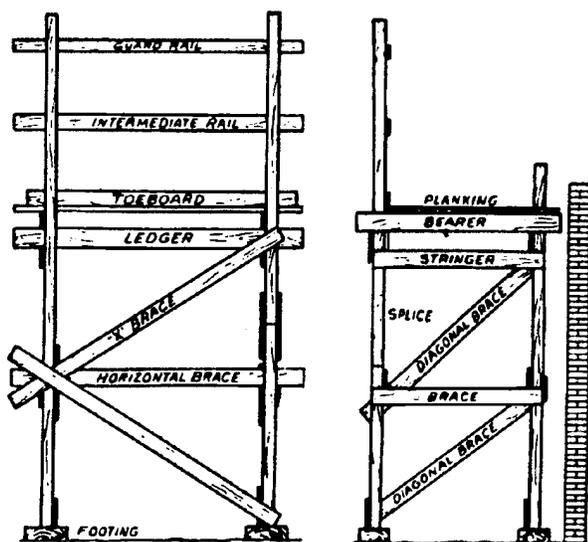
Figure 6: Wood Pole Scaffold Cross Section  
(29 CFR 1926.451(b))

Wood pole scaffolds offer a very flexible option for scaffolding needs. Generally any size or shape can be built. The primary disadvantages of wood are the requirement for reasonably defect-free lumber and the effort required to design and erect the scaffold. Splicing of long members also becomes a problem which can weaken the structure. Contractors usually overcome these problems by reusing scaffold lumber and limiting wood pole designs to relatively small applications. A cross section of a wood pole scaffold is shown in Figure 6.

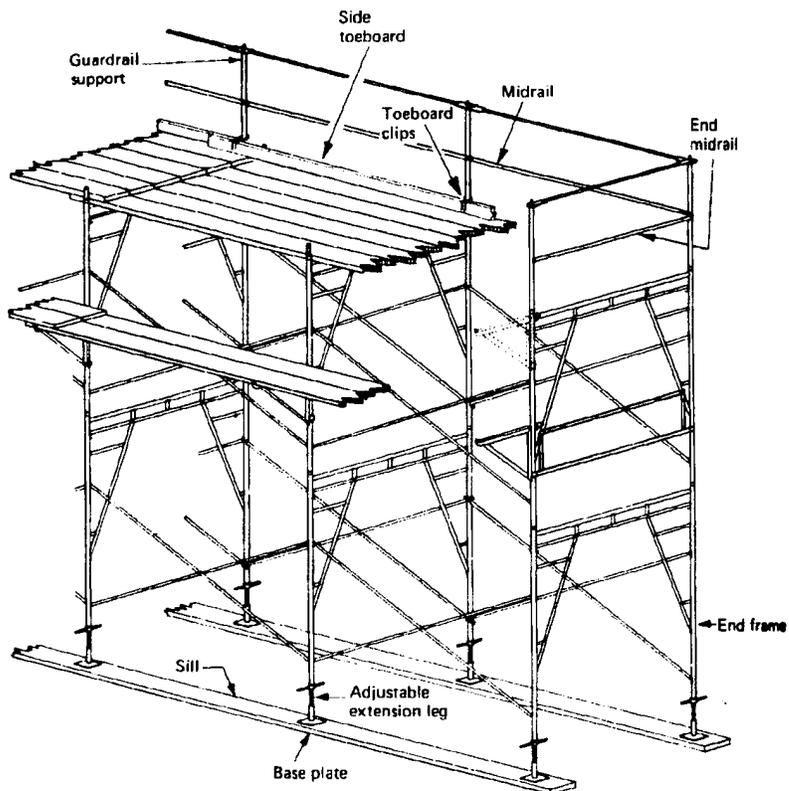
Figure 7: Tubular Welded Frame Scaffold (29 CFR 1926.451(d))

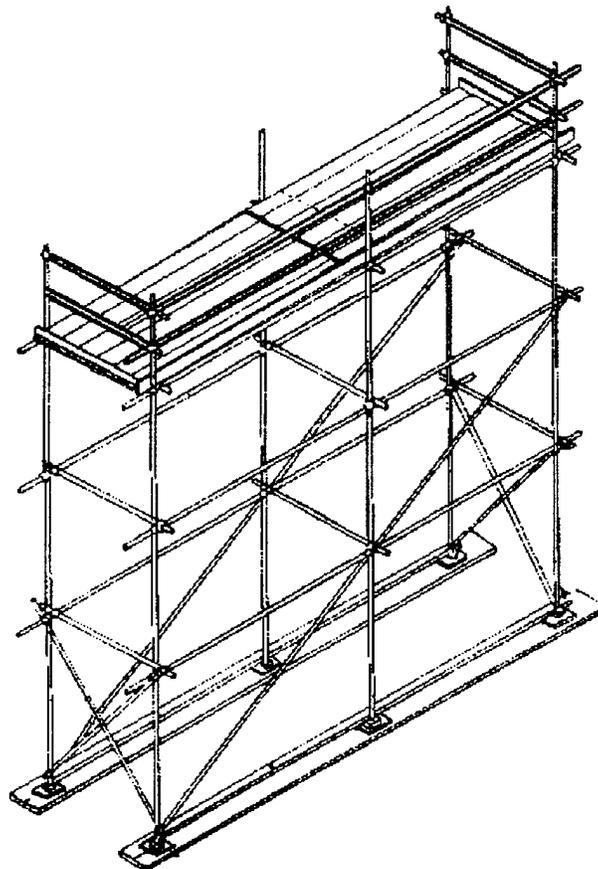
Figure 8: Tube and Coupler Scaffold (29 CFR 1926.451(c))

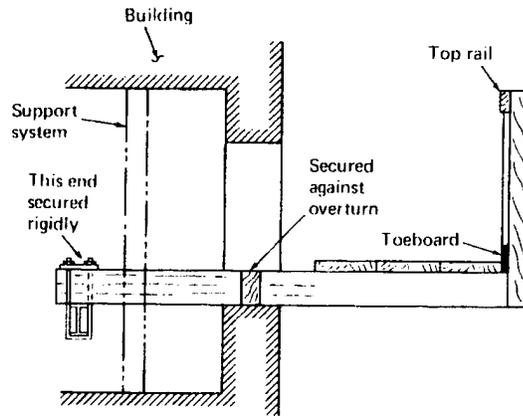
Figure 10: Outrigger Scaffold Cross Section  
(29 CFR 1926.451(g))

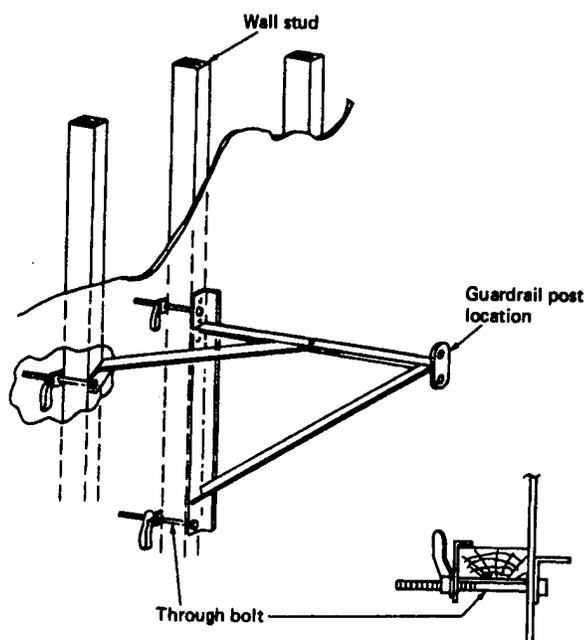
Figure 12: Carpenter's Bracket Scaffold  
(29 CFR 1926.451(m))

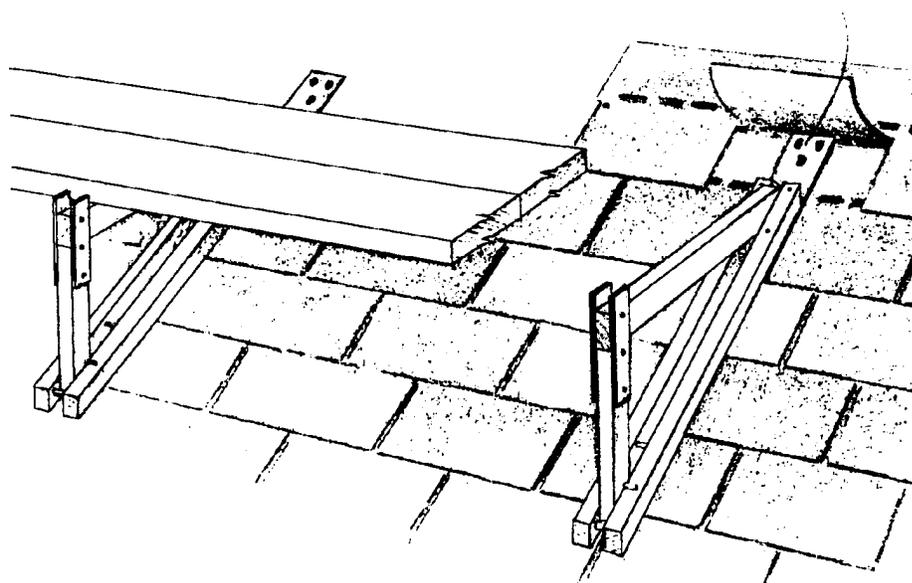
Figure 13: Roofing Brackets (29 CFR 1926.451(u))

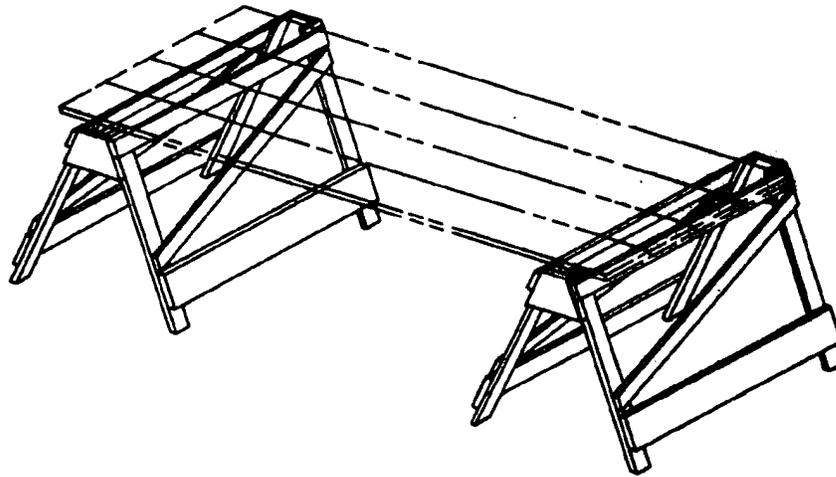
Figure 14: Horse Scaffold (29 CFR 1926.451(o))

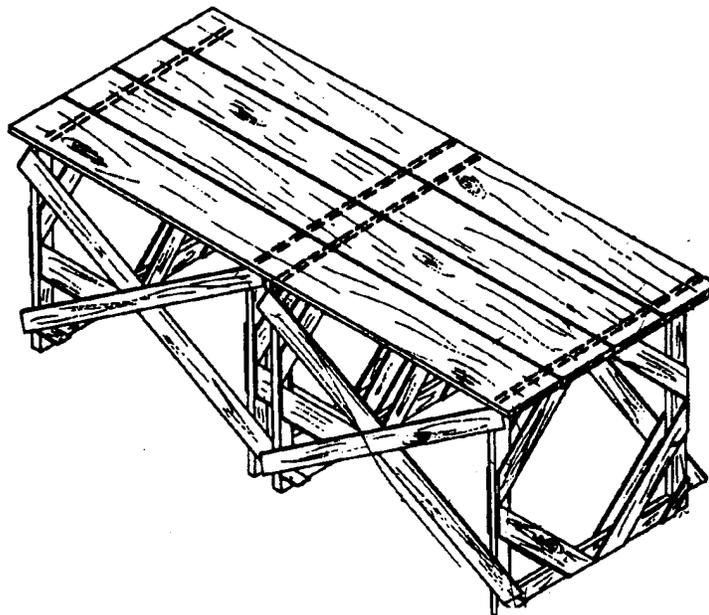
Figure 15: Bricklayer's Square Scaffold  
(29 CFR 1926.451(n))

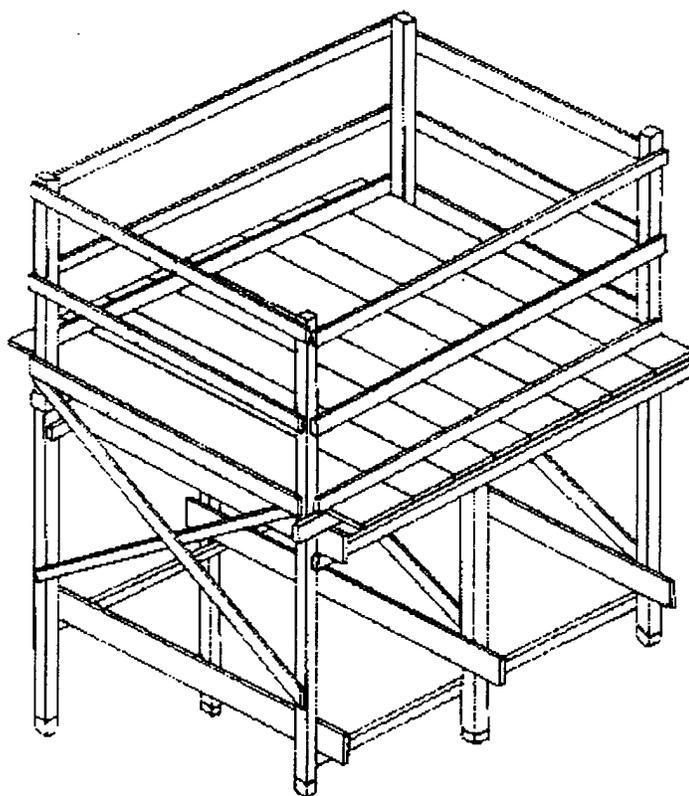
Figure 16: Plaster's, Decorator's and Large Area Scaffold (29 CFR 1926.451(q))

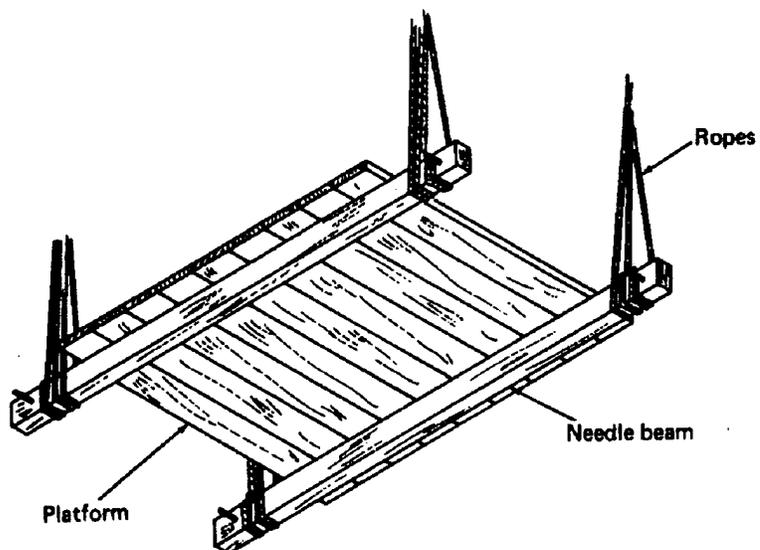
Figure 17: Needle Beam Scaffold (29 CFR 1926.451(p))

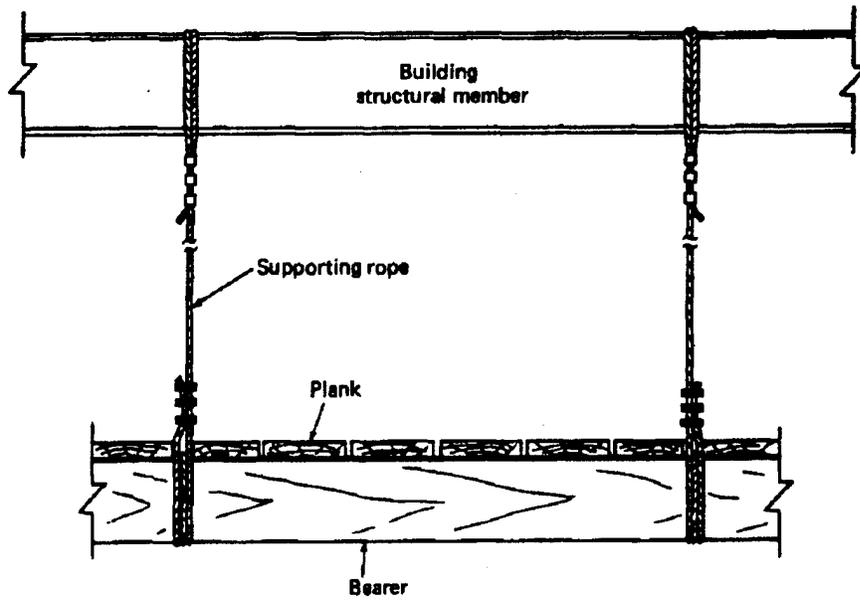
Figure 18: Interior Hung Scaffold Cross Section (29 CFR 1926.451(r))

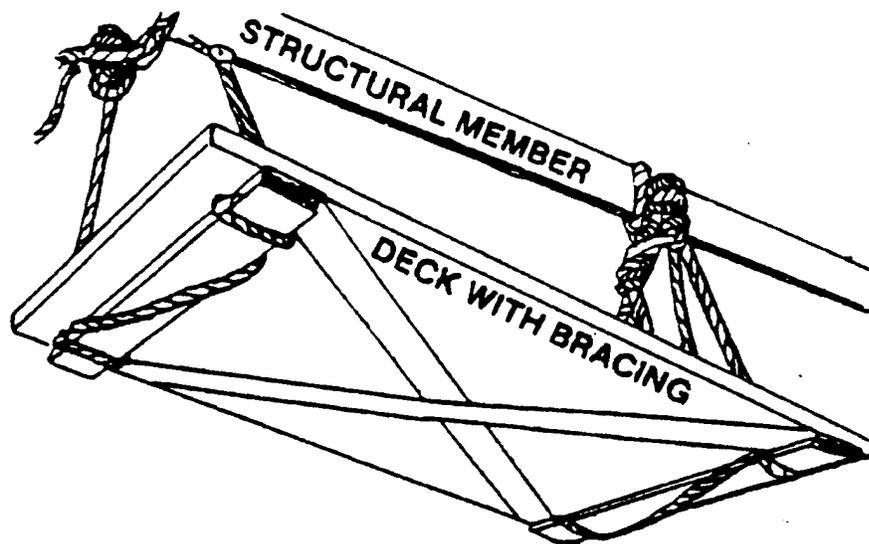
Figure 19: Float or Ship Scaffold (29 CFR 1926.451(w))

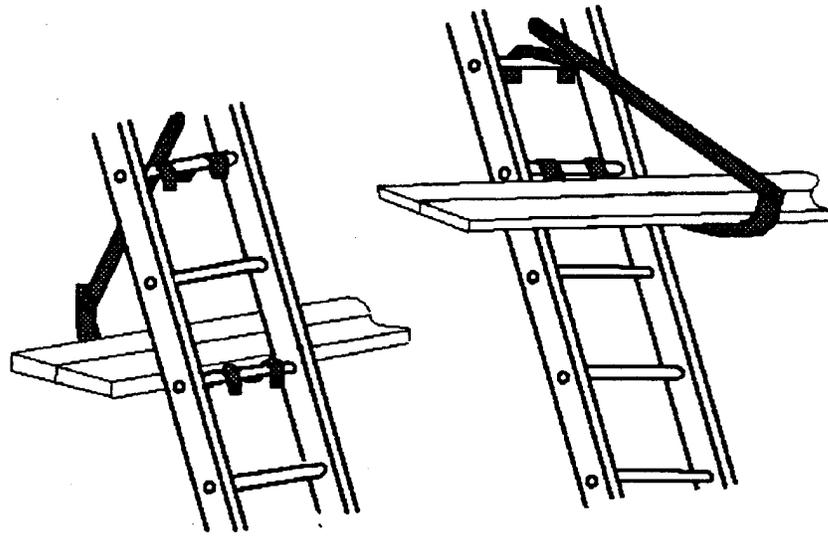
Figure 20: Ladder Jack Scaffold (29 CFR 1926.451(s))

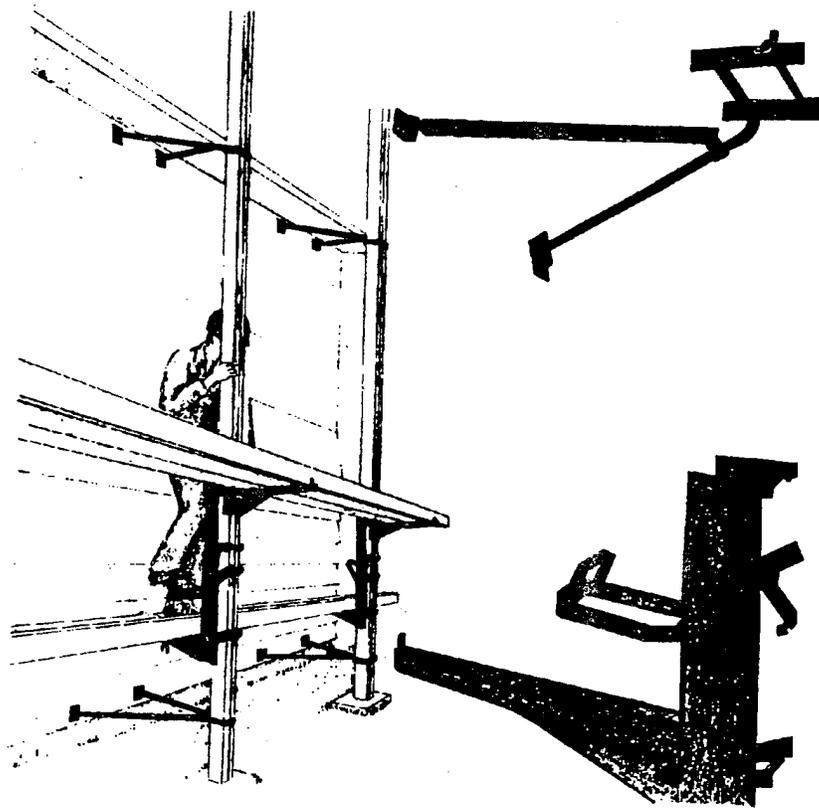
Figure 21: Pump Jack Scaffold (29 CFR 1926.451(y))

Ladder jack and pump jack scaffolds are commonly used to provide a raised platform for exterior residential construction. Ladder jacks simply rely on two ladders or one ladder with another structure for support as shown in Figure 20. With such a dependence on ladders for support the ladder strength and stability become very important safety concerns. Additionally, there are no provisions for guardrails so height is limited and lifelines are recommended. Pump jacks, however, have a built-in work bench which can serve as a guardrail. The pump jack operates by clamping onto a pole of double 2x4's

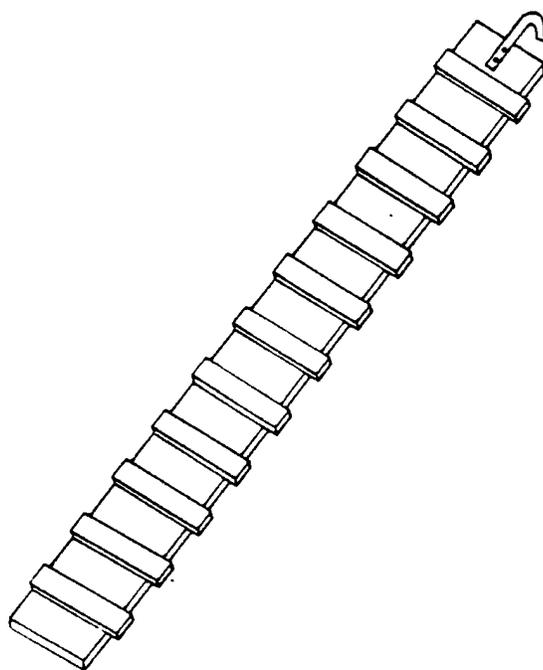
Figure 22: Crawling Board or Chicken Ladder  
(29 CFR 1926.451(v))

Crawling boards (or chicken ladders, as they are also known) and form scaffolds are very specialized for their intended purposes. Crawling boards or chicken ladders are used for roof construction where the top is hooked to the roof ridge for support as shown in Figure 22. This provides a non-slip platform and prevents damage to roof surfaces. Form scaffolds are used to provide access to the tops of concrete formwork as shown in Figure 23. Since the form scaffold depends on the concrete forms for support, extra measures should be taken to ensure the proper erection and bracing of the formwork.

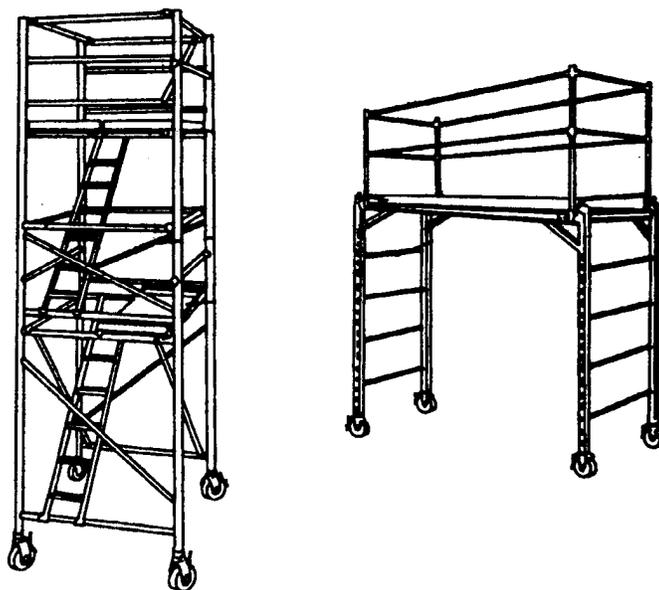
Figure 24: Manually Propelled Mobile Scaffold  
(29 CFR 1926.451(e))

The obvious safety concerns for movable platforms are their limitations to mobility. They are most unsafe while being moved. The need for a level surface, free from obstructions on the ground and overhead, is critical for safe movement. Once in position, it is critical to have a means of securing and stabilizing the scaffold to prevent further movement while workers are on the unit.

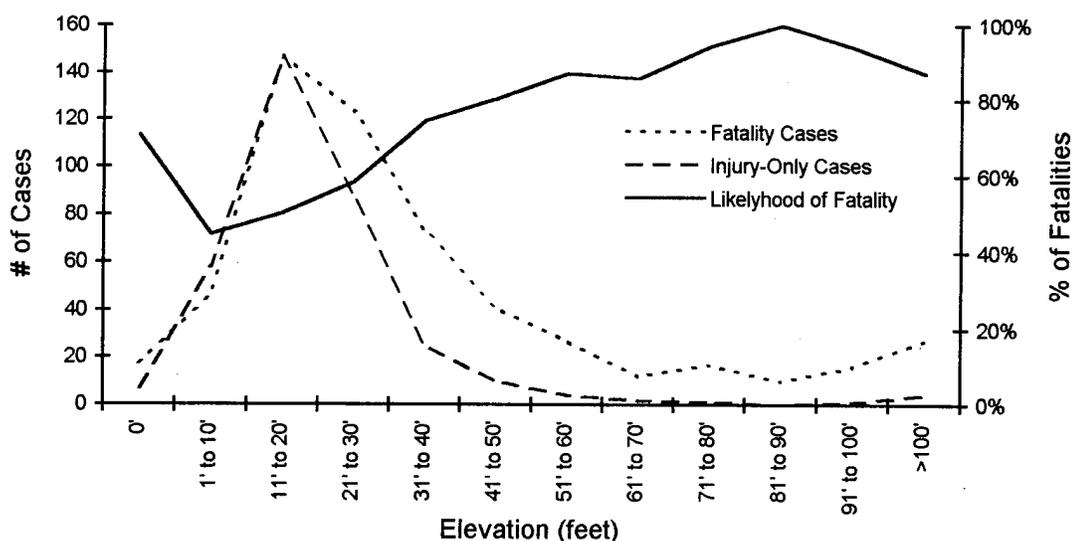
elevation does not necessarily mean that the victim fell, but 93.4% of the cases did involve falling from the elevation recorded. Therefore, when examining the elevation data any significance can be related to a victim falling from that elevation. Both fatality and injury-only cases were most common at heights of 11 to 20 feet, as shown in Figure 43. The median for all cases was at 22 feet, while the median for fatality cases was slightly higher at 27 feet and injury-only cases lower at 18 feet. The number of cases drops off very quickly after this peak of 11 to 20 feet. This indicates that the most common working heights in construction involving accidents are between 10 to 50 feet, as this accounts for 84% of the cases. It can be said that at the 11 to 20 feet level there is roughly a 50% chance that a fall incident will involve a fatality. Using this comparison at the other heights, it can be concluded that the likelihood of a fatality in an accident increases as the elevation of the platform increases, as shown in Figure 43.

Figure 43: Cases by Platform Elevation and % of Fatalities

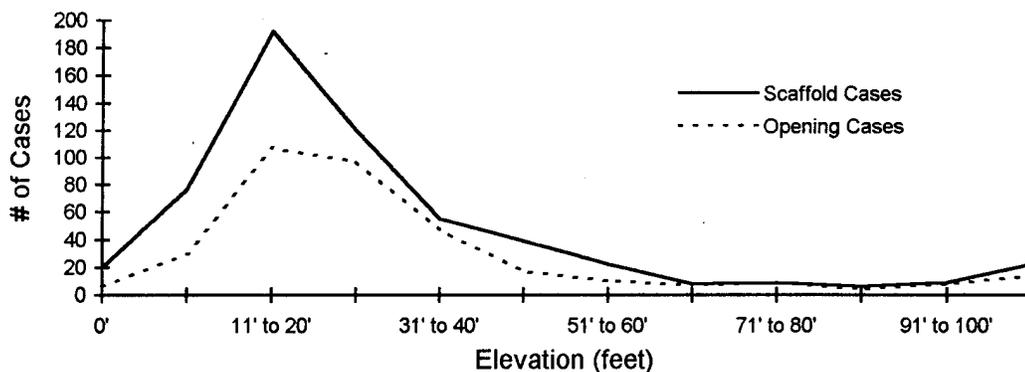
By comparing the elevation data to scaffold or opening cases an interesting similarity is revealed. While the number of cases differs for each, scaffold cases and opening cases both indicate the same predominance for accidents at 11 to 20 feet of elevation, as shown in Figure 44.

Figure 44: Scaffold and Opening Cases by Platform Elevation

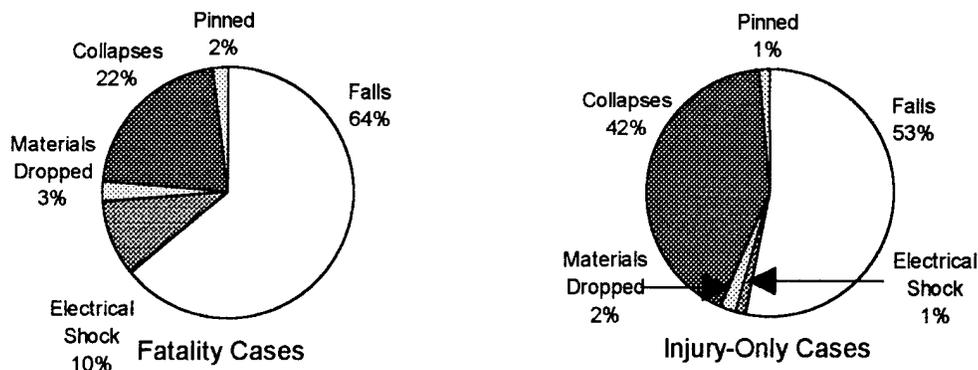
descriptions were inconsequential compared to these two types of fall accidents, as shown in Figure 46. Interestingly, scaffold-related accidents involving electric shock accounted for 1% of scaffold injury-only cases and 9.6% of the scaffold fatality cases. The combination of electricity and scaffolds is not very forgiving as indicated by the higher percentage of fatalities.

Figure 46: Scaffold Cases by Accident Description (Top 5 Types)

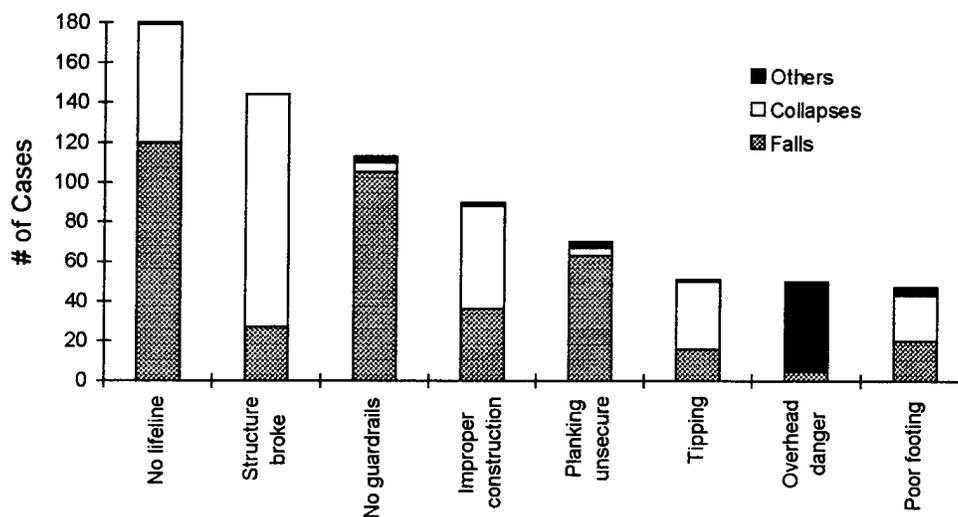
required this protection by 29 CFR 1926.451. Only the two-point suspension, boatswain's chair, needle beam, float, and extensible/articulating boom aerial lift scaffold types specifically require lifelines to be used. The window and roof bracket scaffolds include lifelines as an option if guard rail protection is not provided. Five categories relate directly to the construction of the scaffold: structure broke, no guardrails, improper construction, planking unsecure/broke, and poor footing. Collectively these categories clearly indicate that the major cause contributing to scaffold accidents is the inability to construct a safe scaffold. When the type of accident is distinguished between falls, collapses, and other, the causes reflect expected results. Collapses tend to account for more accidents related to structural failure, improper construction (which often accompany structural failures), and tipping incidents. "Other" type accidents dominate the overhead danger category which is primarily due to electrical shock accidents when scaffolds contact power lines.

Figure 47: Scaffold Cases by Major Causes

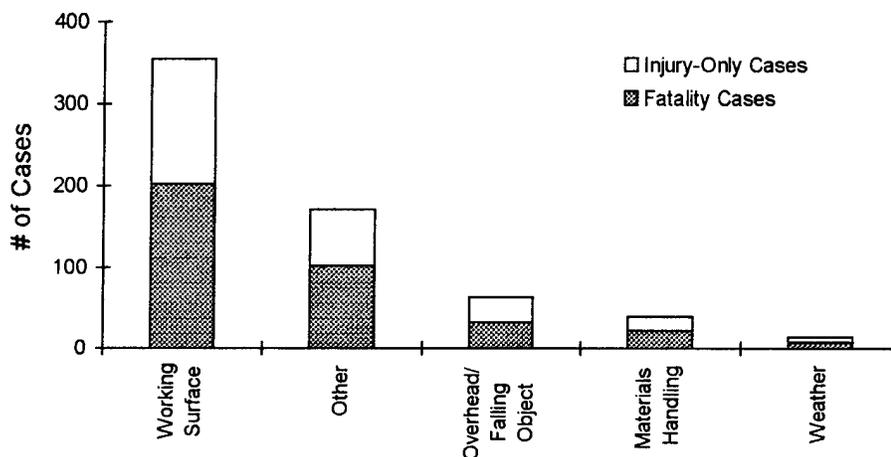
fatality cases) environmental cause cited as a problem was the working surface or facility layout condition (see Figure 48). Unfortunately, many specific environmental conditions could be described by this phase and no clear significance can be drawn from this category. This generality is followed by the second most frequently used code of “other” with 25.5% of all scaffold cases and 26.4% of the scaffold fatality cases.

Figure 48: Scaffold Cases by Top 5 Environmental Causal Factors

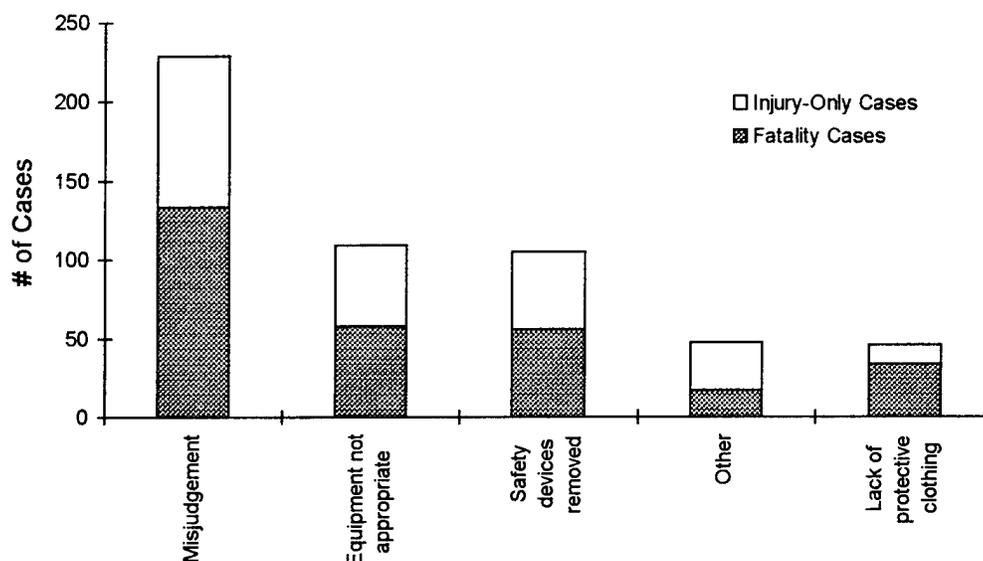
This same lack of specificity is noticed in the human causal factors assigned by the compliance officers (see Figure 49). The most frequently attributed human cause is misjudgment of a hazardous condition which accounts for 34.2% of the scaffold cases and 34.6% of the scaffold fatality cases. Fortunately, some insight might be gathered from the next most common causes of “equipment in use was not appropriate for operation” (16.3% of scaffold cases) and “safety devices removed or inoperative” (15.7% of scaffold cases). These categories are sufficiently specific to give a clear indication of what was done wrong. The next category is an OSHA distinguished “other” classification which, unfortunately, was a frequently used category too general to interpret much information. The last category most frequently used was the lack of protective work clothing which normally includes personal protective equipment (PPE) such as eye protection, hearing protection, and work boots.

Figure 49: Scaffold Cases by Top 5 Human Causal Factors

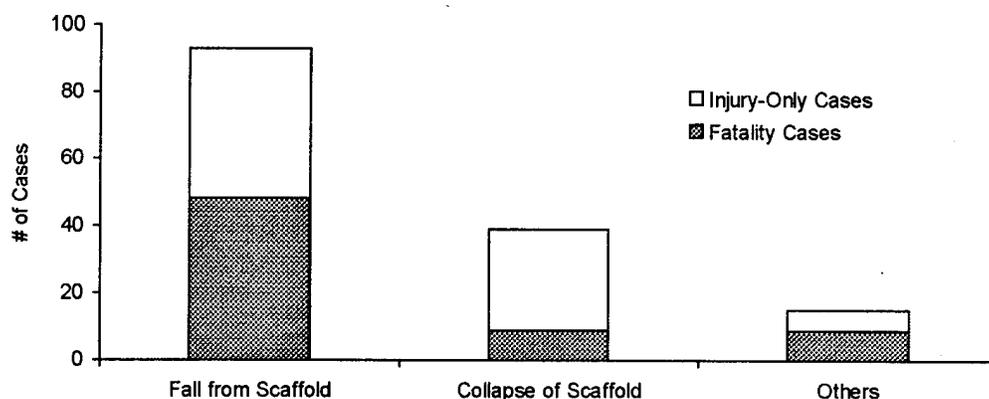
Falls from and collapses of this scaffold accounted for 89.8% of all cases and 86.4% of all fatality cases involving this type (see Figure 53). Interestingly, only 13.6% of the fatality cases were classified as collapses. In many cases the abstract described collapses where the workers on the scaffold “rode the scaffold down” which likely slowed the rate of decent and prevented some fatalities.

Figure 53: Tubular Welded Frame Scaffold Cases by Accident Type

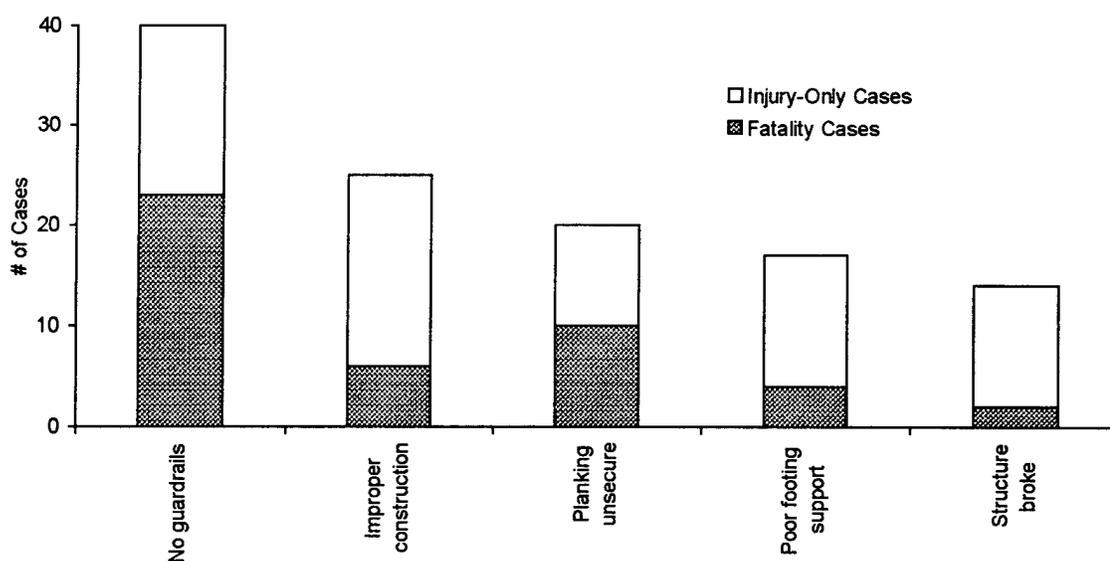
The major causes attributed to tubular welded frame scaffolds focused on the construction of the scaffold (see Figure 54). The 5 most frequent causes involving the construction of the tubular welded frame scaffold accounted for 57% of all cases for this scaffold type. The most surprising fact is that 15.6% of the fatalities are due to not having guardrails installed as required. No complex engineering solution is required to remedy this portion of this scaffold's problem. The equipment simply needs to be utilized as it was designed. Work environment and human causal factors for this scaffold type did not vary from the relative frequencies noticed for all scaffold types reflected in Figures 48 and 49.

Figure 54: Tubular Welded Frame Scaffold Cases by Top 5 Accident Causes

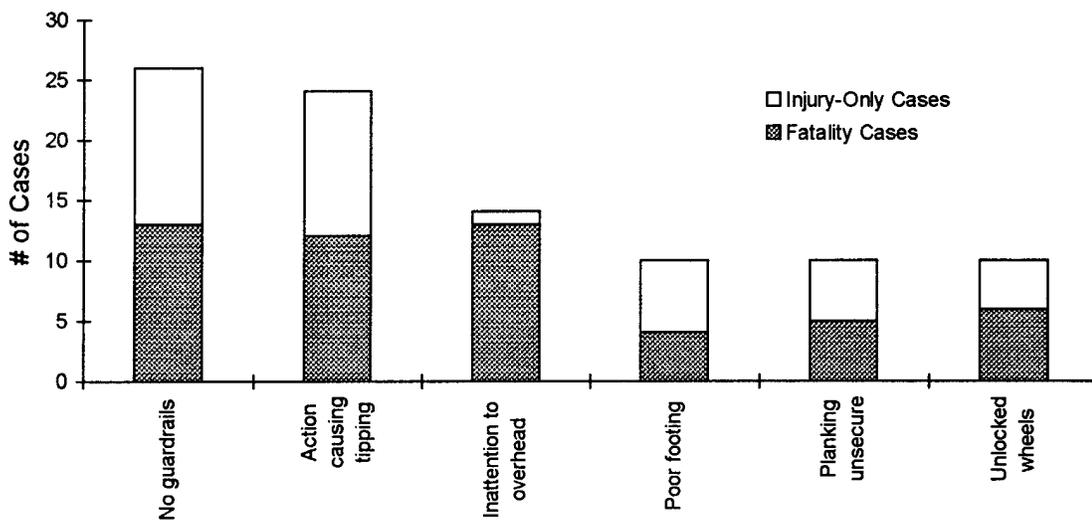
the fatality cases (see Figure 58). This was followed closely by an action which caused the scaffold to tip over (23.5%). The third cause, associated with electrical shock, was inattention to overhead obstacles at 13.7% of the cases. Electrical shock accounted for fatalities in 92.8% of the cases related to this cause. Work environment and human causal factors for this scaffold type did not vary from the relative frequencies noticed for all scaffold types reflected in Figures 48 and 49.

Figure 58: Manually-Propelled Mobile Scaffold Cases by Top 6 Accident Causes

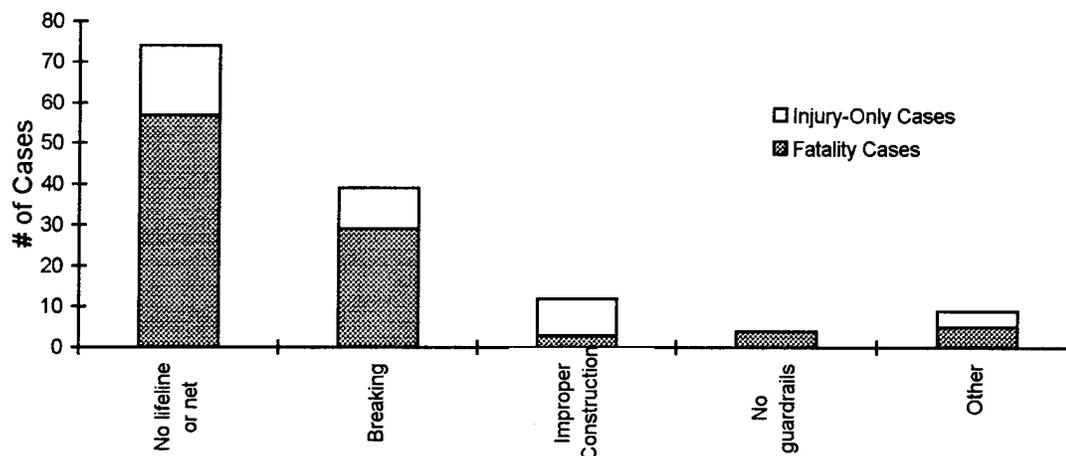
Figure 62: Swinging Scaffold Cases by Accident Causes

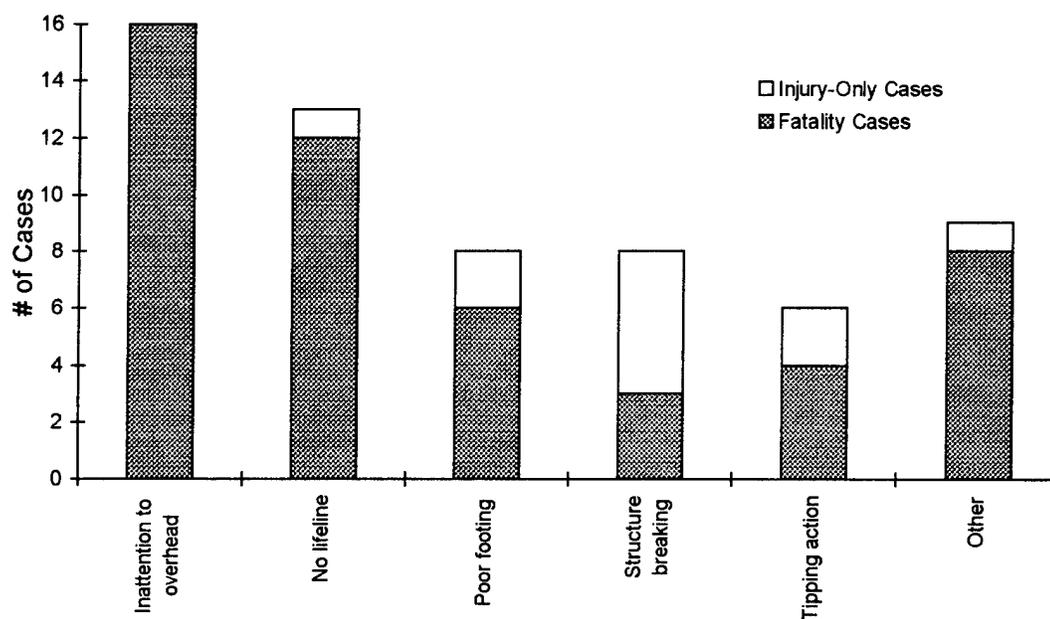
Figure 66: Extensible and Articulating Boom Aerial Lift Cases by Causes

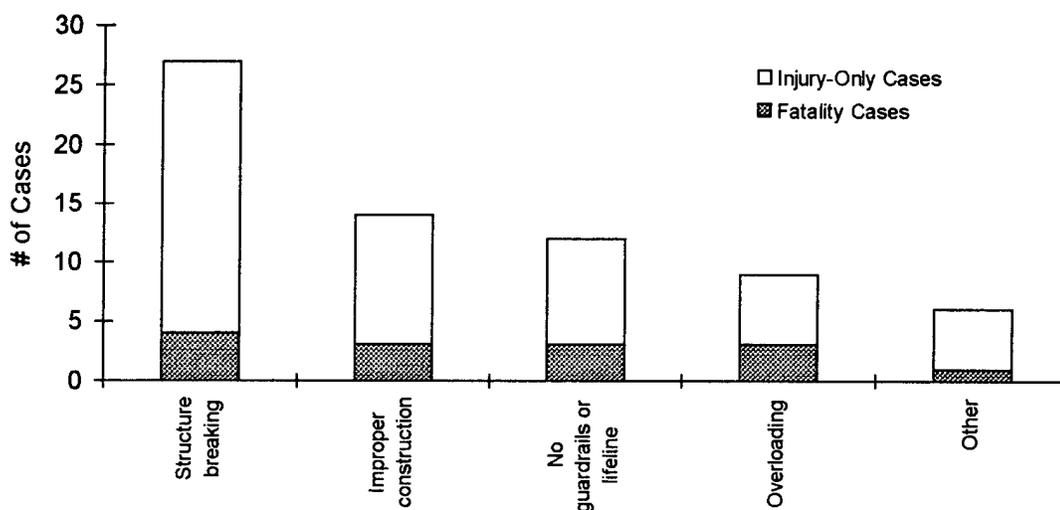
Figure 70: Pump Jack Scaffold Cases by Causes

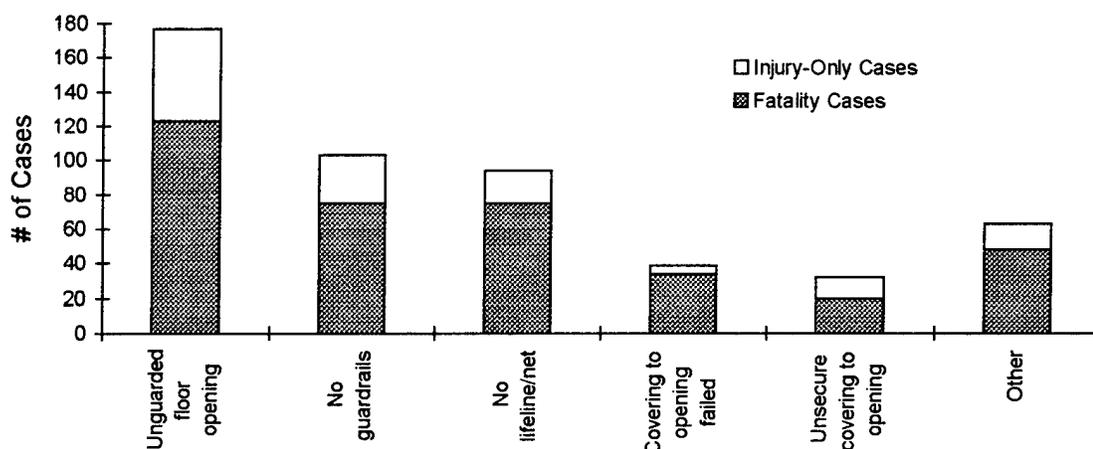
Figure 74: Opening Cases by Causes
