AEDC-TSR-97-V1

**DEEP SPACE THERMAL CYCLE TESTING OF
ADVANCED X-RAY ASTROPHYSICS FACILITY - IMAGING
(AXAF-I) SOLAR ARRAY PANELS TEST**

**J. D. Sisco, B. L. Seiber, and R. A. Dawbarn
Sverdrup Technology, Inc., AEDC Group**

**ARNOLD ENGINEERING DEVELOPMENT CENTER
ARNOLD AIR FORCE BASE, TENNESSEE
AIR FORCE MATERIEL COMMAND
UNITED STATES AIR FORCE**

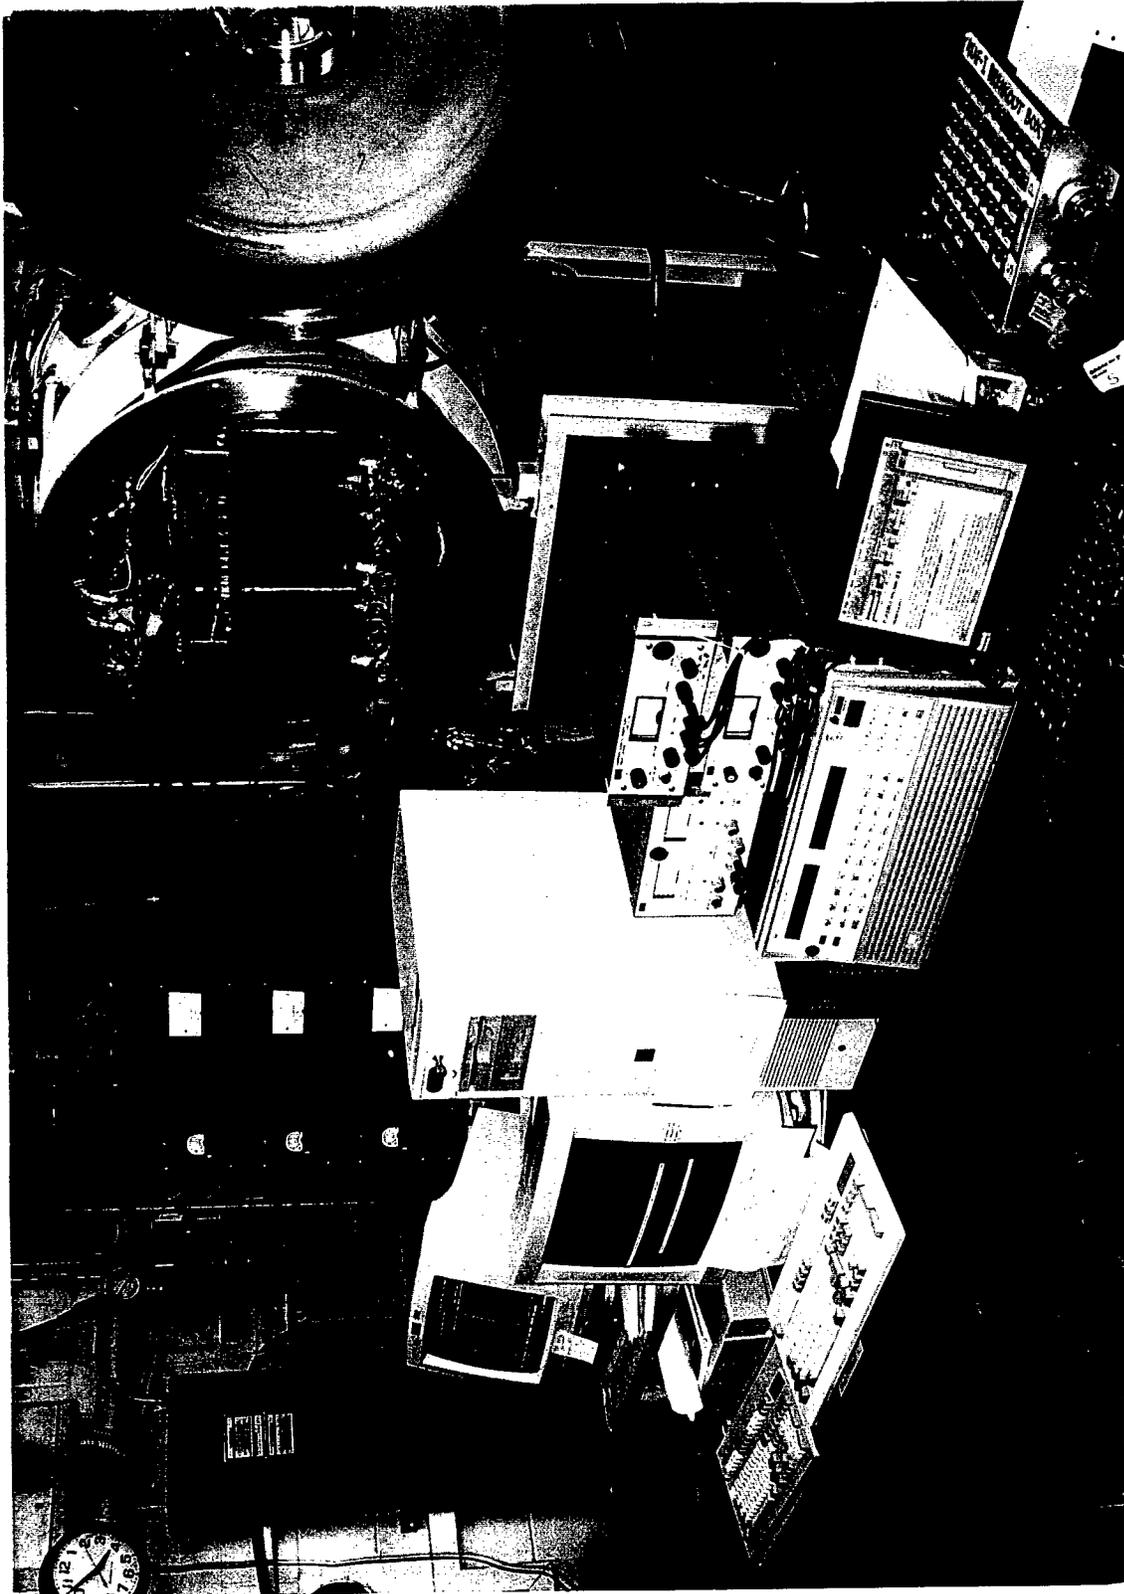
Figure 5. 7A Lamp Controls

The tungsten lamps were rated for 120 volts at 500 W each. The wiring for the lamp array was broken down into three groups of four lamps each for a total of 12 lamps. The power for each group was controlled by a 0-120 Vac supply (Fig. 5). Total full load amperage of each group was 16.7 amp for a total of 6 kW for the entire array.

A Kaye Instruments Digi 4S data logger with a 16 channel multiplexer was used to measure the chamber housekeeping data (Fig. 5). The data logger output was sent to and stored on a personnel computer (PC). The log interval was 5 min. All test data files were backed-up on 3-1/2 in. floppy disks.

A type T jumper wire from the Kaye data logger to NASA-MSFC HP3852 provided dual logging and over/under temperature safety controls. The HP3852 controlled the off/on of the lamps using a relay contact based on the average temperature of the DVT panels. The NASA-MSFC/TRW's test hardware included a continuity monitoring system, power supplies, two temperature controllers, patch panel, PC and wide carriage printer, and HP3852 data logger as shown in Fig. 5.

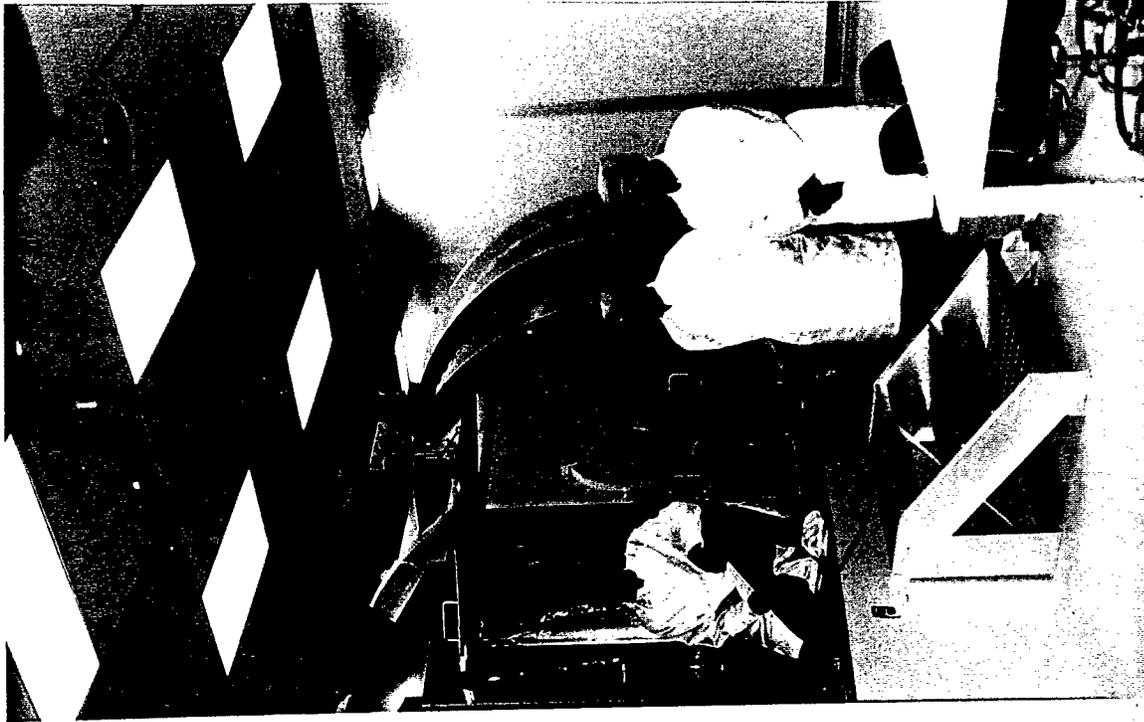
Figure 6. 10V Thermal Vacuum Chamber/Clean Room

The 10V Thermal Vacuum Chamber is located in a large Class 10,000 clean room environment (Fig. 6). The chamber (Fig. 7) is nominally a 10-ft diam by 30-ft length horizontal test chamber. The vacuum shell is constructed of 304 stainless steel, and it is equipped with slide rails to allow a system or optical bench to be rolled into the chamber. Access to the 10V Chamber is through two 10-ft-diam bulkheads located on the east and west ends of the chamber. A 2.5-ft wide by 4.5-ft high entry is located in the middle south side of the chamber. The 20-ft-long by 9.5-ft-diam cryo-liner is located in the west end of the chamber. The Proto-flight solar panel array was installed and removed through the east 10-ft-diam bulkhead.
