# Failure Modes of a Unidirectional Ultra-High-Modulus Carbon-Fiber/Carbon-Matrix Composite

R. J. ZALDIVAR and G. S. RELICK  
Mechanics and Materials Technology Center  
Technology Operations

SPACE AND MISSILE SYSTEMS CENTER  
AIR FORCE MATERIEL COMMAND  
2430 E. El Segundo Boulevard  
Los Angeles Air Force Base, CA 90245

13. ABSTRACT (Maximum 200 words) The objective of this study was to observe the effects of various microstructural features on the in situ, room-temperature tensile fracture behavior of an ultra-high-modulus, unidirectional carbon/carbon (C/C) composite as a function of processing heat-treatment temperature (HTT) over the range of 1100°C to 2750°C. An in situ SEM flexural stage was used to observe the interactions between the advancing crack tip and the microstructural features in the frontal process zone. Following the lowest HTT of 1100°C, failure is dominated by the well-bounded brittle matrix; a tortuous crack path in the E130 fibers appears to contribute to a relatively high utilization of fiber strength in spite of this brittle-matrix failure. Approximate calculations of the interfacial shear stress that might be generated by matrix shrinkage during pyrol

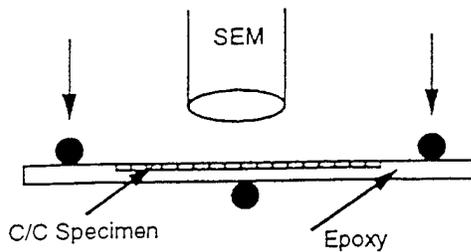
Fig. 1. Schematic diagram of experimental arrangement for *in situ* flexure testing.

epoxy keeps the composite intact during the later stages of crack propagation. Figure 1 shows a schematic of the sample arrangement used for *in situ* SEM observations. The assembly was fitted with a displacement control loading mechanism that could be manually controlled from outside the SEM. The span-to-depth ratio of the samples was approximately 50:1 to ensure a close approximation of tensile failure at the surface. Observations were made on the exposed tensile face. Unfortunately, the stage was not equipped to measure either load or deflection with significant accuracy. Initially, efforts were made to introduce small matrix cracks with a Vickers indenter. However, the results of this approach were that in most cases the manufactured flaws did not initiate a steady-state matrix crack. This is the same observation made by Marshall and Evans<sup>21</sup> in their studies of the *in situ* failure behavior of a SiC/glass-ceramic composite. The best results were obtained by observing the

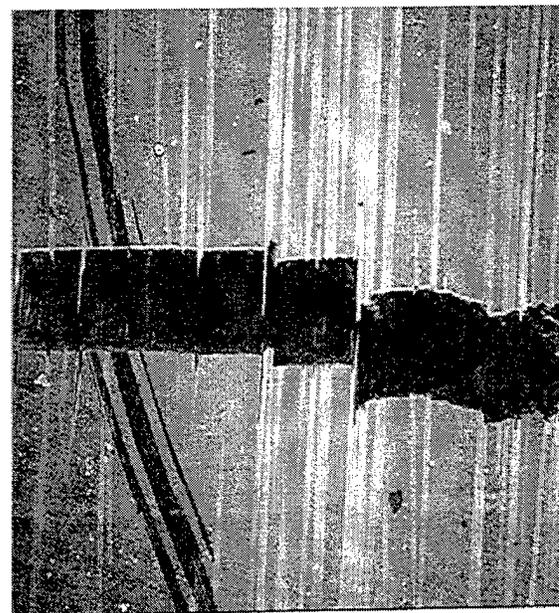
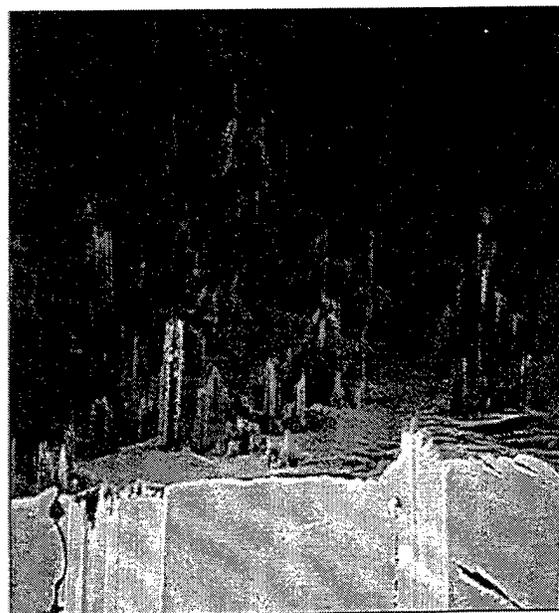
Fig. 2. Brittle fracture of composite heat-treated to 1100°C: (a) low magnification, (b) higher magnification revealing jagged filament fracture.

Figures 2(a) and (b) show the fracture surface of an E130 composite heat-treated to 1100°C. A single matrix crack has propagated through the entire width of the composite (perpendicular to the load direction), fracturing both matrix and fibers. Figure 2(b) reveals that rather than the crack propagating directly through the filaments, as was the case for other E-type fibers in this same matrix,<sup>12</sup> there is a high degree of crack deflection *within* the E130 filaments. Figure 3 shows a high-magnification micrograph of a deflected crack (moving from left to right) within a filament at a point where the crack has not yet opened appreciably. This energy-absorbing fracture path through the filaments very likely contributes to the higher strength utilization of these composites over that of other E-type fiber composites (Table I), all of which experienced planar brittle failure of the fibers and gave significantly lower strength utilizations, consistent with matrix-dominated failure, i.e., composite failure occurring at the failure strain of the matrix. For example, the E75 and E105 composites heat-treated to 1100°C both failed at about 0.1% strain, whereas the E130 composite failed at about 0.2%. The absolute difference, of course, is small, but, we believe, significant. Interface weakening may also play a role in the higher failure strain and FSU of the E130 composite. For example, Edie *et al.*<sup>22</sup> found that the interlaminar shear strengths of these same four fibers in an epoxy matrix decreased monotonically with increasing fiber modulus.

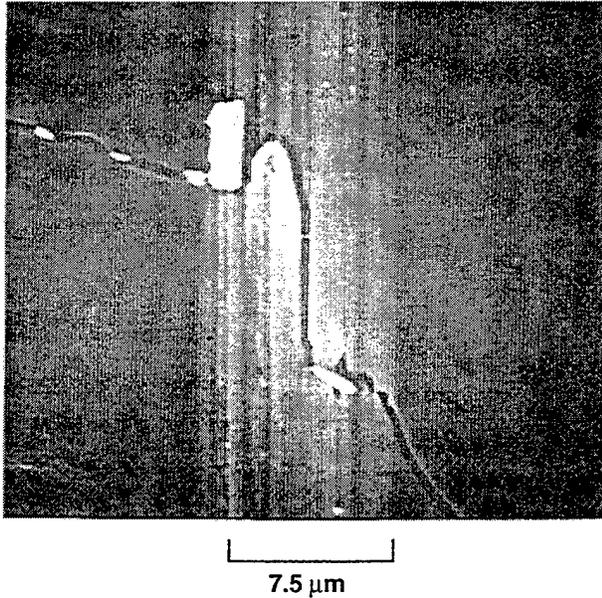
Fig. 3. View of crack propagation in E130 composite prior to crack opening revealing intrafilament crack deflection.

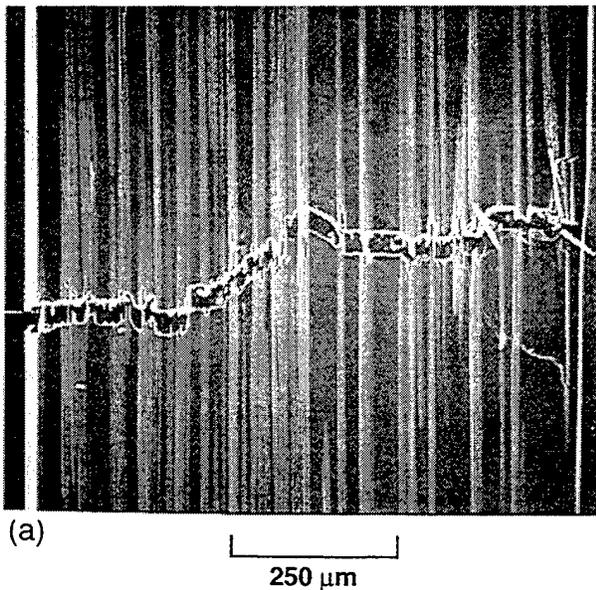
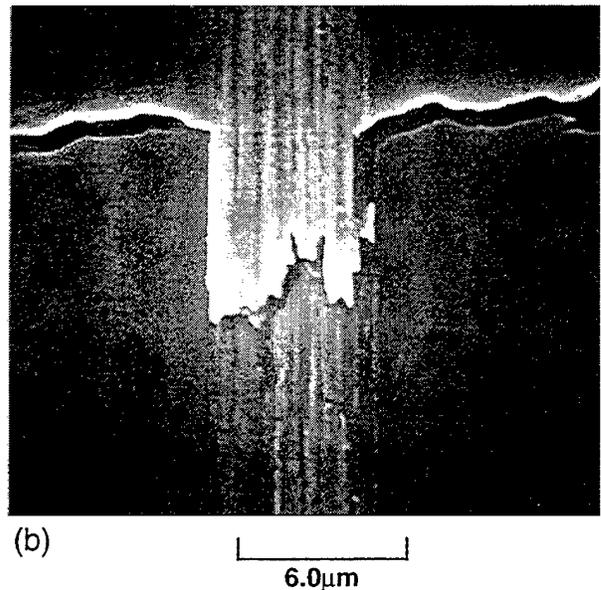
Fig. 4. Fracture behavior of E130 composite heat-treated to 1600°C exhibiting mixed mode failure: (a) low magnification, (b) higher magnification showing a filament break occurring about 6 mm from the matrix crack.

For a HTT of 1600°C, we observed a mixed-mode failure (Figs. 4(a) and (b)); i.e., there was a combination of matrix-induced fiber failure as well as some interfacial crack deflection consistent with some local weakening, or even possibly debonding, of the fiber-matrix interface with HTT. This is illustrated well in Fig. 4(b), where we see one fiber that has failed at a distance of about 6 mm from the primary matrix crack. This fracture mode allows some of the intact fibers to bridge the crack, contributing to crack-tip shielding and leading to higher fiber strength utilizations. (Note: FSU was not measured for the 1600°C HTT.)

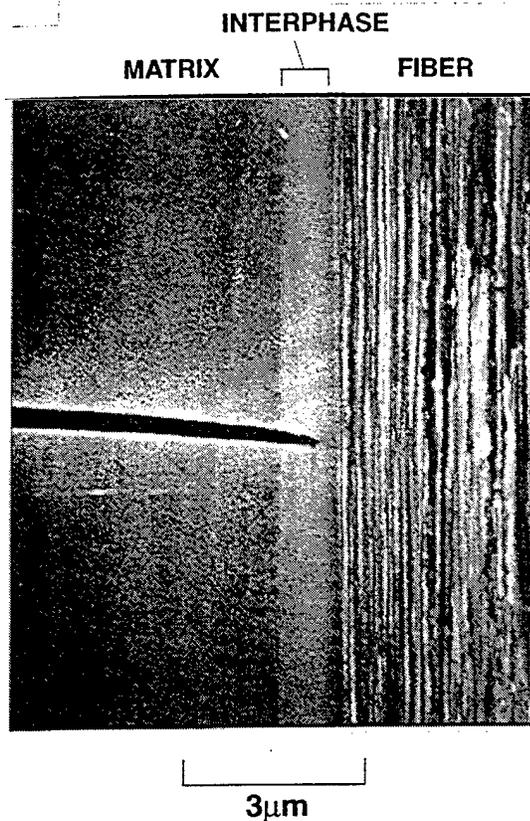
Fig. 5. High-magnification micrograph showing crack blunting in interfacial region of 2150°C heat-treated composite.

With heat treatment to 2150°C, we see the first clear evidence, at typical SEM magnifications, of a matrix interphase structure (Fig. 5). As discussed previously,<sup>20</sup> this interphase is a region of higher preferred orientation and enhanced crystalline development<sup>15</sup> as a consequence of matrix deformation during pyrolysis and carbonization. We have argued that the source of this deformation is the restraint of matrix shrinkage at the fiber surface resulting from attractive or frictional forces between fiber and matrix.<sup>20</sup> Independent measurements by TEM-selected area diffraction<sup>15</sup> of these same and similar composites have confirmed repeatedly that the zone of matrix around the fiber (from ~0.5 to 2.0 µm) is better graphitized and better oriented than the "bulk" matrix farther from the fibers. This is evident at HTTs as low as 1100°C.<sup>15</sup> For the case of the SEM of Fig. 5, the greater brightness of the sheath is most likely the result of its higher density,<sup>18</sup> which results in a higher electron emission. It is also possible that the contrast between interphase and "bulk" matrix is due to the differences in orientation. Also, because of the relatively low HTT of 2150°C, this matrix interphase "sheath"<sup>23</sup> structure is not well graphitized and, therefore, does not have the lamellar graphitic texture seen in the highly graphitized E130 fiber adjacent to it. This lamellar, or grooved, texture of etched graphite, as seen by standard secondary-electron images, is a consequence of topographic contrast. Whether due to ion bombardment or reactive etching, the less crystalline, more defective areas tend to erode more, leaving a topography of "hills and valleys."

and is almost indistinguishable from the graphitic E130 fiber (Fig. 9; compare to Fig. 5). Crack blunting at the graphitized matrix interphase sheath is also shown in Fig. 9. The high degree of orientation and lamellar graphitic structure of the sheath leads to significant delamination cracking in the sheath along the direction of the filament (Fig. 10). However, this intramatrix cohesive failure also reduces the load-carrying capabilities of the matrix. Figures 11(a-c) show the sequence of crack propagation through the 2400°C HTT sample. Note that the darker gray (and usually thicker) regions are nongraphitized, glassy-carbon-type matrix, whereas the sheath structure appears lighter gray like the fiber for the reasons discussed earlier. The extent of orientation and graphitization of the sheath region varies greatly over the length of the composite. The fracture path through the matrix is significantly more tortu-

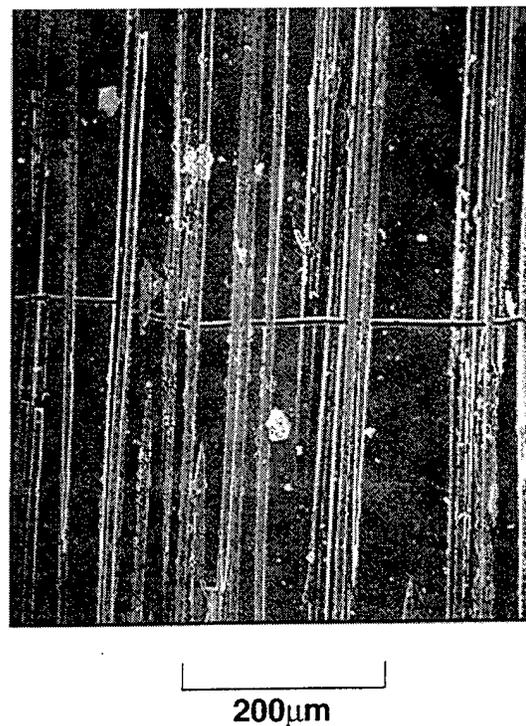
Fig. 6. Matrix crack bridged by intact fibers (2150°C HTT).

this interphase. With further straining, a single matrix crack is formed that traverses the composite, deflecting around the fibers and bridged by intact fibers (Fig. 6). Additional straining of the composite causes the formation of periodic matrix cracks, which divide the composite into blocks of matrix held together by intact fibers. This is shown in the lower magnification photo of Fig. 7, in which the composite is seen in the center of the photo embedded in the epoxy resin matrix.

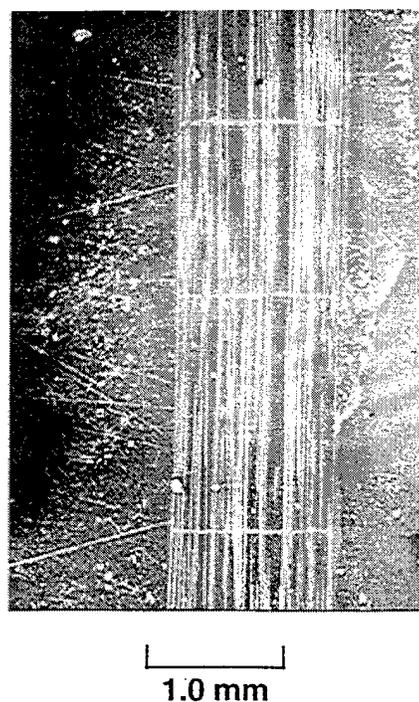
Fig. 7. Multiple matrix cracks formed in 2150°C heat-treated composite.

with heatup and cooldown from these high HTT, as well as by the formation of the well-oriented, graphitized interphase, a subject that we have discussed in detail elsewhere.<sup>19,20</sup> As Fig. 7 reveals, MMC occurs in the 2150°C HTT sample at some point prior to fiber failure. The average spacing of the cracks is about 1 mm. According to Aveston, Cooper, and Kelly,<sup>24</sup> the limiting crack separation in a brittle-matrix composite is between  $x'$  and  $2x'$  where

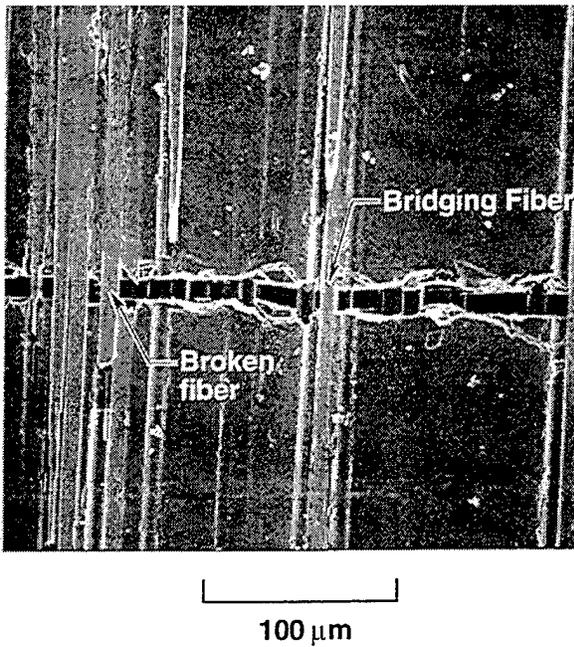
Fig. 8. Matrix slippage over bridging fibers in 2150°C heat-treated composite.

It has been suggested to us by one of the reviewers that the crack-opening displacement seen in Fig. 8 is about 50% of the size of the gaps between the two broken filaments seen on the left of the photo, suggesting significant residual stresses in the fiber; this leads to the question of the role of the epoxy polymer mount in limiting or controlling the damage to the composite. There is little question that the epoxy mount controls the degree of damage, and, in fact, this is one of the reasons for its use. Without it, the cracks would probably move too quickly to follow. But we do not believe the nature of the crack behavior is affected; rather, the mount allows us to gain greater sensitivity and control over what is otherwise a relatively insensitive flexure stage.

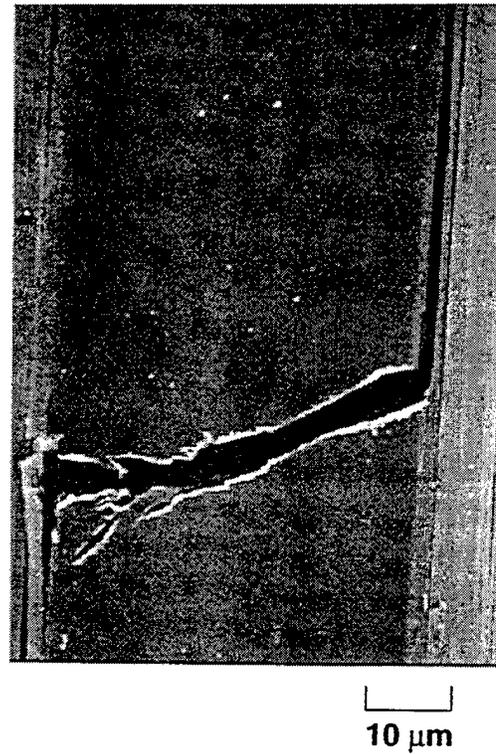
Fig. 10. Short-range longitudinal intramatrix splitting in 2400°C heat-treated composite.

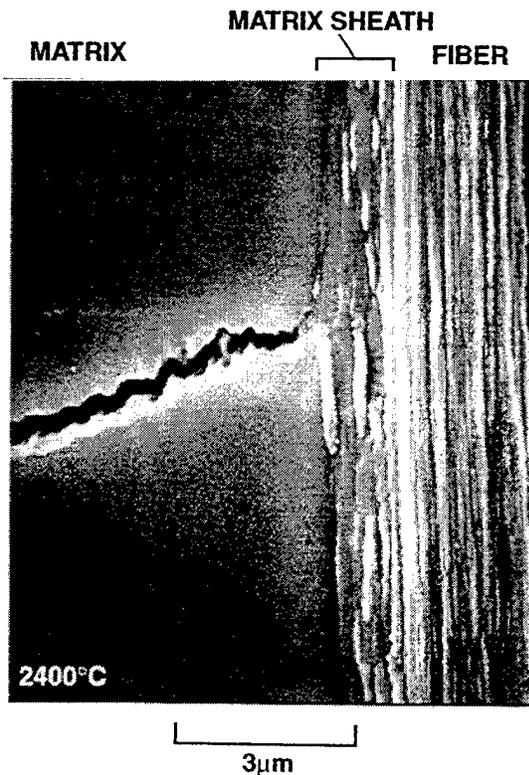
Fig. 9. High-magnification micrograph showing crack blunting at graphitized matrix sheath structure in 2400°C heat-treated composite.

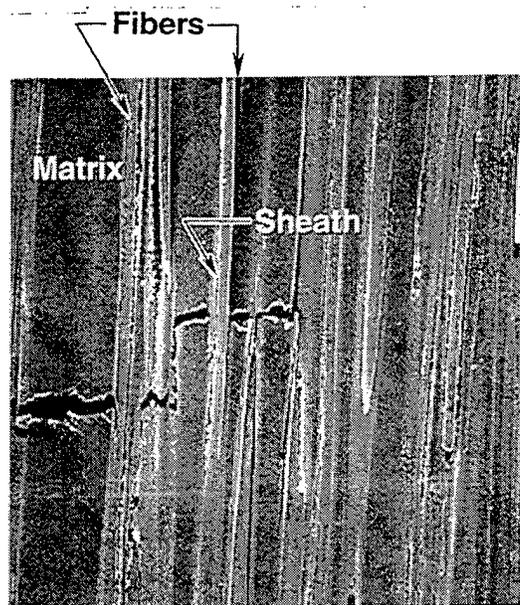
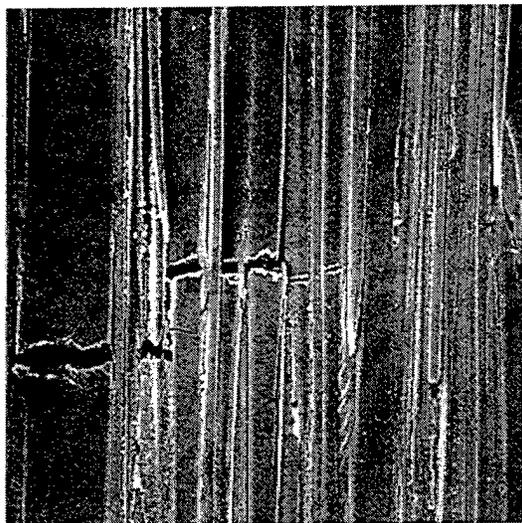
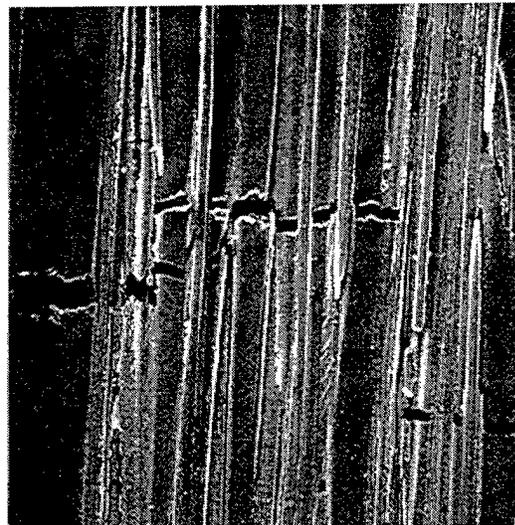
Fig. 11. Crack propagation through a 2400°C heat-treated composite at three levels of strain increasing from (a) to (c). The graphitized sheath appears light gray in the micrographs in comparison to the darker gray less oriented and graphitized matrix regions.

ous than for the 2150°C HTT composite. Although some cracks are deflected at the sheath, crack deflection occurs primarily at the interface between graphitized sheath (i.e., interphase) and fiber. Relative to the lower HTT specimens, a much smaller degree of deflection is required to open the crack. By the time the crack has traversed the composite, the crack opening is quite substantial. The development of this well-oriented and graphitized sheath no doubt facilitates the frictional sliding of the fiber. Figure 12 is a higher-magnification view of a crack showing well-defined regions of nongraphitized matrix, graphitized matrix sheath, and fiber. Note the extensive debonding between fiber and matrix.

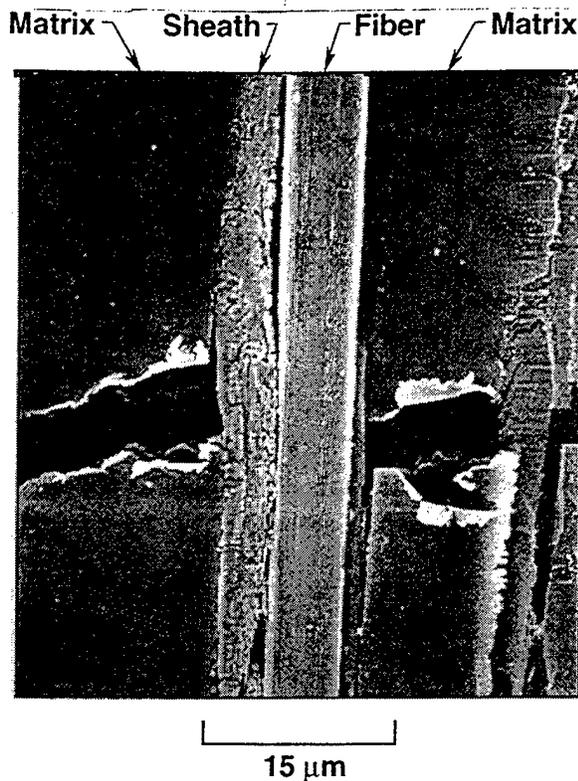
Fig. 12. Crack zone showing well-defined regions of nongraphitized matrix, graphitized sheath, and fiber in 2400°C heat-treated composite.

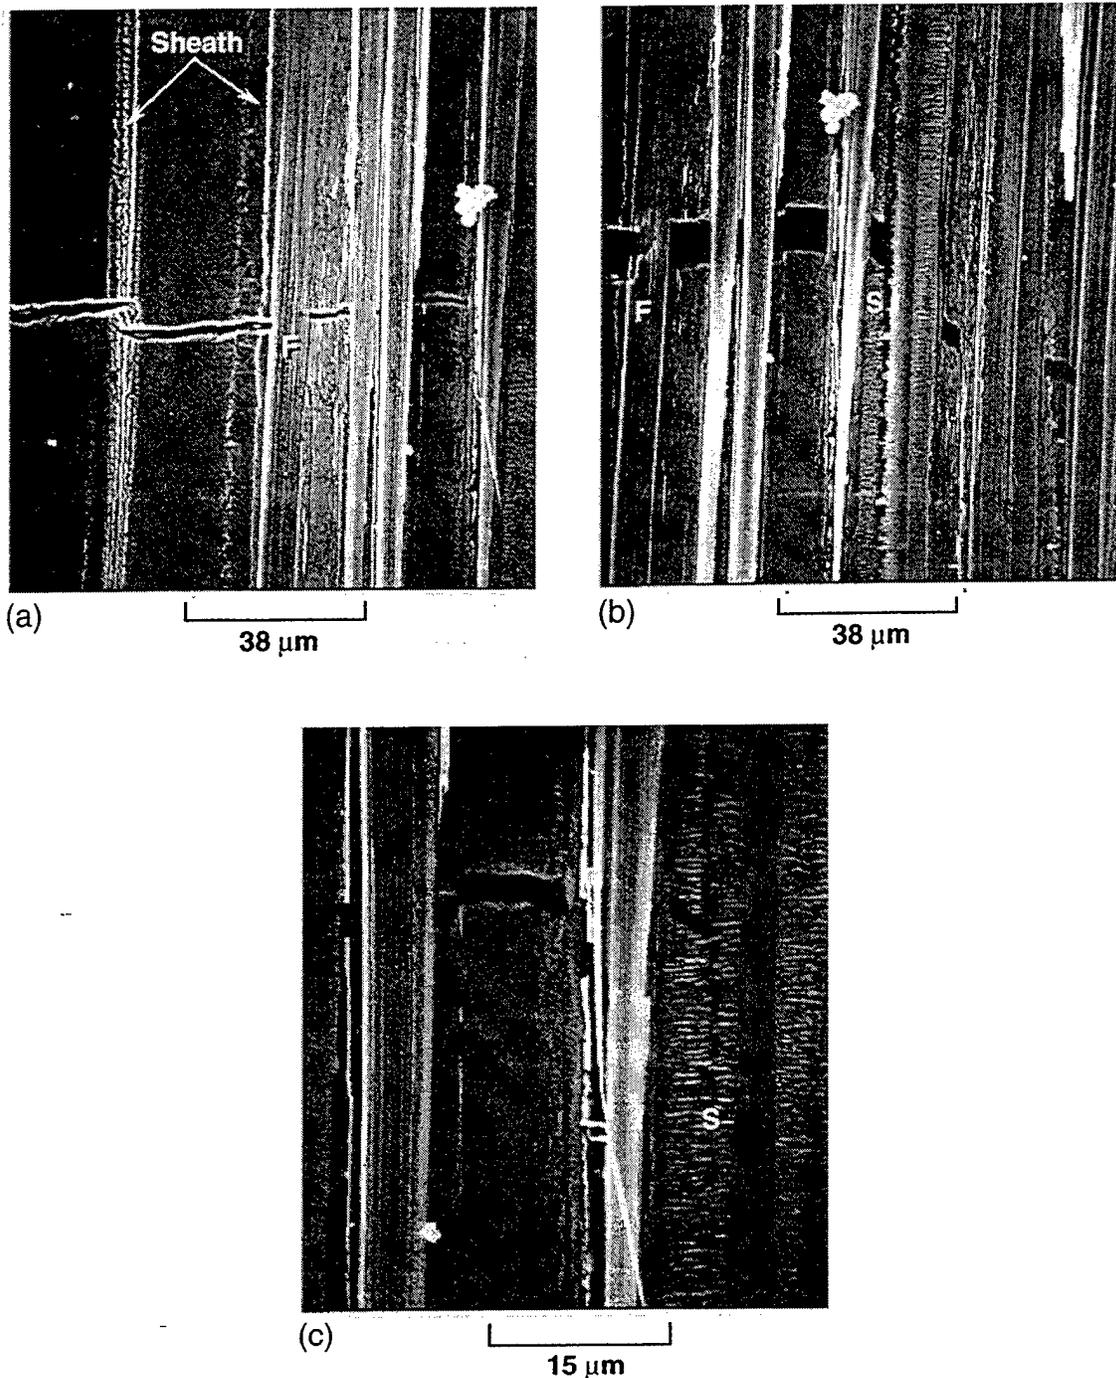
Fig. 13. Crack propagation through a 2750°C heat-treated composite at two different degrees of strain, (a) and (b); (c) is a higher magnification view of (b) at a slightly lower degree of strain.

Following the highest HTT of 2750°C, the development of the graphitized sheath interphase is very extensive along the length of the interfacial region. Figures 13(a) and (b) show a

sequence of two micrographs of the composite as it is strained. As the crack propagates across the width of the composite, it is first deflected around a zone of sheath (left side of Fig. 13(a)). The fiber associated with this sheath has been removed by polishing. The crack then becomes blunted at the fiber F after it passes through a second sheath. Further straining (Fig. 13(b)) leads to partial fracture of the filament F and extensive longitudinal splitting of the matrix sheath region labeled S. Note the saw-toothed structure of the fractured sheath, seen best (better?) in the higher magnification view of Fig. 13(c). At this point, the intramatrix cohesive failure of the sheath is very extensive, leading to a decoupling of the surrounding matrix from the fibers. From Table I we see that the FSU has fallen to its lowest value of 42%. In addition to the very weak coupling between fiber and matrix for this HTT, in the previous study, we also found evidence of fiber degradation resulting from the C/C processing.<sup>12</sup>

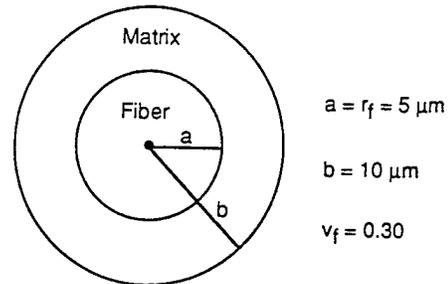
For the above fiber–matrix configuration, we calculate the thermal stresses due to matrix shrinkage on heatup. We use the equations of stress states of a solid rod and a hollow cylinder subject to normal pressure (external for rod and internal for cylinder) as outlined in Timoshenko and Goodier.<sup>37</sup> From our discussion in the text, we use
