**TECHNICAL REPORT  
NATICK/TR-02/017**

# **EVALUATION OF COMMERCIAL NONSTICK COATINGS FOR U.S. ARMY FIELD-FEEDING COOKWARE**

June 2002

**U.S. Army Soldier and Biological Chemical Command  
Soldier Systems Center  
Natick, Massachusetts 01760-5018**

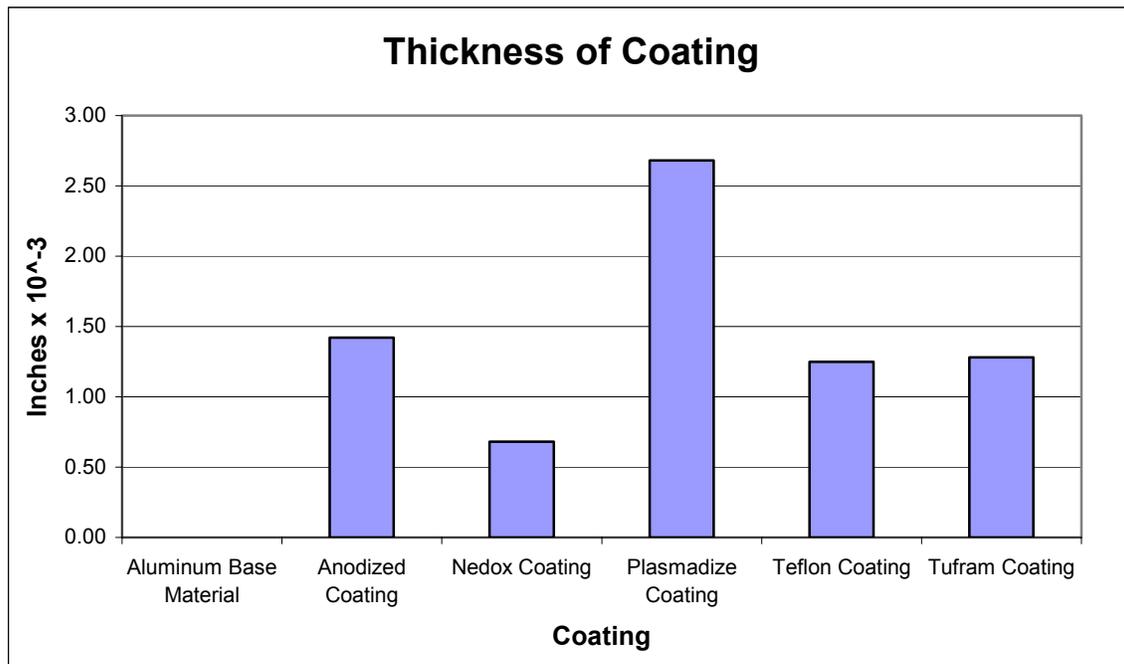
**Figure 1. Thickness of Coating Materials**

Coating thickness is measured by viewing a cross-section of the material under a microscope according to ASTM B487-85. The thickness of a coating is important for several reasons. A thin coating may have excellent hardness and wear properties but may not endure because of the lack of material. Very thick coatings, however, can disturb the tolerances of a part. The thickness of a coating also affects its strength, what was originally plane strain can become complicated by plane stress. The thickness also determines the type of hardness test that must be performed; each test's indenter is rated for a different thickness.

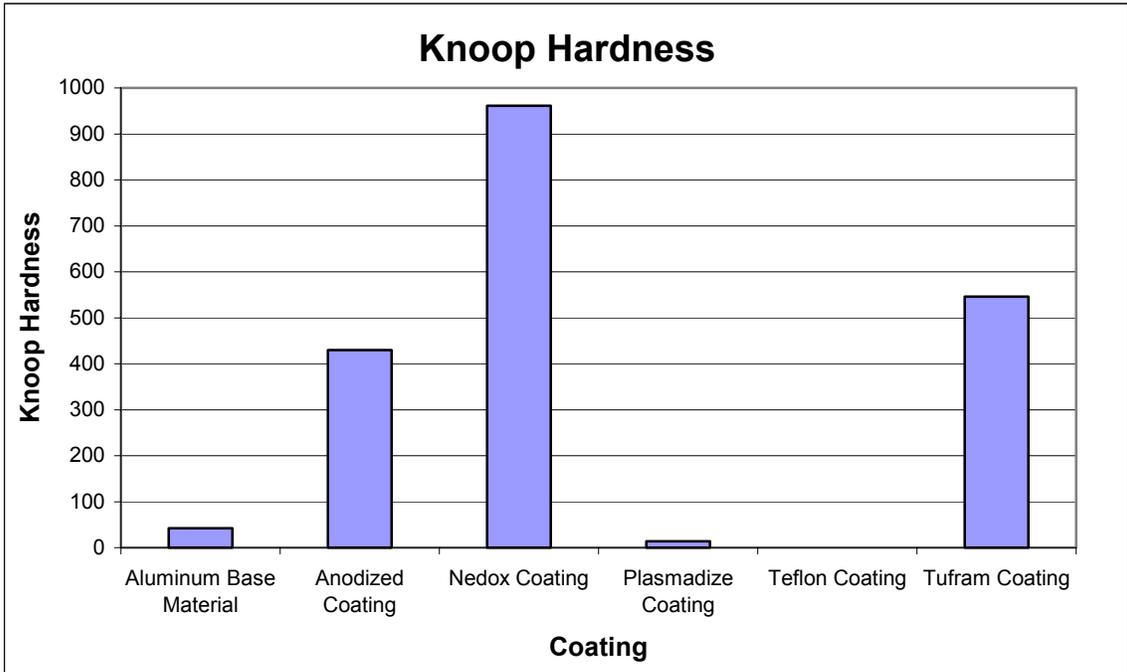
**Figure 2. Knoop Hardness**

Knoop hardness is a method of measuring a material's hardness by its resistance to indentation. The method uses a precision diamond indenter and loads between 1 and 1000 grams force. The size of the impression is measured with a microscope according to ASTM E18-94 and ASTM B578-87.

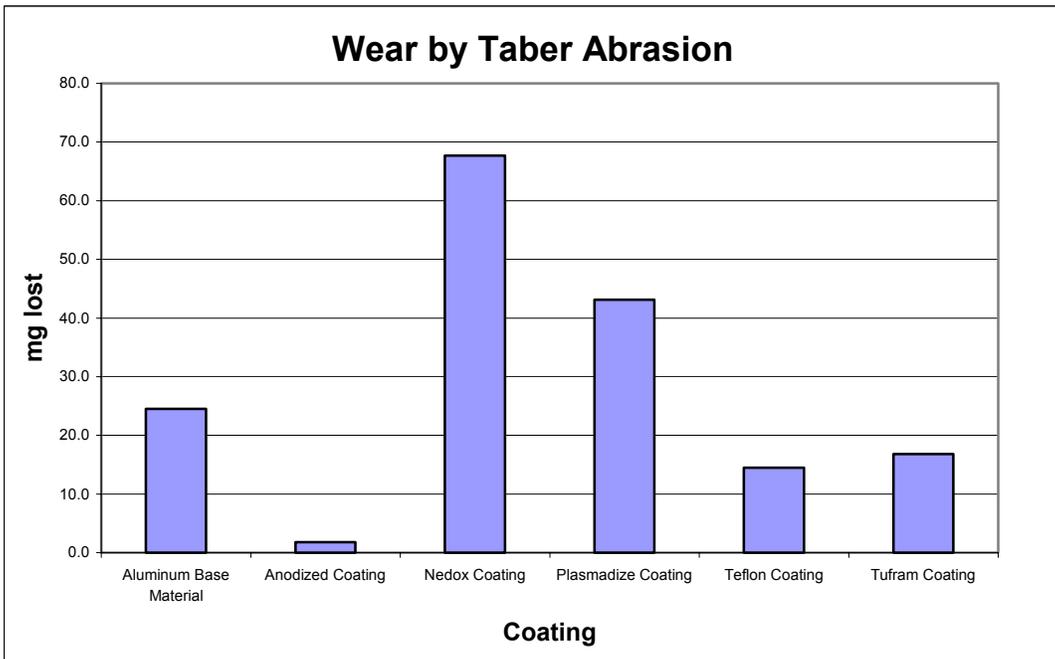
**Figure 3. Taber Abrasion**

Taber abrasion measures a material's resistance to wear by measuring the amount of material scraped off a flat surface subjected to an abrasive rotating disk. The disk is rotated for 1000 cycles under a 1000g weight according to ASTM B137-95 and IAW Fed-Std-141.1.

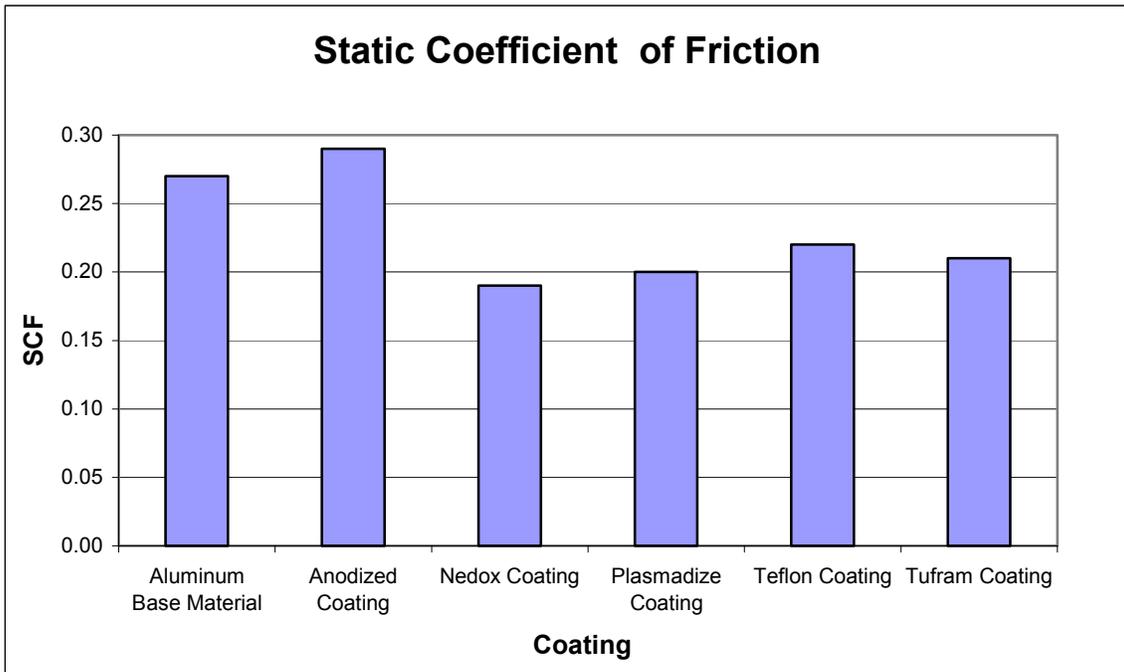
**Figure 4. Static COF**

The coefficient of friction is a dimensionless parameter that determines how slippery a surface is. ASTM D1894-95 gives guidelines for determining both the static and kinetic friction coefficients. The force required to slide stainless steel across the coating is measured. General Magnaplate's coating friction data is shown in Table 1. While a low friction coefficient does not necessarily mean that a surface is nonstick because food can adhere to a surface at the microscopic level, rendering the friction coefficient unimportant, the friction coefficient is involved with non-stick on the macro level and can be an indicator as to the coating's non-stick properties.

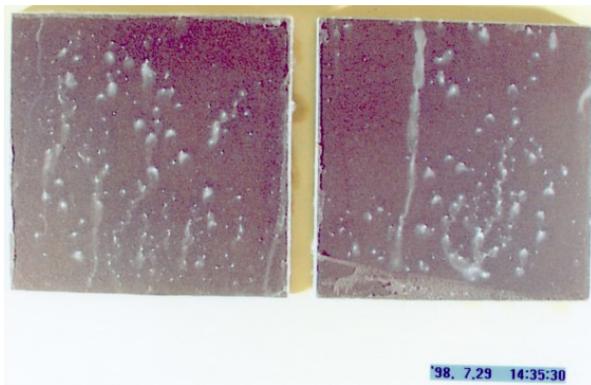
**Figure 10. Teflon® after Salt Spray**

All other samples, including Teflon®, corroded noticeably. The Teflon® coating exhibits sites where salt migrated through the coating and began to corrode the base metal.

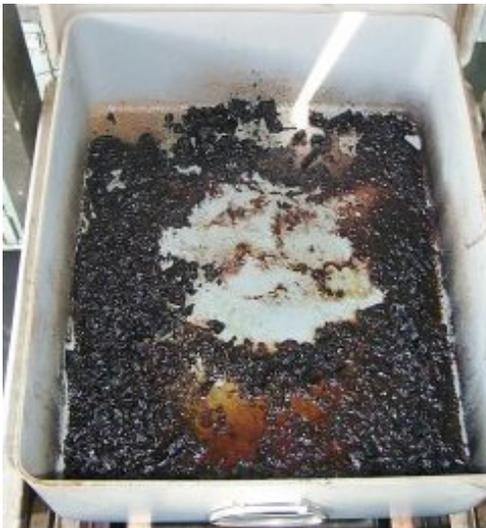
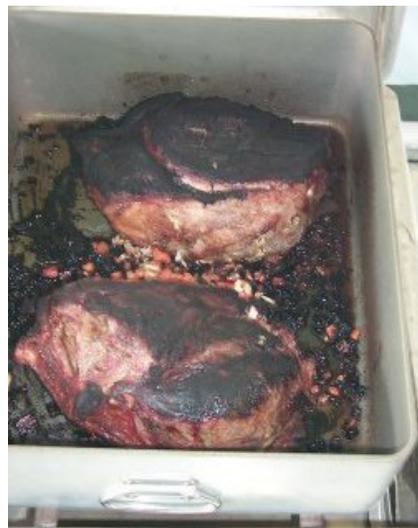
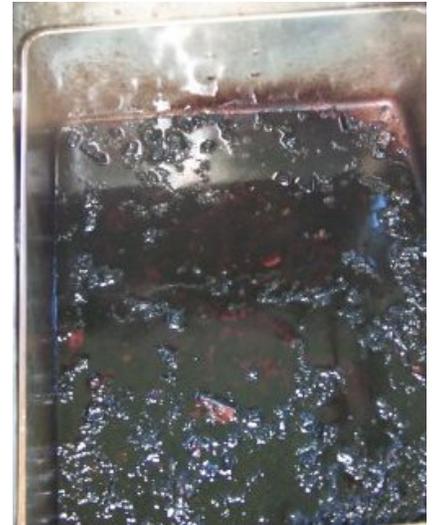
**Figure 15. Food burned on Plasmadize®**

**Figure 16. Food burned on Teflon®**

**Figure 17. Food burned on Teflon® with water added**

Figure 12-Figure 20 depict the results of Meal 1 with the pans starting brand new. Figure 15, Figure 16, and Figure 17 show the aftermath of cooking roasts. The Teflon® in Figure 16 had a handicap; the carrots and onions were added too early, so they ended up burning and becoming charred. The sugars became mixed with juices from the beef to form a layer of sticky carbon on the bottom of the pan. In other cases, such as the

Plasmadize® in Figure 15 this sugary mix had the effect of leaving the carbon layer covering almost the whole bottom of the pan with the exception of where the roasts had been. After cooking was complete, each pan was pre-washed by adding water directly to the hot pan as shown in Figure 17. This pretreatment dissolved much of the carbon immediately, allowing for easier cleaning and sanitizing. Whether or not this practice is performed in the field is unclear, but most cooks should know it is a reliable way to remove burned food from pans. The pre-wash did not influence longevity data on the coating because any damage to the coating had already taken place. Though it could be argued that pre-washing, which allows for slightly easier cleaning, would reduce the necessity to scrape the pans. At any rate, the procedure was carried out identically for each pan. Figures 18-20 show the condition of the pans after the pre-wash. Comparing Figure 19 and Figure 20, it can be seen that a significant portion of the carbon remained stuck to the uncoated pan versus the Teflon®, while almost none stuck to the Plasmadize® in Figure 18. The Plasmadize® was, however, significantly stained by these carbon deposits.

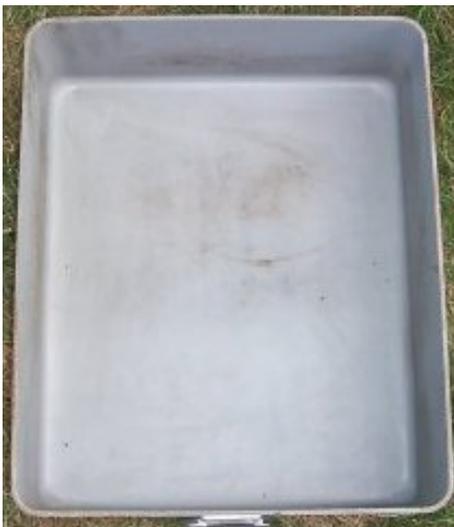
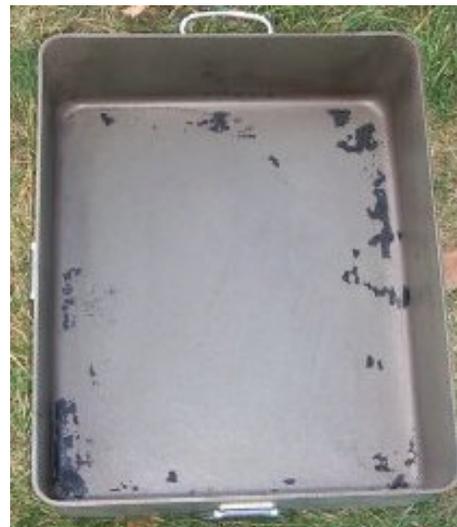
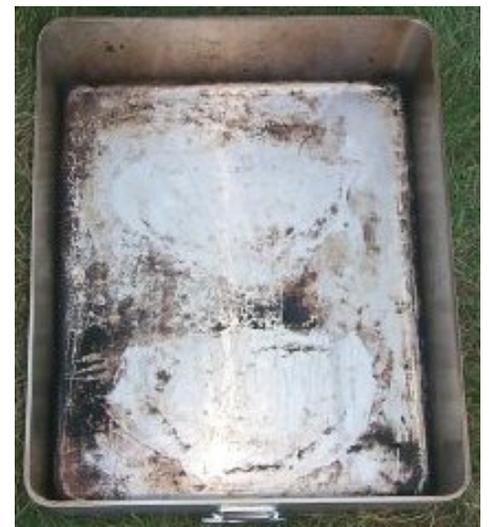
**Figure 18. Plasmadize® (R), pre-washed**

**Figure 19. Teflon®, pre washed**

**Figure 20. Uncoated, pre-washed**

The cleaning and sanitizing process was performed manually, per field regulations. The hands on nature had the added benefit of allowing us to subjectively gauge which coating exhibited the best release properties. After Meal 1, cleaning the Plasmadize® coating was very easy. No food stuck to the pan and only a small layer of grease had to be washed off. The stains could not be removed from the coating. There was no evidence of peeling, or cracking of the coating but some evidence of slight pitting. These pits were hard to document with the camera used so a description will have to suffice. The pitting action was not the same as experienced in Figure 8. Plasmadize® after Salt Spray, rather these were small craters that seemed to form without the migration of metal through the coating. It is not clear if this was due to a loss in coating material, a collapse or denting of the base material under the coating or pores in the base metal that were simply filled by the coating during the coating process.

The Teflon® coating was also easy to clean. There were some solids loosely stuck to the coating but a soft sponge was enough to release them. There were no stains, but some discoloration was observed. There was no evidence of peeling, pitting or cracking of the coating.

The uncoated pan was very difficult to clean. The surface was firmly coated with carbon deposits from burned food. Some of carbon became impregnated in pits in the metal and could not be removed at all. It took significantly more time and effort to clean this pan

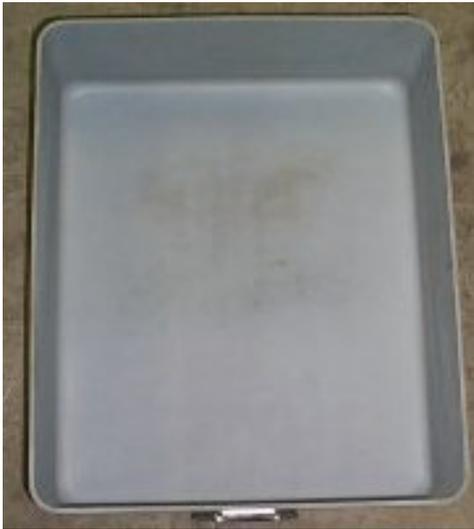
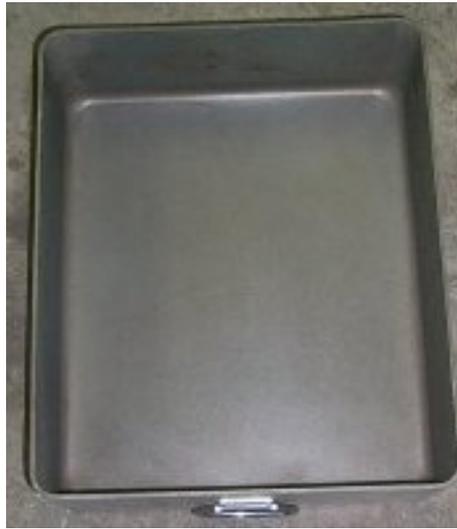
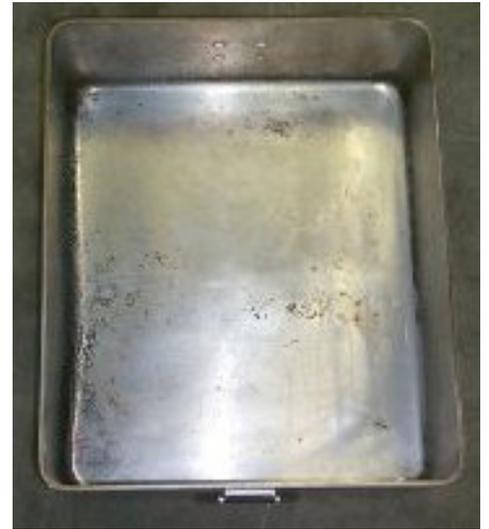
**Figure 21. Plasmadize® initial condition**

**Figure 22. Teflon® initial condition**

**Figure 23. Uncoated initial condition**

Figure 21, Figure 22 and Figure 23 show initial condition of the pans. It is clear the pans did not become completely clean from the prior meal, particularly the Plasmadize® and uncoated pan. The black spots in Figure 23 indicate carbon deposits embedded in pores of the aluminum. In a field situation, a soldier would be told to scrape the pan with hard steel wool or a steel mesh pad until the metal shined. This scraping procedure was not followed because the coatings should not be intentionally scratched and it was important to the results use the same technique on each of the pans. The Plasmadize® pan is showing significant discoloration and evidence of forming pits.

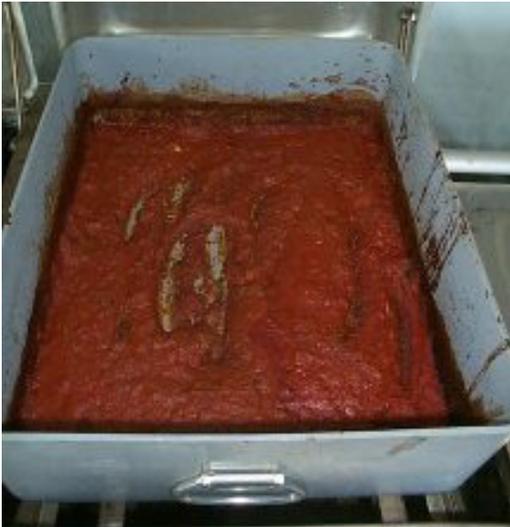
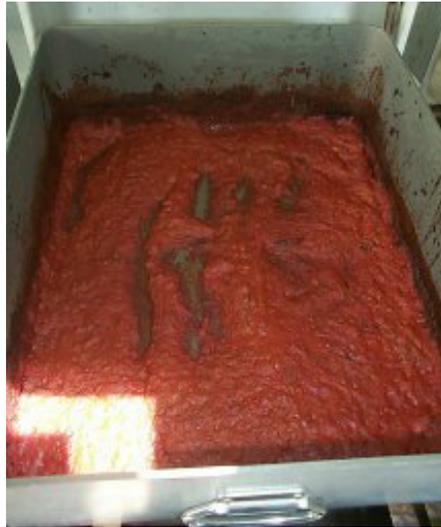
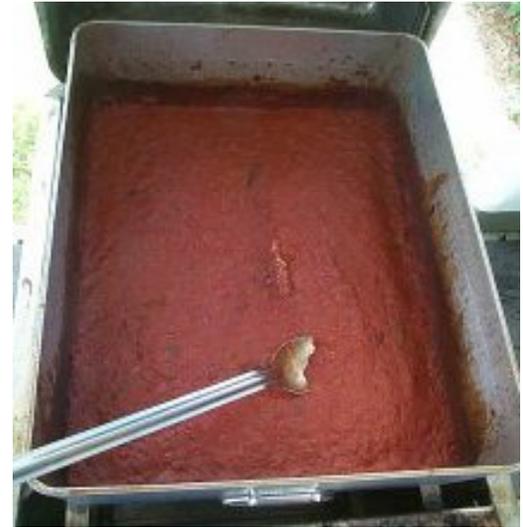
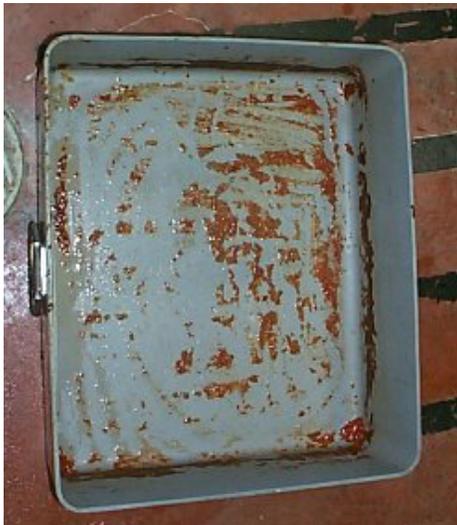
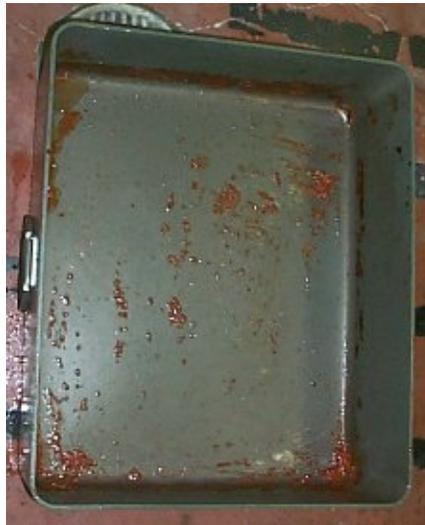
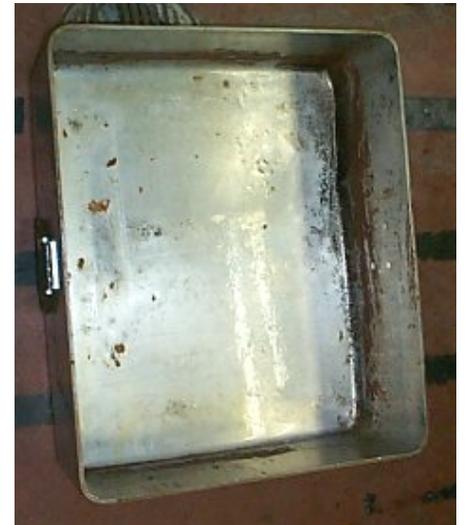
**Figure 24. Plasmadize® w/ baked on sauce**

**Figure 25. Teflon® w/ baked on sauce**

**Figure 26. Uncoated w/ baked on sauce**

**Figure 27. Gently rinsed Plasmadize®**

**Figure 28. Gently rinsed Teflon®**

**Figure 29. Gently rinsed uncoated**

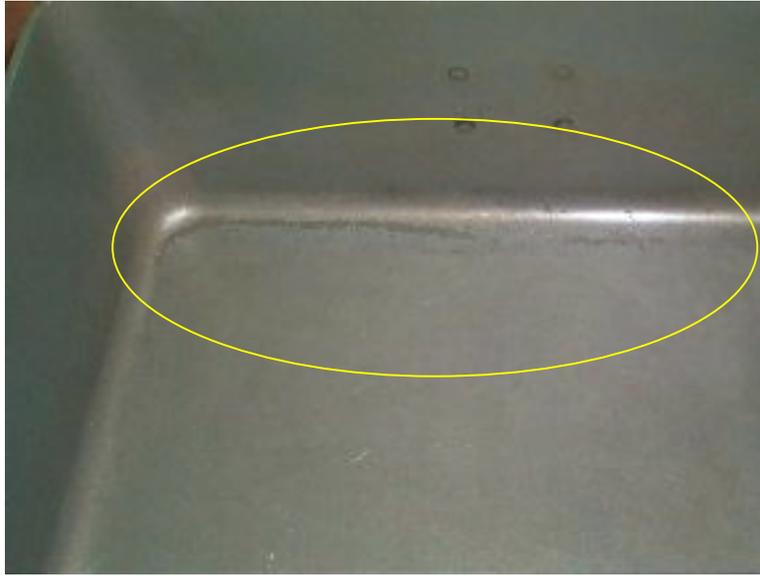
**Figure 30. Teflon® peeling away at the corners and fillets**

It was following this test that the Teflon® was observed peeling away from the corners (Figure 30). It cannot be determined whether this was related to stirring with a metal utensil, the attack of the hot tomato sauce or scrubbing action. It is anticipated all of these factors may have played a part. Instead of ending the test at this point, another meal was planned to observe the effects of the peeling and whether or not the condition would worsen.

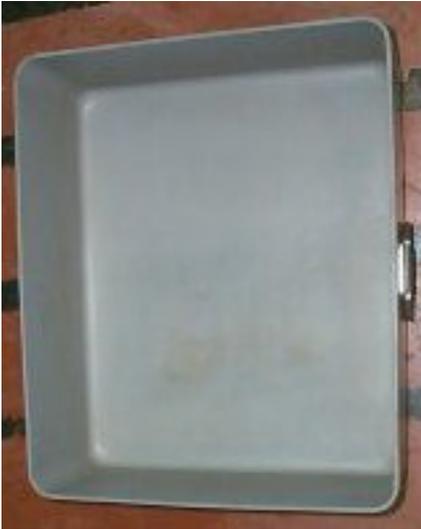
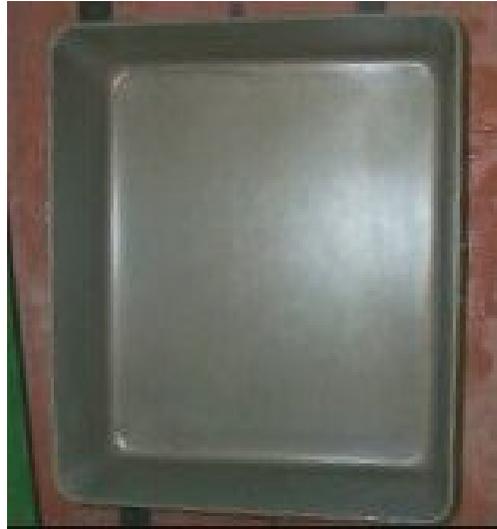
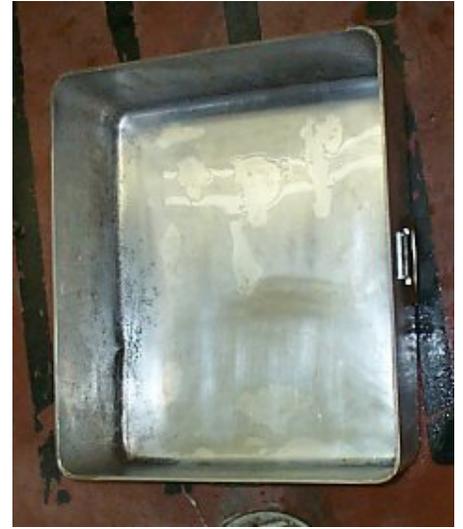
Figure 31. Plasmadize® initial condition

Figure 32. Teflon® initial condition

Figure 33. Uncoated initial condition

The third meal consisted of chili con carne, also a food known to be high in fats and acids. Figure 31-Figure 39 show results for this meal. Figure 31-Figure 33 show that though the pans are clean, the Plasmadize® coating is still stained, the Teflon® coating is peeling in the corners and the uncoated pan has almost irremovable carbon deposits.

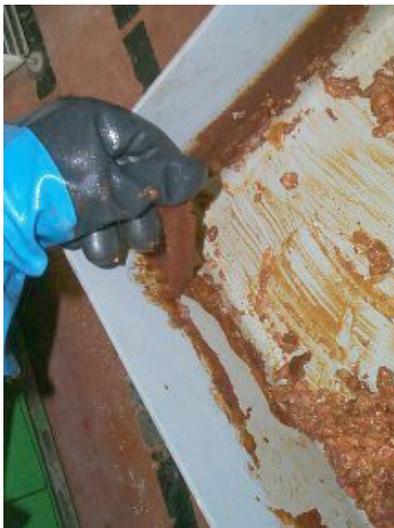
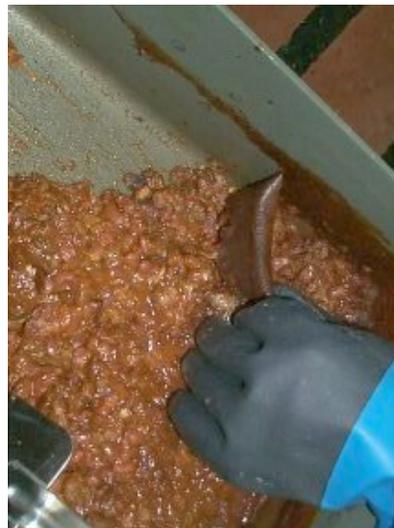
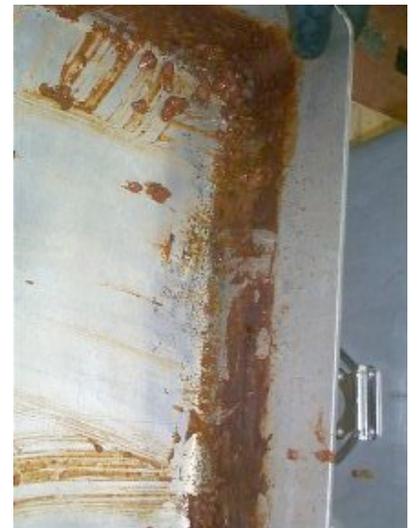
Figure 34. Congealed food peels off

Figure 35. Congealed food lifts off

Figure 36. Food is stuck on

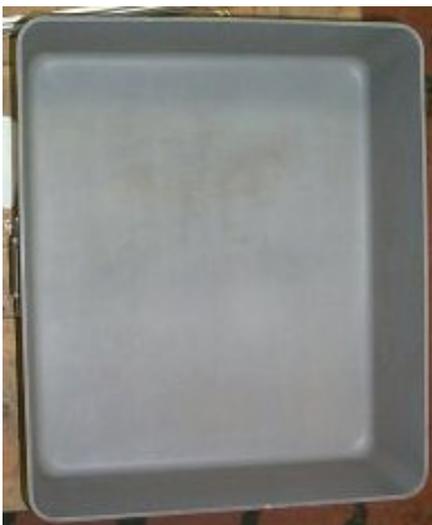
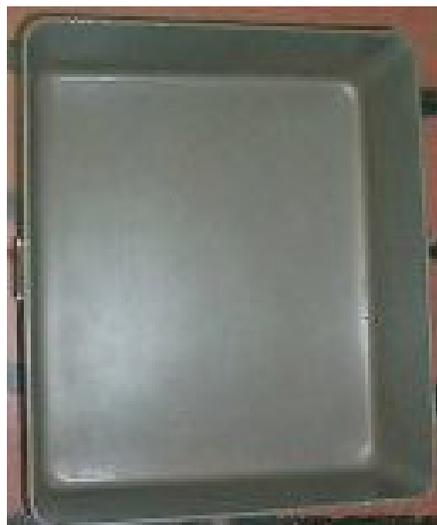
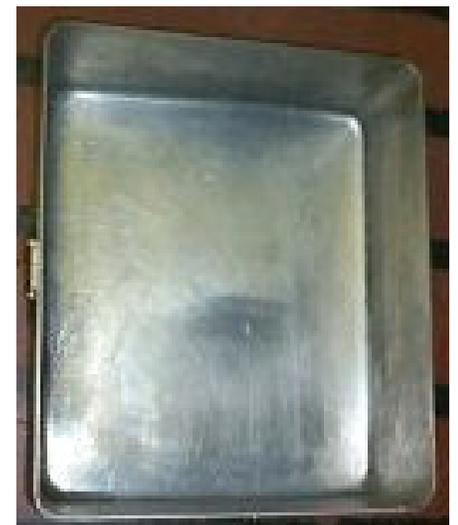
Figure 37. Cleaned Plasmadize®

Figure 38. Cleaned Teflon®

Figure 39. Cleaned uncoated

Figure 37 and Figure 39 show the pans after cleaning; The Teflon® and Plasmadize® pans were effortless to clean. On the uncoated pan, chili residue was stubbornly fused to the sidewalls and took significantly more time and effort to remove. Figure 38 shows that enough time and effort were eventually spent on the pan over the three cleanings to remove most of the burned on food from the first meal.
