NSWCCD-61-TR-2001/21

November 2001

Survivability, Structures, and Materials Directorate
Technical Report

Development of Innovative Nondestructive Evaluation Technologies for the Inspection of Cracking and Corrosion Under Coatings

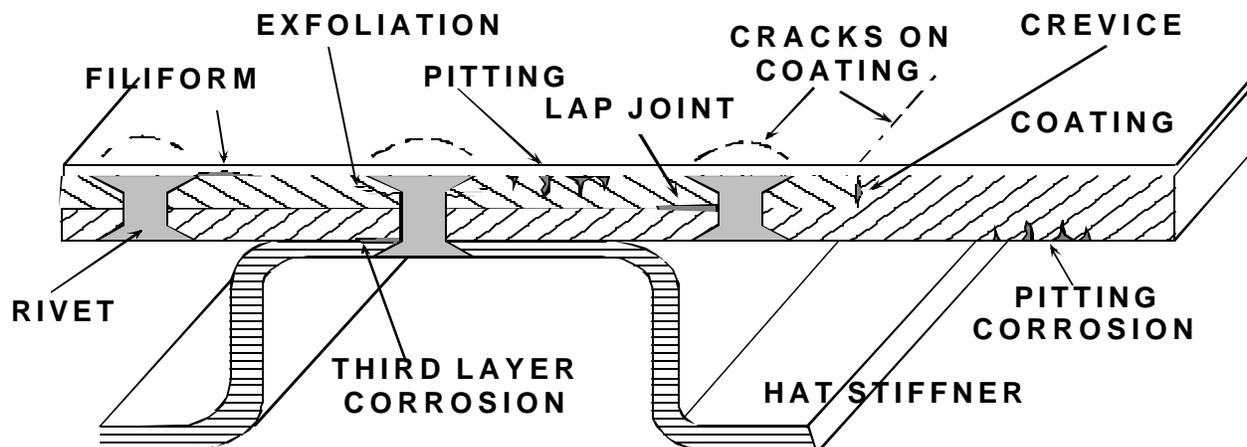
Figure 1. The various types of corrosion that can be found on a typical riveted structure.

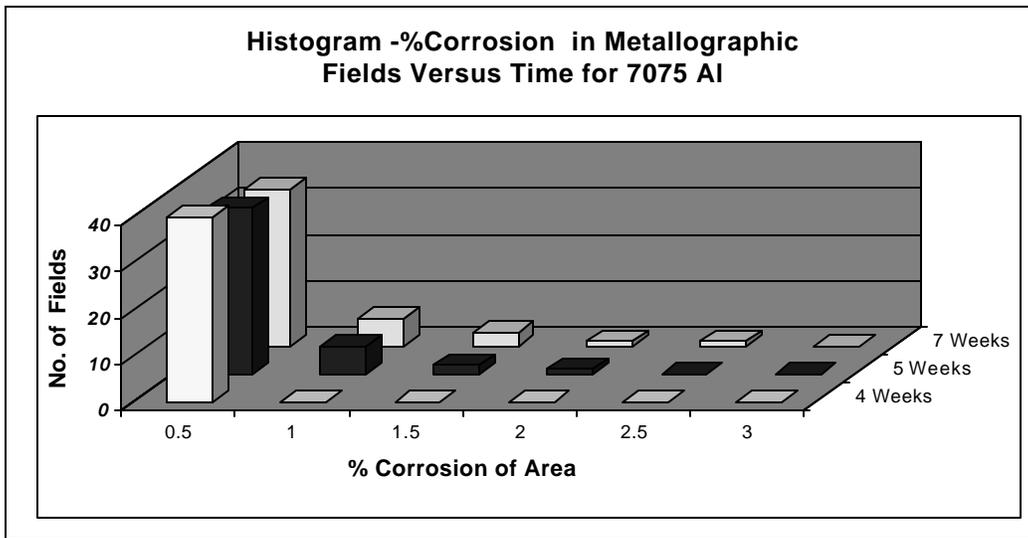
Figure 3. Corrosion severity versus number of fields in the sample versus time.

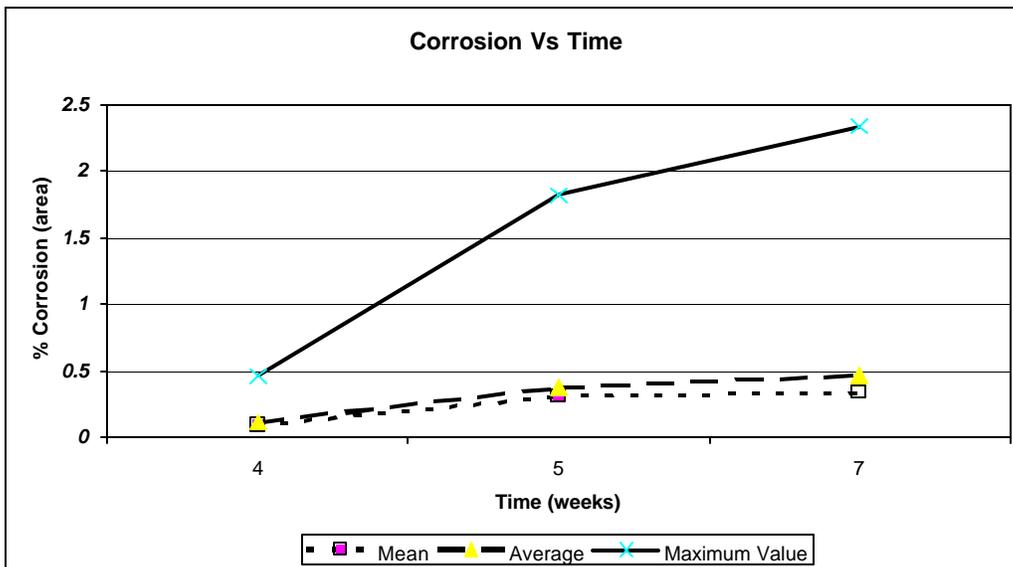
Figure 4. Percent corrosion (area loss) versus time (weeks) in a salt fog environment for 7075 T6 aluminum sheet.

The study of the growth rate of the pits with regard to mean, average, and maximum value clearly demonstrated the formation of small numbers of larger pits as time progressed. The average corrosion severity (% area loss), as calculated, increased only slowly while the maximum corrosion severity increased at a much greater rate as the smaller number of pits grew rapidly. See Figure 4 for clarification.

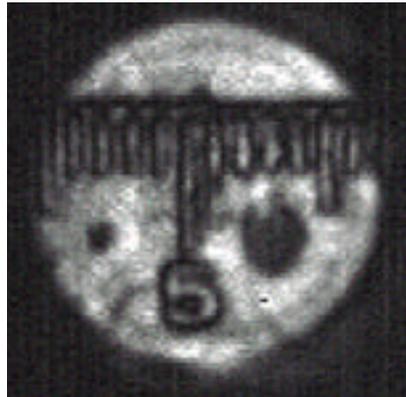
Figure 7. Through transmission real-time ultrasound image of a plastic millimeter scale.

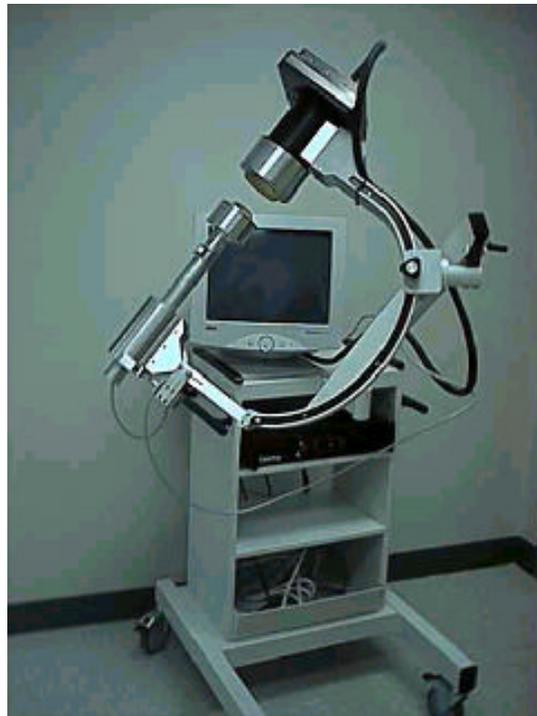
Figure 9. Acoustocam through transmission real-time ultrasound imaging system in C-shaped frame.

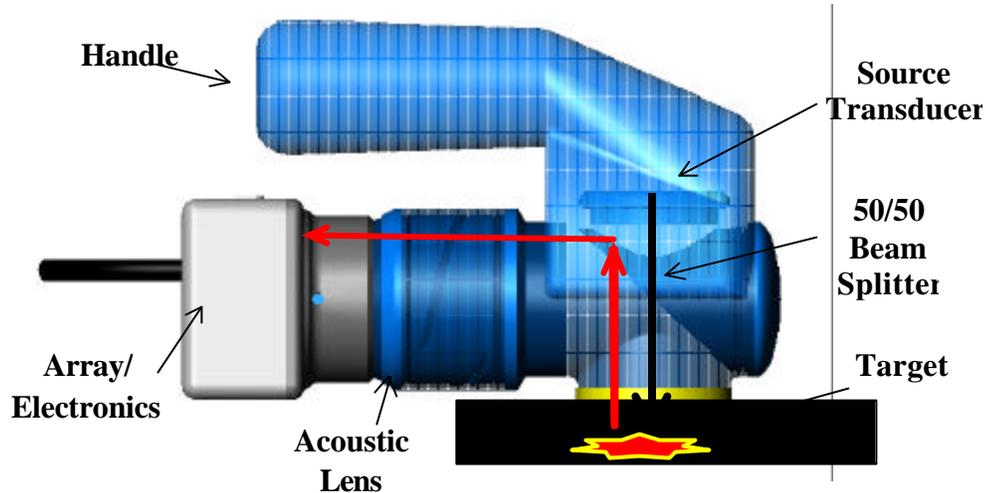
Figure 13. Schematic of re-designed beam splitter reflection camera.

During the course of the SERDP program many changes were made to advance the technology for real-time reflection ultrasound imaging. The electronics necessary to operate the beam splitter Acoustocam reflection camera shrank from a large rack mount panel to a package the size of a pack of playing cards mounted on the end of the unit. Changes in lens design helped to achieve higher resolution and changes in the beam splitter panel increased the clarity and strength of the received signal. A schematic of the re-designed beam splitter Acoustocam reflection camera is shown in Figure 13.

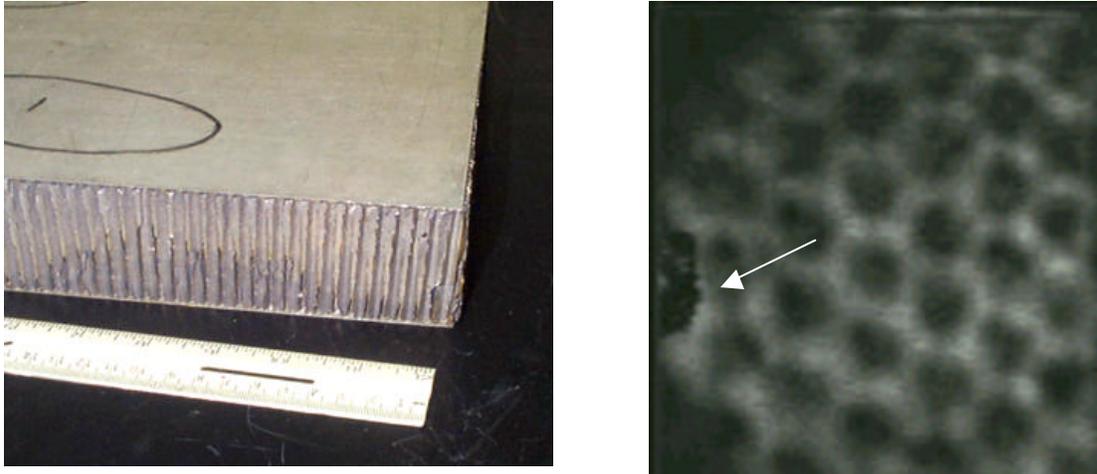
Figure 14. Honeycomb sample (left) and debonding (right) that has occurred within the sample as detected using the reflection Acoustocam system.

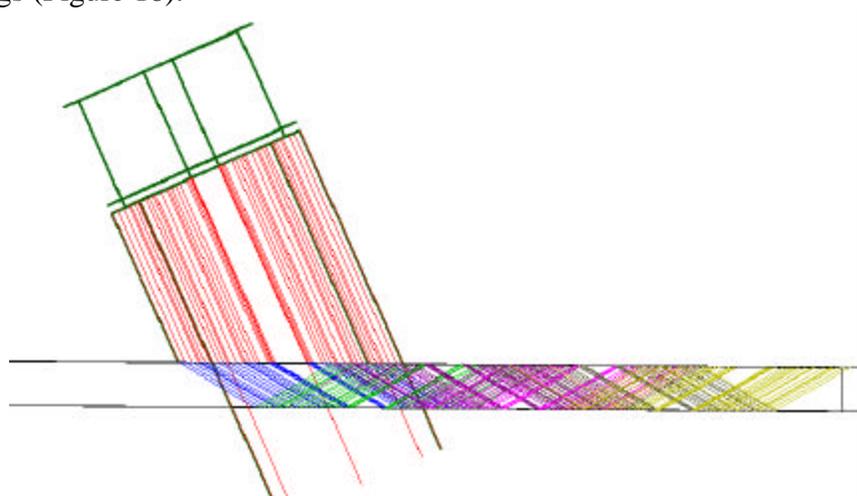
Figure 15. Modeling was used to examine the beam inside a plate during one side inspection using the oblique angle reflection method.

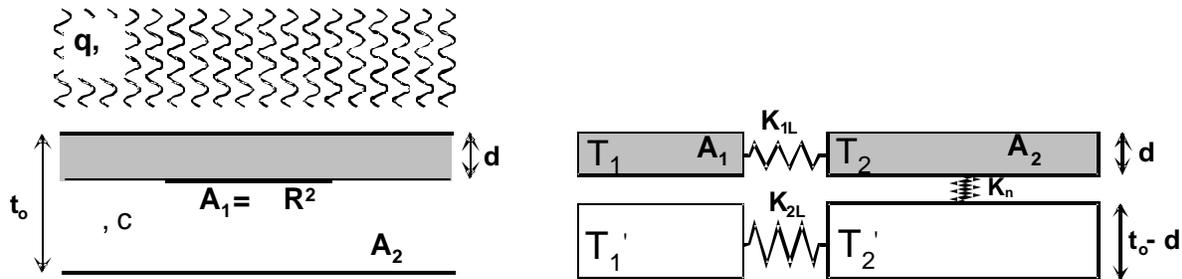
Figure 20. This figure shows the building blocks of the simple calorimetric model. Two different materials with different density and specific heat comprise the panel.

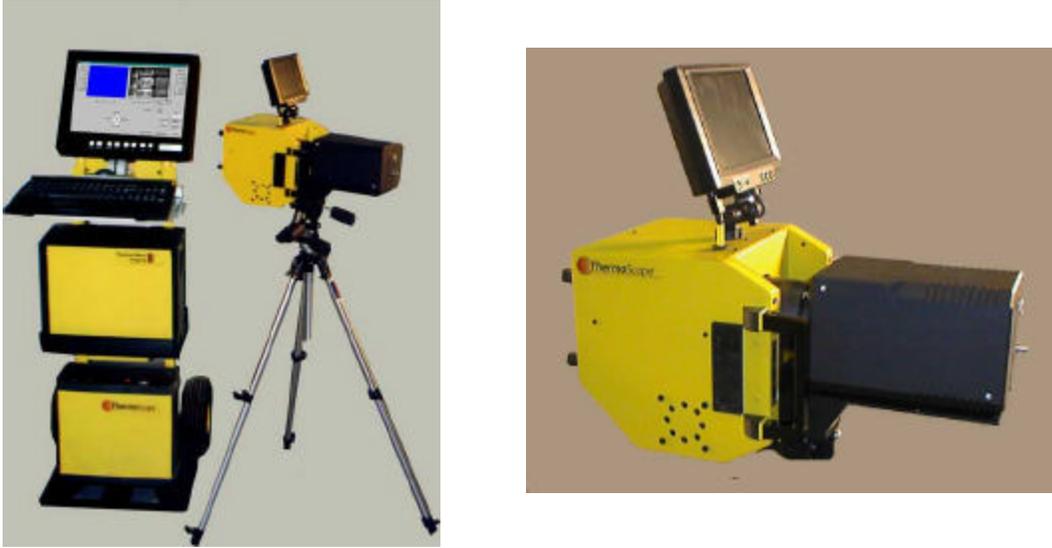
Figure 23. Thermographic inspection system developed by Thermal Wave Imaging, Inc.

Thermal Wave Imaging completed the development of an advanced portable thermographic imaging system with Navy SBIR Phase II funding. A photo of the complete system is shown in Figure 23. The system has many advantages compared with previous generations including, improved lateral resolution, controls that are accessible from the camera head, an LCD display panel located on the camera head, lighter weight, and the system allows for single operator use. In addition, Thermal Wave Imaging developed sophisticated software with automatic detection, segmentation, and classification algorithms for corrosion inspection. Improvements were also made in the data processing, functionality, and storage capabilities of the thermographic system. The advanced portable thermographic imaging system was used in the SERDP program to evaluate the use of thermal imaging for the detection of hidden corrosion and fatigue cracks.

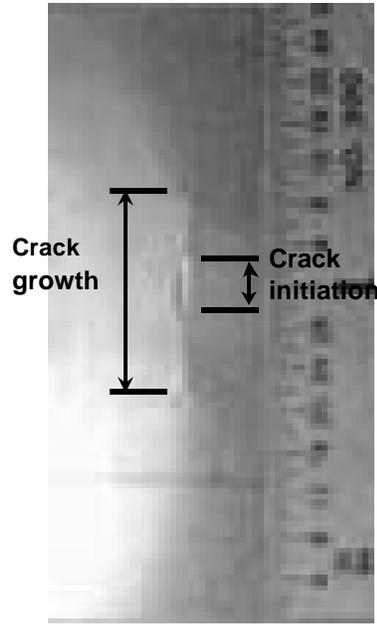
Figure 24. Aluminum panel with a fatigue crack in the center.

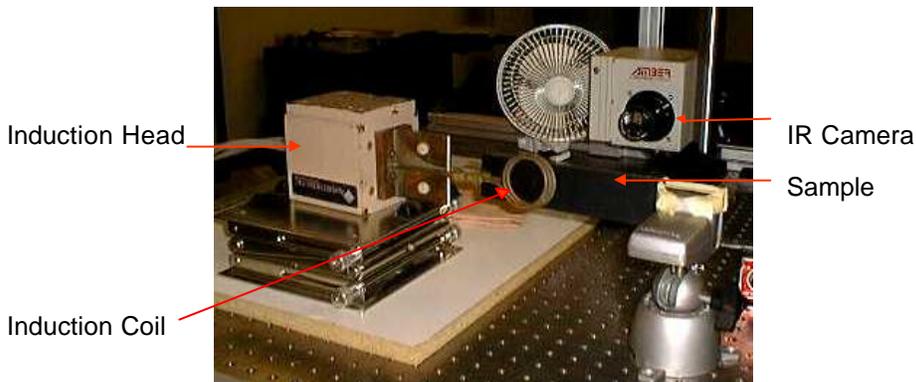
Figure 25. Experimental setup for the inductive heating excitation method of thermal imaging.

Figure 25 shows the experimental setup used for the inductive heating method of thermographic imaging. The key component is the induction head and the induction coil at the center of the photograph (the power supply is not shown). The induction coil consisted of two loops of thin wall copper tube through which water flowed for cooling purposes. A typical thermographic image of the fatigue crack specimen as acquired using inductive heating is shown in Figure 26.

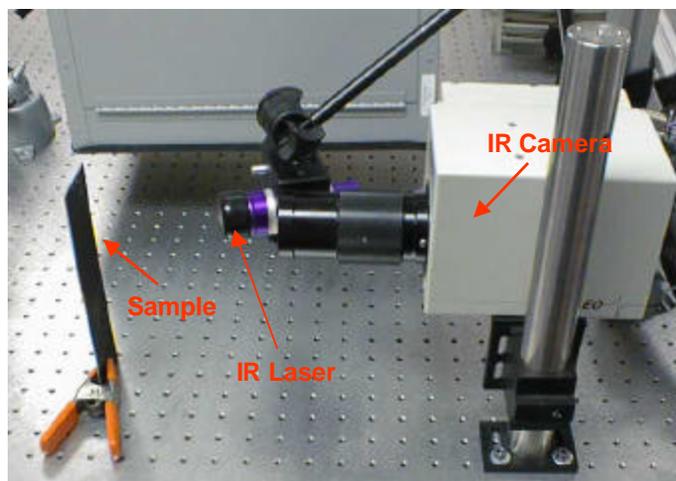
Figure 27. Experimental setup for laser diode heating excitation method of thermal imaging.

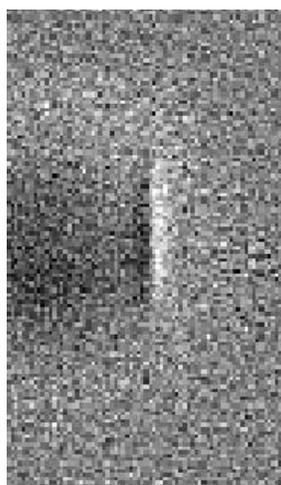
Figure 28. Thermal contrast generated across the fatigue crack by laser diode excitation.

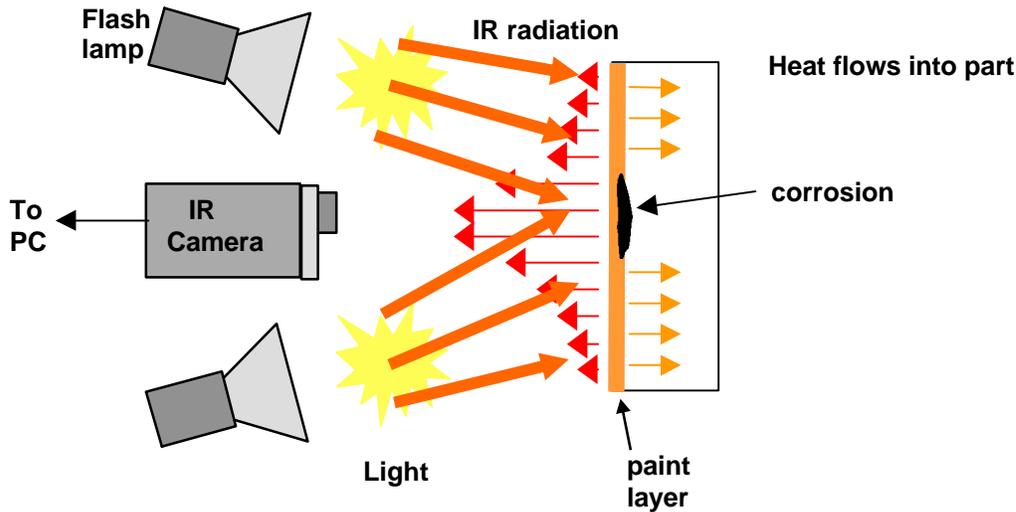
Figure 29. Schematic diagram of the experimental setup for pulse thermography.

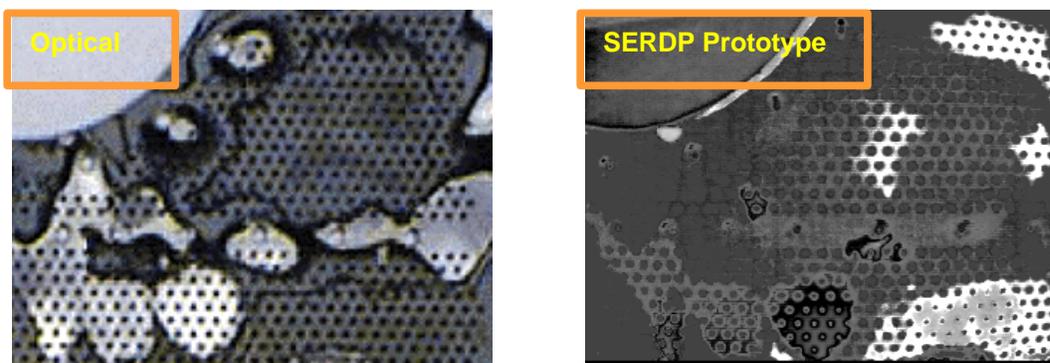
Figure 30. The image on the left shows an optical photograph of an F-18 intake panel in which areas of previously detected corrosion have been ground out. The panel was discolored and had numerous stains. The white areas observed in the thermographic image on the right show regions where corrosion was detected under paint using an optimized pulse thermography system (3 kJ flash energy, 6 oz. uncooled camera, optimized signal processing).

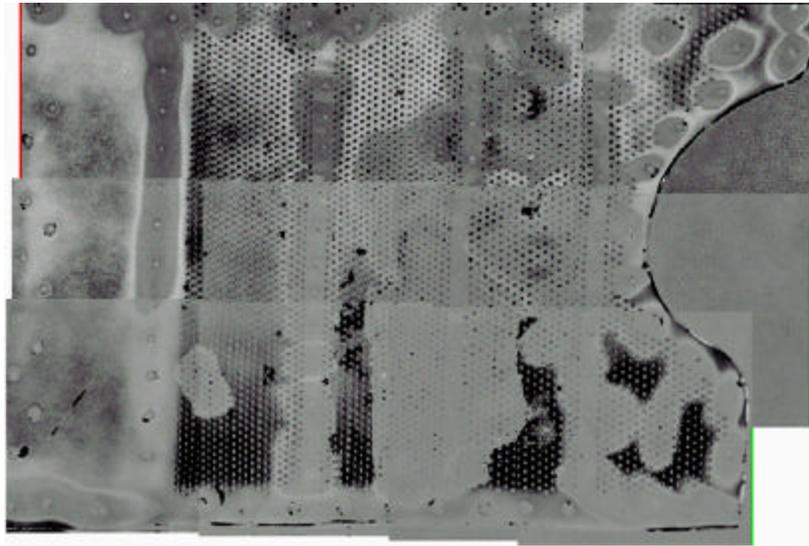
Figure 31. Large composite thermographic image of F-18 intake panel created from 8 smaller individual images.

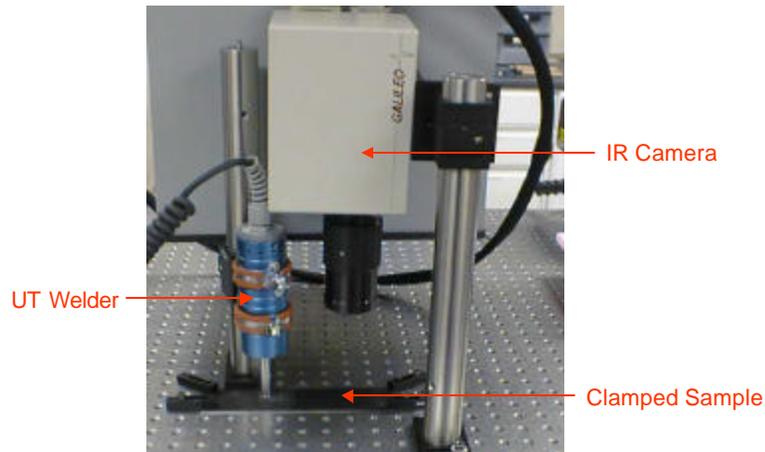
Figure 32. Experimental setup for the sonic excitation method of thermal imaging.

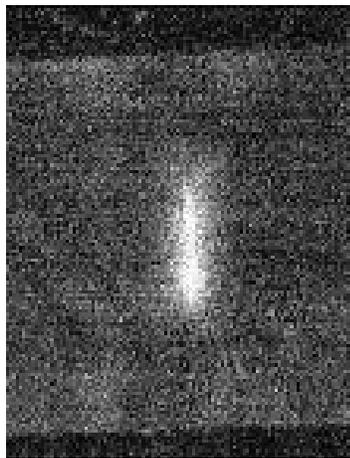
Figure 33. Thermal contrast generated on the fatigue crack specimen by sonic excitation.

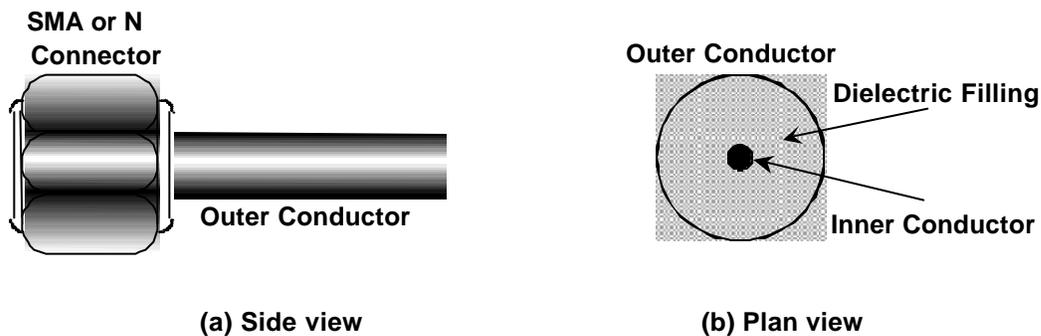
Figure 34. Schematic drawing of open-ended coaxial microwave probe.

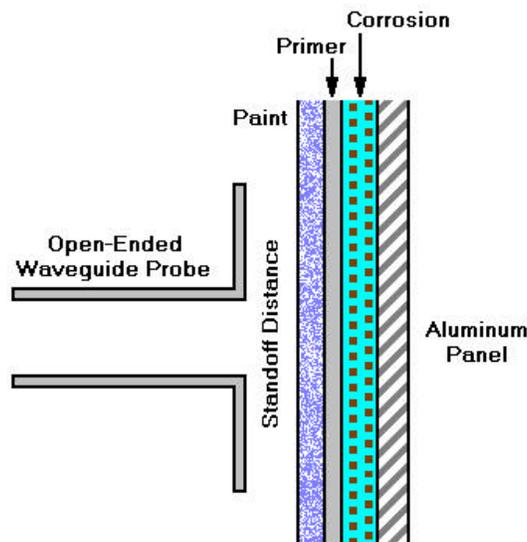
Figure 35. Schematic of open-ended rectangular waveguide used for detecting fatigue cracks and corrosion under paint.

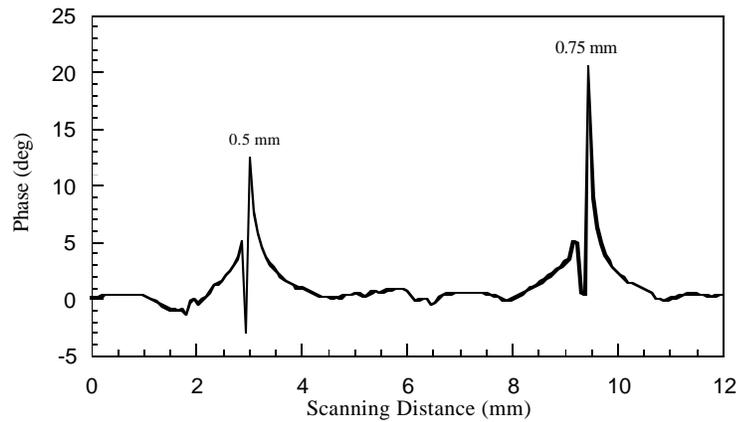
Figure 36. Crack characteristic signal at 11.3 GHz for a slot with a width of ~ 0.200 mm and with different depths, coax inner radius of 0.5 mm and outer radius of 1.5 mm.

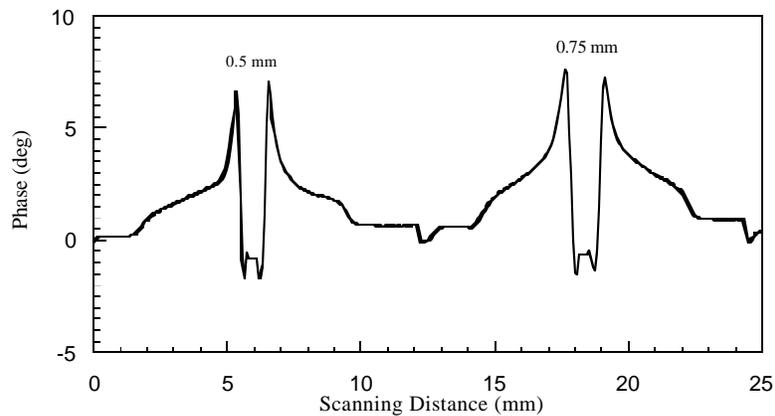
Figure 37. Crack characteristic signal at 11.3 GHz for a slot with a width of ~ 0.200 mm and with different depths, coax inner radius of 1.0 mm and outer radius of 4.0 mm.

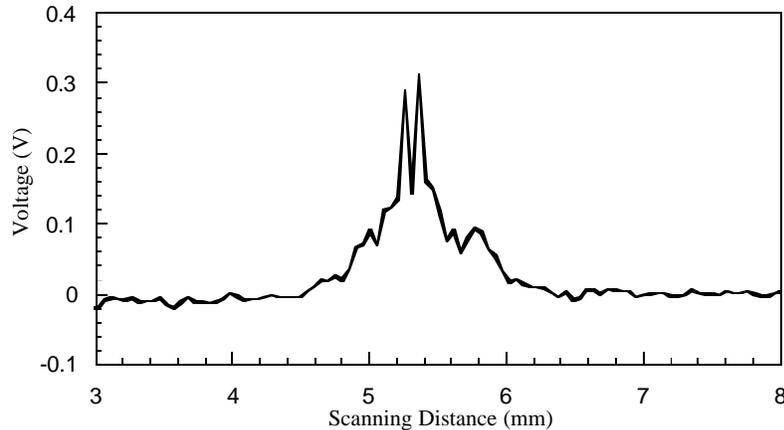
Figure 38. Crack characteristic signal for a fatigue crack with a width of $\sim 3 \mu\text{m}$ and at a frequency of 11.3 GHz.

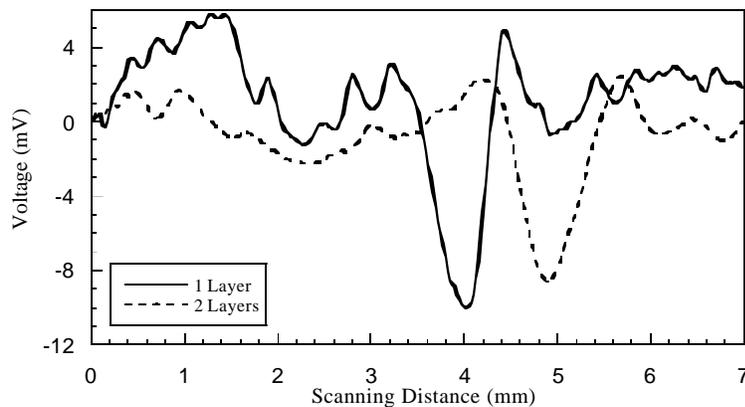
Figure 39. Crack characteristic signal for covered crack with one and two layers of tissue paper.

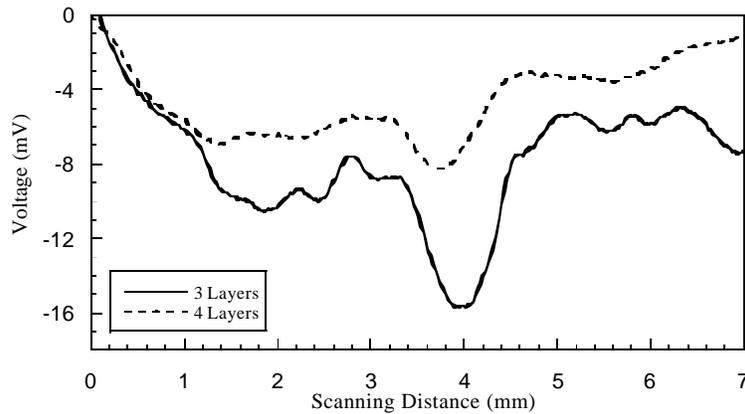
Figure 40. Crack characteristic signal for covered crack with three and four layers of tissue paper.

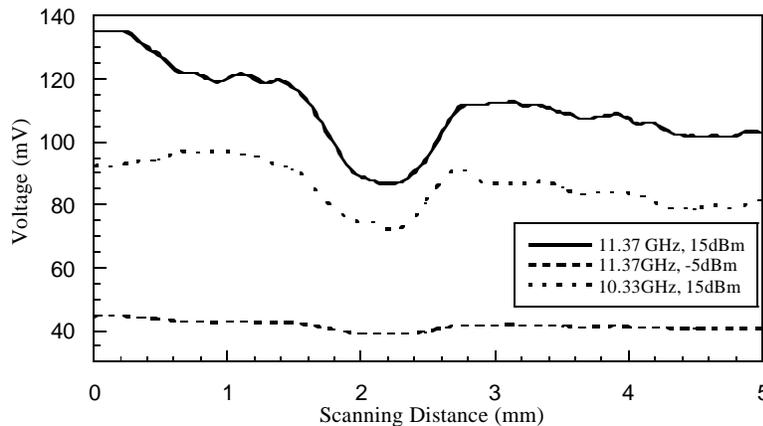
Figure 41. Influence of frequency and incident power on covered crack detection for a slot with a width of 0.15 mm and a depth of 0.75 mm and coating (tape) thickness of 0.11 mm.

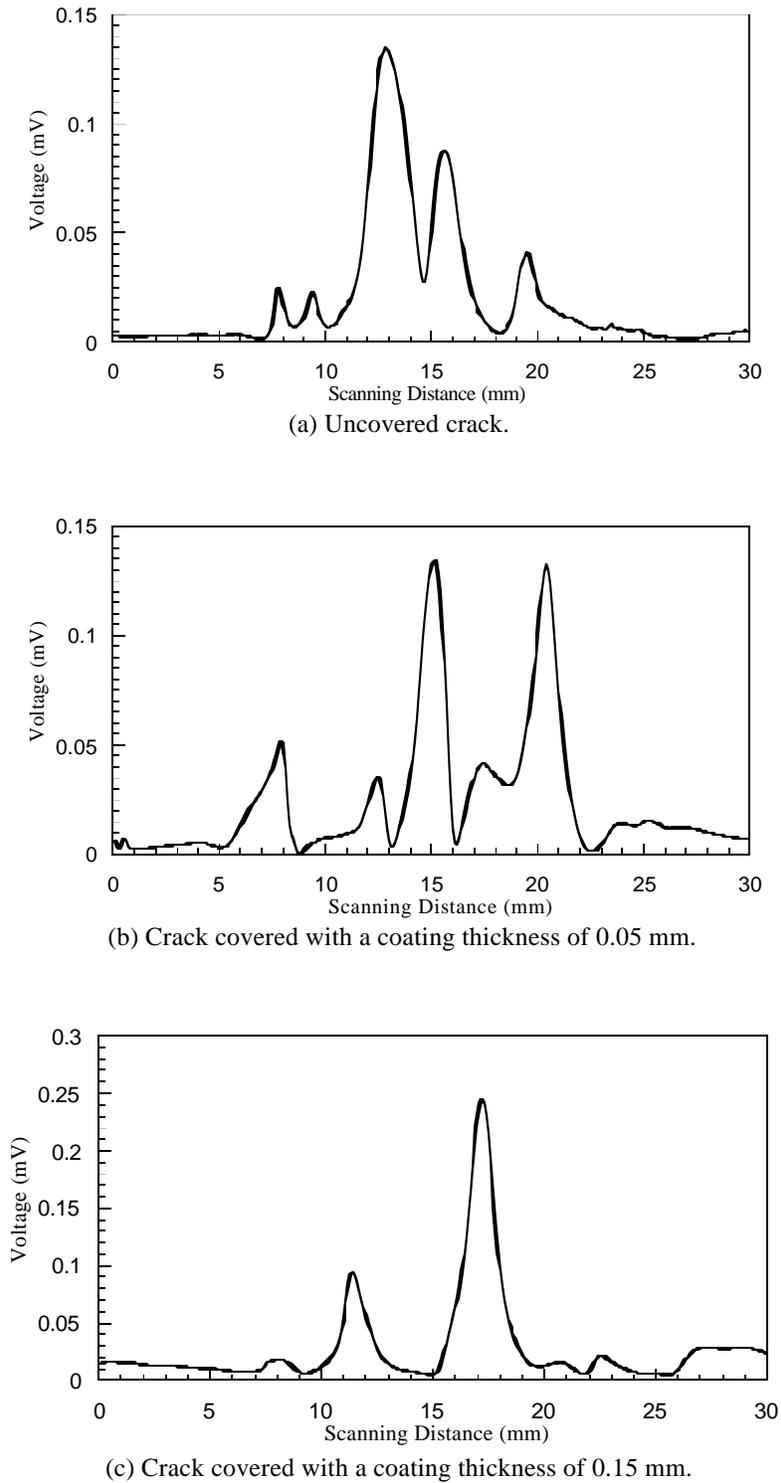
Figure 42. Higher order mode signals generated by the open-ended rectangular waveguide probe for a crack in a brass sample with a width of ~ 0.1 mm and a depth of 0.9 mm at a frequency of 31.5 GHz.

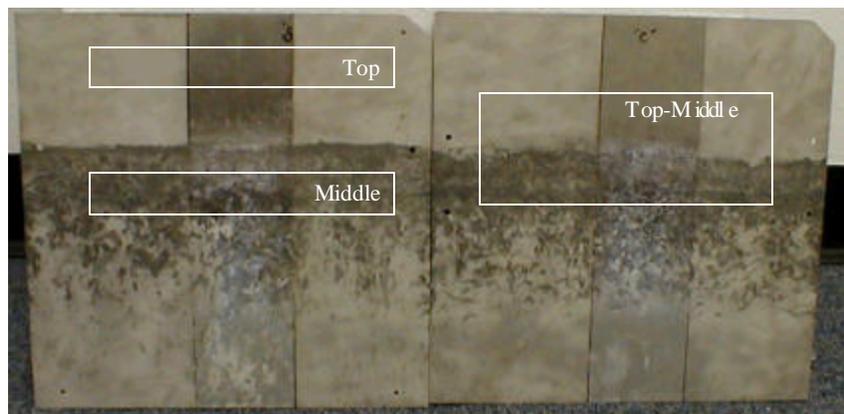
Figure 43. Sample plates C (left) and B (right) showing corrosion before being painted, with areas scanned highlighted.

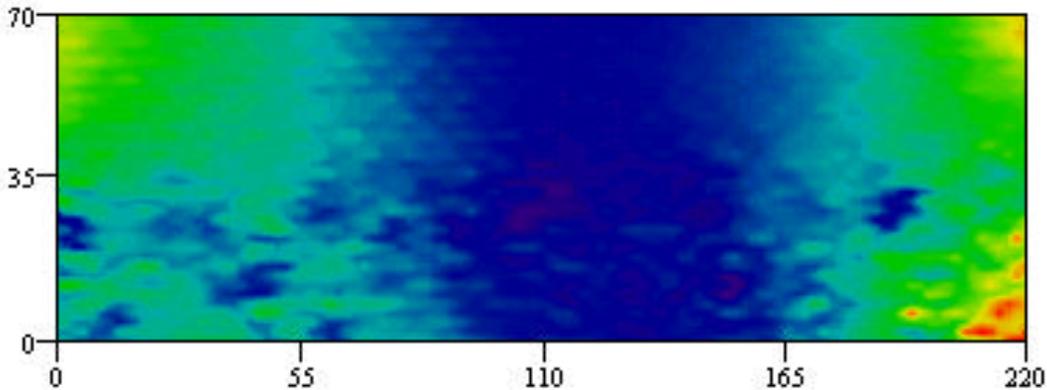
Figure 44. Image acquired using an open-ended rectangular waveguide probe of the top-middle strip of the front of panel B, at a frequency of 24.1 GHz and at a standoff distance of 0 mm (i.e. in contact). (Note: Dimensions are in mm).

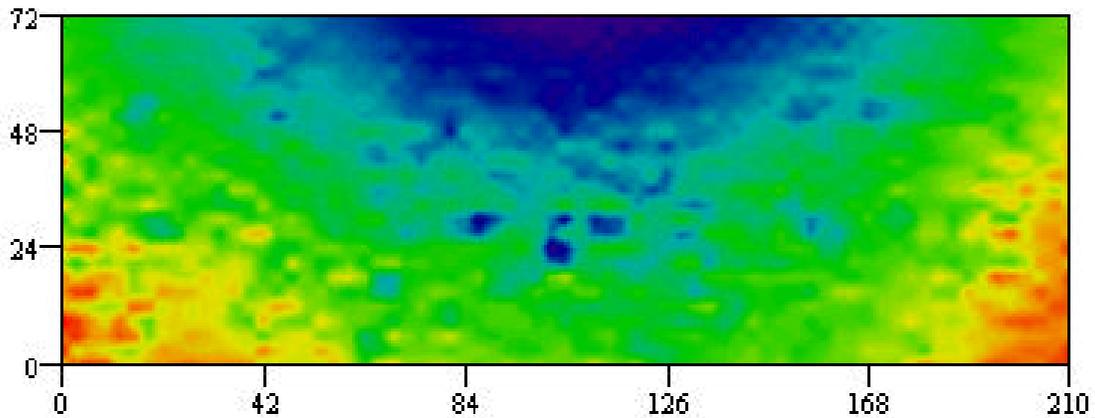
Figure 48. Image acquired using an open-ended rectangular waveguide probe of the top-middle strip of the front of panel C, at a frequency range of 33.5 GHz and at a standoff distance of 2 mm. (Note: Dimensions are in mm).

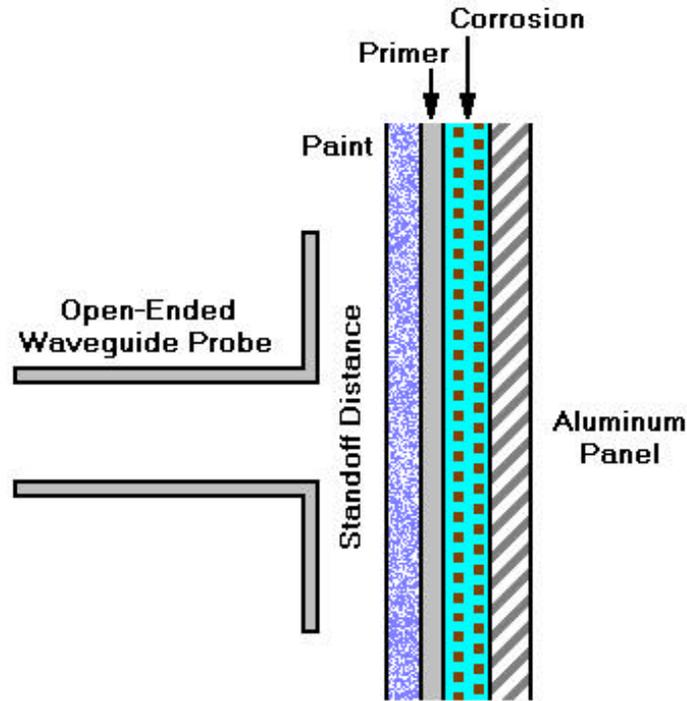
FIGURE 1. Cross-section of aluminum panel under a layer of paint, primer and corrosion.

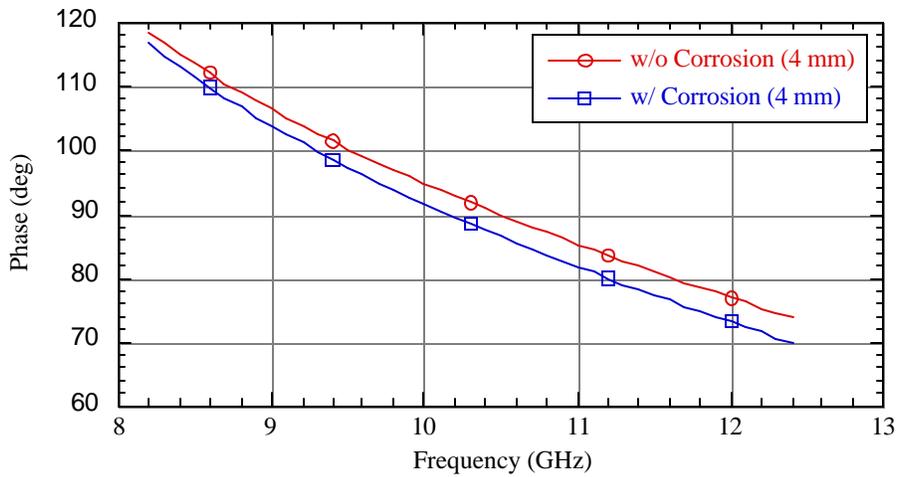
FIGURE 2. Phase of reflection coefficient at X-band with a standoff distance of 4 mm.

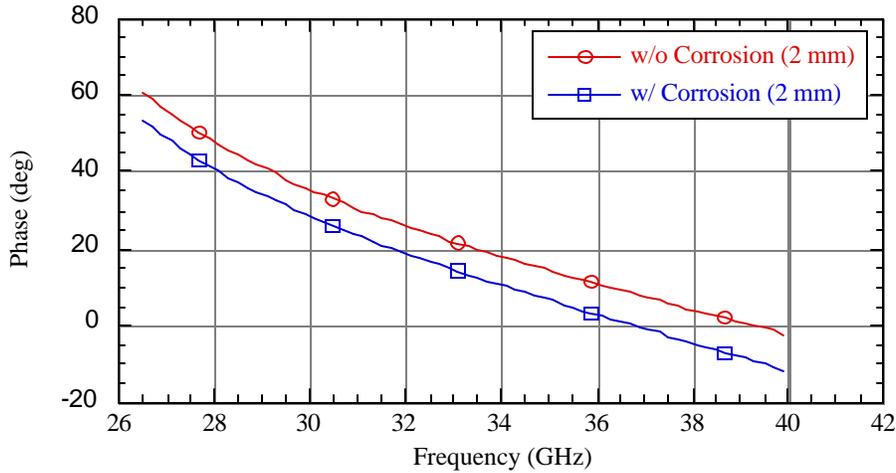
FIGURE 3. Phase of reflection coefficient at Ka-band with a standoff of 2 mm.

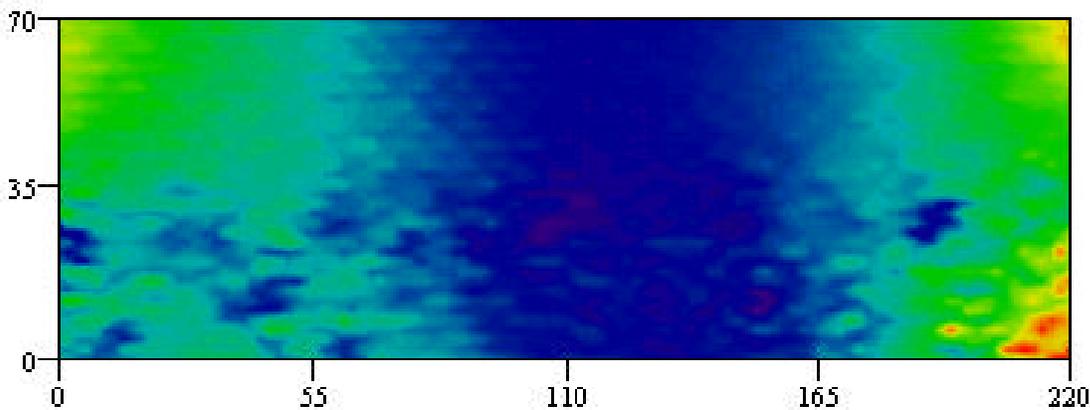
FIGURE 4. Image of the top-middle strip of the front of panel B, at a frequency of 24.1 GHz and at a standoff distance of 0 mm (i.e. in contact).

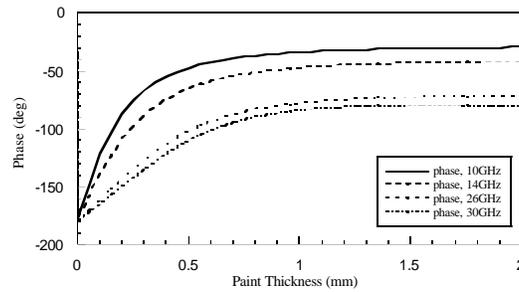
Figure 1a. Phase of reflection coefficient vs. paint thickness.

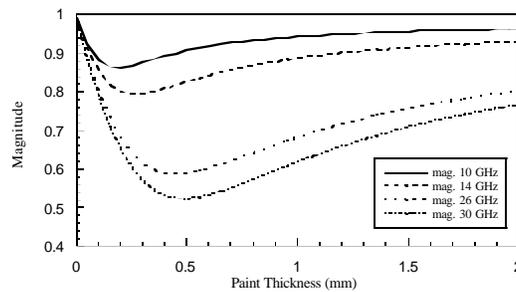
Figure 1b. Magnitude of reflection coefficient vs. paint thickness.

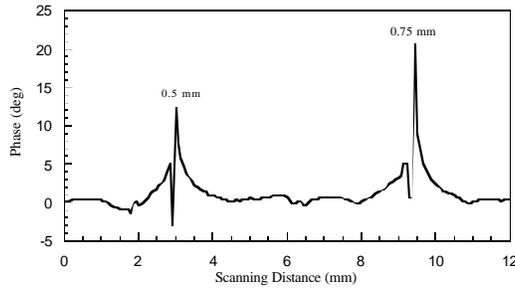
Figure 2a. Crack characteristic signal at 11.3 GHz for a slot with a width of ~0.200 mm and with different depths, coax inner radius of 0.5 mm and outer radius of 1.5 mm.

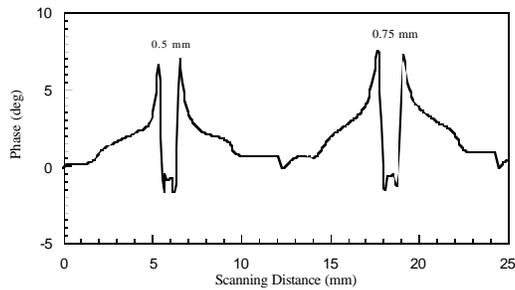
Figure 2b. Crack characteristic signal at 11.3 GHz for a slot with a width of ~0.200 mm and with different depths, coax inner radius of 1.0 mm and outer radius of 4.0 mm.

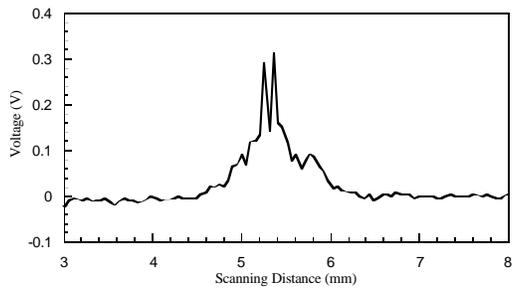
Figure 3. Crack characteristic signal for a fatigue crack with a width of ~3 micrometers and at a frequency of 11.3 GHz.

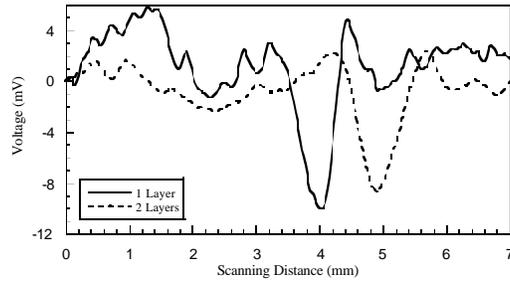
Figure 4a. Crack characteristic signal for covered crack with one and two layers of tissue paper.

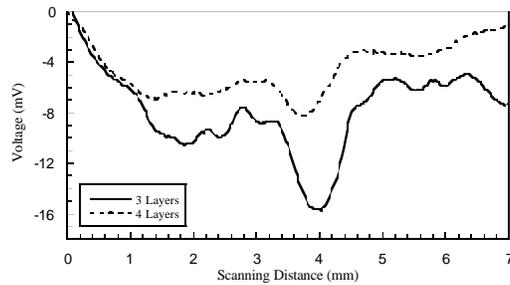
Figure 4b. Crack characteristic signal for covered crack with three and four layers of tissue paper.

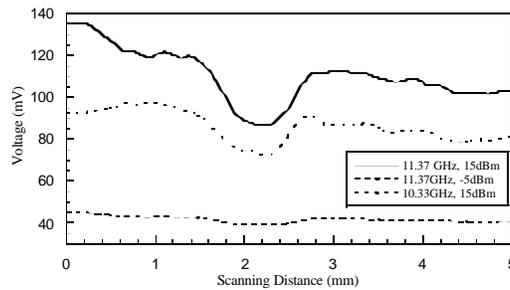
Figure 5. Influence of frequency and incident power on covered crack detection, for a slot with a width of ~0.150 mm and a depth of 0.750 mm and coating (tape) thickness of 0.110 mm.

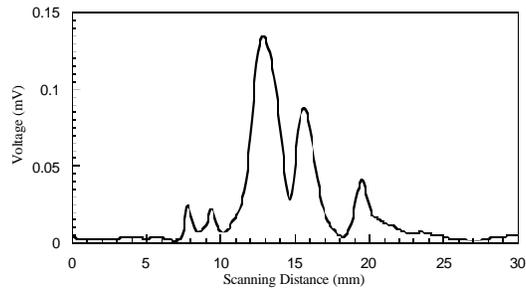
Figure 6a. HOM signal for an exposed crack with a width of ~ 0.10 mm and a depth of 0.90 mm.

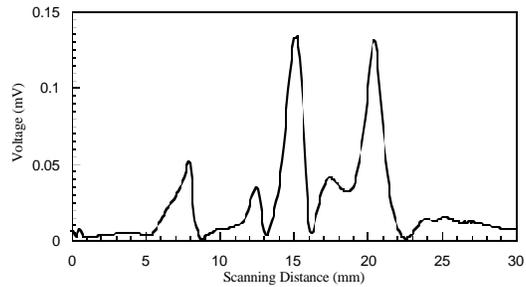
Figure 6b. HOM signal for a crack covered with a coating thickness of 0.05 mm and a crack with a width of ~ 0.10 mm and a depth of 0.90 mm.

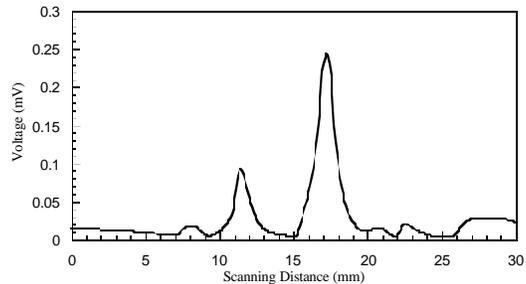
Figure 6c. HOM signal for a crack covered with a coating thickness of 0.150 mm and a crack with a width of ~ 0.10 mm and a depth of 0.90 mm.

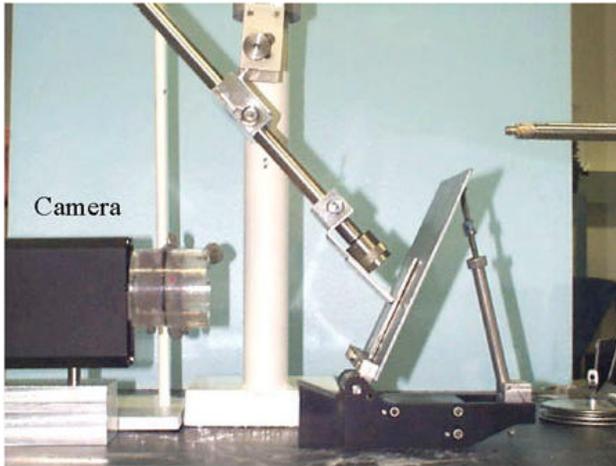
Figure 5. Adjustable Angle Beam Setup

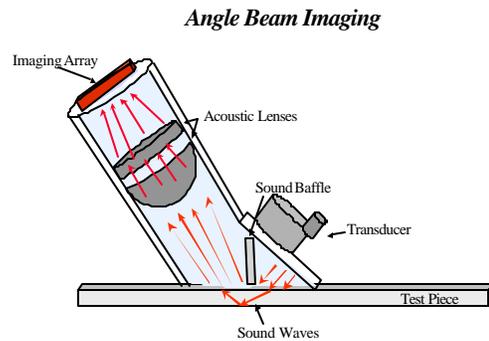
Figure 6. Architecture of the Portable Angle Beam Head

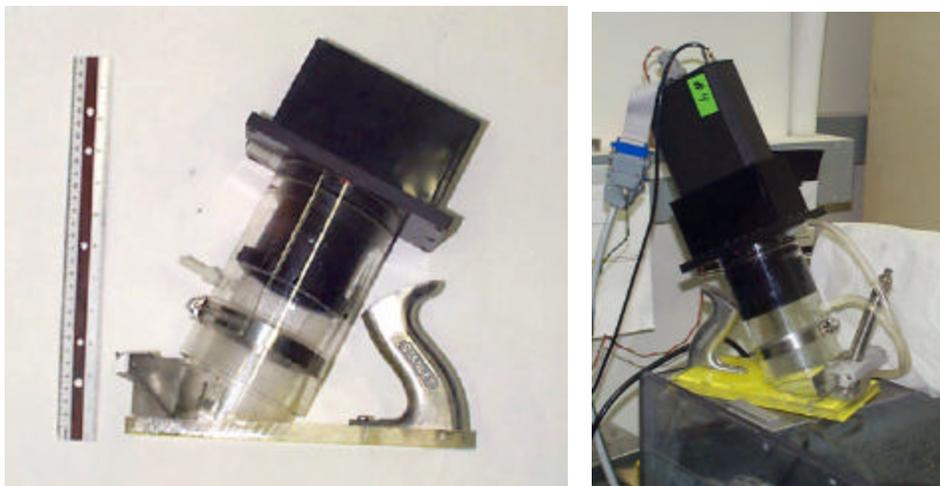
Figure 7. The Portable Angle Beam Inspection Head

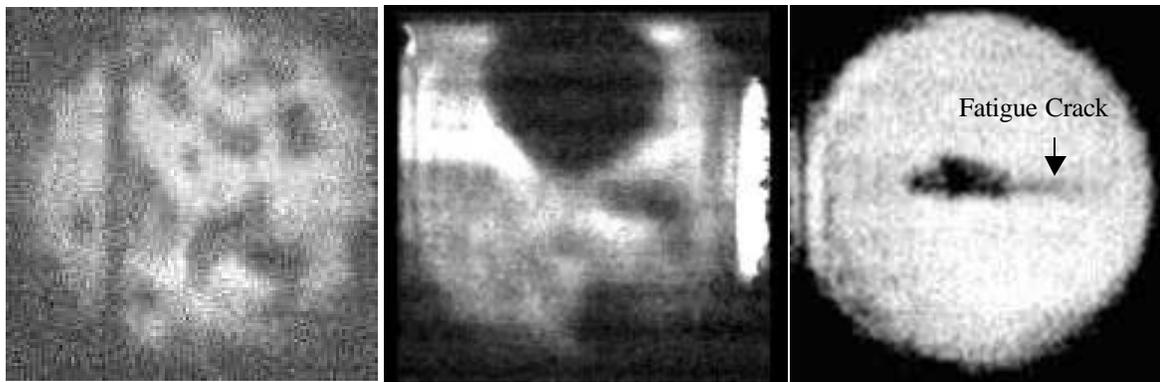
Figure 8. Exfoliation Corrosion (left), Riveted sheet (middle), and a Thin Fatigue Crack in 0.062 inch aluminum sheet (right)

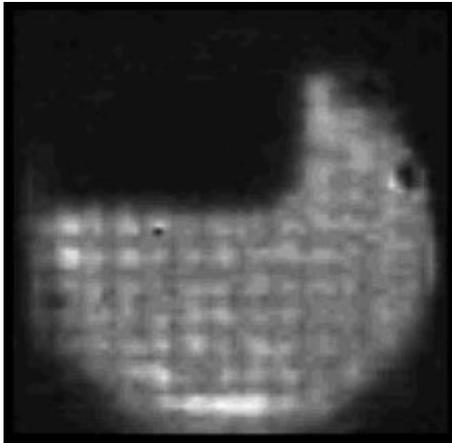
Figure 9. Image of Composite Fibers

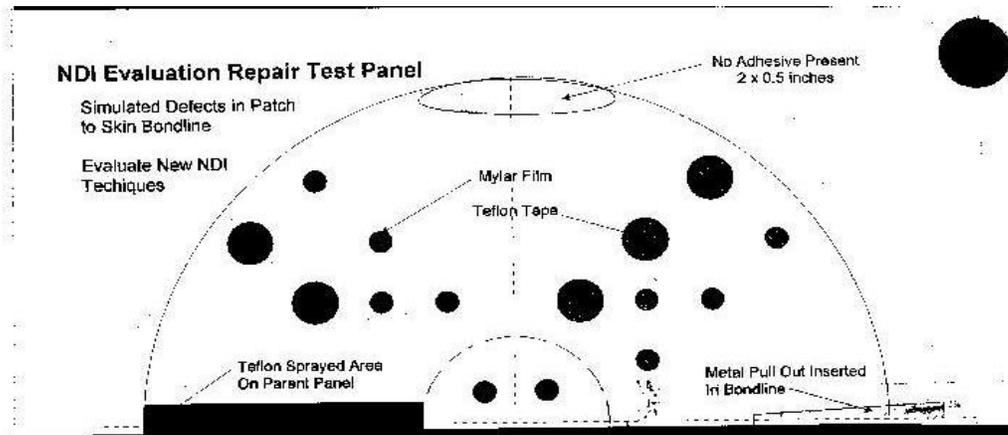
Figure 11. NDI Repair Test Panel

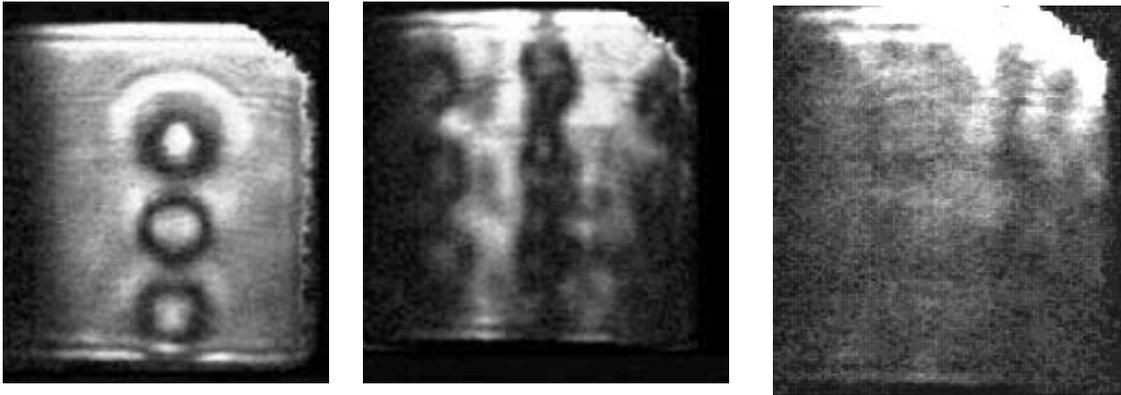
Figure 13. Angle Beam Images. A single back surface 0.010" deep 3/16" diameter flat bottom hole (left). Heavy back surface exfoliation corrosion (middle) and light back surface exfoliation corrosion (right). The multiple bounces of the beam cause multiple images of the discontinuities.

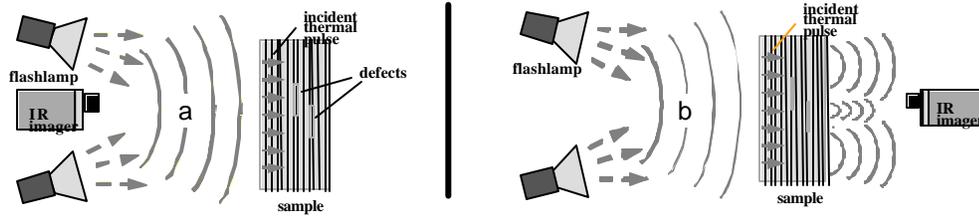
Figure 1. (a) Shows a standard single side inspection setup with the IR camera and the arc lamps in the same side. (b) Shows a through transmission setup which in general provides twice the depth of resolution.

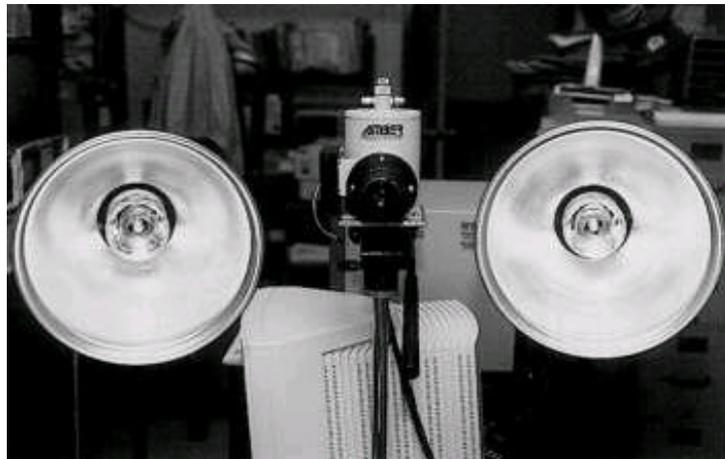
Figure 2: Thermal imaging system used to acquire data.

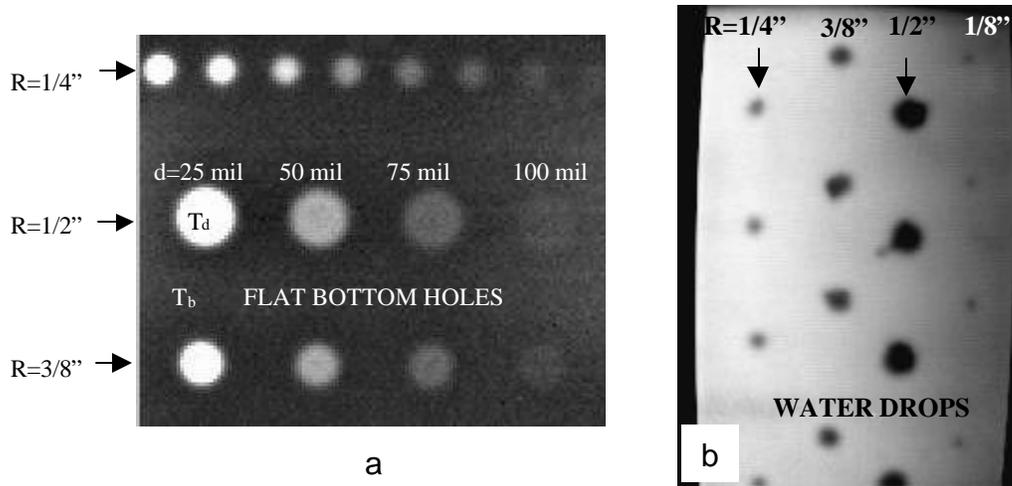
Figure 3. (a) Shows a 1/8" thick aluminum with flat bottom holes of different depth ranging from 25 mil to 100 mil and three different radii of $R=1/2''$, $3/8''$ and $1/4''$. (b) Shows a 1/32" thick aluminum panel with water drops of different radii and different water content.

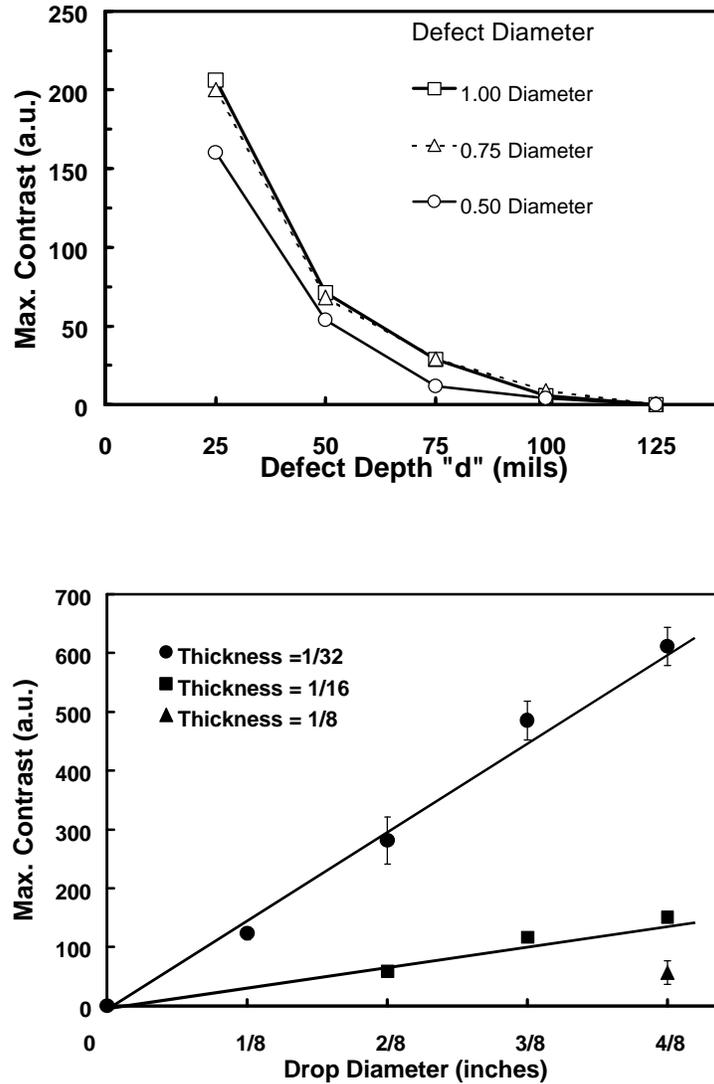
Figure 4. (Top) This graph shows the contrast temperature for all flat bottom holes shown in figure 3a. (Bottom) This graph shows the contrast temperature for all panels with simulated entrapped water shown in Figure 3b.
