NSWCCD-61-TR-2001/21

November 2001

Survivability, Structures, and Materials Directorate
Technical Report

Development of Innovative Nondestructive Evaluation Technologies for the Inspection of Cracking and Corrosion Under Coatings

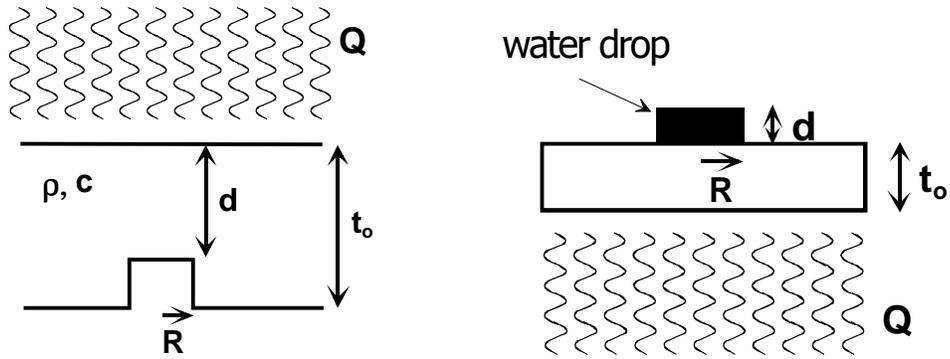
Figure 5. This illustration shows the main parameters used when modeling the thermographic process for mass loss due to corrosion (left) and water entrapment (right)

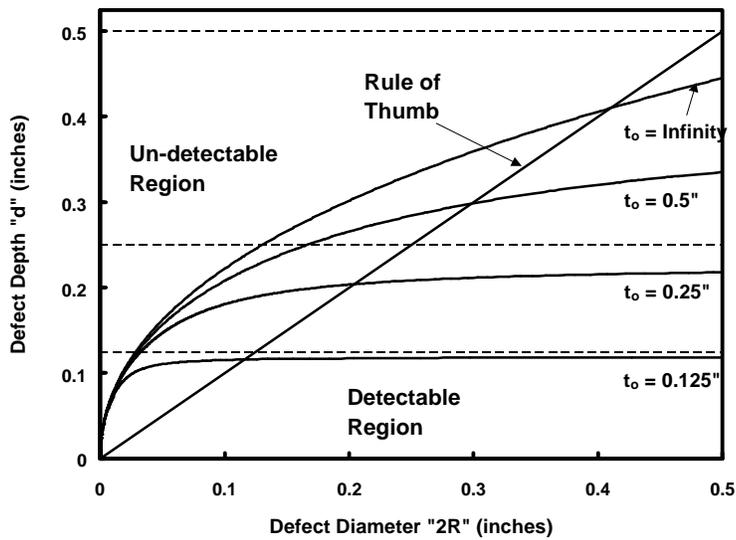
Figure 6. This graph shows curves that separate detectable from undetectable regions of defect of diameter 2R.

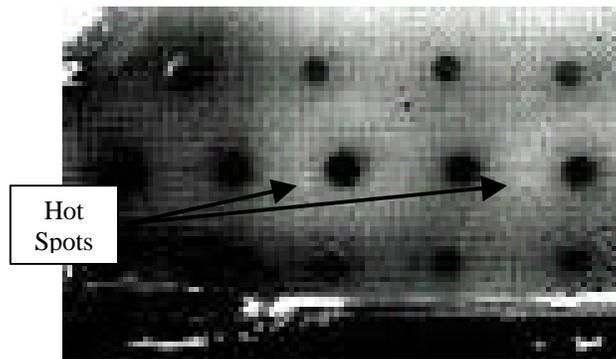
Figure 7. Aluminum lapjoint with three rows of fasteners. There is clear evidence of a hot spots around some fasteners.

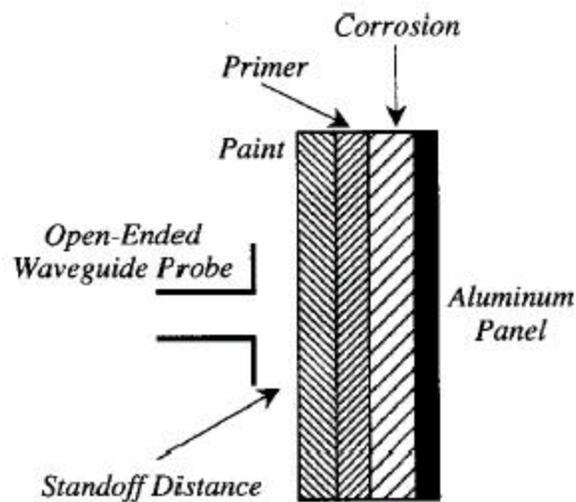
Figure 1. Schematic of an open-ended rectangular waveguide probe radiating into a typical aluminum panel with paint, primer, and rust.

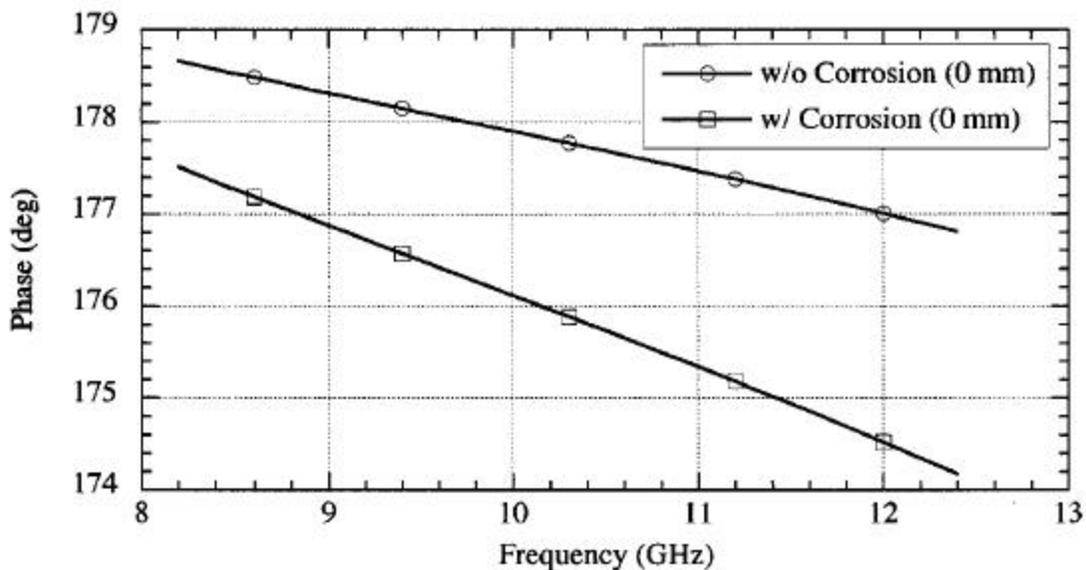
Figure 2. Phase as a function of frequency at a standoff distance of 0mm (i.e., in-contact) at X-band.

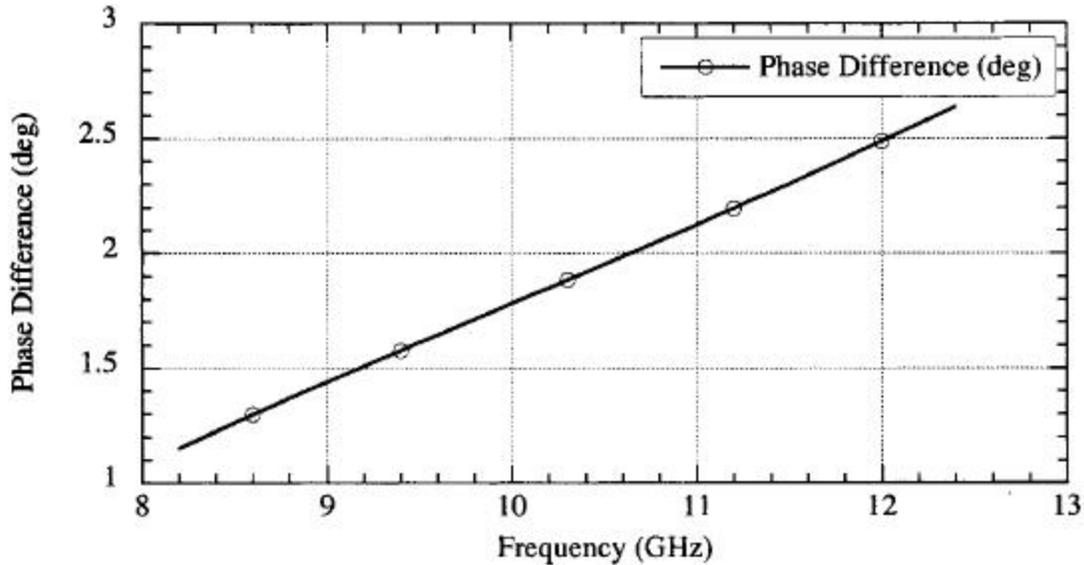
Figure 3. Phase difference as a function of frequency at a standoff distance of 0mm (i.e., in-contact) at X-band.

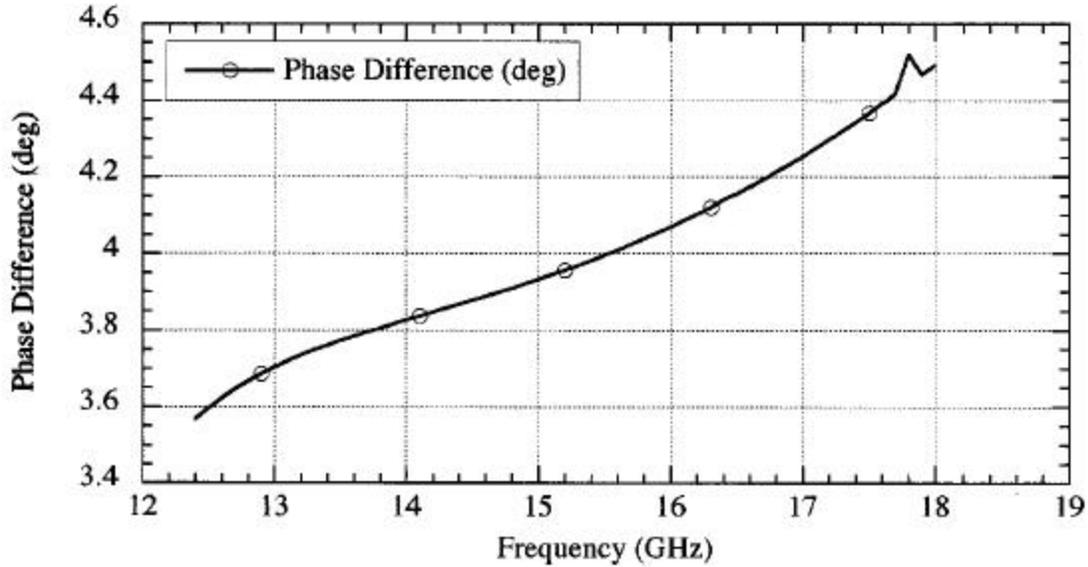
Figure 4. Phase difference as a function of frequency at a standoff distance of 4mm at *Ku*-band.

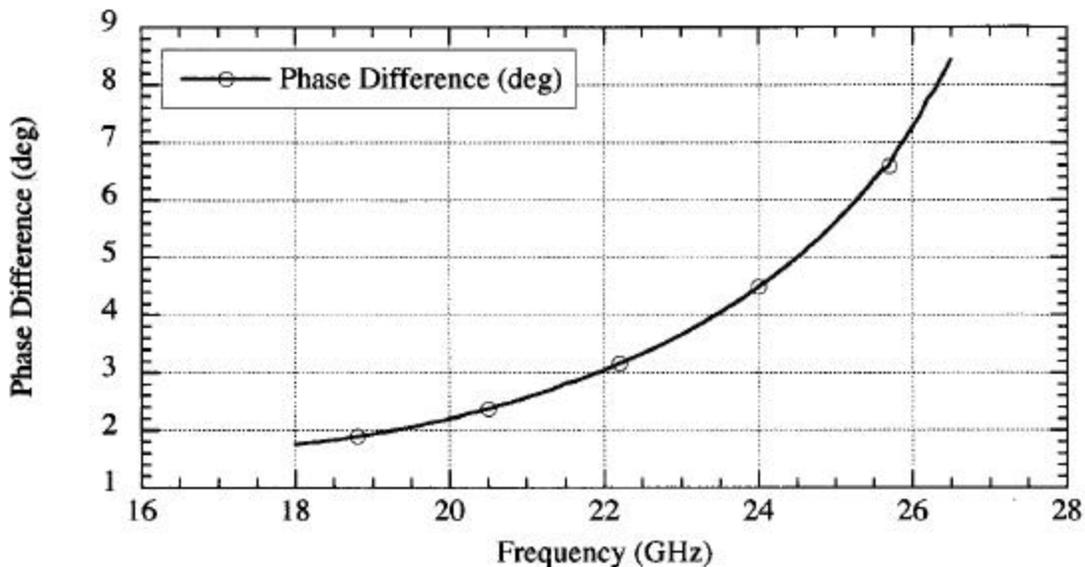
Figure 5. Phase difference as a function of frequency at a standoff distance of 5mm at *K*-band.

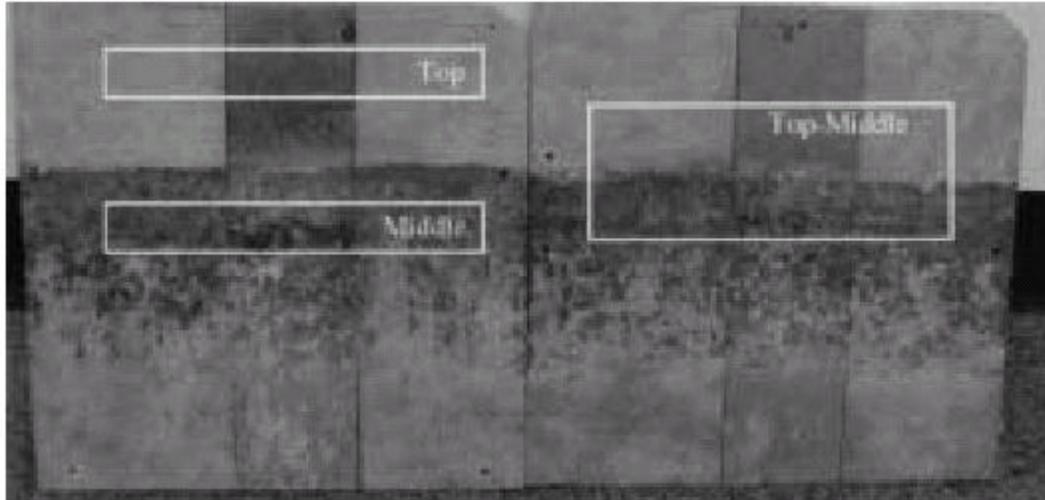
Figure 9. Sample plates showing corrosion before being painted, with areas scanned highlighted.

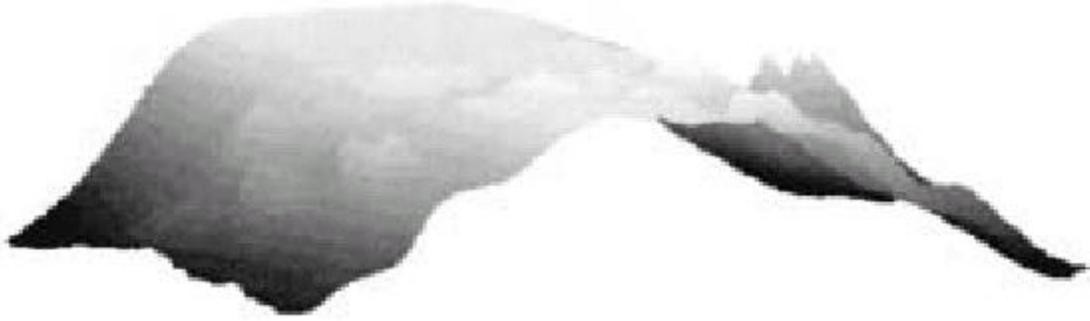
Figure 13. Surface plot of the top-middle strip of panel B, scanned at a frequency of 33.5 GHz and a standoff distance of 4.3 mm.
