**U.S. ARMY AVIATION  
AND MISSILE COMMAND,  
RESEARCH, DEVELOPMENT &  
ENGINEERING CENTER**

**TITLE: Laser Obstacle Detection System Flight Testing**

**DATE (MONTH YEAR): September 2003**

**FINAL REPORT**

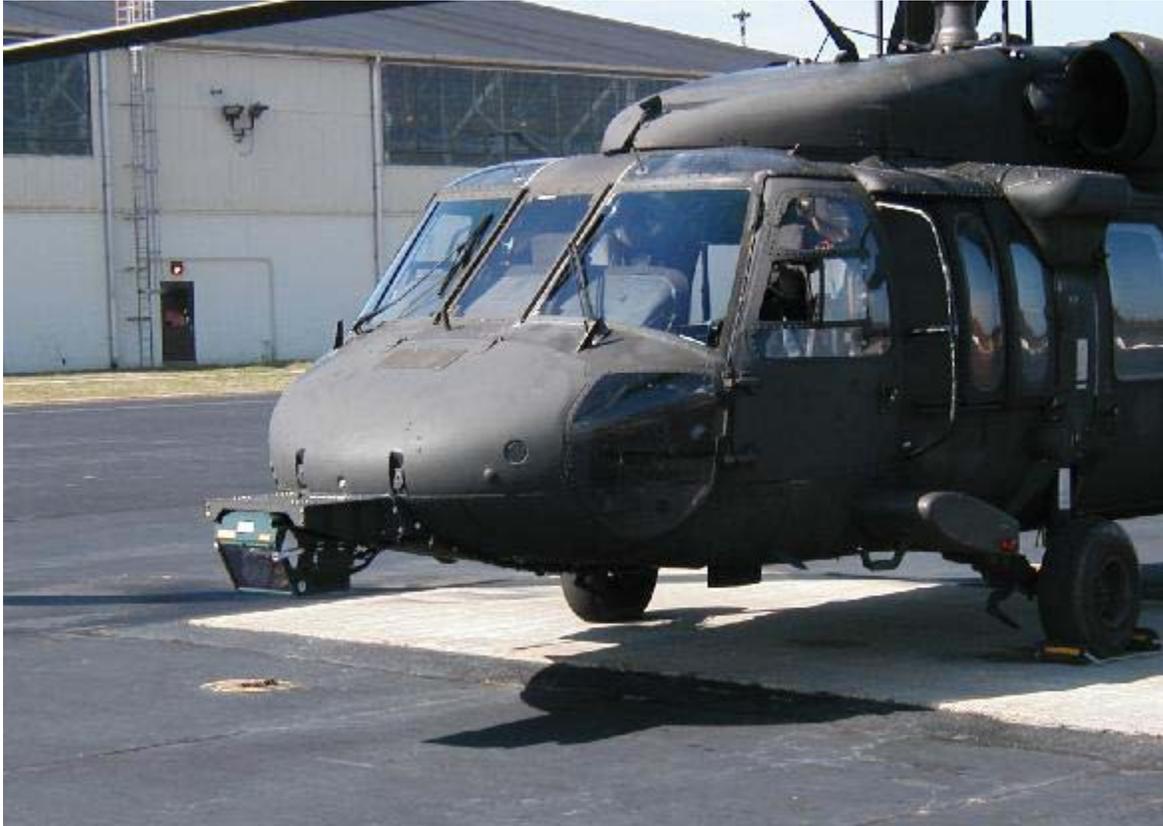
**FIGURE 1:** UH-60 BLACKHAWK WITH MOUNTED HELLAS OBSTACLE DETECTION SENSOR

### c. Aircraft Description

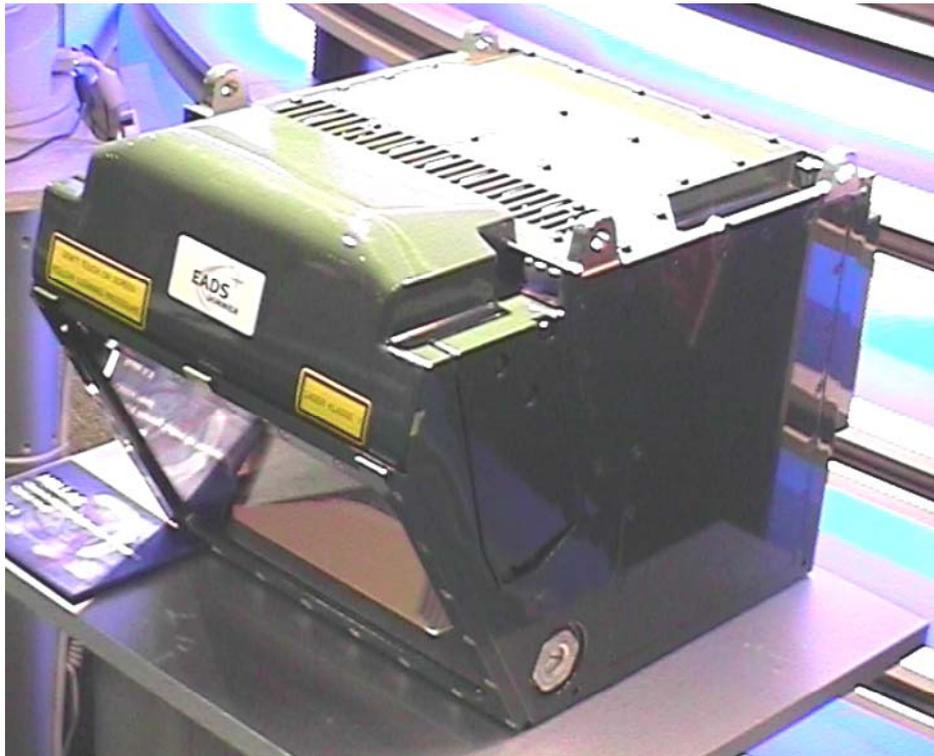
**FIGURE 2:** HELLAS OBSTACLE DETECTION SENSOR

The HELLAS obstacle detection sensor, shown in Figure 2, contains a 1.54  $\mu\text{m}$  wavelength Erbium-Fiber eye-safe laser system is manufactured by EADS Dornier and weighs approximately 62 lbs. The system generates a 3D LADAR image with a 32 degrees of elevation and 32 degrees of azimuth field of view. The sensor uses a two-axis scanning laser radar system to measure the 3-dimensional geometry of objects. The distances to targets are measured with a pulsed laser using time of flight measurements. A more detailed description of the HELLAS is presented in Reference 1d (HELLAS Interface Specification Document). Eye safety was tested by U.S. Army Center For Health Promotion and Preventive Medicine (CHPPM) and the report is included in enclosure 1.

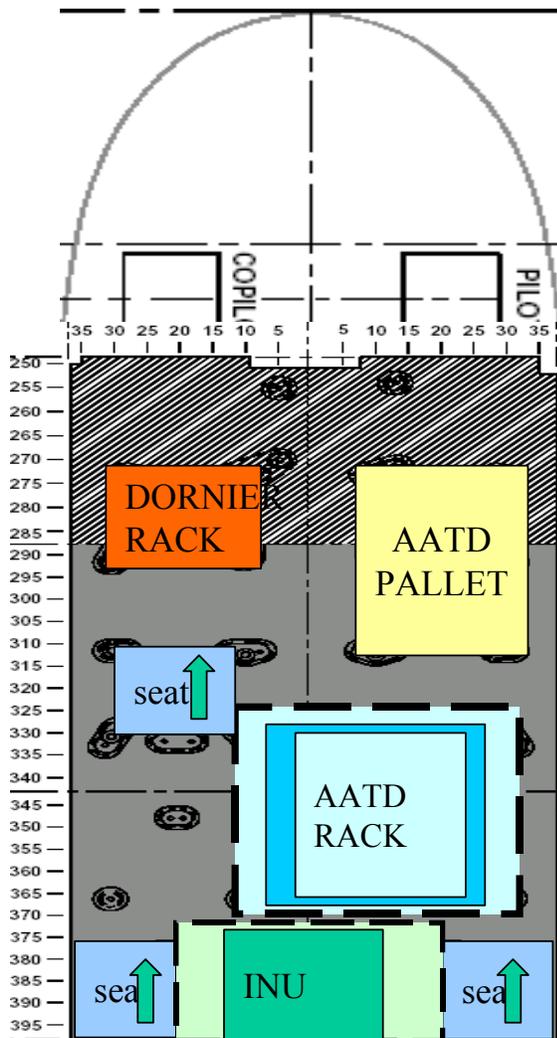
FIGURE 3: UH-60 CABIN FLOOR PLAN FOR LODS

In addition to the racks and pallet, an inertial navigation system (INS) was mounted in the cabin. The INS consisted of an Inertial Navigation Unit (INU), a Control Display Unit (CDU), a Mode Selector Unit (MSU), a Battery Unit (BU) and Standard Pallet System (SPS). The SPS is designed to hold the INU and BU. The INS provided inertial rate and speed data to the HELLAS unit. A diagram of the cabin floor plan is shown in Figure 3.

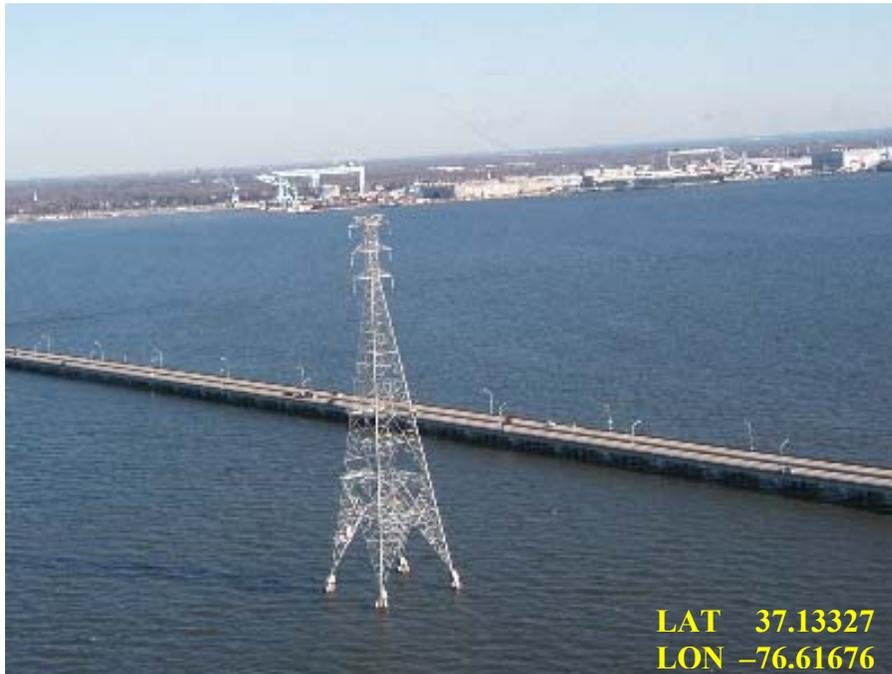
**FIGURE 4:** JAMES RIVER BRIDGE (WIRE SET #1)  
6 LARGE WIRES AND 2 SMALLER GUIDE WIRES  
EASILY DETECTED VISUALLY WITH NO BACKGROUND

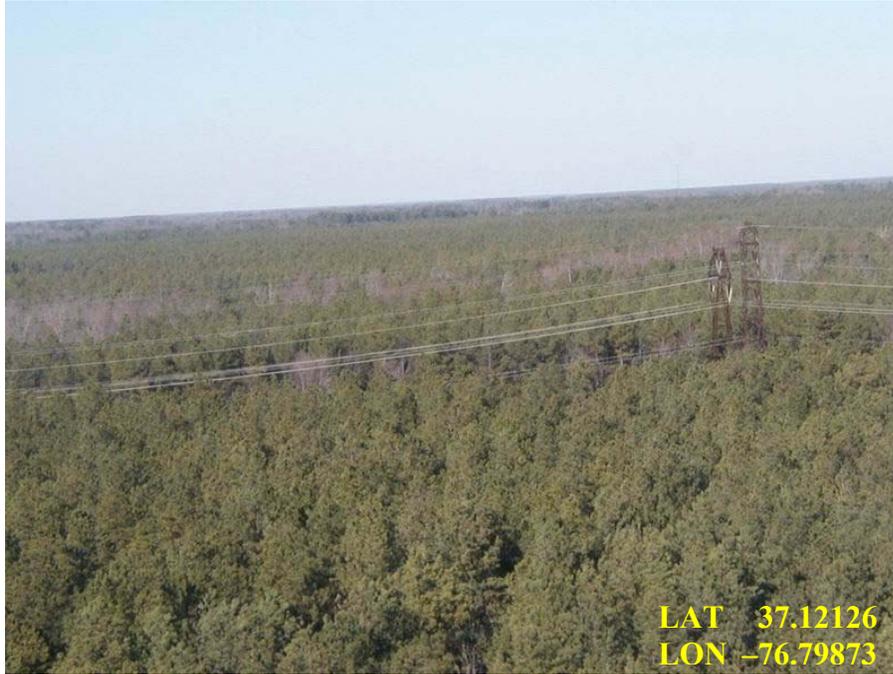
**FIGURE 5:** (WIRE SET #2)  
MANY LARGE WIRES AND SMALLER GUIDE WIRES  
HEAVILY WOODED BACKGROUND

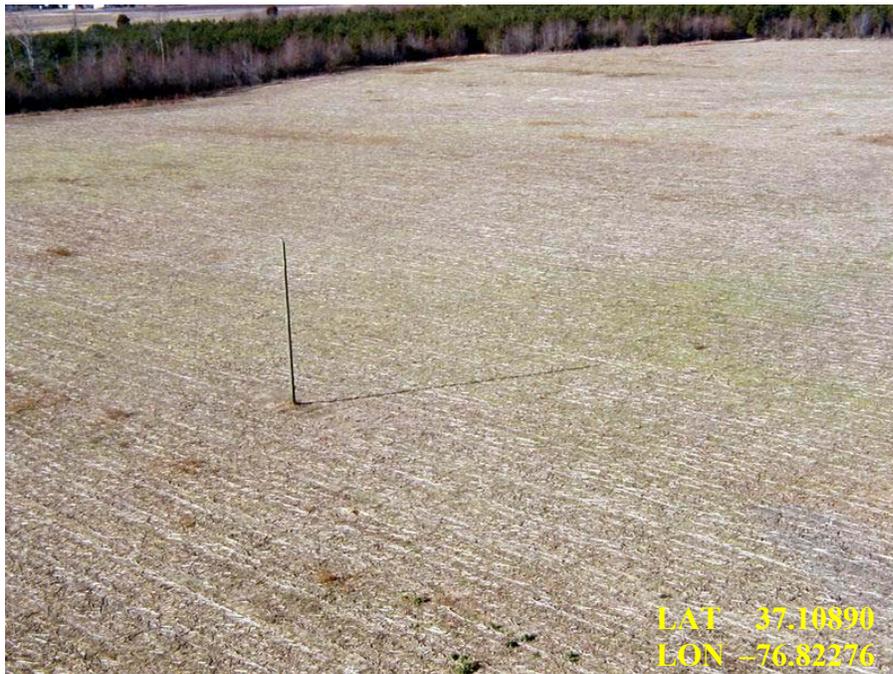
**FIGURE 6:** (WIRE SET #3)  
MANY LARGE WIRES AND SMALLER GUIDE WIRES  
HEAVILY WOODED BACKGROUND

Wire Set #3 was flown during the day and repeated after sunset. The evening flight was cut short due to weather. No additional night flights were flown prior to removal of the system and program completion. During the night flight, no cockpit displays were operational due to hardware and flight release limitations. From the operator’s position, the LODS system functioned comparable to the earlier day flight. Additional flights would be required to determine if the range is increased or decreased under low light conditions.

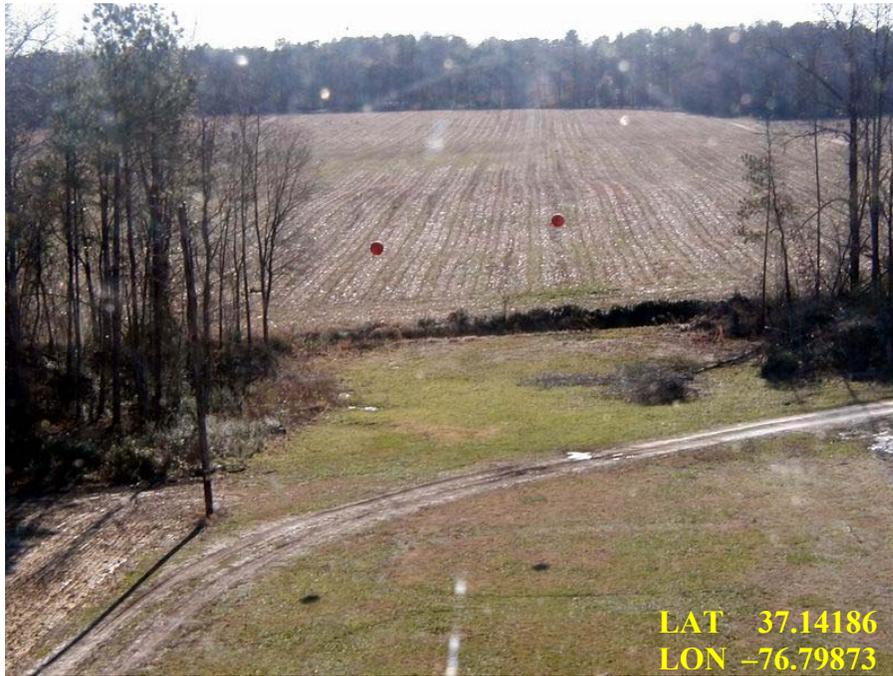
**FIGURE 7:** POLE IN OPEN FIELD (WIRE SET #4)  
2 VERY SMALL WIRES AND NO GUIDE WIRES  
NOT EASILY DETECTED VISUALLY

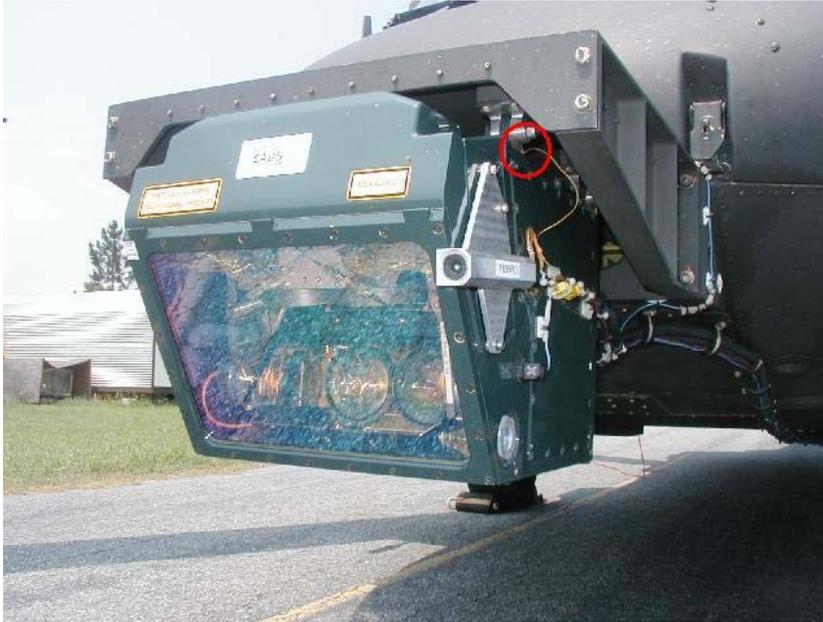
The HELLAS laser was equipped with two thermocouples placed at the exhaust of the laser and taped to the top surface of the HELLAS case. See the following pictures:

**FIGURE 13: THERMOCOUPLE #1 BONDED TO TOP OF CASE**

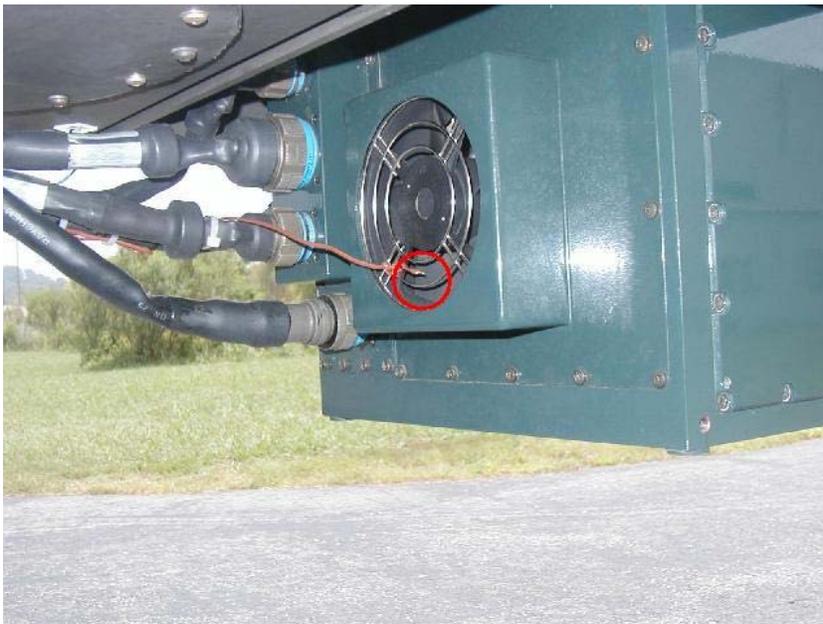
**FIGURE 14: THERMOCOUPLE #2 MOUNTED TO EXHAUST FAN**

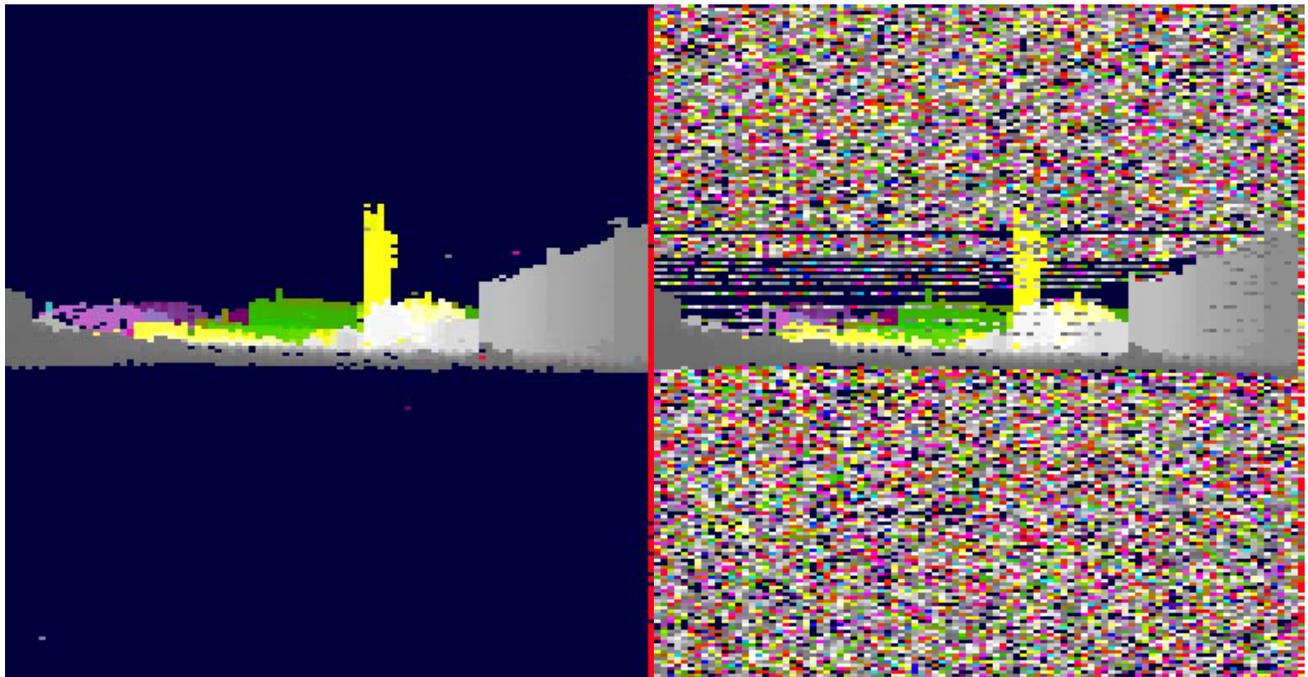
**FIGURE 15:** RAW DATA IMAGE BEFORE AND AFTER FAILURE

This testing confirmed that the failure was due to temperature and was repeatable. More testing in a more controlled environment is required to better understand the full extent of the problem. The manufacturer believes this problem may have been caused by a bad resistor and is planning on verifying that conclusion upon receipt of the HELLAS laser.

The only HELLAS system failure was linked to ambient temperature greater than 90 deg F. This prompted a test to determine maximum temperature the system could withstand before failure and if the

3. The HELLAS malfunctioned multiple times at ambient temperatures around 103 degrees Fahrenheit. A separate test was conducted to try and repeat the problem, see the additional testing section #8. This problem requires further evaluation in a more controlled environment.

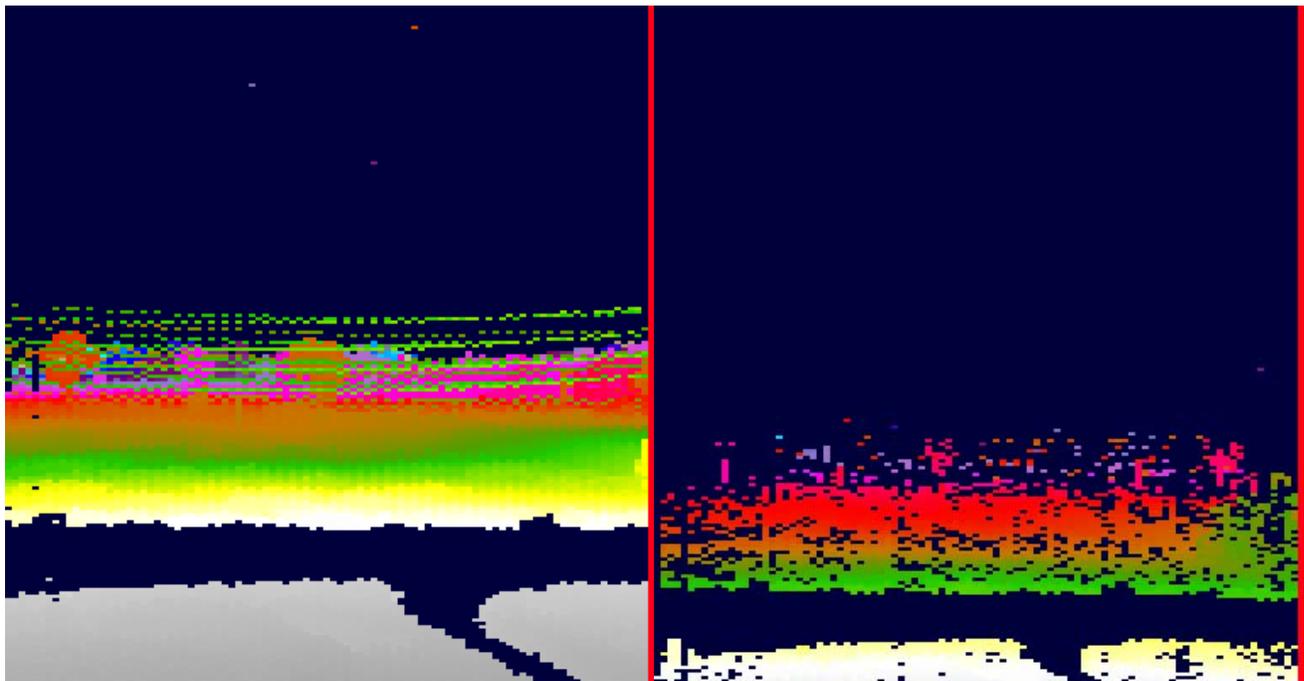
**FIGURE 16:** RAW DATA IMAGE BEFORE AND DURING MODERATE RAIN

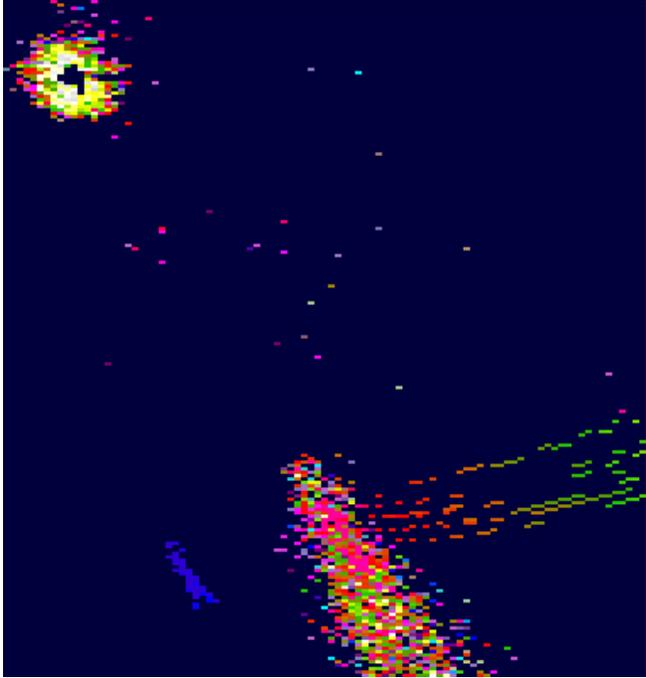
4. Sun and the reflections of the sun appear as obstacles on the HELLAS display. The manufacturer believes filters within the HELLAS laser can reduce this problem. This problem was most evident on the data from flight #5.

**FIGURE 17:** RAW DATA IMAGE OF SUN AND REFLECTION

2. *Temperature effects on system*  
Similar to weather, this should be further evaluated in a laboratory where the conditions can be controlled.
3. *Sun and glare representations as obstacles.*  
Filtering this data return may affect other capabilities of the system while not filtering may increase the false alarm rate. This problem needs to be considered in future evaluations of this or any follow along system.

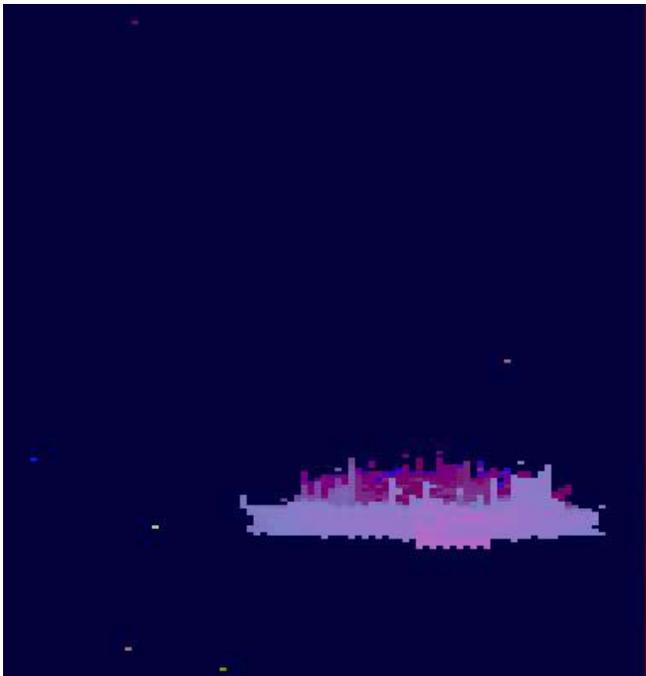
5. The HELLAS does not see water as an obstacle. This problem was most evident on the data from flights #5 through #7.

**FIGURE 18:** RAW DATA IMAGE OF SHIP ON WATER

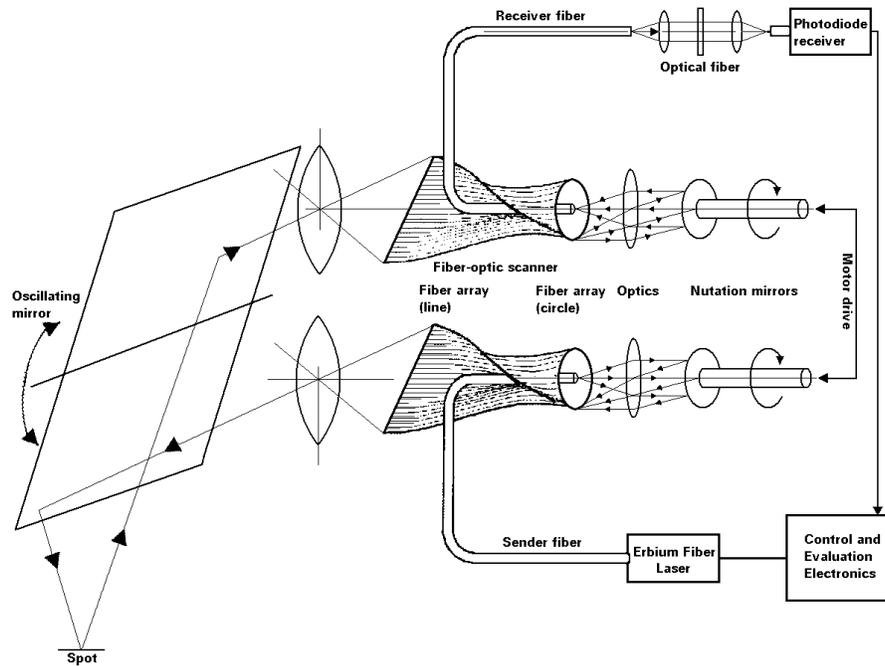
a. System Description. The HELLAS obstacle detection laser system includes a 1550 nm diode-pumped erbium fiber laser, and a fiber-optic scanner, consisting of 96 fibers (core diameter of 200  $\mu\text{m}$ ), scanner motor, optics array, and nutation mirrors. The fiber-optic scanner distributes a laser pulse successively from a single fiber-coupled laser source to a circular 96-fiber array. The fibers end in a linear array mounted at the focus of the array optics forming a horizontal beam fan that is then deflected in the vertical direction by an oscillating mirror forming a rectangular output beam. One of the fibers is used as a reference to measure distance, and not transmitted. Figure 1 shows a line drawing of the optical components. A photo of the HELLAS system mounted on the base of a helicopter is shown in Figure 2.

**Figure 1.** Line drawing of the optical components of the HELLAS.

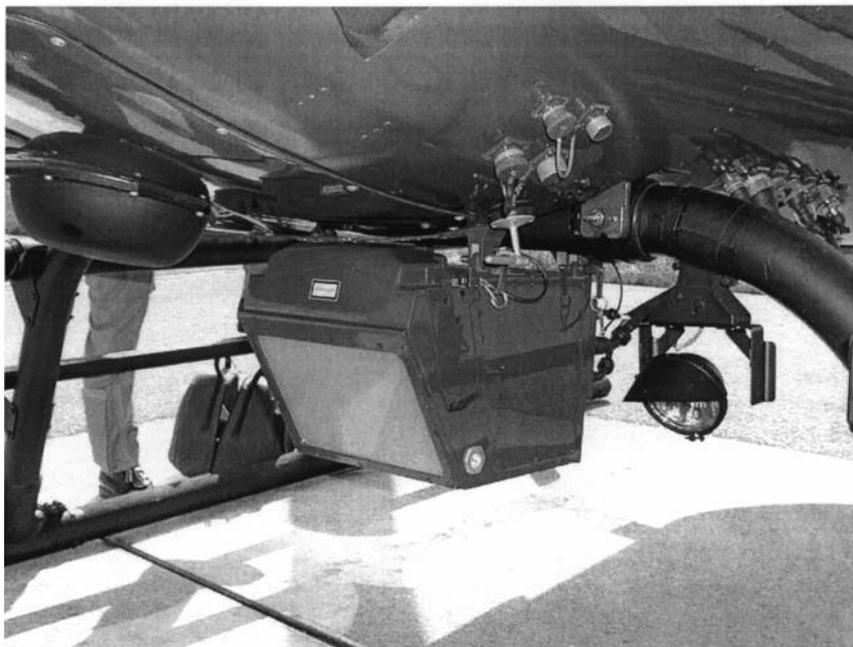
**Figure 2.** HELLAS mounted on helicopter.

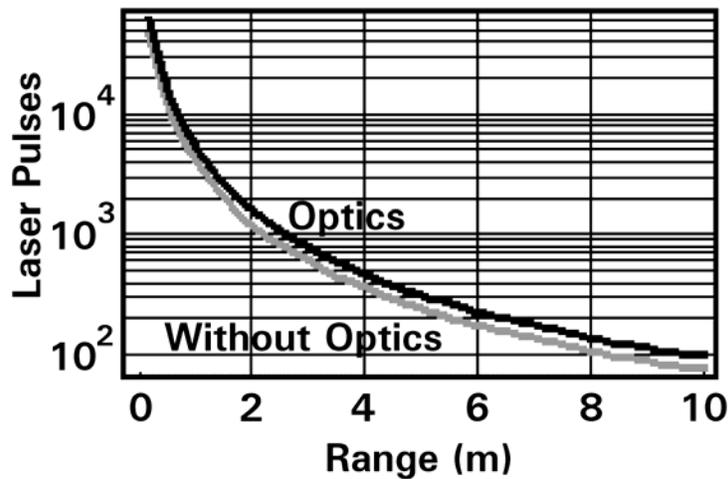
**Number of Laser Pulses thru an Aperture vs Range**

**Figure 3.** The number of laser pulses emitted by the HELLAS that one would be exposed to a various distances for unaided (3.5 mm) and optically aided (2.5 cm) viewing of the beam.

a Maximum Permissible Exposure (MPE). The level of laser radiation to which a person may be exposed without hazardous effect or adverse biological changes in the eye for a repetitively pulsed laser is the more restrictive of several MPE calculations. The calculated MPE for the HELLAS laser system was based on the systems energy per pulse output and the number of pulses one could receive. Since the HELLAS is a scanning system, as you move away from the laser exit aperture, you are exposed to fewer laser pulses, thus continuously changing the MPE. Figure 3 shows the number of pulses one would receive at different distances for both unaided and optically aided viewing of the HELLAS. After calculating the number of pulses in an exposure, the MPE and accessible emission limit (AEL) at that distance could be calculated. The AELs, levels of laser radiation that can be received continuously without chance of injury, for both unaided and optically aided viewing are the top two curves in Figure 4. The lower curves are calculations of the radiant exposures for the HELLAS at various ranges for unaided viewing (Without Optics) and aided (Optics) viewing of the system. The point where the AEL curve crosses the corresponding radiant exposure curve is the lasers nominal ocular hazard distance (NOHD). Beyond this range the laser is safe to view under those condition. In the case of the HELLAS, the only curves that cross are those for optically-aided viewing. It crosses at a range of about 0.5 meter (m), which is shorter than the two-meter measurement distance for optics. Therefore, the laser is safe to view at any distance with or without optics.

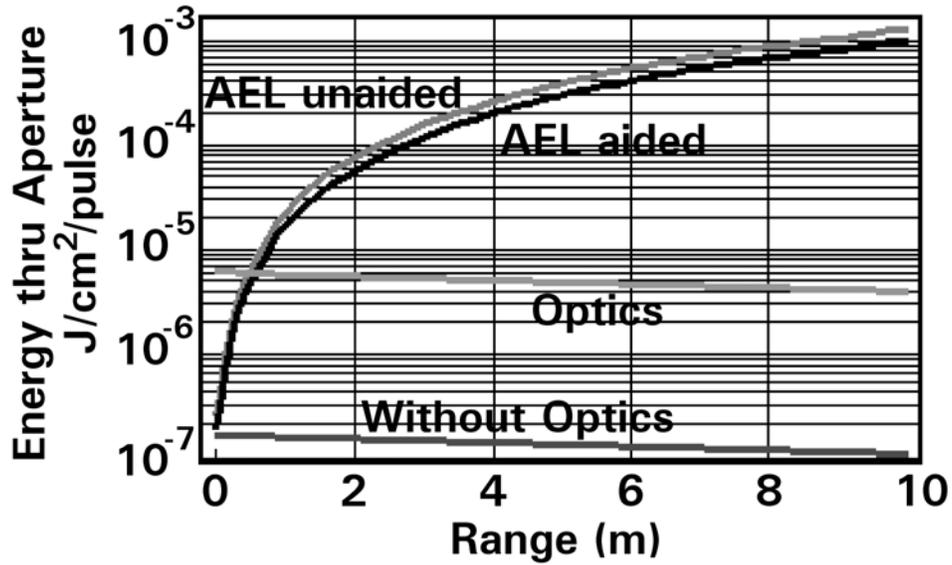
Figure 4. AELs versus Range

### AELs Unaided and Aided Viewing vs Range

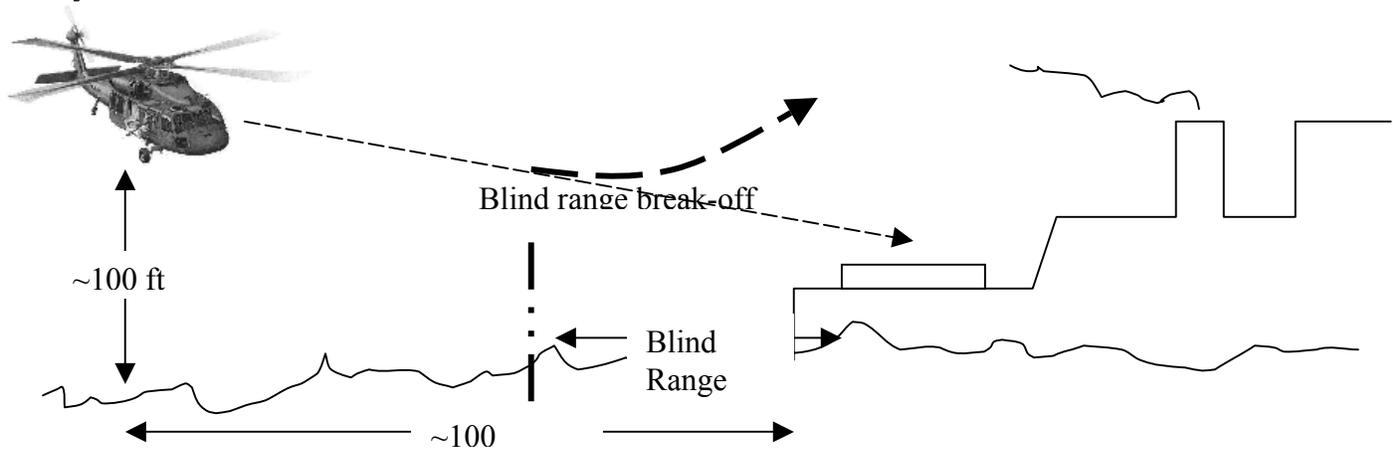
Fig H-1: Deck landing approach profile

Fig. H-1 shows a typical deck landing stern approach, used with cruisers, frigates, and destroyers.

Initially, the helicopter keeps station to the ship at ~100-ft altitude and 100-m distance astern. The helicopter approaches the ship under “fast hover” conditions to within the 50-m HELLAS blind range, then breaks off the approach and circles for another pass.
