NAVAL FACILITIES ENGINEERING SERVICE CENTER
Port Hueneme, California 93043-4370

Technical Report TR-2217-SHR

GRAZING-ANGLE FOURIER TRANSFORM INFRARED SPECTROSCOPY FOR SURFACE CLEANLINESS VERIFICATION

Final Report

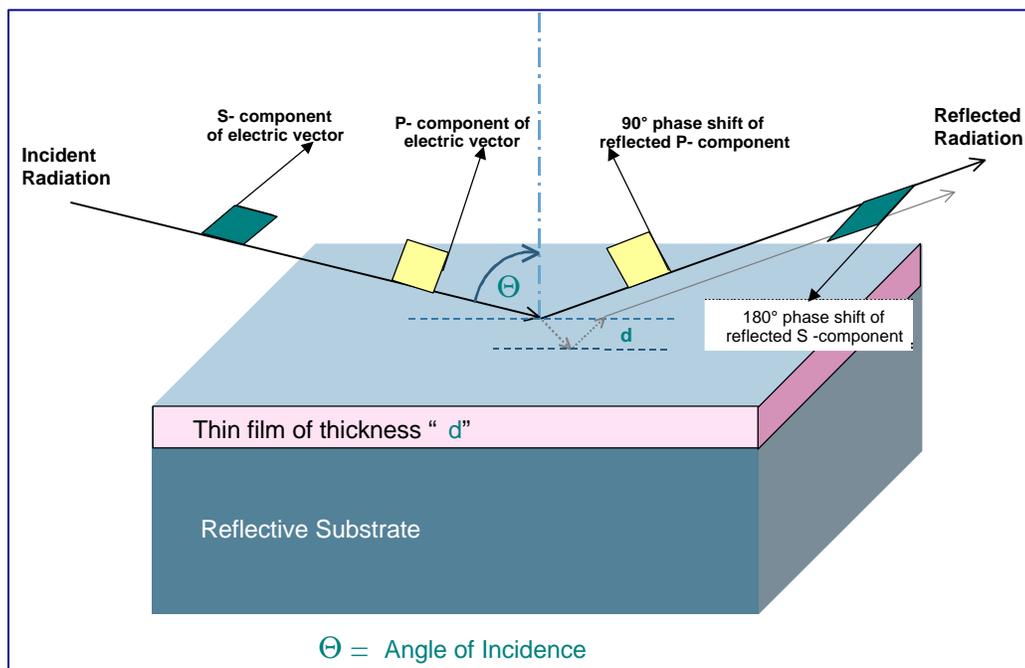
Figure 1. Infrared energy striking a contaminated reflective substrate at a grazing angle of incidence.

Grazing-angle reflectance theory can be explained by referring to Figure 1. In reflection spectroscopy, a portion of the incident radiation beam (in this case infrared) reflects off the surface of a thin film, while the remaining portion travels (is refracted) through the film and reflects off a reflective substrate back through the film. This is known as “double-pass” reflection-absorption (Refs 4 and 5)

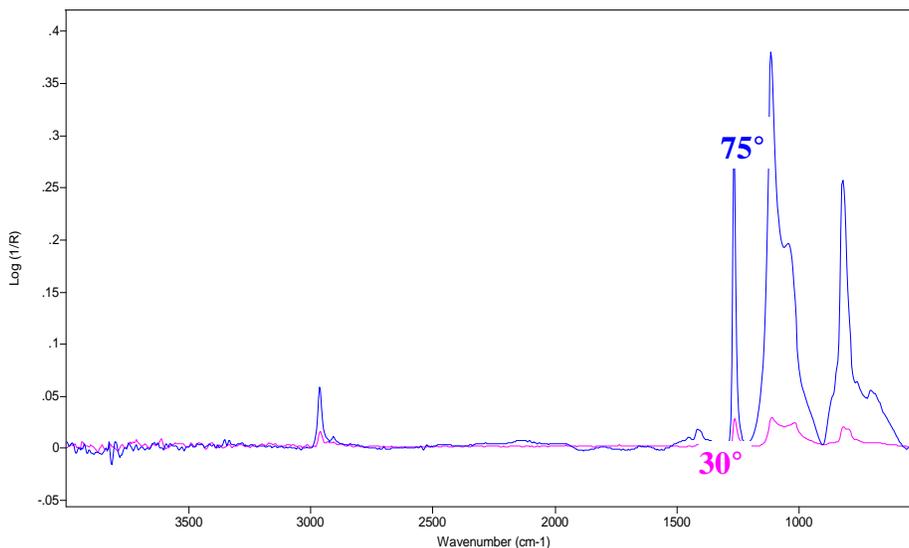
Figure 2. Comparison of a 0.2 μm silicone film on aluminum analyzed at 30° and 75°.

Figure 2 shows a typical reflectance-absorbance FTIR spectrum. The “peaks” or “bands” represent infrared light absorbed by the chemical species being analyzed. The two spectra represent a very thin film of electrically insulating grease on an aluminum substrate analyzed at 0 and 75 degrees (grazing-angle), respectively. The absorbance of the infrared energy in the material is dramatically enhanced at 75 degrees. In the enhanced spectrum, the location and shape of the peaks allow an FTIR analyst to easily classify this material as a silicone.

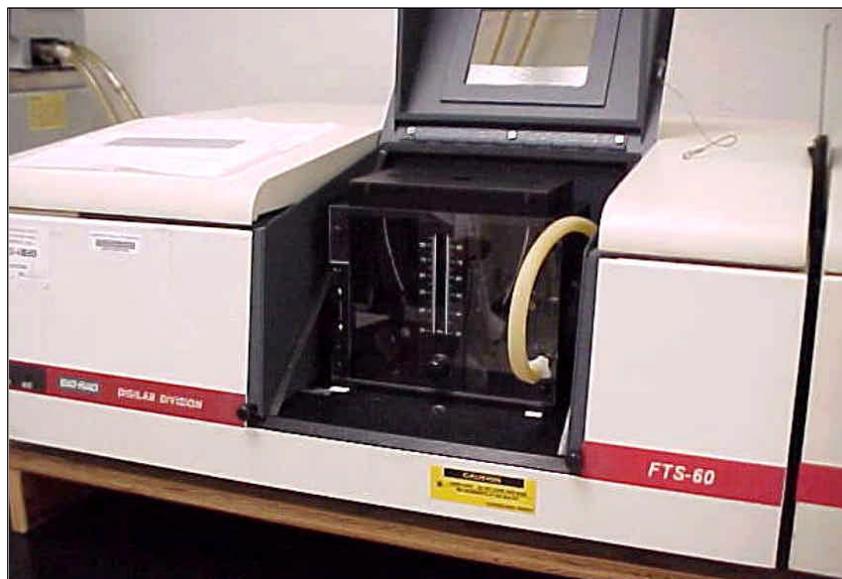
Figure 3. FTIR with variable-angle sampling device.

The grazing-angle sampling device used in the laboratory FTIR is commercially available. It is designed for installation inside the sample compartment of a laboratory FTIR, i.e., non-portable operation (Figure 3). This interface is a variable-angle device, allowing analysis of a variety of reflective parts at incident radiation angles of 30 to 80 degrees.

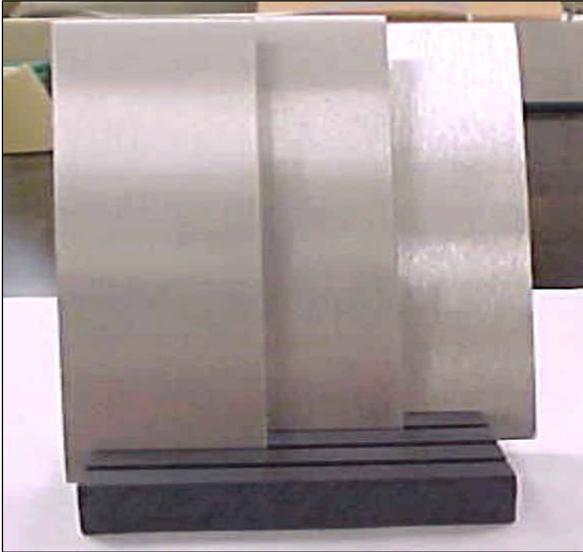
Figure 4. Aluminum surface roughness values 600-, 220-, 80-grit (from left to right).

Three surface roughness finishes of commercially milled aluminum test coupons were selected: 80-, 220-, and 600-grit (600-grit being the smoothest). Grit refers to the sandpaper or abrasive blast used by the vendor to create the surface profiles. Two surface roughness levels, 600- and 220-grit, were selected for the remaining commercial metal types. Values were selected as a result of feedback from potential FTIR users at DOD and contractor fabrication and repair facilities. Figure 4 shows varying roughness levels of the aluminum. Figure 5 shows all of the metal types tested.

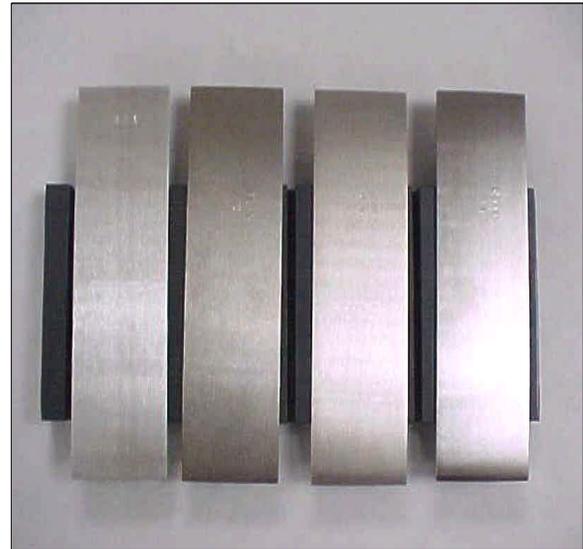
Figure 5. Aluminum, titanium, stainless steel, and steel alloy (from left to right, all at 600-grit).

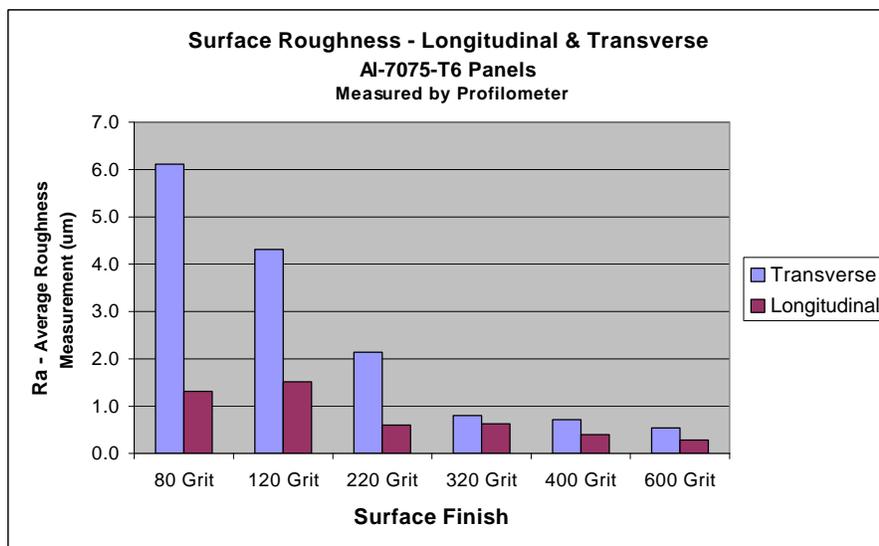
Figure 6. R_a values related to surface finish of test panels.

Due to the nature of metal shop finishing processes, surface roughness values can vary considerably across a given surface area. The metal surfaces of the coupons, upon finishing at the vendor’s facility, acquired a directional “grain” parallel to the coupons’ longitudinal axis. Figure 6 shows the variation in surface roughness for the aluminum panels and the relationship to grit finishes. The profilometer data reveal that R_a differences for longitudinal orientation are not as extreme as the differences for transverse orientation.

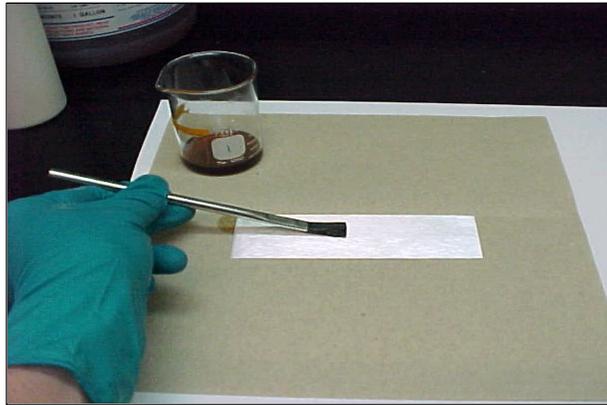
Figure 7. Contaminant being applied to an aluminum panel by manual brushing.

Contaminants were applied by dilution in appropriate solvents and manual brushing onto the panels (Figure 7). Contaminant D, for example, was diluted in a mixture of water and isopropyl alcohol. Water-only dilutions were found to result in poor wetting of the metal substrates. Alcohol-only dilutions resulted in formation of a solid precipitate from Contaminant D. The combination of water and isopropyl alcohol provided sufficient solvating properties for Contaminant D and adequate wetting of the substrate.

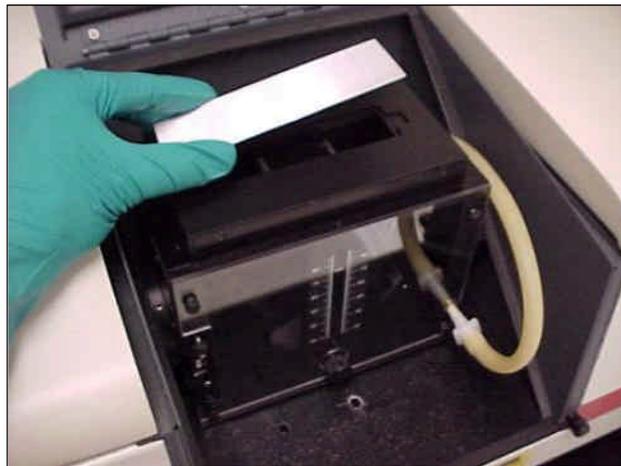
Figure 8. Coupon being placed longitudinally onto sampling device.

The test coupons were analyzed at NFESC with the laboratory FTIR and grazing-angle reflectance sampling device (Figure 8). Spectra were collected at a 75-degree angle of incidence for all of the specimens, and also at 60 degrees for selected samples. Theoretically, incident angles of 80 to 85 degrees provide the greatest enhancement of the reflectance-absorption signal for metal substrates. However, the configuration of a particular instrument and sampling device optics, as well as the characteristics of the sample may dictate using a smaller angle. It was determined during Year 1 that setting the particular laboratory-sampling device to 80 degrees was increasing baseline noise without significantly enhancing the peak intensities in proportion to the noise. Thus, 75-degree measurements were taken instead of 80-degree measurements.

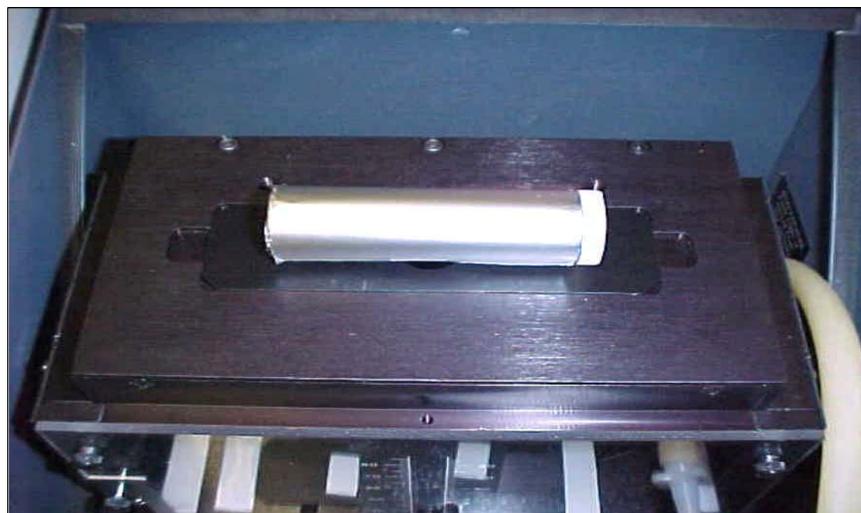
Figure 9. Cylinder being analyzed in a longitudinal orientation.

strips were roughened with 220-grit sandpaper before the other preparation steps. The remaining strips had a finish that approximating the 600-grit flat aluminum panels. The cylindrical strips were analyzed at NFESC in the same manner as the flat panels (Figure 9).

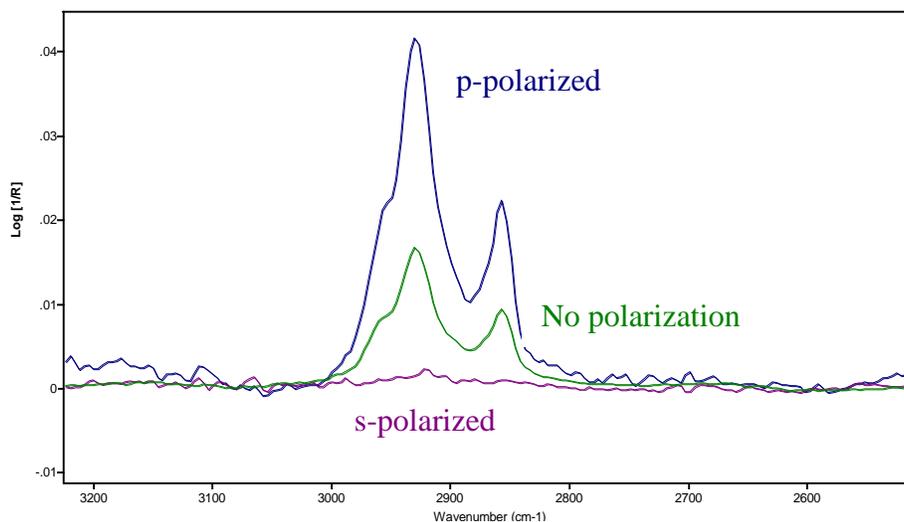
Figure 10. Spectra of a hydrocarbon on vapor degreased aluminum showing the effects of polarization.

All test coupons were analyzed using a polarizer in the reflectance device, both laboratory and portable. Figure 10 shows the C-H stretching spectral region of a hydrocarbon contaminant on a vapor-degreased aluminum panel analyzed at 75 degrees with s-polarization, no polarization, and p-polarization of the reflected radiation, respectively. The spectral peaks are enhanced significantly with p-polarization.

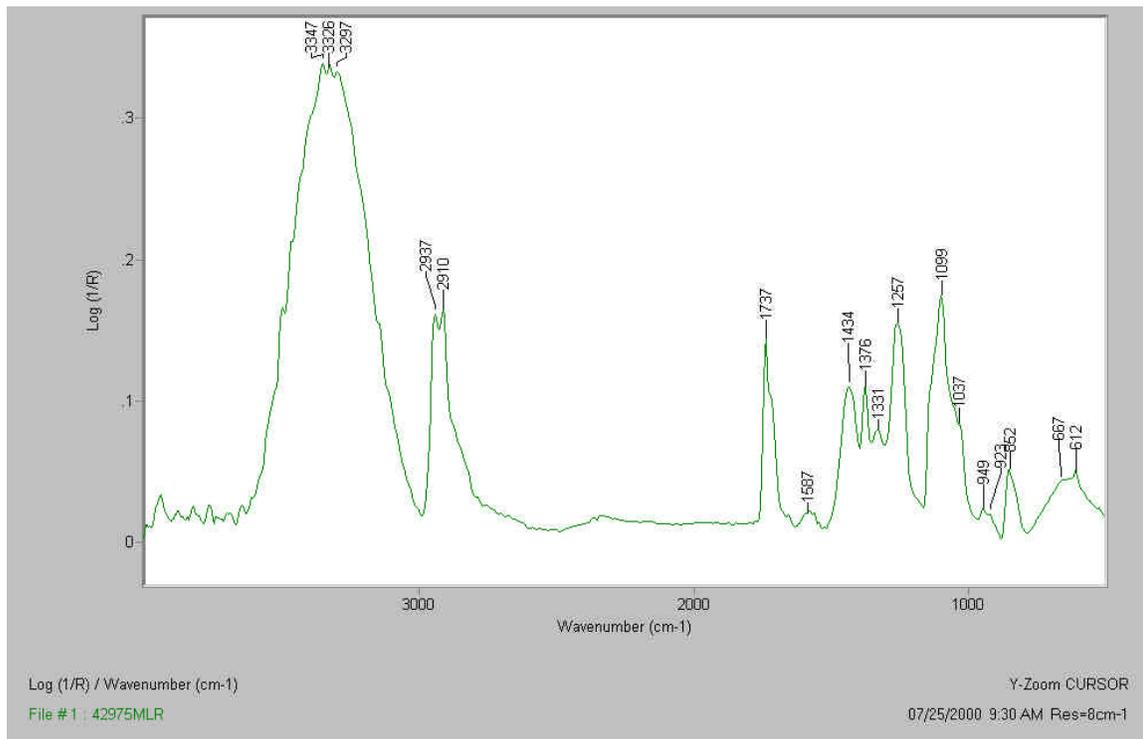
Figure 11. Spectrum of Contaminant D on aluminum coupon ($< 1.0 \mu\text{m}$).

Figure 11 shows a grazing-angle reflectance spectrum of Contaminant D on an aluminum test coupon (600-grit). For the FTIR analyst, accurate interpretation of the peaks and classification of this film as a vinyl polymer is straightforward because the grazing angle spectrum obtained is intense and clear, even at a film thickness level of $< 1 \mu\text{m}$. In contrast, other FTIR methods such as diffuse reflectance or specular reflectance would produce much less intense spectra at this level, making it more difficult to accurately classify or quantify the surface contaminant.

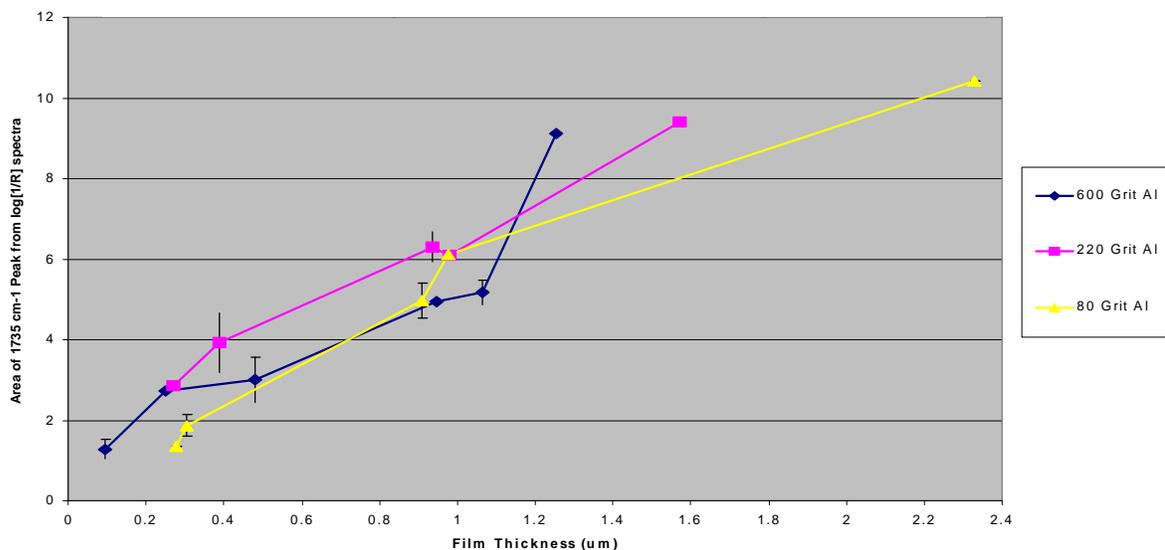
Figure 12. Integrated peak areas of the 1735 cm^{-1} peak in the FTIR reflectance spectra of aluminum panels contaminated with Contaminant D as a function of surface roughness.

A surprising degree of non-linearity was observed for the smoothest aluminum coupons, while the 220- and 80-grit panels produced more predictable results. The 600-grit coupons were expected to yield good linearity, and greater peak intensity, since the contaminant is similar in its physical properties to Contaminant B (analyzed during the first year of the project). Both are liquids, soluble in selected solvents, and easy to apply to the metal substrates. It may be that the smoothest surface resulted in the Contaminant D film being distributed less evenly across the surface in contrast to application on the rougher panels. Selected coupons were analyzed at different locations along their lengths and averaged to check for film uniformity. In Figure 12 the vertical error bars indicate similar amounts of variation were observed for the three surface roughness profiles.

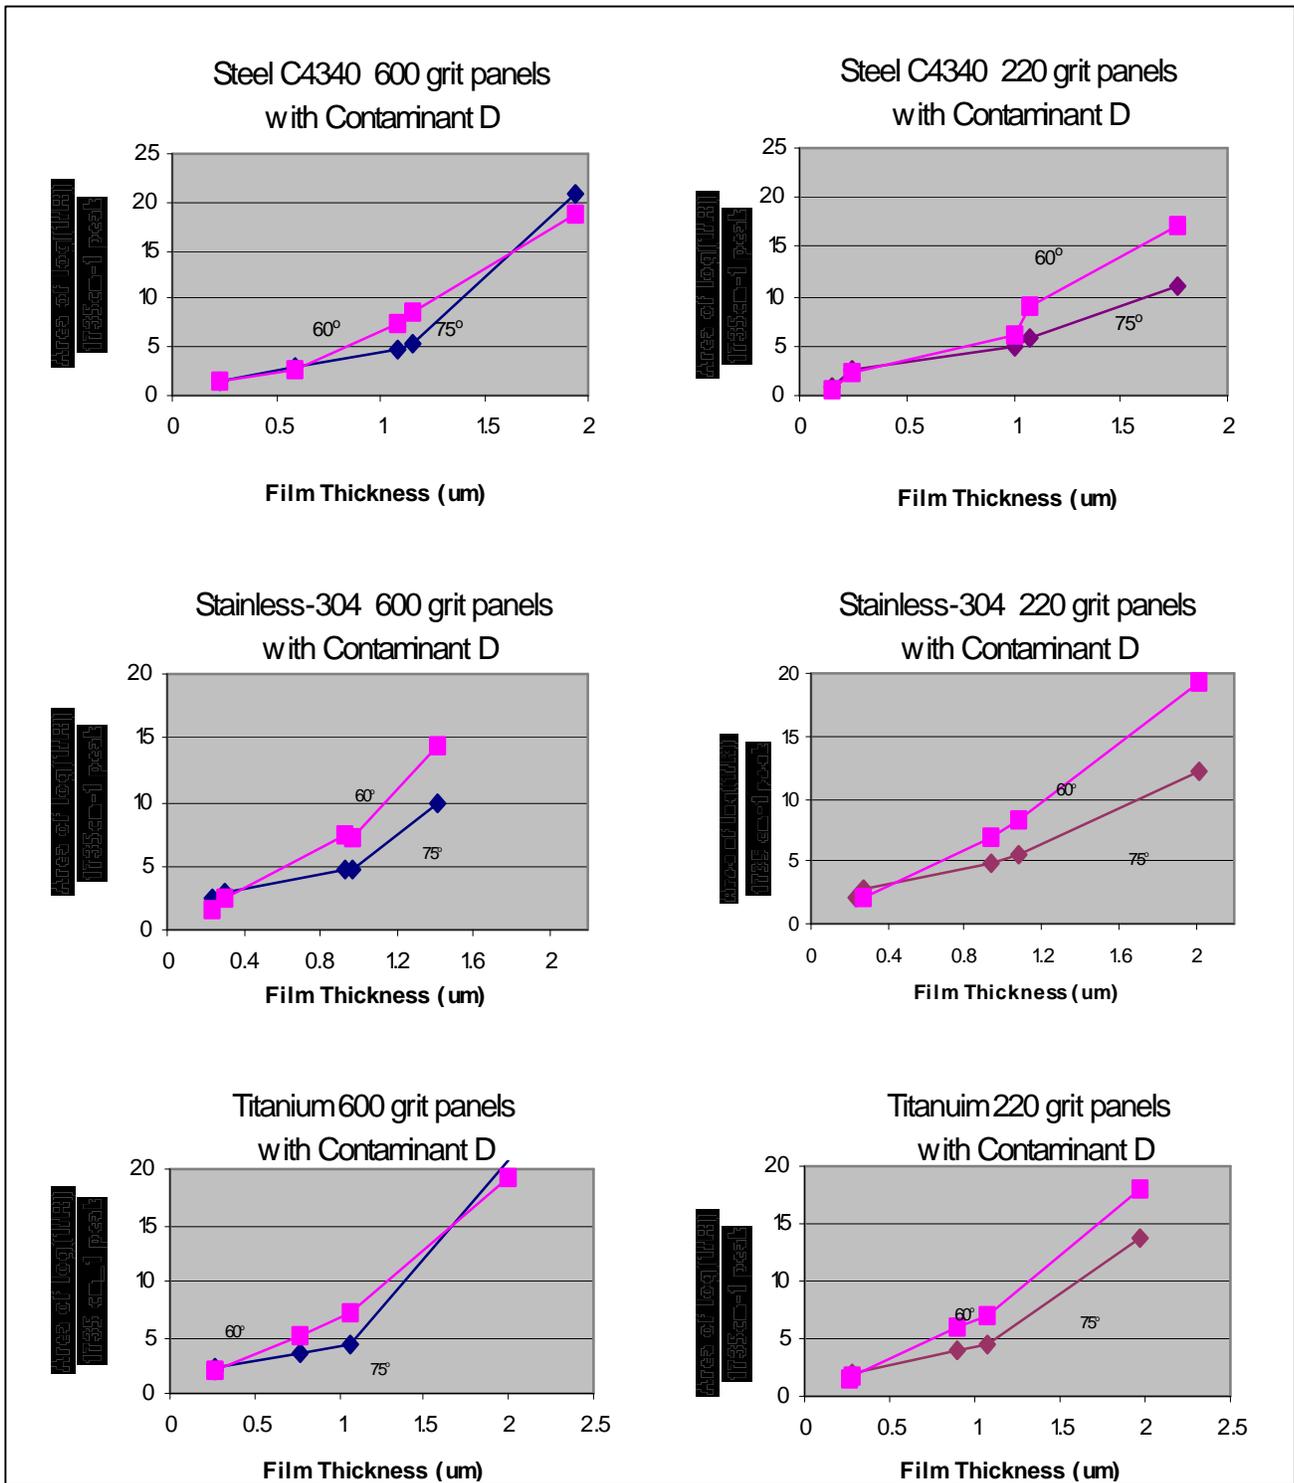
Figure 13. Calibration curves created from calculated spectral peak areas versus film thickness of Contaminant D on three metal substrates with two levels of roughness.

Figure 13 shows calibration curves calculated for Contaminant D on metal substrates other than aluminum. As in Figure 12, the peak area of the carbonyl peak (representing the absorbance level of the contaminant proportional to amount of contaminant present) is plotted against the calculated film thickness values. These curves can then be used to quantify the contamination on specimens with unknown levels.

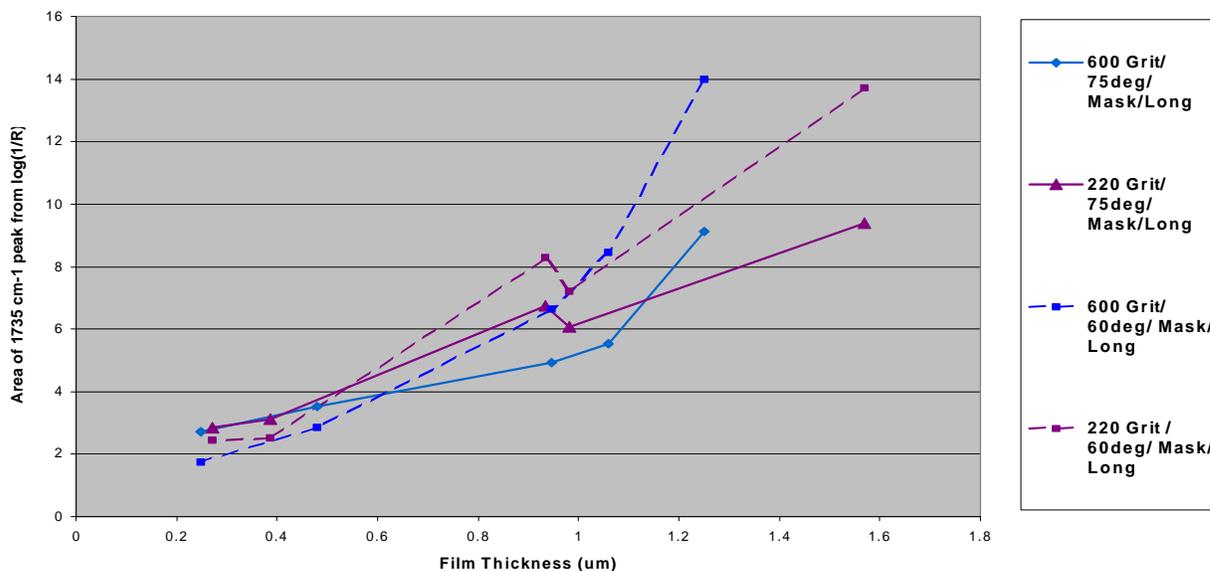
Figure 14. Integrated peak areas of the 1734 cm^{-1} band in the FTIR reflectance spectra of aluminum 7075 panels contaminated with Contaminant D as a function of angle-of-incidence.

In contrast to Contaminant A, however, Contaminant D dries to a glossy, relatively smooth finish. Thus, the lessened intensities for the 75-degree analyses were somewhat unexpected. The refractive properties may be interfering with the IR beam’s ability to travel through the layer by some other mechanism. Conversely, predictable results are obtained at contaminant thickness values below approximately 0.5 μm . The intensities at 75 degrees exceed those at 60 degrees, as expected.

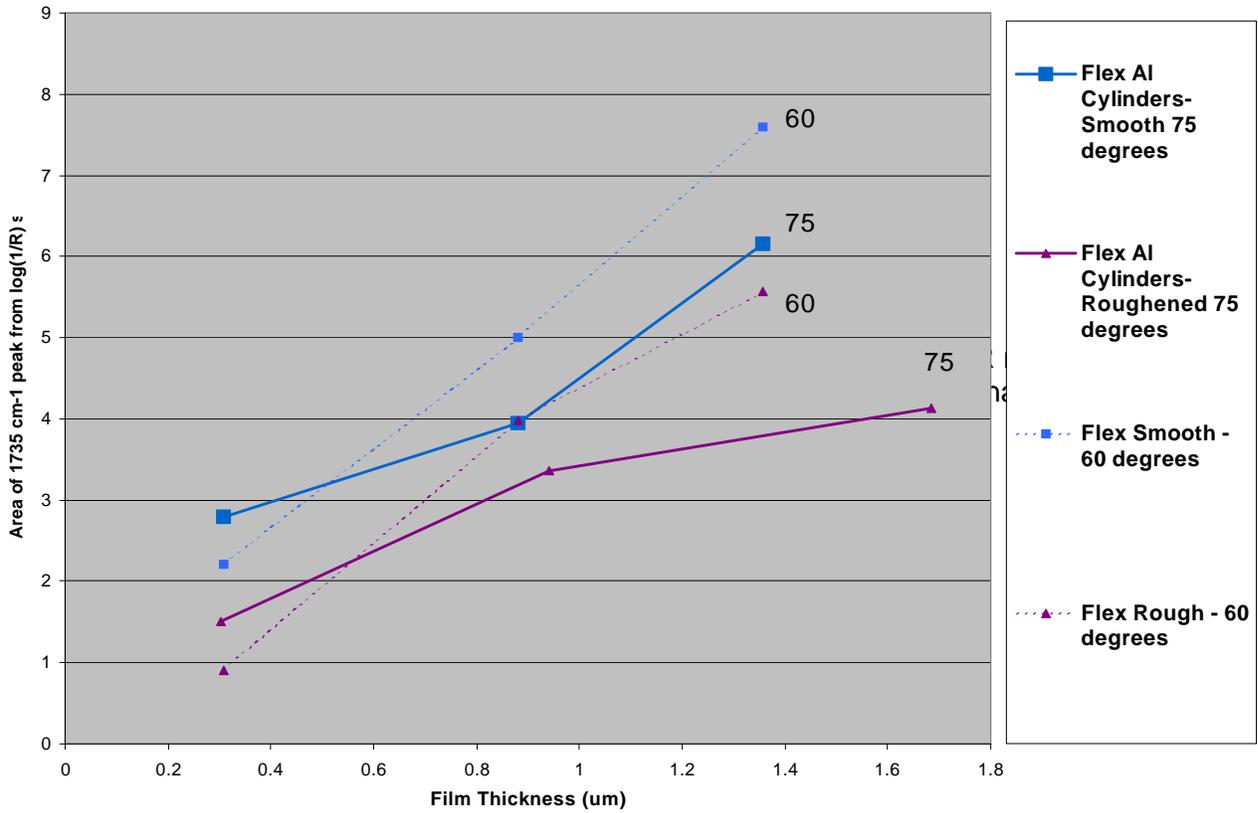
Figure 15. Contaminant D on aluminum cylinders at two angles of incidence and two surface profiles (1-cm radius, longitudinal orientation).

For the cylindrical samples, a cross over of intensity is also seen in Figure 15 for the specimens analyzed at 75 versus 60 degrees, just as occurred with the flat specimens (Figure 15). Predictably, the smoother 600-grit cylinders show more intense contaminant peaks for a given film thickness. A predictable nonlinear increase in peak areas is observed for coupons with $>1 \mu\text{m}$ contamination. That is, the grazing angle technique is not as accurate (linear) at levels of contamination above this region.

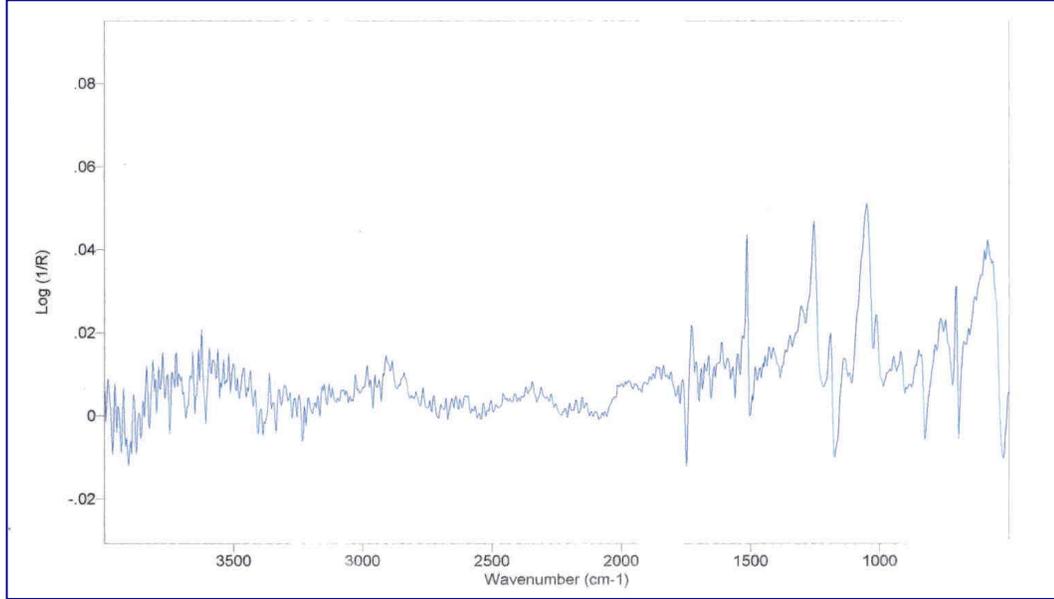
Figure 16. Spectrum of a vinyl ester fiberglass composite soiled with approximately $300 \mu\text{g}/\text{cm}^2$ hydrocarbon mixture and ratioed against a background spectrum of clean composite.

Figures 16, 17, and 18 show the results of the study. Poor quality spectra were obtained. The energy throughput to the detector was low due to the non-reflective, organic background. This is evidenced by the low $\log(1/R)$ values (y axis). Noise, fringe patterns, and “specular reflectance” are evident. Contaminant film concentrations were calculated by weighing to be approximately $300 \mu\text{g}/\text{cm}^2$ for the three samples. At this level of contamination, the peaks from the hydrocarbons on a reflective surface would be strong and easily identifiable, especially in the region of 3000 to 2800 cm^{-1} . The sharp bands in the lower wavenumber region, called “Rehstrahlen” peaks, are due to specular reflectance and are not real peaks from the contaminant. The FTIR operator would not be able to identify a contaminant, nor quantify it, from such spectra. The grazing-angle reflectance technique is unsuitable for analyzing organic contaminants on organic composite surfaces.

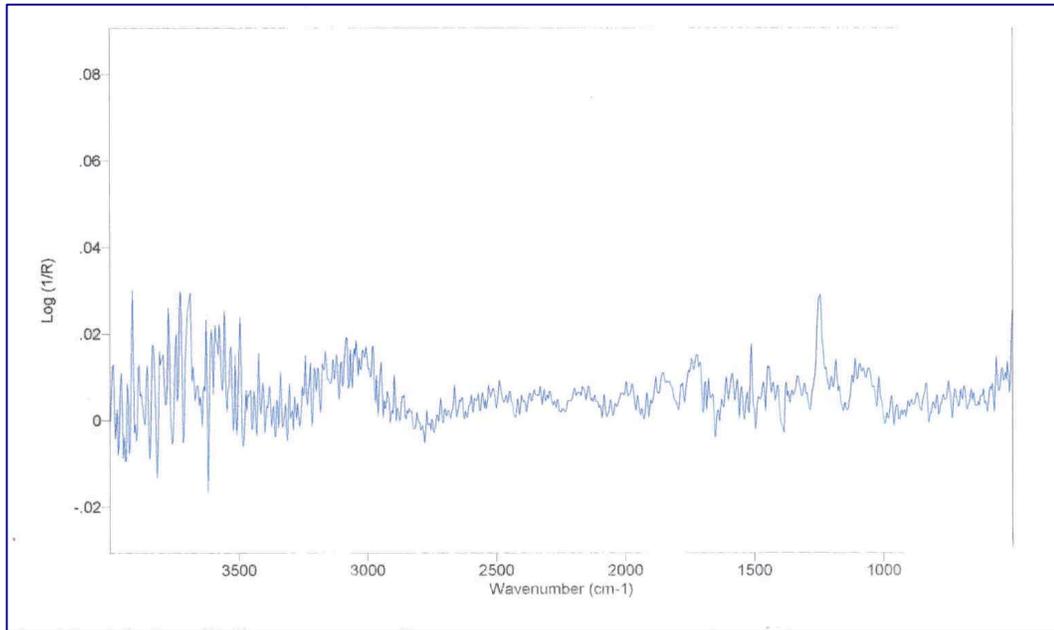
Figure 17. Spectrum of an epoxy fiberglass composite soiled with approximately $290 \mu\text{g}/\text{cm}^2$ hydrocarbon mixture and ratioed against a background spectrum of clean composite.

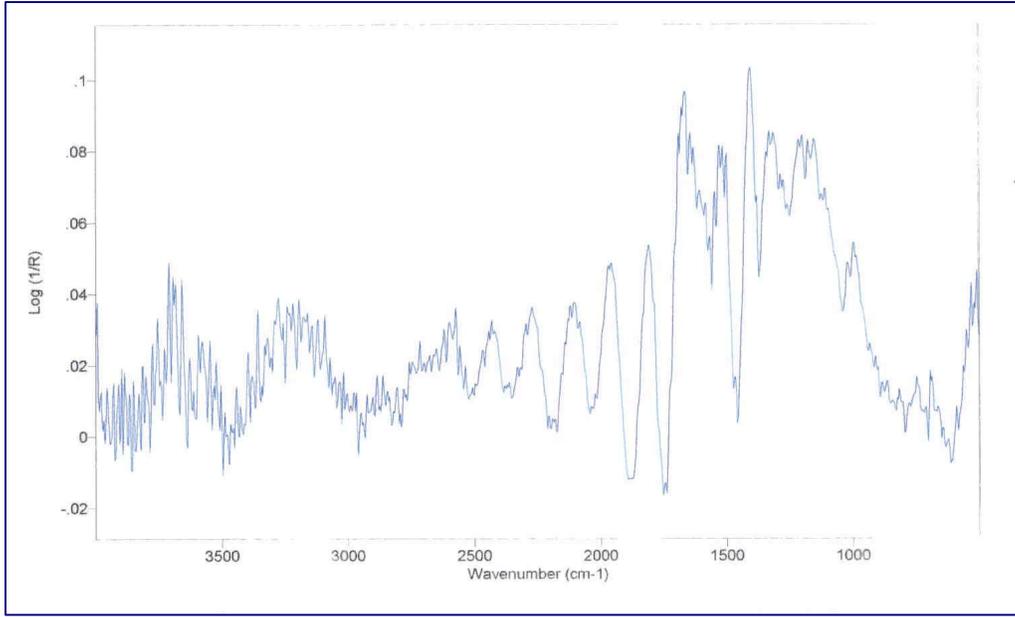
Figure 18. Spectrum of a carbon fiber vinyl ester composite ratioed against a background spectrum of clean carbon fiber vinyl ester composite. A dramatic fringe pattern is evident.

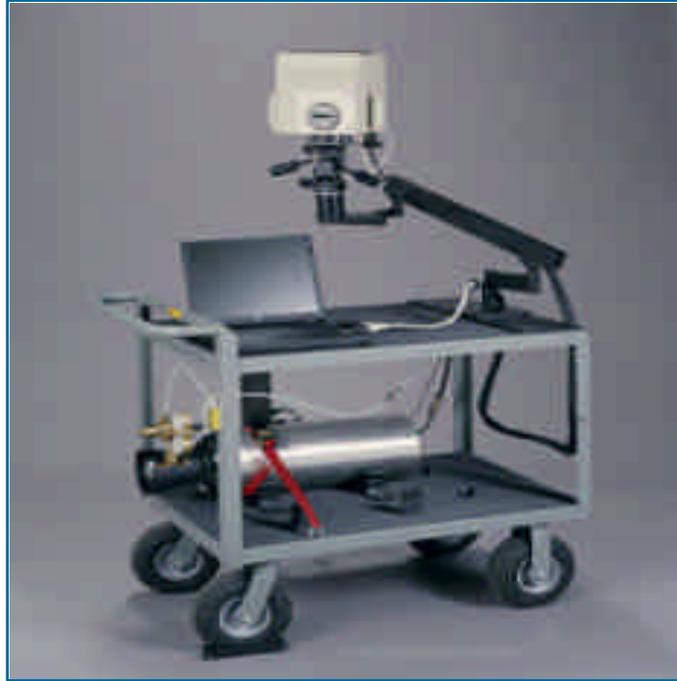
Figure 19. Portable grazing-angle FTIR prototype with computer and cart assembly.

The contract for the development and demonstration of the portable FTIR device was awarded in May 2000 to Surface Optics Corporation (SOC) in San Diego, CA. The design and construction of the grazing-angle reflectance prototype was completed in August 2000, including the construction of a mobile cart for transporting the unit and a swing arm for stable positioning of the unit during analysis. A laptop computer, purge gas supply, and power supply were also included in the prototype package, as shown in Figure 19.

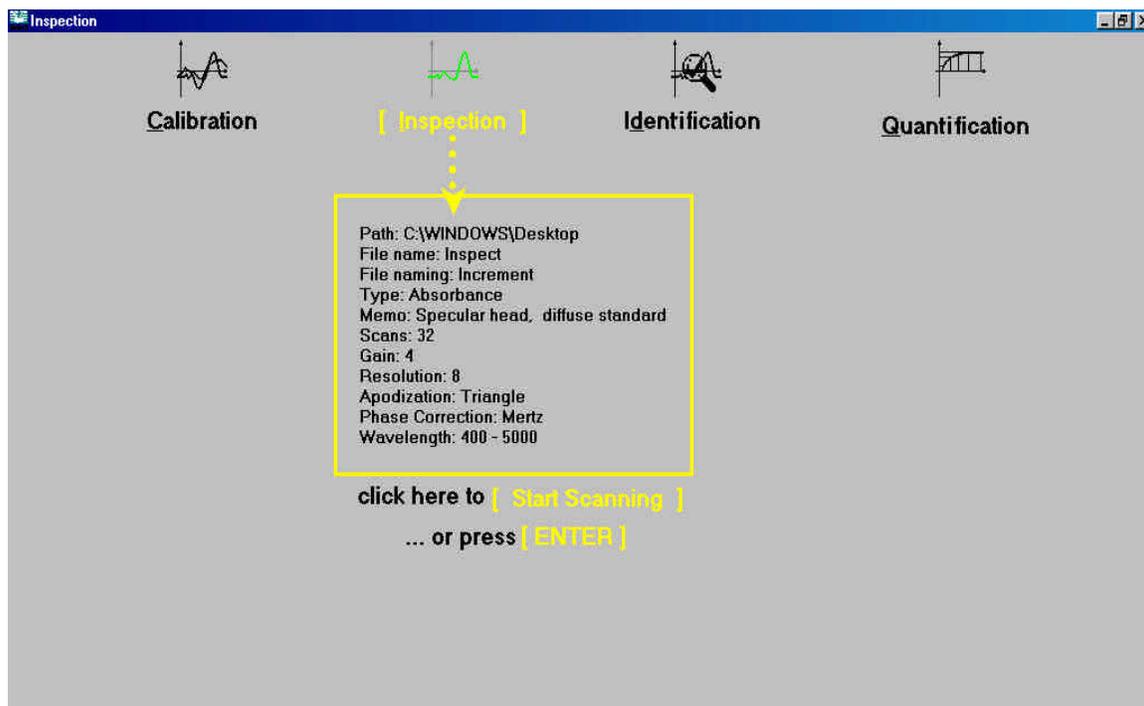
Figure 20. The Inspection Screen is designed for everyday surface inspections use by non-technical personnel.

The goal of the software development was to allow prediction of surface contamination levels with one click of a remote switch. The recorded spectrum is automatically searched against a spectral library of contaminants (either commercially available or user-specific). The operator has an option to accept the automated selection or browse the library for a more intuitive selection. When the selection is made, an appropriate calibration curve is applied and the contamination level is predicted. The software is Windows-based, and many of the operation functions can be accessed by selecting and pressing icons (Figures 20, 21, 22, 23, and 24).

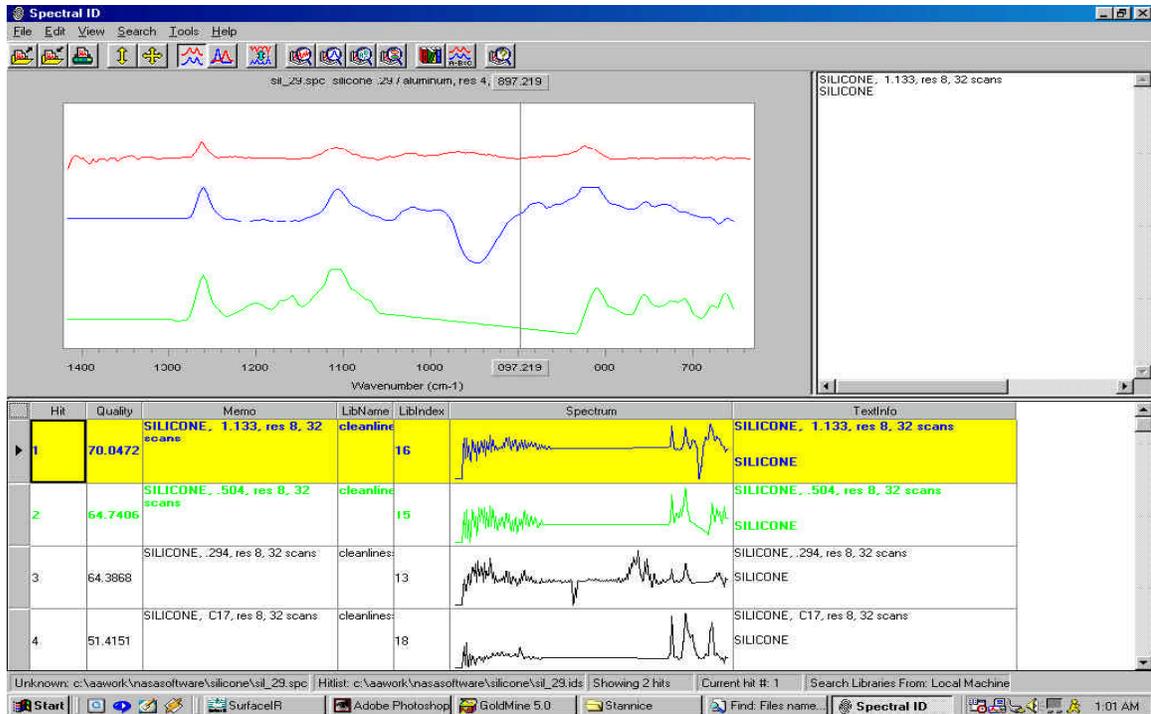
Figure 21. Identification of contamination is based on a search of spectral libraries in the computer. Libraries can be created by the operator using known contaminants on calibrated coupons.

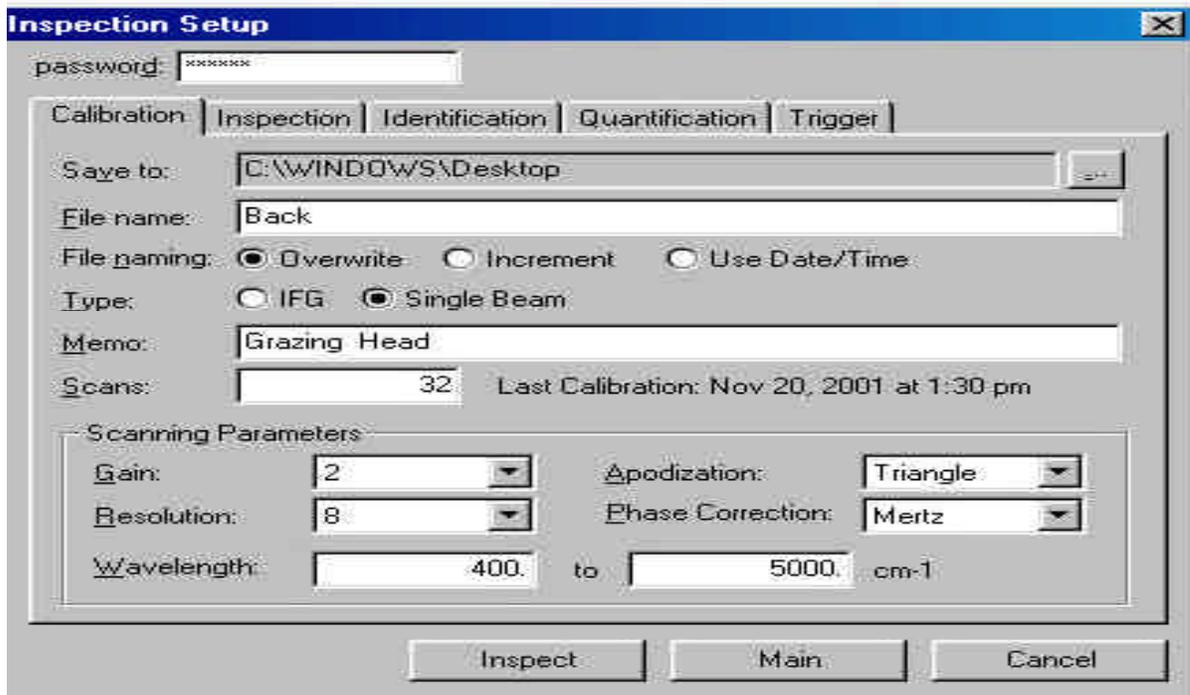
Figure 22. Operator selects parameters for routine operations of calibration, inspection, identification, and quantification.

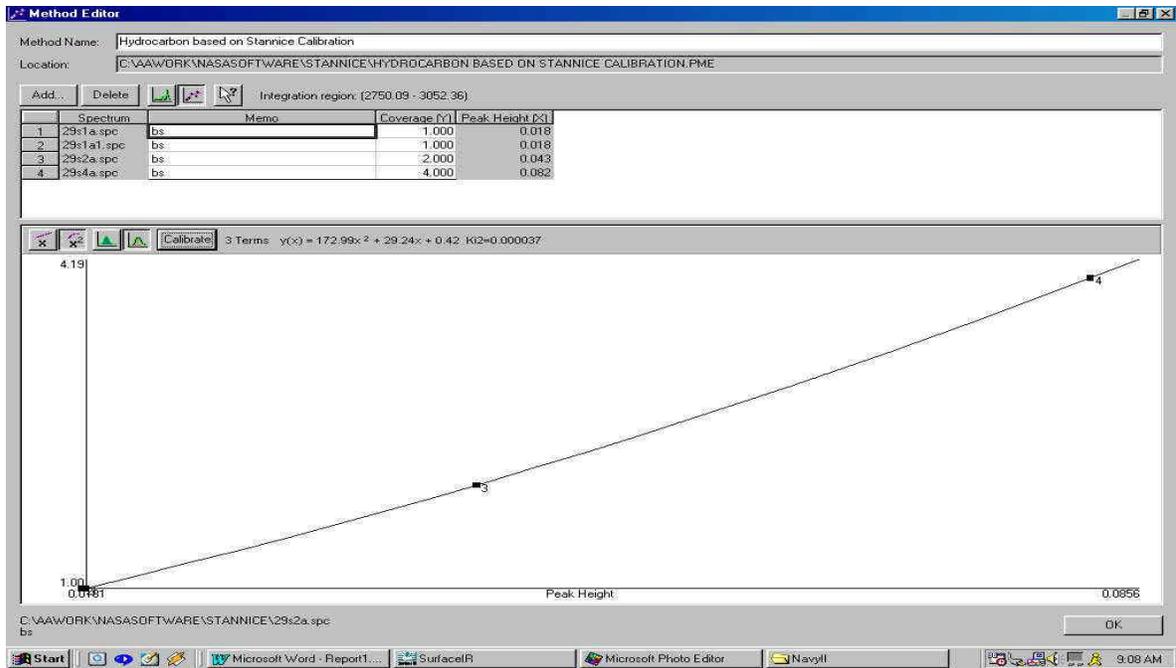
Figure 23. Quantitative analysis is accomplished by generating calibration curves from calibration coupon spectral data.

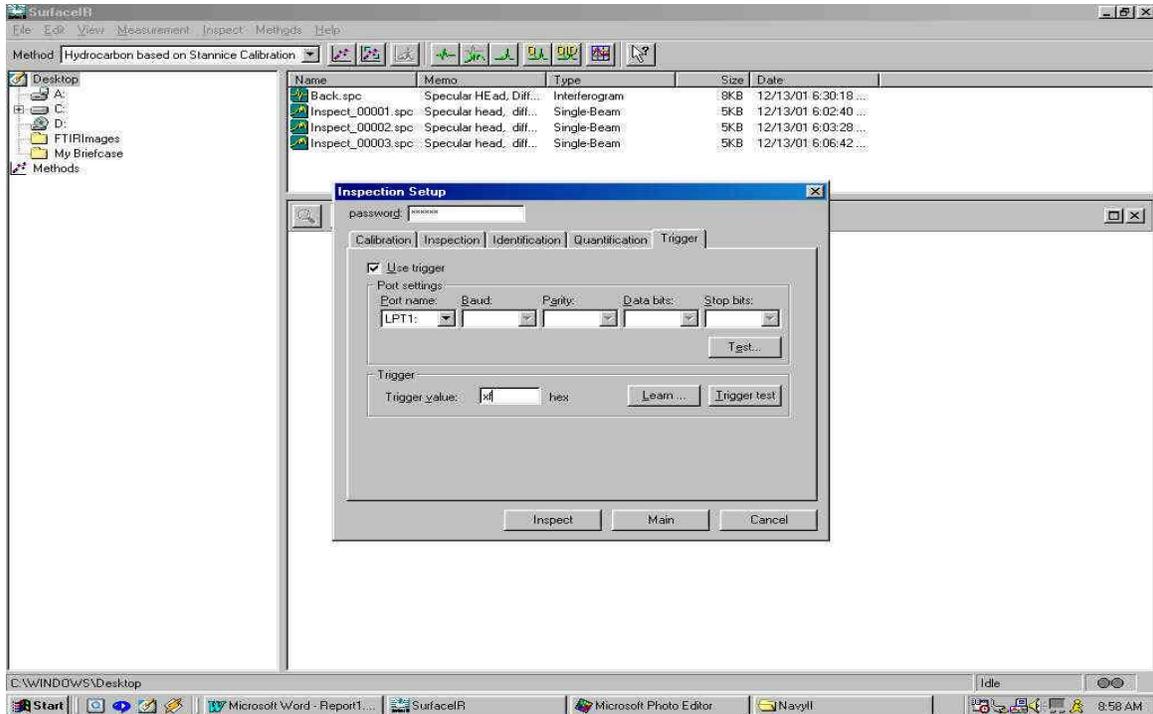
Figure 24. The remote trigger can be set up at the computer.

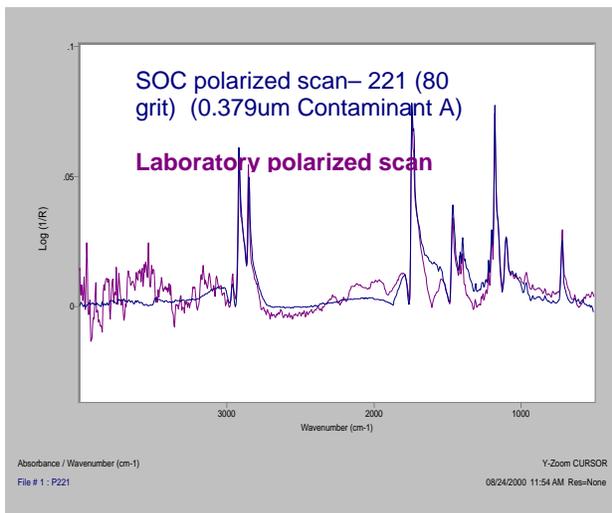
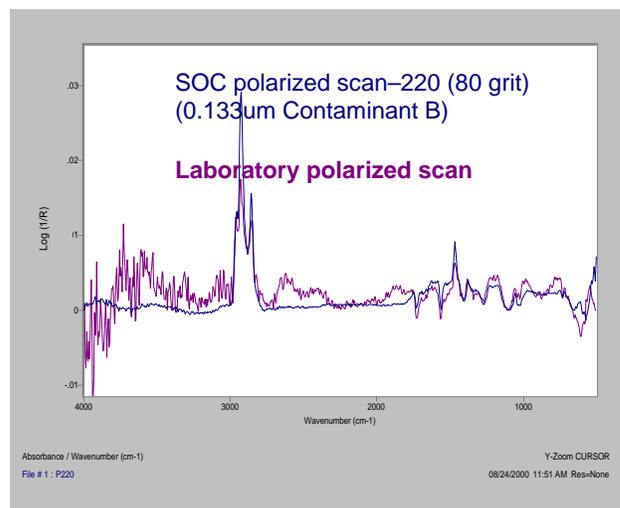
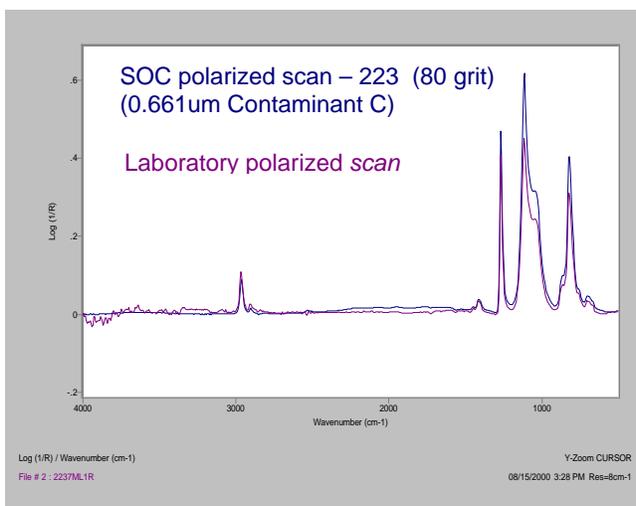
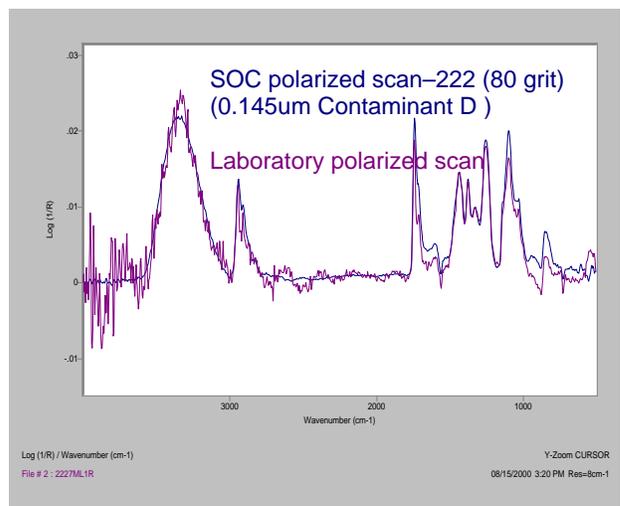
The SOC instrument consistently outperformed the laboratory device in terms of signal-to-noise ratios. In the spectra presented in Figures 25, 26, 27, and 28, the noise level differences are visually dramatic. The lower noise levels allow the FTIR operator (and software) to more easily and accurately assess the contaminant's identity and quantity on the surface of the coupons. The patented design of the SOC FTIR optics allows for this improvement.

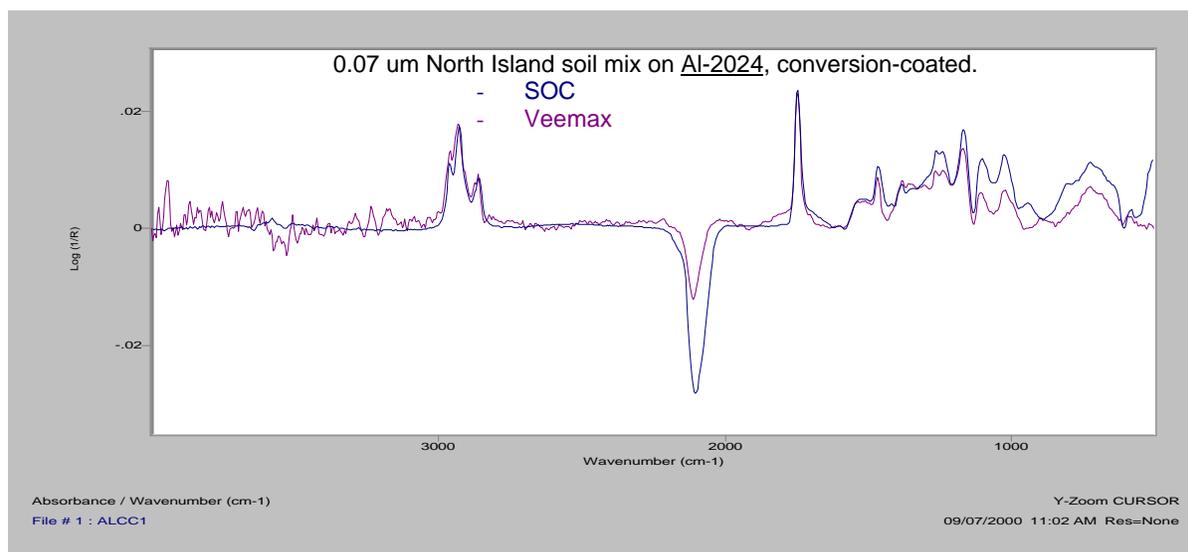
Figure 29. North Island soil mix on conversion coated aluminum. SOC versus laboratory grazing-angle FTIR devices.

NFESC analyzed all of the test panels with its variable-angle laboratory reflectance unit before providing them to SOC. As with the specimens prepared on commercial coupons, for a given number of scans and background material, the prototype device consistently produced spectra with better signal-to-noise levels than those produced with the laboratory unit. Overall, intensities for peaks of a given contaminant and coupon were the same for both the SOC FTIR prototype and the laboratory unit. Figures 29, 30, 31, and 32 show comparative spectra of North Island soil mix on aluminum panels with the various surface treatments.

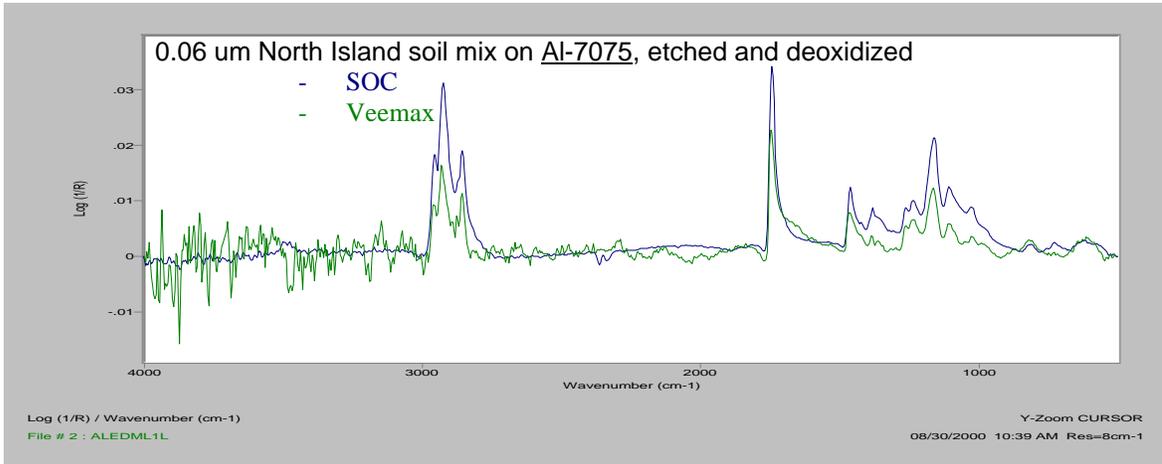
Figure 30. North Island soil mix on etched and deoxidized aluminum.
SOC versus laboratory grazing-angle FTIR devices.

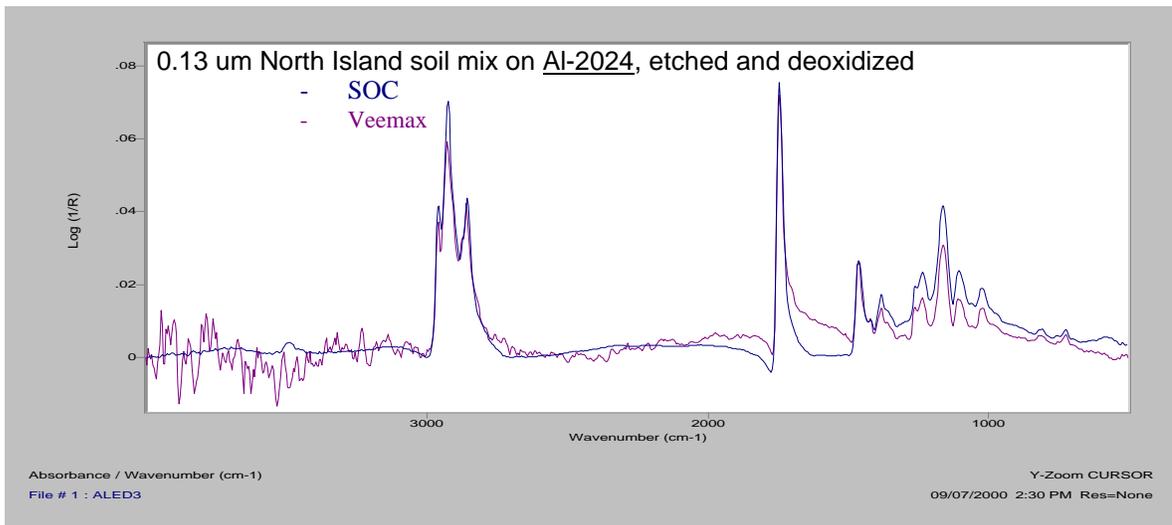
Figure 31. North Island soil mix on etched and deoxidized aluminum 2024.
SOC versus laboratory grazing-angle devices.
