NAVAL FACILITIES ENGINEERING SERVICE CENTER
Port Hueneme, California 93043-4370

Technical Report TR-2217-SHR

GRAZING-ANGLE FOURIER TRANSFORM INFRARED SPECTROSCOPY FOR SURFACE CLEANLINESS VERIFICATION

Final Report

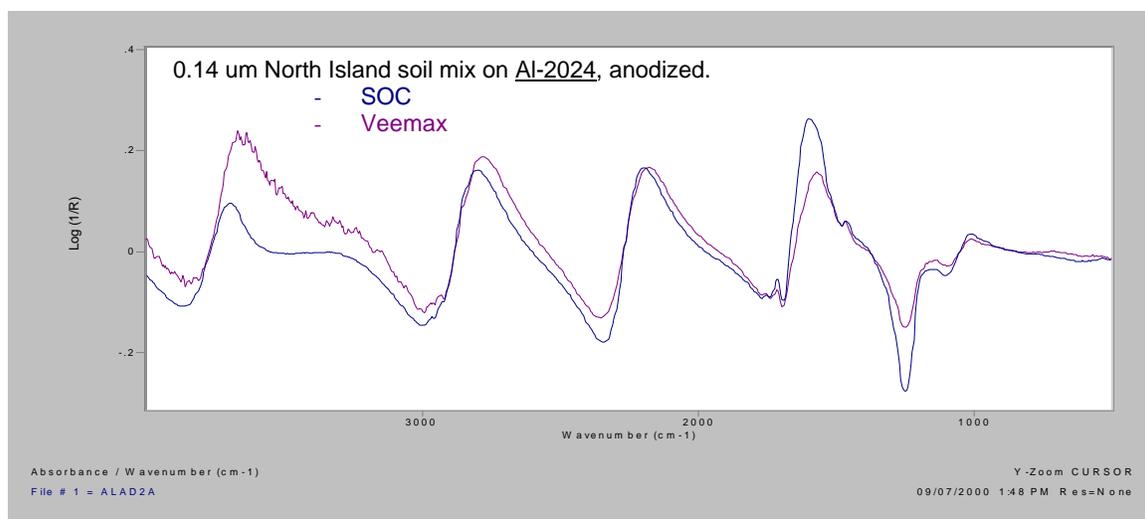
Figure 32. North Island soil mix on aluminum coated with a typical aircraft paint.

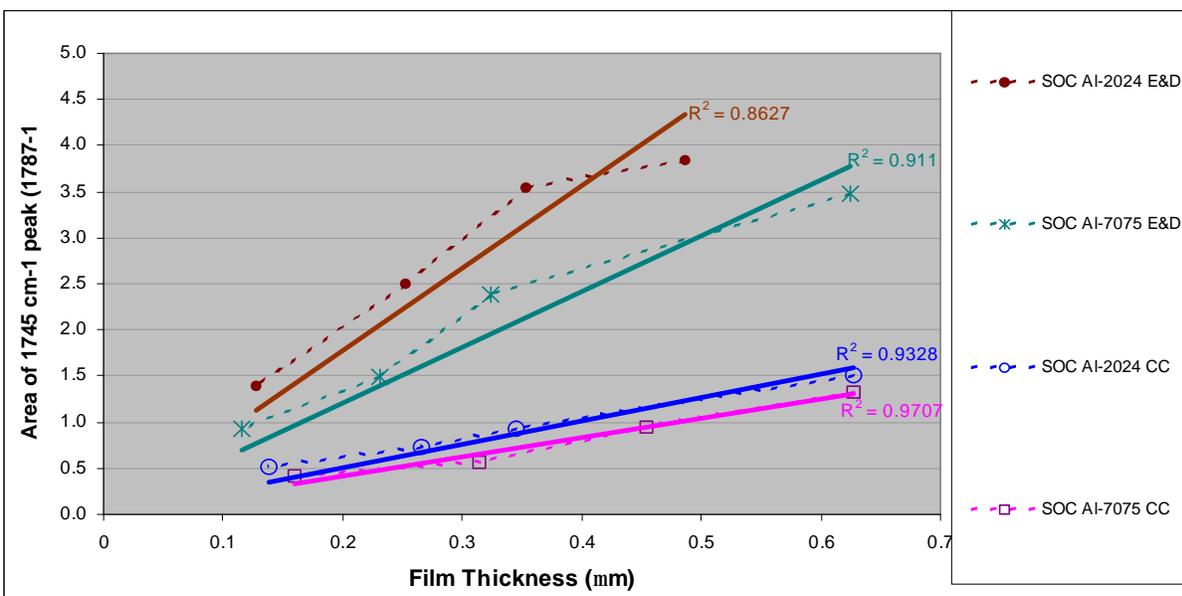
Figure 33. Calibration curves for North Island soil mix on etched and deoxidized, and dichromate conversion coated aluminum (series 2024 and 7075).

Since they were optically thin, the other substrate treatments were successfully analyzed by the grazing-angle devices. Figure 33 below shows the SOC data and calibration curves for two types of aluminum (2024 and 7075) and two types of metal treatment (etched & deoxidized, and dichromate conversion coated) soiled with the NADEP North Island mixture. Overall, very good linearity is observed for the four different substrates.

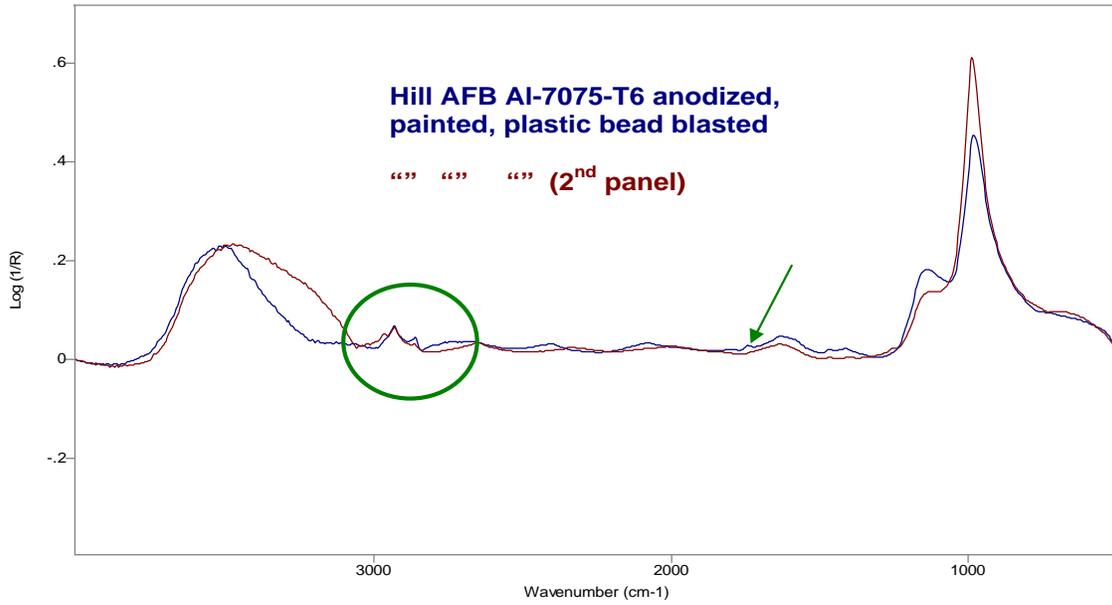
Figure 34 shows two anodized panels, painted then blasted. There is evidence of hydrocarbon contamination (peaks in circle) on both panels. The small but distinctive peak in the blue spectrum at approximately 1740 cm^{-1} (arrow) suggests some of the hydrocarbon contamination is due to an ester material such as that found in the plastic blast media used to strip the surface. The FTIR computer software allows the operator to zoom in on and enlarge peaks of interest for a more accurate assessment.

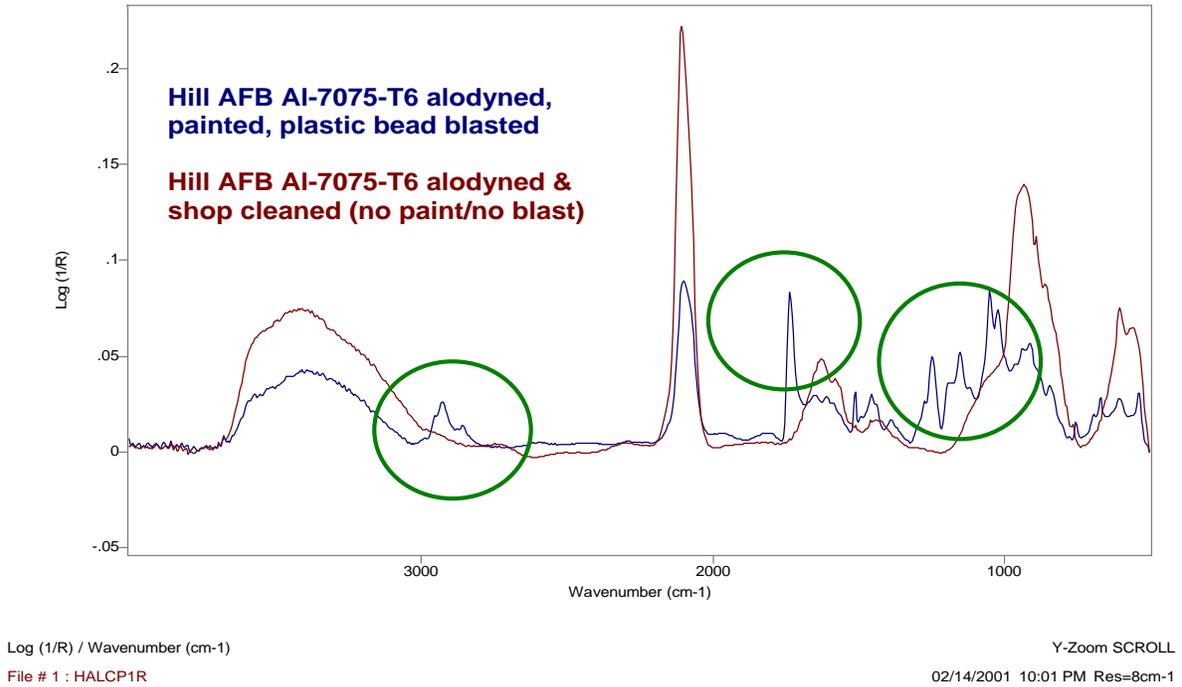
Figure 35. Alodined panels representing two different processing conditions.

In Figure 35, the blue spectrum represents an alodined, painted, then stripped panel. The blue spectrum displays strong peaks (circled) indicating a significant amount of an aliphatic hydrocarbon-carbonyl contamination. This spectrum is indicative of an acrylate, such as would be found in plastic blast beads. The brown spectrum, shown for comparison, is shop-cleaned and alodined but not painted or stripped. The brown peaks are due to the alodyne finish, not hydrocarbon contamination.

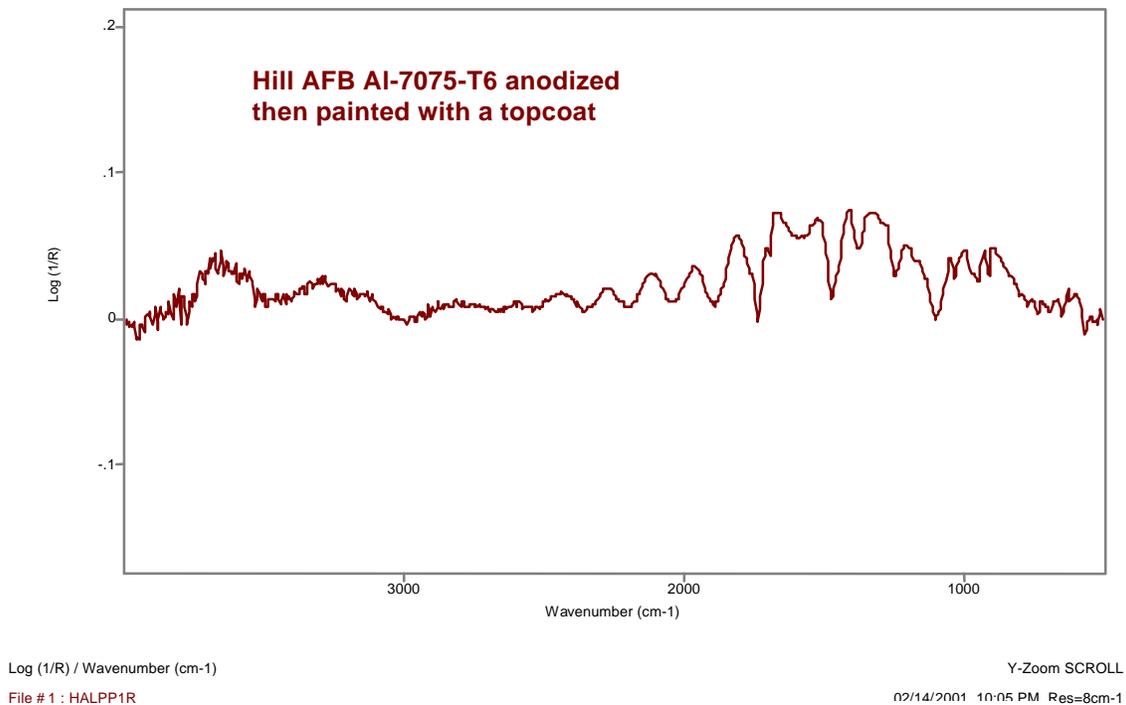
Figure 37. Grazing-angle spectrum of a painted aluminum panel.

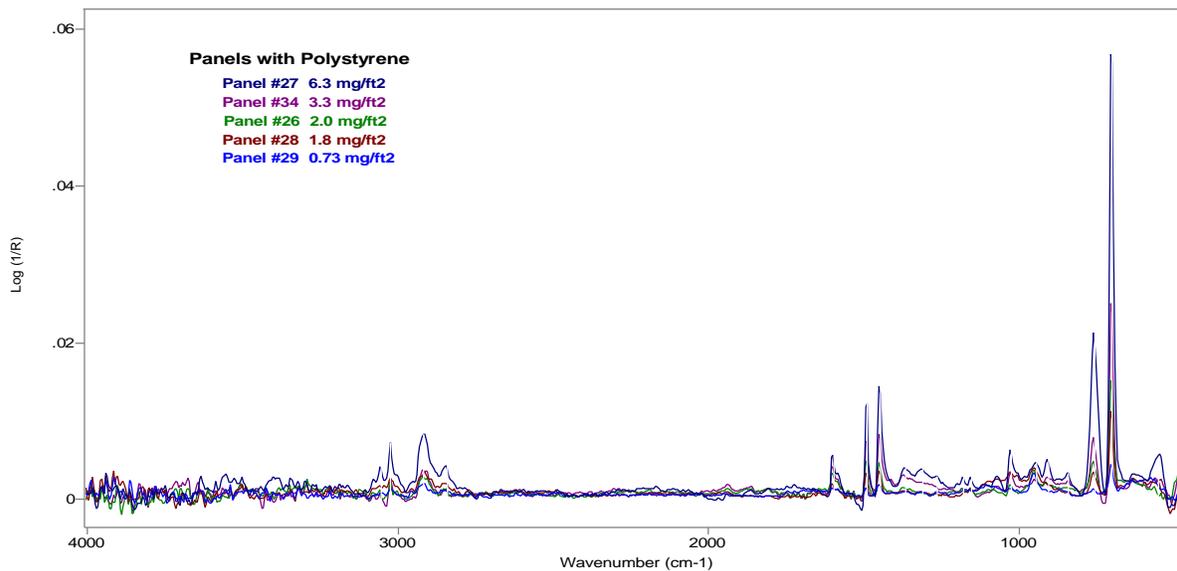
Figure 38. Spectra of varying levels of polystyrene on stainless steel panels.

In September 2001, the Boeing Corporation provided SOC with two series of stainless steel calibration coupons containing ultra-low levels of polystyrene and silicone contamination (lowest level was approximately 0.73 mg/ft^2 or $0.78 \text{ }\mu\text{g/cm}^2$). These coupons were prepared by NASA to be durable calibration standards with uniform thickness levels. SOC personnel analyzed the coupons on the grazing-angle FTIR device. Even at the lowest concentrations, which are near the detection limit of the instrument, the resulting spectra were clear enough to classify the materials. A linear progression was seen in the increasing intensity of the spectral peaks with increasing levels of contamination.

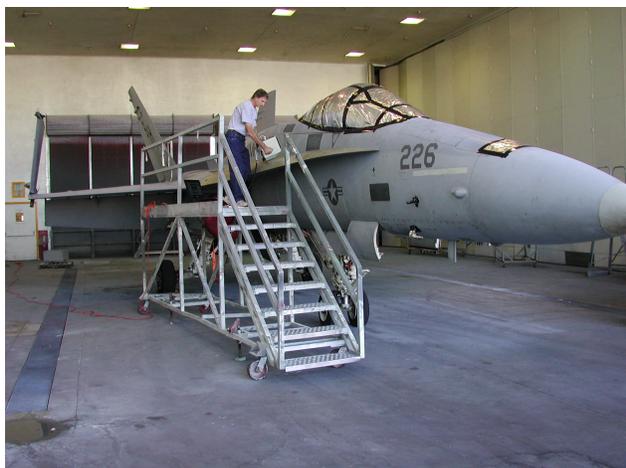
Figure 40. Portable grazing-angle FTIR employed for cleanliness verification of an F/A-18A aircraft wing at North Island.

NADEP North Island personnel reported cleanliness problems from leaking hydraulic fluid or fuel from the seams or connectors of the fuselage and wings. These fluids contaminate the aircraft skin, leading to subsequent coating application problems. Additionally, zero or low VOC coatings are being mandated by environmental emission regulations. The reduced amount of free solvent (used as a vehicle in paint formulae) is no longer able to displace or dissolve low levels of surface contamination and may lead to adhesion problems.

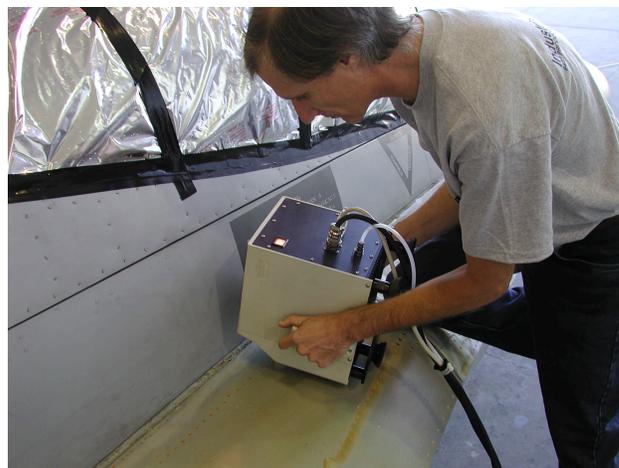
Figure 41. Close-up of the FTIR device sampling a wing awaiting final coating application after cleaning and conversion coating.

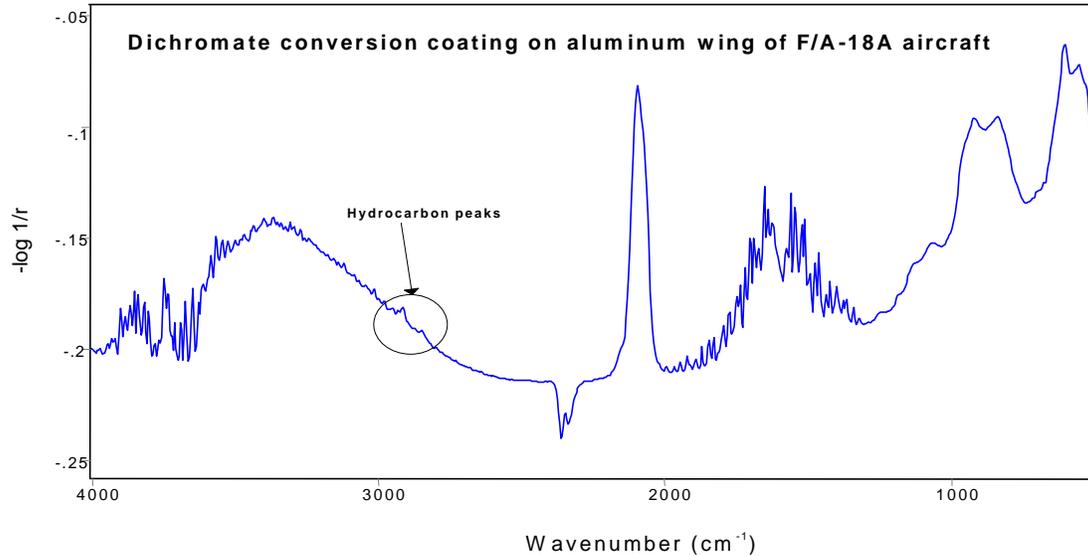
Figure 42. FTIR reflectance spectrum (unpurged) of F/A-18A aircraft wing showing presence of chromate conversion coating AND presence of hydrocarbon contamination.

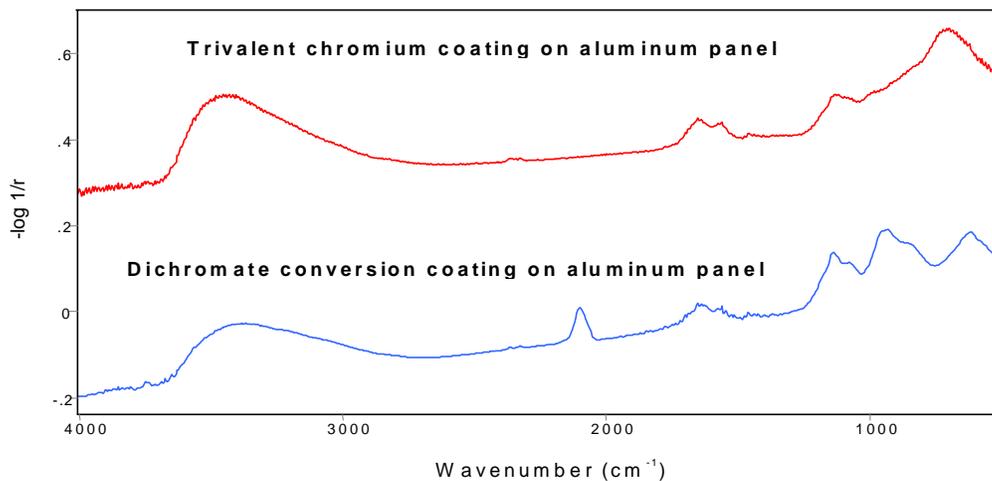
Figure 43. Comparison of grazing-angle spectra of a conventional chromate conversion coating and a trivalent chromium coating on aluminum panels.

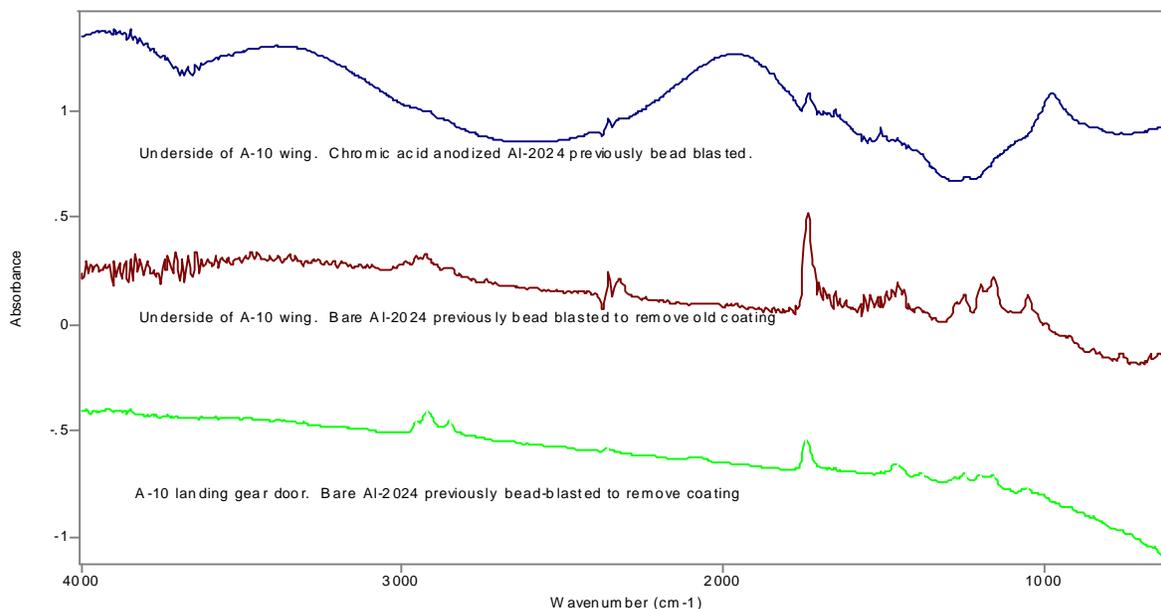
Figure 44. Spectra of aircraft surface contaminants and surface treatments on selected areas of an A10 aircraft at Hill AFB.

The portable instrument was able to detect the invisible contamination, as well as distinguish the anodized coating. In addition to waste stream reductions in cleaning and coating operations, Hill personnel indicated that paint failure analysis (i.e., looking for foreign material on the surfaces of aircraft that may have affected the previous coating's adhesion) is important due to the high cost of stripping and recoating each aircraft. Single aircraft may cost from the 10's to the 100's of thousands of dollars to strip and recoat.

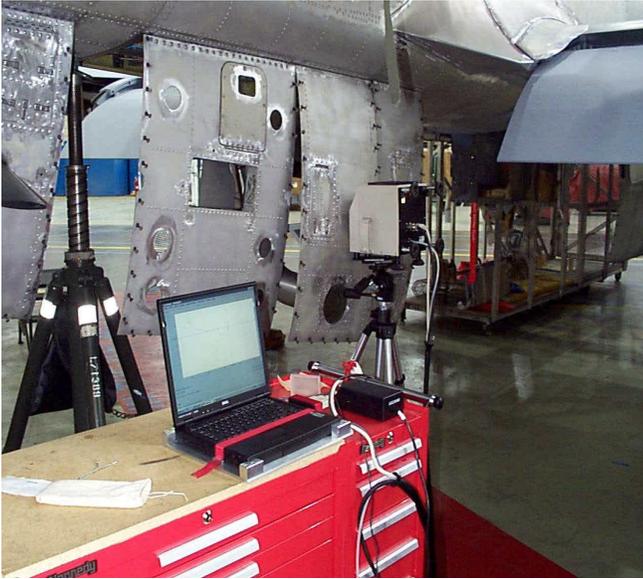
Figure 45 . FTIR unit sampling a landing gear door. Laptop computer controller is in the foreground.

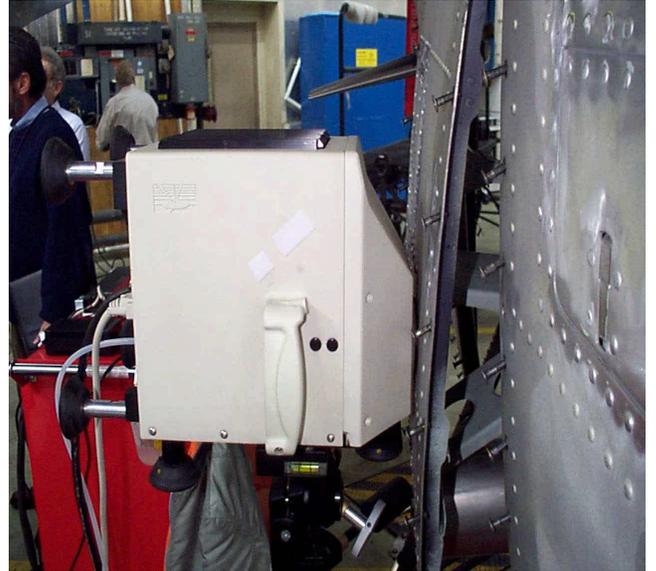
Figure 46. Close-up of FTIR device sampling the landing gear door surface.

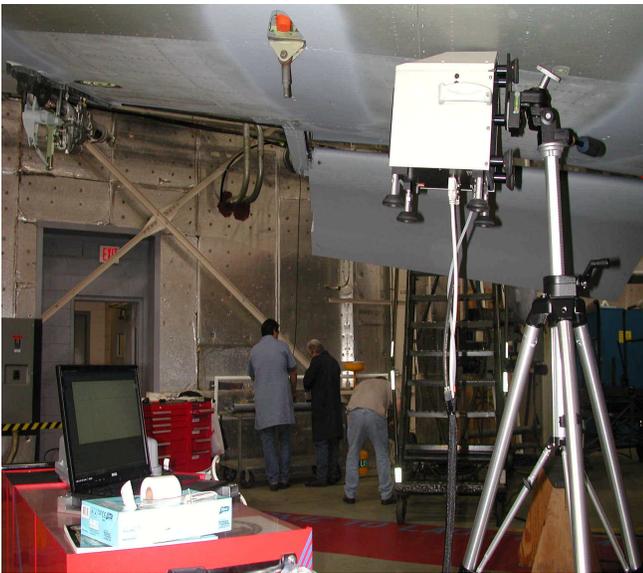
Figure 47. Reorientation of FTIR device on the tripod to analyze the underside of a wing.

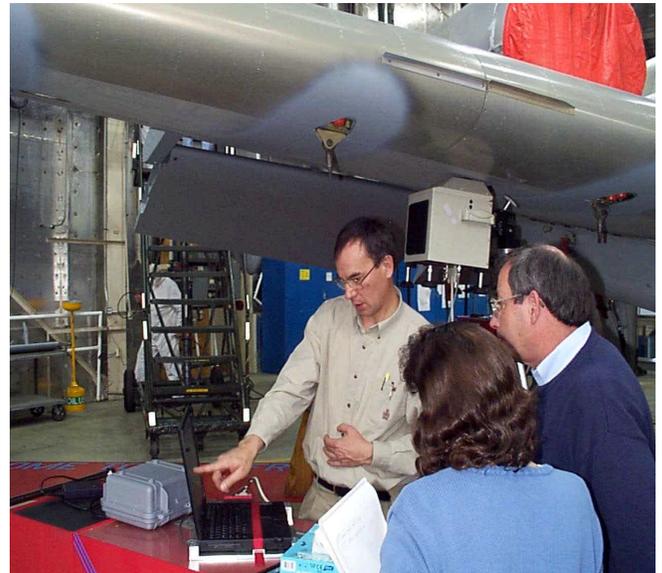
Figure 48. Operators observe collection of data by the FTIR and instantaneous conversion of data to a spectrum on the computer screen.

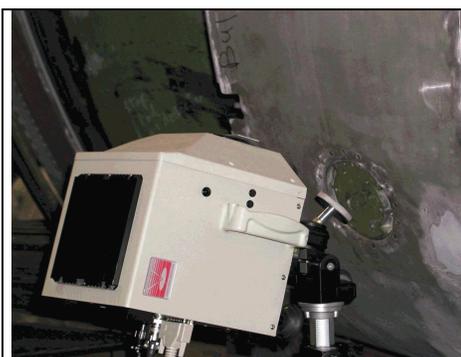
Figure 49. FTIR analyzing a calibration coupon near the C-130.

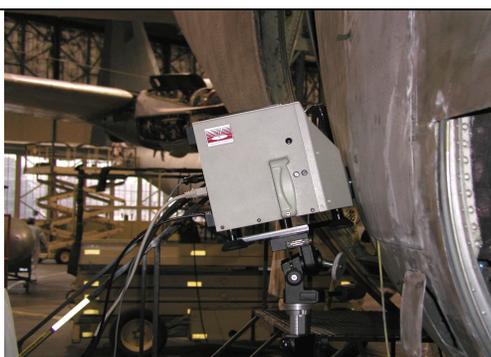
Figure 50. FTIR analyzing C-130 bare aluminum belly.

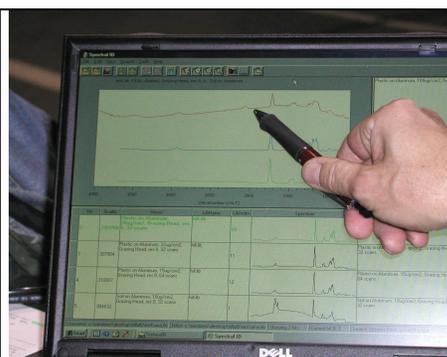
Figure 51. Surface inspection software performing a library search on a contaminant.

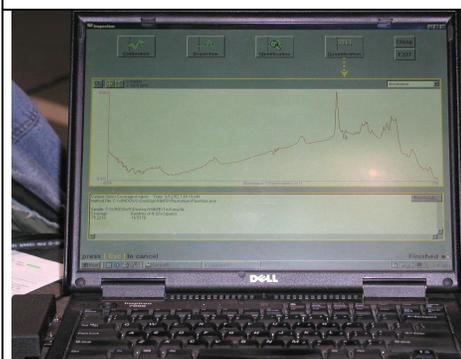
Figure 52. Surface inspection software on laptop computer showing a spectrum of the C-130 surface.

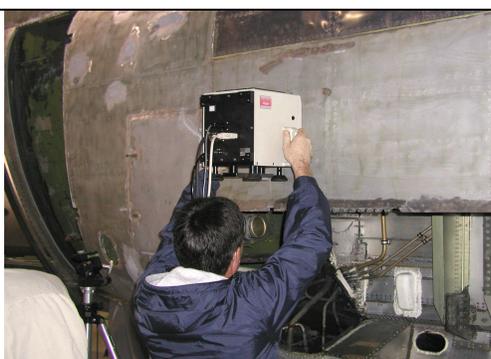
Figure 53. FTIR operator at the C-130 demonstrating hand-held FTIR operation.

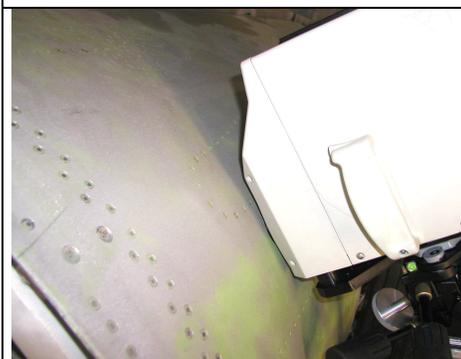
Figure 55. Close-up of the FTIR analyzing an F-16 landing gear door.

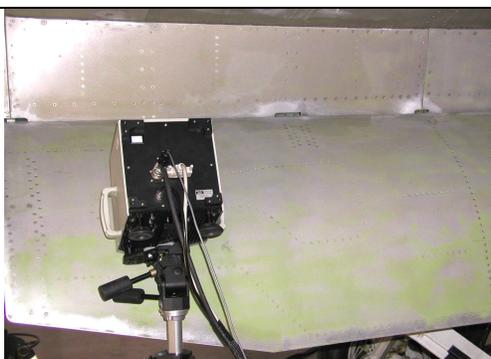
Figure 56. FTIR analyzing an area containing yellow epoxy primer.

Less successful was the analysis of the F-16, due to the presence of the epoxy primer. Since the epoxy primer is organic, its IR absorbance peaks interfere with those of the plastic blast media. This makes it difficult or impossible to determine the presence or absence of the blast media residue. A more successful analysis of the F-16 could be accomplished if a separate sample of the epoxy material could be obtained and analyzed. If the plastic blast media and the epoxy show any significantly different absorbance peaks in their spectra, that spectral region could be used to discern the presence of the plastic media regardless of the presence of any epoxy. Also if the thickness of the epoxy primer were to be determined using a calibration curve of known amounts of epoxy, the spectral features could be subtracted out by the FTIR computer, leaving a spectrum of just the plastic blast media.

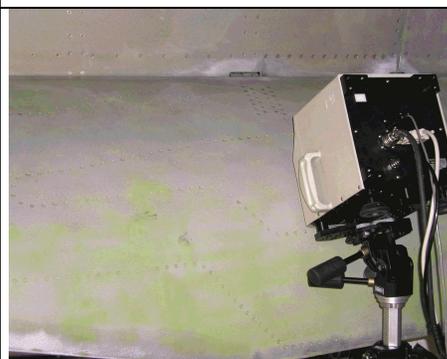
Figure 57. FTIR operating on a camera tripod to analyze the F-16.

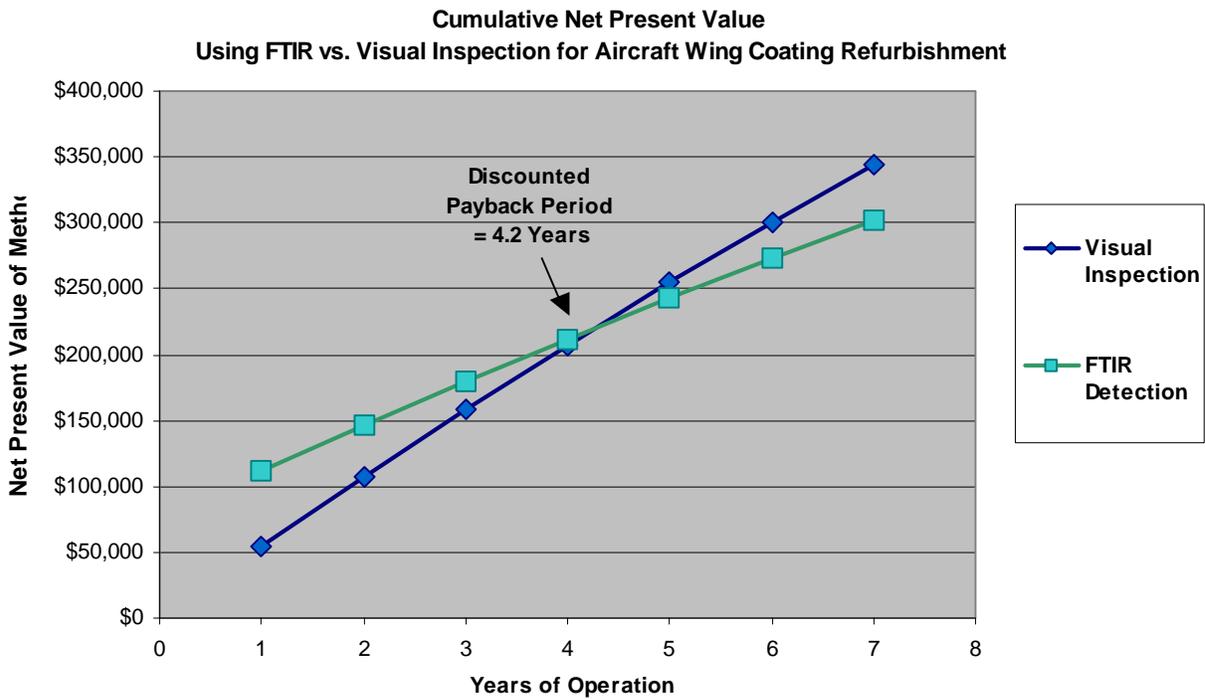
Figure 59. Net Present Values for using FTIR versus visual inspection for aircraft wing coating refurbishment.

Because of its high sensitivity in detecting hydrocarbon contaminants, it was estimated that the FTIR would be able to catch 50% or more of contaminated wings missed by visual inspection. This would be translated into a 50% reduction of the number of wings seen for refurbishment at the depot in out-years, assuming the cause of the infant mortality was surface contamination. Over the life of the FTIR instrument, the number of wings seen back at the depot for this refurbishment should continually decrease. However, to simplify the analysis, it was assumed that a 50% reduction of the original number of wings would occur each year after the first year, during which no reduction would occur.
