Attic Ventilation Guidelines to Minimize Icings at Eaves

BY WAYNE TOBIASSON, JAMES BUSKA AND ALAN GREATOREX

ABSTRACT

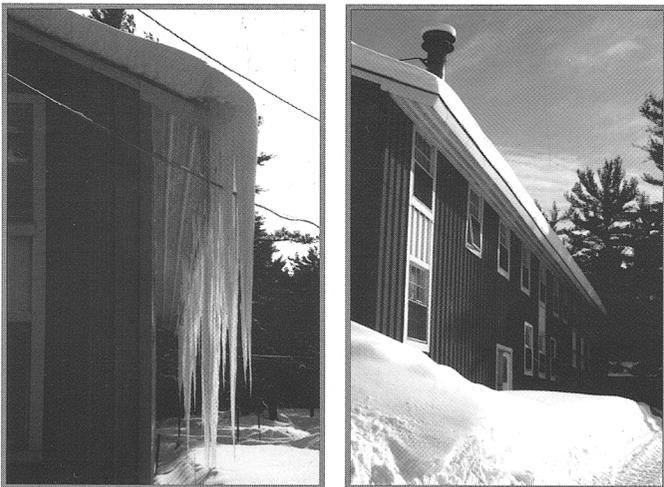
Figure 1: Two identically-constructed roofs photographed at the same time. The building on the right, with no icings, was unheated.

Figure 1 shows two roofs located near Watertown, NY. The two photos of identically constructed buildings were taken within minutes of each other. One roof contains large ice dams and icicles, but the other is ice free. Why? The snow on top of the chimney of one roof is the clue to the difference in behavior. That building was not being heated, while the other building was at room temperature.

This example is used to illustrate that building heat, not the sun, is the primary cause of ice dams and icicles on roofs. When the sun melts snow on roofs, it also warms the eaves, and this tends to minimize the growth of icicles. Certainly, some icicles can form on unheated buildings and from solar heating, but they are usually small, infrequent, and do not cause chronic problems.

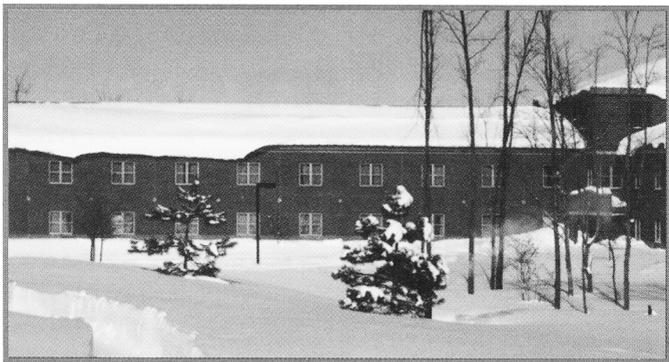
Figure 2: Some creep of snow and cornicing is evident, but no icings occurred on this roof.

A few years ago, many buildings were built at Fort Drum near Watertown, NY. All these buildings have standing seam metal roofing systems above ventilated attics. Standing seam metal roofing systems have both strengths and weaknesses when used in cold regions⁶. Some of these roofs have remained clear of icicles and ice dams (Figure 2). Several have experienced some problematic icicles and ice dams (Figure 3)

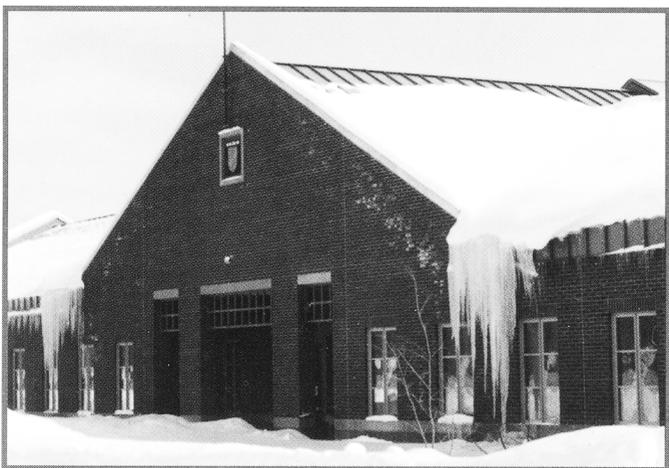
Figure 3: Minor icings occurred along the eaves of this roof and problematic icings developed at the base of valleys.

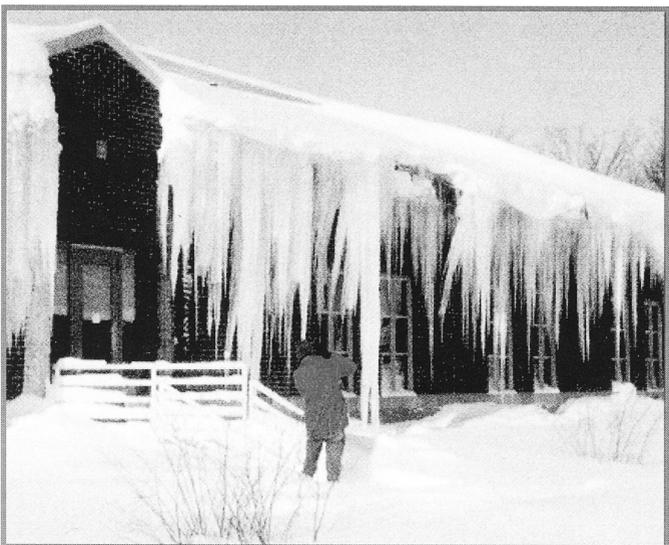
Figure 4: Severe, problematic icings developed all along the eaves of this dining facility.

and others have experienced severe icicles and ice damming (Figure 4). The range in performance is related to the ability of each building's attic ventilation system to remove heat that enters the attic from the warm building below and heat produced by HVAC equipment located in the attic.

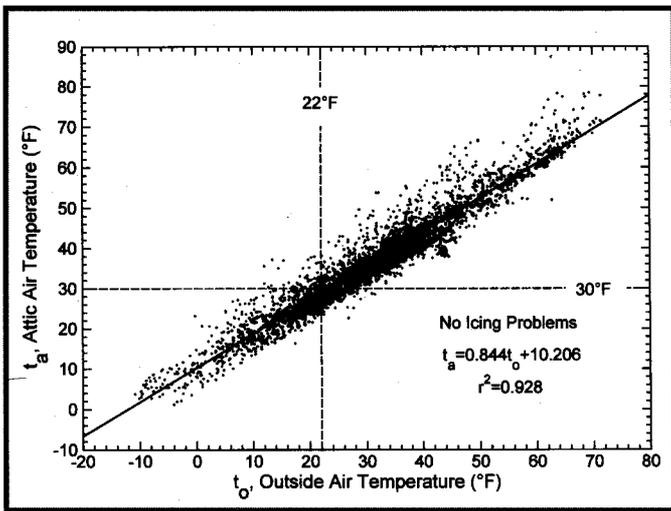
Figure 5: Attic temperature vs. outside air temperature for a roof experiencing no icing problems.

Plots of attic air temperature vs. outside air temperature are presented in Figures 5, 6, and 7 for buildings experiencing no icing problems, "some" icing problems and severe icing problems, respectively. Figure 6 is representative of two other buildings that also experienced "some" icing problems. The least-squares equation of best fit and its correlation coefficient (r^2) are presented on each figure. Horizontal and vertical lines, representing, respectively, an attic air temperature of 30°F and an outside air temperature of 22°F are also presented on each figure. The portion of each graph to the right of the vertical 22°F line is warmer than conditions observed to create icings. The portion of each graph below the 30°F horizontal line is also not within the "icing envelope" because the attic is then so cold that snow on the roof is not melted by building heat.

For the roof with no icing problems (Figure 5), very few data points fall within the icing envelope, as expected. For the roof with "some" icing problems (Figure 6), about 6% of the observations fall within the "icing envelope." For the roof with

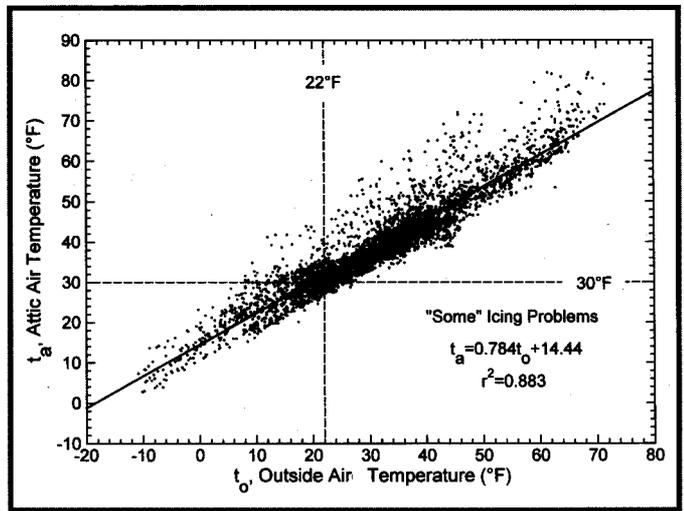
Figure 6: Attic temperature vs. outside air temperature for a roof experiencing "some" icing problems.

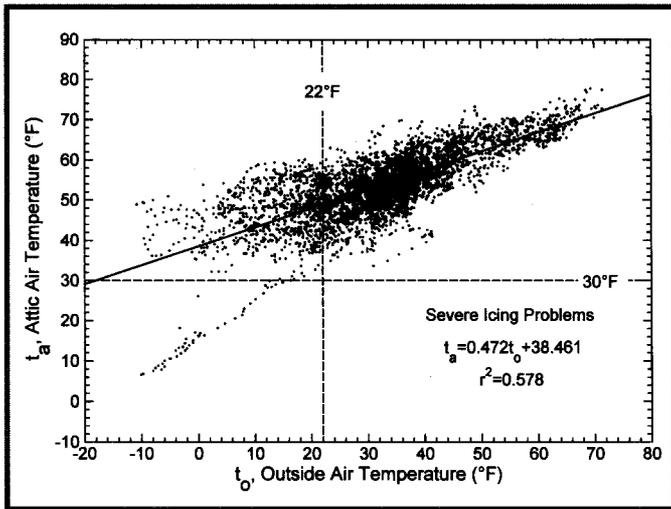
Figure 7: Attic temperature vs. outside air temperature for a roof experiencing severe icing problems.

severe icing problems (Figure 7), 23% of the data (i.e., 23% of the time during the winter) falls within the "icing envelope."

The separate line of points in Figure 7 that runs down toward the lower left corner of the graph represents a 5-day period when the heating system of that building was off due to mechanical problems. Those points provide further evidence that building heat is the primary source of icing problems since, once cool, that building performed out of the "icing envelope."

The attic described by *Figure 7* had experienced severe icing problems. However, it needed help in the form of improved natural ventilation or mechanical ventilation for less than 23% of the winter. We were not able to provide enough inlet area to completely solve this attic's icing problems using only natural ventilation. Thus, several large fans were installed near the ridge as shown in *Figure 9*. The fans were not dampered. This allows the fan openings to serve as outlets for natural ventilation, thereby reducing the amount of time that mechanical ventilation is needed.

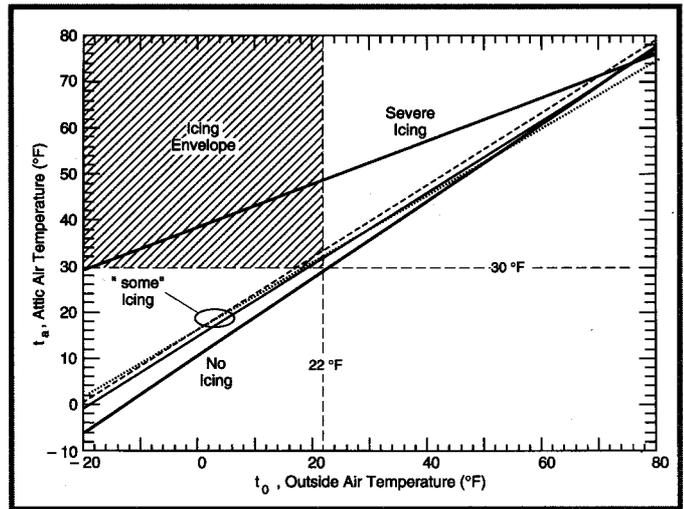
Figure 8: Lines of best fit for the three roofs shown in Figures 5-7, along with similar lines (dashed) for two other roofs also having "some" icing problems.

The lines of best fit for these three roofs are shown together as solid lines on Figure 8 along with similar lines, (shown dashed), for the other buildings we monitored that also had "some" icing problems. This information suggests that icings can be avoided by sizing attic ventilation systems to maintain an attic temperature of 30°F when the outside temperature is 22°F.

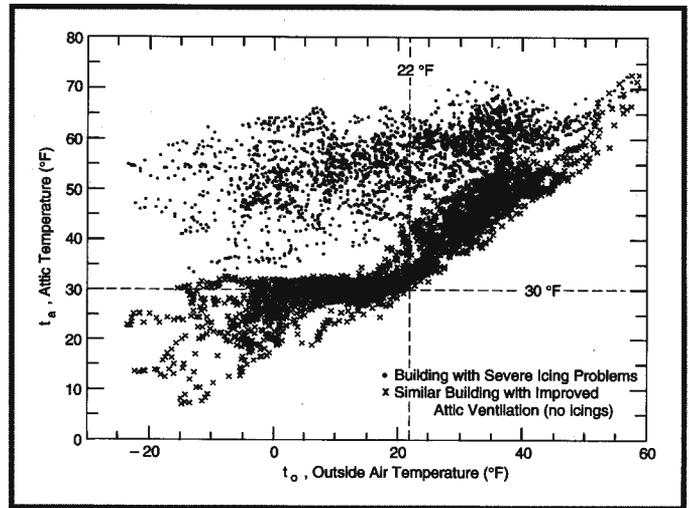
Figure 10: Attic temperature vs. outside air temperature for a building with severe icing problems and a similar building with improved attic ventilation experiencing no icing problems.

Figure 10 compares the modified building to a similar unmodified building for the period Nov. 15, 1993 to Feb. 23, 1994. Both buildings were having similar severe icing problems before one was modified. The portion of each data set to the right of the 22 $^{\circ}\text{F}$ outside air temperature line in *Figure 10* relates to natural ventilation since the fans cannot operate when it is warmer than 22 $^{\circ}\text{F}$ outside. The dramatic difference in that portion of the two data sets indicates that natural ventilation has been improved significantly. We expect that much of this improvement would not have been achieved if the fans contained louvers that were opened only when the fans were on.

The "hunk" taken out of the data set for the building with improved attic ventilation reflects the contribution of the mechanical ventilation system. The mechanical system has been able to keep that attic out of the "icing envelope" most of the time. Without mechanical ventilation, it appears that the attic would have operated within the icing envelope for a significant amount of time with problematic icings expected. This verified our feeling that natural ventilation alone would not solve the icing problems being experienced by some of these buildings.

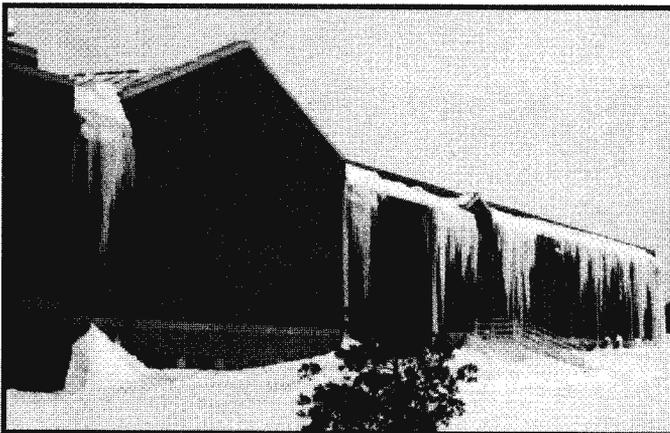
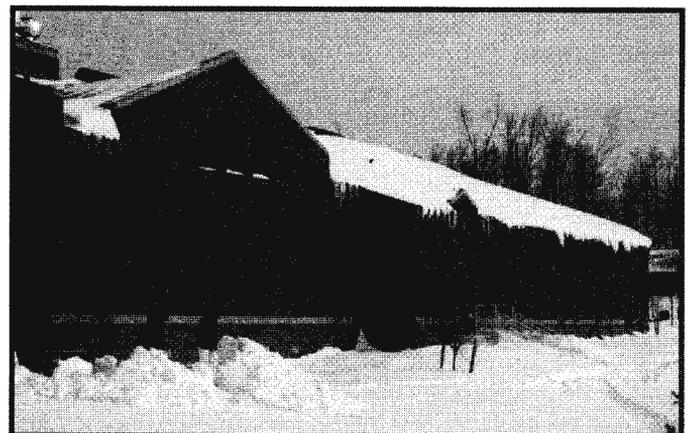
Figure 11: Both buildings from Figure 10 photographed at the same time. The unmodified building shown at the left was experiencing severe icings. The other building with improved attic ventilation had no icing problems.

Figure 11 shows the two buildings just discussed on the same date (Jan. 12, 1994). The unmodified building is subjected to severe icings all along its eaves. There are only a few small icicles at the base of the valleys of the building with improved attic ventilation. All other irregularities along the eaves of that roof are snow cornices, not icicles.
