Damage Evaluation and Analysis of Composite Pressure Vessels Using Fiber Bragg Gratings to Determine Structural Health

Marley Kunzler^a, Eric Udd, Stephen Kreger
Blue Road Research, Gresham, Oregon

Mont Johnson, Vaughn Henrie
ATK Thiokol, Brigham City, Utah

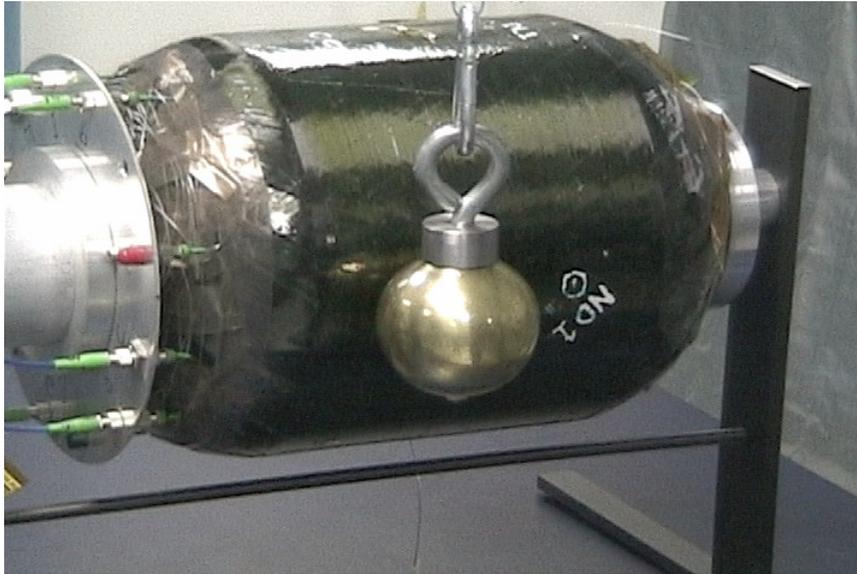
Figure 2. Photograph of impacts to a composite using a brass ball

In the first of a series of tests, a brass weight attached to a pendulum was impacted into the side of a composite from specified heights that yielded a 5, 10, 15, and 20 ft-lbs. impact. Baseline and intermediate scans were taken to

determine if the system was able to sense damage propagation. Figure 2 shows a photograph of the test. The impact occurred in an area among 4 Bragg sensors whose installation location was monitored during the manufacturing process.

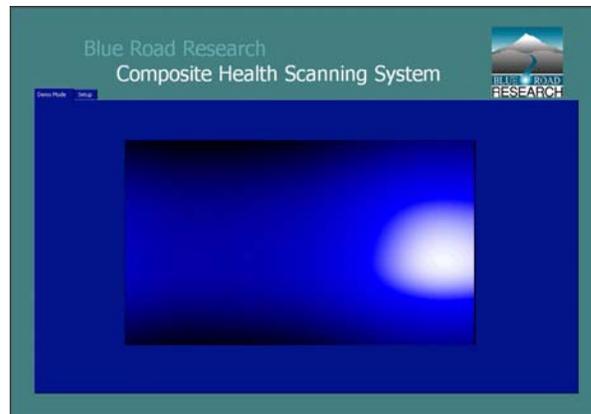
Figure 6. Damage chart shows location and intensity of damage after an impact of 20 ft-lbs

Using the charts of Figures 4-6 to determine the ability of the system to distinguish damage of varying intensities easily show an increase in damage intensity with an increase in damage force applied.
