ERDC/CHL TR-05-1

Monitoring Completed Navigation Projects Program

Monitoring Stone Degradation on Coastal Structures in the Great Lakes – Summary Report

June 2005

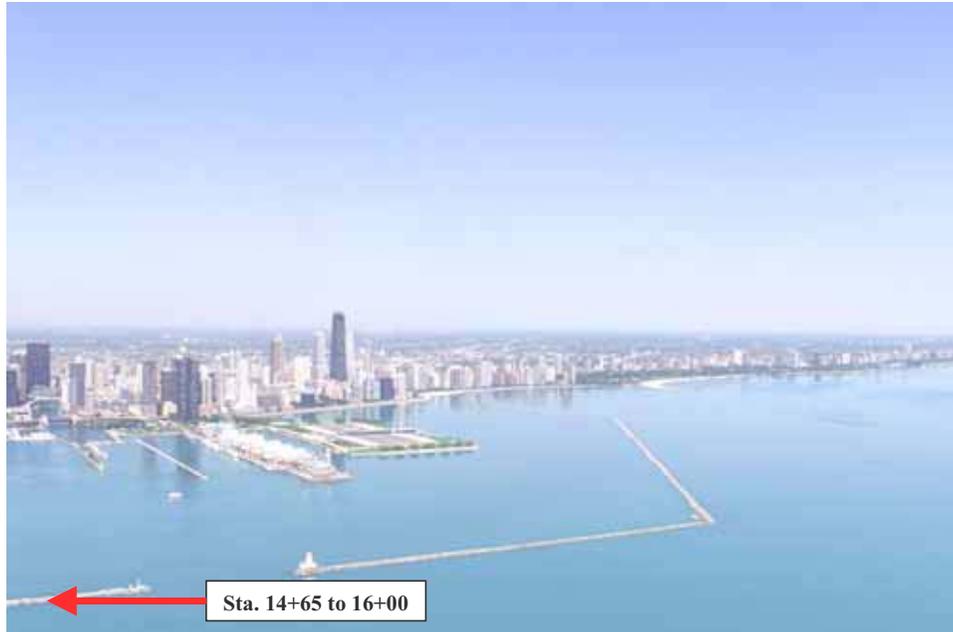
Figure 1. Chicago Harbor breakwater, IL, monitored section

Chicago Harbor breakwater, IL. Valdars Quarry Niagaran series cut dolomite (low energy blasted, drilled and split, and then surfaces cut; see editor's note, p. 149) is concentrated mostly on the north half of this reach of the Chicago Harbor breakwater, IL (Figure 1), in holes created by weathering of the Reed Quarry Salem formation Indiana limestone blocks, and over badly weathered sections of the limestone blocks. The Valdars Quarry dolomite in the monitored section was placed in 1994. Fractures observed in the Valdars Quarry dolomite are of four types: (a) blasting, (b) unloading and stress relief, (c) vugular weathering, and (d) contact parting. Fractured stone is not limited to either lakeside or harbor side of the breakwater.

The Reed Quarry Salem formation cut limestone blocks had been placed in a somewhat random manner, with some stones placed horizontally, some vertically, and some diagonally with respect to bedding planes. The vertical orientation may possibly allow water to permeate the stone along the more permeable bedding direction. However, there is no conclusive relationship between orientation and durability independent of other factors (e.g., clay minerals present along the bedding). The fractures in these limestone blocks are mostly zones of exfoliation or delamination associated with highly porous, fossiliferous grain stone zones adjacent to large stylolites. This stone might have performed better if it had been placed such that the bedding planes were oriented horizontally, although horizontally placed stones have also shown separation along bedding planes in

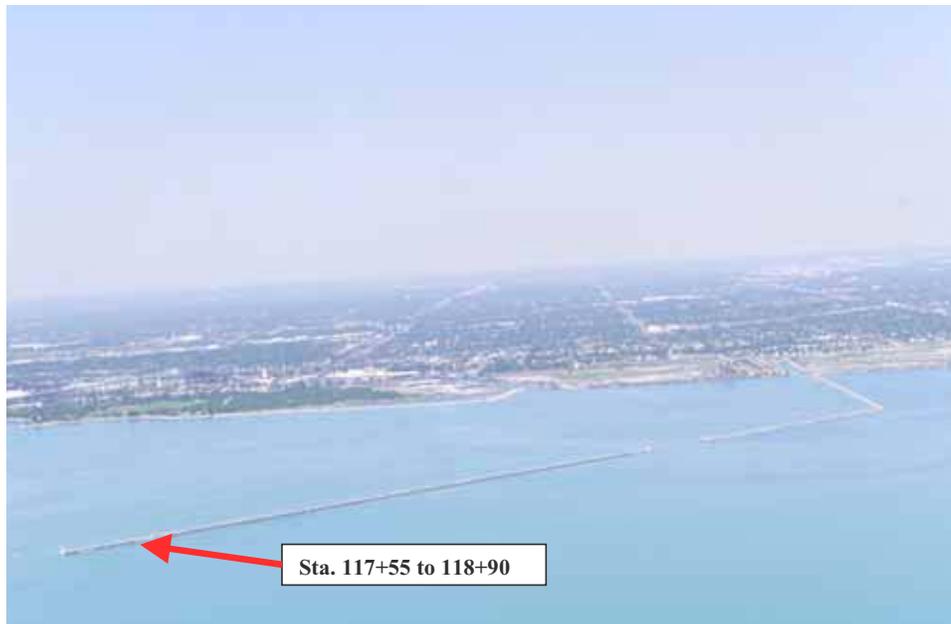
Figure 2. Calumet Harbor breakwater, IL and IN, monitored section

Calumet Harbor breakwater, IL and IN. The Reed Quarry Salem formation cut limestone is located on both the lakeside and harbor side of the double row of steel sheet pile forming the interior walls of the breakwater structure at Calumet Harbor breakwater, IL and IN (Figure 2). The Reed Quarry limestone in the monitored section had been placed in 1988. Just as in the Chicago Harbor breakwater, some of the Reed Quarry cut limestone blocks had been placed with bedding oriented vertical. The fractures in the Calumet Harbor breakwater stone are of three types; (a) mechanical fractures due to waves pounding against the flexible steel sheet pile immediately adjacent to the armor blocks; (b) parting along a stylolite, and (c) exfoliation or delamination zones associated with highly porous fossiliferous grain stone zones adjacent to large stylolites. The combination of the high-porosity zone with the fact that a stylolite is a permeability discontinuity, together with the placement of the blocks such that the bedding is oriented vertically, insures weathering susceptibility. The vertical orientation of the bedding allows the stone to become fully saturated. Freezing is then initiated. With the fully saturated high-porosity zone trapped between the stylolite and a less porous zone, ice forms within the high-porosity zone. Hydraulic pressure due to volumetric expansion of the ice increases as

The Dempsey Quarry Waterloo formation blasted quartzite had been placed on top of the Indiana limestone capstone in those areas of the breakwater where the Indiana limestone had weathered, leaving holes in the capstone. The Dempsey Quarry blasted quartzite in the monitored section had been placed in 1994. Stone fracturing appeared to be strictly a mechanical fracture that occurred either during placement or during a storm event.

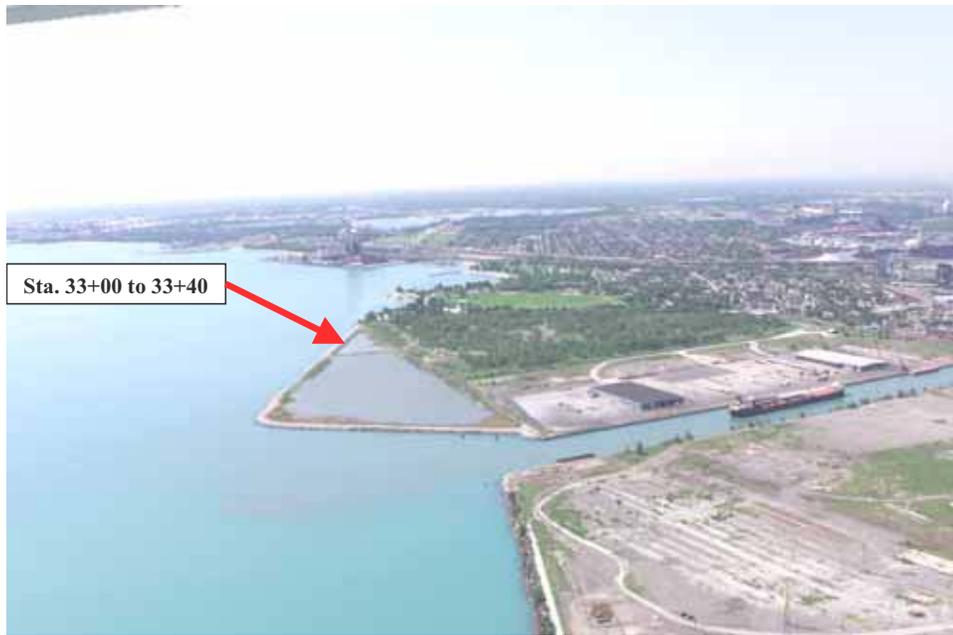
Figure 3. Calumet Harbor CDF revetment, IL, monitored section

Calumet Harbor CDF revetment, IL. The McCook Quarry Niagaran series blasted dolomite armor stone consists of various facies from a reef environment. These various lithologies are evenly distributed over the Calumet Harbor CDF revetment, IL (Figure 3). All of the lithologies contain thin seams and/or disseminated glauconite, and have a chalky, argillaceous appearance. This is generally a poor quality stone. In a random survey of a 30.48-m (100-ft) section of this facility, the following percentages of rock types were encountered; (a) reef dolomite, 16 percent, (b) forereef, 10 percent, (c) backreef, 22 percent, (d) inter-reef, 13 percent, and (e) reef breccia, 39 percent. 80 percent of all blocks were fractured, with the fracture development by rock type as follows; (a) reef dolomite, 0 percent, (b) forereef, 33 percent, (c) backreef, 71 percent, (d) inter-reef, 100 percent, and (e) reef breccia, 100 percent. Fractures were almost totally due to argillaceous (glauconitic) nature of this particular stone source and resulting weathering effects. No blasting fractures were detected. The McCook Quarry blasted dolomite in the monitored section had been placed in 1982.

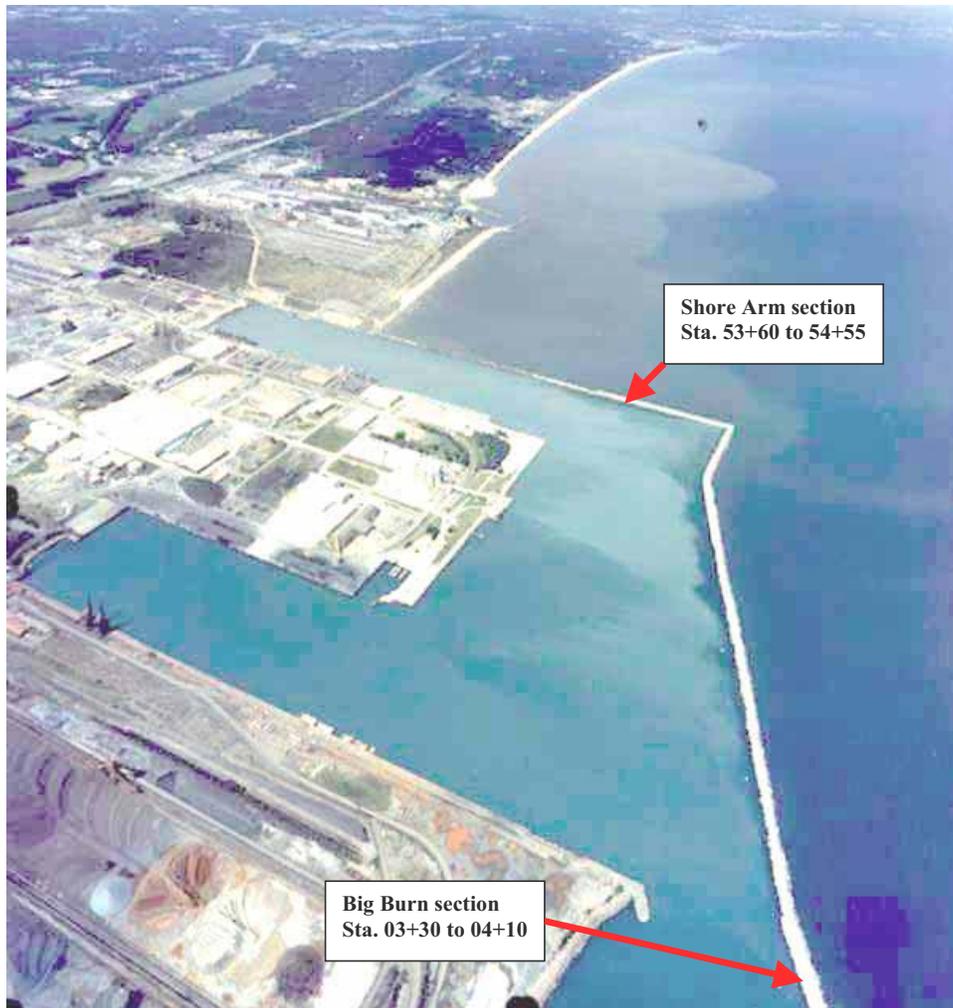
Burns Harbor breakwater, IN. Burns Harbor, IN (Figure 4), is a deepwater harbor at the southern end of Lake Michigan that receives significantly greater wave heights than other navigation harbors around Lake Michigan. The breakwater, completed in 1968, consists of an east-west section (Big Burn section) connected to the shore by a north-south section (Shore Arm section), which is semiprotected from severe Great Lakes storms. The breakwater is a multilayer rubble-mound structure with two layers of randomly-placed Reed Quarry Salem formation cut limestone. The parallelepiped cut stone armor units, which range from 9,070 to 14,515 kg (10 to 16 tons) on the trunk and from 13,605 to 18,145 kg (15 to 20 tons) on the head, are typical for coastal structures in the Great Lakes, but the two-layer random placement is unusual. Numerous repairs have been necessary since about 1975 as the structure was unable to withstand the severe storm waves that it would experience. There exists uncertainty as to whether there is a single cause for the problems or whether there are multiple factors contributing to the need for repairs (e.g., foundation issues, material suitability, greater wave climate than originally believed, etc.) Over the years, repair stone has consisted of Reed Quarry cut limestone, McCook Quarry Niagaran series blasted dolomite, and Dempsey Quarry Waterloo formation blasted quartzite. For the monitored Big Burn section, Reed Quarry cut limestone was placed in 1970, and McCook Quarry blasted dolomite was placed in 1988. For the monitored Shore Arm section, Reed Quarry cut limestone and Dempsey Quarry blasted quartzite were placed in 1995.

Figure 4. Burns Harbor breakwater, IN, monitored sections

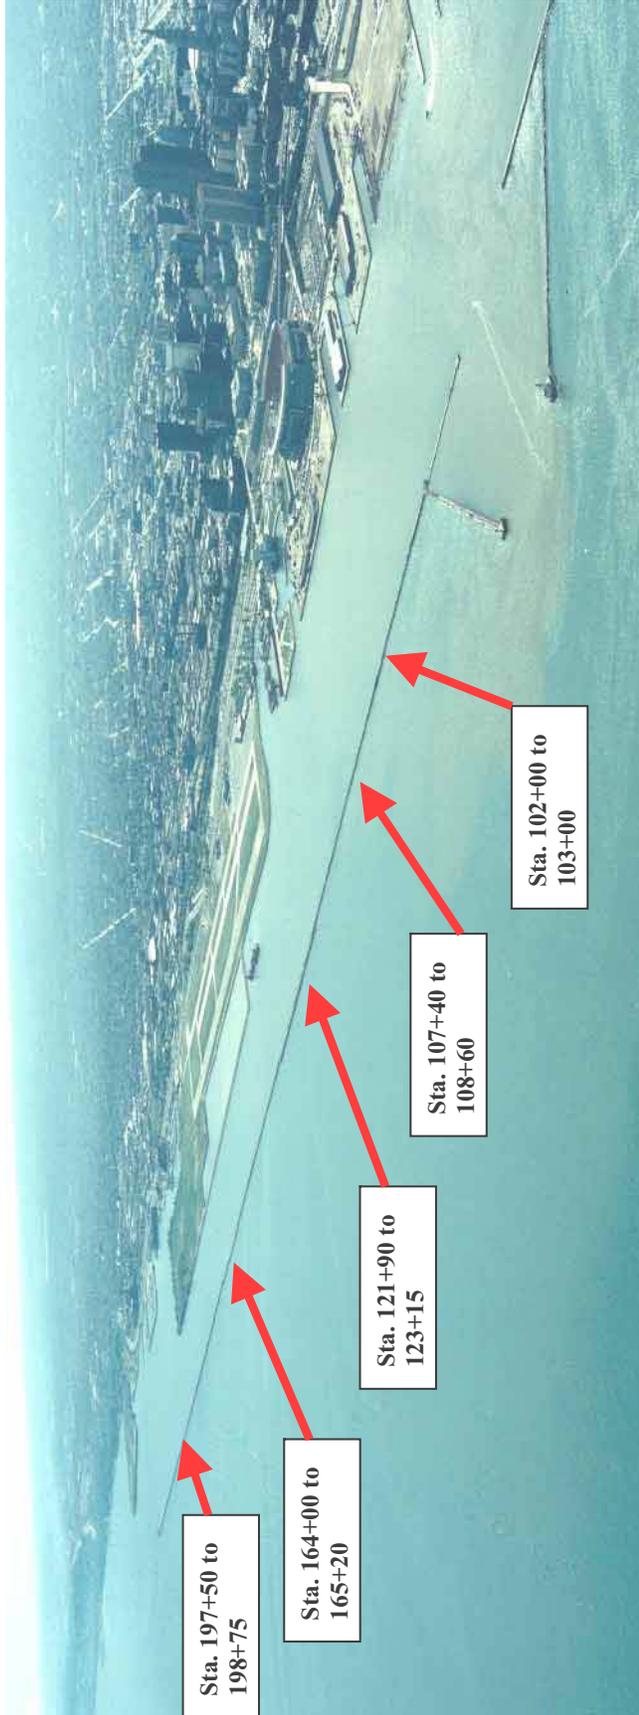
Cleveland Harbor east breakwater, OH. The original east breakwater at Cleveland, OH (Figure 5), was built between 1903 and 1905 as a laid-up structure from cut stone from one or more of the quarries now owned or formerly owned by Cleveland Quarries. One of these is the Johnson Quarry, Kipton, OH. The Johnson Quarry Berea formation cut sandstone blocks are still present in the structure, and form the base of the breakwater structure. In recent years, as the cut stone became more expensive, the U.S. Army Engineer District, Buffalo, has been maintaining the structure with rubble armor stone. This has created a somewhat less stable structure with the blocks of rubble rocking back and forth on the somewhat flat surface created by the laid-up cut stone. Additionally, the much larger blocks of rubble on top of the laid-up cut stone are destroying the stability of the laid-up structure. The Johnson Quarry cut sandstone in the monitored section had been placed over 30 years ago. The only fractures noted in the Berea sandstone are those created by movement of the structure as a result of placement of the less stable and larger rubble blocks.

Figure 5. Cleveland Harbor east breakwater, OH, monitored sections

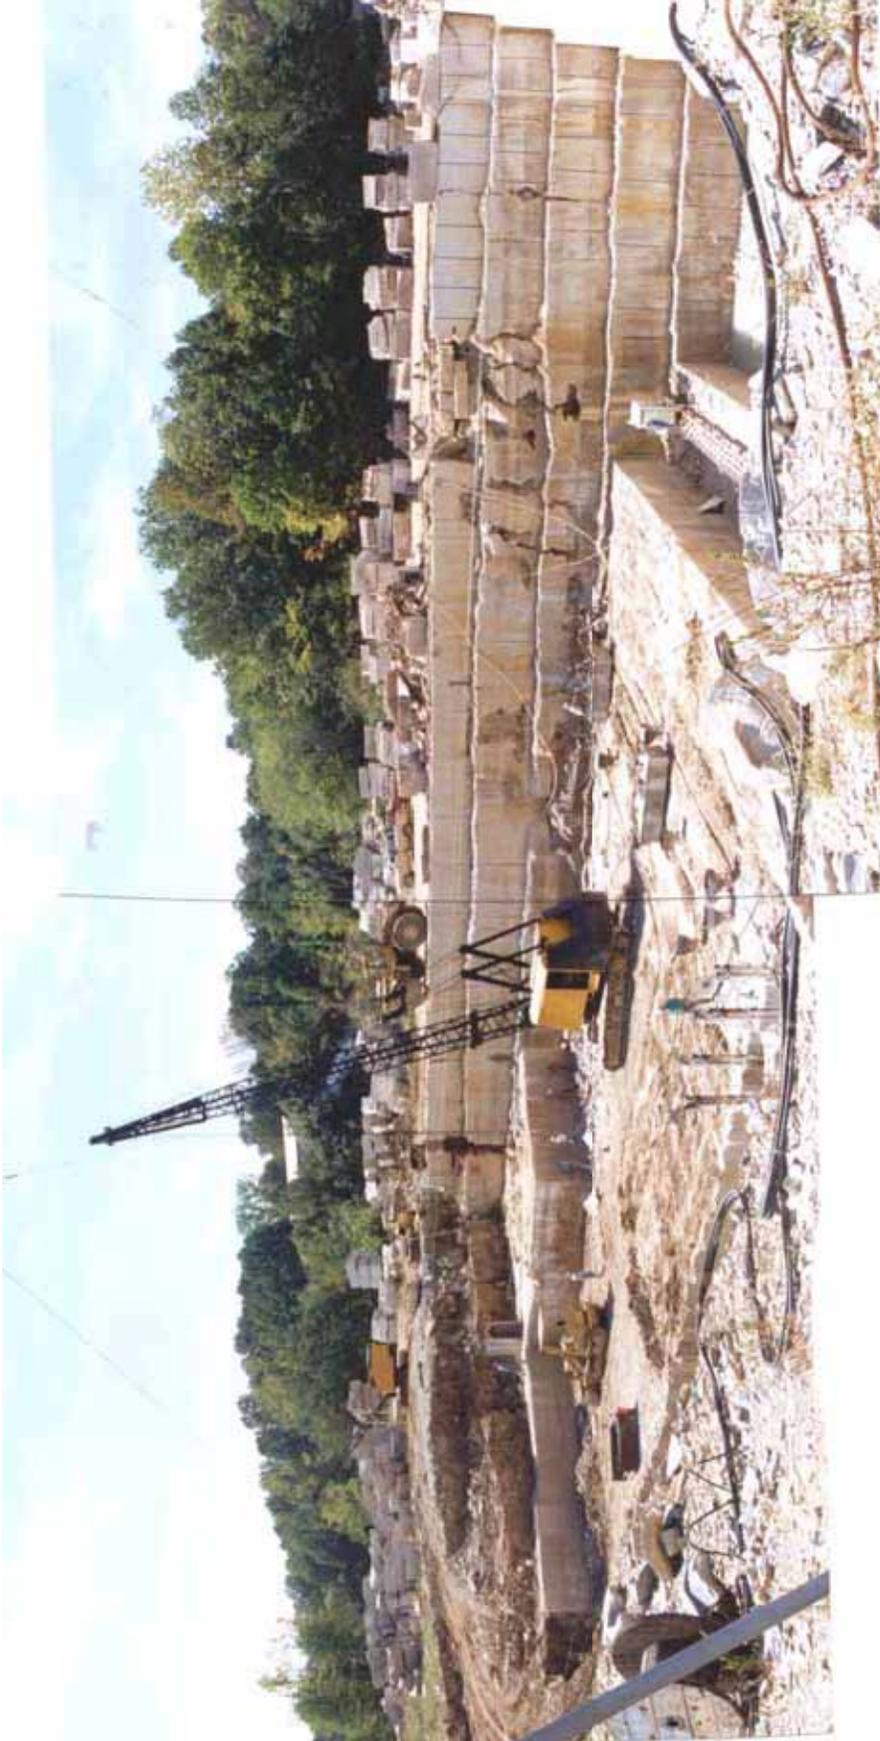
Figure 7. Reed Quarry, Bloomington, IN, overview of operation of new quarry and wire-saw operation (after Rock Products Consultants 1995)

The stone is handled with stone tongs and a crane since it is very soft rock which must be handled carefully to prevent breakage. A clamshell bucket (with either two or four leaves) will destroy or permanently damage stone cut from the soft Salem limestone. All quarried stone is set aside and cured for a minimum period of 60 days. Stone that is unevenly colored cannot be used for architectural purposes and is cast aside in muck piles. The majority of stone in the muck piles has been cured for more than 2 years. Stone from the muck piles is available for use as armor stone. Transportation is by truck only.

Reed Quarry (Figures 6 and 7) is located slightly northwest of Bloomington, IN (Figure 8), and excavates limestone from Mississippian age Salem formation.

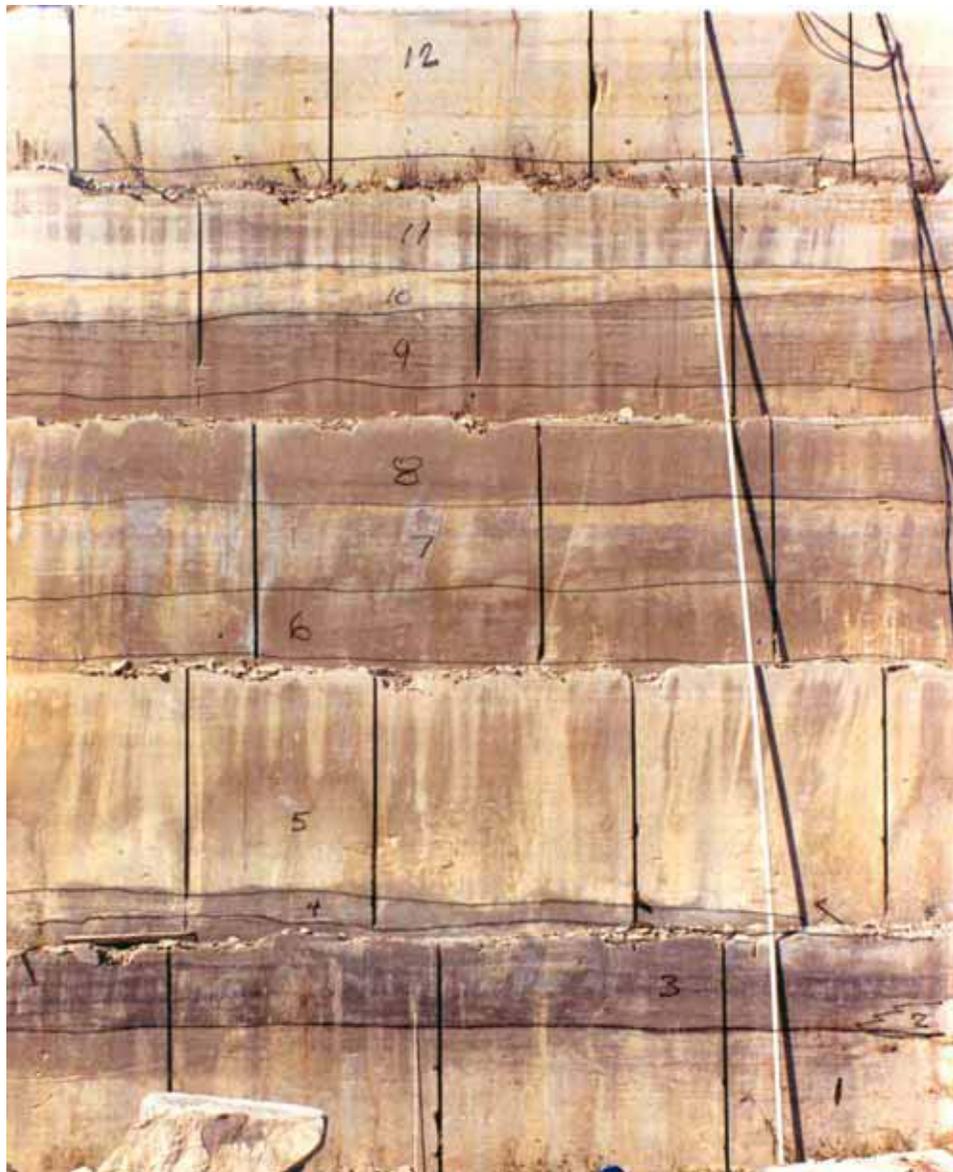
The west face of the quarry consists of 4.9 m (16 ft) of overburden of which 3.7 m (12 ft) are St. Louis Limestone, and the top 1.2 m (4 ft) of the Salem formation are stripped. The working face consists of the following limestone rock units:

Figure 9. Reed Quarry, Bloomington, IN, west face (after Rock Products Consultants 1995)

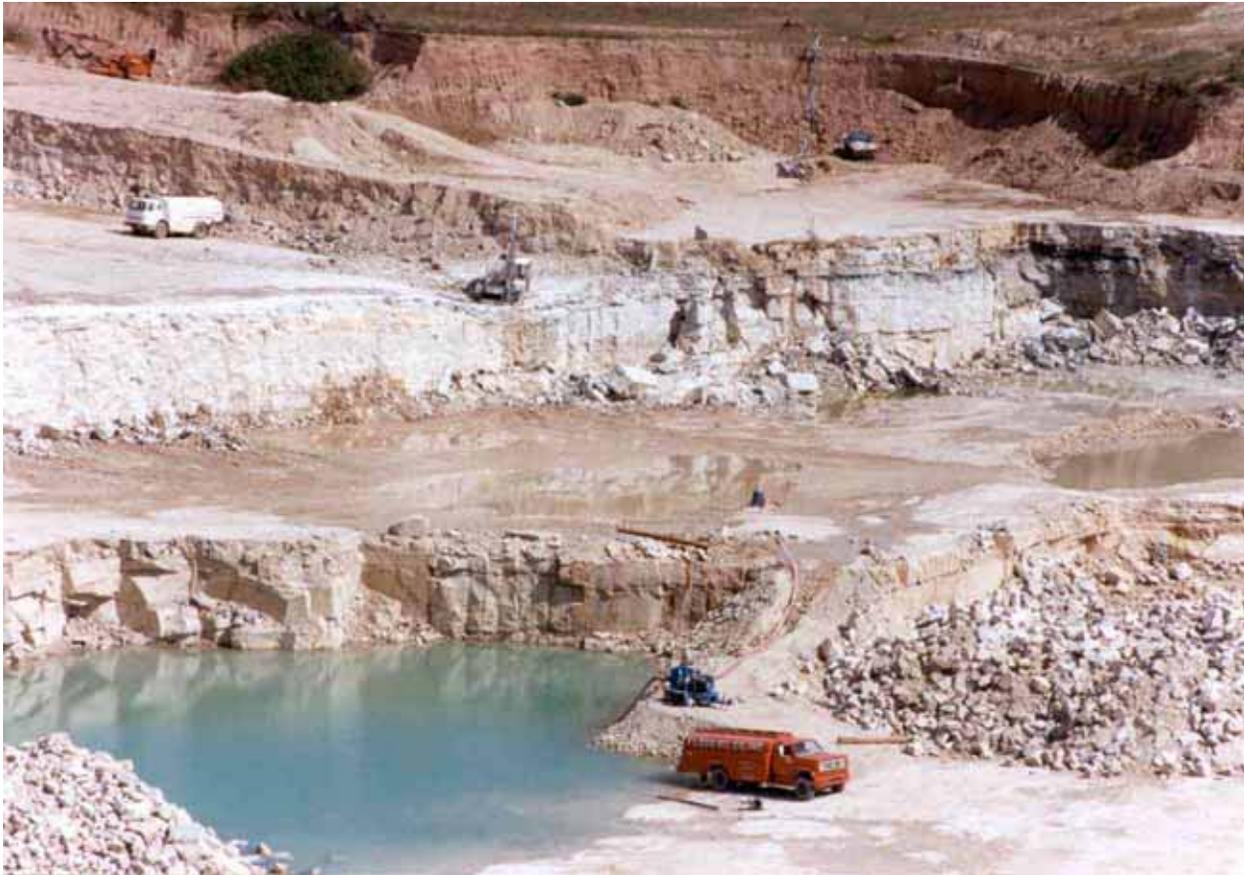
Figure 11. Valders Quarry, Valders, WI, overall view showing lower bench, middle bench (being drilled), and upper bench with glacial till drift overburden (after Rock Products Consultants 1995)

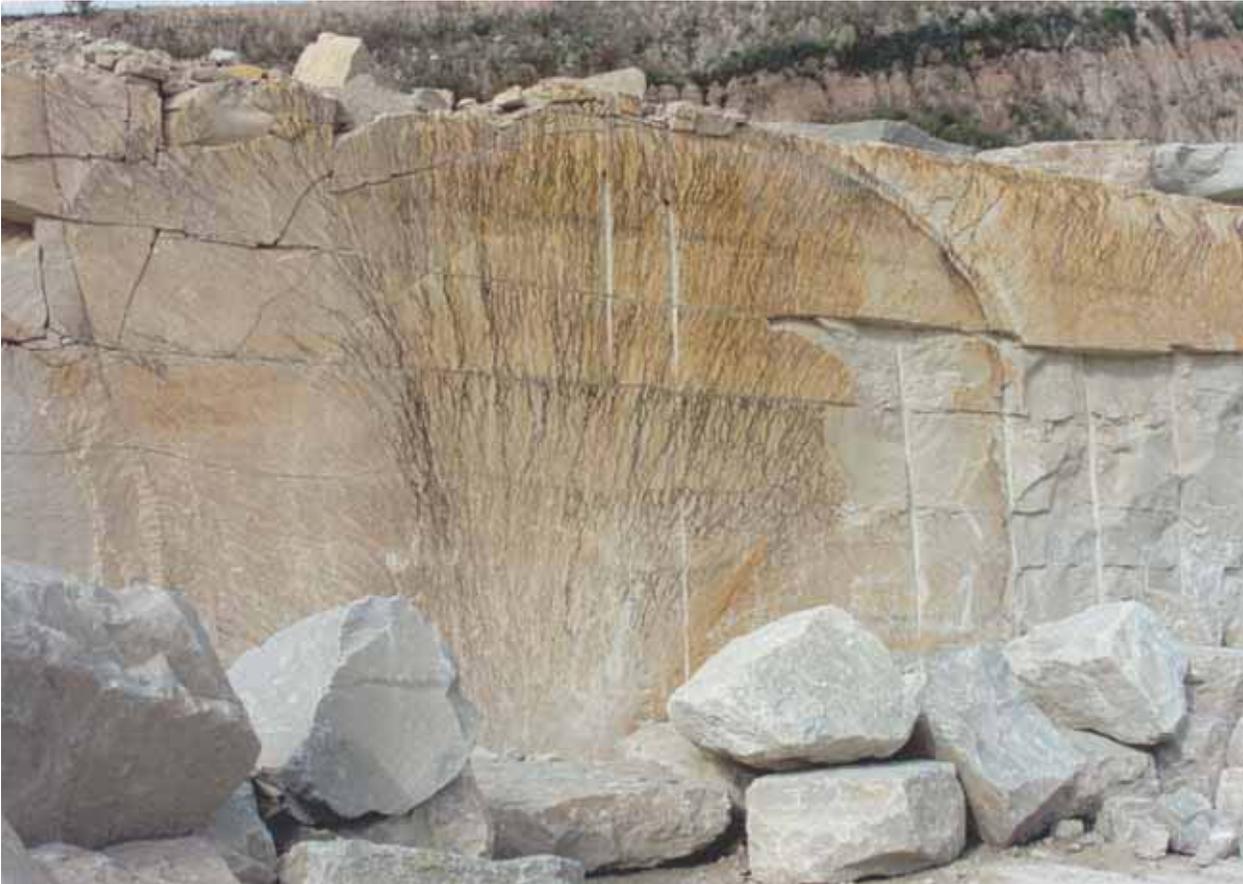
Figure 13. Valders Quarry, Valders, WI, splay of spent explosive blown out along joint (after Rock Products Consultants 1995)

Production is through a single line of 7.6-cm- (3-in.-) diam drill holes with a burden of 0.9 to 1.2 m (3 to 4 ft) and a spacing of 0.9 m (3 ft), from a maximum bench height of approximately 6.4 m (21 ft). The blast program is designed to parallel the principal joint orientation. This blast pattern is specifically designed to minimize overbreak and maximize the production of large armor stone and architectural stone. Stone with excessive vugs or discoloration is considered unsuitable for architectural stone and is readily available for armor stone. Since the architectural stone is taken from the lowermost bench, there is a significant amount of overburden that is wasted. Figure 13 shows waste rock resulting from explosive fracturing.

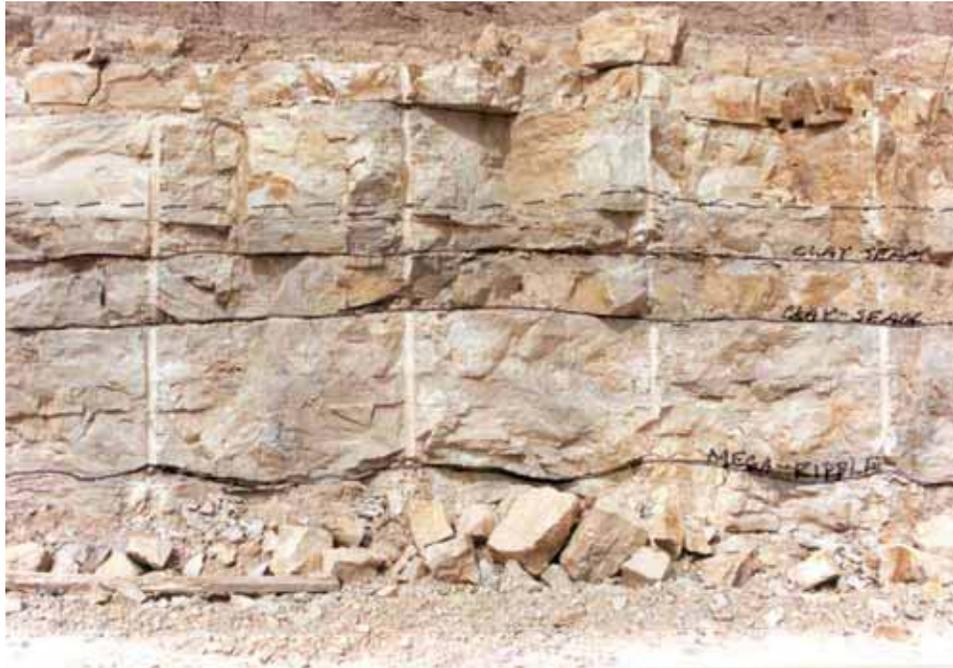
Figure 14. Valders Quarry, Valders, WI, upper bench with mega-ripples near base (after Rock Products Consultants 1995)

homogeneous unit of fairly consistent texture and color and is the primary source for Valder's architectural stone products. The upper bench (Figure 14) contains mega-ripples near the base. The middle bench is a reef-like dolomite that may represent a generation-4 reef development as defined by Droste and Shaver (1977). This correlates well with other generation-4 buildups in other parts of the Michigan Basin. The lower bench (Figure 15) indicates discontinuous horizontal unloading fractures.

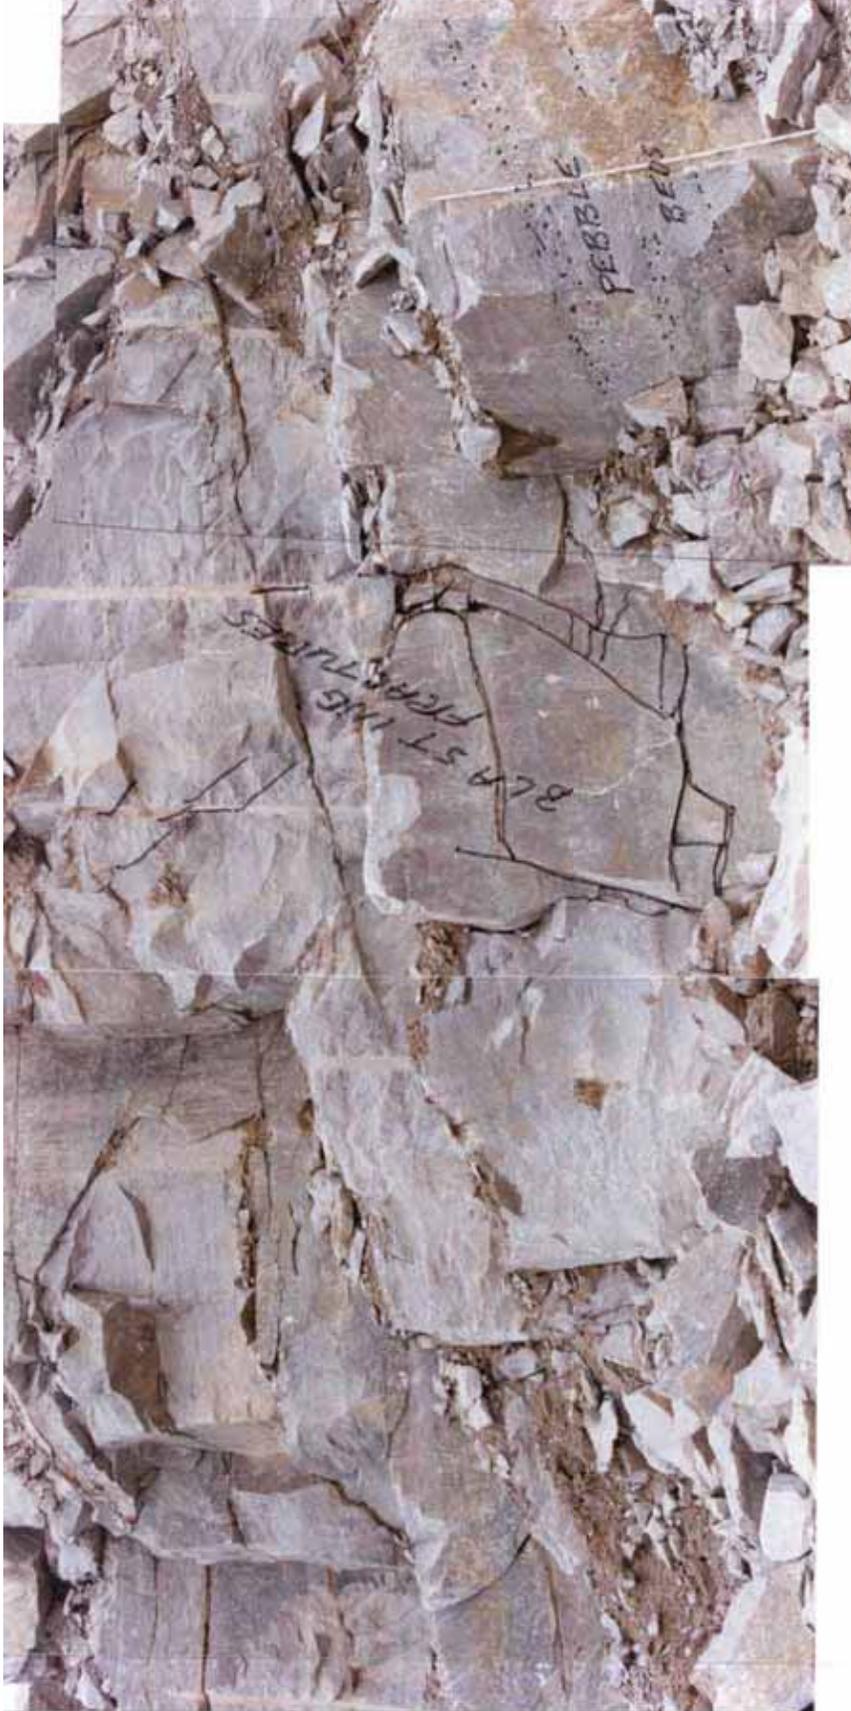
Figure 18. Dempsey Quarry, Waterloo, WI, lower bench, south face (after Rock Products Consultants 1995)

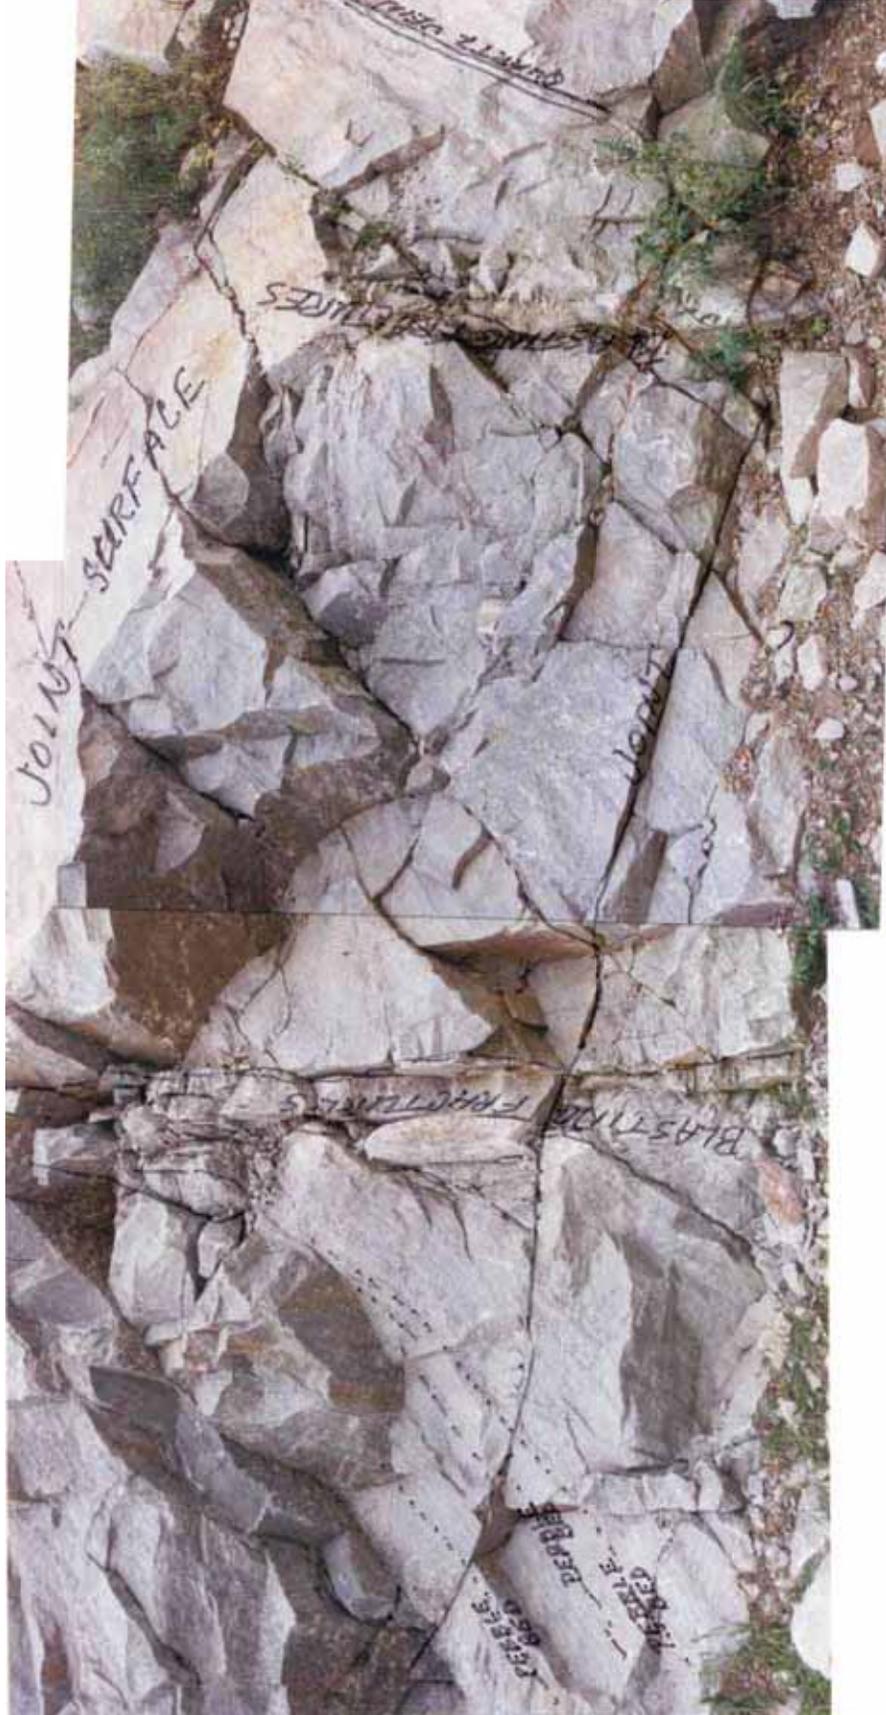
Figure 19. Dempsey Quarry, Waterloo, WI, upper bench, east face (after Rock Products Consultants 1995)

The upper bench (Figure 19) contains alternating beds of pebble gravel layers and coarse quartzite layers with two ripple marked discontinuities. There is also a bed of coarse-grained quartzite with pockets of gravel-sized material. Again, micaceous seams are found at depositional breaks in the sequence. This fabric is indicative of cyclic depositional energy levels, which also could be due to fluvial deltaic processes or alternatively glacial outwash plain from glacial advance and retreat.

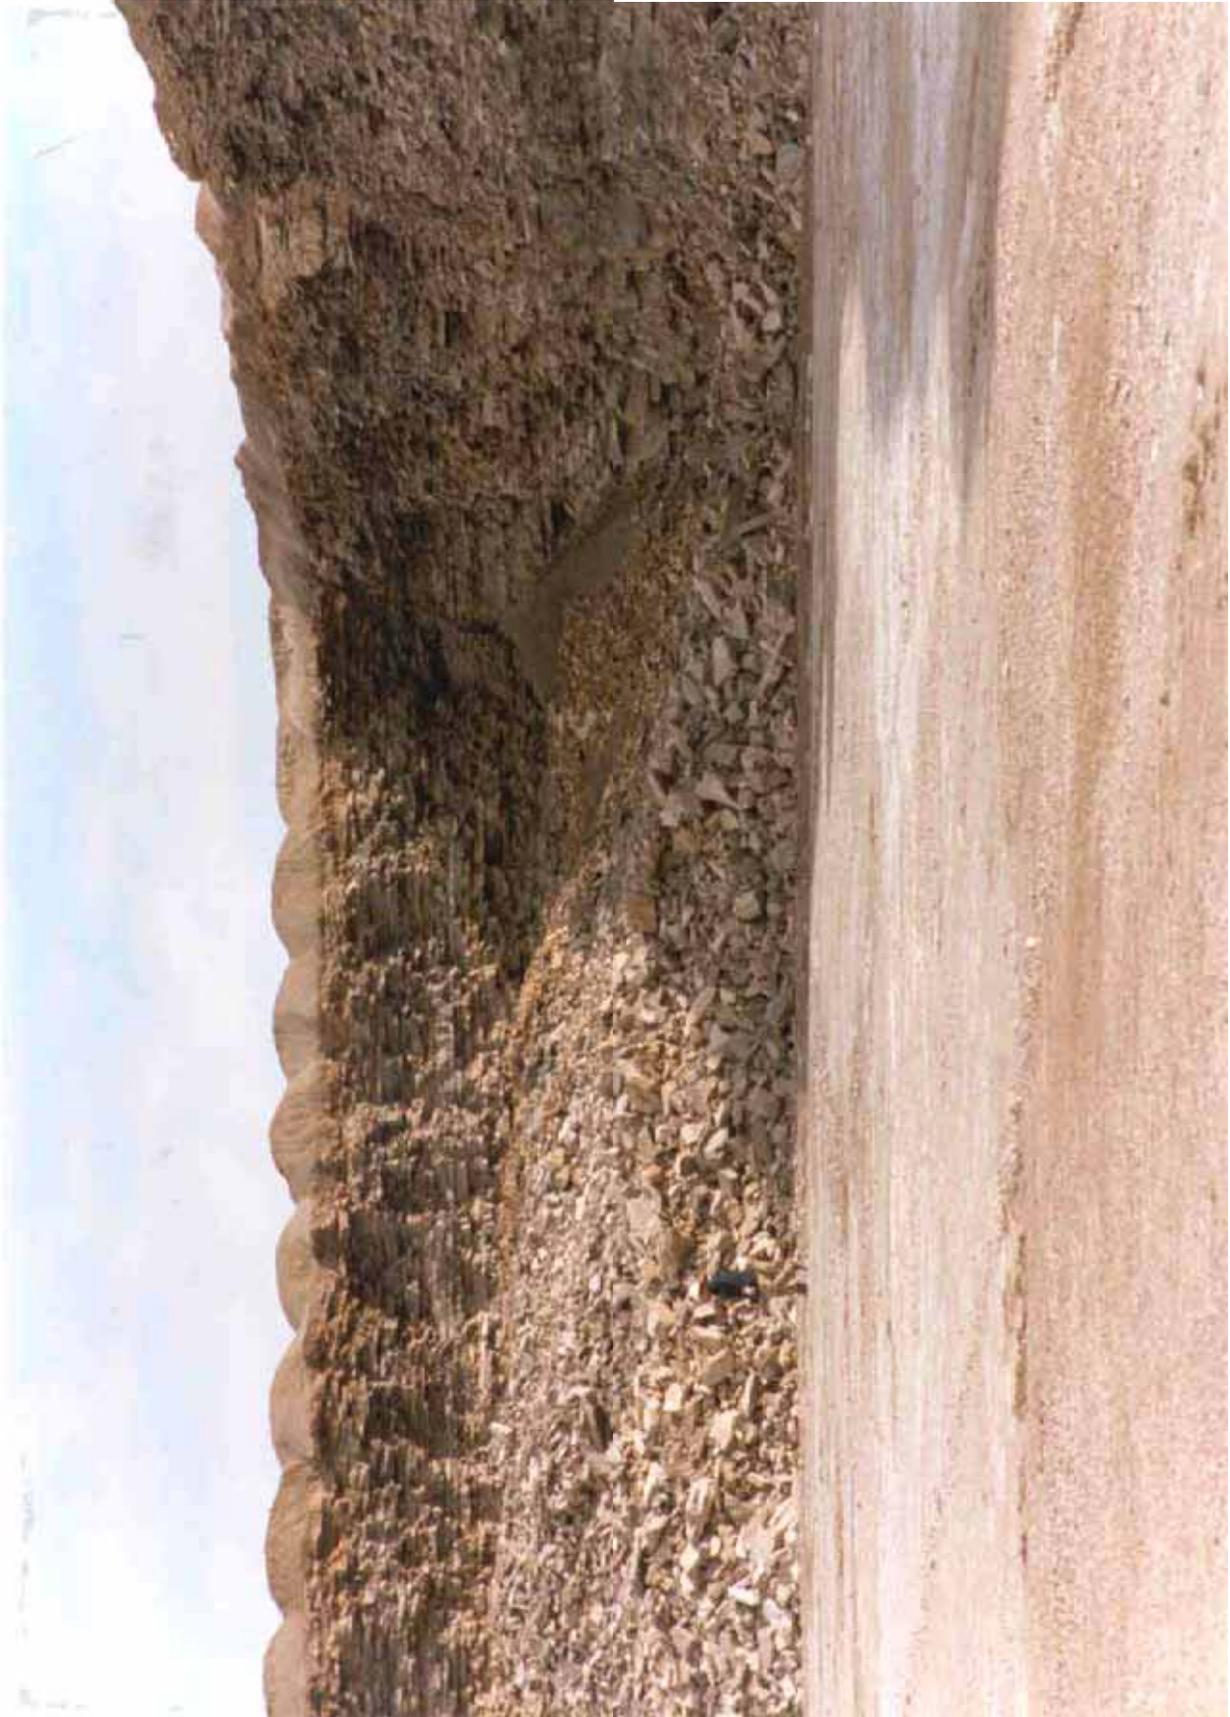
Figure 20. Sandusky Quarry, Parkertown, OH, thin-bedded Delaware formation on east side of quarry (after Rock Products Consultants 1995)

The first bench of the west face consists of approximately 4.6 m (15 ft) of the Delaware formation that is extremely thin-bedded due to glacial unloading (Figure 20). This material is sold as flagstone.

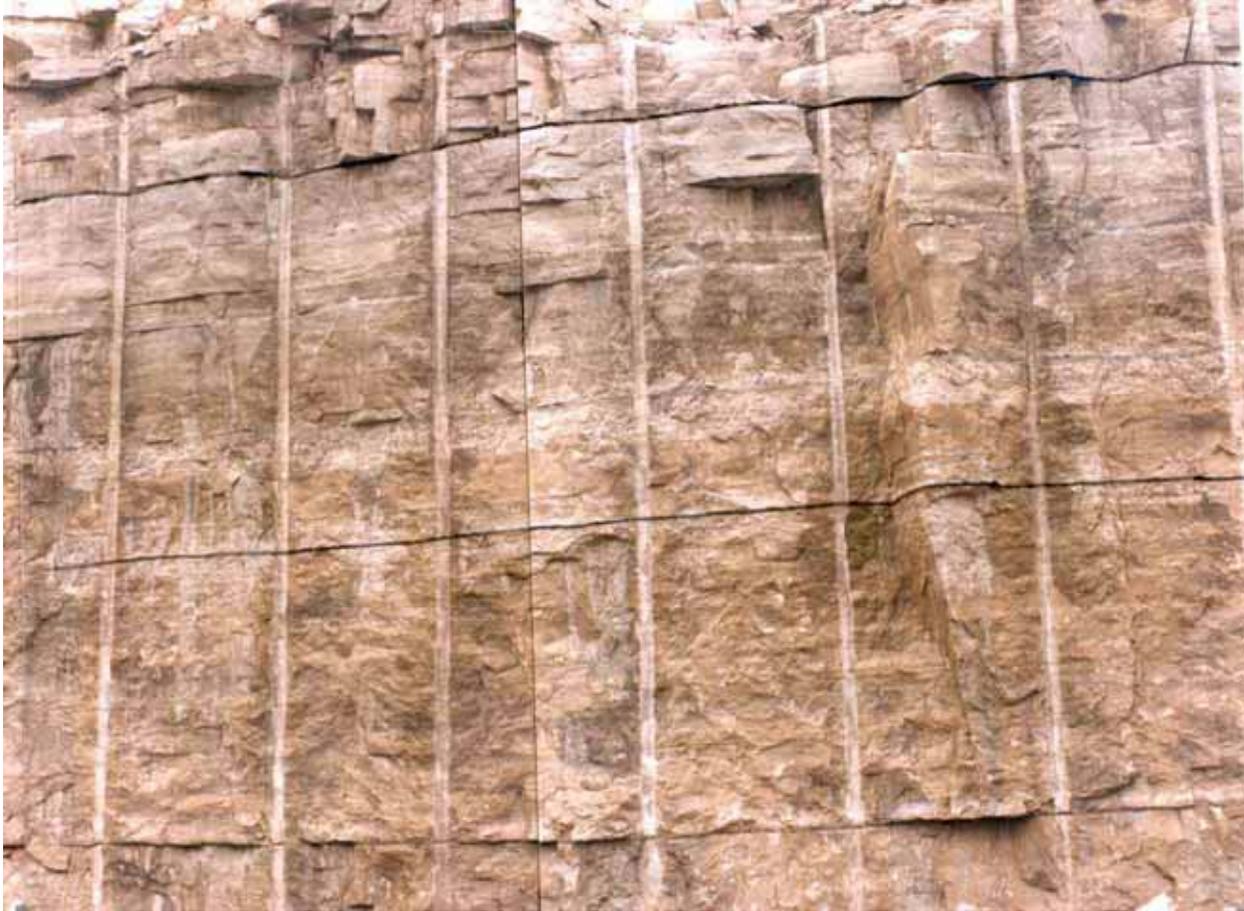
Figure 22. Sandusky Quarry, Parkertown, OH, close-up of contact of Columbus and Delaware formations; also contact of Venice and Marblehead members of Columbus formation (after Rock Products Consultants 1995)

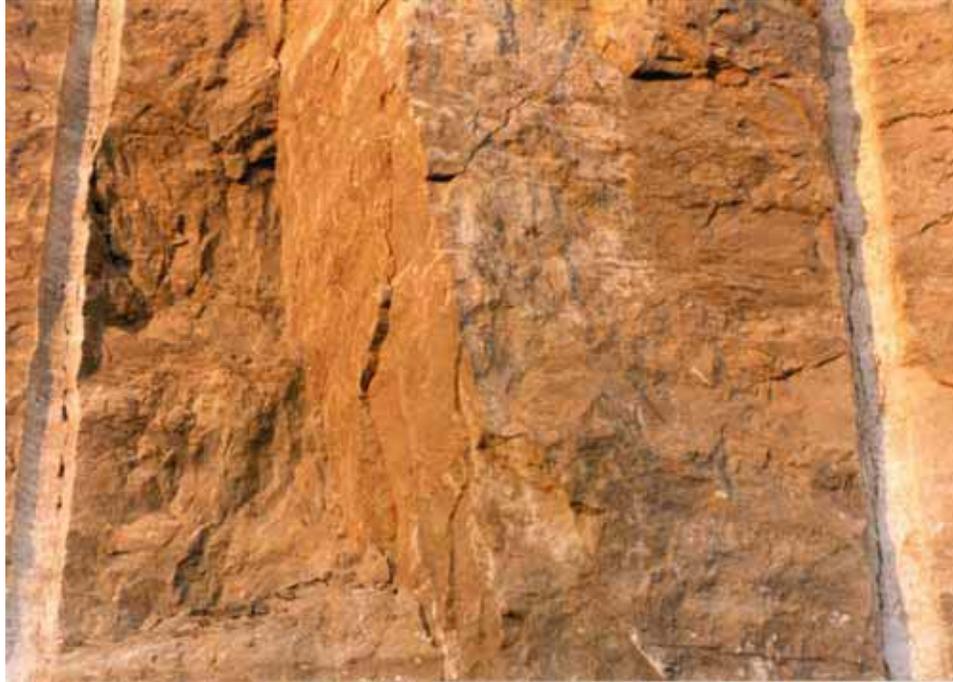
Figure 23. Sandusky Quarry, Parkertown, OH, blasting fractures along blastholes (after Rock Products Consultants 1995)

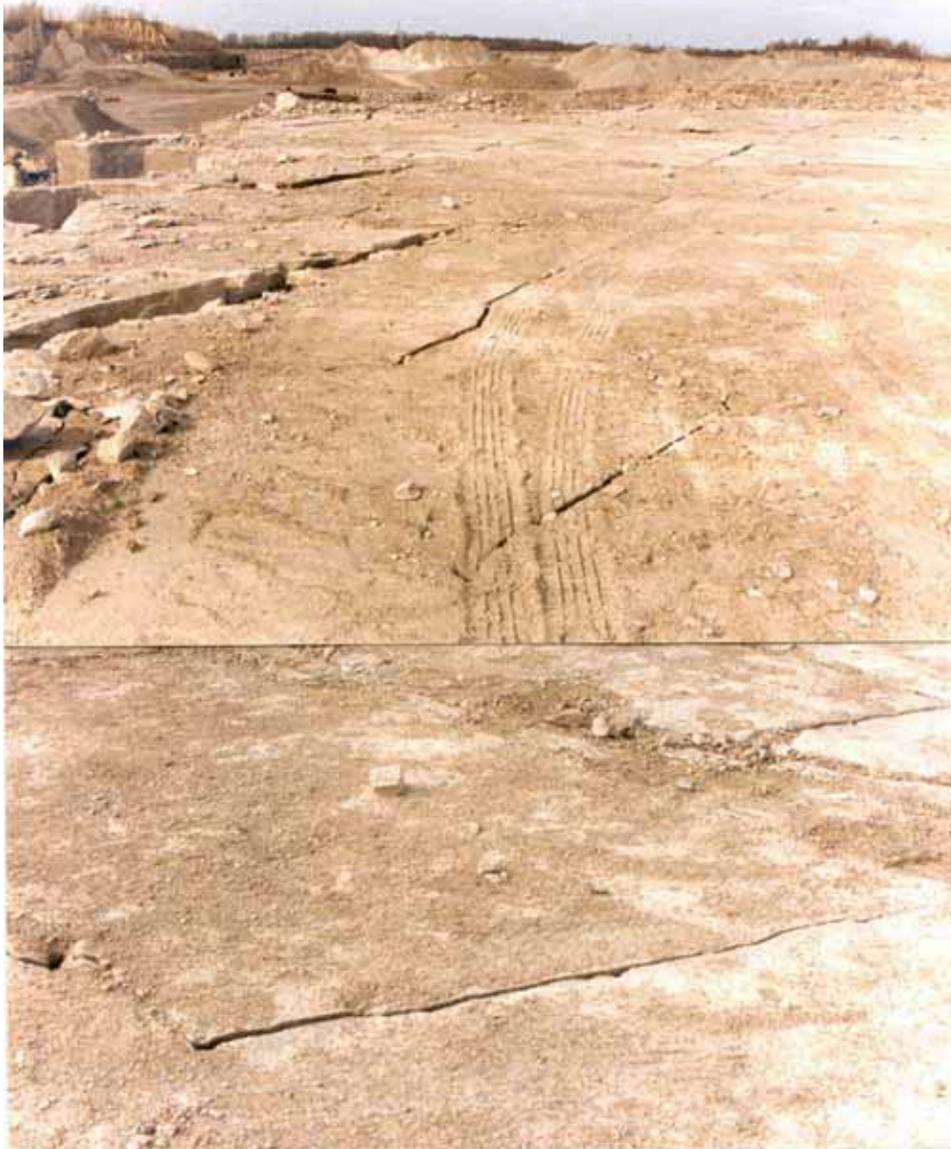
Figure 24. Marblehead Quarry, Marblehead, OH, conjugate system of parallel release fractures opened in a nose or promontory of lower bench as a result of quarrying practices. By allowing nose of lower bench to exist, confining stress was reduced on three sides of rock mass. Over-blasting helped to activate development of these release fractures (after Rock Products Consultants 1995)

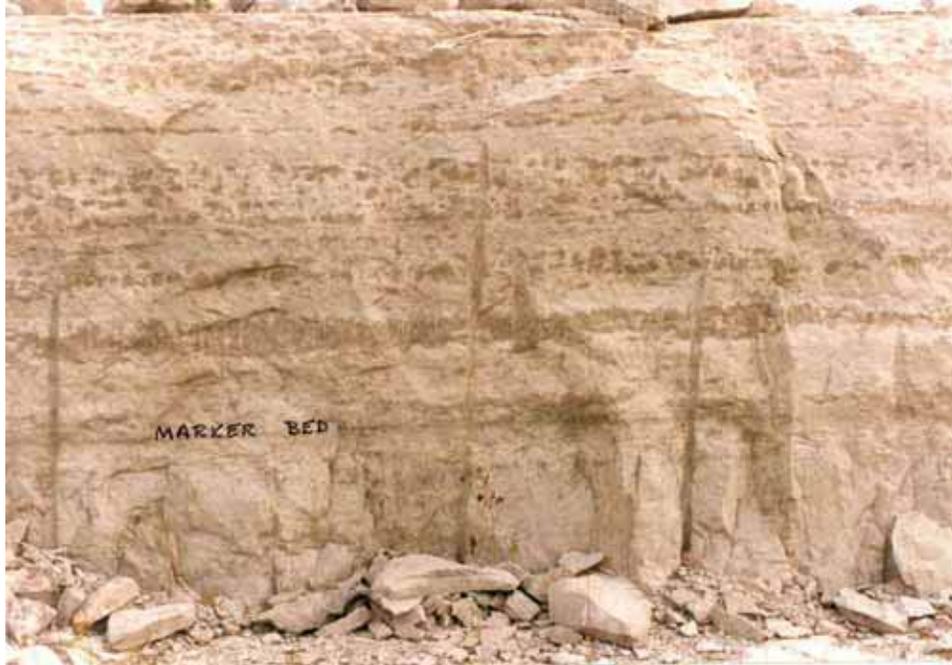
Figure 26. Marblehead Quarry, Marblehead, OH, 2.9 m (9.6-ft) face on east side of quarry from which armor stone was produced, at or near base of Columbus formation (after Rock Products Consultants 1995)

Only the middle bench was investigated (Figure 26). The floor of this bench is the contact between the Lucas and Columbus formations. The bench consists of only two units. The material is fine to medium-grained fossiliferous, bioturbated dolomitic mudstone, and contains numerous thin fossiliferous zones alternating with thicker burrowed mud zones. There are occasional thin, black, wavy shaley seams. Prominent shaley carbonaceous marker bed separates a lower lithologic unit.

The lower lithologic unit is a 0.9-m- (2.9-ft-) thick dolomitic fossiliferous packstone/mudstone. It is pale yellowish brown, fine to medium-grained, very porous (up to 0.3 cm (0.1 in.) in diameter) with widely scattered vugs averaging about 0.3 cm (1 in.) in diameter, and is massive bedded. The lower unit is the base of the Marblehead member of the Columbus formation. A thin (less than 3-cm (0.1-ft) thick), persistent, dark brown bioclastic zone delineates this unit from the unit above.

The upper lithologic unit is a 2.0-m- (6.5-ft-) thick dolomitic burrowed lime mudstone. This unit exhibits extensive bioturbation. Both the lower and upper units are interpreted as lagoonal depositional environment. Hence, the primary facies are (a) massive dolomitic mudstone, (b) bioturbated dolomitic mudstone, and (c) fossiliferous dolomitic mudstone. This unit is pale yellow brown with medium yellowish brown mottling, fine to medium-grained, fossiliferous, massively bedded, but with intensively bioturbated zones. The top surface of the bench is a bioturbated, burrowed shoresurface, with branching corals attached. This unit contains numerous thin (3 to 6 cm (0.1 to 0.2 ft thick)), fossiliferous zones alternating with thicker (12 to 20 cm (0.4 to 0.65 ft thick)) burrowed mud zone. A prominent 4.6-cm- (0.15-ft-) thick fossiliferous zone with thin, black,

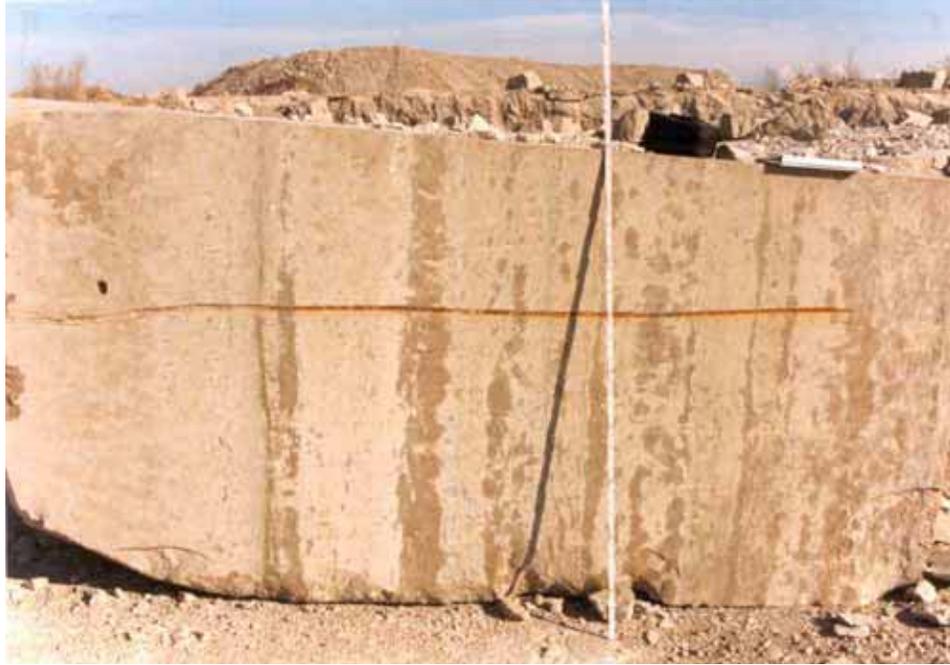
Figure 27. Marblehead Quarry, Marblehead, OH, sawn block with brown marker bed at 0.8 m (2.7 ft) from left side (after Rock Products Consultants 1995)

wavy shaley seams is located at 1.2 m (3.85 ft) from the top. Another prominent marker bed is present at the base of the unit. This marker bed is sometimes distinctively shaley and sometimes just carbonaceous. This marker bed was identified by Hill and Lienhart (1975),¹ and may be traced to other quarries throughout the Sandusky area. Figure 27 shows a sawn block from Marblehead Quarry.
