ERDC/CHL TR-05-1

Monitoring Completed Navigation Projects Program

Monitoring Stone Degradation on Coastal Structures in the Great Lakes – Summary Report

June 2005

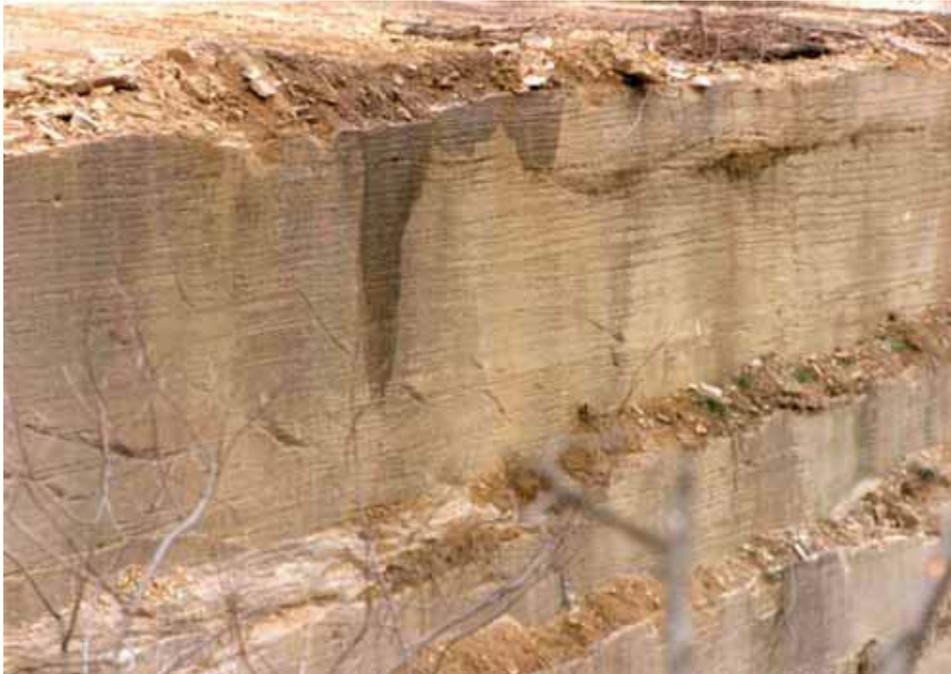
Figure 30. Johnson Quarry, Kipton, OH, thin-bedded upper unit on north side of quarry (after Rock Products Consultants 1995)

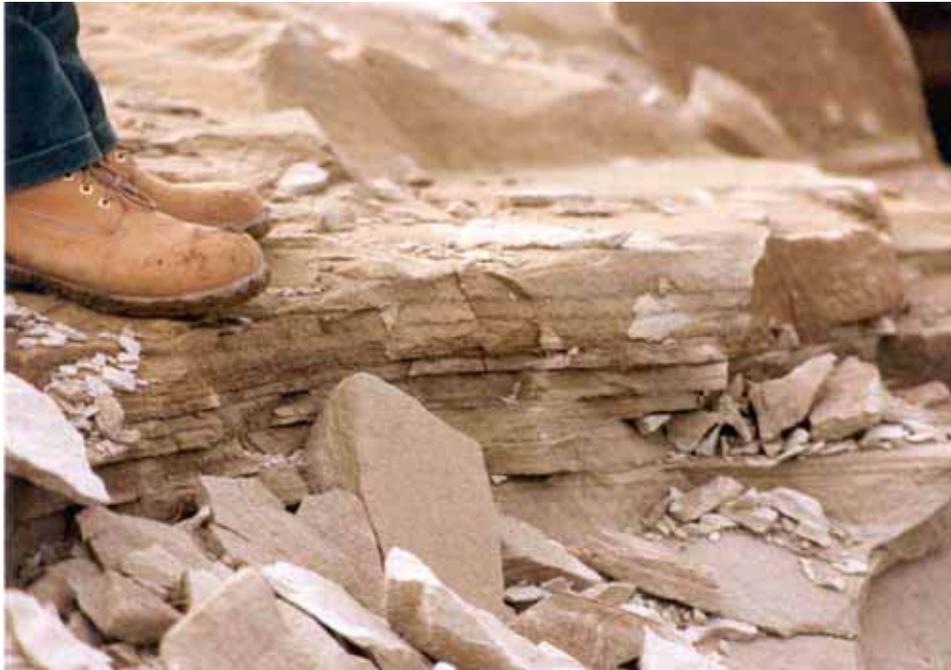
Figure 31. Johnson Quarry, Kipton, OH, close-up of thin-bedded sandstone showing carbonaceous bedding planes (after Rock Products Consultants 1995)

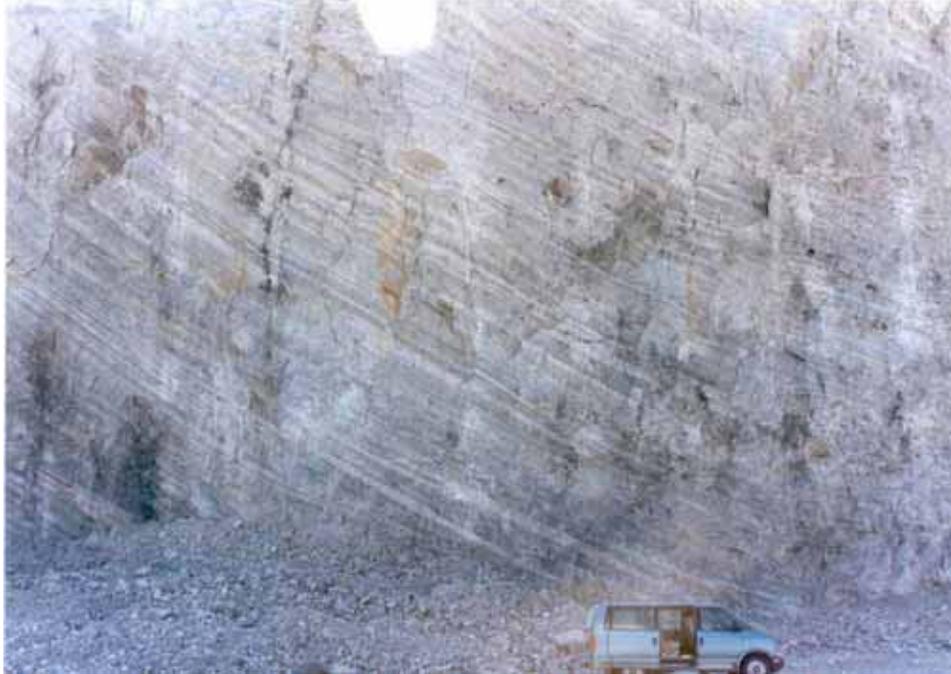
Figure 36. Thornton Quarry, Thornton, IL, northwest quarry, middle bench, showing massive flank beds (after Rock Products Consultants 1995)

The east end of this face exposes the reef core and accompanying reef flank rock. The reef core is a dark brown, almost black, dense to slightly vuggy dolomite. It is massive and free of bedding. The reef flank rock is a massive,

banded, pale yellowish gray and light medium gray dolomite. It is dense with scattered macropores and some vugs. The vugs are mostly small, 0.6 to 1.3 cm (0.25 to 0.5 in.) in diameter, but some may get as large as 46 cm (18 in.) in diameter or even larger. There are no distinct bedding partings in the reef flank facies.

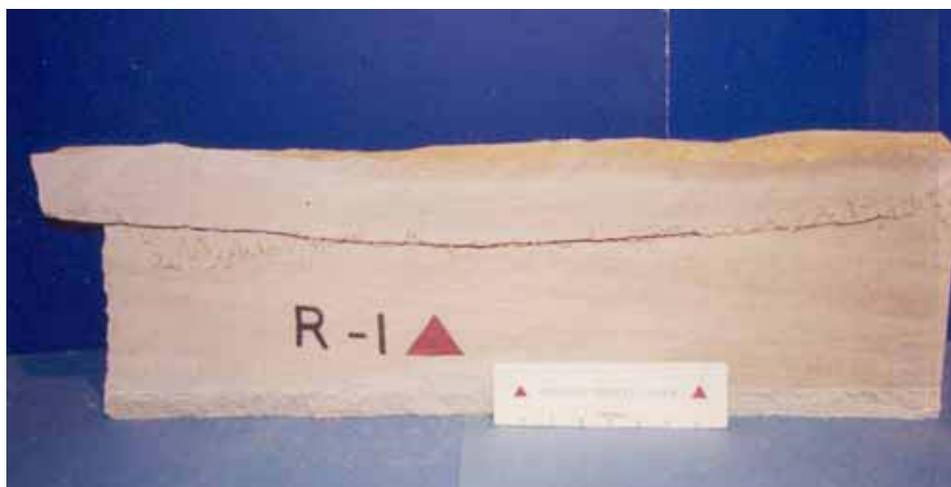
Figure 39. Reed Quarry Salem formation limestone accelerated weathering durability Test Block R-1-FT

Test Block R-1-FT. This test block (Figure 39) was subjected to freeze/thaw (FT) testing only (where FT indicates after freeze/thaw exposure). Samples R-1A-FT and R-1B-FT were extracted from this test block. Subsequently, Thin Section Samples TS-R-1A-1FT, TS-R-1A-2FT, and TS-R-1A-3FT were extracted from Sample R-1A-FT. Thin Section Samples TS-R-1B-1FT and TS-R-1B-2FT were extracted from Sample R-1B-FT.

Macroscopically, the material appears porous and rough. Microscopically, the lack of carbonate cement is predominant. Microscopic analysis revealed approximately 10 percent porosity associated with calcitic cement at grain contacts. These contacts also show some interesting dripstone morphologies of the cement on the underside of grains, formed during lithofication, and can be used to ascertain direction of bedding.

The bedding exhibits irregular, interbedded, and cross-bedded structures. Elongated grains are oriented parallel to the bedding planes, but no planes of weakness appear in the sample. One large, high frequency and moderate amplitude, highly ferrous, stylolitic seam exists parallel to bedding in the middle of the sample. The stylolite has partially parted along one surficial boundary, but was

intact in the area where the tests were taken. The iron-rich character of the stylolite increases the specific gravity slightly in this area, but the general porous quality is still prevalent.

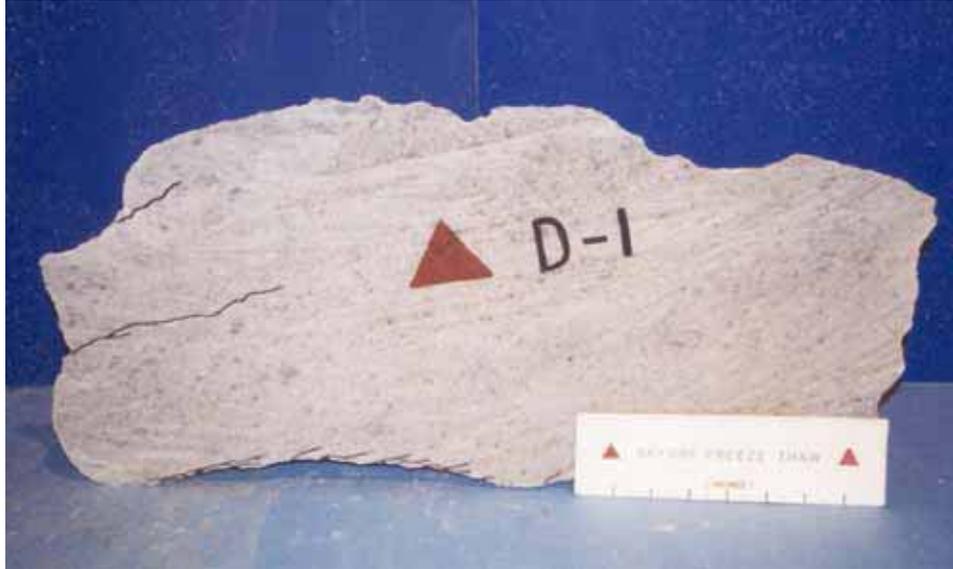
Figure 42. Dempsey Quarry Waterloo formation quartzite accelerated weathering durability Test Block D-1-FT

Test Block D-1-FT. This test block (Figure 42) was subjected to freeze/thaw testing only. Samples D-1A-FT and D-1B-FT were extracted from this test block. Subsequently, Thin Section Samples TS-D-1A-1FT and TS-D-1A-2FT were extracted from Sample D-1A-FT. Thin Section Sample TS-D-1B-1FT was extracted from Sample D-1B-FT.

The test block is pale red to dark dusky red, coarse grained, cross-bedded, high-grade meta-quartzite. Grains are well sutured with no to little void space. Original iron-rich sand grains can be observed within the ground matrix. Freshly fractured surfaces exhibit a fine, sugary texture. Bedding can be determined by vertical color changes, vertical grain size distribution changes, and thin laminations of black iron-oxide mineralization. These iron-rich minerals are formed in small rosettes, probably during metamorphism, and are not associated with any open fracturing.

Short, tight, noncontinuous, stress relief fractures are common and occur perpendicular to bedding or intergranularly. These fractures average 1 cm (0.4 in.) in length, and begin and dissipate in the ground mass. These fractures do not appear to affect the integrity of the sample, but they do have the potential to connect, forming larger continuous fractures. Open fractures do exist, but are predominantly short and are close to the surficial boundaries of the sample. These also dissipate into the groundmass.

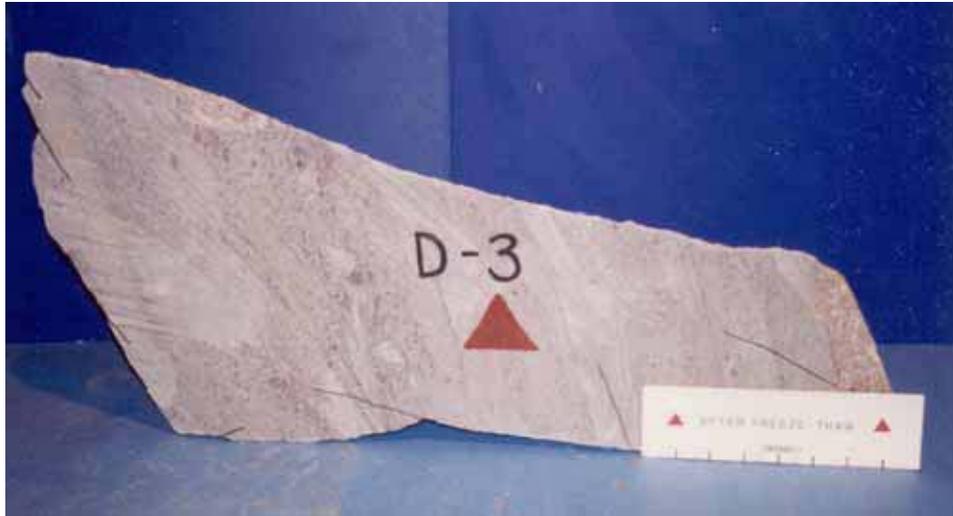
Figure 43. Dempsey Quarry Waterloo formation quartzite accelerated weathering durability Test Block D-3-FT

Test Block D-3-FT. This test block (Figure 43) was subjected to freeze/thaw testing only. Samples D-3A-FT and D-3B-FT were extracted from this test block. Subsequently, Thin Section Samples TS-D-3A-1FT and TS-D-3A-2FT were extracted from Sample D-3A-FT. Thin section Samples TS-D-3B-1FT and TS-D-3B-2FT were extracted from Sample D-3B-FT.

The test block is pale red to dark dusky red, coarse grained, cross-bedded, high-grade meta-quartzite. Grains are well sutured with no to little void space. Original iron-rich sand grains can be observed within the ground matrix. Freshly fractured surfaces exhibit a fine, sugary texture. Bedding can be determined by vertical color changes, vertical grain size distribution changes, and thin laminations of black iron-oxide mineralization. The noticeability of the cross-bedded nature of this sample is much better than Test Block D-1. This is a result of the sharp truncation of medium- to coarse-grained beds with coarse-grained deposits. Some of these coarse grains are up to 3 cm (1.18 in.) in diameter.

Short, tight, noncontinuous, stress relief fractures are common and occur perpendicular to bedding or intergranularly. These fractures average 1 cm (0.4 in.) in length, and begin and dissipate in the groundmass. These fractures do not appear to affect the integrity of the sample, but they do have the potential to connect, forming larger continuous fractures. These also dissipate into the groundmass. Open fractures do exist, predominantly short and close to the surficial boundaries of the sample. However, there are joint sets (with apparent angles of approximately 55 and 125 deg) that permeate the sample fairly deep and, in some cases, run the width of the sample. Upon parting, secondary micaceous mineralization can be readily noticed partially infilling these joint sets.

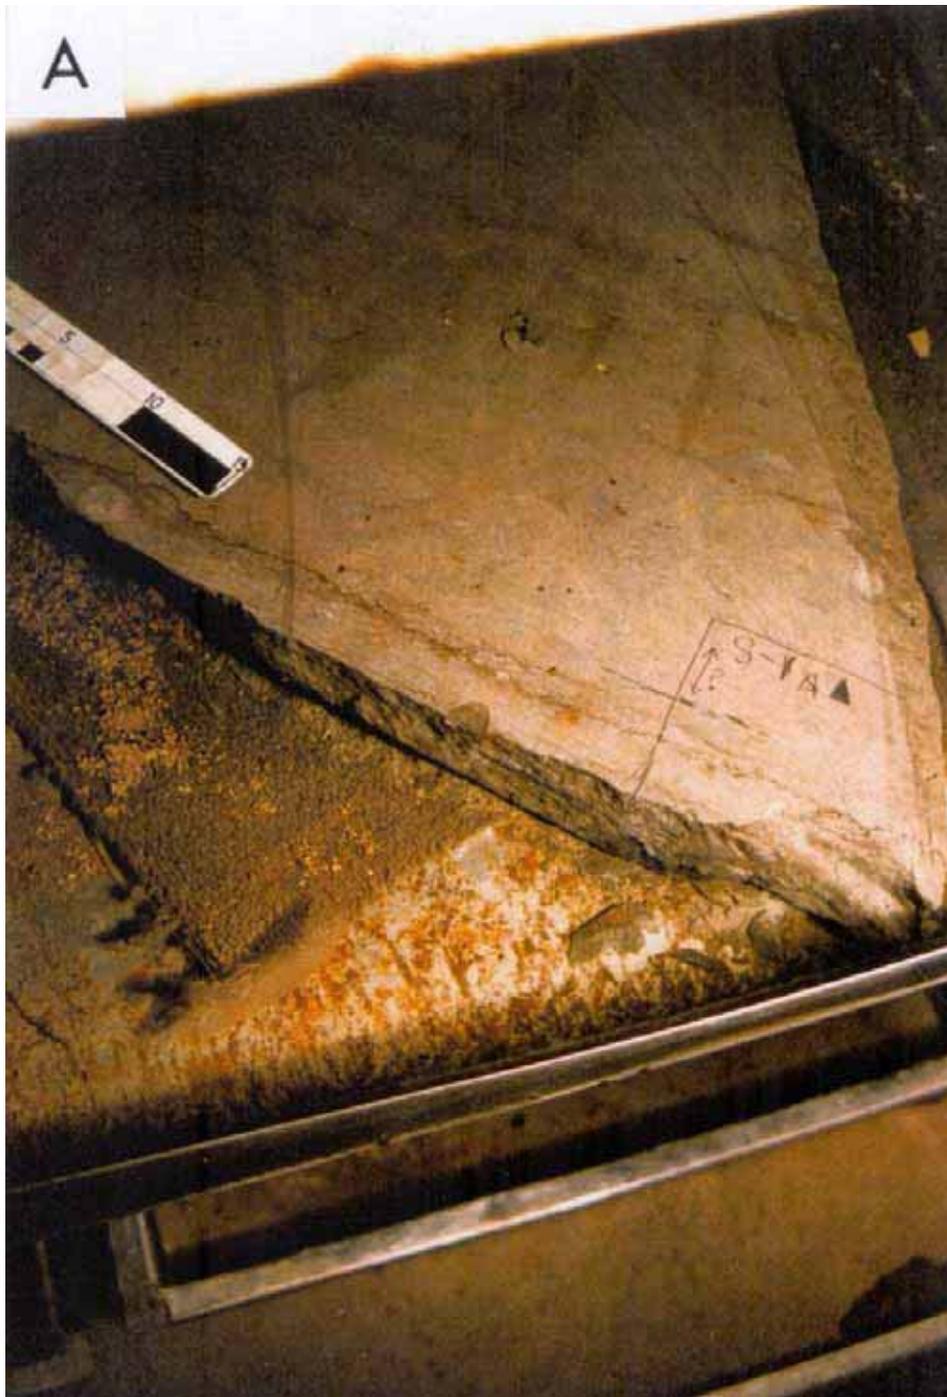
Figure 44. Sandusky Quarry Columbus formation limestone accelerated weathering durability Test Block S-1-FT/WD

Test Block S-1-FT/WD. This test block (Figure 44) was subjected to both freeze/thaw and wet/dry (WD) testing (where FT/WD indicates after both freeze/thaw and wet/dry exposure). Samples S-1A-FT/WD and S-1B-FT/WD were extracted from this test block. Subsequently, Thin Section Samples TS-S-1A-1FT/WD and TS-S-1A-2FT/WD were extracted from Sample S-1A-FT/WD. Thin Section Samples TS-S-1B-1FT/WD and TS-S-1B-2FT/WD were extracted from Sample S-1B-FT/WD.

The test block is light gray to olive-gray, coarse-grained limestone, poorly sorted, well-packed, well lithofied, fossiliferous wackestone to packstone (30 percent fossils; 70 percent calcitic and micritic matrix). The matrix consists of intergranular argillaceous micrite with crystalline calcium carbonate grains. Fossils consist of mostly medium grained crinoid fragments and other fossil hash.

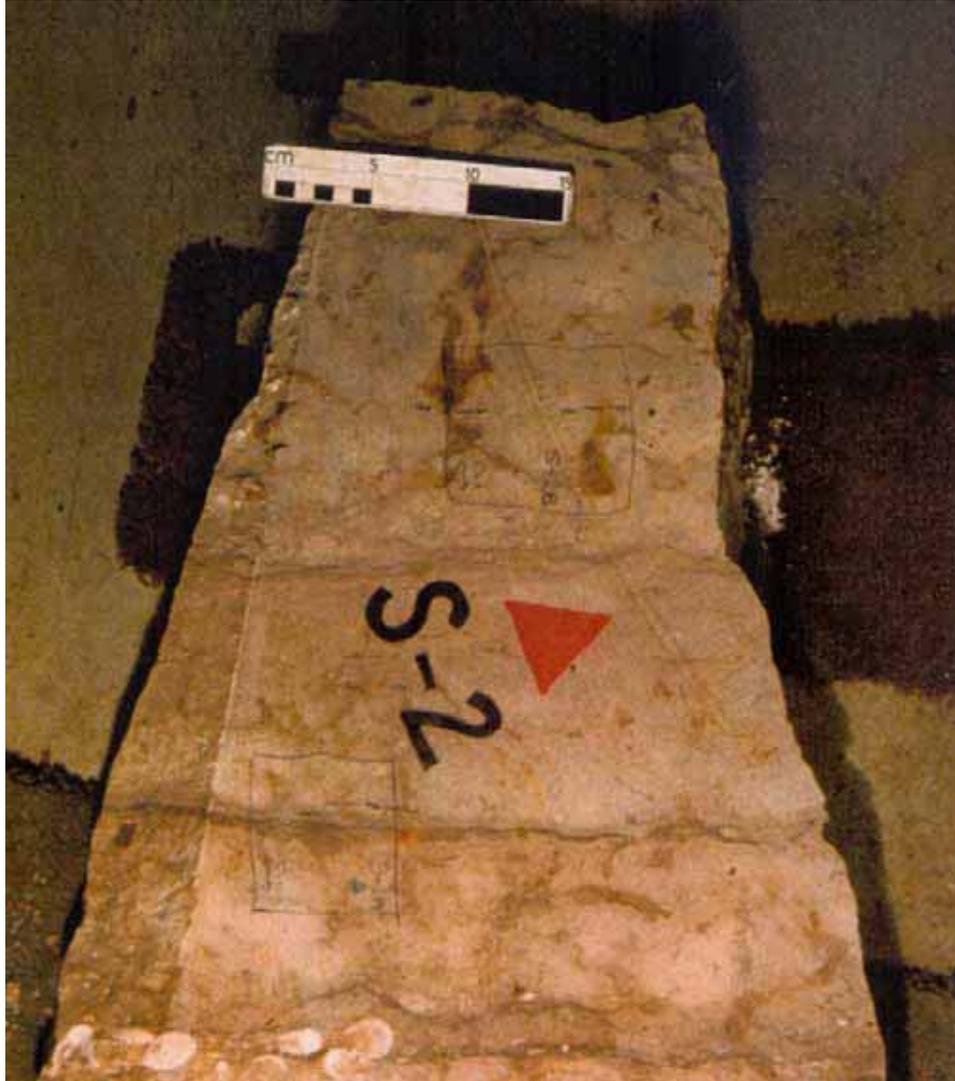
Figure 45. Sandusky Quarry Columbus formation limestone accelerated weathering durability Test Block S-2-FT

Test Block S-2-FT. This test block (Figure 45) was subjected to freeze/thaw testing only. Samples S-2A-FT and S-2B-FT were extracted from this test block. Subsequently, Thin Section Samples TS-S-2A-1FT and TS-S-2A-2FT were extracted from Sample S-2A-FT. Thin Section Samples TS-S-2B-1FT and TS-S-2B-2FT were extracted from Sample S-2B-FT.

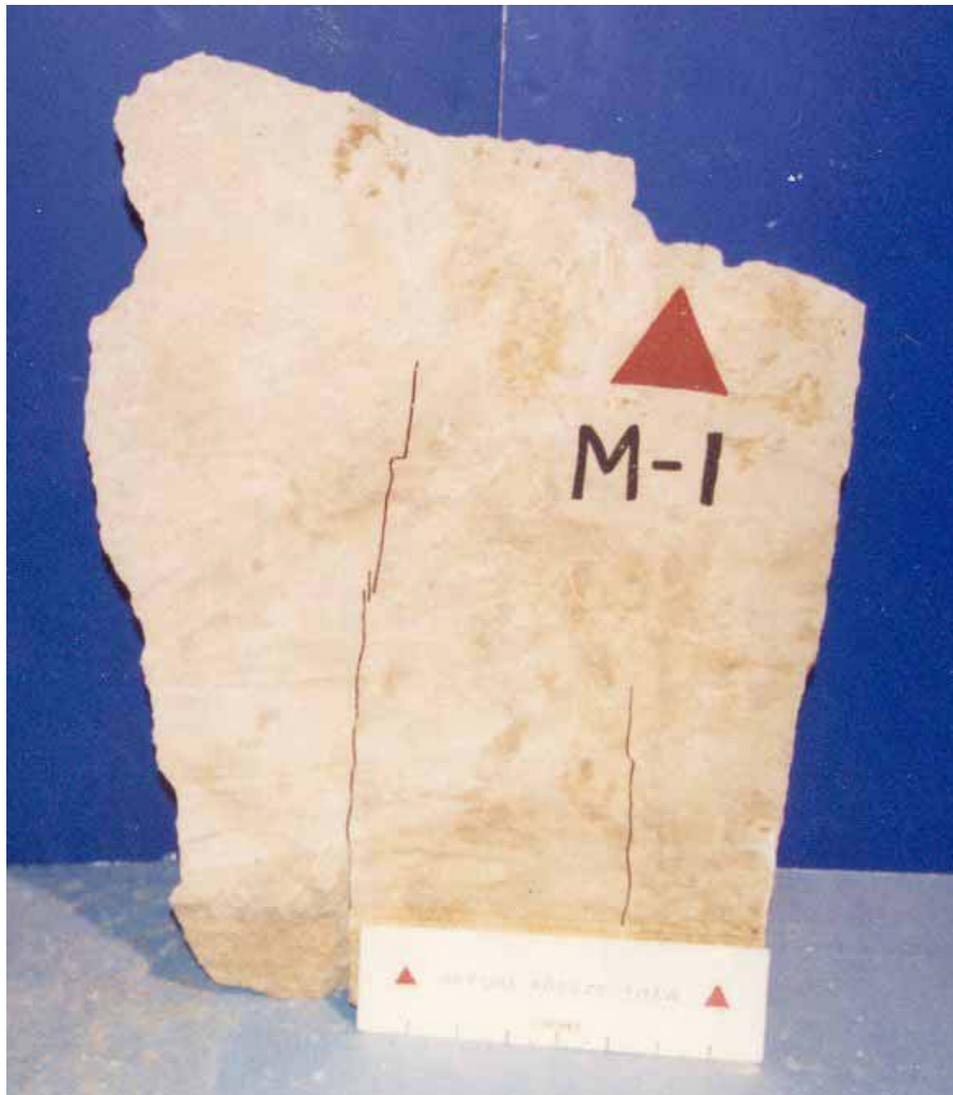
Figure 46. Marblehead Quarry Columbus formation dolomitic limestone accelerated weathering durability Test Block M-1-FT

Test Block M-1-FT. This test block (Figure 46) was subjected to freeze/thaw testing only. Samples M-1A-FT and M-1B-FT were extracted from this test block. Subsequently, Thin Section Sample TS-M-1A-1FT was extracted from Sample M-1A-FT. Thin Section Samples TS-M-1B-1FT and TS-M-1B-2FT were extracted from Sample M-1B-FT.

The test block is medium to dark brownish-gray, fine to medium grained dolomite, with mottled texture. Common dissolution voids of fossil fragments ranging from moderately large voids up to 1 cm (0.4 in.) to microscopic voids exist. Most voids do not exceed 2 mm (0.08 in.) in diameter. Dolomitized fossil fragments consist mostly of bryozoan and crinoid remnants. Bedding is very difficult to determine, with no prominent planes or orientation to elongated grains. An overall bedding can be weakly seen due to vertical color changes. The sample is porous but not permeable in the macroscopic scale. All major, open fractures run parallel to each other, and perpendicular to the weakly observable bedding planes. Minor, tight fractures occur randomly, wavy, and noncontinuously between or branching from the major open fractures. Most of the fractures begin and dissipate into the groundmass or voids. Freshly broken surfaces exhibit a sugary texture.

Overall, the test block is hard, tough, and fairly porous. The freeze/thaw percent loss was 0.31 percent, due to surficial spalling. The specific gravity was 2.58. Absorption was 3.21, and adsorption was 0.05, resulting in an adsorption/absorption ratio of 0.02.

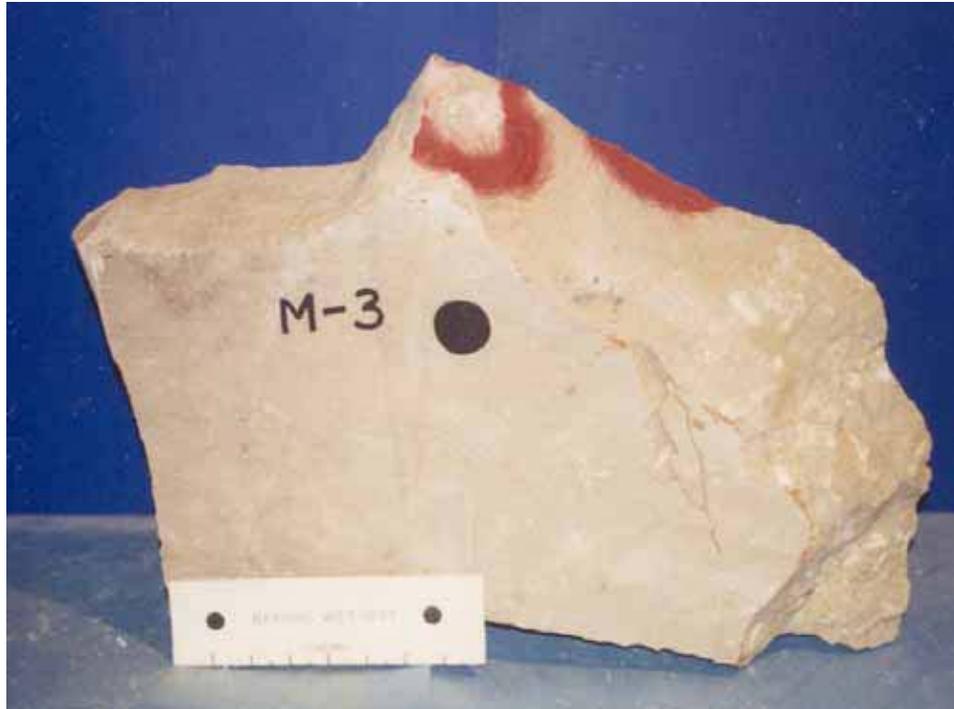
Figure 48. Marblehead Quarry Columbus formation dolomitic limestone accelerated weathering durability Test Block M-3-FT/WD

Test Block M-3-FT/WD. This test block (Figure 48) was subjected to both freeze/thaw and wet/dry testing. Samples M-3A-FT/WD and M-3B-FT/WD were extracted from this test block. Subsequently, Thin Section Sample TS-M-3A-1FT/WD was extracted from Sample M-3A-FT/WD. Thin Section Samples TS-M-3B-1FT/WD and TS-M-3B-2FT/WD were extracted from Sample M-3B-FT/WD.

The test block is medium to dark brownish-gray, fine to medium grained dolomite, with mottled texture. Dolomitized fossil fragments consist mostly of bryozoan and brachiopod remnants with occasional crinoid fragments. Large bryozoan (up to 3 cm (1.2 in.)) are common and are often lapped over by argillaceous laminations. Bedding is pronounced as alternating layers of dark brown, highly argillaceous laminations with dense, medium brownish-gray, mottled dolomite. Elongated grains are oriented lengthwise parallel with the bedding planes. The sample is dense, but some small voids 1 to 2 mm (0.04 to 0.08 in.) in diameter are present. All major, open fractures run parallel to each other, and perpendicular to the bedding planes. Minor, tight fractures occur randomly, wavy, and noncontinuously between or branching from the major open fractures. Most of the fractures begin and dissipate into the ground mass or voids. Freshly broken surfaces exhibit a sugary texture.

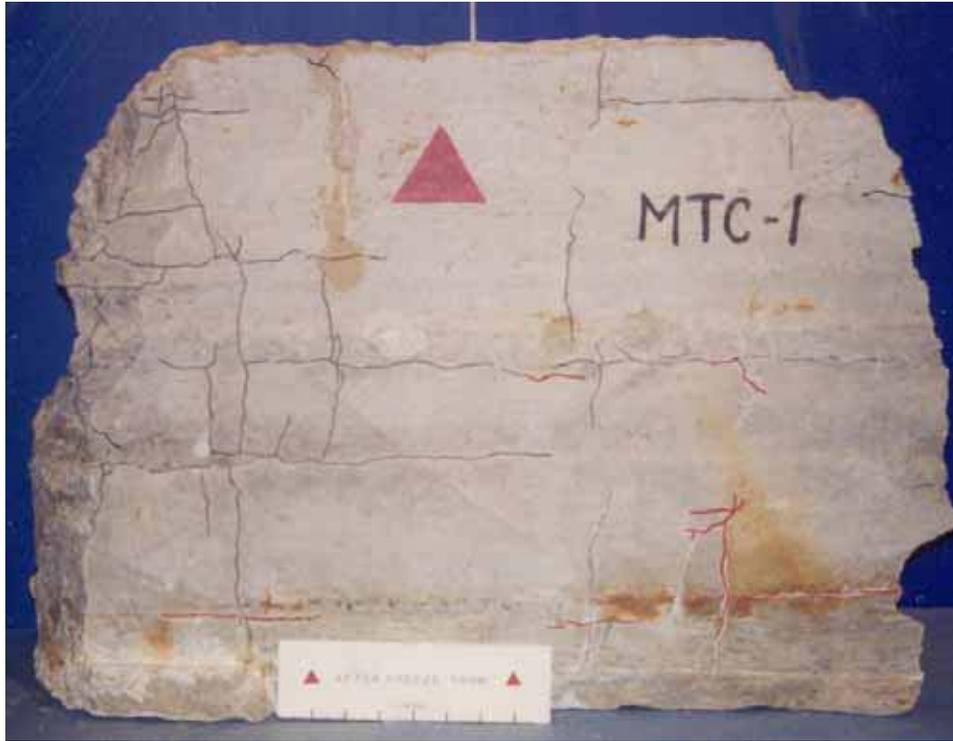
Figure 51. Thornton Quarry Racine formation dolomite accelerated weathering durability Test Block MTC-1-FT/WD

Test Block MTC-1-FT/WD. This test block (Figure 51) was subjected to both freeze/thaw and wet/dry testing. No samples were extracted from this test block for microstructural analyses.

The test block is light to medium bluish-gray, fine-grained, micritic dolomite with a highly mottled texture. Bedding is determined by algal mat remnant structures oriented elongate to the horizontal length of the samples. These algal structures are fine grained, ranging from white to a dark bluish-gray color and often are quite dense. These structures are rarely more than 2.0 cm (0.8 in.) thick and are continuous across the entire length of the sample. They are mostly sinuous to wavy, and do not affect the parting of the sample.

Overall, the test block is dense, tough, and hard. The freeze/thaw percent loss was 0.37 percent, due to surficial spalling. The wet/dry percent loss was 0.28 percent, due to surficial spalling. The specific gravity was 2.70. Absorption was 1.56, and adsorption was 0.21, resulting in an adsorption/absorption ratio of 0.13.

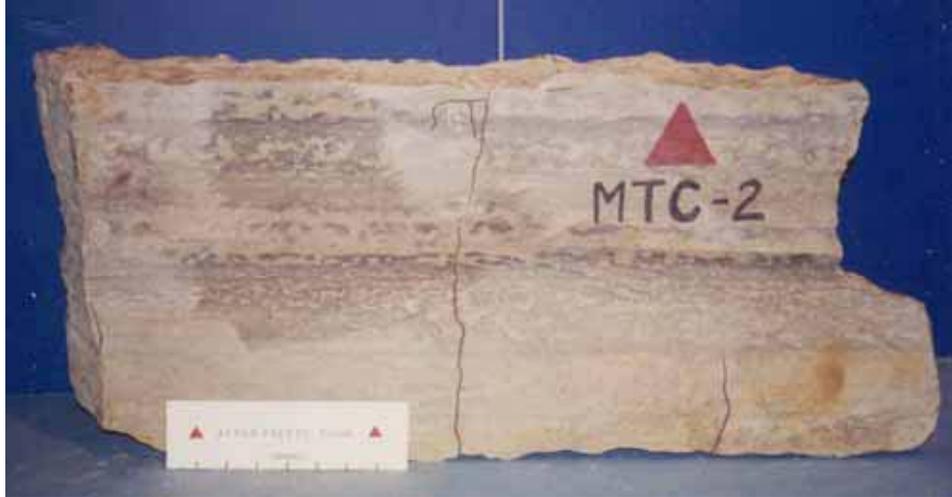
Figure 52. Thornton Quarry Racine formation dolomite accelerated weathering durability Test Block MTC-2-FT

Test Block MTC-2-FT. This test block (Figure 52) was subjected to freeze/thaw testing only. No samples were extracted from this test block for micro-structural analyses.

The test block is light to medium bluish-gray, fine-grained, micritic dolomite with a highly mottled texture. Bedding is determined by algal mat remnant structures oriented elongate to the horizontal length of the samples. These algal structures are fine grained, ranging from white to a dark bluish-gray color and often are quite dense. These structures are rarely more than 3 cm (1.2 in.) thick and are continuous across the entire length of the sample. They are mostly sinuous to wavy, and do not affect the parting of the sample.

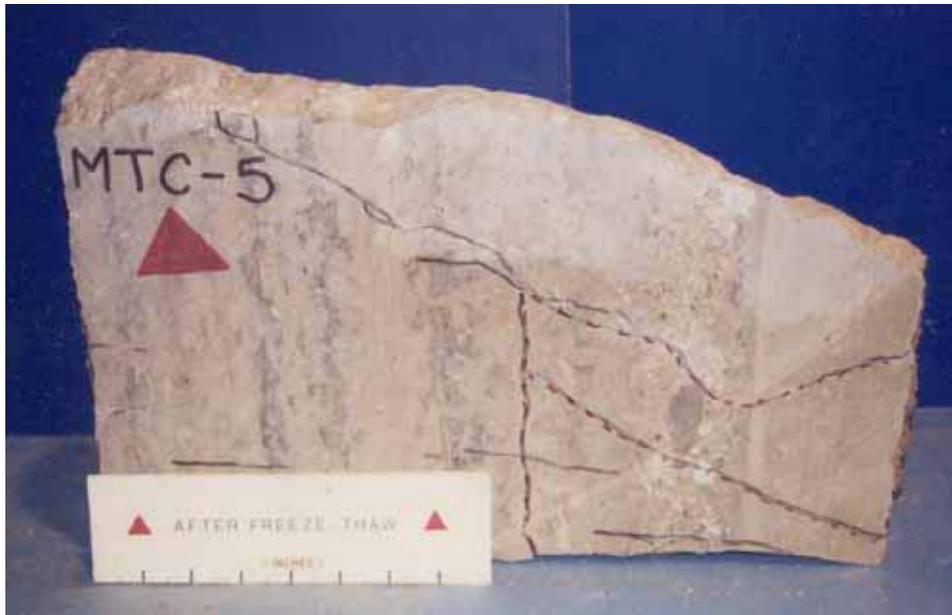
Figure 55. Thornton Quarry Racine formation dolomite accelerated weathering durability Test Block MTC-5-FT/WD

Test Block MTC-5-FT/WD. This test block (Figure 55) was subjected to both freeze/thaw and wet/dry testing. No samples were extracted from this test block for microstructural analyses.

The test block is light to medium bluish-gray, fine-grained, micritic dolomite with a highly mottled texture. Bedding is determined by algal mat remnant structures oriented elongate to the horizontal width of the samples. These algal

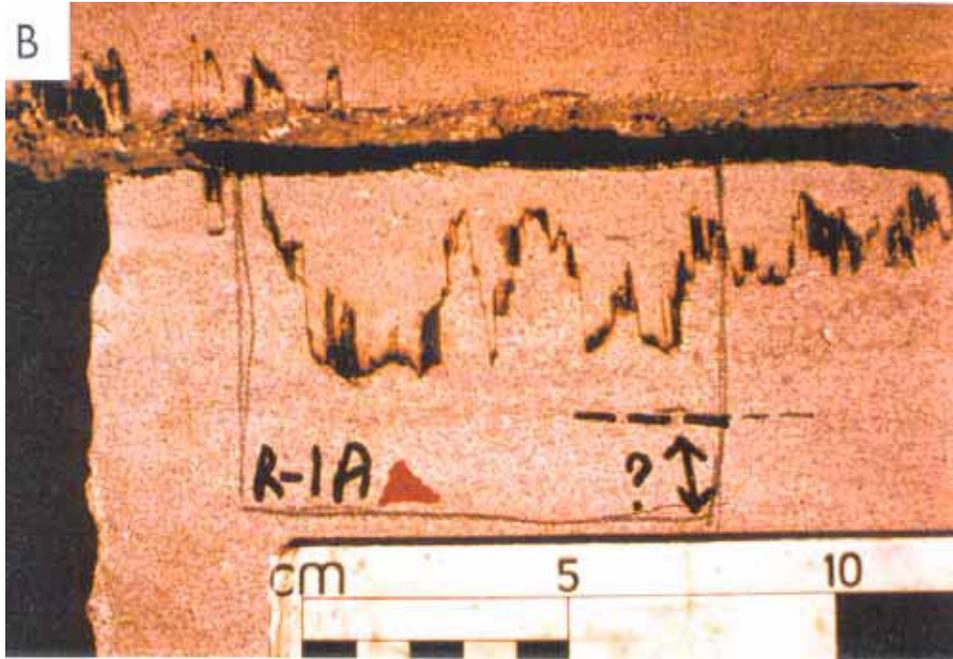
Figure 57. Reed Quarry Sample R-1A-FT, including stylolite seam (after Agar 1998)

- a. *Sample R-1A-FT.* This sample (Figure 57) was located in one half of the test block to include a portion of the stylolite seam that did not coincide with the main throughgoing fracture. The stylolite has an undulation amplitude of up to 5 cm (2 in.) and is delineated by dark brown/black staining that varies in thickness from less than 1 mm (0.04 in.) to 0.5 cm (0.2 in.). Thin Section Sample TS-R-1A-1FT was located on the original marked surface of the block with the stylolite centrally located in the section. Thin Section Sample TS-R-1A-2FT was placed on a vertical plane perpendicular to the original marked surface to sample the stylolite. Thin Section Sample TS-R-1A-3FT was located away from the stylolite seam to examine the undisrupted fabric (not shown). Thin Section Sample TS-R-1A-3FT was stained with K-ferricyanide (ferrous carbonate).

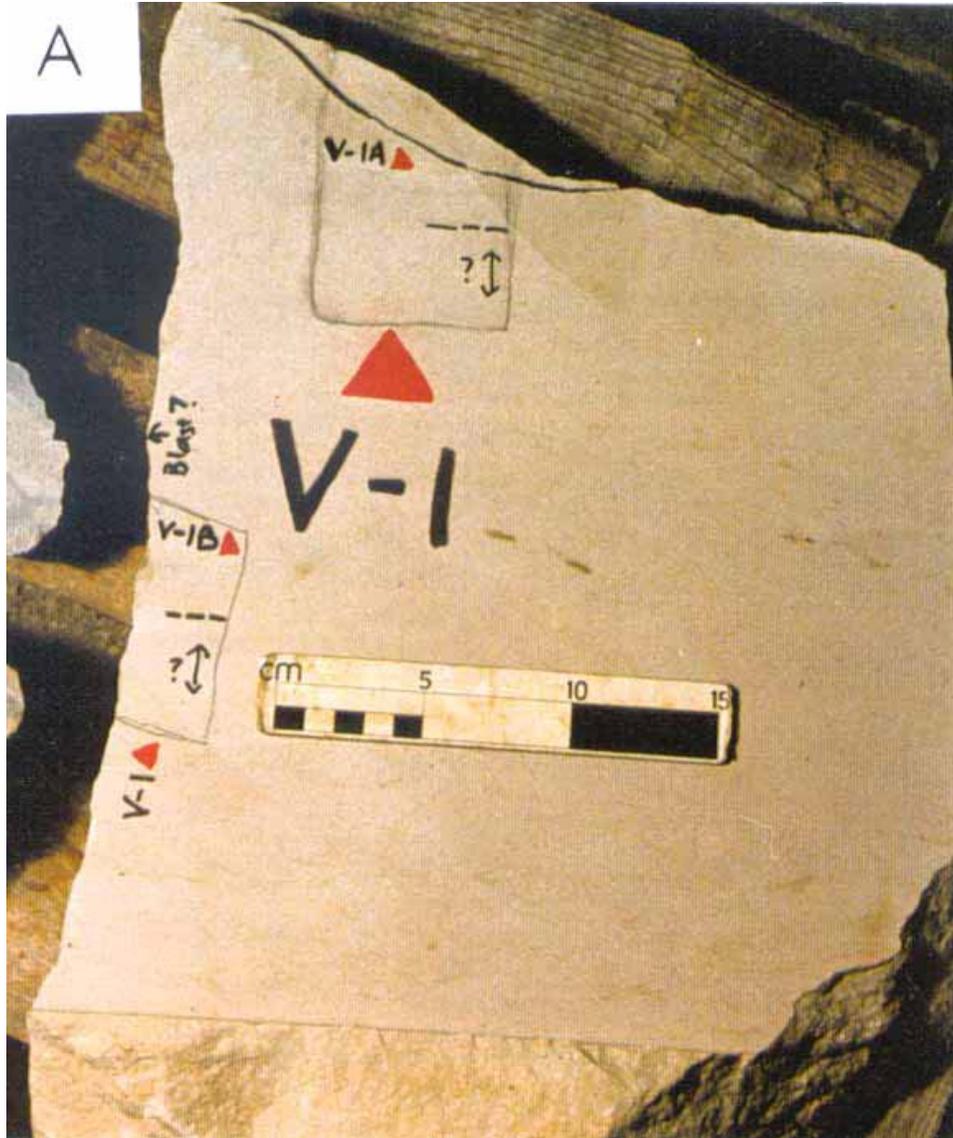
Figure 59. Valders Quarry Test Block V-1-FT sample locations. Arrows show direction perpendicular to interpreted bedding plane based on fine color banding and clay seams (after Agar 1998)

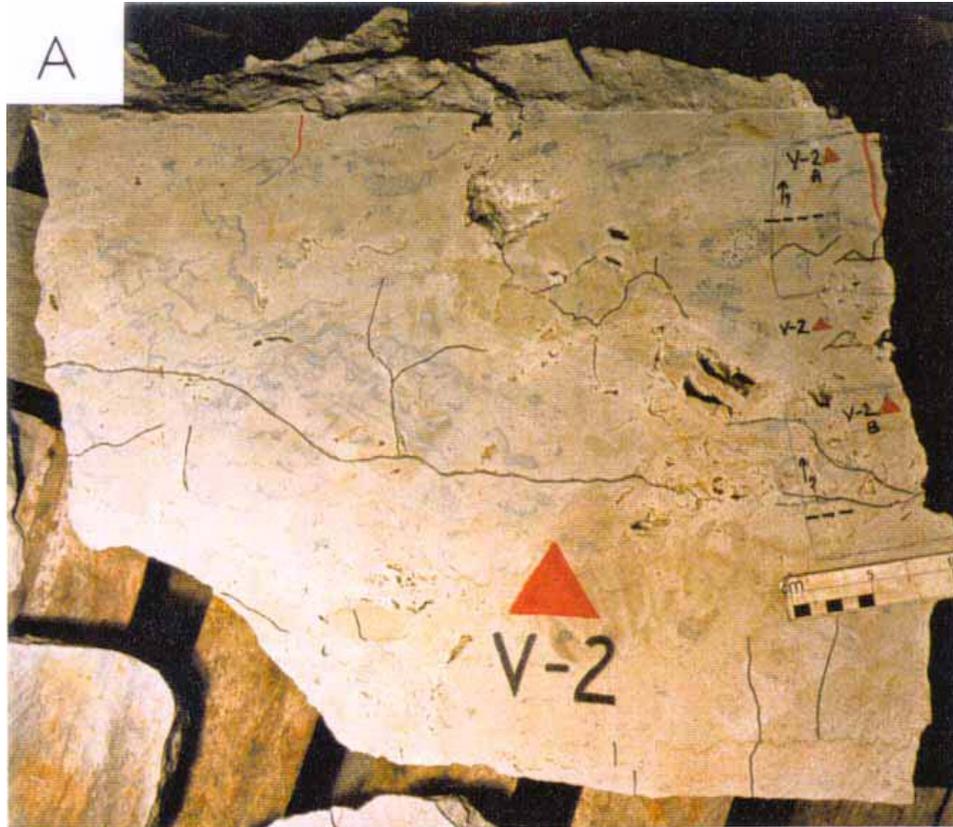
Figure 62. Valders Quarry Test Block V-2-FT sample locations. Arrows show direction perpendicular to interpreted bedding planes based on clay seams and associated stylolites (after Agar 1998)

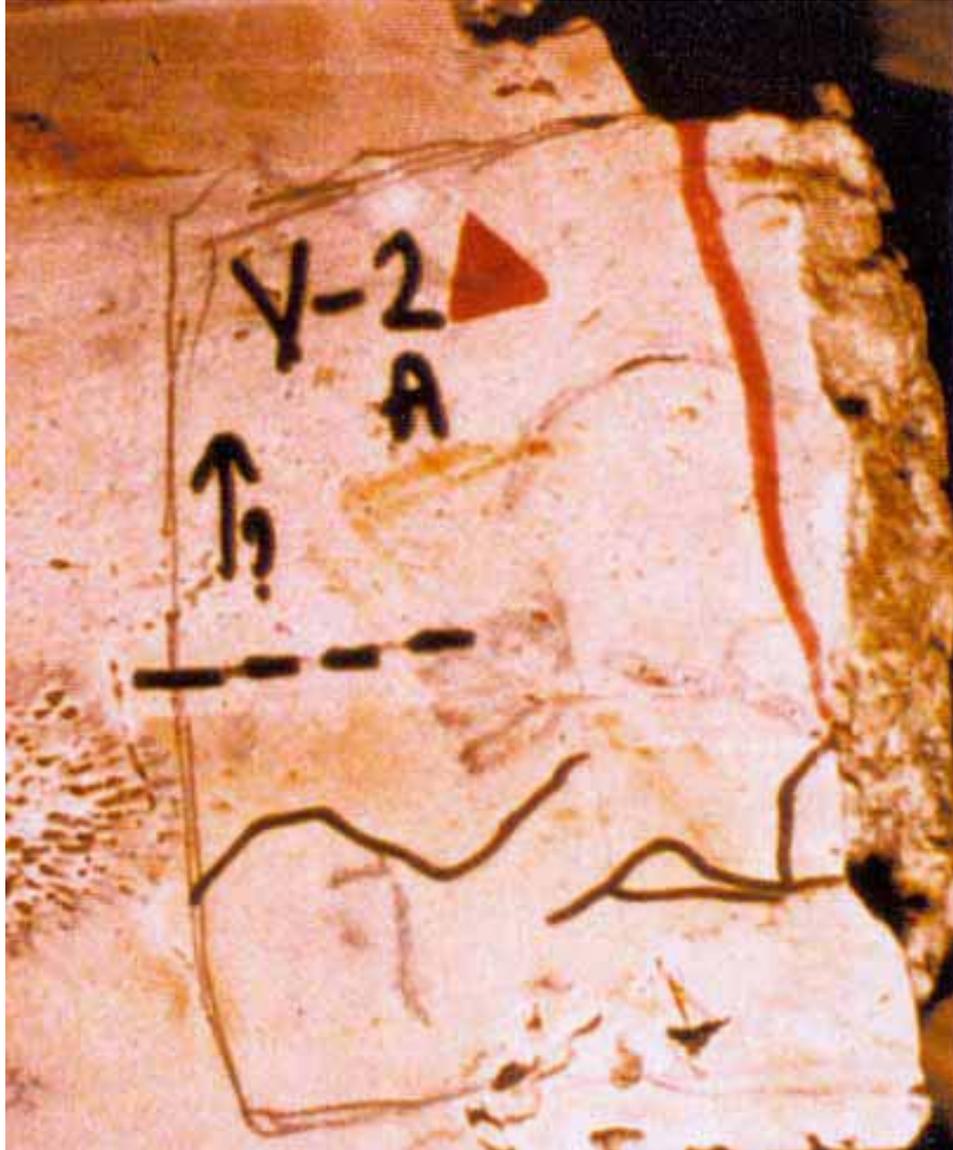
Figure 63. Valders Quarry Sample V-2A-FT close-up (after Agar 1998)

- a. *Sample V-2A-FT.* This sample (Figure 63) was selected to include several irregular pretest fractures and one post-test fracture. Overall this sample has fewer vugs than Sample V-2B-FT, but they are otherwise similar. Thin Section Sample TS-V-2A-1FT includes the fractured edge of the surface block and a zone of irregular pretest fractures. Thin Section Sample TS-V-2A-2FT contains the steeply dipping post-test

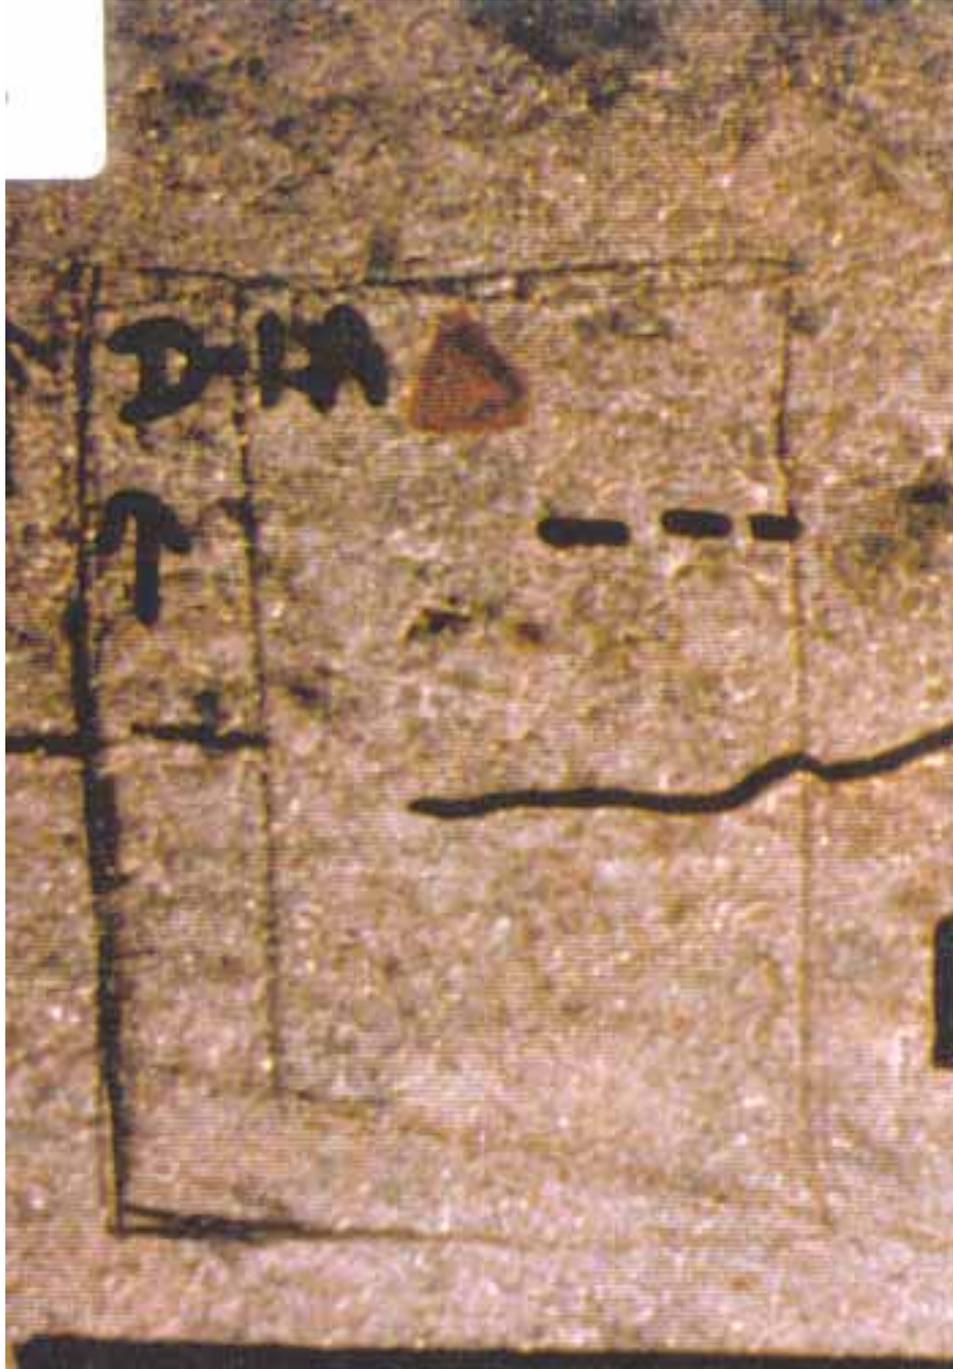
Figure 66. Dempsey Quarry Sample D-1A-FT close-up (after Agar 1998)

- a. *Sample D-1A-FT.* This sample (Figure 66) was positioned to include the tip of the longest pretest fracture in the block. Thin Section Sample TS-D-1A-1FT was positioned on the original marked surface of the block and included the tip of the fracture that extended to the edge of the block. Thin Section Sample TS-D-1A-1FT was impregnated with blue epoxy in order to examine porosity. Thin Section Sample TS-D-1A-2FT was positioned to include the same fracture that dips at about 50 deg on the plane that is perpendicular to the original marked surface, and was stained for potassium feldspar. This thin section also includes the open fractured edge of the sample. Both thin sections were oriented with a single headed arrow to show the way-up.

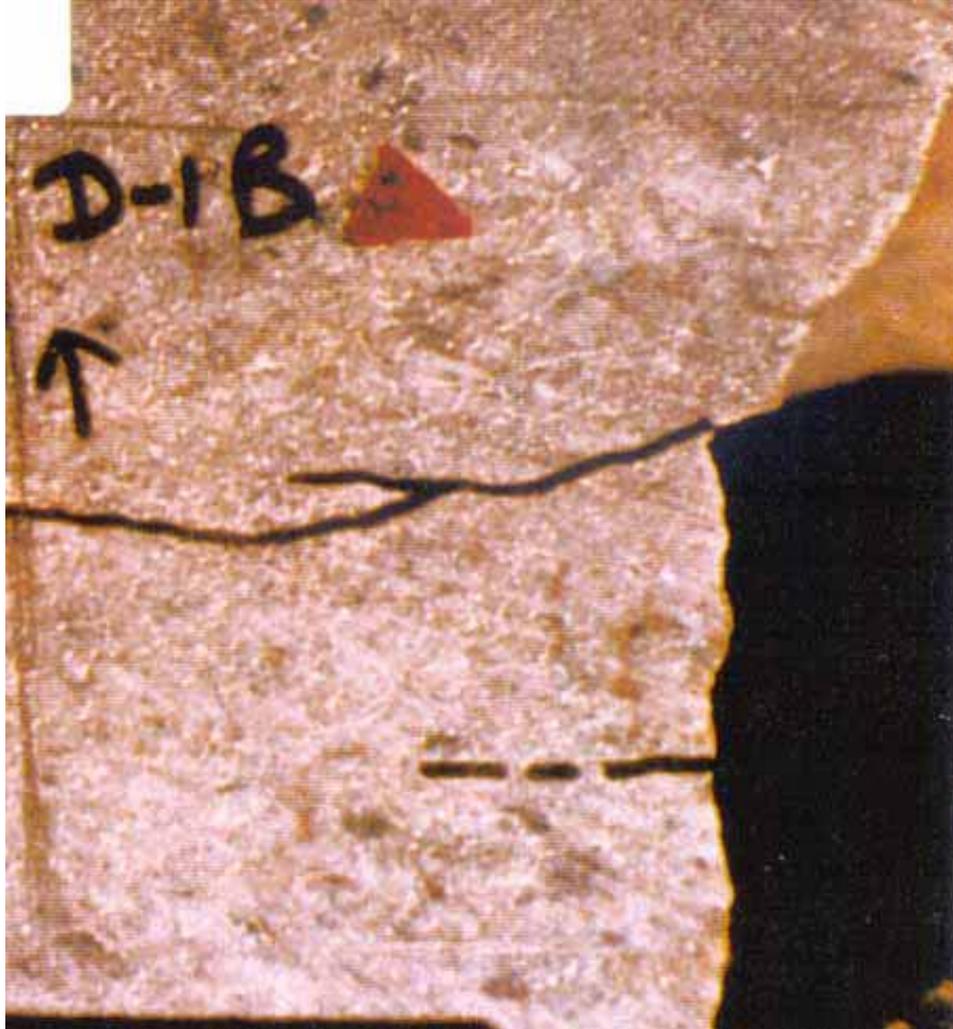
Figure 67. Dempsey Quarry Sample D-1B-FT close-up (after Agar 1998)

Sample D-1B-FT. Optical microscopy shows zones about 2 mm (0.08 in.) wide of open transgranular microcracks pervading quartz grains along the boundary of the open pretest fracture surface. In places the microcracks have no strong preferred orientation but in other locations they form an array that parallels the fracture surface. The sample displays dense intragranular fracturing in quartz surrounding muscovite seams. There are also dislodged regions of fine-grained aggregates of potassium feldspar, muscovite, and quartz. The splay fracture propagates into the specimen along a mica seam that forms a clear plane of weakness controlling the fracture.

Not all micas, however, are oriented parallel to the fracture surface and in places fractures cut across micas. Mica seams are not continuous even on the thin section scale. At the fracture tip the single fracture aperture decreases and splays into irregular cracks in the surrounding quartz grains. Different displacements between muscovite, feldspar, and quartz may have dissipated the main fracture displacement in this region.

- b. *Sample D-1B-FT.* This sample (Figure 67) included the intersection of the same fracture whose tip was sampled in Sample D-1A-FT with the edge of the test block where the fracture splays. Thin Section Sample TS-D-1B-1FT was positioned to include the open fracture surface on one edge of the section at a fracture splay. The rest of the width of the thin section was positioned to examine the distribution of subsidiary fractures relative to the main fracture. The thin section was impregnated with blue epoxy and way-up delineated by a single-headed arrow. A fragment of the fracture surface was mounted for secondary electron imaging.

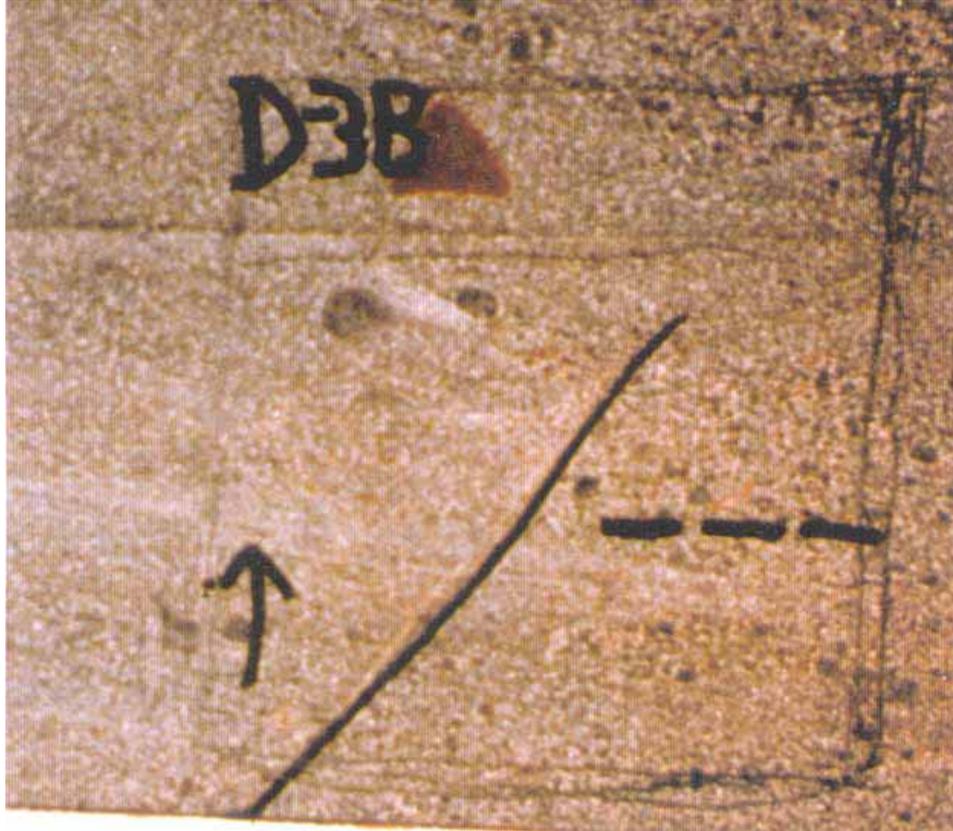
Figure 70. Dempsey Quarry Sample D-3B-FT close-up (after Agar 1998)

Sample D-3B-FT. A fracture in this sample trends about 60 deg to the layering and foliation in the rock. Backscattered electron images show that this part of the test block has a much weaker foliation than other sections from Samples D-3A-FT, D-1A-FT, and D-1B-FT. The crack cuts across mica with relatively little deflection by the grain shape anisotropies. Although approximately planar in hand sample, the fracture has a slightly irregular trace that was deflected by quartz grain boundary locations. The termination of the crack is located at a quartz/mica junction where the grain boundaries have opened up slightly more than other grain boundaries away from the crack tip. Disaggregation occurs along grain boundaries in the region adjacent to the fracture.

A second fracture can be traced along the lower edge of the specimen on the right hand side. The backscatter images show no discernible chemical changes around the fracture. This suggests that the fracture is a recent feature that has not been subjected to weathering. The fracture ends in zone of microcracks with different orientations controlled by grain boundaries. In the perpendicular section (Thin Section Sample TS-D-3B-2FT), the fracture exhibits similar characteristics with intergranular hairline cracks running parallel to the main fracture margins.

- b. *Sample D-3B-FT.* This sample (Figure 70) included the tip region of a fracture that cuts relict bedding at an angle of approximately 60 deg. Thin Section Sample TS-D-3B-1FT was placed to include the tip region of the fracture. Thin Section Sample TS-D-3B-2FT was oriented on a bedding parallel plane, perpendicular to the original marked surface of the block. This thin section included the same fracture plane as that examined in Thin Section Sample TS-D-3B-1FT. A combination feldspar stain was used on this second section.

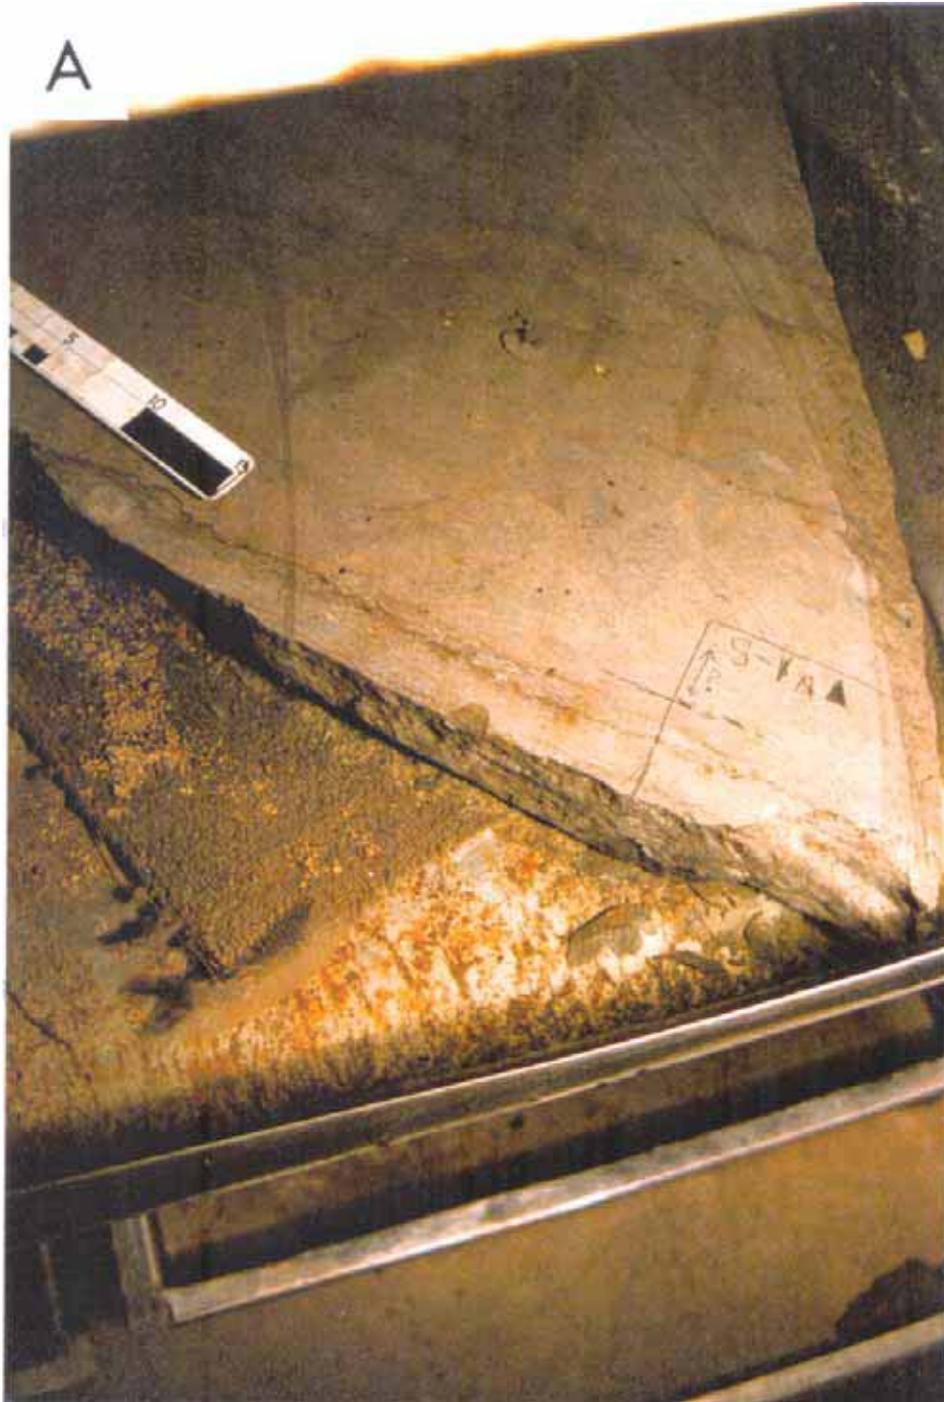
Figure 71. Sandusky Quarry Test Block S-1-FT/WD sample locations. Bedding is identifiable in block, but way-up could not be determined (after Agar 1998)
