ERDC/CHL TR-05-1

Monitoring Completed Navigation Projects Program

Monitoring Stone Degradation on Coastal Structures in the Great Lakes – Summary Report

June 2005

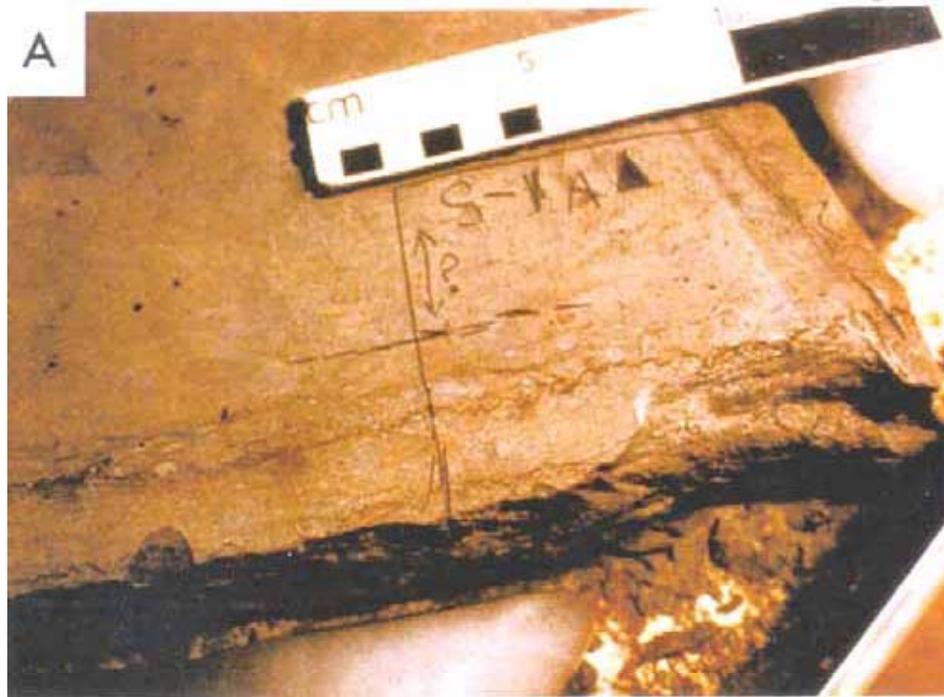
Figure 72. Sandusky Quarry Sample S-1A-FT/WD showing stylolitic seam parallel to bedding, close to edge of block (after Agar 1998)

- a. *Sample S-1A-FT/WD.* This sample (Figure 72) was located in one corner of the test block close to a fractured edge. A stylolitic seam, oriented parallel to bedding, could be identified during sampling. This seam fell apart during sample cutting, dividing the sample into two parts. Thin Section Sample TS-S-1A-1FT/WD samples the region above a fracture surface that formed during cutting of the test block. Dark gray seams form closely spaced laminations near the edge of the opened stylolite seam/fracture. Thin Section Sample TS-S-1A-2FT/WD samples the region below the fracture surface and includes a discrete stylolitic seam. The fractured edge of the sample trends obliquely (10 to 20 deg) to the stylolite in the center of the section.

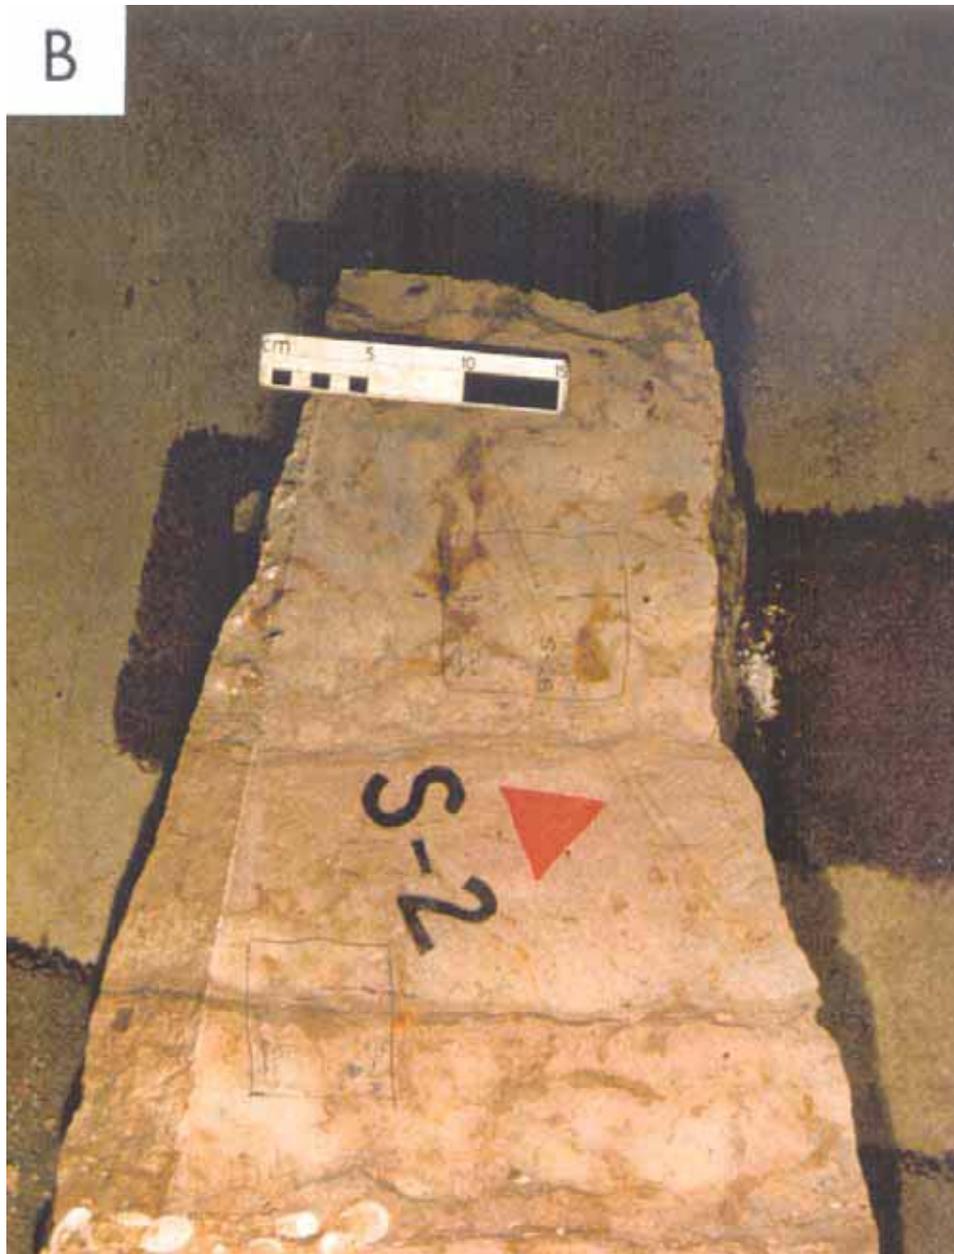
Figure 74. Sandusky Quarry Test Block S-2-FT sample locations. Bedding is identifiable in block, but way-up could not be determined (after Agar 1998)

Test Block S-2-FT. This test block is shown in Figure 74.

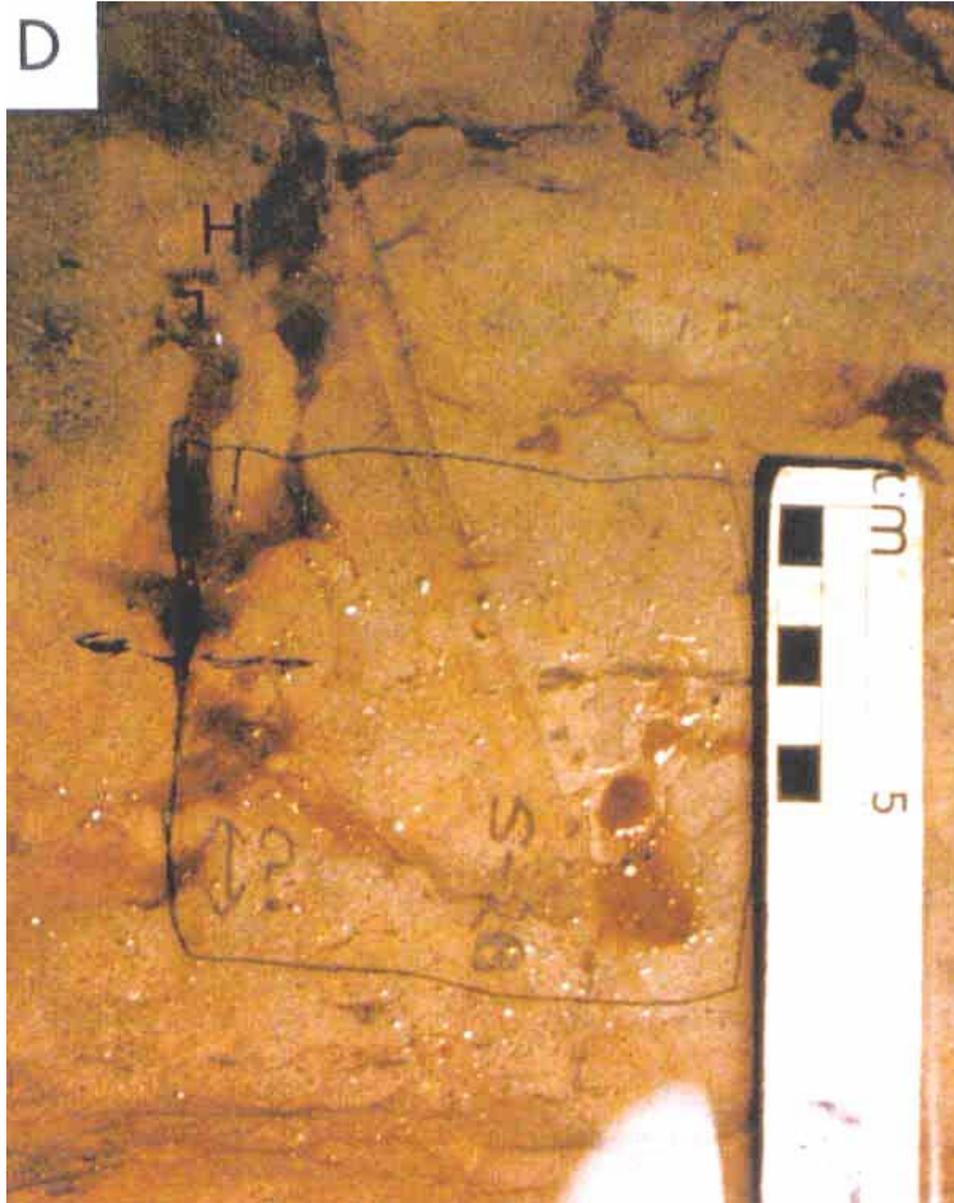
Figure 76. Sandusky Quarry Sample S-2B-FT. Sample shows dark discoloration in irregular patches on exposed surface (after Agar 1998)

- b. *Sample S-2B-FT*. This section (Figure 76) exhibits dark discoloration in irregular patches on its exposed surface. Thin Section Sample TS-S-2B-1FT samples dark gray streaks that trend parallel to bedding. Thin Section Sample TS-S-2B-2FT includes a region of patchy discoloration evident on the original marked surface of the block that reflects the incomplete dolomitization of the sample. When the block is dry, the discoloration appears yellow brown.

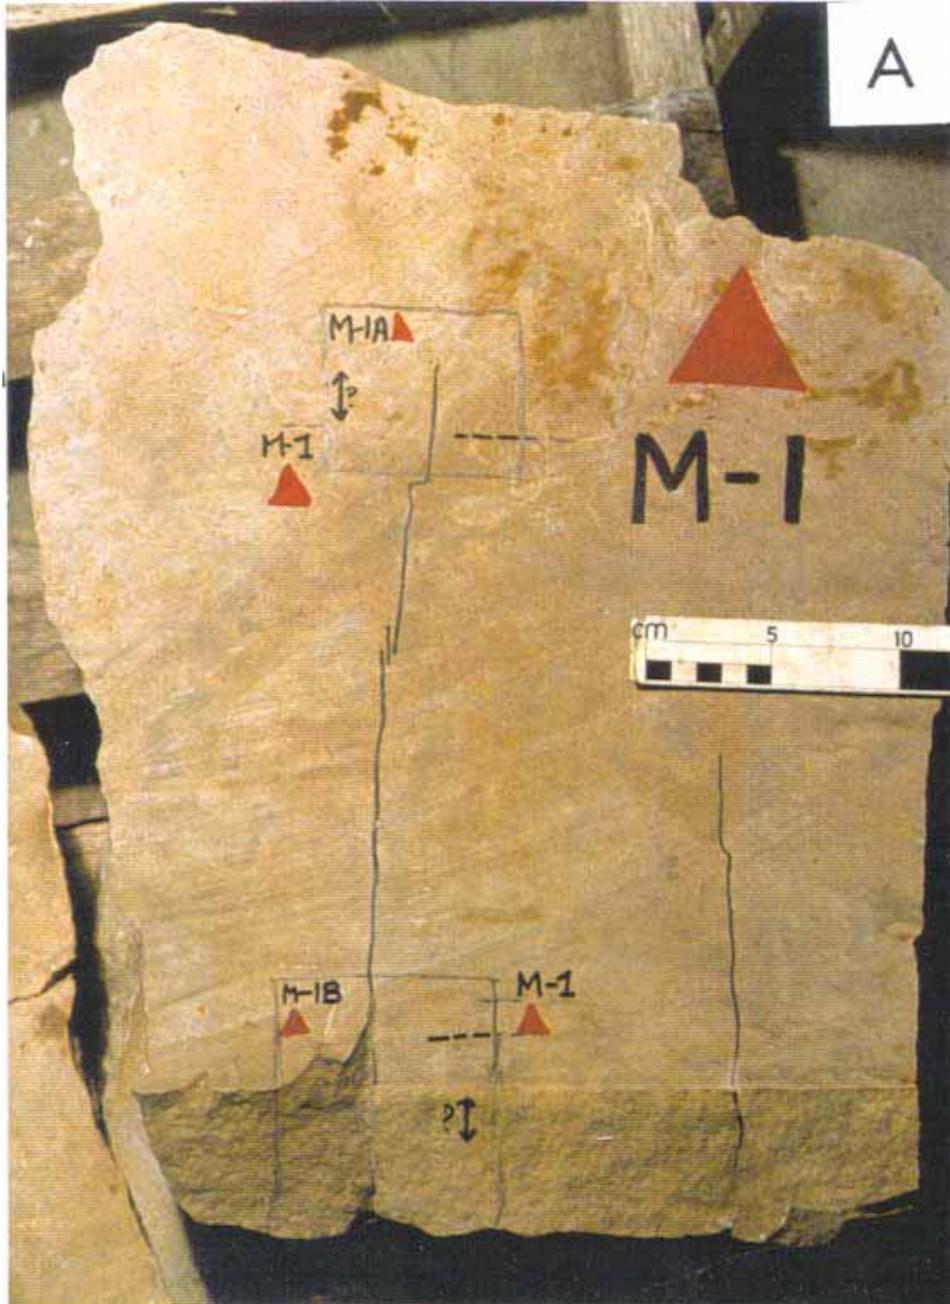
Figure 77. Marblehead Quarry Test Block M-1-FT sample locations, showing large pretest fractures (after Agar 1998)

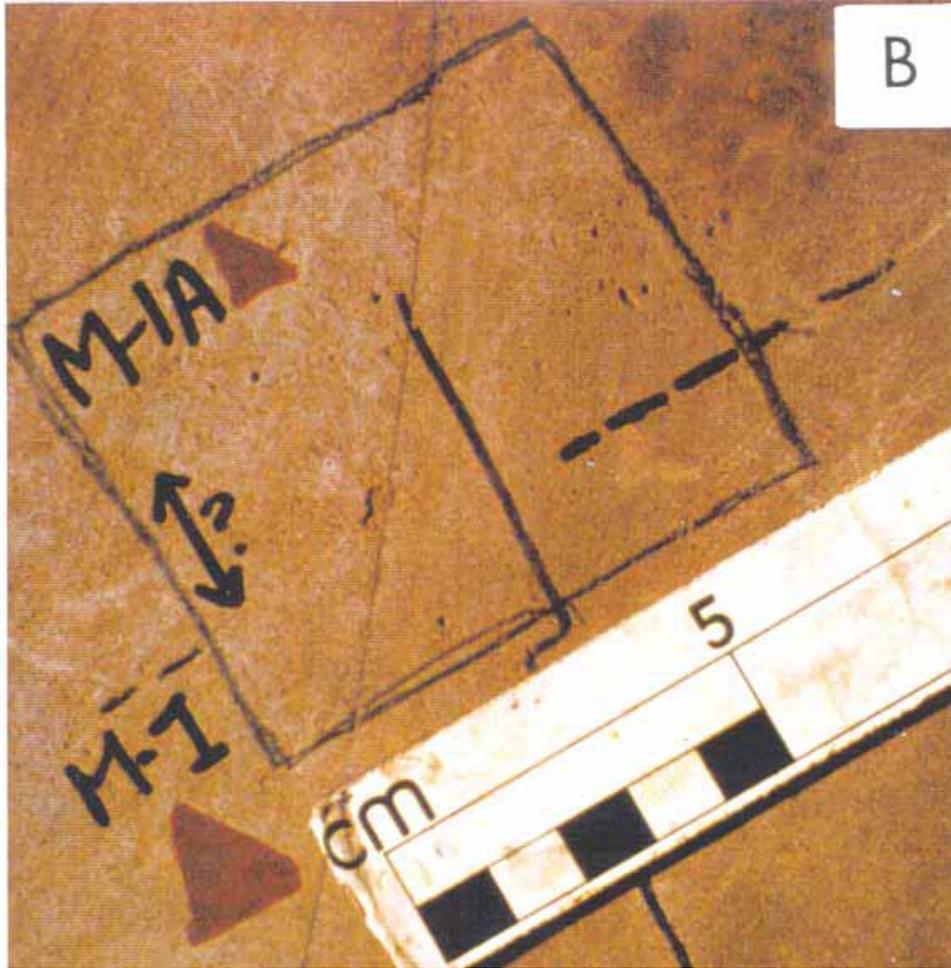
Figure 78. Marblehead Quarry Sample M-1A-FT showing pretest fracture tip. Dashed line indicates inferred orientation of bedding (after Agar 1998)

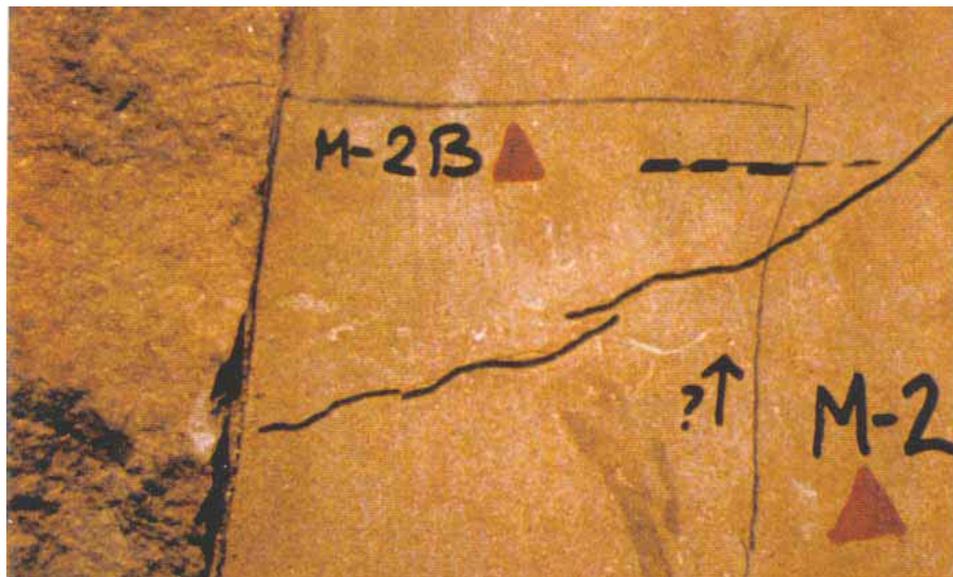
Figure 82. Marblehead Quarry Sample M-2B-WD containing overlapping pretest fractures that trend approximately 30 deg to bedding (after Agar 1988)

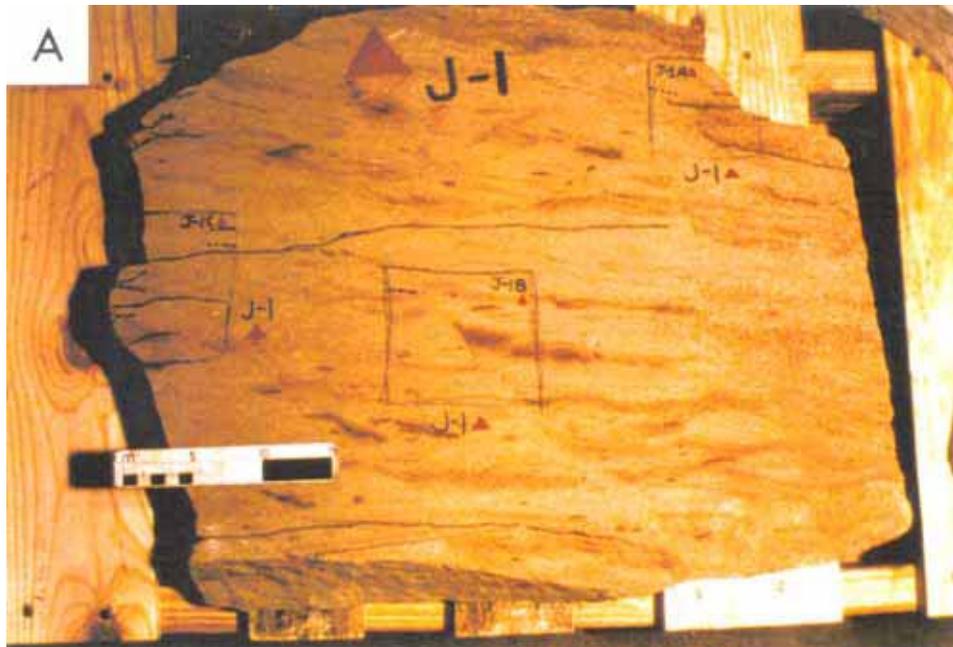
Figure 86. Johnson Quarry Test Block J-1-WD sample locations (after Agar 1998)

Test Block J-1-WD. Test Block J-1-WD is shown in Figure 86. Only pretest fractures were identified in Test Block J-1-WD. One of these fractures extends from a right angle on the edge of the block across more than two-thirds of the width of the block subparallel to the laminations. The pretest fractures have clearly nucleated from relief on the edge of the test block. The way-up was not recorded on the original test block. Samples were marked with a double-headed arrow to show the direction perpendicular to bedding. Although way-up could not be confirmed from preliminary observations of the test block during sampling, it is possible that careful mapping of the fault curvature on the block surface would give better clues to the way-up.

Samples J-1A-WD, J-1B-WD and J-1C-WD were acquired from a freeze/thaw test block of medium-grained moderately well sorted buff sandstone. The block contains numerous laminations defined by brown to dark brown staining. The thickness of these laminations varies from 0.04 in. (1 mm) to more than 2 cm (0.8 in.) over short distances. There are isolated patches of dark brown black material (probably organic matter) that is soft and loosens easily from the sample surface. Some laminae are truncated by minor faults, several of which can be identified in hand specimen. The faults are typically narrow (less than 1 cm (0.4 in.)), and have apparent dips ranging between 50 and 20 deg. There is no fault gouge and the sandstone character is only slightly altered to a lighter color in the deformed regions. The lack of intragranular deformation in these zones suggests that faulting occurred prior to cementation. It is therefore probable that these minor faults are related to the synsedimentary faults reported to control sediment accumulations in the Johnson Quarry area. Steep intralayer micro-faulting deforms some layers and local contortions of laminae are also evident.

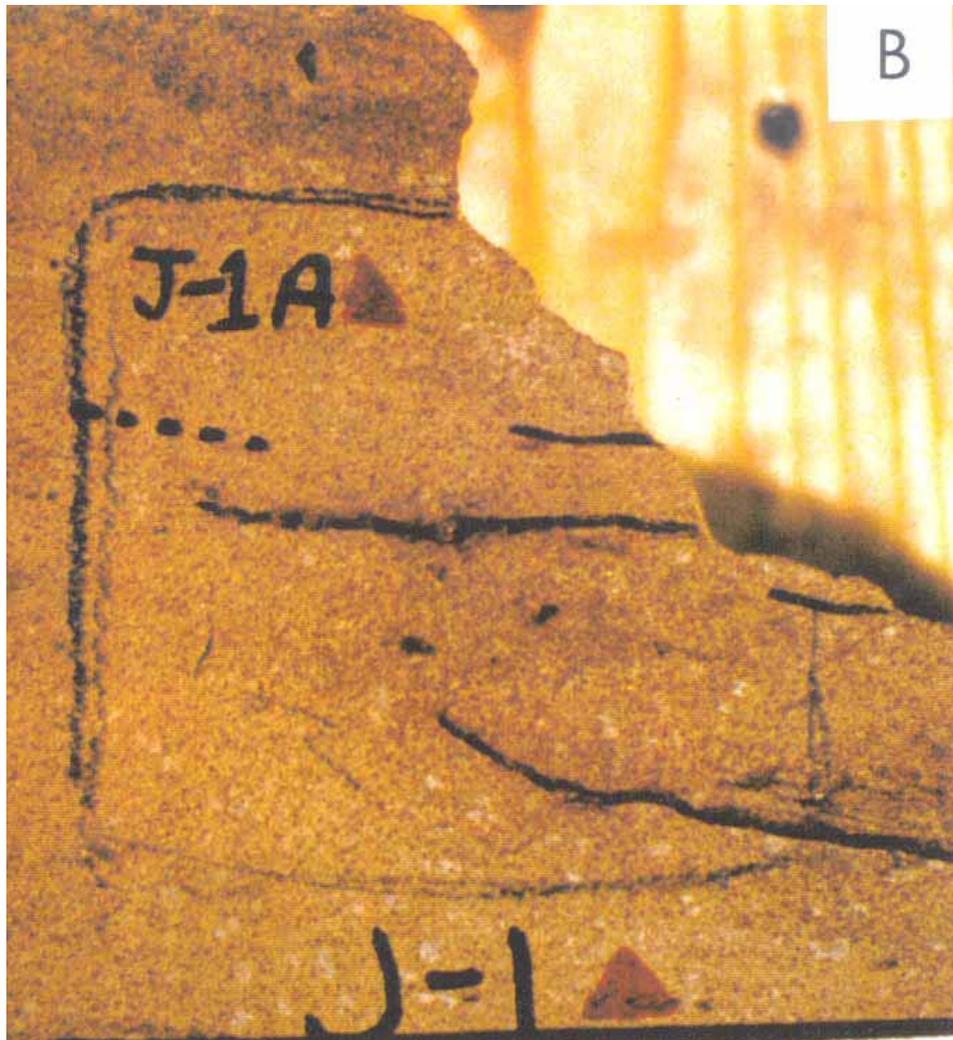
Figure 87. Johnson Quarry Sample J-1A-WD with pretest fractures penetrating from edge of sample (after Agar 1998)

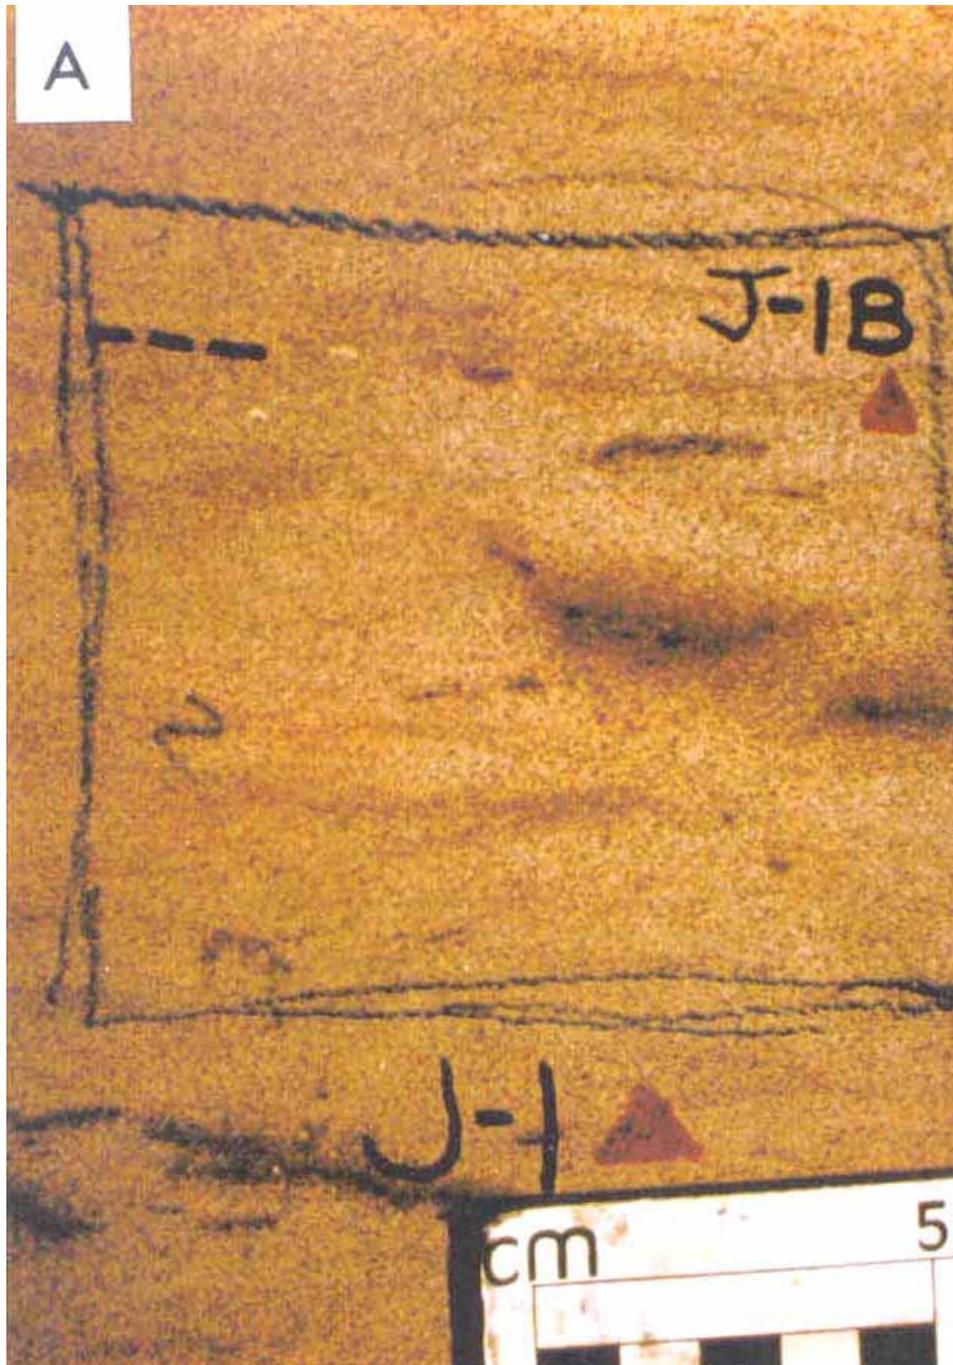
Figure 88. Johnson Quarry Sample J-1B-WD (after Agar 1998)

- b. *Sample J-1B-WD.* This sample (Figure 88) was cut in the center of the test block. The sample includes dark brown, elongate patches that are truncated by a fault with an apparent dip of 40 deg. The open fractures were deemed by the Corps to be more critical to the objectives of this study than the fault characteristics. Therefore Thin Section Sample TS-J-1B-1WD was placed to include two fractures that connected to the sample edge and a small portion of the fault. Thin Section Sample TS-J-1B-2WD was cut on a vertical surface perpendicular to that in Thin Section Sample TS-J-1B-1WD to compare structures in different orientations.

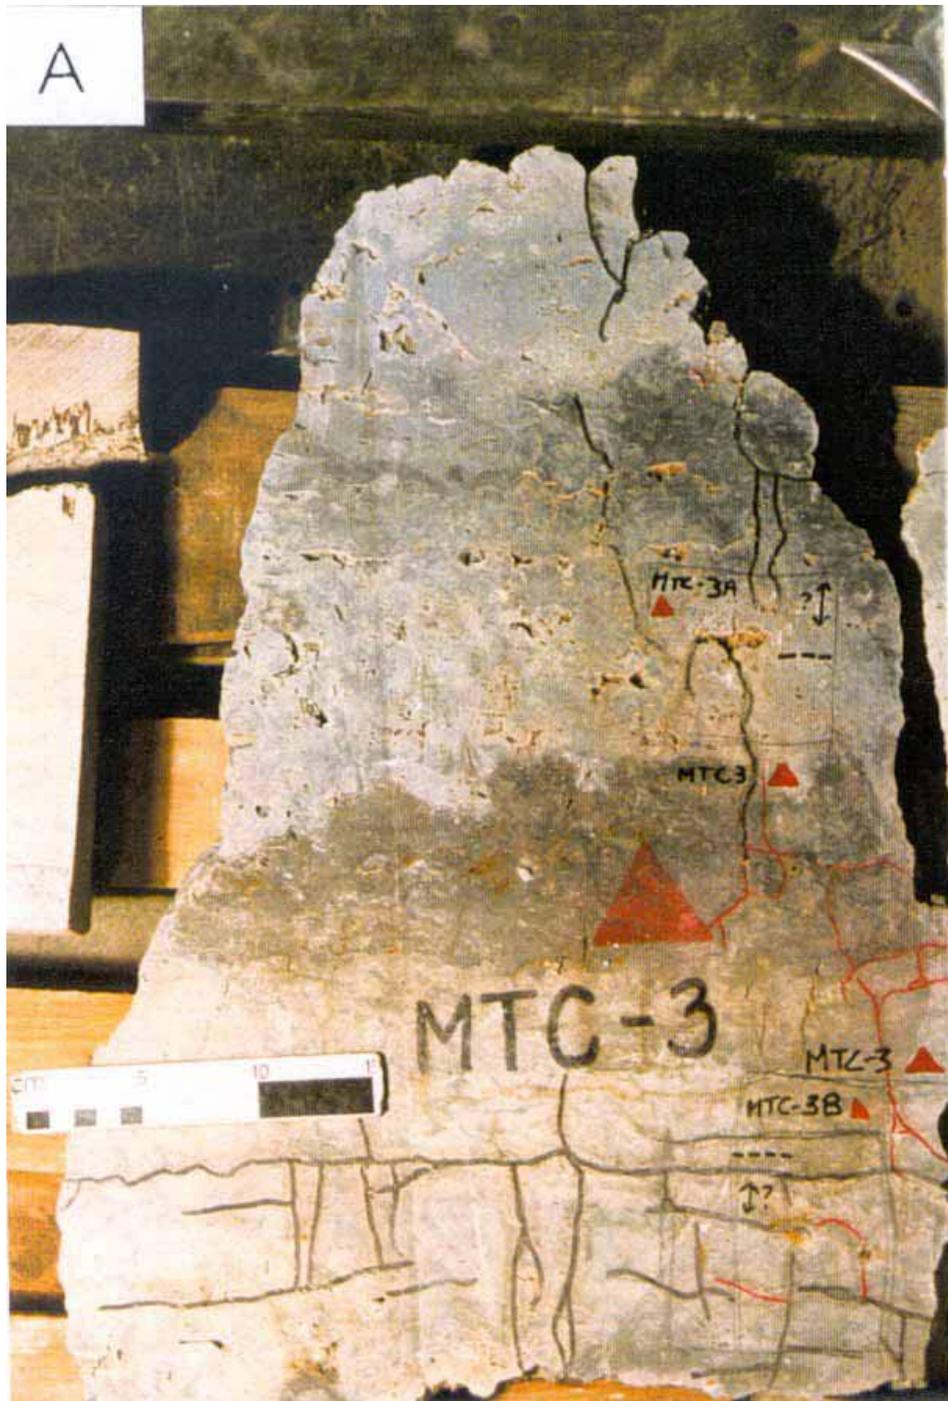
Figure 94. Thornton Quarry Test Block MTC-3-FT/WD sample locations. Arrows show direction perpendicular to interpreted bedding plane based on clay seam orientations (after Agar 1998)

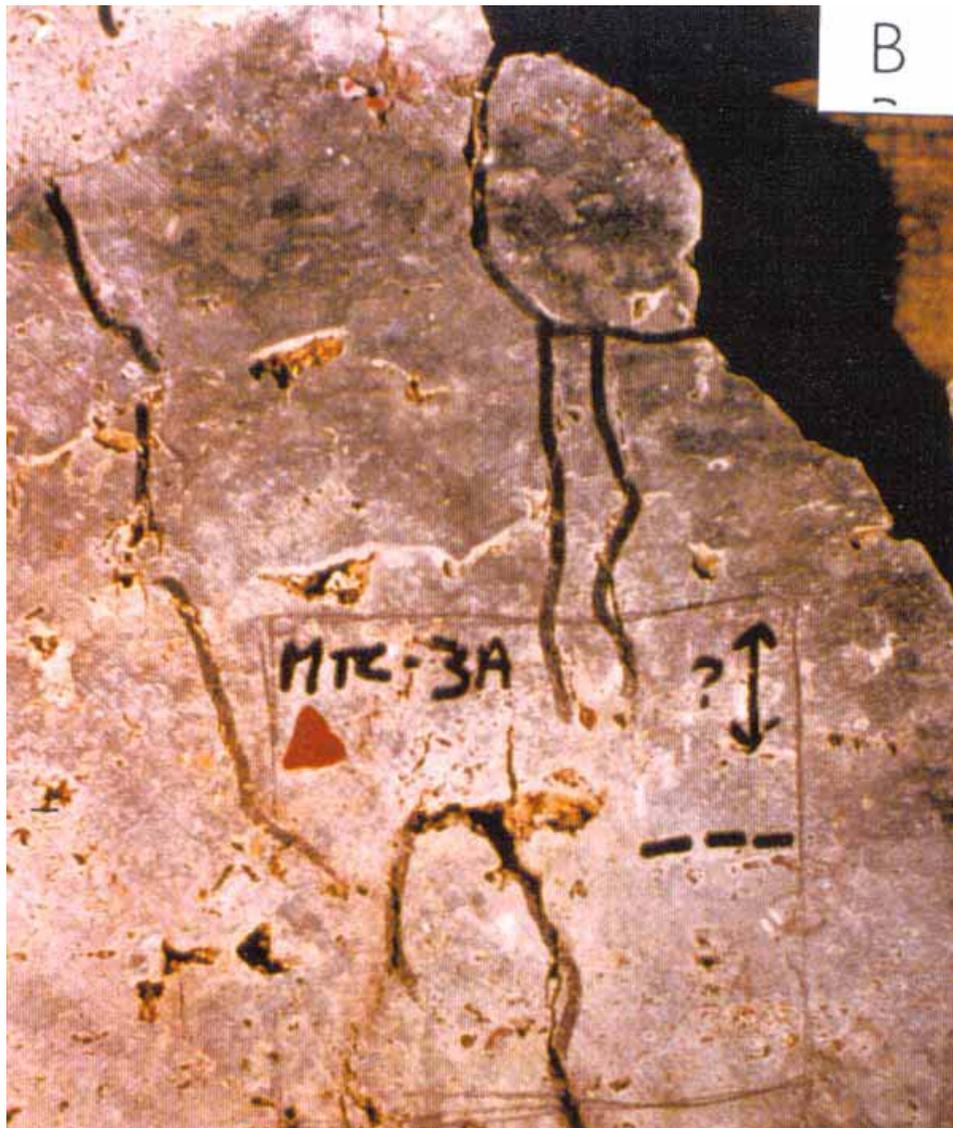
Figure 95. Thornton Quarry Sample MTC-3A-FT/WD (after Agar 1998)

- a. *Sample MTC-3A-FT/WD.* This sample (Figure 95) was selected to include several pretest (black lines) fractures in the interior part of the test block. Two thin sections were cut on the original marked surface of the block. Thin Section Sample TS-MTC-3A-1FT/WD includes three subvertical pretest fractures that taper into the center of the section. Several vugs are also present. Thin Section Sample TS-MTC-3A-2FT/WD was cut to include the open fracture surface of another steeply dipping pretest fracture that is deflected to a moderate dip into the sectioned area. Thin Section Sample TS-MTC-3A-1FT/WD was stained with Alizarin red to detect calcite.

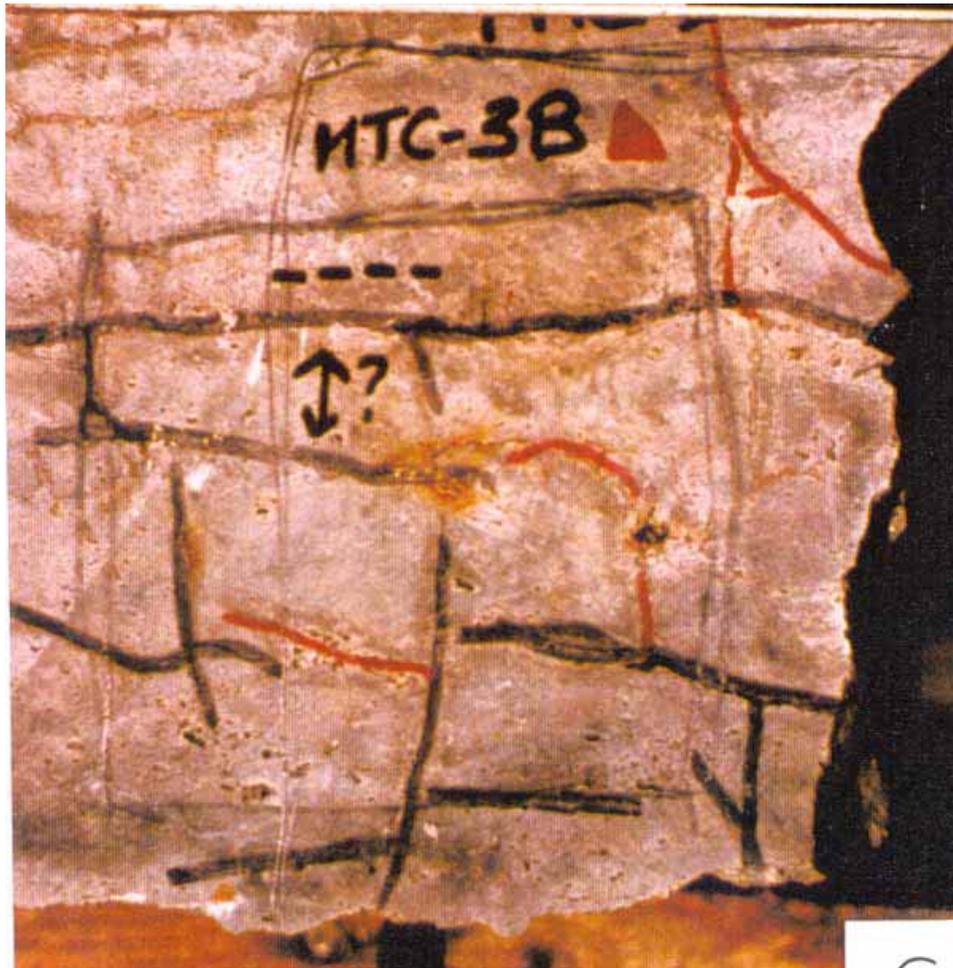
Figure 96. Thornton Quarry Sample MTC-3B-FT/WD (after Agar 1998)

- b. *Sample MTC-3B-FT/WD.* This sample (Figure 96) was selected to include pre- and post-test fractures near the edge of the test block. Thin Section Sample TS-MTC-3B-1FT/WD includes one subvertical post-test fracture and one horizontal pretest fracture. The pretest fracture links into the post-test fracture. A vertical fracture extends below the post-test fracture, but it was not marked as either a pre- or post-test fracture. A splay from the post-test fracture veers toward the margin of the thin section. Thin Section Sample TS-MTC-3B-2FT/WD includes one subvertical and one subhorizontal example of pre- and post-test fractures. Both of the post-test fractures stop at the pretest fractures. Thin Section Sample TS-MTC-3B-2FT/WD was stained with K-Ferricyanide to detect ferrous carbonates.

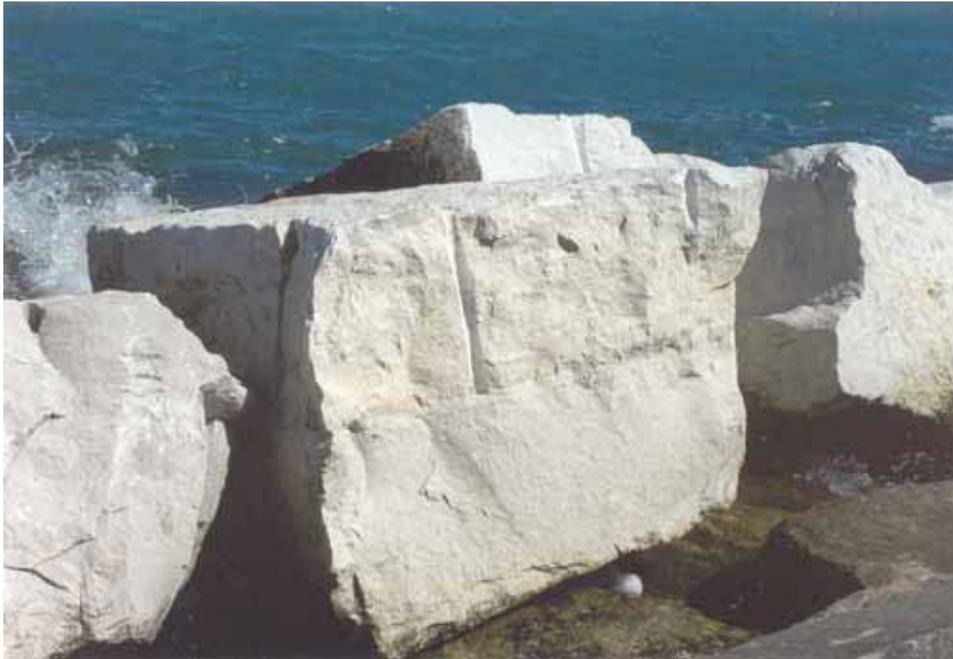
Figure 97. Chicago Harbor breakwater, Valders Quarry cut dolomite (low energy blasted, drilled and split, and then surfaces cut; see editor's note, p. 149). Dolomitic mudstone/reef-rock and dolomitic mudstone in one block. Although not presently fractured, there is excellent probability that this block will eventually fracture along the contact between the two rock types (Rock Products Consultants 1995)

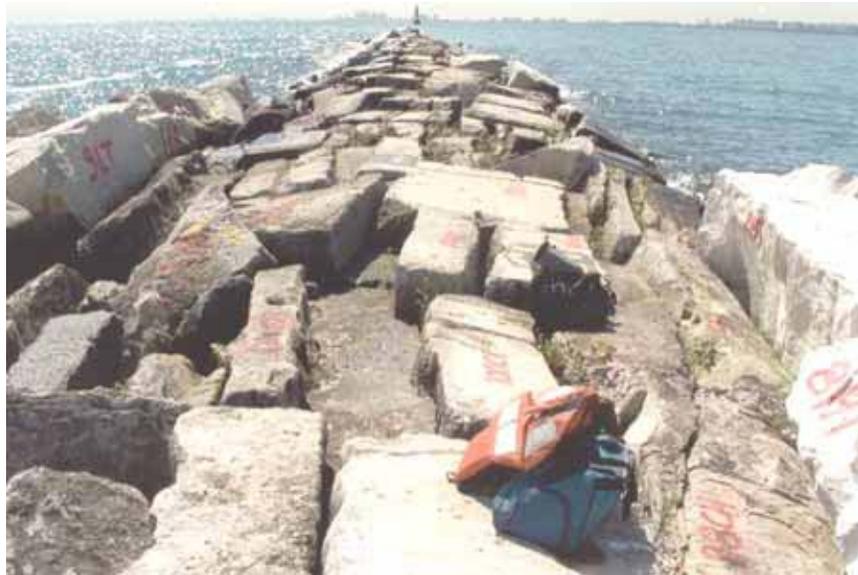
Figure 98. Chicago Harbor breakwater, Reed Quarry cut limestone. These blocks have been in place about 75 years (Rock Products Consultants 1995)

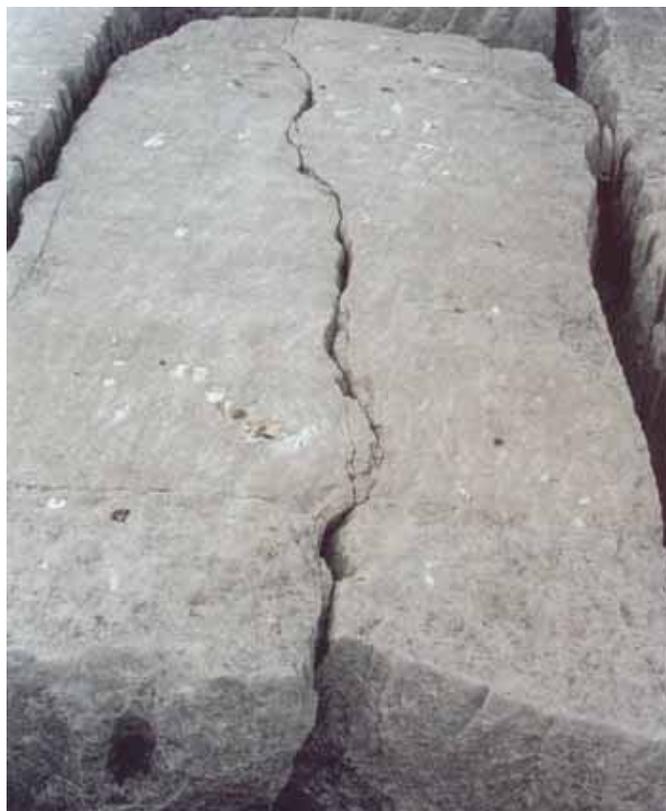
Figure 99. Calumet Harbor breakwater, Reed Quarry cut limestone. Mechanical fractures both parallel and normal to bedding. This stone has been in place for about 30 years (Rock Products Consultants 1995)

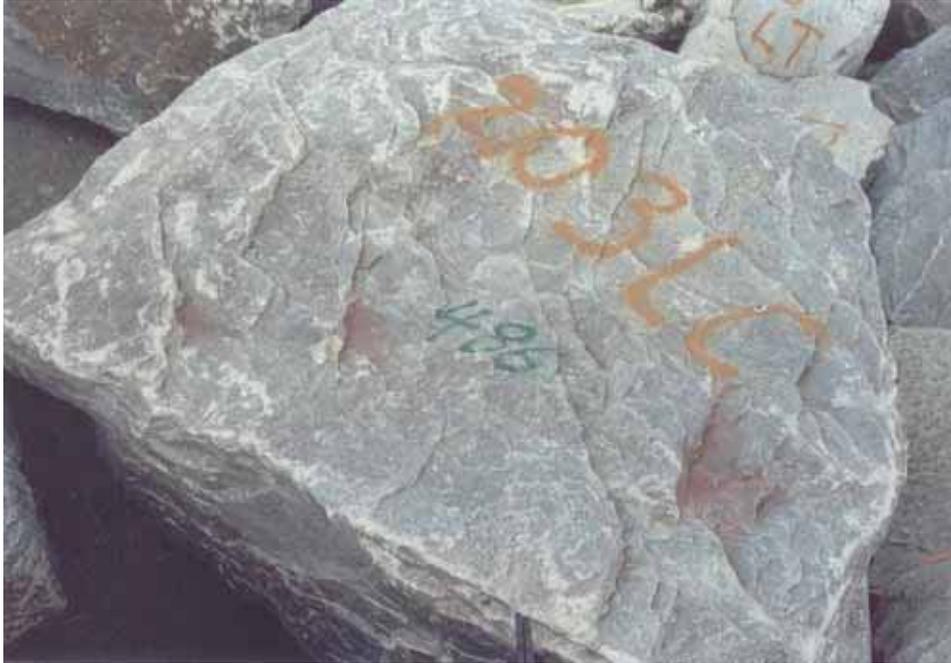
Figure 100. Calumet Harbor breakwater, Dempsey Quarry low energy blasted quartzite (Rock Products Consultants 1995)

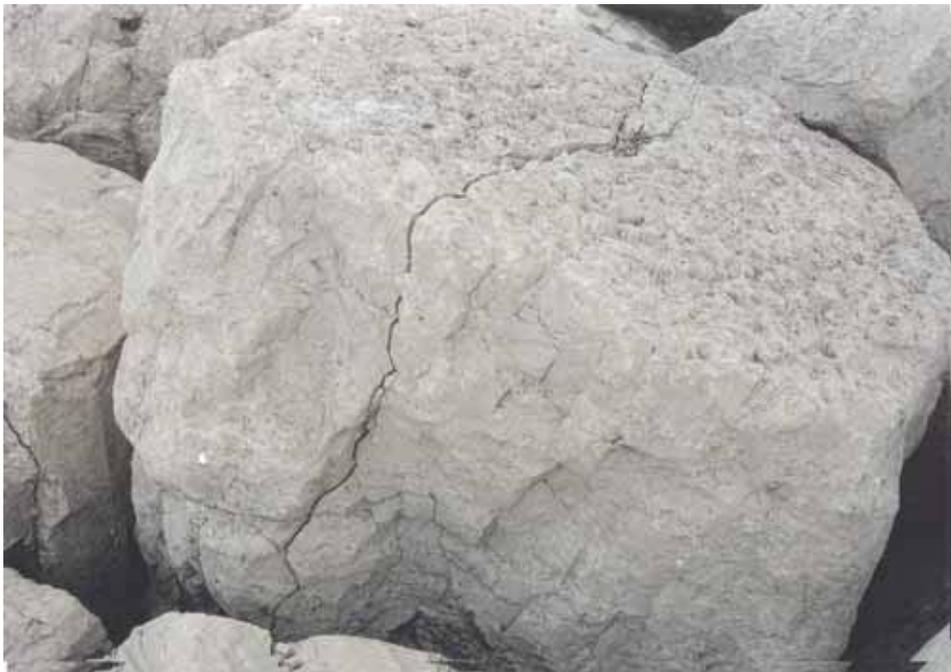
Figure 101. Calumet Harbor CDF, McCook Quarry high energy blasted dolomite. Dolomitic reef rock with somewhat brecciated appearance and a fracture normal to bedding. The fracture could either be blast-related or simply mechanical (Rock Products Consultants 1995)

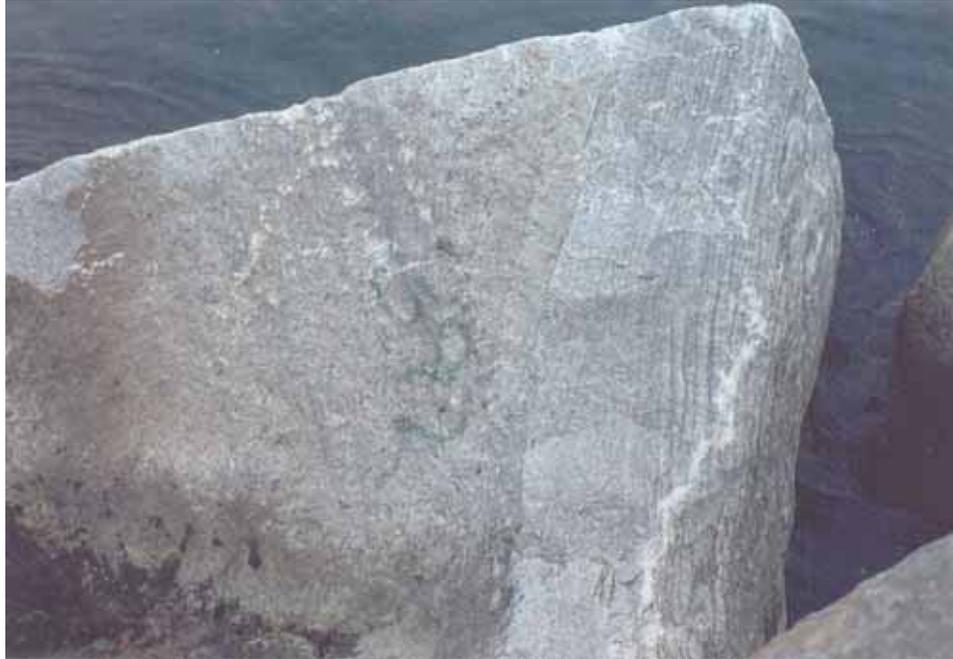
Figure 102. Burns Harbor breakwater (Shore Arm section), Dempsey Quarry low energy blasted quartzite (Rock Products Consultants 1995)

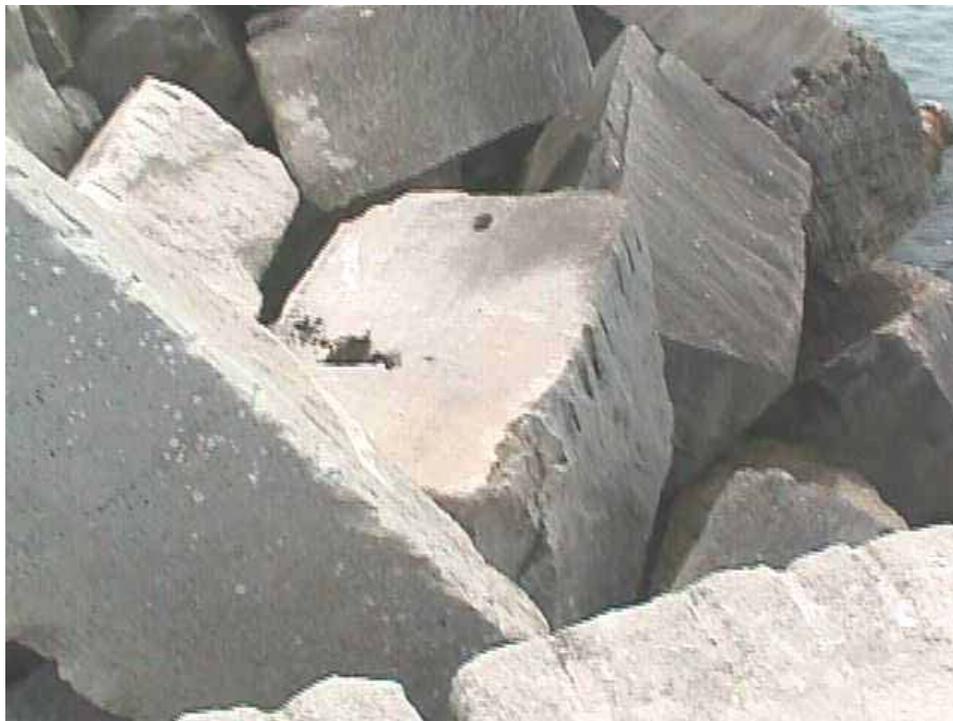
Figure 103. Burns Harbor breakwater (Big Burn section), Reed Quarry cut limestone (photo by Robert R. Bottin, ERDC)

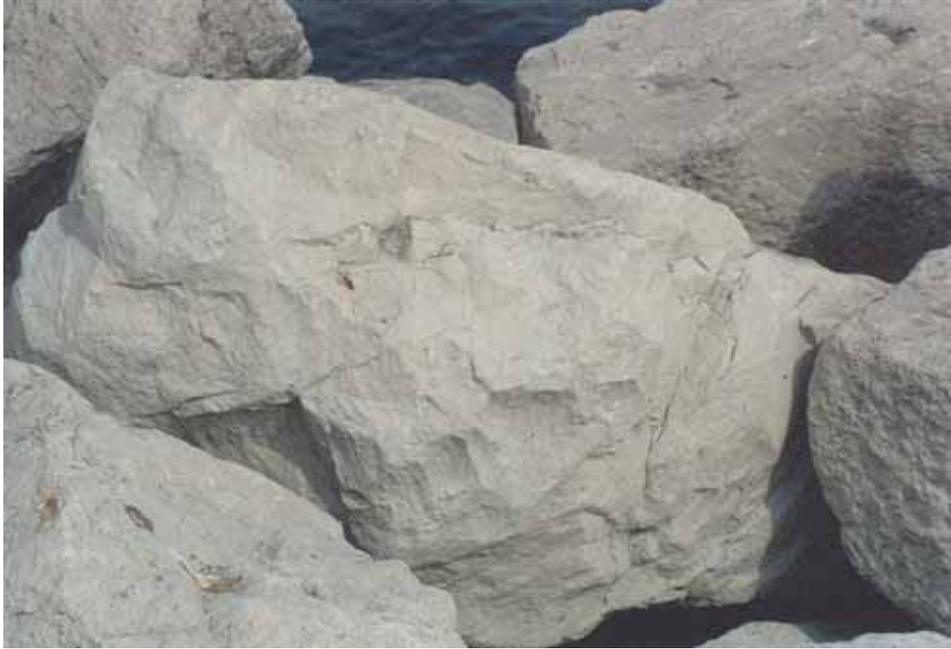
Figure 104. Burns Harbor breakwater (Big Burn section), McCook Quarry high energy blasted dolomite. Dolomitic mudstone exhibiting fracturing due to weathering processes (Rock Products Consultants 1995)

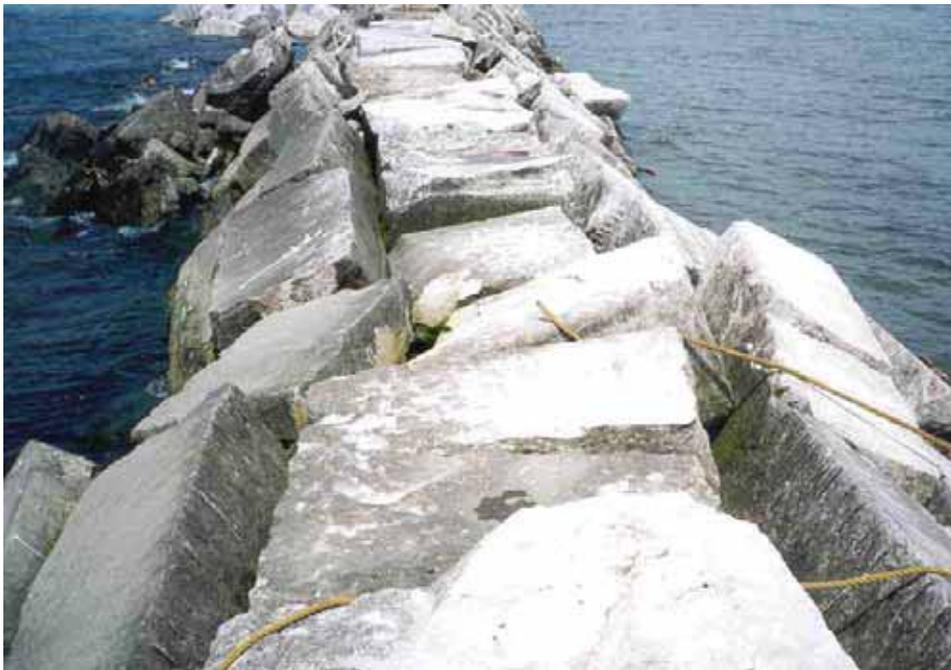
Figure 105. Cleveland Harbor east breakwater, Johnson Quarry cut sandstone (photo by Robert R. Bottin, ERDC)

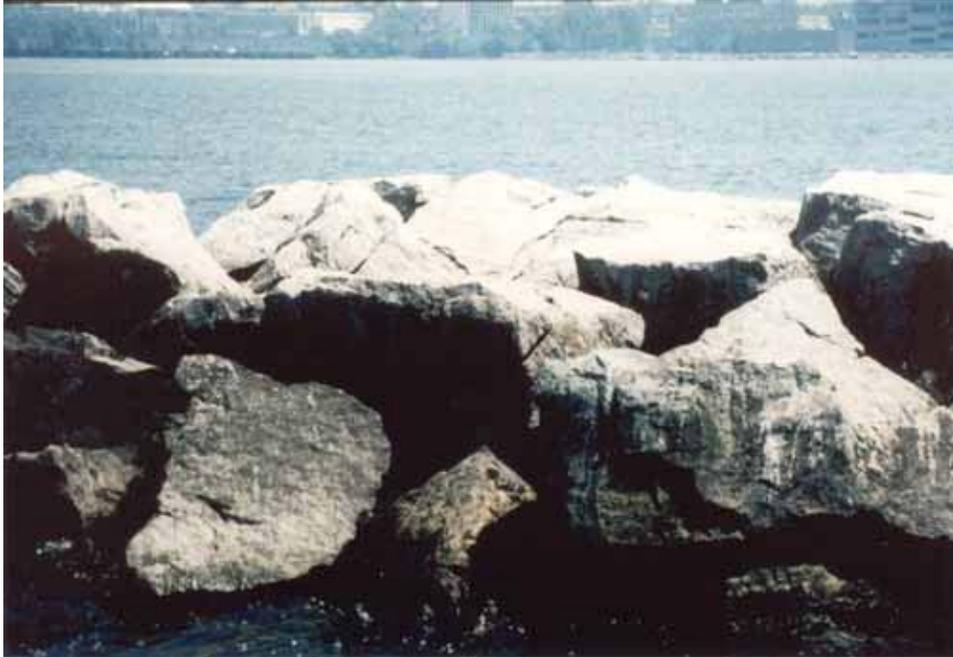
Figure 106. Cleveland Harbor east breakwater, Marblehead Quarry low energy blasted dolomitic limestone. Note extensive fracturing (Rock Products Consultants 1995)

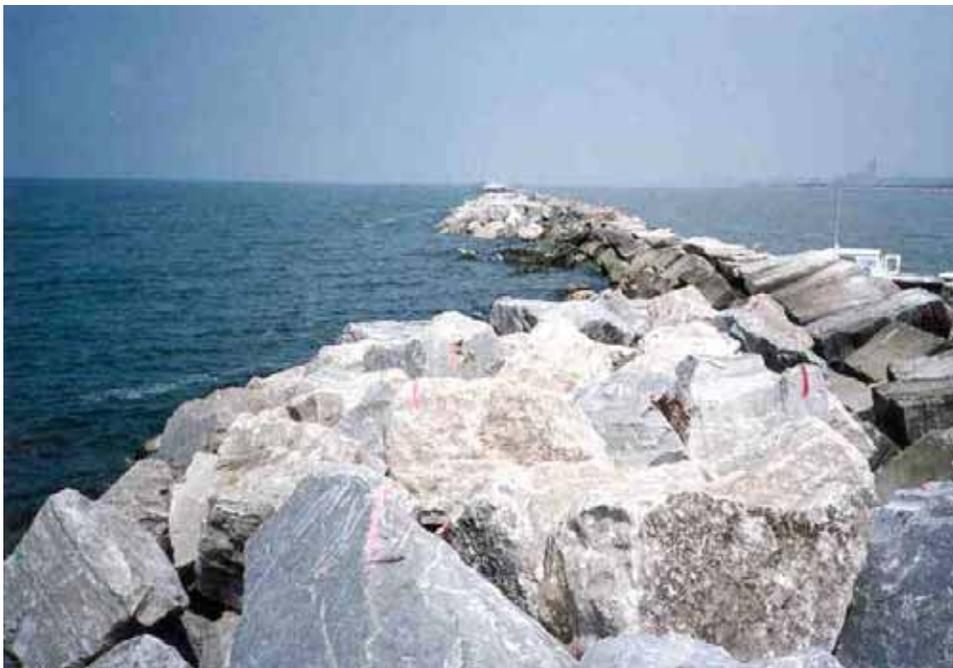
Figure 107. Cleveland Harbor east breakwater, Sandusky Quarry high energy blasted limestone (photo by Robert R. Bottin, ERDC)

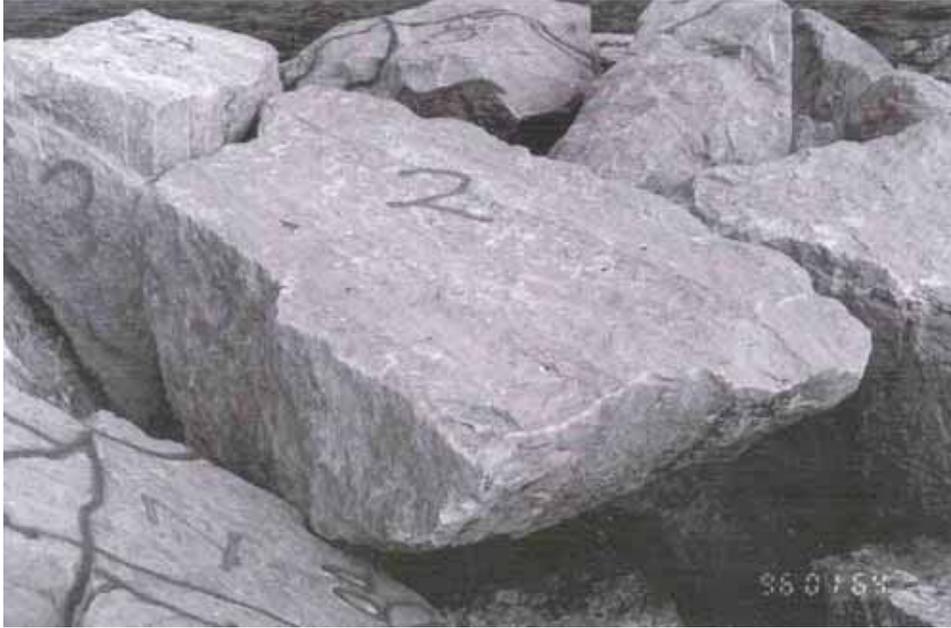
Figure 108. No cracks, Cleveland Harbor east breakwater, Sandusky Quarry high energy blasted limestone, quality rating = 100 percent

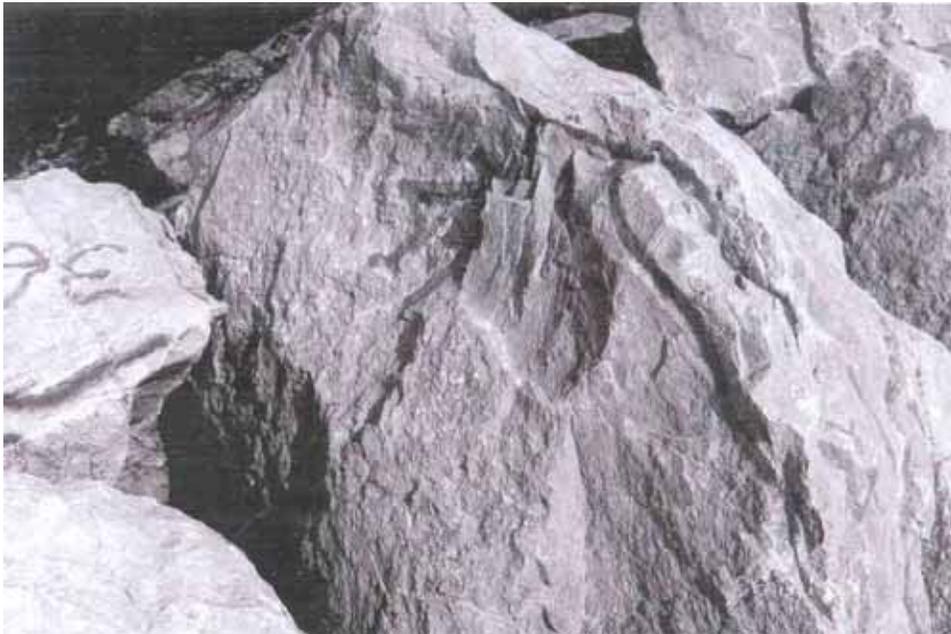
Figure 109. Minor cracks, Cleveland Harbor east breakwater, Sandusky Quarry high energy blasted limestone, quality rating = 80 percent

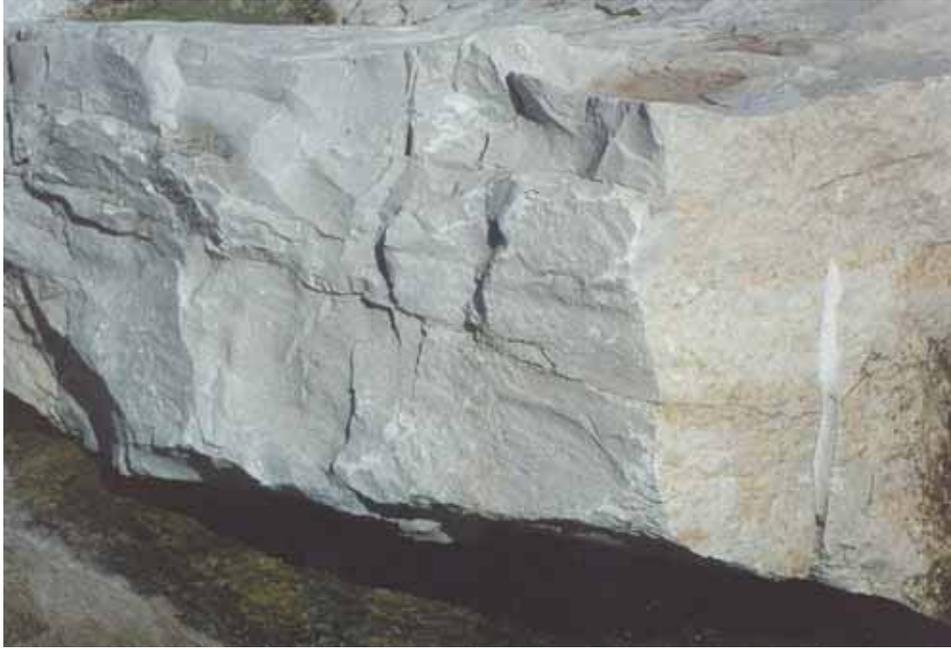
Figure 110. Multiply minor cracked, Chicago Harbor breakwater, Valders Quarry cut dolomite (low energy blasted, drilled and split, and then surfaces cut), quality rating = 70 percent (courtesy of Rock Products Consultants 1995)
