ERDC/CHL TR-05-1

Monitoring Completed Navigation Projects Program

Monitoring Stone Degradation on Coastal Structures in the Great Lakes – Summary Report

June 2005

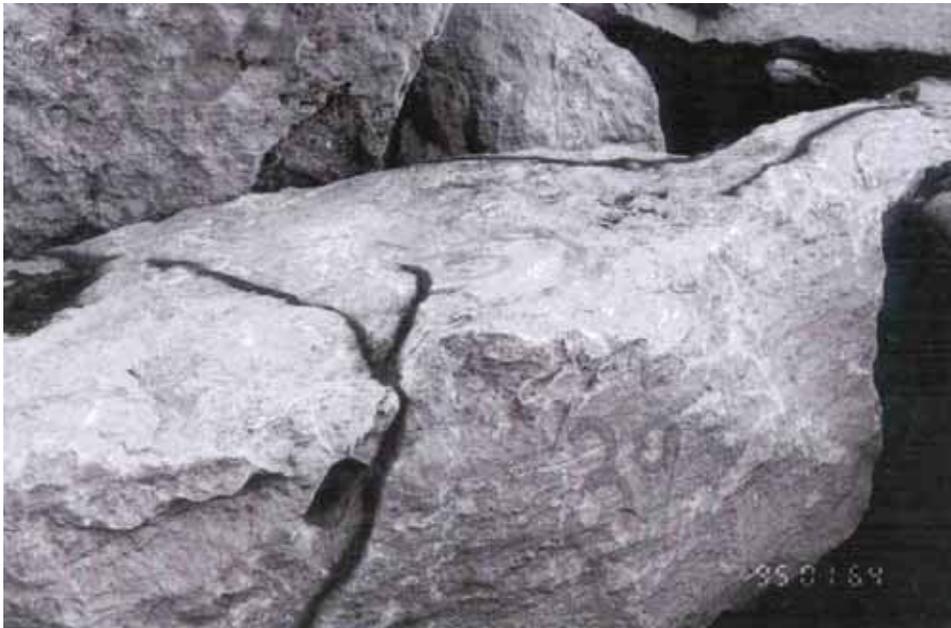
Figure 111. Significant cracks, Cleveland Harbor east breakwater, Marblehead Quarry low energy blasted dolomitic limestone, quality rating = 60 percent

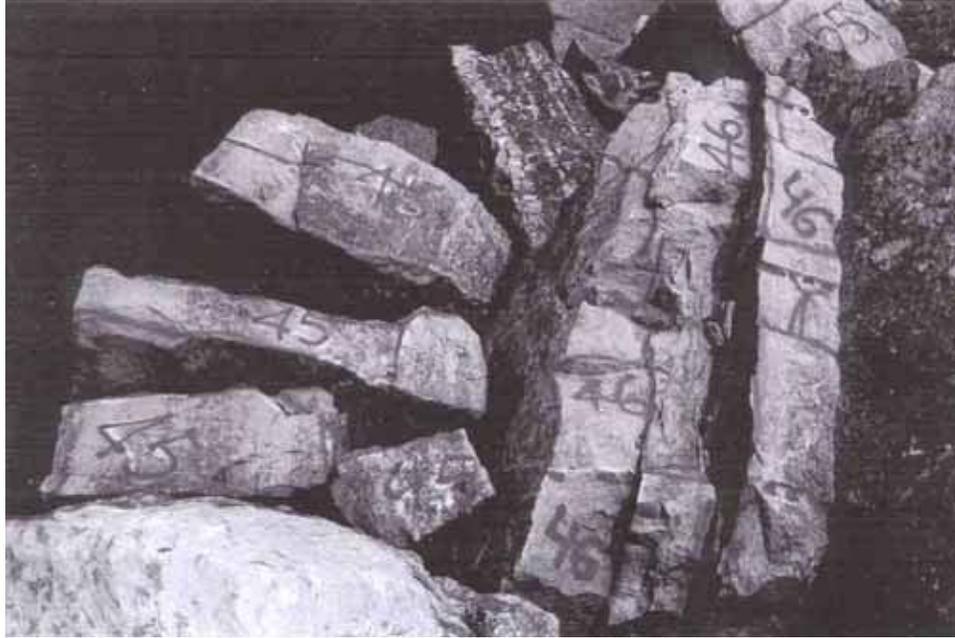
Figure 114. Multiply failed, Cleveland Harbor east breakwater, Marblehead Quarry low energy blasted dolomitic limestone, quality rating = 30 percent

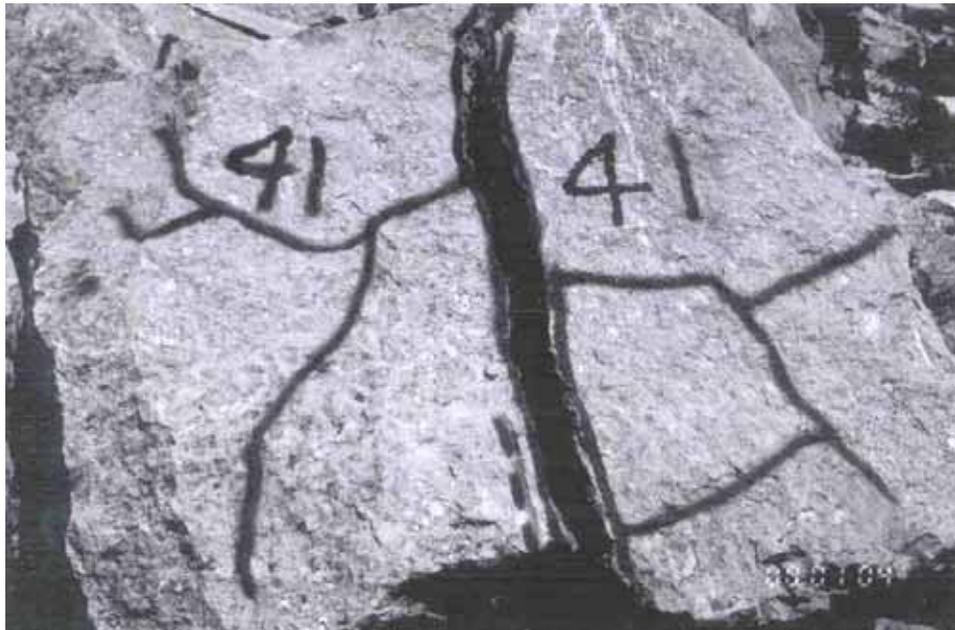
Figure 115. Fragmented, Cleveland Harbor east breakwater, Marblehead Quarry low energy blasted dolomitic limestone, quality rating = 20 percent

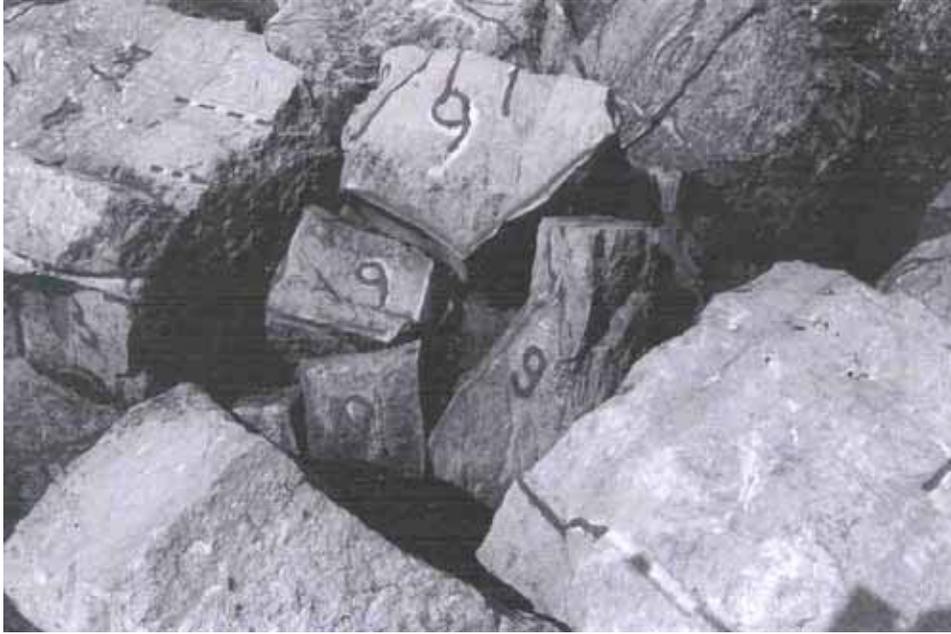
Figure 116. Multiply fragmented, Cleveland Harbor east breakwater, Marblehead Quarry low energy blasted dolomitic limestone, quality rating = 10 percent

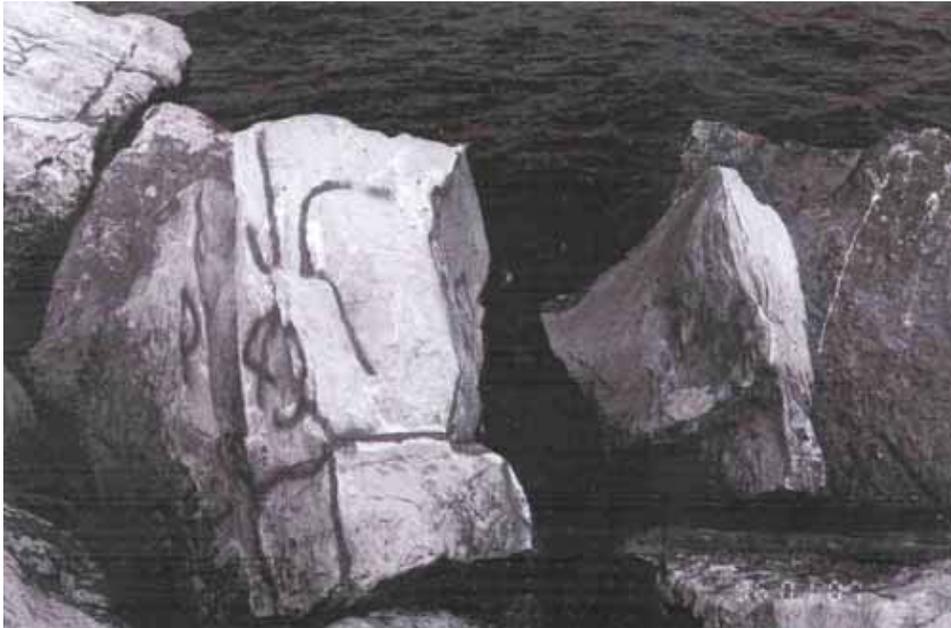
Figure 117. Displaced, Cleveland Harbor east breakwater, Marblehead Quarry low energy blasted dolomitic limestone, quality rating = 5 percent

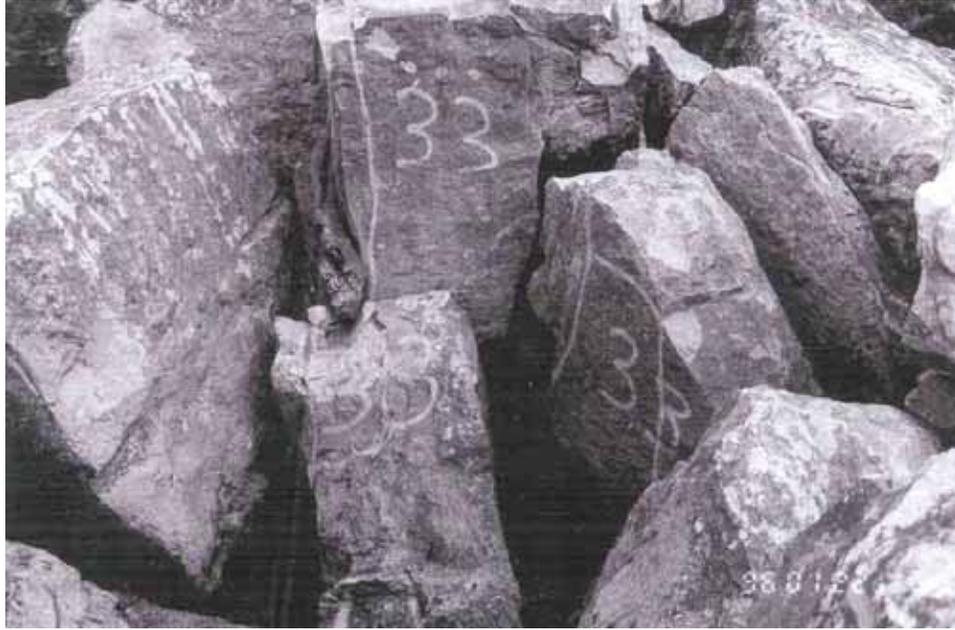
Figure 118. Multiply displaced, Cleveland Harbor east breakwater, Marblehead Quarry low energy blasted dolomitic limestone, quality rating = 3 percent

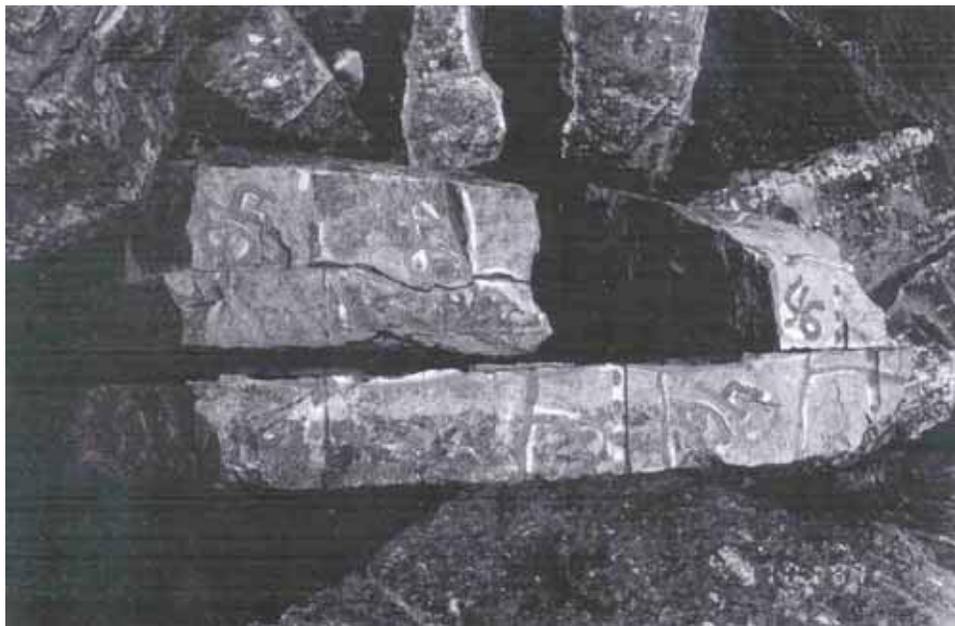
Figure 119. Lost1, Cleveland Harbor east breakwater, Marblehead Quarry low energy blasted dolomitic limestone, quality rating = 2 percent

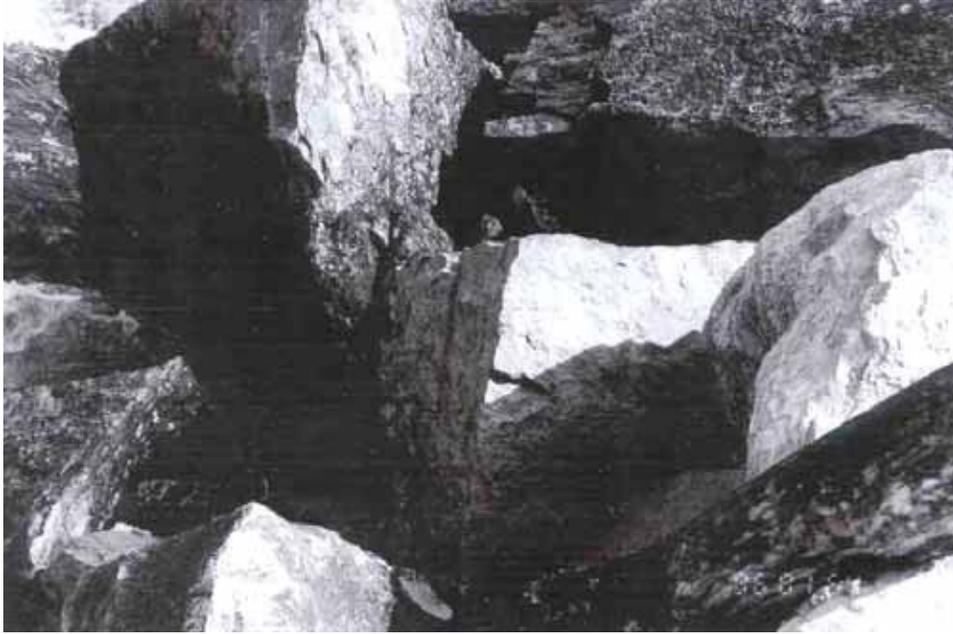
Figure 120. Lost2, Cleveland Harbor east breakwater, Sandusky Quarry high energy blasted limestone, quality rating = 1 percent

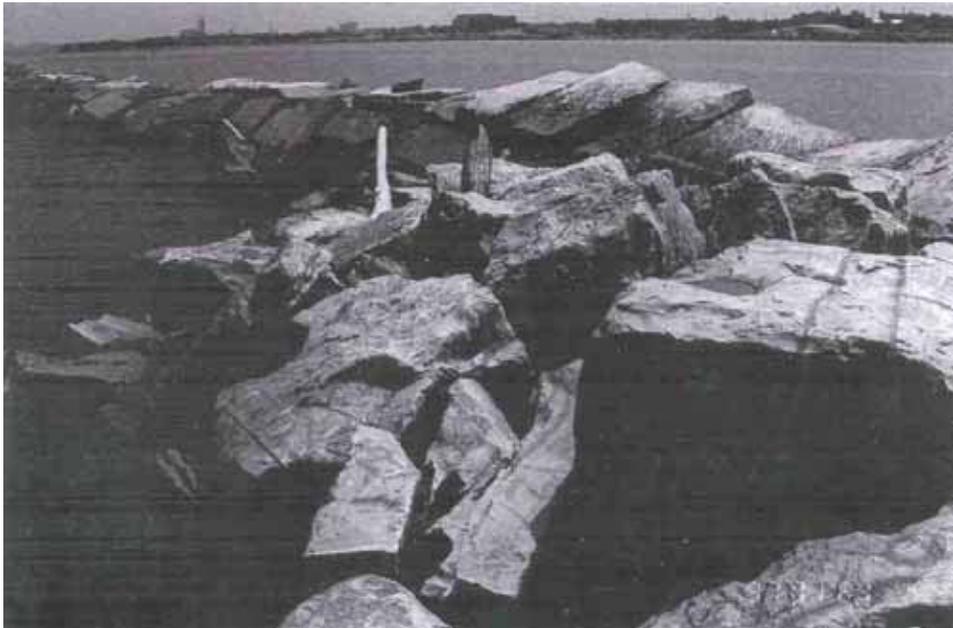
Figure 121. Lost3, Cleveland Harbor east breakwater, Marblehead Quarry low energy blasted dolomitic limestone, quality rating = 0 percent

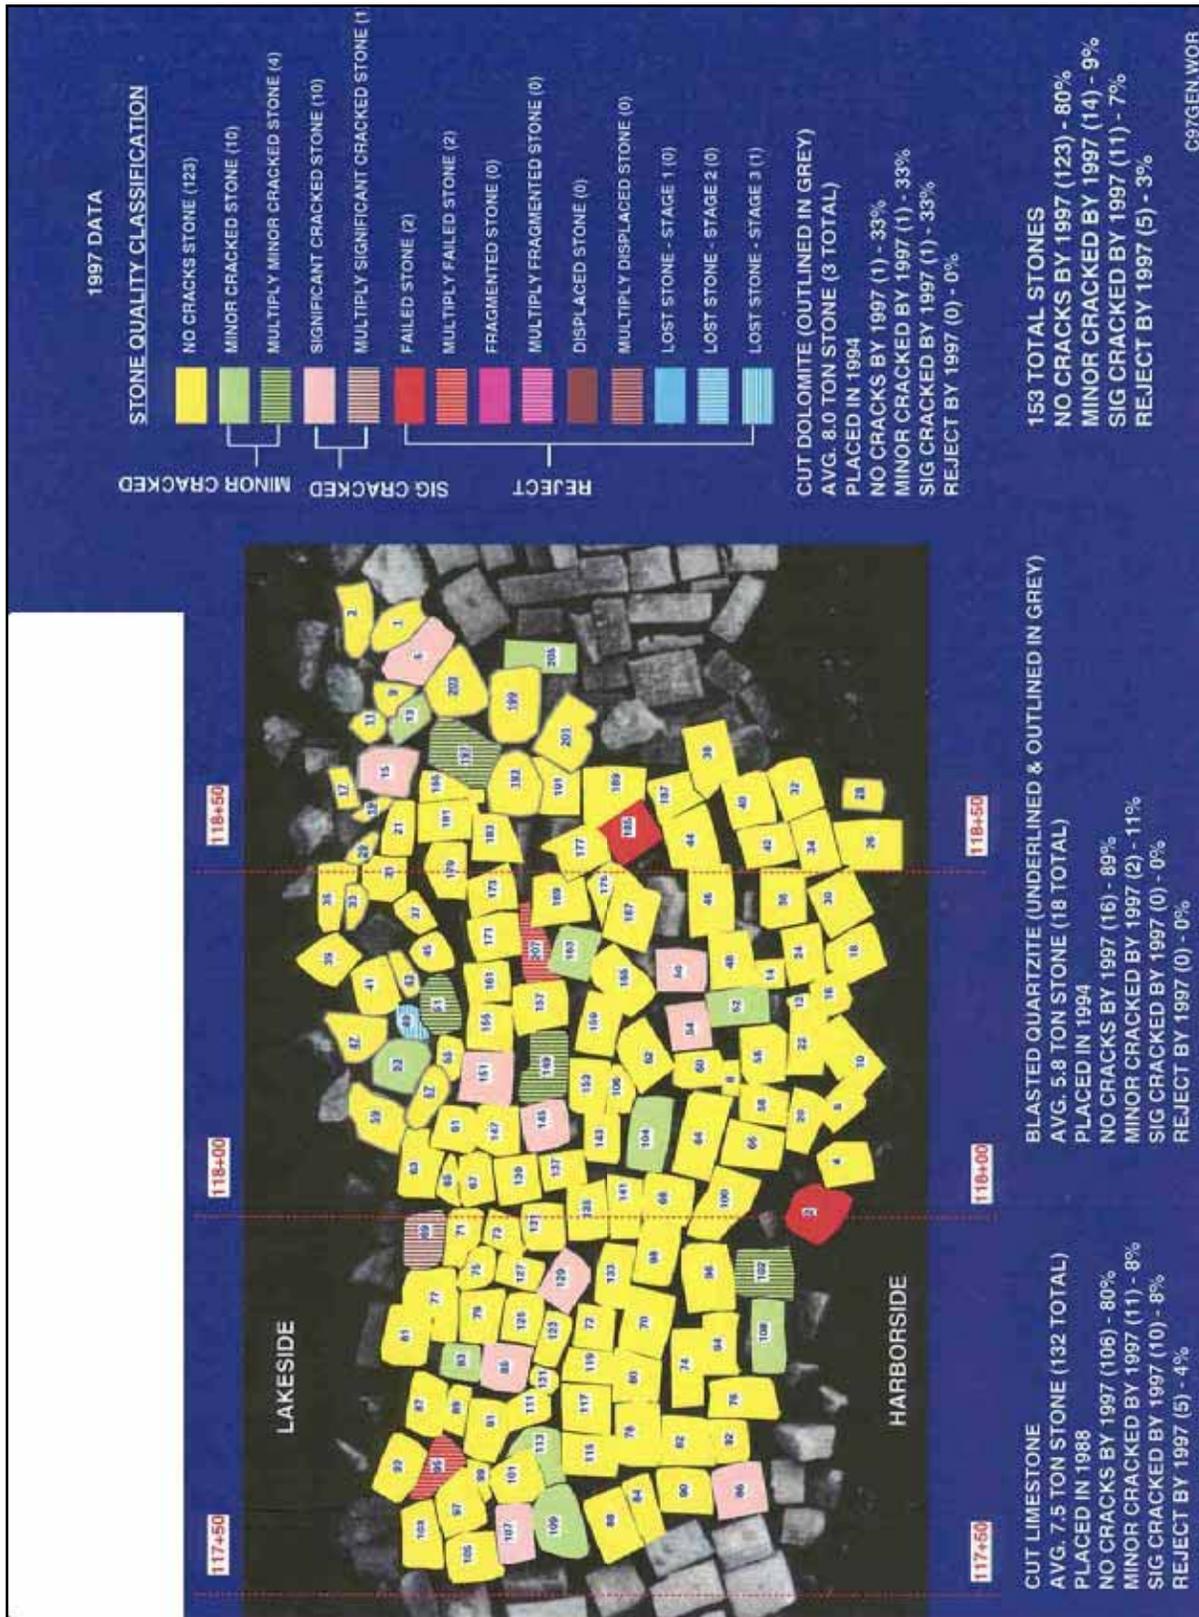
Figure 123. Calumet Harbor breakwater, sta 117+55 to sta 118+90, stone quality classification, end of 1997

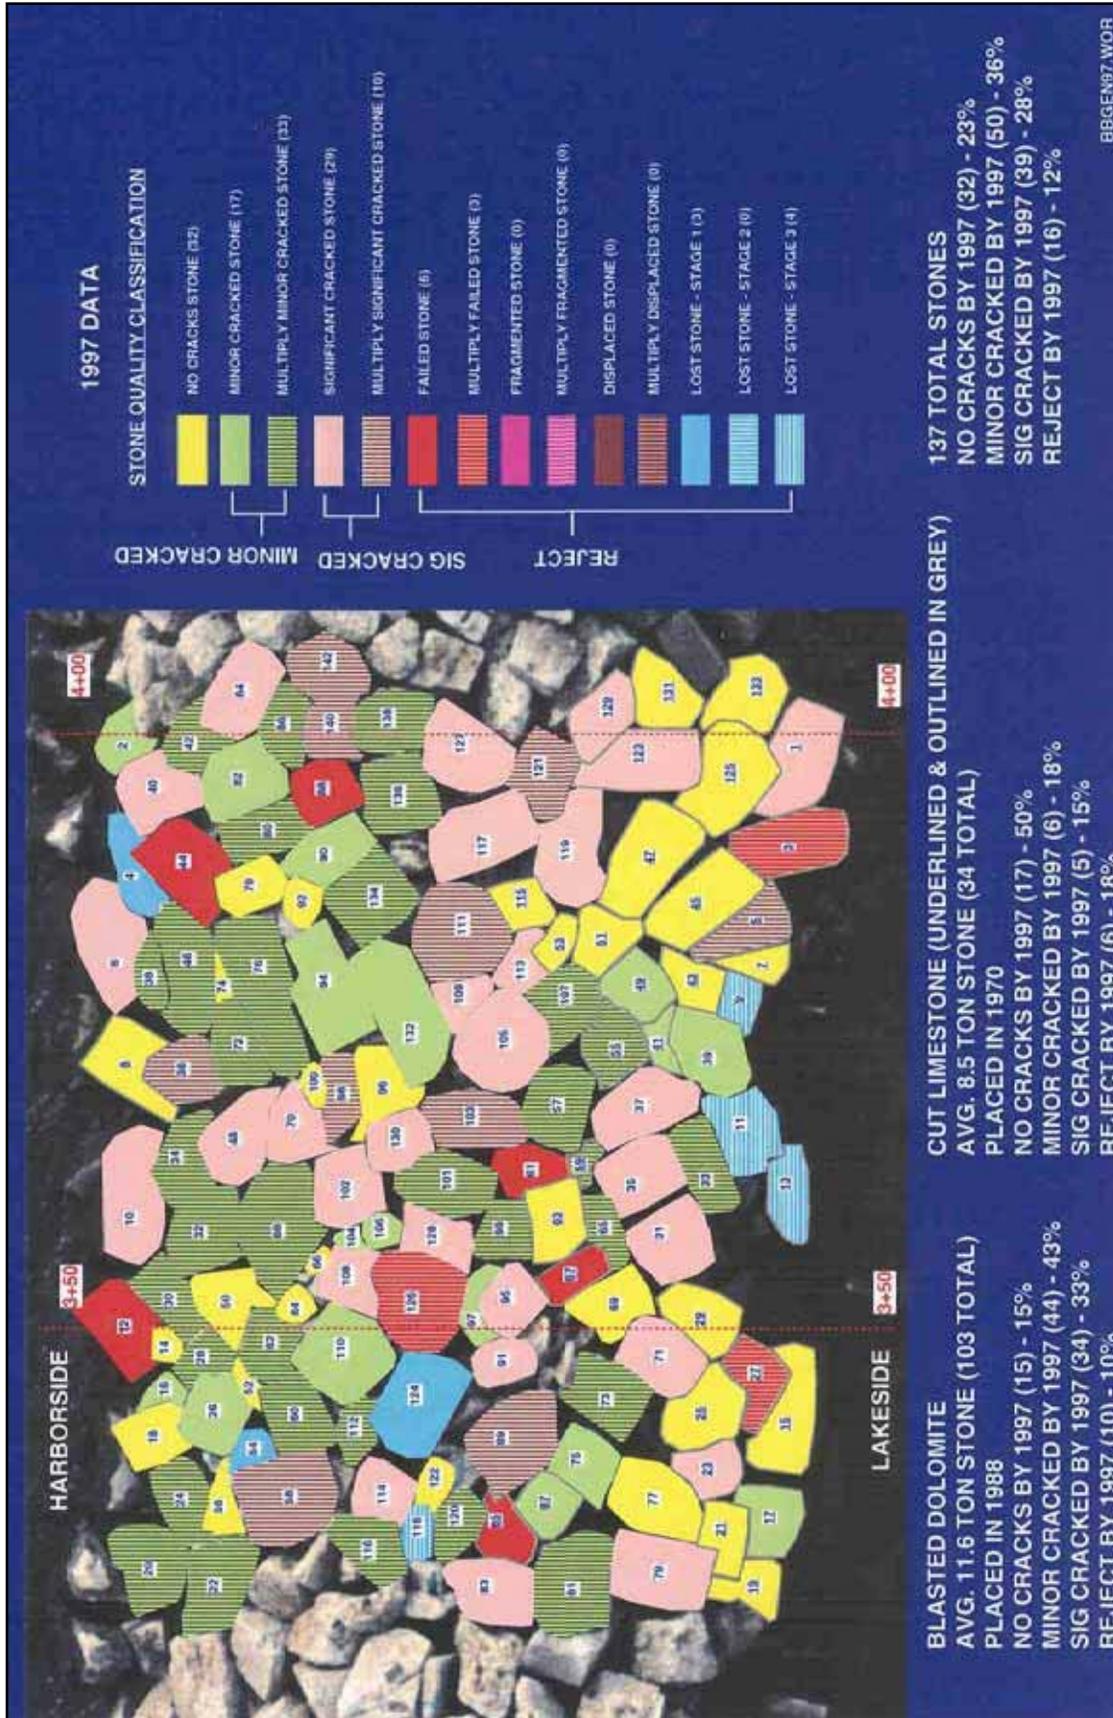
Figure 126. Burns Harbor breakwater (Big Burn section), sta 3+30 to sta 4+10, stone quality classification, end of 1997

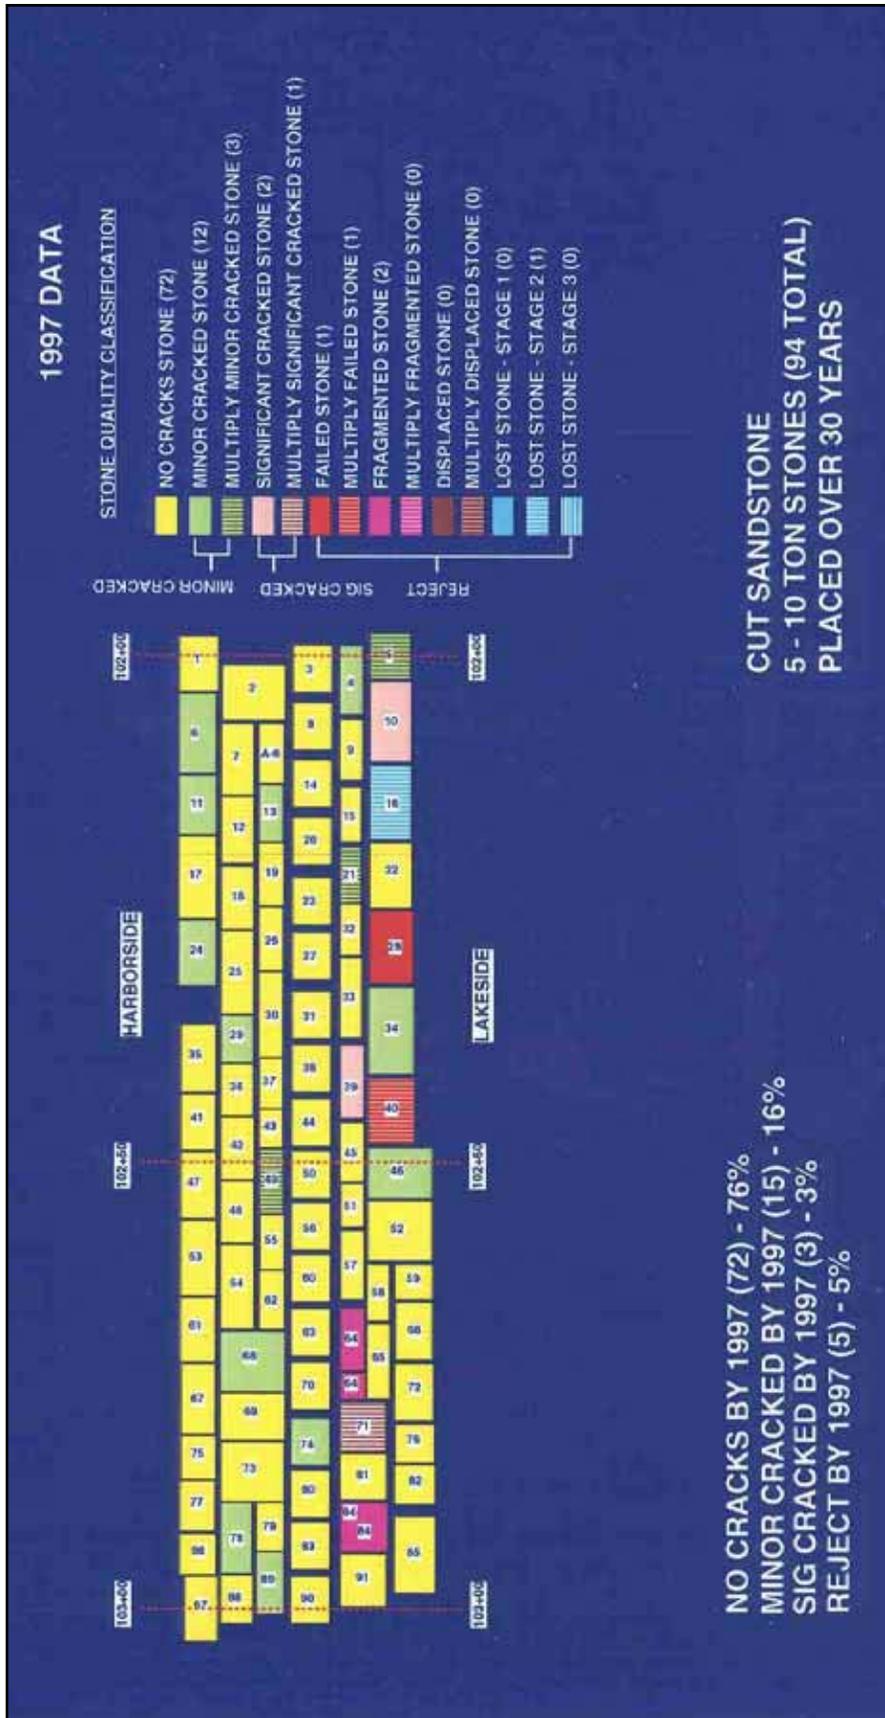
Figure 127. Cleveland Harbor east breakwater, sta 102+00 to sta 103+00, stone quality classification, end of 1997

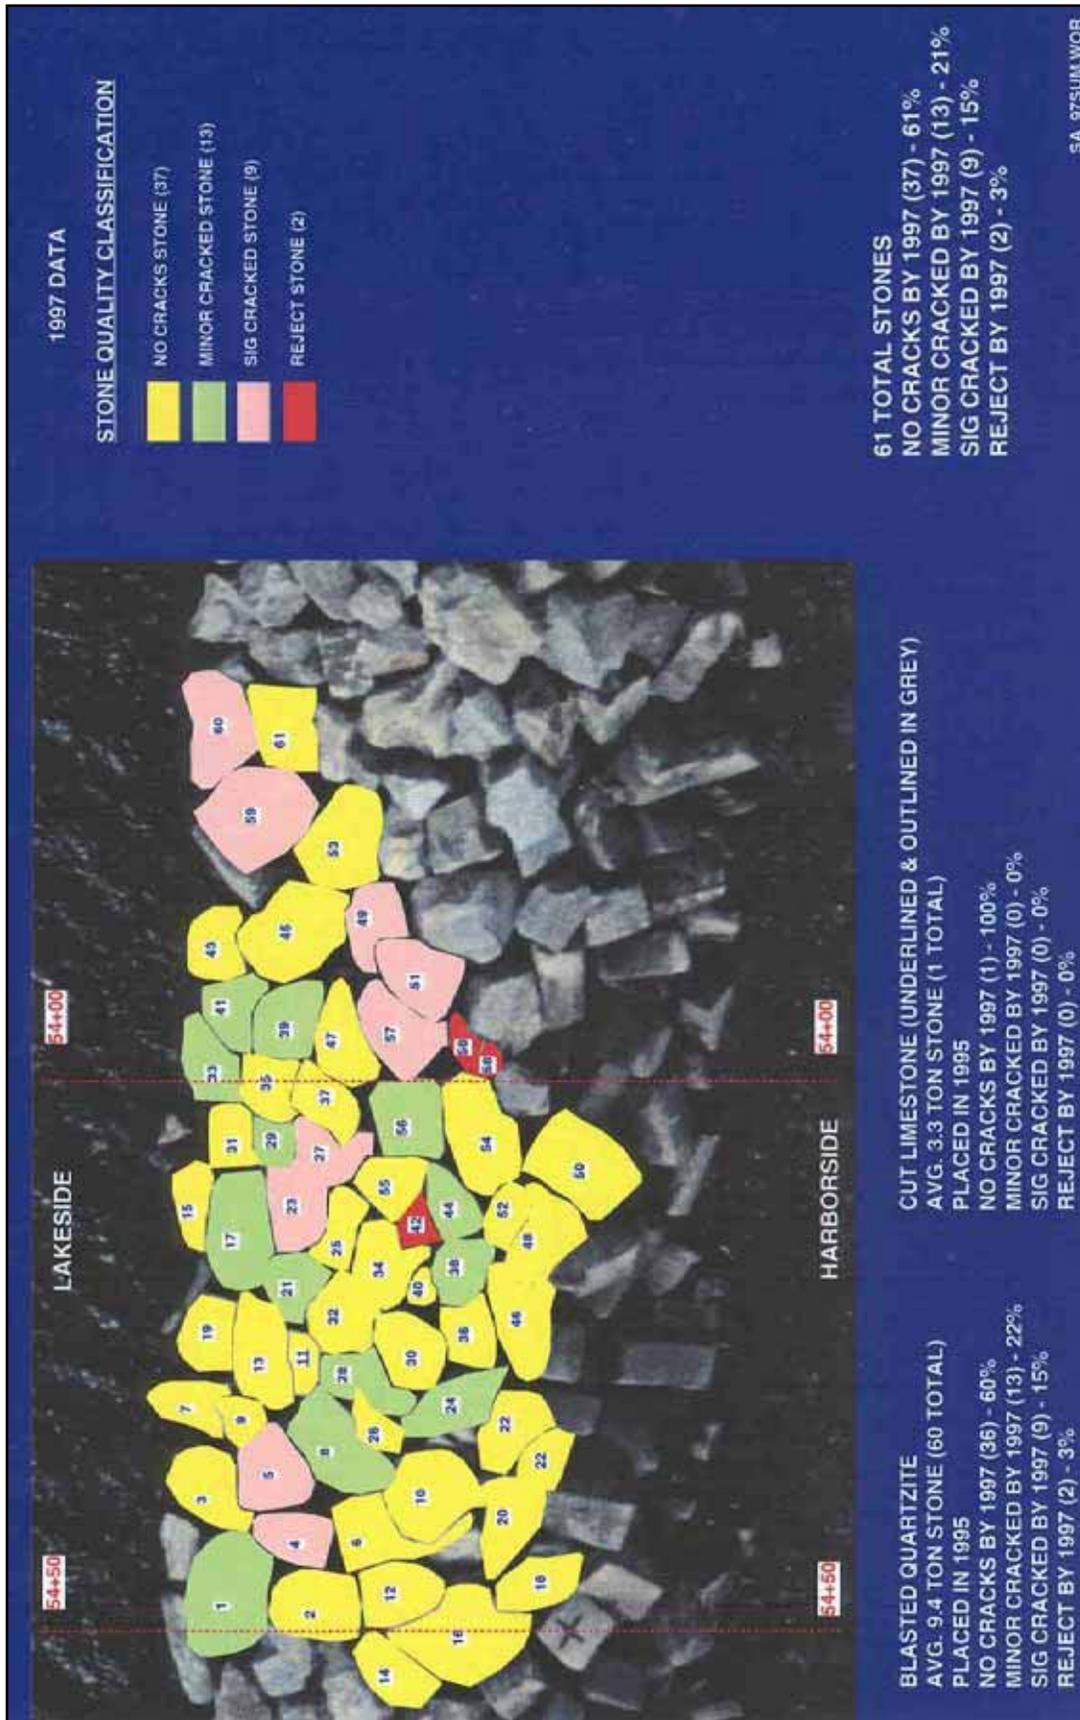
Figure 135. Burns Harbor breakwater (Shore Arm section), sta 53+60 to sta 54+55, acceptable versus rejected stone, end of 1997

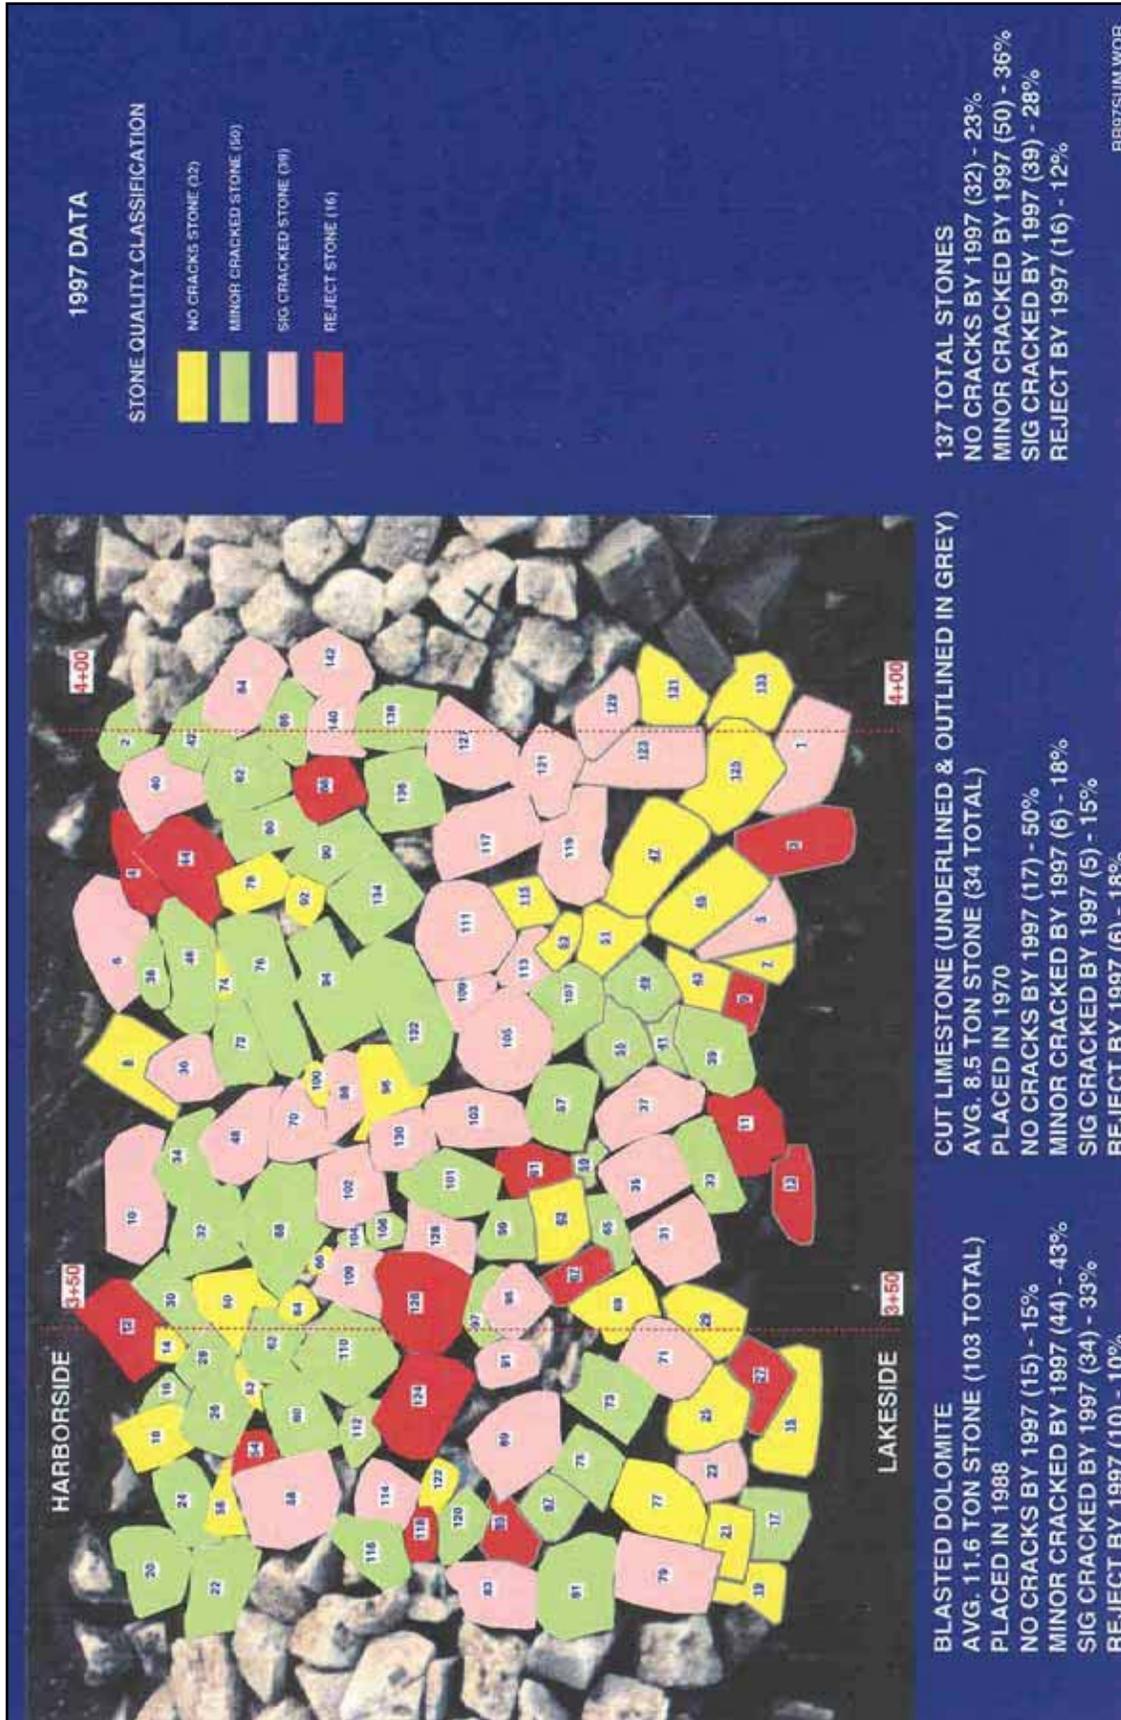
Figure 136. Burns Harbor breakwater (Big Burn section), sta 3+30 to sta 4+10, acceptable versus rejected stone, end of 1997

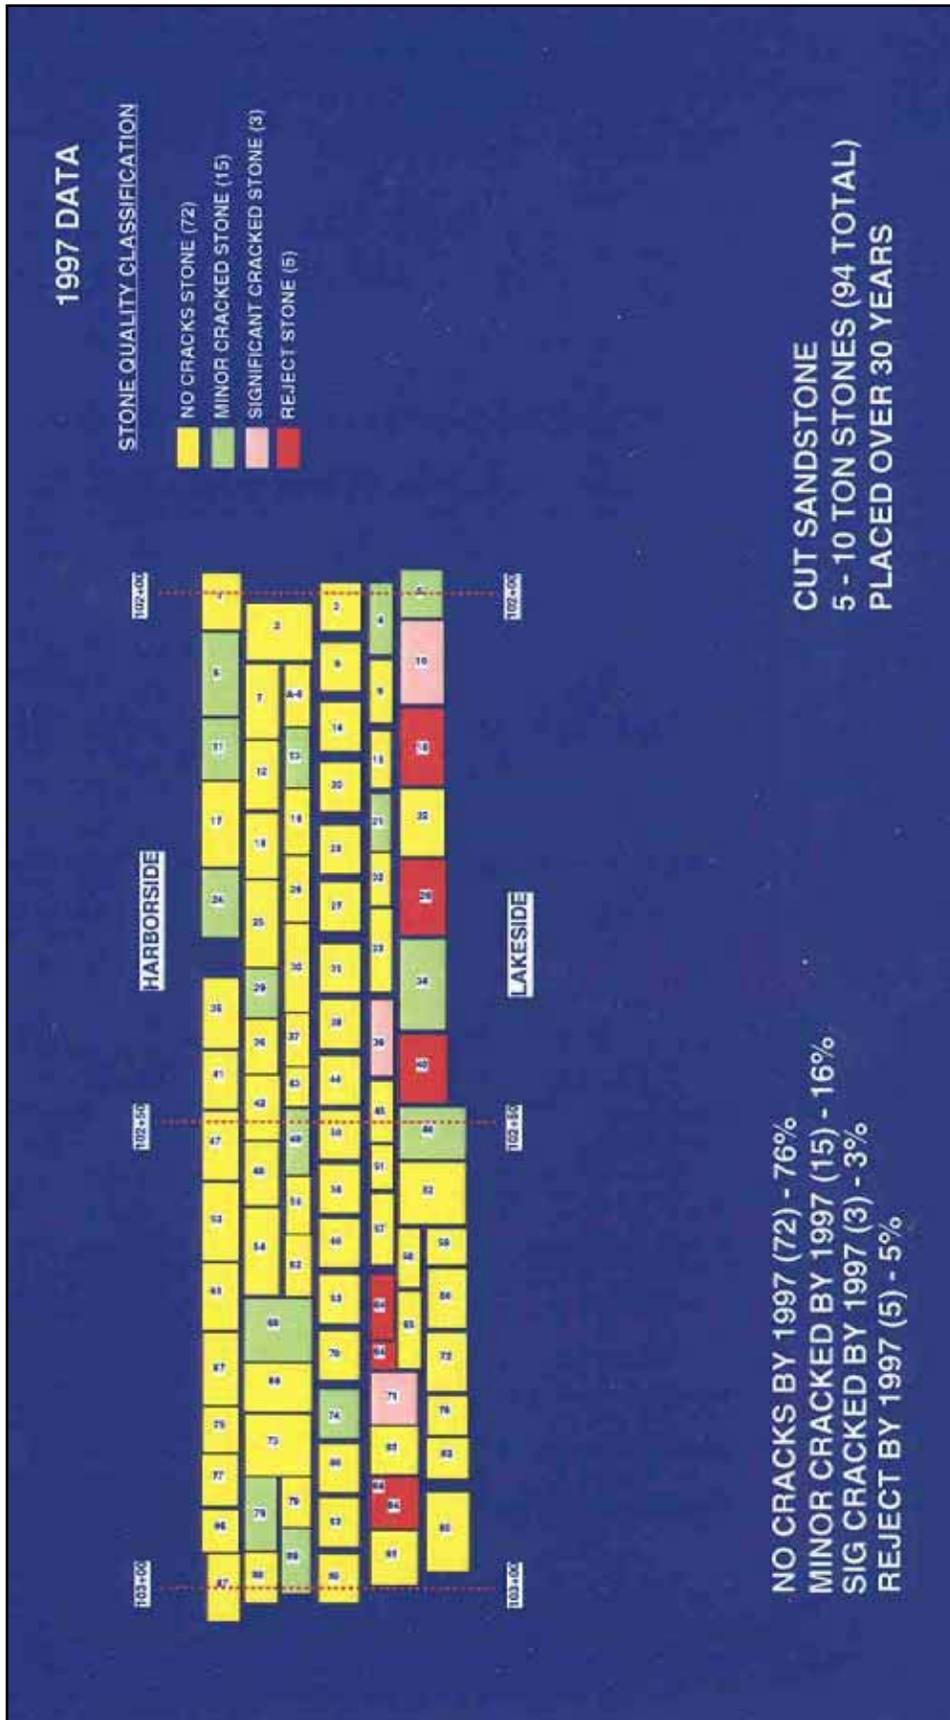
Figure 137. Cleveland Harbor east breakwater, sta 102+00 to sta 103+00, acceptable versus rejected stone, end of 1997

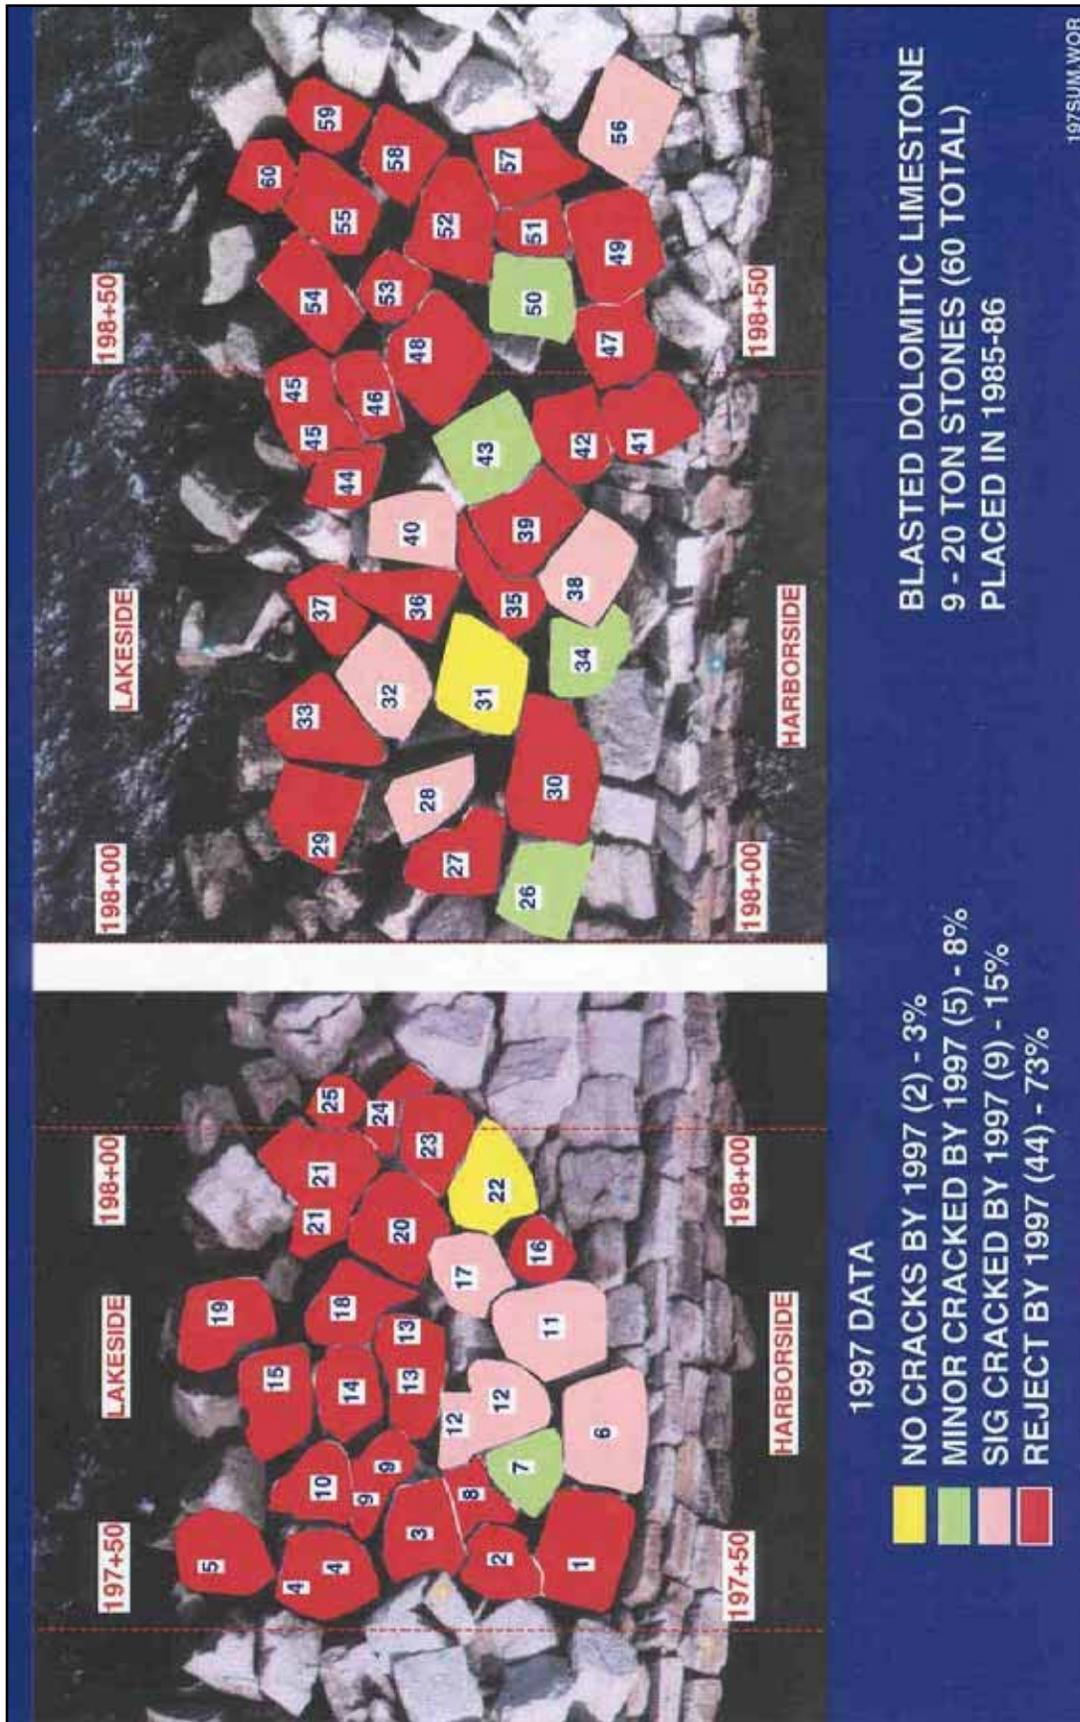
Figure 141. Cleveland Harbor east breakwater, sta 197+50 to sta 198+75, acceptable versus rejected stone, end of 1997

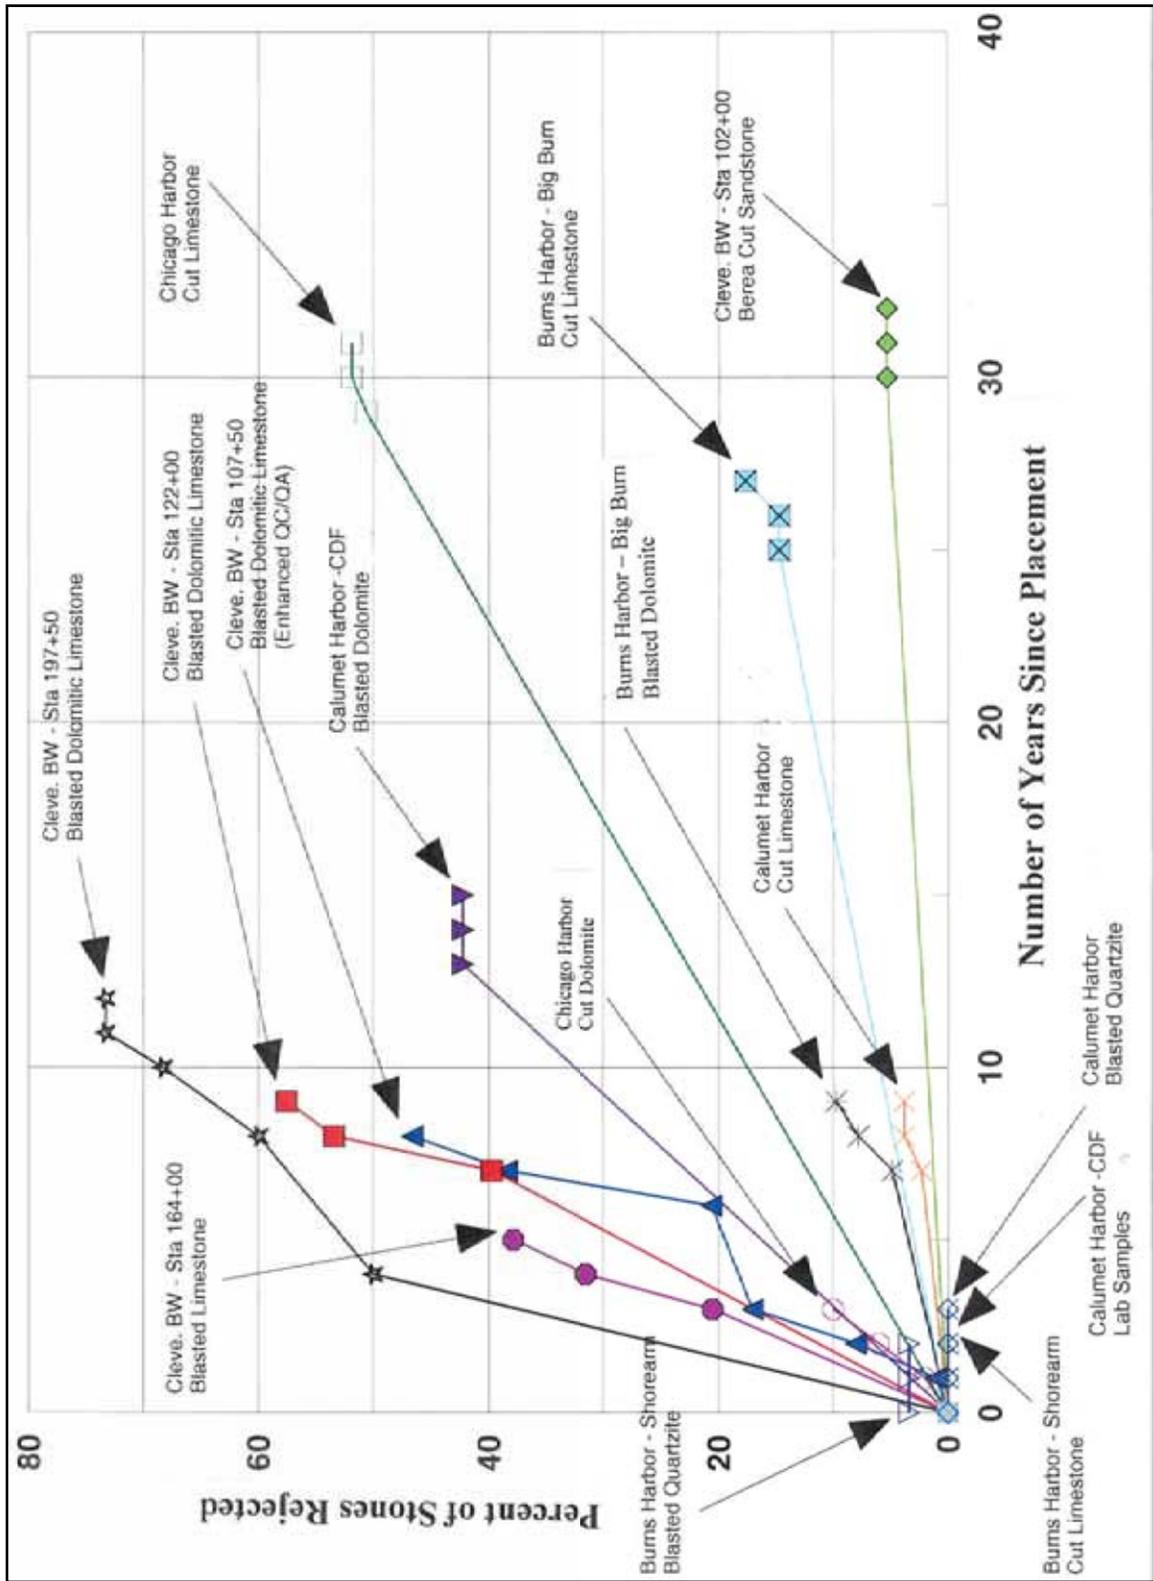
Figure 142. Percentage of rejected stones at monitored breakwater structure sections by stone type since those stones were originally placed

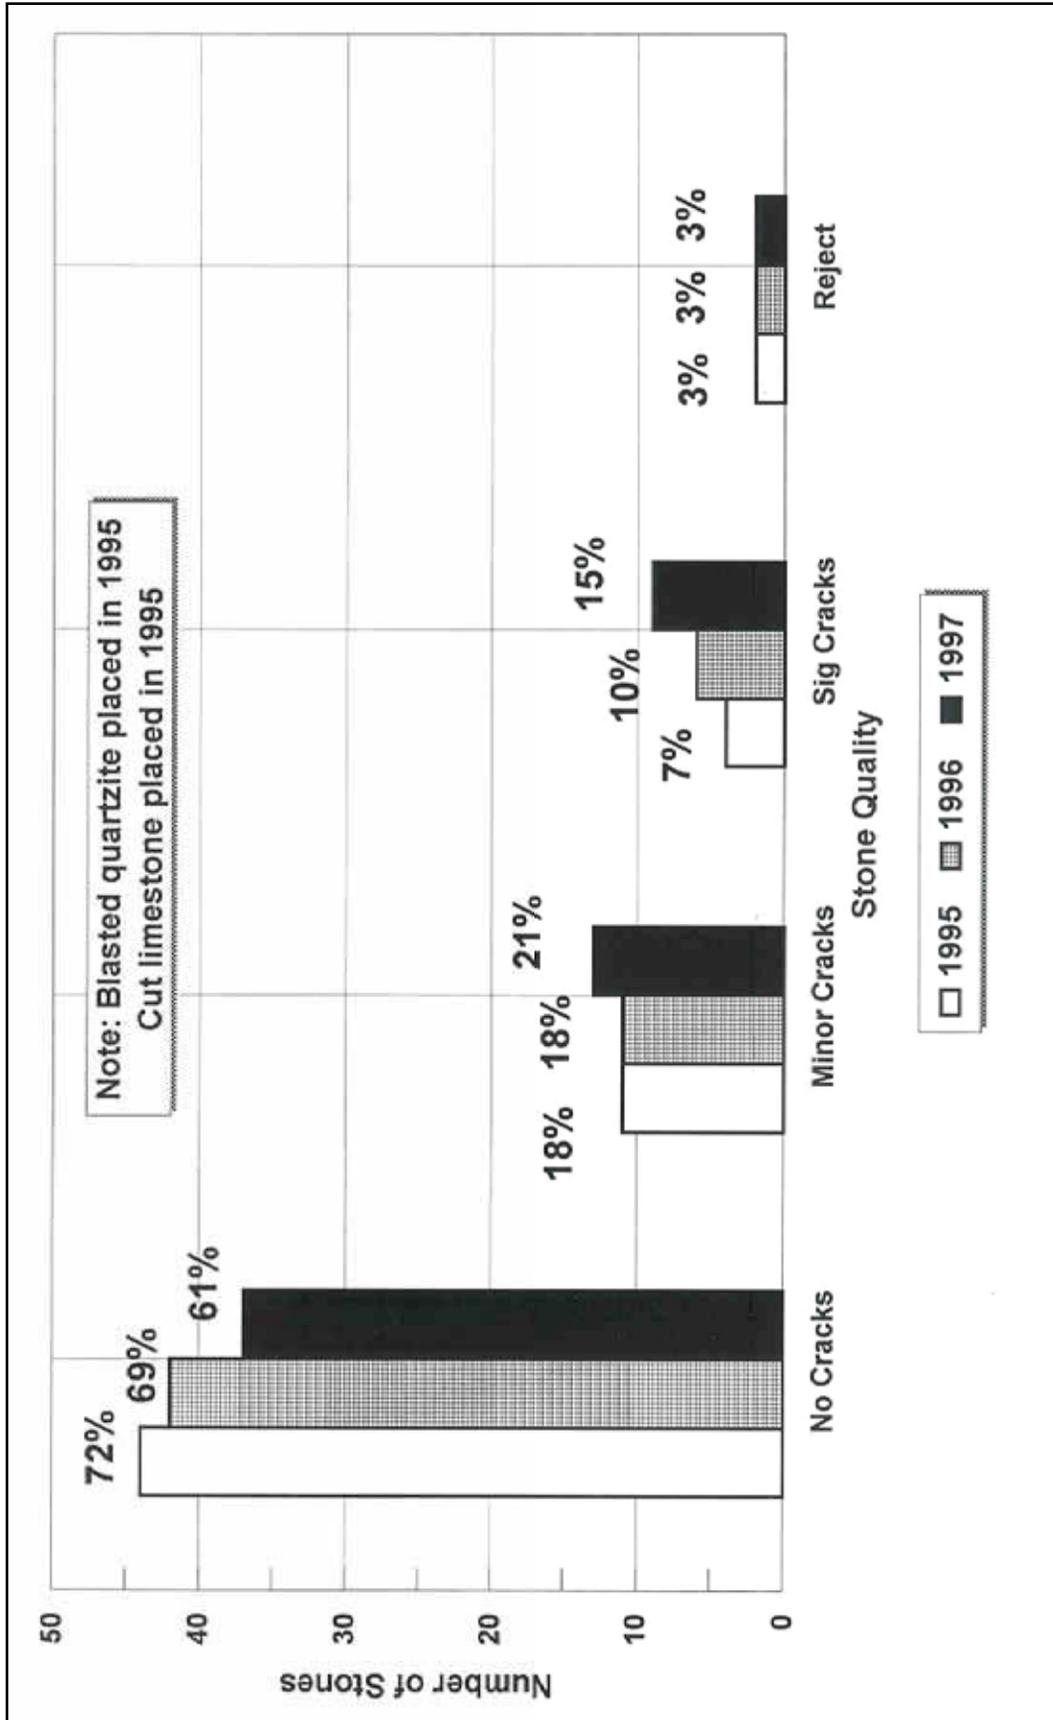
Figure 148. Stone quality comparison for monitored years at Burns Harbor breakwater (Shore Arm section), sta 53+60 to sta 54+55, for total of 61 stones (composite of blasted quartzite placed in 1995, and cut limestone placed in 1995)
