ERDC/CHL TR-05-1

Monitoring Completed Navigation Projects Program

Monitoring Stone Degradation on Coastal Structures in the Great Lakes – Summary Report

June 2005

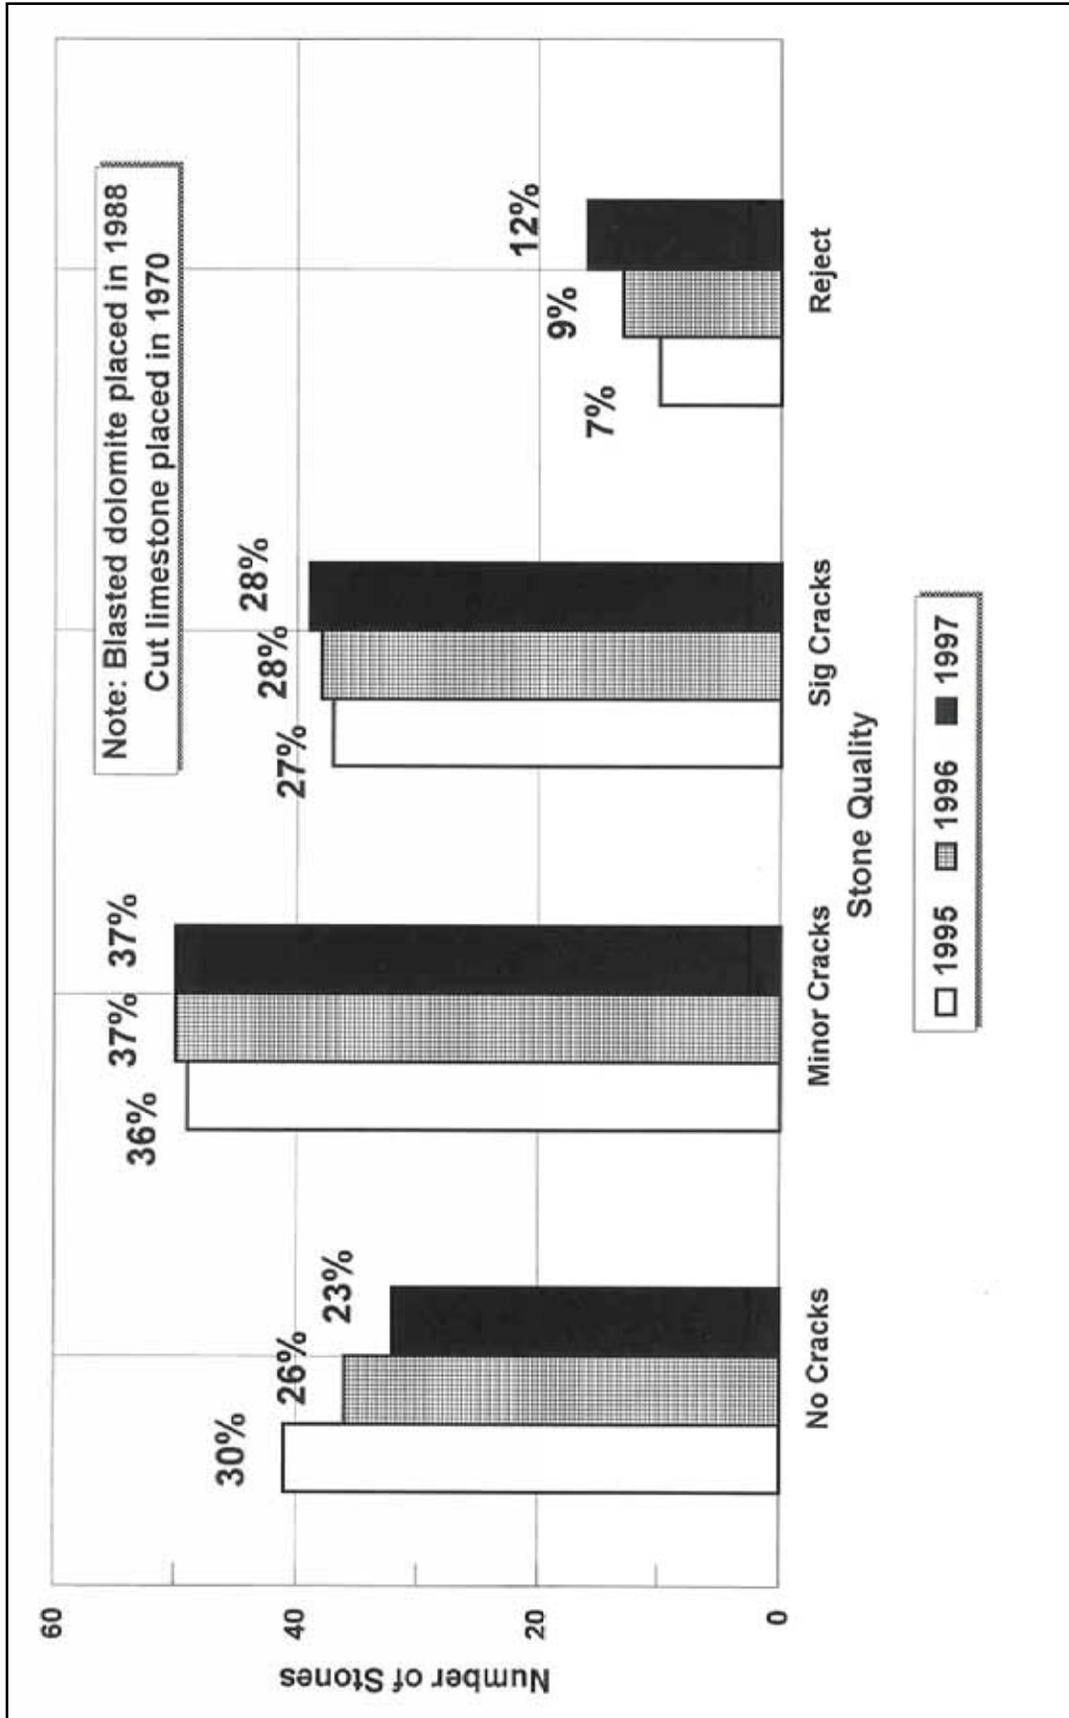
Figure 149. Stone quality comparison for monitored years at Burns Harbor breakwater (Big Burn section), sta 3+30 to sta 4+10, for total of 137 stones (composite of blasted dolomite placed in 1988, and cut limestone placed in 1970)

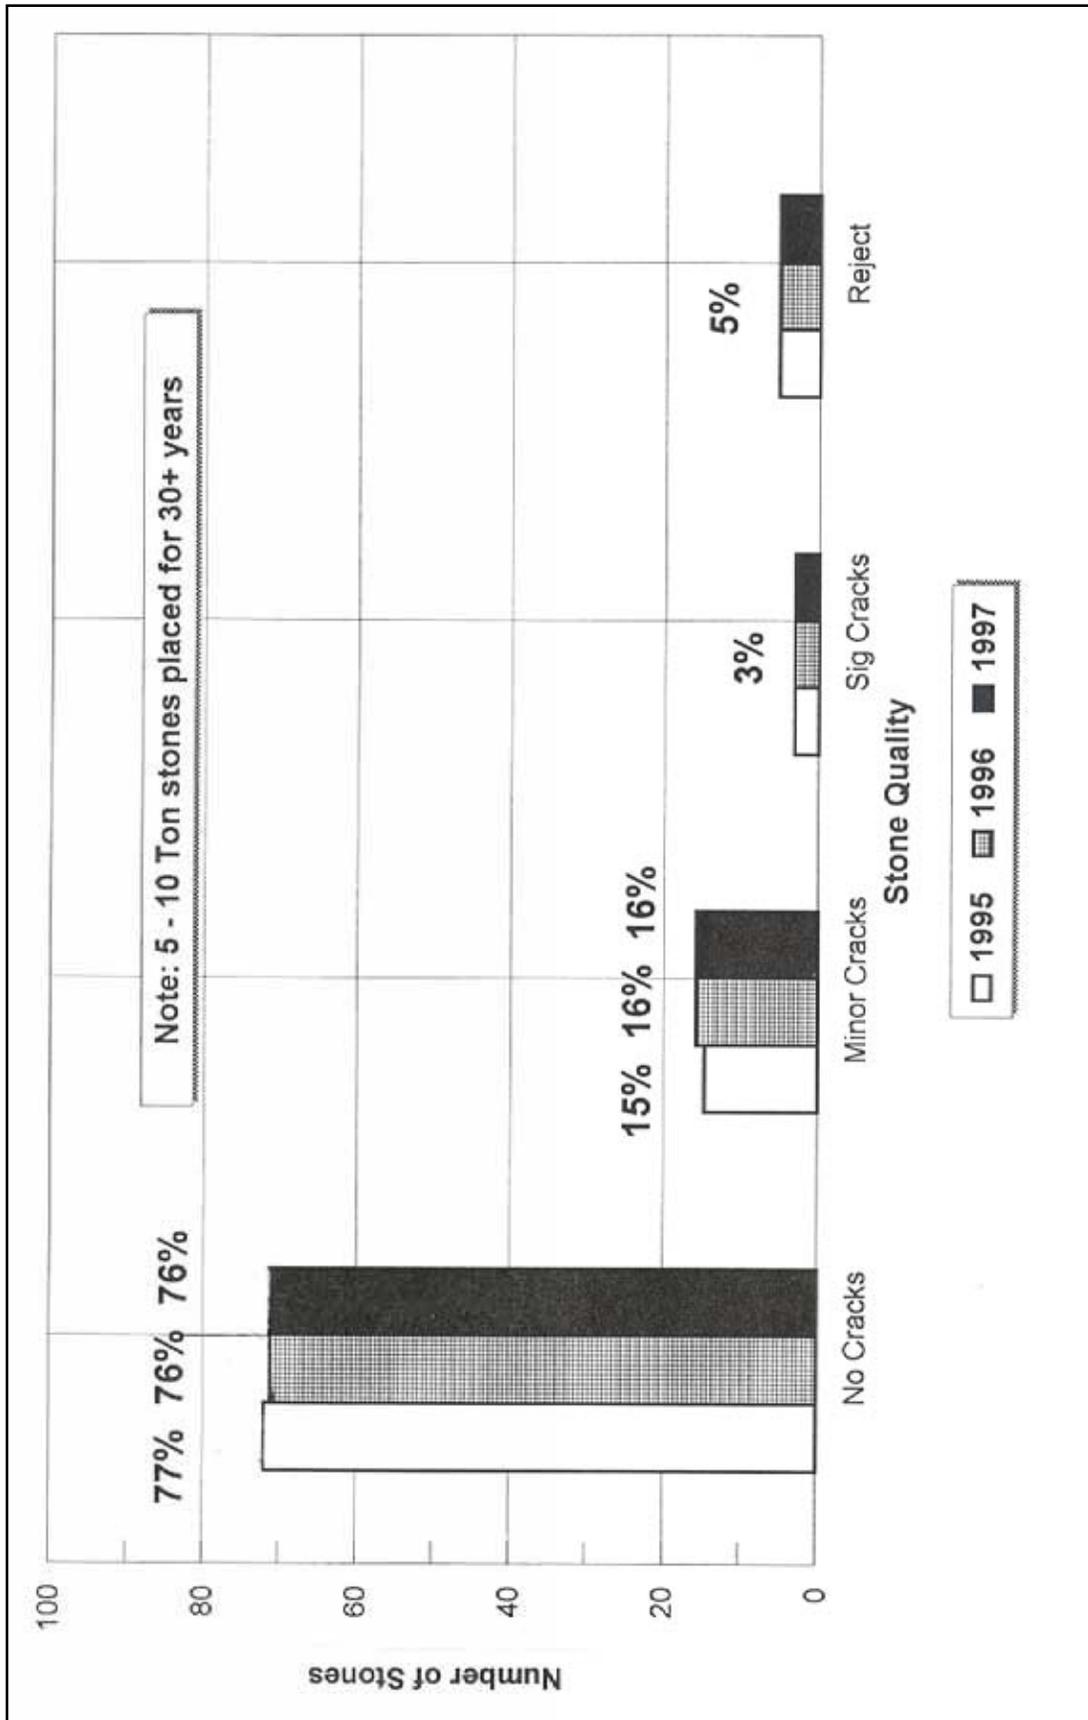
Figure 150. Stone quality comparison for monitored years at Cleveland Harbor east breakwater, sta 103+00 to sta 102+00, for total of 94 stones (cut sandstone placed over 30 years)

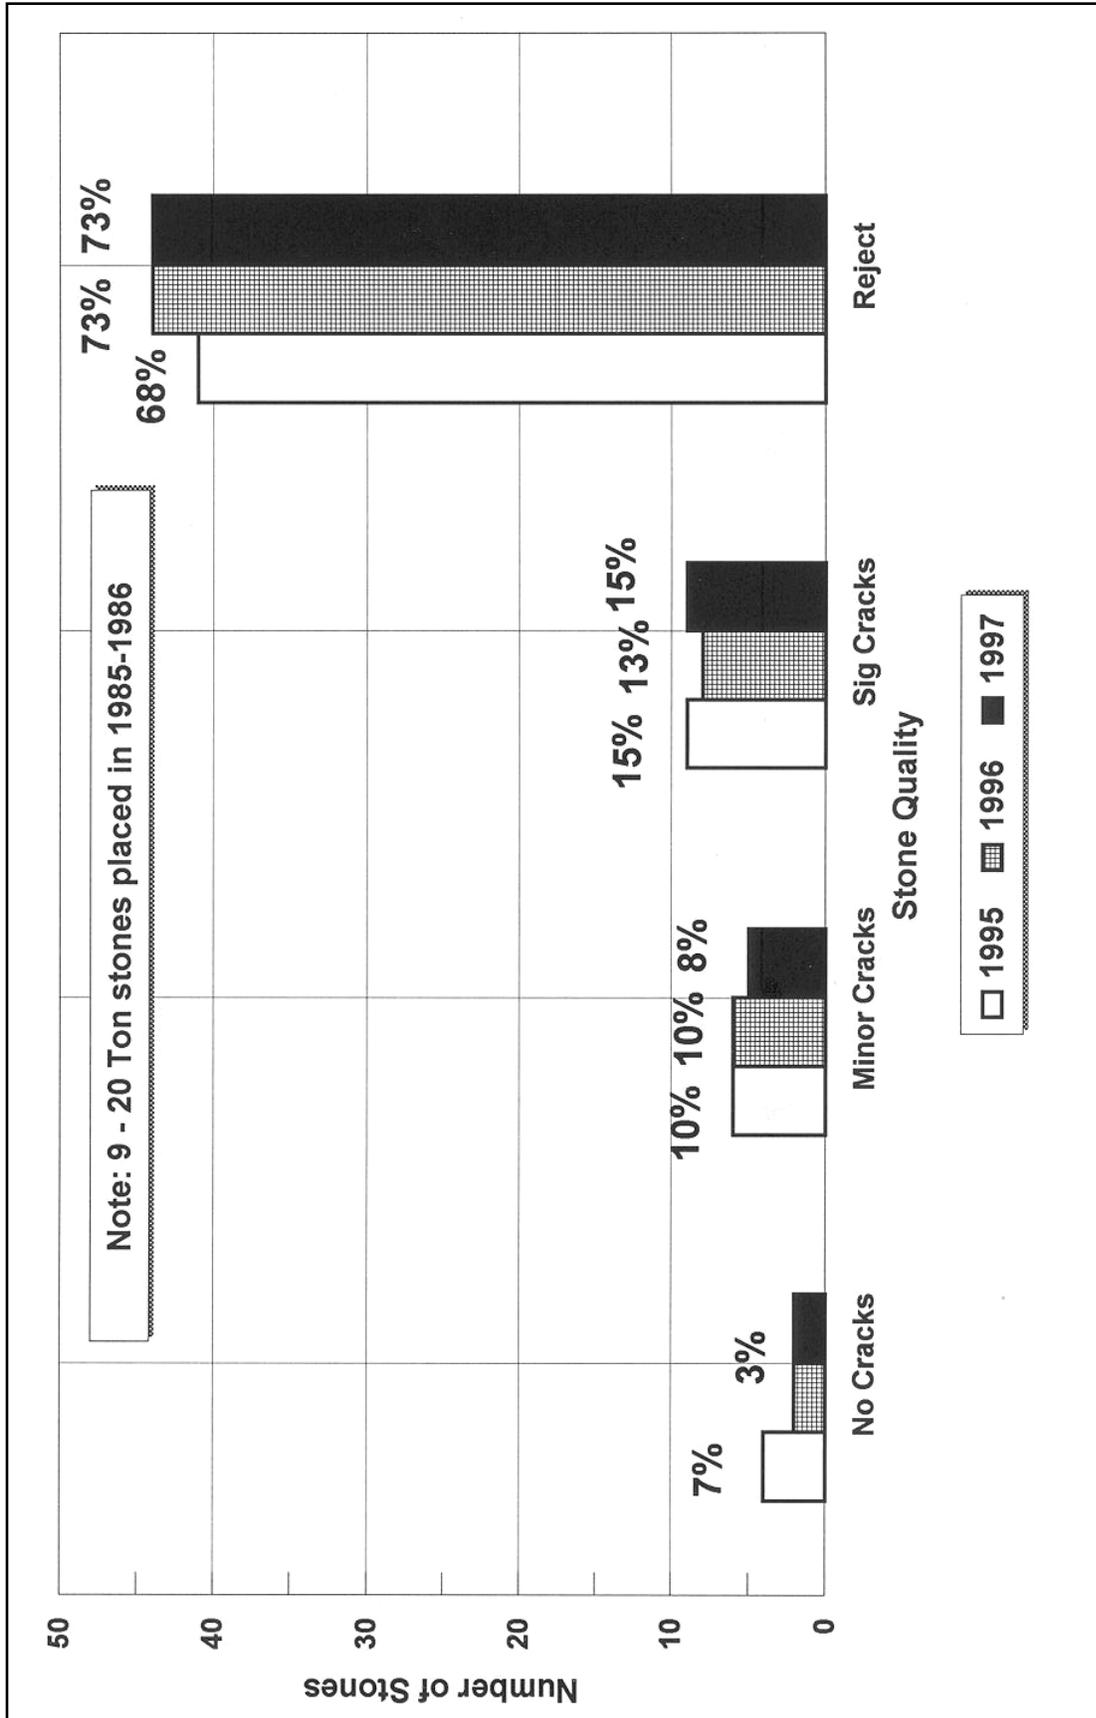
Figure 154. Stone quality comparison for monitored years at Cleveland Harbor east breakwater, sta 197+50 to sta 198+75, for total of 60 stones (blasted dolomitic limestone placed in 1989)

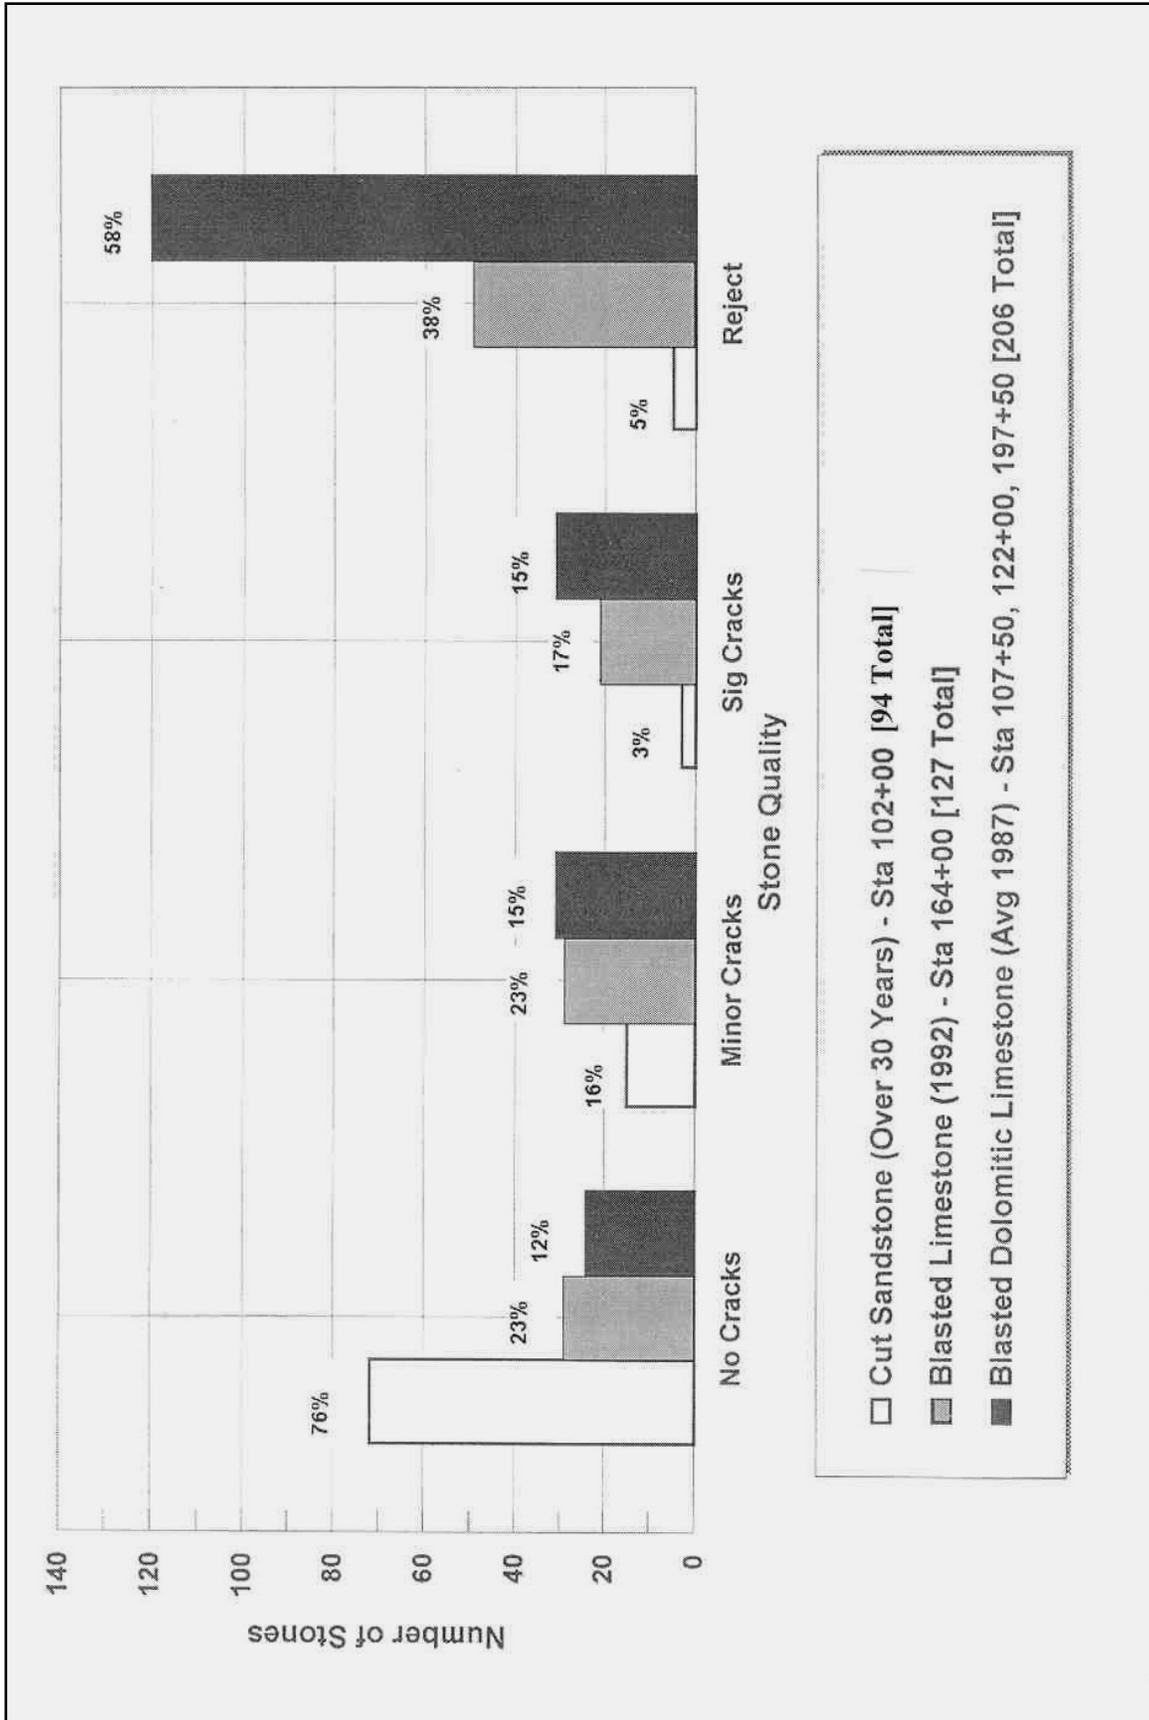
Figure 155. Cleveland Harbor east breakwater stone quality classification for three stone types on the monitored structure sections, for total of 427 stones, and a comparison of their degree of deterioration at end of monitoring period (1997)

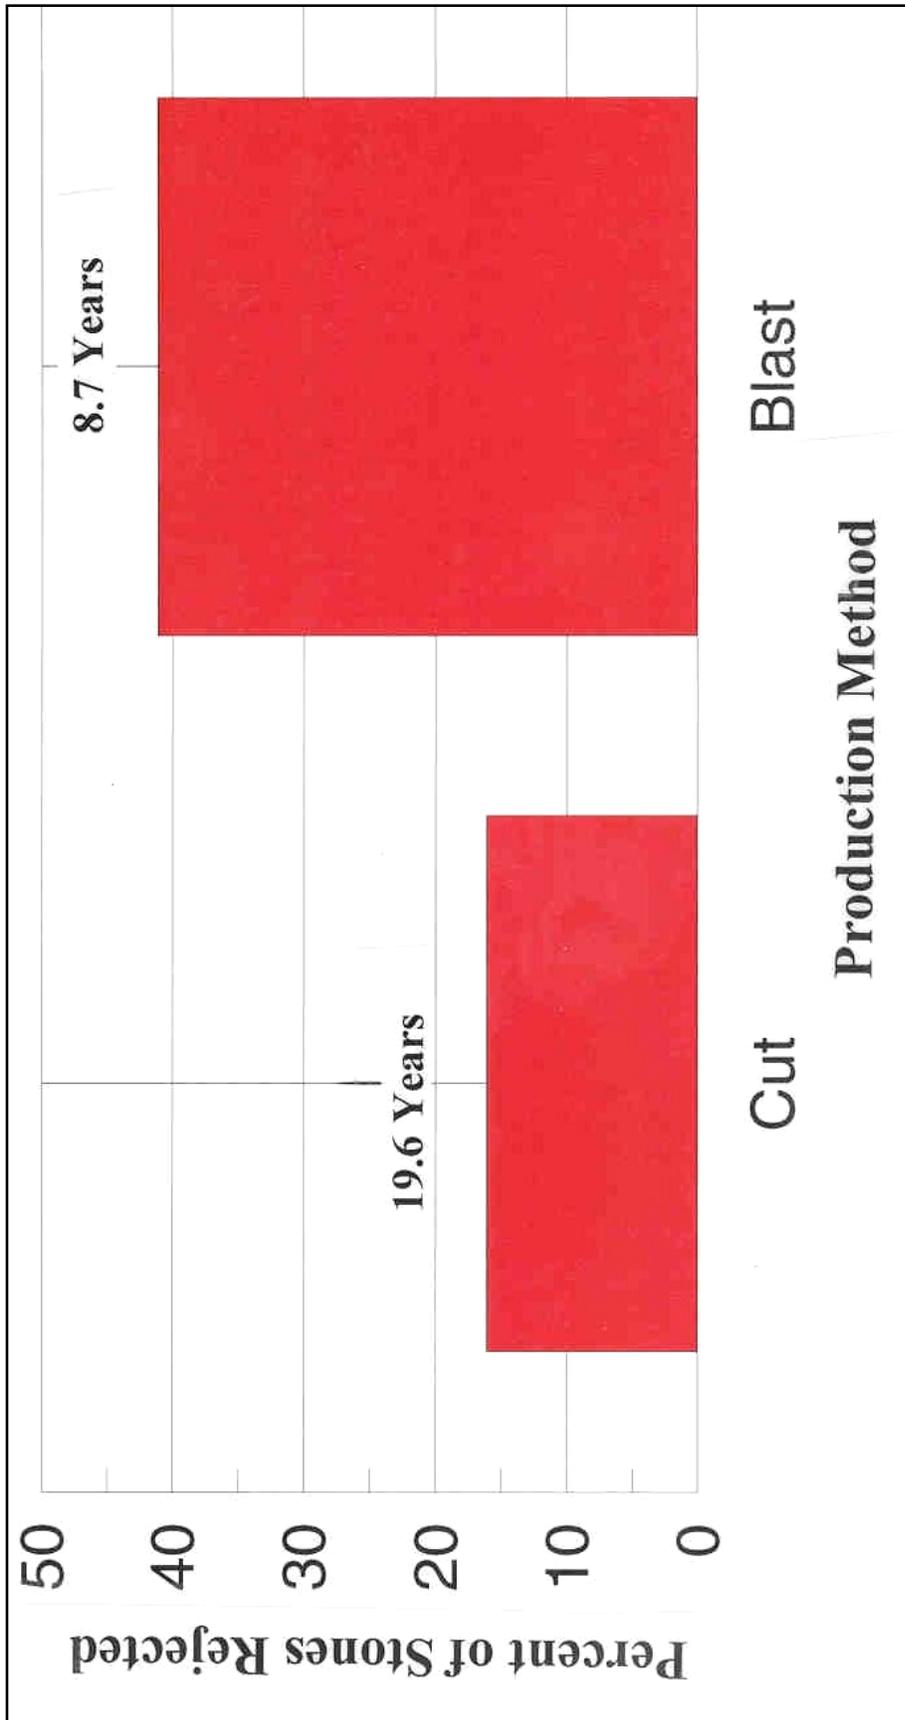
Figure 156. Cut versus blasted comparison of rejected sedimentary stones (limestone, sandstone, dolomite, and dolomitic limestone) on monitored structure sections, and weighted average number of years since placement of stone on structure

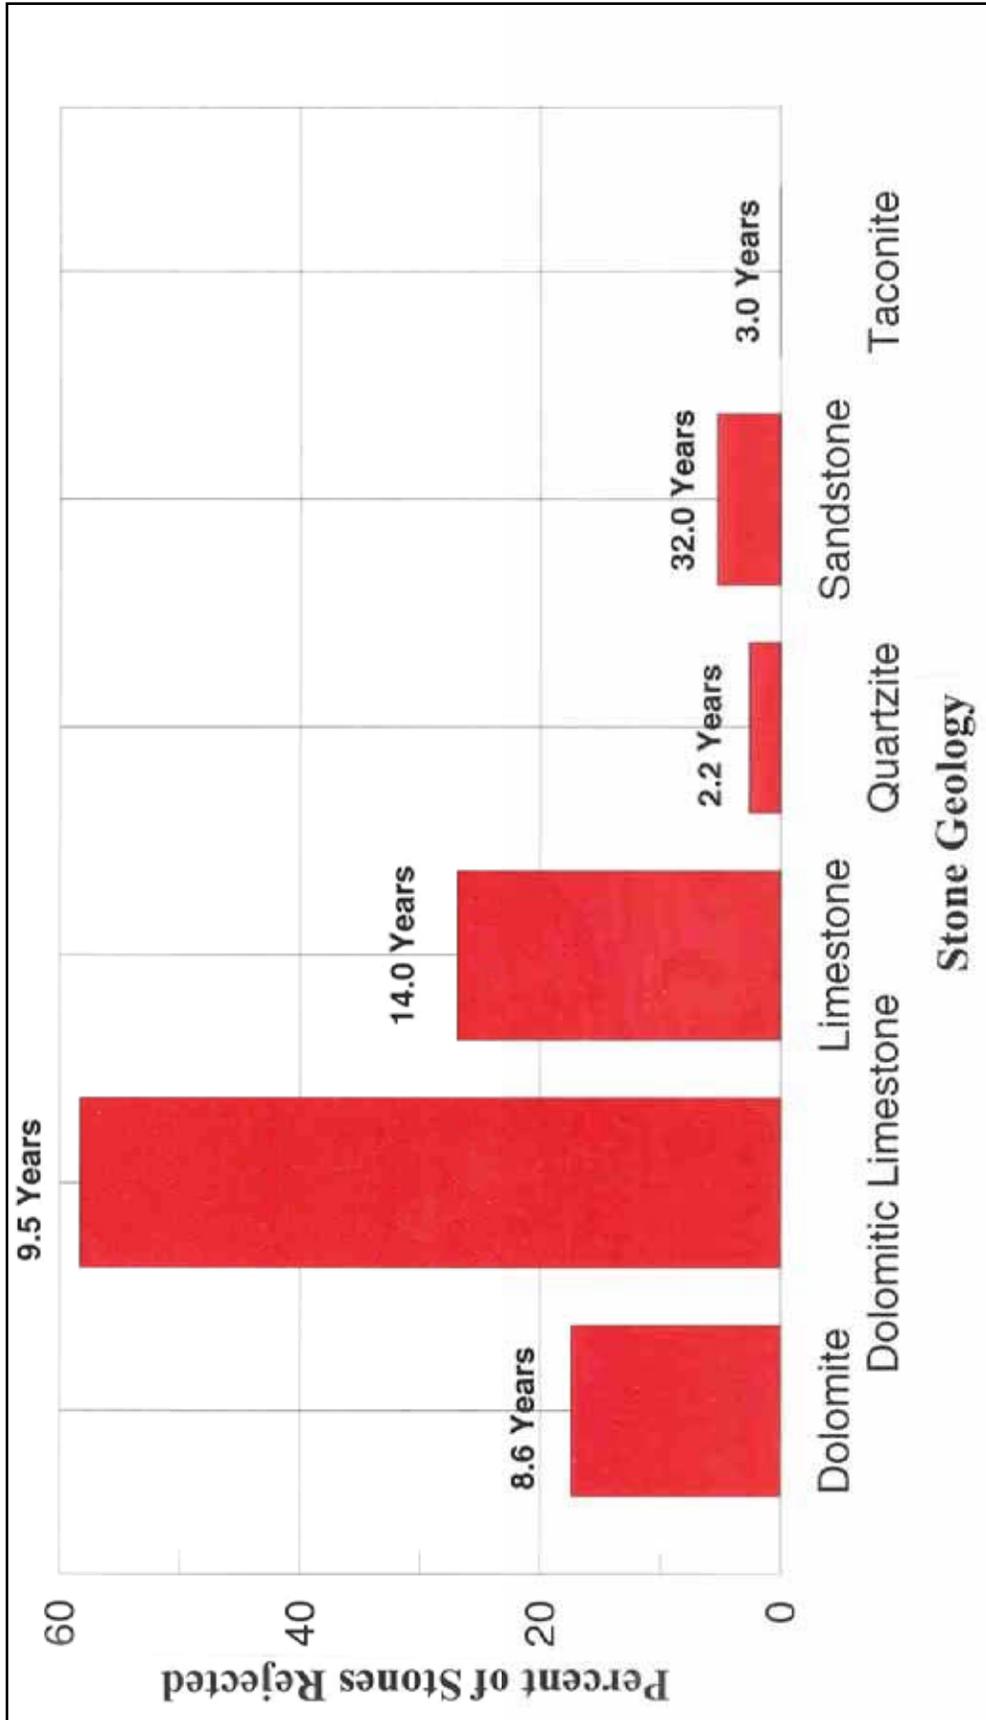
Figure 157. Percentage of stones rejected on monitored structure sections versus six stone geologies evaluated, and weighted average number of years since placement of stone on structure

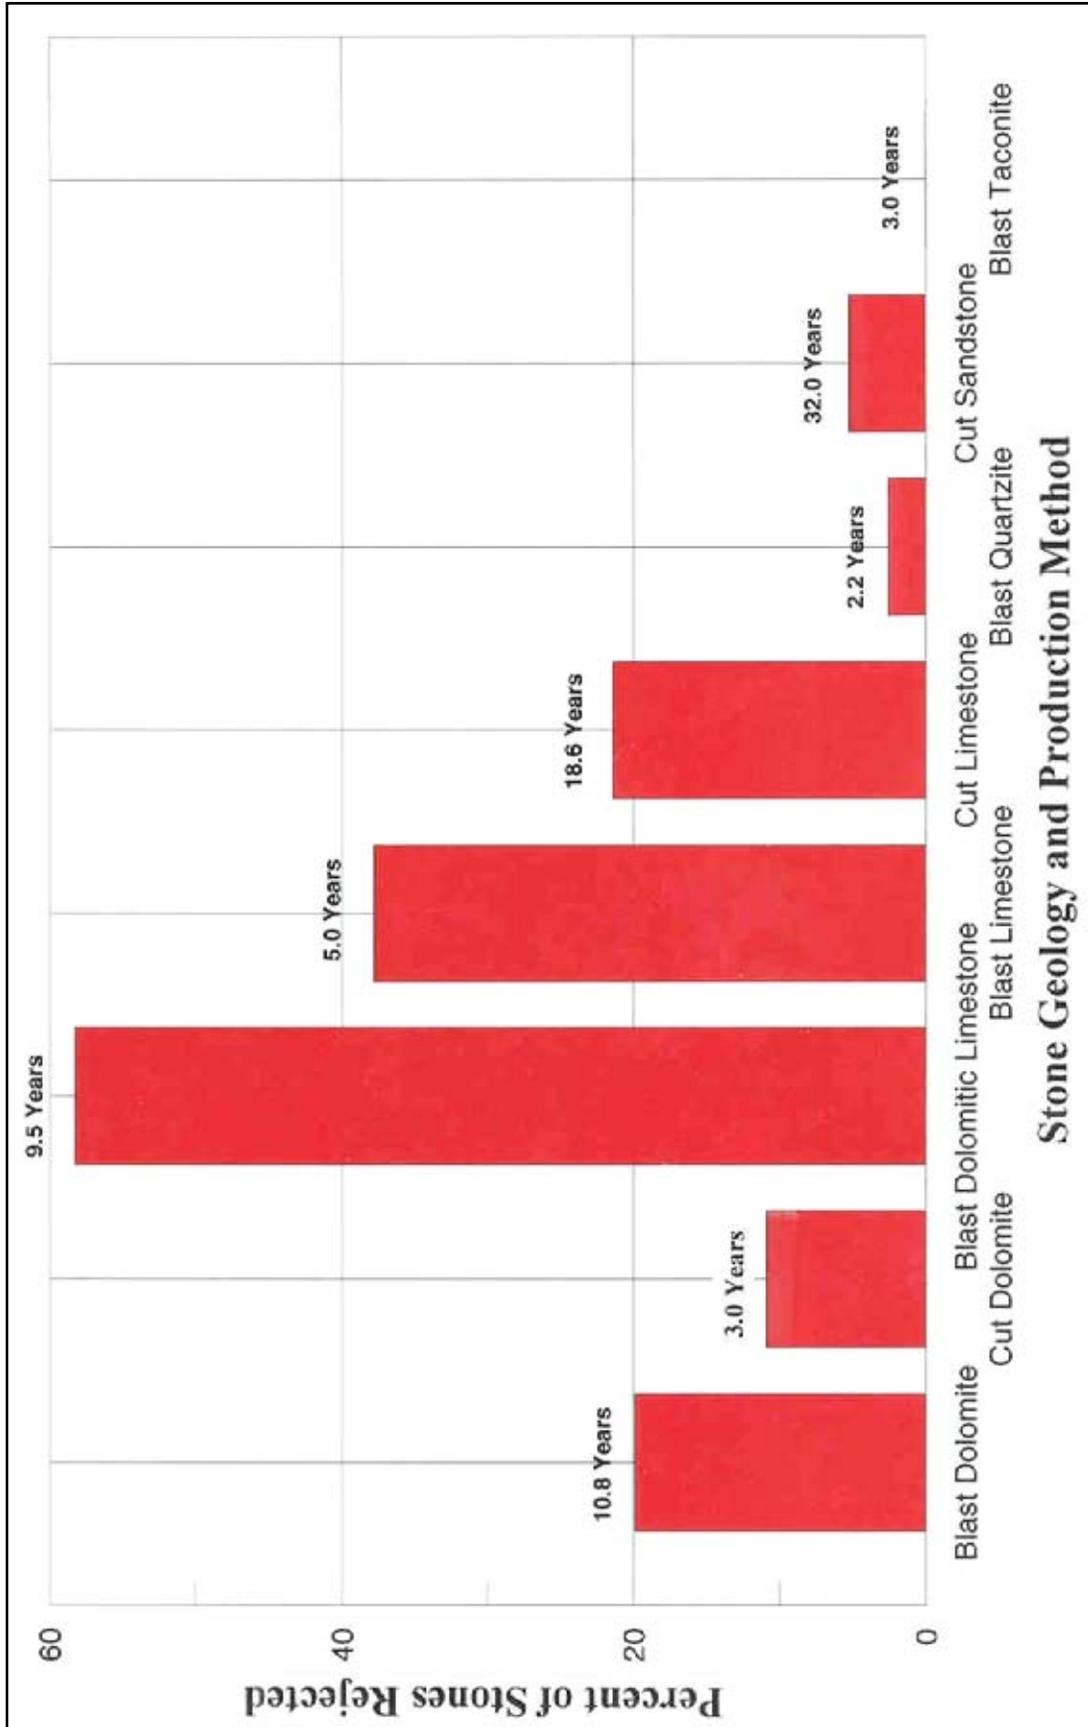
Figure 160. Percentage of stones rejected on the monitored structure sections versus stone geologies and production methods (cut and blasted methods of extraction), and weighted average number of years since placement of stone on structure

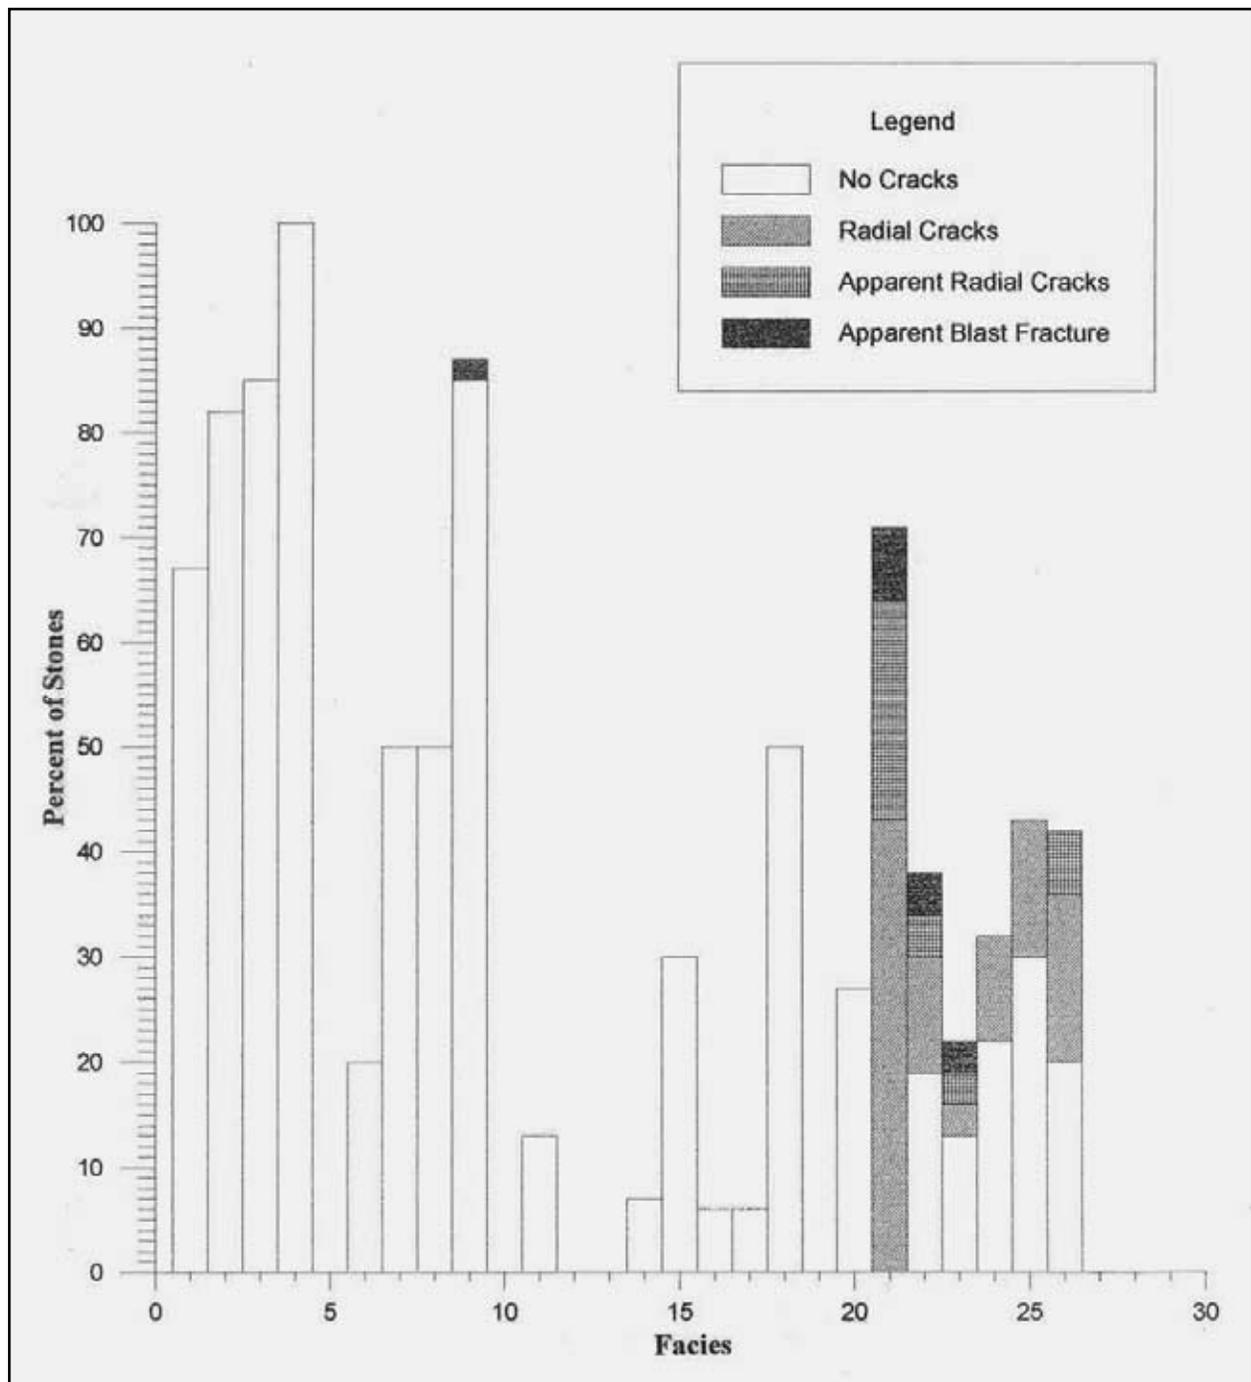
Figure 161. Crack association with quarry facies, 10 years or younger stones, for crack types 0 through 3

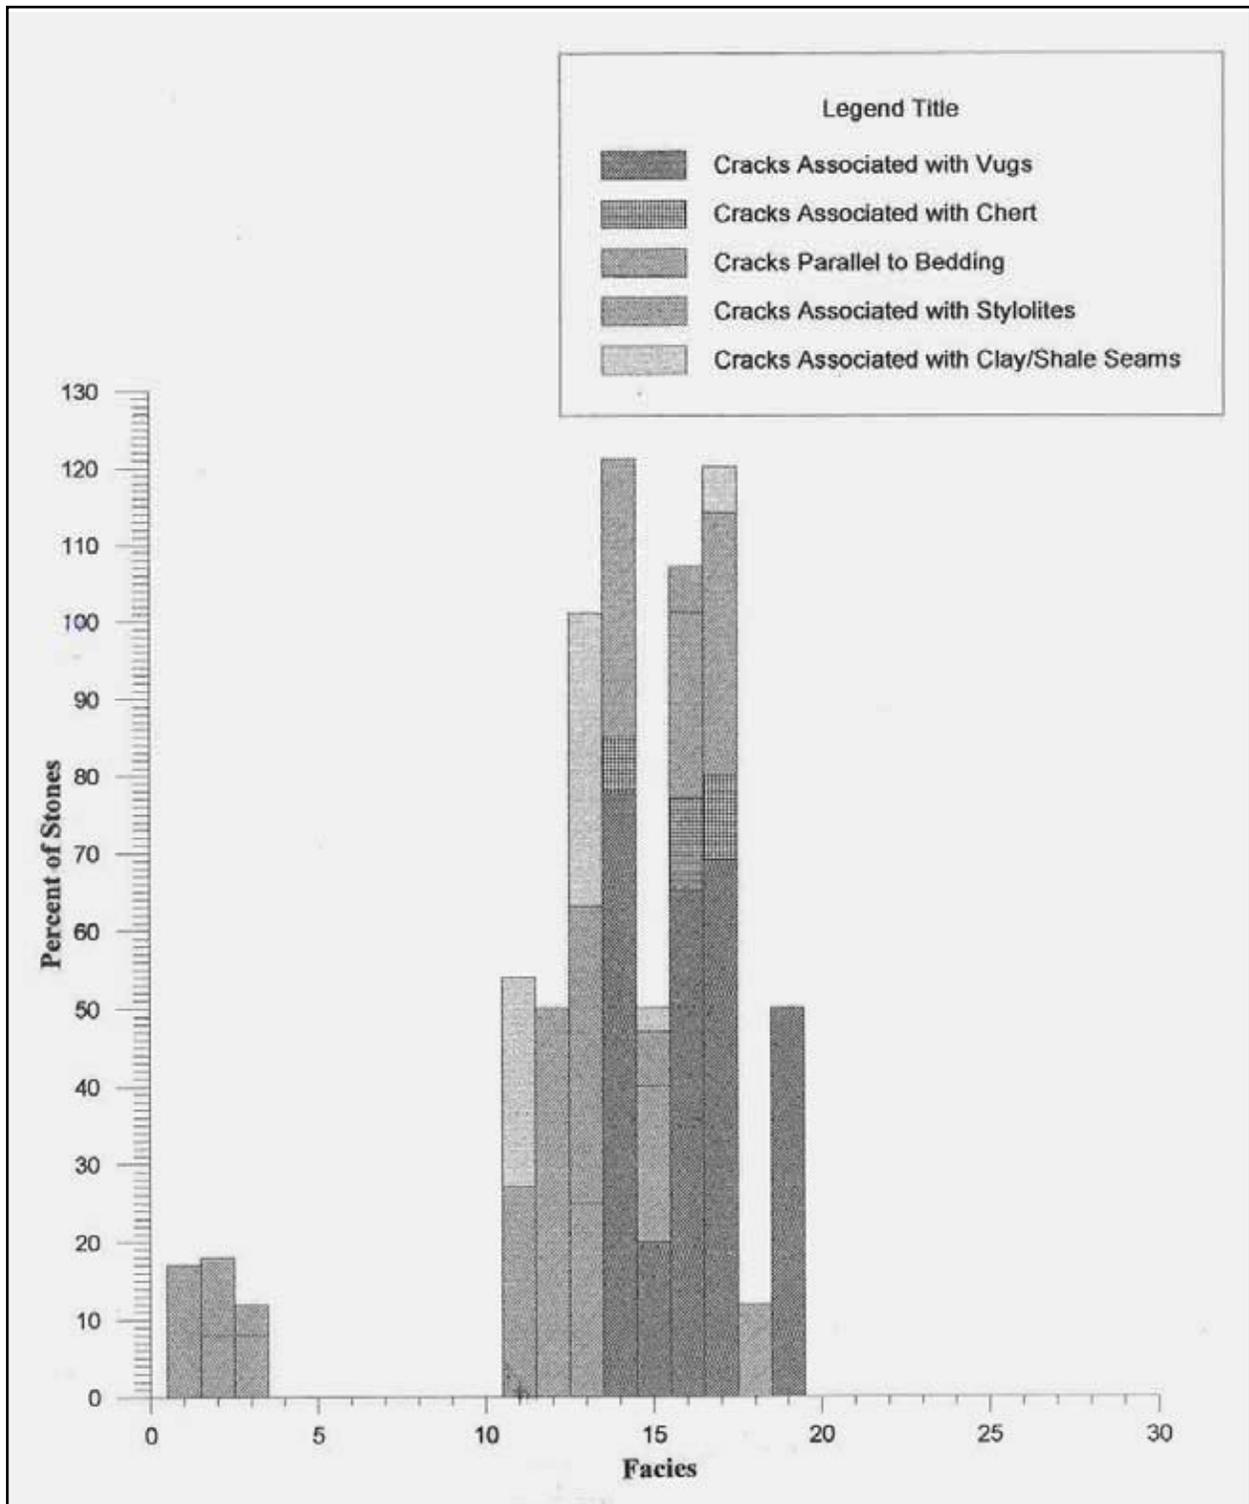
Figure 162. Crack association with quarry facies, 10 years or younger stones, for crack types 5 through 9

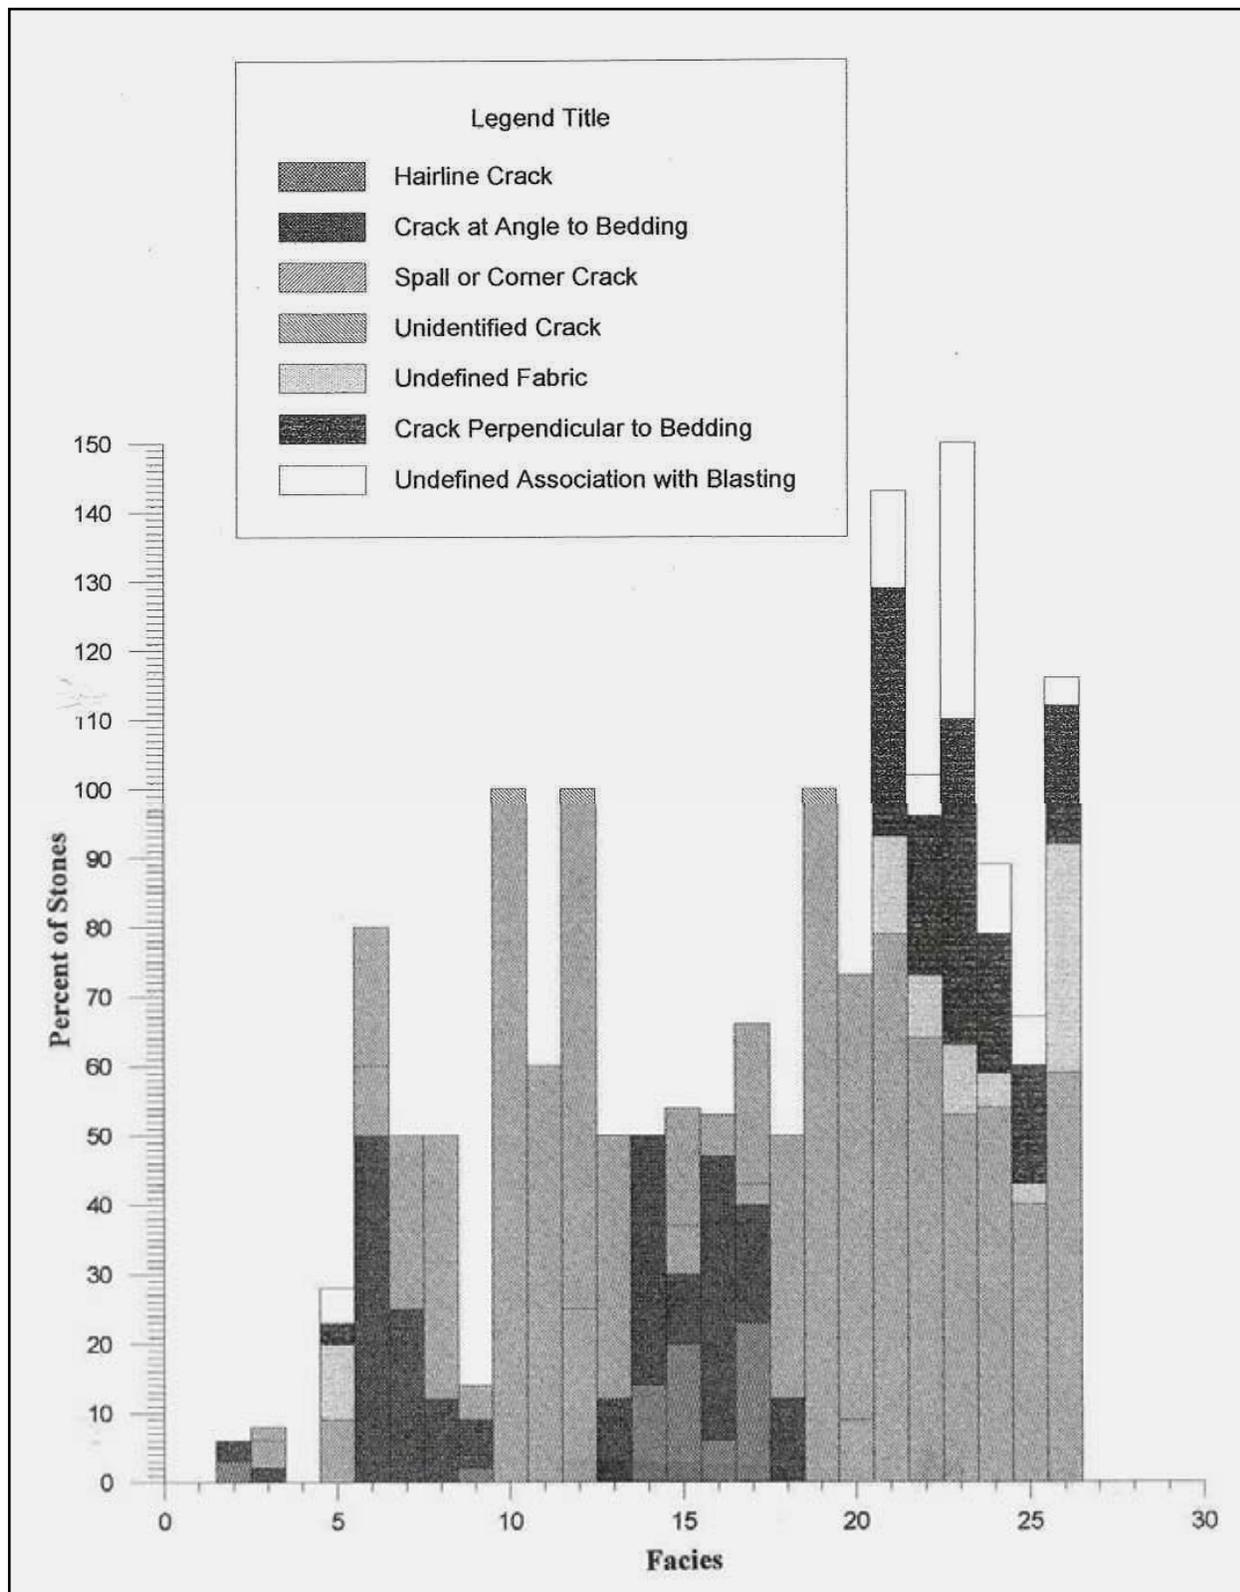
Figure 163. Crack association with quarry facies, 10 years or younger stones, for crack types 11 through 17

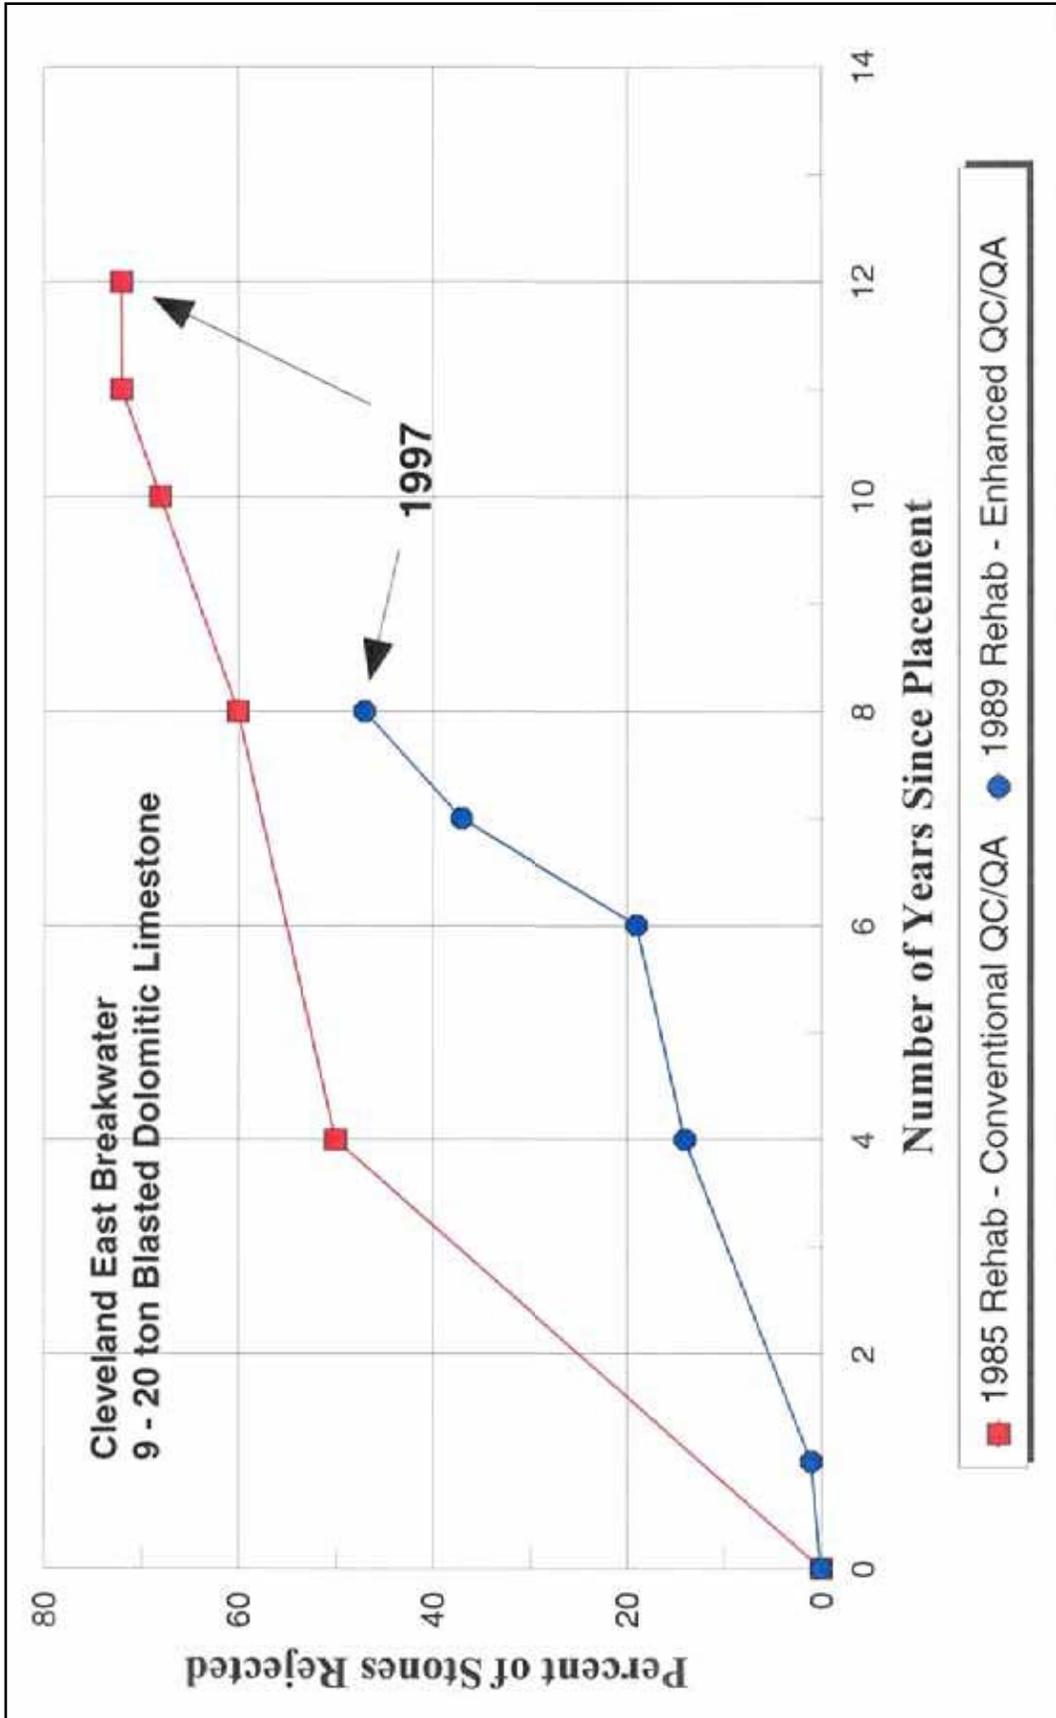
Figure 164. Conventional rehabilitation 1985 QC/QA versus enhanced rehabilitation 1989 QC/QA

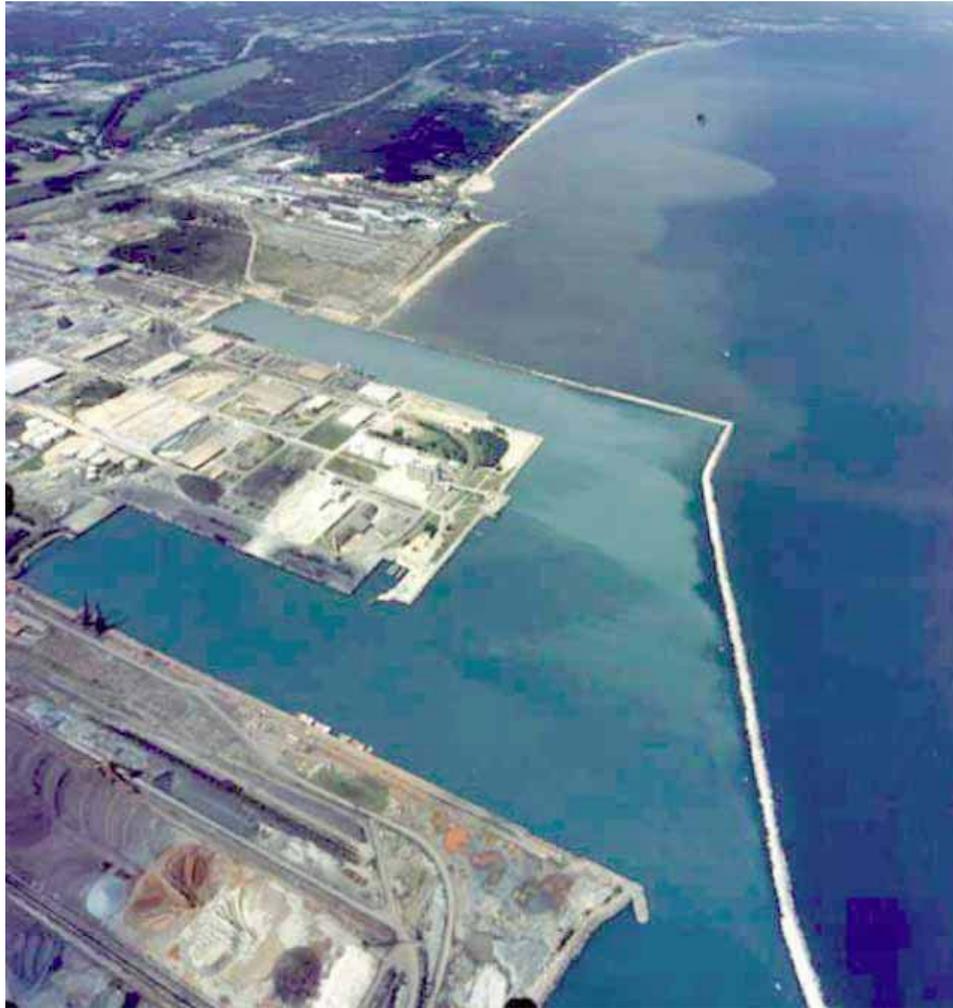
Figure A1. Burns Harbor, IN, breakwater looking west

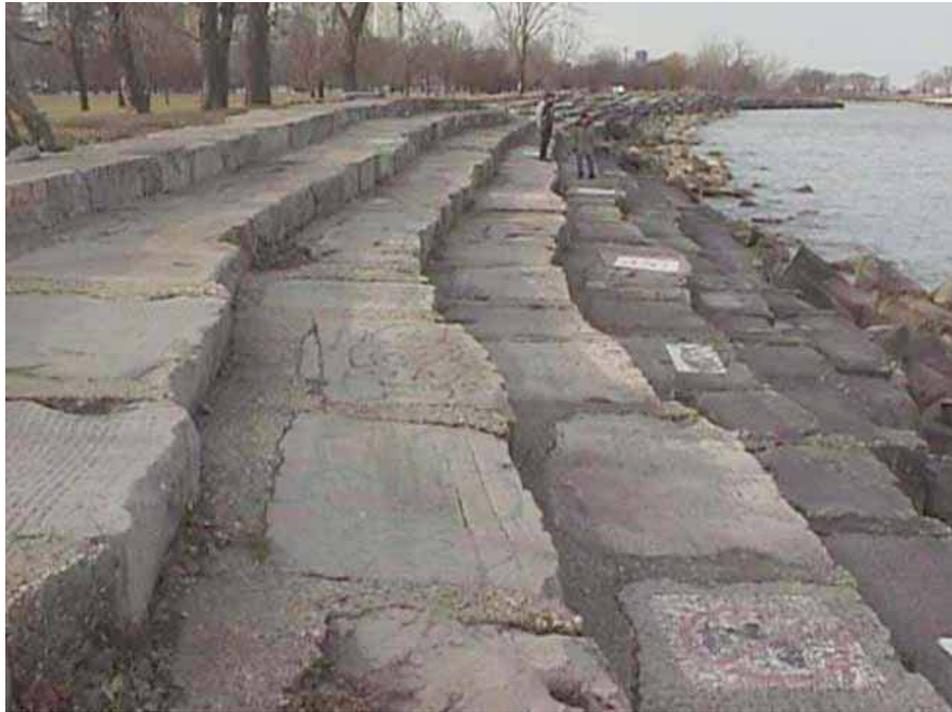
Figure A2. Limestone blocks in place along Chicago shoreline – Belmont to Diversey

stone quality and stone type determine the structure's resistance to weathering and mechanical deterioration from ice and wave action. The preferential selection of rock type can contribute to the longevity of structures by providing materials that will resist the elements for the duration of the project design life.

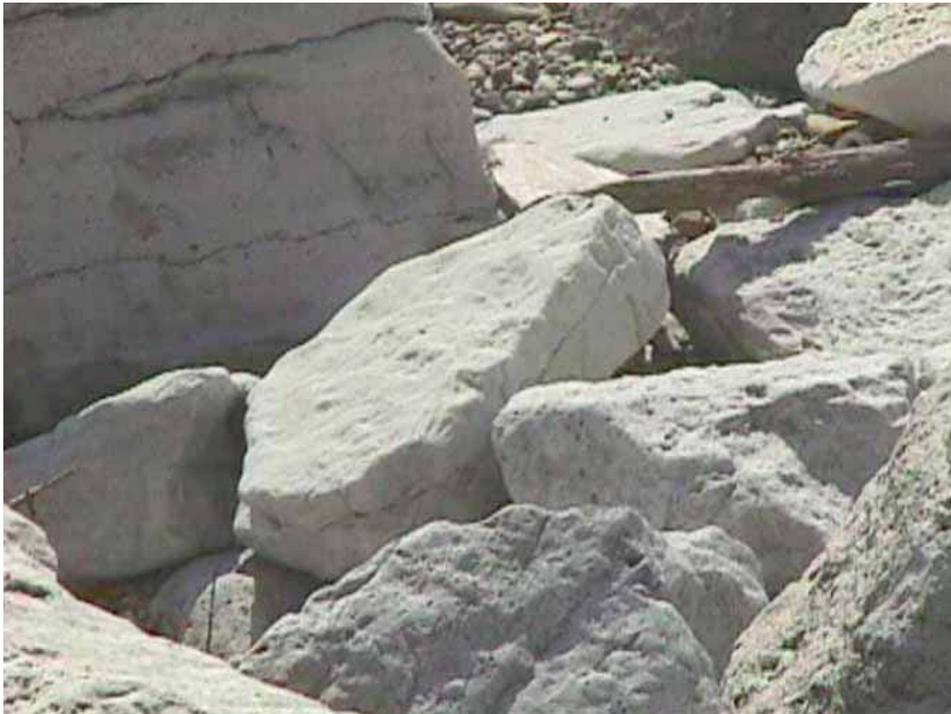
Figure A3. Dolomite armorstones showing stylolites in various degrees of separation
