ERDC/CHL TR-05-1

Monitoring Completed Navigation Projects Program

Monitoring Stone Degradation on Coastal Structures in the Great Lakes – Summary Report

June 2005

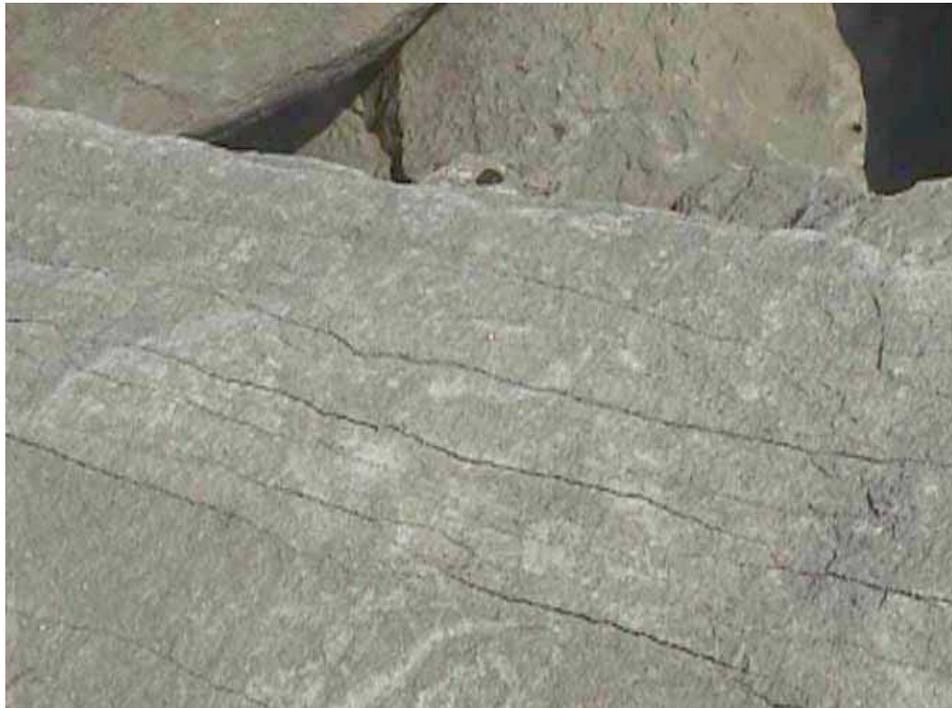
Figure A4. Bedding planes in limestone armor stone on Chicago shoreline showing separation

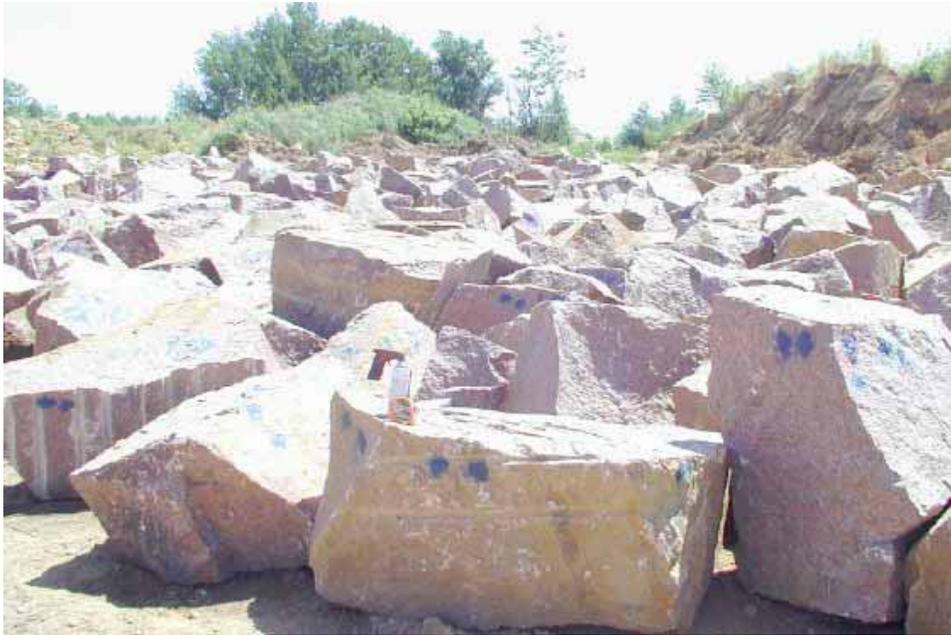
Figure A5. Granite armor stone during sorting process – note absence of discontinuities

Aside from inherent orthogonal jointing patterns that are obvious to the quarry operator and inspectors because they are clearly visible, these rocks are more prone to random fractures resulting from blasting. Fractures in sedimentary rocks (including limestone and dolomite) that exploit and follow preexisting planes of weakness are likely to extend farther, compared to those in isotropic rocks – just as it is easier to split wood with the grain than it is to split composition materials without grain.

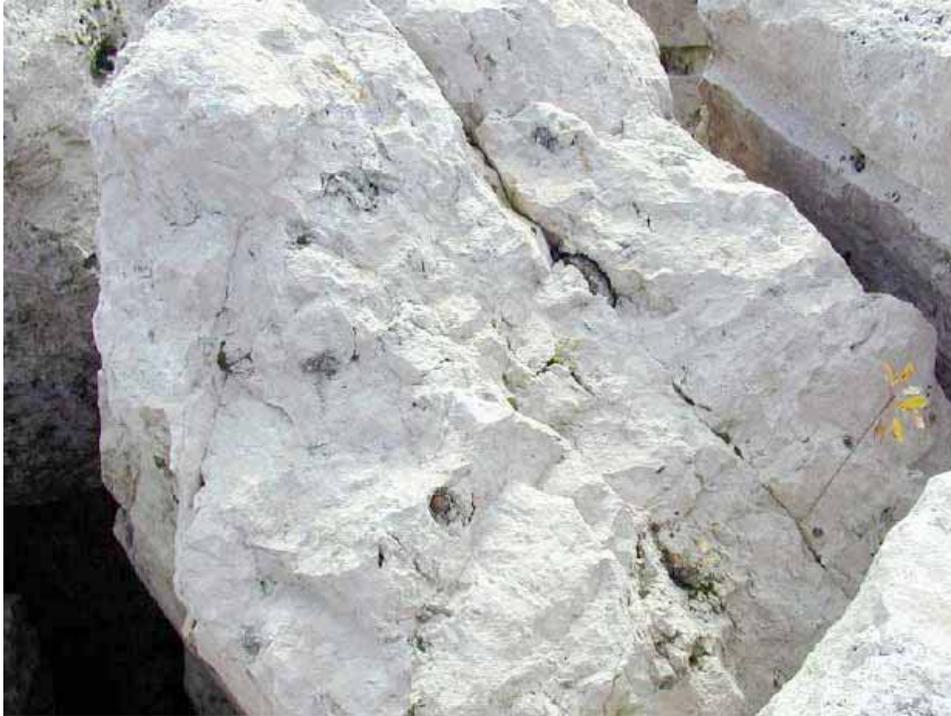
Figure A6. Even with QA/QC practices, this armor stone and others like it appear in Reach 5 breakwater. Note separations occurring at planar weaknesses
