AFRL-ML-WP-TR-2005-4120

**LIFE PREDICTION
METHODOLOGIES FOR AEROSPACE
MATERIALS**

**University of Dayton Research Institute
Structural Integrity Division
300 College Park
Dayton, OH 45469-0128**

Final Report for 25 May 1998 – 24 May 2004

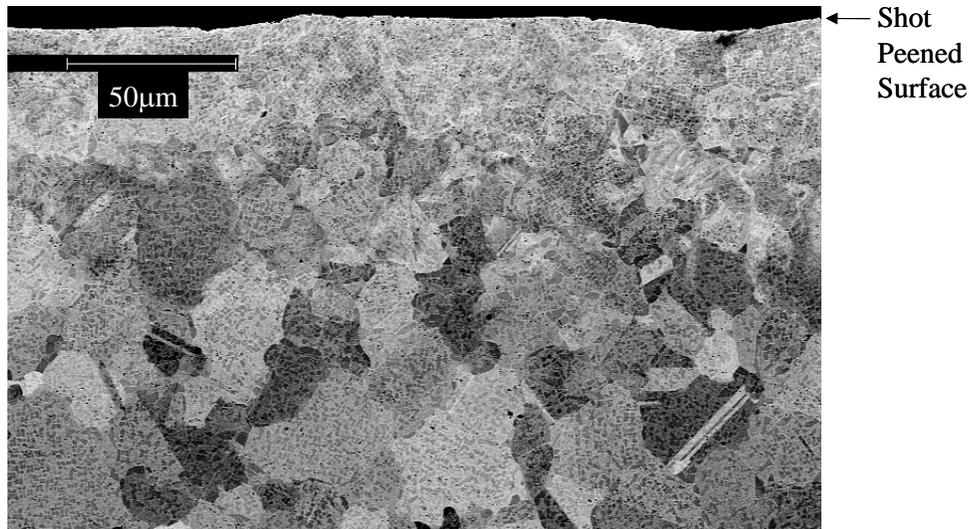
FIG. 1— *Cross section of IN100 as shot peened microstructure (no thermal exposure).*

Four baseline residual stress depth profiles with no thermal exposure were measured. Three of the depth profiles, one from each plate (A2, B2, C1), were measured by Lambda Research Inc. and a fourth was measured elsewhere. Each profile was interpolated to a common set of nominal depths. The average residual stress and range of measurements are shown in Fig. 6. Overall the peak compressive stresses and the overall response for all four samples were similar. The peak compressive residual stress always occurred within 50 microns of the surface, consistent with the changes in the microstructure as shown in Fig. 1.

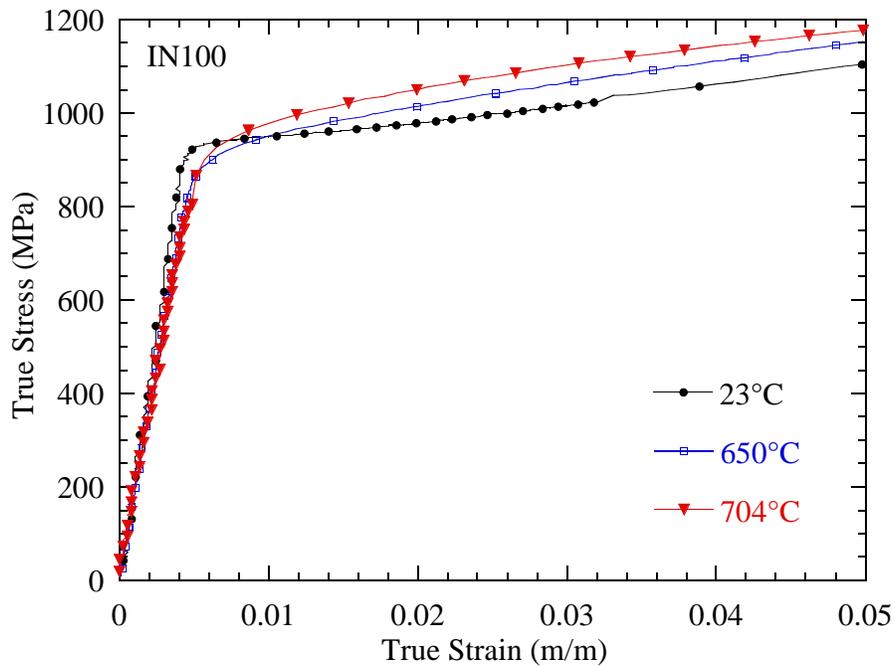
FIG. 2— Monotonic true stress-true strain curves for IN100 at temperatures 23°C, 650°C, and 704°C.

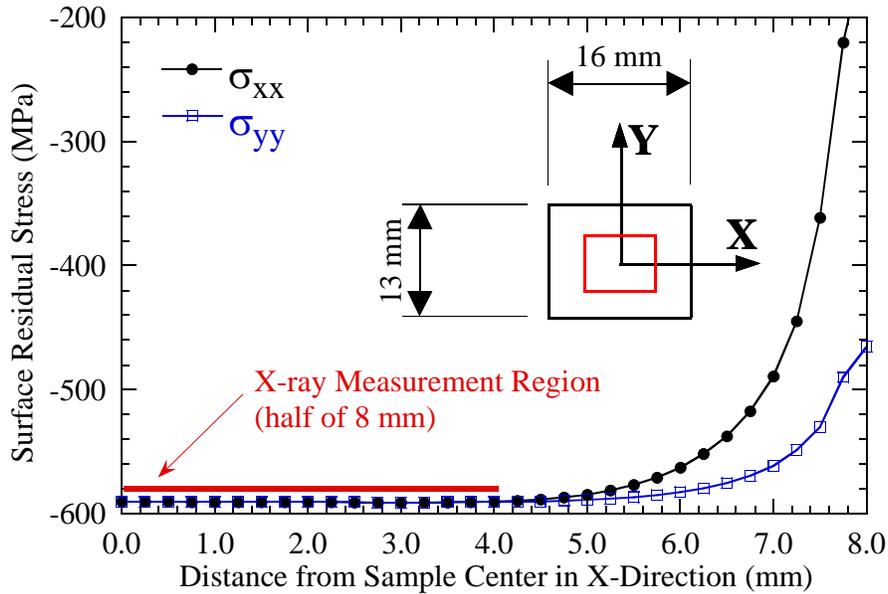
FIG. 3— Profile of FE simulated surface residual stresses (σ_{xx} and σ_{yy}) from the center of sample to edge of sample in x-coordinate direction.

the center of the specimen to the edge of the specimen in the y-direction. This line is perpendicular to the line described in Fig. 3. The thick solid line represents half the width (2.5 mm) of the irradiated region in the y-direction. Both stresses decrease in magnitude as they approach the edge of the sample. The stresses in the y-direction change rapidly as it approaches the free surface where it becomes zero.

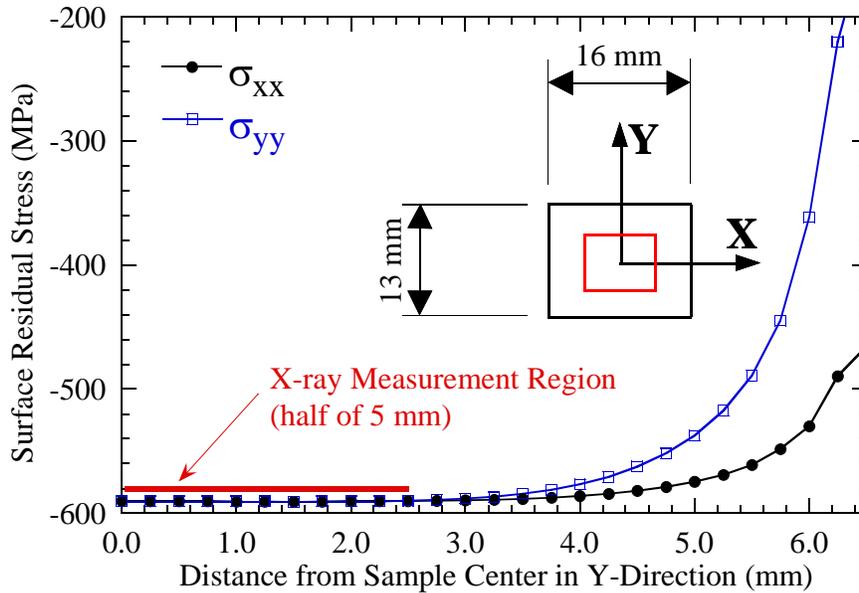
FIG. 4— Profile of FE simulated surface residual stresses (σ_{xx} and σ_{yy}) from the center of sample to edge of sample in y-coordinate direction.

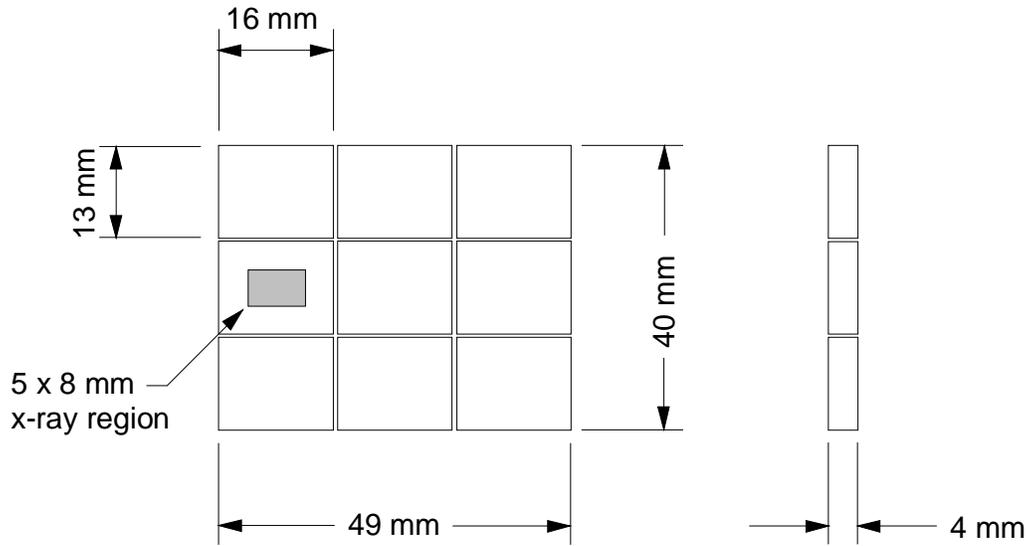
FIG. 5— Schematic of cutout plan for shot peened plates of IN100 for thermal exposure and x-ray analysis.

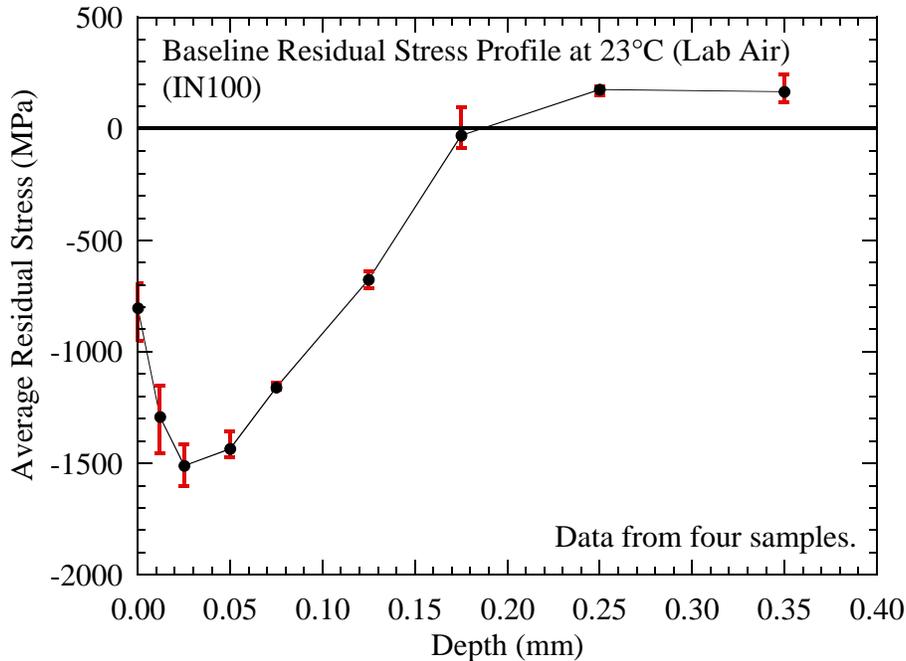
FIG. 6— *Repeatability of baseline residual stress distribution in IN100 at 23°C.*

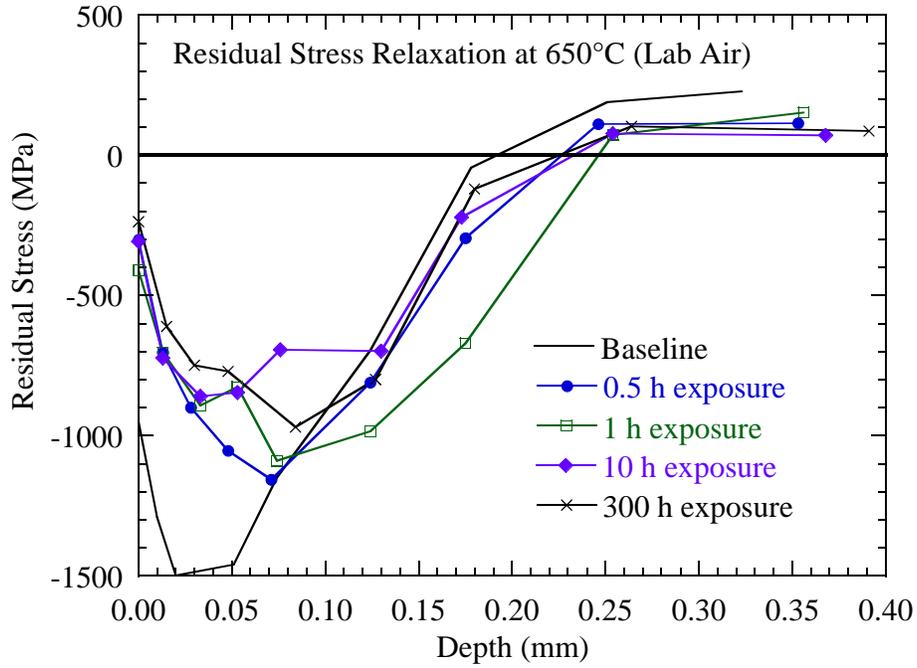
FIG. 7— Residual stress distribution in IN100 versus exposure time at 650°C.

Figures 7 and 8 show the residual stress and cold work depth profiles, respectively for IN100 thermally exposed at 650°C for up to 300 hours. These results were collected on five samples, all taken from plate (C1). A compressive surface residual stress of 250-400 MPa remained at the surface for all exposures. Stress relaxation was greatest at the free surface. The stress relaxation was less for the peak compressive stress. However, after 300 hours of exposure to 650°C residual stress retention is approximately 65%. There was also a shift of the peak compressive stress from 25 μm to approximately 75 μm . Below the free surface the residual stress profile did not follow the expected relaxation with increased exposure time. In particular at a depth of 50 to 130 μm the 300-hour exposure had a more compressive residual stress than the 10-hour exposure. In contrast, there was a clear trend of decreasing cold work with increasing exposure time as shown in Fig. 8. The cold work profiles show a large change at the surface and to a depth of approximately 175 microns with increased exposure. This depth was coincident with where the stresses are below the monotonic yield strength of the material.

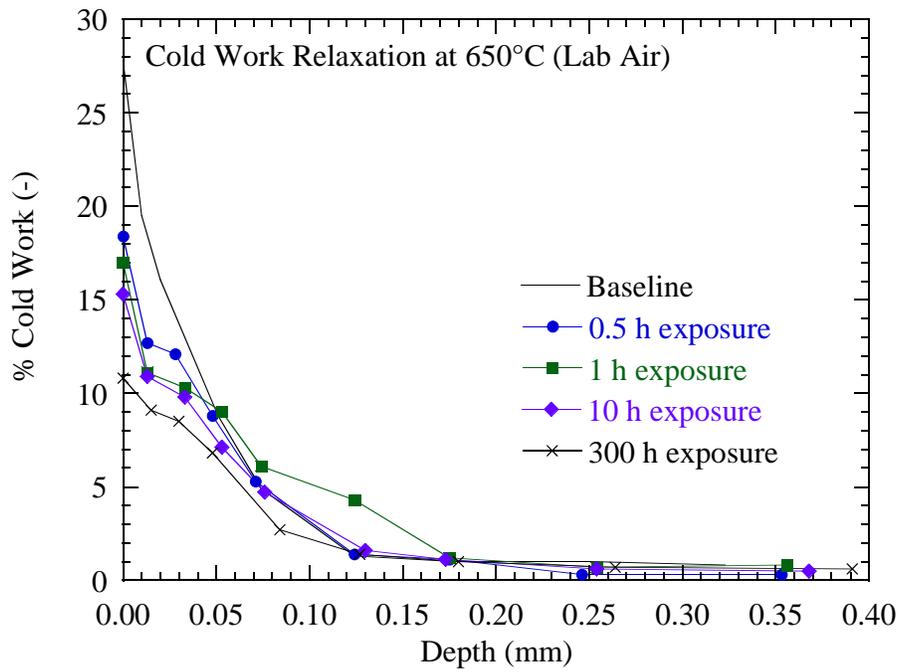
FIG. 8— Cold work distribution in IN100 versus exposure time at 650°C.

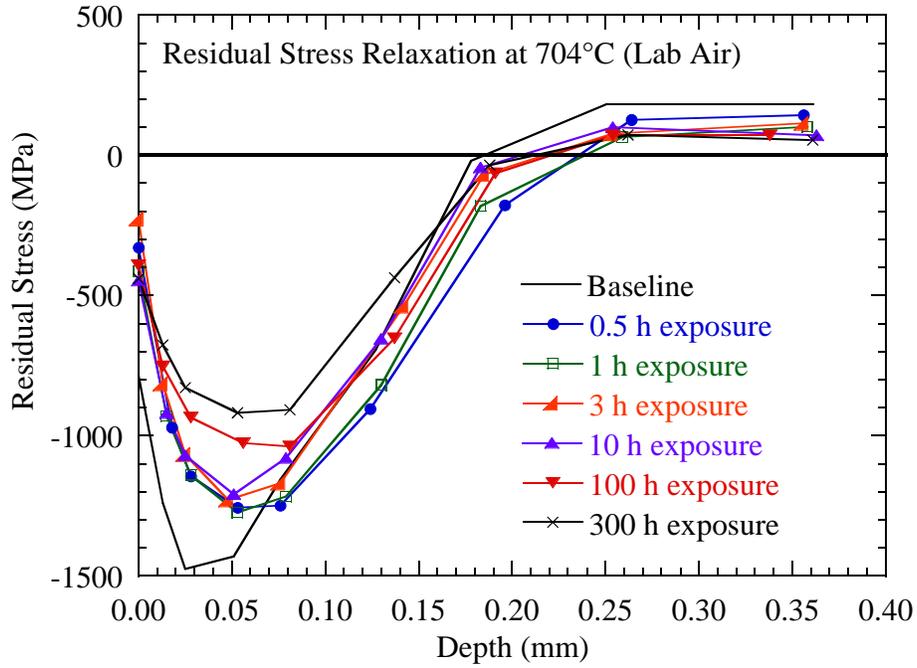
FIG. 9— Residual stress distribution in IN100 versus exposure time at 704°C.

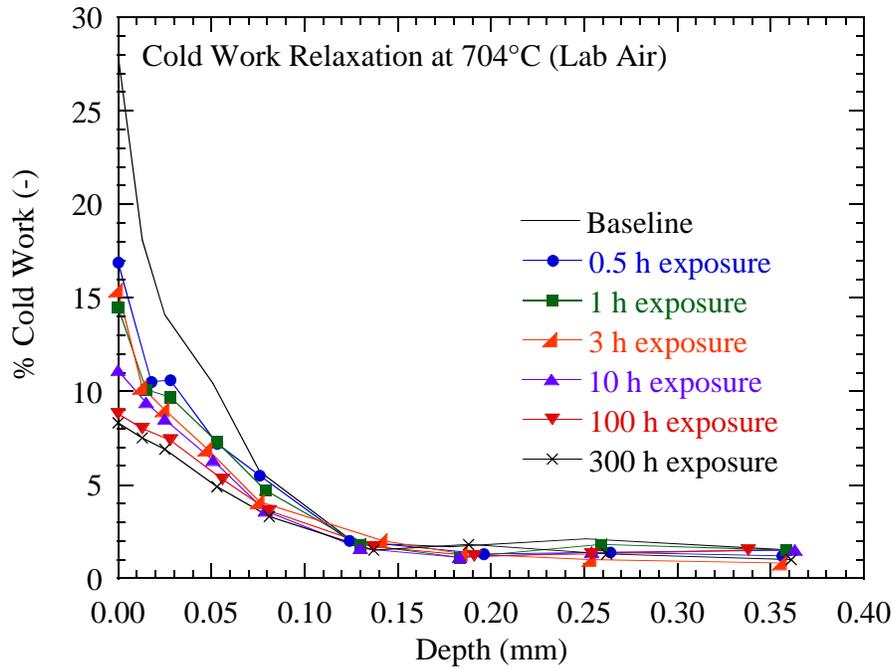
FIG. 10— Cold work distribution in IN100 versus exposure time at 704°C.

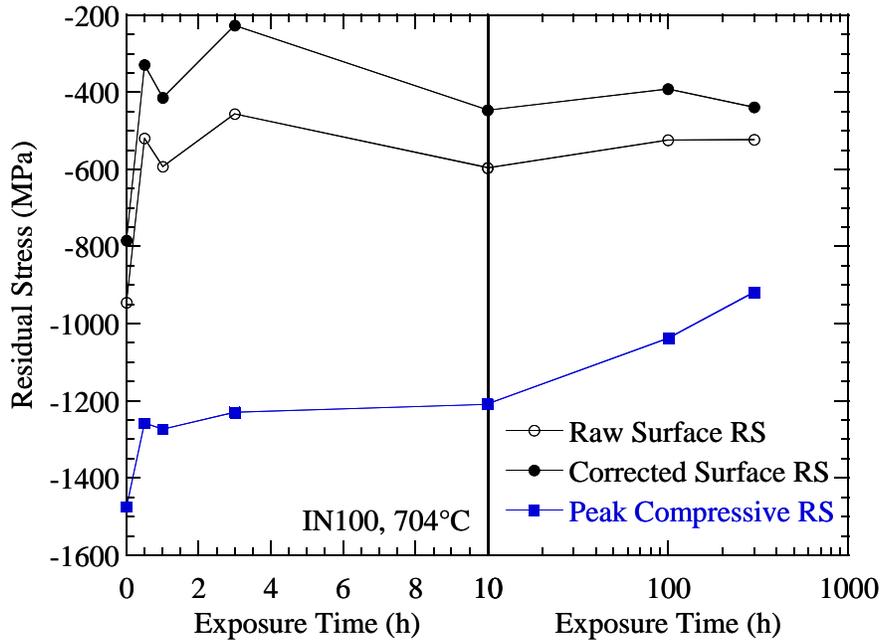
FIG. 11— *Surface and peak residual stress with increasing exposure time at temperature 704°C in IN100.*

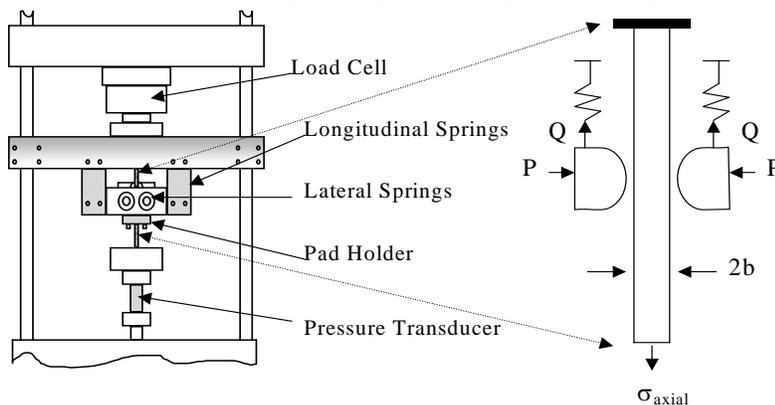
The AFIT fretting fatigue fixture uses a cylinder-on-flat contact configuration. The pads are applied to either side of a dogbone specimen, using a fretting fixture attached to a servo-hydraulic machine (see Fig. 1). In this arrangement, an axial stress, σ_{axial} , and a shear force, Q , may be applied to the specimen while keeping the contact force, P , constant. Applied axial and tangential loads are measured using a load cell in the top grip and a pressure transducer in the bottom grip. The contact force is applied through lateral springs and measured by pressure gauges on both sides of the specimen. A careful pad alignment is performed prior to each test to ensure uniform contact.

Fig. 1. AFIT fretting fatigue apparatus.

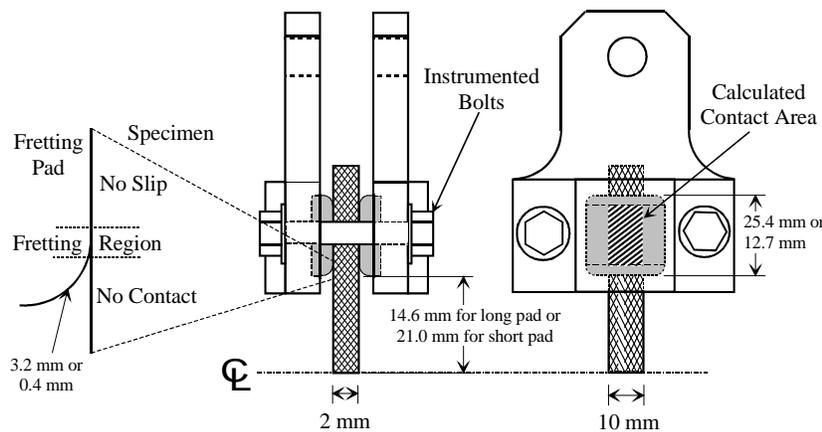
The AFRL fretting fatigue fixture uses a flat-on-flat contact configuration with blending radii at the edges of contact. Normal and shear loads are applied to the specimen using instrumented bolts, as shown in Fig. 2. Axial loads are applied to the specimen using an electromagnetic shaker system. The test geometry differs from conventional fretting fatigue tests [1,2] in two fundamental ways. First, the axial stress is transferred entirely to the fixture through shear, thus restricting the maximum nominal shear stress to that which can be reached for a given nominal clamping stress before total slip occurs. Resulting stresses in the specimen are zero on one end of the pad, so the shear force into the pad is determined from the load applied to the specimen. Second, symmetry of the apparatus provides a specimen which breaks on one end, leaving the other end with a fretting scar and damage obtained under nominally identical conditions. As with a conventional fretting fatigue apparatus, the clamping force is constant and only the axial and shear loads are oscillatory.

Fig. 2. AFRL fretting fatigue apparatus.

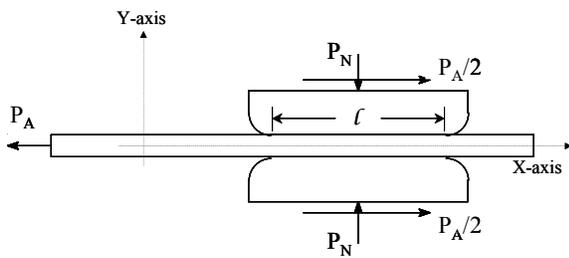
Fig. 3. AFRL finite element geometry.

Analyses of both experimental fixtures were conducted to determine the states of stress for each material combination of interest. In both the AFIT and AFRL models ABAQUS was used as the analysis package. Quasi-static linear elastic behavior under plane stress was assumed and the meshes in the regions of highest expected peak stresses were refined to $\sim 6 \mu\text{m}$. Details of the finite element methods are presented in [9,10] for the AFRL system and the AFIT system, respectively.

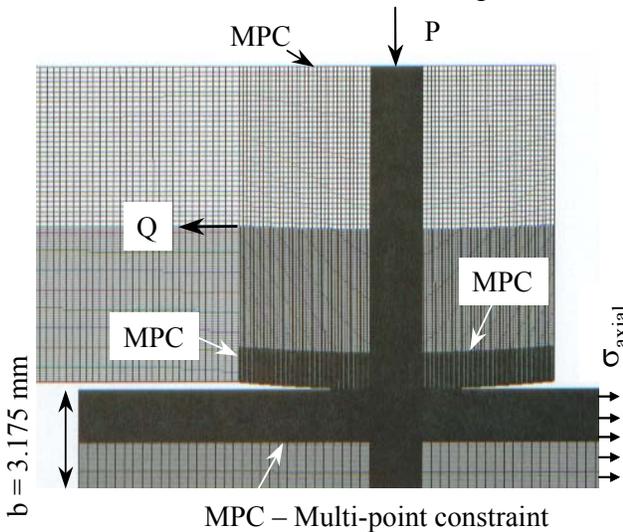
Fig. 4. AFIT finite element model geometry.

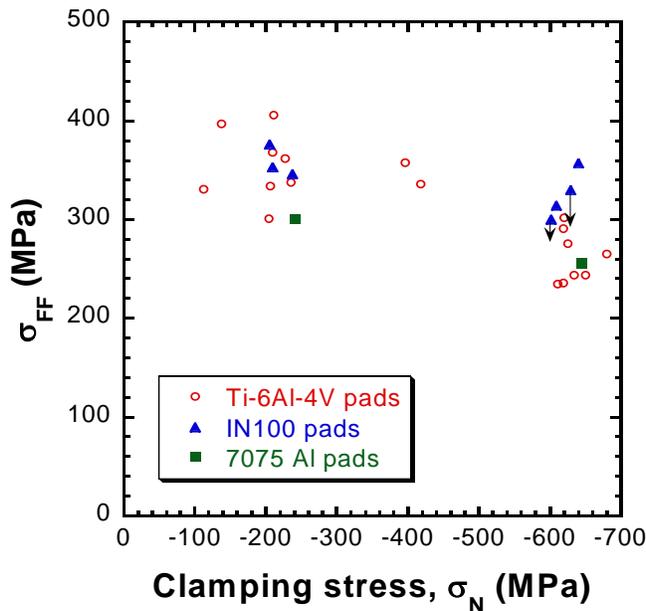
Fig. 5. AFRL results – fretting fatigue strength, σ_{FF} for a 10^7 cycle fatigue life versus applied clamping stress, σ_N .

Results from the AFRL test system are shown in Figs. 5 and 6. In Fig. 5 the results from the initial AFRL work are shown [12]. The fretting fatigue limit stresses (σ_{FF}) for a 10^7 cycle fatigue life are plotted as a function of average applied clamping stress. Only specimens tested against IN

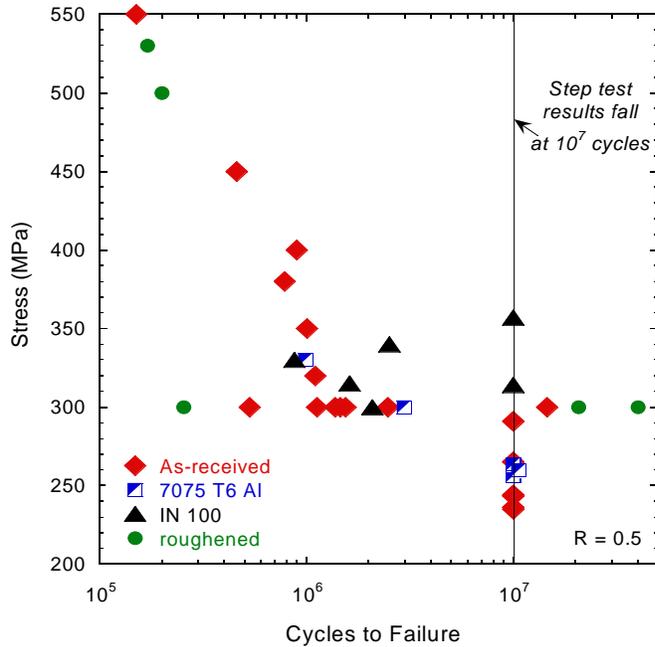
Fig. 6. AFRL results – maximum axial stress versus cycles to failure.

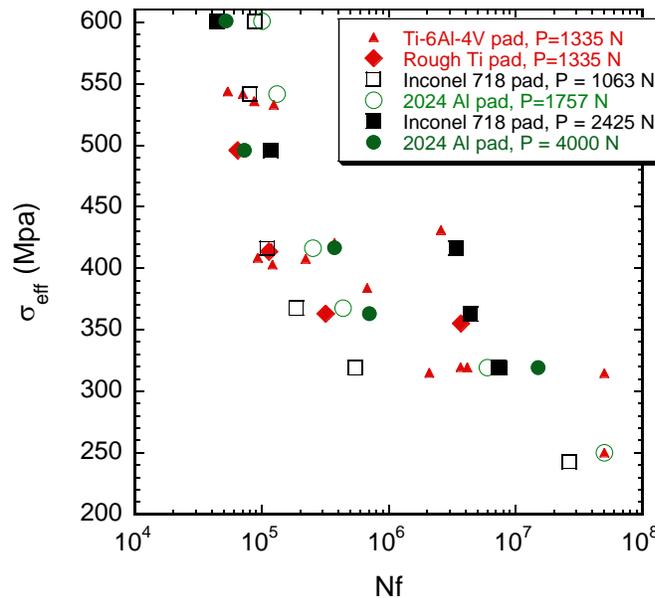
Fig. 7. AFIT results – effective stress versus fatigue life.

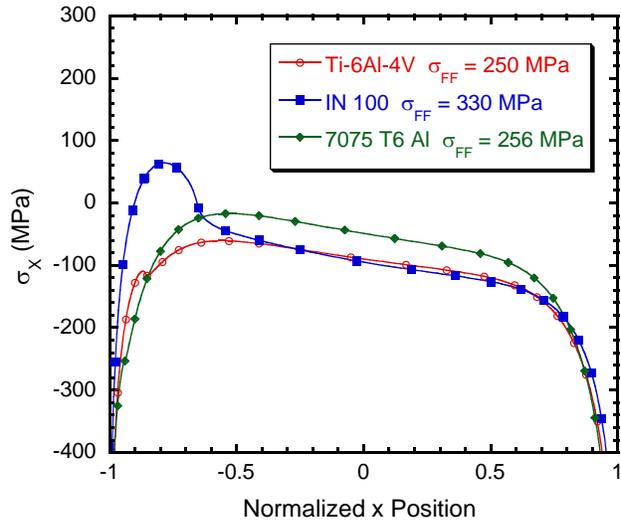
Fig. 8. AFRL – x-component stress distribution under contact pad.

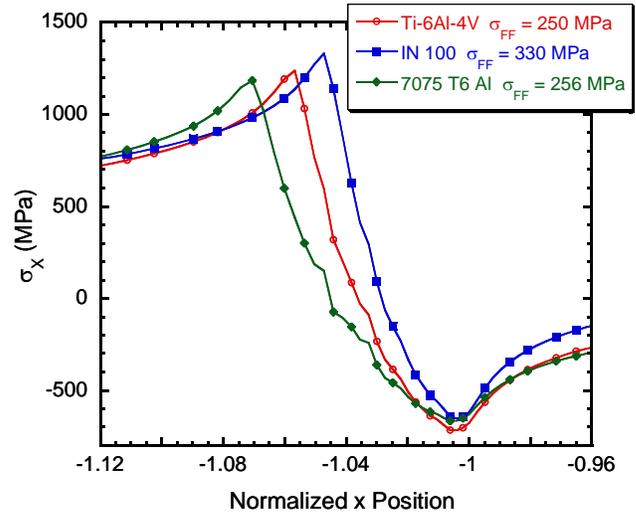
Fig. 9. AFRL – x-component stress concentrations at EOC.

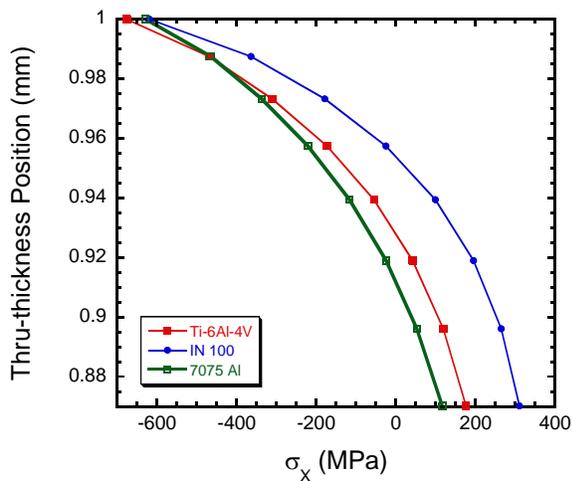
Fig. 10. AFRL – x-component stress distribution into specimen thickness. 1 corresponds to the specimen surface.

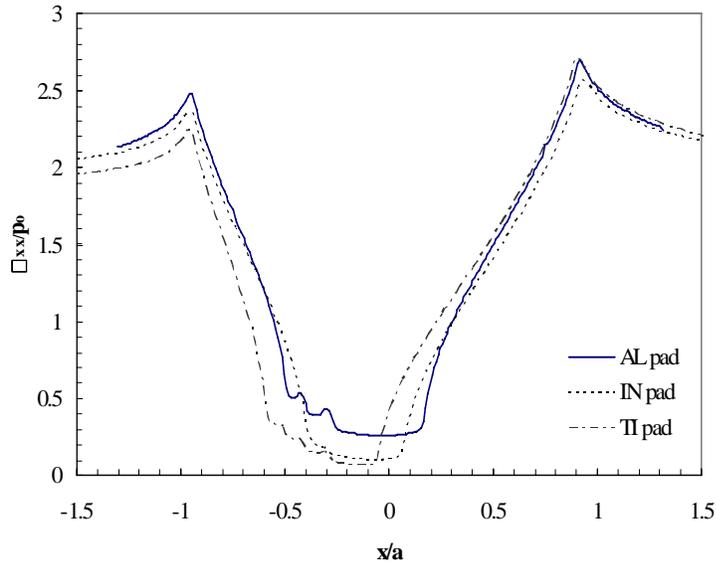
Fig. 11. AFIT – x-component stress distributions for the three pad materials.

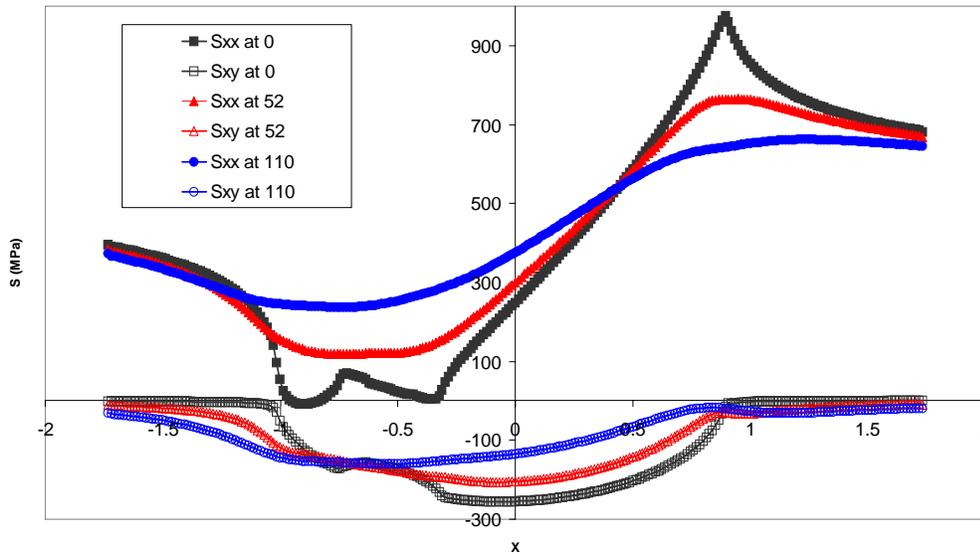
Fig. 12. AFIT – x-component and shear stresses for different locations within a specimen in contact with a Ti-6Al-4V pad. 0 coincides with the specimen surface, 52 indicates 52 μm below the specimen surface, and 110 indicates 110 μm below the specimen surface.

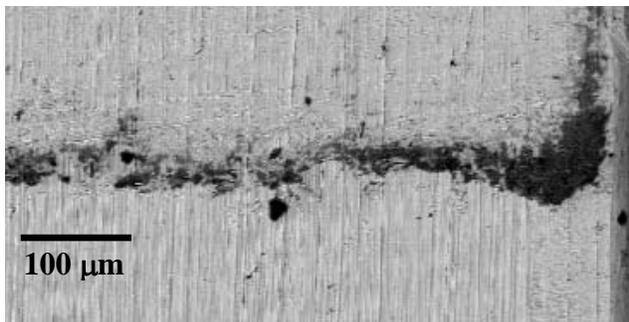
Fig. 13. Fretting scar from an AFRL specimen tested at 250 MPa axial stress (R=0.5) using Ti-6Al-4V pads.

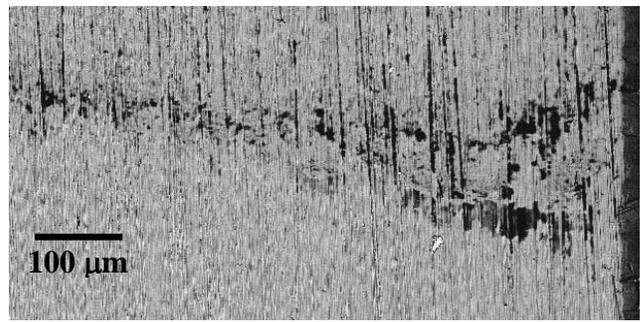
Fig. 14. Fretting scar from an AFRL specimen tested at 256 MPa axial stress (R=0.5) using 7075 Al pads.

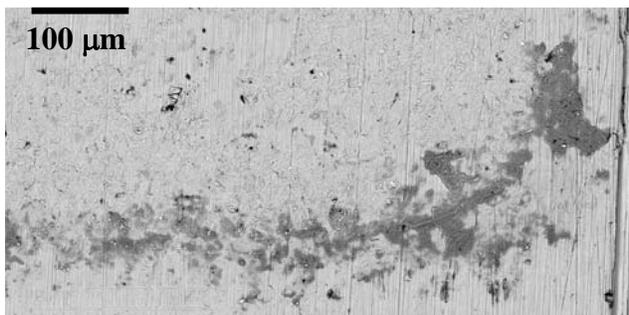
Fig. 15. Fretting scar from an AFRL specimen tested at 300 MPa axial stress (R=0.5) using IN 100 pads.

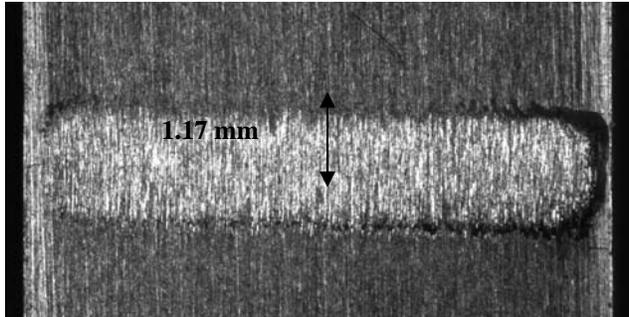
Fig. 16. AFIT specimen fretting scar – Inconel 718 pad, $\sigma_{eff} = 363$ MPa, $P = 2425$ N

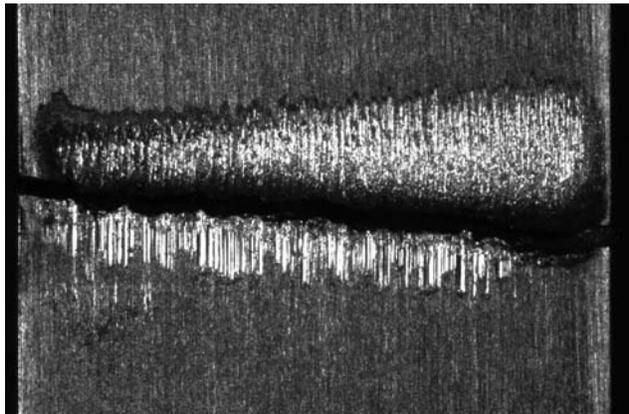
Fig. 18. AFIT specimen fretting scar – Inconel 718 pad, $\sigma_{eff} = 601$ MPa, $P = 2425$ N

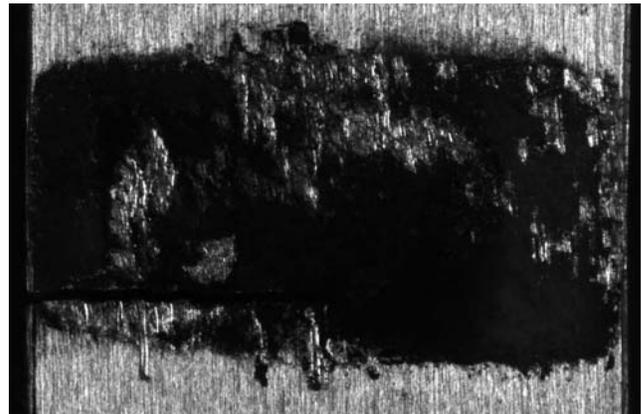
Fig. 19. AFIT specimen fretting scar – Inconel 718 pad, $\sigma_{eff} = 601$ MPa, $P = 1063$ N

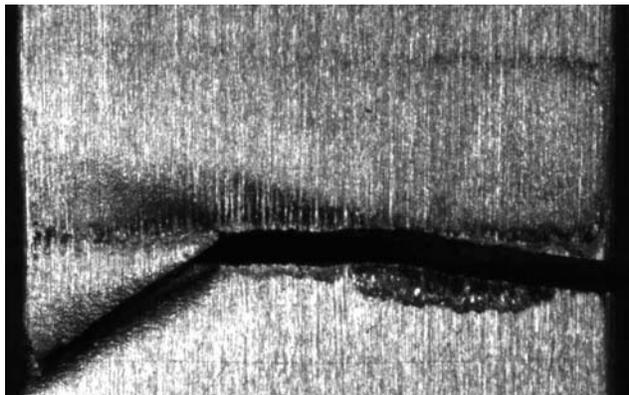
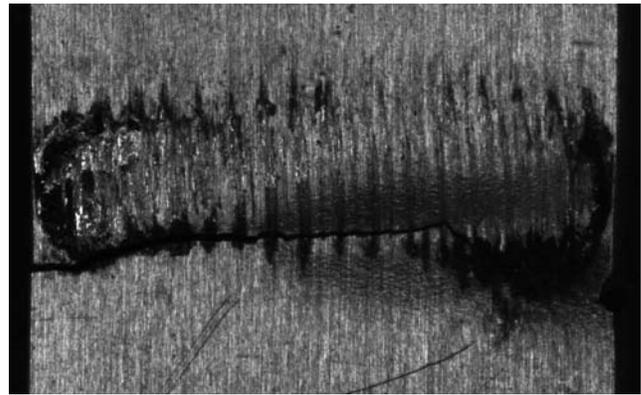
Fig. 20. AFIT specimen fretting scar – 2024 Al pad, $\sigma_{\text{eff}} = 495$ MPa, $P = 4000$ N Fig. 21. AFIT specimen fretting scar – 2024 Al pad, $\sigma_{\text{eff}} = 417$ MPa, $P = 1757$ N

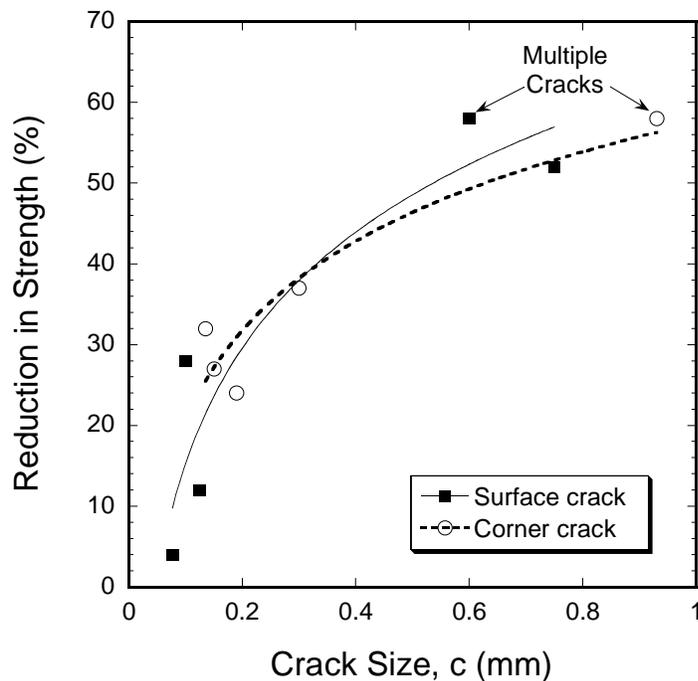
Fig. 1. Crack surface length (corner crack) or surface half-length (surface crack) vs. reduction in fatigue strength.

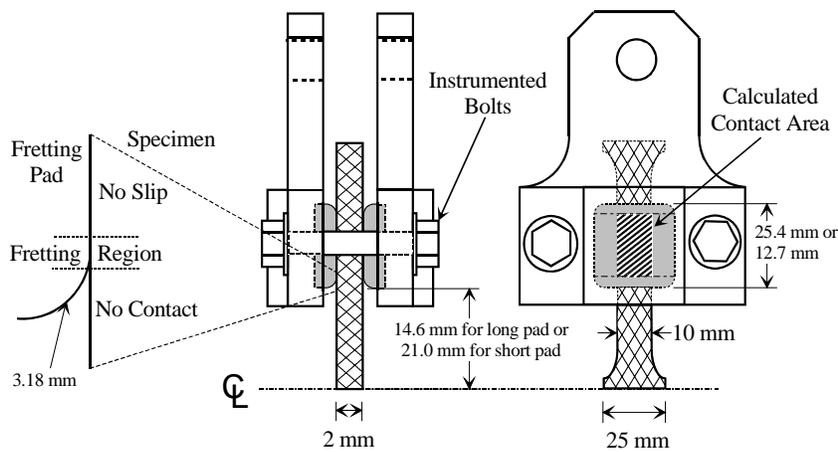
Fig. 3. Test fixture schematic indicating pad lengths, distance from center of specimen to lower edge of pad, and blending radius at edge of contact. [11]

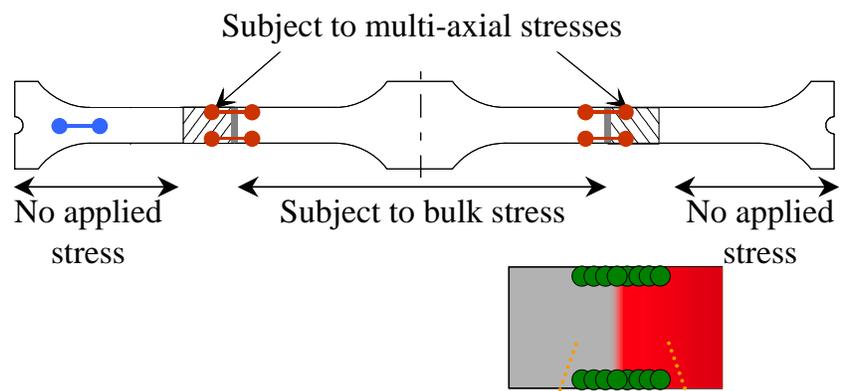
Fig. 4. Schematic of locations where residual stresses were measured on the twin dogbone specimens. Blue line denotes the location of baseline data acquisition. Red lines denote measurements made in the fretting fatigue regions of interest. (Inset: red shaded region denotes contact region, row of green circles corresponds to the red lines in schematic.) The vertical dashed line indicates bisecting location for post-fretting characterization and testing.

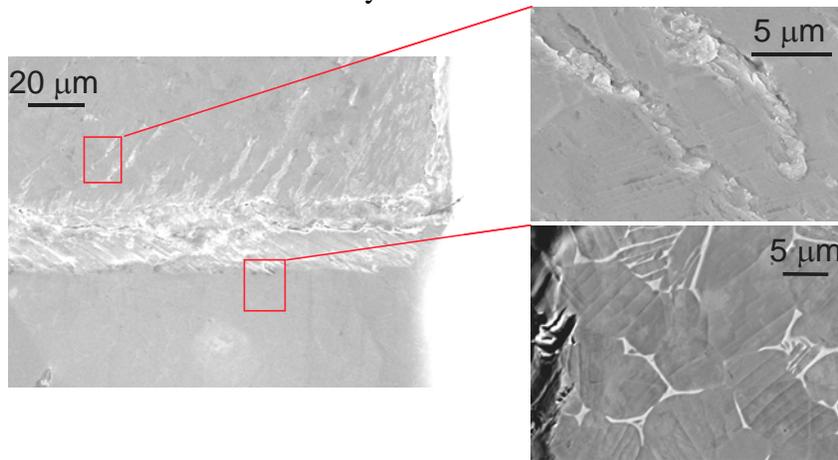
Fig. 5. Overall SEM image of a fretting scar on a highly polished specimen (left), and two regions adjacent to the fretting fatigue crack that show evidence of underlying dislocation structure in the form of persistent slip bands. Note that both magnified views are rotated 90 degrees counter clockwise from their orientation in the left-hand photo. [14]

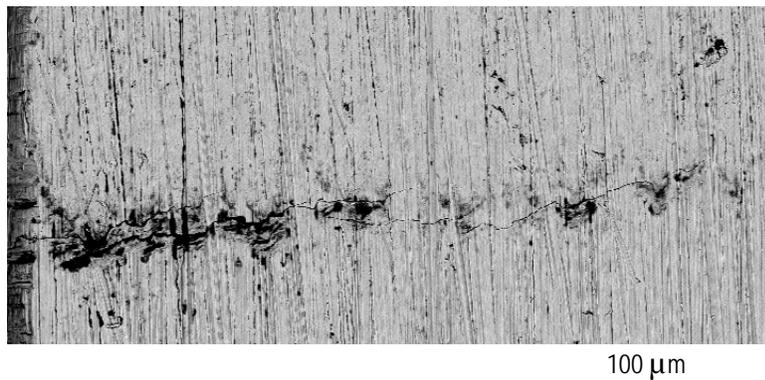
Fig. 6. 750 μm fretting fatigue crack and related wear damage. [11]

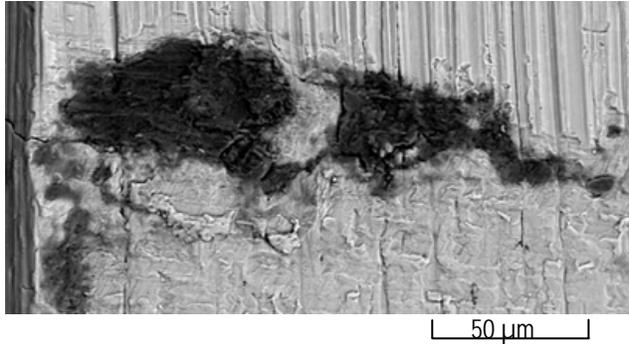
Fig. 7. 150 μm fretting fatigue crack and associated wear damage. Specimen edge is at the left side of the photo. [11]

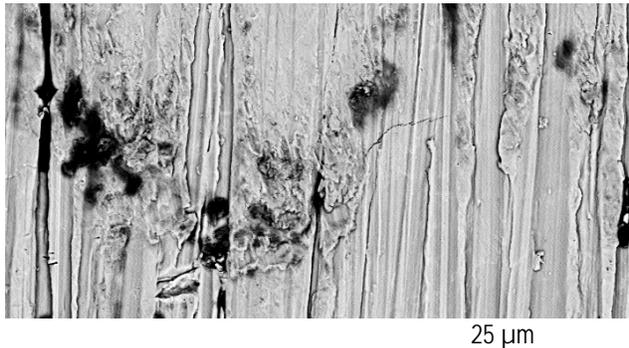
Fig 8. 50 μm fretting fatigue crack and associated wear damage. Specimen edge is at the left side of the photo. [14]

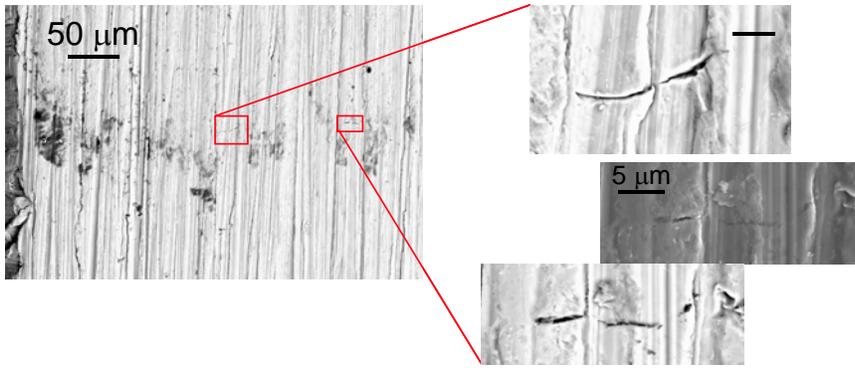
Fig. 9. 10 μm fretting fatigue cracks and adjacent wear damage. Specimen edge is at the left side of the left-hand photo. Red boxes indicate locations of magnified views. The two images in the lower right-hand corner are of the same region, but were taken using different techniques to emphasize the ability of wear debris to obscure small cracks. [14]

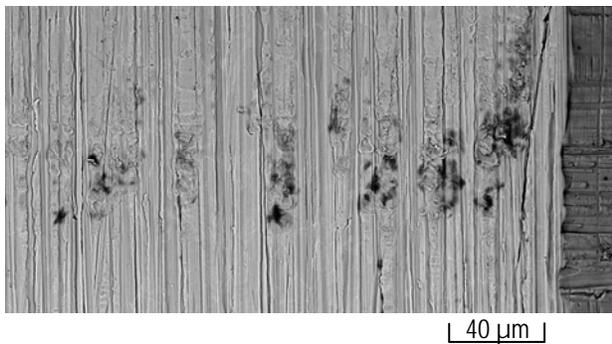
Fig. 10. Wear damage on an as-received specimen without fretting fatigue nucleated cracks.

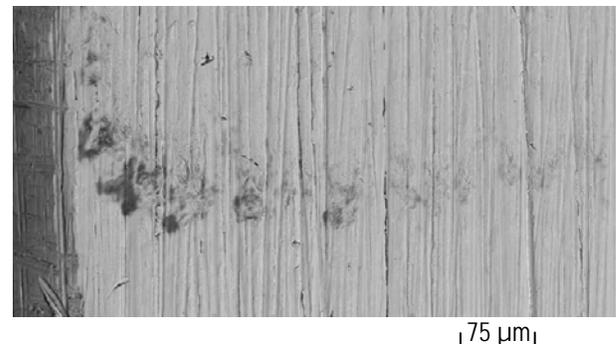
Fig. 11. Wear damage on an as-received specimen without fretting fatigue nucleated cracks.

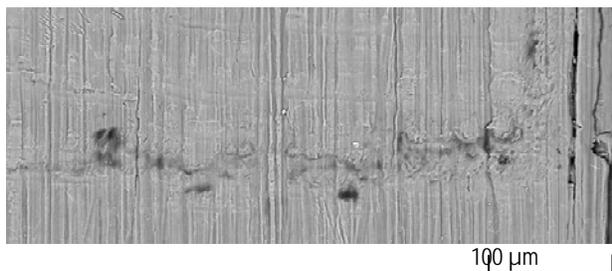
Fig. 12. Wear damage on a stress-relief annealed specimen without fretting fatigue nucleated cracks.

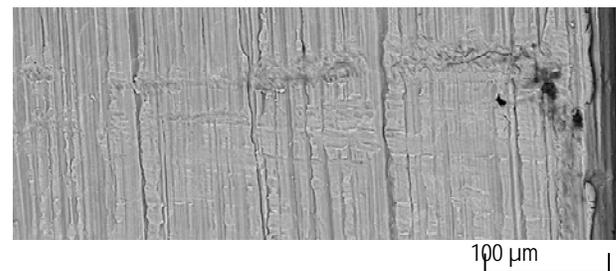
Fig. 13. Wear damage on another stress-relief annealed specimen without fretting fatigue nucleated cracks.

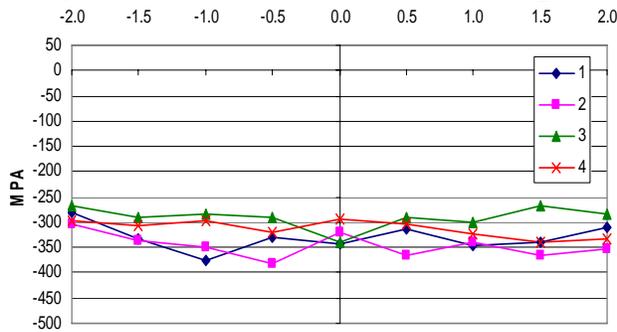
Fig. 14. Residual stresses plotted as a function of location for the as-received specimens.

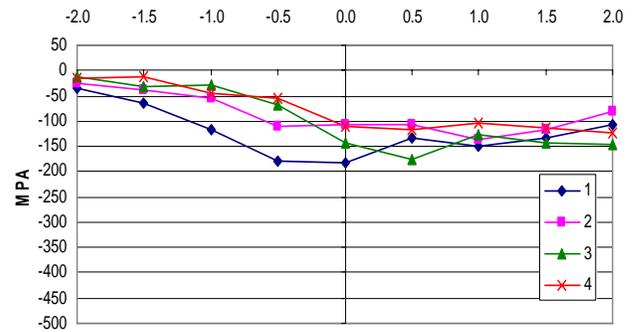
Fig. 15. Residual stresses plotted as a function of location for the stress-relieved specimens.

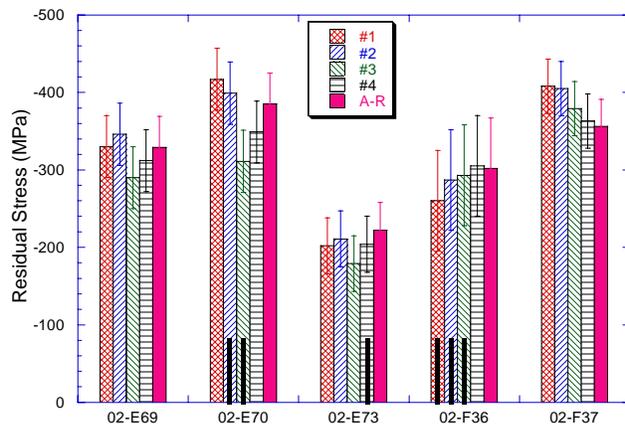
Fig. 16. Average residual stress values for all as-received specimens. Pink bars represent the stresses measured from the untested specimen surface. Black vertical lines on the bars indicate the presence of cracks, 20 μ m or smaller.

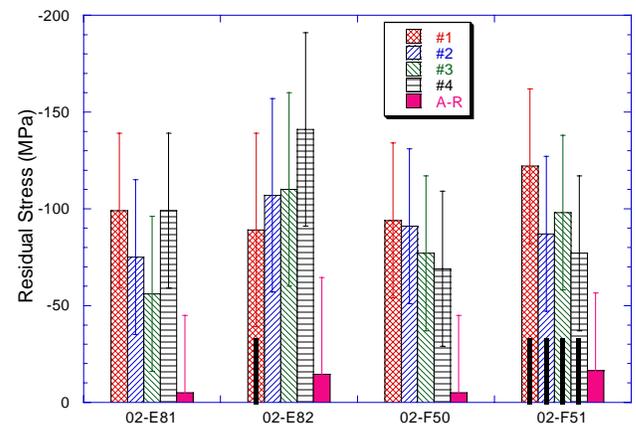
Fig. 17. Average residual stress values for all stress-relieved specimens. Pink bars represent the stresses measured from the untested specimen surface. Black vertical lines on the bars indicate the presence of cracks, 20 μ m or smaller.

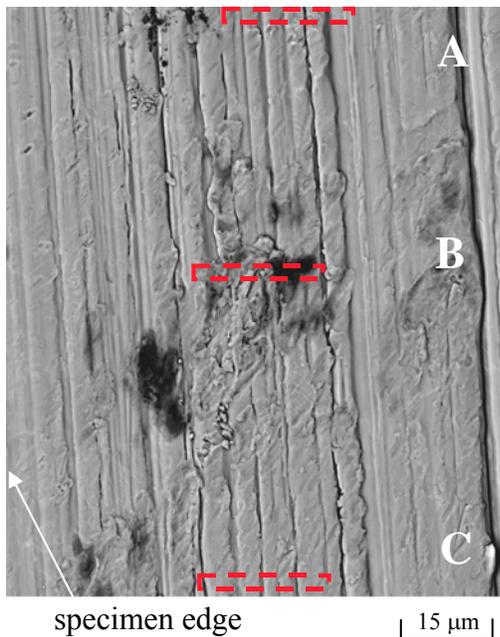
Fig. 18. Region of as-received specimen where TEM foils were taken (red dashed boxes). Region B = edge of contact, C = under the pad and A = adjacent to the pad.

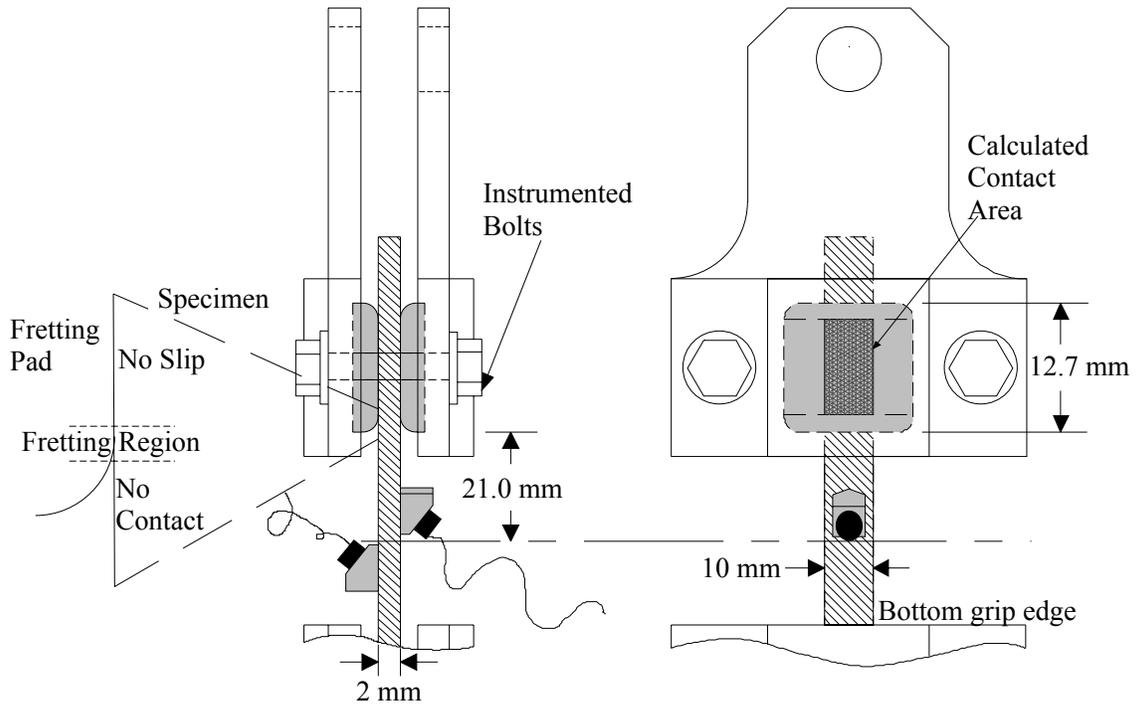
Figure 1. Schematic showing the fretting fatigue gripping system and the ultrasonic transducer placement.

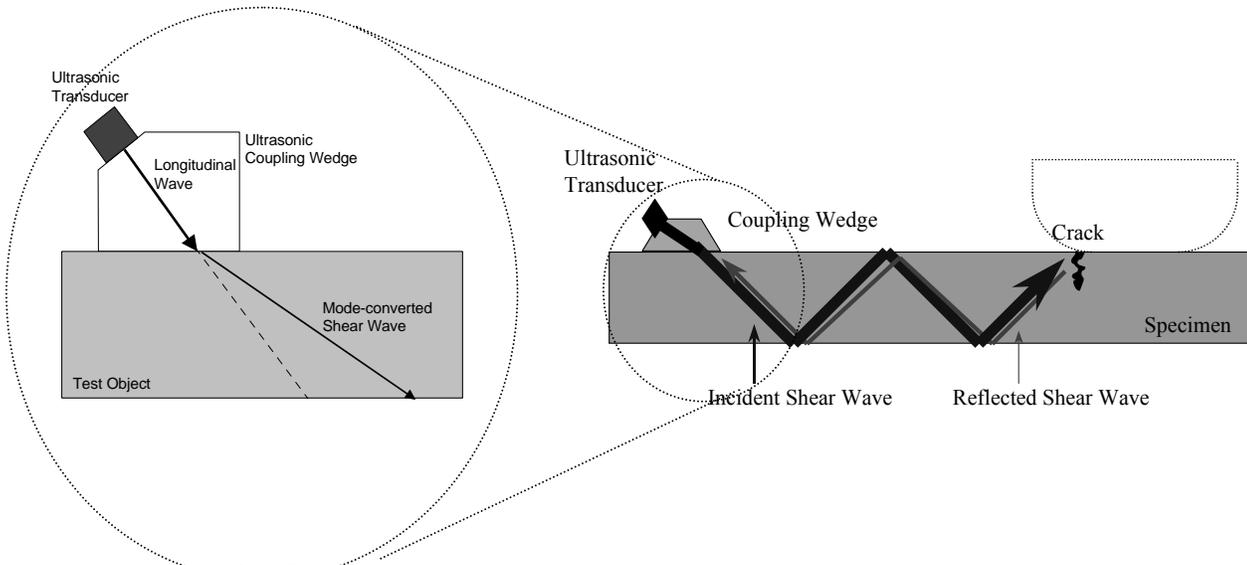
Figure 2. Coupling wedges were used to convert ultrasonic energy from longitudinal to shear wave modes. Internal reflections of the shear waves allowed ultrasonic energy to propagate through the specimen to the location underneath the fretting pads where fatigue crack initiated.

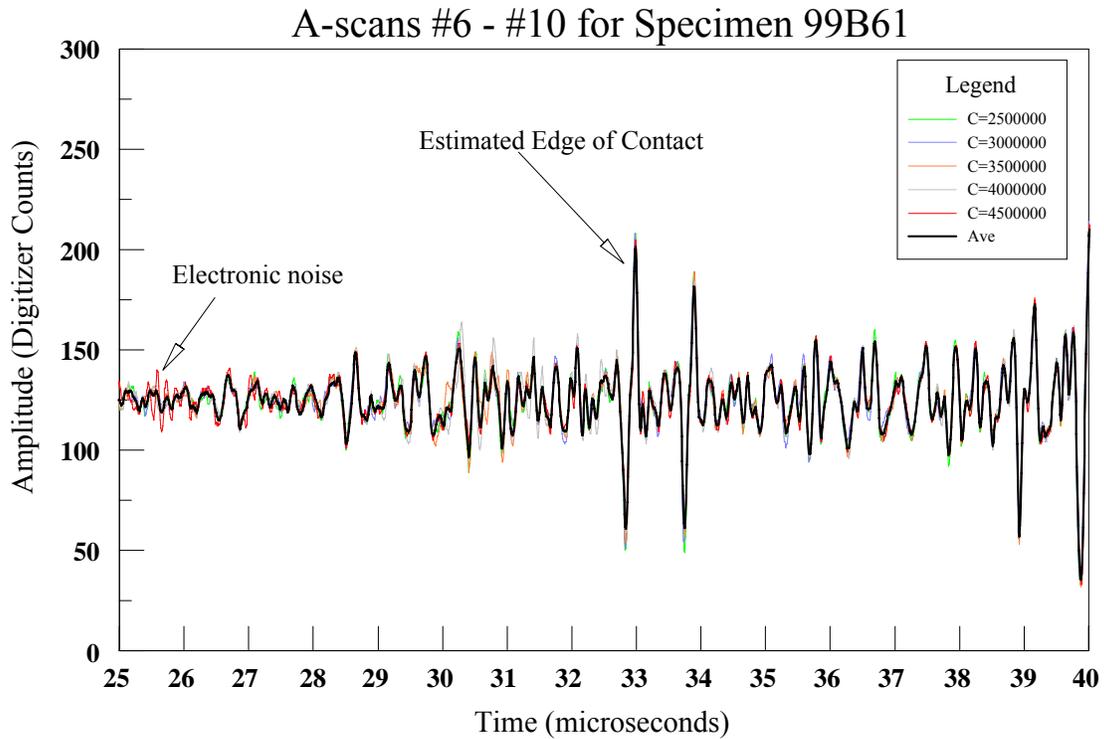
Figure 3. Ultrasonic waveforms from the early part of experiment 99B61 plotted as waveform amplitude versus time in μs .
