AFRL-ML-WP-TR-2005-4120

**LIFE PREDICTION
METHODOLOGIES FOR AEROSPACE
MATERIALS**

**University of Dayton Research Institute
Structural Integrity Division
300 College Park
Dayton, OH 45469-0128**

Final Report for 25 May 1998 – 24 May 2004

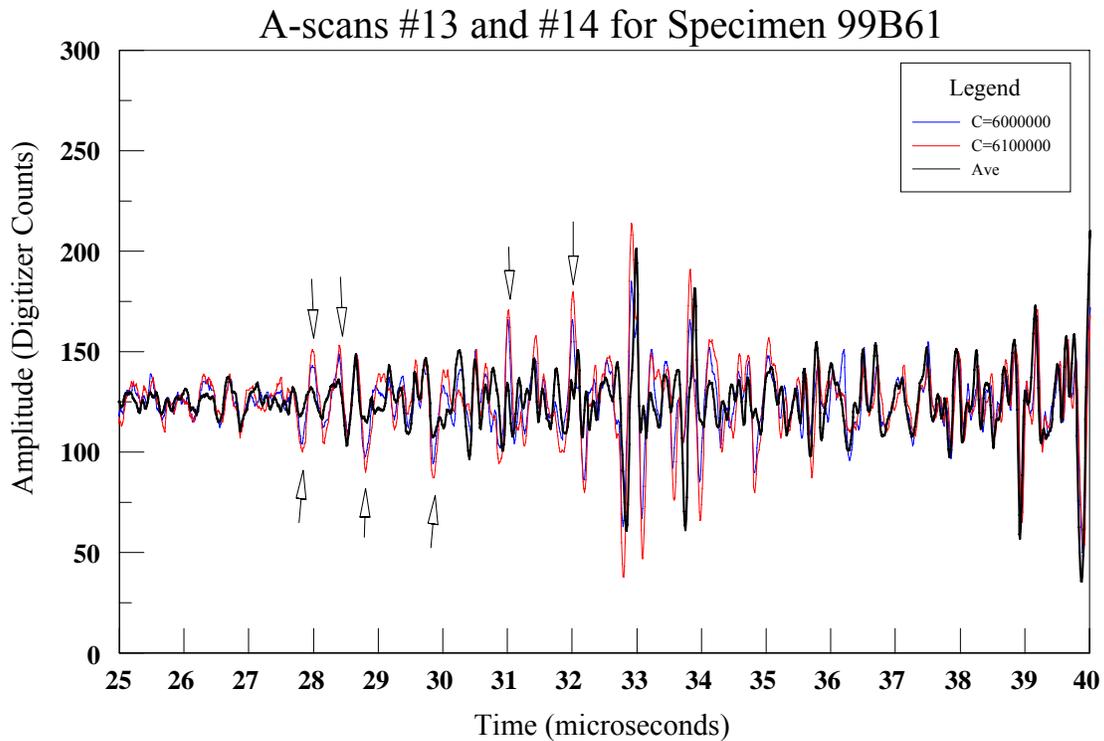
Figure 4. Ultrasonic waveforms from later in 99B61 compared with the average shown in figure 3. Changes indicative of fretting nucleated cracks are indicated with arrows.

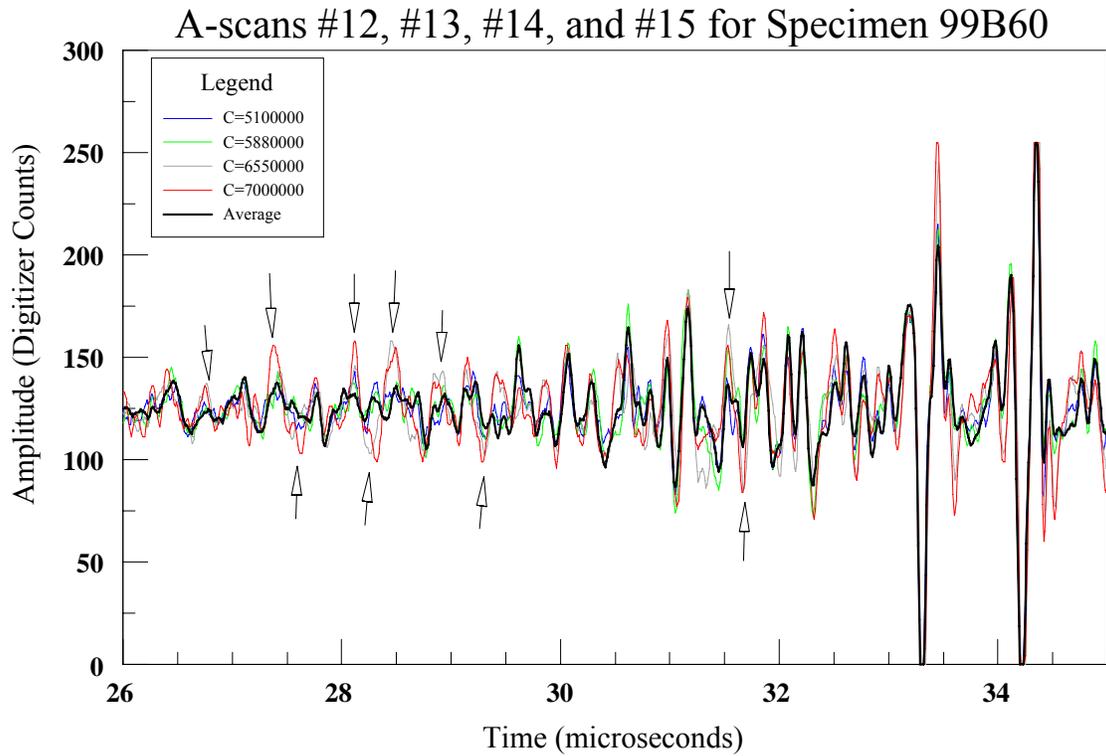
Figure 6. Ultrasonic waveforms from the latter part of experiment 99B60 compared with an average of waveforms obtained early in the experiment. Changes indicative of fretting nucleated cracks are indicated with arrows. (Note: time scale is expanded to enhance waveform details.)

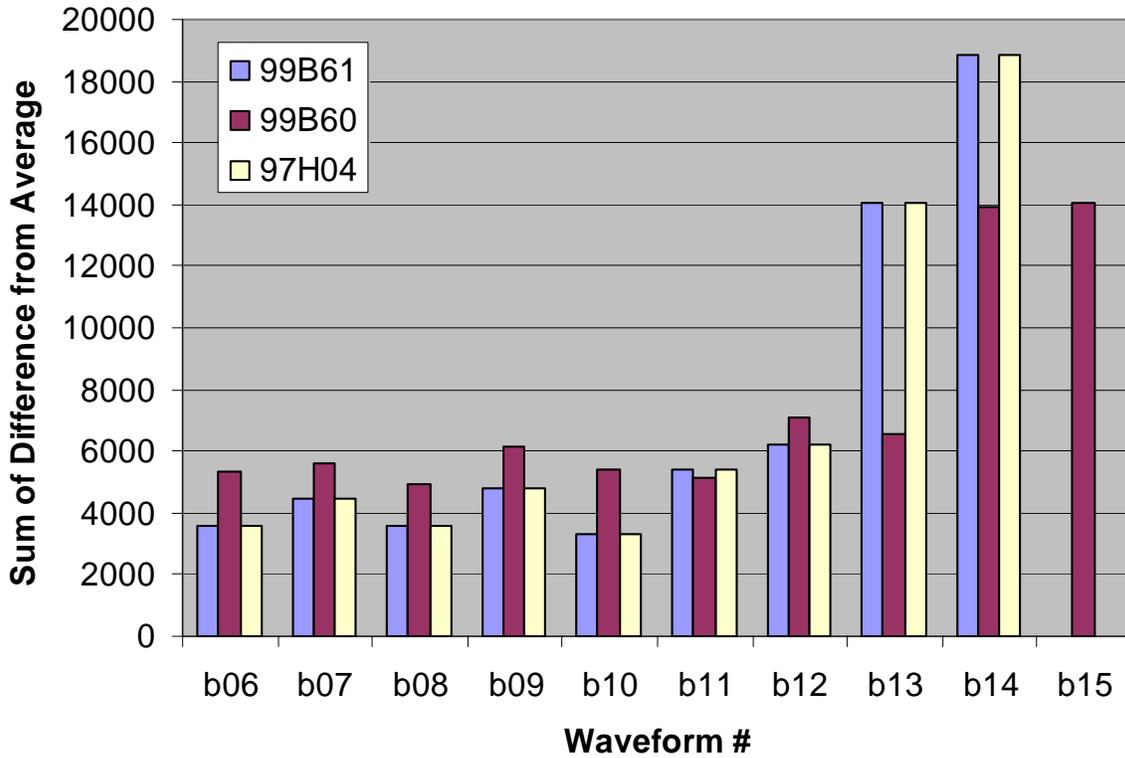
Figure 8. Sum of difference between average waveform and individual waveforms for time = 25 to 40 μ s (high clamping stress tests).

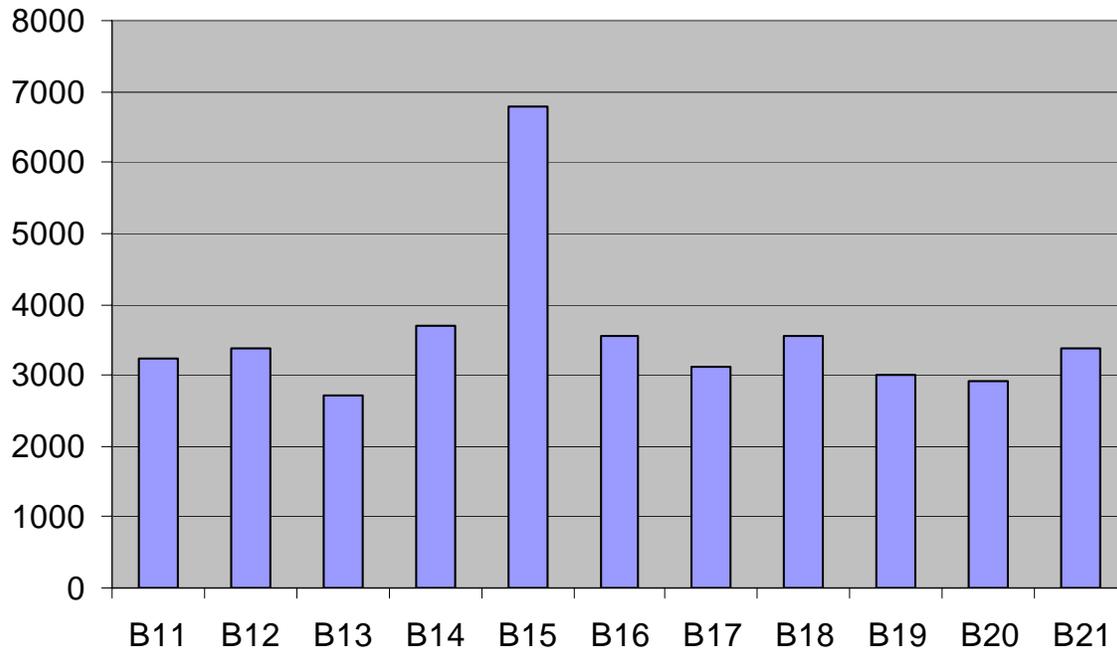
Figure 9. Sum of difference between average waveform and individual waveforms for time = 25 to 40 μ s for 99B57, on which no cracks were identified after 10.9 million cycles (low clamping stress).

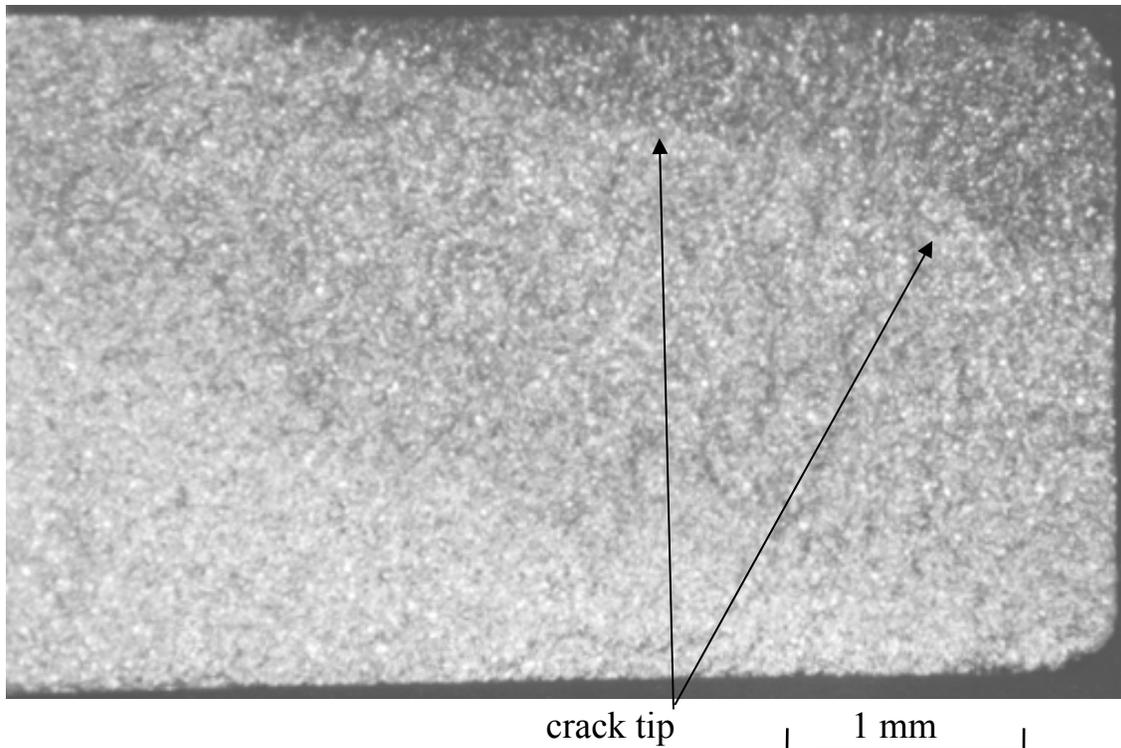
Figure 7. Fracture surface of specimen with successful shear wave crack detection ($N = 7,020,000$ cycles – 99B60). Arrows indicate crack tip position at time of crack detection.

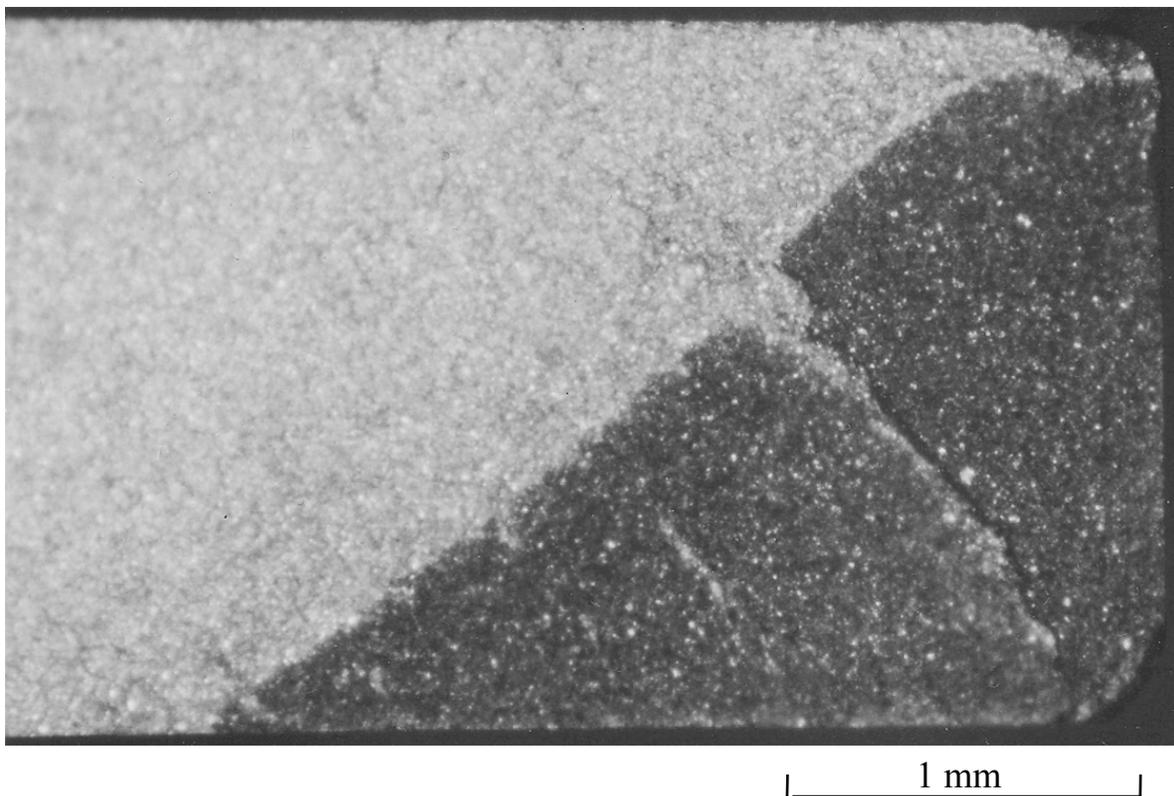
Figure 5. Fracture surface of specimen with successful shear wave crack detection ($N = 6,125,000$ cycles – 99B61).

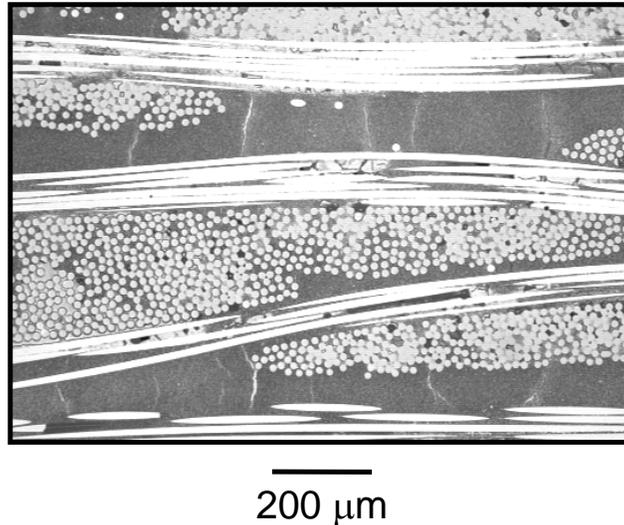
Figure 1. Microstructure of ($0^\circ/90^\circ$) 8HSW Nextel™720/AS-0 microstructure highlighting the matrix cracks due to processing.

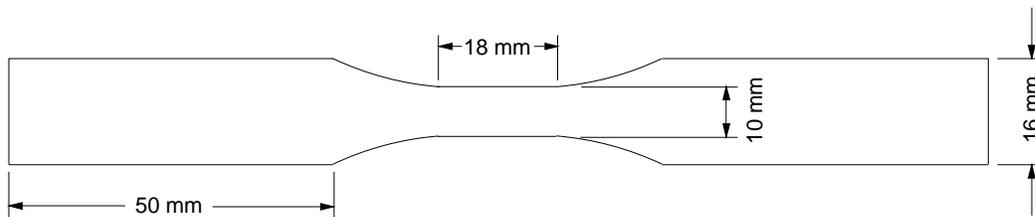
Figure 2. Dogbone specimen test geometry.

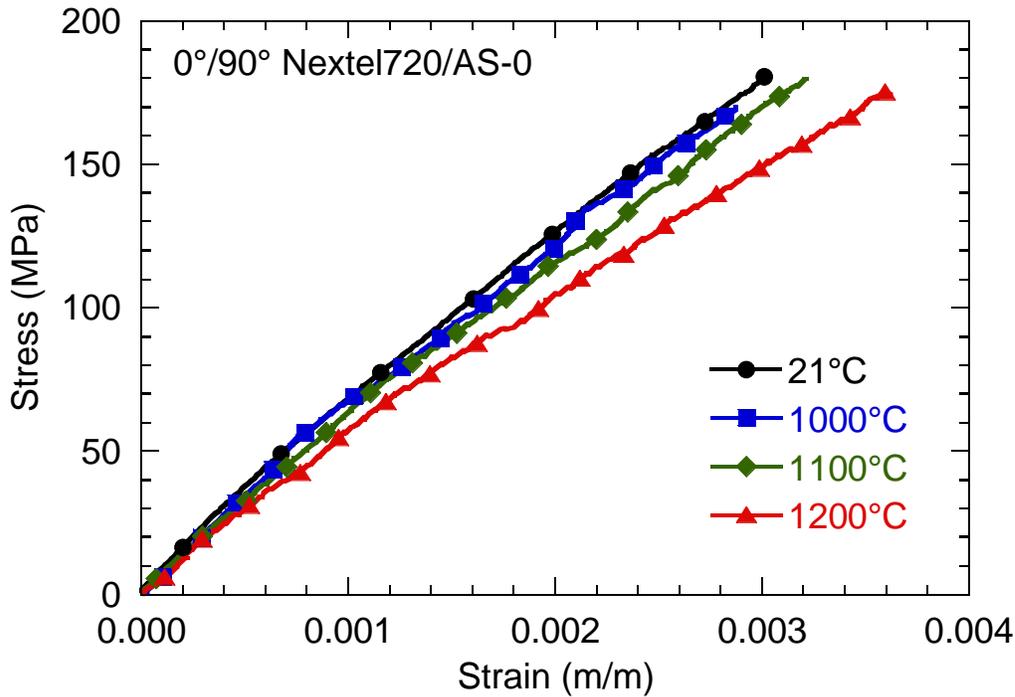
Figure 3. Stress versus strain for Nextel™720/AS-0 oriented in the 0°/90° RT-1200°C.

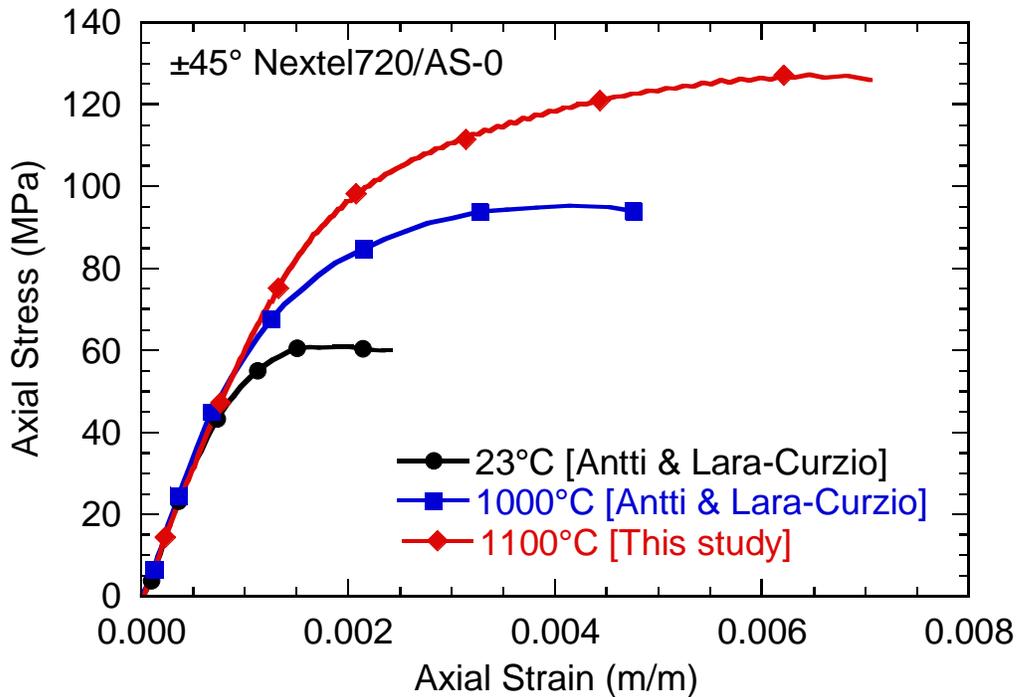
Figure 4. Stress versus strain for Nextel™720/AS-0 oriented in the $\pm 45^\circ$ RT-1100°C.

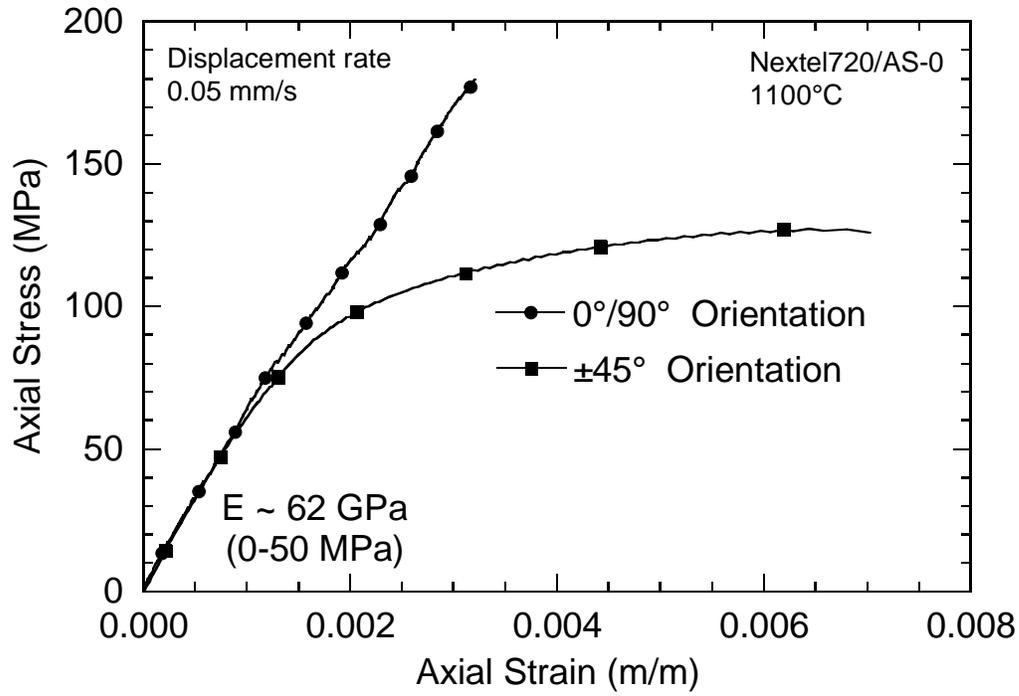
Figure 5. Stress versus strain for Nextel™720/AS-0 oriented in the $0^\circ/90^\circ$ and $\pm 45^\circ$ at 1100°C .

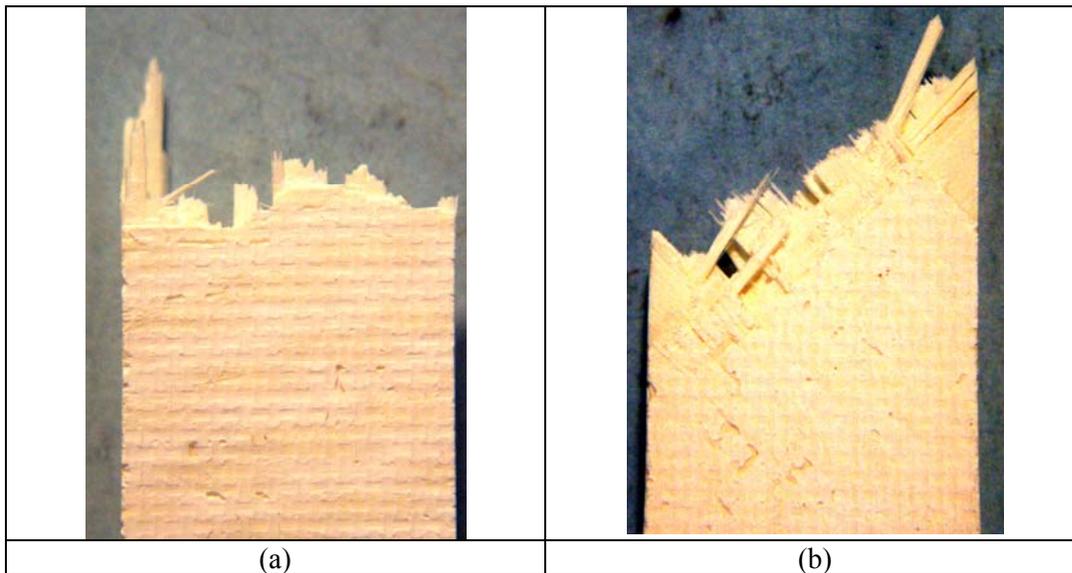
Figure 6. Fracture surface of tensile tested Nextel™720/AS-0 at 1100°C (a) $0^\circ/90^\circ$, (b) $\pm 45^\circ$.

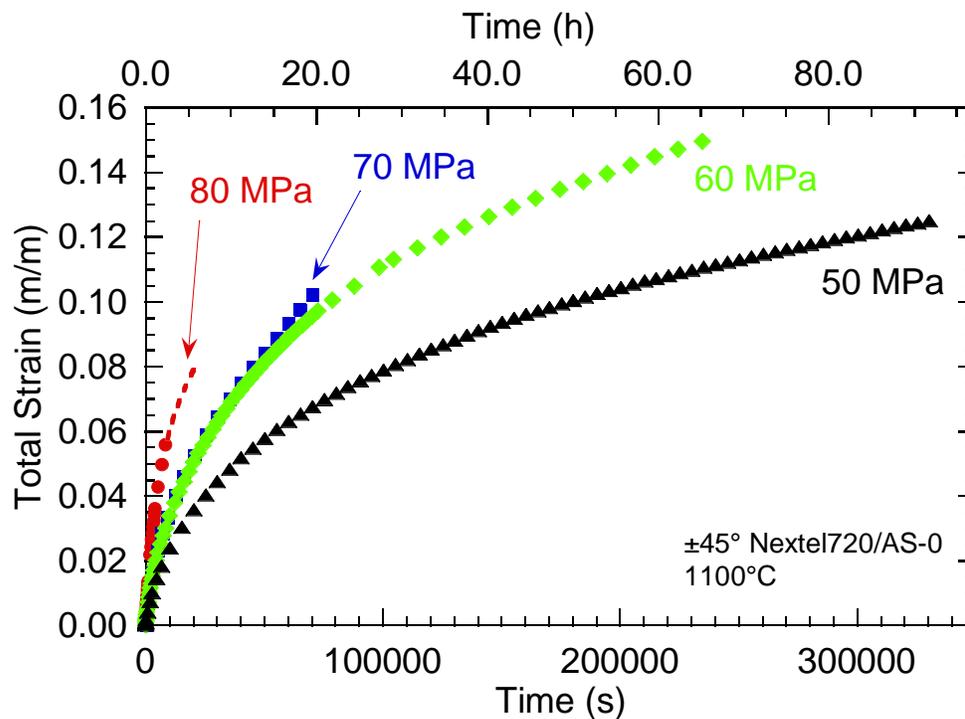
Figure 7. Total strain versus time for $\pm 45^\circ$ Nextel720/AS-0 at 1100°C .

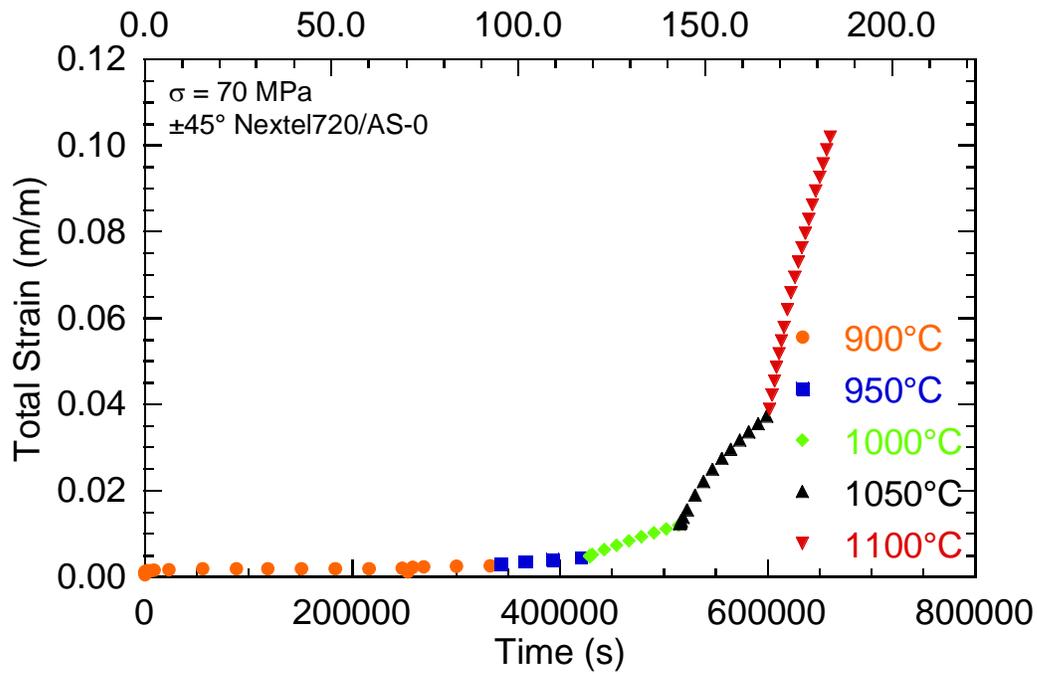
Figure 8. Total strain versus time for $\pm 45^\circ$ Nextel720/AS-0 for stepped temperature (900-1100°C) creep test at 70MPa.

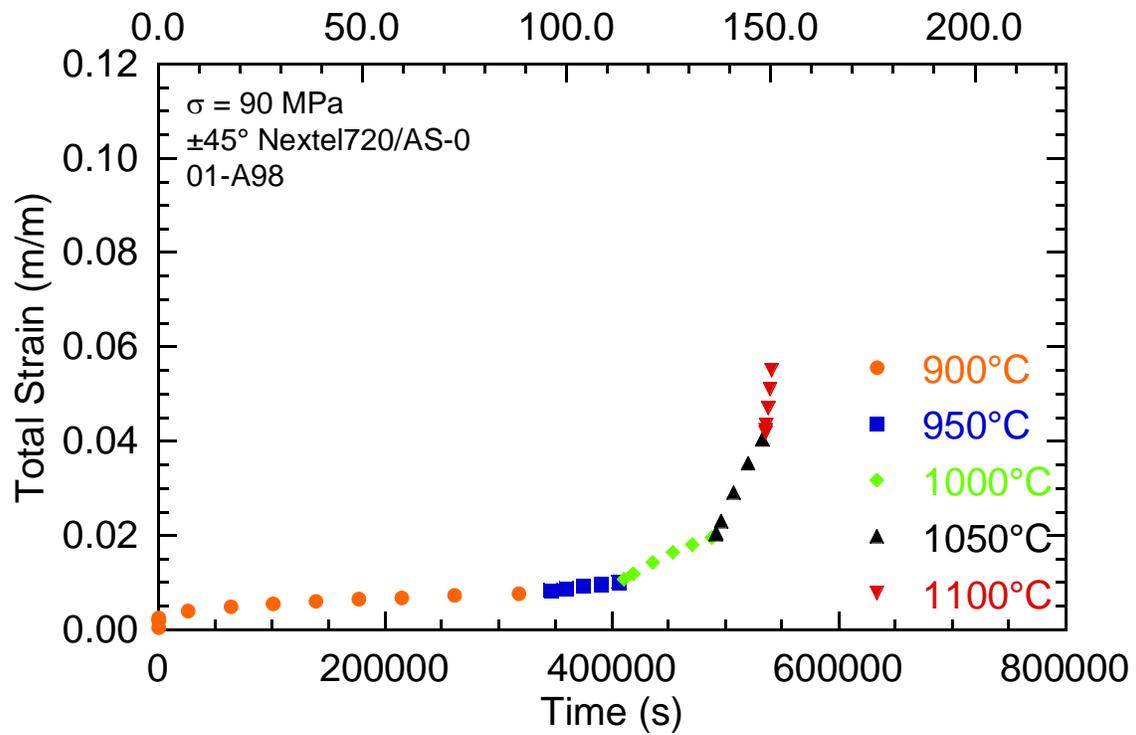
Figure 9. Total strain versus time for $\pm 45^\circ$ Nextel720/AS-0 for stepped temperature (900-1100°C) creep test at 90MPa.

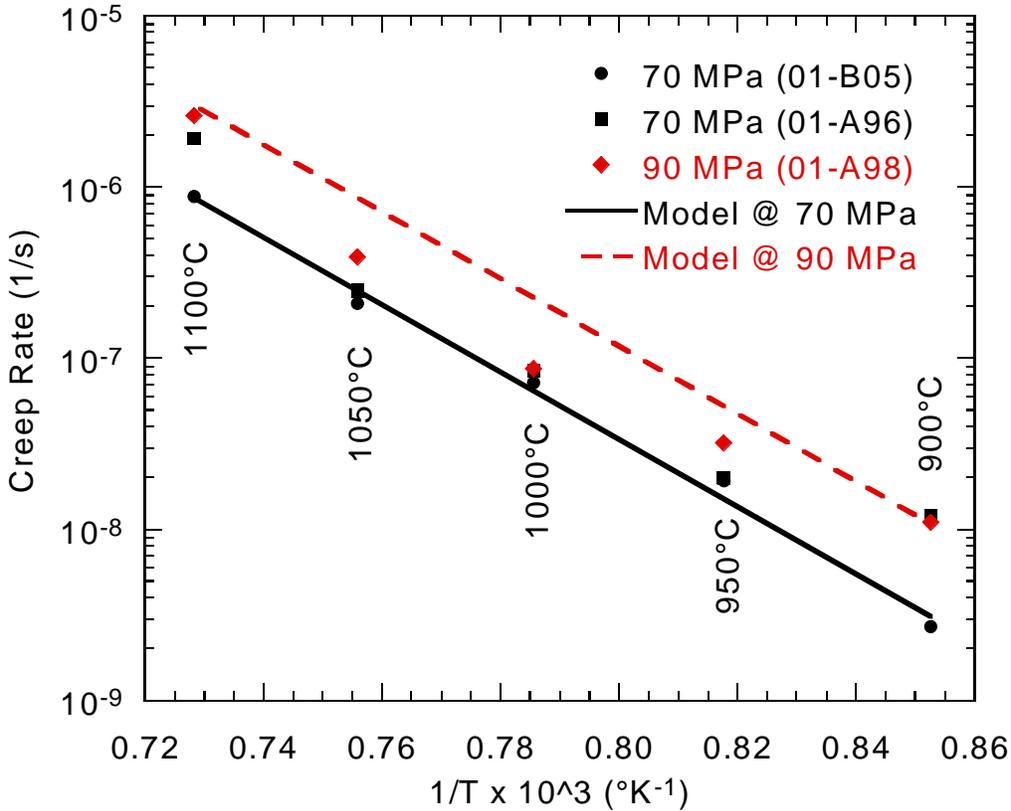
Figure 10. Strain rate versus $1/T$ for creep of $\pm 45^\circ$ Nextel720/AS-0.

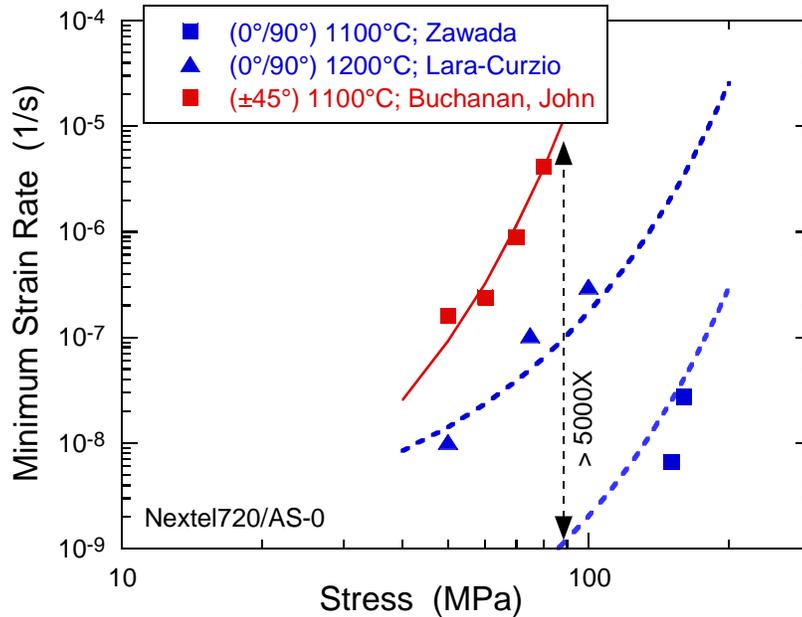
Figure 11. Minimum strain rate versus stress for creep of $0^\circ/90^\circ$ and $\pm 45^\circ$ Nextel720/AS-0.

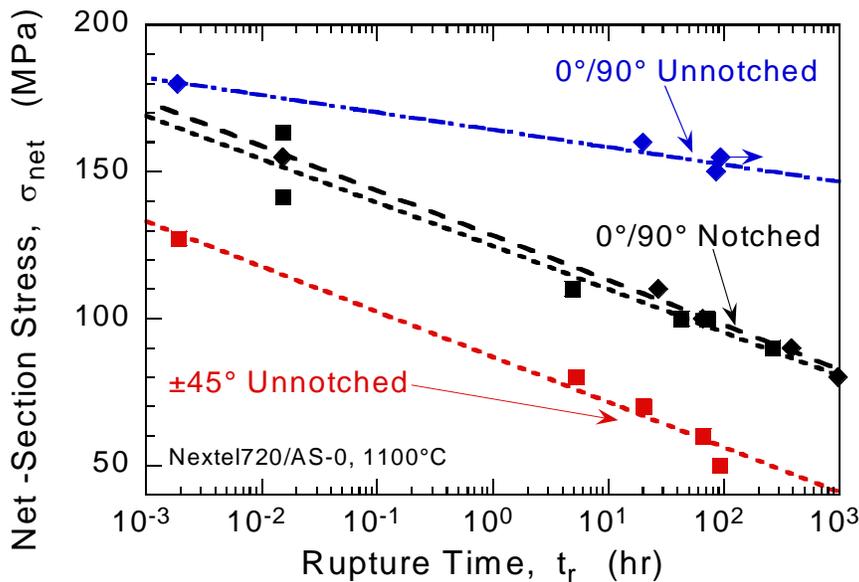
Figure 12. Creep rupture behavior of $0^\circ/90^\circ$ and $\pm 45^\circ$ Nextel720/AS-0 at 1100°C .

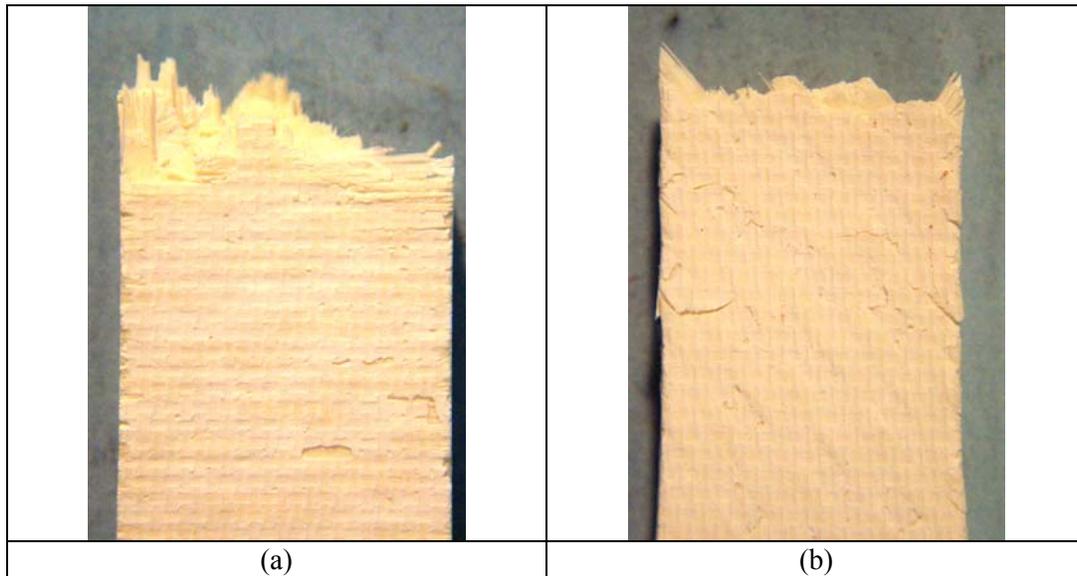
Figure 13. Fracture surface of sustained load (creep) tested Nextel™720/AS-0 at 1100°C (a) $0^\circ/90^\circ$, $\sigma = 160\text{ MPa}$, $Tr = 20\text{ hrs}$, (b) $\pm 45^\circ$, $\sigma = 70\text{ MPa}$, $Tr = 20\text{ hrs}$.
