**NAVAL
POSTGRADUATE
SCHOOL**

THESIS

**DESIGN AND VALIDATION OF IMPROVED DYNAMIC
CYLINDER PRESSURE MEASUREMENT FOR A DIESEL
ENGINE**

September 2005

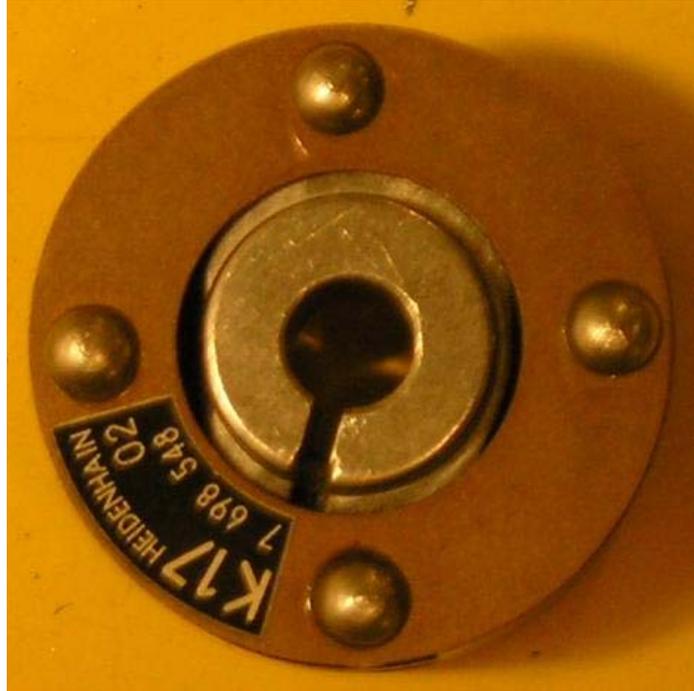
The optical encoder is bolted to the engine frame closest to the number one cylinder. The optical encoder housing is made of 2 plates of aluminum and uses three 3/8 inch bolts to secure the housing to the engine block. This design is similar to the previous iterations, but the previous designs had three aluminum plates in the engine block mount. Since the new design fit with only two plates, less vibration would be picked up by the optical encoder. Additionally, the optical encoder mount is fit with a coupling that damped out the radial and axial vibrations that had damaged previous encoders. This coupling device can be seen in Figure 2, and the entire optical encoder mount can be seen in Figure 3.

Figure 2. Coupling Device

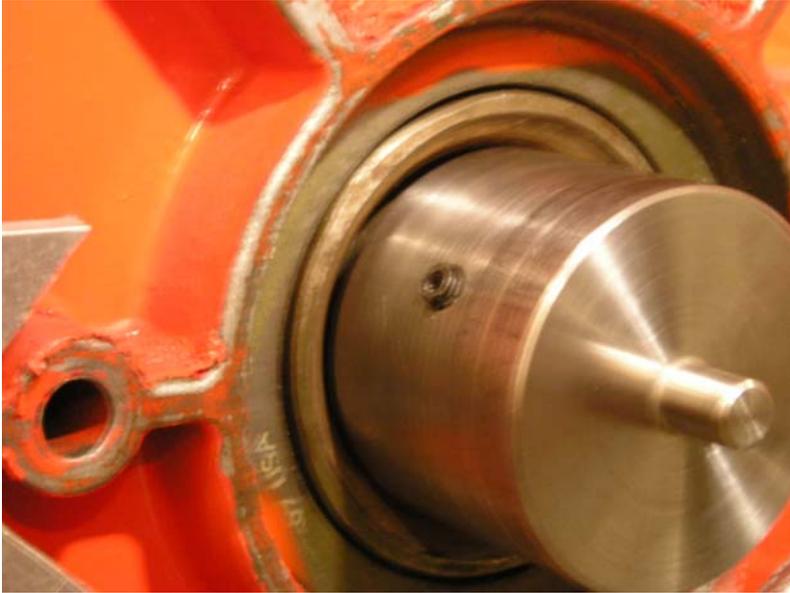
The encoder mount was designed similarly to Hudson's design. However, since the total thickness of encoder mounting system was constrained by the diameter of the engine block mount opening, the diameter of the encoder mount had to be smaller because a collar was going to slide over the set screws. Additionally, the extension where the flexible coupling attaches had to be at least 0.5" long. Since the jig had three 0.25" holes 120° apart, the encoder mount had to have the same parts. This would be a clearance fit, with the same dimensions as the jig. A picture of the after it has been installed on the crankshaft can be seen in Figure 6, and the machine drawings can be seen in Appendix B.

Figure 6. New encoder mount.
Note set screw installed and clearance between
crankshaft seal and encoder mount

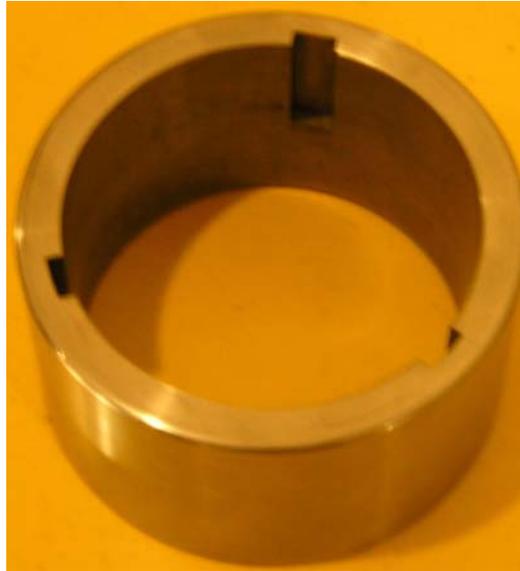
The collar was designed to slip over the encoder mount with three slots cut out at 120° apart. The slots stopped where the set screws were designed to come in, so the set screws would be able to slide into the slots and would hold the collar in place. It was necessary to ensure that the back of the collar did not rest on the crankshaft seal so the data acquisition would not be altered by outside sources. The collar can be seen in Figure 7, and the machine drawings are included in Appendix B.

Figure 7. Picture of Collar.
Note the depth of the slots.

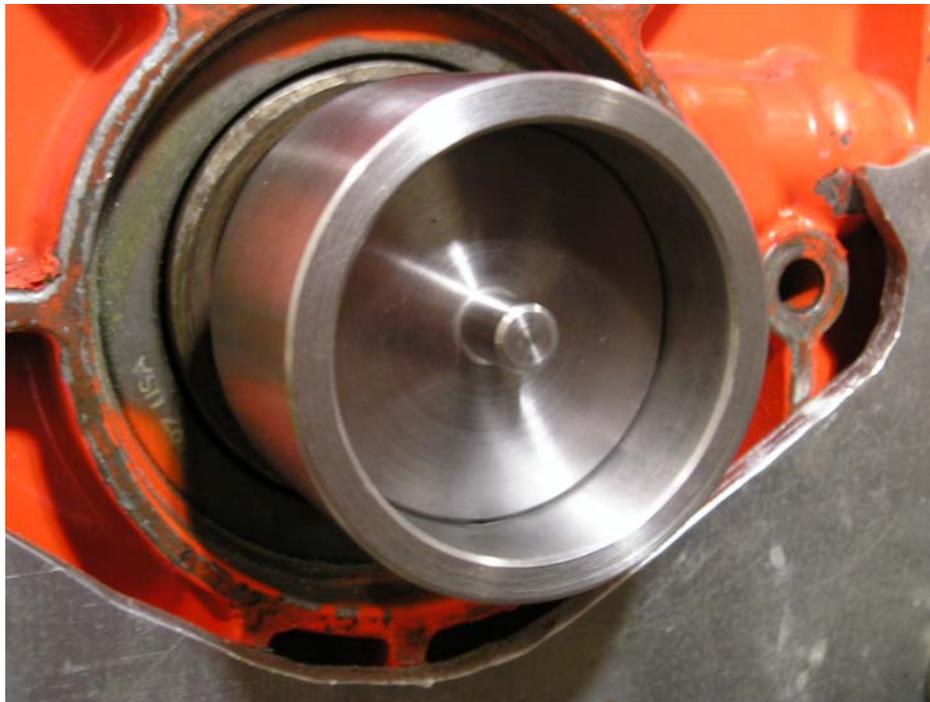
After the parts were manufactured, the parts had to be installed before the new system could be verified experimentally. After bolting the jig onto the crankshaft, drilling the holes, and removing the crankshaft, the three holes were found to be drilled to the proper depth. The installation of the encoder mount was next. Since there is very little clearance between the crankshaft and the mount, the encoder mount has to be arranged perpendicular to the crankshaft to facilitate installation. After the encoder mount was in place, loc-tight was considered for the set screws but was deemed not necessary since the set screws were going to be physically unable to back out after the collar was installed. After the set screws were in place, the slots in the collar did not fit over the set screws. It turned out that the set screws were not designed to be machined to the degree of accuracy calculated, so they had to be filed down a few thousandths of an inch before the collar slipped over the encoder mount. Figure 8 shows how the collar did not fit over the set screws, and Figure 9 shows the collar locked into place.

Figure 8. Installation of the collar over the encoder mount before the set screws were filed down

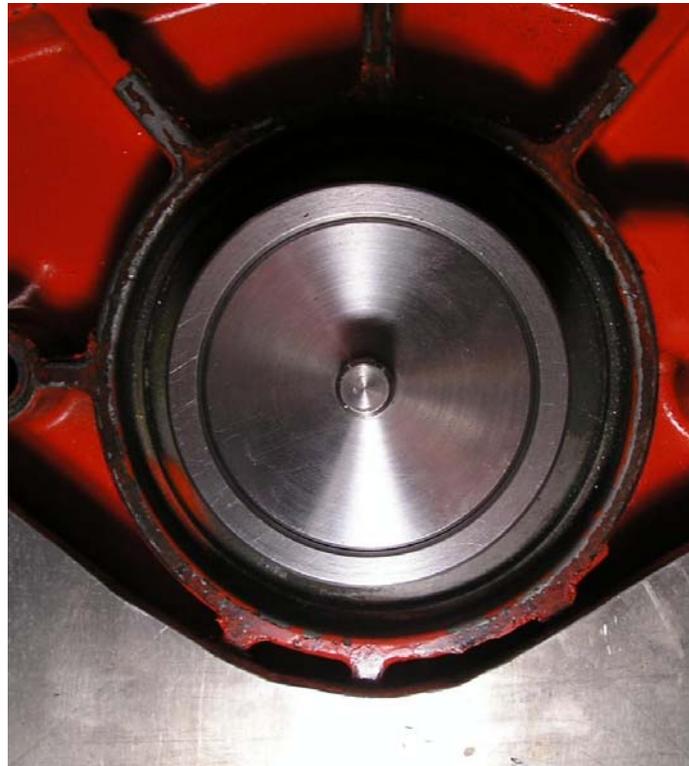
Figure 9. Encoder mount with collar installed after filing.
