The Influence of Surface Enhancement by Low Plasticity Burnishing on the Corrosion Fatigue Performance of AA7075-T6

Paul S. Prevéy (pprevey@lambda-research.com)
Lambda Research, 5521 Fair Lane, Cincinnati, Ohio 45227

John T. Cammett (cammettjt@navair.navy.mil)
Naval Aviation Depot, PSC Box 8021, MCAS Cherry Point, NC 28533

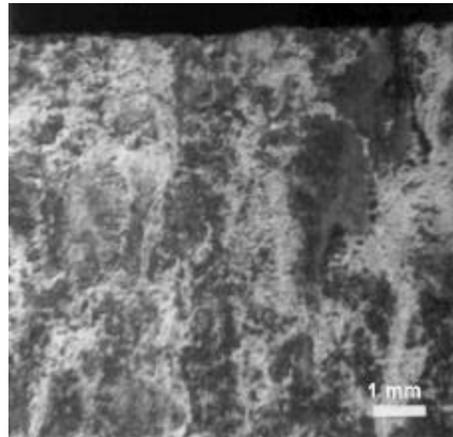
Figure 1 - Macroscopic appearance of a 7075-T6 specimen after 100-hr. salt fog exposure showing patches of Al₂O₃ corrosion product.

The salt fog exposures were performed at 35° C per ASTM B117 for a period of 100 hours. The fog produced was such that 1.0-2.0 ml/hr. of NaCl aqueous solution collected on each 80 cm² of horizontal surface. The pH of the solution was maintained between 6.5 and 7.2. Following exposure to the salt fog, the samples were soaked and then rinsed in tap water, followed with a distilled water rinse to remove any salt solution remaining, and then dried. Patches of gray and white corrosion product evident on the surface in Figure 1 of the samples were

identified by x-ray diffraction as α -Al₂O₃. The corrosion product was not removed prior to fatigue testing.

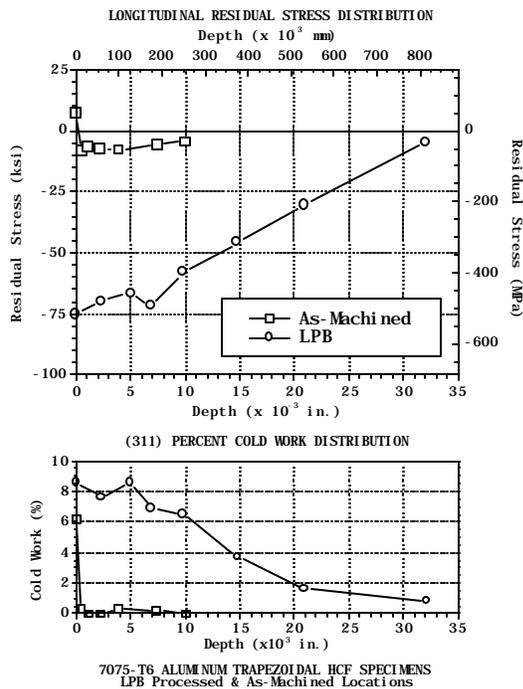
Figure 2 – Residual stress and cold work distributions produced by end milling and LPB in 7075-6.

The residual stress distributions developed by machining and LPB processing are shown in Figure 2. Machining produced low tension on the surface and compression of less than -68 MPa (-10 ksi) below the surface. In contrast, LPB produced maximum compression on the order of -480 MPa (-70 ksi) between the surface and a depth of nominally 0.2 mm (0.008 in.). Maximum cold work of nominally 8% was observed from the surface through the region of maximum compression, and then diminished with greater depth. The compressive layer extended to over 0.75 mm (0.030 in.), diminishing in magnitude nearly linearly with depth. X-ray diffraction measurements could not be made reliably below a depth of 0.75 mm (0.030 in.) because of the coarse grain size encountered at depths beneath the deformed surface layer.

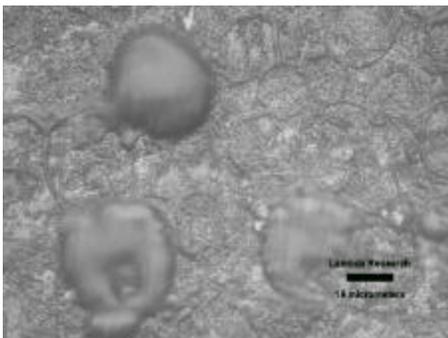
Figure 3 – Circular oxidation patterns at mid-width of an LPB 7075-T6 surface after 100 hr. salt fog exposure.

the surface, the corrosion crevices often were observed to progress laterally, thereby delaminating layers of material and apparently following the elongated grain boundaries produced during rolling of the plate. Salt fog exposure for 100 hr. after LPB produced a different pattern of oxidation. Predominantly, circular patterns were observed in the surface oxide at higher magnification, as shown in Figure 3. Striking spiral patterns were observed at the edges of the exposed surface, as shown in Figure 4. Shallower pitting was observed on the surfaces that received LPB after machining and prior to salt fog exposure than those machined surfaces directly exposed without LPB. Pits in the LPB surfaces after 100-hr. salt fog exposure had irregular boundaries, but overall equiaxed shapes with a $34\ \mu\text{m}$ (0.0014 in.) average depth and a nominal $44\ \mu\text{m}$ (0.0018 in.) diameter. This is nominally one-third the depth of pitting observed for the machined samples exposed without LPB treatment.

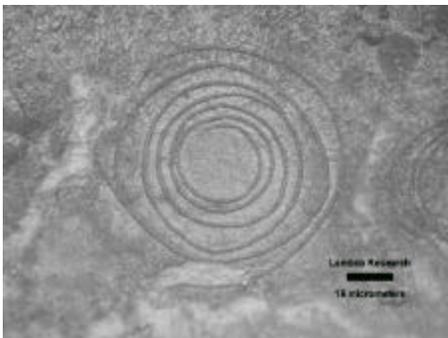
Figure 4 – Spiral oxidation patterns at the edge of an LPB 7075-T6 surface after 100 hr. salt fog exposure.

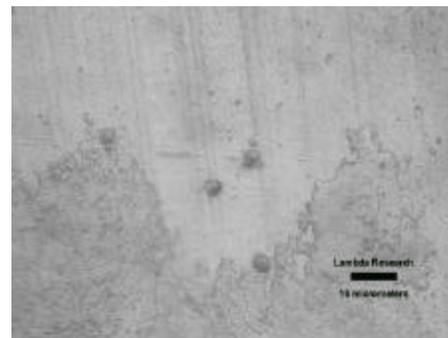
Figure 5 – Central gage section pitting and surface oxidation produced by active corrosion during fatigue testing of a machined 7075-T6 surface.

Active corrosion during fatigue cycling at ambient temperature produced much shallower pits than 100 hr. salt fog exposure at 35C, even in samples receiving the maximum exposure for the full 10^7 cycles to run-out (108 hours of testing in 3.5% NaCl solution). For both the machined and LPB surfaces, the pits were nominally $9\ \mu\text{m}$ (0.0004 in.) deep and were numerous across the entire exposed surface. Pits on the machined surface tended to be circular with a nominal diameter of $5\ \mu\text{m}$ (0.0002 in.). Pits on the LPB surface tended to be irregular and interconnecting, extending up to $20\ \mu\text{m}$ (0.0008 in.). A typical group of pits produced by active corrosion on the machined surface is shown in Figure 5 adjacent to a region of oxide film. A comparable region in the gage section of an LPB sample is shown in Figure 6.

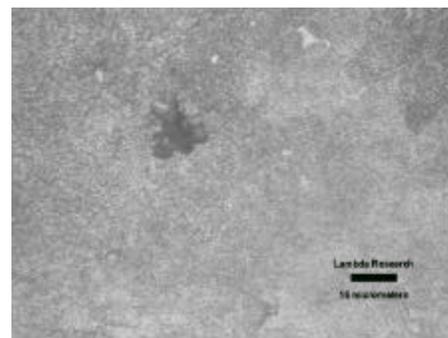
Figure 6 – Pitting and surface oxidation produced by active corrosion during fatigue testing of a 7075-T6 machined surface after LPB.

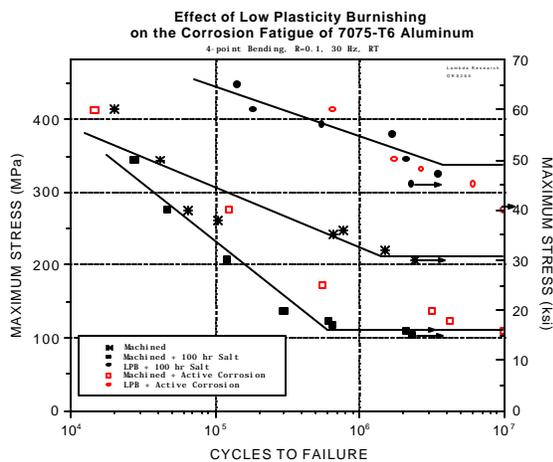
Figure 7 - High cycle fatigue results for salt fog pitted and active corrosion fatigue of machined 7075-T6 with and without LPB processing prior to exposure to corrosion.

The S/N curves generated for 7075-T6 in both the baseline as-machined condition and with LPB after 100-hr. salt fog exposure or prior to active corrosion fatigue are presented in Figure 7. Fatigue tests were continued for a minimum of 2.5×10^6 cycles if no failure occurred first. Maximum run-out sustained was 1.2×10^7 cycles.

The S-N curves for samples with pitting from prior salt fog exposure appeared to exhibit an endurance limit, implying infinite life below that stress level. The S-N curves for samples exposed to active corrosion fatigue during testing do not appear to have an endurance limit, as is commonly reported in studies of corrosion fatigue.¹⁶ Because fatigue tests were limited in both number of samples and applied load cycles to nominally 1.0×10^7 cycles, the presence of a true endurance limit cannot be confirmed without additional testing. In the discussion that follows, the results are considered and compared in terms of the fatigue life at nominally 2×10^6 cycles. The fatigue data in Figure 7 are presented as semi-logarithmic S-N curves at stress ratio, R, of 0.1, in terms of the maximum stress.

The machined (end milled) surface condition produced an apparent endurance limit on the

order of 200 MPa (30 ksi). Salt fog exposure for 100 hrs. reduced the endurance limit to nominally 100 MPa (15 ksi), half that of the original machined surface before exposure to salt fog. The fractional loss of fatigue life at stress levels above the endurance limit for salt fog exposed samples increased rapidly with decreasing maximum stress level, reaching an order of magnitude at the 200 MPa (30ksi) endurance limit. Active corrosion fatigue in 3.5% NaCl solution, with no prior corrosion damage, degraded the fatigue strength relative to the as-machined condition by an amount only slightly less than for prior pitting corrosion from 100 hr. salt fog exposure up to a life of 10^7 cycles. A failure occurred in active corrosion fatigue at 10^7 cycles, i.e., at the nominal 100 MPa endurance limit for pitting corrosion. The data appear to suggest both further reduction in fatigue strength with increasing life and the absence of an endurance limit for active corrosion fatigue. LPB prior to salt fog pitting resulted in a 70% increase in the endurance limit, from nominally 200 MPa (30 ksi) to over 330 MPa (48 ksi). The fatigue life at stress levels above the 310 MPa (45 ksi) endurance limit for LPB prior to corrosion is two orders of magnitude (100X) greater than that of the baseline machined surface. A comparable benefit in fatigue performance was observed for LPB prior to active corrosion fatigue in 3.5% NaCl solution. As noted earlier, a true endurance limit may not exist for the active corrosion fatigue mechanism, however, the fatigue strength at 10^7 cycles was at least 282 MPa (41ksi). Fatigue lives were 100 times that of the baseline machined surface for stress levels above 275 MPa (40 ksi).

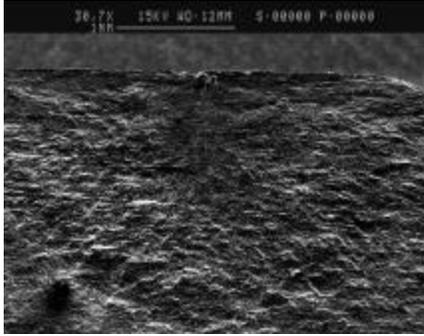
Figure 8 – Typical surface fatigue initiation site on machined 7075-T6 in active corrosion fatigue.

Fractographic analysis revealed that all fatigue failures in specimens without prior LPB, whether exposed to salt fog pitting or active corrosion fatigue, initiated at the surface. A typical surface fatigue initiation site is shown in Figure 8. All salt fog pitted sample initiations were exclusively from corrosion pits, as shown in Figure 9. Specimens tested at lower stresses generally exhibited fatigue origins from a single pit, while specimens tested at higher stress levels tended to have multiple origins.

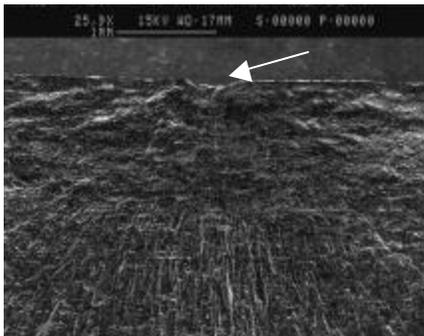
Figure 9 – Fatigue fracture surface of typical machined + 100hr salt fog exposure sample. Arrow indicates fatigue origin at the site of corrosion pit.

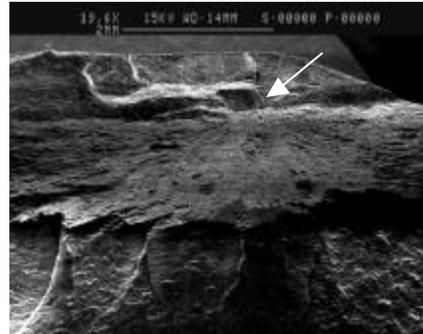
Figure 10 – Subsurface fatigue origin below the compressive layer produced by LPB.

The effect of the layer of high residual compression produced by LPB was to drive fatigue origins below the surface by as much as 1 mm (0.04 to 0.05 in.). All fatigue cracks in the LPB + salt fog pitted samples initiated not at the damaged surface, but subsurface. The subsurface stress in bending simply exceeded the fatigue limit of the material below the compressive layer. A typical subsurface origin is shown in Figure 10. Only one active corrosion fatigue sample failed from the LPB surface. This was at the highest load tested. Subsurface initiation was observed in a previous study of LPB after pitting corrosion damage.¹ As fatigue failures did not originate at the LPB processed surface, the results can be interpreted as demonstrating that the LPB surface has even higher fatigue strength than indicated in this testing.

The subsurface initiations are thought to be associated with the tensile residual stress developed below the compressive layer. The coarse grain size of the material used in this

investigation prohibited direct measurement of the maximum subsurface tensile stress. Finite element analysis and fatigue life modeling are being employed to more thoroughly analyze the subsurface failure mechanism.
