**GEOMORPHIC AND VEGETATIVE RECOVERY
PROCESSES ALONG MODIFIED
STREAM CHANNELS OF WEST TENNESSEE**

Prepared by the
U.S. GEOLOGICAL SURVEY

in cooperation with the
TENNESSEE DEPARTMENT OF TRANSPORTATION

Open-File Report 91-502

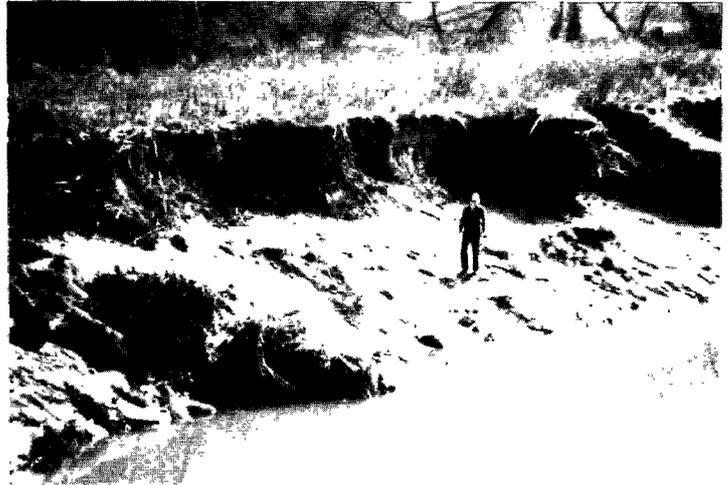
Figure 34.—Typical planar failure, South Fork Obion River (station number 07024550, river mile 11.4, 1984).

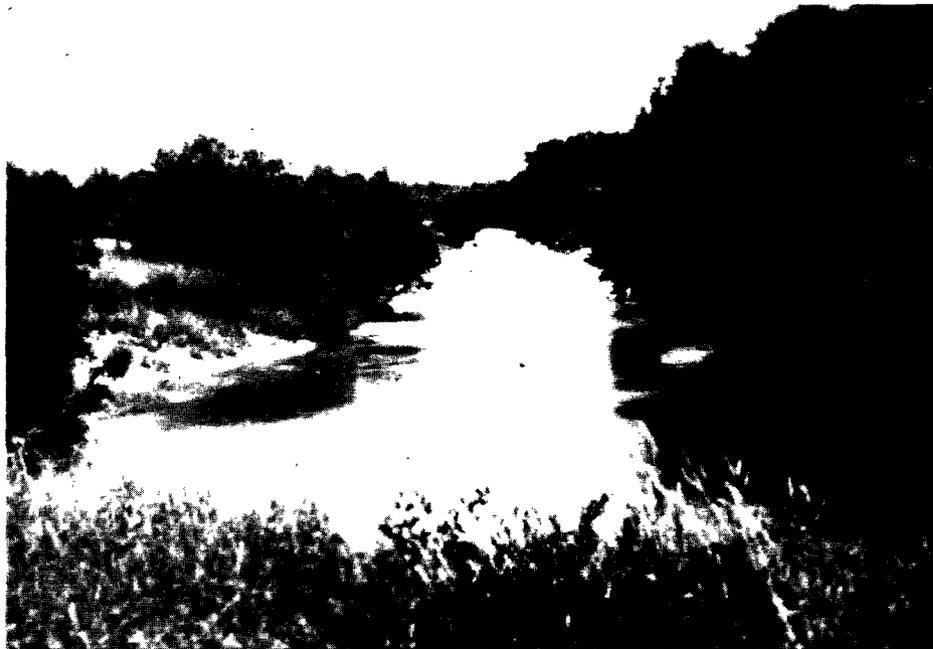
Figure 50.--Point-bar development along a reach during late aggradation stage (stage V), Porters Creek at Hebron, Tenn. (station number 07029445).

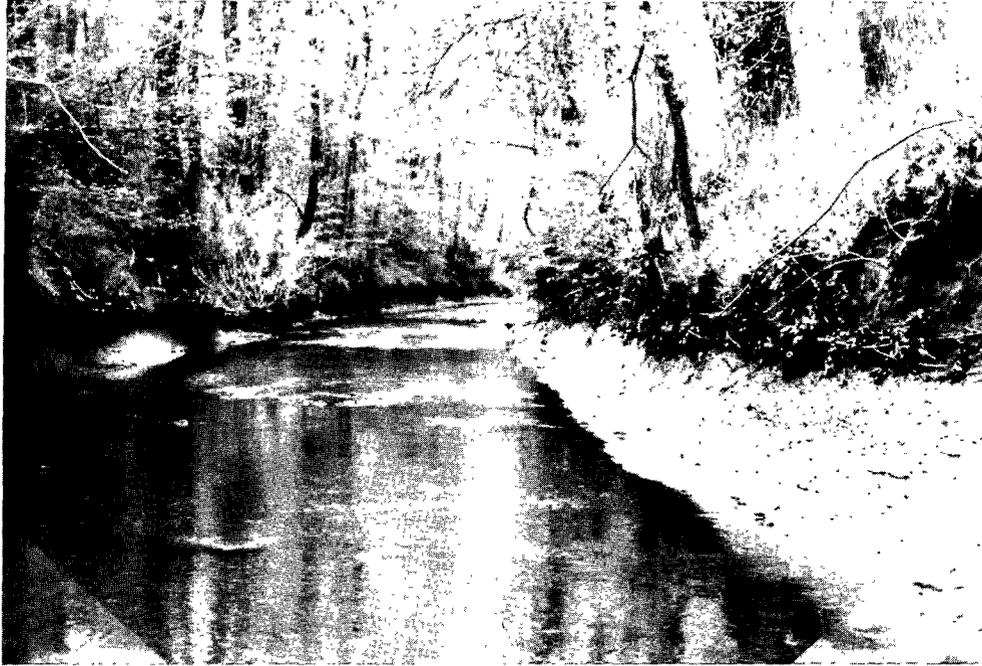
Figure 56.—Upstream view of Davidson Creek near U.S. Highway 51; site is a typical reach during degradation stage (stage III).
