**ENERGY EFFICIENT WINDOW RETROFITS IN HISTORIC FACILITIES**

**Submitted by  
Kent Hendricks  
Department of Construction Management**

**In partial fulfillment of the requirements  
For Degree of Master of Science  
Colorado State University  
Fort Collins, Colorado  
Spring 2006**

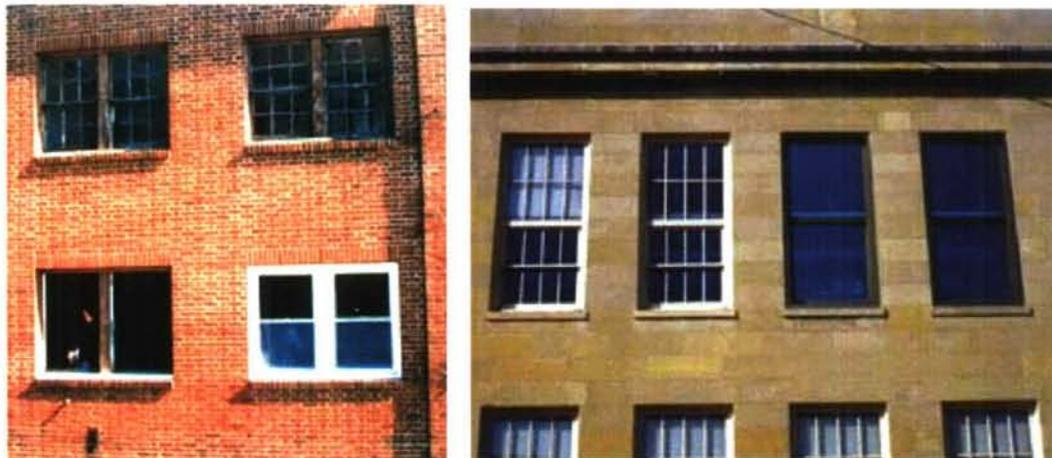
*Figure 1.* Improper window replacements (National Park Service, 1978)

If the overall appearance of the building would be changed noticeably when the windows were removed or radically altered, then the windows are probably significant. In the case of significant windows, replacement in kind is essential in order to maintain the historic character of the building (National Park Service, 1984). See Figure 1 below for examples of improper window replacement resulting in a loss of the buildings' historical character. However, for less

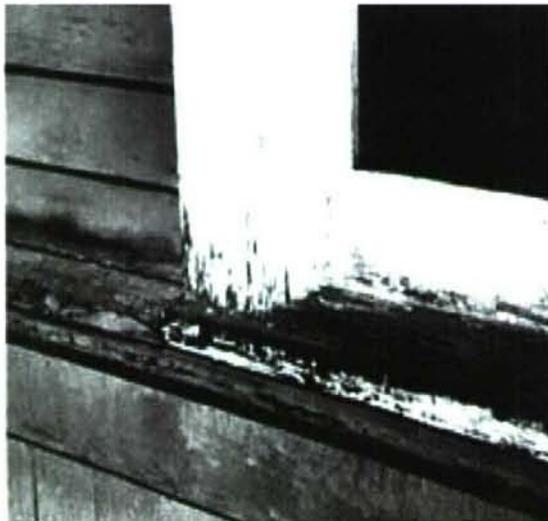
*Figure 2.* Deteriorated wood sill and sash (National Park Service, 1981)

Wooden sash windows often appear seriously deteriorated, but may in fact only need a good cleaning. Deterioration of wood windows begins at the time of installation. Moisture is the primary contributing factor in wooden window deterioration. Water penetration is the most serious cause of deterioration, causing structural damage and affecting the overall appearance of the window (New York Landmarks Conservancy, 1992). One clue to the location of areas of excessive moisture is the condition of the paint; therefore, each window should be examined for areas of paint failure (National Park Service, 1981). Figure 2 below shows an example of deterioration caused by water saturated wood. After noting areas of paint failure, the next step is to inspect the condition of the wood, particularly at the points identified during the paint examination.

Many windows will show some additional degree of physical deterioration, but even badly damaged windows can be repaired using simple processes. Wood which is split, checked or shows signs of rot, can be repaired by drying, treating with a fungicide, waterproofing, and filling cracks and holes with putty, sanding and then repainting (National Park Service, 1981). Wood may also be strengthened and stabilized by consolidation, using semi-rigid epoxies which saturate the porous decayed wood and then harden to restore near original strength.

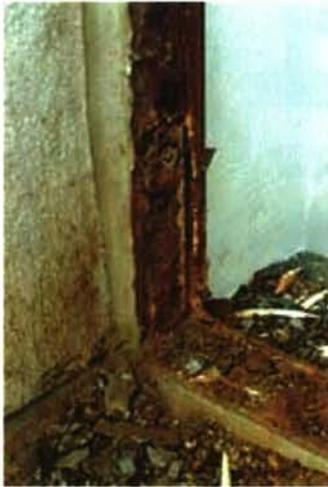
*Figure 3.* Corroded steel window frame (National Park Service, 1984)

deterioration, metal corrosion generally results in a slight increase in the material's mass while at the same time making the metal fragile (New York Landmarks Conservancy, 1992). Metal corrosion occurs whenever there is a failure of the protective paint or other coating and the metal is exposed to oxygen and rainwater on a prolonged basis. Figure 3 below shows corroded metal window frame that can be repaired in place. The presence of bowing or misalignment of metal

sections, the amount of glass needing replacement, and the condition of the masonry or concrete surrounds must be assessed in the evaluation process (National Park Service, 1984). These are key factors in determining whether or not the windows can be repaired in place. Since moisture is the primary cause of corrosion in steel windows, it is essential that excess moisture be eliminated and that the building be made as weather-tight as possible before any other work is undertaken (National Park Service, 1984). Moisture can accumulate from cracks in the masonry, from spalling mortar, from leaking gutters, from air conditioning condensation runoff, and from poorly ventilated interior spaces (National Park Service, 1978).

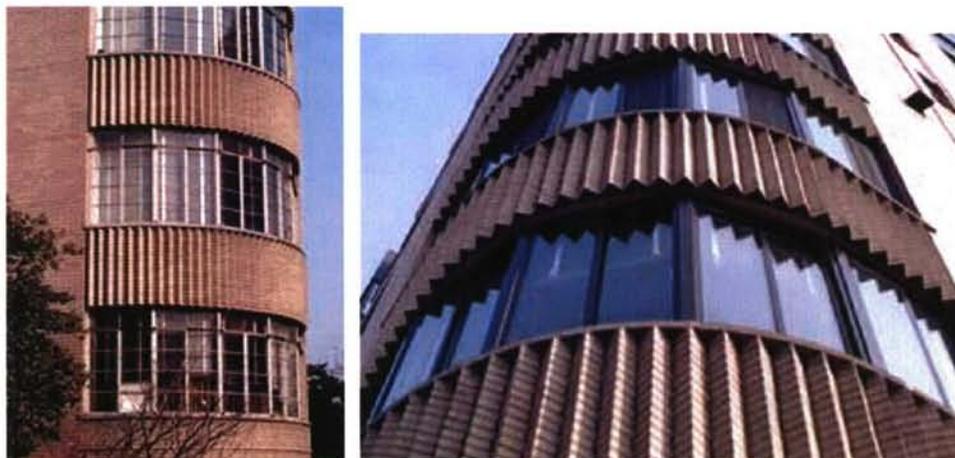
*Figure 4. Improper replacement of metal windows (National Park Service, 1984)*

Replacement should be considered only as a last resort. However, when the extent of deterioration or the unavailability of replacement sections renders repair impossible, replacement of the entire window may be justified. See Figure 4 below for an example of improper replacement of historic metal windows. Windows manufactured from other materials generally cannot match the thin profiles of the rolled steel sections. Aluminum, which is three times weaker than steel, and wooden or vinyl replacement windows generally are not fabricated in the industrial style, nor can they reproduce the thin profiles of the rolled steel sections, and consequently are generally not acceptable replacements (National Park Service, 1978). A number of metal window manufacturing companies produce rolled steel windows and most can reproduce the historic configuration (National Park Service, 1984). Additionally, some manufacturers still carry the standard pre-World War II multi-light windows using the traditional 12 inch by 18 inch or 14 inch by 20 inch glass sizes (National Park Service, 1984, p. 13).

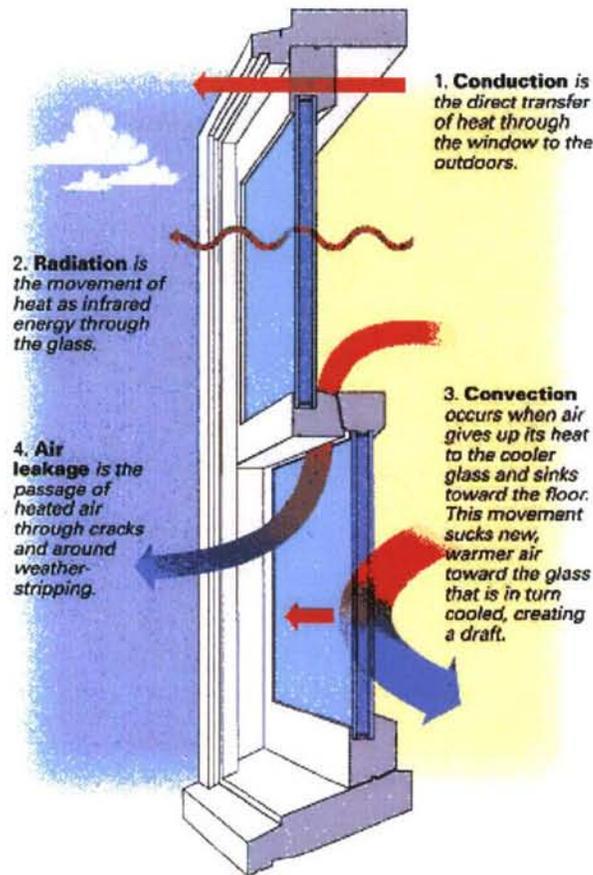
Figure 5. Window heat transfer methods (Fisette, 1998)

Many historic buildings have energy saving physical features and devices that contribute to good thermal performance. Studies by the Energy Research and Development Administration show that the buildings with the poorest energy efficiency are actually those built between 1940 and 1975 (National Park Service, 1978). Older buildings were found to use less energy for heating and cooling and hence probably require fewer weatherization improvements (National Park Service, 1978). Historic buildings usually use less energy because they were built with a well-developed sense of physical comfort and because they maximized the natural sources of heating, lighting and ventilation. The most obvious inherent energy saving characteristic was the use of operable windows to provide natural ventilation and light. To minimize the heat gain or loss from windows, historic buildings often include interior or exterior shutters, interior venetian blinds, curtains and drapes, or exterior awnings (Haynes, 1987). Windows lose and gain heat by conduction, radiation, convection, and air infiltration. Some of these qualities can be improved by a single improvement, but a combination of methods may be necessary to improve the overall thermal properties of particular historic windows. Each heat transfer method is depicted in Figure 5.

Heat flow from the warmer side to the colder side of a window and frame is a complex interaction of all the heat transfer mechanisms described above. The ability of a window assembly to resist heat transfer is referred to as its insulating value (Carmody et al., 1996). Heat flows from warmer to cooler bodies, thus from inside to outside in winter, and reverses direction in the summer months. The R-value is a resistance measure of the insulating qualities of the materials of which a wall or window is made. The higher the R-value the less heat is transferred or lost through a surface in winter. The material thickness of a surface as well as air space between surfaces and insulating materials inserted into an air space contribute to the R-value (Carmody, et al, 1996). Thermal blankets and blown in fiberglass insulation is often added to walls and ceilings to increase the R-value.

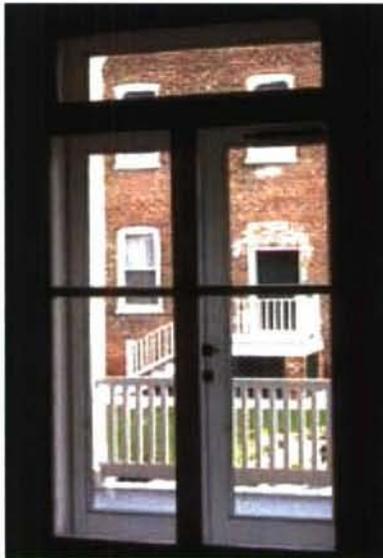
*Figure 6.* Interior storm windows (National Park Service, 1978)

The decision to place storm windows on the inside or outside of the window depends on whether the window opens in or out, and on the visual impact of adding storm windows either on the exterior or interior appearance. Interior storm window installations can be as thermally effective as exterior storm windows; however, there is high potential for damage to the historic window and sill from condensation (Barista, 2001). Figure 6 above shows an example of interior storm windows installed on historic single pane windows. Condensation occurs when the glass temperature falls below the dew point of the room air temperature. With storm windows on the interior, the outer historic sash will be cold in the winter, and hence moisture may condense there. This condensation often collects on the flat surface of the sash or window sill causing paint to blister and the wood deterioration to begin.

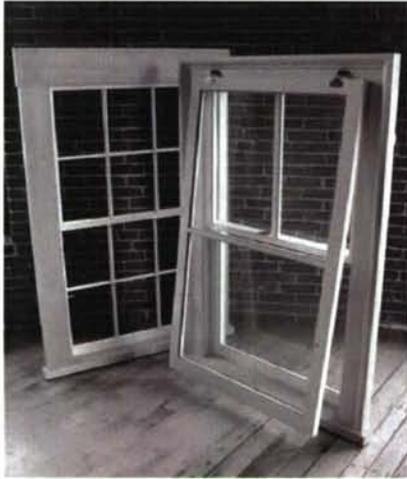
Figure 7. Exterior storm windows (lowes, 2005)

The use of exterior storm windows should be investigated whenever feasible because they are thermally efficient, cost-effective, reversible, and allow for the retention of the original windows (National Park Service, 1981). Colors should be selected so that they match the existing trim color. Various configurations are available, even arched, in wood, vinyl, aluminum, or plastic. In addition to energy savings, external storm windows provide a layer of protection against air pollutants and vandals. Usually external storm windows partially obscure the prime historic window, but the storm window can always be removed during favorable weather seasons to expose the full view of the prime window. See Figure 7 for an example of exterior storm windows.

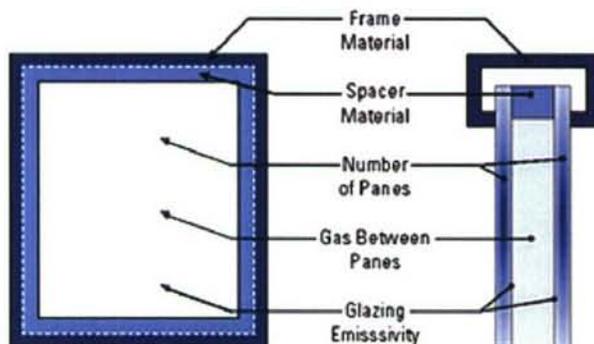
Figure 8. Factors affecting window thermal performance (wbdg, 2005)

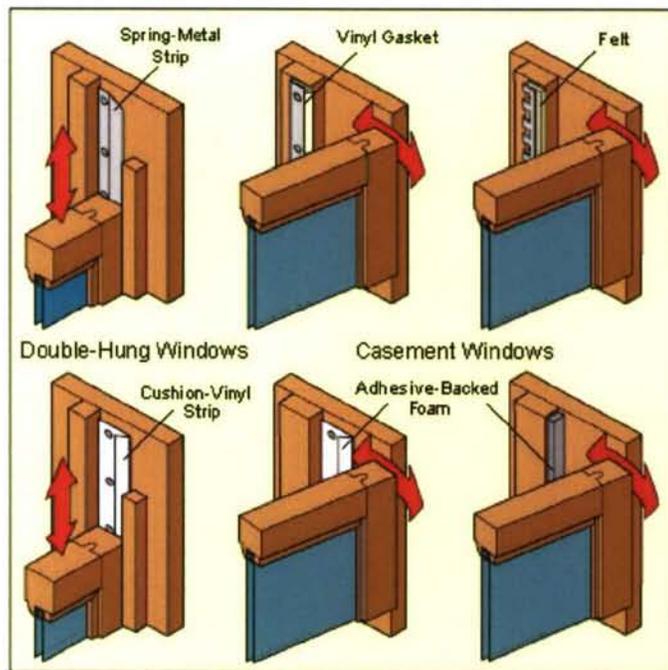
Figure 9. Examples of weatherstripping (aboutsavingheat, 2005)

Historic metal and some wooden windows are generally not energy efficient; this has often led to their wholesale replacement (National Park Service, 1984). Historic windows can, however, be made more energy efficient in several ways. Caulking and periodically repairing the caulking, around the masonry openings and adding weatherstripping are important first steps in reducing air infiltration around the windows (Ivy, 1992). Although weatherstripping is one of the least expensive components of a window, it can be responsible for as much as 50 percent of the window's energy performance (New York Landmarks Conservancy, 1992). The four common types of weatherstripping are spring-metal, vinyl strips, compressible foam tapes, and sealant beads (National Park Service, 1984). See Figure 9 for examples of weatherstripping.

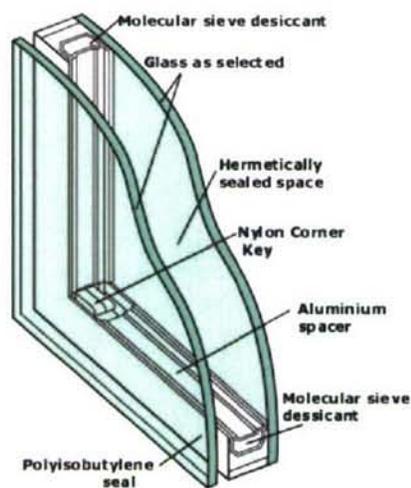
Figure 10. Hermetically sealed double-glazing (pilkington, 2005)

of the windows; therefore, cost and aesthetic considerations usually determine the choice of method (National Park Service, 1984). The least expensive method is to install a clear material, such as rigid sheets of acrylic or glass, over the existing single pane window (Historic Preservation Education Foundation, 1997). The entire window opening can be covered in this manner or on a smaller unit basis with panels that affix to the sash with screws or gaskets. Condensation can be avoided by providing a small 1/8 inch opening at the top corner as a vapor bleed (New York Landmarks Conservancy, 1992). Single glazed window panels can be replaced with thermal glass or a secondary glazing can be applied. See Figure 10 below for example of double-glazing applied to existing window.

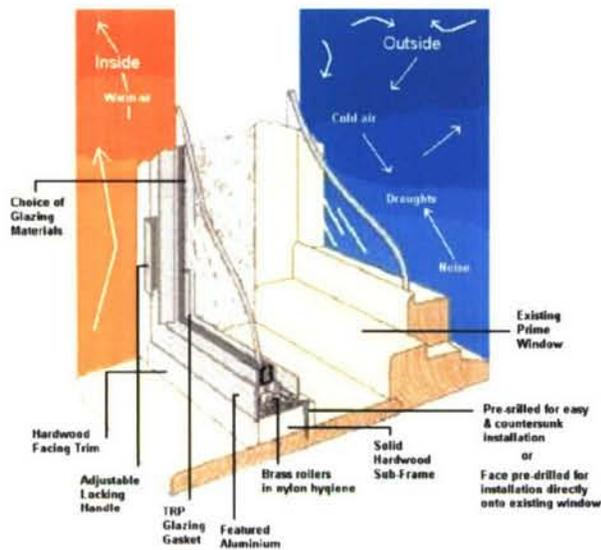
Figure 11. Interior double-glazing added to existing window (protechwindows, 2005)

Unfortunately, a common weatherization measure, especially in larger buildings, has been the replacement of historic windows with modern double paned windows (National Park Service, 1978). As stated in the previous section adding exterior storm windows is a viable alternative to replacing the historic windows and it is the recommended approach in preservation retrofitting. However, if the historic windows are severely deteriorated and their repair would be impractical, or economically infeasible, then replacement windows may be warranted. The new windows, of either wood or metal, should closely match the historic windows in size, number of panes, muntin shape, frame, color and reflective qualities of the glass (Haynes, 1987).

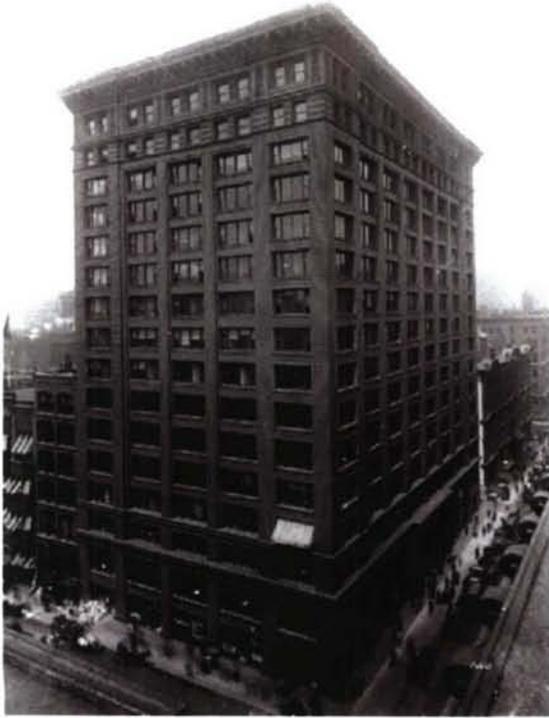
*Figure 12.* Marquette Building, Chicago circa 1895 (gsa, 2006)

The 16-story Marquette Building, constructed in 1895, is one of Chicago's finest commercial buildings and is listed in the National Register of Historic Places. In the 1970's the occupancy rate fell to ten percent, and the decision was made in 1978 to renovate the building for prime office and retail space in Chicago's Loop (gsa, 2006). The modified Chicago-style windows, which fill the bays between the structural piers, are one of the most prominent features of the building's facade. Nearly 350 double-hung windows principally on the upper three floors and throughout the northern facade facing on an alley, the 182 Chicago-style windows were of greatest interest because of their style, prominence, and large size (gsa, 2006). See Figure 12 below for Chicago-style and double-hung windows. Although the windows vary in size, most measured about 12 feet wide by 8 feet high. Constructed out of quality mahogany, the windows were still in sound physical condition despite over ninety years of exposure to Chicago's winter weather and years of neglect due to deferred maintenance. While some of the sills needed repair, the windows primarily needed to be repainted and to have some interior trim replaced.

In conjunction with a heating, ventilating, and air-conditioning (HVAC) analysis, the following three window alternatives were considered: a) repairing the existing windows and fixing them closed due to HVAC system, b) modifying the existing windows by installing insulated glazing for improved thermal performance, or c) replacing the existing windows with high-quality, aluminum units with insulating glass that matched the appearance of the original (gsa, 2006).

The estimated cost of repairing the windows was \$65,000, including the repair and reinstallation of fixed frames and glass in 28 windows where a material hoist and trash chutes were locating during the rehabilitation. The second alternative of modifying the existing sash examined the cost-effectiveness of installing insulated glazing in both the existing fixed panes and the double-hung sash throughout the building. This window work would achieve further savings by reducing energy consumption and permitting installation of a small HVAC system.

After an in-depth study of the repair, modifications, and replacement alternatives in which such factors as energy costs, construction costs, and finance charges were considered, the architect and owners determined that the most cost-effective solution was to repair the existing windows. Assuming the worst conditions for infiltration, insulating glass would have resulted at best in energy savings of 10 percent in heating costs and 15 percent reduction in cooling costs (gsa, 2006). Building management decided to save the money since there was a long, almost nonexistent pay back. Total rehabilitation cost was \$17,000,000 and the window repair cost, exclusive of the storefronts was \$65,000 (gsa, 2006).

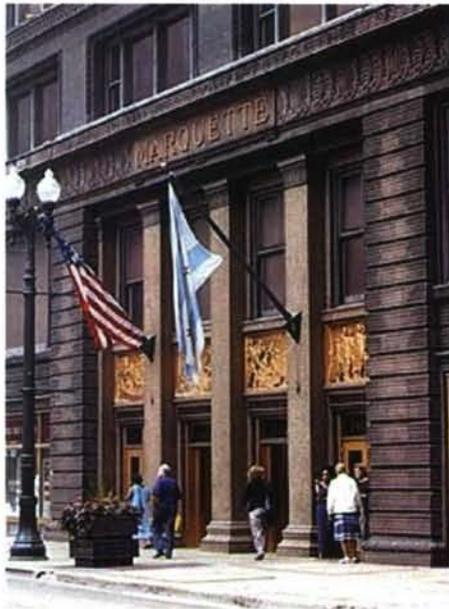
*Figure 13.* Marquette Building storefront (gsa, 2006)

Construction costs, however, were estimated to be \$860,000. The estimated cost of aluminum replacement windows that matched the appearance, size and configuration of the existing windows was nearly \$1,600,000 (gsa, 2006). See Figure 13 showing entrance to the Marquette Building after completion of the renovation project.
