# USATHAMA

## Report of Sampling and Analysis Results

Clementon Army Housing Units  
Clementon, New Jersey

April 1991

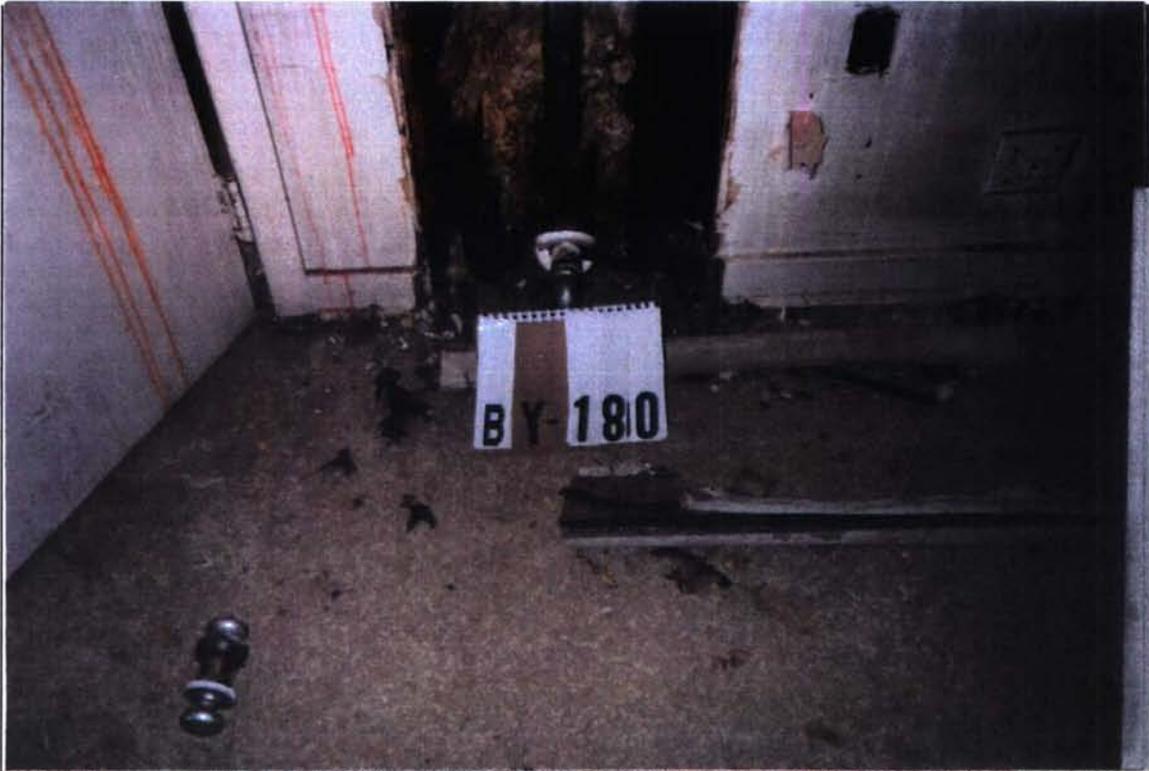
Each of the units was inspected to determine if suspect materials were present. The pipe runs for the domestic water supply system in the units were once insulated with a corrugated paper, air-cell type insulation. Due to extensive vandalism and theft of copper water pipes from all of the units, the pipe run insulation is in very poor condition (See Figures 2.1 and 2.2). Six samples of pipe run insulation were collected for analysis. The pipe run insulation is friable, as defined in the United States Environmental Protection Agency (EPA) regulations, meaning that it can be crushed, crumbled, pulverized, or otherwise reduced to a powder using hand pressure. Friable asbestos-containing materials (ACM) are considered to be more hazardous than non-friable ACM since they are much more likely to release asbestos fibers. Because of its friability and instances of damage, the pipe run insulation is considered to be the most hazardous type of ACM in the Clementon FHU.

FIGURE 2.1 PIPE RUN INSULATION IN THE KITCHEN OF UNIT 320

Analytical results of the pipe run insulation confirmed that asbestos is present in all of the samples taken. All of the asbestos-containing pipe run insulation should be removed prior to renovation or demolition of the units, to comply with the NESHAP provisions. This work must be done by workers trained in asbestos abatement procedures. The material appears to be damaged to a degree that repair and management under an Operations and Maintenance (O&M) program is not a viable option.

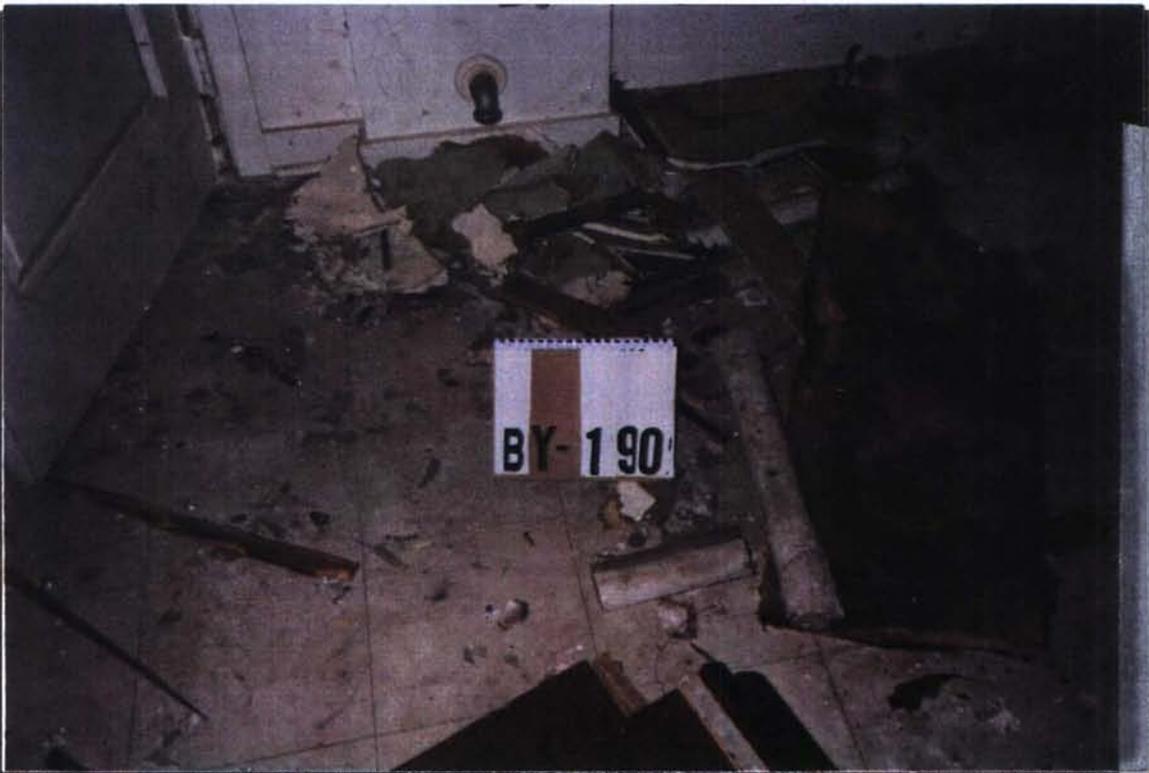
FIGURE 2.2 PIPE RUN INSULATION IN THE KITCHEN OF UNIT 311
