LBP Concerns in Producing Recycled Concrete Aggregate from Former Fort Ord Family Housing

Stephen D. Cospers

January 2007

Final report

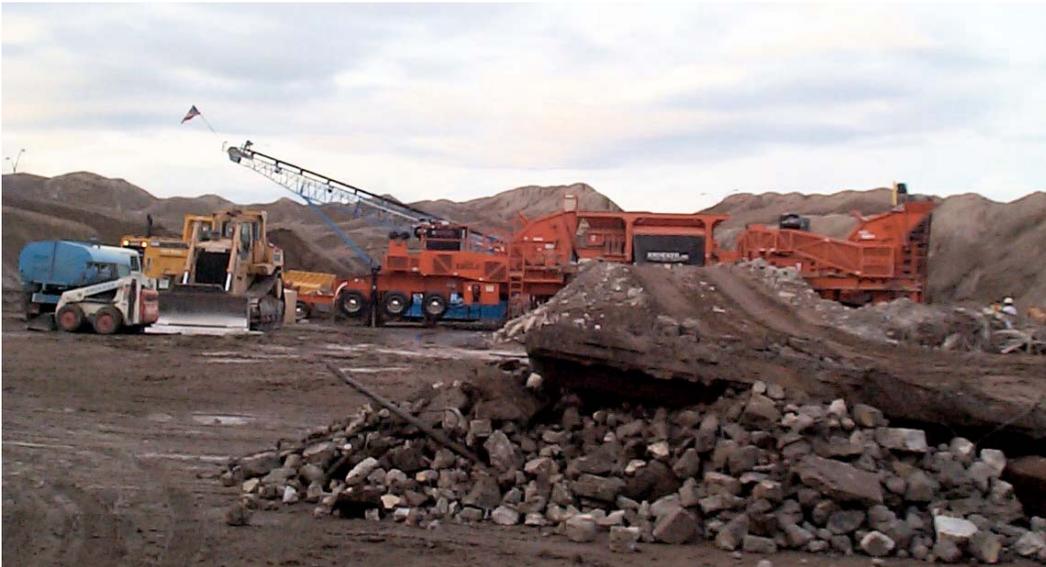
Figure 1. Overview of crusher plant.

Kroeker used an Eagle Crusher, Model CV 1400; an Eagle triple deck screen, Model 65D006; and associated conveyors. Go to the Eagle website <http://www.eaglecruser.com/?articleid=73> for an article with more specifics. Figure 1 shows the crusher plant in operation.

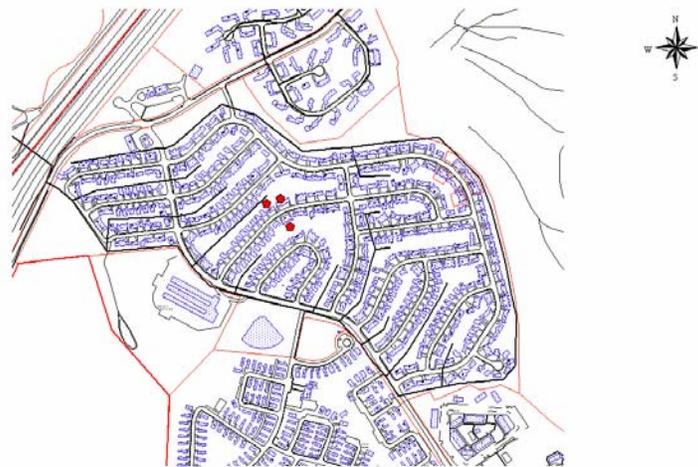
Figure 2. Hayes Park Army family housing.

Buildings 8039, 8040 & 8062
Hayes Park, Former Fort Ord

Three sample structures were chosen to study their LBP content. They were some of the last units to be demolished under the redevelopment project, and had already been stripped down to concrete walls. Two of these were duplex family housing units. The addresses were 223, 225-227, and 226-228 Napier Street. Figure 2 shows a map of the Hayes Park neighborhood. The numbers on the map are the Army real property building numbers. This report uses the common street addresses. Figure 3 shows a typical building in this neighborhood.

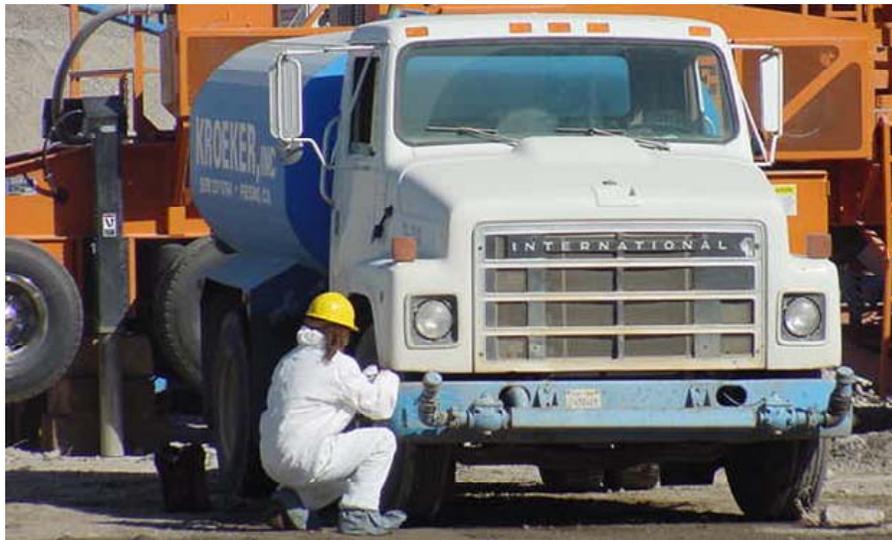
Figure 4. Dust wipe sampling.

sults of Pb wipe samples at the crusher site. Figure 4 shows a CCC staff member taking a wipe sample from a truck at the crusher site.

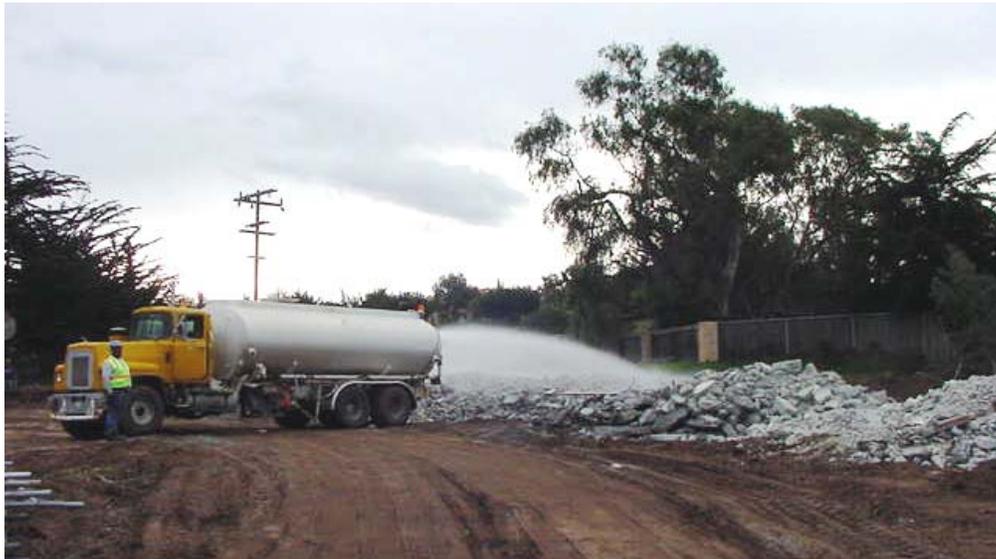
Figure 6. Dust control truck.

As evident from the results in Table 5, between the Contractor's use of water spray from tanker trucks for dust control (Figure 6), and the heavy, humid air of the rainy season conditions, the levels of air-borne, lead-laden dust were below normally detectable levels. These combined factors produce a very low risk of worker exposure to lead-laden dust at the demolition site.

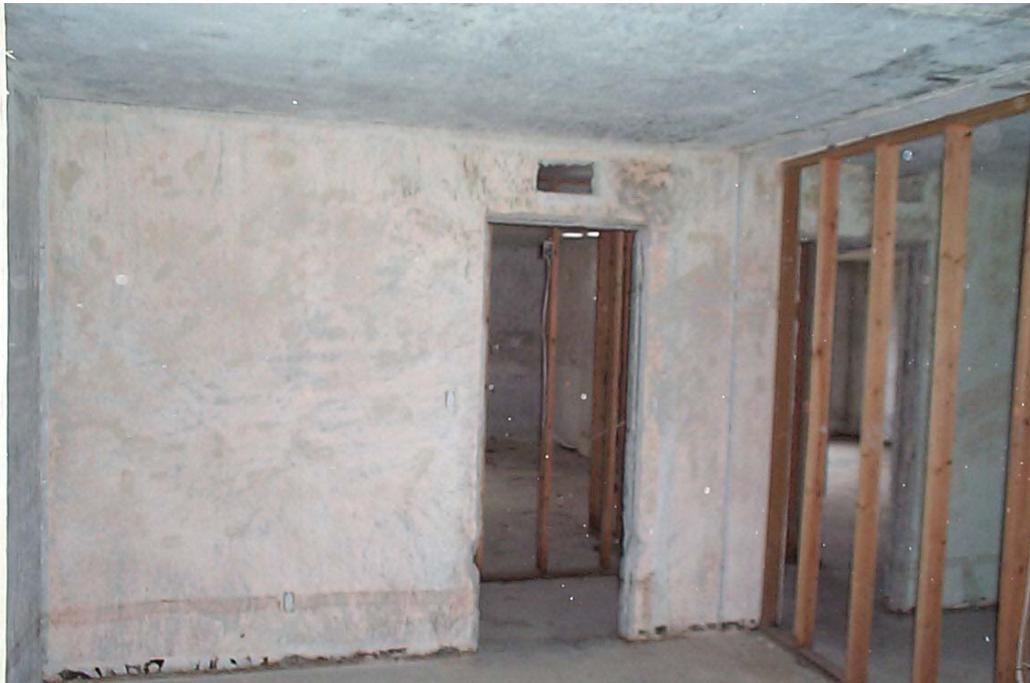
Figure 7. Remaining coating on interior walls.

As mentioned previously, interior paints had an asbestos component, as well as Pb content. Because of the asbestos, all interior wall surfaces were scraped, and most walls were covered in a sealant material, which is a sign of abatement completion. Some paint still remained on interior walls (Figure 7), and exterior paint remained intact. CCC sampled all wall surfaces for Pb content. The purpose was to help calculate the overall Pb content of the structures. CERL also took concrete samples, as described in the next section. The results of the Pb content of the paint samples are included in Table 7.

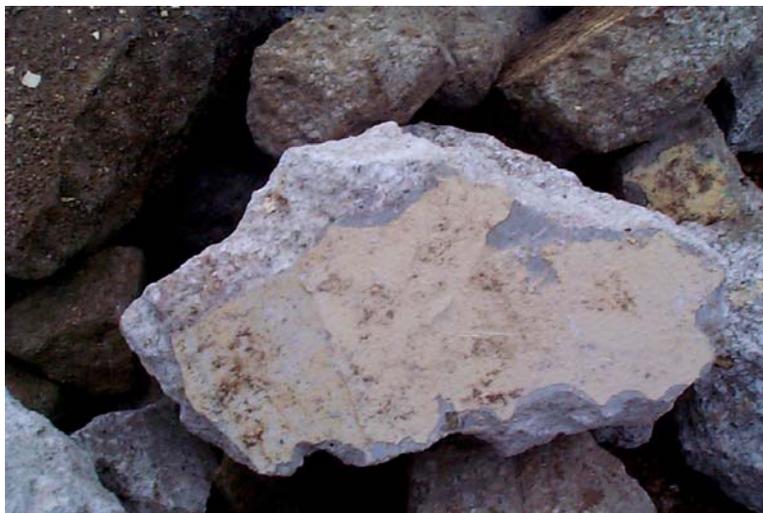
Figure 8. Painted concrete piece.

In addition to the CCC paint samples described in the previous section, CERL also took several samples for Pb analysis from the housing site and the crusher site. These samples represented the range of materials (Figure 9 for example) that would be combined at the crusher site to produce the recycled concrete aggregate (Figure 9) for use as road base and other products. CERL took 34 samples, and subjected them to various combinations of Pb analysis. Table 9 summarizes analytical results from these samples.

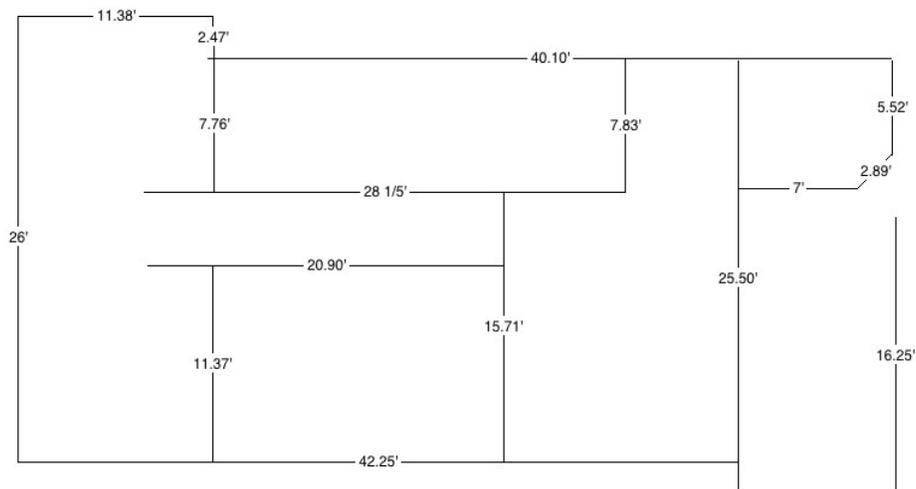
Figure 10. Line drawing of 223 Napier Street.

Figures 10, 11, and 12 show line drawings of buildings 223, 224, and 225 Napier Street based on field measurements. House 224 is half of a duplex with 226; 225 is duplexed with 227. Each side is a mirror image. It is assumed that paint measurements for building 224 will be valid for 226.

Based on Figures 10–12 and some design assumptions for residential-scale construction, CERL developed surface area models for each of the three structures, as summarized in Table 10. Mass calculations are highlighted.

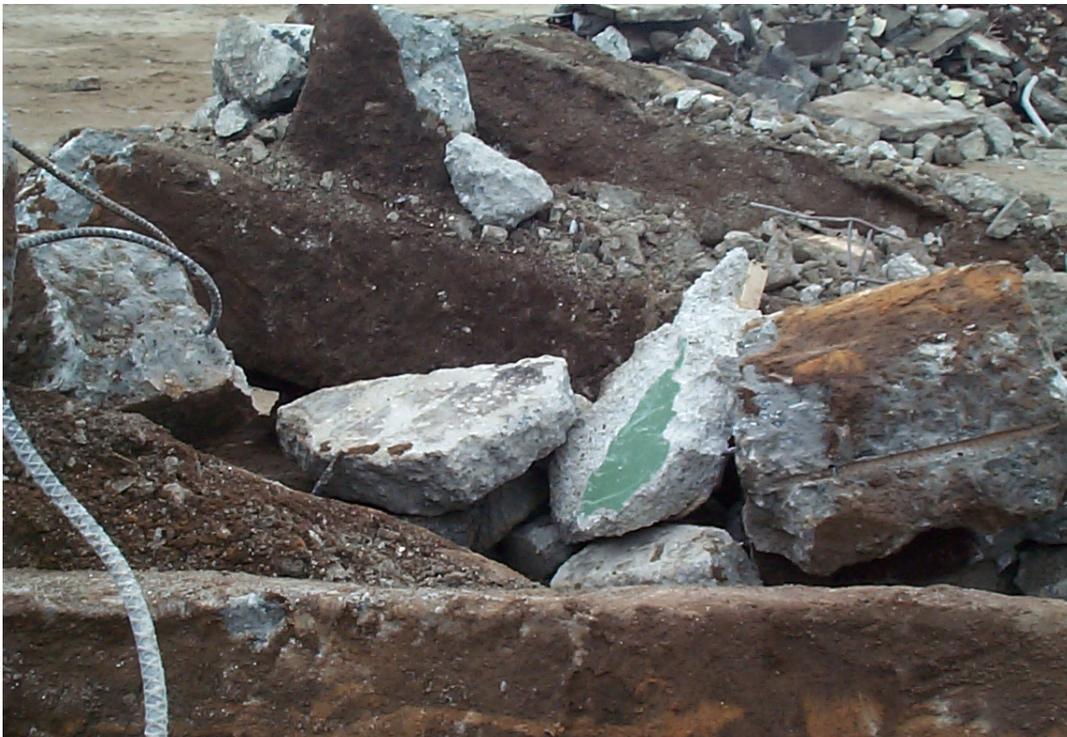
Figure 13. LBP covered concrete in mixed debris pile.

To perform total Pb analysis, an environmental chemistry laboratory requires only a few grams of material. A representative sample from a concrete demolition project might be several kilograms. The problem arises when trying to prepare a representative subsample. This is a long recognized problem with determining overall Pb concentration for building debris when trying to take representative samples for TCLP for RCRA hazardous waste determination (Figure 13).

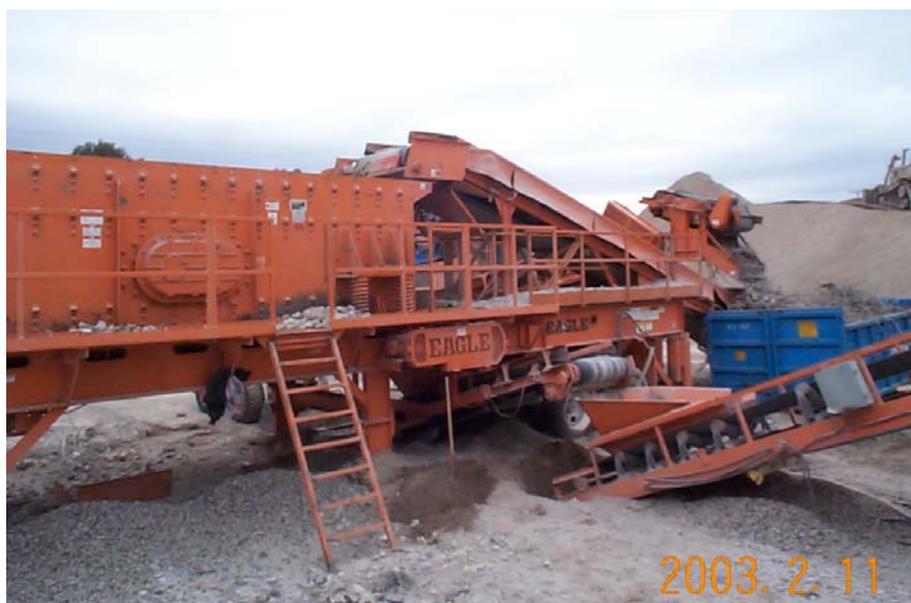
Figure 14. Fines sample location.

Three samples of fines from under the crusher were taken one evening as the crew was cleaning up. The average total Pb concentration was 111 ppm. It appears that this type of location is a major sink for LBP particles (Figure 14). Through the crushing process, loose paint flakes off and enters the fines waste stream. The Pb concentration in the fines is below the USEPA limit for Pb-in-soil for residential application. Because the fines are respirable as workers move around and clean up, appropriate personal protective equipment is recommended. CERL performed TCLP for Pb on the two samples with the highest total Pb (160 and 130 ppm). As with the crushed RCA product, the result was less than 0.01 ppm. The Pb in the fines would

be expected to be more “leachable” because more surface area is exposed to interaction with the acid test solution. However, much more concrete surface area is also exposed, which will neutralize the extracting solution.
