Experimental investigation of the strength of damaged pressure hulls – Phase 1

J. R. MacKay

Defence R&D Canada – Atlantic

Technical Memorandum
DRDC Atlantic TM 2006-304
February 2007

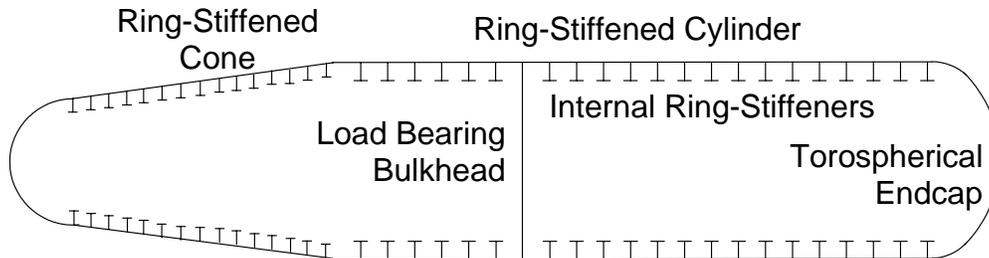
Figure 1. Typical pressure hull structure

Pressure hulls are primarily designed to withstand hydrostatic pressure through compressive stressing of the structure. Circular geometries are best suited to efficiently resist pressure hull design loads. Consequently, pressure hulls are typically composed of a continuous series of ring-stiffened cylinders and cones. These are separated into compartments by load-bearing watertight bulkheads, and terminated on either end by hemi- or toro-spherical domes (Figure 1).

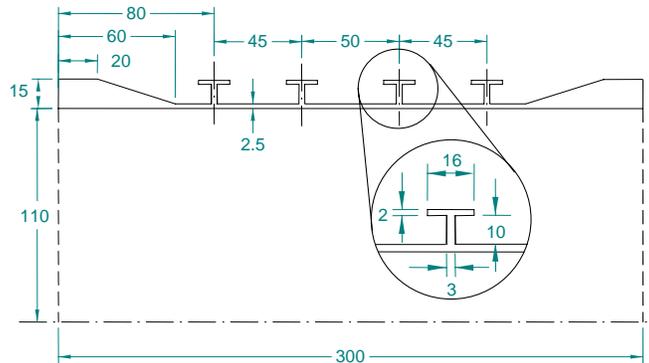
Figure 2. Basic geometry of short cylinder (mm)

The short cylinders were designed to fail locally in an interframe collapse mechanism. The design geometry for the undamaged (i.e. no simulated corrosion) short cylinders is shown in Figure 2. The short cylinders were stiffened with external T-section rings, which were proportioned to be relatively stiff compared with the shell in order to force failure to occur in the shell through a combination of material yielding and lobar buckling (Figure 3). The stiffener spacing was specified to be greatest in the central bay to encourage failure at this location. The cylinders had thick end rings that tapered gradually to the mean shell thickness to prevent end-bay failure.

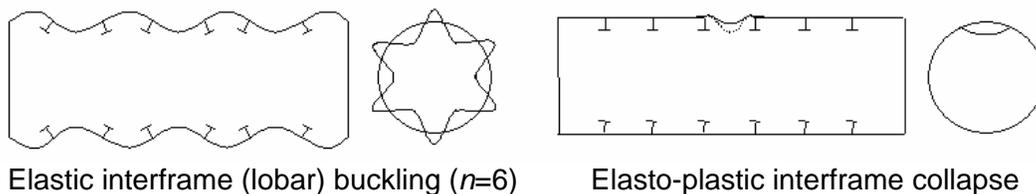
Figure 3. Interframe collapse modes

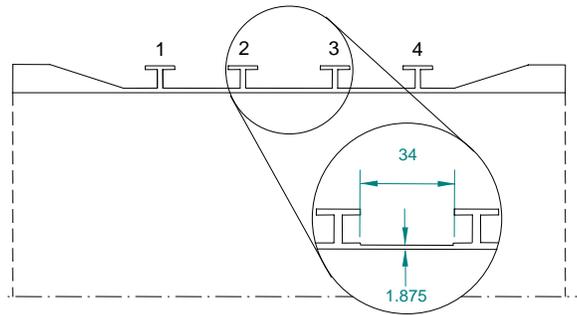
Figure 4. Short cylinder with uniform shell corrosion at mid bay (with frame numbers)

Corrosion damage in real pressure hull structures, if not repaired by clad welding or replacement, is treated by grinding away the corroded material. The net effect of corrosion damage followed by grinding was simulated by machining away the shell material to produce a square area of uniformly reduced thickness on the outside of the middle bay of a short cylinder (Figure 4 and Figure 5). The region of corrosion was nominally 34 x 34 mm in area and 0.625 mm in depth (approximately 25% of the shell thickness). Two short cylinders with simulated corrosion were manufactured: the first (L300-No3) was instrumented with strain gauges, and the second (L300-No4) was not instrumented.

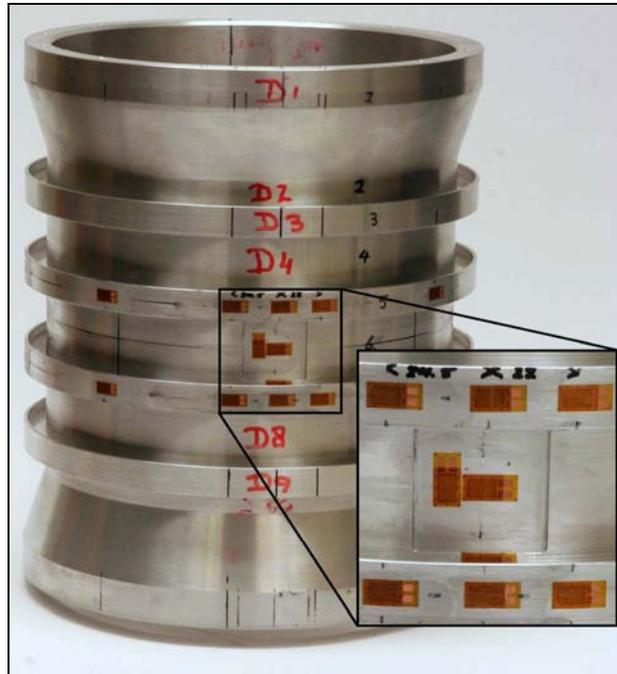
Figure 5. Photograph of short cylinder (L300-No3) with shell corrosion at mid bay

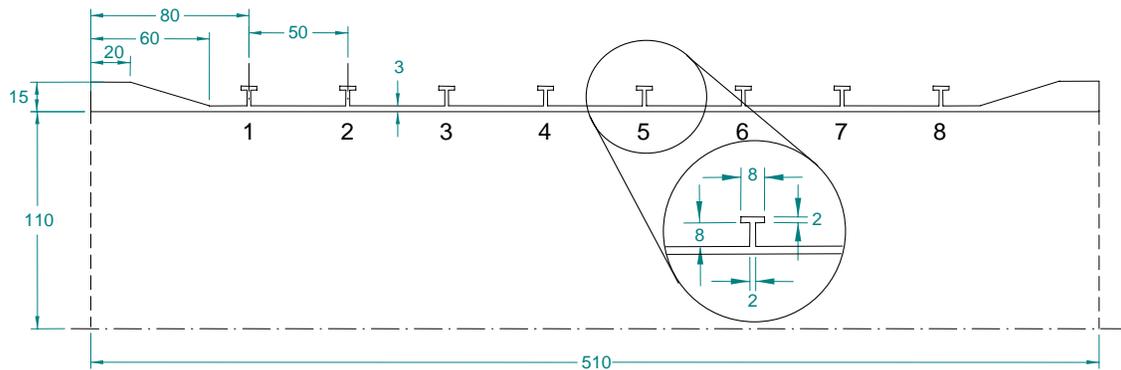
Figure 7. Basic geometry of long cylinder (mm) with stiffener numbers

The design geometry for the undamaged long cylinders is shown in Figure 7. The long cylinders were also stiffened with external T-section rings, which were proportioned to be relatively weak compared with the shell in order to favour overall collapse. The stiffener spacing was uniform over the length of the cylinder. These cylinders also had thick end rings to prevent end-bay failure. A single undamaged long cylinder (L510-No1) was manufactured and instrumented with strain gauges (Section 2.6.2).

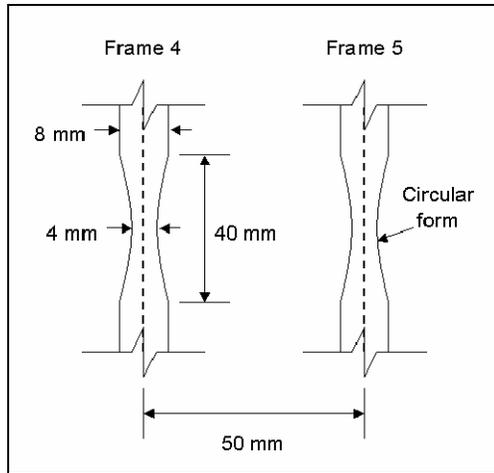
Figure 8. 'Dog-bone' flange corrosion on long cylinder

Corrosion was simulated in two long cylinders by machining away material from the two central stiffener flanges to produce a ‘dog-bone’ type pattern (Figure 8 and Figure 9). The corrosion was located at a single circumferential location, and was intended to induce overall collapse by instigating an early onset of yield in the corroded region of the stiffener flange due to the reduced section area.

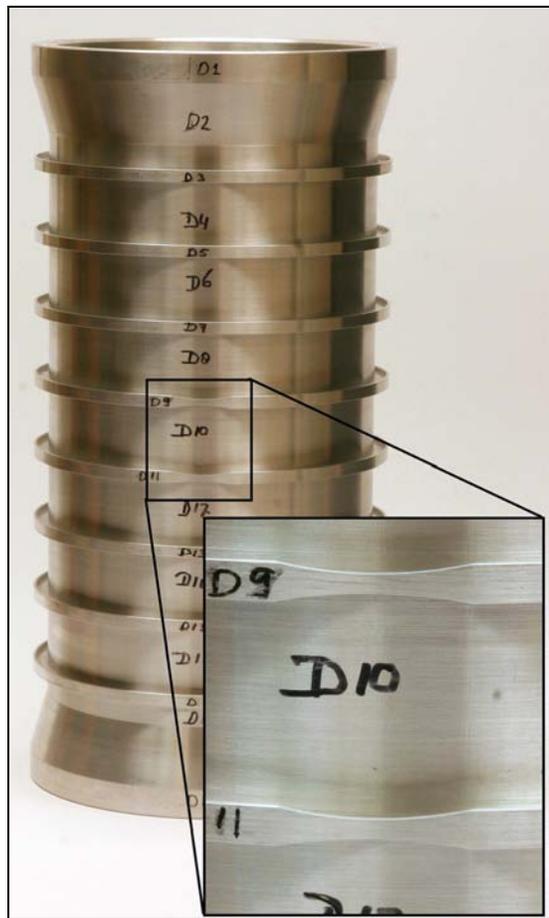
Figure 9. Photograph of long cylinder with 'dog-bone' flange corrosion

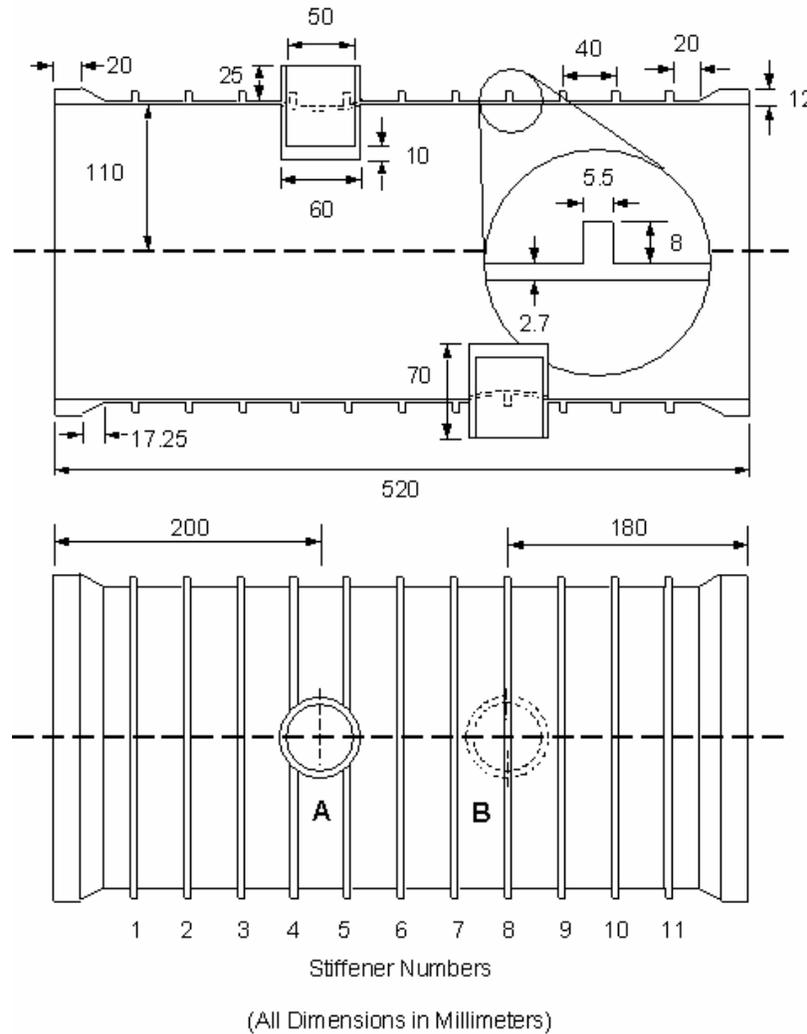
Figure 10. Geometry of cylinder with penetrations

The cylinder with penetrations was designed to fail by overall collapse. The design geometry for this cylinder is shown in Figure 10. The cylinder was approximately the same length and radius as the long cylinders described in Section 2.2.2, with two important differences: 1) the cylinder was stiffened with external rectangular section rings rather than T-sections, and 2) the cylinder had two stiffened penetrations instead of simulated corrosion.

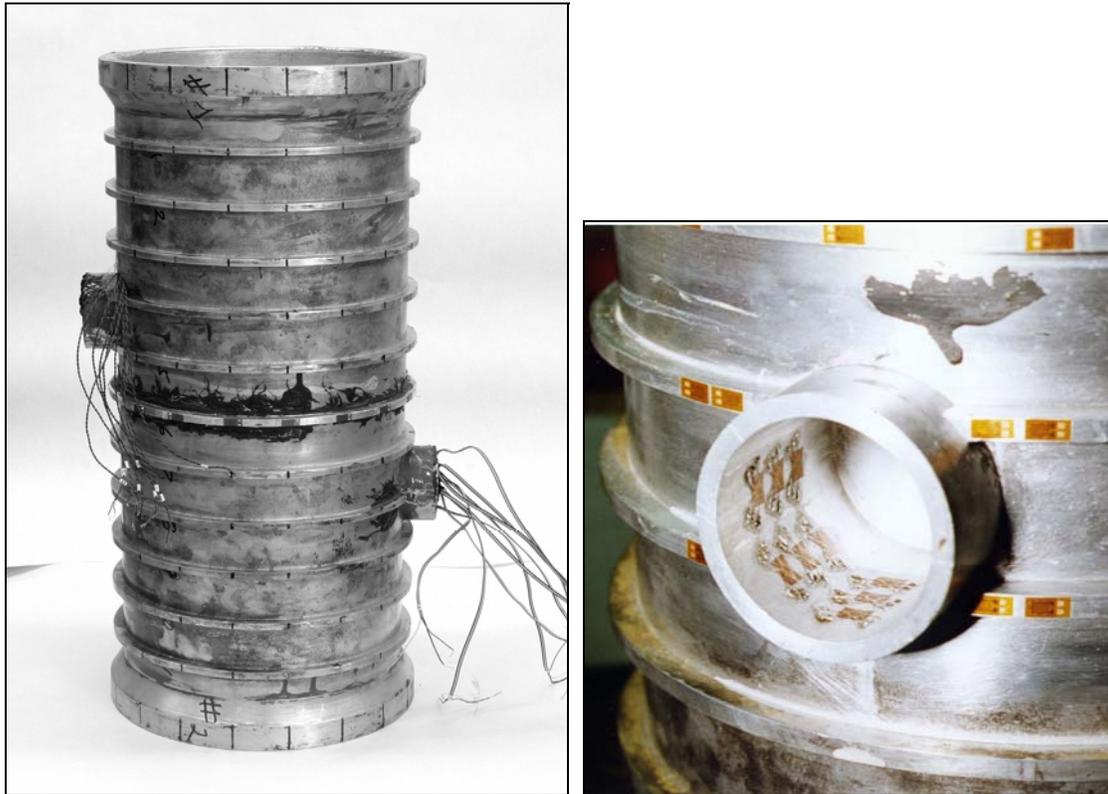
Figure 11. Photograph of cylinder with penetrations and close-up of crown penetration (A)

One penetration (A) was located at the crown (0°) and intersects stiffeners S4 and S5, and the other penetration (B) was at the keel (180°), intersecting stiffener S8 only (see Figure 10). The penetrations were reinforced by relatively stiff conning-tower-like structures (Figure 11), which were soldered to the cylinder shell. The conning towers were meant to simulate the behaviour of reinforced penetration structures in real pressure hulls, as well as to keep the penetrations sealed under external hydrostatic pressure.

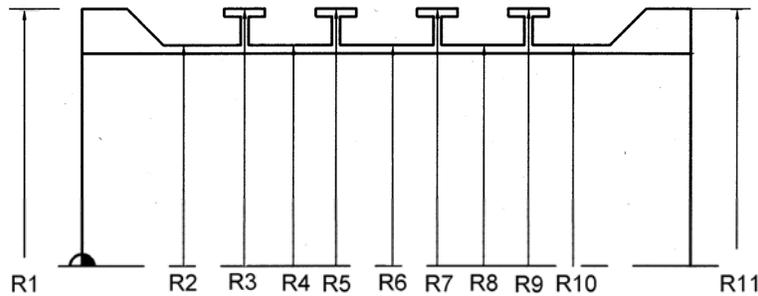
Figure 12. Schematic drawing of OOC measurement locations for short cylinders

For the short cylinders, OOC was quantified by taking radial measurements at eleven axial locations (Figure 12). At each axial location, 36 equally spaced measurements were taken about the circumference (10° increments). Exclusively outer radii were measured for all axial locations except the central bay (R6), where inner radii were also determined to allow the shell thickness to be estimated (see Section 2.4). Radial measurements were taken using the Zeiss UMM550 coordinate-measuring machine, which had a precision of 0.001 mm. Maximum eccentricity at each axial measurement location is reported for each specimen, as well as Fourier amplitudes up to and including wave number $n=18$ ($N/2$).

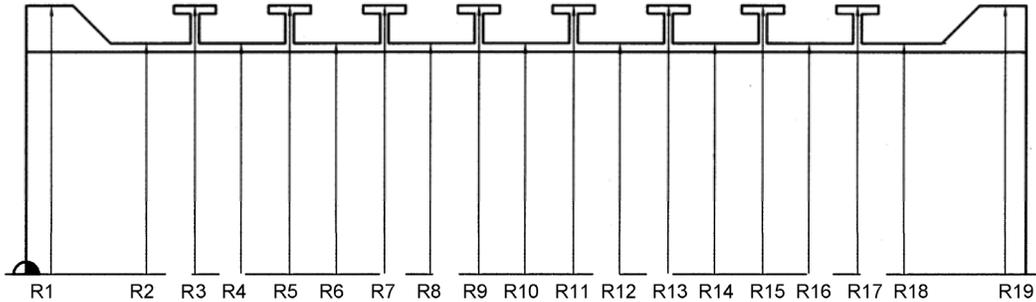
Figure 13. Schematic drawing of OOC measurement locations for long cylinders

Out-of-circularity for the long cylinders was measured in a similar manner to that used for the short specimens. Radial measurements were taken at nineteen axial locations (Figure 13). Only outer radii were measured at all axial locations except the central bay (R10), where inner radii were also measured to allow the shell thickness to be estimated (see Section 2.4).

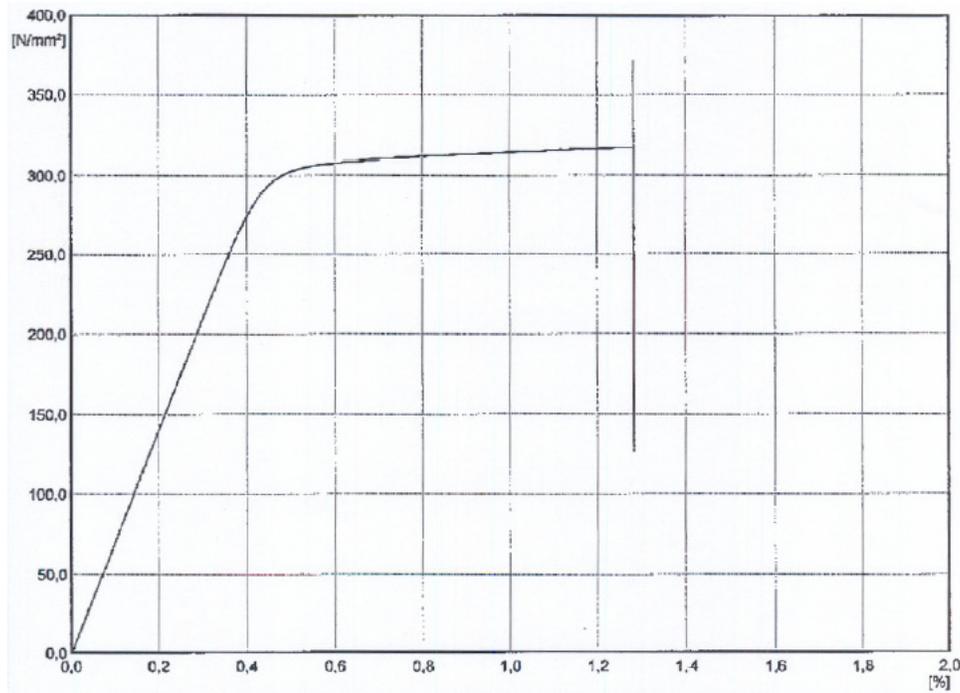
Figure 14. Typical stress-strain relationship for T-stiffened cylinders (coupon No. 1966-3)

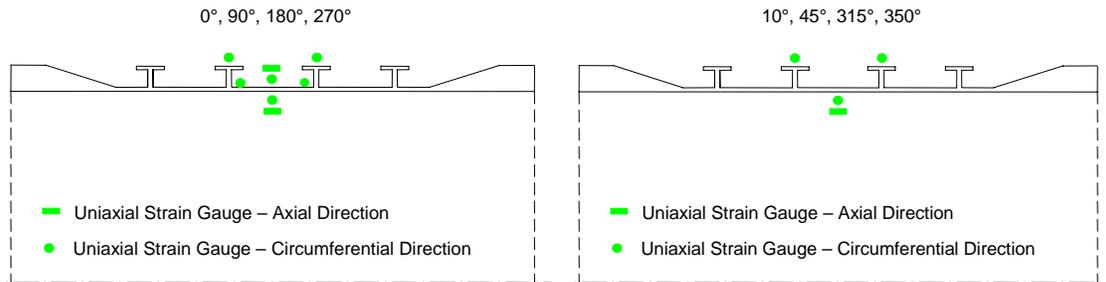
Figure 15. Strain gauge layout for short cylinder with simulated corrosion (L300-No3)

- 4 gauge locations about the circumference (0°, 90°, 180°, and 270°), in the circumferential direction only, on the outside of the shell at the butt of the T-section stiffener (2 x 4 = 8 gauges) – these gauges are intended to allow verification of the design formulae stresses, as well as provide information on the mode of failure
- Total of 16 + 8 + 8 = 32 gauges on the outside of the cylinder
- Inside gauges
 - 8 gauge locations about the circumference (0°, 10°, 45°, 90°, 180°, 270°, 315°, and 350°), in both the axial and circumferential directions, on the inside of the shell at the midpoint of the central bay (2 x 8 = 16 gauges) – these gauges are intended to allow verification of the design formulae stresses, as well as provide information on the mode of failure
 - Total of 16 gauges on the inside of the cylinder
- Grand Total of 48 gauges

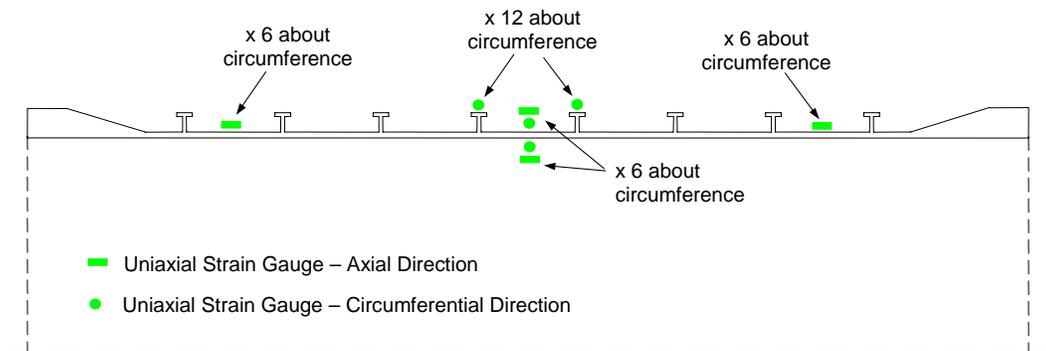
Figure 16. Strain gauge layout for undamaged long cylinder (L510-No1)

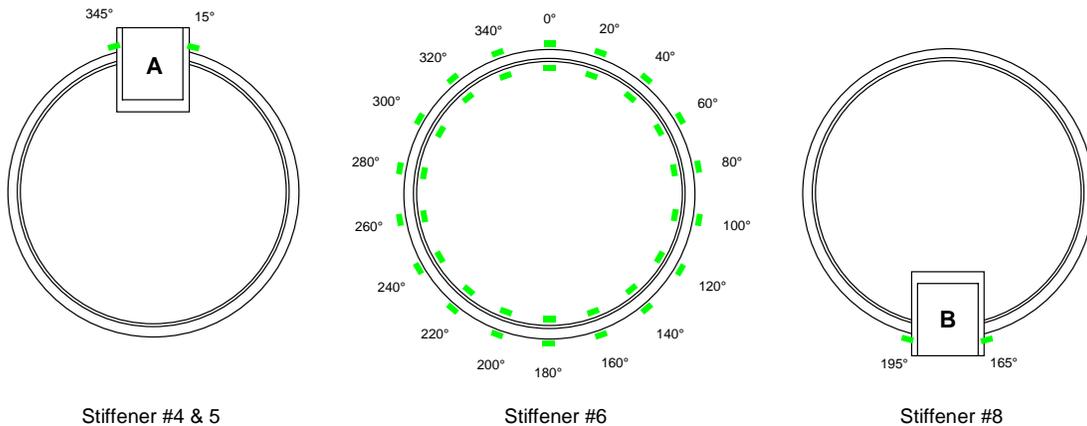
Figure 17. Uni-axial strain gauge layout for cylinder with penetrations

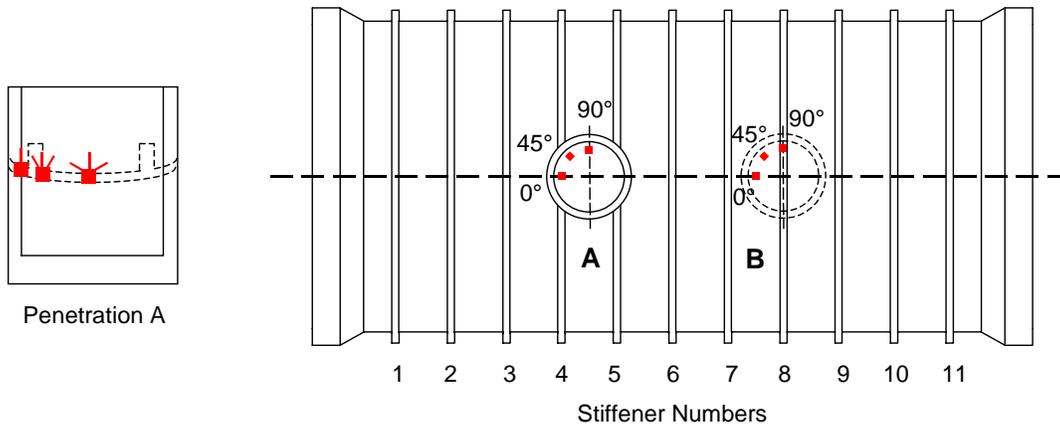
Figure 18. Rosette strain gauge layout for cylinder with penetrations

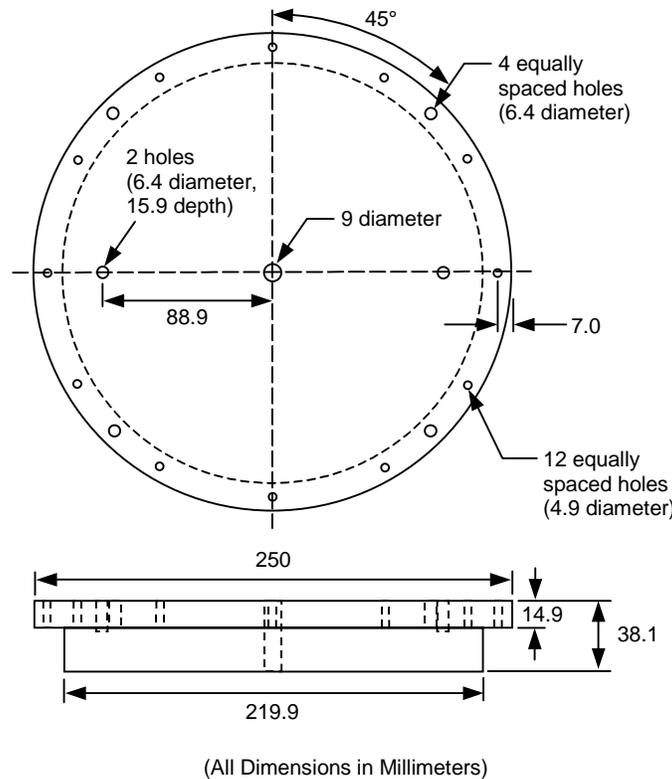
Figure 19. Schematic drawing of specimen end-cap (without hole for cables)

In addition, steel end-caps (Figure 19), manufactured at the DRDC Atlantic machine shop, were attached to the specimens before testing. These served several purposes: 1) to provide a watertight seal during the application of hydrostatic pressure, 2) to increase the weight of the specimens, thereby ensuring negative buoyancy in the testing tank, and 3) to provide additional stiffness to the cylinders at the boundaries. The end-caps were attached to the specimens using 12 equally spaced bolts. The end-caps also have a drain-hole at the centre, two threaded holes for attaching support cables, and four threaded holes for aiding in the removal of the end-caps after testing.

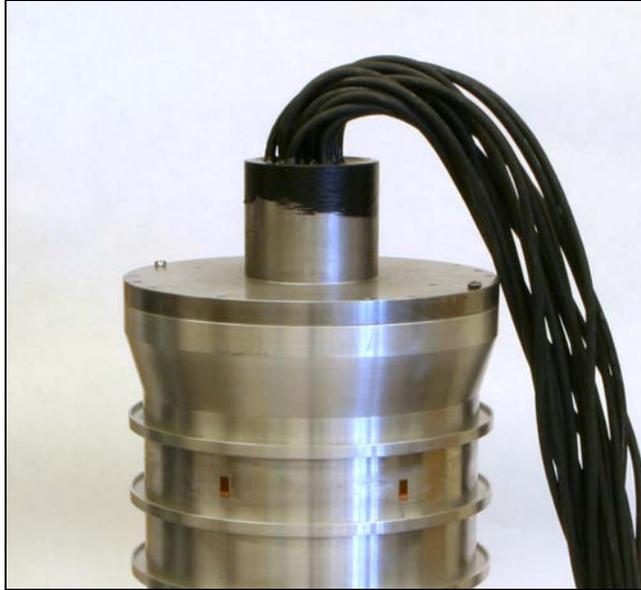
Figure 20. Cylinder with instrumentation cables passing through end cap

3M) was cast to fill the portion of the hole on the end-cap not taken up by these cables. The hole in the end-cap, as well as the end-cap-cylinder joint, was covered with fuel tank sealant (PR-1422, manufactured by PRC-Desoto International) to prevent leakage into the specimen during pressure testing.

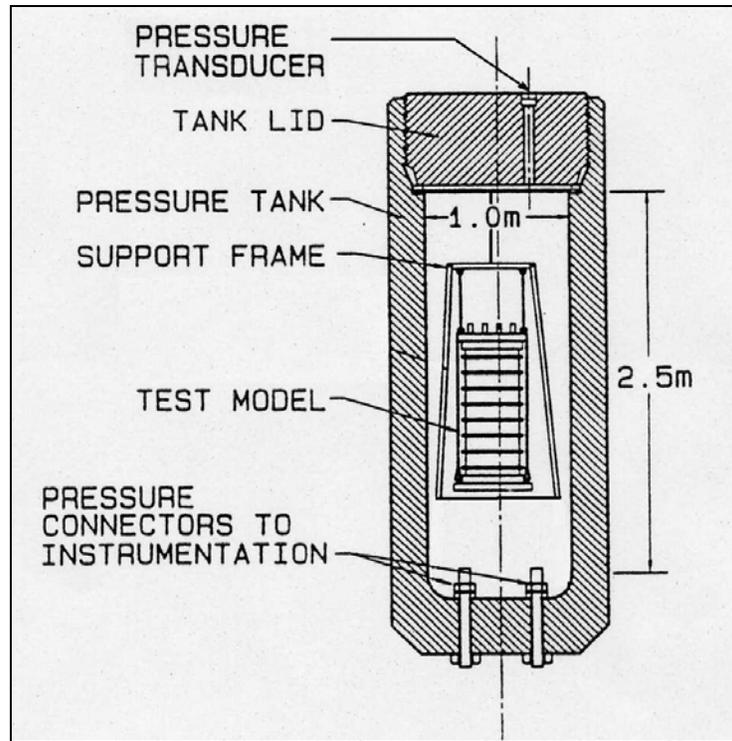
Figure 21. High-pressure tank at DRDC Atlantic

Only the bottom portion of the tank was filled with water during testing. The top one-third of the tank (enough to cover the specimen) was filled with a non-conductive general-purpose mineral oil (Shell Vitrea® 22). This allowed the specimen to be pressurized with minimal risk of short-circuiting wires and cables.

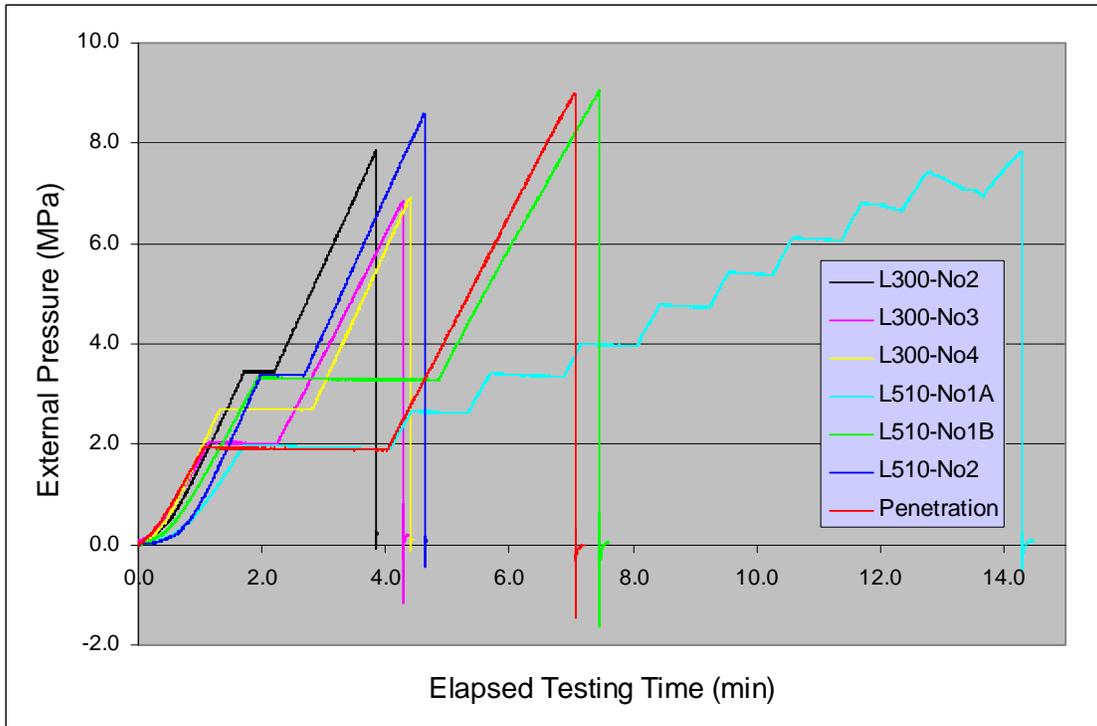
Figure 22. Load-time histories for individual specimens

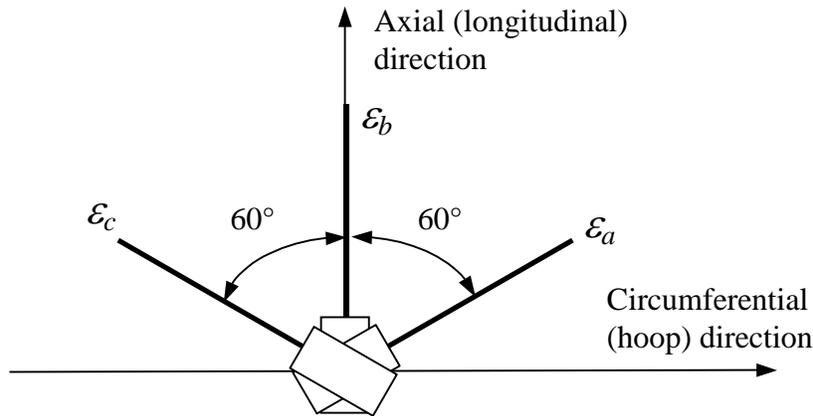
Figure 23. Rosette strain configuration in the penetrations

The principal rosette stresses are calculated using Equation (7), assuming the principal strains coincided with the orthogonal strains.

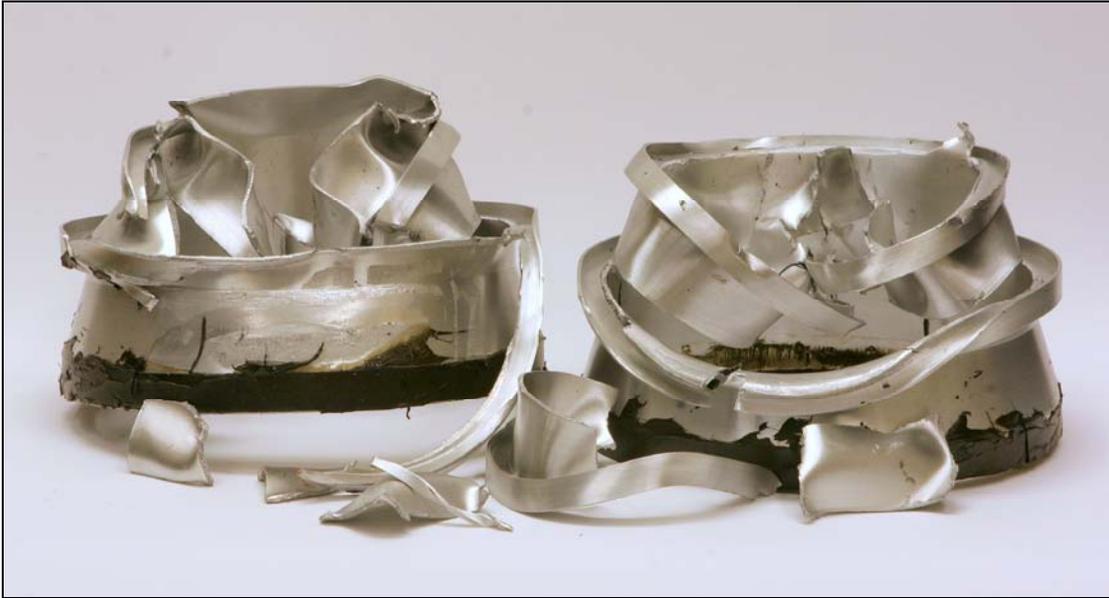
Figure 24. Specimen L300-No2 after testing

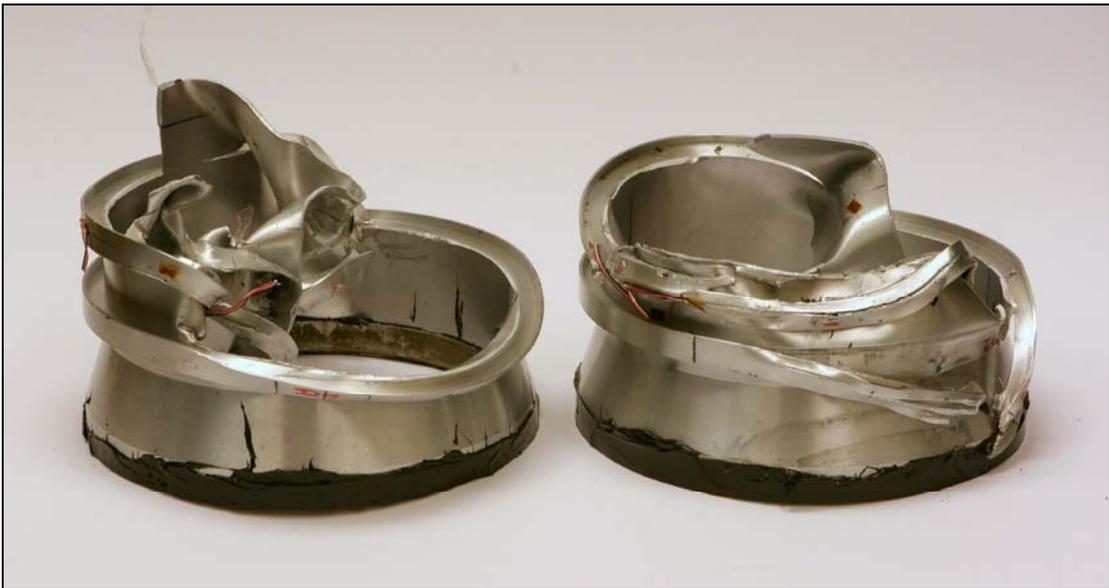
Figure 25. Specimen L300-No3 after testing

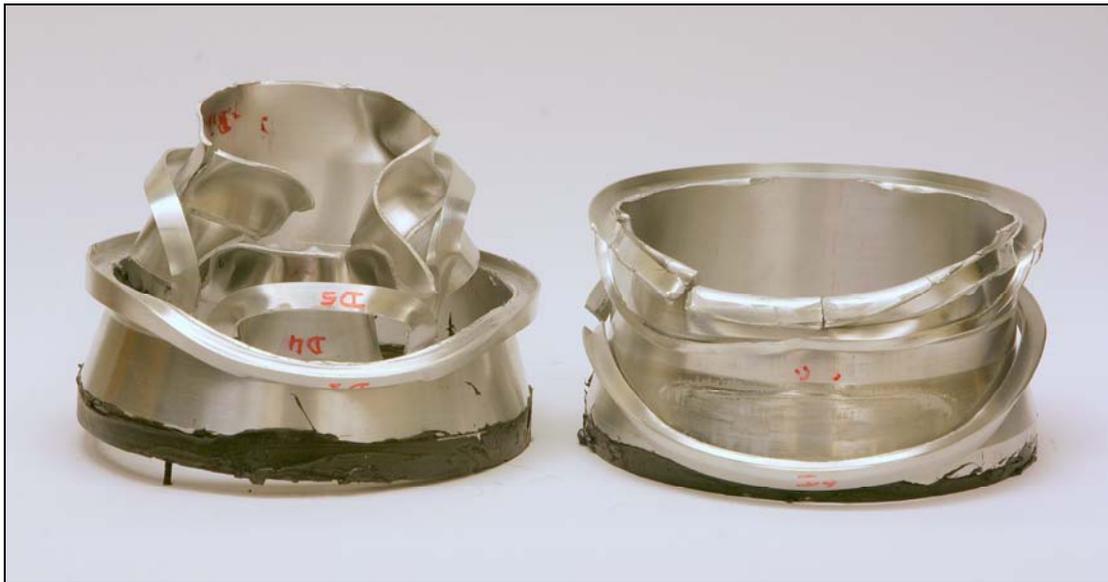
Figure 26. Specimen L300-No4 after testing

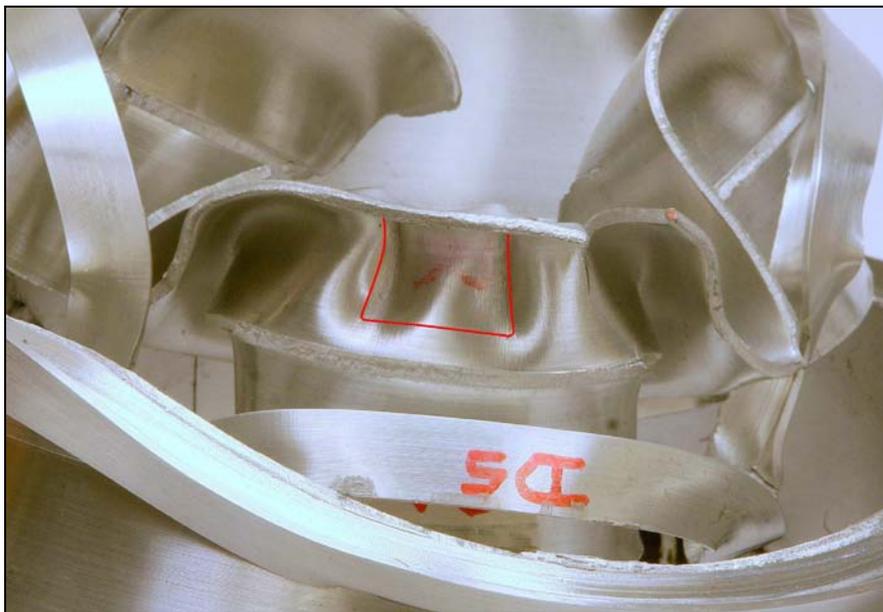
Figure 27. Close-up of corroded region (highlighted in red) of L300-No4 after testing

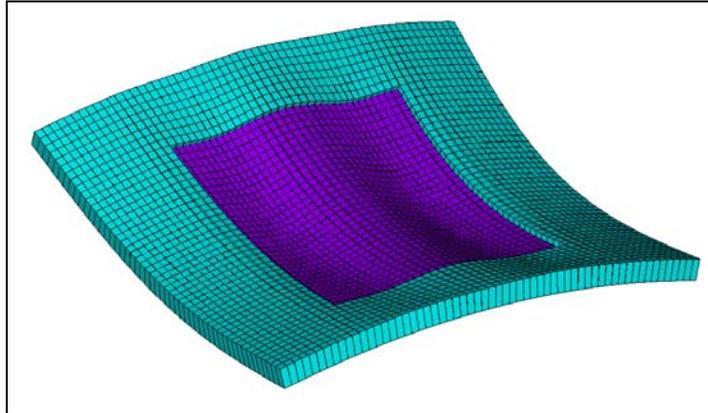
Figure 28. Schematic representation of local buckling in the corroded short cylinders

yielding first occurred at the edges of the corrosion (10° and 350°), which is consistent with the bending caused by the reduced stiffness and eccentricity at the corrosion.

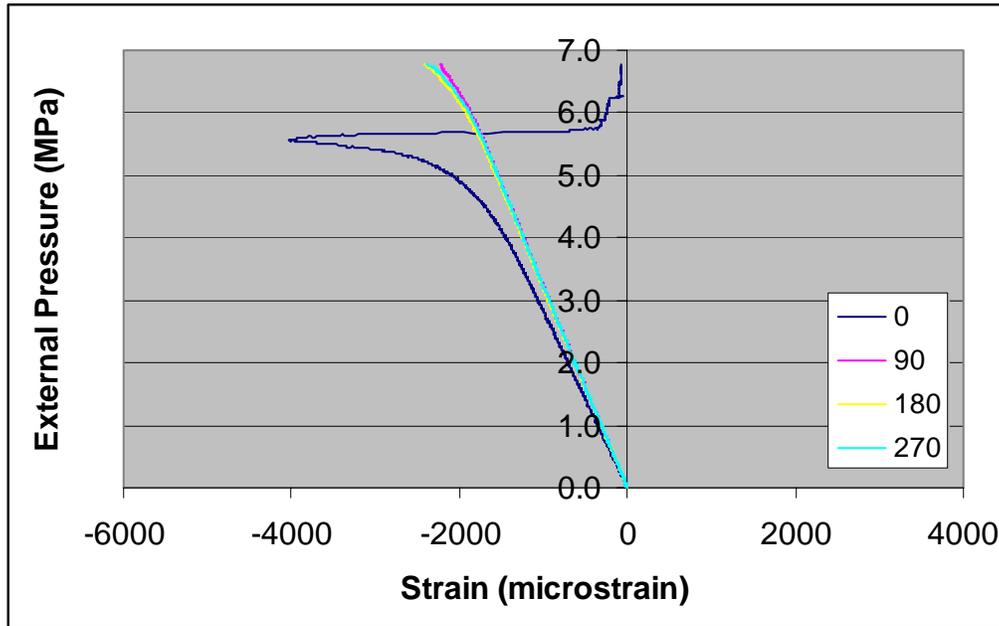
Figure 29. L300-No3 – circumferential strain on outside of shell at central bay (mid-bay)

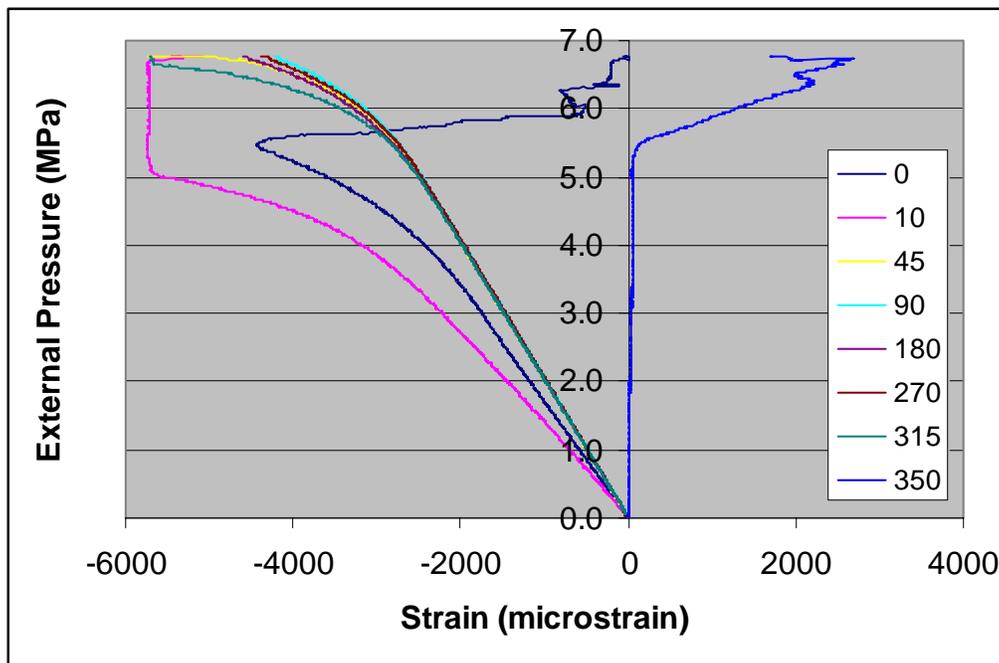
Figure 30. L300-No3 – circumferential strain on inside of shell at central bay (mid-bay)

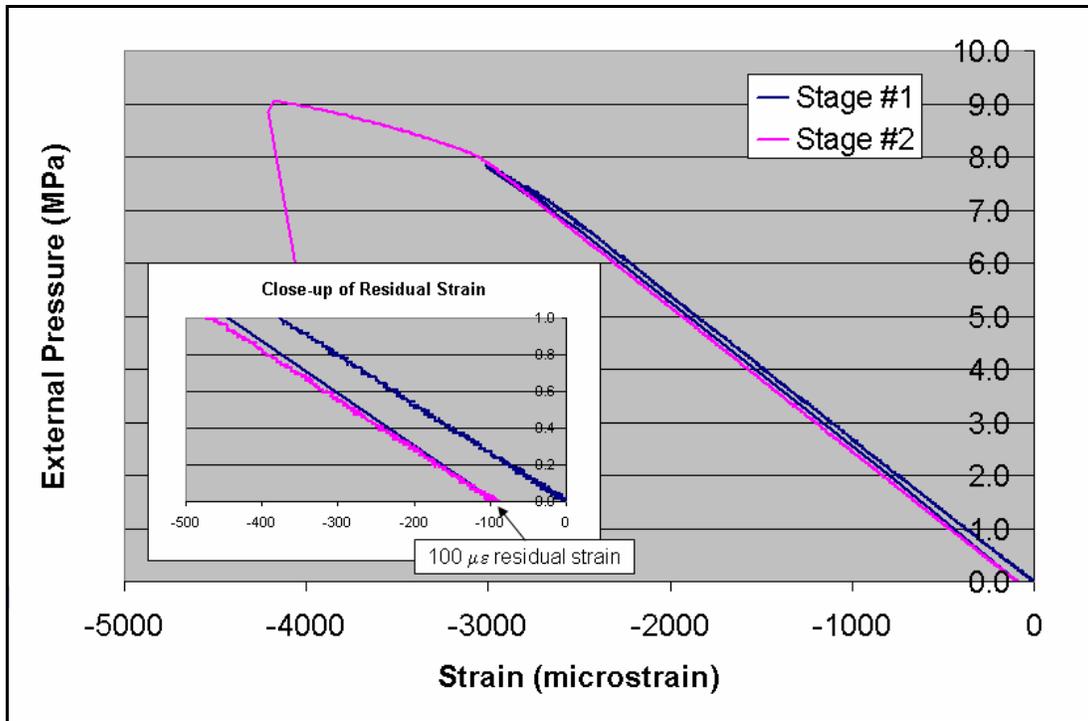
Figure 31. L510-No1 – circumferential strain at 0° on stiffener #4

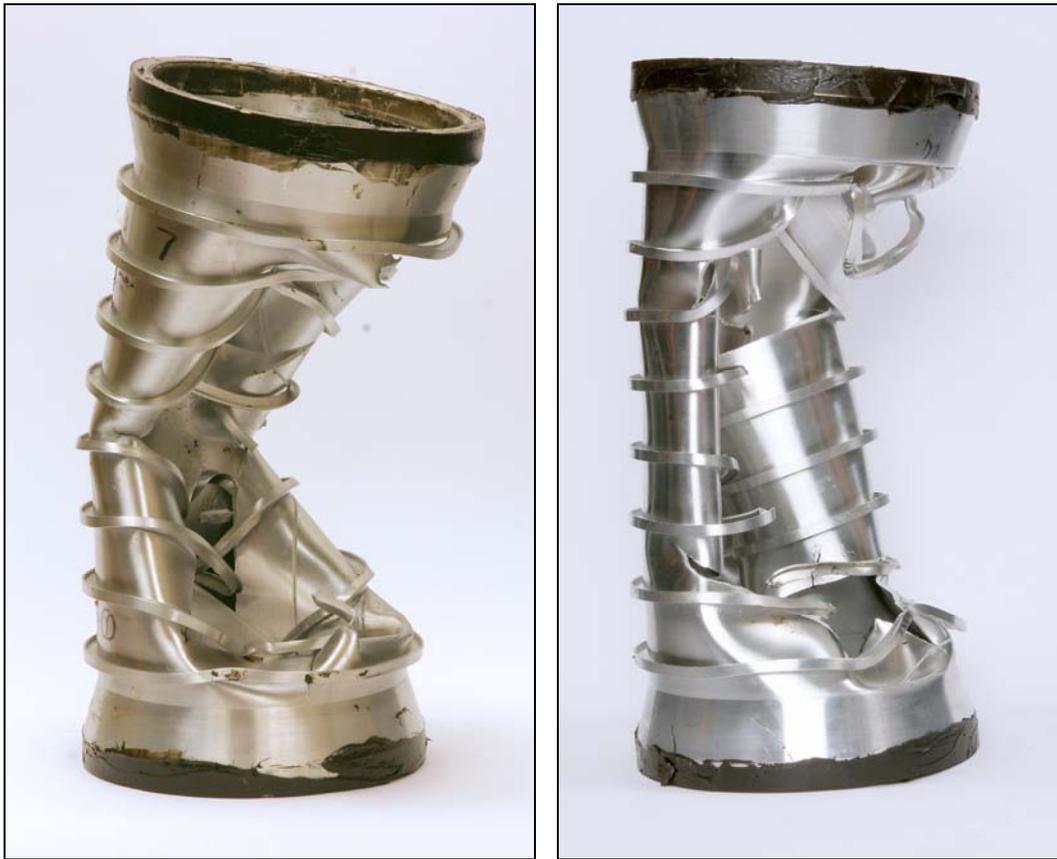
Figure 32. Specimens L510-No1 (left) and L510-No2 (right) after testing

As with the short cylinders, the long cylinders failed catastrophically (Figure 32). Visual inspection suggested that the long cylinders failed in an overall collapse mode, however the exact mode shape was not discernable from the destroyed cylinders. Overall collapse was indicated by the deformed frames, which experienced similar displacements as the shell, and the global nature of the failure. The final deformed shape of both long cylinders can be roughly described as a half sine wave over the length of the cylinder, and apparently two waves about the circumference.

final two-wave shape of the destroyed cylinders is likely a post-collapse development. The actual collapse shape appears to be dominated by an $n=3$ mode, which is in agreement with the analytical predictions.

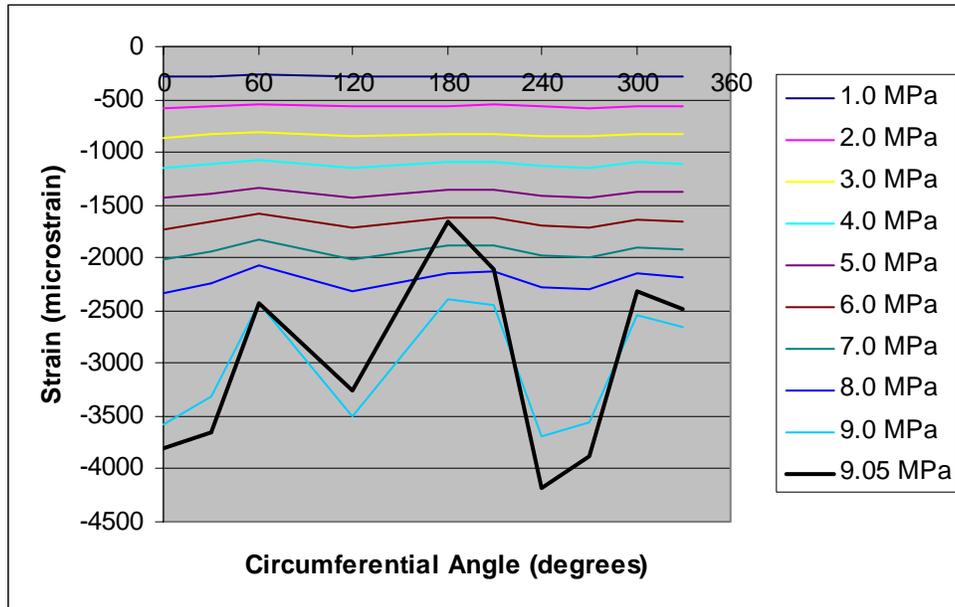
Figure 33. Circumferential strain in stiffener #4 of L510-No1 (up to collapse)

tively, is equal to the ratio of outer to inner radius (1.12 for the long cylinder). Thus, a likely candidate for this yield location is the shell at the base of the stiffeners, which is under a greater axisymmetric stress than the stiffener flange in externally stiffened cylinders. This theory is supported by the analytical calculations (Section 2.7), which indicate that overall collapse will be initiated by yielding of the shell at the base of the stiffener (P_p) rather than yielding of the flange ($P_{y(n)}$).

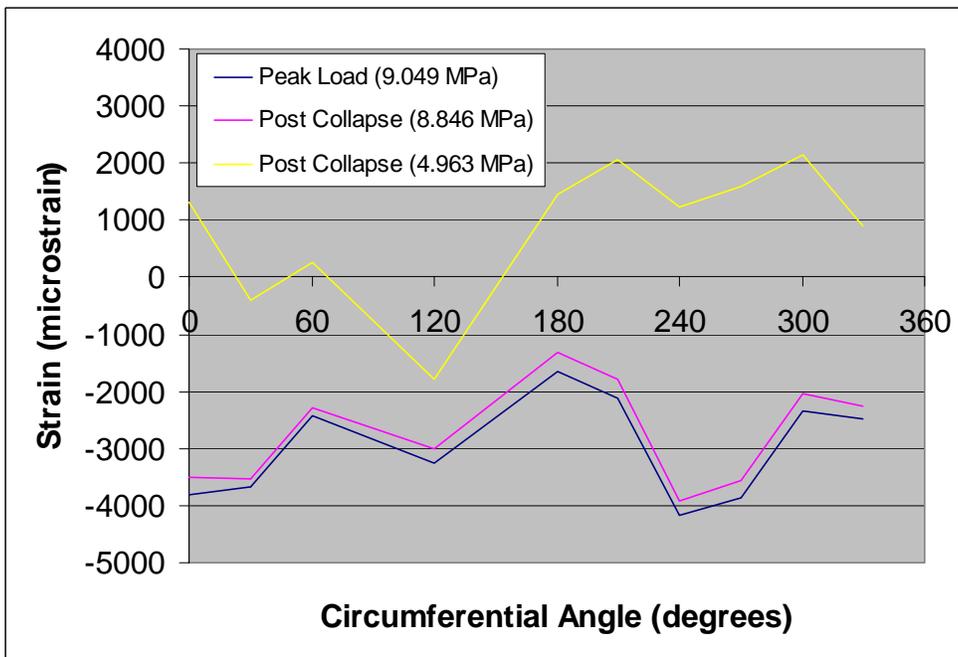
Figure 34. Circumferential strain in stiffener #4 of L510-No1 (post collapse)

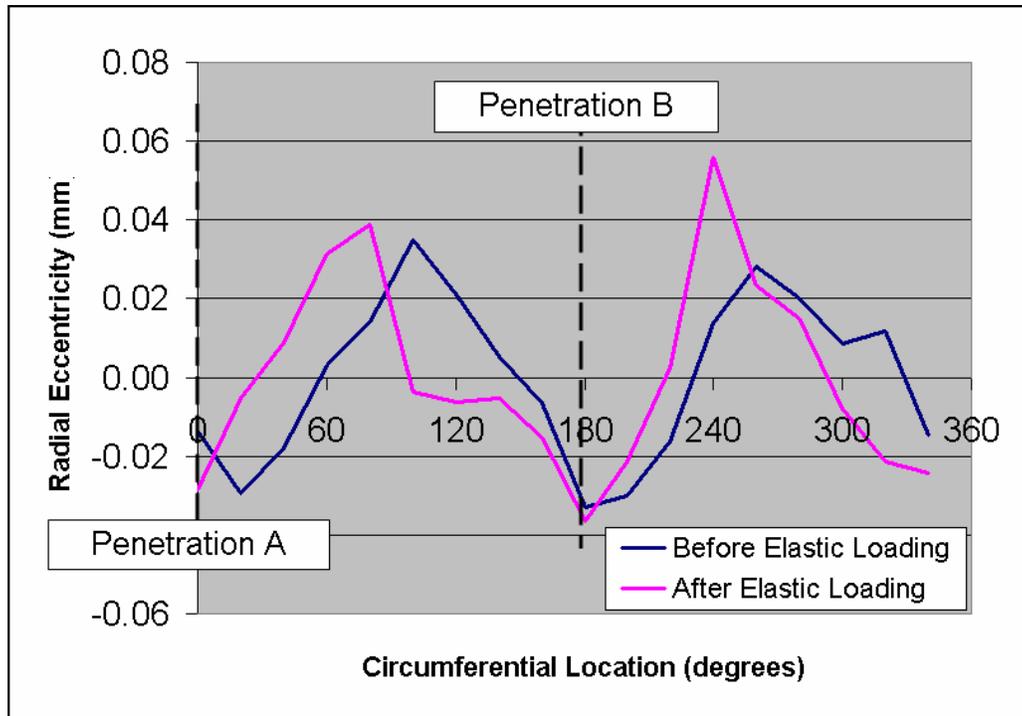
Figure 35. OOC of the cylinder with penetrations (S6) before and after elastic loading

tion measurements (OOC) from the centre stiffener taken before the initial elastic loads were applied closely resemble the measurements taken before the cylinder was tested destructively as part of the current project (Figure 35). This indicates that the initial load cycles were indeed in the elastic range.

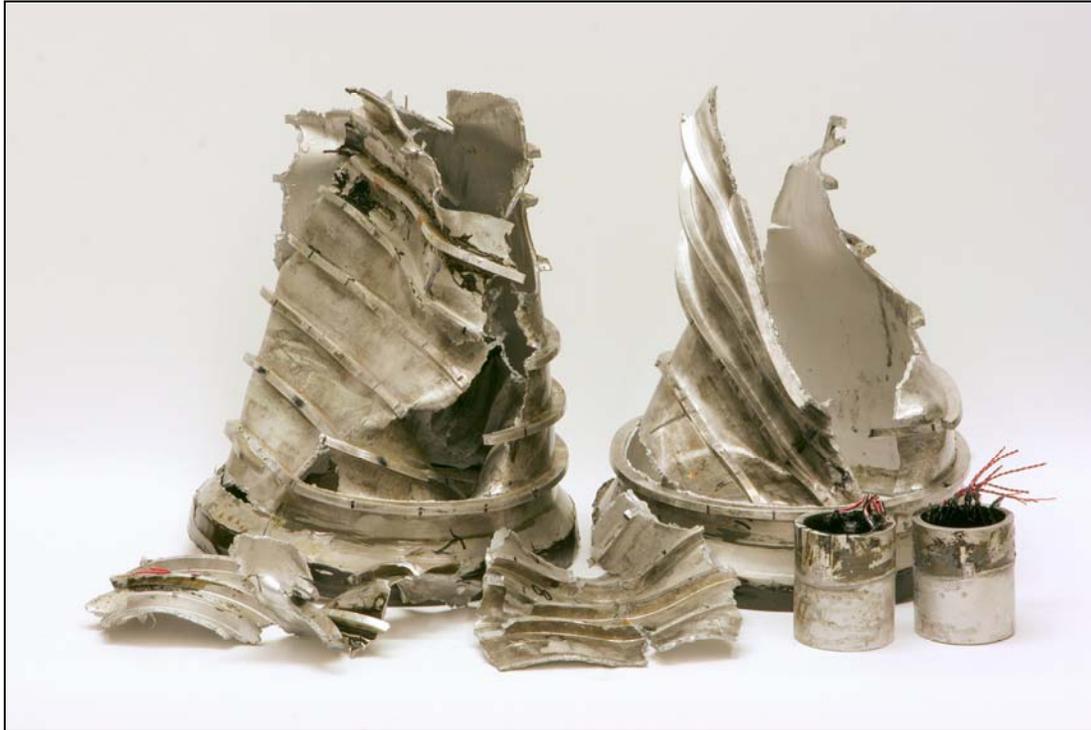
Figure 36. Cylinder with penetrations after testing

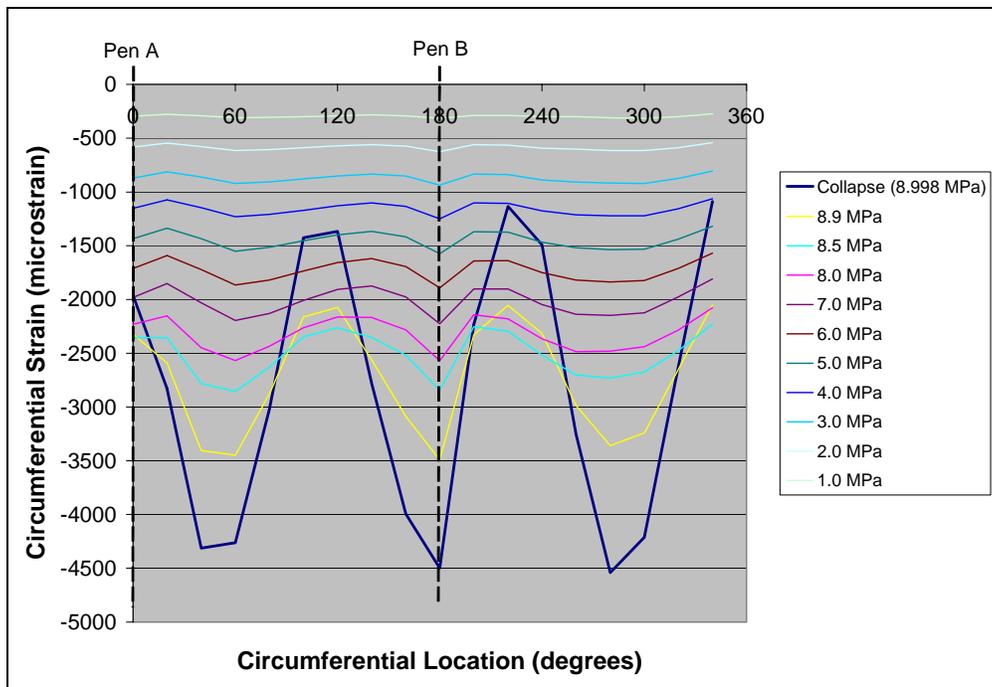
Figure 37. Cylinder with penetrations – circumferential strains at centre stiffener

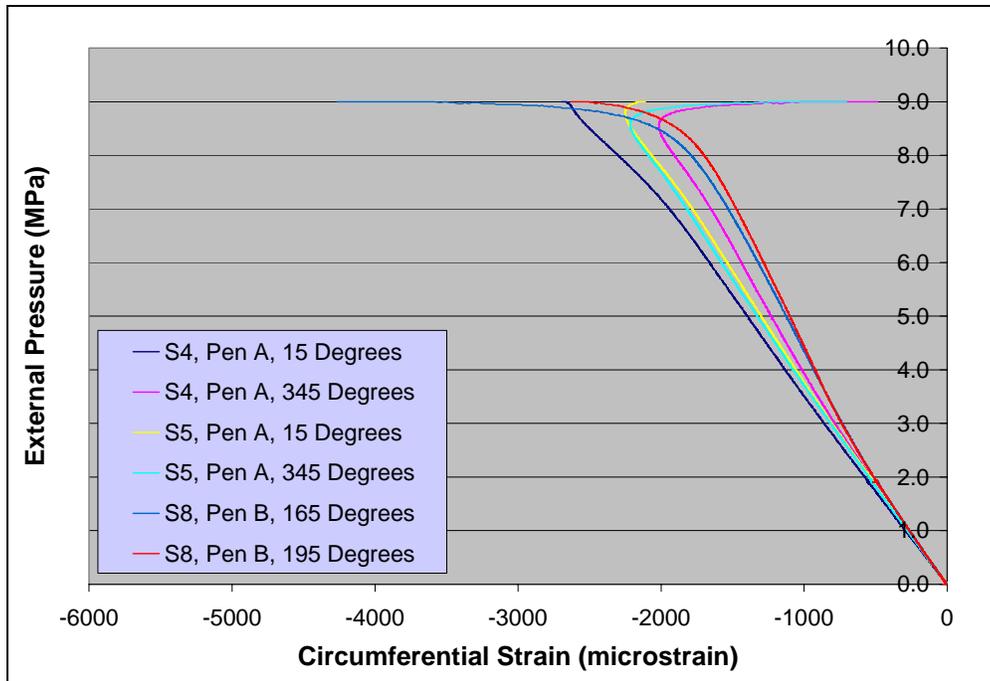
Figure 38. Cylinder with penetrations – circumferential strain adjacent to penetrations
