Experimental investigation of the strength of damaged pressure hulls – Phase 1

J. R. MacKay

Defence R&D Canada – Atlantic

Technical Memorandum
DRDC Atlantic TM 2006-304
February 2007

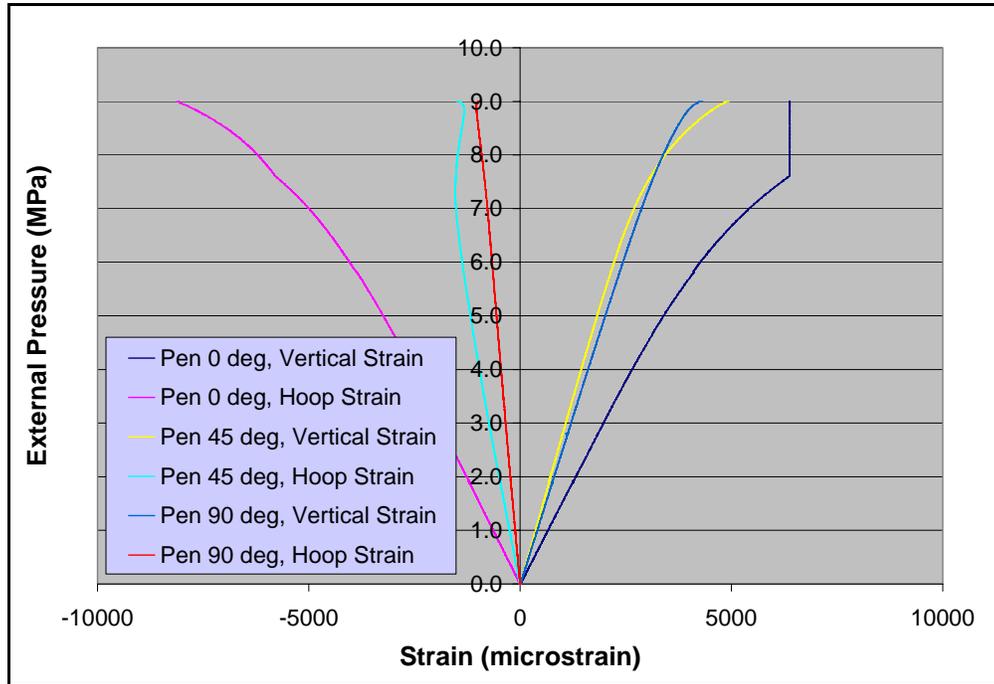
Figure 39. Cylinder with penetrations – orthogonal strains at penetration A

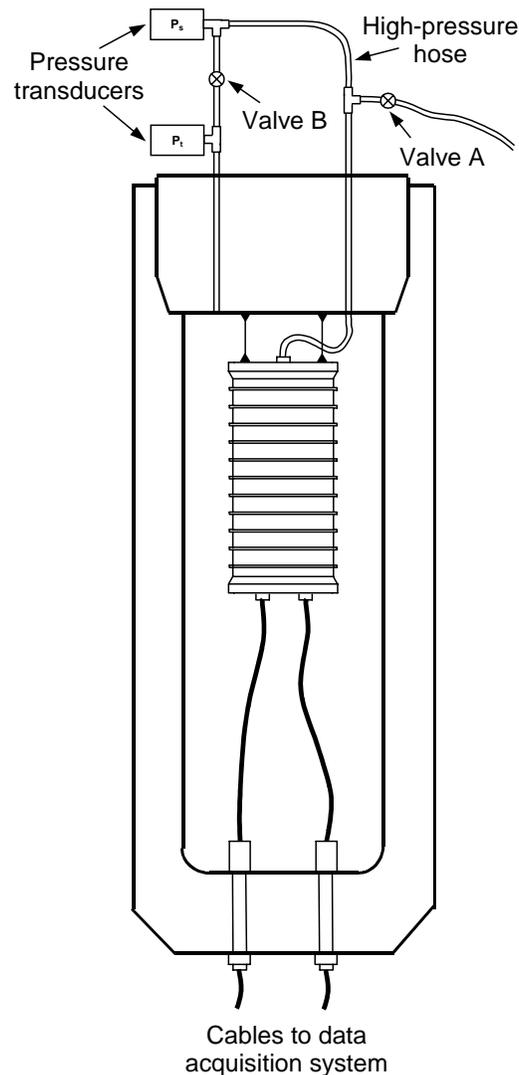
Figure 40. Schematic drawing of improved pressure testing apparatus

This method has another benefit in that the pump doesn't have to be used after step 2. This eliminates the electronic noise associated with the operation of the pump.

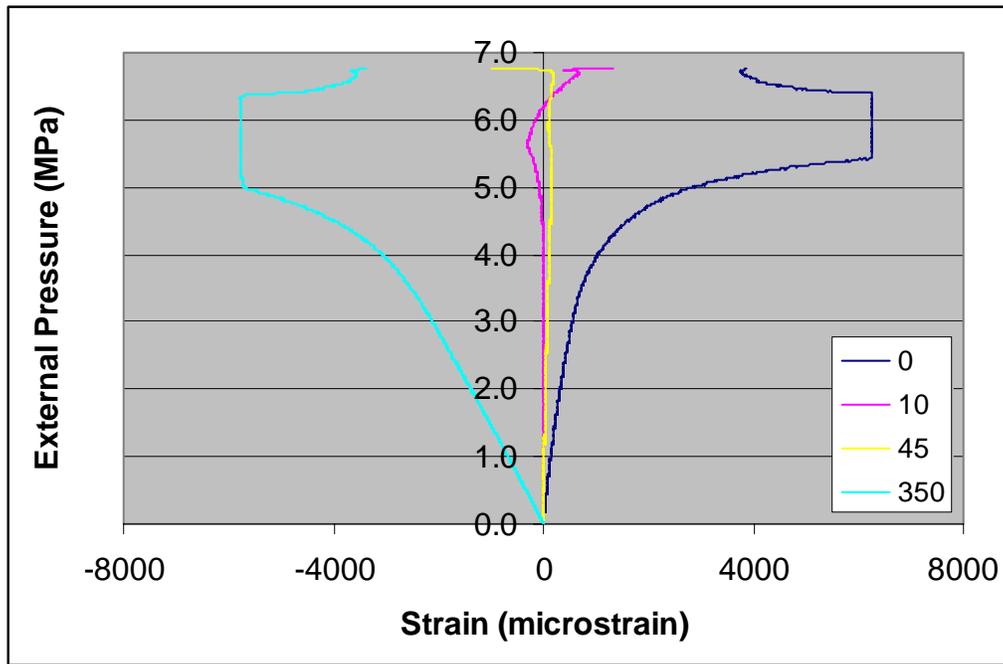
Figure 41. L300-No3 – axial strain on inside of shell at central bay (mid-bay)

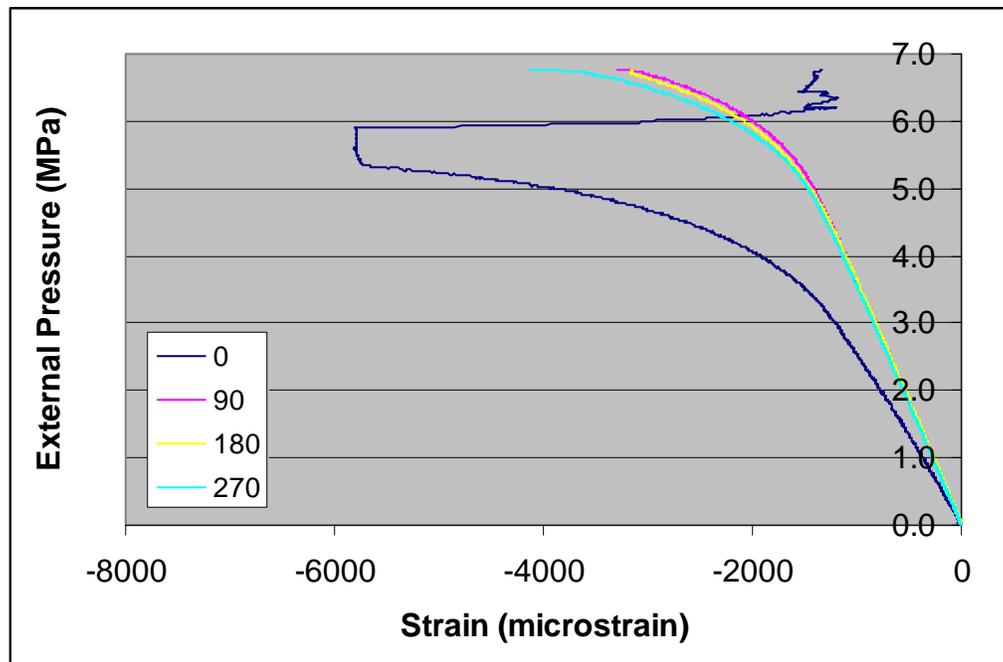
Figure 42. L300-No3 – axial strain on outside of shell at central bay (mid-bay)

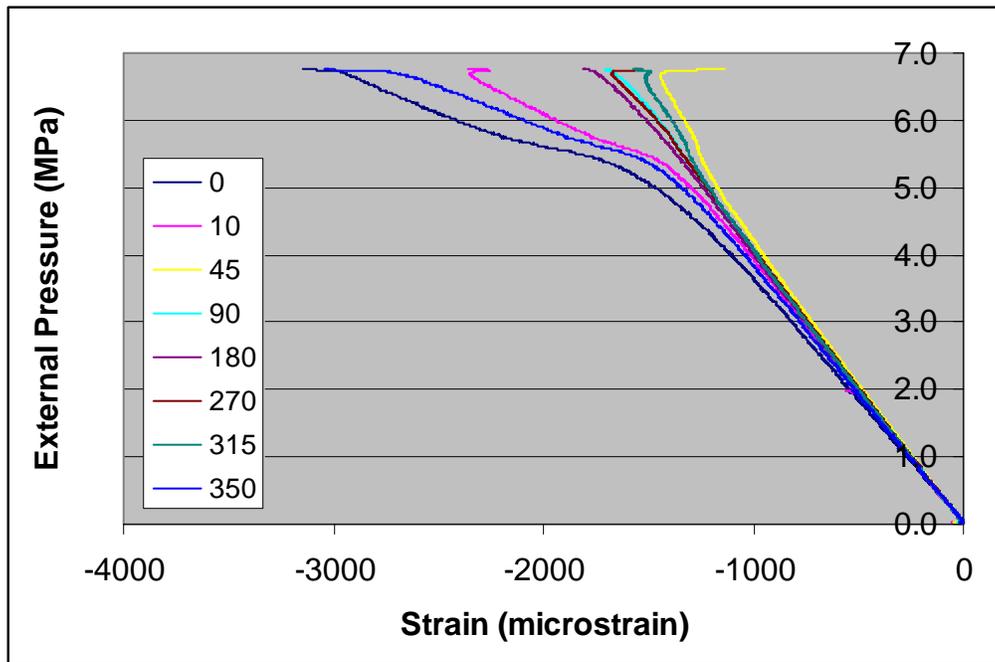
Figure 43. L300-No3 – circumferential strain in the flange of frame #2

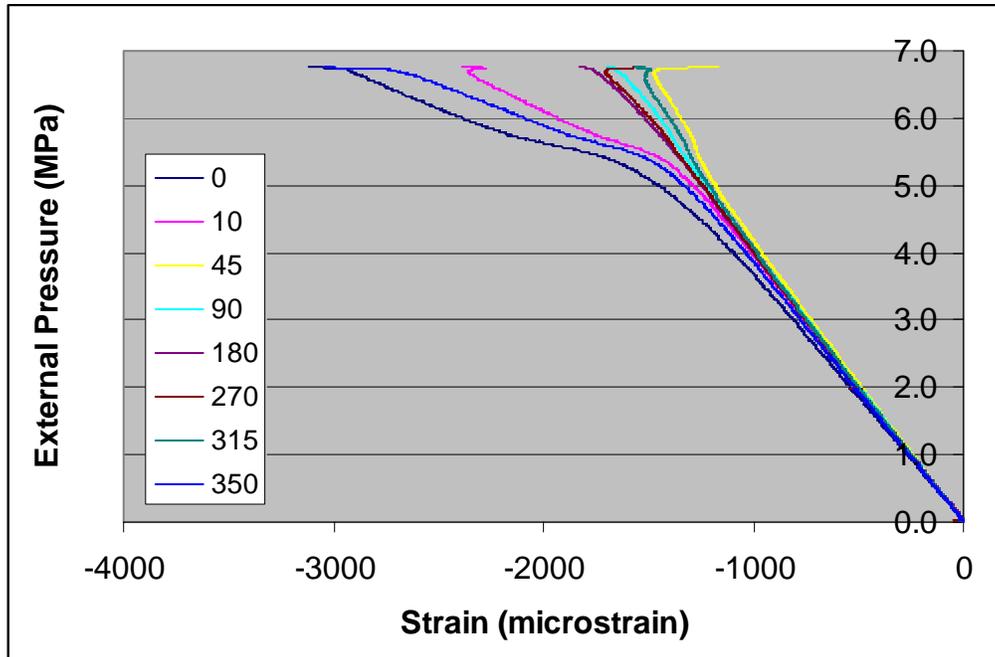
Figure 44. L300-No3 – circumferential strain in the flange of frame #3

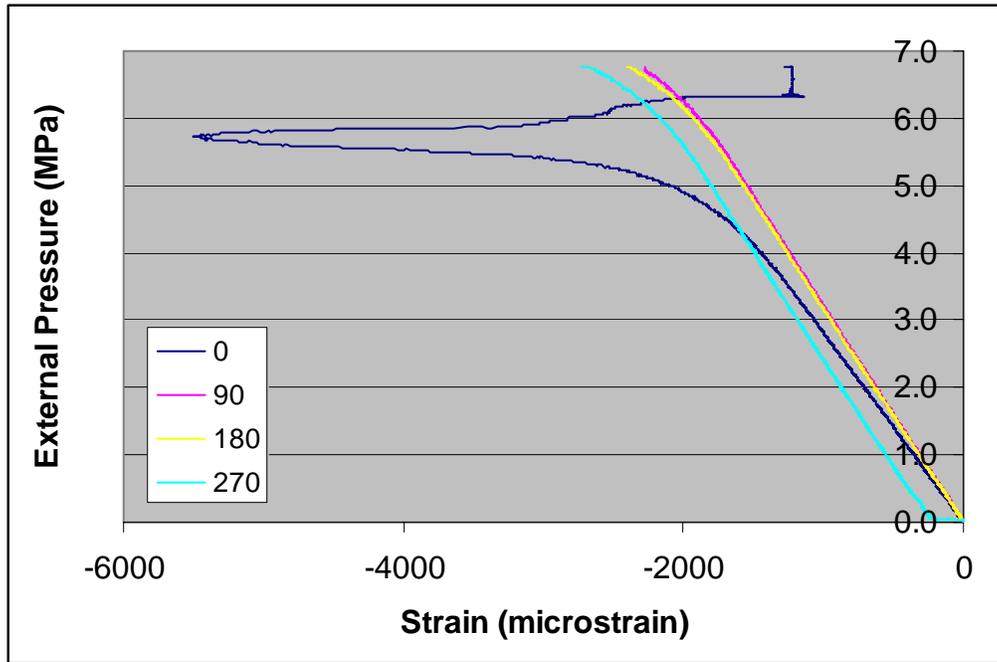
Figure 45. L300-No3 – circ. Strain on the outside of the shell adjacent to frame #2

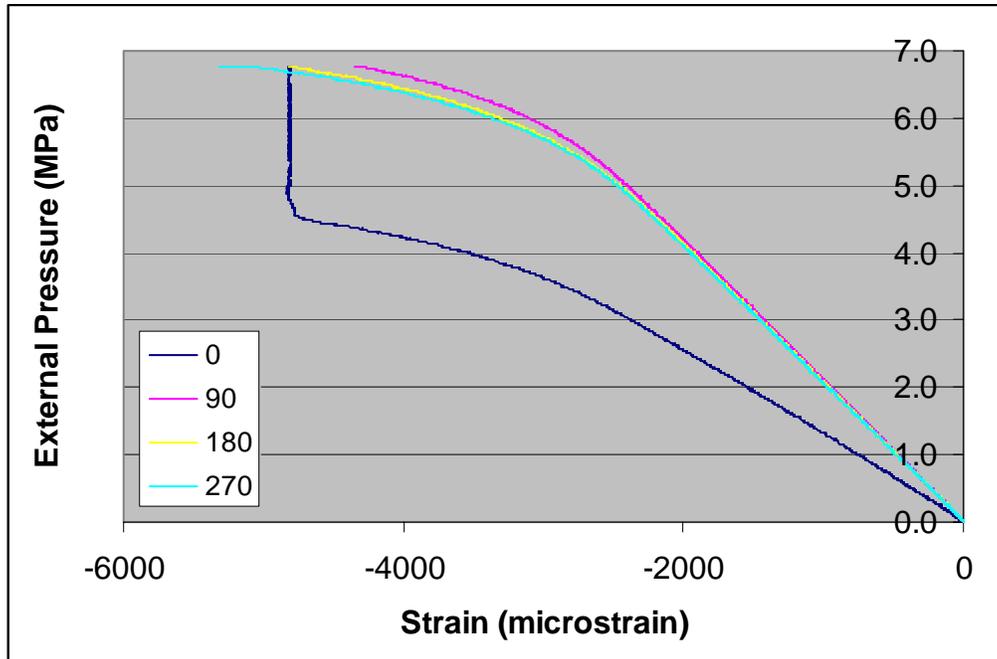
Figure 46. L300-No3 – circ. Strain on the outside of the shell adjacent to frame #3

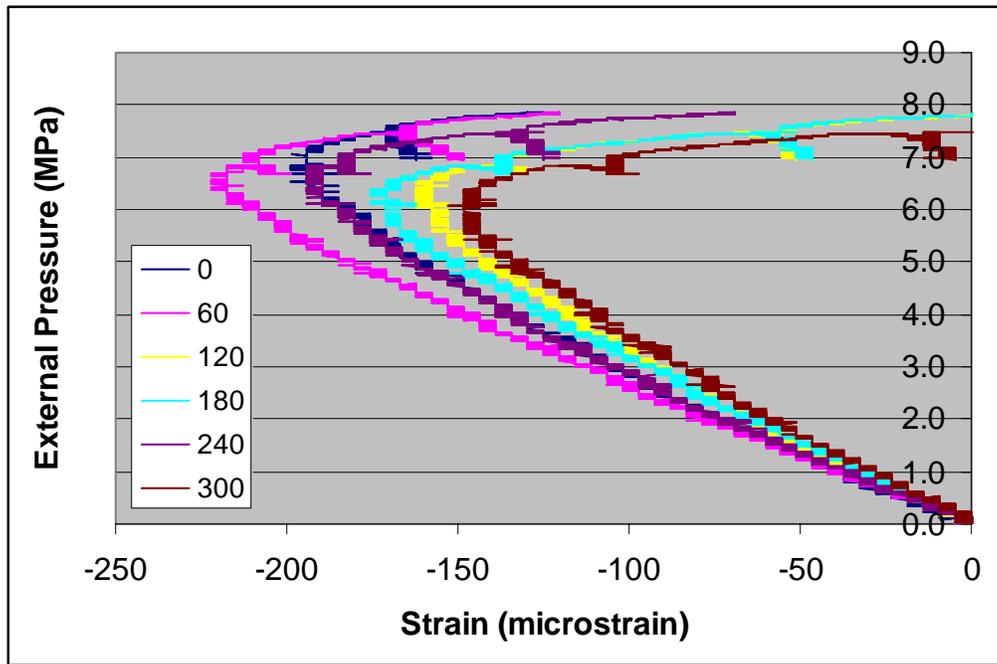
Figure 47. L510-No1A – axial strain on inside of shell at central bay (mid-bay)

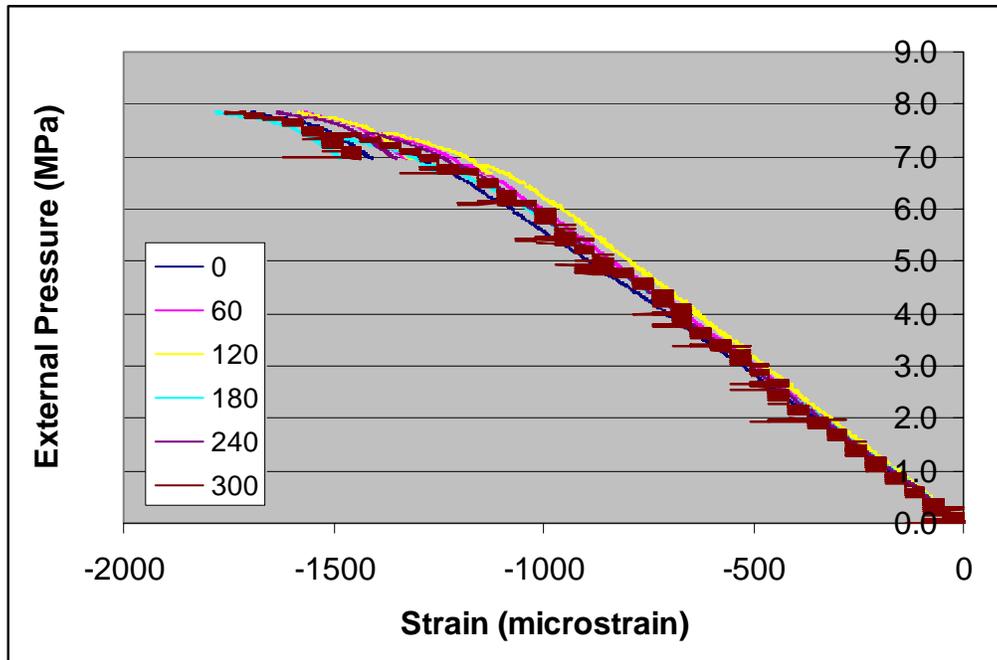
Figure 48. L510-No1A – axial strain on outside of shell at central bay (mid-bay)

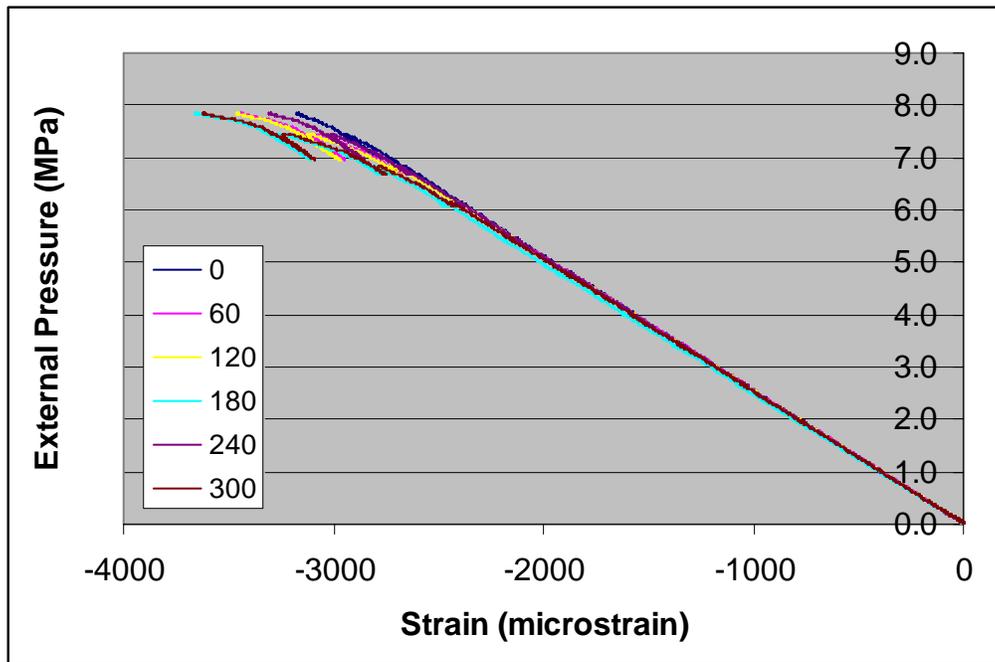
Figure 49. L510-No1A – circumferential strain inside shell at central bay (mid-bay)

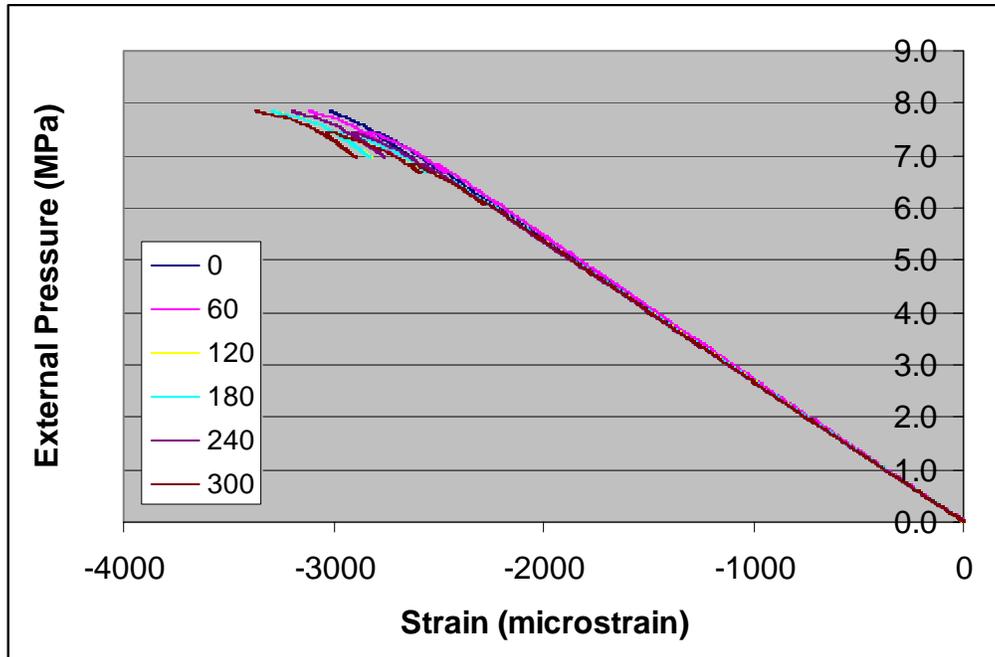
Figure 50. L510-No1A – circumferential strain outside shell at central bay (mid-bay)

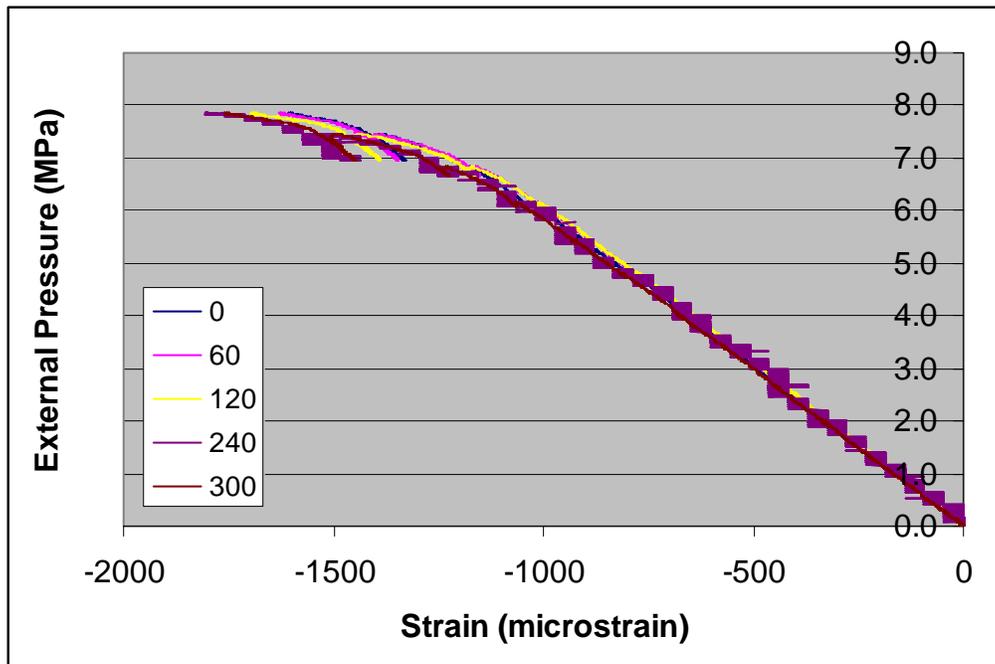
Figure 51. L510-No1A – axial strain on outside of shell at end –bay (Fr#1-Fr#2)

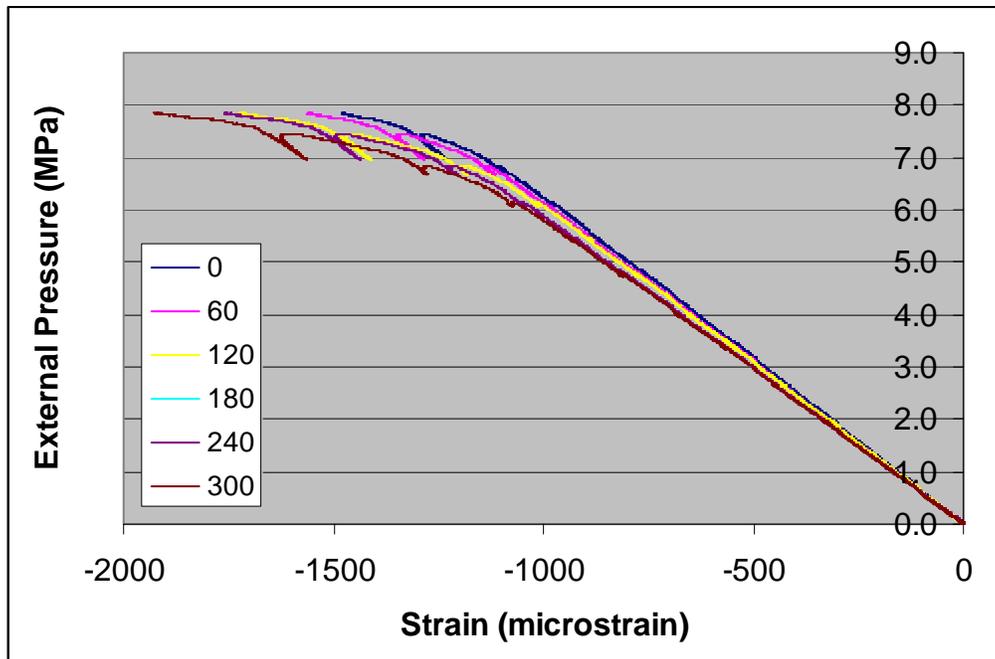
Figure 52. L510-No1A – axial strain on outside of shell at end –bay (Fr#71-Fr#8)

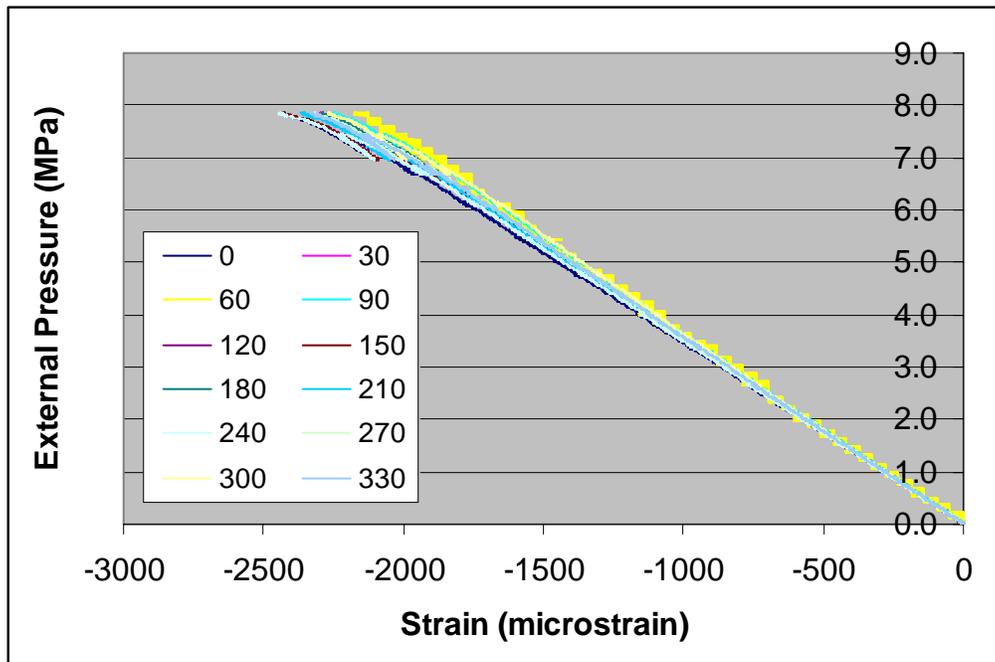
Figure 53. L510-No1A – circumferential strain in the flange of frame #4

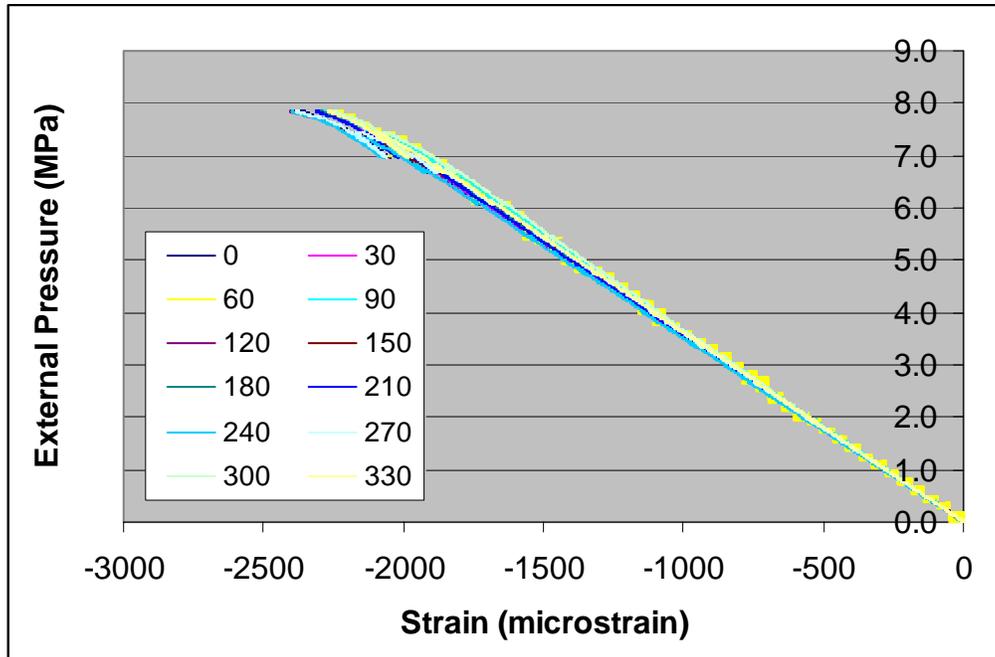
Figure 54. L510-No1A – circumferential strain in the flange of frame #5

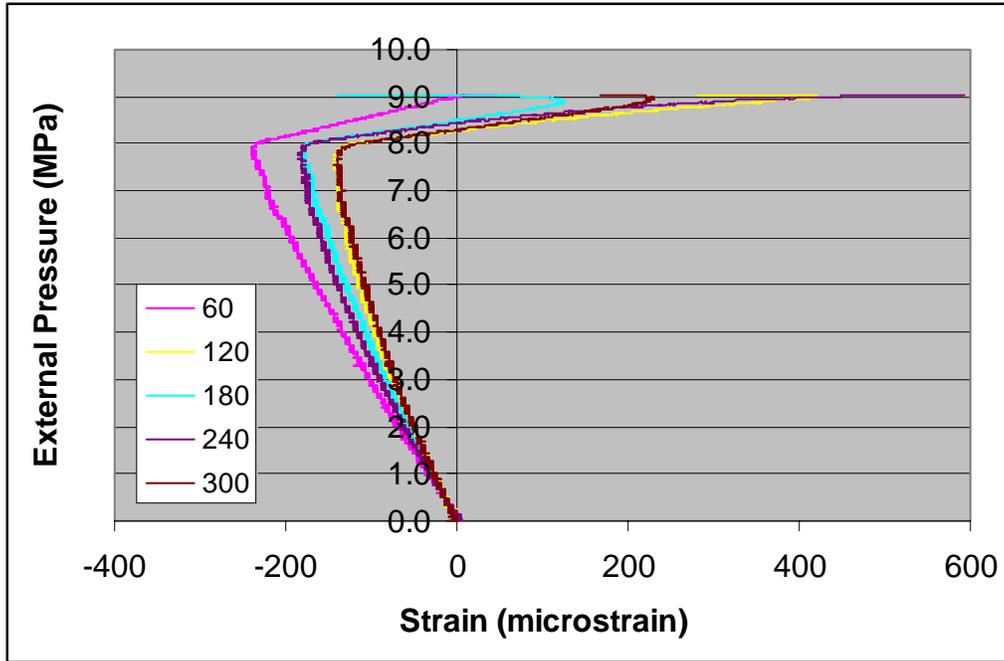
Figure 55. L510-No1B – axial strain on inside of shell at central bay (mid-bay)

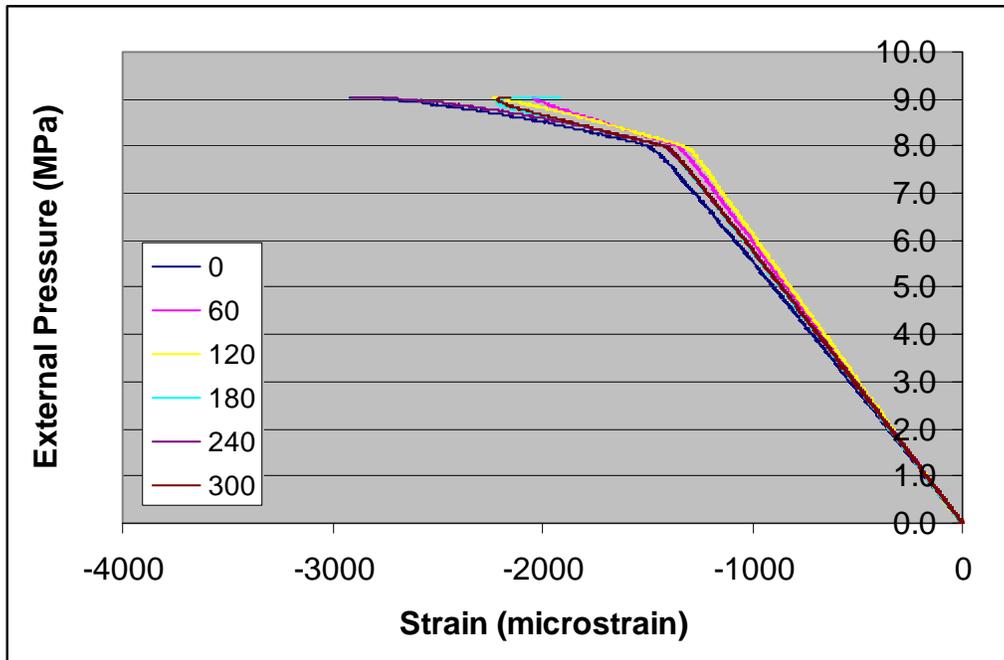
Figure 56. L510-No1B – axial strain on outside of shell at central bay (mid-bay)

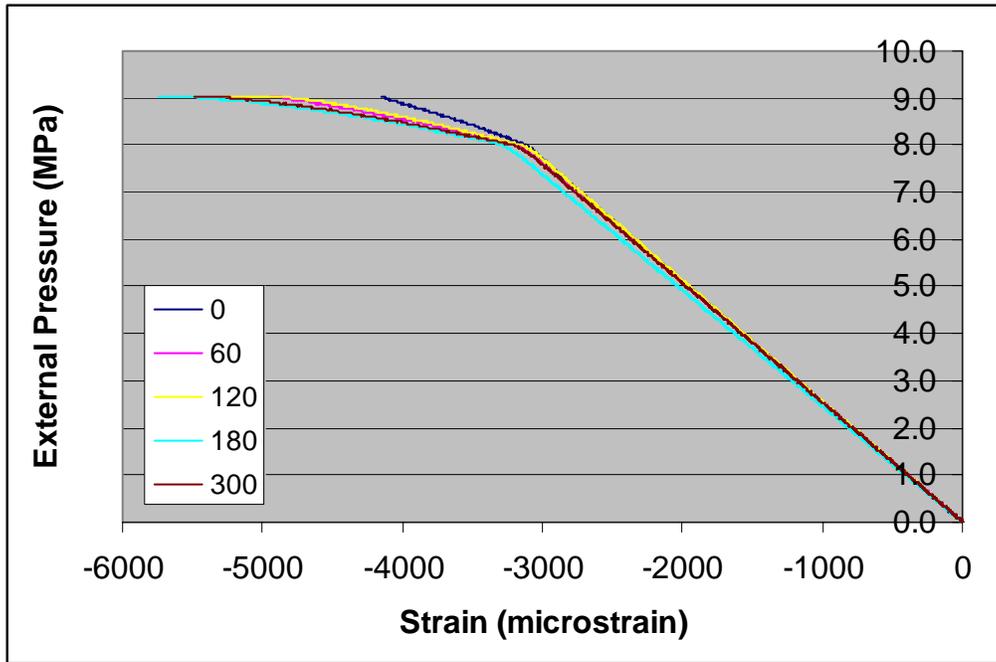
Figure 57. L510-No1B – circumferential strain on inside of shell at central bay (mid-bay)

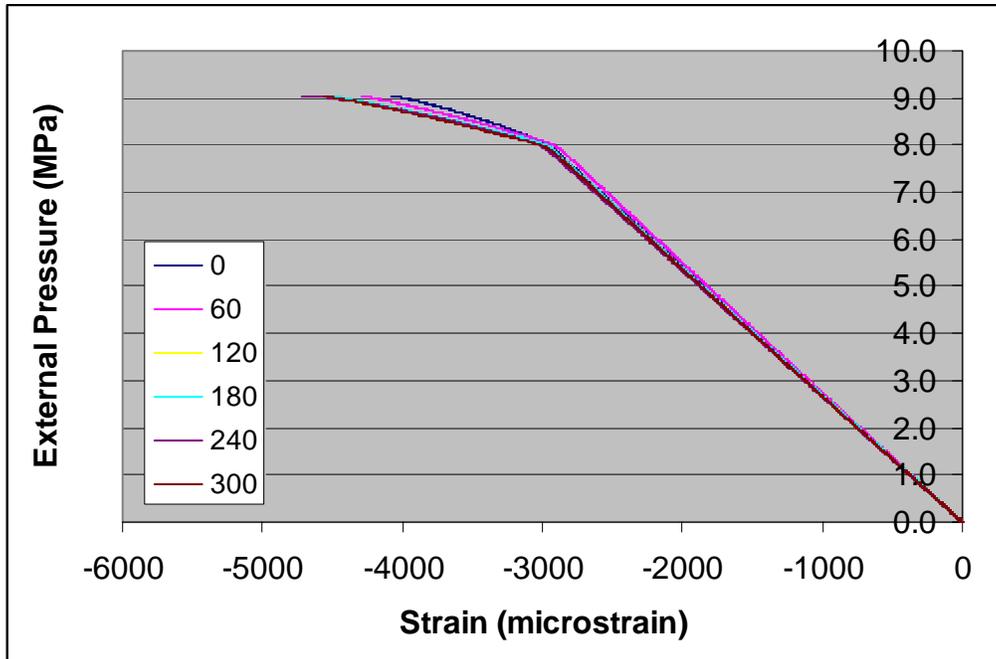
Figure 58. L510-No1B – circumferential strain on outside of shell at central bay (mid-bay)

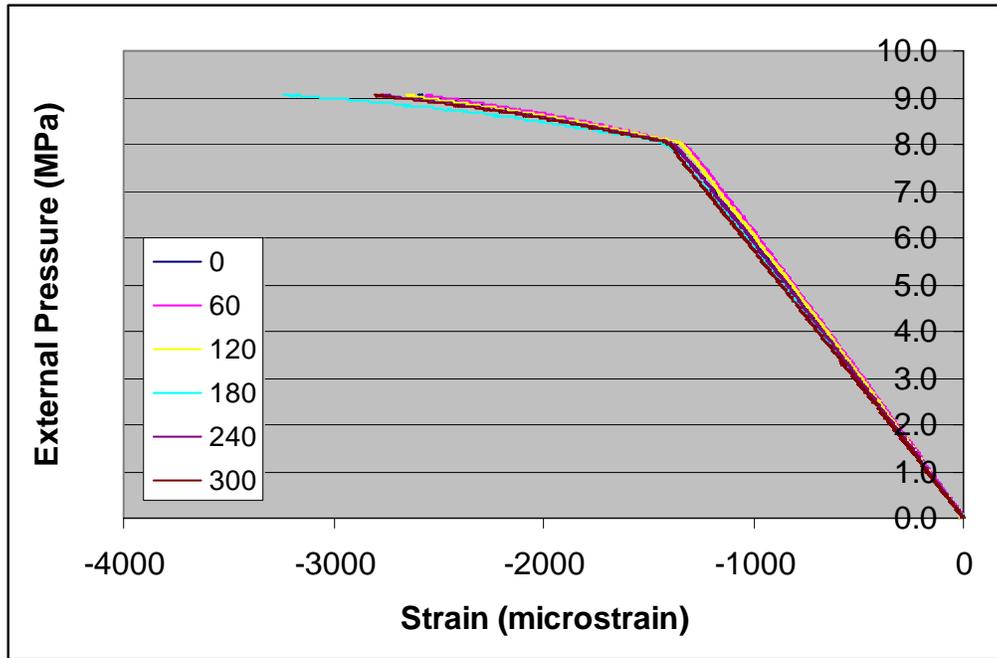
Figure 59. L510-No1B – axial strain on outside of shell at end –bay (Fr#1-Fr#2)

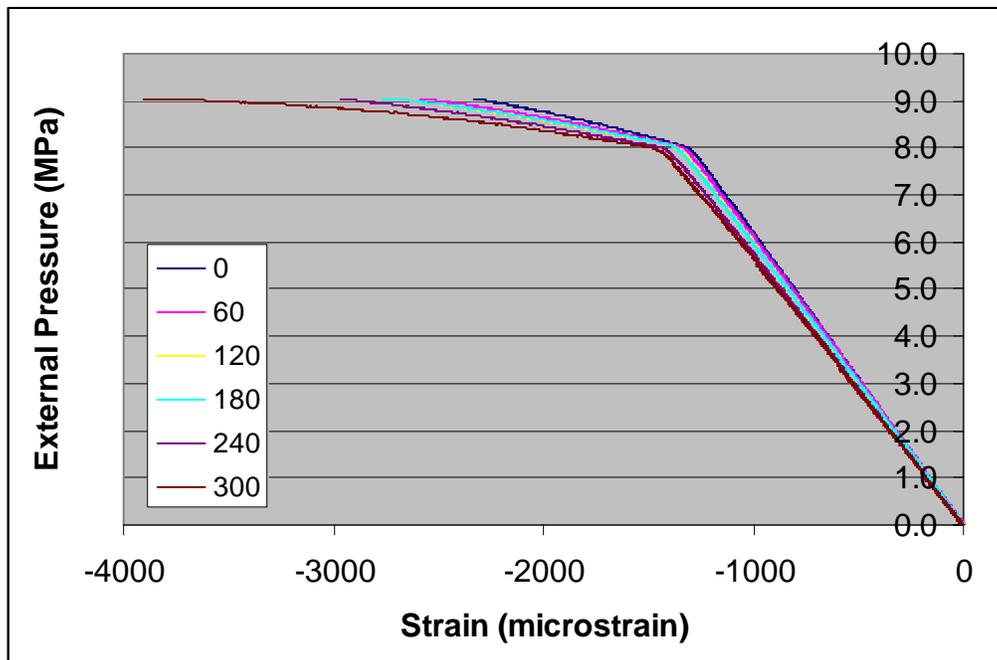
Figure 60. L510-No1B – axial strain on outside of shell at end –bay (Fr#71-Fr#8)

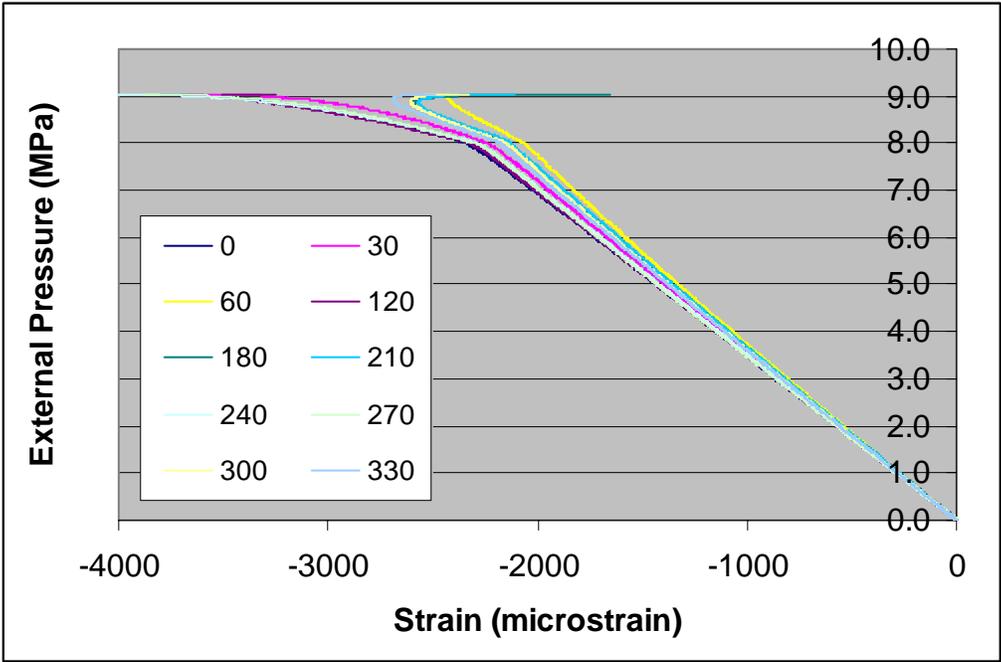
Figure 61. L510-No1B – circumferential strain in the flange of frame #4

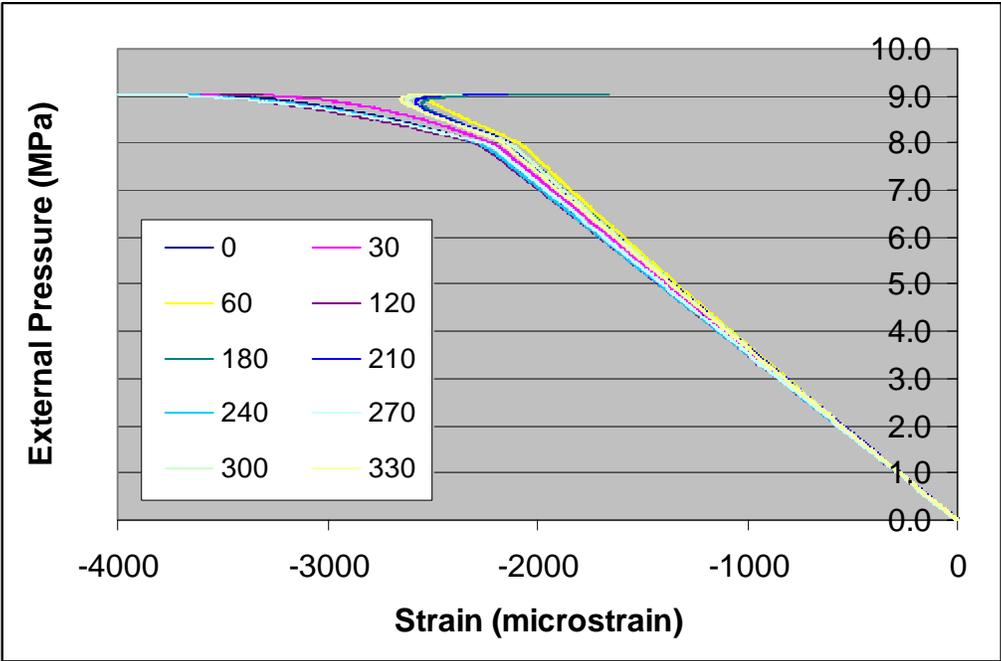
Figure 62. L510-No1B – circumferential strain in the flange of frame #5

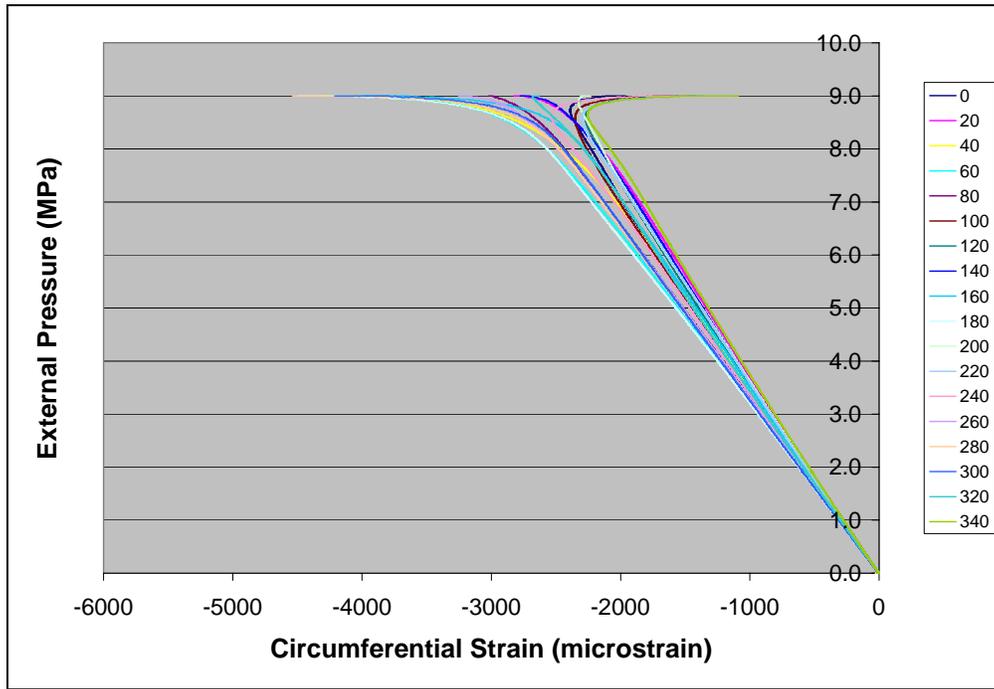
Figure 63. Cylinder with penetrations – circumferential strain on central stiffener (S6)

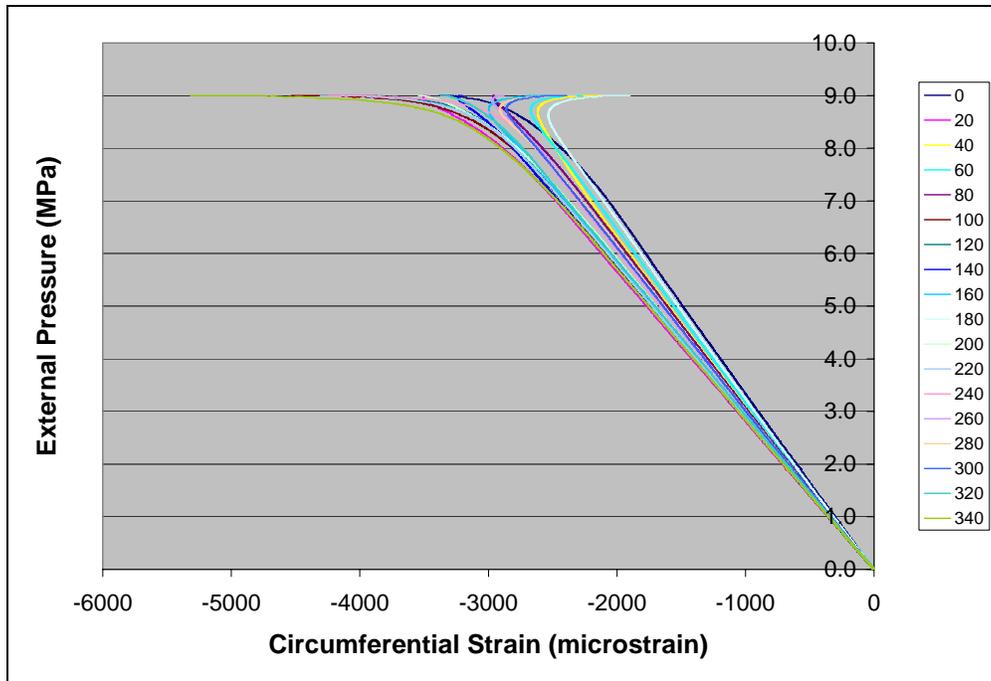
Figure 64. Cylinder with penetrations – circ. Strain inside shell opposite stiffener S6

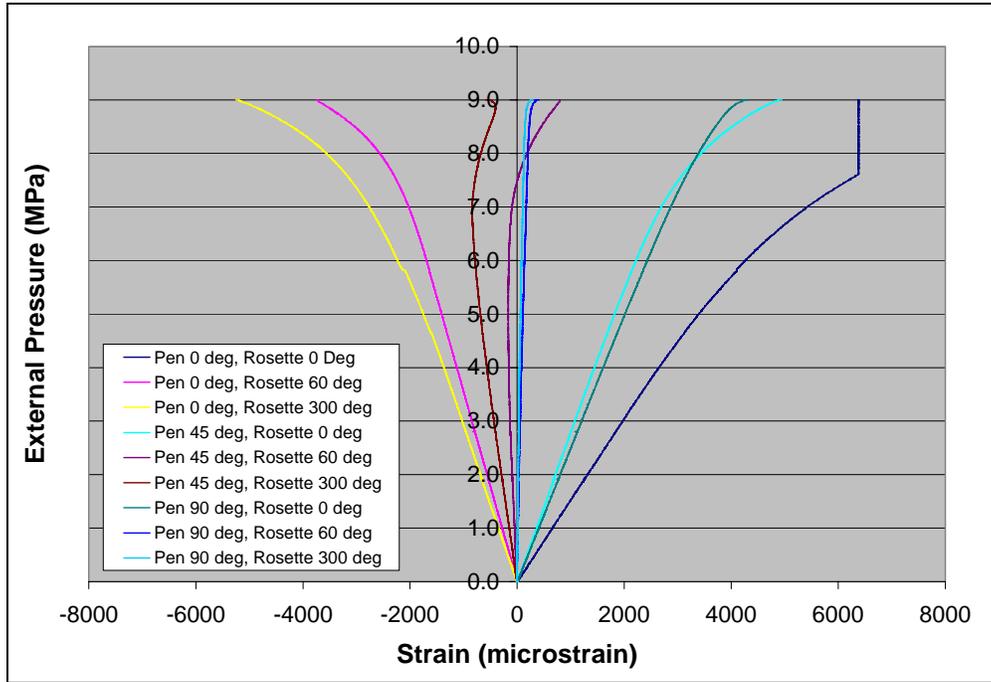
Figure 65. Cylinder with penetrations – rosette strains at penetration A

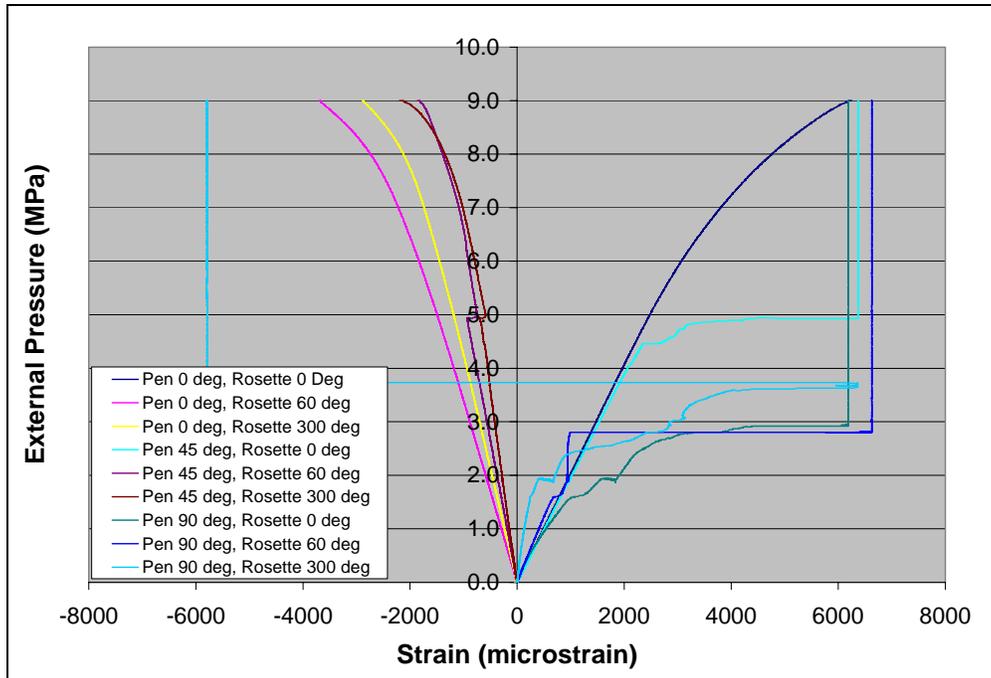
Figure 66. Cylinder with penetrations – rosette strains at penetration B

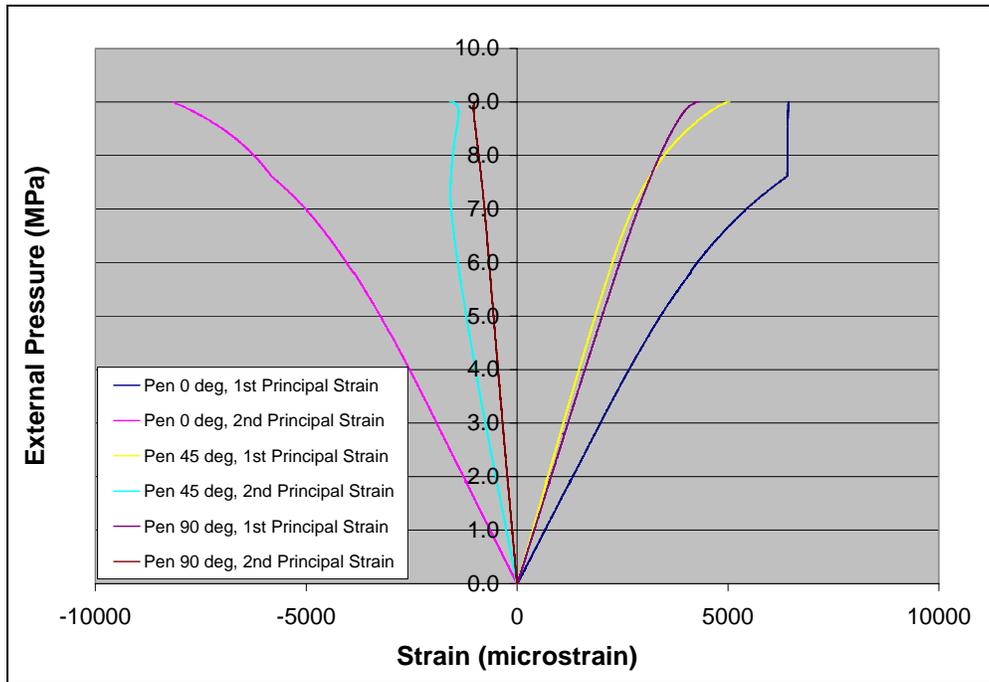
Figure 67. Cylinder with penetrations – principal strains at penetration A

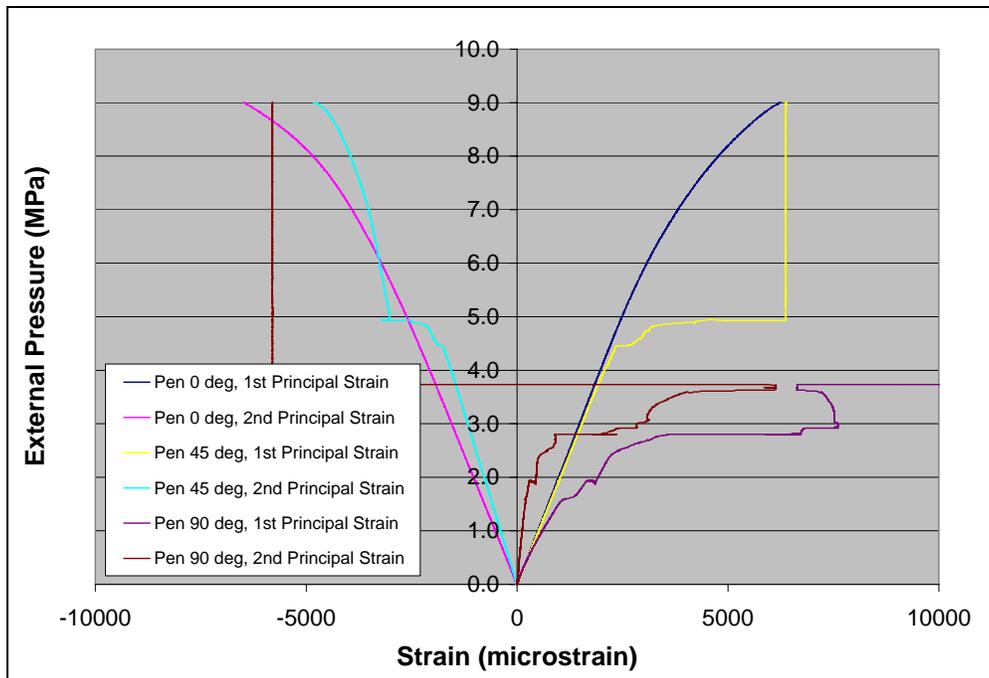
Figure 68. Cylinder with penetrations – principal strains at penetration B

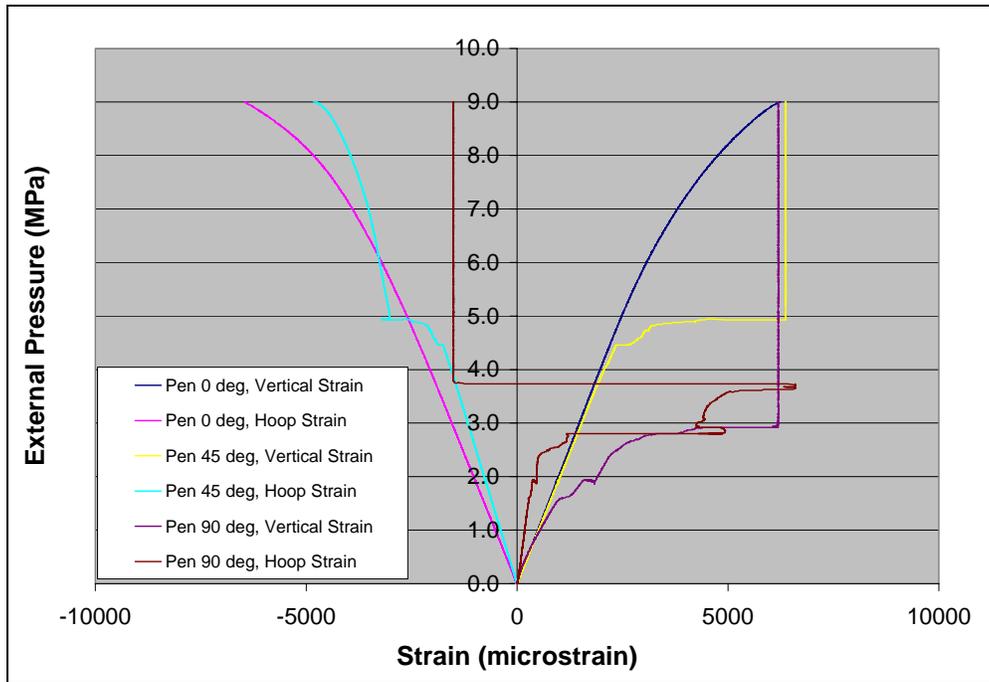
Figure 69. Cylinder with penetrations – orthogonal strains at penetration B

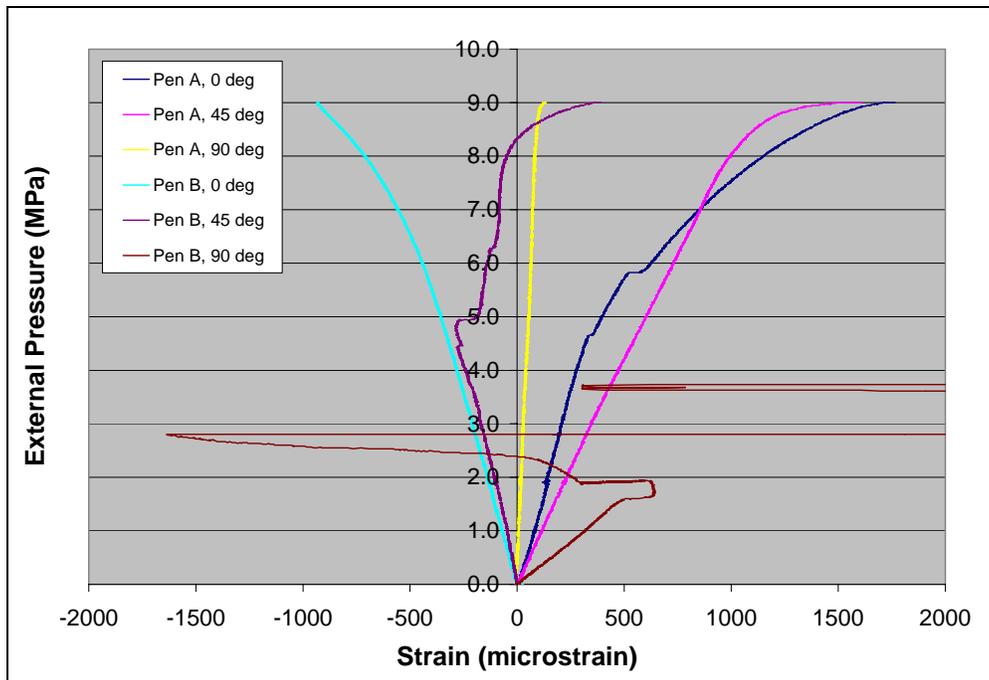
Figure 70. Cylinder with penetrations – shear strains at penetrations
