# **USE OF PRECAST CONCRETE WALLS FOR BLAST PROTECTION OF STEEL STUD CONSTRUCTION**

**Stephen D. Grumbach and Clay Naito  
Applied Research Associates  
P.O. Box 40128  
Tyndall Air Force Base, FL 32403**

**NOVEMBER 2007**

# Use of Precast Concrete Walls for Blast Protection of Steel Stud Construction

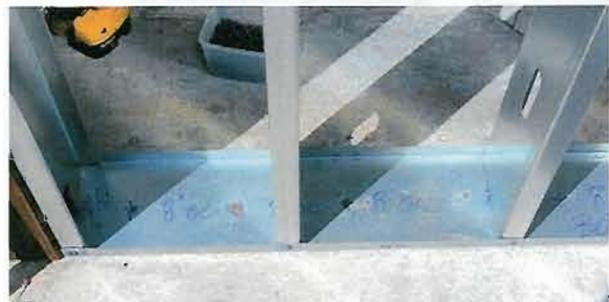
Figure 1: Stud connection details

The un-retrofitted wall system examined consists of traditional steel studs as an infill. The wall consists of 8-in. deep steel studs used as an infill in a steel tube frame building system. The studs are attached to the building system through an 18 gage track fastened to the reinforced concrete ground slab and a hollow structural section at the top. Powder-actuated fasteners are used to attach the track to the floor and frame beams. The studs are connected to the track using self tapping bugle head screws. Studs are spaced at 16-in. on center. The wall construction sequence is shown in Figure 1.

a) Wall elevation

b) Track detail

c) Track – stud connection
