COASTAL INLET BANK EROSION

William C. Seabergh¹

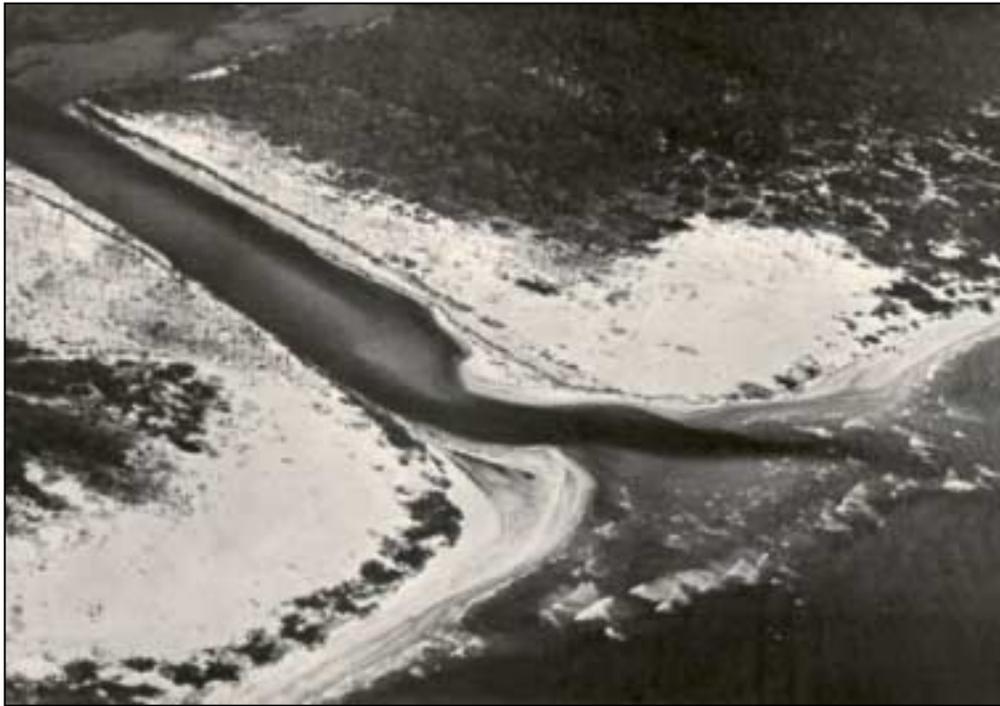
Figure 1. St. George Island Channel, Florida, before jetties (1955).

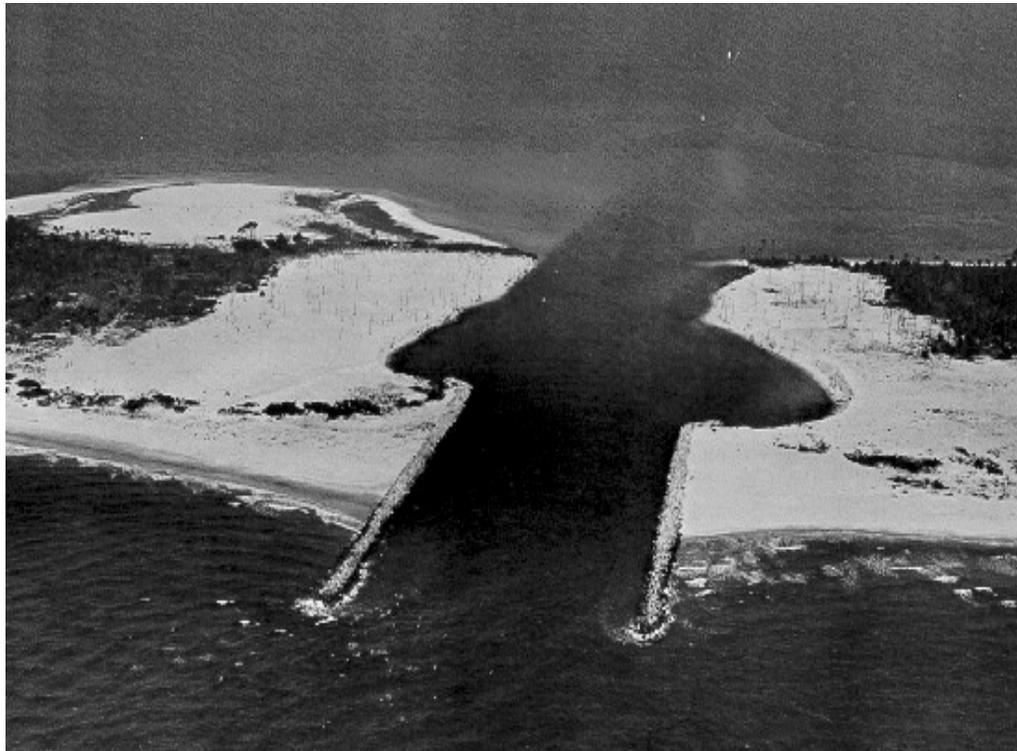
Figure 2. St. George Island Channel 12 years after jetties were constructed (1969). Note inner bank erosion on both sides of channel. The eroded area on right side is approximately 90 m into the bank line and 210 m in the along-channel direction.

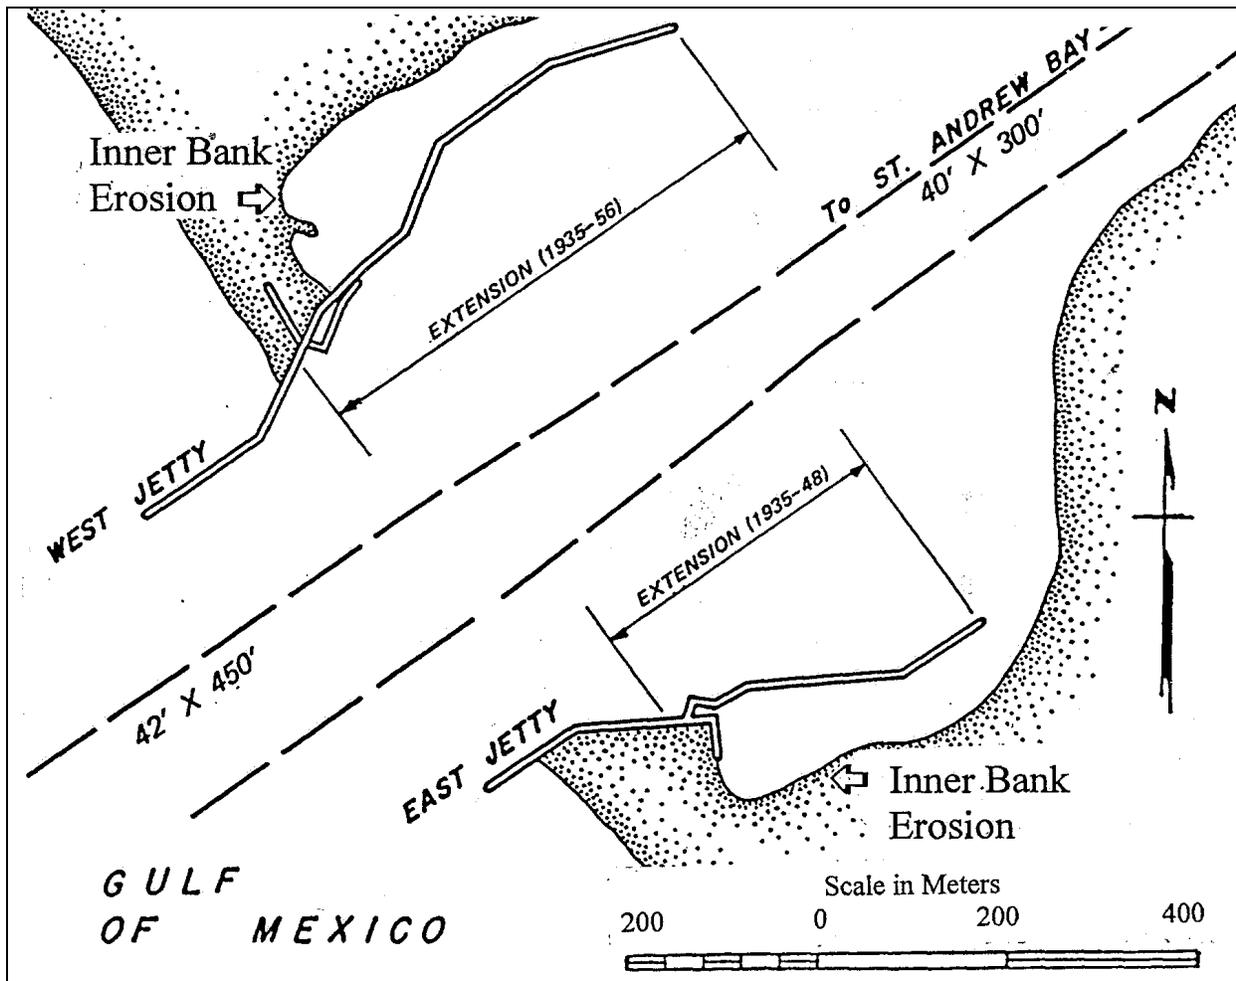
Figure 3. Panama City Harbor, Florida, showing jetty extensions constructed to prevent additional erosion.

Flanking is the action of breaching the thin neck of sand, created by cutting back of the inner bank towards the ocean beach. A breakthrough from the inner-bank erosion area to the ocean shoreline could potentially occur during a storm with high water level and large waves. Often, at the end of the jetty extension or revetment, erosion reoccurs. The author noted this commonly occurring recession of the inner bank of an inlet by examination of aerial photographs at jetty structures on all United States coasts, including the Great Lakes.

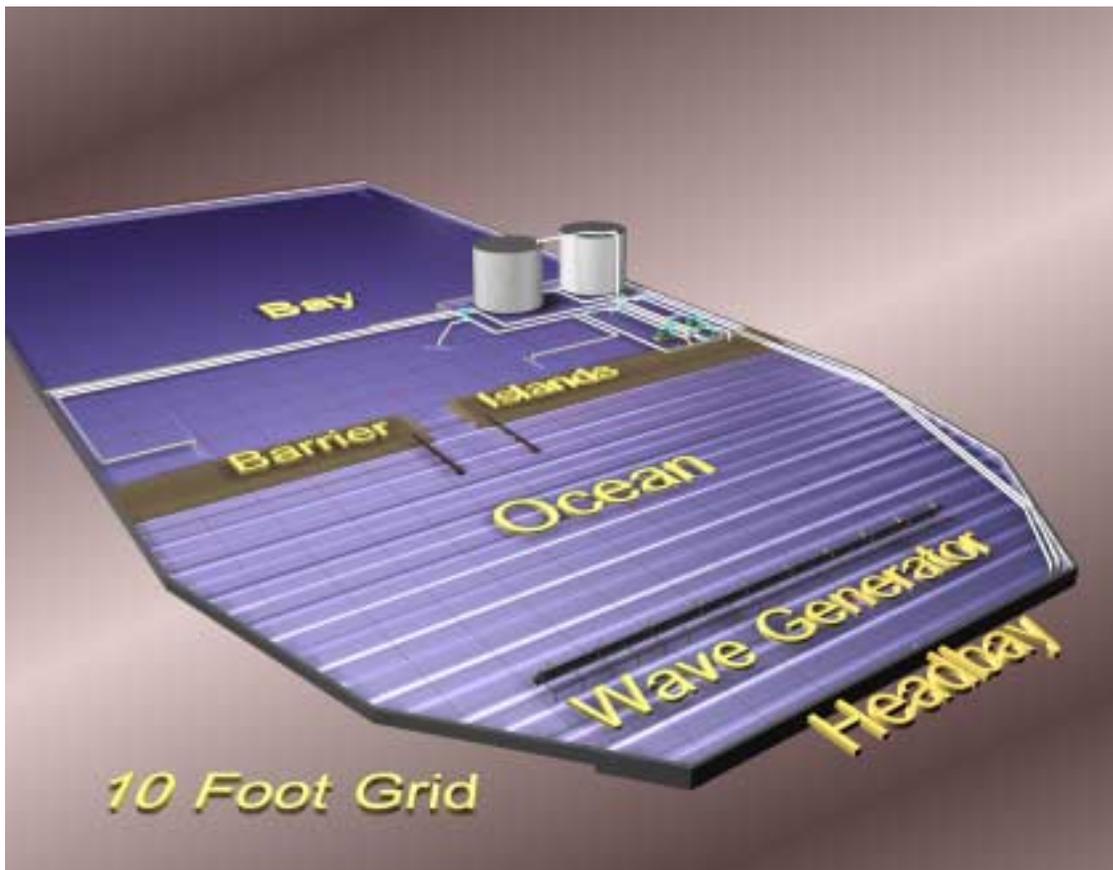
Figure 4. Coastal Inlet Research Program laboratory and model facility.

Laboratory Setup. A coastal inlet was designed within a 46 m wide by 99 m long concrete basin with 0.6 m high walls (Figure 4). The approach was to design an idealized inlet with simplified

bathymetry and steep beach slopes so additional features (such as an ebb shoal) could easily be added. In addition, a fine sand (placed over the concrete bottom in a thick veneer) served as both a tracer and as a fully mobile bed. A 1:50 undistorted scale was assumed to determine reasonable inlet dimensions to model; however, other scales can be assumed to accommodate study of specific processes with the simplified bathymetry. For this study a fully movable-bed was placed along the entrance channel, from a region just inside the jetties bayward.

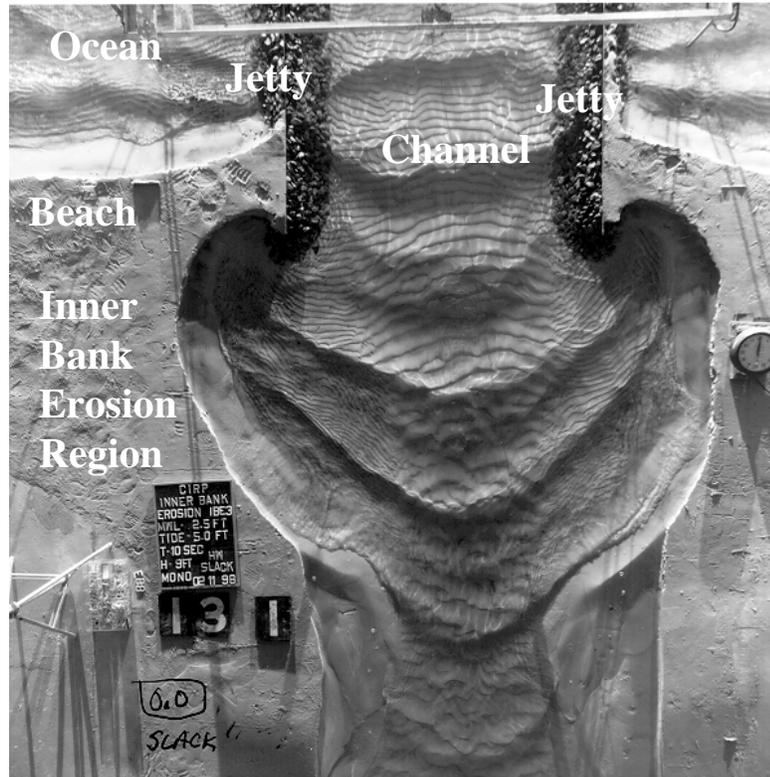
Figure 5. Waves entering the jettied entrance channel and producing crenulate-shaped (eroded) embayments.

Inner-Bank Erosion Experiment. The first wave condition was chosen as 2.7-m height, 10-sec period (scaled to prototype), and no currents were reproduced. The model was run until equilibrium plan view and vertical profile shape were reached for the given wave and water level, and then the bathymetry was measured. For this wave-only condition, the lateral run-up produced by the water level variation as wave crests, then troughs, moved past the terminal end of the structure, initiated the erosion at the jetty terminus. The run-up and run-down motion at the tip of the landward terminus of the jetty created a notch in the sand, which gradually deepened, then widened, permitting increasing wave diffraction to carve out the embayment. The erosion region developed from a straight bank line into the crenulate shaped embayments as seen in Figure 5. The eroded region reached an equilibrium shape after about 20 hours model time. The addition of currents with the waves increased the size of the embayment, but the initiating process was observed to be the same as the no-current experiment. Sediment eroded from the embayment moved along the edge of the inlet channel. With the no-current condition, sediment built out into the center of the entrance channel and reduced the rate of removal from the eroded region. The flood current increased the angle of wave attack and movement of sediment out of the embayment. With a tide plus waves condition, a similar shape embayment formed as for previous conditions, larger than the no current condition, but smaller than the wave plus steady-state flood current. The variation in tidal elevation permitted a deeper cut in the embayment. With currents (steady-state or tidal) present, the eroded volumes increased in the range of 8 to 45 percent.

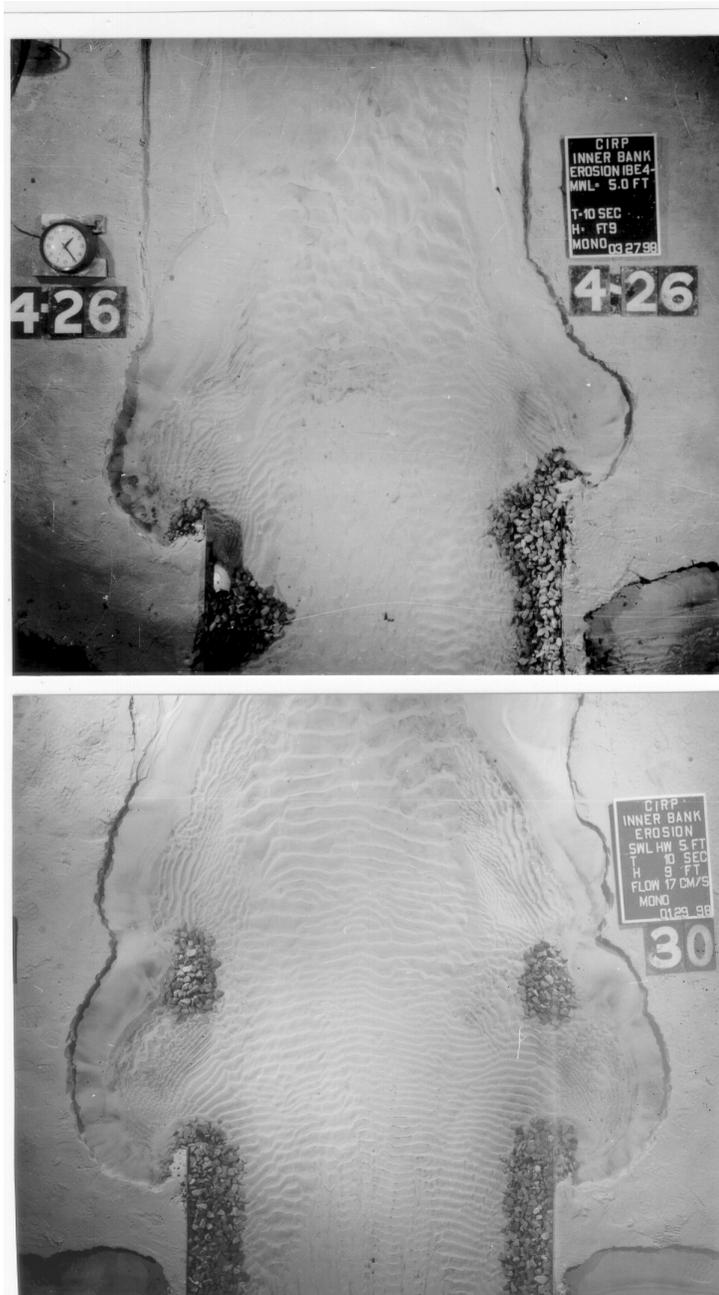
Figure 6. Top photo shows "diamond" end (right side) and a seaward diffraction structure (left side) and bottom photo shows a mound structure on each side, bayward of jetties.

Inner-Bank Erosion Prevention Methods. Follow-up experiments examined potential solutions to minimize erosion by placing hardpoints to create smaller embayments or altering jetty structure slope and lateral extension into the channel. A diamond shape (in plan view) was built on the end of the right jetty and functioned to reduce wave energy at the end of the jetty. Because of its extension into the beach, it also prevented flanking, as shown in Figure 6, top photo, right side. On the left side

of the top photo, Figure 6, a channel-side structure is placed seaward from the jetty terminus, and flanking of the jetty occurred because there was no tie-in to the beach. The headland concept was adopted by adding a hardpoint (a rock mound) on a line bayward of the jetty, to create a smaller embayment region than was created without the additional structure (Figure 6, bottom photo). These are compared to the non-structure experiment in Figure 5 for wave and tidal current conditions. Volumes eroded and surface area removed was reduced for the prevention methods. The diamond structure clearly reduced erosion and prevented flanking of the structure, reducing volume loss 58 and 47 percent on the right (initially steep slope) and left (initially relatively flat slope) inner-bank regions, respectively.

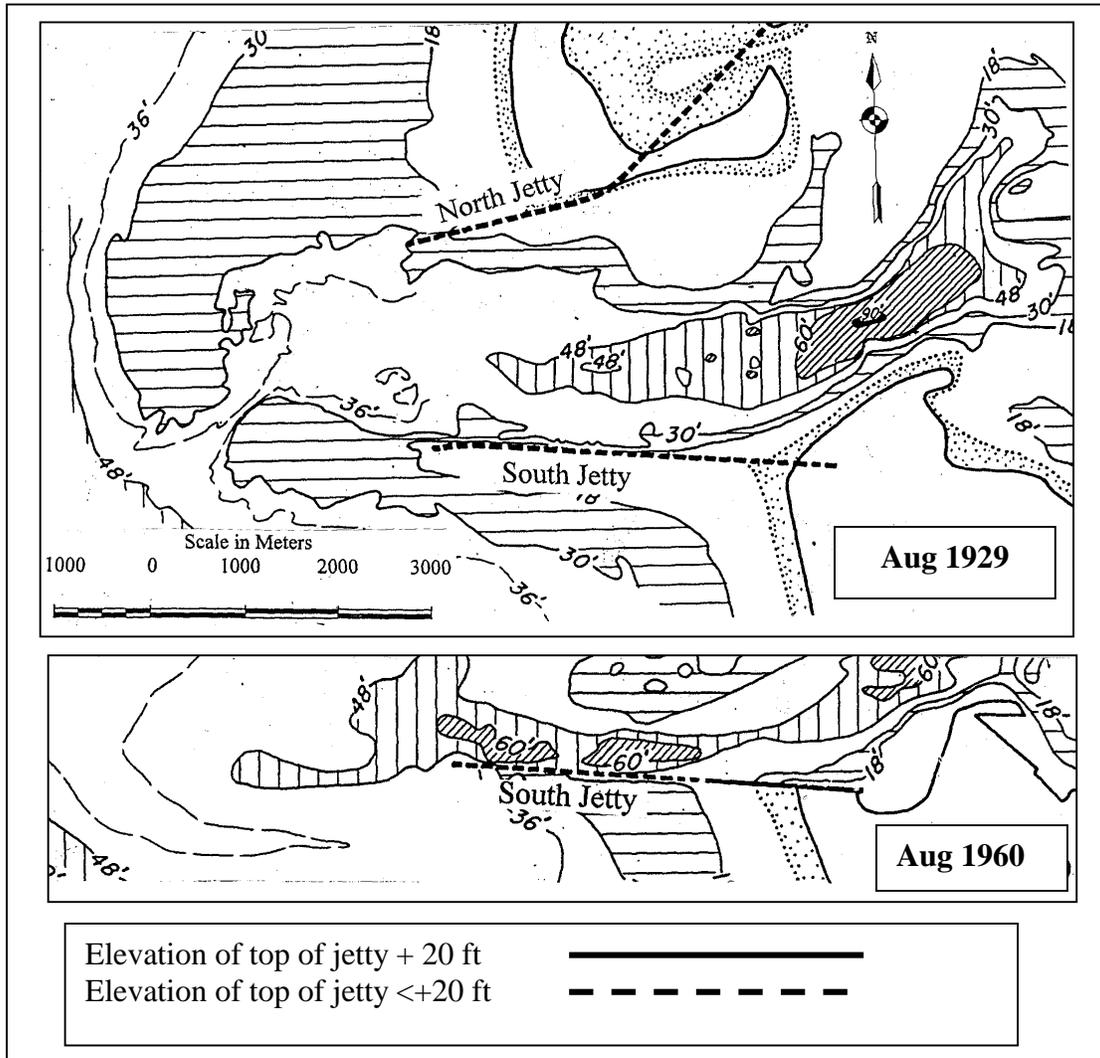
Figure 7. Grays Harbor, Washington, entrance. August 1929, before South Jetty shoreward portion raised and Aug 1960 about 24 years after south jetty raised to + 20 ft. Note creation of inner bank erosion area.

Grays Harbor, on the Pacific Coast of Washington, has a large entrance channel. South jetty construction commenced in 1898 and north jetty construction was completed in 1913. By 1929, the inlet entrance was as shown in the top map of Figure 7. Focussing attention on the shore end of the south jetty, which had a crest elevation of +2.4 m, mllw, there was a continuous shoreline from ocean-side to bayside at the south jetty junction with the shore. Apparently, in this region of high wave climate (average significant wave height of 2 m, with storm waves of 5 m not unusual) and large tide range (diurnal tide range of 2.7 m), sediment can move over and through the jetty at the

shoreline during high water and storm conditions. Earlier maps of the inlet, after the jetties were built, showed this continuous shoreline through the south jetty also. In the 1936-1939 time frame, the south jetty crest elevation was increased to +6.1 m, mllw. This addition in elevation was sufficient to reduce or cut off the sediment supply from the beaches to the inner bank shoreline. As seen in Figure 7, initially the inner bank was receding eastward, and by 1946 the jetty terminus was exposed. An eroded region evolved at the south jetty terminus, as seen in the 1960 timeframe. In 1960, the curved notch extended approximately 640 m landward from the jetty terminus, and was recessed

200 m laterally into the inner bank. By 1993, the eroded region had increased to dimensions of 730 m long by 275 m wide. From 1946 to 1960, it expanded at a rate of about 46 m/year in length and 14 m/year in width. From 1960 to 1993, the rate of increase was reduced significantly. In late 1993, the region just south of the south jetty was breached during a storm, and emergency measures had to be taken to repair the breach. The navigation channel was in close proximity, located on the inner edge of the south jetty, and tidal flow could potentially enlarge the breach and cause additional erosion to the region. Increased exposure to wave action was also a possibility for the City of Westport, located east of the eroded area. The ocean-side beach had also been receding, so the combination of inner bank erosion and beach recession greatly increased the potential for breaching. The gap was filled with dredged material in this emergency. To prevent a reoccurrence of the breakthrough, the Seattle District, U.S. Army Corps of Engineers designed a mound structure based on the conceptual model experiments of the Coastal Inlets Research Program described above. A model study was conducted

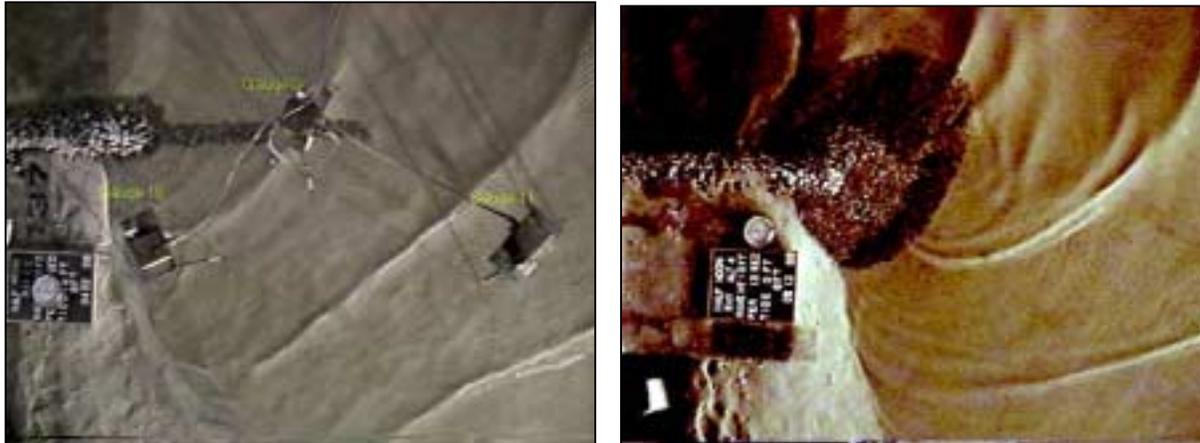
Figure 8. Model study photos: left photo shows the pre-diffraction structure condition and right photo the mound structure diffracting waves.

to replicate the shoreward region of the south jetty and some of the navigation channel in the laboratory facility. This work confirmed the design. Figure 8 shows the existing condition in the model and the plan selected for construction. The wave angle sweeping along the shoreline is modified by the mound, directing it more perpendicular to the inner bank shoreline. Also wave heights were significantly reduced in this region. Figure 9 shows the structure as constructed in 1999.

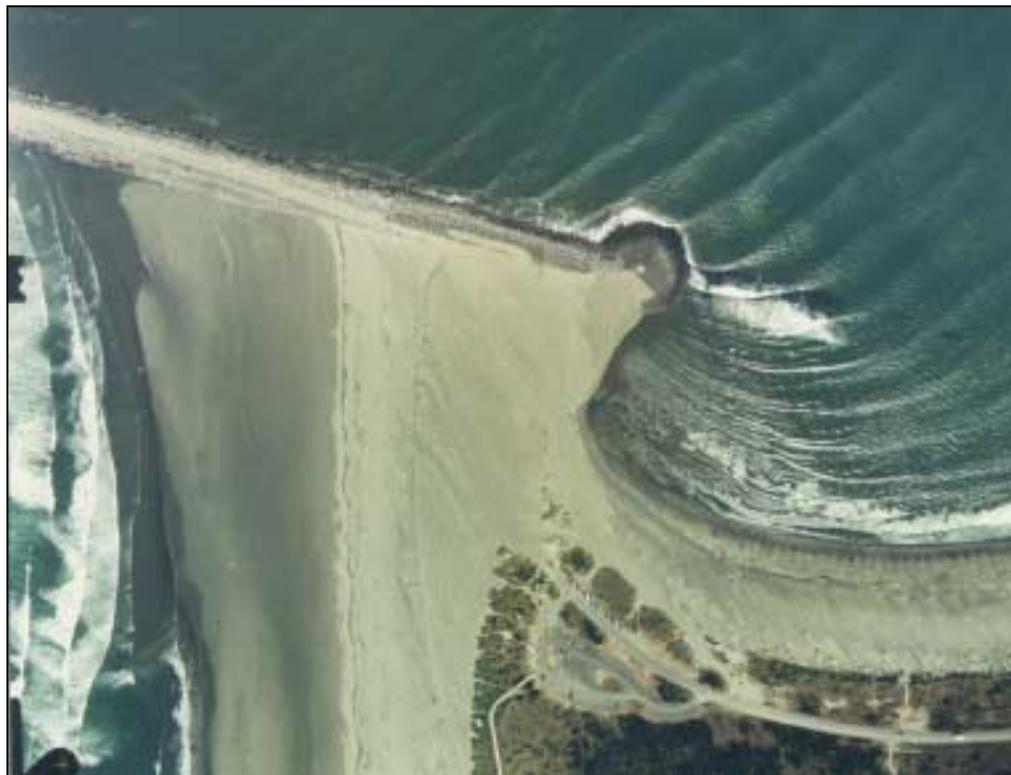
Figure 9. Mound diffraction structure as constructed at Grays Harbor, Half Moon Bay.
