Technical Report ARMET-TR-08023

GALVANIC CORROSION STUDY ON STAINLESS STEEL CARTRIDGE DESIGN

November 2008

U.S. ARMY ARMAMENT RESEARCH, DEVELOPMENT AND
ENGINEERING CENTER

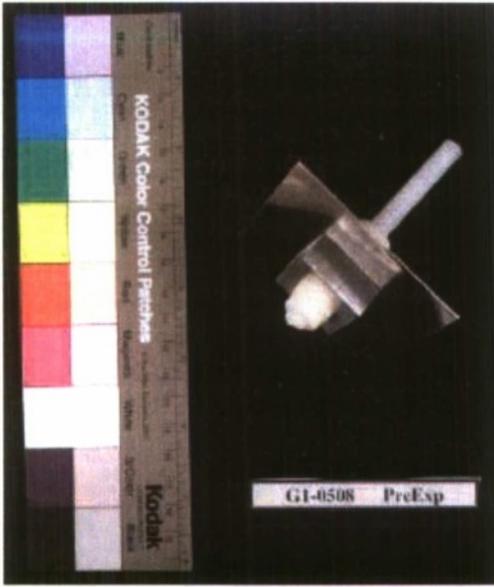
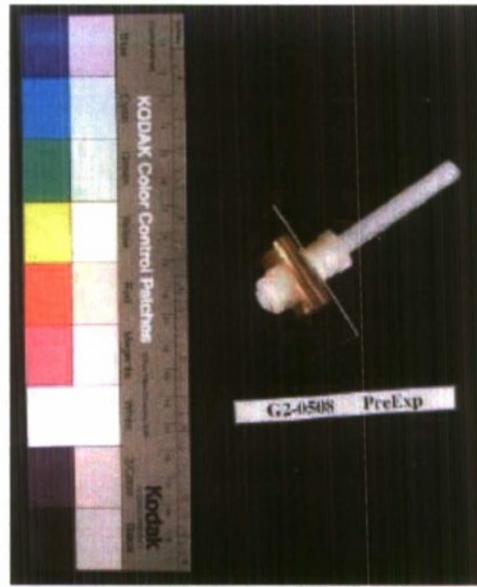
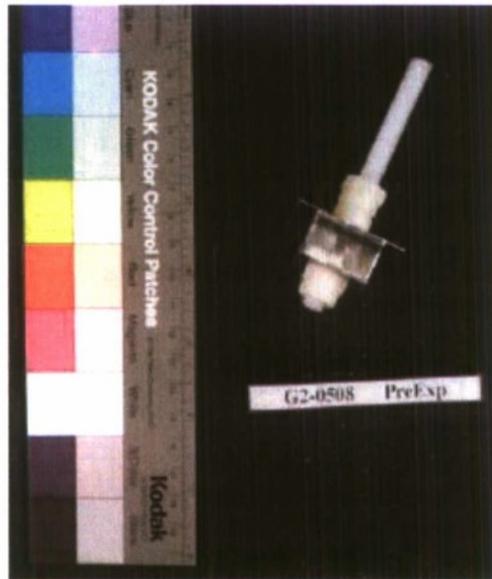
(a)
Aluminum with stainless steel

(b)
Copper alloy with stainless steel

(c)
Carbon steel and stainless steel

Figure 1
Galvanic couple specimens before atmospheric exposure
(Materials are held together using nylon rods and nuts.)

Nylon rod coupled specimens (figs. 1 and 2) were placed on rack A in the corrosion instrumented test yard (CITY) located at the U.S. Army Armament Research, Development and Engineering Center (ARDEC), Picatinny Arsenal, New Jersey in compliance with ASTM G50 (ref. 4). Three sets of triplicate specimens and two sets of control specimens were exposed for 1 month, 3 months, and to be decided. Digital pictures were taken on a regular basis and post-exposure examination was conducted.

Nylon rod coupled specimens (figs. 1 and 2) were placed in 500 mL plastic containers completely submersed in ASTM D1141 (ref. 5) artificial seawater. Specimens were held vertical and evenly spaced using additional nylon rods and nuts. Separate containers were used for the aluminum-stainless steel couples and the copper alloy-stainless steel couples. One set of replicates for each specimen type were removed after 2.5 weeks of immersion and after 5 weeks of immersion. Digital pictures were taken on a regular basis and post-exposure examination was conducted.

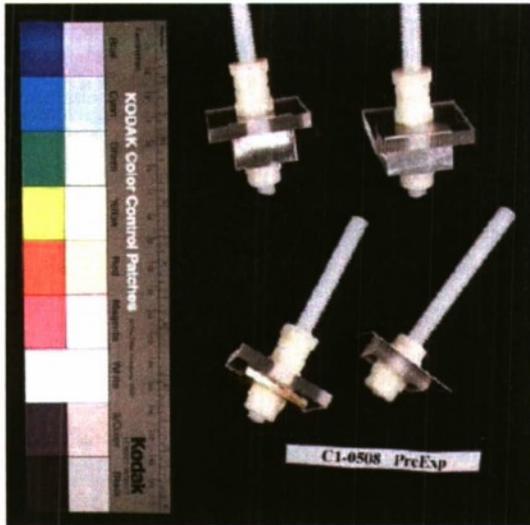
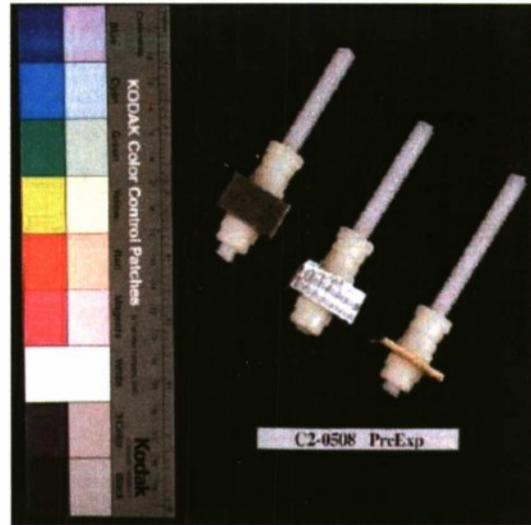
(a)
Control type 1 (with plastic backing)

(b)
Control type 2 (without plastic backing)

Figure 2
Uncoupled specimens (controls) before atmospheric exposure
(Materials are held together using nylon rods and nuts.)

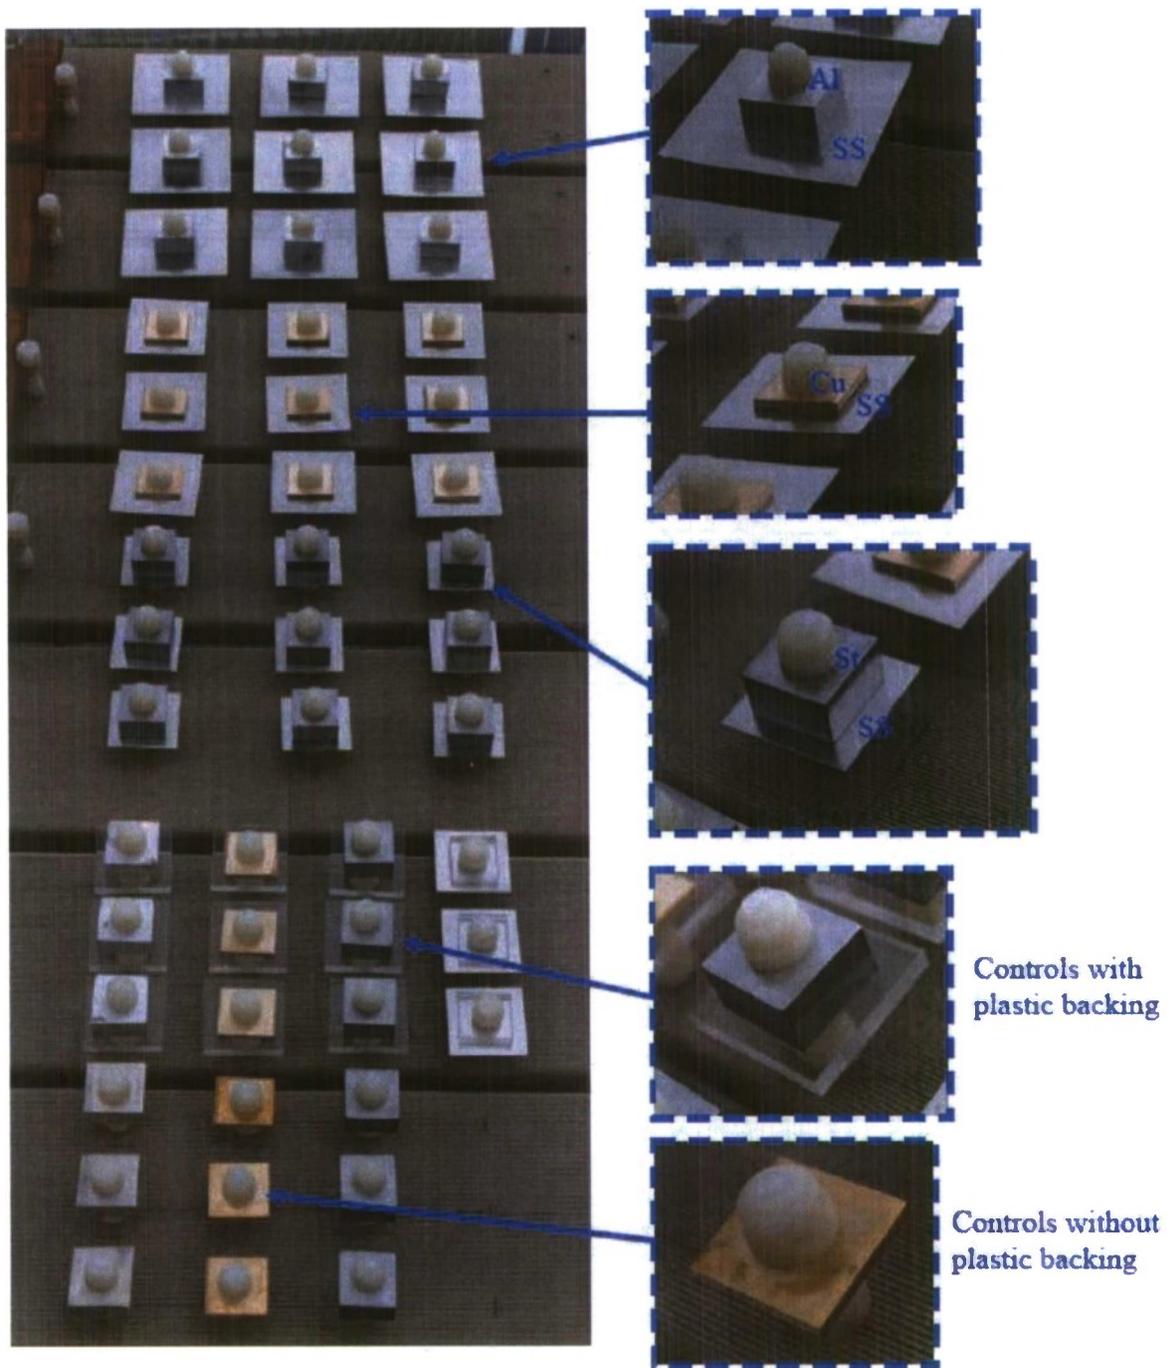
Figure 3 shows specimens after initial exposure in the CITY. Several sets of replicates for each type were tested to accommodate removal after different exposure durations.

Figure 3
All atmospheric specimens after initial exposure in CITY

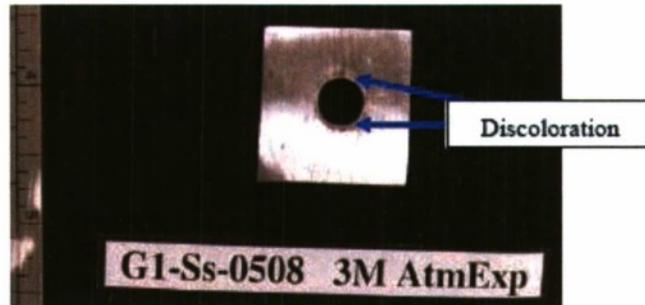
Figure 4
Slight discoloration on aluminum backside that was mated with the stainless steel

No significant difference was visible between the aluminum-stainless steel coupled and uncoupled materials after 1 month and 3 months of exposure. This was expected because both aluminum and stainless steel form strong passive oxide layers in the presence of oxygen in the atmosphere. These oxide layers protect the substrates from further corrosion. Only slight discoloration on the aluminum was noticed on the face that was mated with the stainless steel after 3 months of exposure (fig. 4). Some pitting was apparent on the stainless steel possibly due to the slight crevice created from the aluminum-stainless steel interface. The crevice corrosion control specimen supported this theory. Figure 5 shows the pitting.

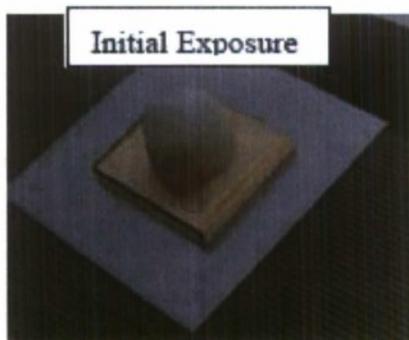
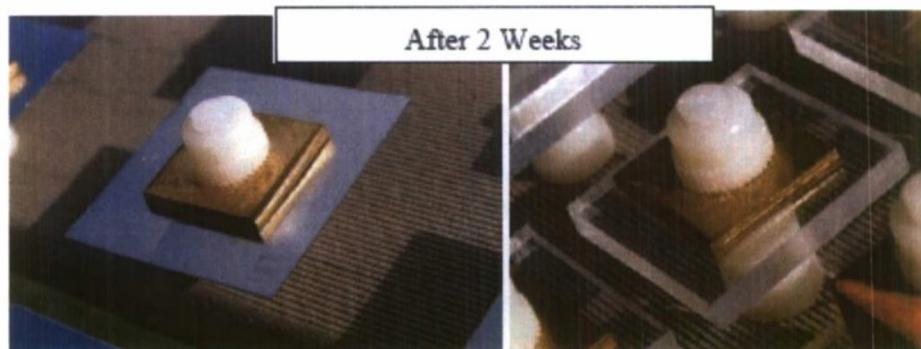
Galvanic couple (copper alloy-stainless steel) after initial exposure

Galvanic couple (copper alloy-stainless steel) after 2 weeks exposure

Control specimen (copper alloy-plastic backing) after 2 weeks exposure

Figure 6
Tarnishing of copper surface during atmospheric exposure

As in the case of the aluminum-stainless steel couples, the copper alloy-stainless steels materials did not corrode significantly different when coupled versus uncoupled. The surface of the copper alloy did tarnish after 2 weeks of exposure. This was apparent on the fronts of all three copper alloy specimens (fig. 6). The corrosion on the backside of the galvanic couple specimen was more evident than that of the plastic-backed specimen (fig. 7). The crevice formed in both setups appears to have contributed to the degradation, but the galvanic couple provided a stronger driving force. The stainless steel specimens (both coupled to the copper alloy and the plastic) exhibited pitting (fig. 5) from the crevice formed.

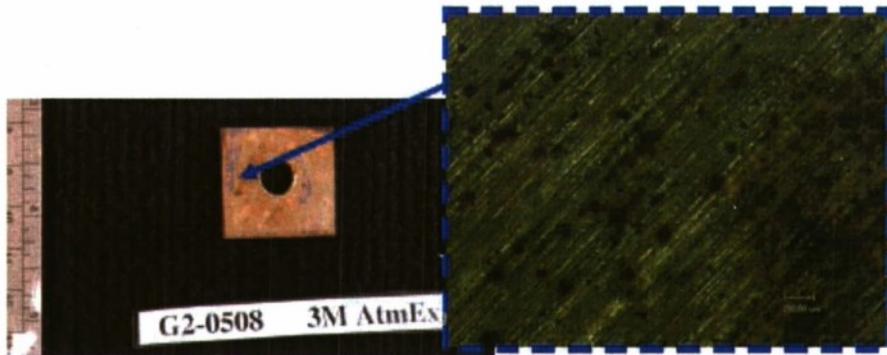
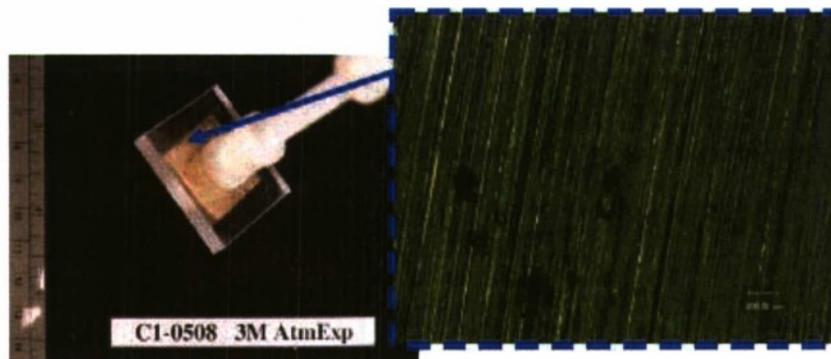
(a)
Face coupled to stainless steel

(b)
Face coupled to plastic backing

Figure 7
Corrosion after 3 months atmospheric exposure on copper alloy
(Images on right side were taken at 100x magnification.)

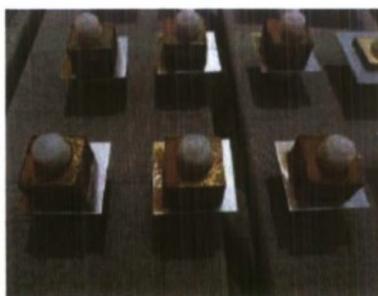
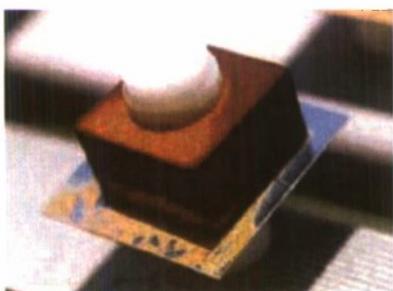
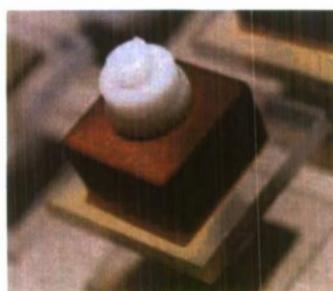
(a)
After 1 week

(b)
Galvanic couple (carbon steel-stainless steel) after 3 months

(c)
Control with plastic backing after 3 months

Figure 8
Corrosion of carbon steel specimens during atmospheric exposure

As expected, the carbon steel specimens exhibited the most atmospheric corrosion degradation of all the materials. However, the corrosion was not significantly different in the coupled as compared with the uncoupled arrangement. General corrosion was apparent on the surface of all carbon steel specimens after 1 week of atmospheric exposure (fig.8a). After 3 months, the carbon steel corrosion on the galvanic couple specimen was consistent with the corrosion on the control specimen (with plastic backing) (fig. 8a and b).

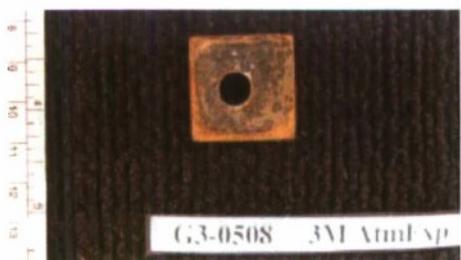
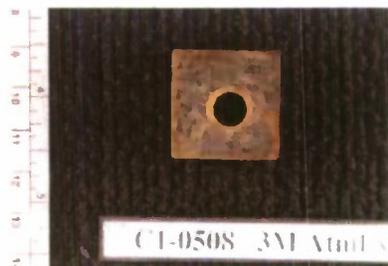
(a)
Galvanic couple specimen

(b)
Plastic-backed specimen

Figure 9
Corrosion product on carbon steel surfaces after 3 months atmospheric exposure

The corrosion on the backside was a little more interesting. In both the coupled and plastic-backed setups, the degradation was similar although there was slightly more red corrosion product in the galvanic couple specimen (fig. 9). This could be due to the galvanic reaction between the carbon steel and the stainless steel and the penetration of water from the less tightly fitting galvanic couple setup.

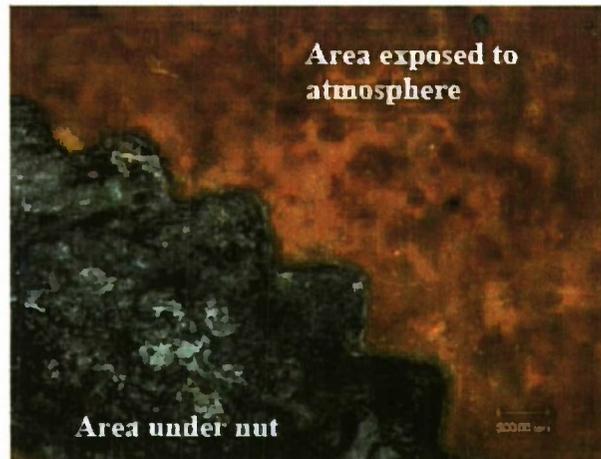
Border of crevice created by nylon nut on front face of carbon steel specimen after 3 months of atmospheric exposure (Image taken at 50x magnification.)

The black iron oxide (magnetite) formed due to lack of oxygen in the crevice while red iron oxide (hematite) formed on the exposed surfaces. Figure 10 shows evidence of this on the front side of a carbon steel specimen at the border where the nylon nut created a crevice.

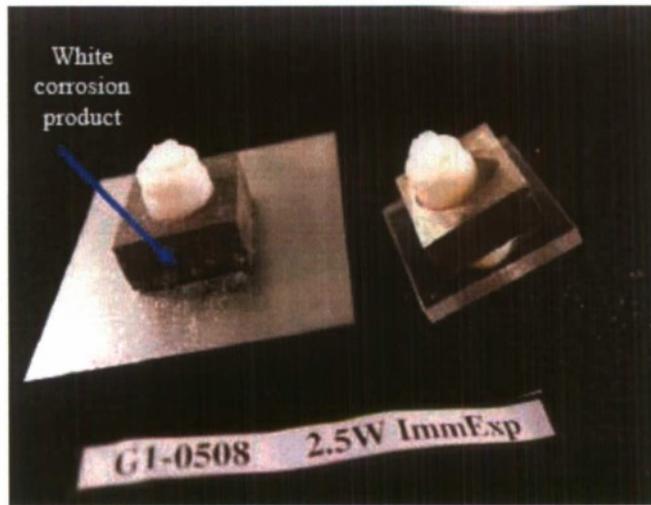
Figure 11
Specimens removed from constant immersion in artificial seawater after 2.5 weeks
[Left - aluminum coupled with stainless steel and right - aluminum with plastic backing]

After 2.5 weeks of immersion in artificial seawater, the galvanic coupled aluminum had a considerable large amount of white corrosion product (fig. 11). When the couples were separated for further examination, it was very clear that the galvanic couple had accelerated the aluminum corrosion rate. There was a greater amount of white corrosion product than on the uncoupled aluminum sample (with plastic backing) after 2.5 and 5 weeks of immersion (fig. 12).

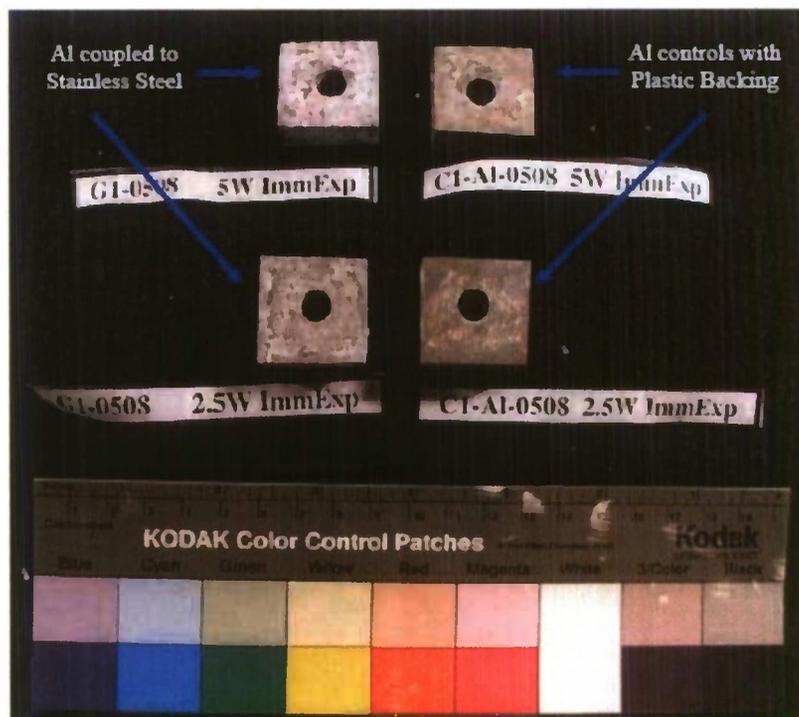
Figure 12
Aluminum specimens after 2.5 weeks (bottom row) and 5 weeks (top row) of constant immersion
in artificial seawater (Left side specimens were coupled to stainless steel and right side
specimens has a plastic backing.)

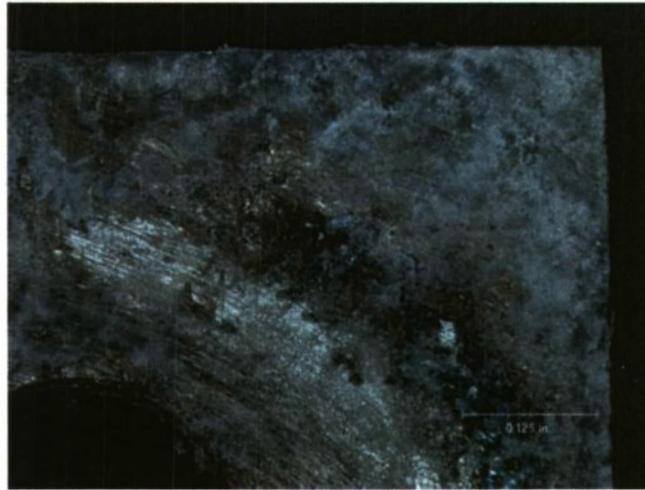
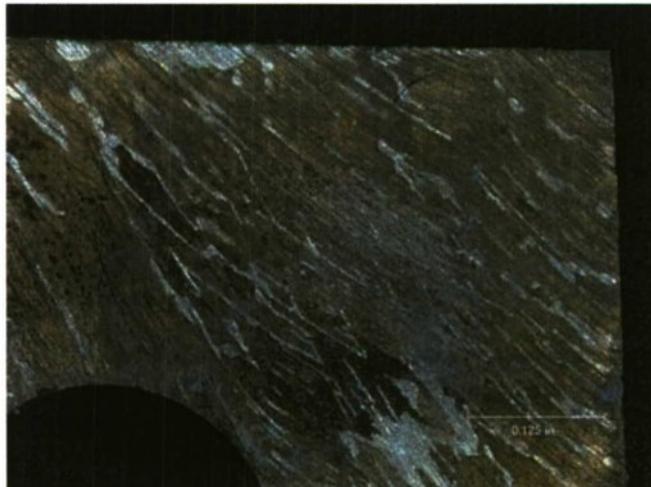
(a)
Coupled with stainless steel

(b)
Plastic backing

Figure 13
Digital microscope images at 20x magnification of aluminum specimens after 5 weeks of constant immersion in artificial seawater

Higher magnification digital pictures were taken to better illustrate the difference in corrosion products between the galvanic couple aluminum and the plastic-backed aluminum. Figure 13 shows there is clearly a difference in corrosion damage. The galvanic coupled aluminum has a significant amount of white corrosion product covering the surface. Alternatively, the plastic-backed aluminum has discoloration, but no corrosion product build-up. A reddish material was evident in the coupled specimen, which later turned to white with exposure to air. This material will be further investigated.

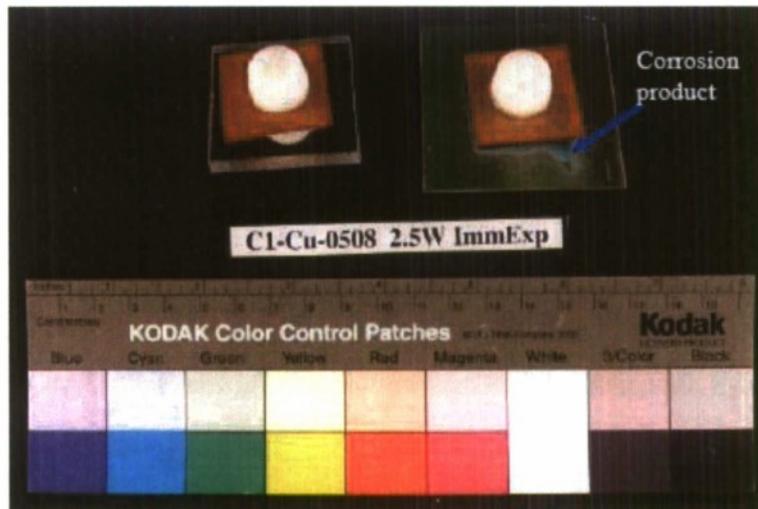
Figure 14

Images after 2.5 weeks of constant immersion in artificial seawater (Left side is the control copper alloy specimen with plastic backing and the right side is the galvanic couple of the copper alloy and stainless steel.)

After 2.5 weeks of immersion in artificial seawater, one set of specimens was removed for inspection. It was already apparent that the galvanic couple copper alloy was corroding more than the plastic-backed specimen. In figure 14, the blue/green corrosion product can be seen coming off the copper alloy at the copper-stainless steel interface. The surface corrosion on both specimen types is very similar (fig. 15). The area underneath the nylon nut is still untarnished.

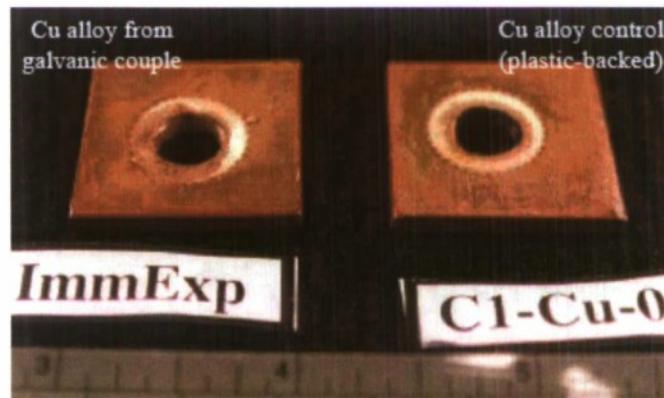
Figure 15

Front sides of copper alloy specimens after being separated from coupling setups (These specimens were exposed for 5 weeks in artificial seawater.)

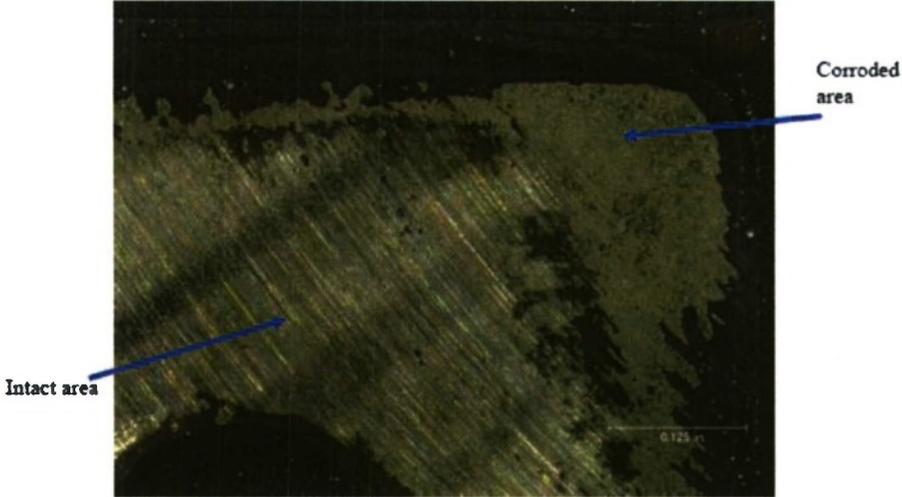
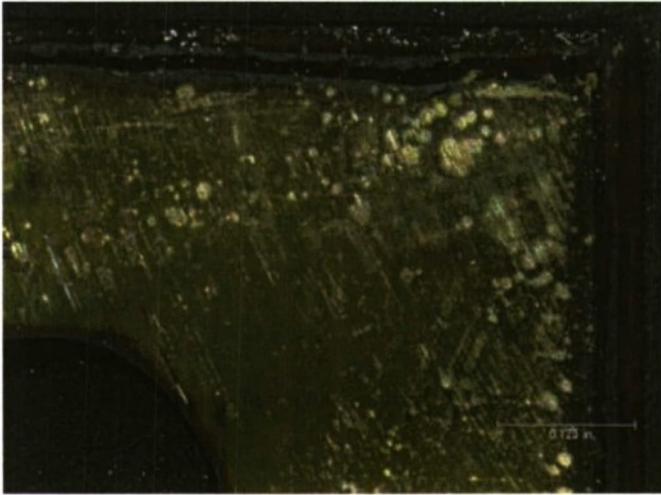
(a)
Coupled with stainless steel

(b)
Plastic backing

Figure 16
Digital microscope images at 20x magnification of copper alloy specimens after 5 weeks of constant immersion in artificial seawater

Although the front sides were similar, the sides in contact with the coupling material had different results. Figure 16a shows the copper alloy that was coupled to the stainless steel corroded in distinct areas. The copper alloy specimen that was coupled to the plastic did not show as distinct of corrosion areas (fig. 16b). The damage was more spread out and not as extensive.

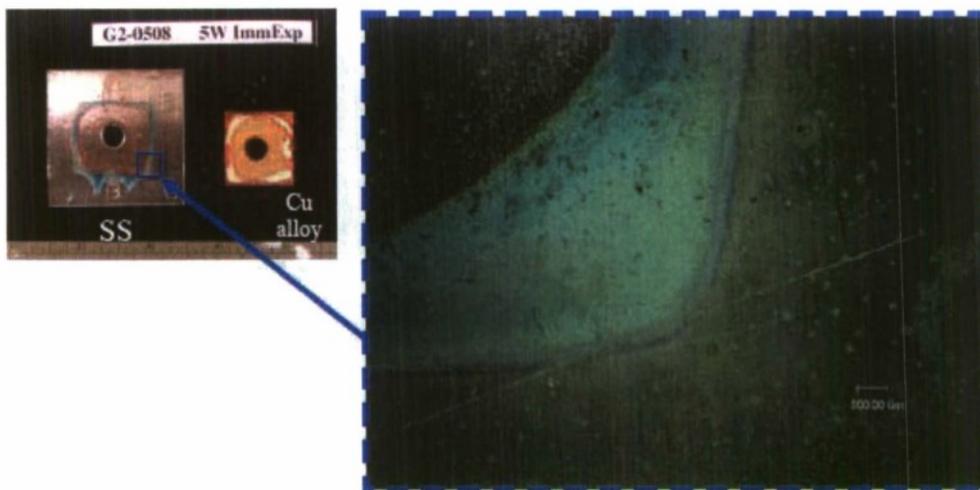
Digital microscope image at 30x magnification of corrosion product residue from the copper alloy on the stainless steel specimen after 5 weeks of immersion in artificial seawater

Further analysis was conducted on the corrosion product that remained on the stainless steel specimen that was coupled to the copper alloy. Figure 17 shows a closer look at the blue/green corrosion product at the corner where the two specimens met. The analysis of this corrosion product (included in appendix D) supported the idea that the corrosion product was from the copper alloy. The Energy Dispersive X-ray Analysis (EDXA) also showed that the red material contained a large amount of calcium and sulfur (possibly some type of calcium sulfate residue).

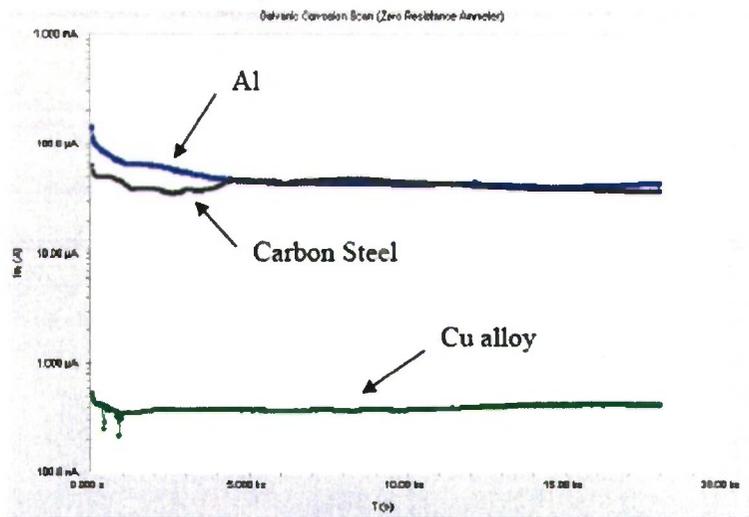
Figure 18
Plot of galvanic current (log A) versus time (s) for different materials coupled with stainless steel in artificial seawater

A plot of the galvanic current recorded during the test is shown in figure 18. The current was plotted on a log scale. Higher current correlates to higher corrosion rates. From these results, it is apparent that when coupled with stainless steel (1:1 area ratio) in artificial seawater the aluminum and carbon steel corroded at a faster rate than the copper alloy. Figure 19 is a plot of the corrosion potentials as a function of time. The low corrosion potentials of the aluminum-stainless steel and carbon steel-stainless steel system demonstrate their sacrificial protection of the stainless steel. A SCE was used as the reference electrode in this system.

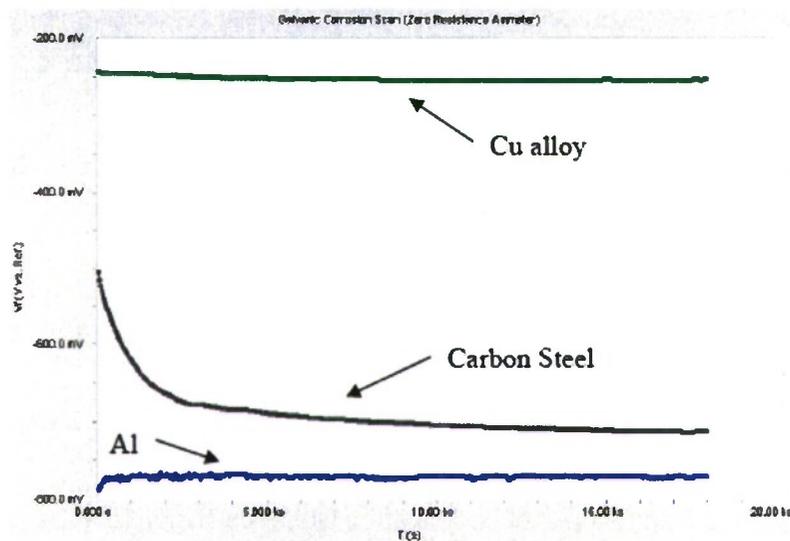
Figure 19
Plot of corrosion potential (mV versus SCE) versus time (s) for different materials coupled with stainless steel in artificial seawater

In each of the three galvanic couple ZRA experiments (aluminum-stainless steel, copper alloy-stainless steel, and carbon steel-stainless steel), the stainless steel remained intact while the other coupled material corroded. Images of this corrosion are shown in figure 20. This confirms that the galvanic current recorded was a result of the stainless steel acting as a cathode (more noble) during the ZRA experiments.

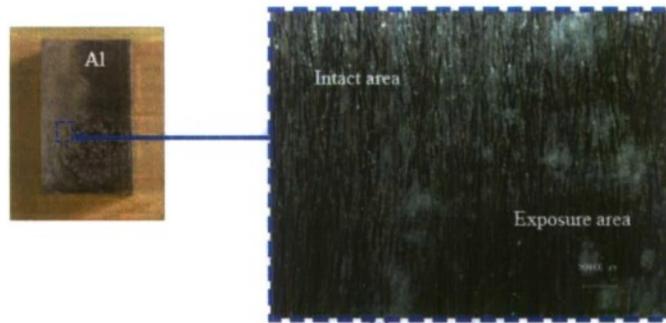
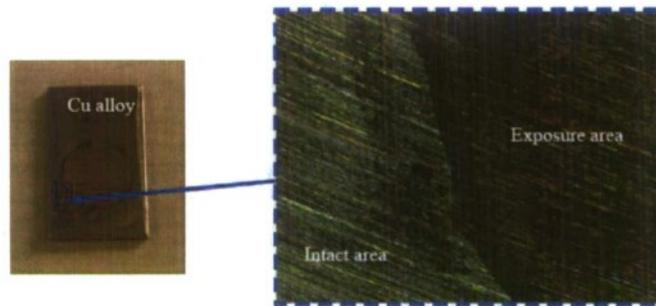
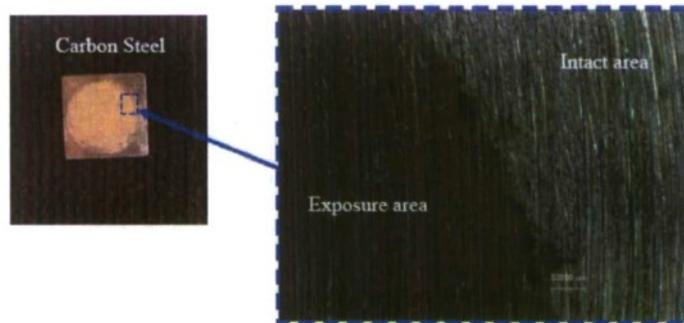
(a)
Aluminum coupled with stainless steel

(b)
Copper alloy coupled with stainless steel

(c)
Carbon steel coupled with stainless steel

The circles of discoloration shown on the left side are where the electrolyte (artificial seawater) was in contact with the material.

Figure 20
Digital microscope images at 50x magnification of exposure areas from galvanic corrosion ZRA experiments

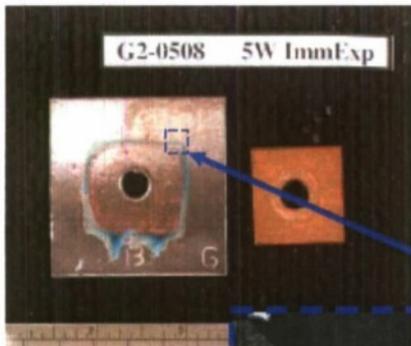
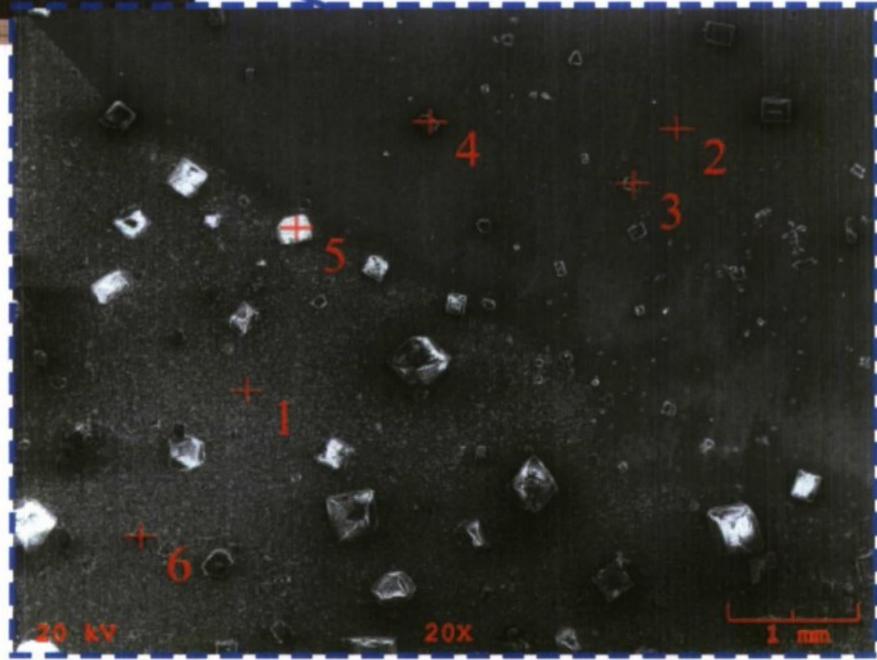
EDXA analysis of Cu alloy corrosion product residue and salts on Stainless Steel surface after 5 weeks of constant immersion in artificial seawater.

Secondary e⁻ SEM micrograph

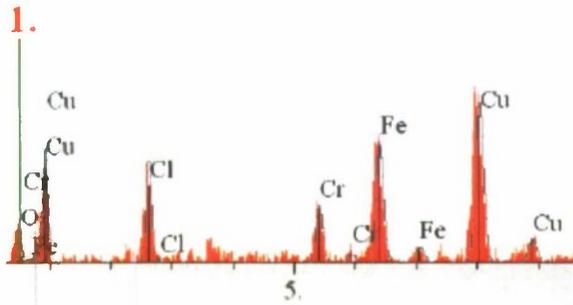
Elt.	Line	Intensity (c/s)	Error 2-sig	Conc	Units	
O	Ka	1.21	0.284	6.439	wt.%	
Cl	Ka	5.10	0.583	7.400	wt.%	
Cr	Ka	3.68	0.495	6.998	wt.%	
Fe	Ka	8.07	0.733	20.524	wt.%	
Cu	Ka	11.93	0.892	58.639	wt.%	
				100.000	wt.%	Total

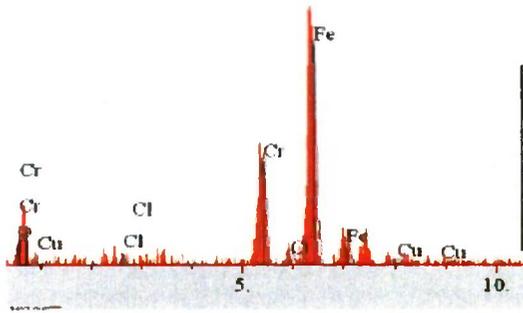
2.

Elt.	Line	Intensity (c/s)	Error 2-sig	Conc	Units	
Cl	Ka	0.83	0.389	0.832	wt.%	
Cr	Ka	16.15	1.721	20.883	wt.%	
Fe	Ka	34.78	2.526	74.410	wt.%	
Cu	Ka	1.00	0.428	3.874	wt.%	
				100.000	wt.%	Total

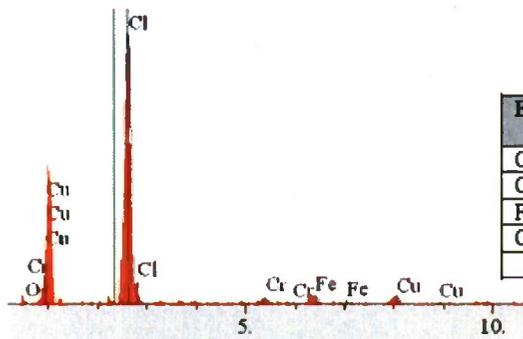
3.

Elt.	Line	Intensity (c/s)	Error 2-sig	Conc	Units	
Cl	Ka	58.59	2.427	76.573	wt.%	
Cr	Ka	1.37	0.372	3.504	wt.%	
Fe	Ka	2.24	0.474	7.277	wt.%	
Cu	Ka	2.28	0.479	12.646	wt.%	
				100.000	wt.%	Total

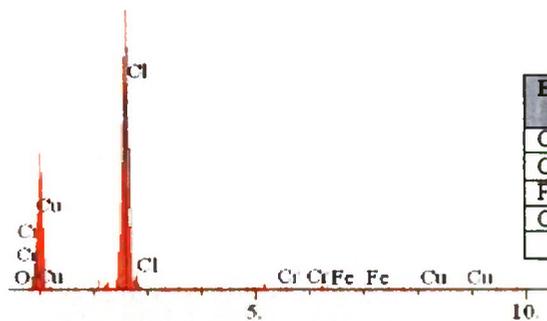
4.

Elt.	Line	Intensity (c/s)	Error 2-sig	Conc	Units	
Cl	Ka	83.87	6.126	98.259	wt.%	
Cr	Ka	0.67	0.548	1.741	wt.%	
Fe	Ka	0.00	0.000	0.000	wt.%	
Cu	Ka	0.00	0.000	0.000	wt.%	
				100.000	wt.%	Total

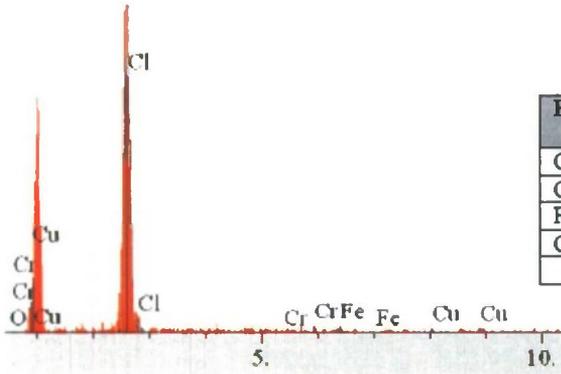
5.

Elt.	Line	Intensity (c/s)	Error 2-sig	Conc	Units	
Cl	Ka	73.95	5.380	94.733	wt.%	
Cr	Ka	0.76	0.546	2.119	wt.%	
Fe	Ka	0.89	0.591	3.148	wt.%	
Cu	Ka	0.00	0.000	0.000	wt.%	
				100.000	wt.%	Total

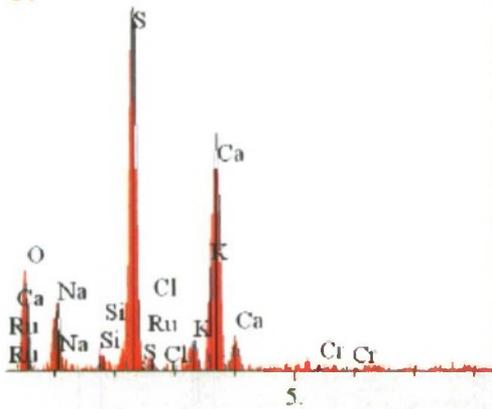
6.

Elt.	Line	Intensity (c/s)	Error 2-sig	Conc	Units	
O	Ka	4.53	0.629	41.895	wt.%	
Na	Ka	4.10	0.598	6.801	wt.%	
Si	Ka	0.39	0.184	0.343	wt.%	
S	Ka	28.44	1.575	24.830	wt.%	
Cl	Ka	0.53	0.216	0.578	wt.%	
K	Ka	2.45	0.462	2.554	wt.%	
Ca	Ka	20.04	1.322	22.479	wt.%	
Cr	Ka	0.29	0.159	0.519	wt.%	
Ru	La	0.00	0.000	0.000	wt.%	
				100.000	wt.%	Total
