## **Fort Gordon Woodworth Library**

Historic Building Survey

WOODWORTH LIBRARY

(Building No. 33500)

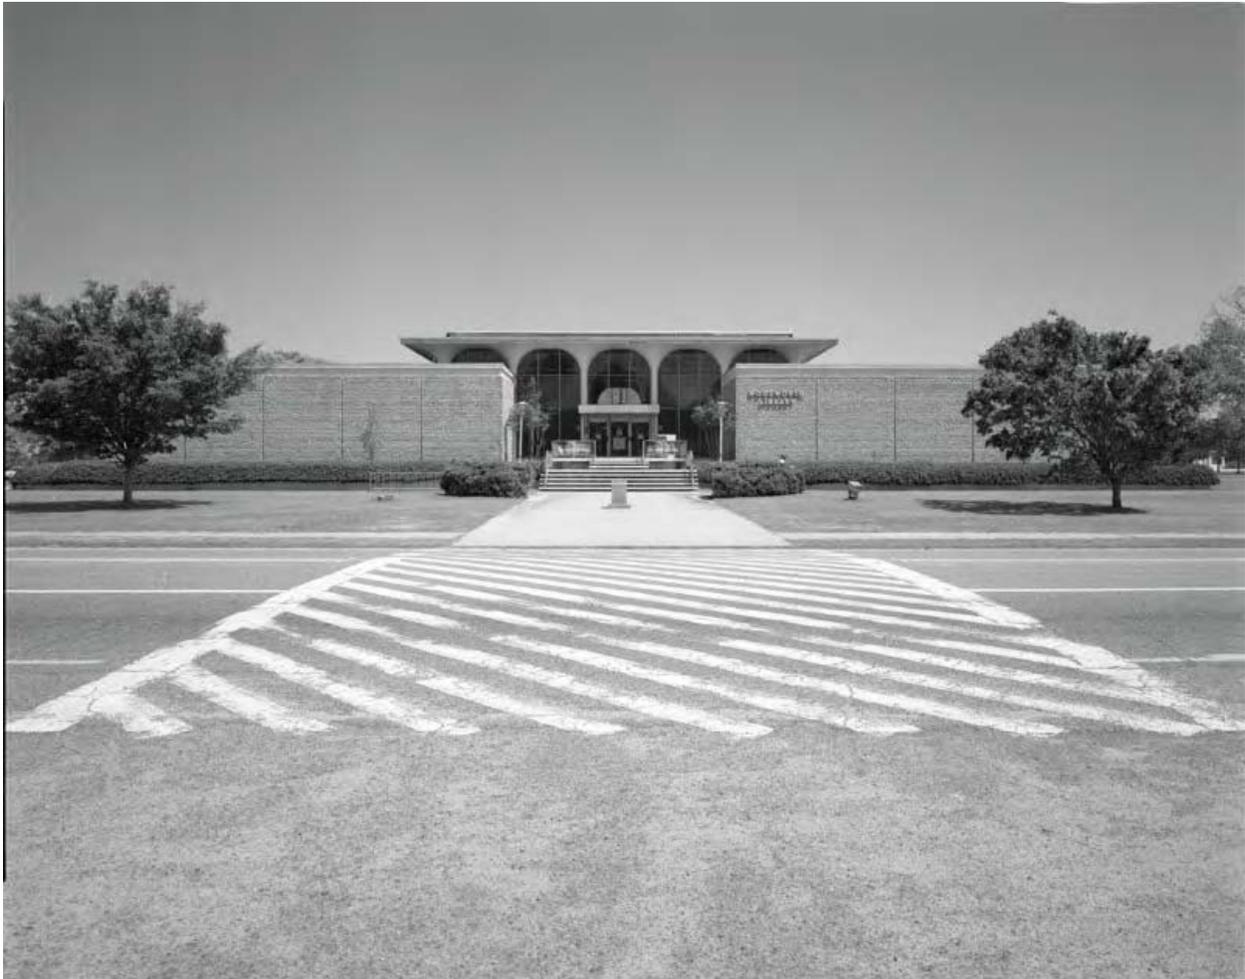
**Photo 1 – exterior general view of west main façade, view to east.**

The west elevation (Photo 1, Photo 2, and Photo 3) is the main entrance into the library. This elevation displays the most architecturally interesting features. The main entry is recessed and is located in the center of the west elevation. The entry is defined by three double-height, arched, plate glass and aluminum windows framed by concrete mushroom columns, a metal canopy, an elevated porch paved with slate tiles, concrete and metal steps, and metal handrails (Photo 2). The tiled porch measures 22'-0" wide by 18'-0" deep. The metal canopy is 7'-4 ½" above the porch and is 1'-3 ¼" thick. The main entrance into the library is composed of three plate glass and aluminum doors. Formed concrete planters are located on either side of the main entry. Both planters are 74'-9 ¾" wide by 8'-0" deep. The planters located on the west elevation were designed with four additional round concrete planter pads; two on each side of the entry. Original metal lettering spelling out "Woodworth Library" is anchored to the ashlar-cut granite veneer panels to the right of the main entry (Photo 4). There are two original light fixtures positioned on either side of the entry (Photo 5).

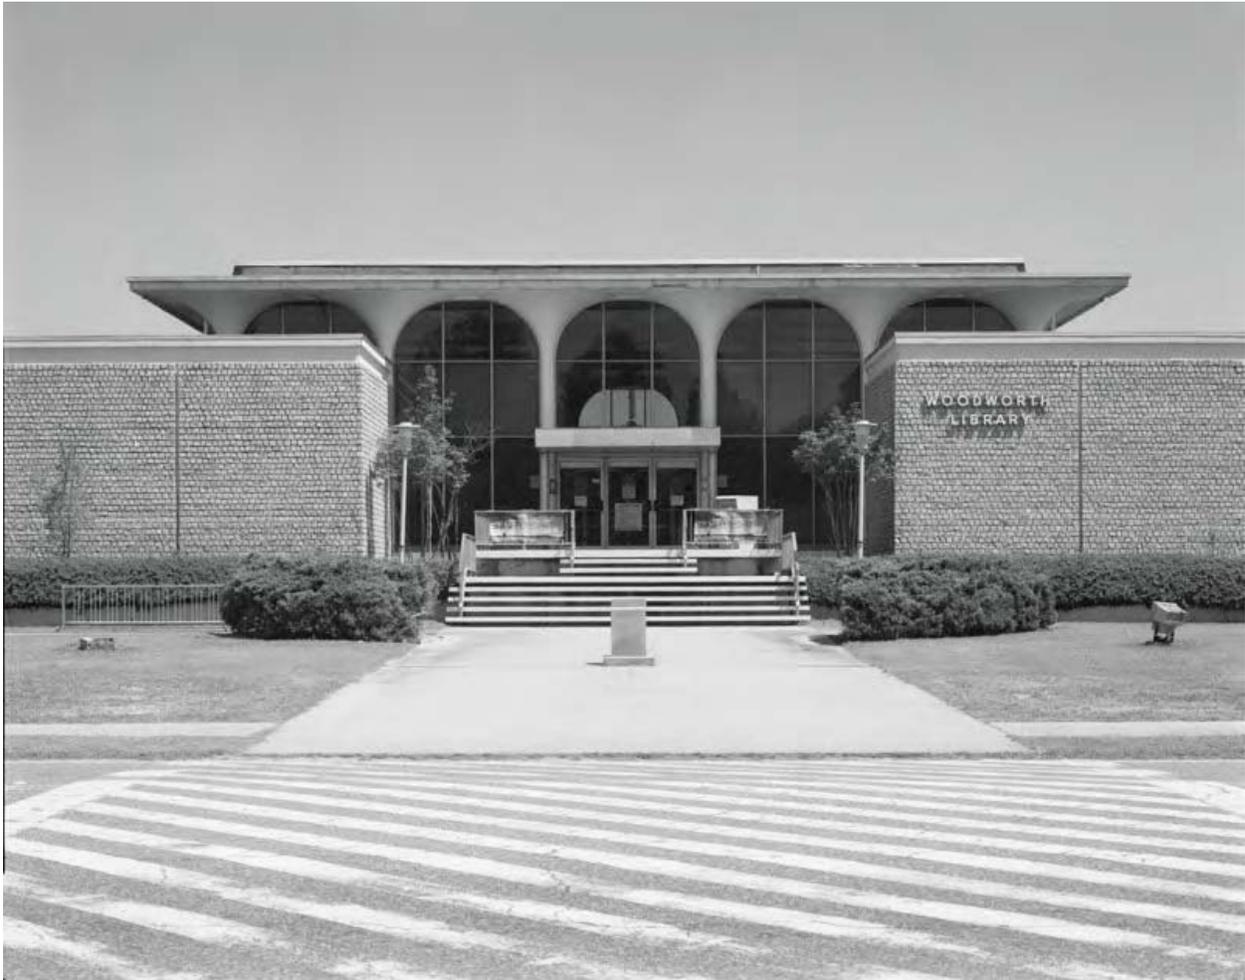
**Photo 2 – exterior detail of center west facade and main entry, view to east.**

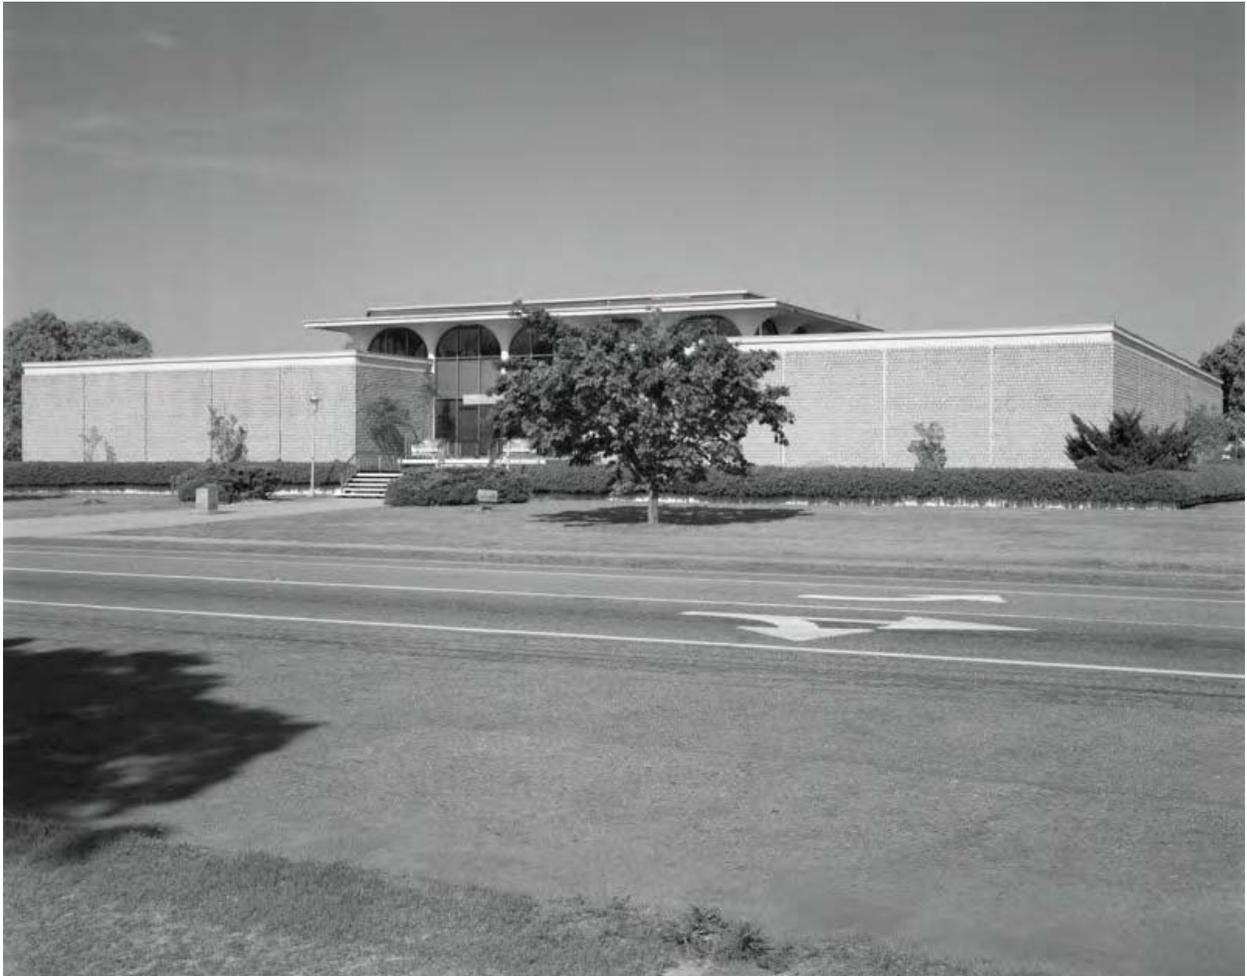
**Photo 3 – exterior general oblique view of west facade and south face, view to northeast.**

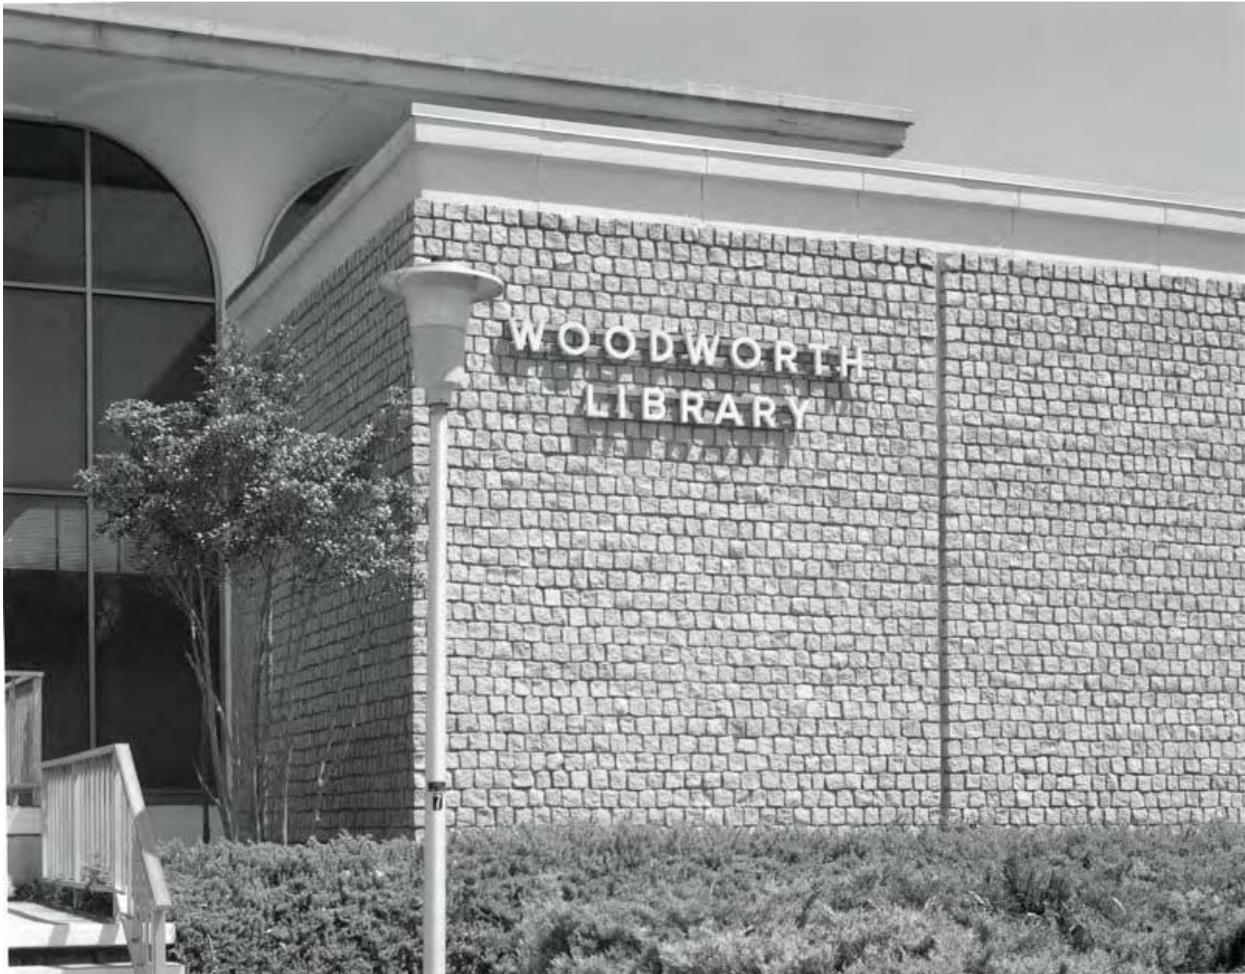
**Photo 4 – exterior close view showing building name “WOODWORTH LIBRARY” in full relief aluminum letters, west facade, view to southeast.**

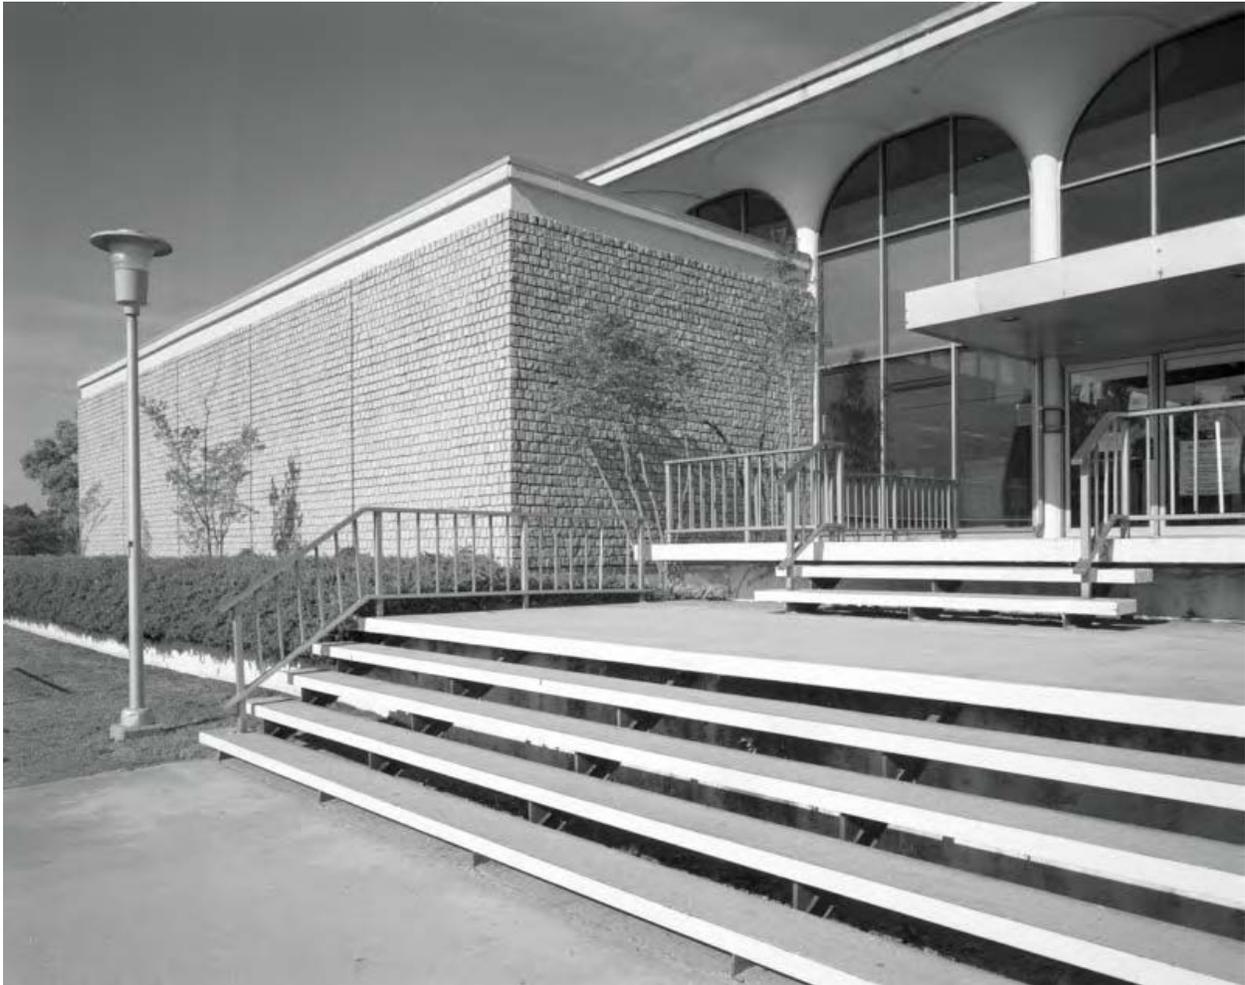
**Photo 5 – exterior detail, main central entry area with stairs showing ashlar granite panels northeast module projecting to west, view to northeast.**

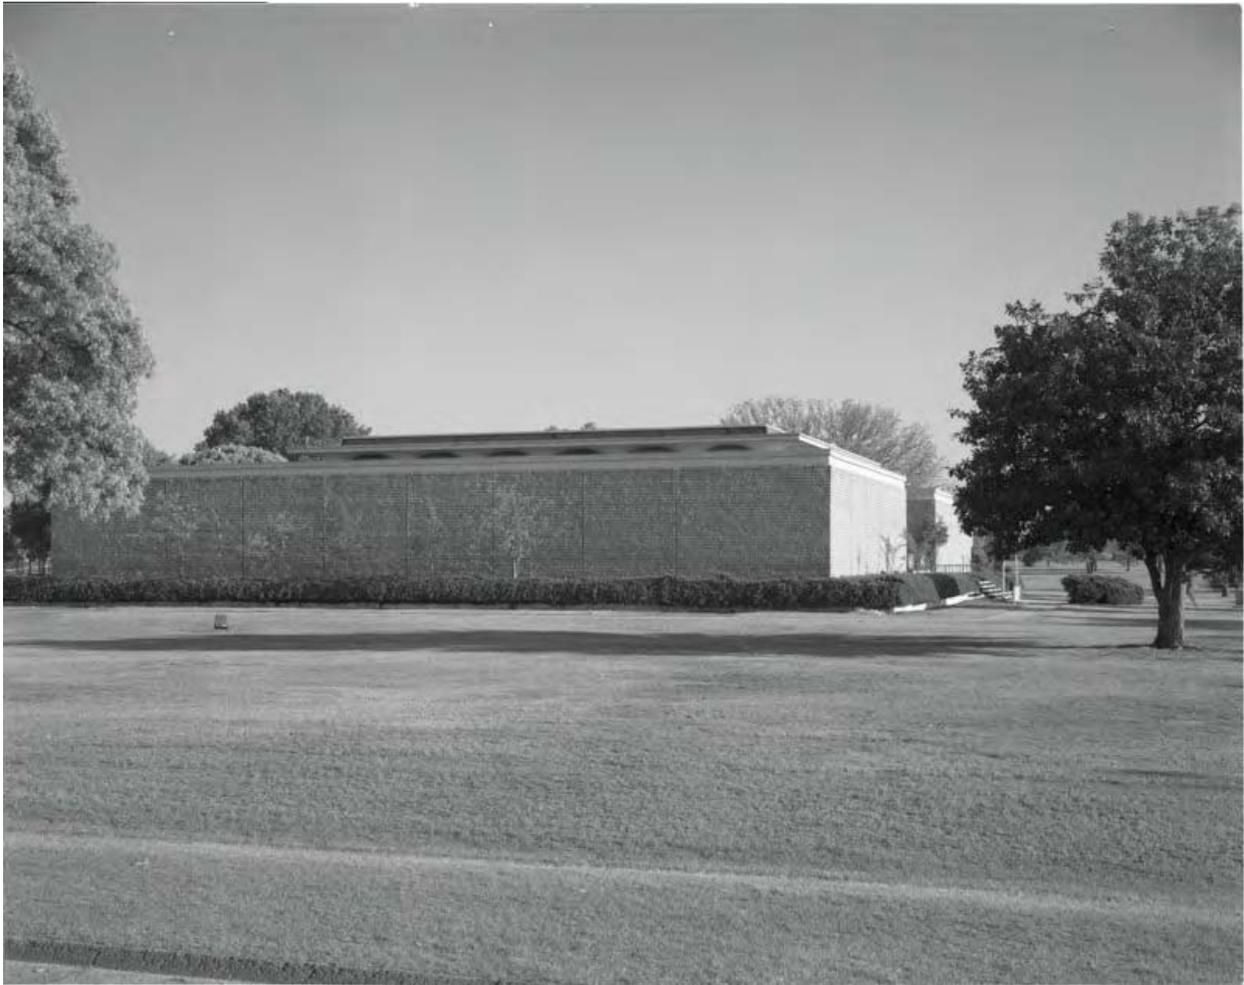
**Photo 6 – exterior general view south side and west facade right, view to south.**

The north elevation (Photo 6) is a solid wall of ashlar-cut granite veneer panels with no window or door openings. Each panel is 12'-0" wide. The exterior wall is 109'-7 1/2" long. The concrete planter box stretches 127'-3" across the elevation and is 7'-0" wide. There are five arched windows visible above the one-story roof height.

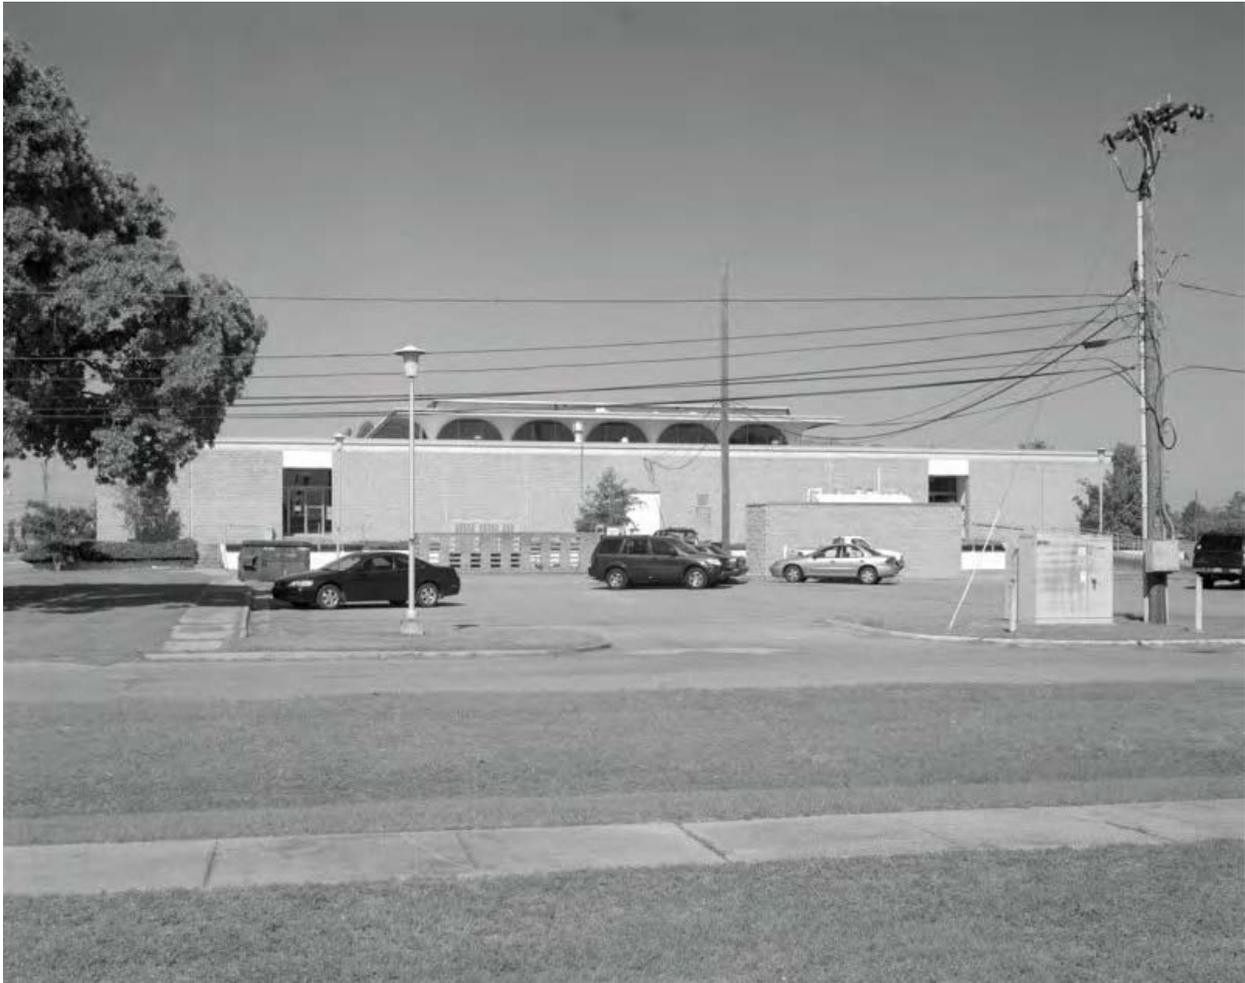
**Photo 7 – exterior general view east elevation with loading dock, note clerestory and arches above, view to west.**

The east elevation (Photo 7) is where the service area is located. The east elevation faces a small, open, paved parking lot. The exterior wall is covered with ashlar-cut granite veneer panels. There are two elevated and recessed service entries and a set of mechanical doors on the east wall. The entry on the left side of the elevation is 25'-5 3/4" from the left side of the elevation. This entry is the main loading dock area (Photo 9). The entry is 7'-0" wide composed of two plate glass and bright aluminum doors, two large sidelights, and one transom. There are two original light fixtures above the entry. There is a set of poured concrete steps located to the left of this entry and a concrete platform in front of the doors to

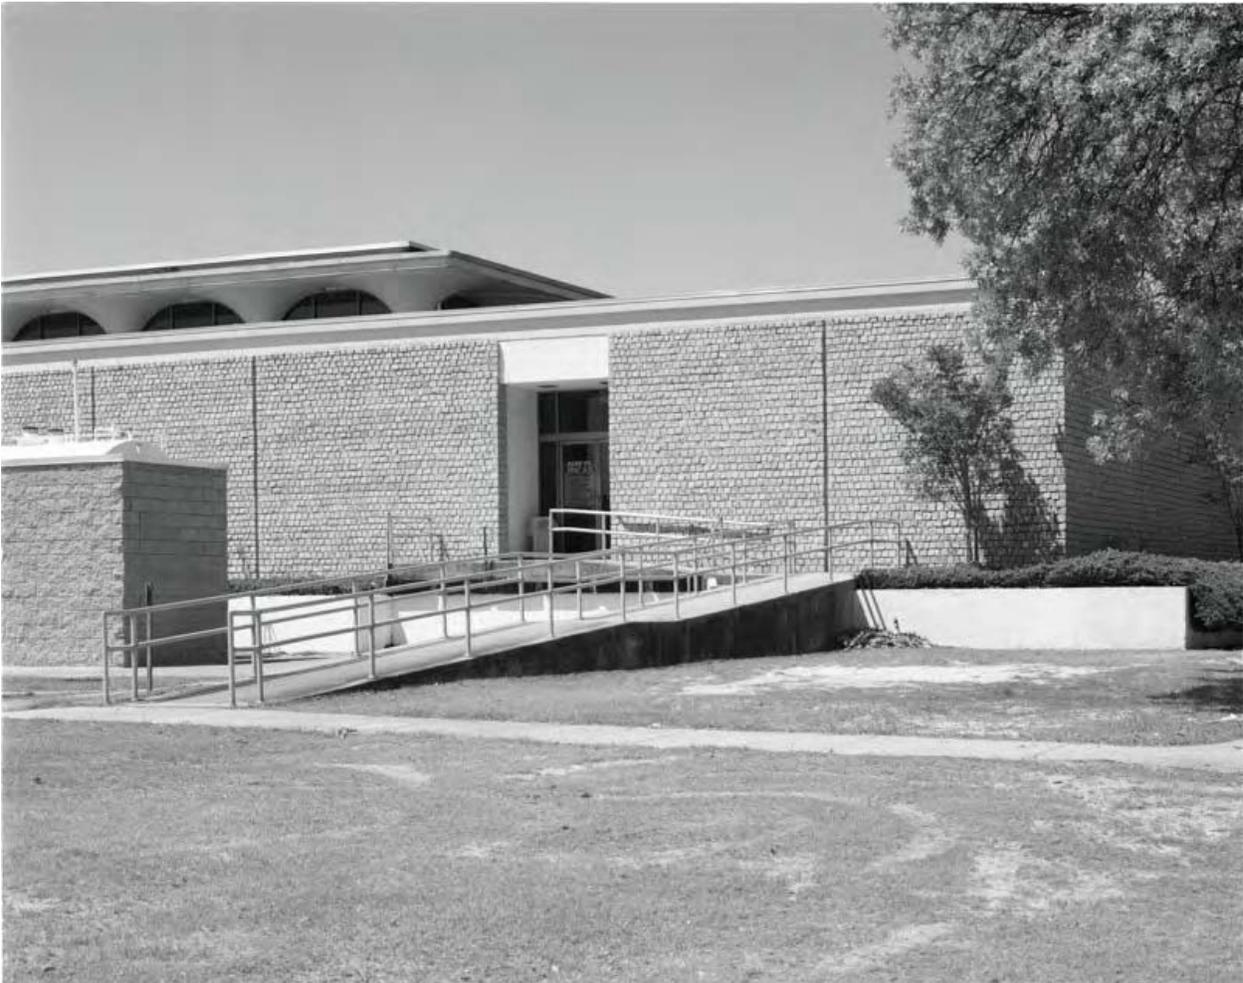
**Photo 8 – exterior detail east side, north end, with ADA ramp and employee/service entrance, view to southwest.**

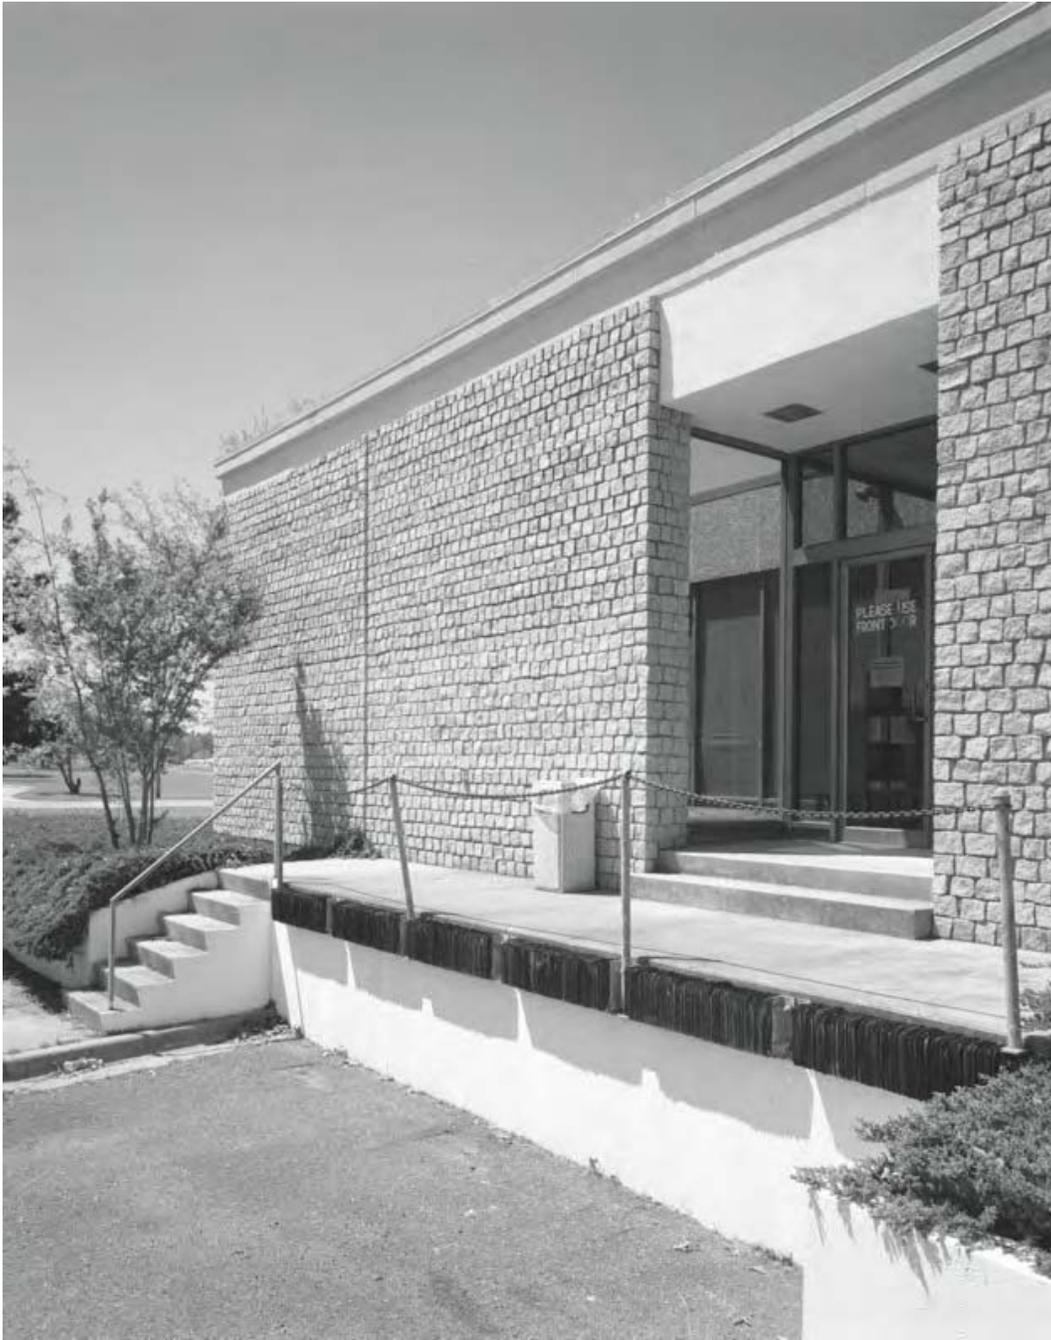
**Photo 9 – exterior detail, loading dock at south end of east elevation, showing stairs and recessed entry, view to southwest.**

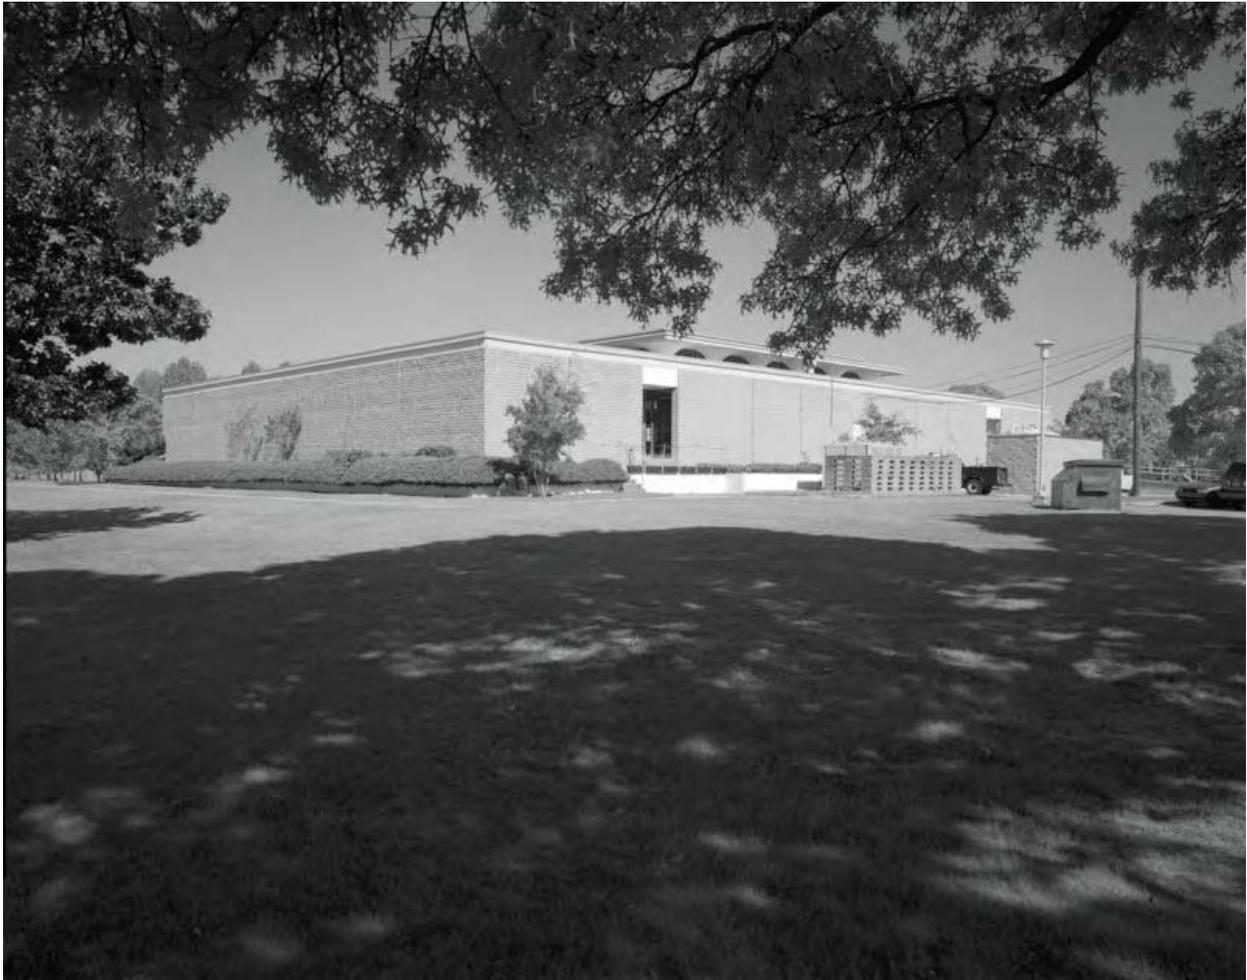
**Photo 10 – exterior general oblique view south and east elevations, view to northwest.**

The south elevation (Photo 10) mirrors the north elevation. The south wall is a solid wall of ashlar-cut granite veneer with no window or door openings. Each panel is 12'-0" wide. The concrete planter box stretches 109'-7 ½" across the elevation and is 7'-0" wide. There are five arched windows visible above the one-story roof height (Photo 11).

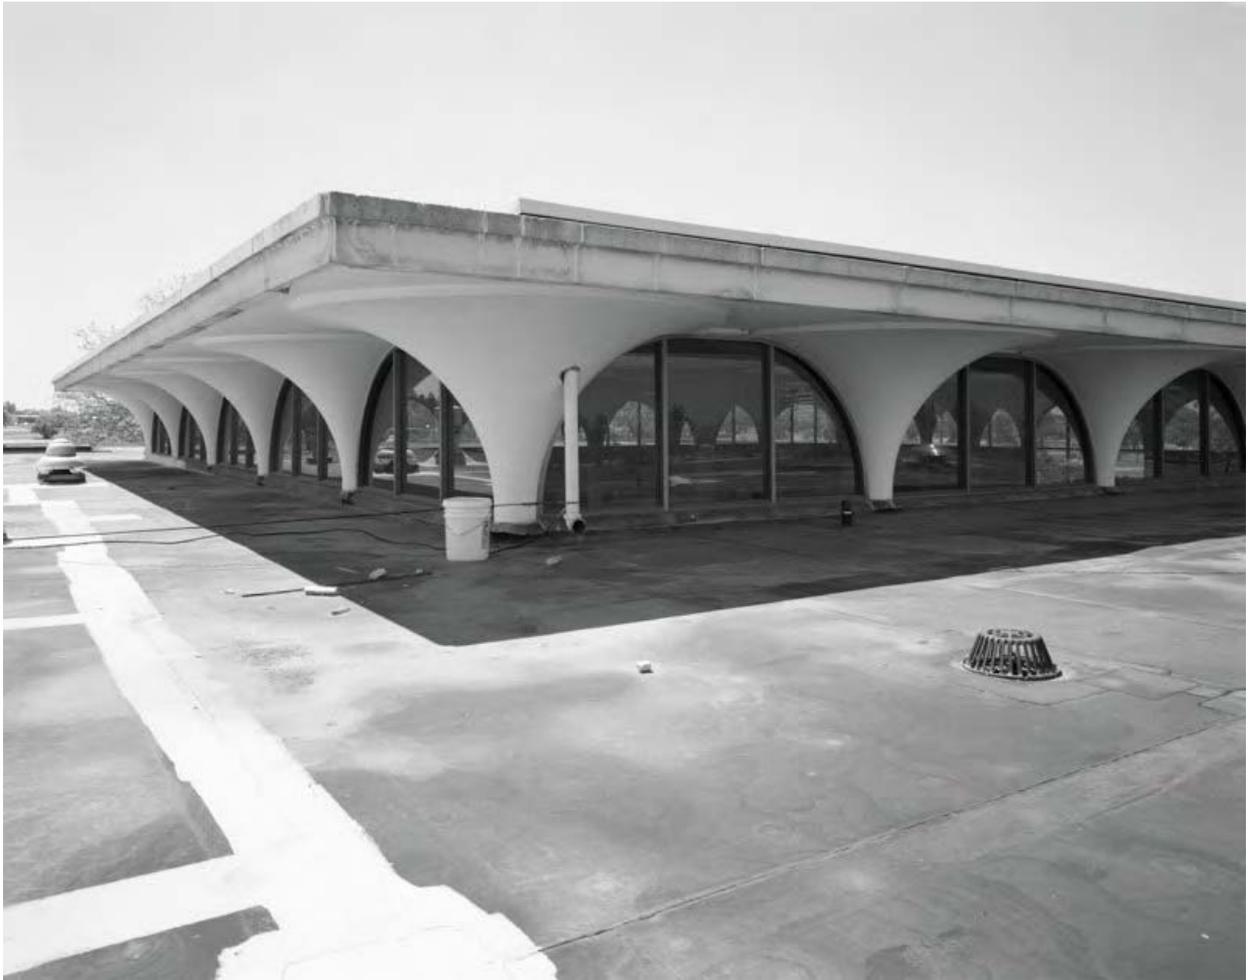
**Photo 11 – exterior detail on roof showing tops of “mushroom” capitals forming clerestory, view to southwest.**

- c. Windows: There are not many windows on the four exterior walls of the library; however, the defining feature of the building is the concrete mushroom columns that frame large arched windows. The north, south, and east elevations mirror each other with similar window types and patterns. The five arched windows on these elevations are visible above the one-story roof height. These arched windows are divided into three separate pieces of glass by aluminum framing. The framing is 0'-2" wide. Each window is 10'-3 3/4" wide and 4'-4" tall (Photo 11).

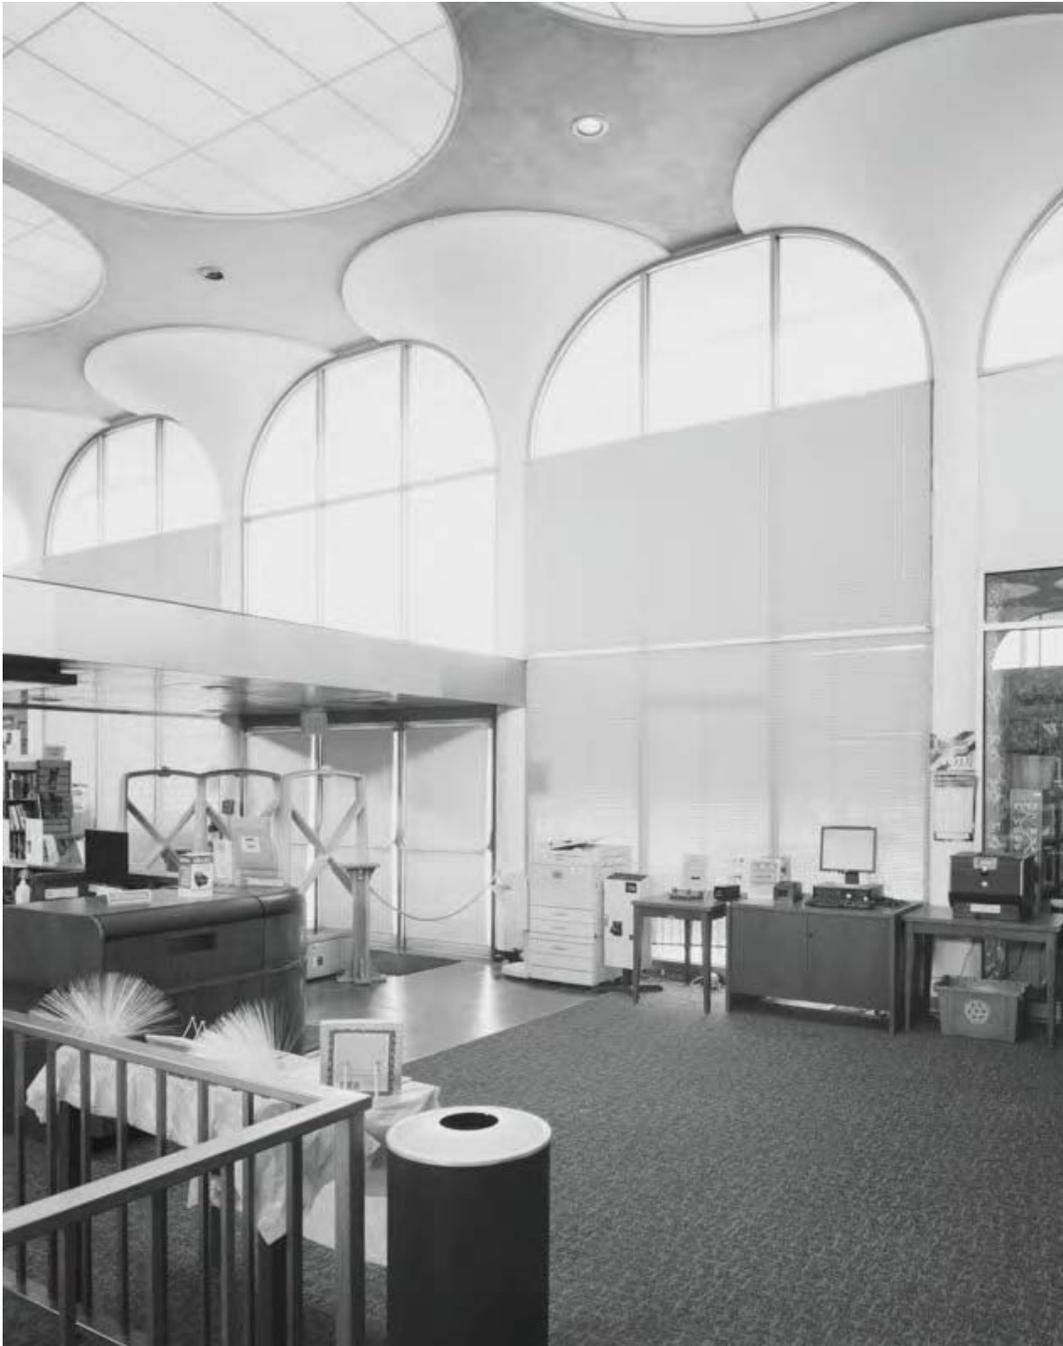
**Photo 12 – interior general view of entry/lobby area, view to southwest.**

The main circulation desk is located on the west side of the plan and is defined by a wood desk and a flat pressed aluminum canopy (Photo 12). The canopy extends from the main entry doors on the west wall over the entry area and circulation desk (Photo 13). Canned recessed lighting is fitted into the underside of the canopy. The enclosed spaces are located along the perimeter of the plan.

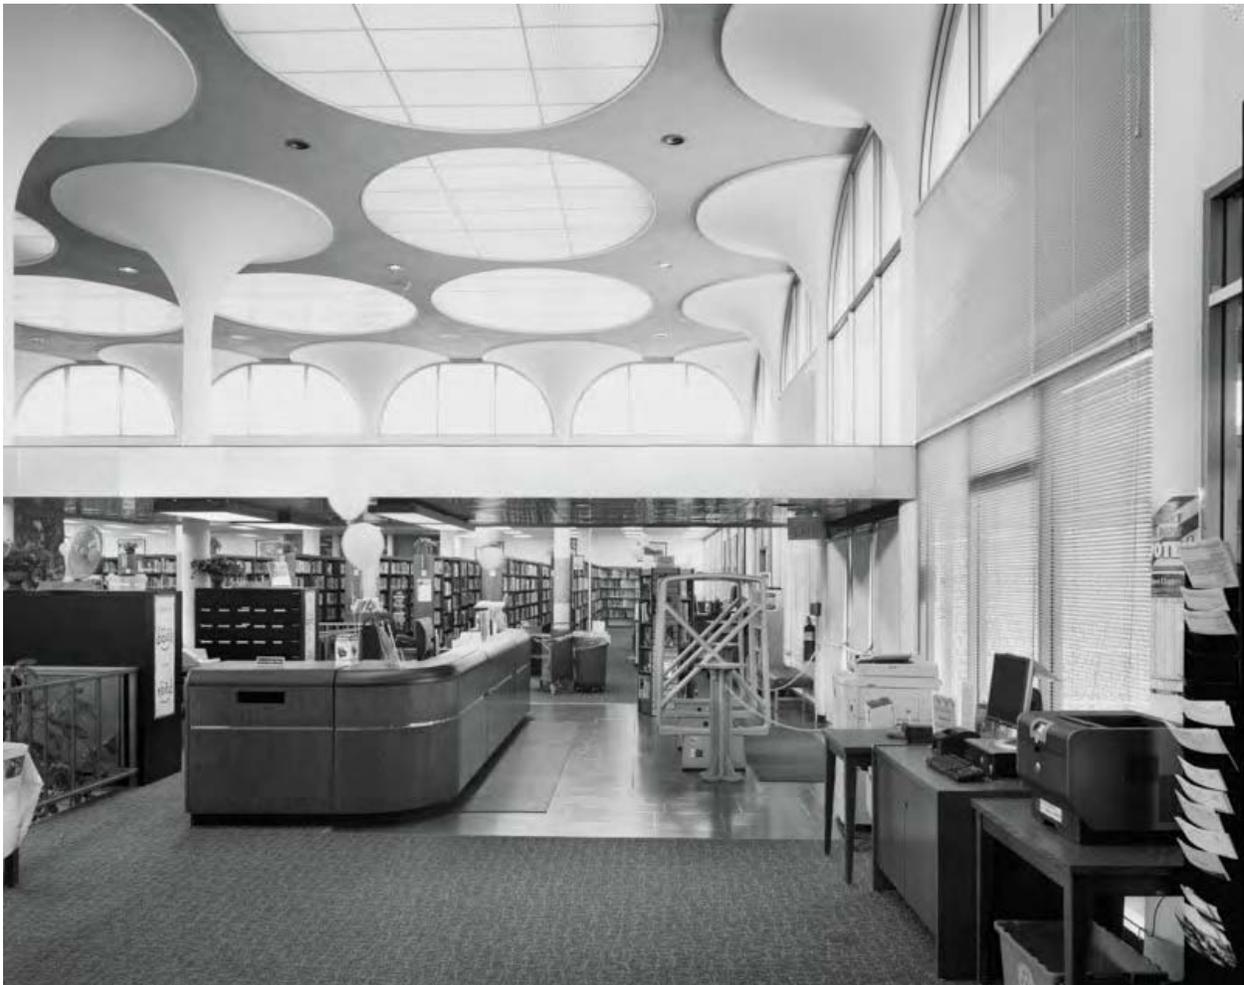
**Photo 13 – interior general view showing entry area and reception desk with cantilevered overhang continuing from exterior, view to south.**

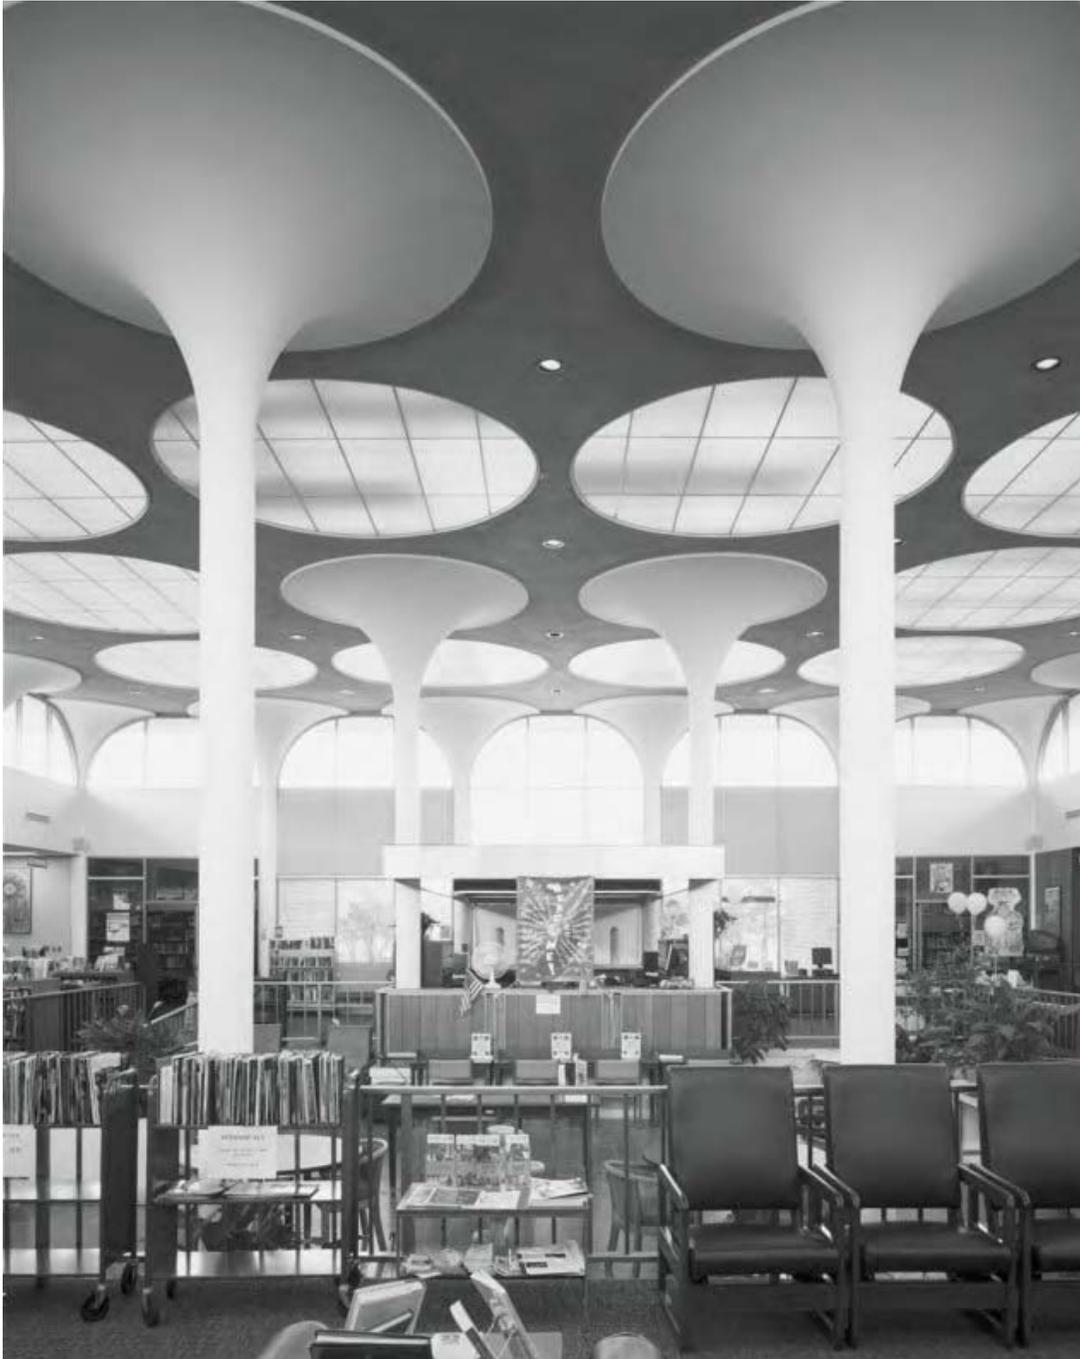
**Photo 14 – interior view along central axis from east wall toward reception area view to west.**

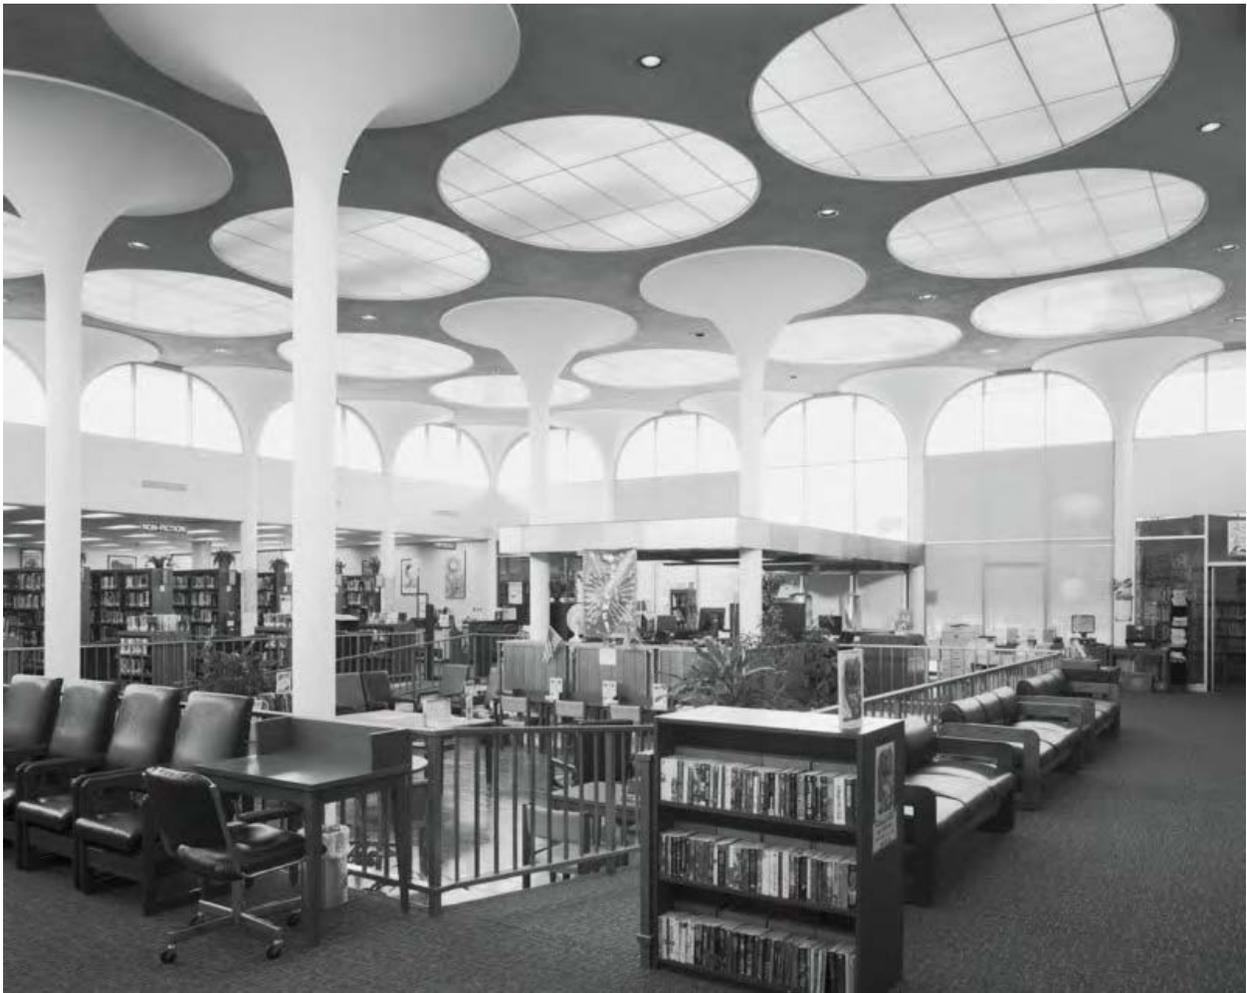
**Photo 15 – interior general view from southeast corner, view to southwest.**

4. Structural System, Framing: The exterior walls of the library are composed of concrete block. The double-height of the central roof is supported by twenty-two round concrete columns that measure 12" in diameter. The columns are 12'-0" apart. The columns mushroom out to 5'-0" on each side of the center line of the column (Photo 15).

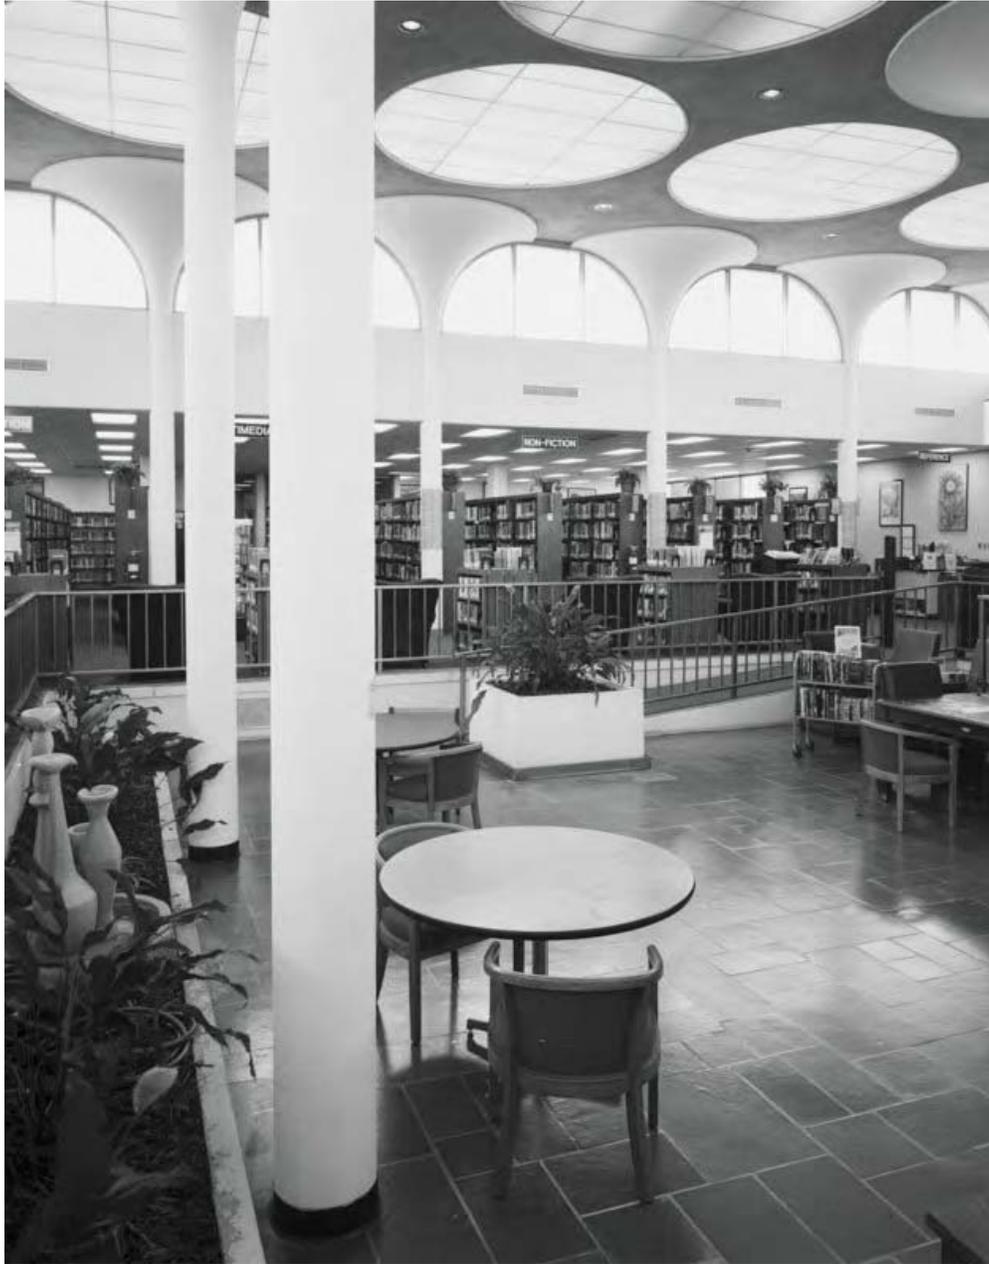
**Photo 16 – interior view, sunken reading area showing intact planter to left and original ramp on south side, view to southwest.**

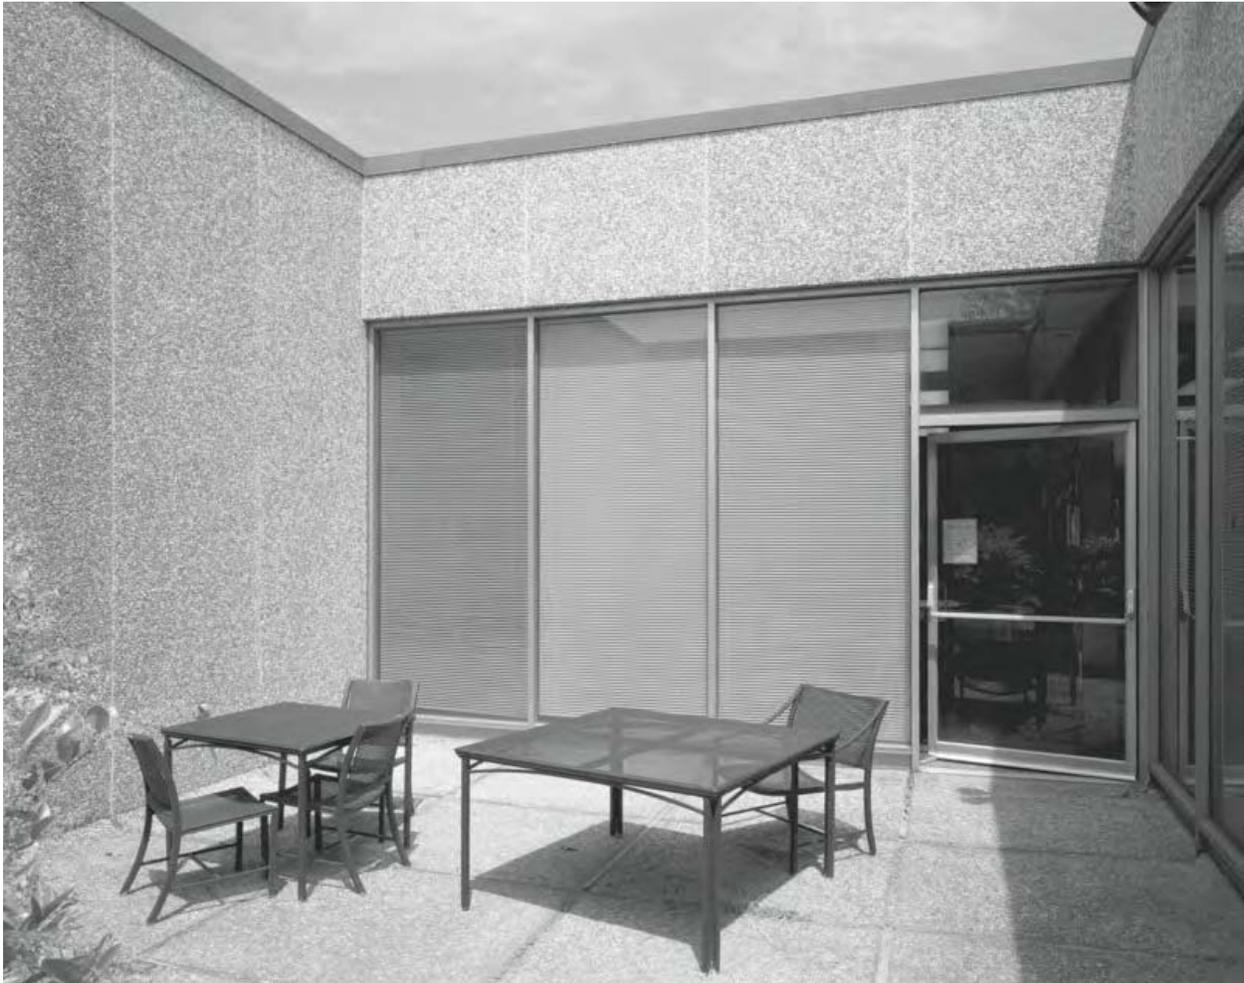
**Photo 18 – detail enclosed exterior courtyard at southwest corner of building, accessible via “music room” (photo #17), view to northwest (note intact vintage metal chairs and tables, see Photo 24 for historic view).**

The west side of the plan consists of a children's room, the main entry, the reference room, and two courtyards. The children's room is located on the west wall north of the main entry and measures 35'-4" x 17'-6". Two small storage closets are located along the east wall of the room. The reference room is located on the west wall south of the main entry and measures 35'-4" x 17'-6" (Photo 17). One courtyard is accessed through the children's room, while the other one is accessed through the reference room (Photo 18).
