## **Fort Gordon Woodworth Library**

Historic Building Survey

WOODWORTH LIBRARY

(Building No. 33500)

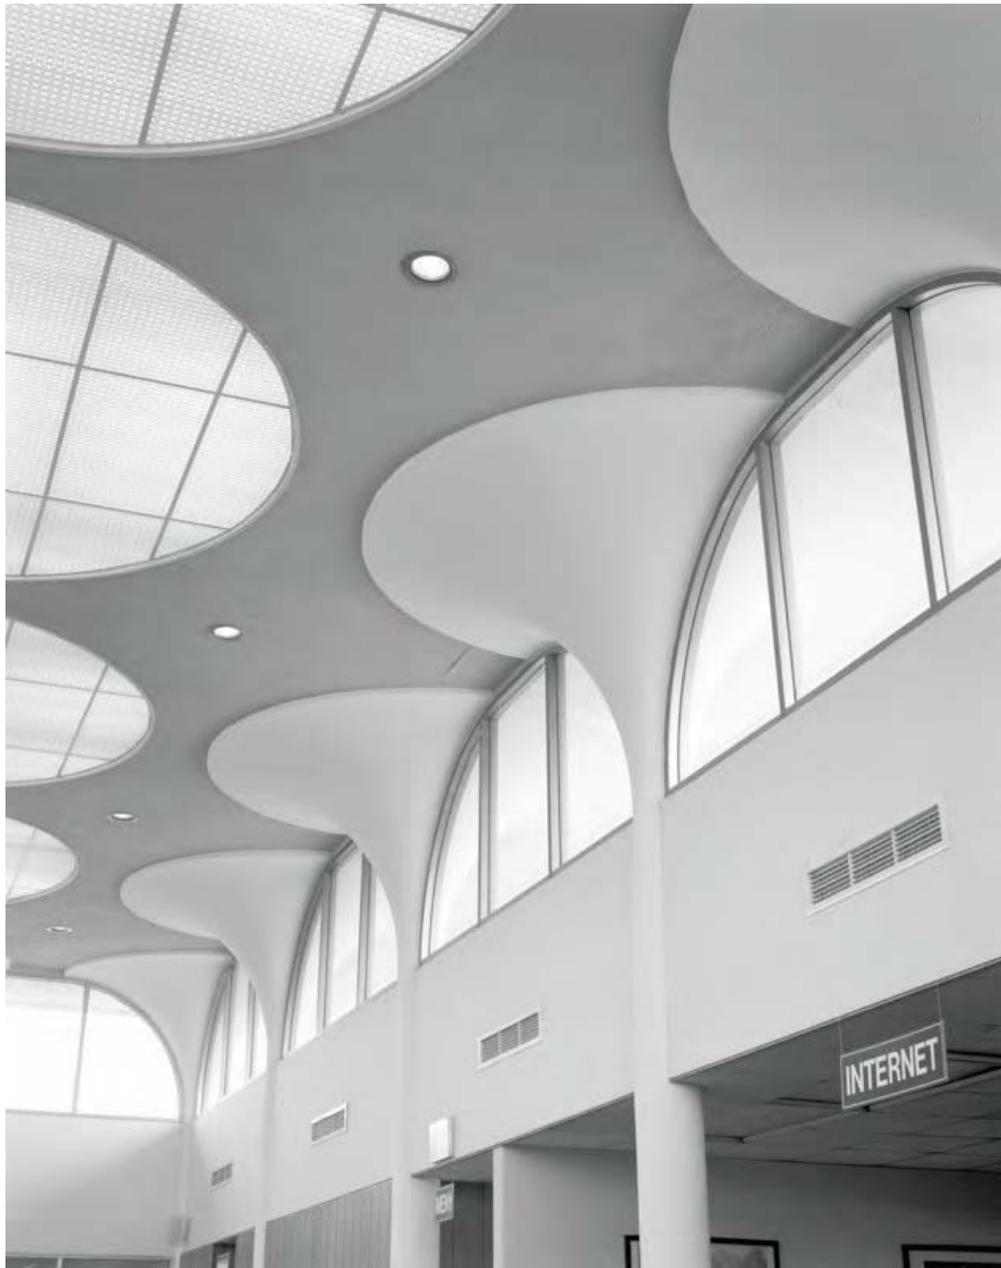
**Photo 19 – interior detail, column tops at north side of clerestory section, forming arches for glazing panels, view up and to northwest.**

with a mixture of drywall and wood paneling. A 3'-0" plaster band encompasses the central reading room. The band is located above the ceiling height of the perimeter rooms and is below the groups of arched windows of the double-height roof (Photo 19).

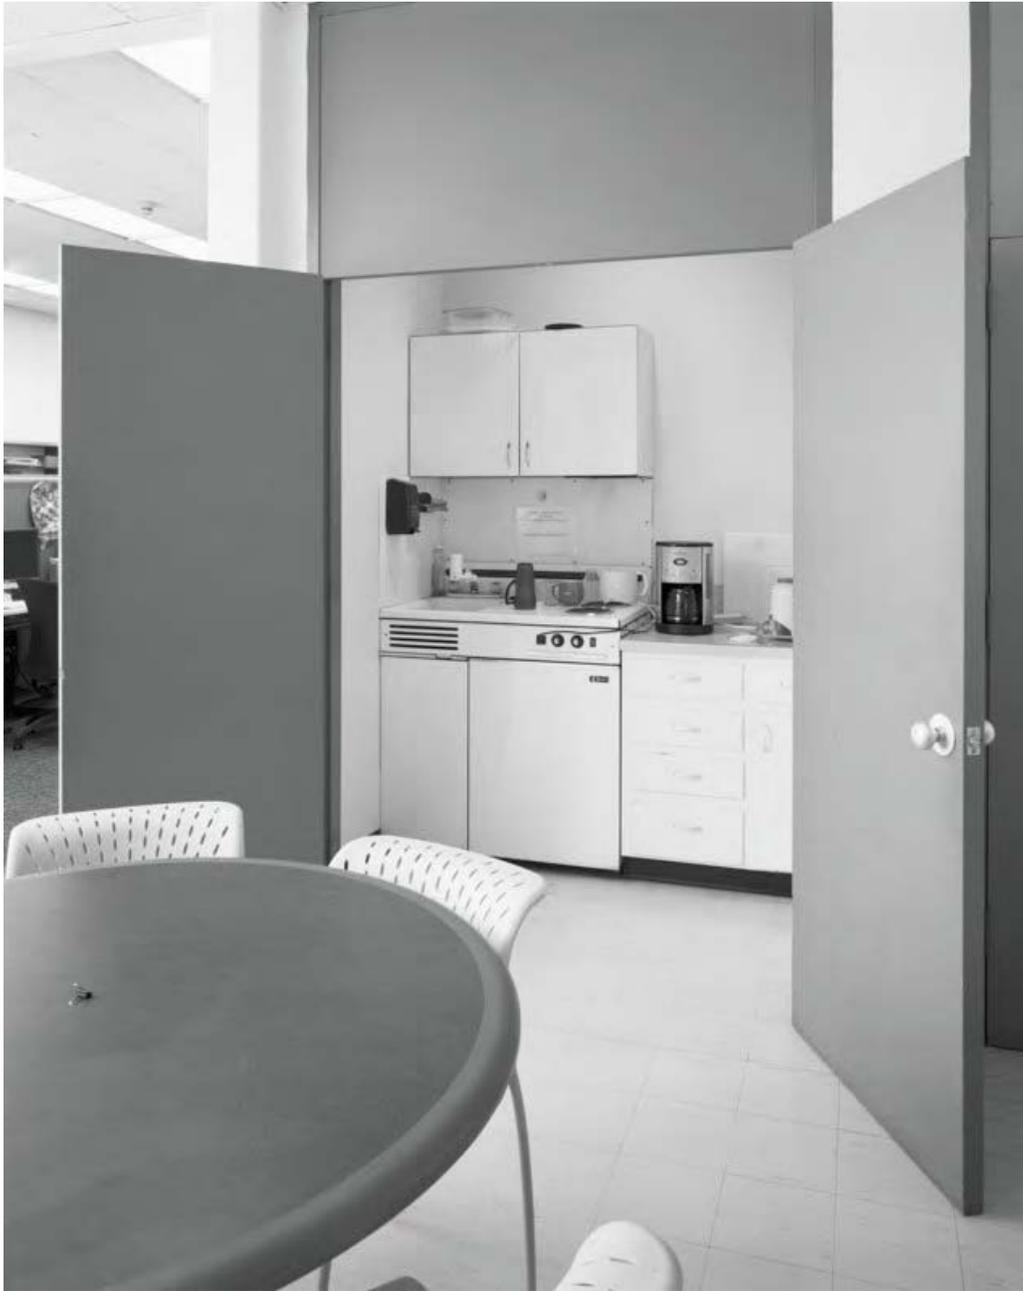
**Photo 20 – interior detail, original kitchen in employee lounge area, view to northeast (see Photo 25 for historic view).**
