**TWA FLIGHT 800  
1/4-SCALE CENTER WING TANK JET A EXPLOSIONS**

**Larry L. Brown  
Applied Research Associates, Inc.  
5941 S. Middlefield Road, Suite 100  
Littleton, Colorado 80123  
(303) 795-8106; (303) 795-8159 (FAX)**

**ABSTRACT**

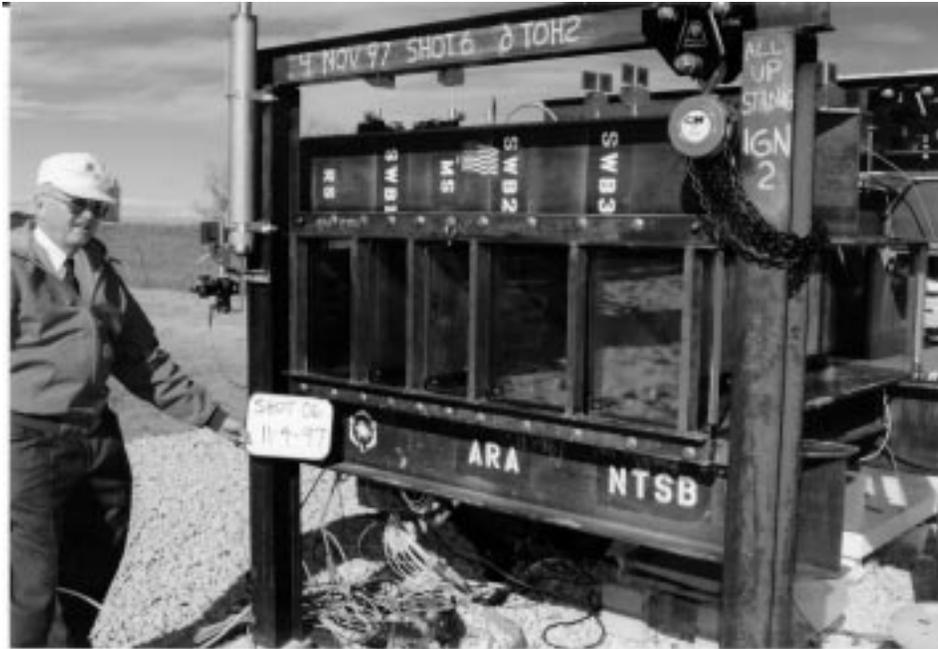
Figure 2 shows the 1/4-scale test fixture in position. The fixture was set on, and anchored to, concrete pads which allowed leveling of the tank pre-test and prevented tank movement during the combustion event. Figure 3 shows an overview of the 1/4-scale fixture and surrounding instrumentation housings.

Figure 2. 1/4-Scale Test Fixture in Test Position

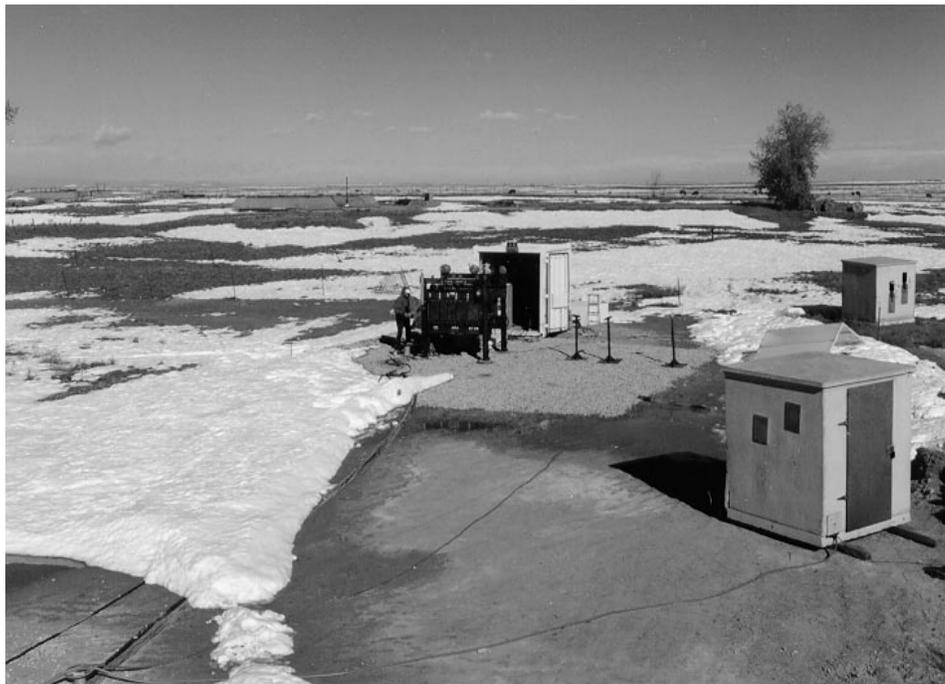
Figure 3. Overview of 1/4-Scale Structure and Test Site

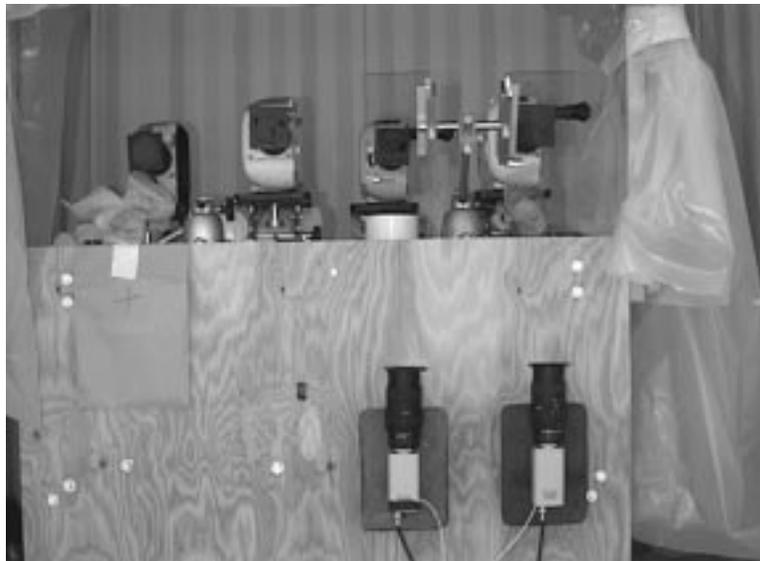
combustion photography light sources as viewed from behind the tank and Figure 6 shows the high-speed and video cameras used to record the images.

Figure 6. Combustion Photography Camera Station

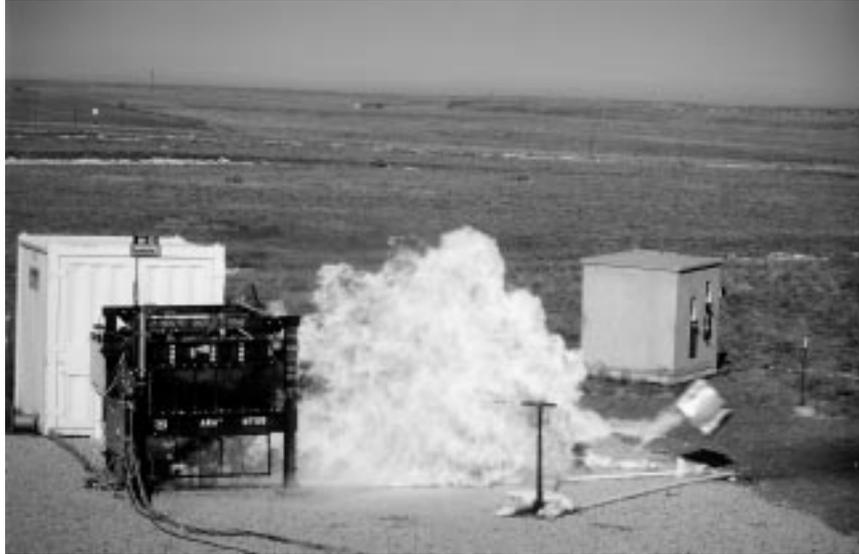
Figure 9.

Figures 9 and 10 show typical film records of a test with the surrogate fuel vapor with a Jet A liquid fuel layer on the bottom of the tank. Note the ejection of the weak partitions in Figure 9, and the extent and size of the fireball in Figure 10.
